**Balmichael WTW, Arran:  
Archaeological Monitoring**

Data Structure Report

issued 14<sup>th</sup> February 2011

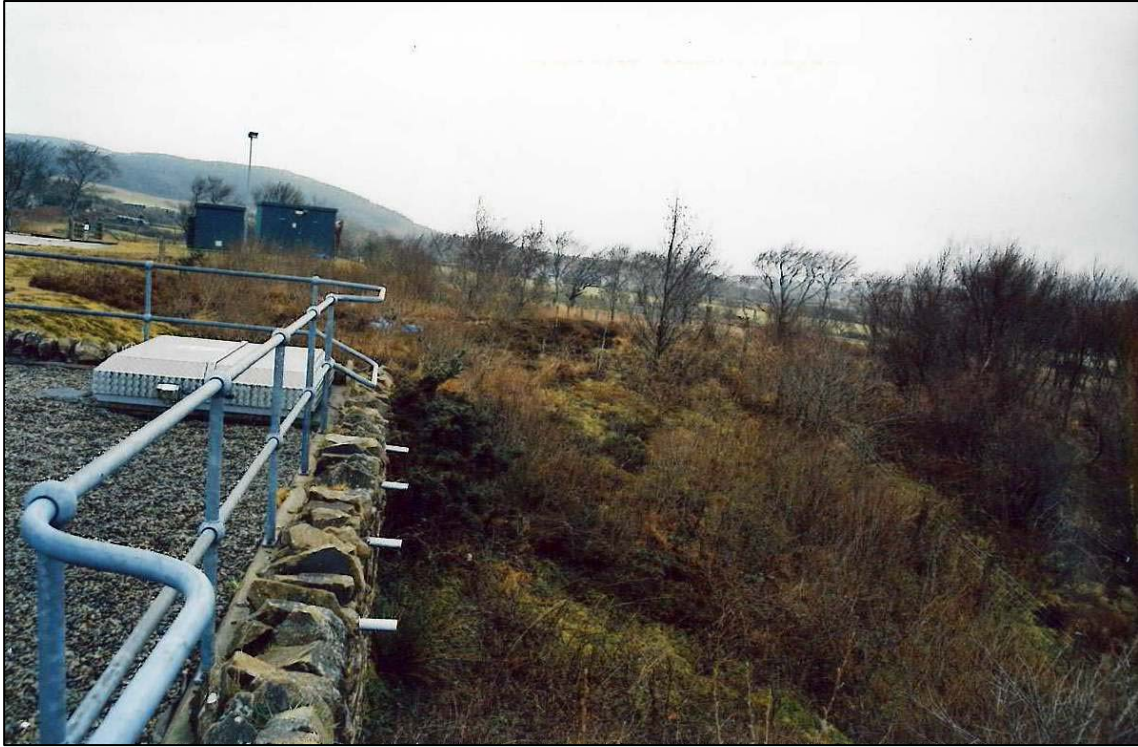
Figure 2a: NW Knoll at Balmichael WTW from the North

31. The last Test-Pit 5 within the compound lay on the north-western knoll, within the FIRAT excavation area. While this rise is known to have been stripped and excavated in 1999, it appears now to be an undisturbed portion of the site that is subject to the natural regeneration of woodland. The test-pit did reveal a topsoil rich in small scale modern detritus, but no archaeologically significant material. This was the expected condition given the prior excavation.

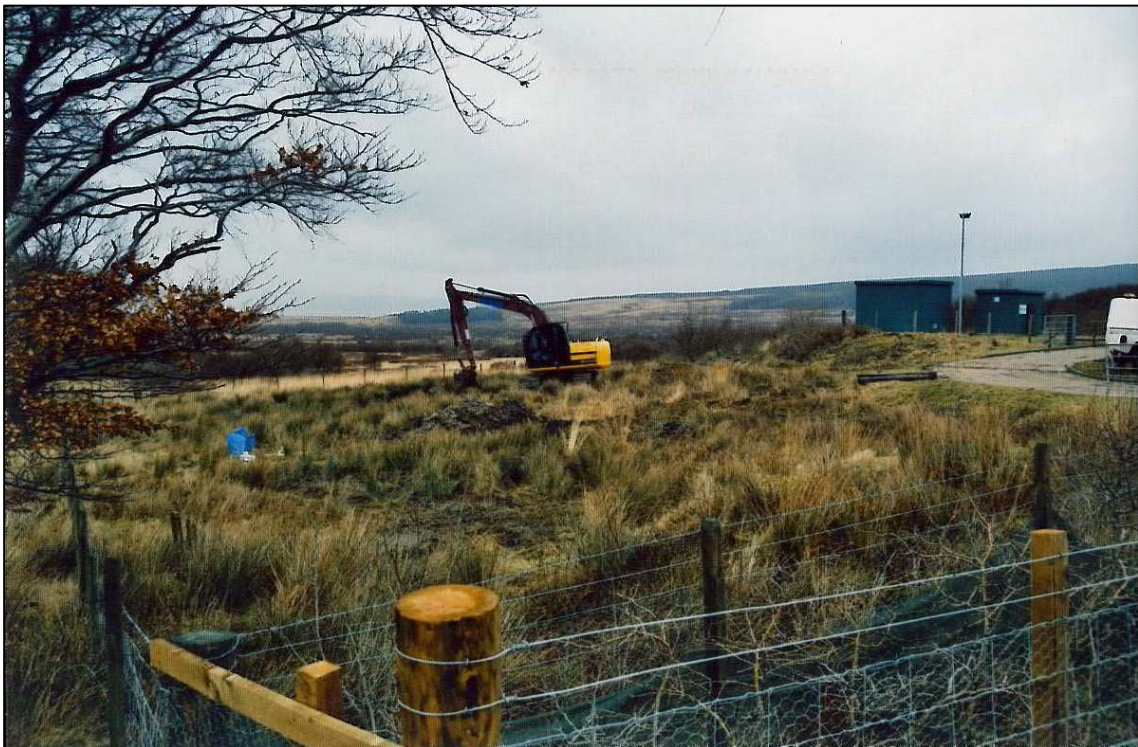
Figure 2b: Southern area at Balmichael WTW from the East

32. Prior to the test-pit exercise the southern portion of ground has had an uncertain history of use relative to the construction process in 1999. The evaluation covered this ground and the subsequent mitigation was planned to include the excavation of the 'cairn' and the photographic register circulated by FIRAT implies that this was done. This illustrates that it was considered in 1999 as part of the development area with the intention to site underground services through this area and to base the contractor's compound here.

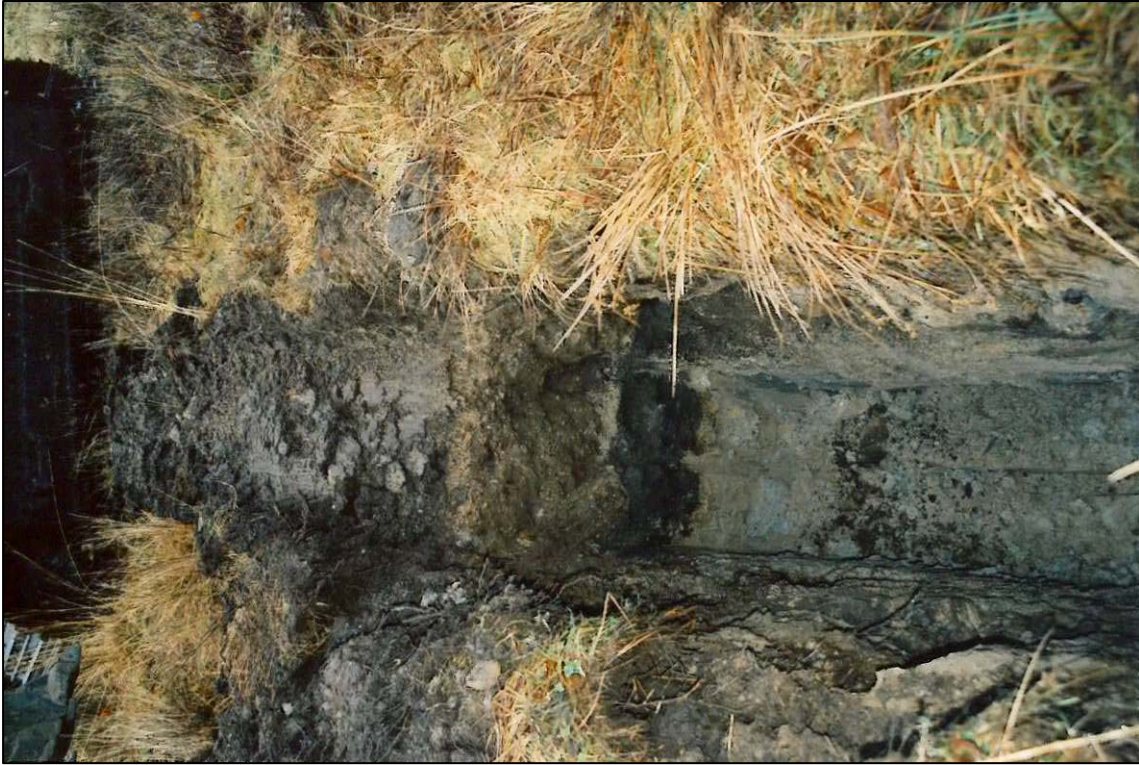
Figure 4a: Test Pit 1, note subsoil and topsoil dump over natural soil sequence

34. Ground condition in the general, open, boggy portion of the southern ground suggested prior to excavation that Test-Pits 1 and 4 would exhibit natural soil sequences. However, a general horizon of re-deposited sediment was observed in Test-Pit 1. This is taken to illustrate a general levelling up of the eastern half of the southern ground by material extracted from the core works site during its construction in 1999. A careful re-examination of the visible landscape supported this as the southern boundary of the site was a bank surmounted by mature trees; however this became a line of trees flush with the ground surface in this eastern portion.

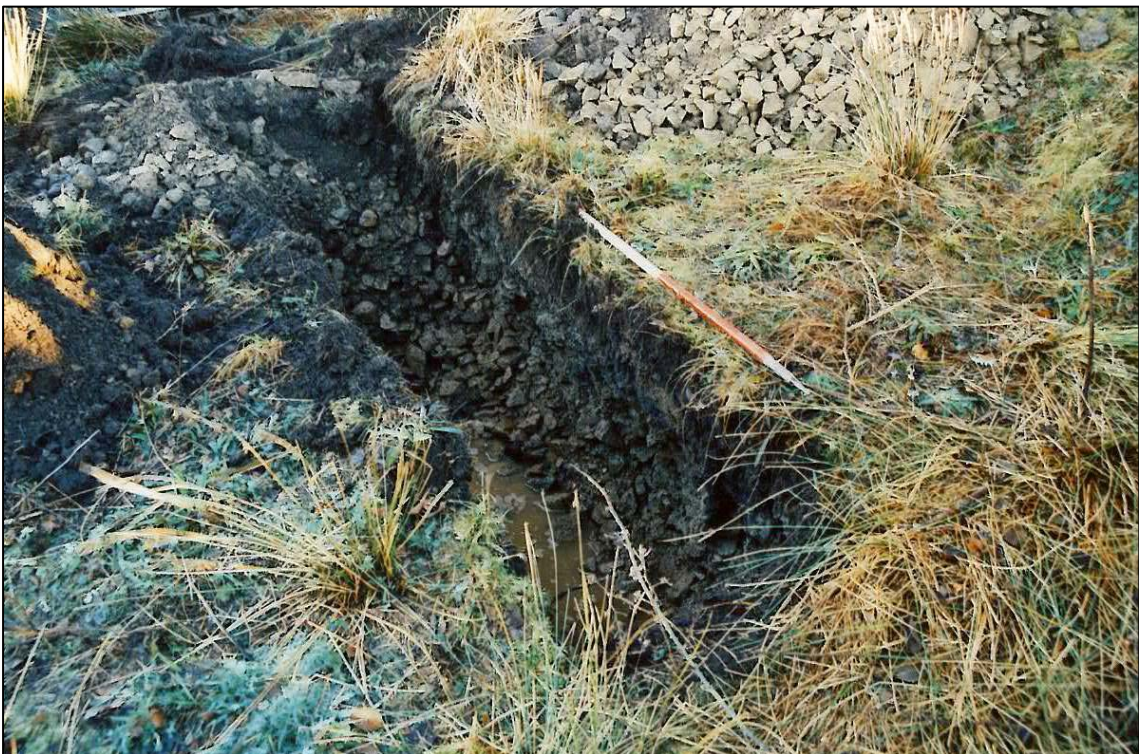
Figure 4b: Test Pit 3, note engineered material at depth

30. In contrast Test-Pit 3 was in a location below an obviously engineered slope falling to the west of the Works. The current vegetation cover and general condition strongly suggested that this test-pit was placed beyond the ground disturbed by the construction. The evidence from the excavation of the test-pit strongly contests this with a considerable depth of engineered material, showing that construction impact is larger than the visible machined surface.

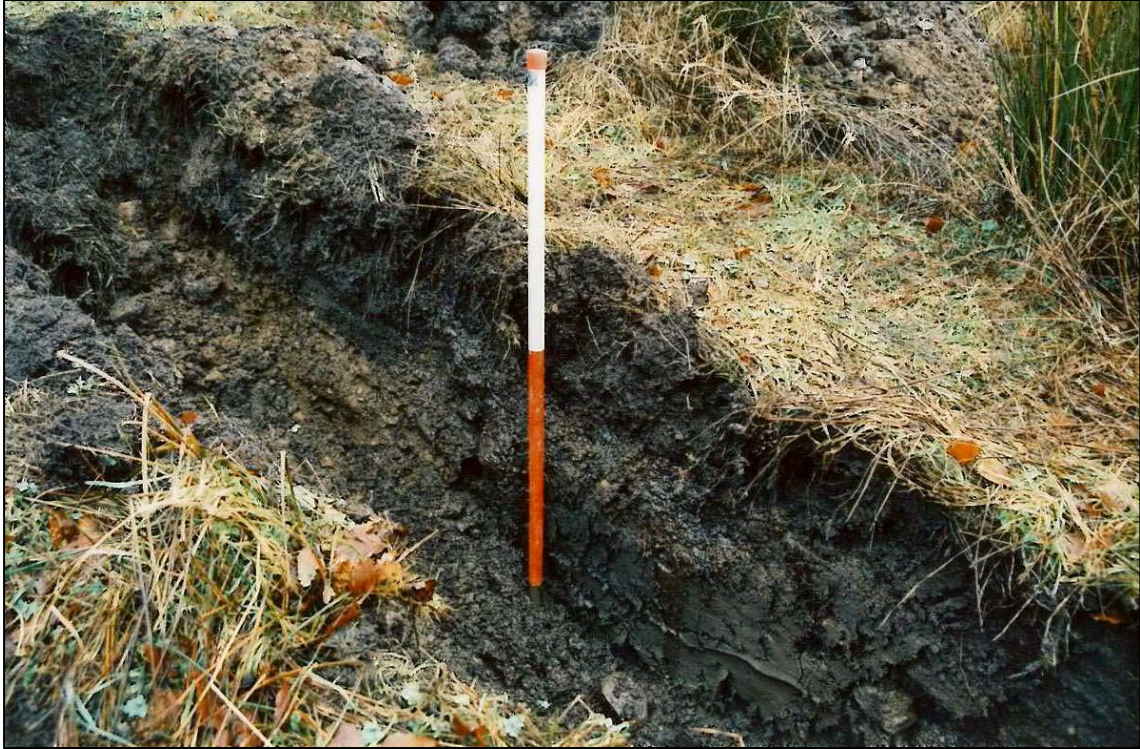
Figure 5a: Test Pit 4, note split in stratigraphy

35. Test-Pit 4 did exhibit a natural soil sequence for half of its length, but the remaining portion of the trench was filled by dumped modern detritus, again reflecting disruption of a comparable if at a shallower depth, to that seen within Test-Pit 7.

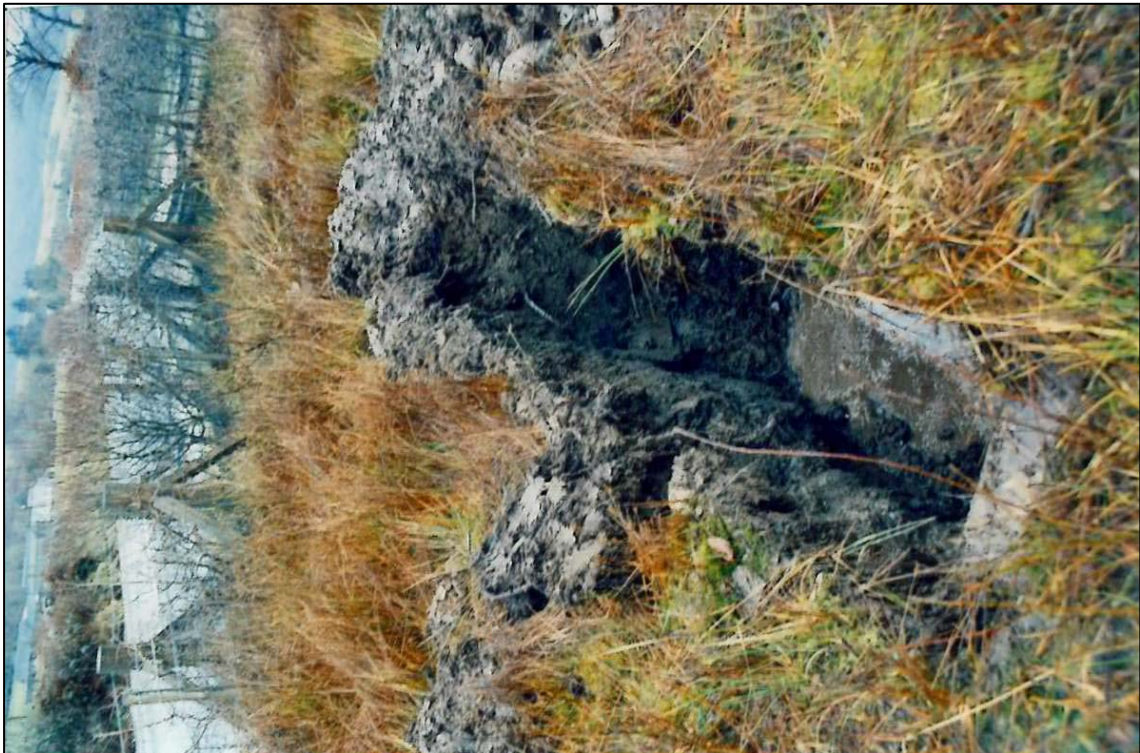
Figure 5b: Test Pit 7, note buried construction waste at depth

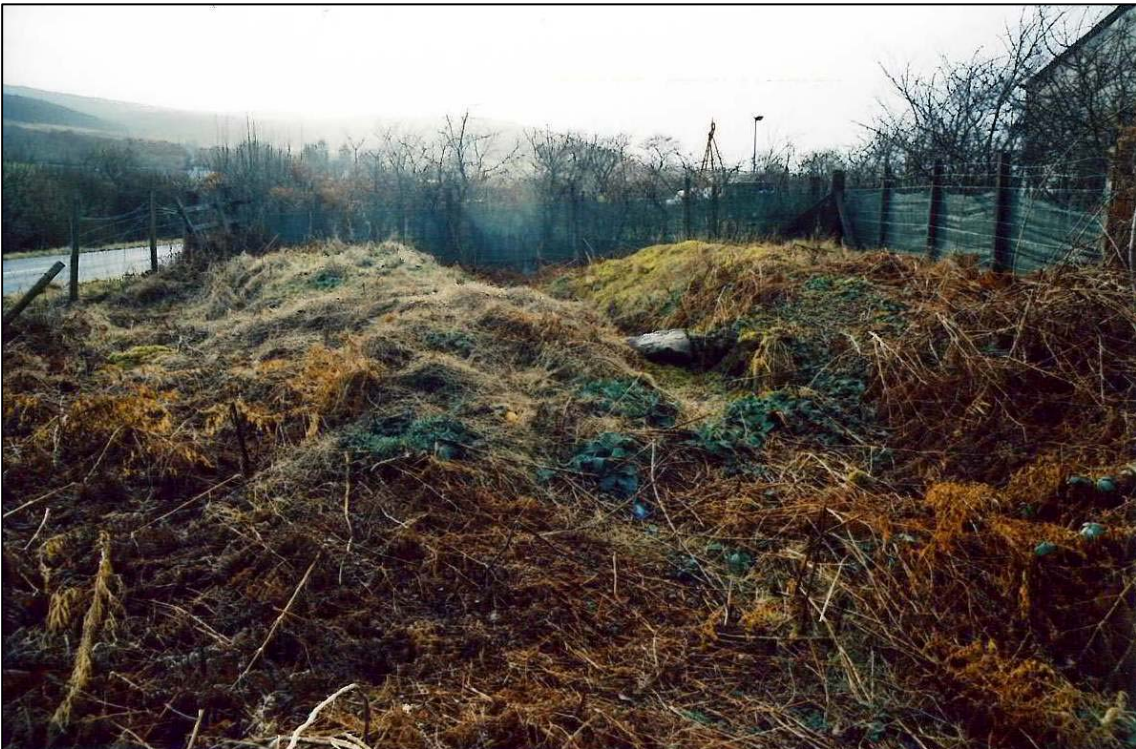
17. To the immediate east of the main building, is a concrete structure retaining ground adjacent to The String. This retained ground was overgrown, and contained the remains of the limekiln excavated prior to the construction by FIRAT. The ground was fenced from the road, but this fence had failed; an intact well maintained fence stands at the top of the retaining structure.

Figure 6b: Limekiln in marginal ground adjacent to the String Road

41. More broadly, the current site operator (Scottish Water) may like to consider within their management plan for the site the appropriate long-term treatment of the limekiln which was retained for long-term presentation by the original mitigation strategy in 1999. This ground was successfully excluded from the original development but is now overgrown and poorly presented. Should there be the capacity we would recommend:

- ❖ Renewing the post and wire fence around site including a pedestrian gate to prevent stock and vehicle encroachment while encouraging site access by the public;

- ❖ Erecting interpretive signage to explain the site to the public, promoting the role of Scottish Water in safeguarding this site; and
  - ❖ Establishing an intermittent grass/vegetation cutting within the fenced compound to ensure the long term stability of the protected monument.
