# **Saracen Pottery, Glasgow: Archaeological Excavation**

Data Structure Report

by Alan Matthews and Claire Williamson

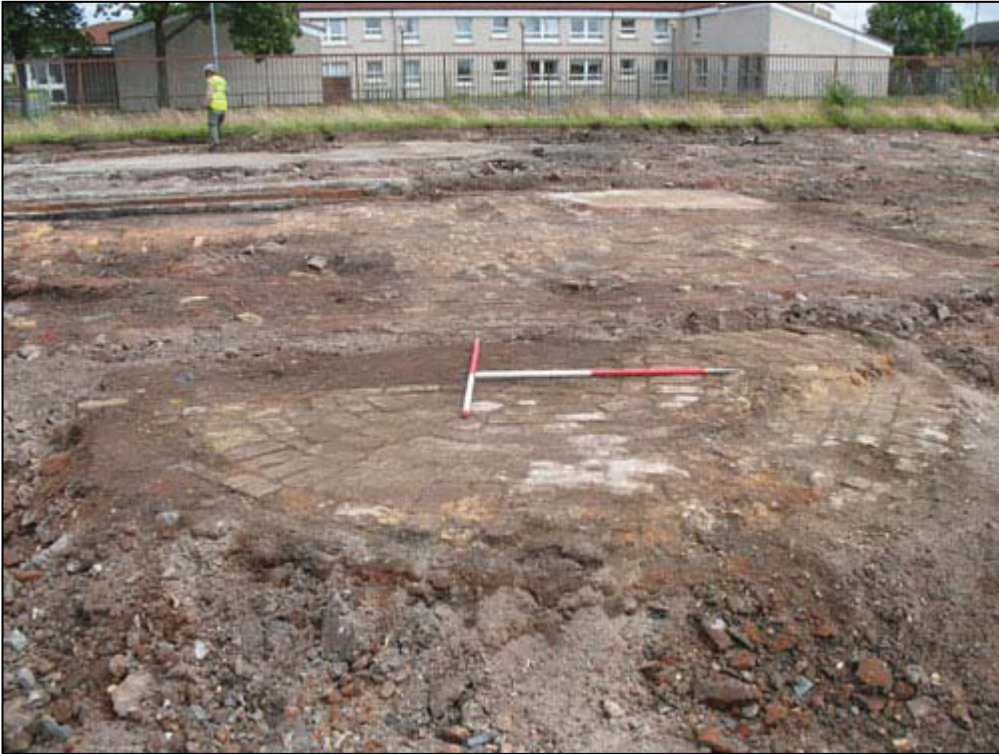
Figure 4a: Kiln (108) and Surface (106)

26. Immediately to the south of the northern disturbance (see above) was a combination of a kiln base (108) (Figure 4a), a square structure (110), an area of flooring (106) and walls (107) and (113). This combination of structures was recognised as being significant archaeological remains and recorded as such. Kiln (108) partially appears at the south end of GUARD evaluation Trench 7. Kiln (108) was disturbed by a modern service trench (116), running north-south. Service Trench (116) was a typical example of a modern drainage trench containing plastic ducting and in-filled with hardcore. These drains most likely relate to the establishment of the blaes pitch.

28. To the immediate east of Kiln (108) there was a large brick surface covering an area of approximately 7.2m by 5.4m. Surface (106) (Figure 4a) was featureless, constructed of regularly laid bricks of similar appearance to Kiln (108). The northern half of Surface (106) was destroyed although the bricks were still visible, loose in the disturbed area. In the south-east corner of Surface (106) was a concrete surface (109) approximately 1.5m by 1m. Although it is possible that this concrete was a later insertion it should be noted that the brick was laid as if to edge the concrete. In the south-west corner of Surface (106) and extending south for 5m two parallel double lines of brick (114) (Figure 6g) were recorded.

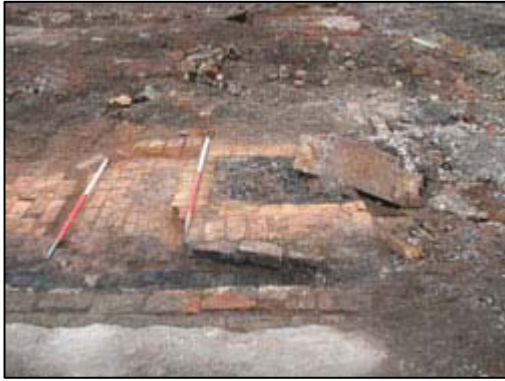
Figure 6a: Structure (110)

29. In the north-east corner of Surface (106) a roughly square brick structure (110) (Figure 6a) approximately 1.2m by 1.3m with an infilled central shaft 1.2m by 0.5m (Figure 6d). Structure (110) was excavated to a depth of 1.2m (Figure 6f), exposing 7 courses of brick to the base and an additional two courses beneath. It is not certain that the base of the structure was reached but the depth of excavation and the danger of collapse of the fragile brick structure meant that further excavation was not possible.

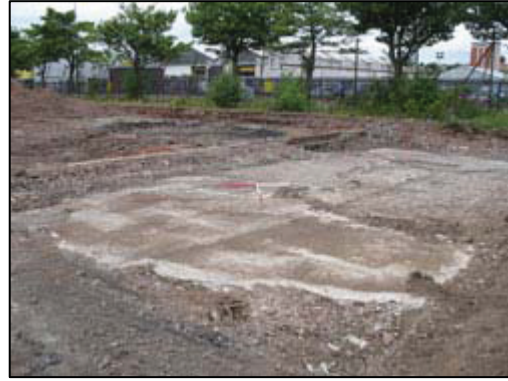
Figure 6b: Surface (117)

32. The entire eastern boundary of the north-east area was occupied to a breadth of 6m by a large concrete surface (117) (Figure 6b) and adjoining foundations (103). The concrete surface was known to exist to a depth of more than 1.3m because excavation work had partially removed the upper surface at the north end which investigating the area of the former warehouse. Surface (117) extended approximately 15m south while the western boundary was marked by a service track (118) identical to Service (116) and in the north-western corner by the foundation of a brick wall.

34. As well as the depth investigated at the north end of Surface (117), which demonstrated that Concrete (103) continued to a depth of more than 1.3m, two test pits were excavated through the exposed foundations at the south end to investigate depth of disturbance. These test pits were excavated to a depth of more than 1.2m through the foundation structures but at this depth the test pits flooded so as to make deeper excavation or recording impossible. It shall be demonstrated that the average depth to archaeologically sterile natural soils was no more 0.7m; in addition, all of the significant archaeological features were exposed at a depth of approximately 0.5m. There is therefore no reasonable chance of significant archaeological features surviving in the area occupied by Surface (117) or the adjoining foundations.

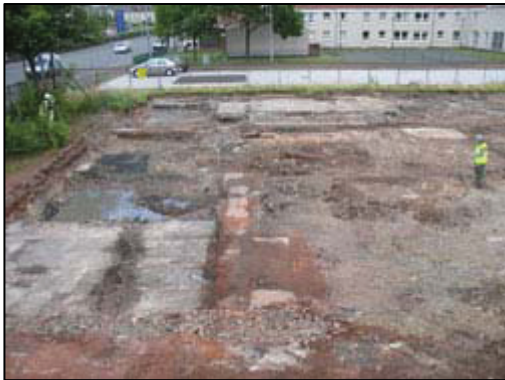
Figure 6c: Wall (124)

31. A large brick wall foundation (124) (Figure 6c) existed to the north-west of Surface (106) This wall was approximately 0.5m wide and extended to include a concrete and brick stance at the western end. Three lines of less substantial brick walls ran east-west through the north-eastern area as we move progressively south. These walls were all two bricks wide, surviving to a height of three, and aligned east-west. The lowest course of these walls was typically wider as a foundation course. The three pairs may be grouped as follows; Walls (129) (Figure 6e) and (142); Walls (145) and (151) and Walls (147) and (153) (Figure 6h). All of these walls were heavily disturbed by later features.

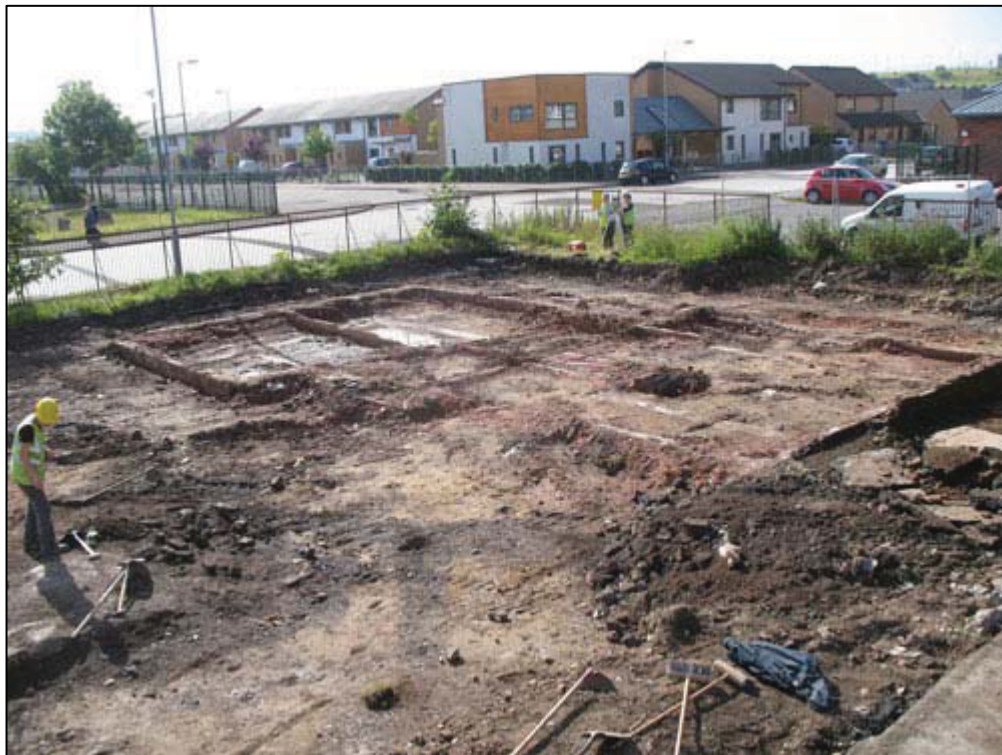
Figure 8a: South-Eastern Area

44. In the south-eastern corner of the development area was the lower walls and foundations of the former Janitor's House (163) (Figure 8a). This structure was demolished in the last few years and so the form and nature of the structure is well known and may be definitively described as not significant archaeological remains. However, it was recorded and surveyed in order to demonstrate its interaction with and surviving significant archaeological features in the same area.

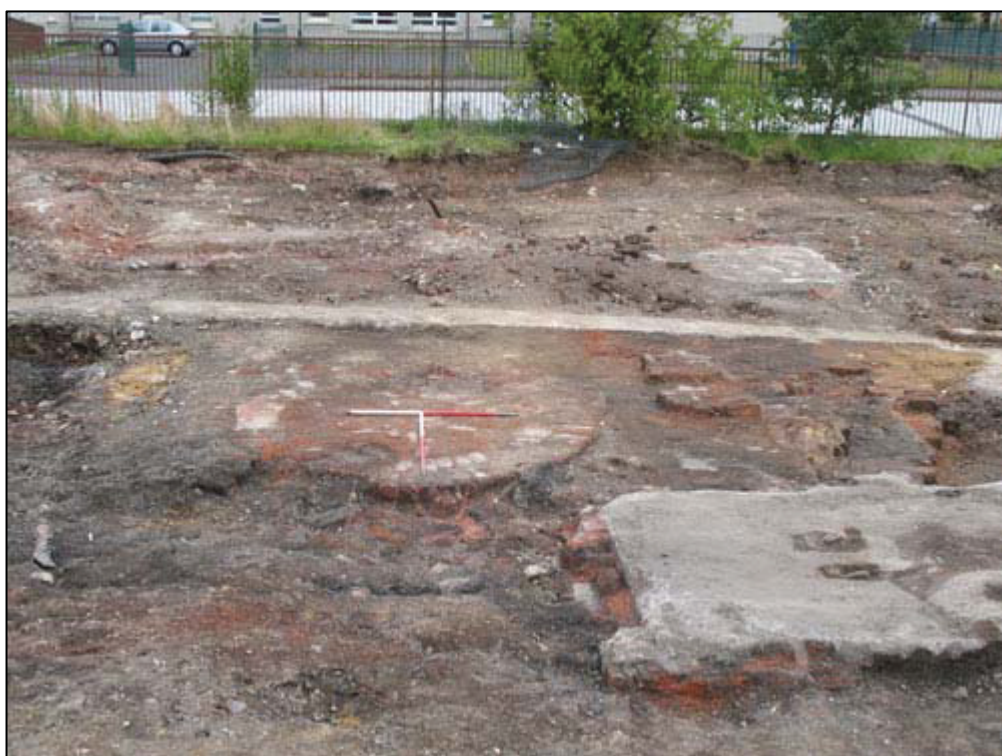
Figure 8b: Structure (162) and Surface (166) and (168)

40. In the approximate centre of the south-eastern area several red brick structures (Figure 8b) were uncovered in the course of the machine stripping. These adjoining structures consisted of a circular brick structure (162), a brick surface (168) extending to the south and an element of the brick surface was two small rectangular brick structures. Surface (168) was approximately 4m by 2.5m and was broken or eroded by subsequent structures. To the west Surface (168) connected with Concrete Base (166) and it was unclear if these structures were contemporary constructions or if the concrete was a later addition. Similar erosion of Surface (168) had taken place to the south where it met Concrete (178). The two irregularly shaped brick structures which formed an element of the Surface (168) were raised by two courses and were approximately 1m square.

41. The circular brick structure (162) was approximately 2.5m in diameter, upon excavation three courses of brick deep and excavated into the natural drift geology (164) (Figure 11a), which is orange brown clay disturbed in the upper 0.1m. Structure (162) was constructed of three concentric circles of red brick with a mass of red brick regularly arranged in the centre. There were no features or designs in the layout of the structure that would suggest use (i.e. as a kiln base). On the eastern edge Structure (162) did extend out into a short section (2.6m) of brick wall running approximately north-south.

73. Circular Structure (162) and the adjoining brick Surface (168) were, from first appearances, associated with the archaeologically significant phases of the occupation of the site. In other words the Saracen Pottery Co., Possil Pottery Co. and Nautilus Pottery. However, examination of the structures themselves did not, at first, lend itself to an explanation of their origins given that there was no fire-mouth, heat resistant brick, heat damage or other characteristics which would indicate a kiln base. In addition the small raised brick structures within Surface (168) require explanation perhaps as the base of a larger structure.

74. Comparison with the 2<sup>nd</sup> edition Ordnance Survey Town Plan (1893) suggests immediately that Structure (162) and Surface (168) are the surviving elements of the chimney, shown on the plan at the approximate centre of the factory where it extends into the central courtyard. Structure (162) may therefore be identified as the foundation of the chimney. The brick stances on Surface (168) must relate to the structure, shown on the plan, to the south and east of the chimney and the machinery contained therein.

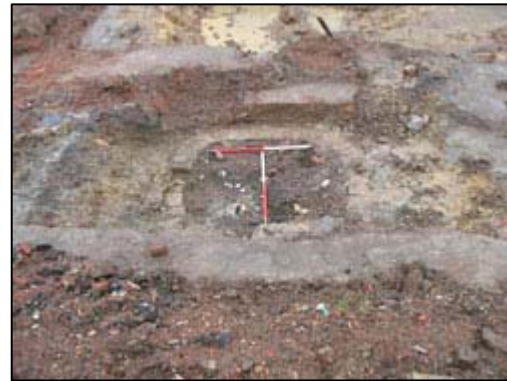
Figure 9f: Structure (214)

37. A sunken brick structure (214) was located in northern centre of the south-eastern area. This structure was enclosed by brick walls, (167) and (218). Structure (214) (Figure 9f) was shaped into a rounded rectangle from a single layer of brick but as several courses deep. The structure was approximately 2m in diameter. In order to determine the depth and nature of Structure (214) and surrounding deposits a test pit was excavated through the eastern half of Structure (214). The test pit determined that Structure (214) continued to a depth of more than 1.5m from initial ground level and that the fill, (216), changed progressively from rubble and made ground to light grey clay. However, at this depth the fragility of the structure and flooding made further excavation unsafe.

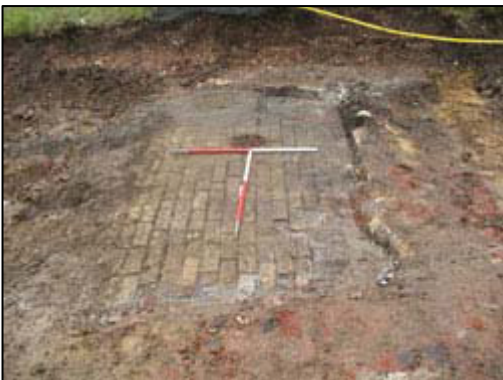
Figure 9g: Surface (222)

38. At the south-eastern end of GUARD Trench 6 the evaluation works noted a small area described as a tiled floor. After widening the excavation to reveal the entire surface (222) (Figure 9g) it became clear that this was in fact a surface composed of glazed brick. The surface was approximately 3m east-west by 2m north-south. A small concrete stance was an element of the surface in the north-eastern corner and the northern edge was delimited by a wall line (227). In the area of disturbance and made ground immediately to the north of Surface (222) it was possible to excavate a test pit to determine the potential depth of significant archaeological deposits. After removing the made ground archaeologically sterile natural soil was reached at a depth of approximately 0.8m below initial ground level.

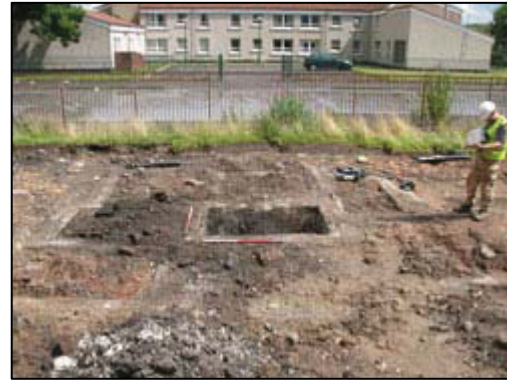
Figure 9h: Test Pit (206)

35. To the south of Surface (117) were several brick structures (206) (Figure 9h) arranged in a grid pattern. Structures (206) took the form of sunken walls delimiting squares each approximately 1.5m by 1m. These structures also joined a concrete stance (206). Excavation of the deposits within these structures revealed mostly made ground and 20<sup>th</sup> century infill consisting mostly of demolition material. At the base of one test pit formed but unfired clay artefacts were recovered from waterlogged deposits.

order to determine the date of these features. This may also provide us with a better idea of their use. The brick Structure (206) creates several discrete brick boxes which may have been used for storage or may be exposed foundations filled with waste material.
