**Northern Marine Management,  
Clydebank, West Dunbartonshire:  
Archaeological Mitigation**

Data Structure Report

issued 11<sup>th</sup> April 2011

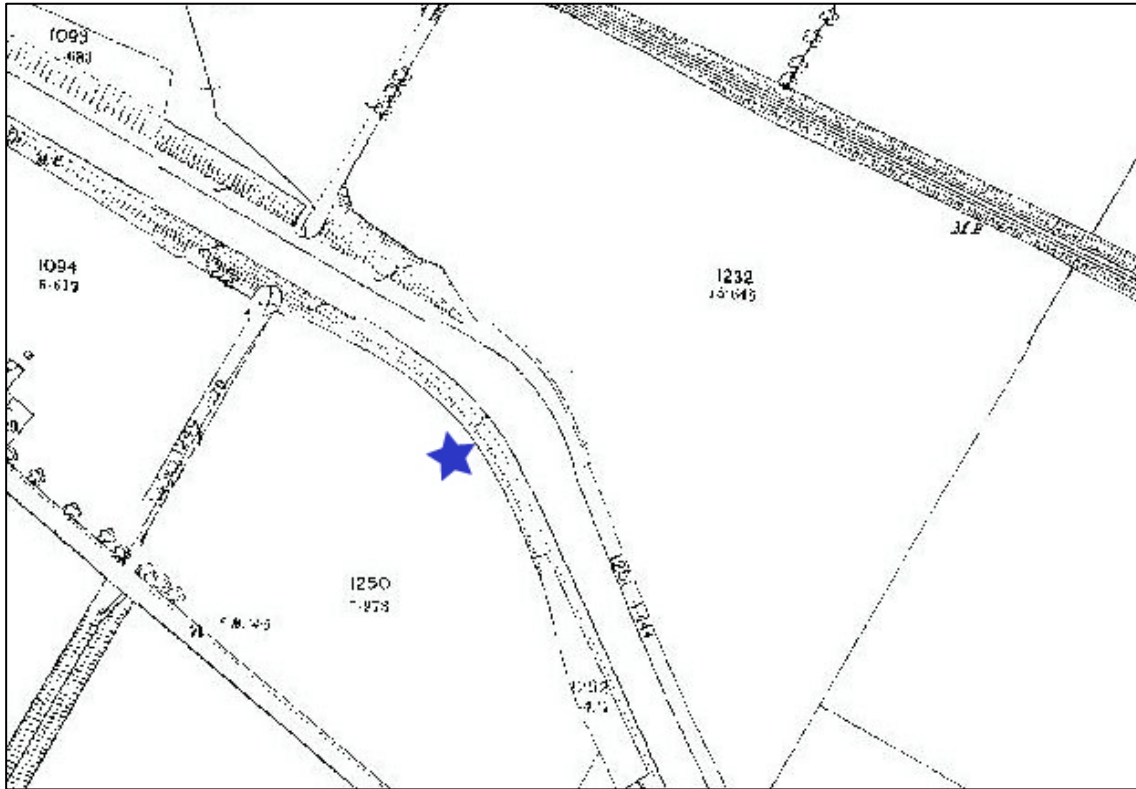
Figure 1a: 1<sup>st</sup> edition Ordnance Survey (1850)

10. Examination of the available historical mapping of the area shows some of the changes in the landscape over the late 19<sup>th</sup> and early 20<sup>th</sup> century. The 1<sup>st</sup> edition Ordnance Survey map (1850) (Figure 1a) shows the Forth-Clyde Canal in its original location. As we can see by comparison with the 2<sup>nd</sup> edition Ordnance Survey map (1900) (Figure 1b) the line of the canal was moved south at some point in the late 19<sup>th</sup> century in order to facilitate

the construction of the railway tunnel. Figure 1a and Figure 1b show the location of the excavated area in relation to the historical mapping. It is worthy of note that the scheduled area relates to the current route of the canal rather than the original route shown on the 1<sup>st</sup> edition.

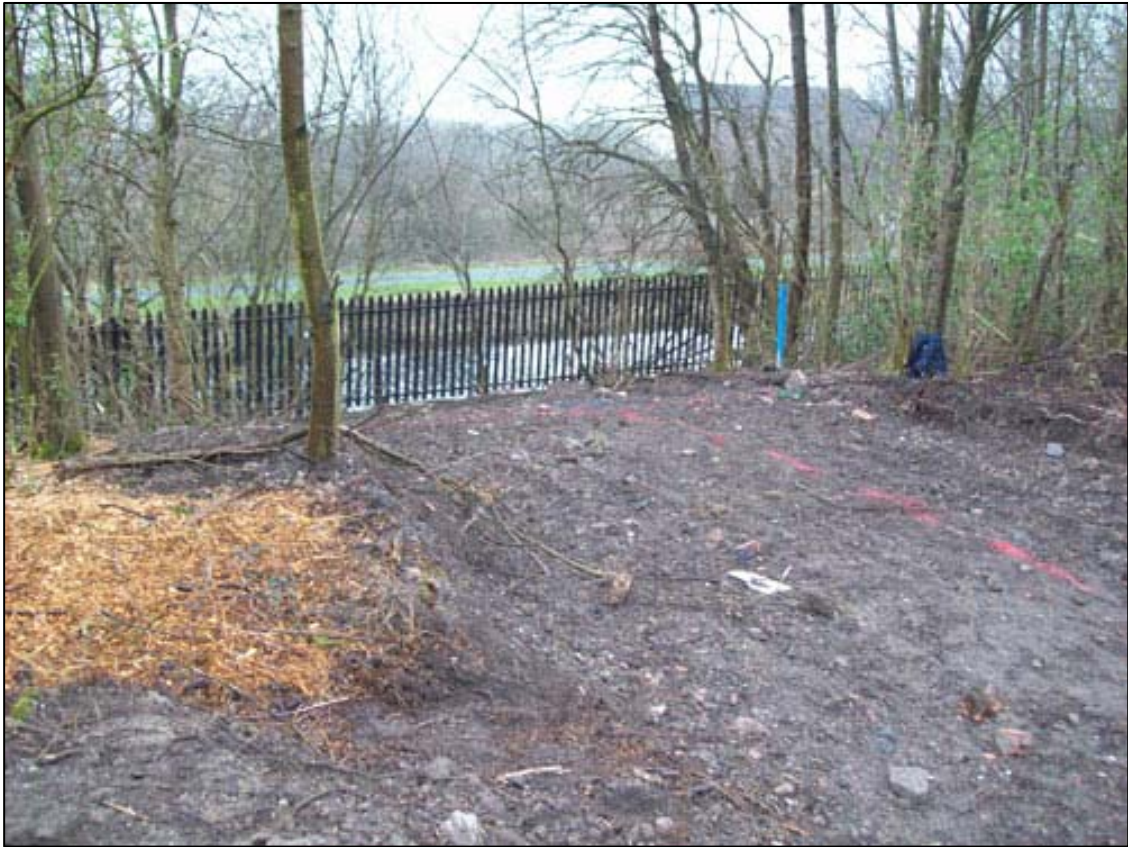
Figure 2a: Line of outflow marked out

11. Archaeological monitoring of the all ground breaking works within the boundary of the Scheduled Monument took place from 30<sup>th</sup> until the 31<sup>st</sup> March 2011. The ground breaking works involved the excavation of tracks for the placement of drainage and access (Figure 2a).
12. This connected into the network of drainage already established as an element of the larger development works to the north and ended with an outflow into the Forth-Clyde Canal. These works were carried out using a 13t 360<sup>0</sup> excavator. Hand excavation was carried out in proximity to the fabric of the canal or when near services.

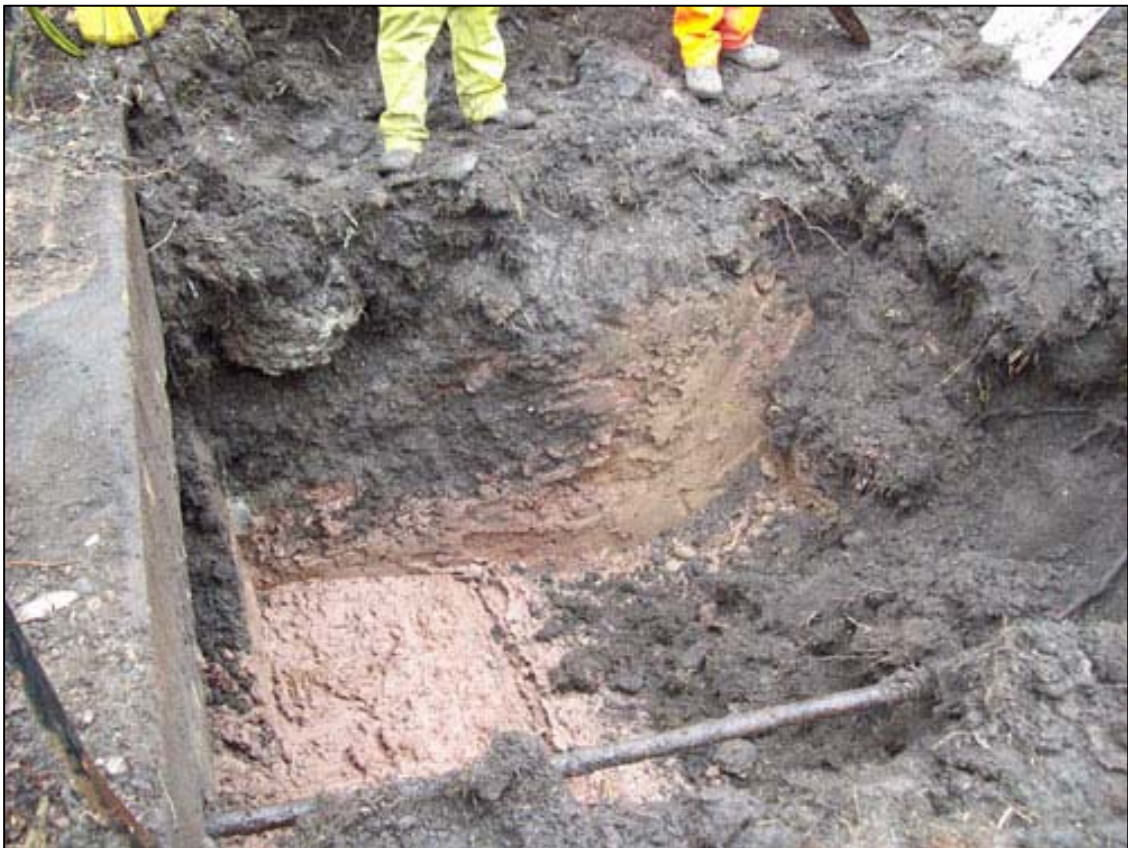
Figure 2b: Excavation close to the canal wall

17. Excavation work began adjacent to the concrete wall which forms the current bank of the canal (Figure 2b). This work was initially carried out by hand and supported by the 13t 360<sup>0</sup> excavator using a toothless bucket. It was necessary to excavate to a depth of 1.6m from the top of the canal wall but due to the steepness of the ground this quickly deepened the further the excavation was carried out north from the canal. The instability of sediments along with the depth of excavation required that, for reasons of Health & Safety, the excavated trench which was within 10m of the canal wall was stepped in order to prevent collapse (Figure 3a). At this distance there was a pause in the work as the excavation encountered a previously unknown gas service.

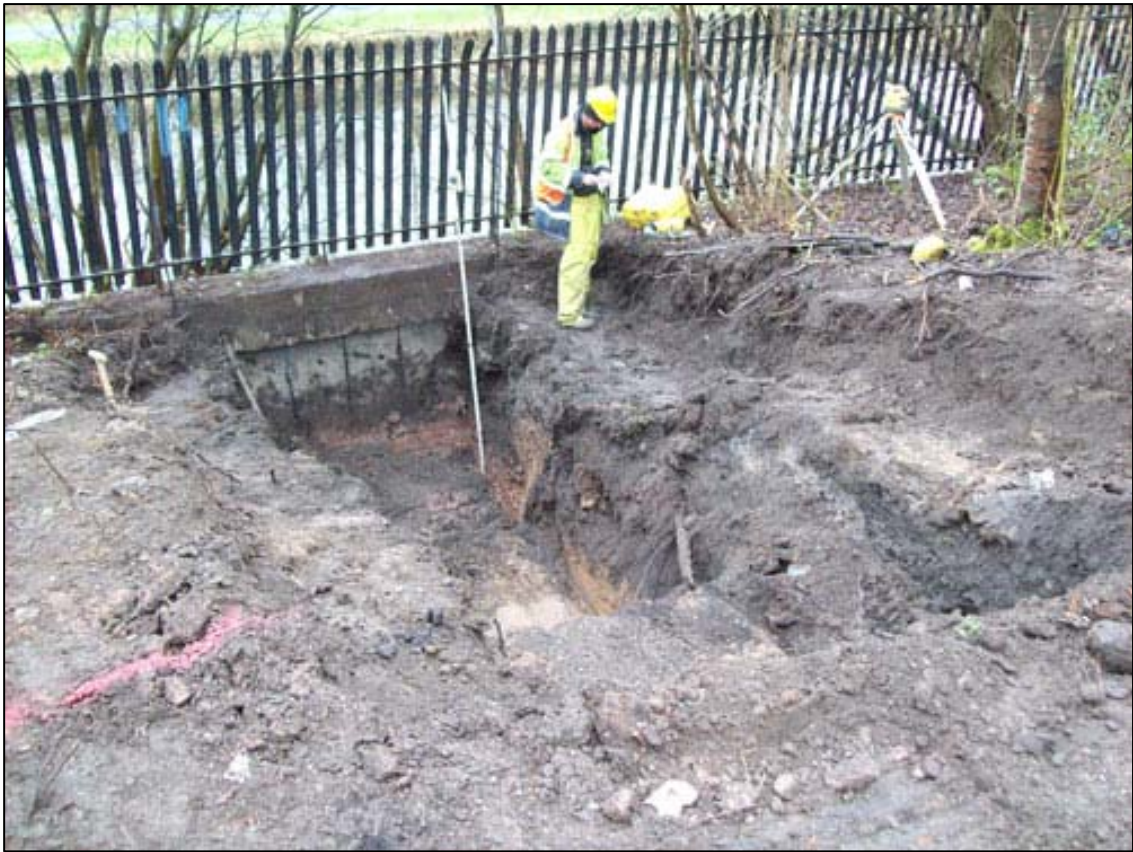
Figure 3a: Excavation extending away from the canal

18. Within the first 10m from the canal wall a track was excavated to approximately 2m wide and stepped out approximately a further 600mm at the top on both sides of the trench. The canal wall (002) which was exposed at this point was composed of cast concrete slabs held together by concrete coping (Figure 3b). This coping was anchored in the sediments to the north by use of a steel pole which was embedded in a large block of concrete (007) 8m from the canal and buried to a depth of approximately 1.5m. It is not surprising therefore that the sediments encountered in this area were massively disturbed by modern works (Figure 4a). Approximately the first 300mm (001) was made up of topsoil and other organic material consistent with the floor of a wooded area including modern rubbish. Beneath this upper layer was between 500mm and 1.2m of made ground (003). These deposits contained modern (20<sup>th</sup> century) building material as well as disturbance from the roots of trees. Other modern deposits in the first 10m from the canal wall included: a deposit of ash (004) and a large dump of modern rubbish (005) including timber, fabric, plastic bags and concrete. Beneath these deposits was yellow-orange clay (006) which continued for the remaining depth of the excavation.

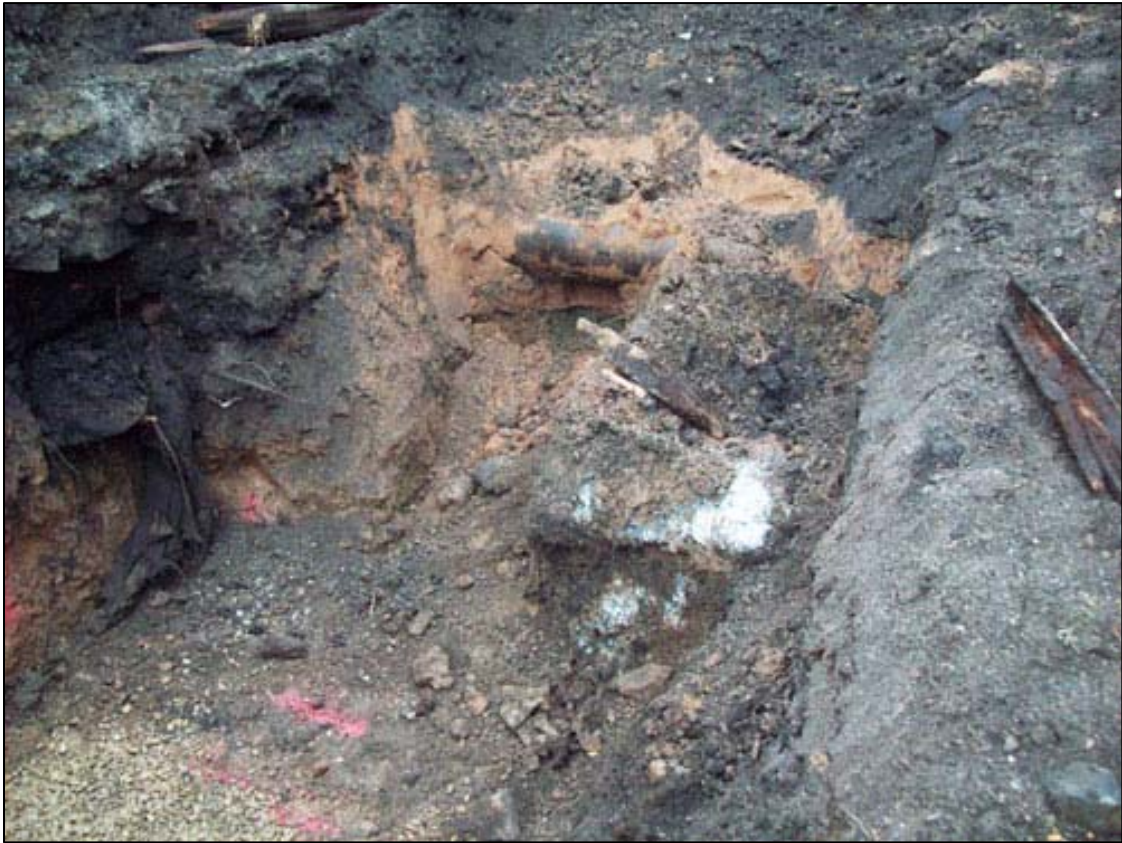
Figure 4a: Concrete anchor and large gas pipe

19. Services were known to exist within the proposed excavation area for the outflow pipe. These included a high voltage electrical cable and a telecommunications cable running parallel to the canal. These services were located just beyond the edge of the scheduled area however an additional service, previously unknown, was located at a depth of 2.5m approximately 9m from the canal wall. This was identified by the marker tape as a gas pipe. Disturbance for the placement of this gas pipe included excavation of a track running parallel to the canal and approximately 1m wide (008). The fill (009) at its base consisted of sand and a pipe approximately 300mm in diameter.

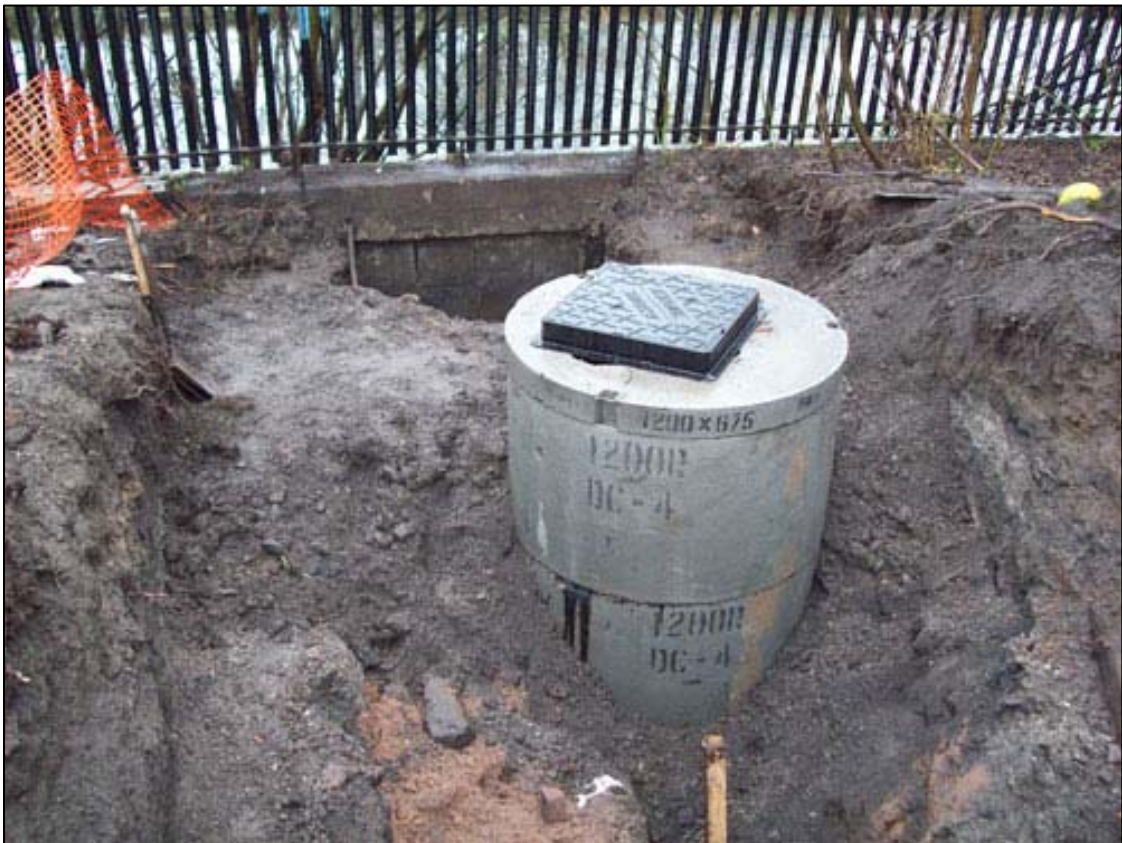
Figure 4b: Placement of manhole

- ❖ the placement of a manhole access chamber within the same track (NS 4903 7085).
14. The Scheduled Area includes the structure and the bank of the Forth-Clyde Canal; however, the extent to which the boundary of the Scheduled Area extends beyond the canal itself varies along its length.

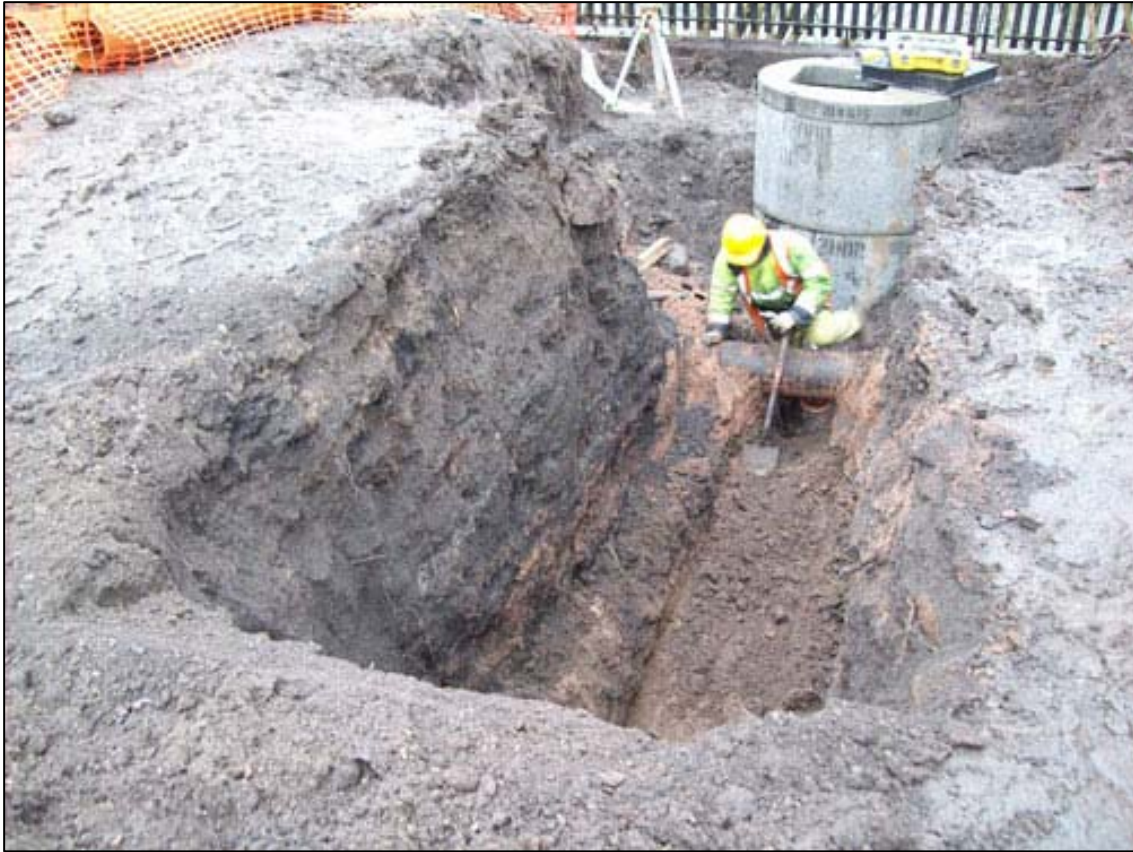
Figure 5a: Excavation beyond the gas pipe

20. The track which was excavated to the north of the gas pipe was approximately 1.5m wide and between 3 and 4m deep. This track was made safe for working by placing a box in the trench and so observation of the section and sediments had to be made from original ground level rather than from the base of the trench. The sediments in this area, beneath the topsoil layer (001), were entirely composed of made ground (010). This deposit included several layered inclusions of modern building material such as concrete, brick and timber. The deposit also included fragments of fabric and plastic even at depths of more than 2m. This deposit of made ground continued beyond the base of the excavated track.

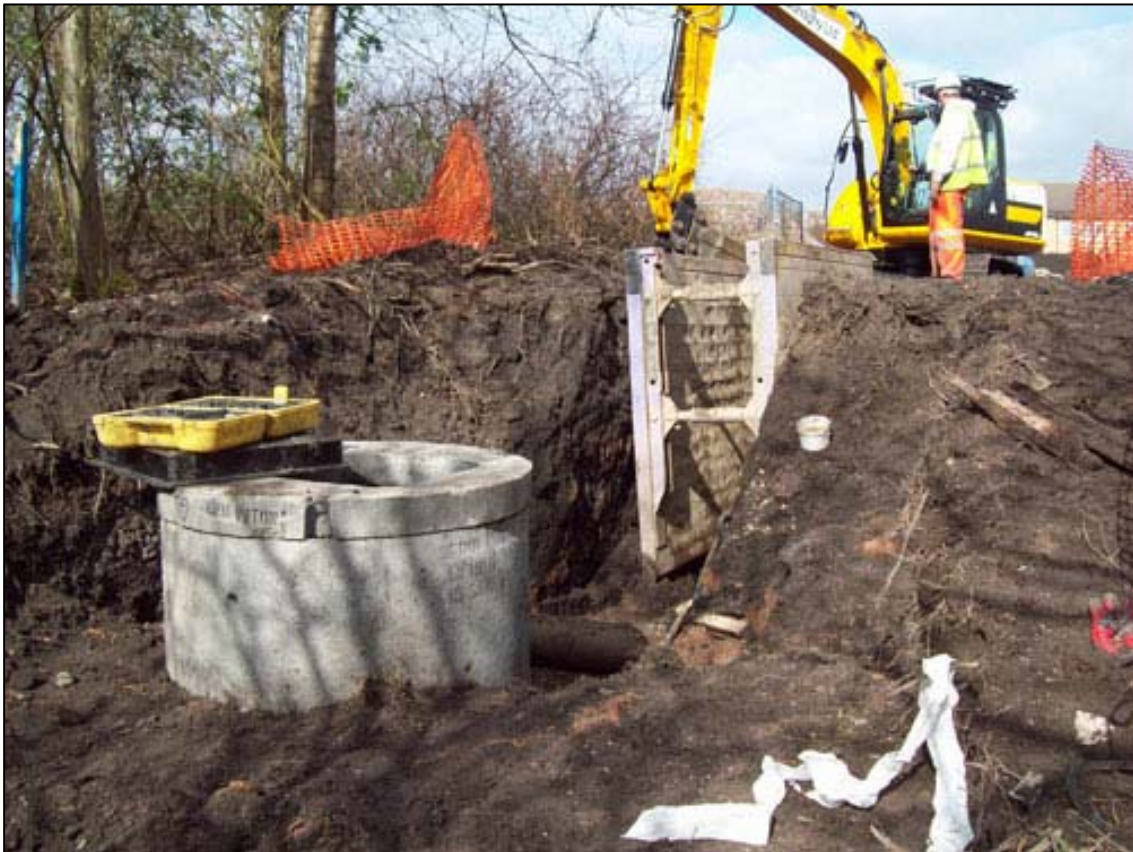
Figure 5b: Excavated area looking from the canal

26. The deposit of clay which was observed at depths of more than 1.2m and in proximity to the canal did not show any signs of being redeposited in the small amount which was observed. This clay contained no inclusions and appeared to be uniform and undisturbed natural clay. However, given that it was not located anywhere else in the excavation and given that only a small area of it was observed the possibility remains that it relates to the building of the canal during its relocation in the late 19<sup>th</sup> century. Archaeologically sterile natural subsoil was not observed at any other location during the excavation works (Figure 5b).
