**Antonine Access Improvement Project
Archaeological Monitoring**

Data Structure Report

by Alan Matthews and Claire Williamson

issued 28th June 2011

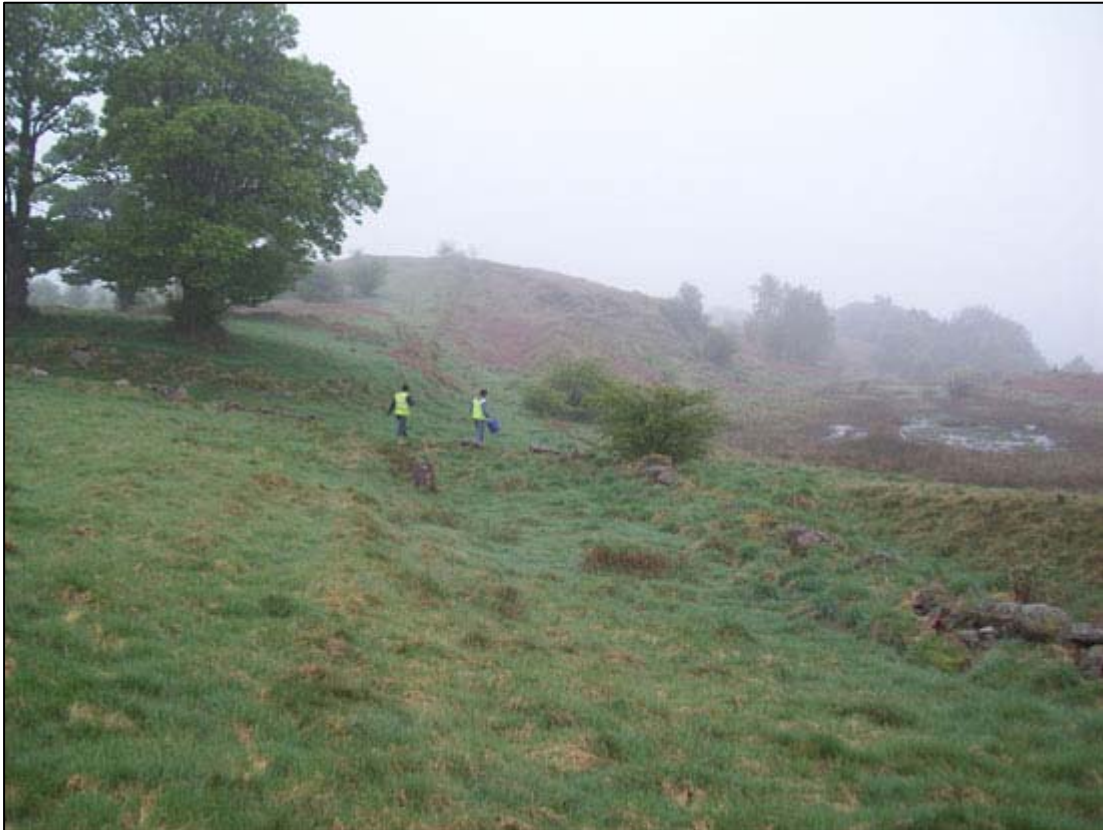
6. The primary focus of the archaeological monitoring works is the possibility of disturbance or recovered of Roman remains. The Antonine Wall was a stone and turf fortification which extends east to west across the Central Belt from the Firth of Clyde to the Firth of Forth. Construction began in AD 142 at the order of Roman Emperor Antoninus Pius, and took about twelve years to complete. As built, the wall was typically a bank, about four metres high, made of layered turves and occasionally earth with a wide ditch (Figure 1a) on the north side, and a military way on the south.

Figure 1a: Antonine Wall to the south of Croy Hill

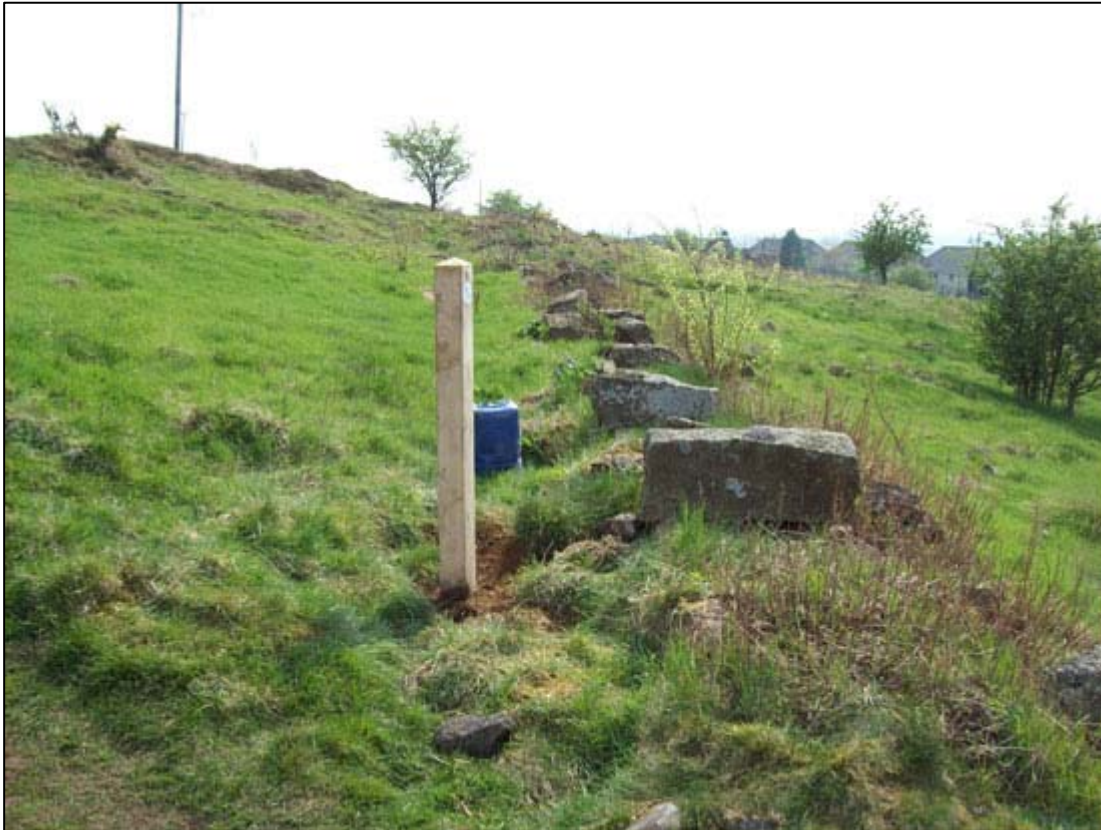
Figure 4a: Waymarker at Location 5

18. When subsoil was encountered during the excavations for waymarkers it varied considerably in character between the excavations. At Location 5 and 30 the subsoil was very compact grey silty-clay (006). At Location 7 yellow-brown degraded fragments of sandstone were encountered, (002). At Location 12 the subsoil was mottled grey sandy clay (008). At Location 13 dark brown silty-sand with small stones was encountered, (007). As before the excavations carried out were so small that it was not possible to be certain that the subsoil was *in-situ*. No anthropic material was recovered from any of these excavation other than that which would suggest modern (20th or 21st century) use of the area.

19. The waymarker at Location 5 was relocated, with the permission of Historic Scotland, approximately 50m to the east and uphill of the location shown on the original map of the improvement works. The new location was still within the boundary of the Scheduled Monument. No significant archaeological features or anthropic material was uncovered during the monitoring of the excavation for this waymarker.

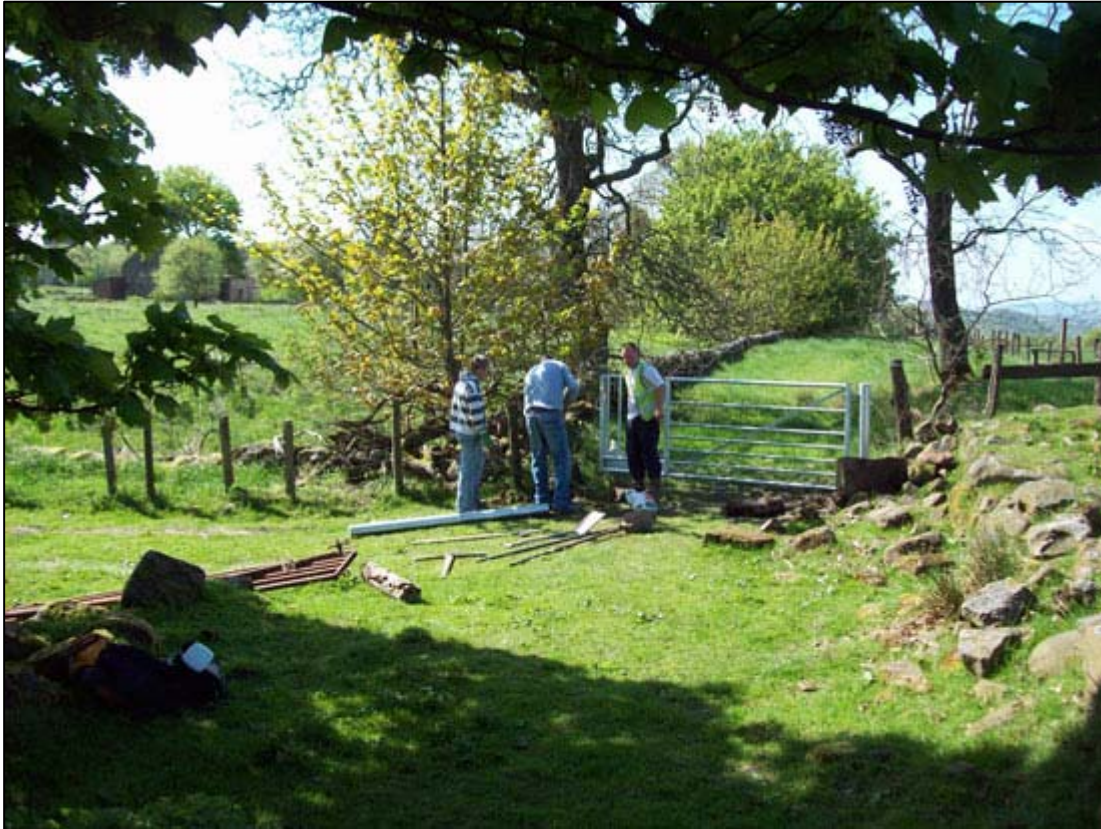
Figure 5a: New gate at Location 16

21. Kissing gates were placed at Locations 11, 20, 28, 31 and 32; farm gates (Figure 5a) were placed at Locations 16, 17, 20 (Figure 5b) and 26. The overlap in the numbers is the result of locations where both kissing gates and farm gates were placed at a given location. At locations where a new gate could be hung on existing posts no archaeological monitoring was carried out. At most locations where existing farm gates were replaced by new gates, new gate posts were also installed. At Location 26 the new gate hung was a York gate, to allow easy passage on horseback; however this did not affect the nature of the ground disturbance required.

26. Typically new farm gates were hung on large wooden posts unless a sufficiently strong post existed in the location. Two new posts were put in at Locations 16, 17 and 20; and at Location 26 the existing post was broken out and relocated. All gate posts were typically excavated to a depth of 700mm to 800mm depending on slope of the ground. The excavation was between 500mm and 600mm in diameter and where possible this excavation was an expansion of existing ground disturbance.

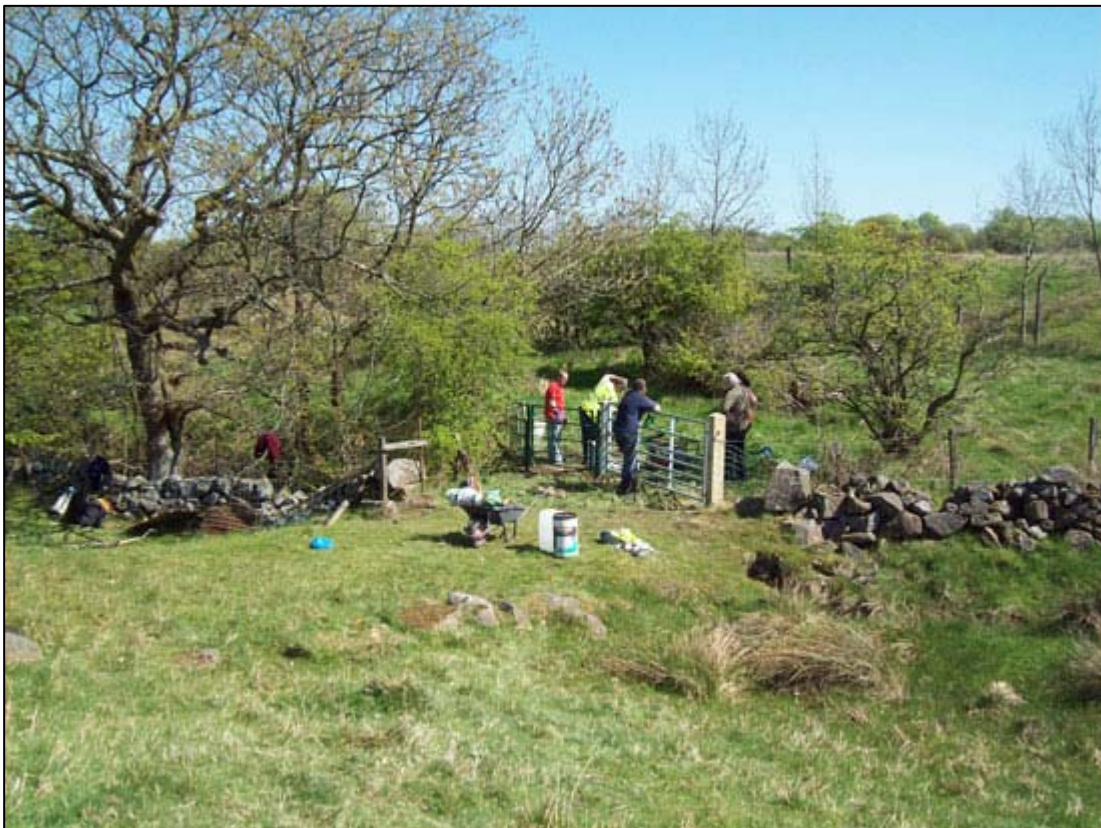
Figure 5b: New gate at Location 20

25. Location 20 was an example of the placement of both a farm gate and a kissing gate at the same location. In addition, it was necessary to repair the fence on either side of the gates. At this and other locations it was necessary to place a wooden post adjacent to the new gate for anchoring the fence. Where possible this was fixed in the same hole as the gate post and any additional excavation works were subject to archaeological monitoring. The gates at Location 20 were also placed over a culvert for a small burn. The deposit (014), fully of large stones in a loose soil matrix, may indicate the build up of made ground in order to create an informal track over the burn.

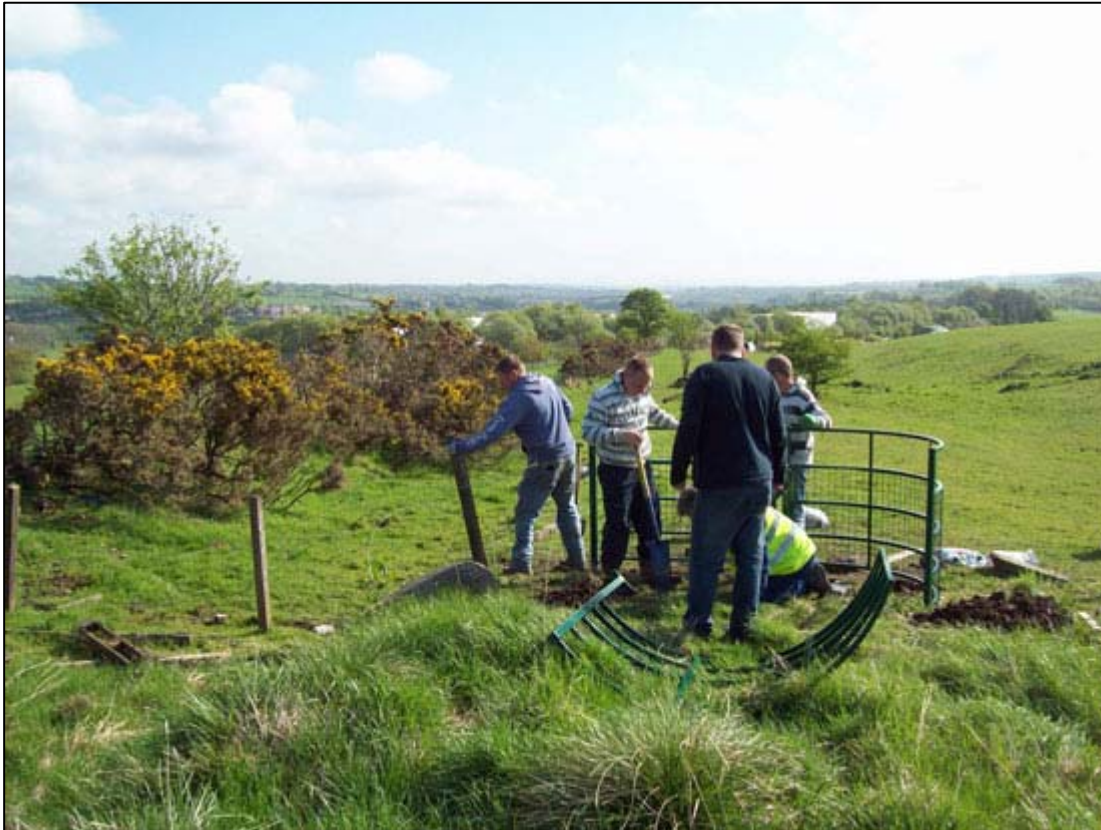
Figure 6a: New kissing gate at Location 31

23. While placing kissing gates the topsoil encountered was always dark brown silty sand with small stones (003) and in the case of Location 31 the topsoil extended to the full depth; however, the subsoil varied from gate to gate. At no point, during the excavation for these gates were significant archaeological features observed. All of the gates monitored were placed within the boundary of the Scheduled Monument but the only anthropic material which was recovered from any of the excavations suggested modern (20th or 21st century) use of the area.

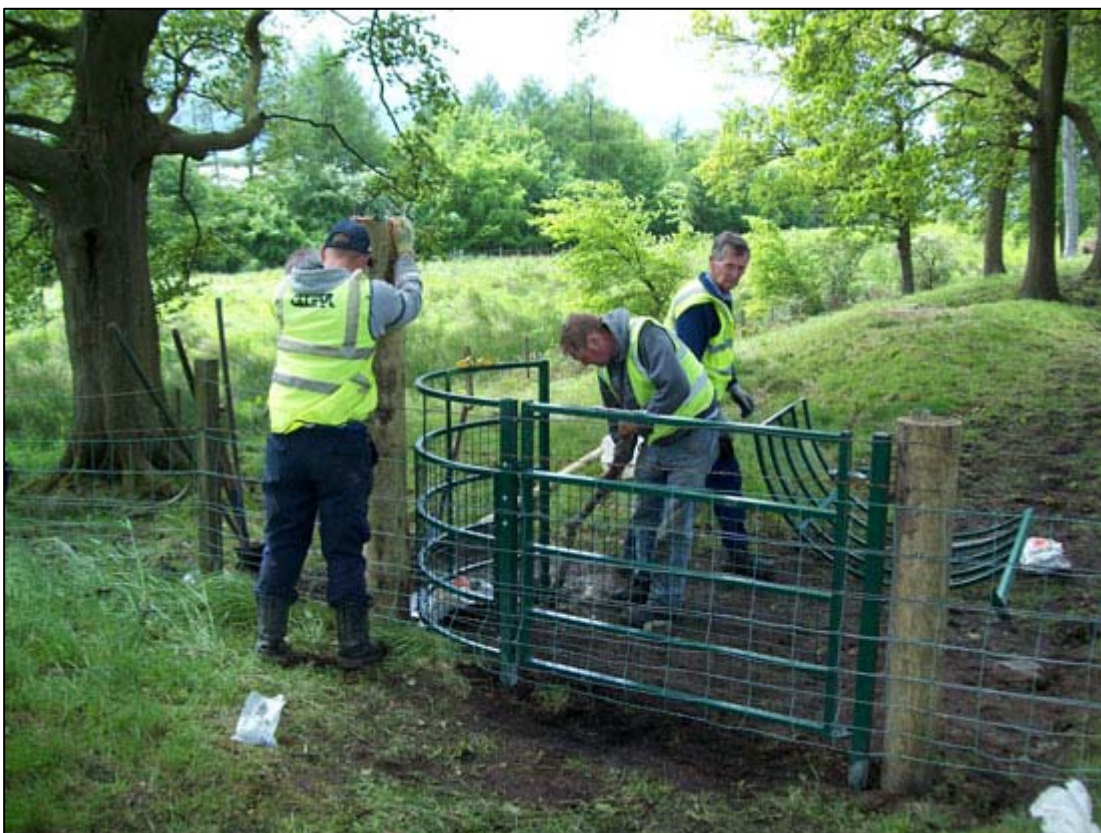
Figure 6b: New kissing gate at Location EX 2

24. Four additional kissing gates were placed between Location 26 and Location 27 with the permission of Historic Scotland; Locations EX 1, EX 2 (Figure 6b), EX 3 and EX 4. These gates took exactly the same form as the other kissing gates being put in with a long trench connecting two post holes and two additional post holes for the gate surround. In all cases the surrounding fence was repaired and this usually involved the replacement of an existing fence post. Where possible this was done by utilising the existing excavation however at Location EX 2 an additional hole for a fence post was dug. The sediments uncovered were similar to those uncovered over the rest of the development area. The topsoil contained more roots and humic material than other wise seen, indicative of the floor of a forested area (017). The subsoil frequently contained large fragments of sandstones (018). While again the subsoil was only seen in small quantities, due to the position of these locations on the northern upcast bank of the Antonine Wall there is a high chance that the subsoil here has been redeposited. Despite the potential in this prominent location, no significant archaeological features other than the redeposited subsoil were uncovered and no anthropic material was recovered other than that which would relate to the modern (20th or 21st century) use of the site.

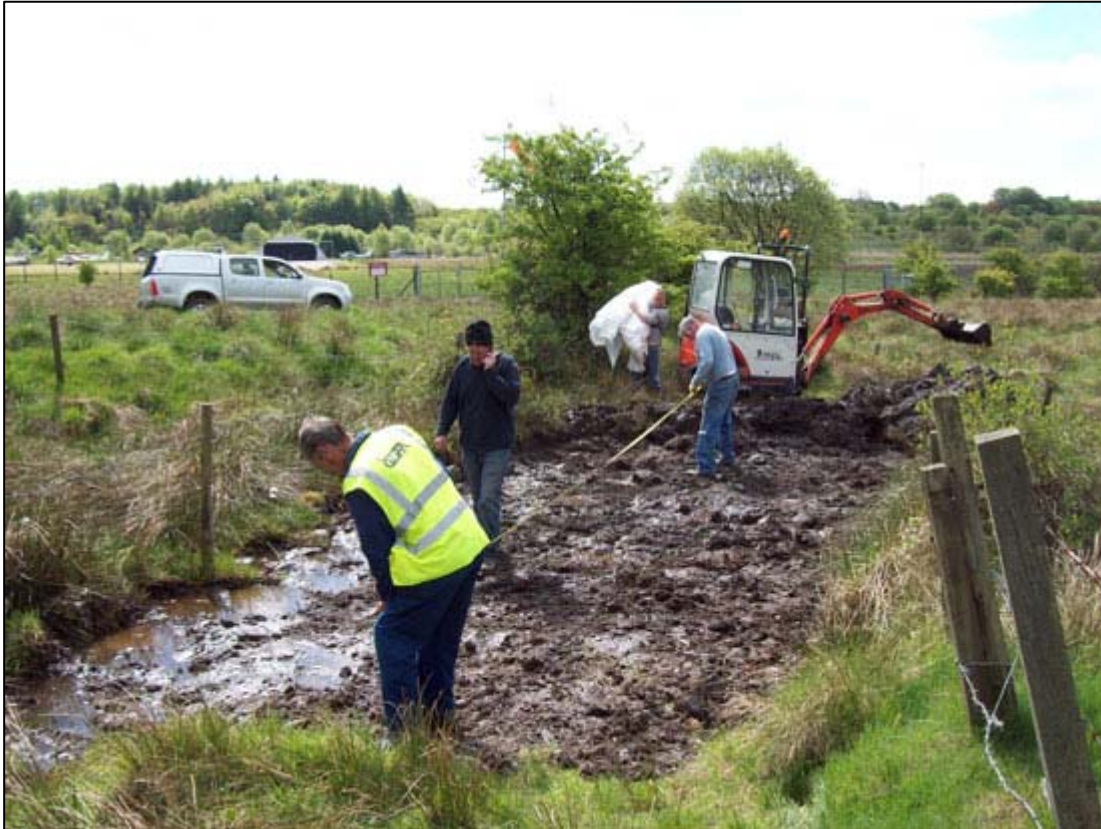
Figure 7a: Area of topsoil stripped at Location 25

29. At Location 25 (Figure 7a) an existing informal farm track was to be improved and to be made more easily usable by pedestrians. The existing track occupied a hollow of ground between two farm gates caused by the natural lay of the land and exaggerated by the form of the Antonine Wall in the area. The track was marshy ground with mud present to a depth of between 100mm and 200mm; the intention of the improvement works was to remove the topsoil from the area of the track and replace it with gravel.

30. The topsoil was removed from an area of approximately 15m by 4m to a depth of between 100mm and 250mm. This exposed the upper surface of a layer of compact gravel which may have been a previous attempt to surface the track. Gravel was then layered within the cleared area grading from coarse rock at the base to type-1 gravel and fine gravel, and a drain was placed within the gravel.

31. No significant archaeological features were uncovered during the monitoring of this topsoil strip. No anthropic material was observed other than that which would relate to the modern (20th or 21st century) of the site.

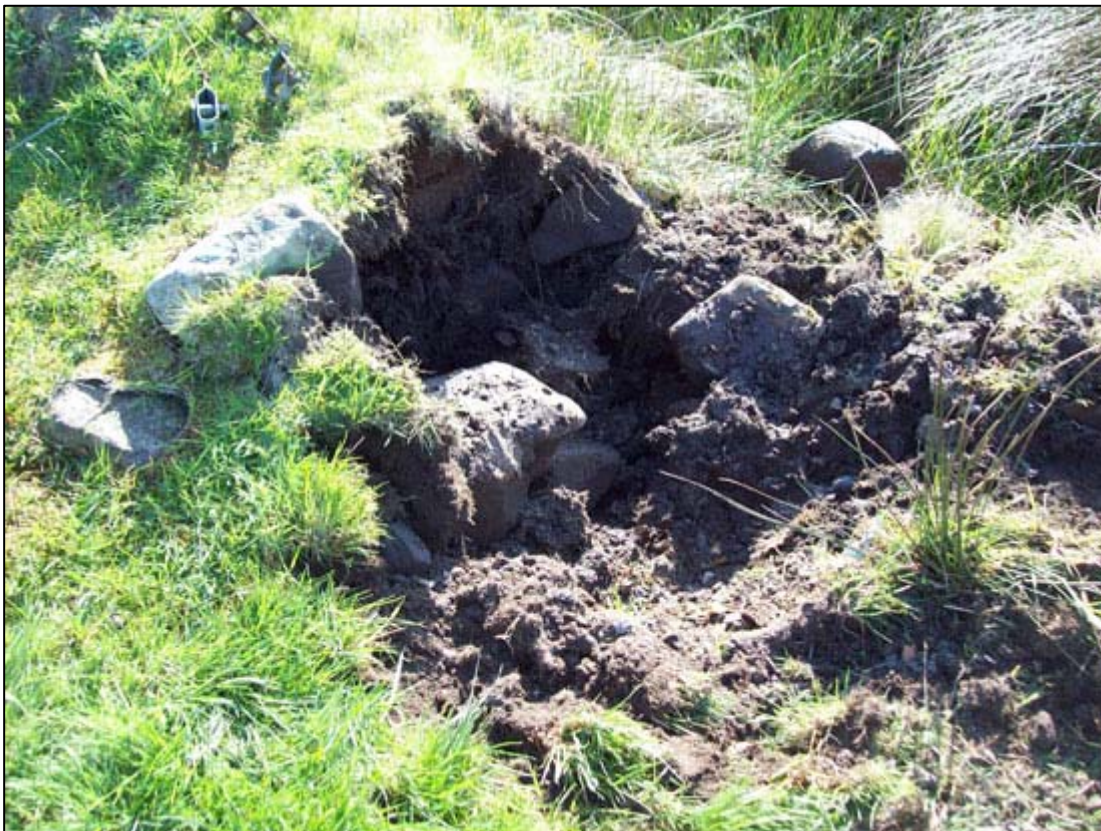
Figure 7b: Removal of fencepost at Location 26

28. At Location 26 (Figure 7b) the existing iron fence post was set with a degraded drystone wall. Excavation to remove and reset the post revealed that the deposit of large stones which was partially removed for the excavation extended to a depth of approximately 700mm. No sign was uncovered during the excavation of *in-situ* structural remains of the wall. No anthropic material was recovered which would suggest that deposits older than the 20th century were disturbed during the excavation work. No significant archaeological features were observed during the excavation for placement of farm gates and no anthropic material was recovered which would indicate other than modern (20th or 21st century) use of the area.

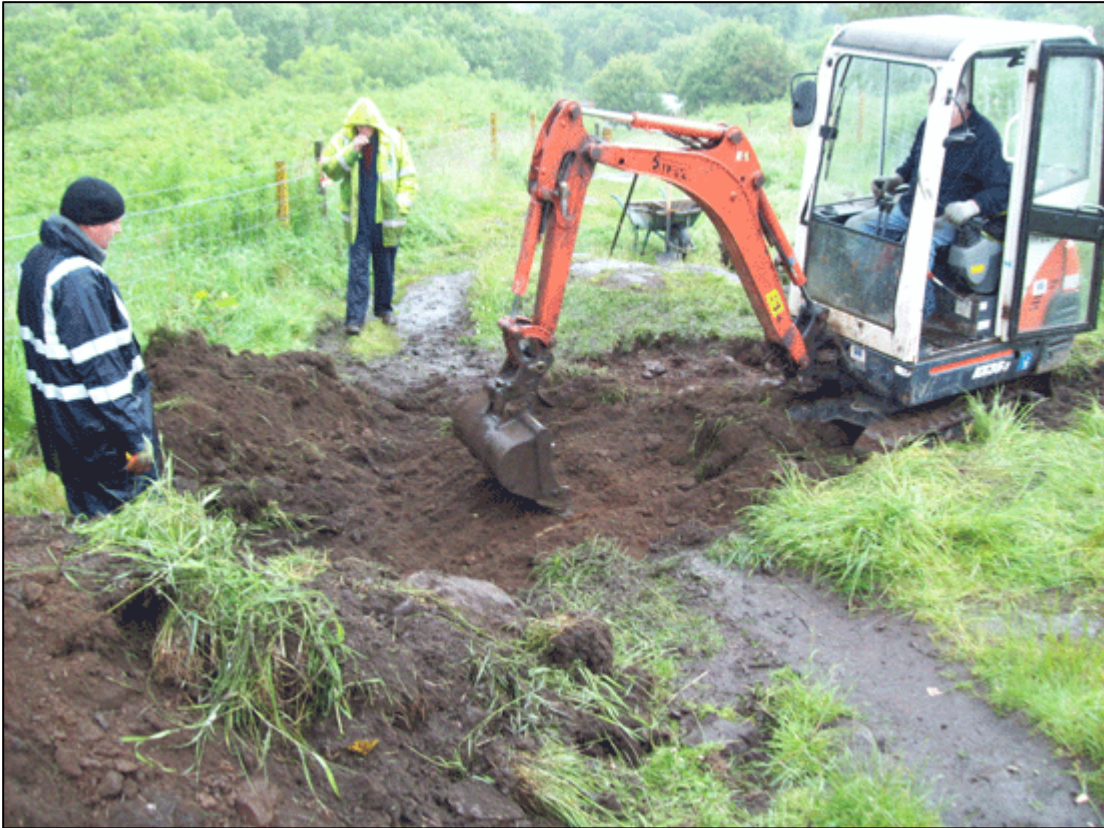
Figure 8a: Stripping the area for new entrance gate at the location of ENT 1

34. At ENT 1 the stripped area measured 9.1m long (NW-SE) by approximately 2.2m maximum width (SW-NE) at the outermost point of the semi-circle. At ENT 2 the stripped area measured 6.42m long (NE-SW) by approximately 2.6m maximum width (NW-SE).

35. At both locations the topsoil was revealed to be a brown silty clay with frequent stone inclusions (020)/(023) which measured 200-250mm thick. At ENT 1, underlying the topsoil was a thin layer of red sandy gravel (021) which appeared to be degraded sandstone acting as a b-horizon between the topsoil and the sandstone bedrock (022) which was revealed at the base of the trench along its SW side. ENT 2 revealed the presence of orange clay subsoil (024) only just reached at the base of the trench. No significant archaeological features were uncovered; both areas likely to have been heavily disturbed by the installation of the pre-existing features.

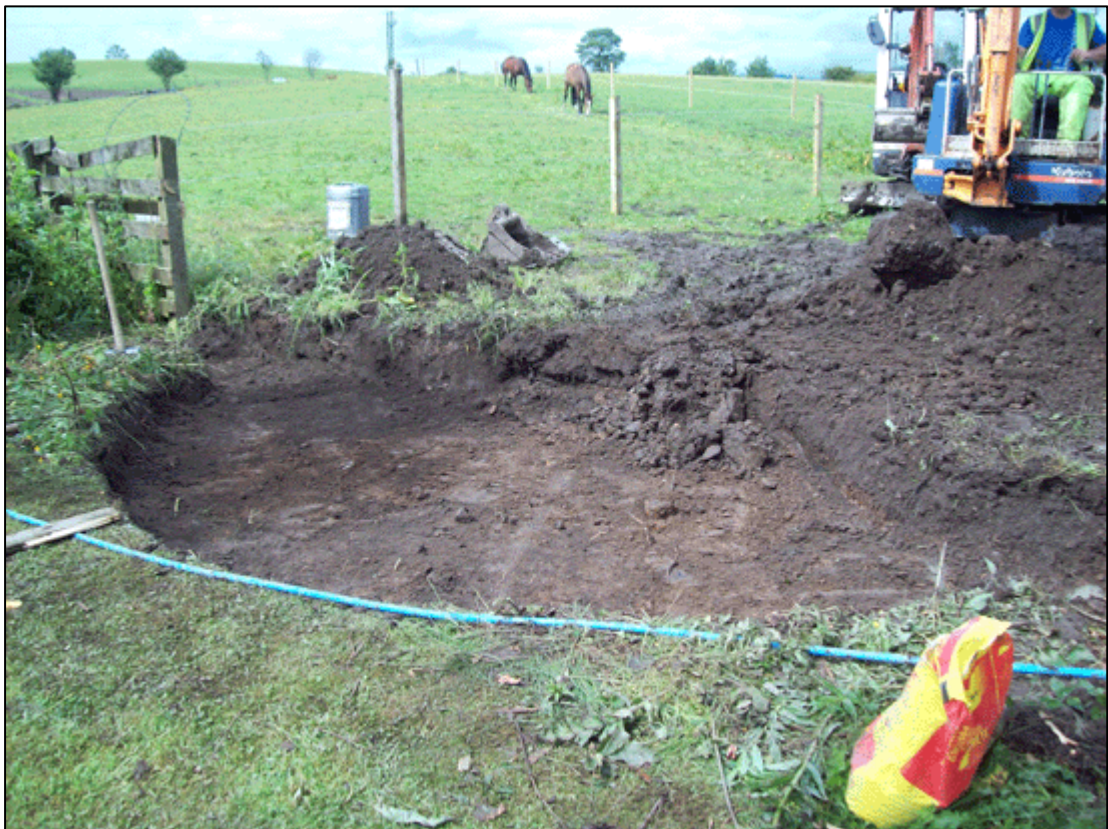
Figure 8b: Area stripped for new entrance gate at the location of ENT 2
