**Easterhouse Woods, Lanarkshire
Scottish Lowlands:
Archaeological Survey**

Data Structure Report

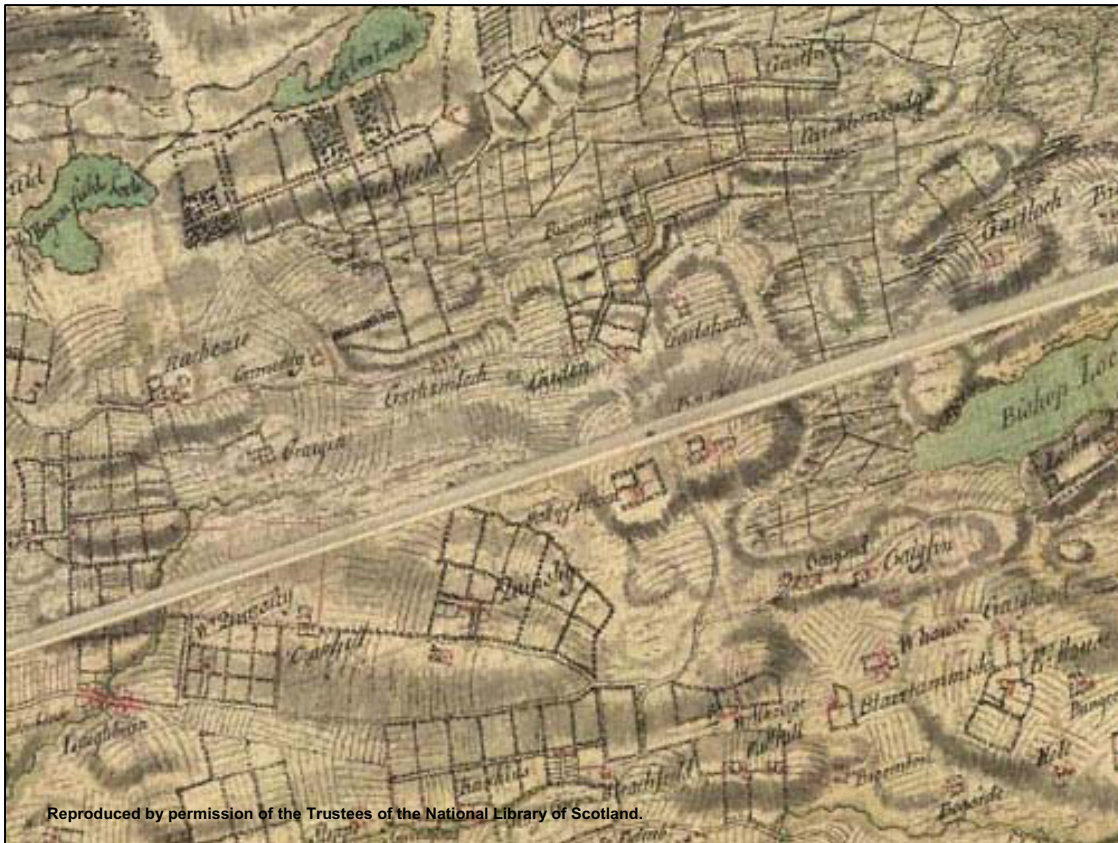
Figure 2a: William Roy's Military Survey of Scotland (1747-55)

8. The earliest available mapping which shows the Easterhouse land parcels in detail is provided by William Roy's Military Survey of Scotland (1747-55) (Figure 2a). It is difficult to reconcile the depiction on Roy's map with the modern topography of the area given that the surrounding land use has changed so much. However, the general scheme is that what is now in the midst of the eastern part of the urban sprawl of Glasgow and its suburbs is depicted on Roy as improved agricultural land much of it enclosed or delimited as small estates.

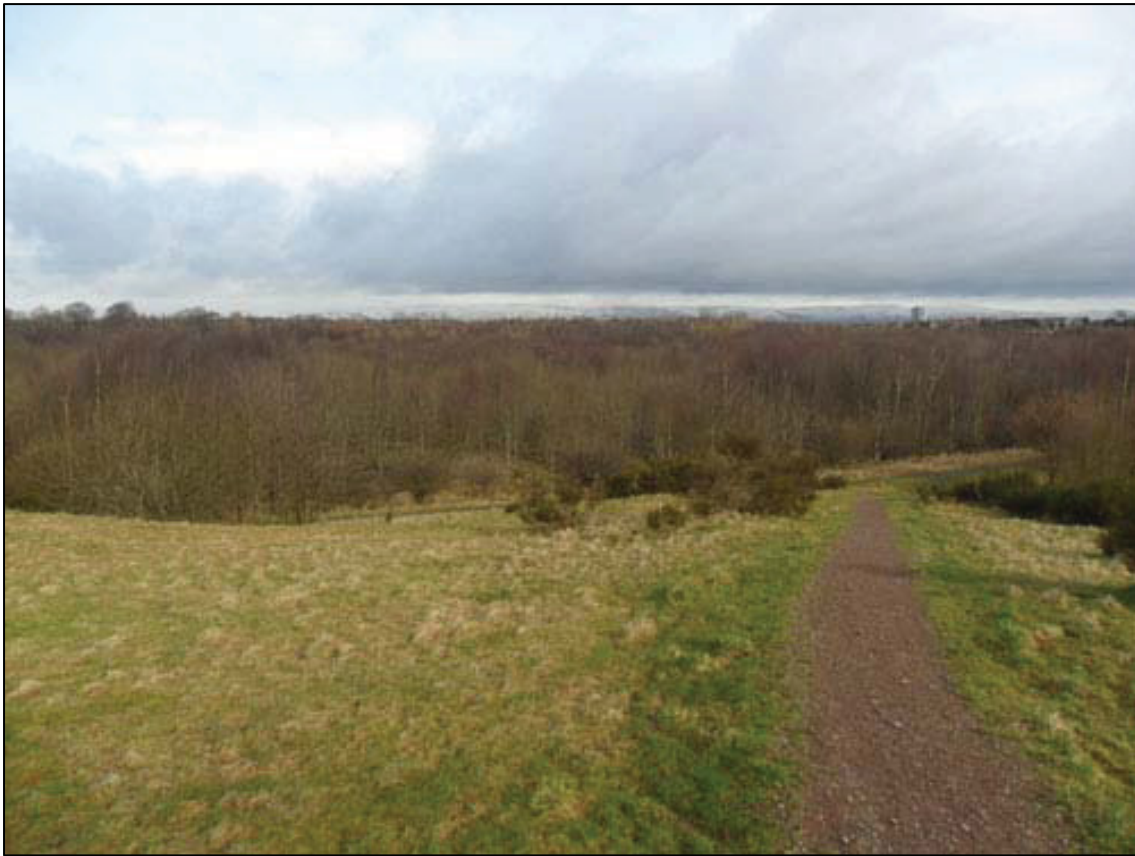
Figure 4a: Parcel 1 from the south

19. Parcel 1 was an L-shaped area to the north of Craigend. The area is heavily wooded (Figure 4a) with deciduous woodland (Figure 4b). It can be clearly seen in the landscape that this woodland is the result of deliberate planting. The evidence of ploughing and accompanying attempts at drainage can be seen in all of the large areas of woodland. Parcel 1 occupies a low point in the surrounding landscape (however, this may in itself be an artificial feature) sloping gently from the north and more steeply from the southern boundary. The central and eastern parts of Parcel 1 are heavily waterlogged despite obviously modern attempts at drainage (see Figures 9a, 9b and 10a).

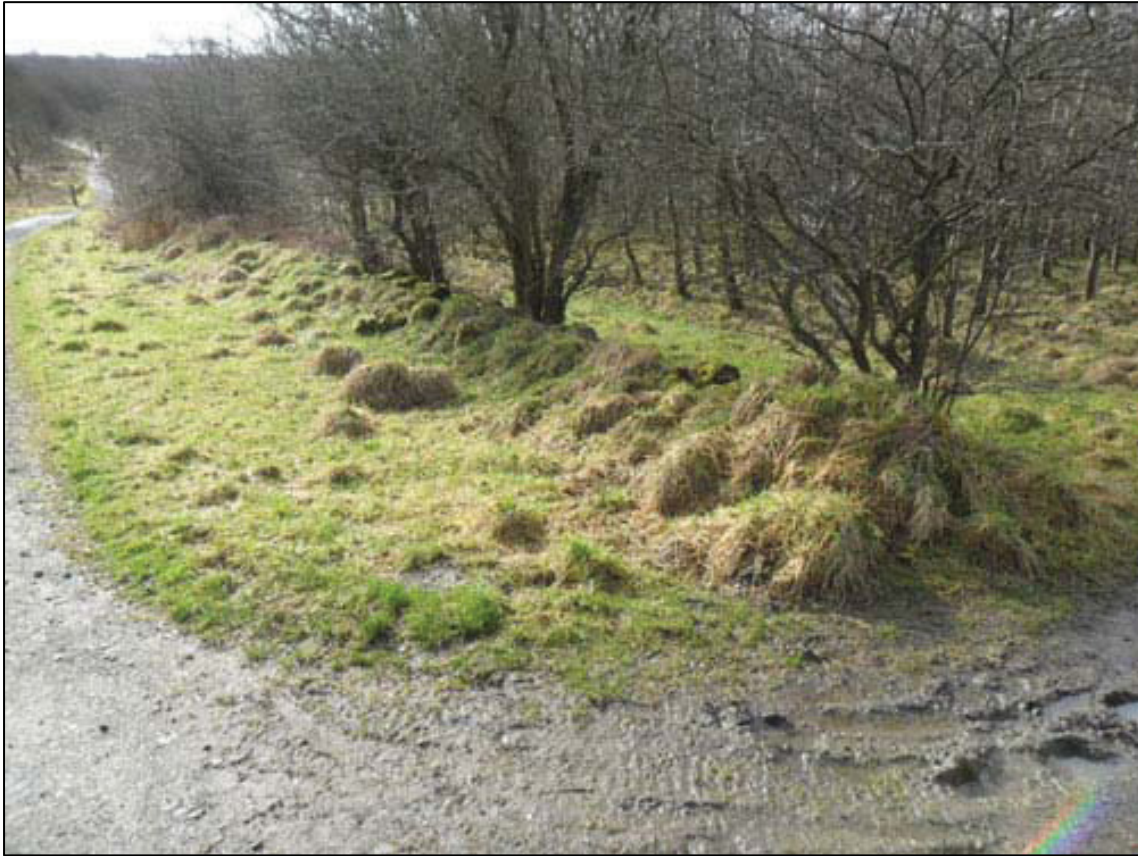
Figure 5a: Boundary wall (**RA11009b.03**)

addition, an area in the centre of Parcel 1 is fenced of and marked as dangerous due to the presence of soft mud and potential for sinking. This is supported by the fact that much of the central area is very waterlogged. The only potentially significant historical or archaeological features within Parcel 1 were located along the northern boundary of the parcel where drystone walls (**RA11009b.02** and **RA11009b.03**) and potential enclosure features (**RA11009b.01**) were noted (Figure 5a, 5b and 10b).

32. Also in Parcel 1 two boundary walls (**RA11009b.02**) (**RA11009b.03**) which extended south from the northern boundary of the parcel. These walls were collapsed and overgrown but were still clearly visible in the landscape as upstanding remains approximately 600mm high and 1.2m wide. The most likely explanation of their origin is that they relate to the old field boundaries shown on 1st to 4th edition Ordnance Survey mapping. As such they most likely to field boundaries set out along with improved agricultural practices in the area in the mid 19th century.

37. The estate road (**RA11009b.01**) at the northern boundary of Parcel 1 is of local significance and therefore planting or development which will affect the integrity of the site should be avoided. The same criterion should be applied to the boundary walls (**RA11009b.02**) (**RA11009b.03**) (**RA11009b.04**). In line with the FES Archaeological Survey Guidelines unnecessary damage should be avoided and where possible breaches in these features should be made through existing gaps. Sub-surface remains may exist at the southern end of (**RA11009b.04**) relating to the demolition of North Mains House (**RA11009b.05**), however as this structure is already demolished and recorded by AOC Archaeology Ltd in a previous walkover survey preservation of remains in this area is not required.

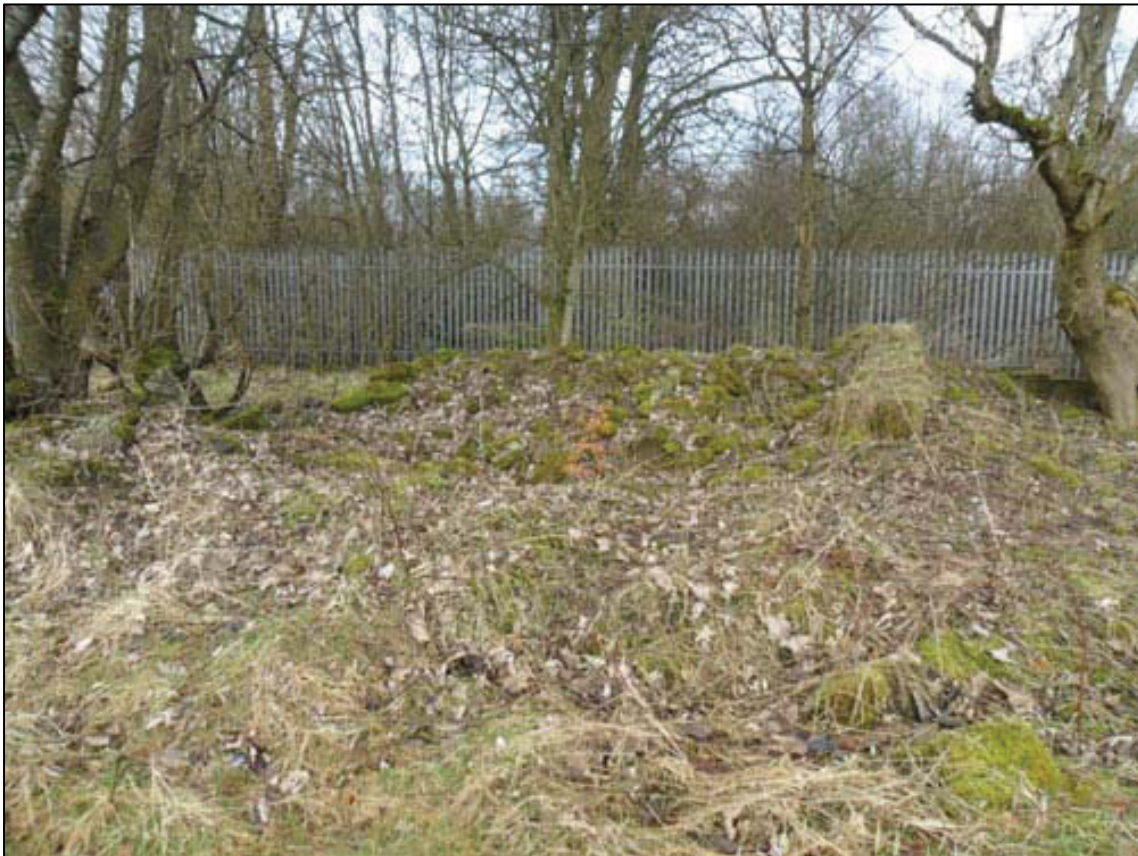
Figure 5b: Enclosure part of (**RA11009b.01**)

31. The northern boundary of Parcel 1 is marked by three small dry stone enclosures linked by a dry stone wall running along the north side of the path (**RA11009b.01**). The path itself is often flanked by what appears to be the grown out remains of a decorative hedgerow. This site is most likely equated with the estate road shown on 1st edition Ordnance Survey mapping leading to Frankfield House. For this reason it is possible that the small enclosures represent decorative features of a driveway rather than practical agricultural or industrial features. In addition, this would imply that the modern fence to the immediate north of these features represents a shifting of the land boundaries north to those shown on the 1st edition Ordnance Survey.

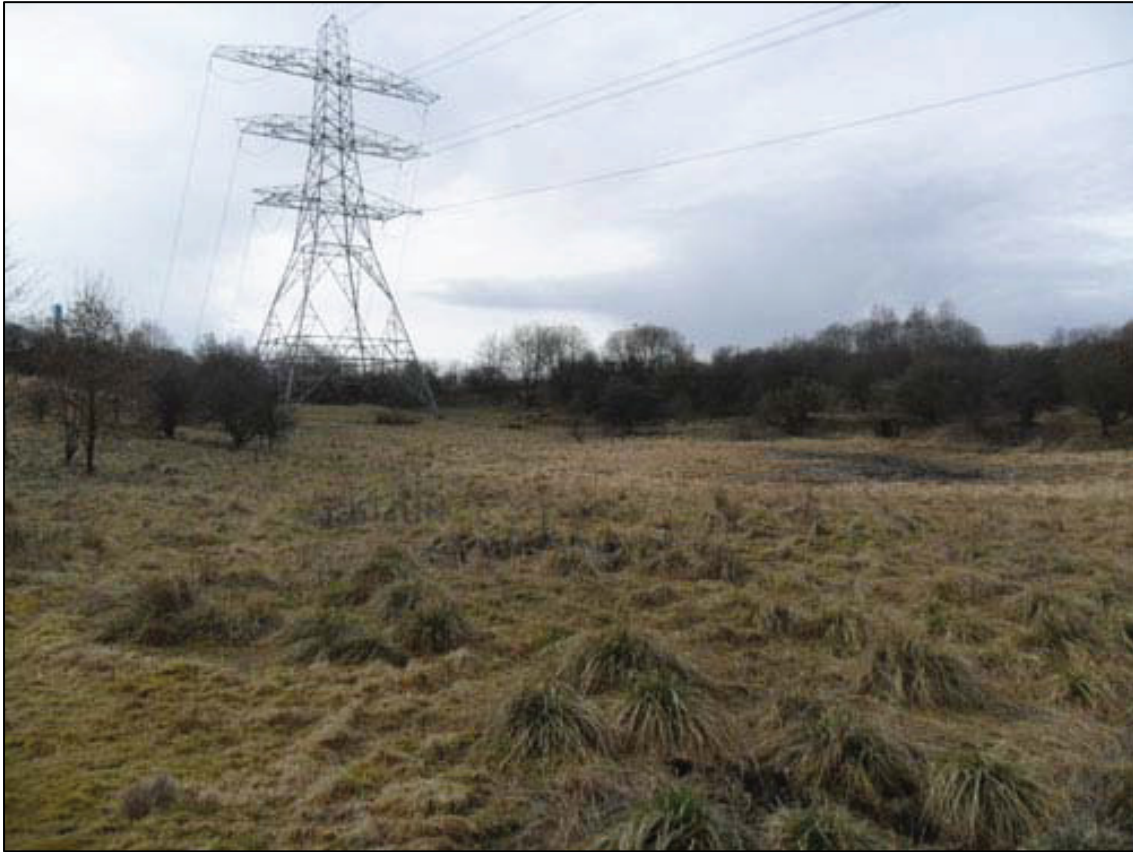
Figure 6a: West end of Parcel 2

21. Potential evidence of mine workings was also evident in Parcel 2, to the north of Garthamlock. Broadly Parcel 2 slopes down from the south. The western third, approximately, of Parcel 2 slopes irregularly and in some places quite steeply (Figure 6a). As with Parcel 1 the topography of this area would be typical of cosmetically landscaped material from mine workings. In addition, a large electrical pylon sits in the western third of Parcel 2 connected to a small substation. The central part of the western third, beneath the electrical cables, is heavily waterlogged. Trees extend into the southern part of the western third. Clearly this area has been massively disturbed by recent industrial activity. Although no structures or features of historical or archaeological significance were noted on the survey.

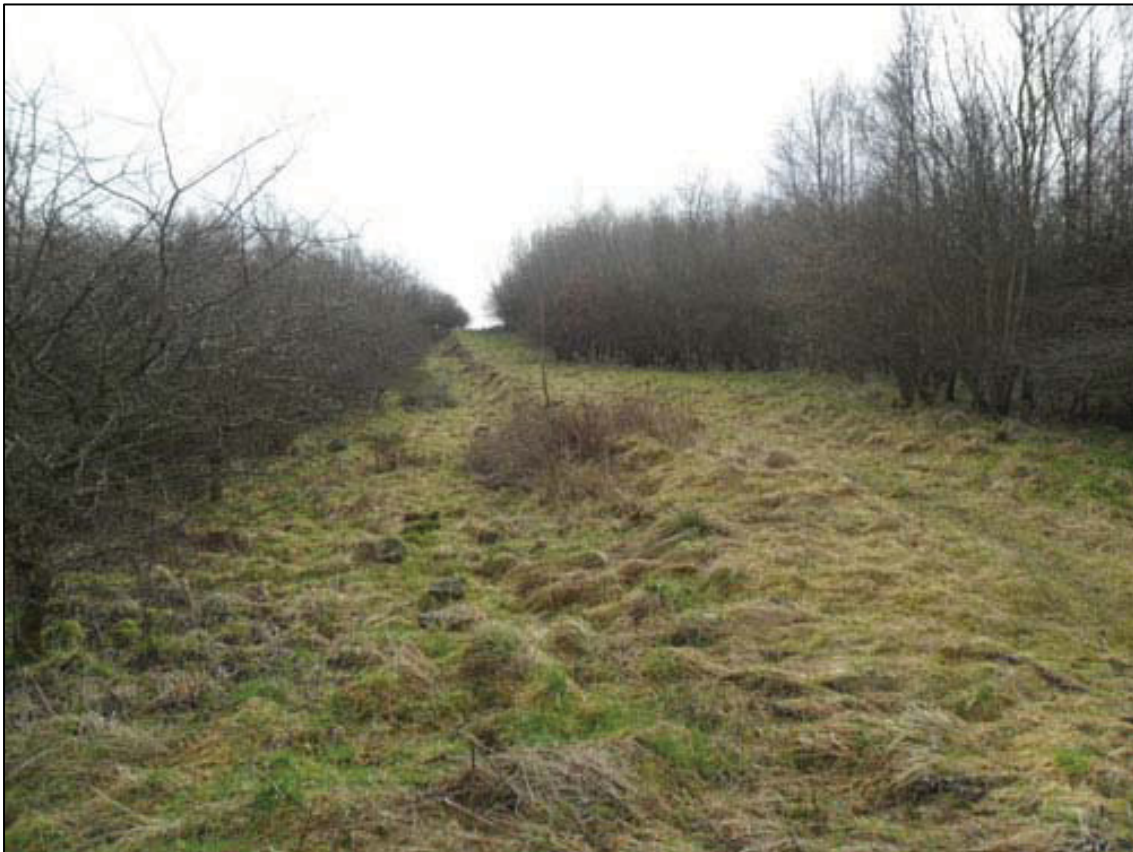
Figure 6b: Boundary wall (**RA11009b.04**)

33. A similar boundary wall (**RA11009b.04**) was located in Parcel 2 and appeared as a similar linear raised mound approximately 600m high and 1.2m wide running roughly north-south up the slope of the hill. In the case of the wall in Parcel 2, however, we can see from the 1st to 4th edition Ordnance survey maps that it relates to the boundary which runs north from the farm of North Mains House. This demonstrated the potential for sub-surface remains to exist after the demolition of North Mains House (**RA11009b.05**). North Mains House is recorded as being an early 19th century farmhouse demolished in the 20th century with the building of modern houses.

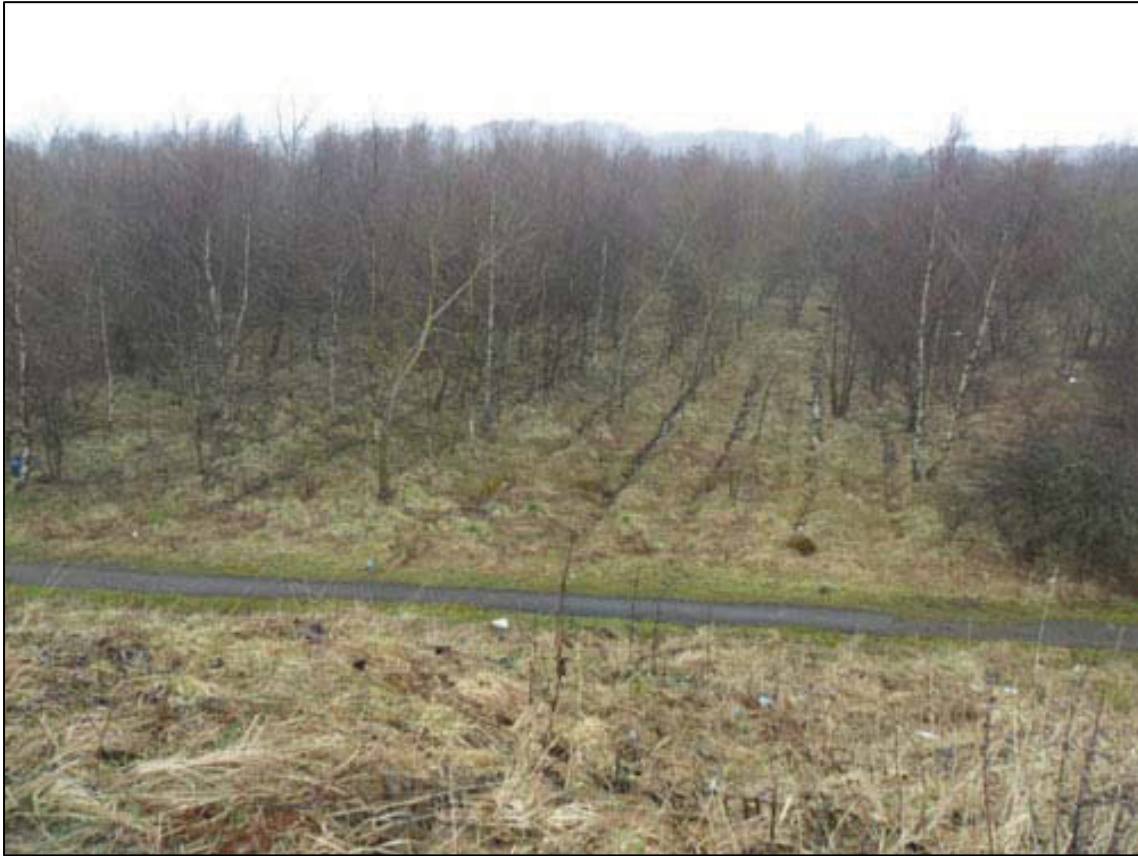
Figure 7a: Centre of Parcel 3

23. The western third of Parcel 3, located to the north-west of Easterhouse, has been ploughed and planted with deciduous woodland (Figure 7a). Footpaths have been constructed through the western third along with accompanying drainage but the remainder of the wooded area is very waterlogged. This reflects that much of Parcel 3 is in low lying land to the immediate south-west of Bishop Loch. The central third of Parcel 3 is also ploughed and planted with deciduous woodland. Footpaths make this area more accessible along its southern boundary. Clearly the central and western third of this parcel have been heavily disturbed by the planting of modern woodland.

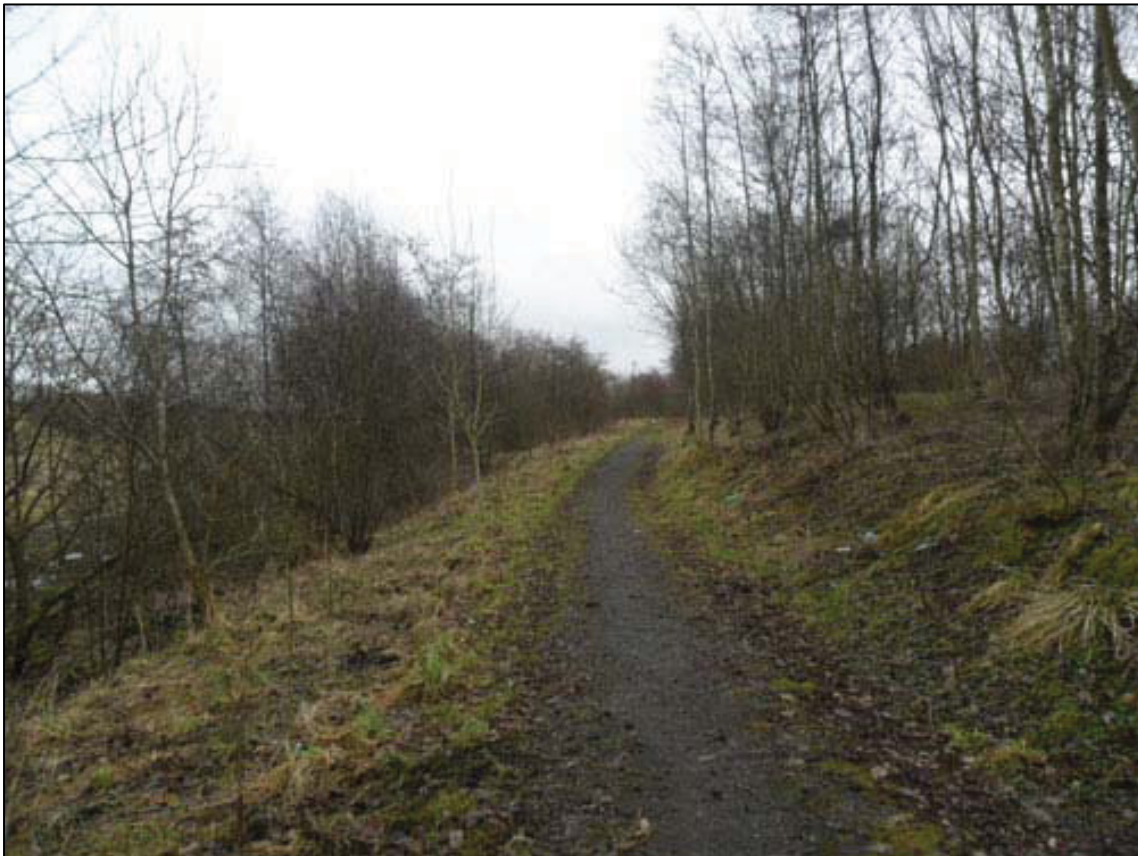
Figure 7b: Centre of Parcel 4

26. Parcel 4 was located to the north-east of Easterhouse. This narrow L-shaped parcel of land could be characterised as forming the boundary of the urban area to the south. The extended part of Parcel 4 is approximately 50m wide, sloping down from south to north and split in the centre by a footpath (Figure 7b). This area is covered by deciduous woodland. The eastern end of Parcel 4 is a square area where the footpath curves south. Overhead electrical cables run from east to west though the centre of this area with two pylons standing within the parcel (Figure 12a). The woodland in the eastern area shown signs of having been ploughed and planted.

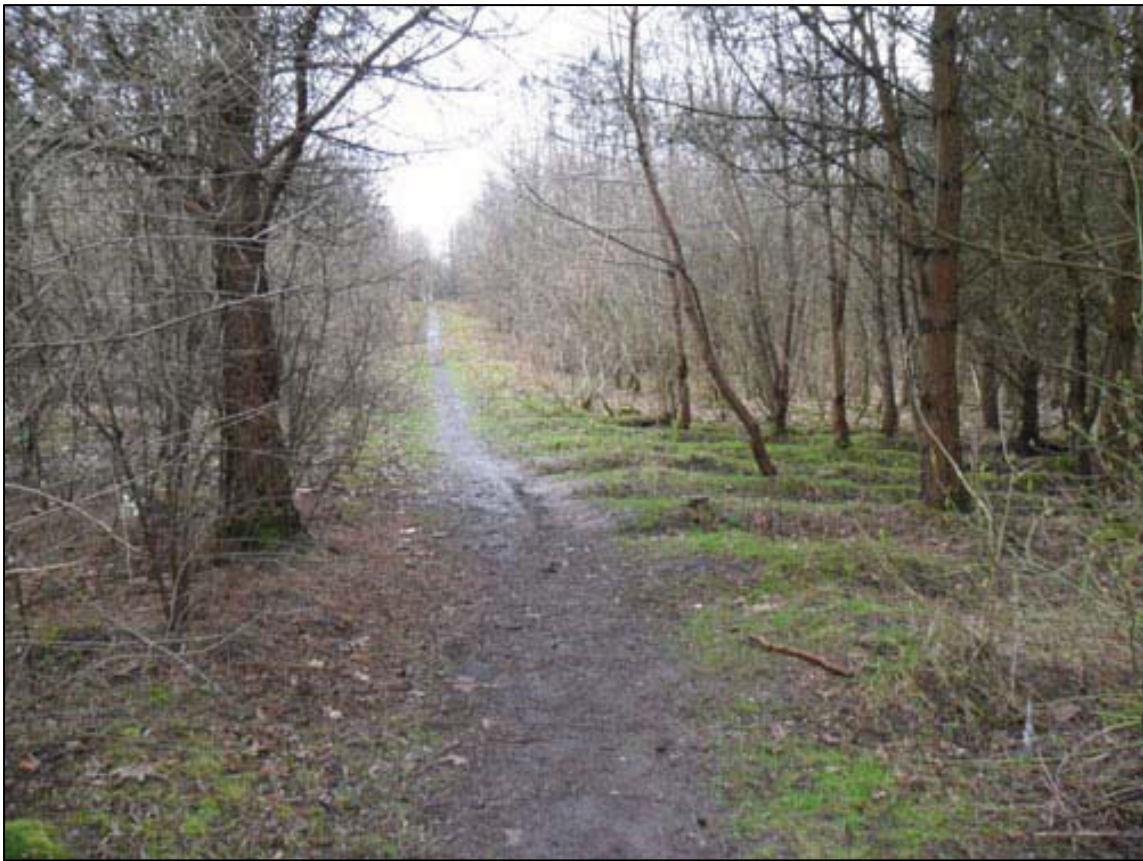
Figure 8a: Paths and planting in Parcel 5

28. Parcel 5 of this study area was located to the south of Easterhouse and to the immediate north of the M8 motorway. The area slopes steeply up at first from the disused road which forms its southern boundary. Almost the entire northern and western half of this parcel has been ploughed and planted with woodland (see Figures 8a and 12b). Informal paths make this area more accessible. The ground is predominantly well drained as it occupied the high ground with regards to the local topography. The south-eastern and central portions of Parcel 5 are more sparsely wooded with some open areas of grass and reeds (Figure 8b). Parcel 5 extends into a heavily wooded area to the north-east. A smaller section, to the south-east is on the other side of the disused road. This area is also raised when compared to the surrounding landscape and entirely covered with ploughed and planted deciduous woodland. The buildings and backplots shown on the early Ordnance Survey mapping beyond the southern boundary of Parcel 5 have been destroyed by the placement of the M8 motorway and the disused road. Some fragments of brick concrete around the south-eastern corner of Parcel 5 may be the redeposited remains of these structures.

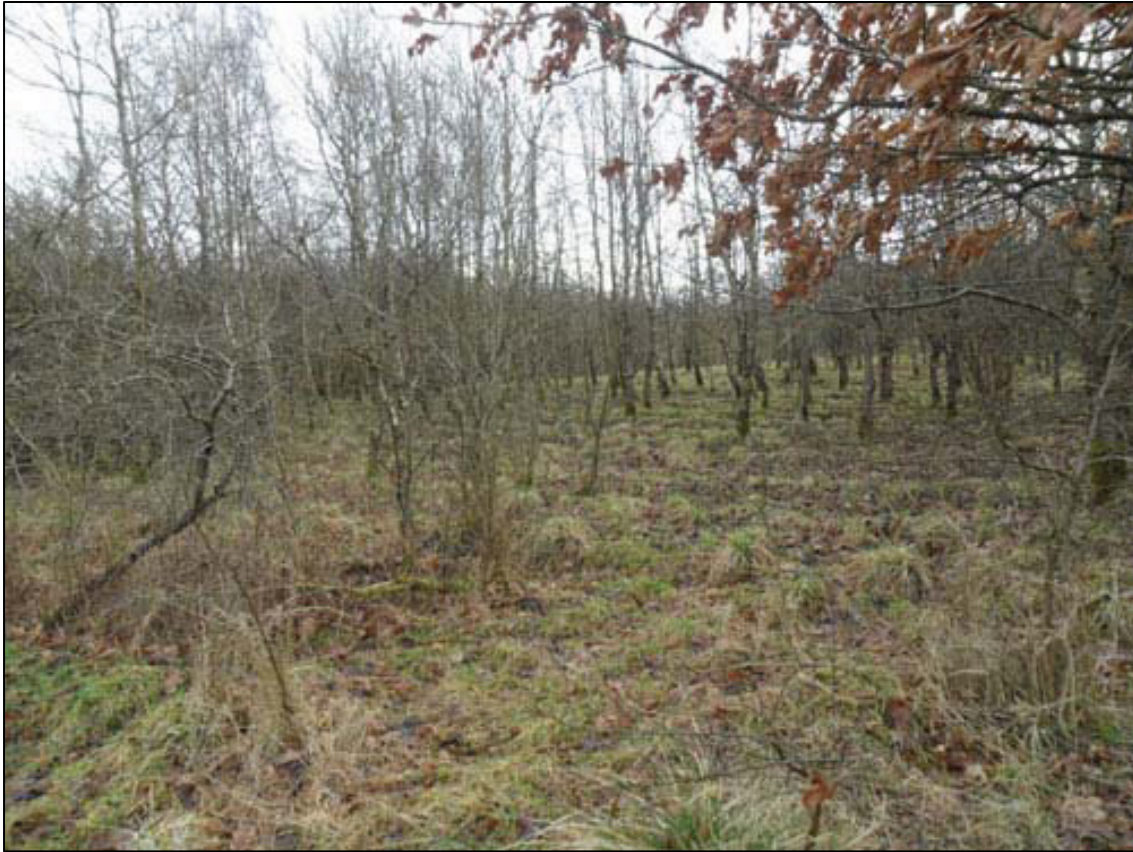
Figure 11a: Machine planting Parcel 2

22. The eastern two thirds of Parcel 2 slope more gently and uniformly. This area has almost entirely been covered in deciduous woodland. It is also clear that this woodland has been planted by ploughing and therefore heavily disturbed the landscape (Figure 11a). The Desk based work had identified mine workings and, possibly, accompanying railway in the vicinity of Parcel 2. However, apart from the obviously artificial nature of the landscape in the western third no upstanding evidence of this remains. A drystone boundary wall (**RA11009b.04**) was recorded running north-south (Figure 6b) at the east end of Parcel 2. This wall ran to the known location of the demolished North Mains House (**RA11009b.05**).

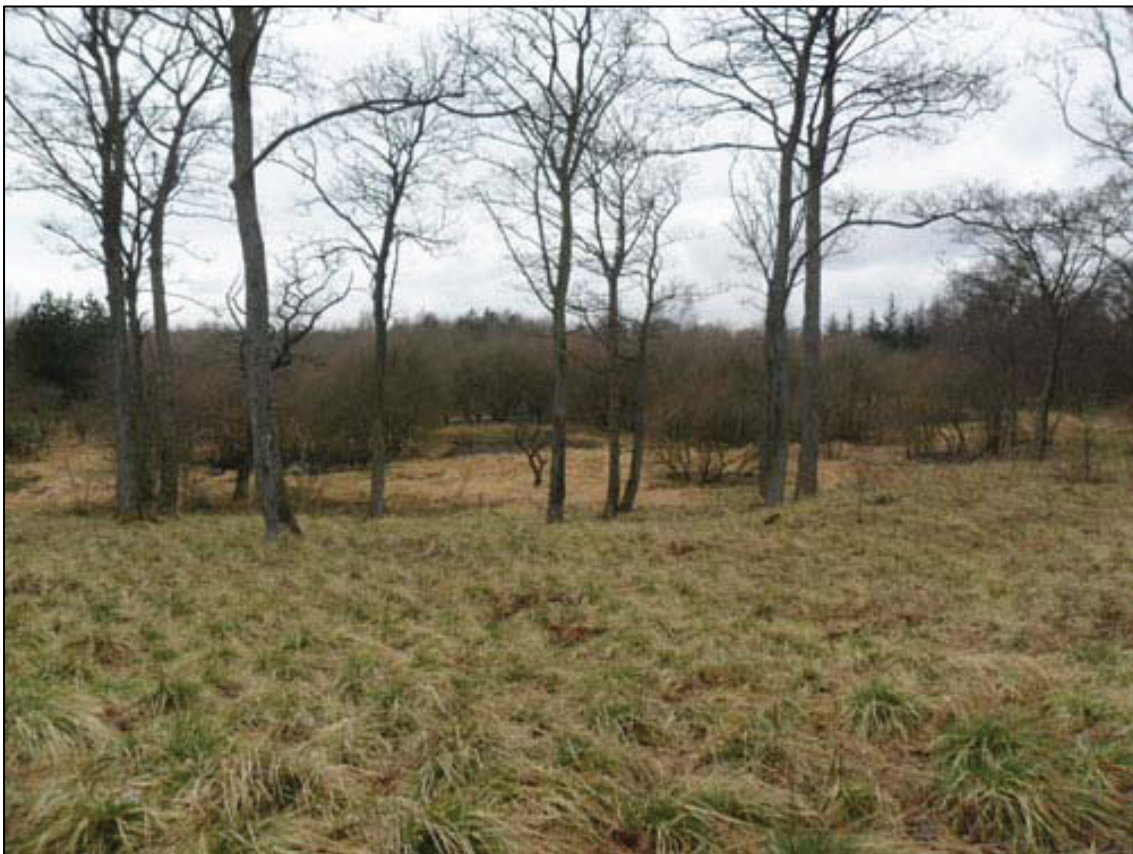
Figure 11b: Eastern end of Parcel 3

24. The eastern third of Parcel 3 has a more varied topography. It slopes down from the south and east to a waterlogged area in the centre (Figure 11b). Almost all of this area is woodland but only in patches is it ploughed and planted. Around the centre and south-east of this area there are large, widely spaced, mature trees. The north-eastern corner of Parcel 3 extends west in the form of two roughly triangular areas of ploughed and planted deciduous woodland. Some rough landscaping has taken place in the eastern third of Parcel 3 for the placement of footpaths.
