GEOPHYSICAL SURVEY REPORT 2006/46

WINDSOR CASTLE, Berkshire

2006 / 46 Windsor Castle, Berkshire

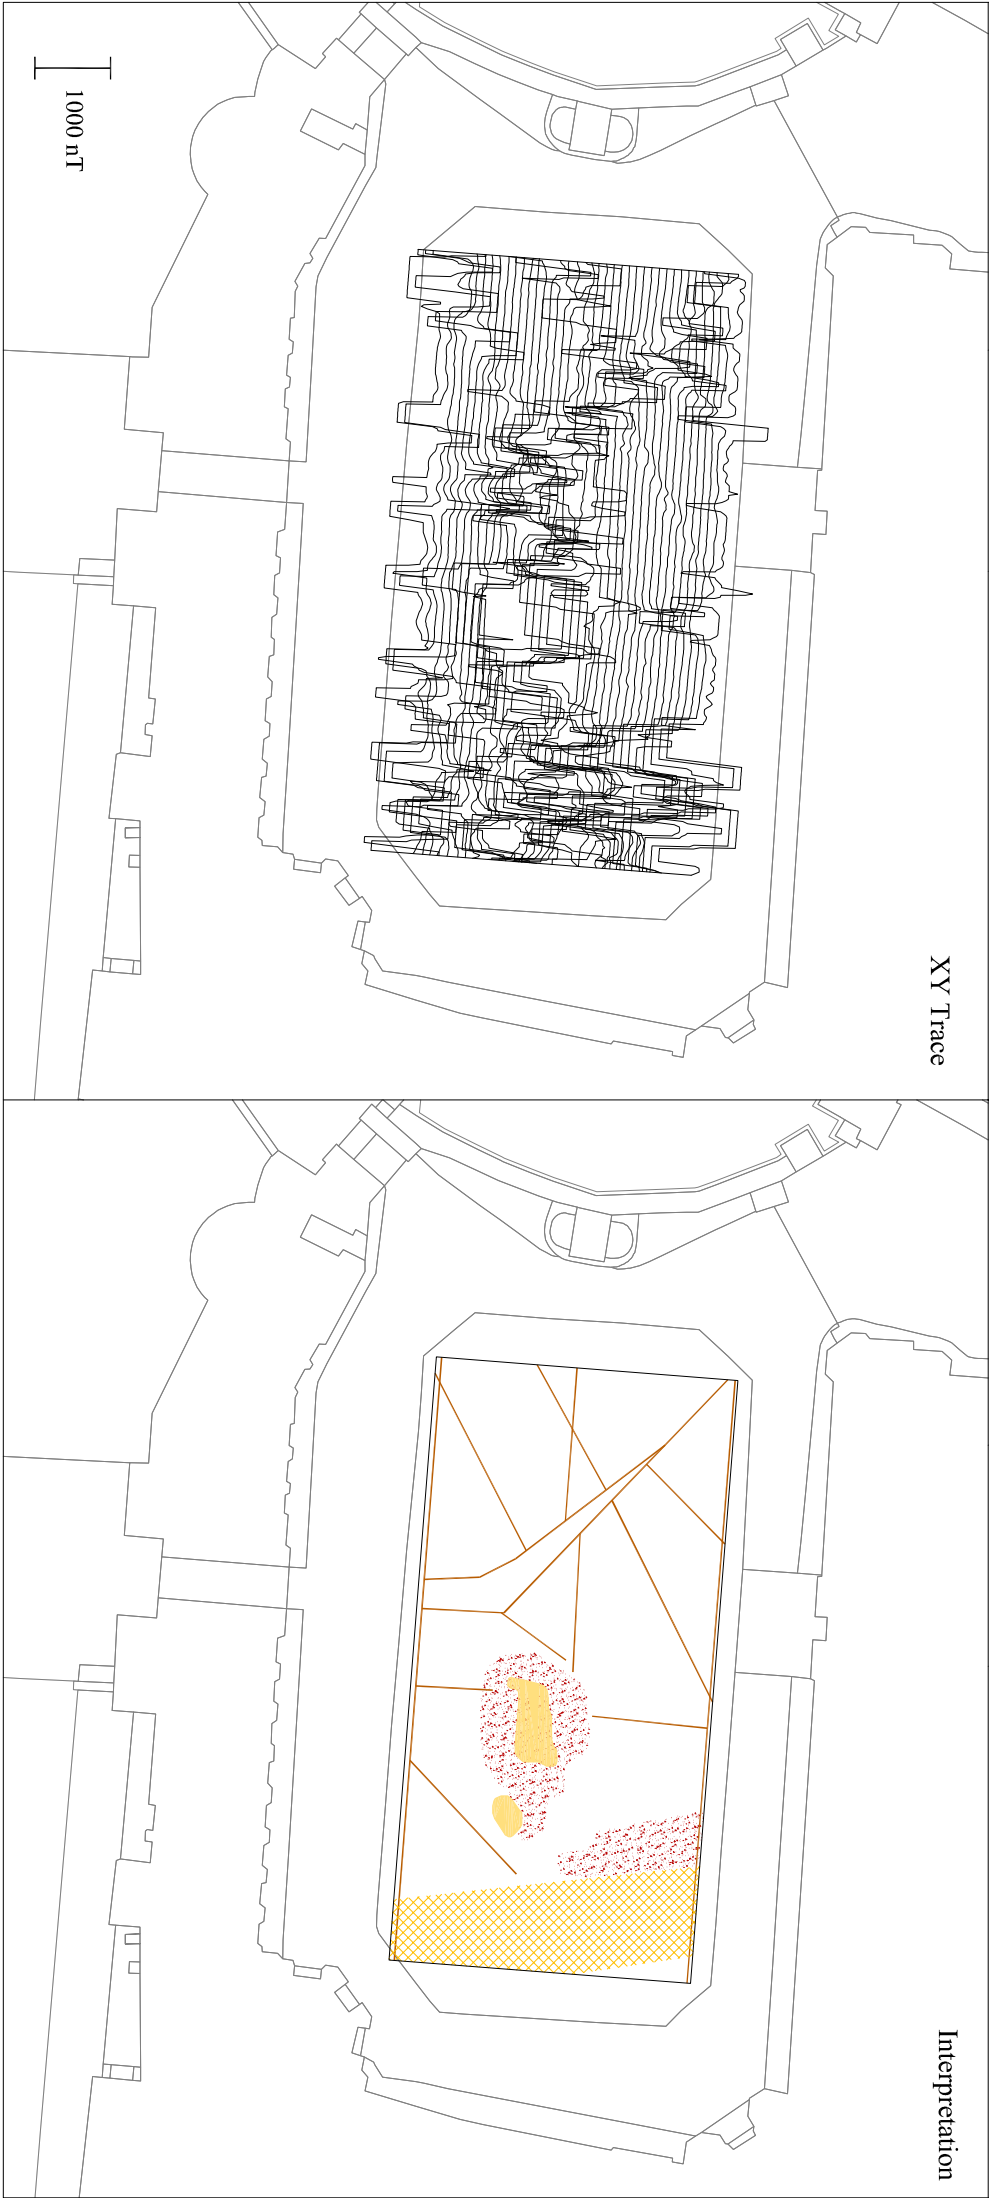
Figure 4

- 5.1 The fluxgate gradiometer data reflect a magnetically disturbed site; the strength of the anomalies associated with the buried services and the large 'tank' (see 4.1) that have been identified will have clearly masked any features of potential archaeological interest. However, the results can be used to pinpoint the location of services and compare the information with existing plans. It should be noted that some plastic pipes and cables may not have been detected by the gradiometer; a full 'Catscan' is recommended prior to any invasive work.

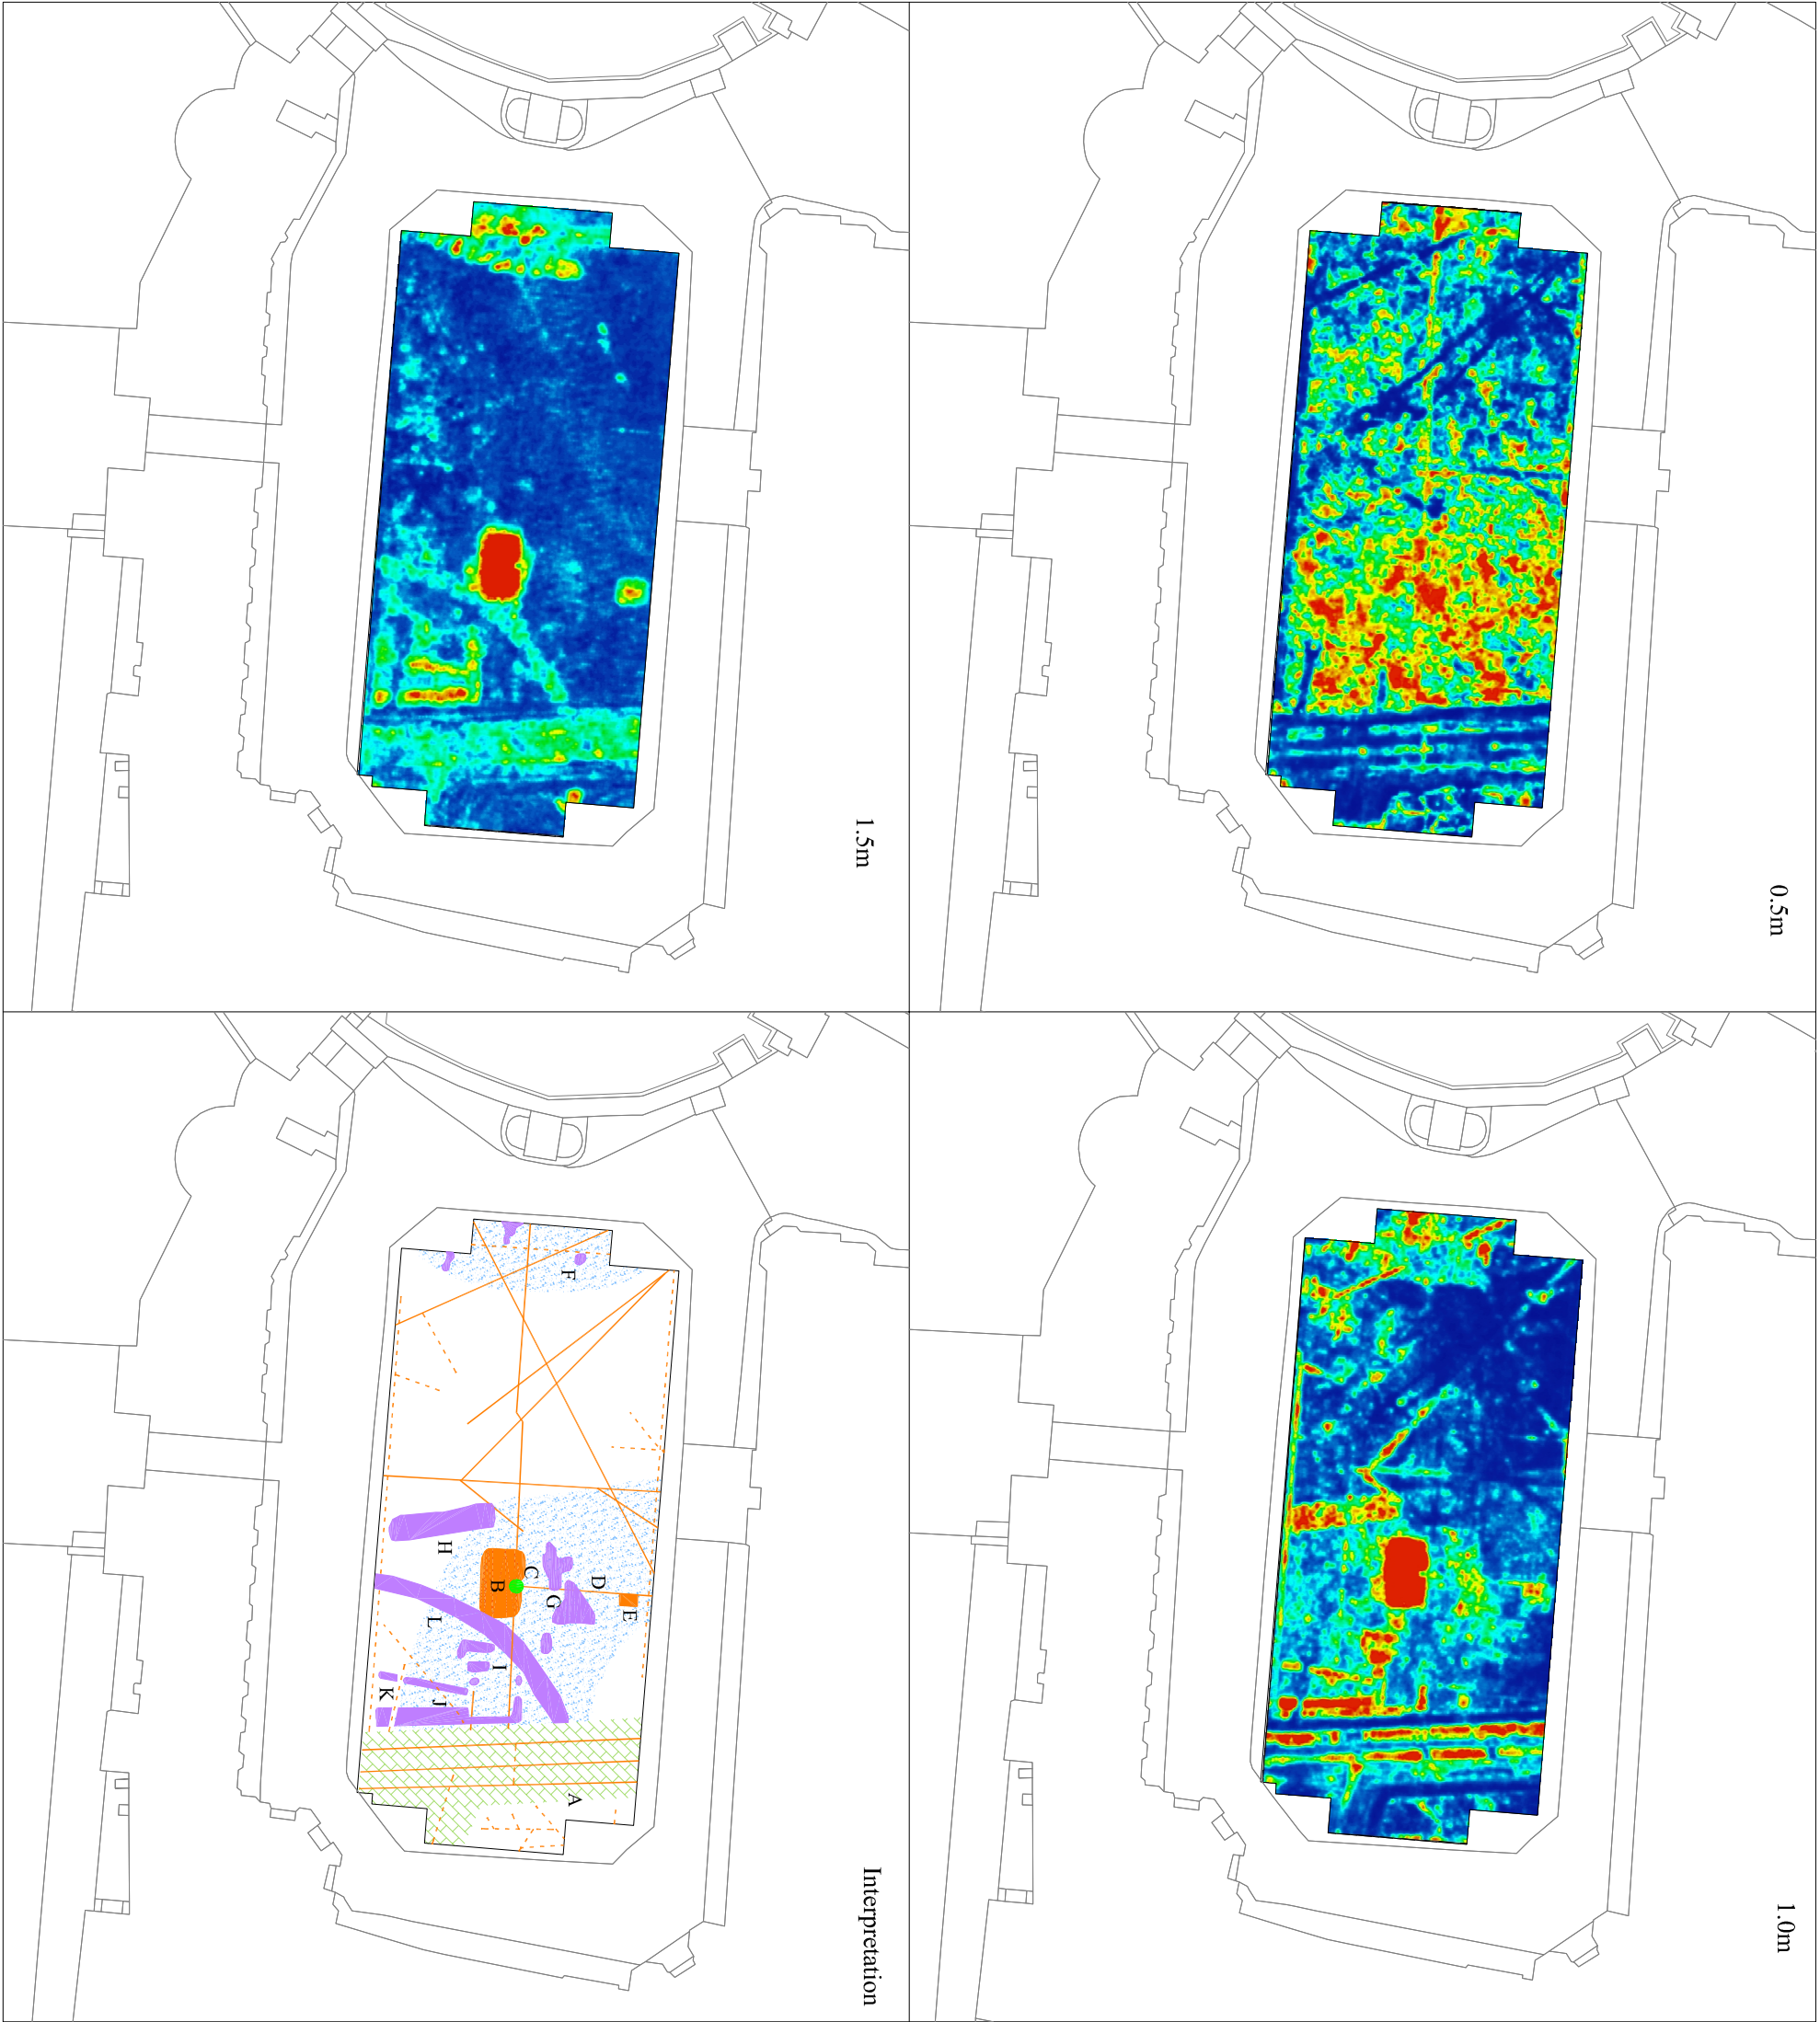
Figure 5

- 6.2 The most obvious services are those under the eastern end of the lawn where a broad anomaly (A) has been produced presumably by the digging and relaying of a large swathe of turf. This manifests as a zone of few reflections in the time-slices (Figures 5, 7 and 8) and a distinct discontinuity in the radargrams (Figure 6). Within this are three main services with a branch off to the southeast.

- 6.5 There is seemingly a central band of increased reflectivity, as indicated by the ‘increased amplitude response’ category in the interpretation diagrams (Figure 5), which is in contrast to the responses further west. The presence of services (A) has made ascertaining the eastern limit to this increased response impossible. Within this zone, as the time-slices deepen, more well-defined zones of high amplitude responses become apparent. Some of these (G) show little diagnostic form to aid interpretation, but they may still warrant further investigation as they are not obvious services.

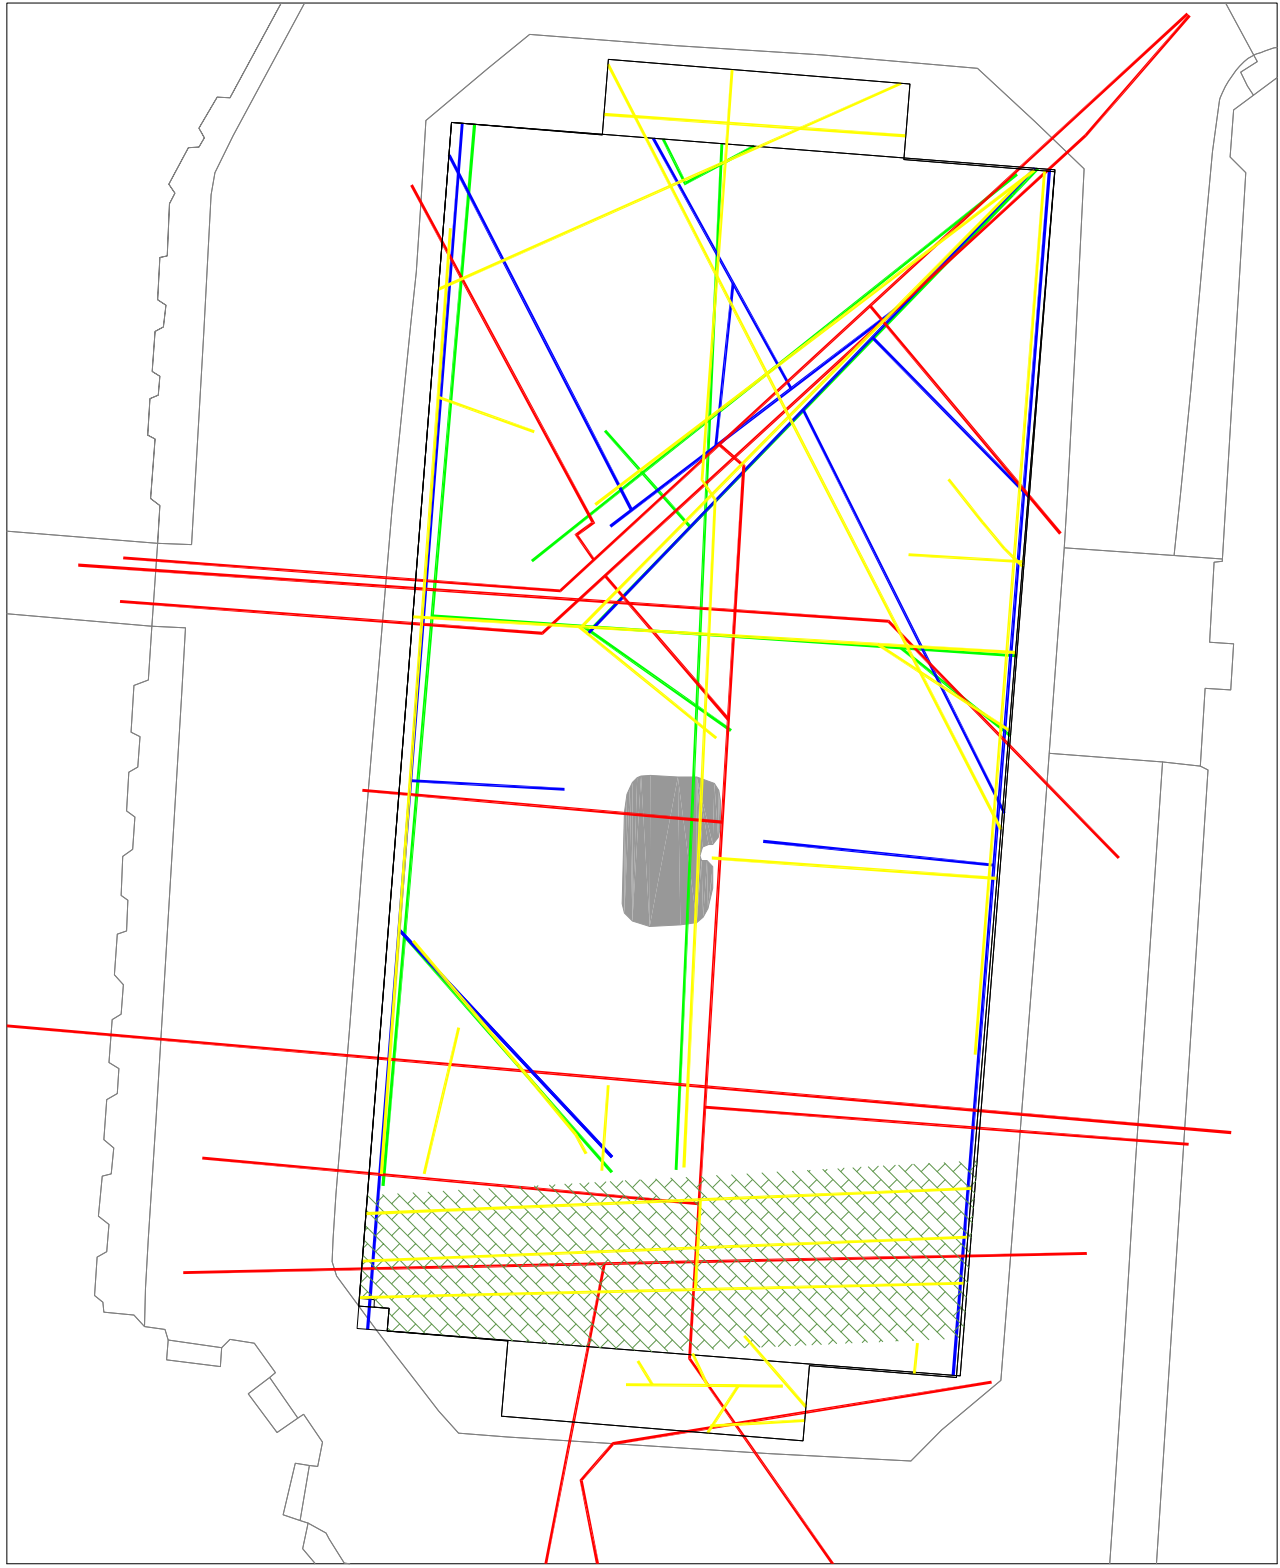
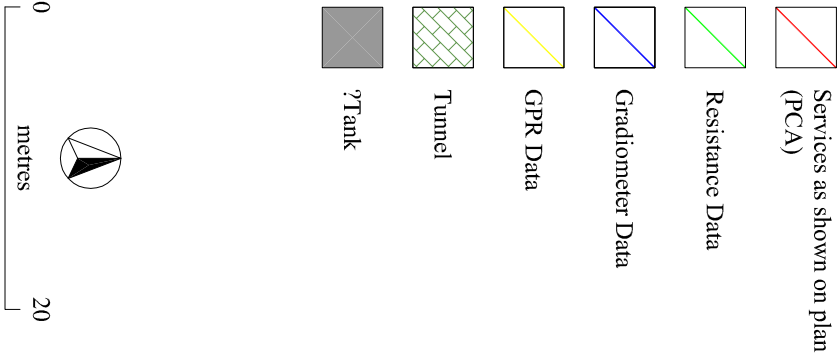
Figure 10 is a summary diagram showing the location of all the services detected by the three geophysical techniques plotted alongside the Ploughman Craven Associates (PCA) plan of known services. While there appears to be good correlation of the evidence the possibility that other services remain undetected or unmapped cannot be ignored.
