GEOPHYSICAL SURVEY REPORT

**Land adjacent to Chediston Street,
Halesworth, Suffolk**

Survey Report
10989

Date
March 2017

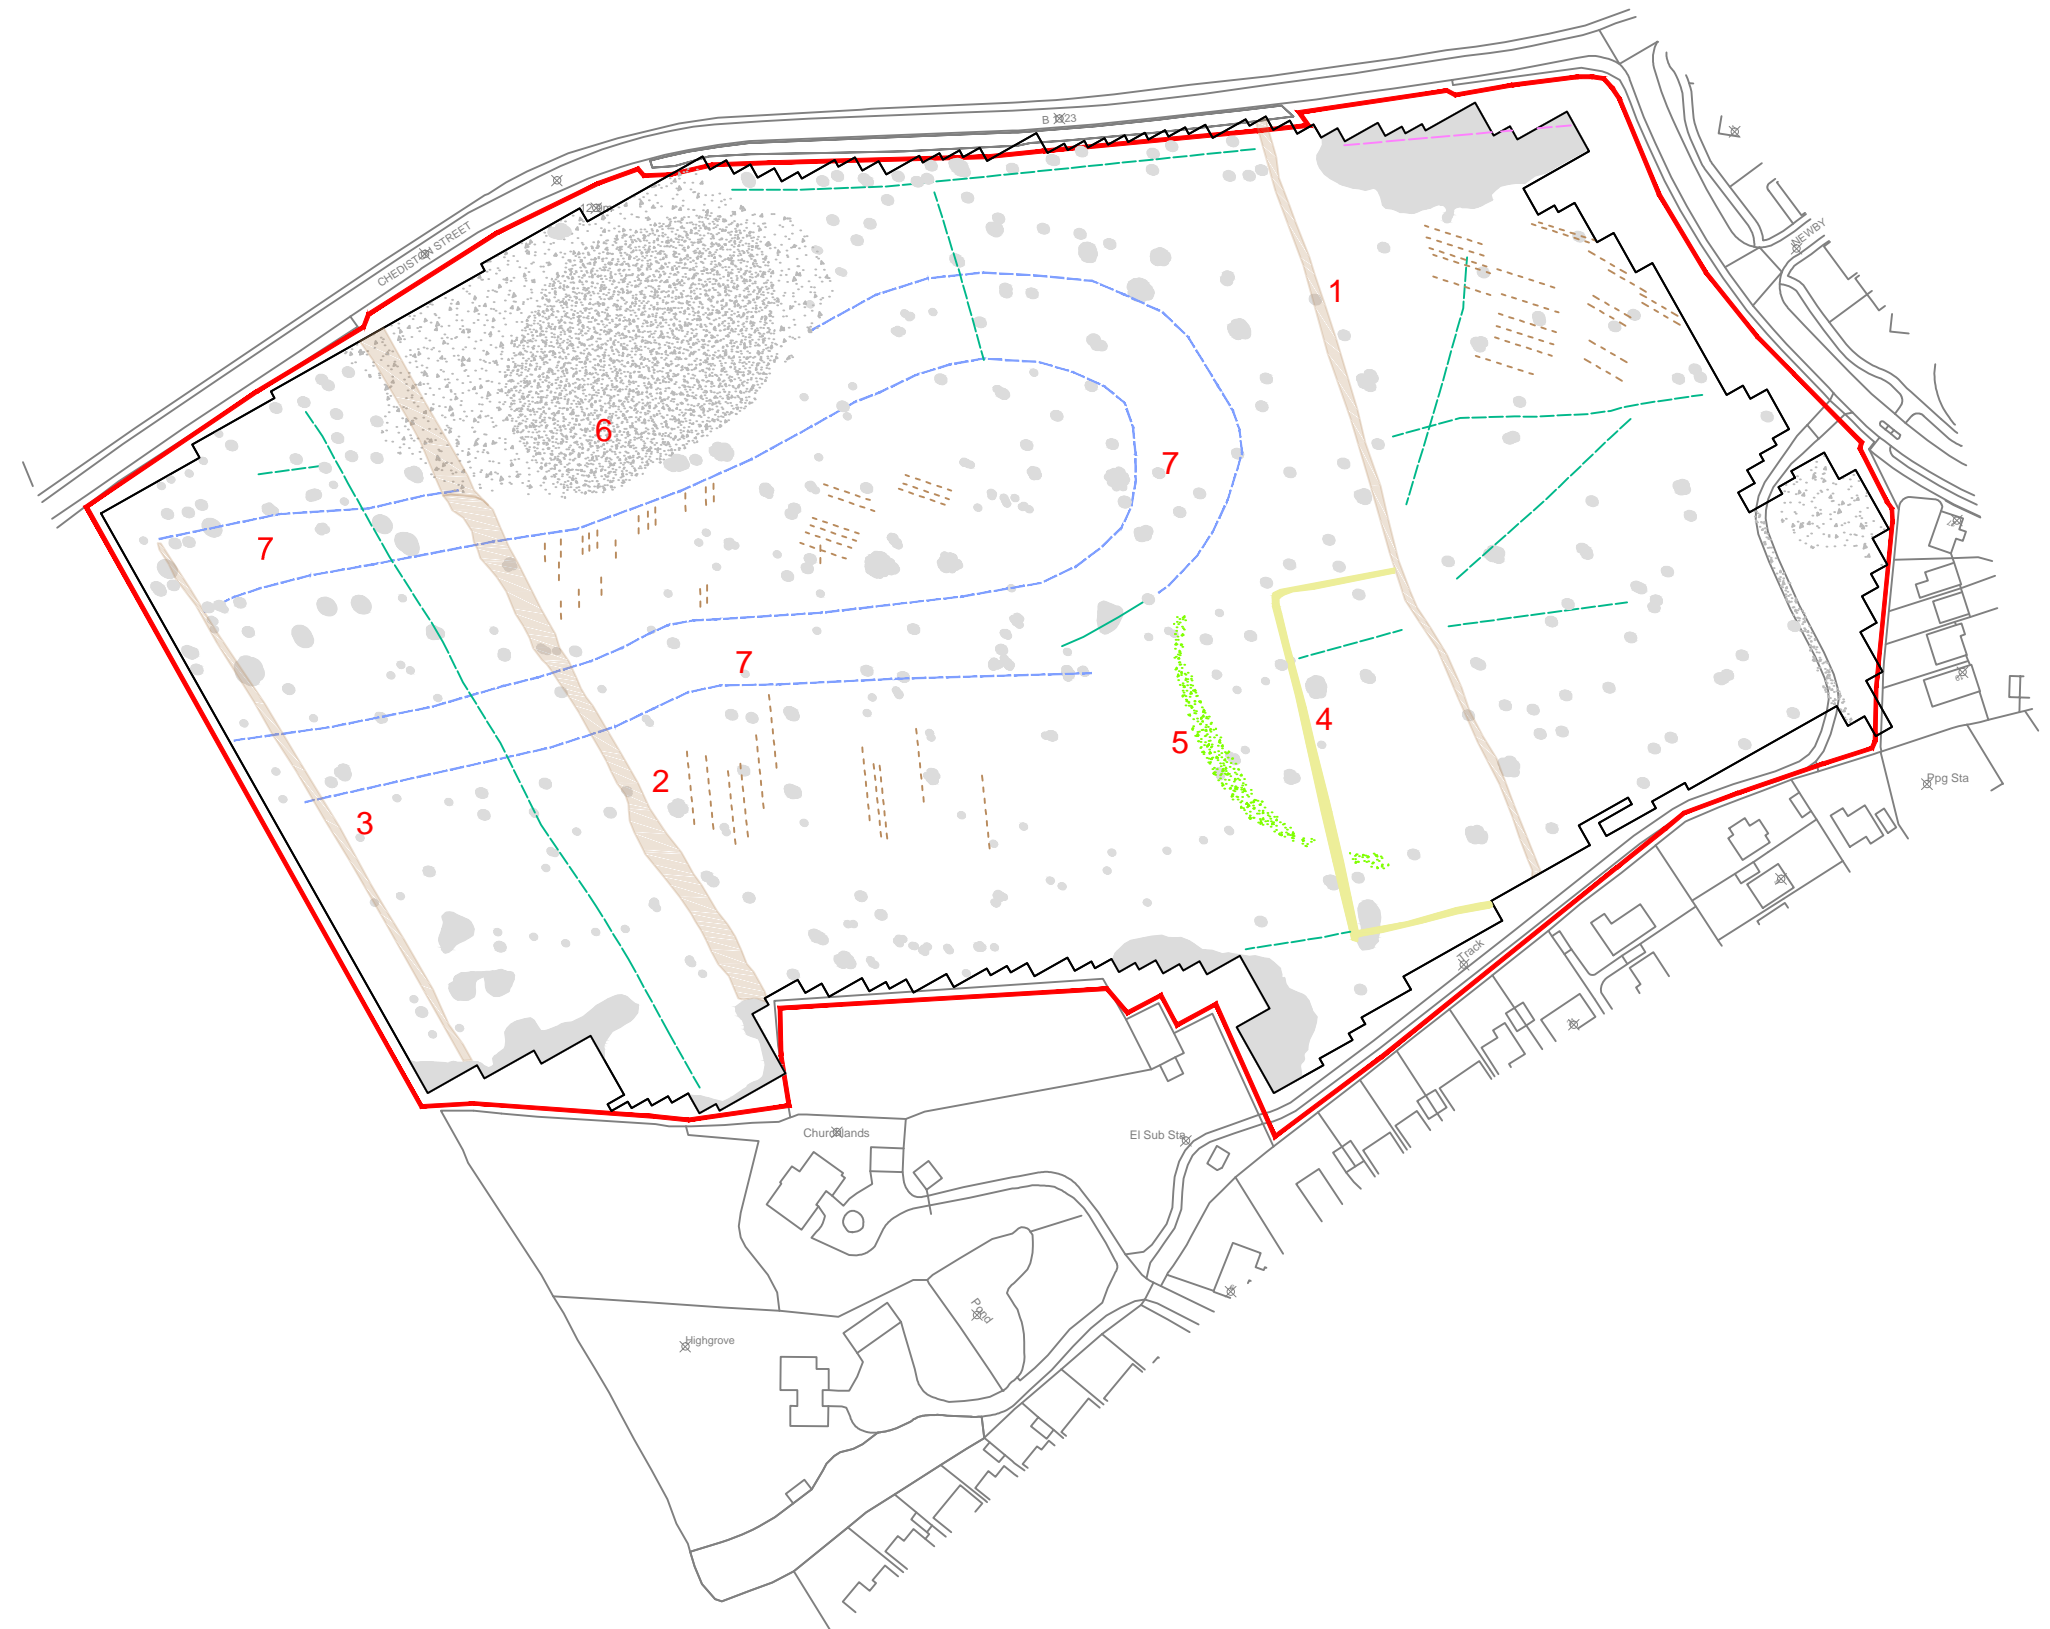
1:2000 @ A3	Fig No: 4

Title:	Magnetometer Survey Interpretation	
Client:	CgMs Consulting Ltd.	
Project:	10989 Land Adjacent to Chediston Street, Halesworth	
Scale:

Three former field boundaries are visible in the data as linear magnetic responses. Anomalies [1] and [2] are recorded on the 1884 OS map whilst [3] is marked on the 1938 map. The latter may simply coincide with the limit of allotments / gardens marked at this location.

Linear anomaly [4] appears to be appended to [1] forming a small rectilinear enclosure though nothing is visible on early mapping to support this interpretation. It seems unlikely that the feature is of any great antiquity.

A narrow curving band of amorphous responses [5] is typical of natural magnetic anomalies recorded on sands and gravels.

An area of magnetic disturbance [6] coincides with the location of a former sandpit visible on mapping between 1888 and 1957, but infilled by 1972. Modern debris including general rubbish has been dumped on the site of the pit and this accounts for some of the disturbance.

A former horse racing track is clearly visible in the data [7] and it survives as a feature on the ground. It is also visible on Google imagery as a clear image.

There are several linear trends in the data, especially in the eastern part of the site; they could be agricultural, or related to the horse racing track. As such, a more precise interpretation is not possible.

Ferrous responses close to boundaries are largely due to adjacent fences and gates, though a linear in the north-east corner marks a service pipe and manhole cover. A large metal container and farm machinery has added to the ferrous responses.

Smaller scale ferrous anomalies ("iron spikes") are present throughout the data and their form is best illustrated in the XY trace plots. These responses are characteristic of small pieces of ferrous debris (or brick / tile) in the topsoil and are commonly assigned a modern origin. Only the most prominent of these are highlighted on the interpretation diagram.
