BARN NEAR SHORTRIDGE COTTAGE

LITTLE SHORTRIDGE

Historic Building Recording and Archaeological Monitoring and Recording

South West Archaeology Ltd. report no. 220726

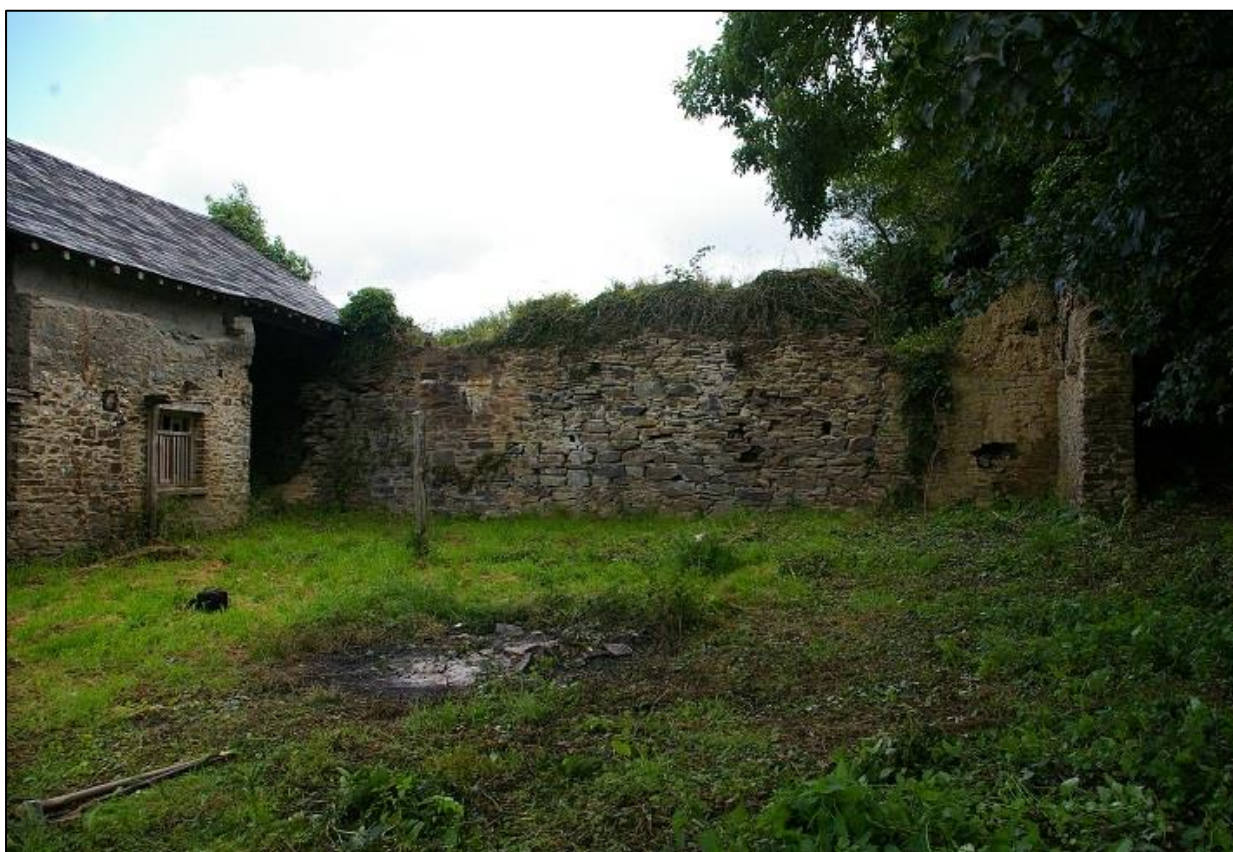
The site survives as an L-shaped range, ruined to the south-east, upstanding but patched with a lot of corrugated sheeting to the north-west. The scarring on the walls and footprint, including some historic cobbled areas indicate that the complex was once larger and possibly U-shaped with a south-eastern range having been lost, the north-west standing range has also been truncated at the west end, obviously once much longer and the eastern rear range now only survives as multi-phase rebuilt stone wall.

FIGURE 7: THE RUINED WALLS WHICH FRAME THE STANDING BARN ON THE SITE; FROM THE WEST.

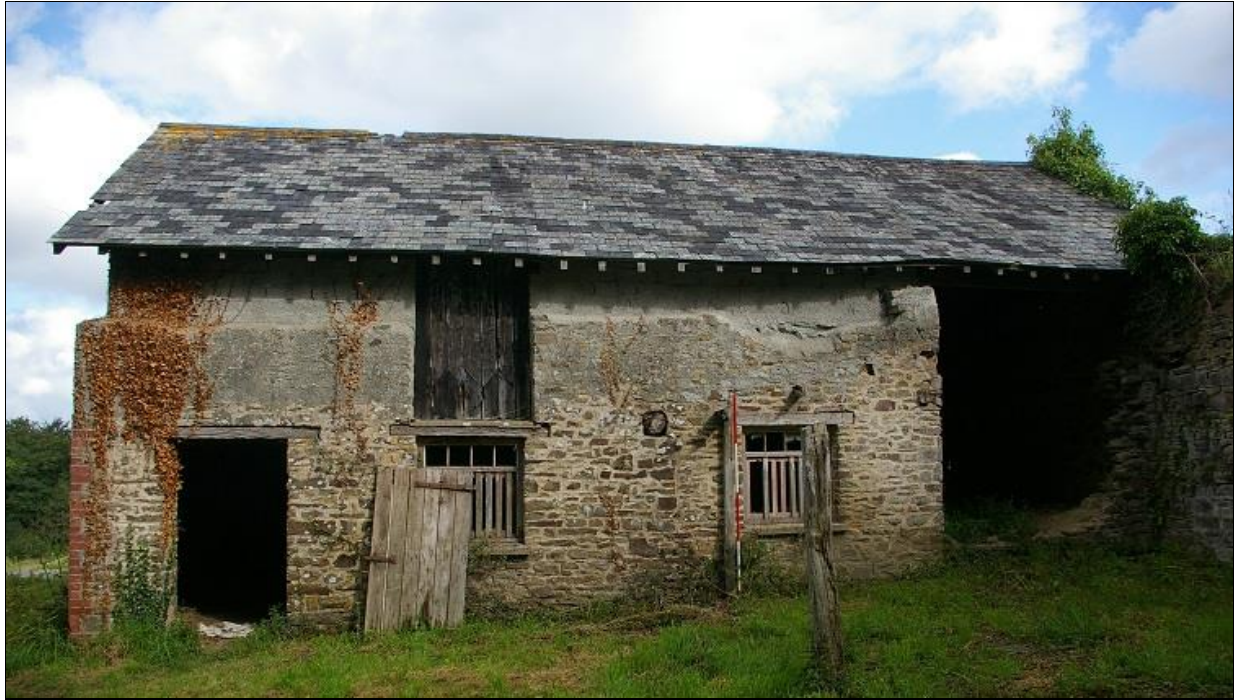
The south elevation of the standing barn is of random rubble, a mix of local stone, in a clay and lime mortar with some brick repairs, and patches of cob used as mortar; above is a grey cob build to the west end, with the upper wall to the east rebuilt in cement mortar, thinly coated by sprayed cement render. The wall is raised (c.0.5m) in concrete block at the eaves, from one and a half storeys to a full two storeys and this is also covered by a thin coat of sprayed grey cement render. The openings on the ground floor of the elevation are a pedestrian door to the west end, with thin timber lintel, the door frame removed and two windows, one to centre and east. The centre window is set low in the wall, with concrete sill and thin timber lintel, it has a plain timber frame with hopper opening casement above timber barred lower louvre, slatted for air venting.

The eastern window has been formed in an area of disturbed stone, where it looks like an adjacent wall, running south has been demolished and the former joint repaired. There is a build line, with a set of quoins; to the east of this build line the rubble is infill/rebuild, where the adjacent range was demolished. The window is taller and slightly narrower than that to the centre, but has the same fixed pane hopper opening, now without glass, above a slatted louvre system. Above at first floor is a large loading door, accessing the loft, with a 20th century plank door on iron hinges. This opening has been forced in with a shallow cap of concrete over the timber lintel of the window below. To the east end a contiguous roof covering encloses and open space, boxed in with corrugated sheeting to the north, bounded by a cob and stone wall to the east end. This has been used for equipment storage in the recent past. There are the remains of a cobbled floor here, open to the elements, patched with concrete block. The open area has been formed by the demolition of a stone wall, the ragged end of which can be seen to the right-hand side, projecting from the eastern stone wall of the complex.

FIGURE 8: THE SOUTHERN ELEVATION OF THE STANDING BARN; FROM THE SOUTH-SOUTH-EAST (2M SCALE).

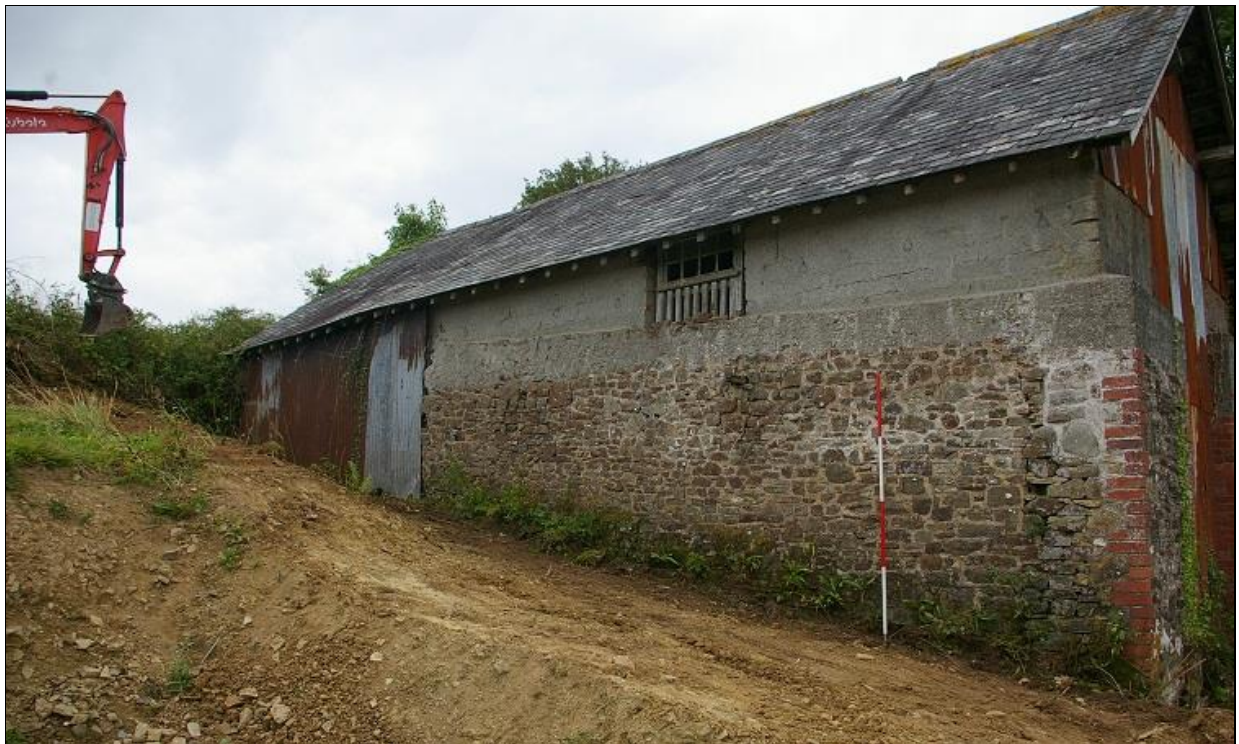
The long north wall of the barn has largely been rebuilt to the west and centre in the same rubble as the west elevation, loosely packed with lots of lime mortar; this is supported by internal piers. The wall has had the same cement render treatment to the top of the stonework which looks to have been rebuilt with a cement mortar and above there is again a raise of c.0.5m at the eaves. The west end of the stonework is again ragged, with evidence of the range being truncated, the newer stone and brick crudely tied in. A window has been created in the upper concrete block raise, this appears to recycle a domestic small pane 19th century frame, with slats nailed over the removed lower pane, to create a louvre. To the east end, the wall it reverts to cob on a low stone plinth but is covered externally with corrugated sheeting; internally this earlier walling can be seen to have collapsed and been removed, with merely a slump of fallen stone and soil to the north-east corner.

FIGURE 9: THE NORTH WALL OF THE BARN; FROM THE WEST-NORTH-WEST (2M SCALE).

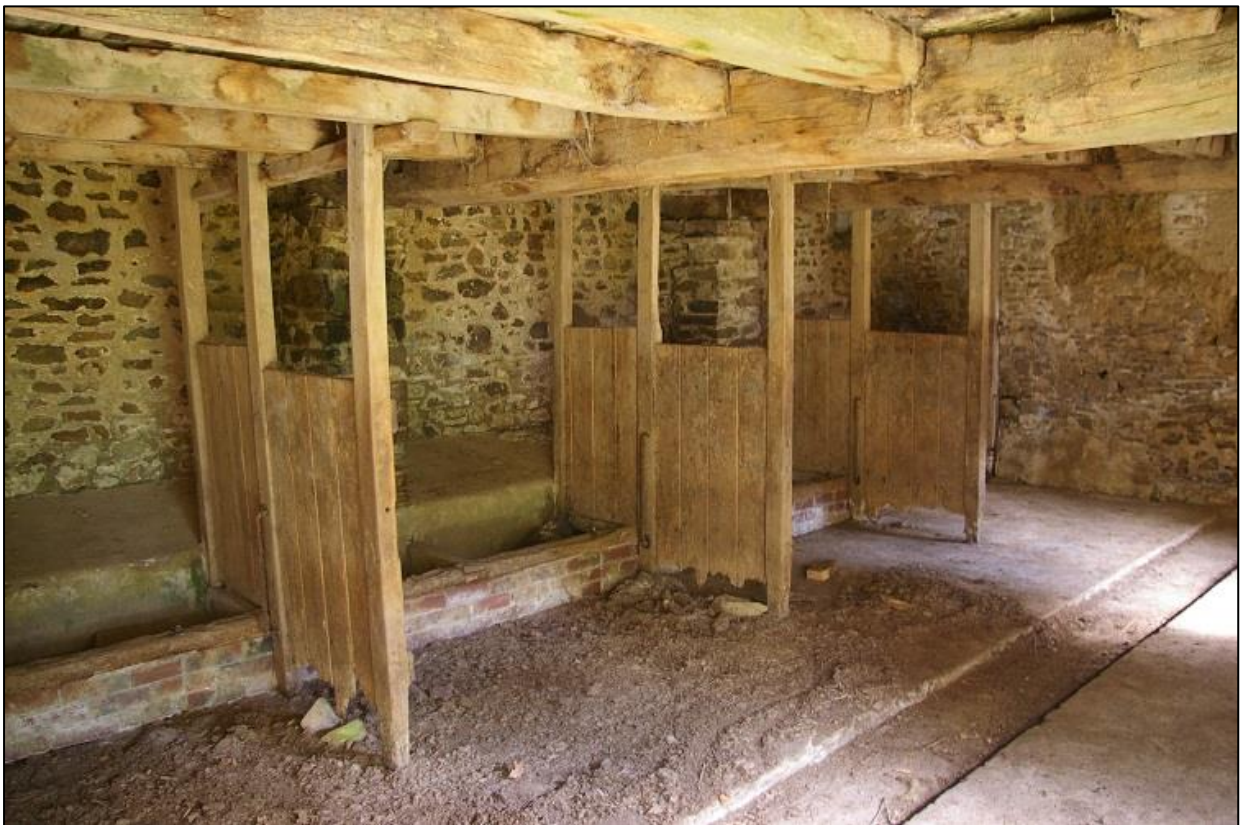
Inside the standing barn, on the ground floor there is a cobbled floor with central drain, covered by a thick layer of concrete, visible in the rough cross section exhibited by the truncated west end. There is a wide 'feed passage' to the south side of the space, with pine plank and post stalls of 19th century date to the north side of the space, served by 20th century brick troughs, smoothed by cement render, built between stone piers, where there are also cattle chains in situ. Behind the troughs, which have had to be cut into and under the stalls there is a large, infilled mass of cement and concrete block, it appears these may have been higher rubble troughs, (for horses?) immediately adjacent to the wall but have been used as a form of underpinning to support the north wall when the ground levels changed within the field. The interior of the west wall is lined with concrete block, the outer stonework seemingly a single outer skin. The 19th century stalls are spiked to heavy beams, with chunky chamfers and run out stops, which are carried on the stone piers at the north side of the space, socketed into the wall to the south; suggestive of these being reused, since they are too short for the space and have a much more weathered patina. There are also some adze-cut chunky joists, carrying the loft, which have been fixed into the back of the beams, in sockets intended for larger timbers, many braced with a small wedge, cut with overlapping joints. The planks of the loft are thick in depth, wide, some of oak but looking at grain pattern some may also be elm; these also exhibit nails and spikes, holes and socket marks which suggest they may also have been reused here, sourced from another building. No fittings survive in the loft and only one historic truss remains in the roof structure.

FIGURE 10: THE TIMBER STALLS AND BRICK TROUGHS; FROM THE SOUTH-WEST.

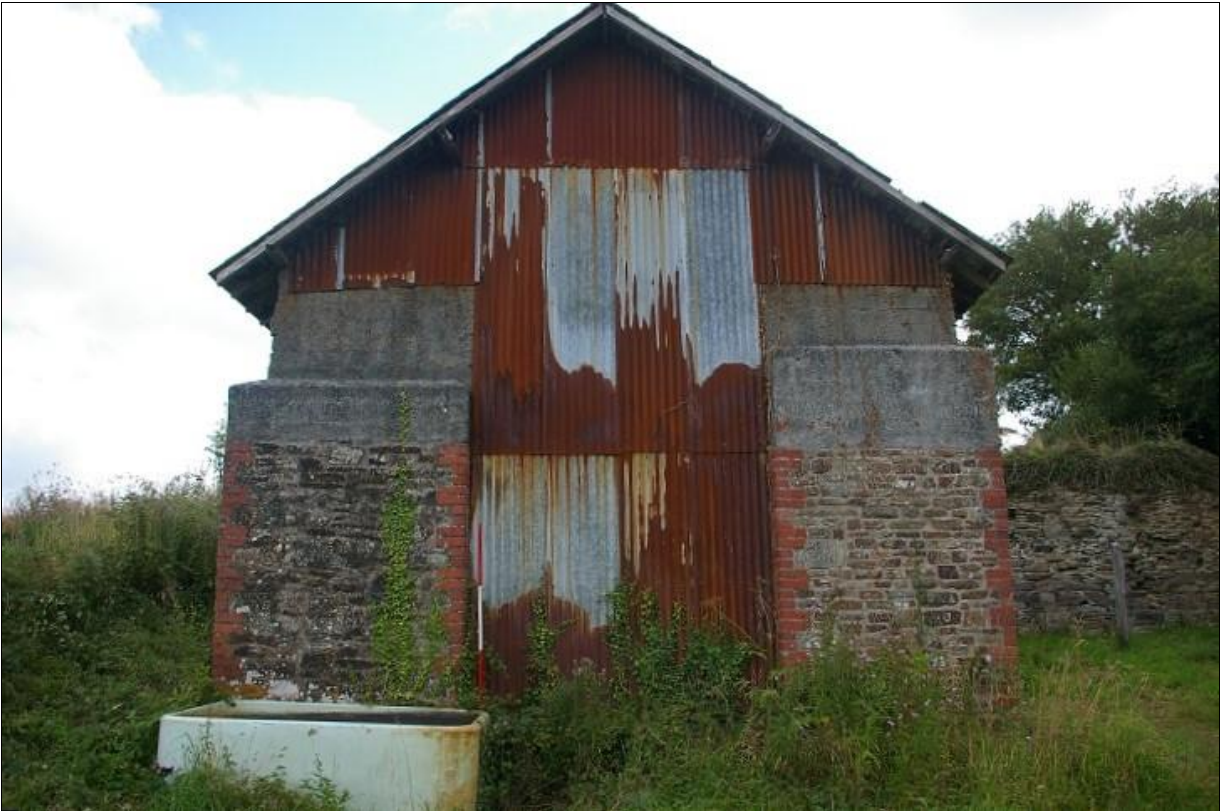
The west gable end elevation which faces across the valley has largely been rebuilt in rubble stone, in cement mortars, with brick quoins, an early-mid 20th century repair, the ragged poorly patched north and south walls evidence this building has been truncated here. The upper part of the gable has been infilled with corrugated tin. At the base of the wall more ragged stonework and a truncated stone cobbled floor, projecting below the concrete floor installed inside, again indicates that the range continued. There is a significant change in ground level between the former floor of this building and the platform it was built on and the current access track and sloping yard, this suggests a large amount of ground surface has already been removed in the 20th century, with the associated loss of archaeological deposits.

2. THE WESTERN, TRUNCATED ELEVATION OF THE BARN (2M SCALE), REBUILT IN THE 20TH CENTURY; FROM THE WEST.

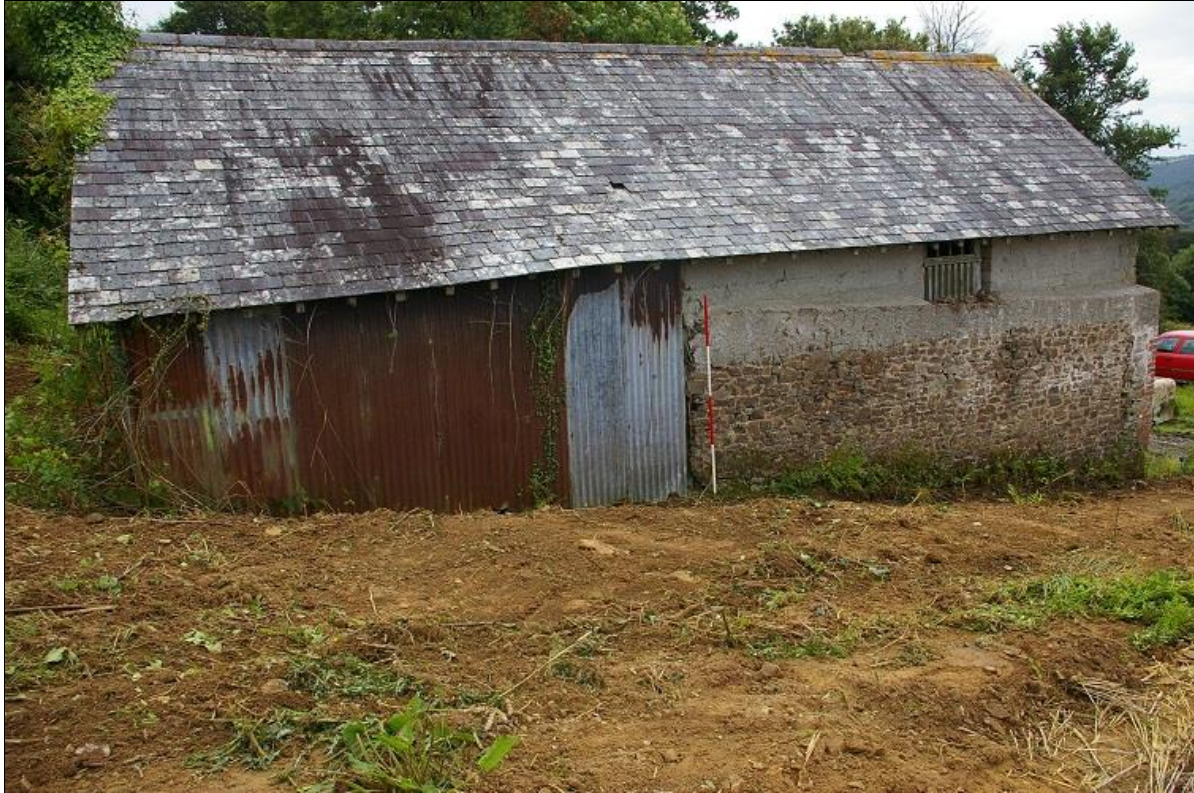
3. THE NORTH WALL OF THE BARN (2M SCALE), WITH CLEARED VEGETATION; FROM THE NORTH-NORTH-EAST.

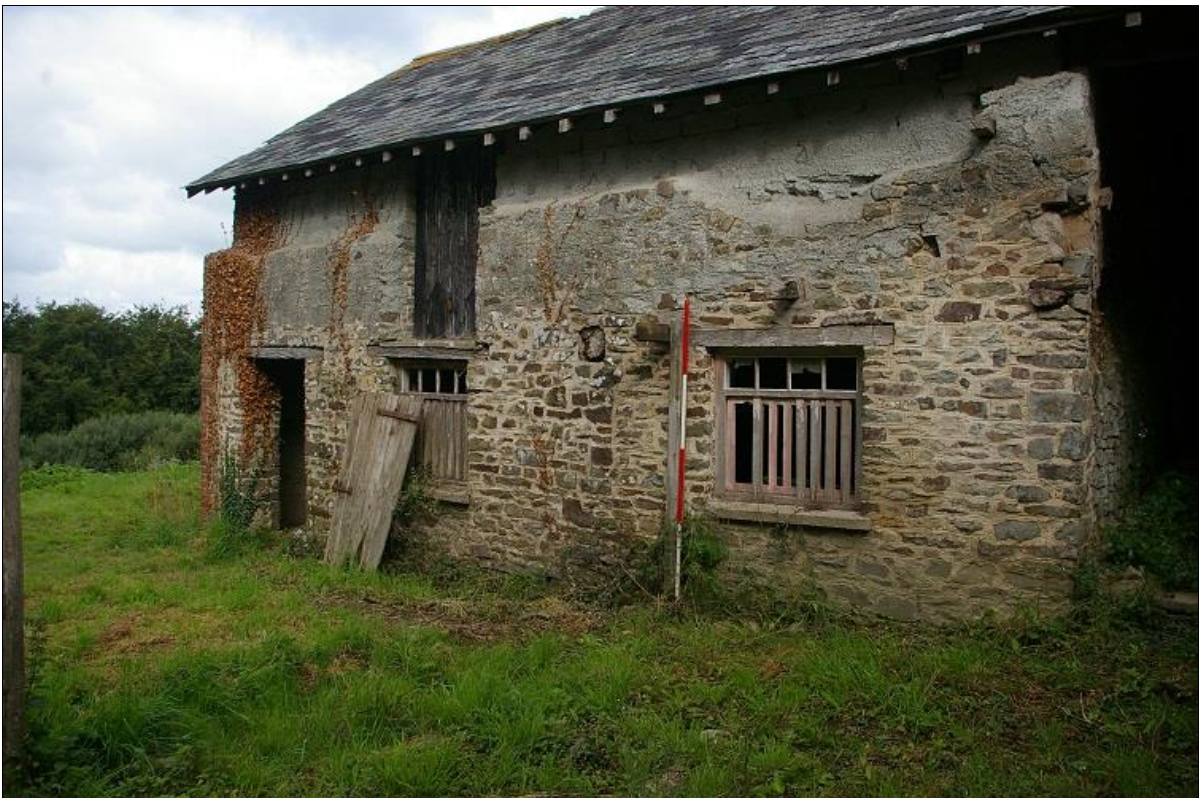
6. THE STANDING BARN (2M SCALE), SHOWING BUILD LINE TO THE CENTRE OF THE ELEVATION, FROM THE SOUTH-EAST.

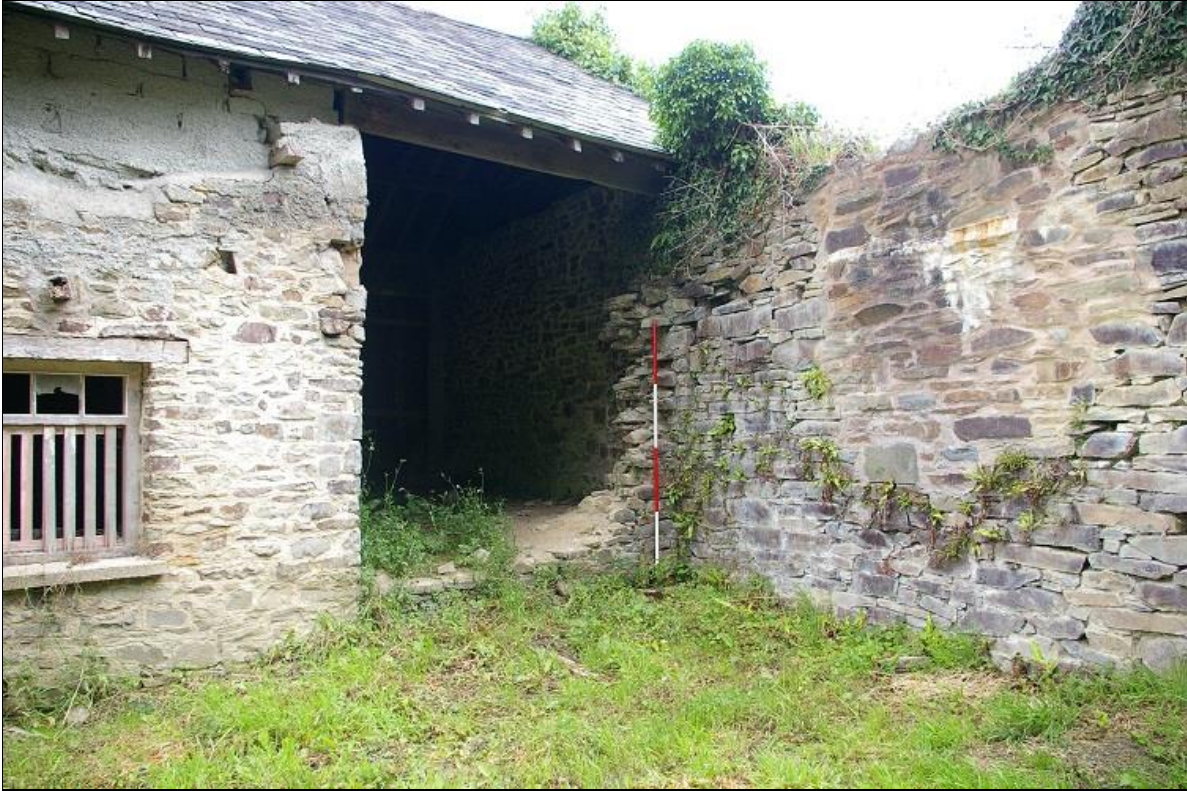
7. THE EAST WALL OF THE COMPLEX, WITH MULTIPLE PHASES OF REBUILT WITHIN THE STONE (2M SCALE) AND TRUNCATED EAST END OF THE STANDING RANGE; FROM THE SOUTH-WEST.

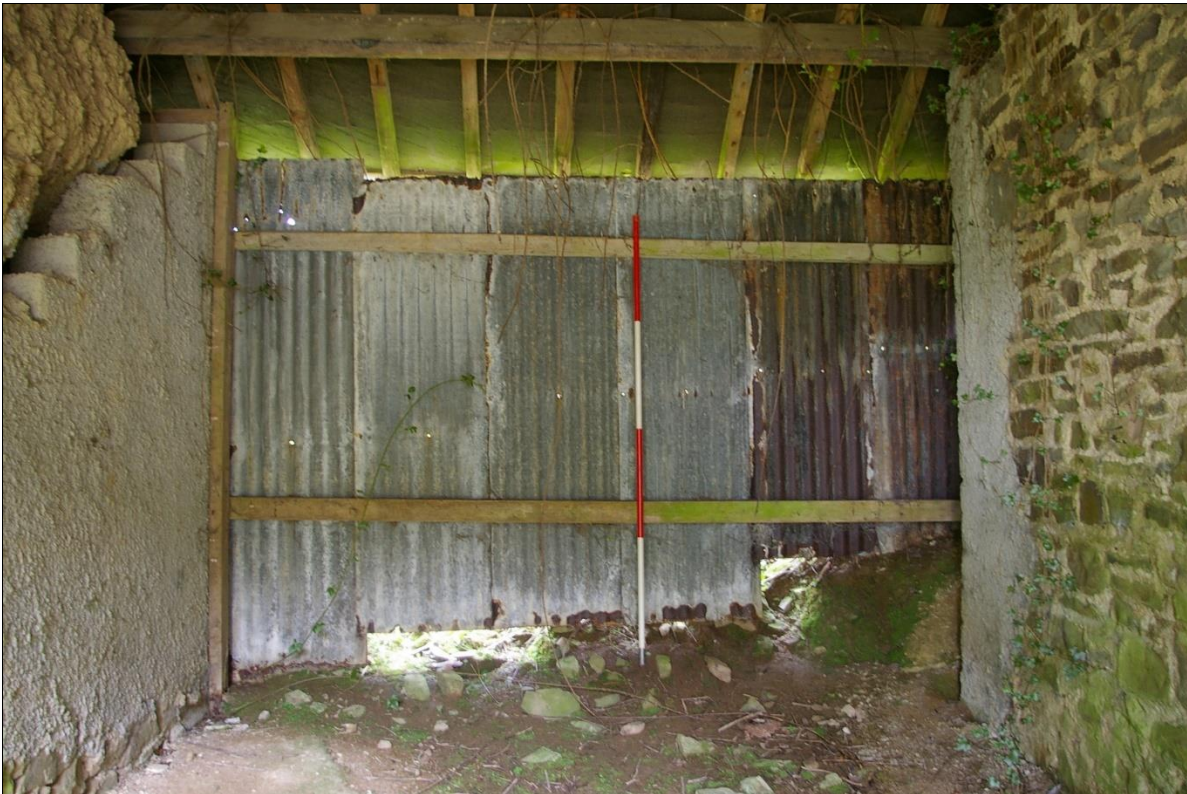
8. THE TIMBER AND CORRUGATED FRAMING AT THE EASTERN END OF THE STANDING RANGE (2M SCALE); FROM THE SOUTH.

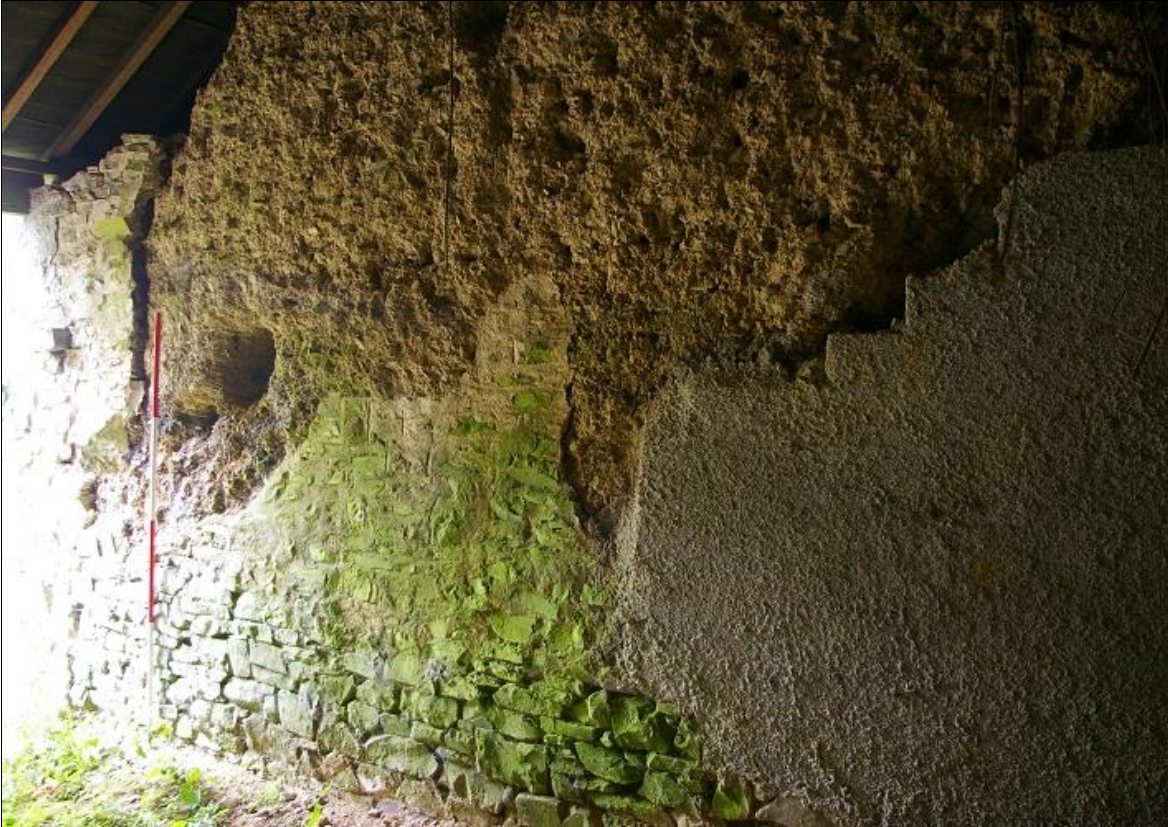
9. THE THICK COB WALL TO THE EAST END OF THE STANDING RANGE, A FRAGMENT OF AN EARLIER COMPLEX (2M SCALE); FROM THE NORTH-EAST.

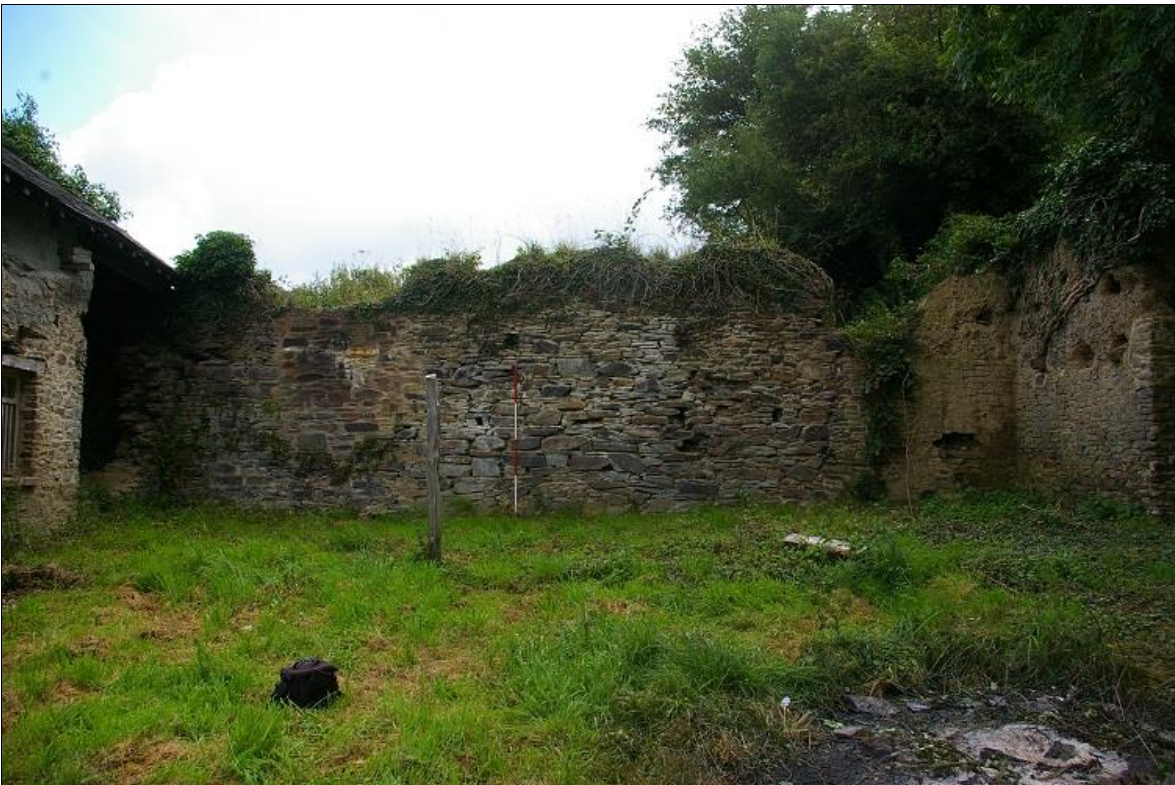
10. THE EAST WALL, LINKING THE EARLIER COB RANGES (2M SCALE); FROM THE WEST.

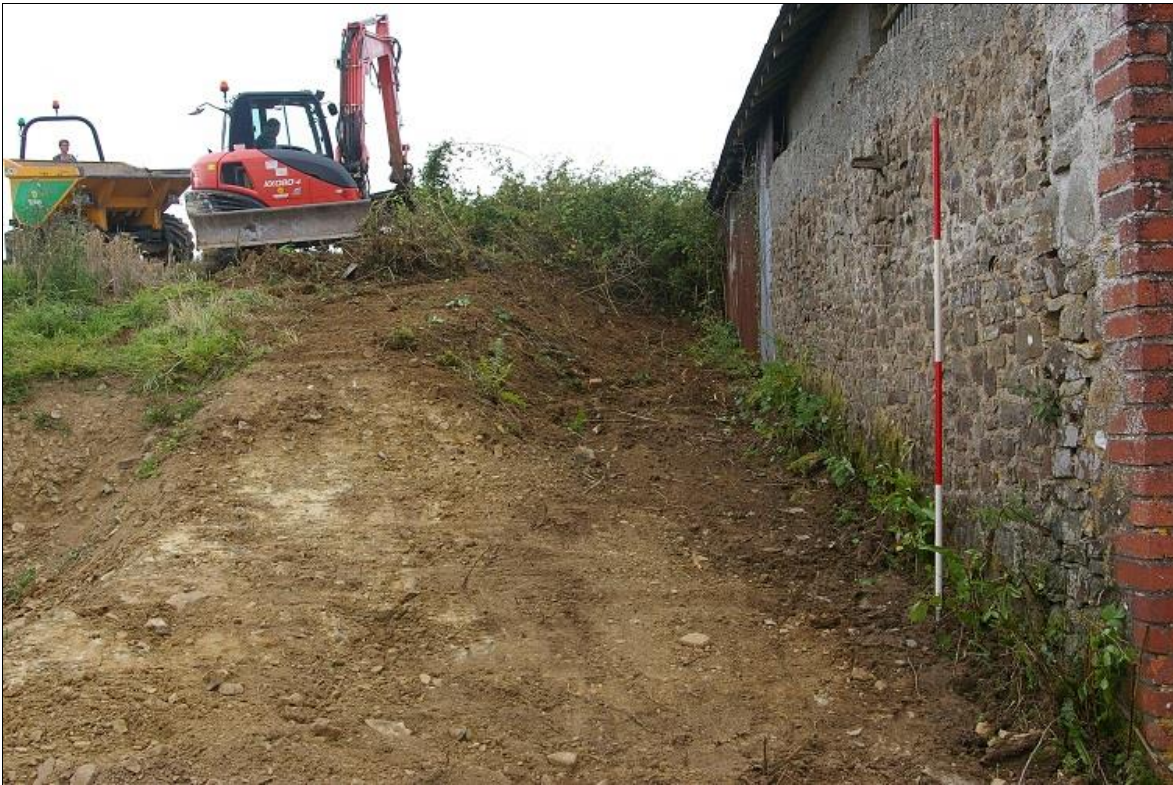
12. VIEW ALONG THE NORTH ELEVATION OF THE STANDING BARN, WITH FOLIAGE REMOVED, SHOWING BANK AND HISTORIC CUT/TERRACE FOR THE BUILDING, FILLED WITH DARKER, LOOSE SOIL (2M SCALE TO SIDE); FROM THE WEST.

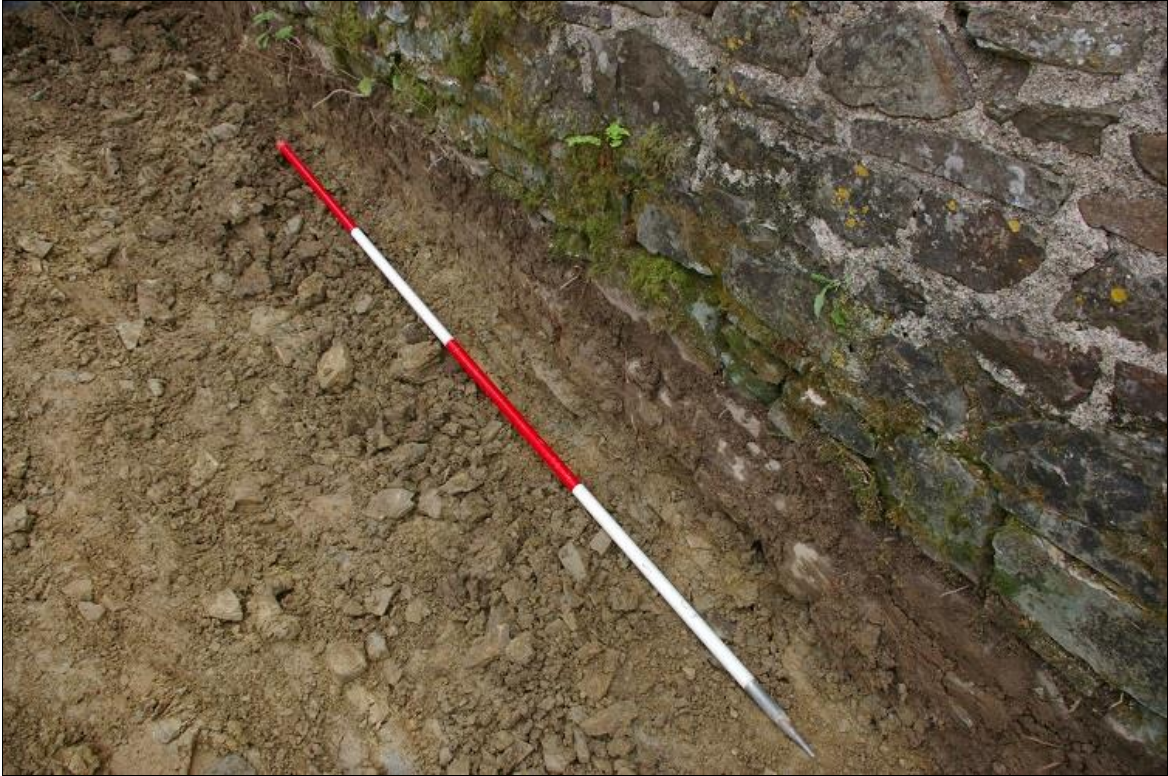
13. THE BASE OF THE NORTH WALL OF THE BARN, BUILT ONTO THE ROCKY SUBSOIL AND SHILLET (2M SCALE); FROM THE WEST-NORTH-WEST.

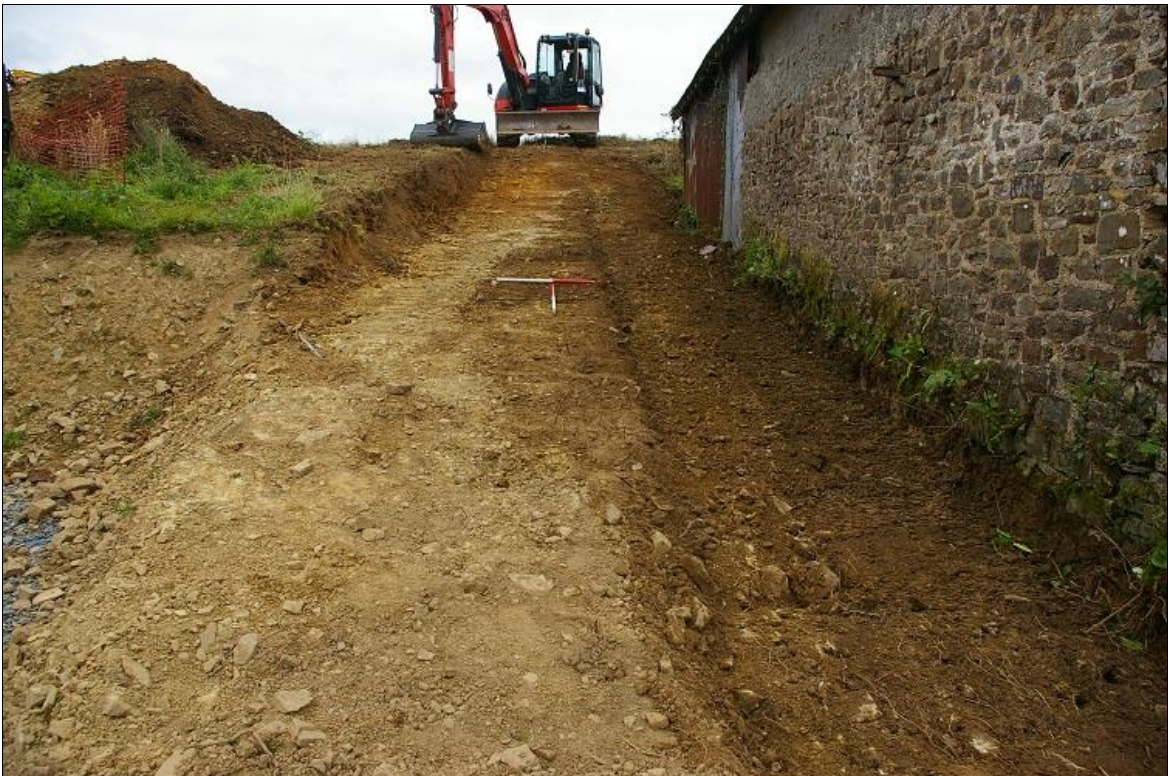
14. LOWERING THE LEVELS BEHIND THE BARN, SHOWING A CURVED CUT BEHIND THE BUILDINGS, SET INTO THE NATURAL SLOPE OF THE GROUND (2 x 1M SCALE); FROM THE WEST.

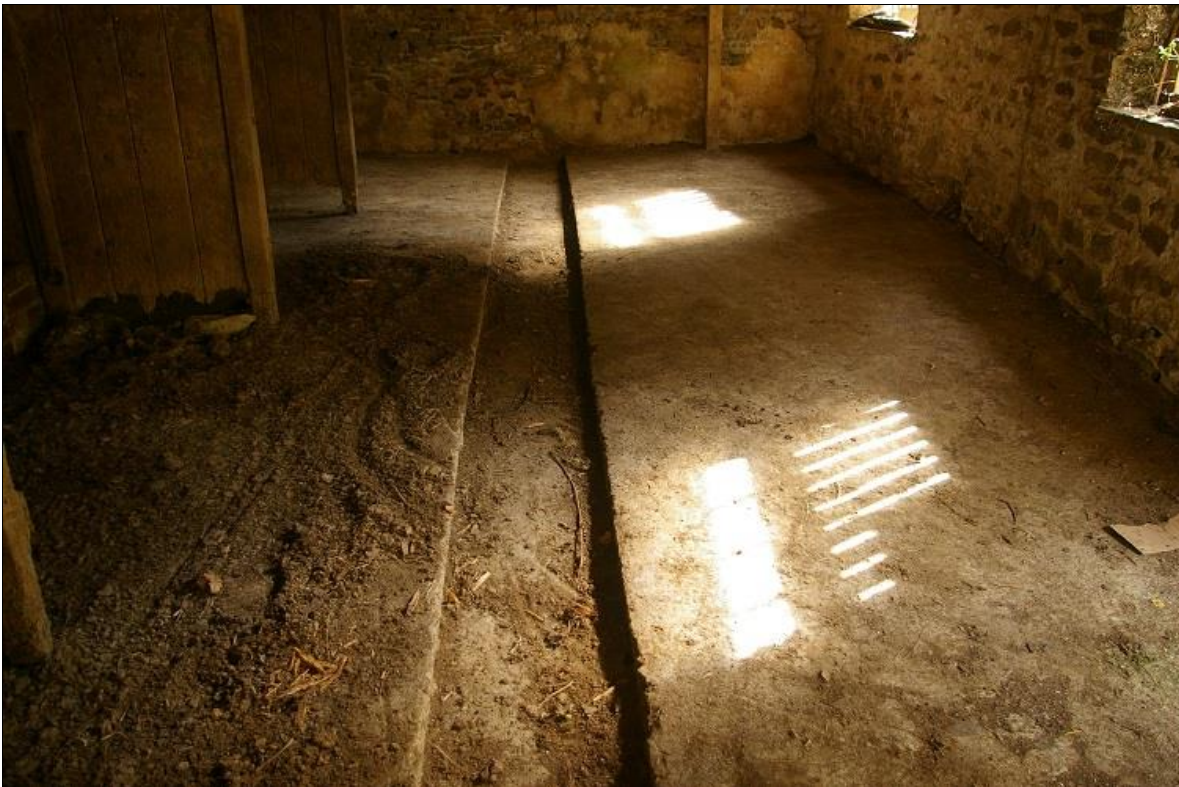
18. THE CONCRETE FLOOR, COVERING AN OLDER COBBLED FLOOR AND DRAIN; FROM THE WEST.

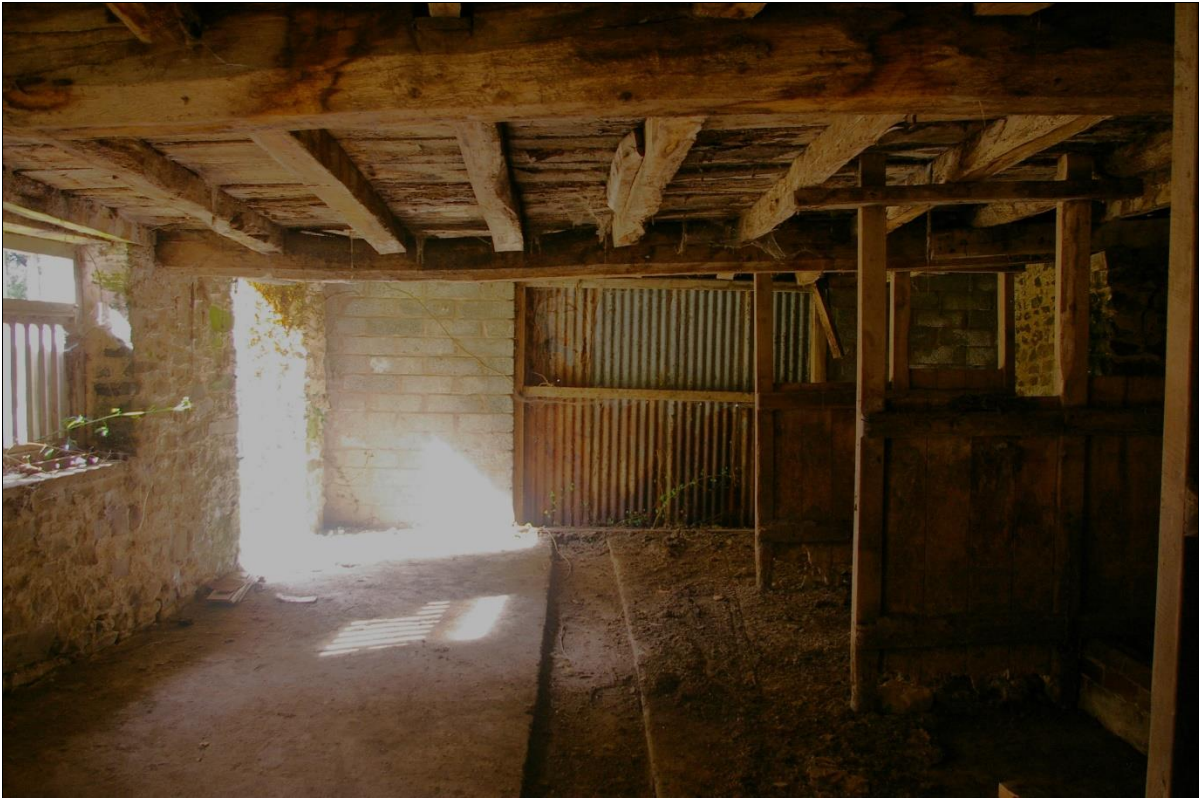
19. THE INTERIOR GROUND FLOOR OF THE BARN, SHOWING REBUILT WEST WALL WHERE THE RANGE HAS BEEN TRUNCATED; FROM THE EAST.

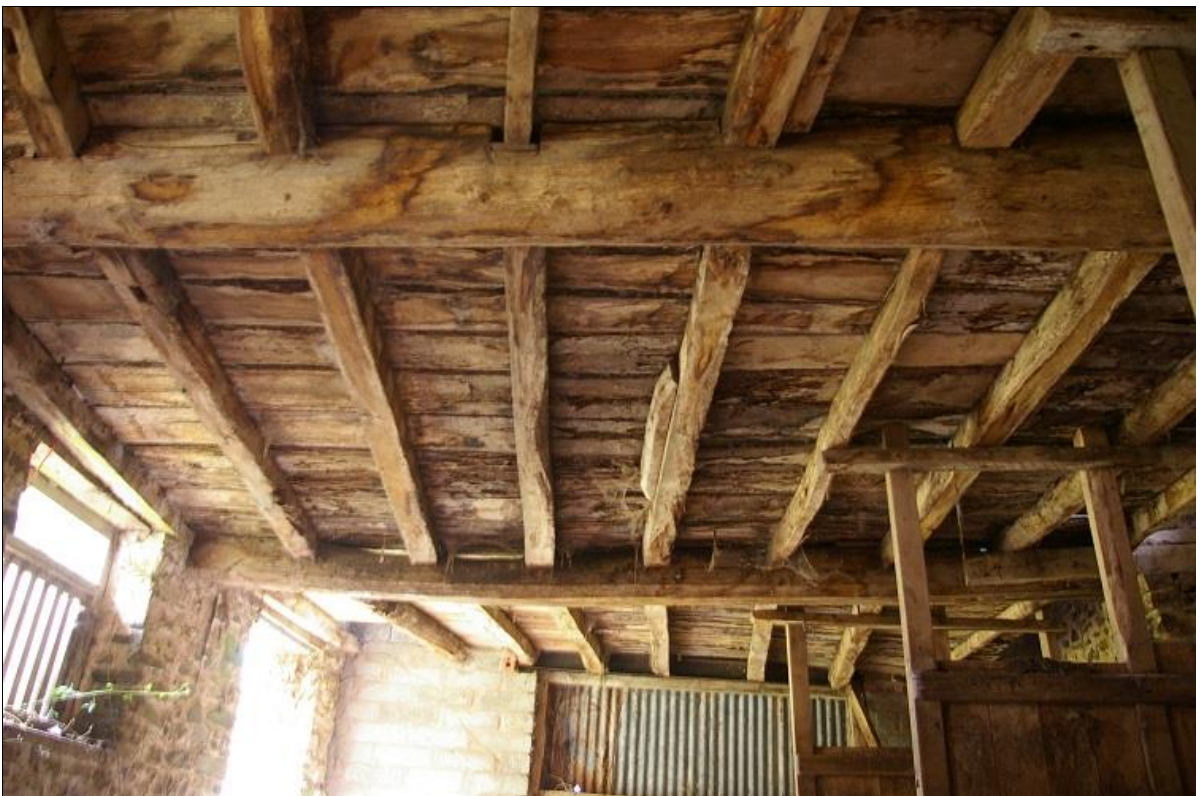
20. THE TIMBER LOFT, REUSING SOME EARLIER MATERIAL, CRANKED TO THE WEST END WHERE THE WALL HAS BEEN TRUNCATED; FROM THE EAST.

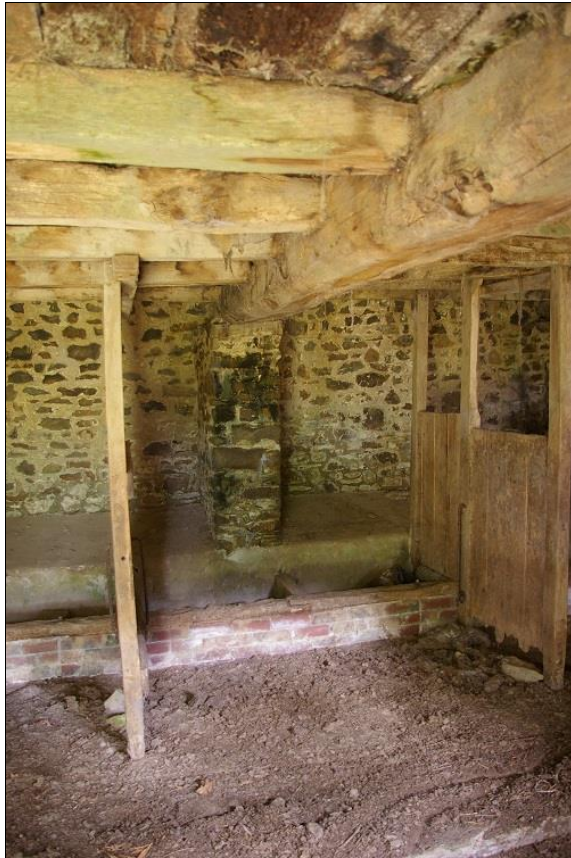
21. EXAMPLE OF ONE OF THE PIERS HOLDING UP THE SHORTER BEAMS AND BRACING THE LOFT FLOOR, AS WELL AS THE TROUGHS AND CONCRETE BRACING; FROM THE SOUTH-WEST.

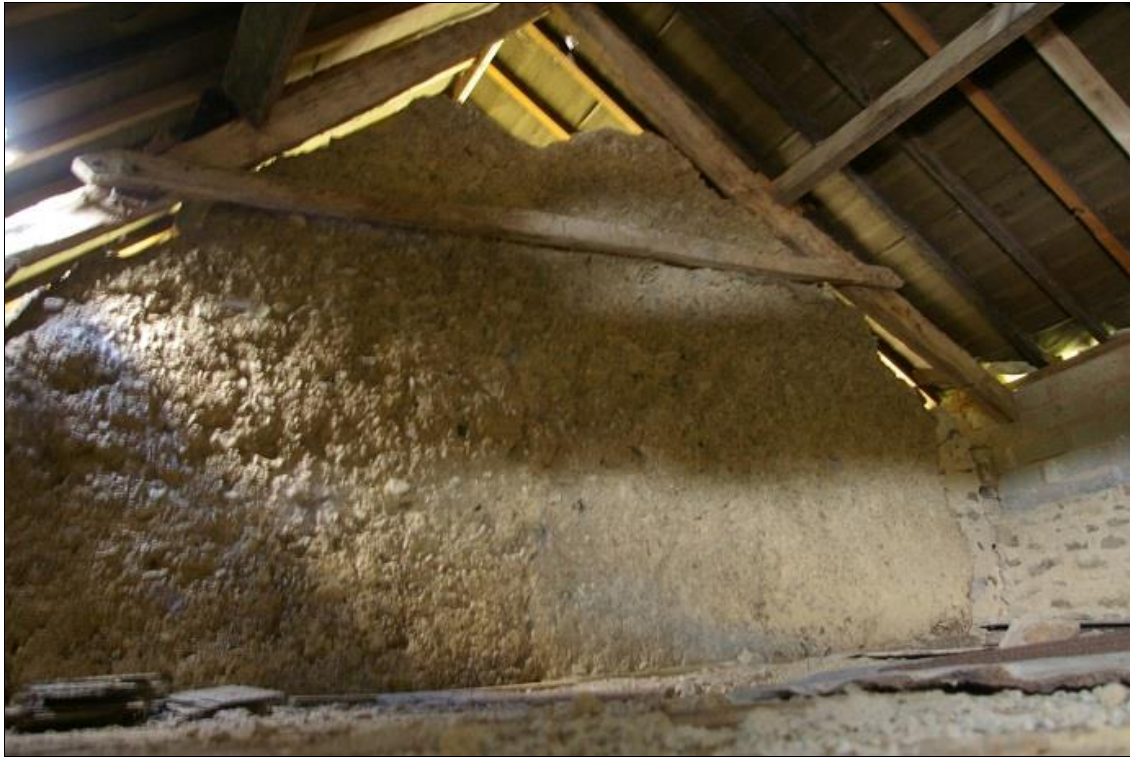
24. THE COB WALL IN THE STANDING BARN, WITH A-FRAME; FROM THE WEST-NORTH-WEST.

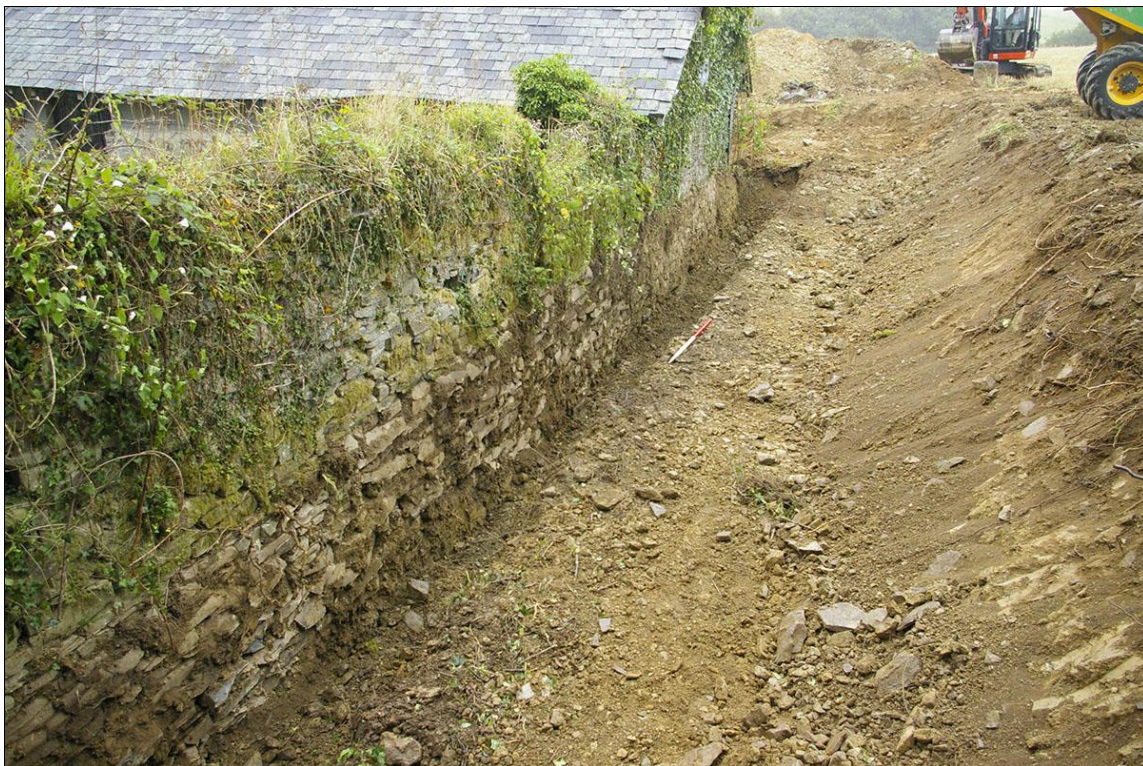
25. VIEW OF THE DRAINAGE TRENCH BEING EXCAVATED BEHIND THE EAST WALL, EXPOSED THE TRADITIONAL BUILD, WITHOUT A 'FACE', AS IT HAS BEEN BUILT INTO THE BANK, WITH 1M SCALE; FROM THE SOUTH-EAST.

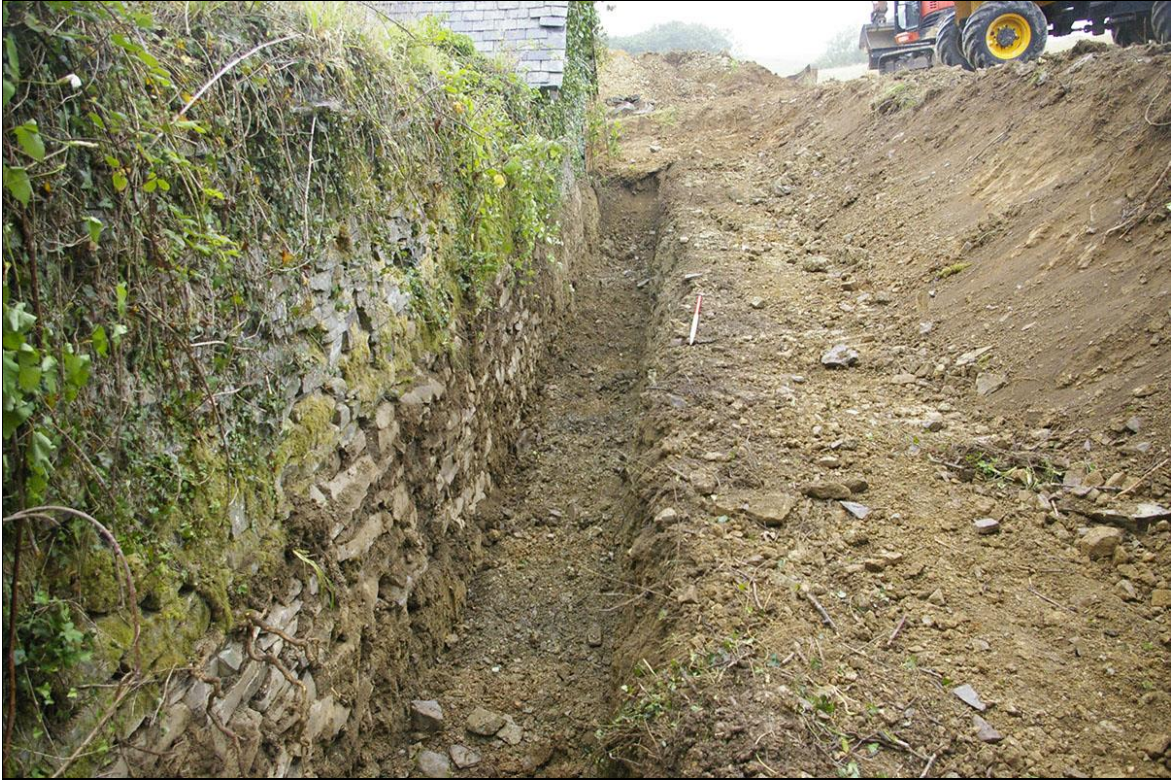
26. VIEW ALONG THE TRENCH, SHOWING THE WALL IS MERELY BUILT ON SUBSOIL ABOVE THE BEDROCK, WITH NO DEFINED FOUNDATIONS, WITH 1M SCALE; FROM THE SOUTH-SOUTH-EAST.
