BARN NEAR SHORTRIDGE COTTAGE

LITTLE SHORTRIDGE

Historic Building Recording and Archaeological Monitoring and Recording

South West Archaeology Ltd. report no. 220726

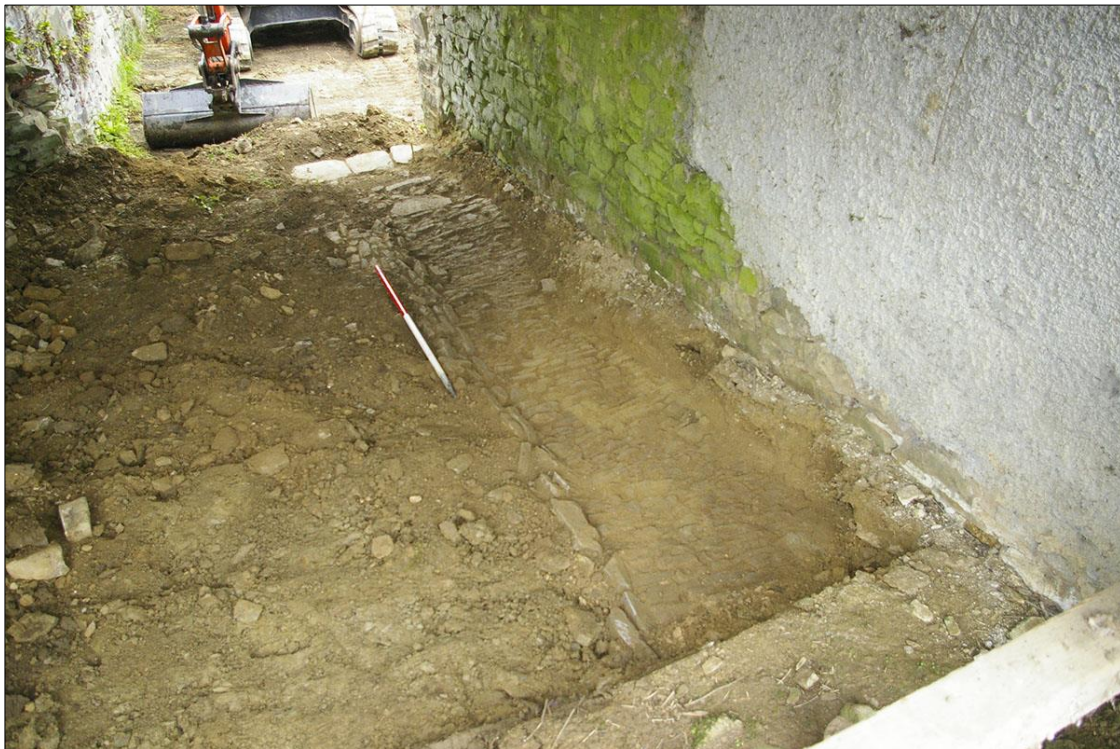
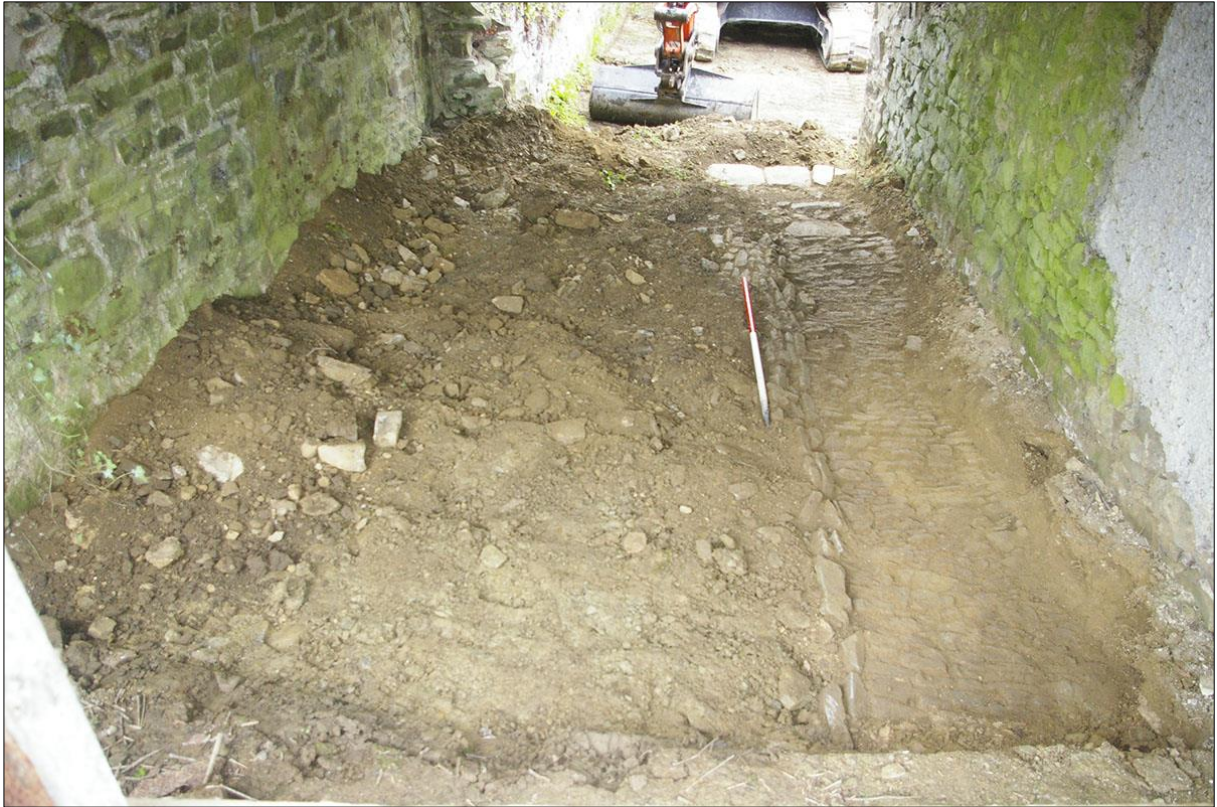
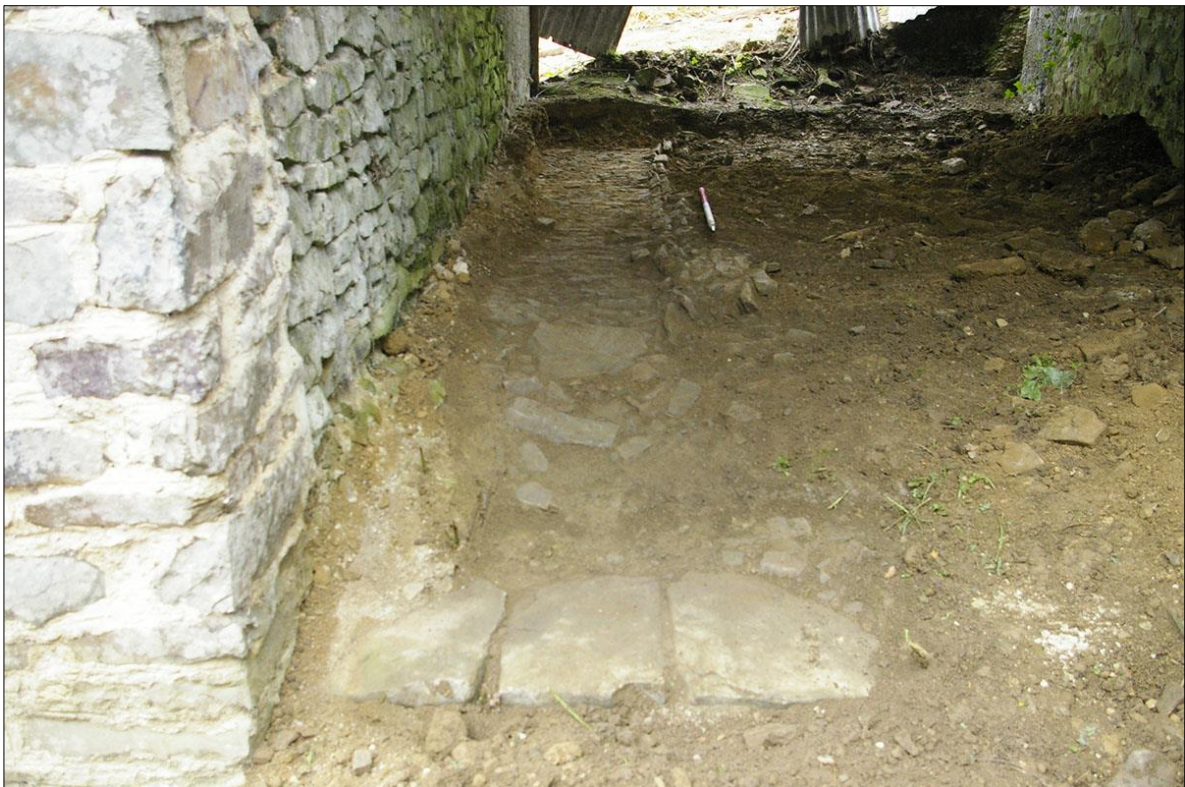
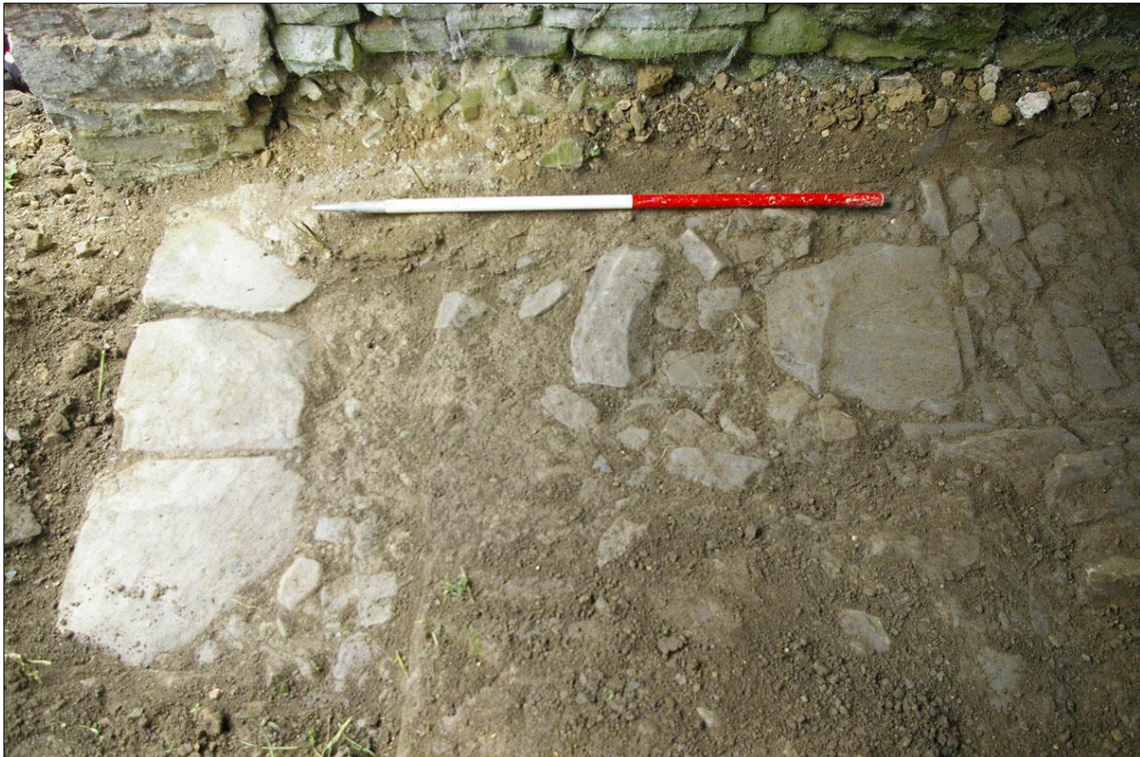
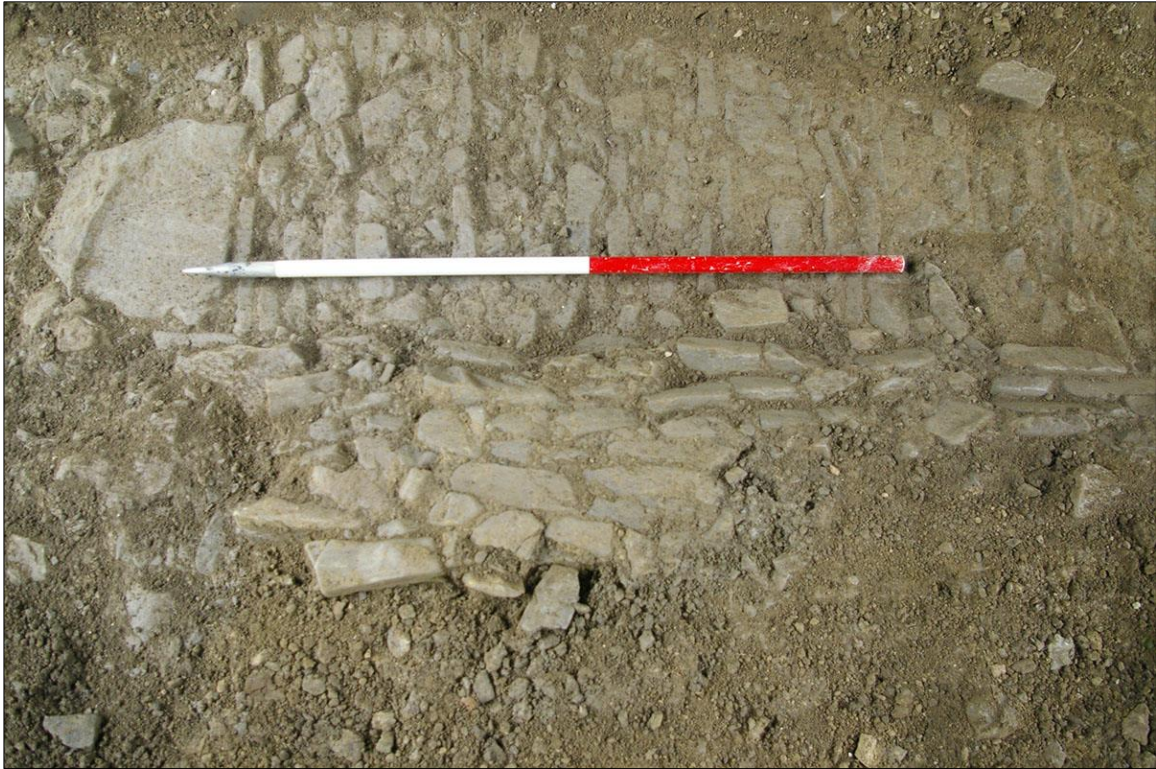
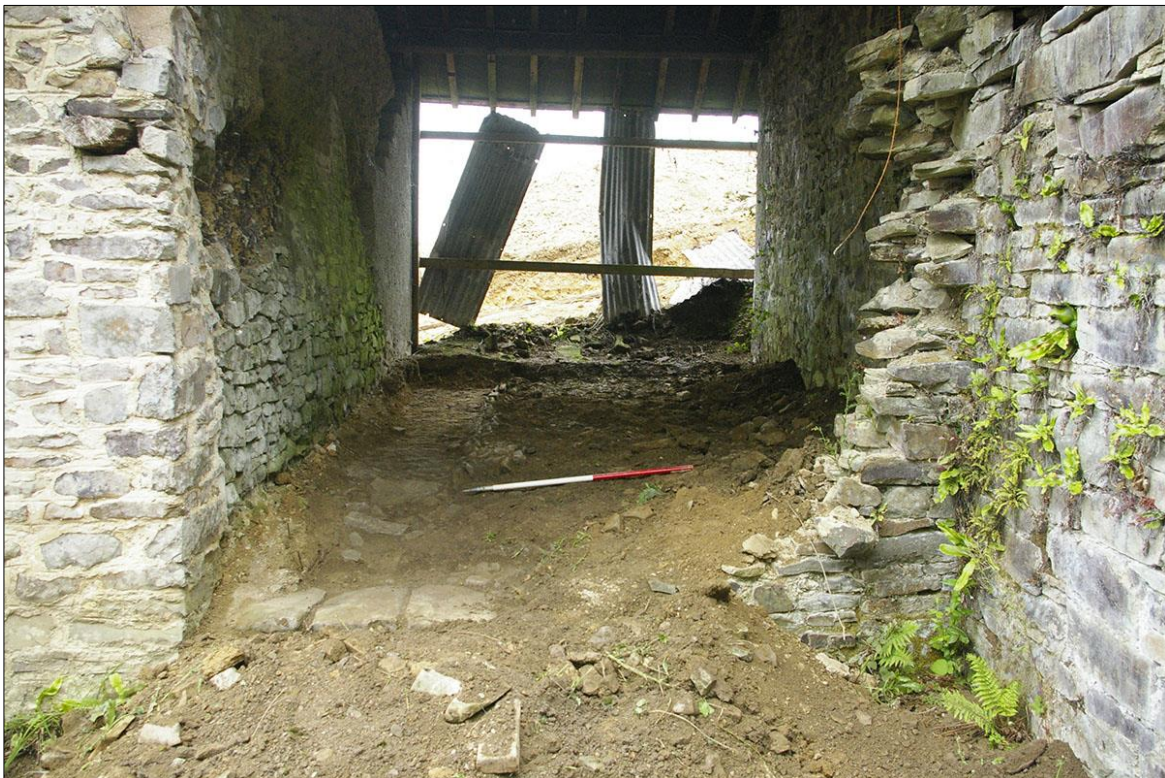
29. COBBLES (104); FROM THE EAST-NORTH-EAST (1M SCALE).

30. COBBLES (104); FROM THE NORTH-EAST (1M SCALE).

31. COBBLES (104); FROM THE SOUTH-WEST (1M SCALE).

33. COBBLES (104) DETAIL; FROM THE EAST (1M SCALE).

34. COBBLES (104) DETAIL; FROM THE EAST (1M SCALE).

35. BARN ROOM WITH COBBLES (104); FROM THE SOUTH-WEST (1M SCALE).

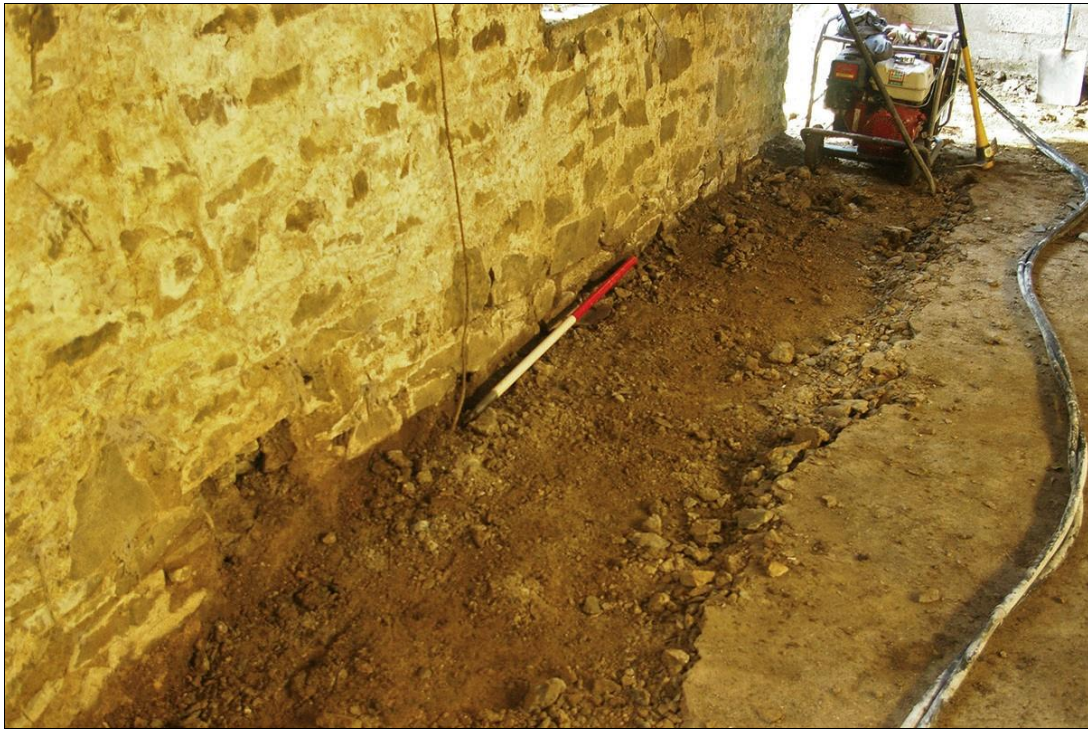
38. VIEW OF REMOVAL OF CONCRETE FLOOR IN BARN, SHOWING LOOSE DAMAGED FORMER COBBLED FLOOR BENEATH (1M SCALE); FROM THE EAST-NORTH-EAST.

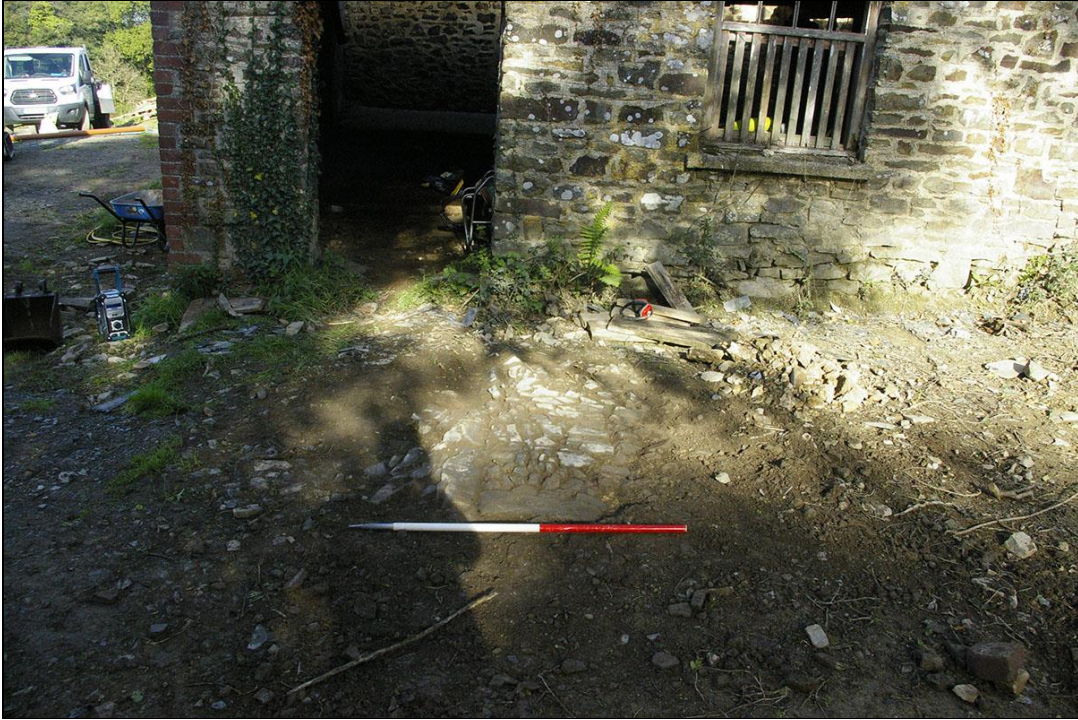
40. VIEW OF THE COBBLES IN THEIR YARD SETTING, WITH REMAINS OF A DRAIN (1M SCALE); FROM THE SOUTH.

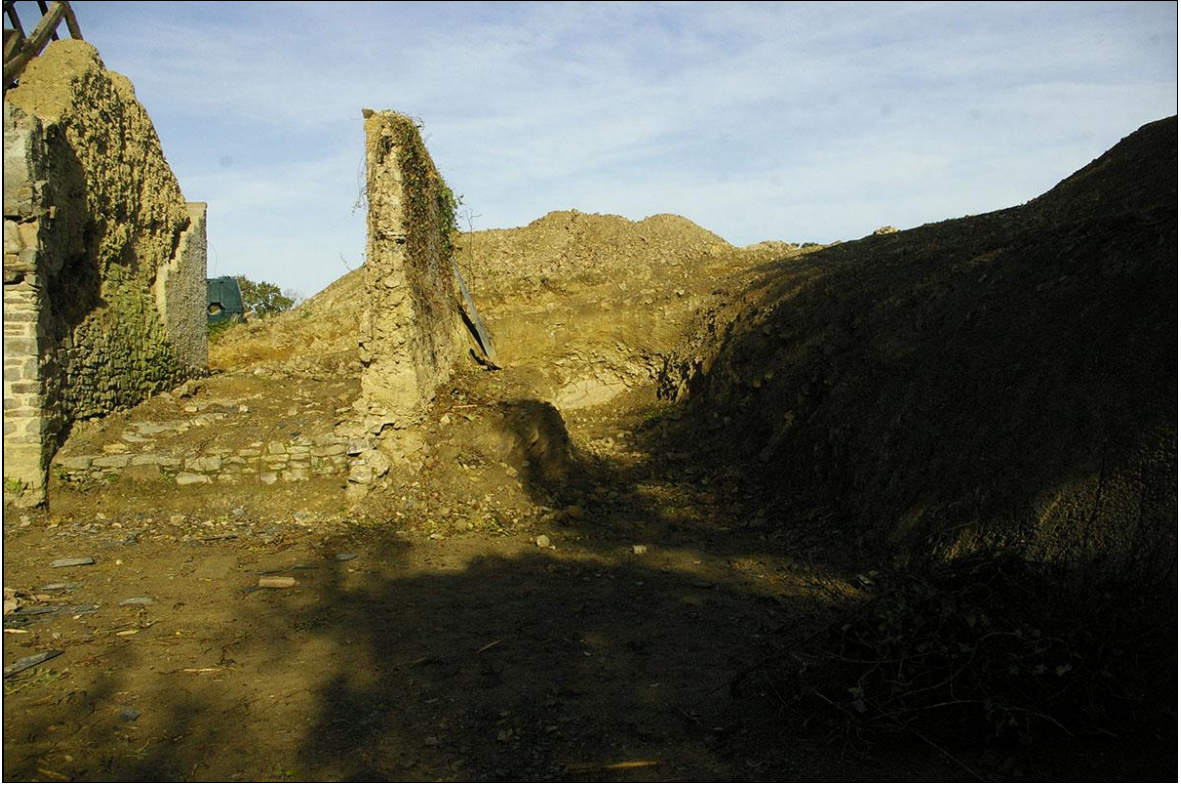
42. THE EAST END OF THE STANDING RANGE, SHOWING IT IS BUILT ONTO THE BEDROCK, WHICH HAS BEEN UNDERCUT FOR FOUNDATIONS AND DRAINAGE; FROM THE SOUTH.
