# the former KITTS CORNER

## 51 CHAPEL STREET

## *Archaeological Monitoring and Recording*

Work undertaken by SWARCH for a private client  
NGR: SW 47391 30131  
Planning Reference: PA20/11357 & PA20/11358 (LBC)  
OASIS reference: SOUTHWES1-417059  
South West Archaeology Ltd. report no. 230308

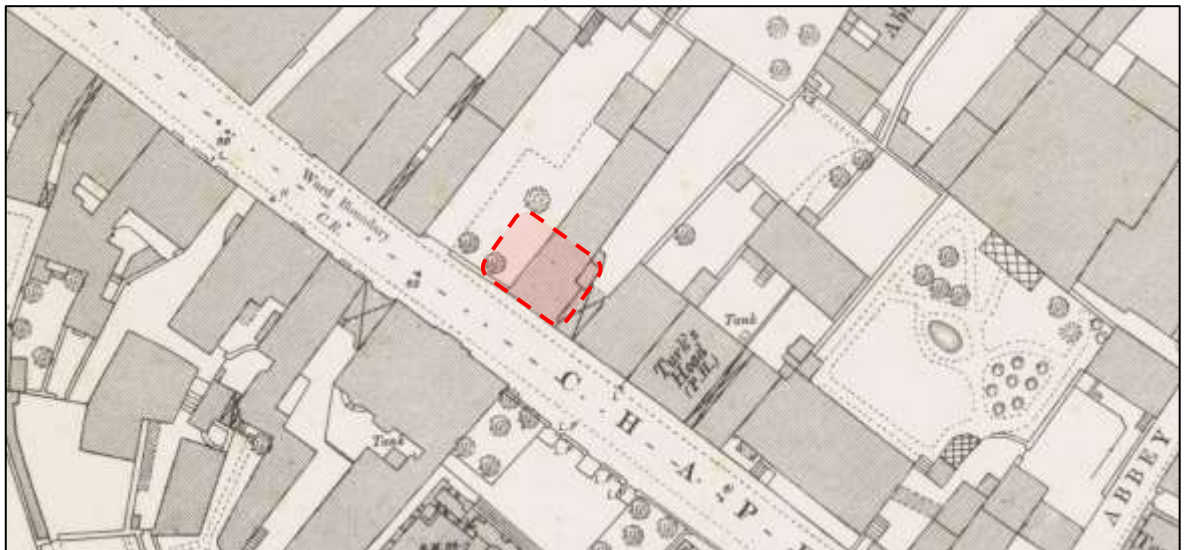
FIGURE 2: EXTRACT FROM THE 1878 1:500 OS TOWN PLAN OF PENZANCE (CORNWALL SHEET LXXIV.2.23, SURVEYED 1875).

The building is not shown on the Penzance tithe map (non-titheable), so the earliest depiction is the 1:500 scale 1878 Ordnance Survey (OS) town plan of Penzance (Figure 2).

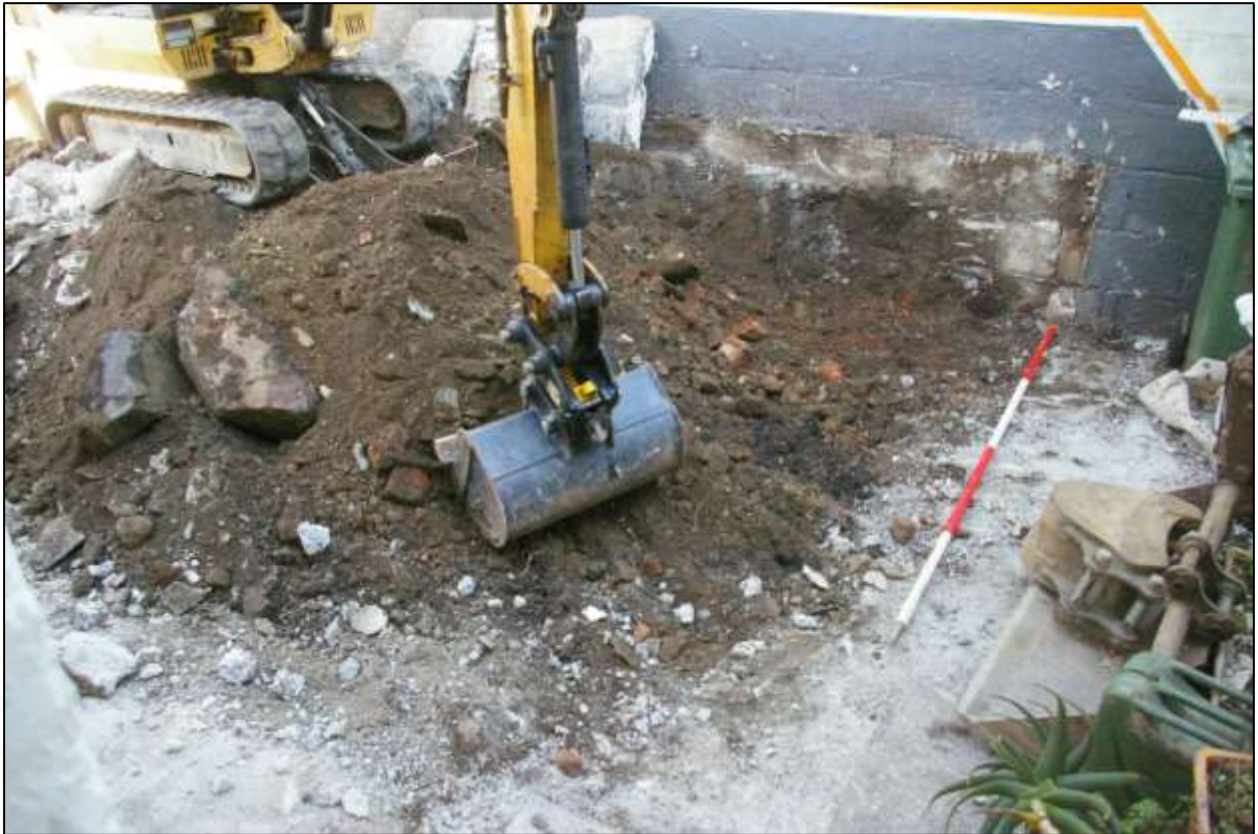
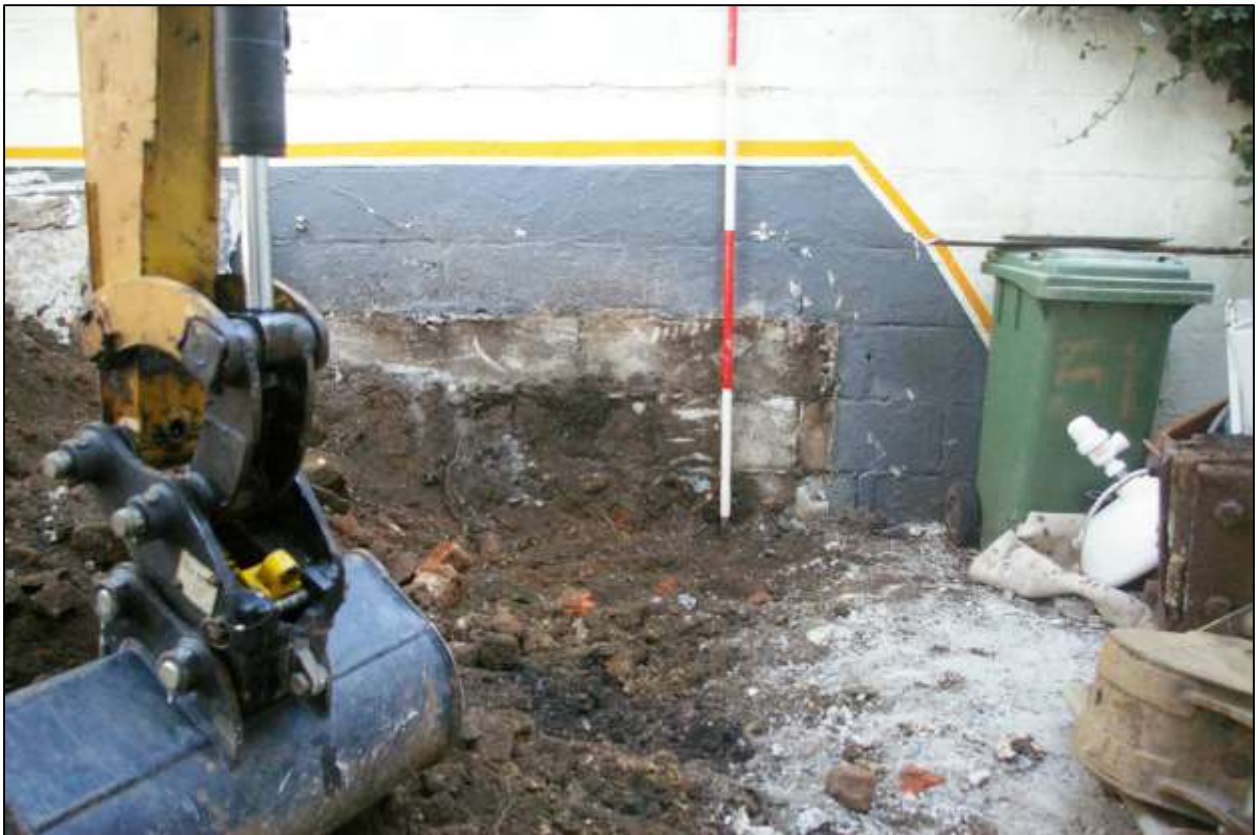
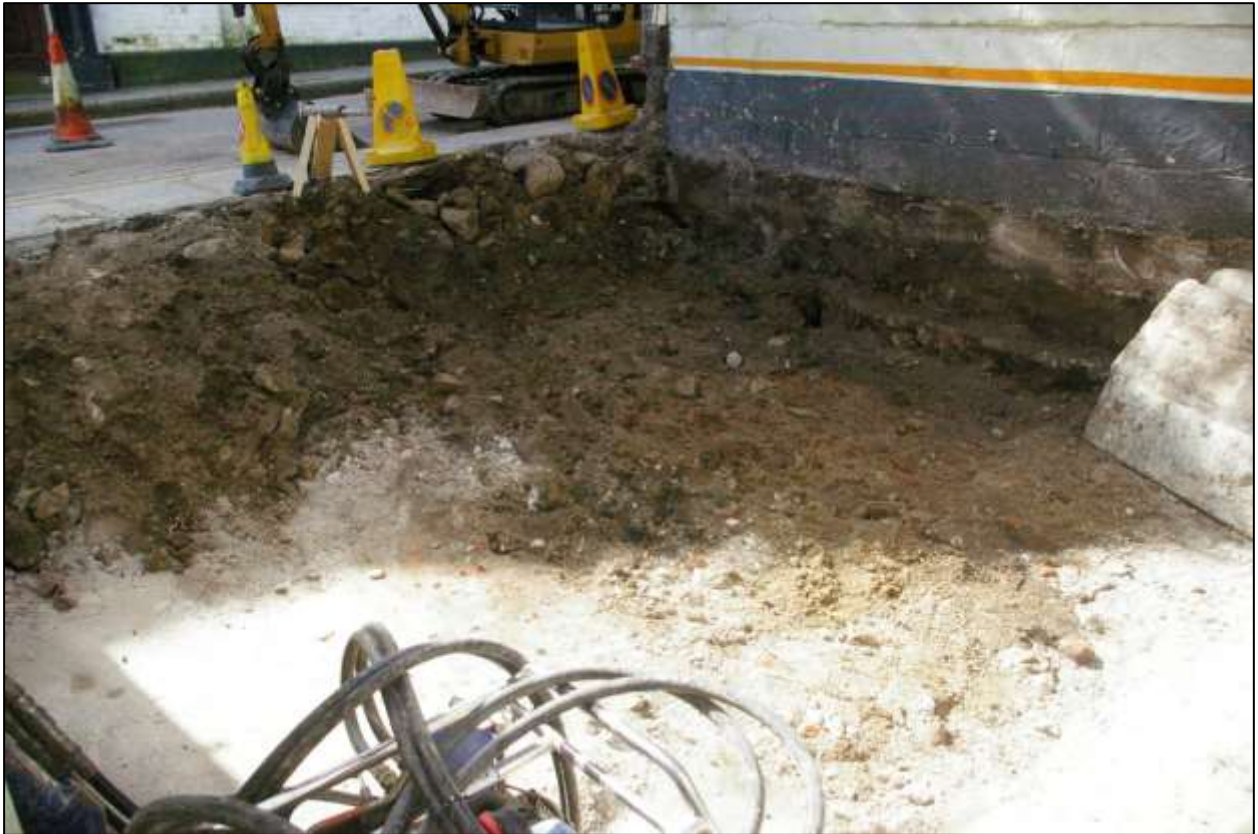
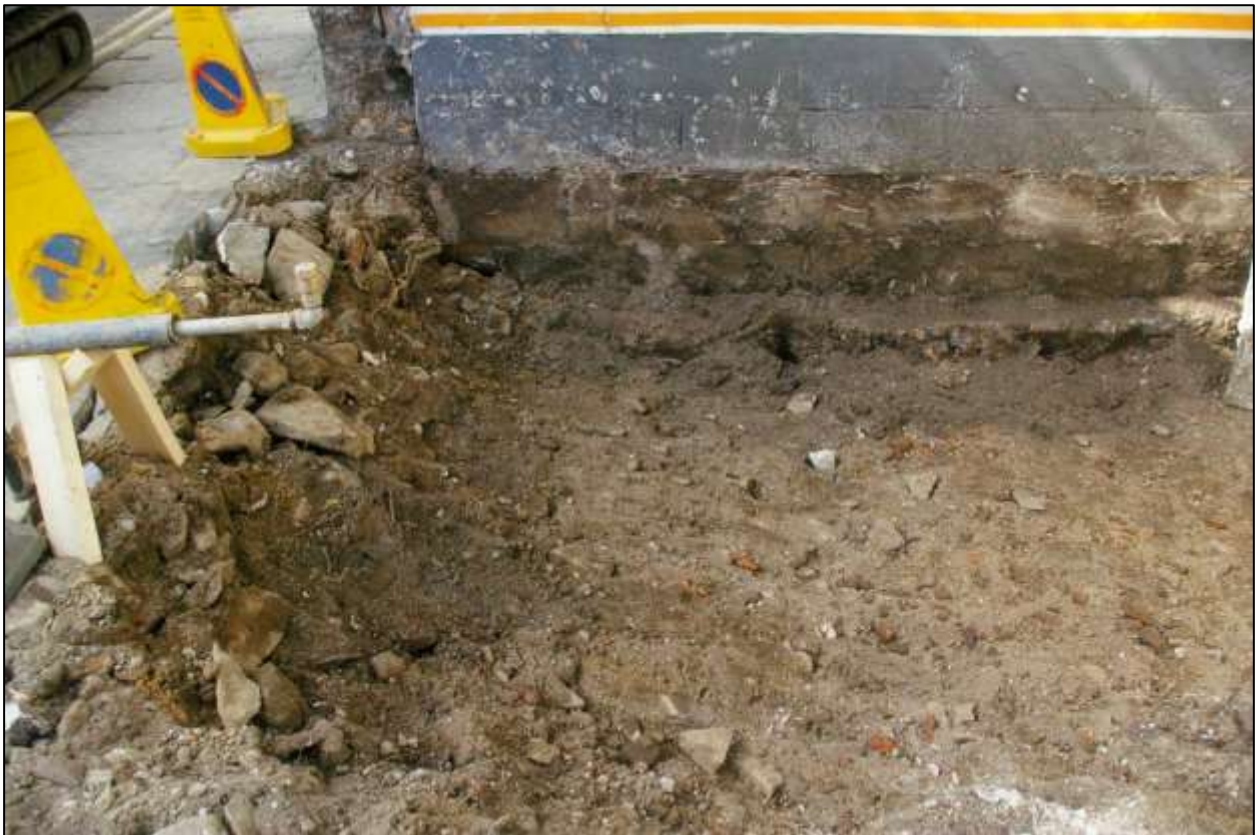
FIGURE 6: THE PATIO AREA UNDER EXCAVATION; VIEWED FROM THE EAST (SCALE 2M).

FIGURE 7: AS ABOVE (SCALE 2M).

FIGURE 8: THE PATIO AREA FOLLOWING GROUND REDUCTION, VIEWED FROM THE NORTH-EAST (NO SCALE),

FIGURE 9: AS ABOVE, VIEWED FROM THE EAST (NO SCALE).

Monitoring took place in the small patio garden in the angle between no.51 Chapel Street, its single-storey 20<sup>th</sup> century kitchen extension, and the street. Removal of the concrete surfaces (100) determined that the raised patio area, which was at the same level as the street, consisted of a relatively recent deposit of loose brownish-grey gritty sandy-silt loam with rubble (101). This material contained frequent brick and slate fragments. The ground was reduced to the level of the lower concrete slab. No features were revealed, and no diagnostic finds were recovered. (See Figures 6-9.)

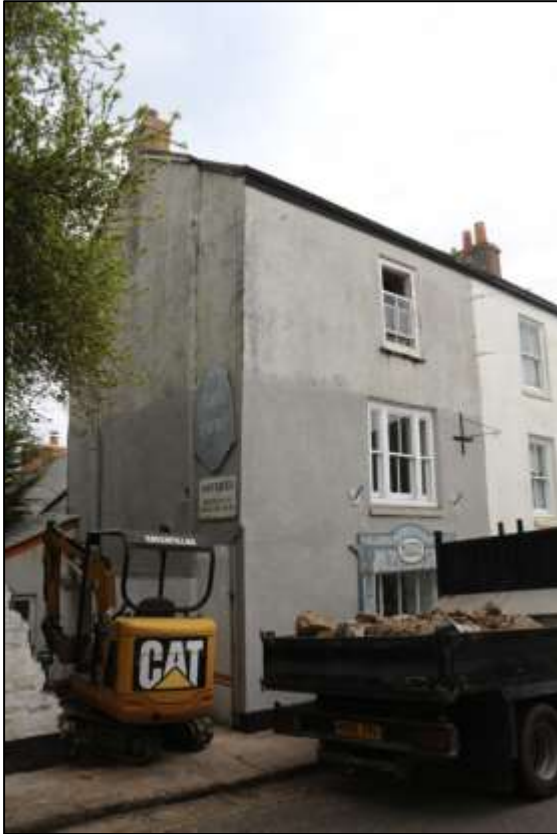
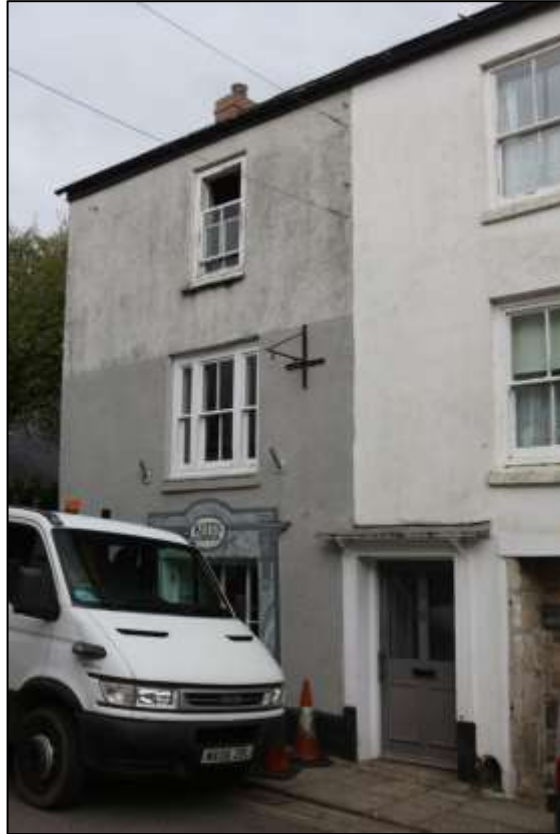
LEFT FIGURE 10: THE SOUTH AND WEST ELEVATIONS; VIEWED FROM THE SOUTH-WEST.

RIGHT FIGURE 11: THE SOUTH ELEVATION; VIEWED FROM THE SSE.

The south wall faces onto the street, three storeys, with central windows at each floor and an off-centre door (now with a flying freehold above). The ground-floor window is a modern eight-pane fixed window with narrow glazing bars, with a faux Graeco-Roman marble exterior surround with the words 'Kitt's Corner' set into a medallion at the top. The first-floor window is a later 19<sup>th</sup> century tripartite two-over-two sash with narrow fixed one-over-one lights to each side. The second-floor window is a narrow later 19<sup>th</sup> century two-over-two hornless sash. The ground-floor door is covered by a shallow weather porch with reeded pilasters; this is modern as the timbers are butted together rather than mitred. The door is a later 19<sup>th</sup> or even 20<sup>th</sup> century four-panel door where the upper two panels have been replaced with glass. Brass door fittings. To the right of the door is a cast-iron boot-scraper built into the wall. Beyond this is the passage through into Kitts Court; there are three guard stones along the base of the walls to protect against carriage wheels, suggesting the passage is of some antiquity. The west elevation is almost blind, with a shallow projecting stack with a modern short brick chimney, and a forced ground-floor door to the left set with a modern timber and glass door. The north elevation contains a projecting stair turret and is abutted by the low two-storey buildings of Kitts Court. On the first floor there is a modern awning window crammed into a space above the roof of the modern extension. Above this at second-floor level is a reset early 19<sup>th</sup> century six-over-six hornless sash with thin glazing bars. The turret has a later 19<sup>th</sup> century small two-over-two horned sash that overlooks the roof of Kitts Court. No.51 abuts the adjacent structure to the east; the east elevation of the stair turret has a modern timber awning window. All the external surfaces are rendered and painted.

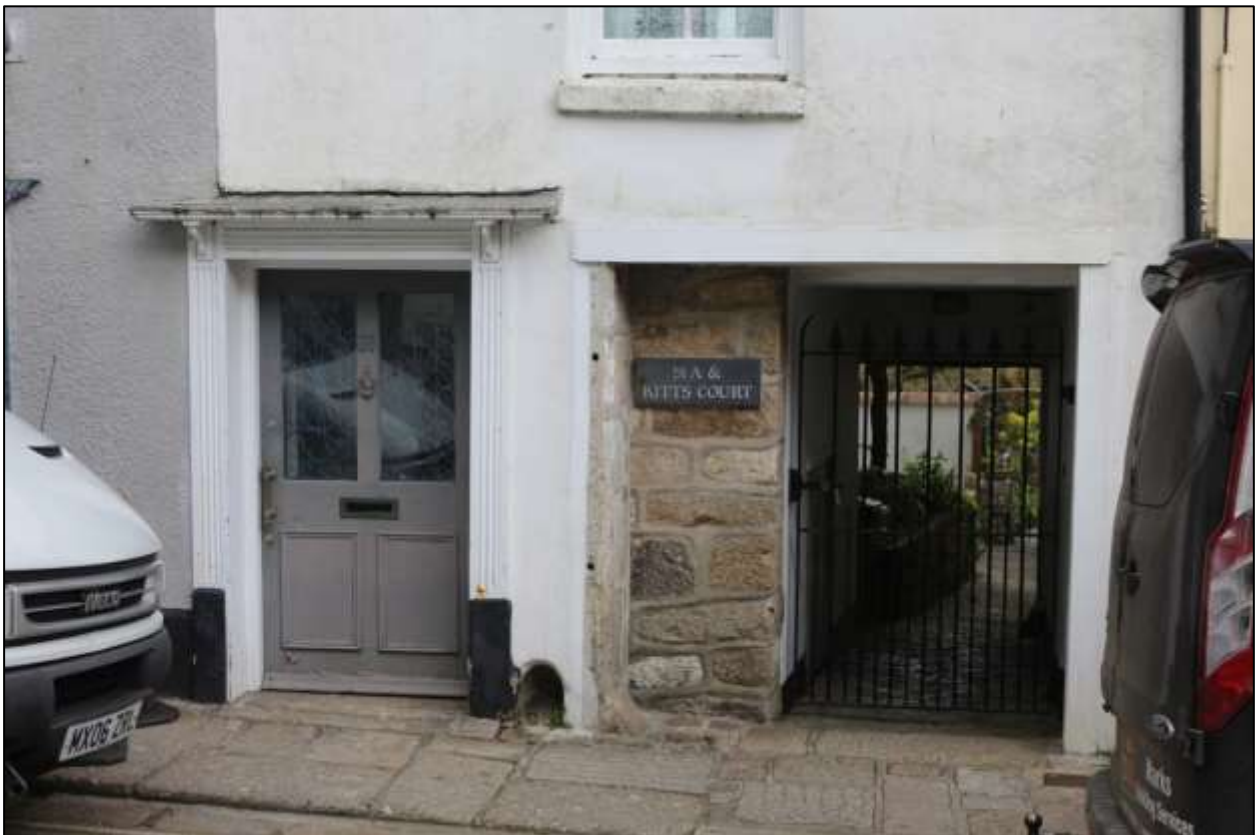
FIGURE 12: THE FRONT DOOR AND FORCED (GATED AND LOCKED) PASSAGE THROUGH TO KITTS COURT; VIEWED FROM THE SOUTH.

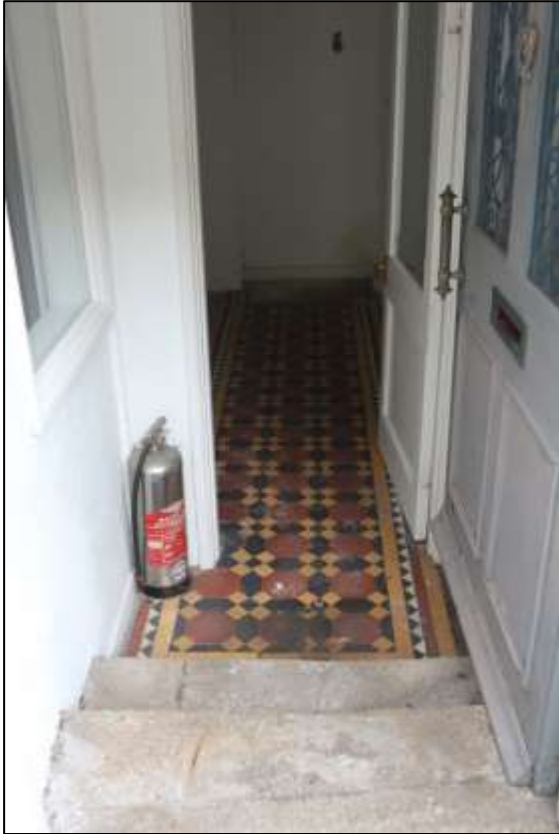
FIGURE 13: THE POLYCHROMATIC GEOMETRIC TILED FLOOR IN THE LATE C19 PASSAGE; VIEWED FROM THE SOUTH.

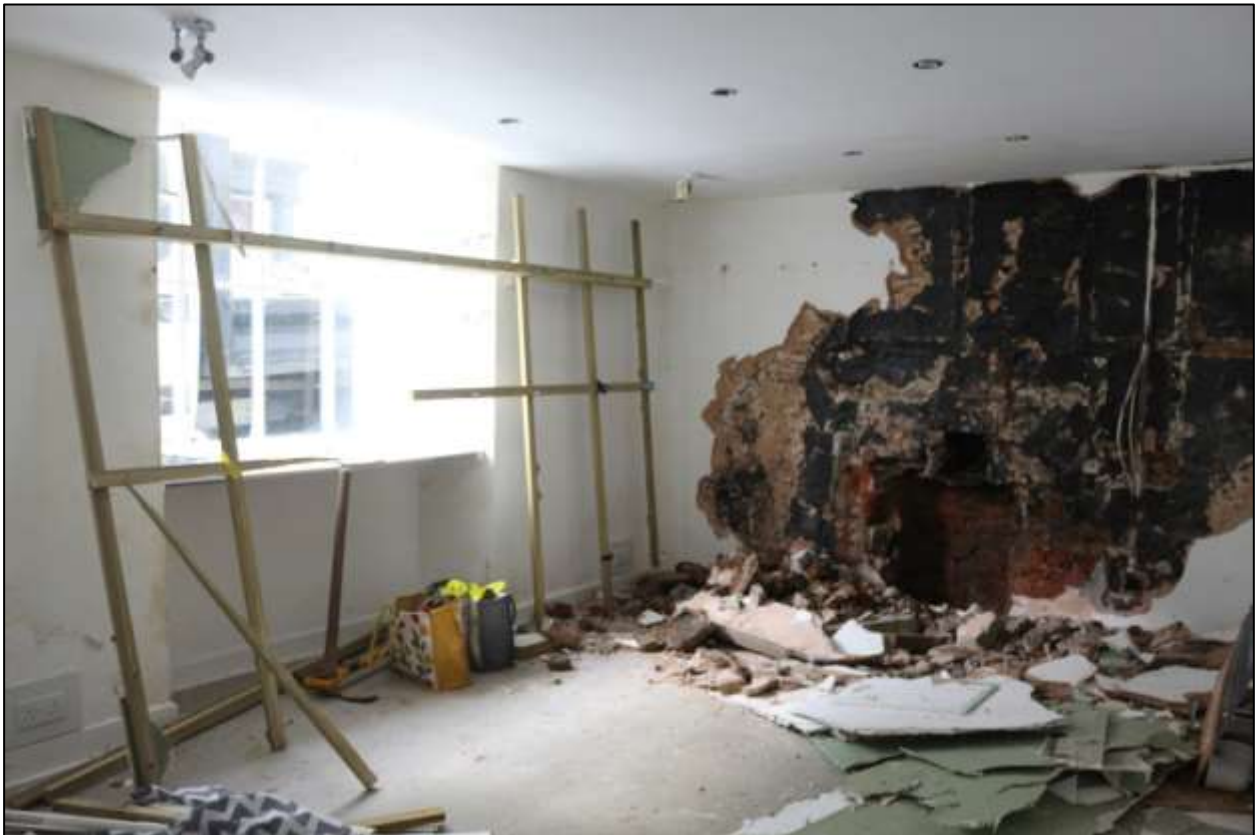
FIGURE 14: R1, VIEWED FROM THE NORTH-EAST.

The ground floor is divided into four spaces: the former shop (R1), stairwell (R2), corridor (R3), and kitchen in the modern extension (R4). Access to R1 is via the front door, dropping down two worn granite steps to a modern weather lobby and a polychromatic geometric tiled floor in the former passage. This has been opened out to the rest of R1 and an RSJ inserted above. At the back of the passage is a blocked doorway that opened onto the court. In the west wall is a forced blocked fireplace, no surviving detail. The window in the south wall sits in a full-height opening. R3 is a modern corridor created with a partition. There is an understairs alcove, with several cast concrete steps that drop down to a blocked doorway in the north wall that once gave access to the building to the north. Solid floors throughout.

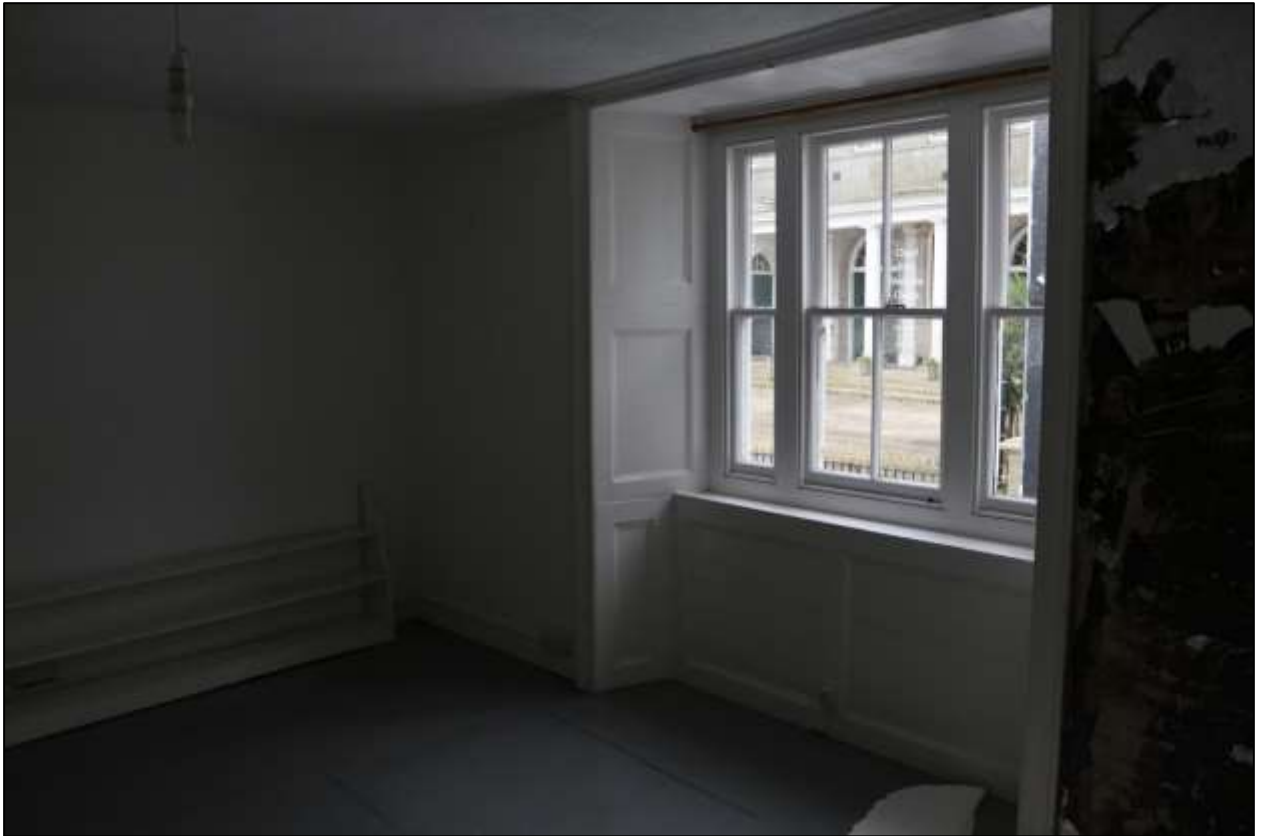
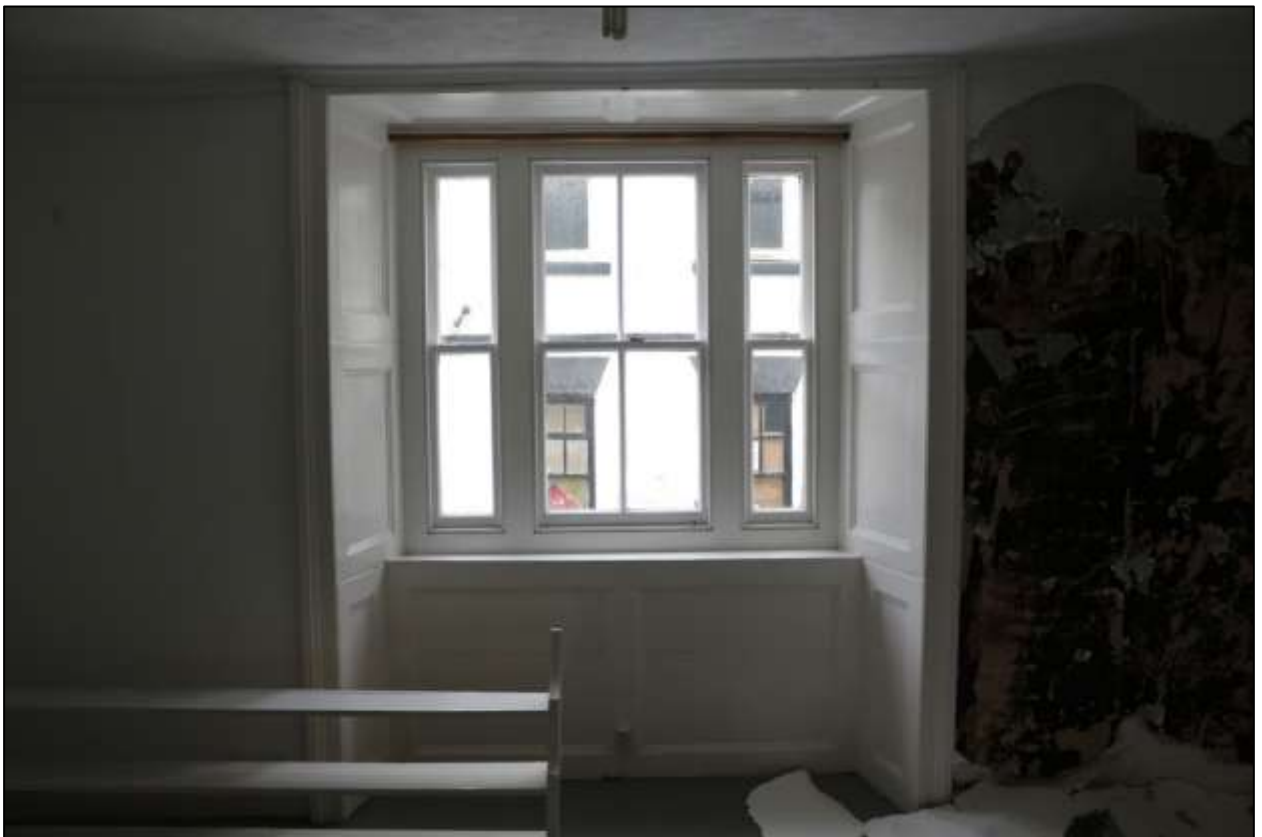
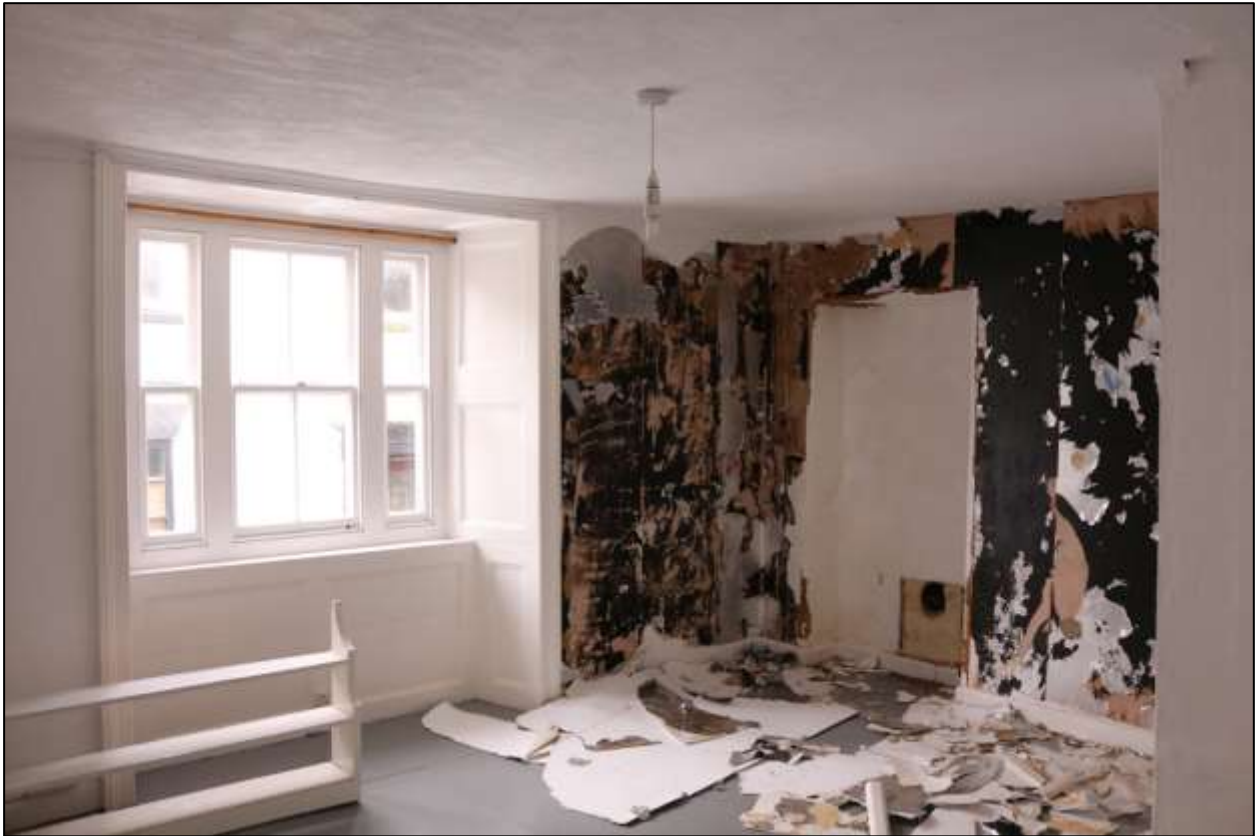
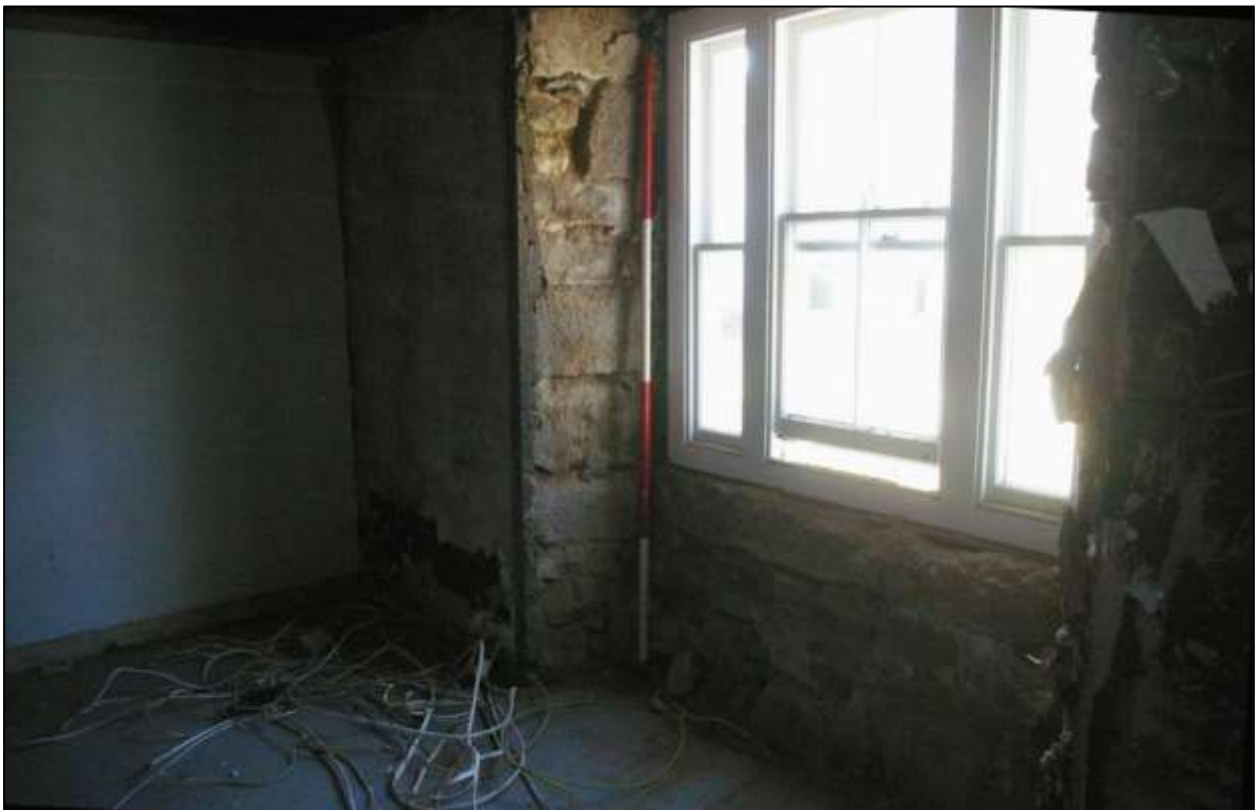
FIGURE 15: R7, THE EARLY C19 PANELLED SURROUND TO THE LATER C19 TRIPARTITE SASH; VIEWED FROM THE NORTH-WEST.

FIGURE 16: R7, AS ABOVE; VIEWED FROM THE NORTH.

FIGURE 17: R7, VIEWED FROM THE NORTH-EAST.

FIGURE 18: R7, THE WINDOW FOLLOWING THE REMOVAL OF THE PANELS; VIEWED FROM THE NORTH-WEST (SCALE 2M).

The first floor is divided into three rooms: the landing (R5), bathroom (R6), and bedroom (R7). R5 and R6 feature even-width pine floorboards; the floor of R7 was concealed beneath painted fibre board. The large tripartite sash window in R6 sits in a full-height opening with early 19<sup>th</sup> century

moulded panelling to each side, and a later and more awkward set of panelling below, perhaps replacing a window seat. Removal of the panelling revealed some nicely-dressed, if somewhat irregular, granite quoins. In the west wall there is an alcove down the side of the stack (perhaps a blocked doorway?) with an opening for a vent pipe, set down low.

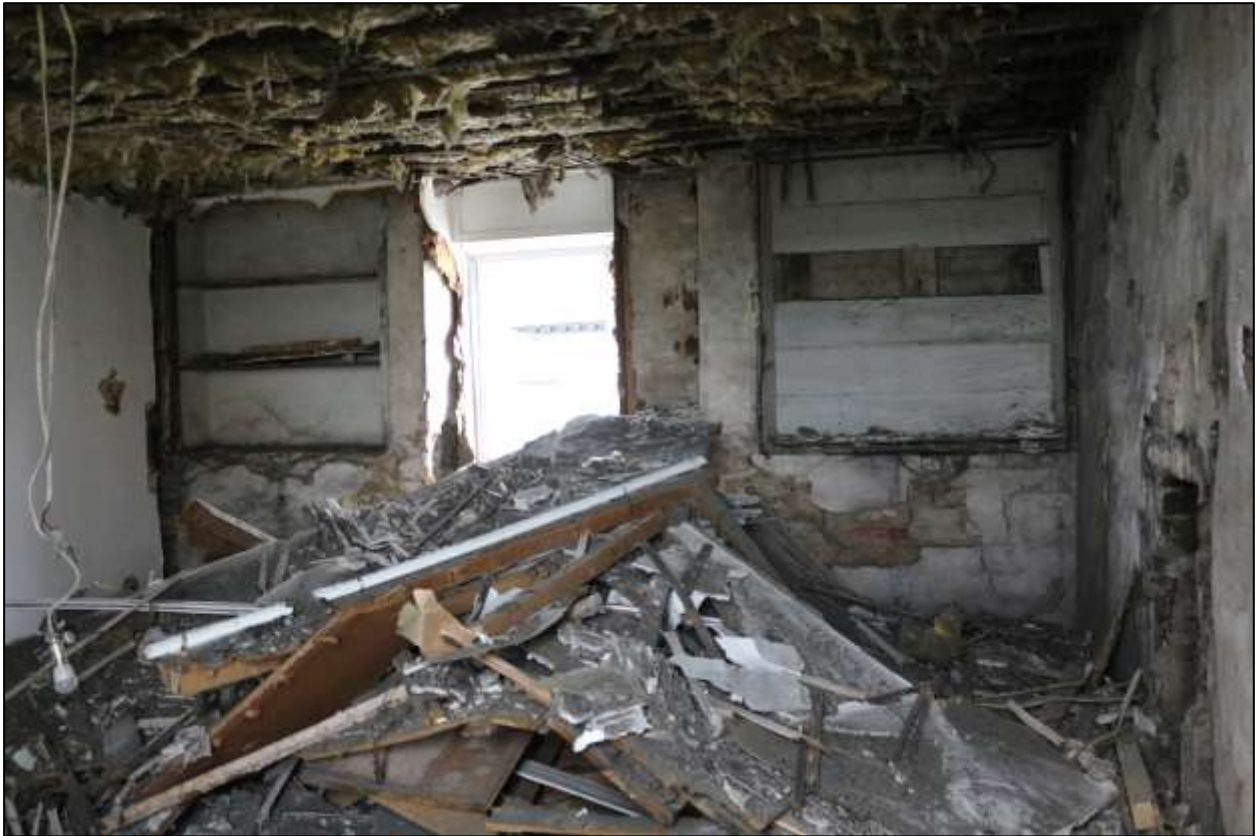
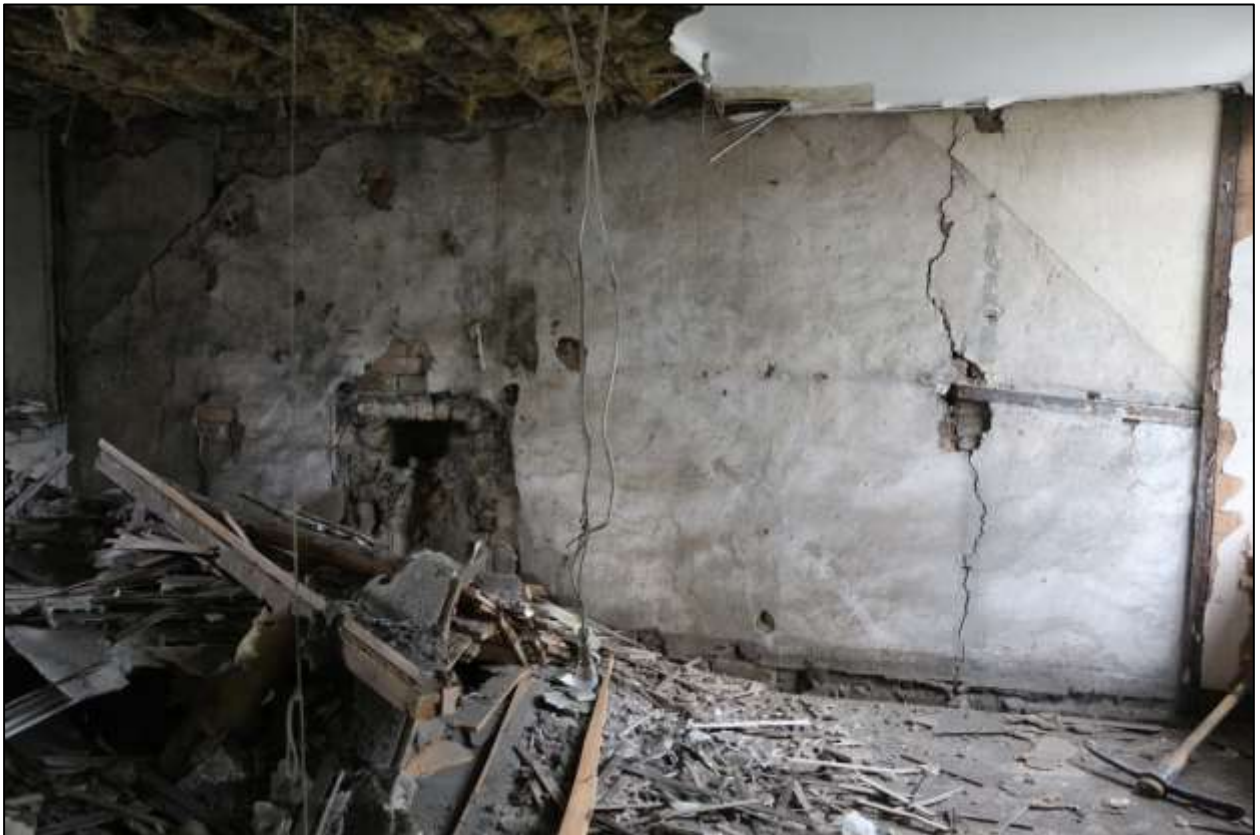
FIGURE 19: R9/R10 DURING THE STRIP, SHOWING THE RAISE TO THE SOUTH WALL AND THE INSERTED SHELVES; VIEWED FROM THE NORTH.

FIGURE 20: R9/R10, THE WEST GABLE WALL SHOWING THE FORCED FIREPLACE AND THE LINE OF THE ORIGINAL ROOF; VIEWED FROM THE EAST.

The second floor is divided into three rooms: the landing (R8), a small back bedroom (R9), and a larger front bedroom (R10). R9 is separated from R10 by a thin wall of later 19<sup>th</sup> century tongue-and-groove pine boards. The roof has been raised by 0.94m to create a full-height second storey. In the south wall the roof trusses sit on thin brick pillars, the spaces to each side of the slightly off-centre window are boarded (and now externally rendered) and set with three shelves, themselves later covered over. The sash window has been raised, suggesting the original (and wider) window was lower and featured a dormer. The early 19<sup>th</sup> century sash window in the north wall is located within the raise, so must be reset from elsewhere. The line of the former roof is clearly marked in the rendered west wall, and also in the party wall to the east. This is a stud wall with lath-and-plaster to the east, and early 19<sup>th</sup> century vertical planks to the west. There are the remains of Regency-era monochromatic wallpaper adhering to the planks, indicating a date of c.1800-1820. There is a narrow doorway in this wall that is blocked with concrete blocks. A narrow (and therefore 19<sup>th</sup> century) grate was forced into the west wall, of which only the cast of a foliate design in the mortar around the opening remains.

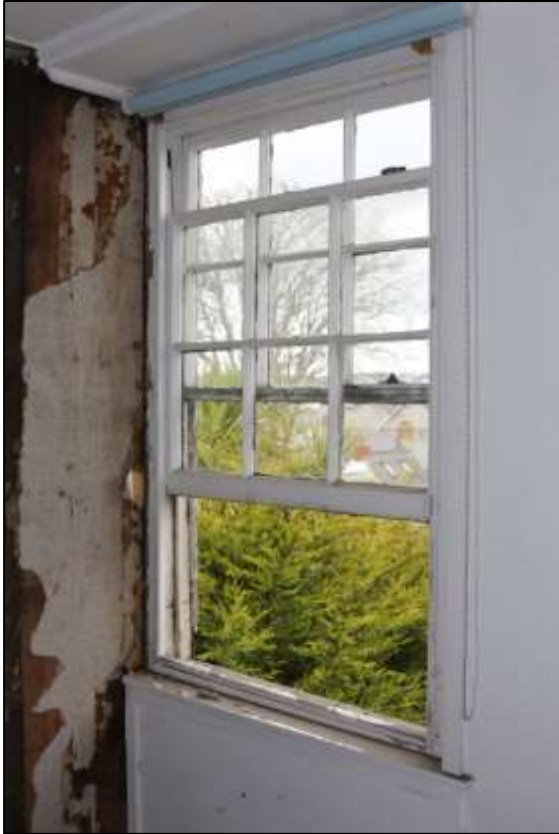
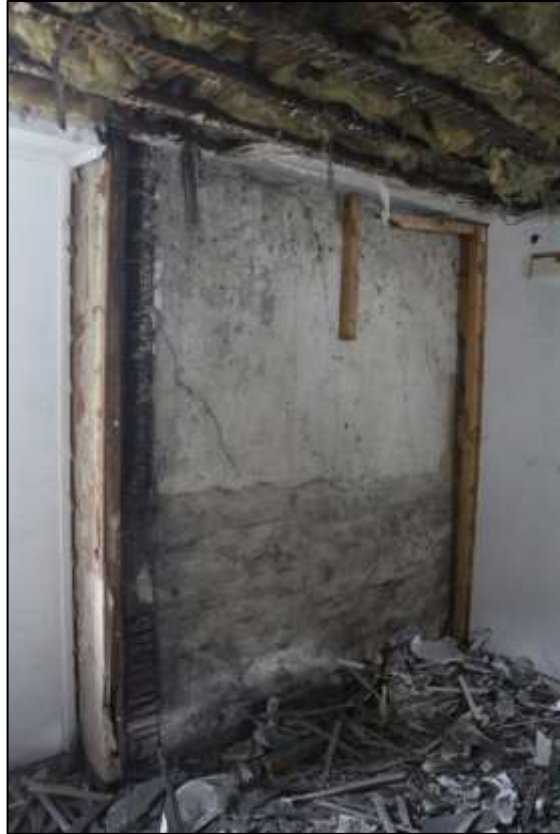
LEFT FIGURE 21: R9, THE RESET EARLY C19 SASH WINDOW; VIEWED FROM THE SOUTH-EAST.

RIGHT FIGURE 22: R9, THE STUD WALL WITH LATH AND PLASTER AROUND THE STAIRWELL; VIEWED FROM THE SOUTH-WEST.

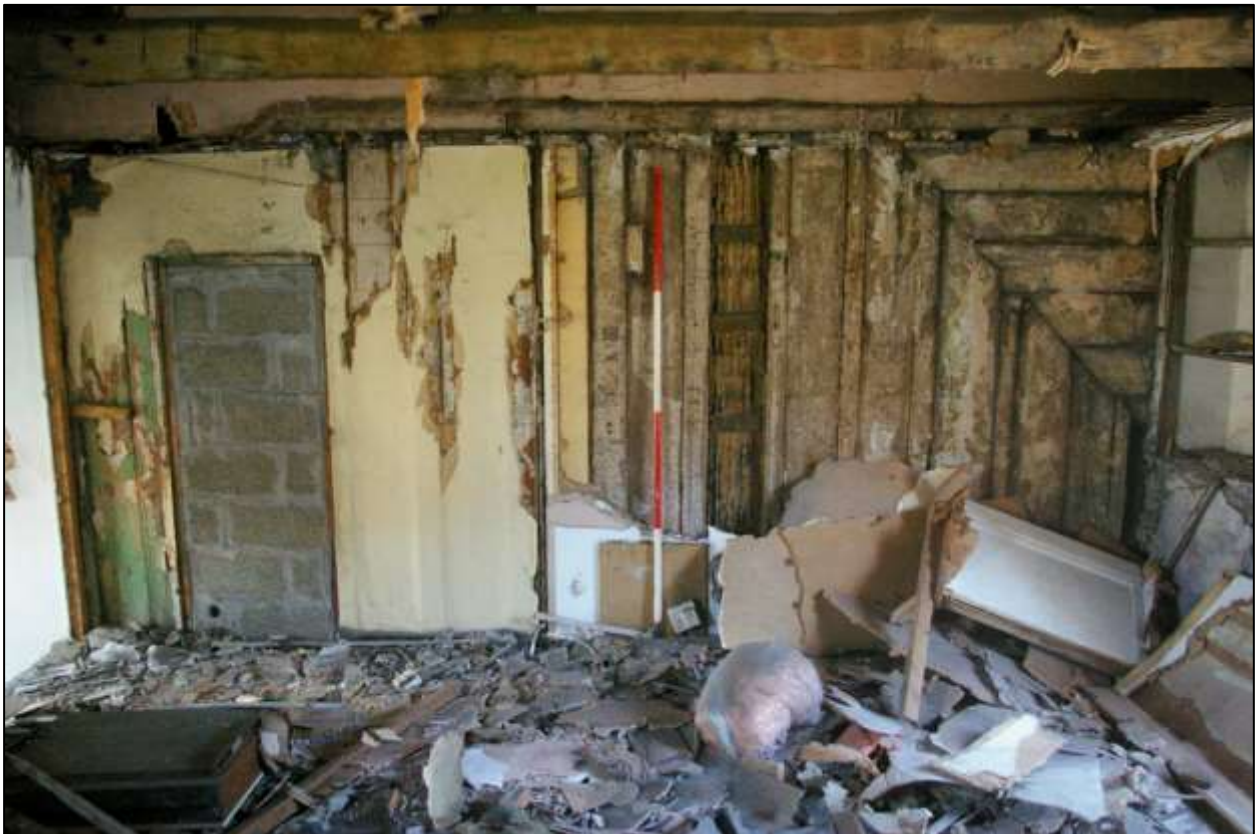
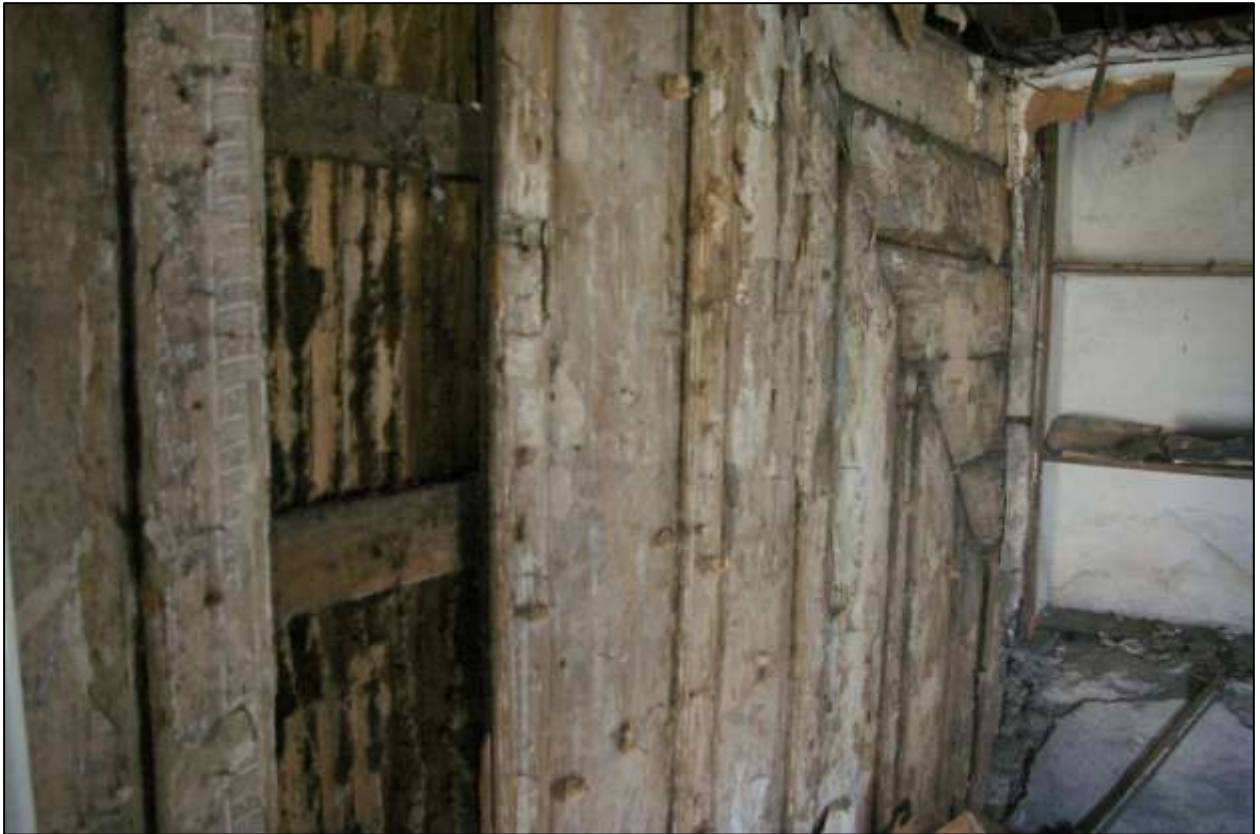
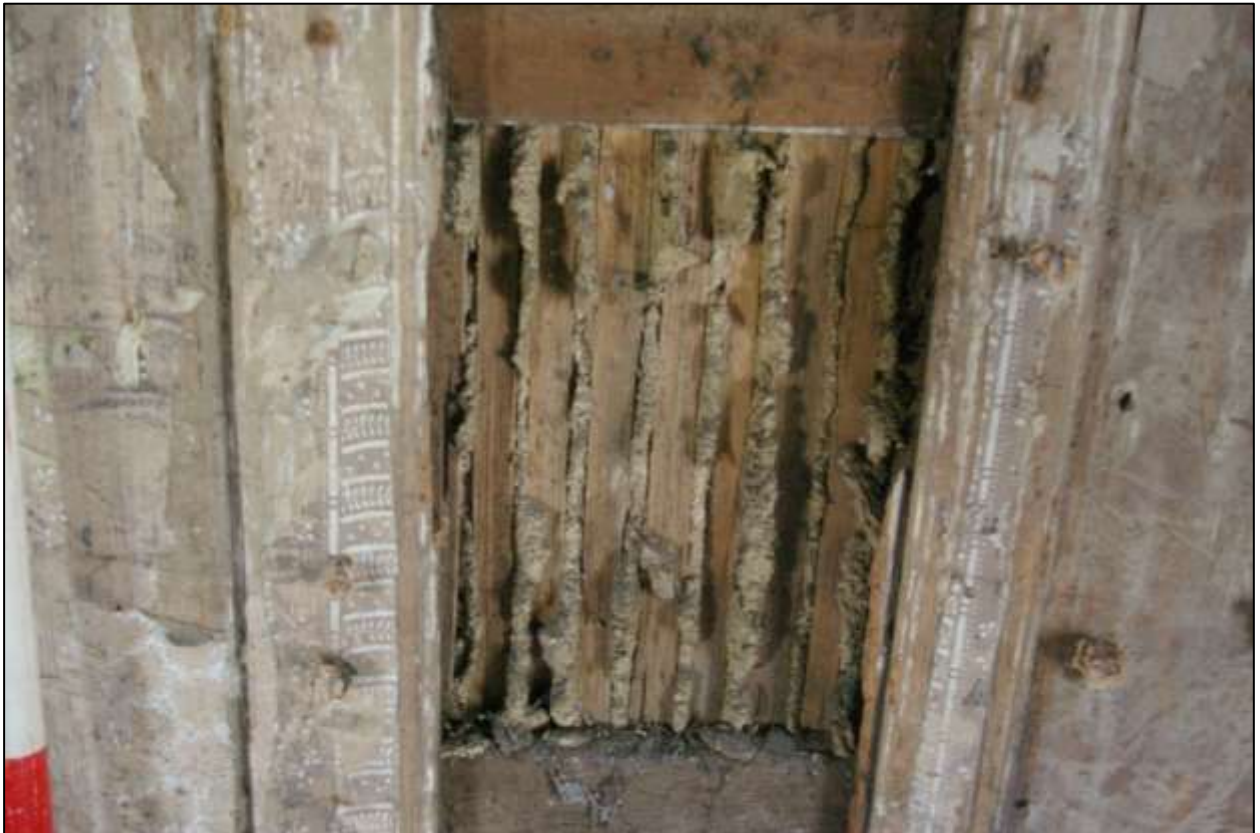
FIGURE 23: R8/R10, THE EAST PARTY WALL SHOWING THE VERTICAL PLANK BOARDING AND EVIDENT OF THE RAISE (LEFT); VIEWED FROM THE WEST.

FIGURE 24: R10, DETAIL OF THE VERTICAL PLANK BOARDING; VIEWED FROM THE NORTH.

FIGURE 25: R10, DETAIL OF THE REGENCY WALLPAPER ADHERING TO THE PLANKS, AND THE VERTICAL LATH AND PLASTER ON THE REVERSE OF THE WALL; VIEWED FROM THE WEST.

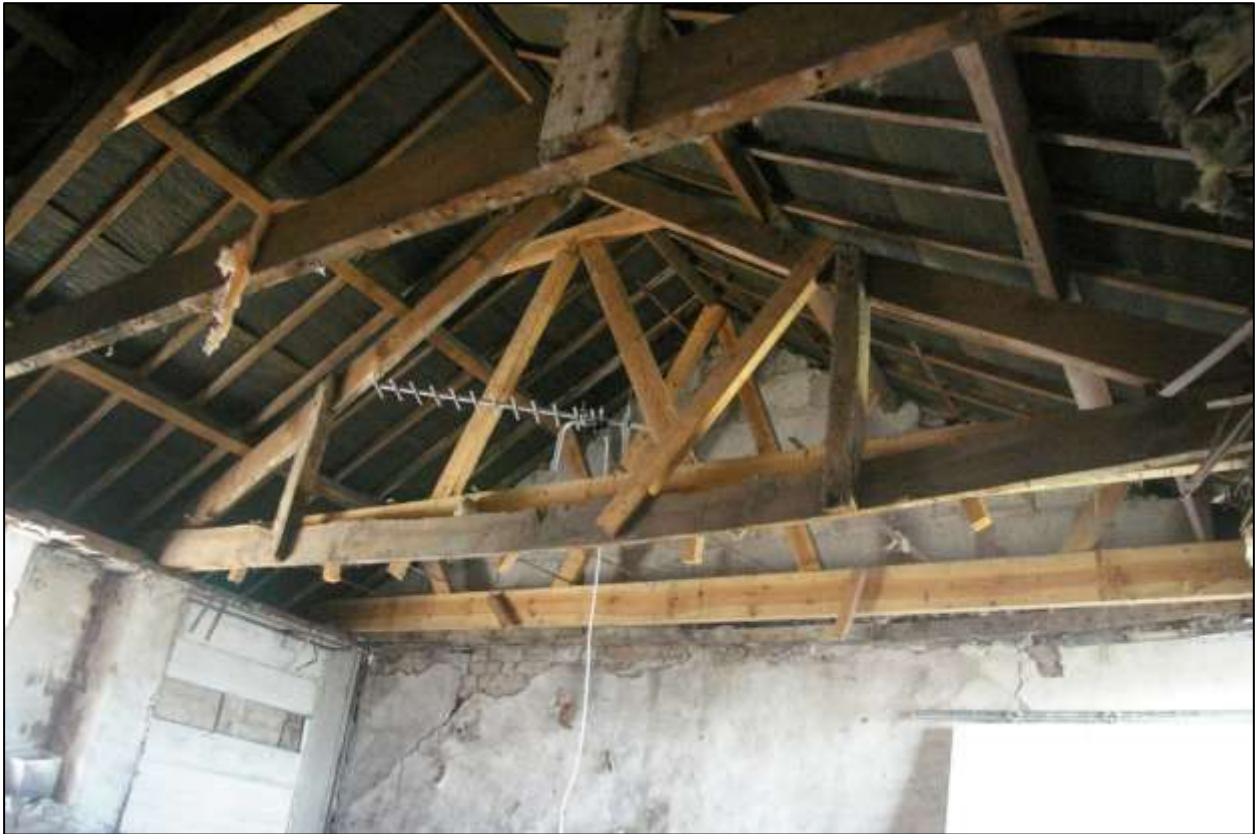
FIGURE 26: R9/R10, DETAIL OF THE ROOF STRUCTURE; VIEWED FROM THE NORTH-EAST.

The roof of regular sawn pine rafters is carried on two simple pine A-frames, half-lapped at the apex; a tie-beam at wallplate height with vertical queen struts, all nailed. These have been reinforced in the 20<sup>th</sup> century by high collars, additional struts, and a completely new truss set up against the west gable wall, which is of (or concealed by) concrete blocks above wallplate height.
