# the former KITTS CORNER

## 51 CHAPEL STREET

## *Archaeological Monitoring and Recording*

Work undertaken by SWARCH for a private client  
NGR: SW 47391 30131  
Planning Reference: PA20/11357 & PA20/11358 (LBC)  
OASIS reference: SOUTHWES1-417059  
South West Archaeology Ltd. report no. 230308

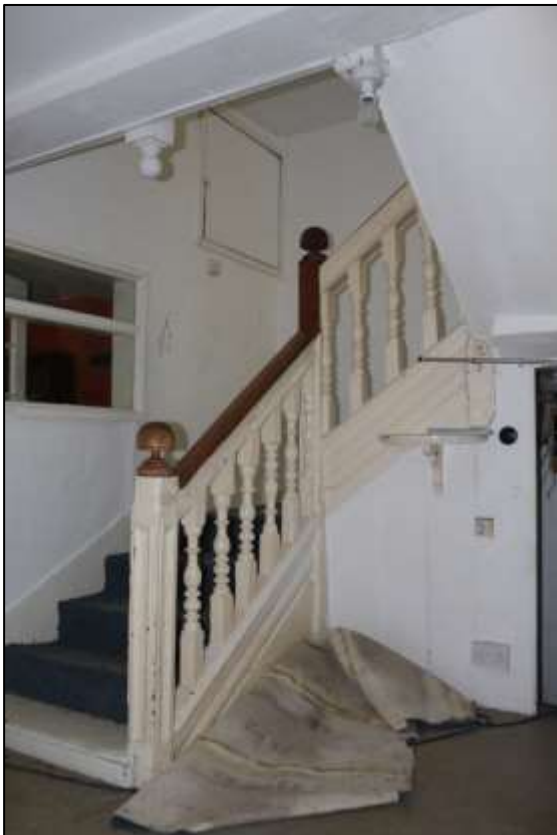
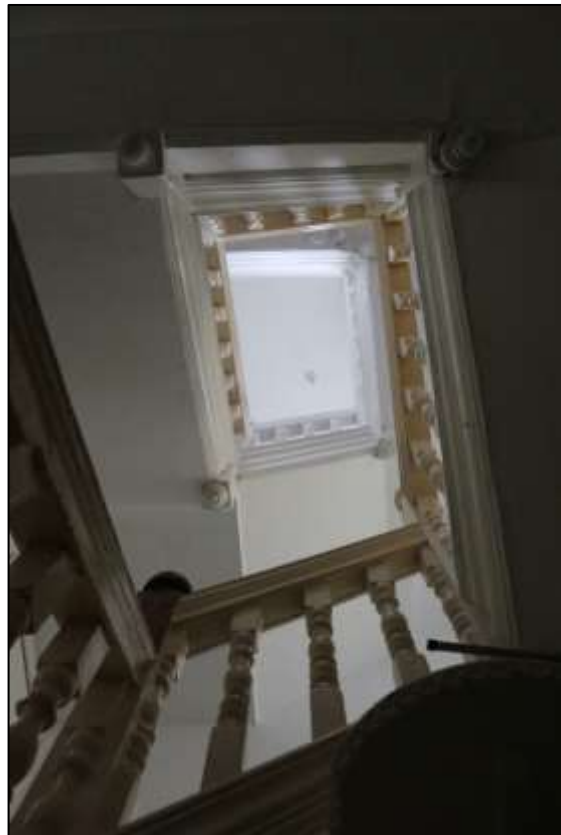
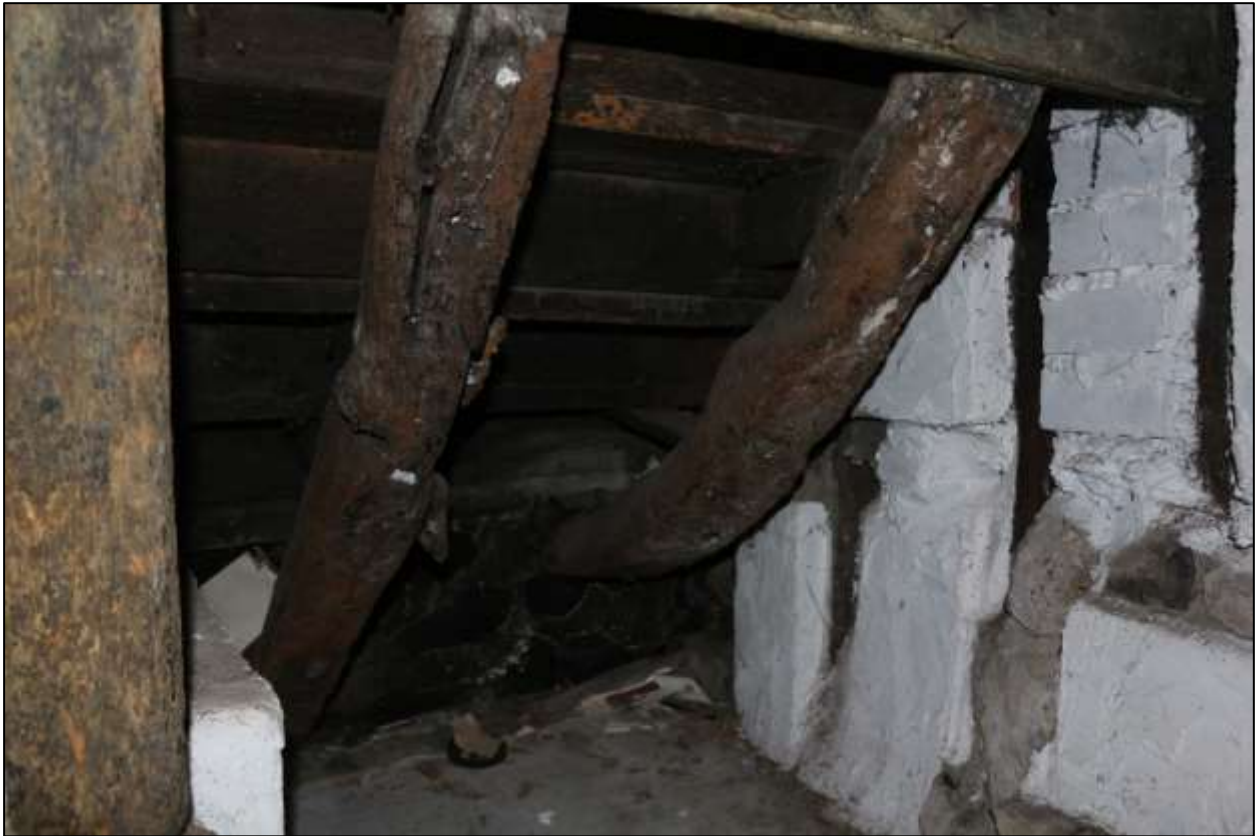
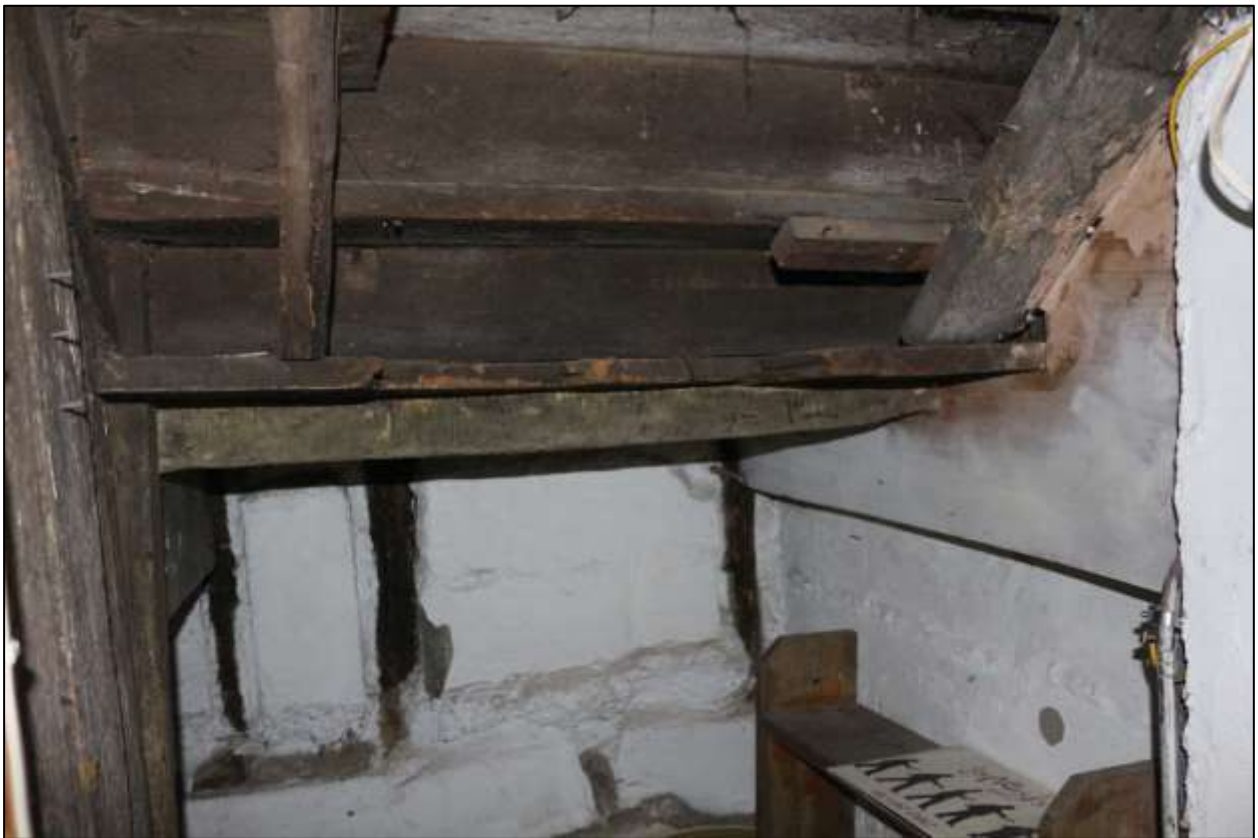
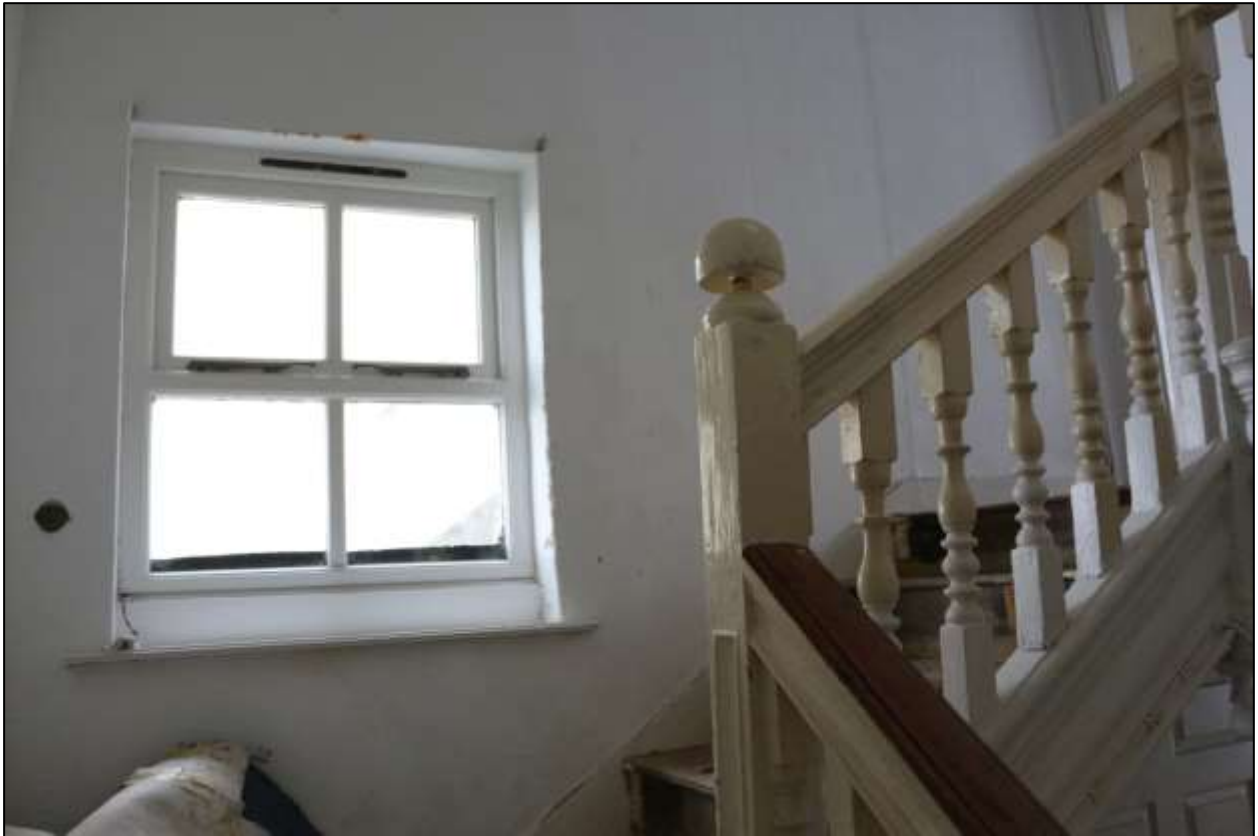
LEFT FIGURE 27: R2, THE BASE OF THE STAIRWELL; VIEWED FROM THE SOUTH.

RIGHT FIGURE 28: R2, LOOKING UP THE STAIRWELL FROM BELOW.

FIGURE 29: R2, BENEATH THE FIRST FLIGHT OF STEPS, SHOWING THE ?INSERTED CARRIAGE BRACES; VIEWED FROM THE NORTH.

FIGURE 30: R2, BENEATH THE SECOND FLIGHT OF STEPS, SHOWING THEM BRACED AGAINST THE FLOORBOARDS OF THE FIRST HALF-LANDING; VIEWED FROM THE WEST.

FIGURE 31: R2, THE STAIRS, SHOWING THE NEWEL AND BALUSTERS AT THE SECOND HALF LANDING; VIEWED FROM THE WEST.

The most interesting, indeed, the outstanding and unexpected, feature of this building is the closed-string winder stair that rises from ground floor to second floor around its well. There are six short flights of four and five steps separated by four half-landings and the first-floor full landing (R5). At each turn there are tall square-section newel posts, topped with later (perhaps Arts & Crafts era) dome-shaped finials on an iron pintle. The finial on the newel to the ground-floor is a more recent replacement, the upper corners of the newel are slightly chamfered, and something was affixed to it (a dog gate?) suggesting something slightly different here. The uppermost newel post lacks the dome-shaped finials, and instead features a plain curving chamfer, which is likely to be original. The underside of the newel posts, where exposed, featured moulded pendants, of which one survives; the others are modern replacements. To first-floor level the newel posts have rectangular recessed panels with ogee moulding; above this they are plain. The frog's back handrail is heavily moulded, as is the string capping to the stair well, but the skirting boards are entirely plain and without mouldings. The balusters are fairly chunky, of turned vase form with unturned tops and base. Each north-south flight has five steps; each east-west flight has four steps. This is mirrored by the turned balusters, with five balusters plus two half-balusters to each north-south flight, and three balusters plus two half-balusters to each east-west flight. The stairs are thickly painted with white gloss paint; where this has been stripped off, it is shown to be pine. The pine treads, some of which are replacements or reinforced with fibreboard, are supported to the first flight by rough carriage braces nailed together with blacksmiths nails; elsewhere the stairs are post and frame, suggesting either repairs or a transitional design; for the second flight rising from the first half-landing, thin braces sit on the floorboards of the landing below. Overall, the stairs are not square, and reflect the lack of right-angle corners throughout the building. In terms of dating, the character and form of the stair would suggest a date c.1690, but the detailing (e.g. the overall preference for ogee over bolection moulding) would indicate a date of 1700-1710 is more probable.

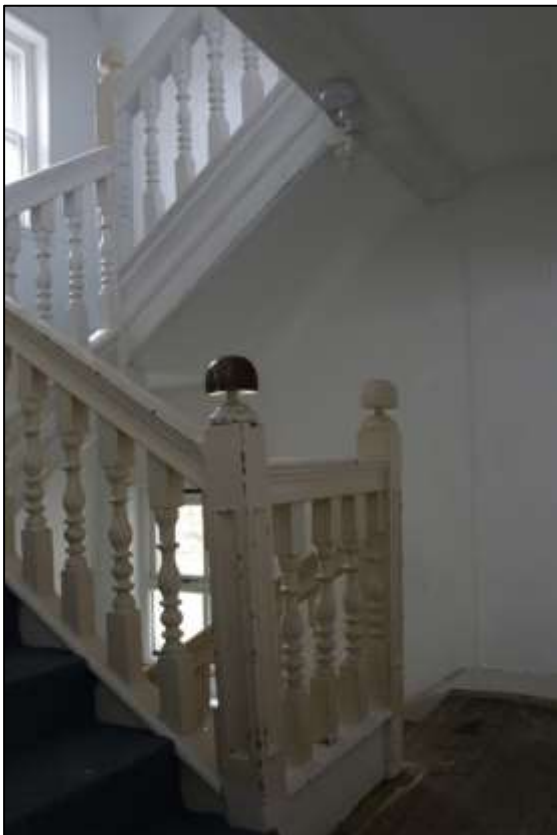
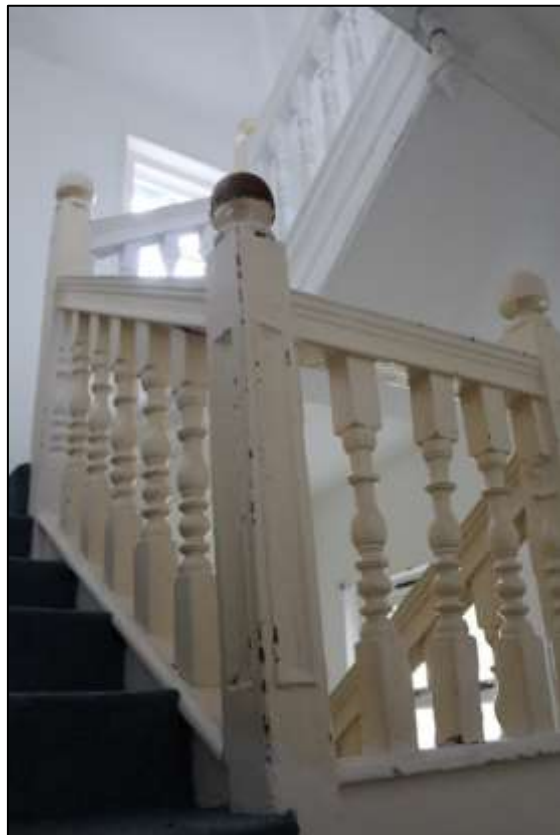
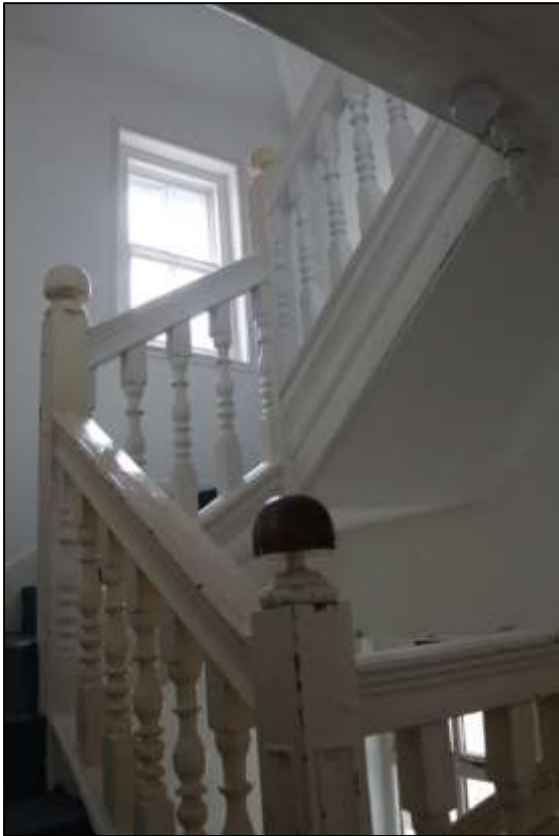
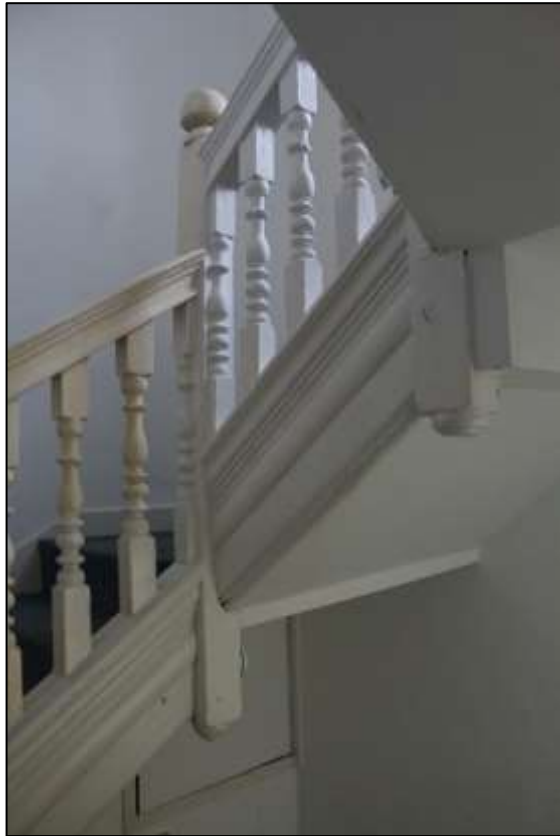
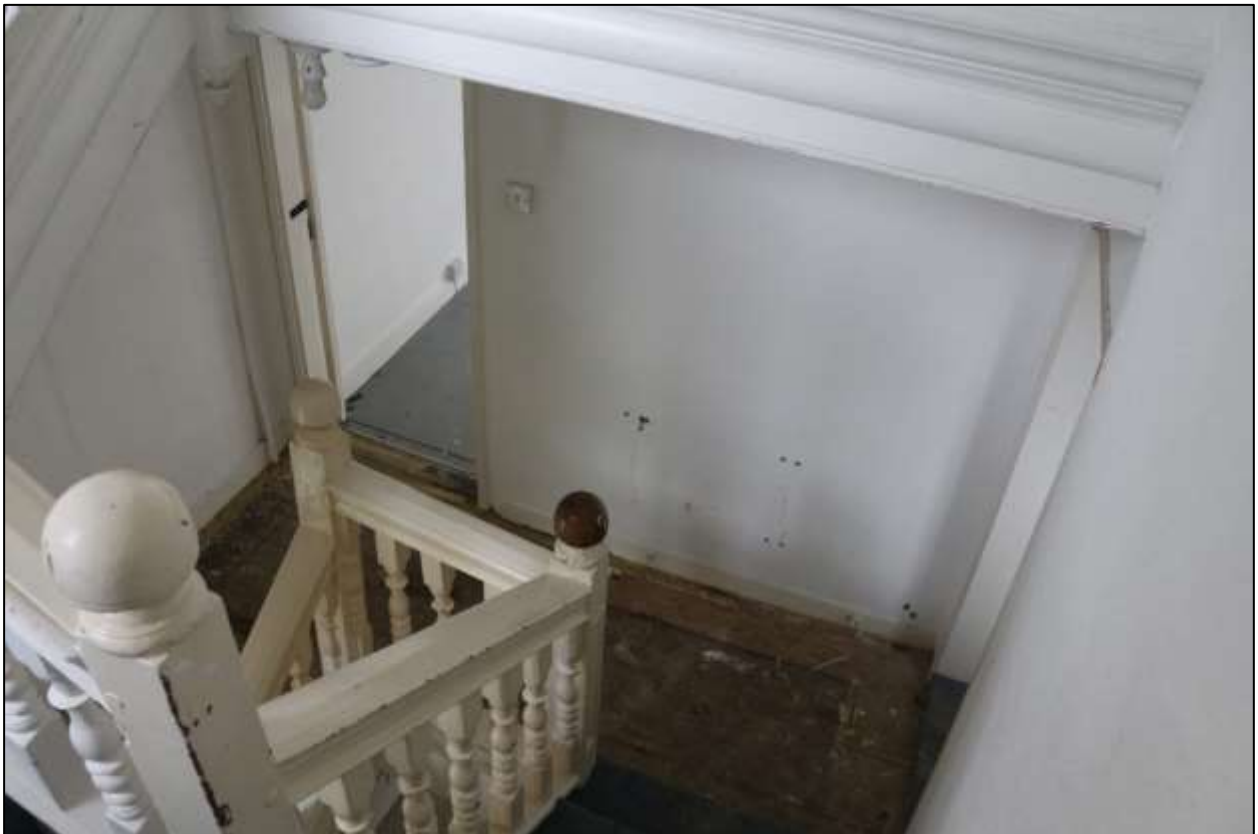
LEFT FIGURE 32: R5, THE STAIRS FROM THE FIRST-FLOOR LANDING; VIEWED FROM THE WEST.

RIGHT FIGURE 33: R5, DETAIL OF THE NEWEL AND BALUSTERS ON THE FIRST-FLOOR LANDING; VIEWED FROM THE SOUTH-WEST.

LEFT FIGURE 34: R5, LOOKING UP TO THE NEXT TWO FLIGHTS OF STAIRS; VIEWED FROM THE SOUTH-WEST.

RIGHT FIGURE 35: R5, LOOKING ACROSS TO THE STAIRS, DETAIL OF THE MOULDING BELOW THE STRING STEP; VIEWED FROM THE SOUTH-EAST.

FIGURE 36: R5, LOOKING DOWN TO THE LANDING; VIEWED FROM THE NORTH.

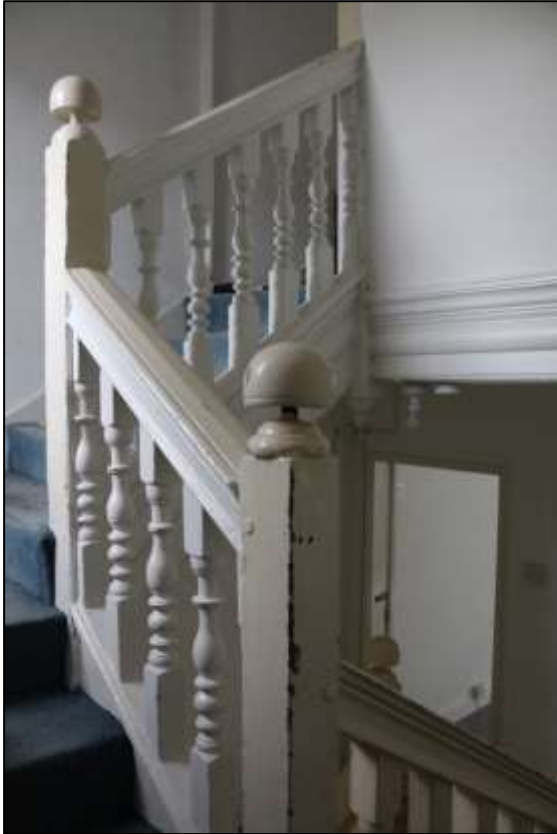
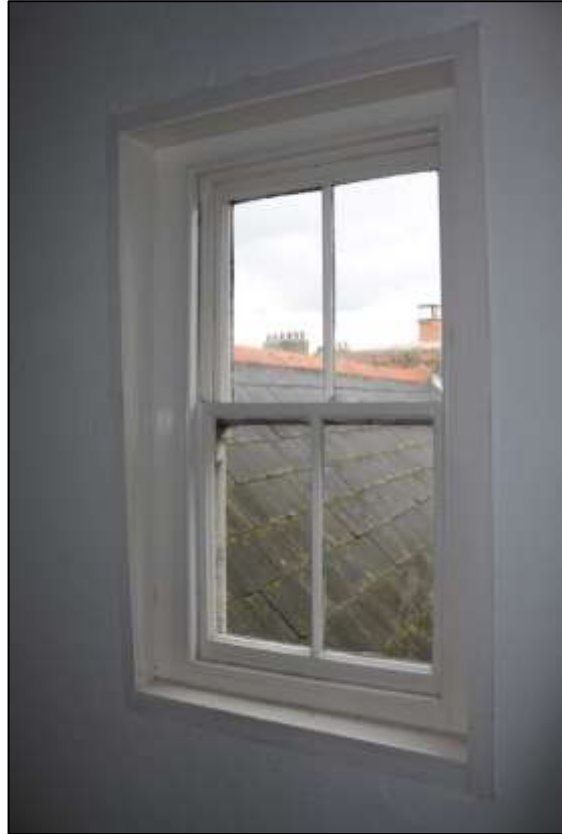
LEFT FIGURE 37: R8, DETAIL OF THE UPPER NEWELS (UNDECORATED) AND BALUSTERS; VIEWED FROM THE NORTH-EAST.

RIGHT FIGURE 38: R8, THE LATER C19 SASH WINDOW OVERLOOKING THE ADJACENT KITTS COURT; VIEWED FROM THE SOUTH.

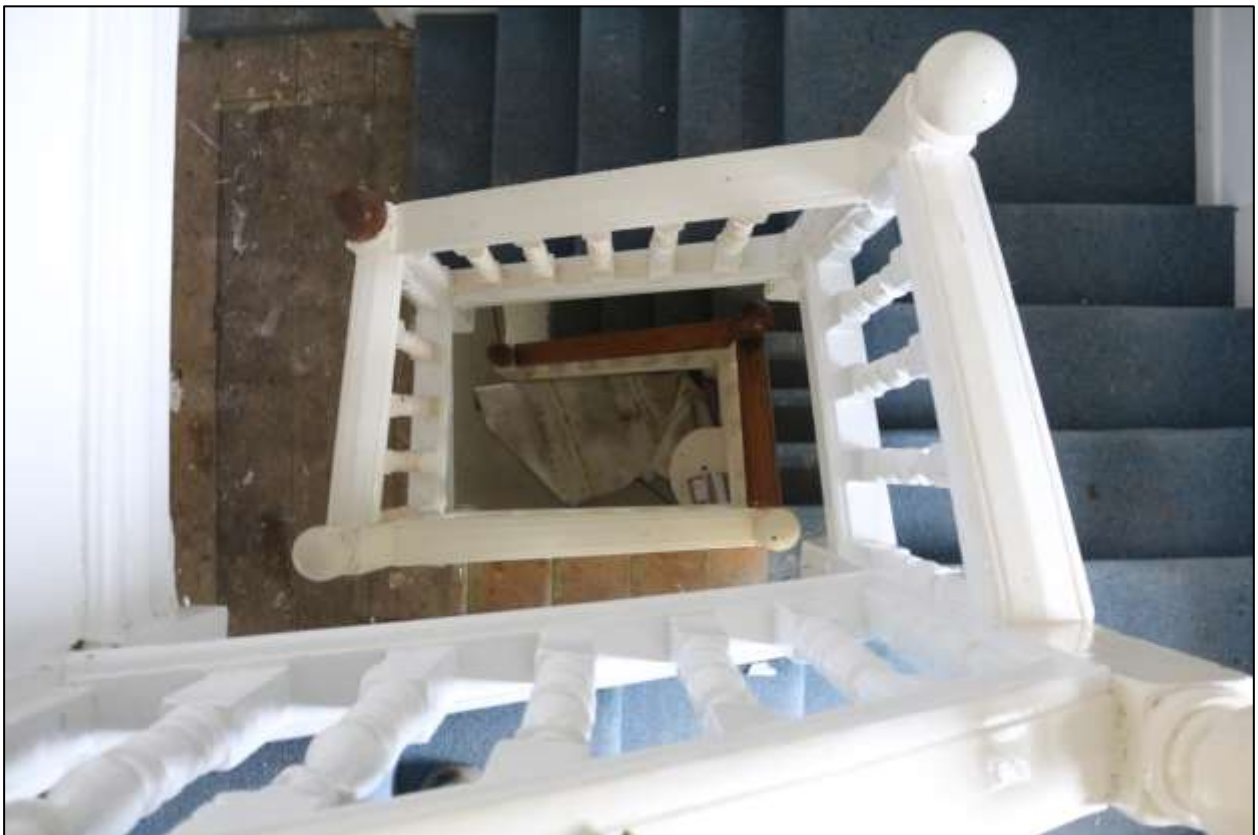
FIGURE 39: THE VIEW DOWN THE STAIRWELL FROM THE TOP; VIEWED FROM THE EAST.
