WIND TURBINE AT WHEAL MARTYN PIT

Heritage Impact Assessment

South West Archaeology Ltd. report no. 210517

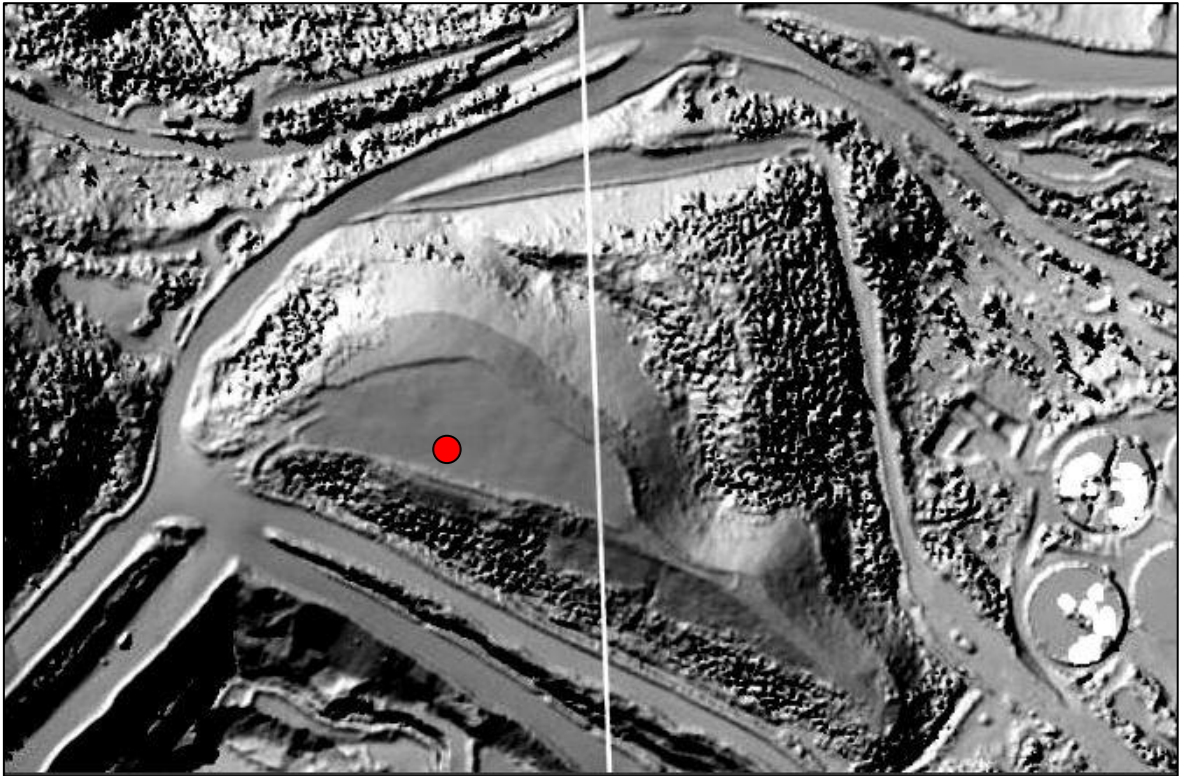
FIGURE 6: HILLSHADE IMAGE USING 2017 ENVIRONMENT AGENCY 1M DSM LIDAR DATA. PROCESSED USING QGIS VER.3.8. CONTAINS DATA USED UNDER THE OPEN GOVERNMENT LICENCE 3.0. THE APPROXIMATE LOCATION OF THE TURBINE IS INDICATED.

A review of readily available commercial aerial photographs indicate that the site lies on a large spoil heap, within a landscape of tracks and structures relating to the Wheal Martyn China Clay works. There is no indication of any surviving historic features here, beyond that of the spoil heap from the former Vale Pleasant works.

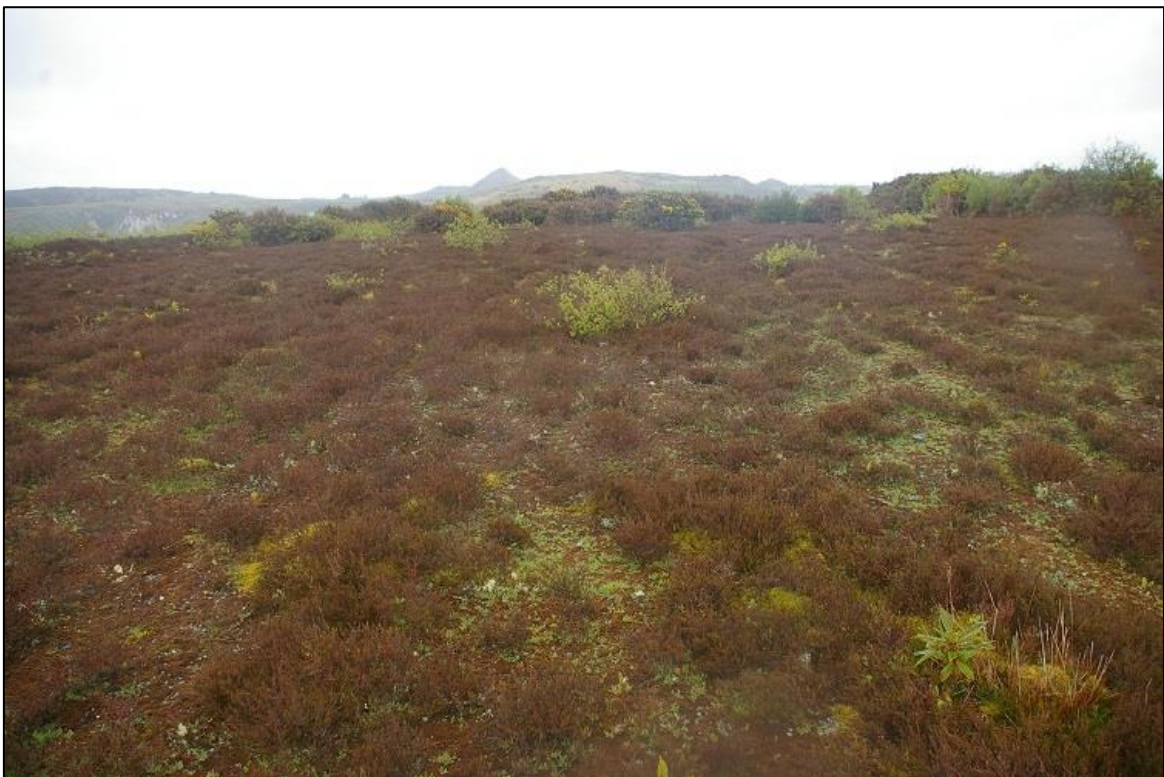
FIGURE 7: THE FLAT TOP OF THE CLAY-PIT TIP - SITE OF THE PROPOSED TURBINE; VIEWED FROM THE WSW.

The site was visited by E. Wapshott in May 2021; the weather was bright and breezy in the morning, becoming increasingly overcast, with intermittent hail and rain in the afternoon. The proposed turbine would be located within the flat top of a small bench-tip between the Gunheath and Wheal Martyn working clay-pits. The top of the bench tip is a small wedge-shaped parcel of ground, dominated by gorse and lowland scrub trees with more open patches of heather to the west end, where the turbine is to be located. An overgrown vehicle track accesses the top of the tip from the west end, leading off the main Wheal Martyn access road. The tip is privately owned by Imerys, its scrub covered sides appear to be open to the rest of the site and it has been left for habitat regeneration. The nature of the location means there are 360-degree views from the site but it is blocked within the landscape by the much larger bench tip to the immediate west. Views down towards the historic Wheal Martyn (Wheal Martin) site and adjacent Carthew Farm could not be confirmed from ground level but there would certainly be intervisibility with these assets and the turbine, once built.

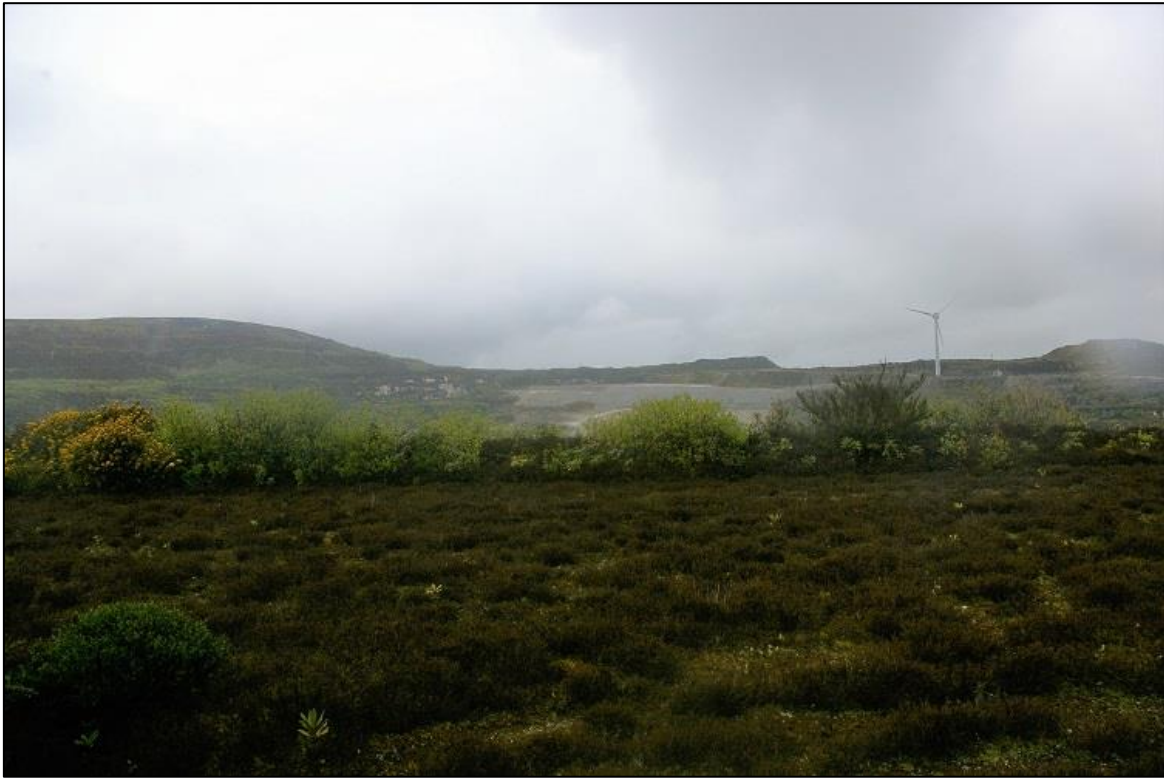
FIGURE 8: VIEW ACROSS THE PROPOSED SITE TO THE EXTANT GUNHEATH TURBINE AND WORKING CLAY-PIT LANDSCAPE; FROM THE SOUTH.

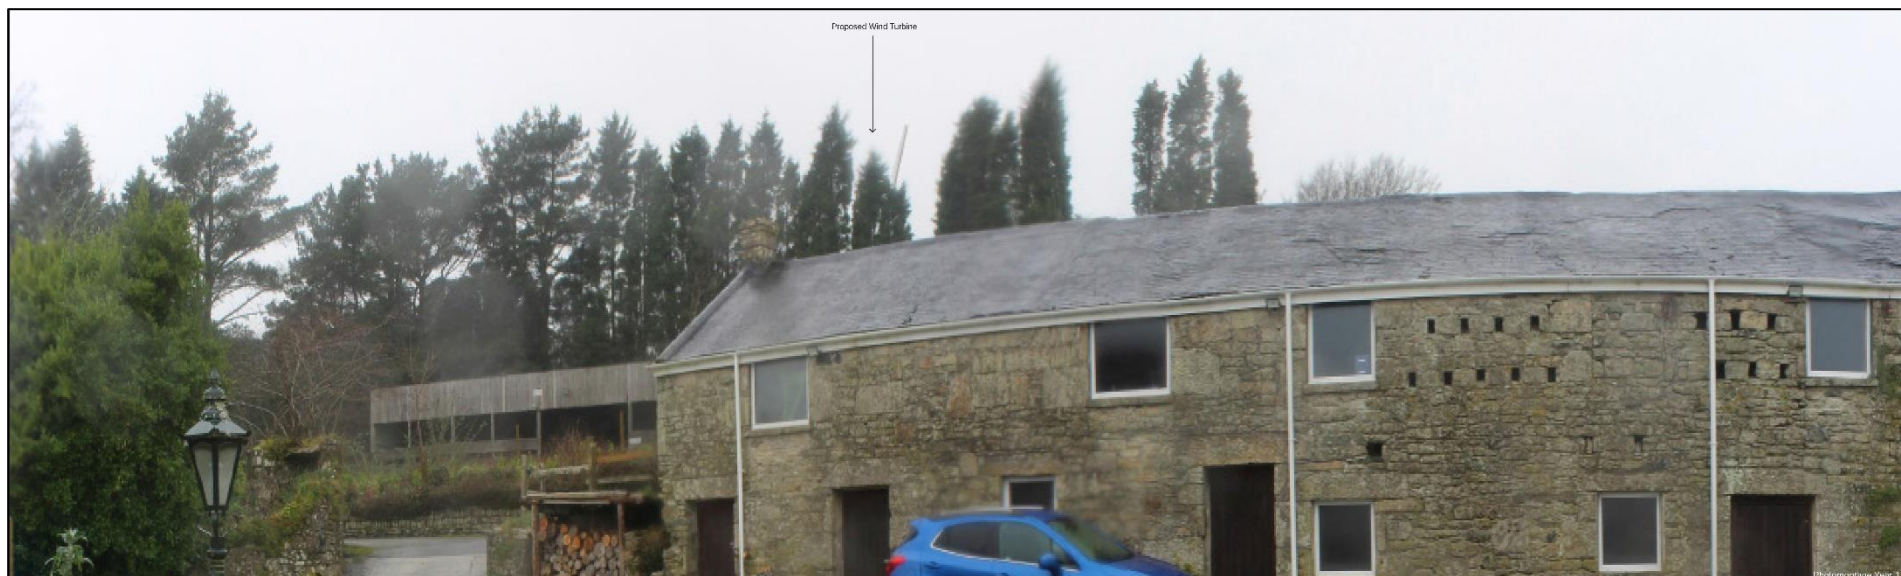
FIGURE 14: VISUALISATION BY AMALGAM LANDSCAPES FROM THE SOUTHERN FARMYARD.

<p><i>Principal Views:</i> The owner kindly provided free access to the farm and house, and it is clear (despite the misty conditions) that there are wide views, primarily to the south and south-east from the farmhouse. Views east across the river valley and to the landscape beyond are possible, but are largely screened by woodlands from around the building group. Views to the west were limited and views out from the yards are limited, although the fir trees located on the skyline to the north-west (and the direction of the proposed turbine) are visible from the southern parts of both yards.</p> <p>Views to the farmstead would be from the adjacent valley slopes, and its former farmland to the south and south-east. The farm is also visible in views from the valley base to the south-east (see Figure 17).</p>
<p><i>Landscape Presence:</i> The farmstead does enjoy some local landscape presence, set on the mid-to-upper slopes and is visible from the wider landscape. The landscape presence of the house is somewhat limited by the banks of trees but there is a particular view along the B3274 from the south-south-east, up the valley – the house and group of farm buildings stands on the skyline in these views – framed by trees (Figure 18) – it appears to be placed intentionally for this view, as its principle façade is turned to face south-east down the valley.</p>

<p><i>Magnitude of Impact:</i> Medium value + Moderate change = Negative/moderate effect</p>
<p><i>Overall Impact Assessment:</i> Negative/moderate</p>

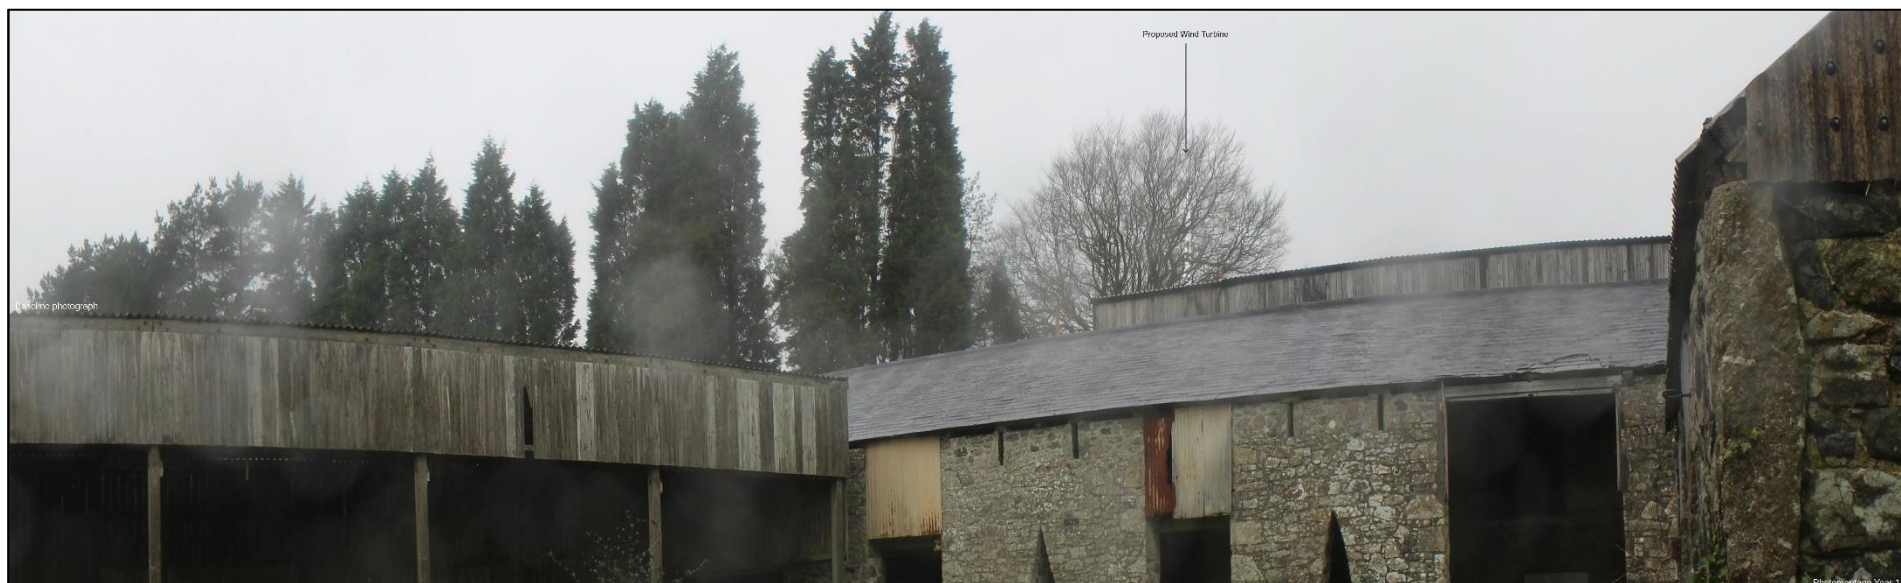
FIGURE 15: VISUALISATION BY AMALGAM LANDSCAPES FROM THE NORTHERN FARMYARD.

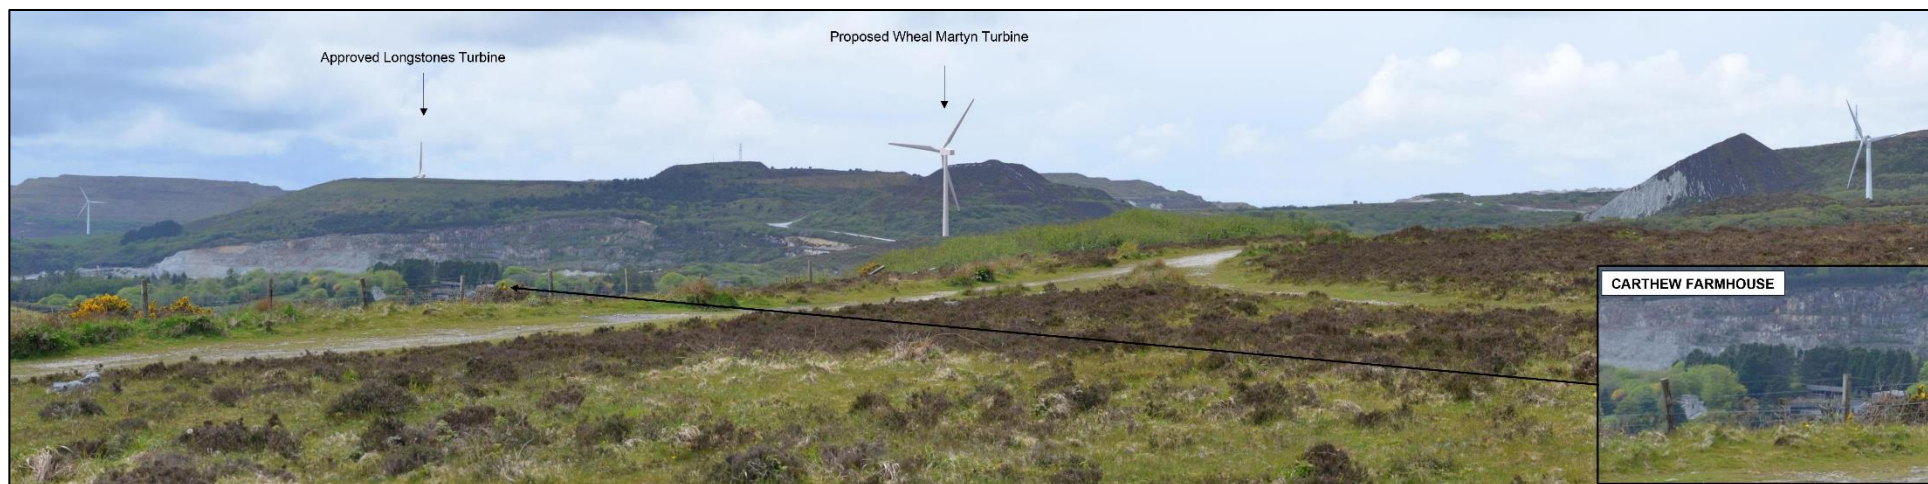
FIGURE 16: VISUALISATION BY CLEAN EARTH ENERGY LTD SHOWING THE POTENTIAL CUMULATIVE VISUAL IMPACT OF THE TURBINE ON CARTHEW FARMHOUSE.

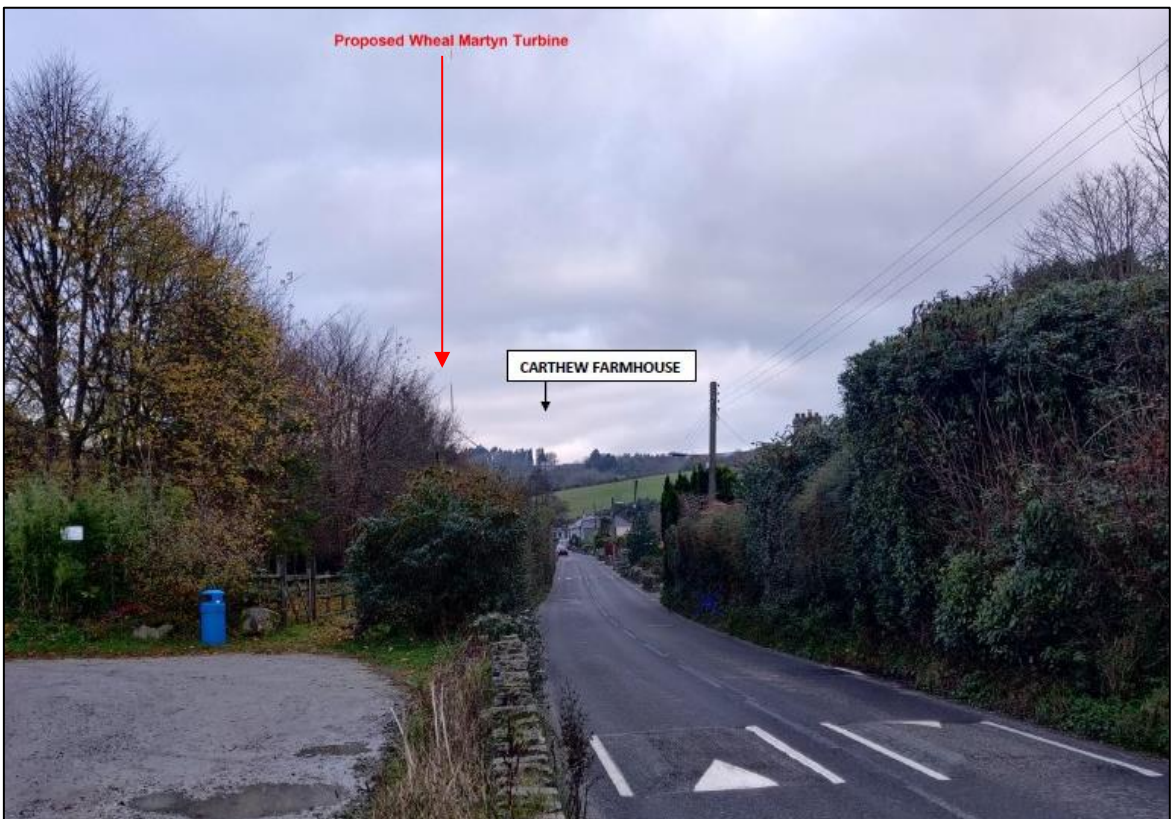
FIGURE 18: VISUALISATION BY CLEAN EARTH ENERGY LTD SHOWING THE POTENTIAL VISUAL IMPACT OF THE TURBINE ON CARTHEW FARMHOUSE.

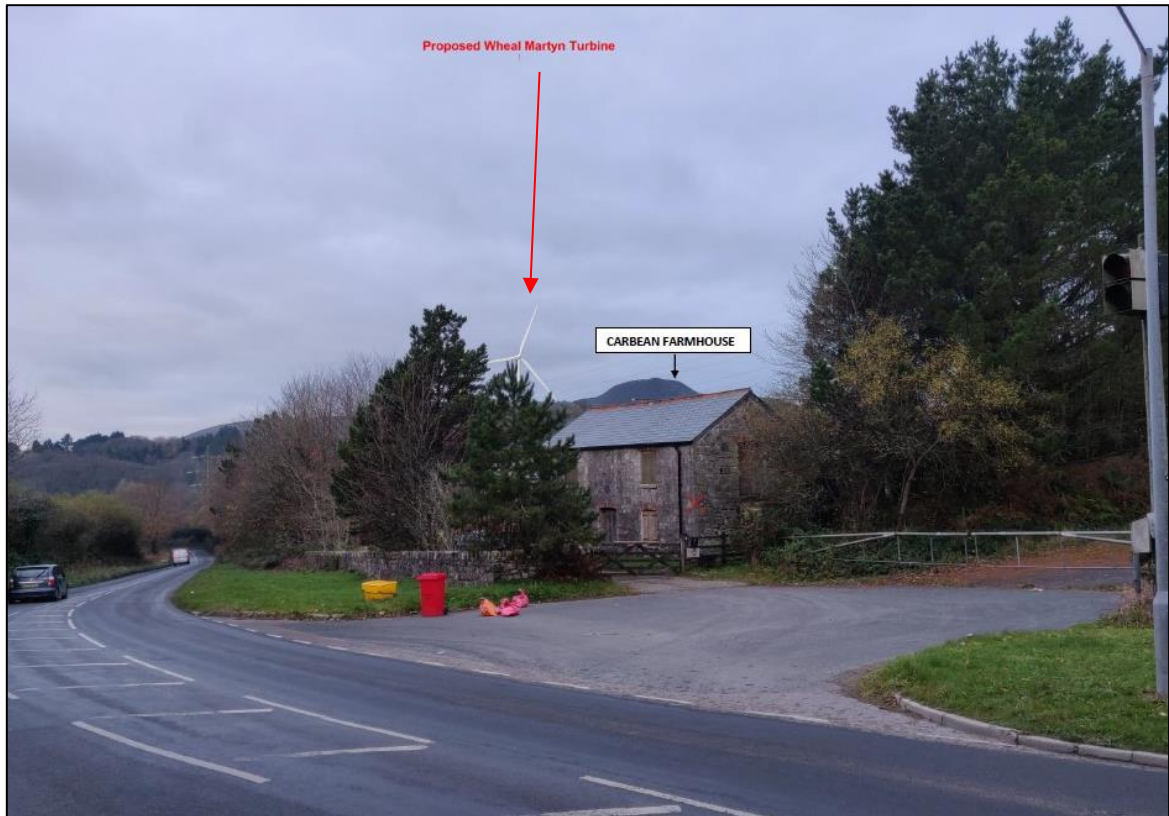
FIGURE 19: VISUALISATION BY CLEAN EARTH ENERGY LTD, SHOWING THE POTENTIAL VISUAL IMPACT OF THE TURBINE ON CARBEAN FARMHOUSE.

<i>Contribution of Setting to Significance of Asset:</i> Incidental. The house was constructed within a working agricultural landscape which is now relict and largely swept away, fragmentary at best. The house sits within a landscape of historic china clay tips. Its immediate setting and outbuildings are important and allows for the correct interpretation of this older asset in a much-changed setting.	
<i>Magnitude of Effect:</i> The turbine will be very visible down the valley directly to the south-west, drawing the eye away from the farmhouse – as one approaches along the road. The trees and farm buildings would insulate the farmhouse from direct outward views to a greater extent, particularly as it faces away from the turbine on its principle side, although general views from the farmyard and fields would obviously include the turbine, which will visually dominate the wider setting.	
<i>Magnitude of Impact:</i> Medium value + Moderate = Negative/moderate

<i>Overall Impact Assessment:</i> Negative/moderate

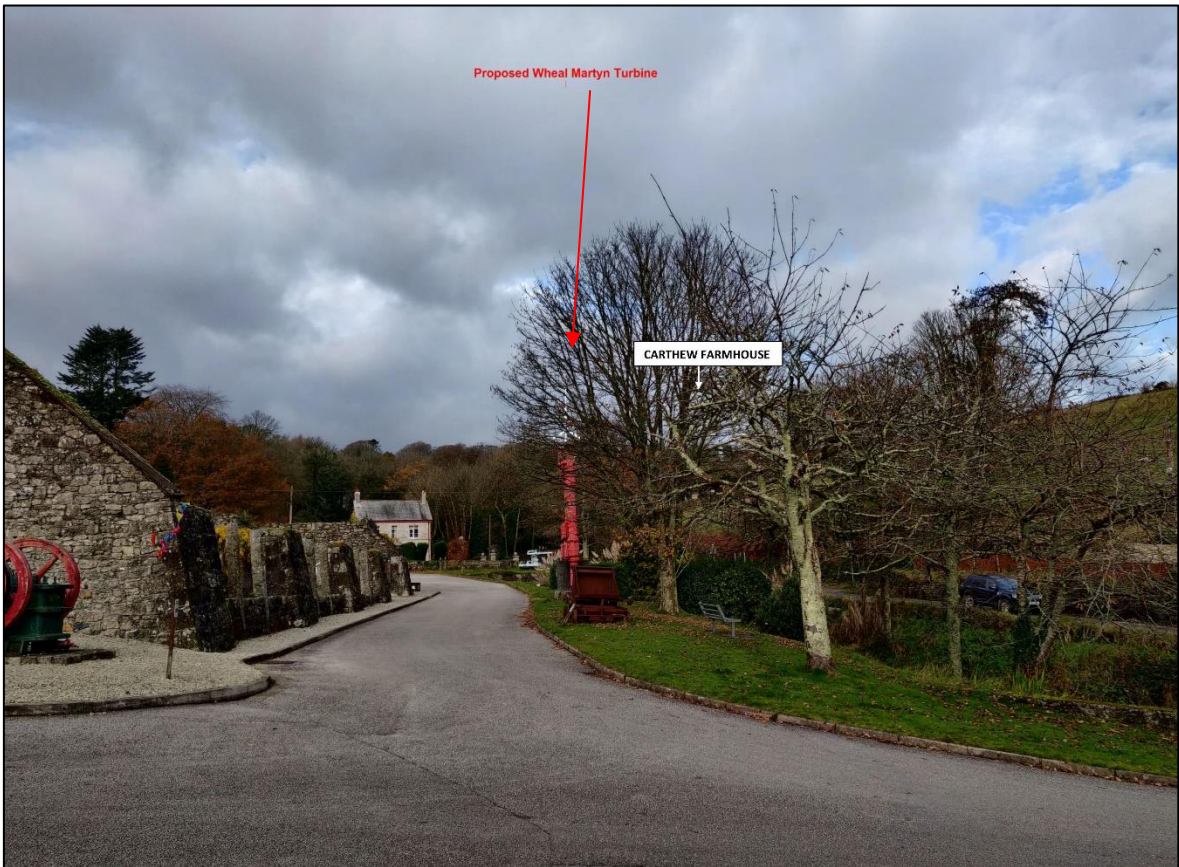
FIGURE 27: VISUALISATION BY CLEAN EARTH ENERGY LTD, SHOWING THE POTENTIAL VISUAL IMPACT OF THE TURBINE ON WHEAL MARTYN.

<p><i>Magnitude of Effect:</i> The turbine will stand on the downs immediately to the west of the clay pits standing south of the already visible Gunheath turbine. The industrial assets at Wheal Martyn are part of an ongoing process of resource extraction across the landscape, the wind energy features are part of a cultural continuation.</p>	
<p><i>Magnitude of Impact:</i> High value + Negligible change = Negligible/slight effect.</p>	
<p><i>Overall Impact Assessment:</i> Neutral</p>
