# LAND AT NUTHURST LANE

Heritage Impact Assessment

South West Archaeology Ltd. report no. 210925

Work undertaken by SWARCH for Aardvark EM Ltd. (The Agent)

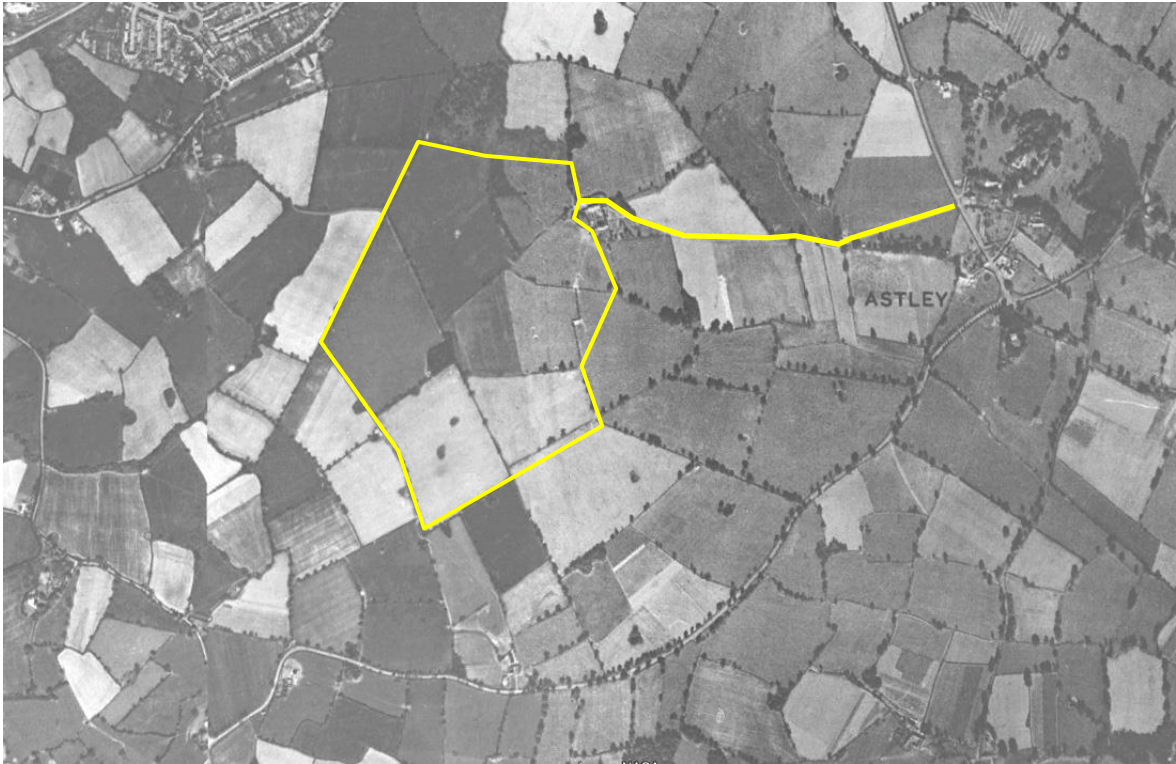
FIGURE 12: AERIAL PHOTOGRAPH FROM C.1945 SHOWING LITTLE CHANGE IN THE STRUCTURE OF THE FIELDS, ALTHOUGH SOME BOUNDARY LOSS HAS OCCURRED (© 2021 THE GEOINFORMATION GROUP).

A review of readily available recent aerial photographs (Figures 12-14) shows relatively little change to the area of the proposed development over the last 70 years. There has been some boundary loss, as fields have been enlarged. The main change has been the loss of Duke's Farm. It is unclear exactly when it was abandoned, but it was probably in the late 1970s/early 1980s. The farmstead was flattened, so perhaps there was a catastrophic fire or similar. There is no Environment Agency LiDAR data for the survey area.

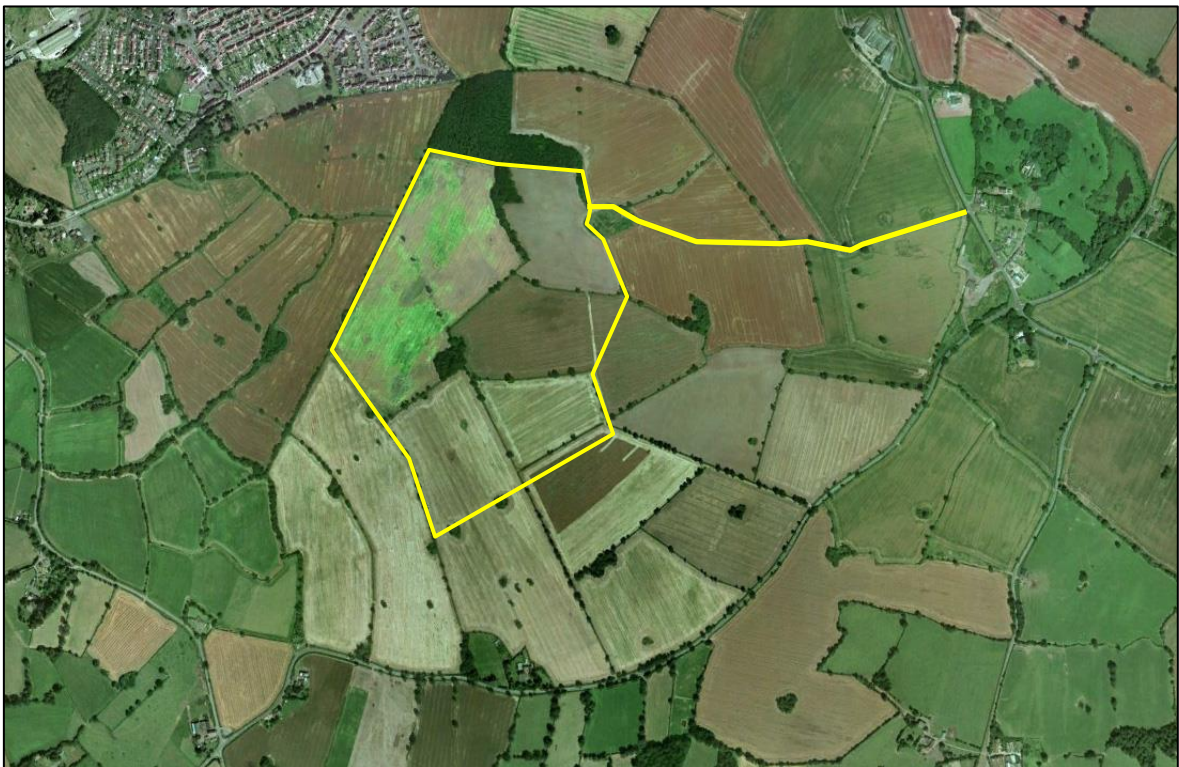
FIGURE 13: AERIAL PHOTOGRAPH FROM 1999 SHOWING LIMITED CHANGE IN THE FIELDS COMPRISING THE SITE OTHER THAN A SMALL AMOUNT OF BOUNDARY LOSS (© 2021 INFOTERRA LTD & BLUESKY).

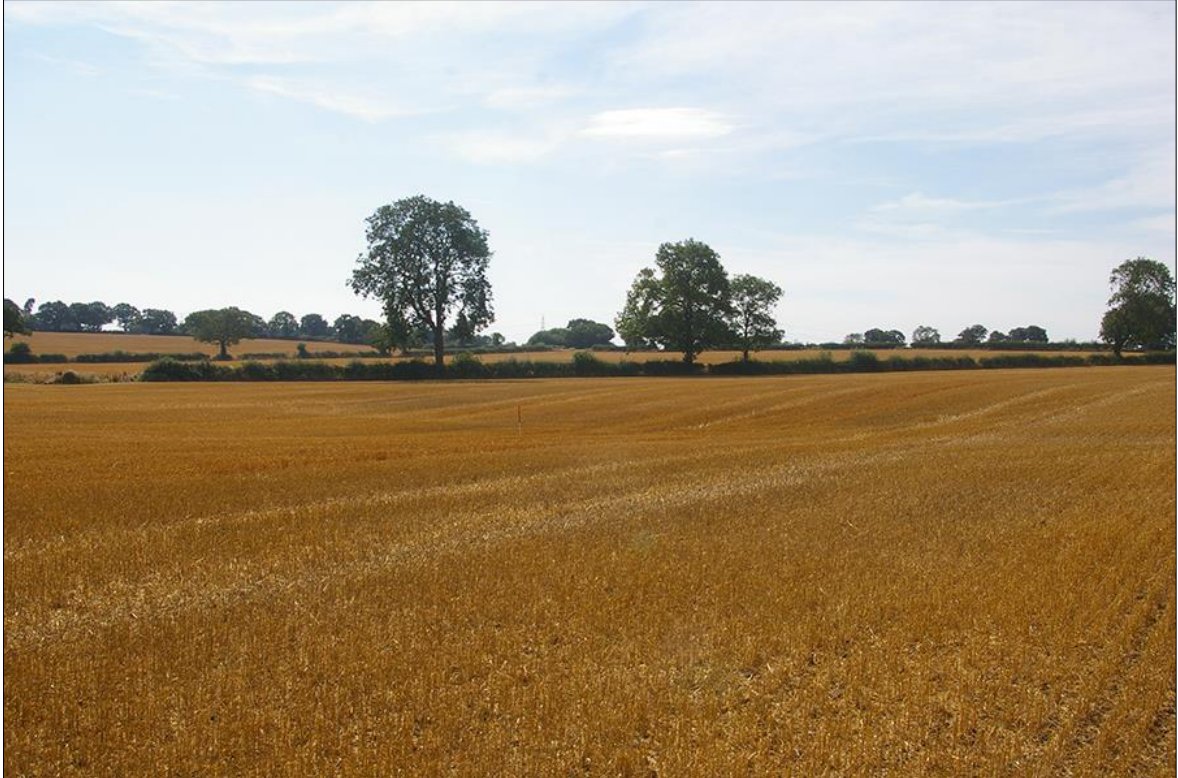
FIGURE 18: F3, DETAIL OF THE LARGE HOLLOW DEPRESSION WITHIN THE FIELD; VIEWED FROM THE NORTH-EAST (1M SCALE).

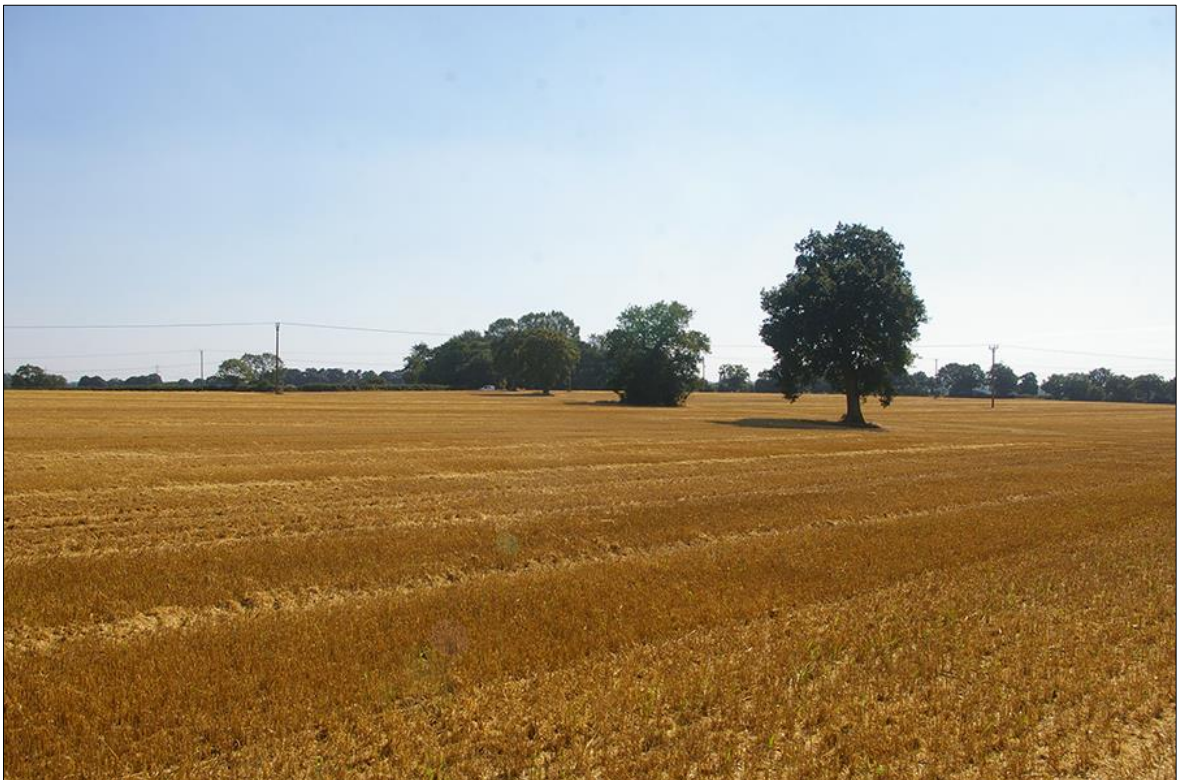
FIGURE 19: F4, VIEW ALONG THE TREE LINE INDICATING THE PRESENCE OF A FORMER FIELD BOUNDARY; VIEWED FROM THE NORTH-EAST (NO SCALE).

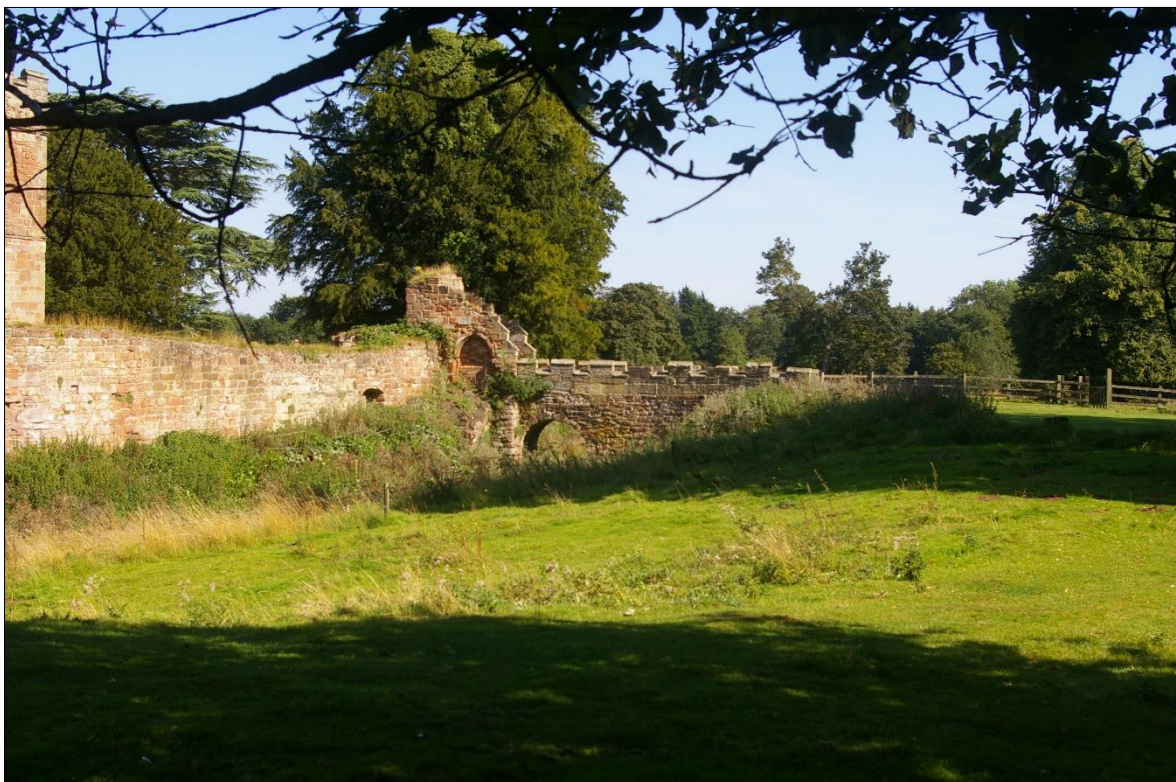
FIGURE 28: THE BRIDGE AND REMAINS OF THE GATEHOUSE AT ASTLEY CASTLE; VIEWED FROM THE WEST-SOUTH-WEST.

<p><i>Authenticity and Integrity:</i> The surviving structure is partly ruinous and has undergone repairs/renovations to return its functionality</p>
<p><i>Setting:</i> The bridge crosses the moat to provide access to the House, between the moated site and the field adjacent to the churchyard. To the south-west is the churchyard and the Grade I Listed church, with a line of houses and a school beyond, with the Listed stables to the south. Beyond the immediate curtilage is Nuthurst Lane to the west and the B4102 to the east, with scattered trees and a largely arable agricultural landscape beyond.</p>
<p><i>Contribution of Setting to the Significance of the Asset:</i> Intentional. The bridge and gatehouse were threshold structures providing (or withholding) access to the fortified enclosure. As such, views to the structures would be most important, and those from the structure down the approach from the south.</p>

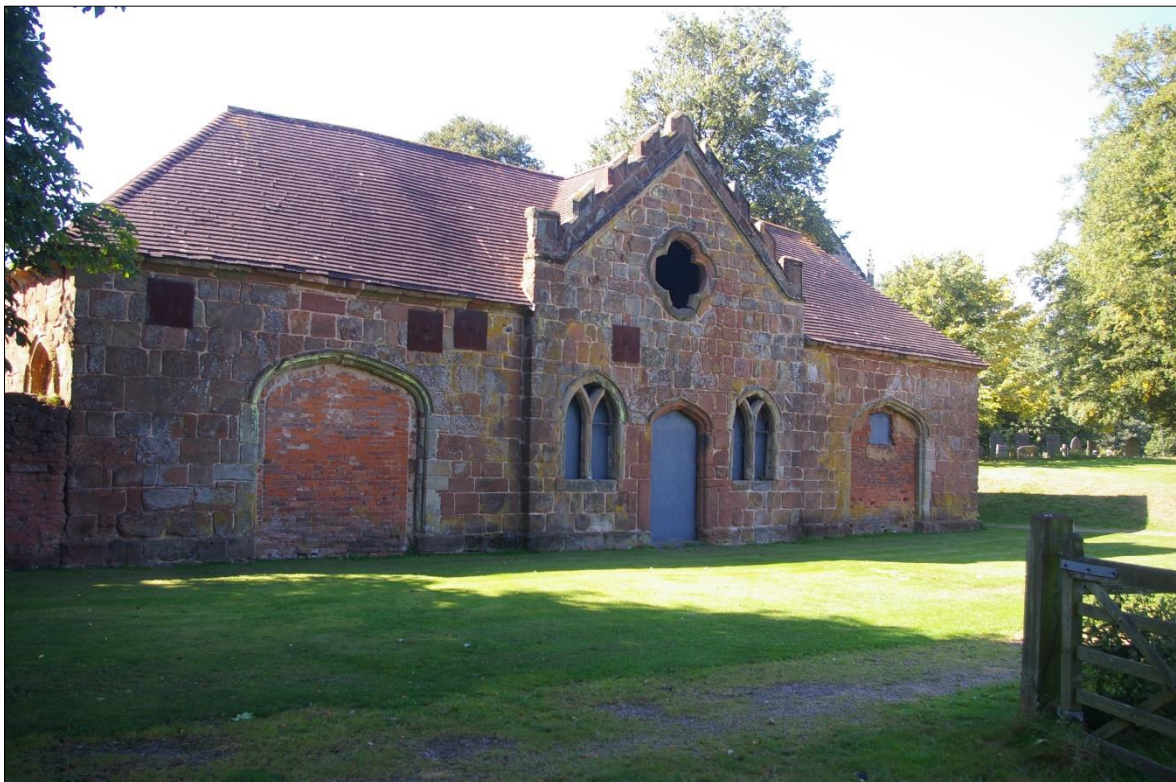
FIGURE 29: THE STABLE BLOCK AT ASTLEY CASTLE; VIEWED FROM THE SOUTH-EAST.

projects slightly and has embattled gable parapet. Double-chamfered doorway with plank door. Windows have Y-tracery. Gable has large moulded quatrefoil opening, partially bricked-up and damaged. First and fifth bays have large bricked-up double-chamfered arches, probably originally coach houses. At rear, gabled wing at centre; later cart entrance on right with added gable above. INTERIOR: Some of the original roof structure remains and interior fittings said to have been largely replaced. This is a good example of C18 Gothick Revival style.

*Authenticity and Integrity:* The surviving structure appears in good condition with working buildings behind and is currently in use at least partly for storage. Google Streetview would indicate the building and structure to the rear (west) was renovated and partly rebuilt in c.2011.

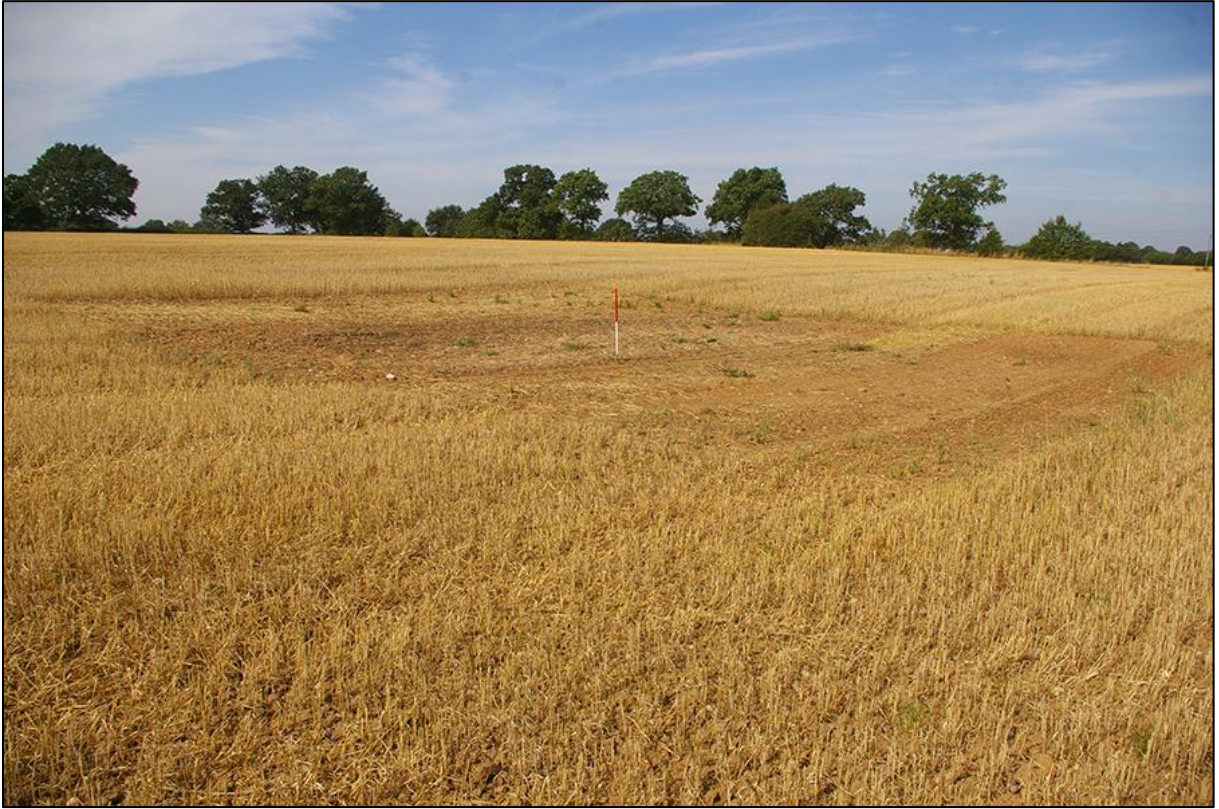
9. DETAIL OF THE NORTH-EASTERN LARGE HOLLOW DEPRESSION WITHIN FIELD F1; VIEWED FROM THE EAST-SOUTH-EAST (1M SCALE).

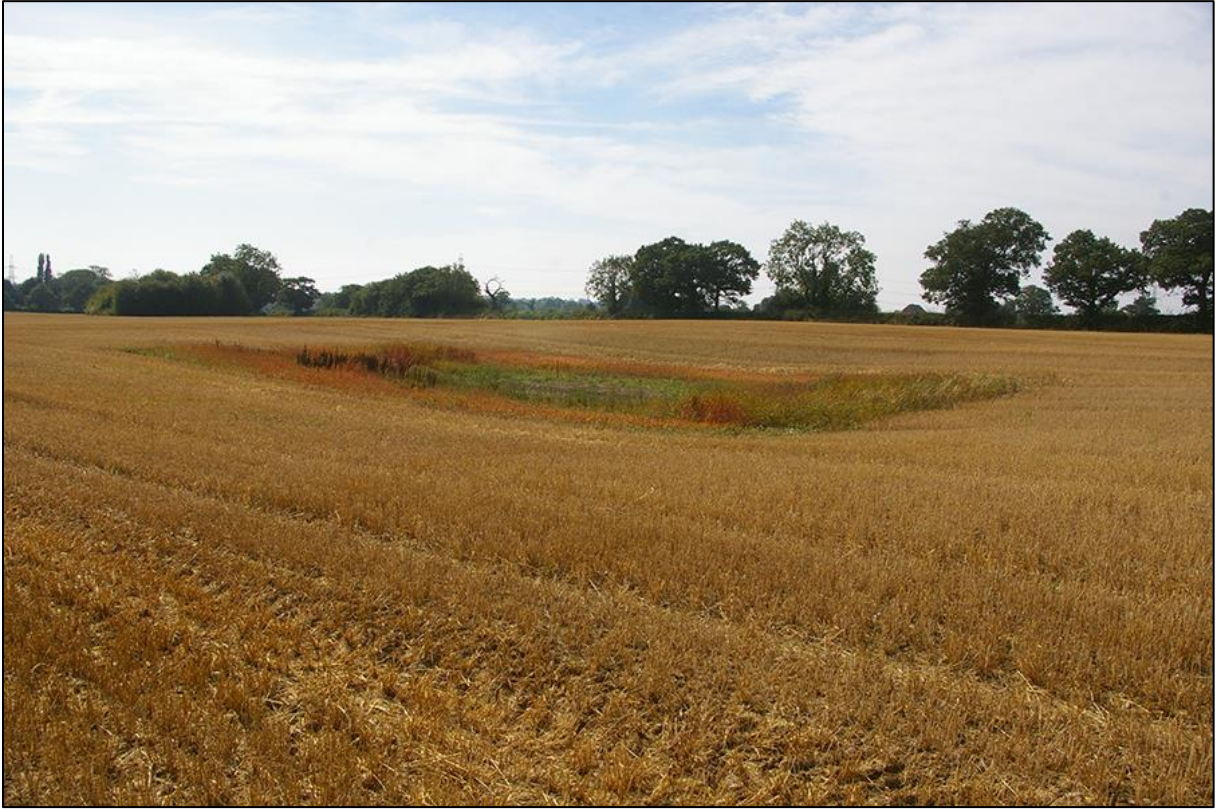
11. DETAIL OF THE SOUTH-WESTERN LARGE HOLLOW DEPRESSION WITHIN FIELD F1; VIEWED FROM THE NORTH-EAST (1M SCALE).

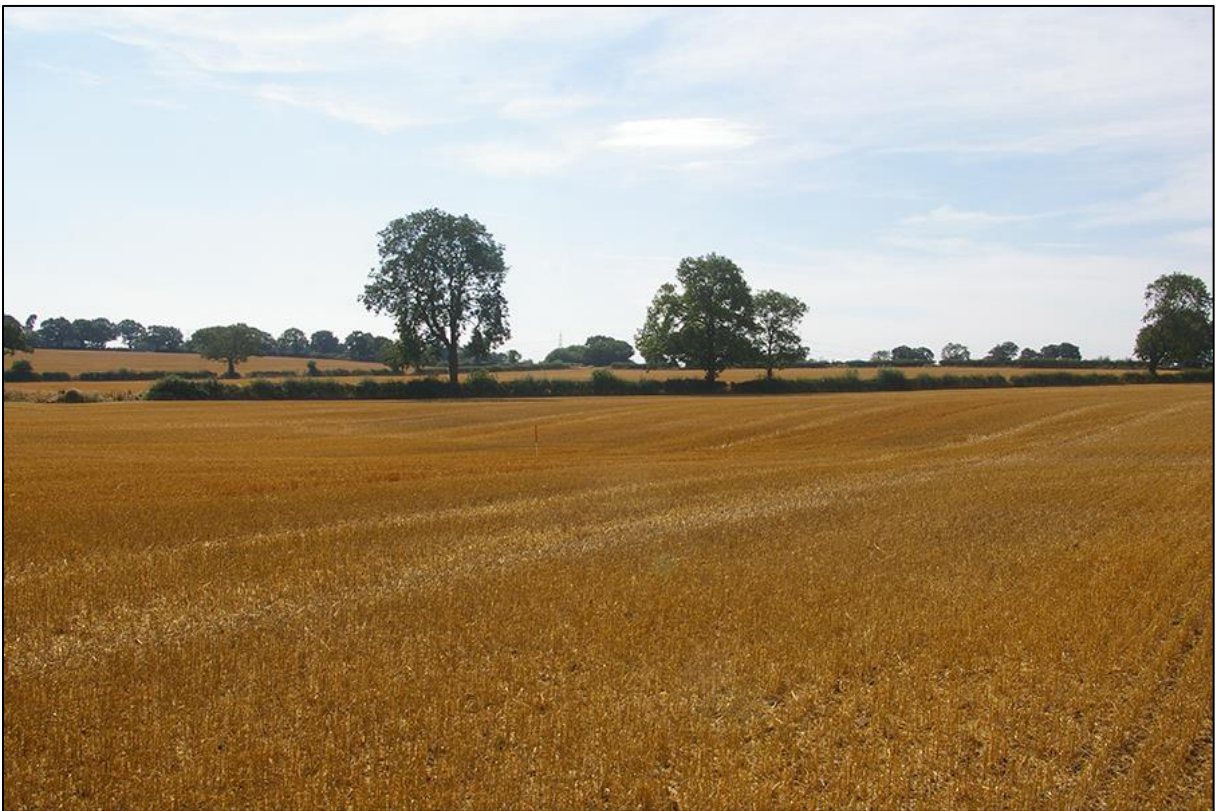
26. DETAIL OF THE LARGE HOLLOW WITHIN FIELD F3; VIEWED FROM THE NORTH-EAST (1M SCALE).

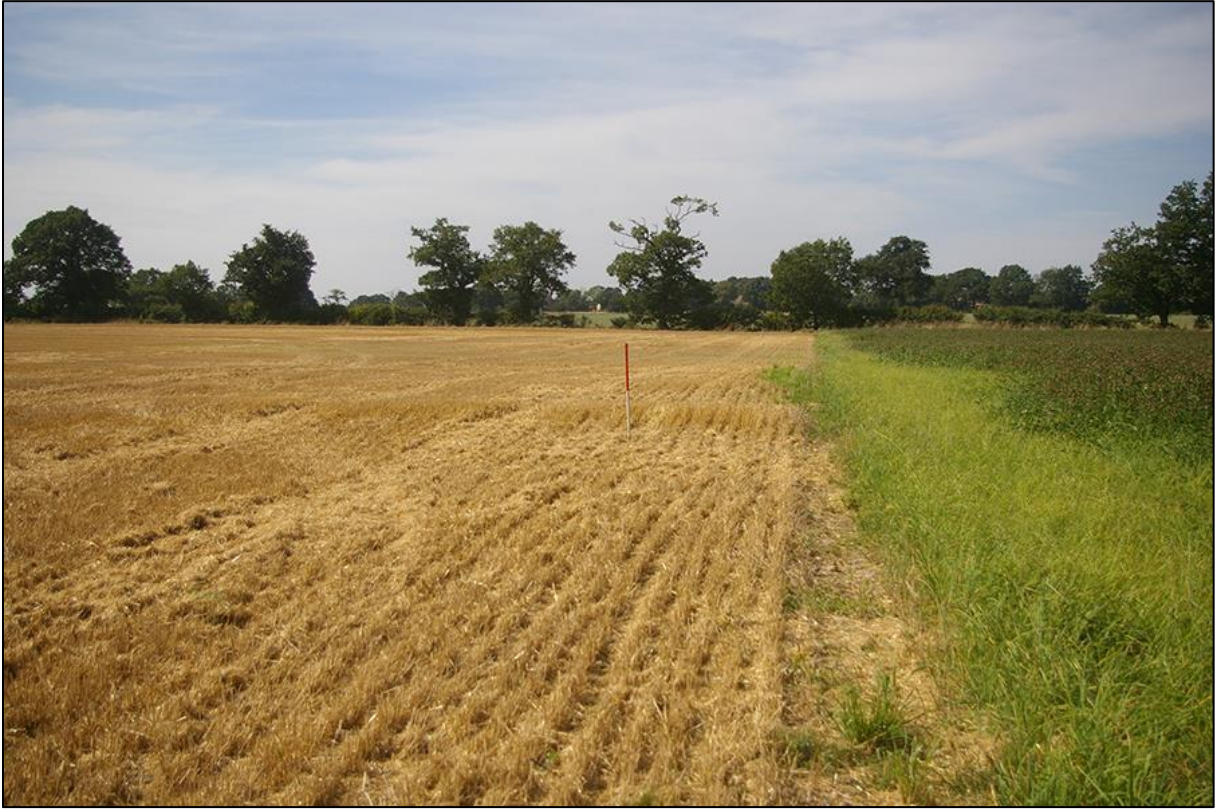
37. DETAIL OF THE POSSIBLE RIDGE AND FURROW EARTHWORK UNDULATIONS WITHIN FIELD F4; VIEWED FROM THE EAST (1M SCALE).

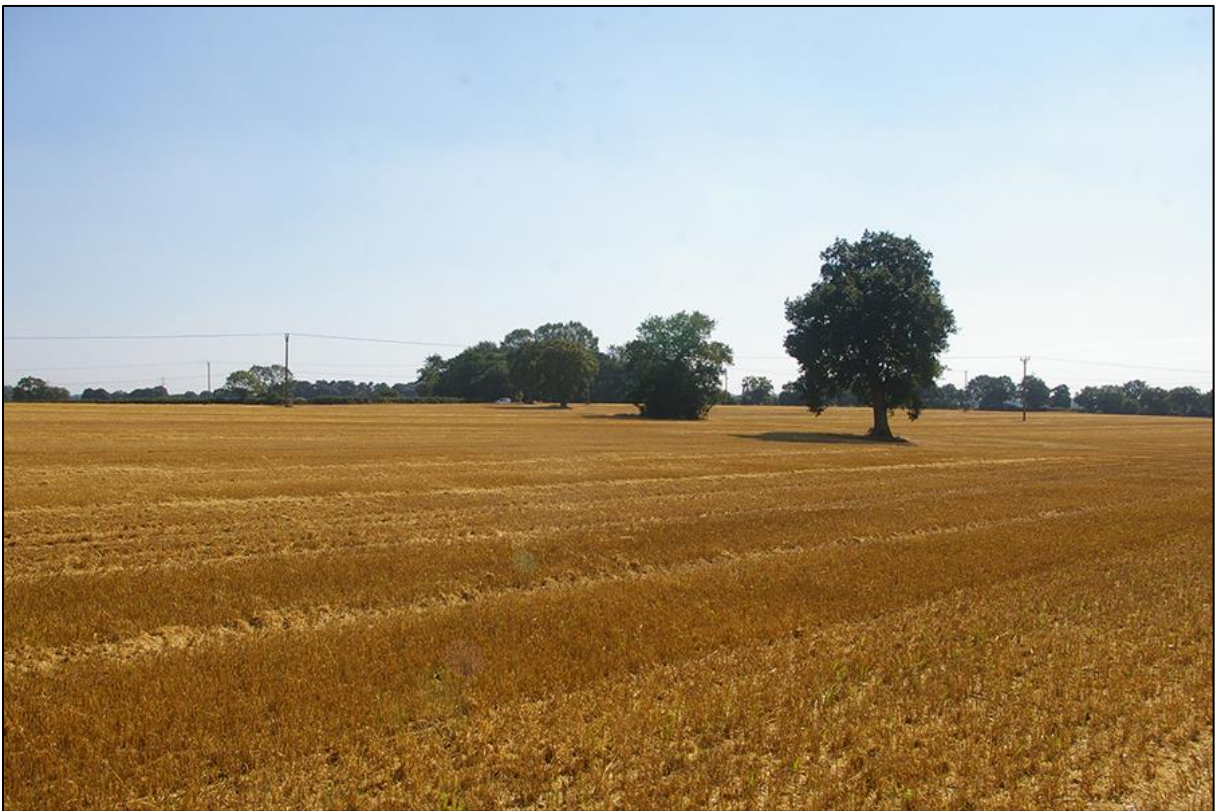
38. DETAIL OF THE TREE LINE INDICATING A FORMER FIELD BOUNDARY WITHIN FIELD F4; VIEWED FROM THE NORTH-EAST (NO SCALE).

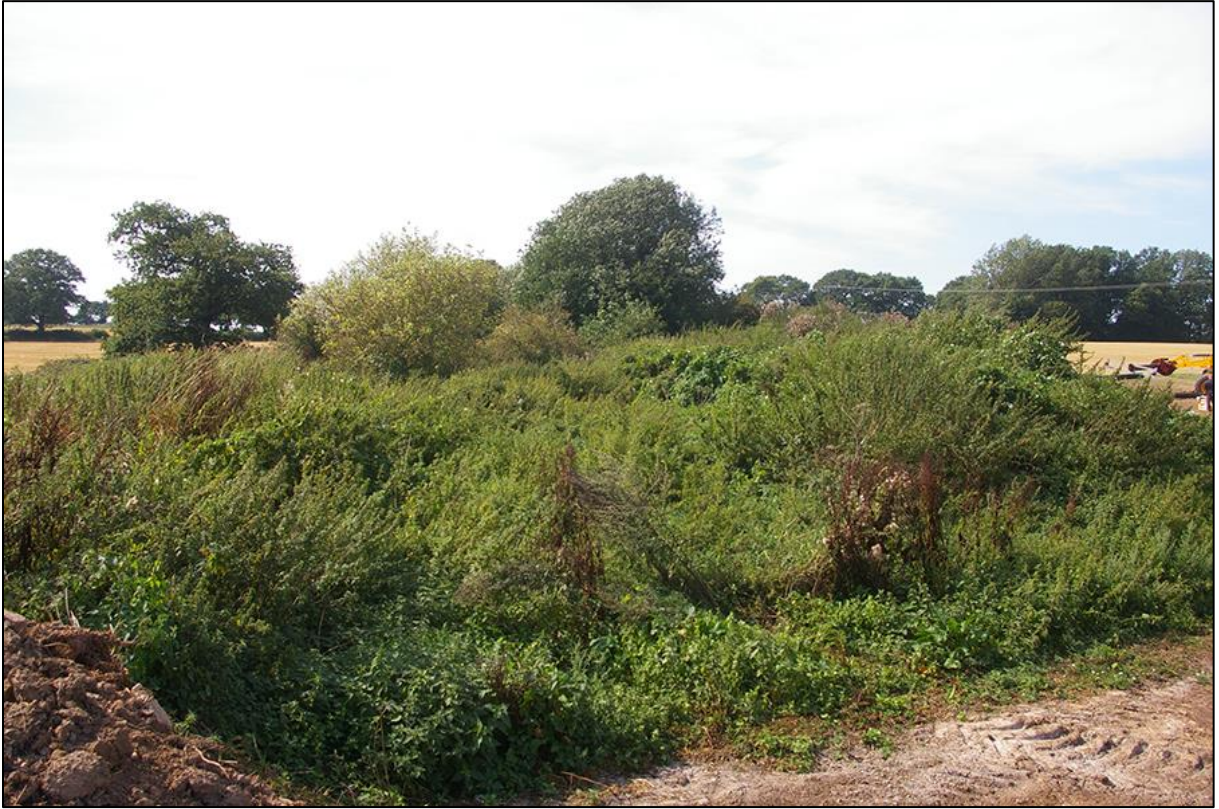
45. DETAIL OF THE OVERGROWN AREA OF THE SITE OF DUKE'S FARM TO THE EAST OF FIELD F5; VIEWED FROM THE EAST (NO SCALE).

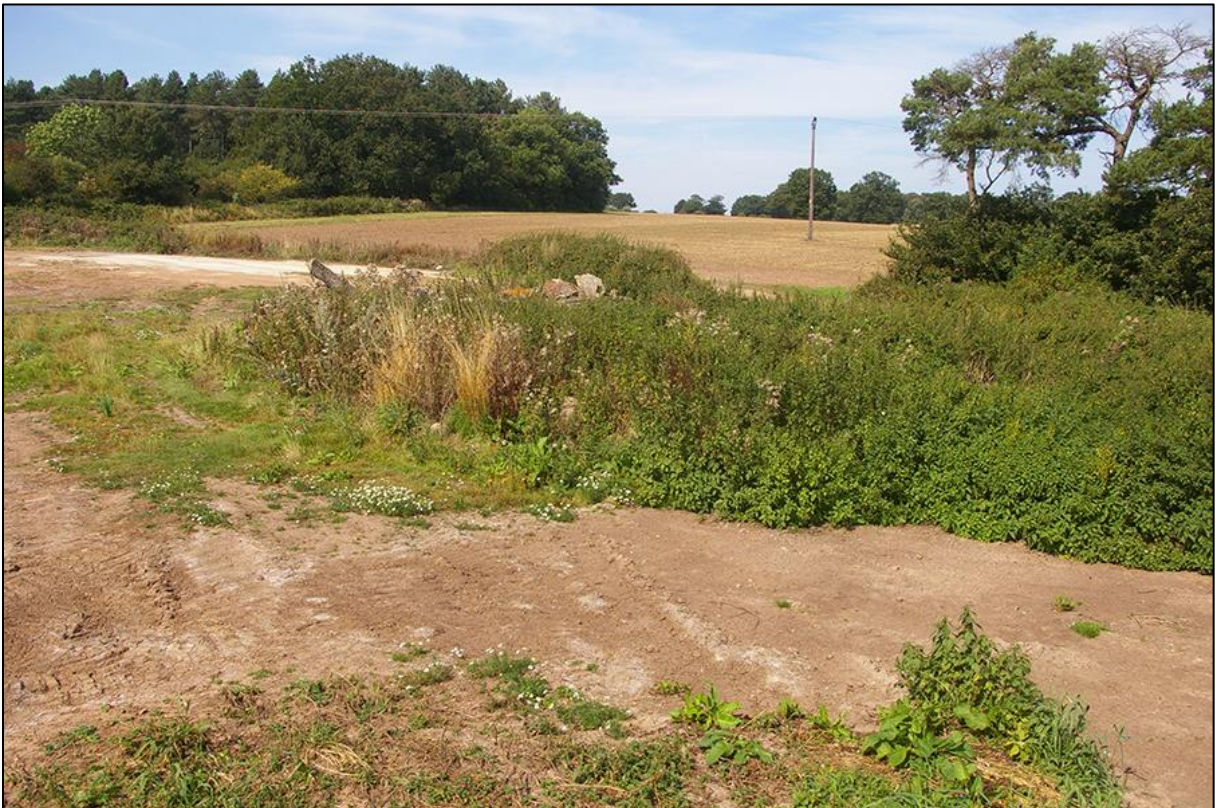
46. DETAIL OF THE OVERGROWN AND PARTIALLY STRIPPED AREA OF THE SITE OF DUKE'S FARM TO THE EAST OF FIELD F5; VIEWED FROM THE SOUTH (NO SCALE).
