# LAND AT KENLEY FARM

Heritage Impact Assessment

South West Archaeology Ltd. report no. 210726

*This report presents the results of a heritage impact assessment carried out by South West Archaeology Ltd. (SWARCH) for a proposed PV development on Land at Kenley Farm, Wawne, East Riding, Yorkshire. This work was carried out on behalf of Aardvark EM Ltd. (The Agent) in advance of a planning application.*

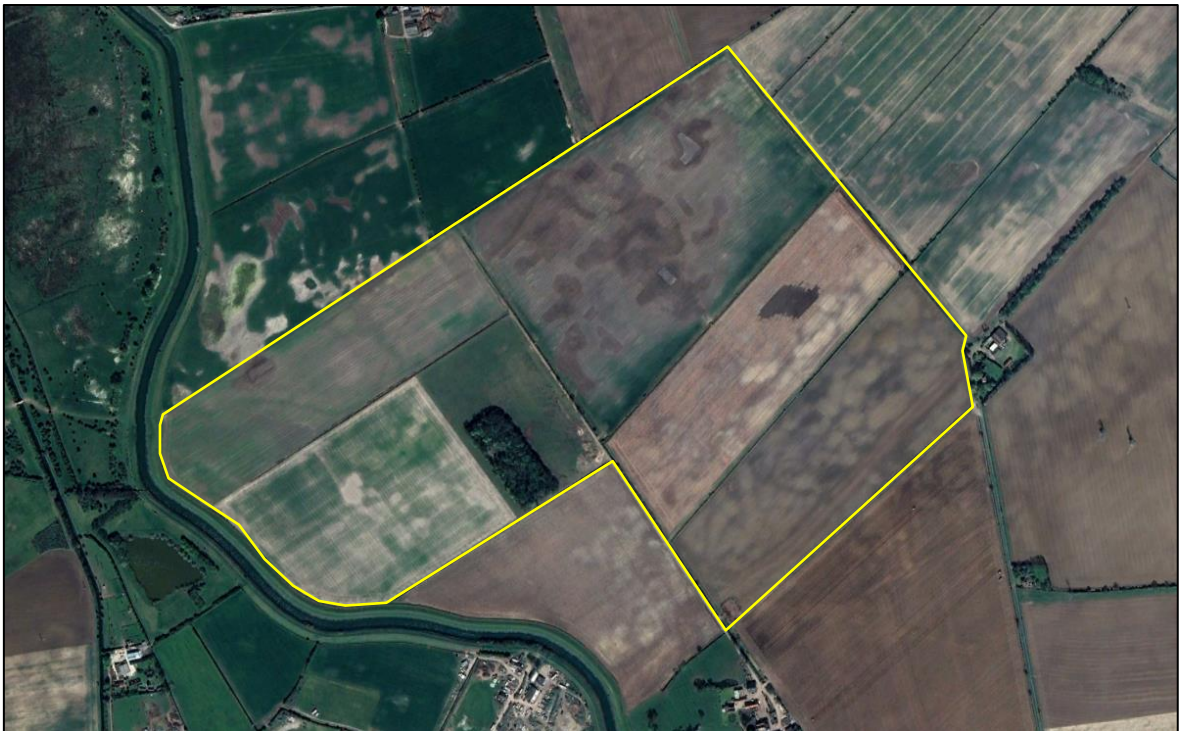
FIGURE 13: AERIAL PHOTOGRAPH FROM 2020 SHOWING LITTLE CHANGE TO THE SITE AREA FROM EARLY 20<sup>TH</sup> CENTURY MAPPING. © GOOGLE MAPS.

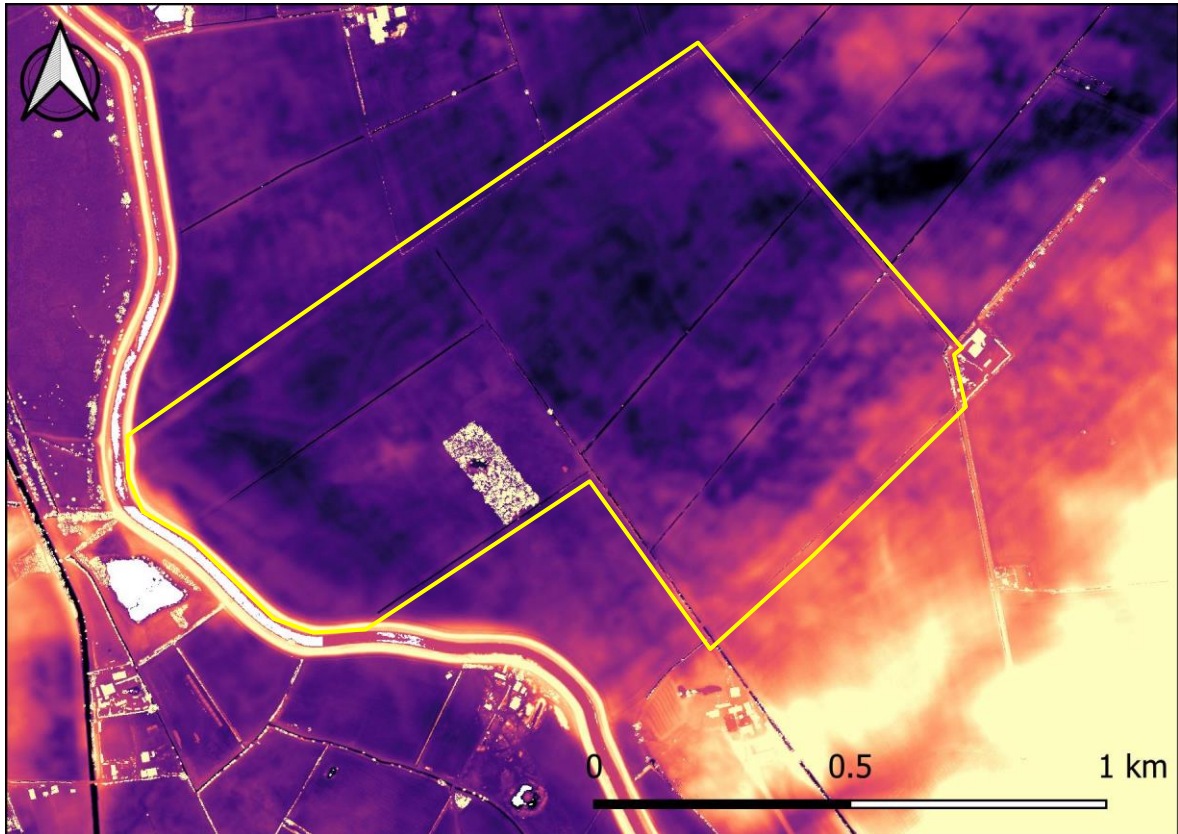
50cm digital terrain (i.e., bare earth, DTM) data was processed. The LiDAR data for the site indicates a gently undulating ground surface with a clear palaeo-channel running through the two northern fields. A quarry is shown in the plantation. Other slight linears are also visible and largely appear to correspond with removed boundaries shown on historic maps. A square edge is visible cut immediately to the north-east of the plantation; this relates to the soil-stripping activities noted on the 2003 aerial photograph. *Slip Bank/Ash Dike Bank* is shown as a slight linear bank. The LiDAR would indicate the land naturally drained to the east-north-east. A well-preserved albeit small patch of ridge and furrow is visible just to the west of Kenley Farm.

FIGURE 14: LIDAR DTM DATA PROCESSED USING QGIS 3.10 (SIMPLE COLOUR RAMP APPLIED TO THE BASE ASCII DATA; THE LIGHTER THE COLOUR, THE HIGHER THE GROUND). THE SITE IS INDICATED. CONTAINS PUBLIC SECTOR INFORMATION LICENCED UNDER THE OPEN GOVERNMENT LICENCE.

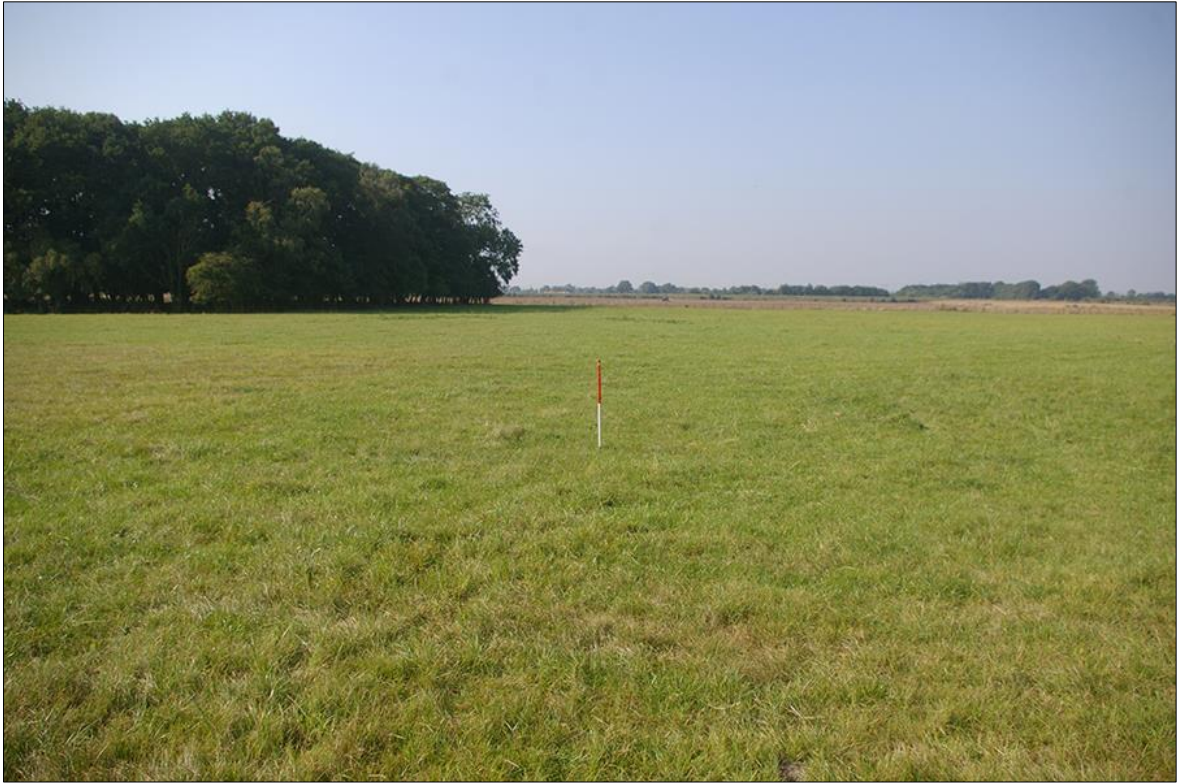
FIGURE 16: F1, DETAIL OF SHALLOW HOLLOW DEPRESSIONS OF POSSIBLE QUARRY PITS; VIEWED FROM THE NORTH-EAST (1M SCALE).

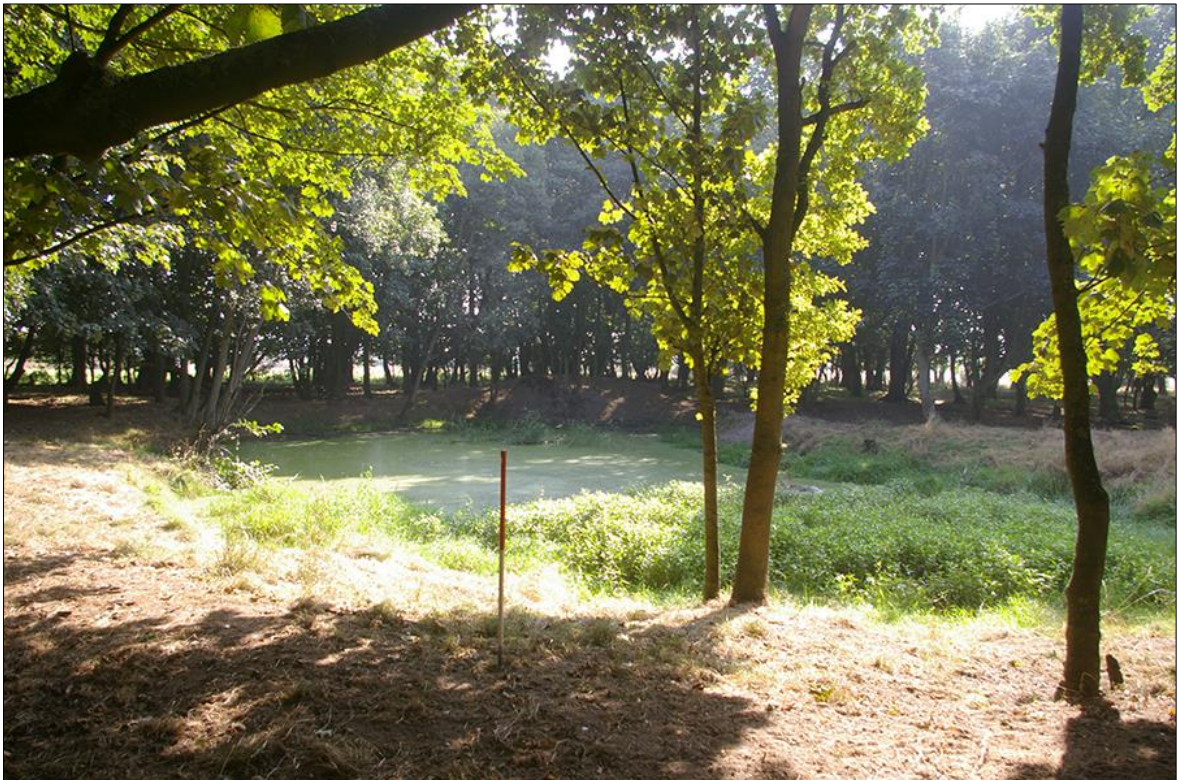
A rectangular area (c.1.5ha) of mixed woodland orientated approximately north-west to south-east and set within the south-western corner of F1. The woodland comprises a mix of oak, sycamore and pine and has grown surrounding a heavily quarried area with a large irregular pit (water filled) and surrounding spoil mounds. These may be associated with historic quarrying in the area.

FIGURE 17: F1A, DETAIL OF LARGE WATER FILLED QUARRY PIT; VIEWED FROM THE NORTH-EAST (1M SCALE).

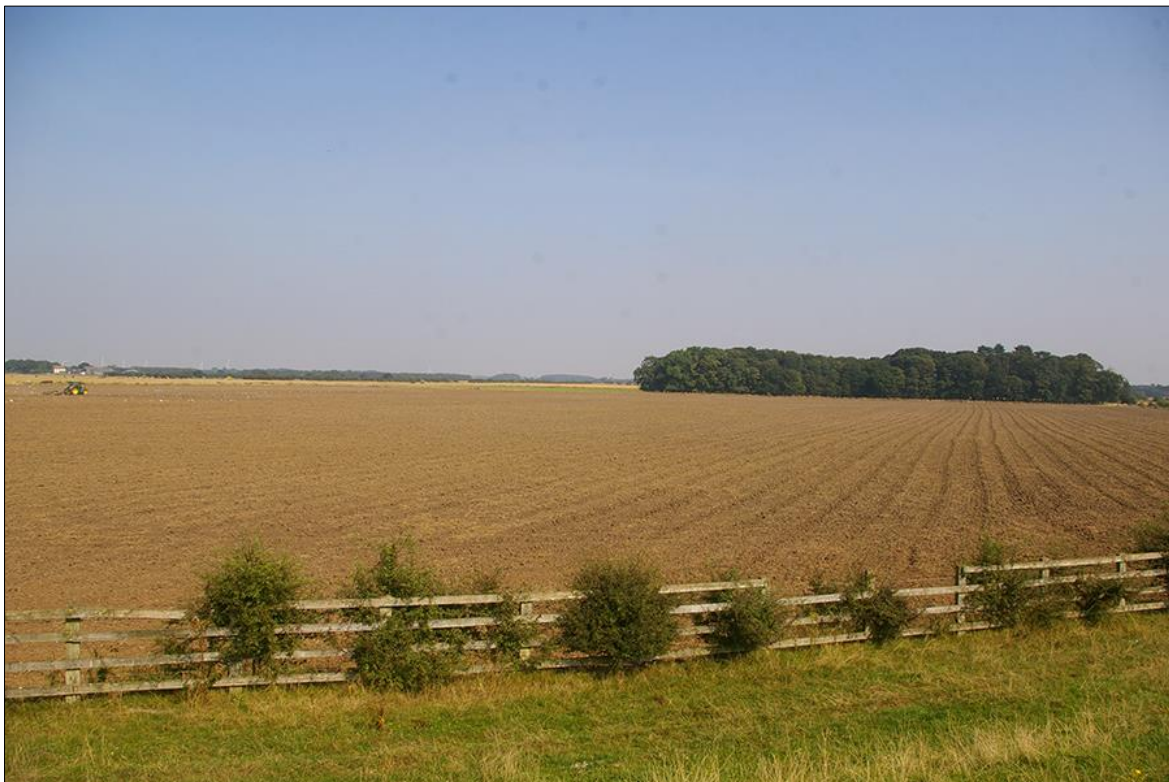
The ground within this field was undulating with a sinuous channel running east to west across the field likely indicating a former channel of the Kenley Reach or perhaps the line of a former drainage channel.

FIGURE 18: F2, VIEW ACROSS THE FIELD; VIEWED FROM THE WEST-SOUTH-WEST (NO SCALE).

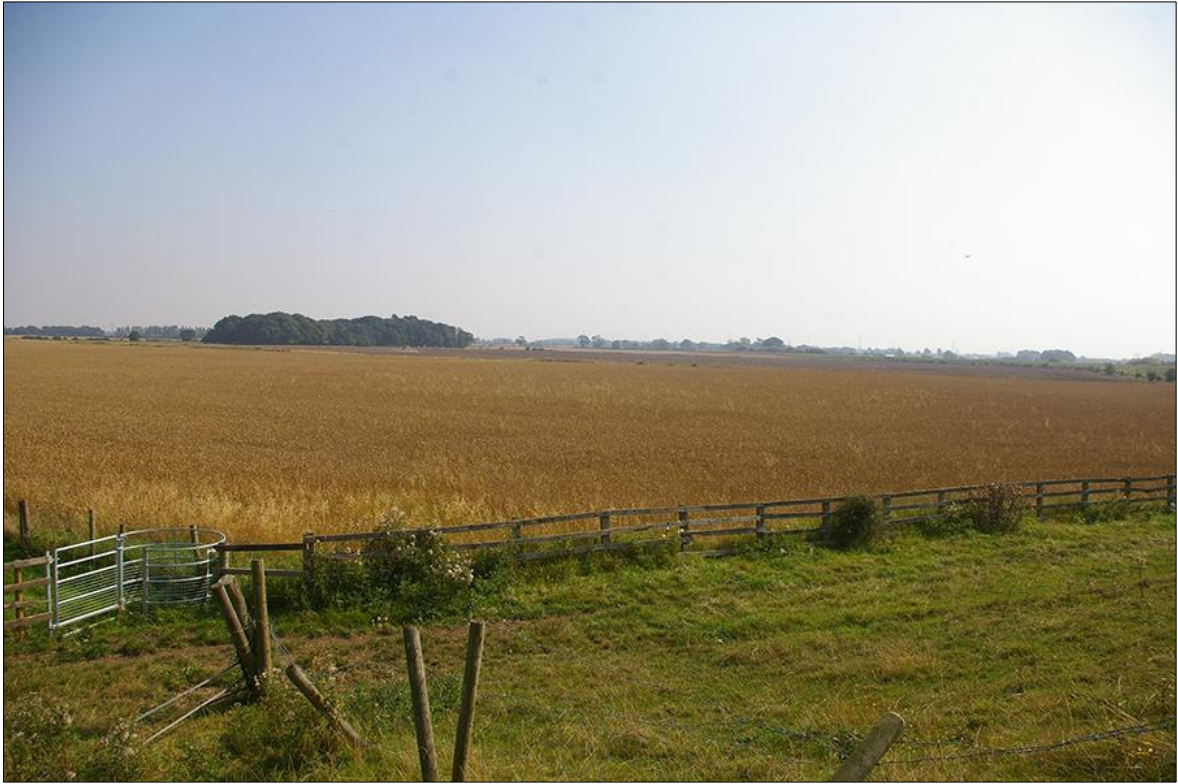
FIGURE 19: F3, VIEW ACROSS THE FIELD; VIEWED FROM THE WEST (NO SCALE).

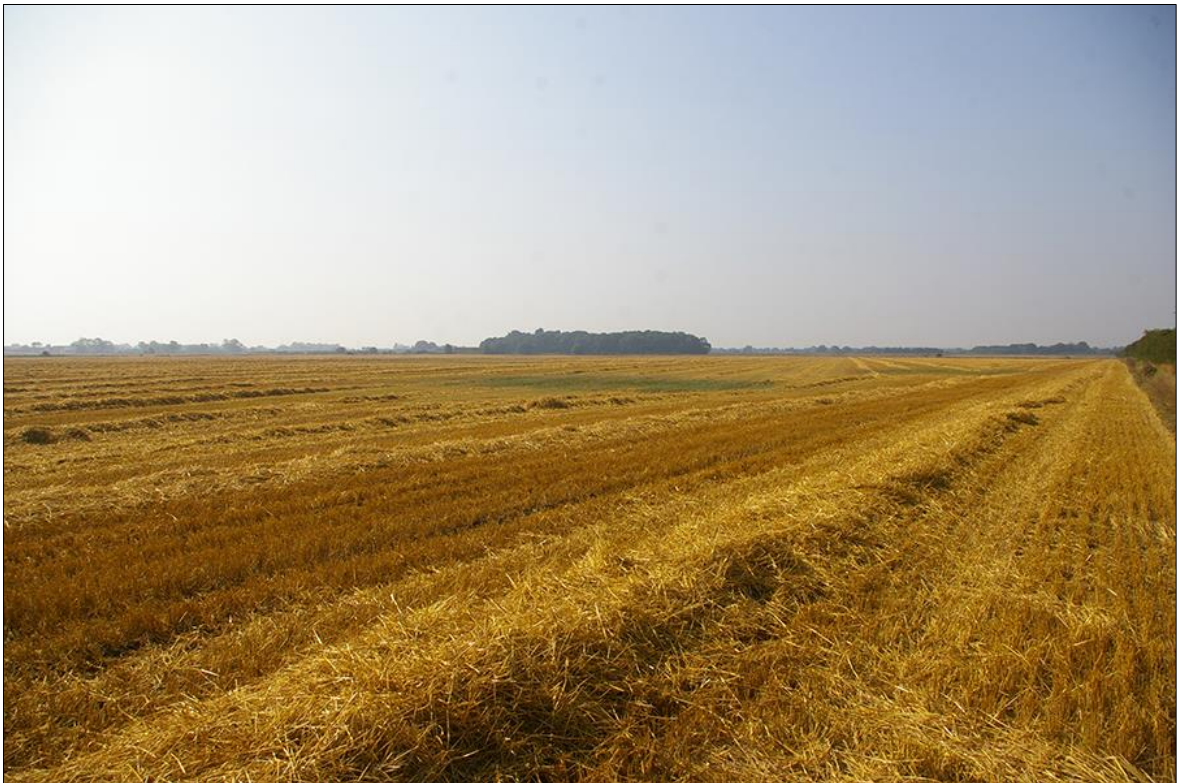
FIGURE 20: F4, DETAIL OF LIKELY FORMER QUARRY PITS; VIEWED FROM THE NORTH (NO SCALE).

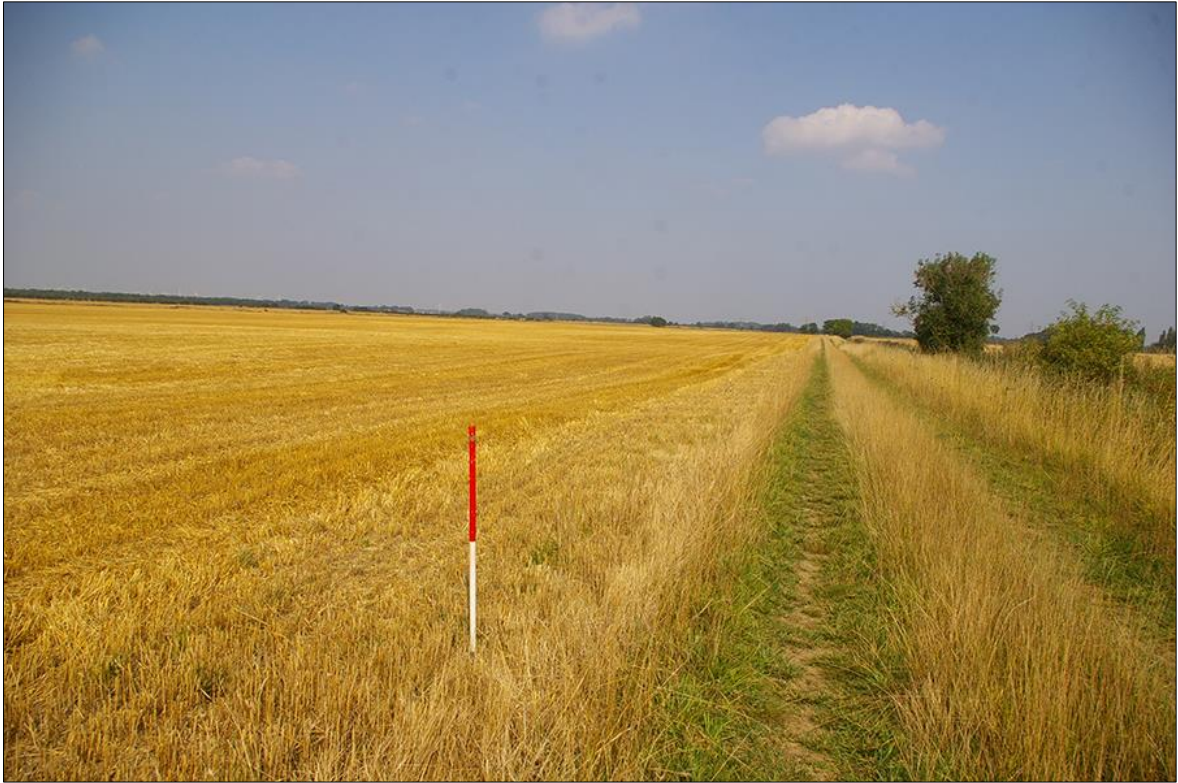
FIGURE 21: F5, VIEW ACROSS THE FIELD SHOWING LINEAR UNDULATIONS OF PROBABLE LAND DRAINAGE; VIEWED FROM THE SOUTH-SOUTH-WEST (1M SCALE).

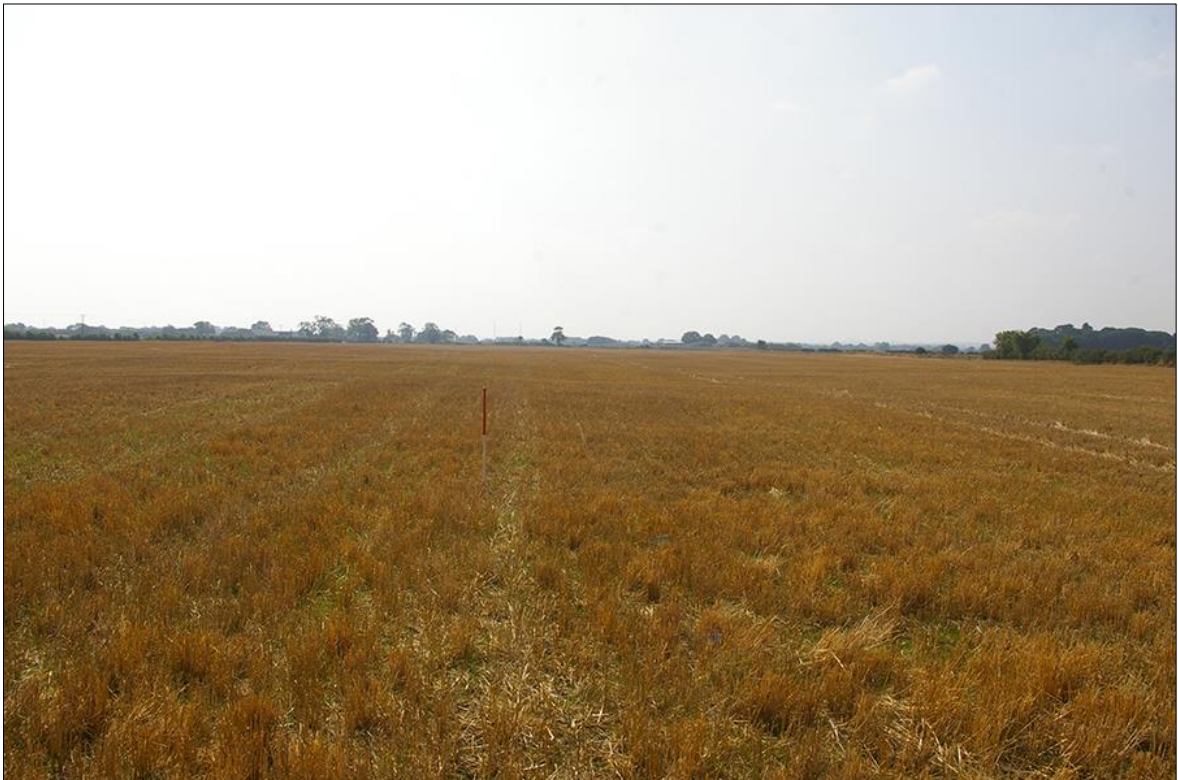
FIGURE 22: F6, VIEW ACROSS THE FIELD SHOWING LINEAR UNDULATIONS OF PROBABLE LAND DRAINAGE; VIEWED FROM THE NORTH-EAST (1M SCALE).

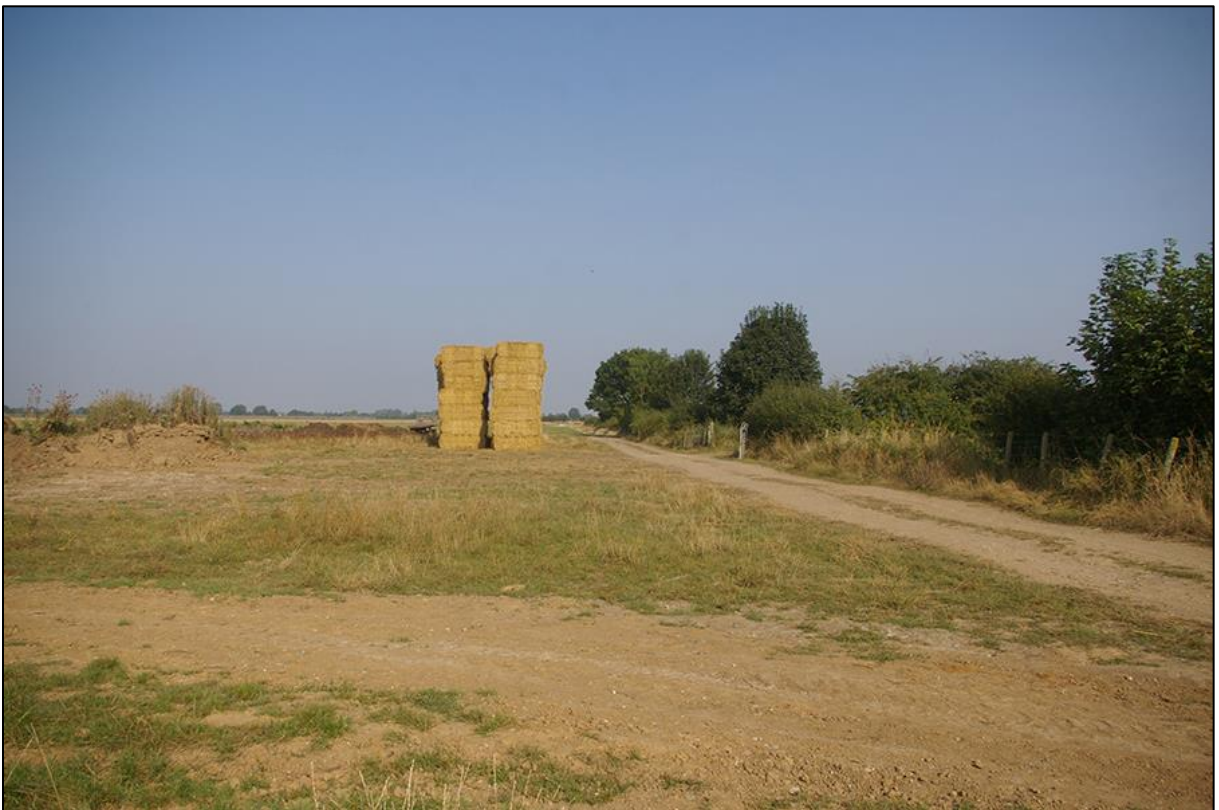
4. DETAIL OF SOIL STORAGE IN THE SOUTH-EASTERN CORNER AND TRACK RUNNING ALONG THE EASTERN BOUNDARY OF FIELD F1; VIEWED FROM THE SOUTH-EAST (NO SCALE).

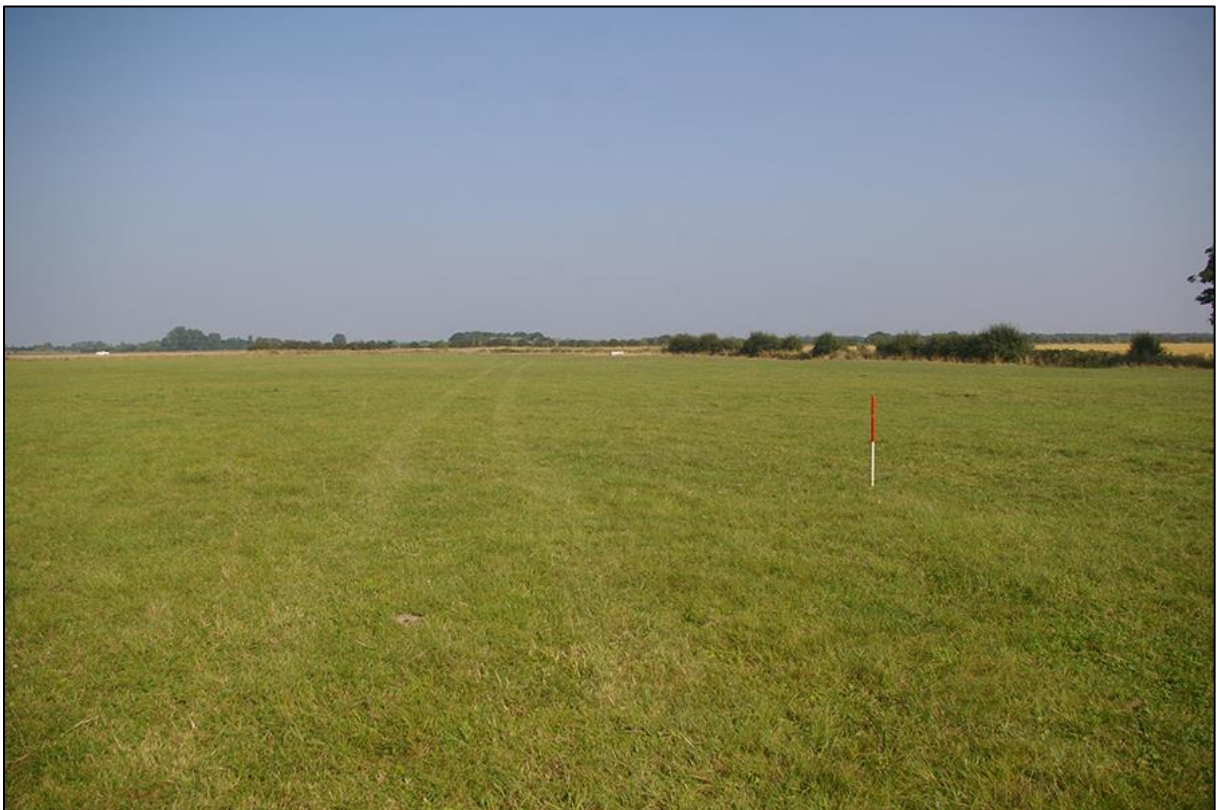
6. DETAIL OF ONE OF THE SLIGHT HOLLOW DEPRESSIONS TOWARDS THE NORTH-EASTERN CORNER OF FIELD F1; VIEWED FROM THE SOUTH (1M SCALE).

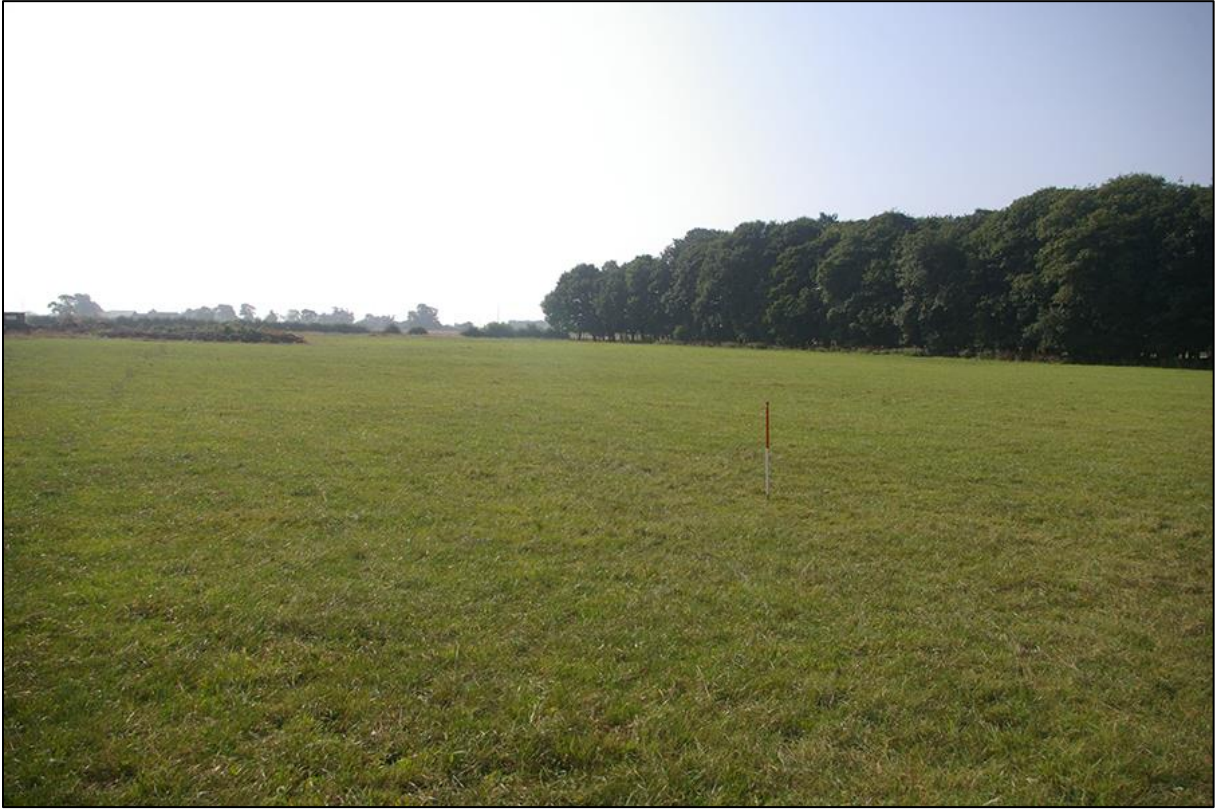
7. DETAIL OF THE SLIGHT HOLLOW DEPRESSIONS IN THE NORTH-EASTERN CORNER OF FIELD F1; VIEWED FROM THE NORTH-NORTH-EAST (1M SCALE).

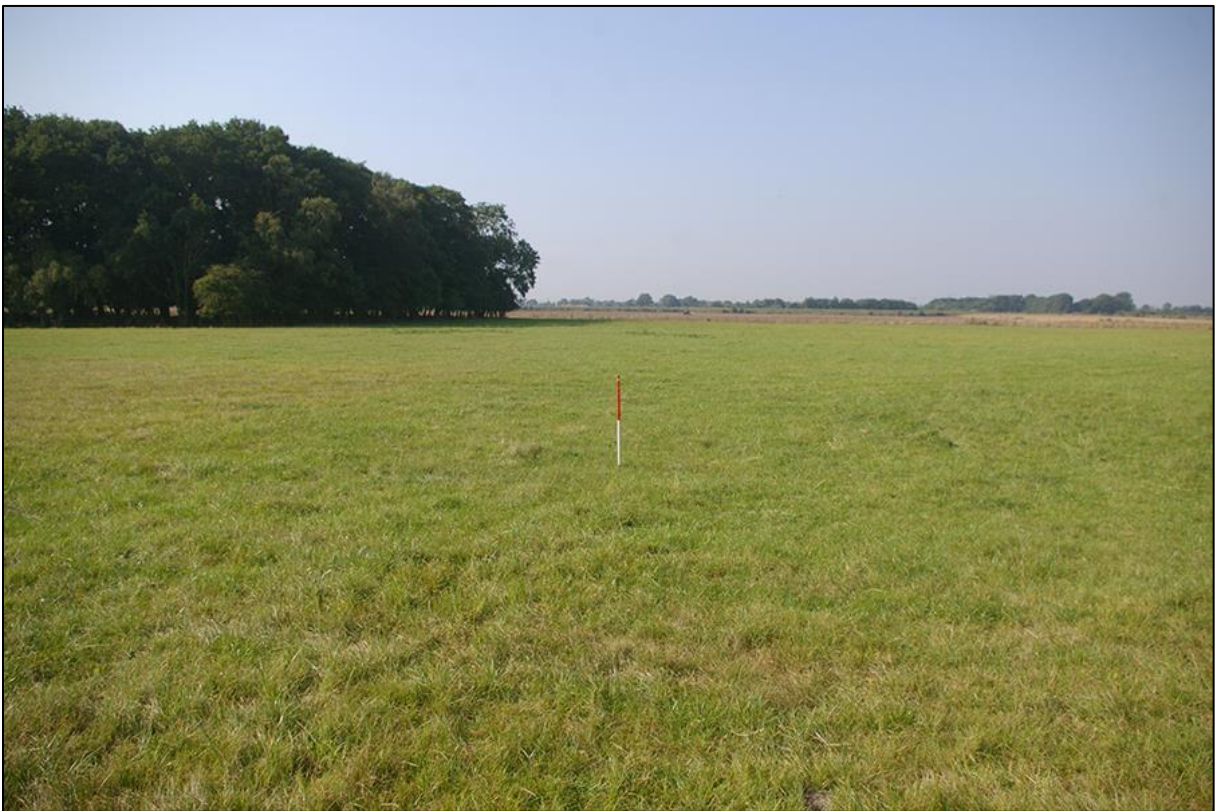
8. DETAIL OF THE SLIGHT HOLLOW DEPRESSIONS IN THE NORTH-EASTERN CORNER OF FIELD F1; VIEWED FROM THE NORTH-EAST (1M SCALE).

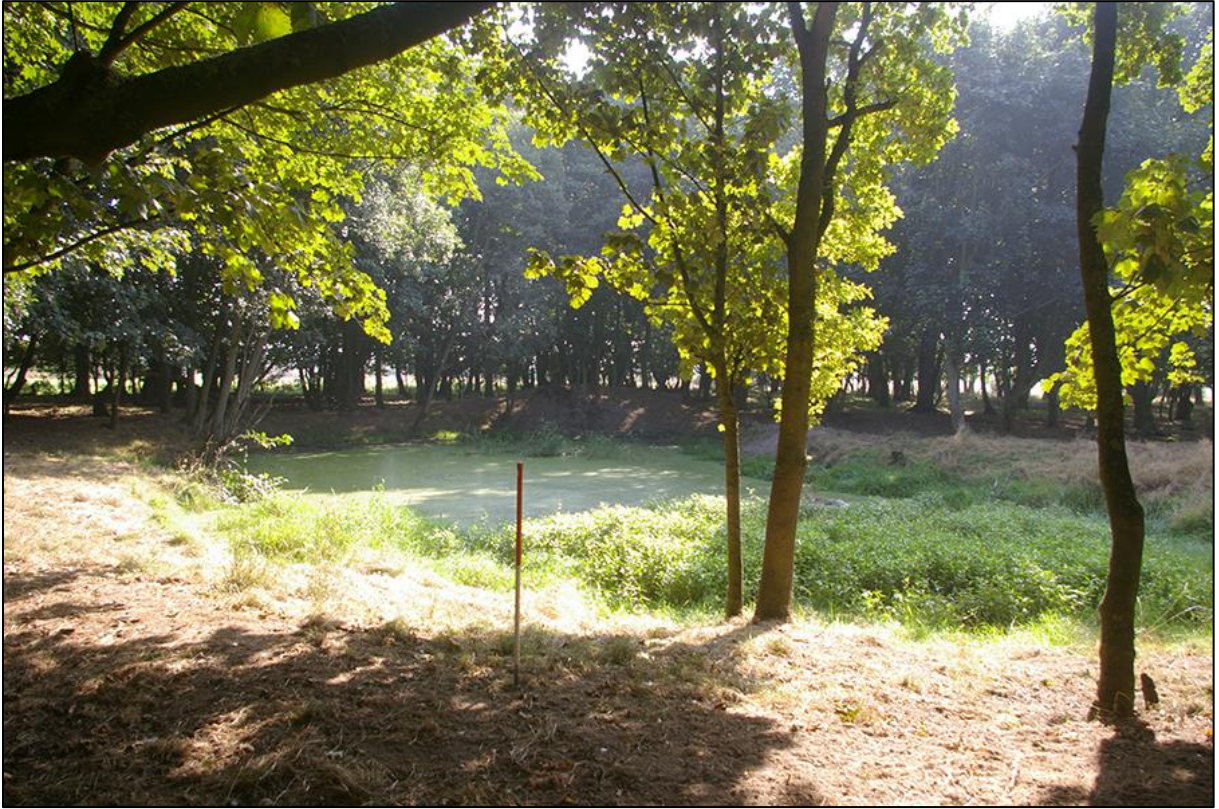
9. DETAIL OF THE POND/QUARRY PIT WITHIN FIELD F1A; VIEWED FROM THE NORTH-EAST (1M SCALE).

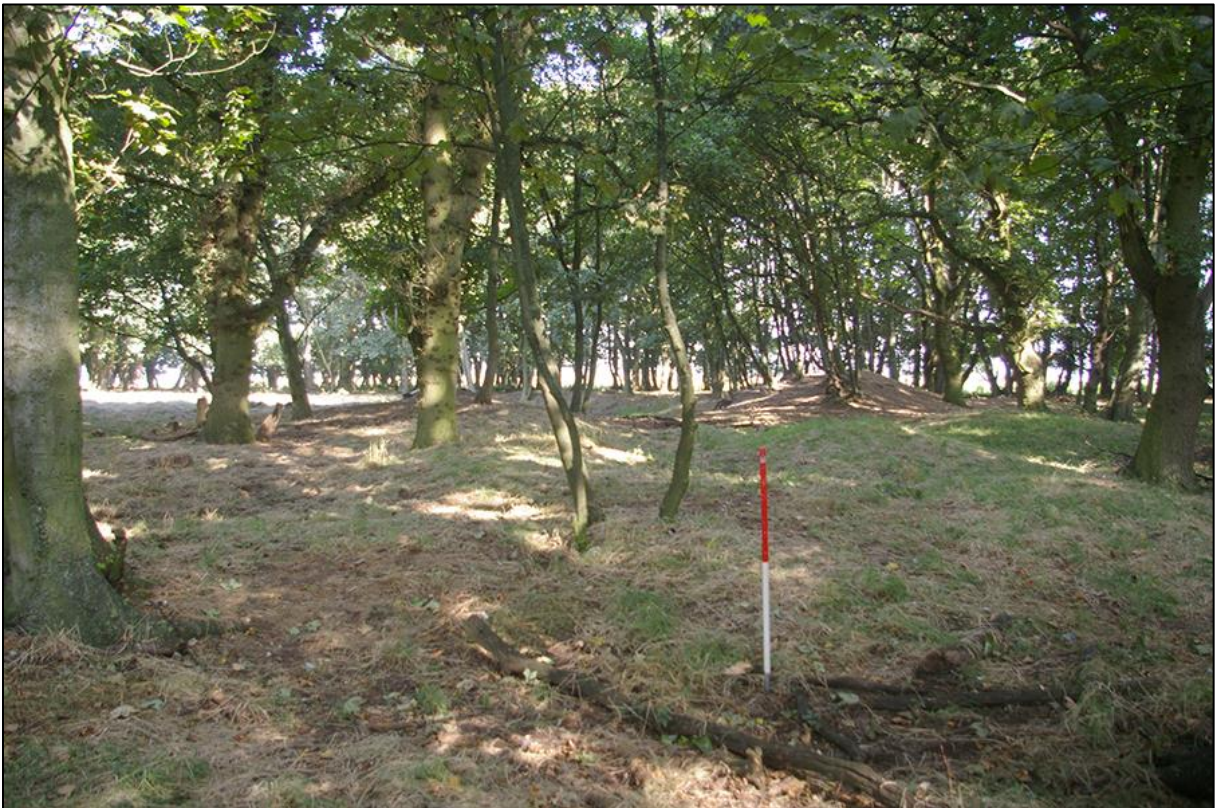
10. DETAIL OF THE EARTHWORK MOUNDS WITHIN FIELD F1A; VIEWED FROM THE SOUTH (1M SCALE).

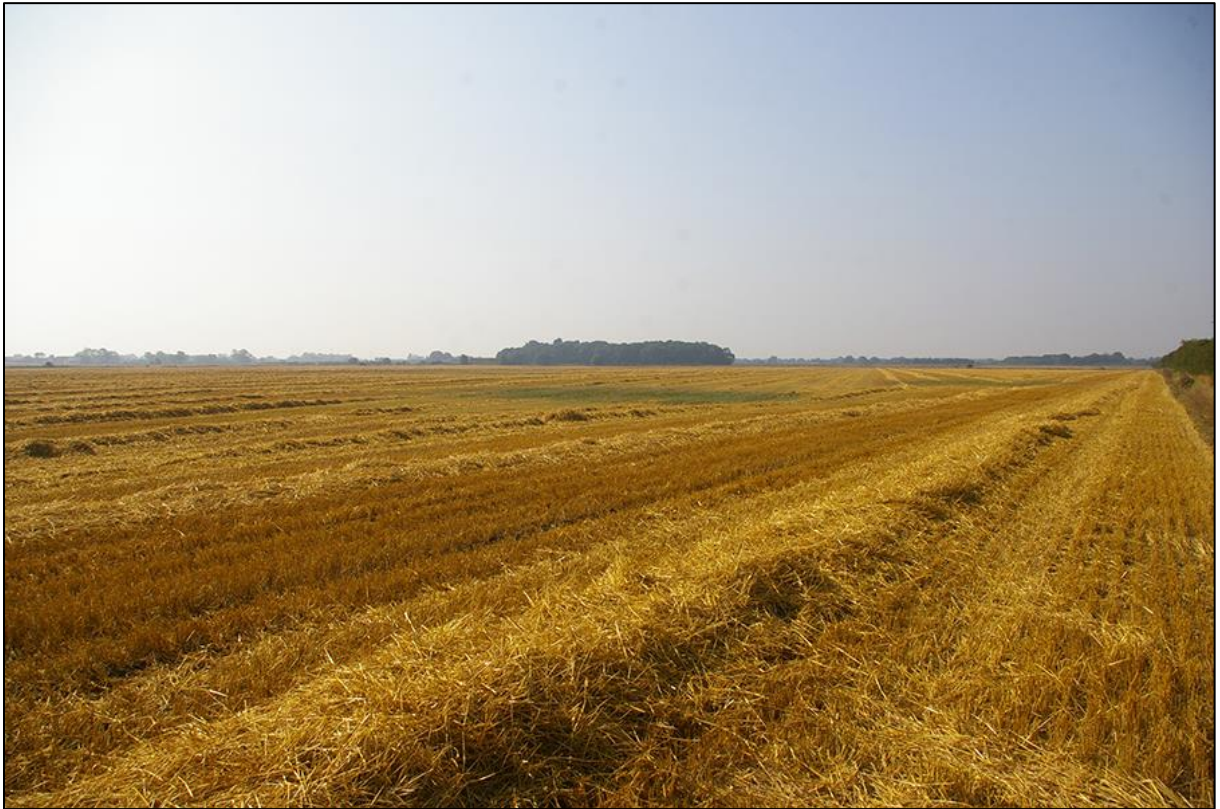
21. VIEW ACROSS FIELD F4 SHOWING THE LARGE HOLLOWES; VIEWED FROM THE NORTH (NO SCALE).

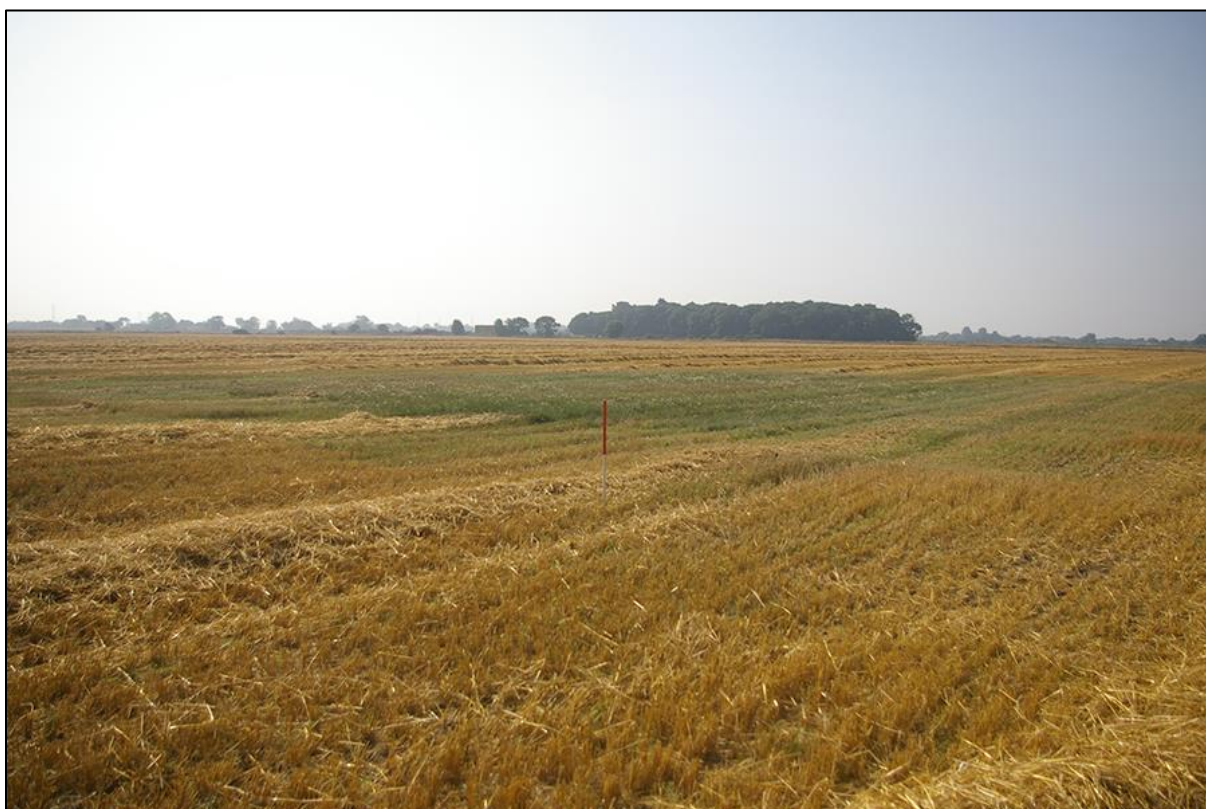
24. DETAIL OF ONE OF THE LARGE HOLLOW IN THE NORTH-EASTERN CORNER OF FIELD F4; VIEWED FROM THE NORTH (1M SCALE).

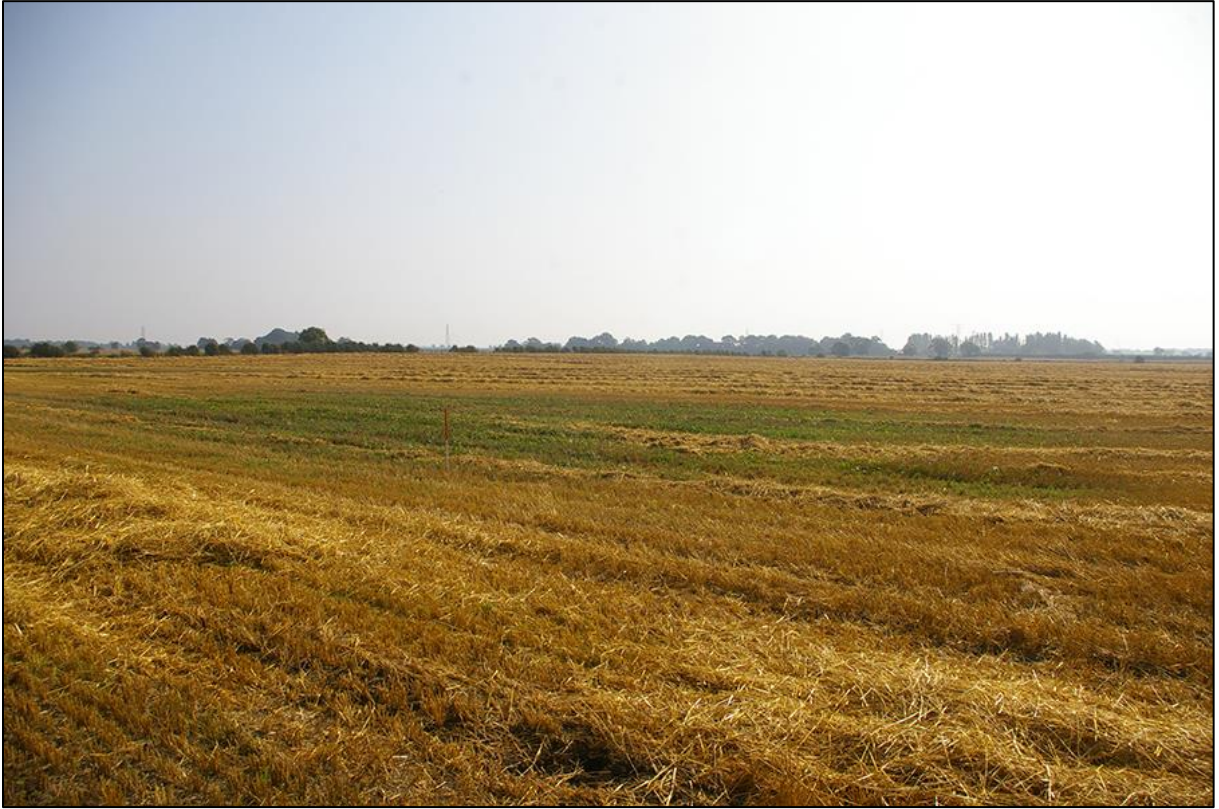
25. DETAIL OF ONE OF THE LARGE HOLLOWS IN THE NORTH-EASTERN CORNER OF FIELD F4; VIEWED FROM THE NORTH-WEST (1M SCALE).

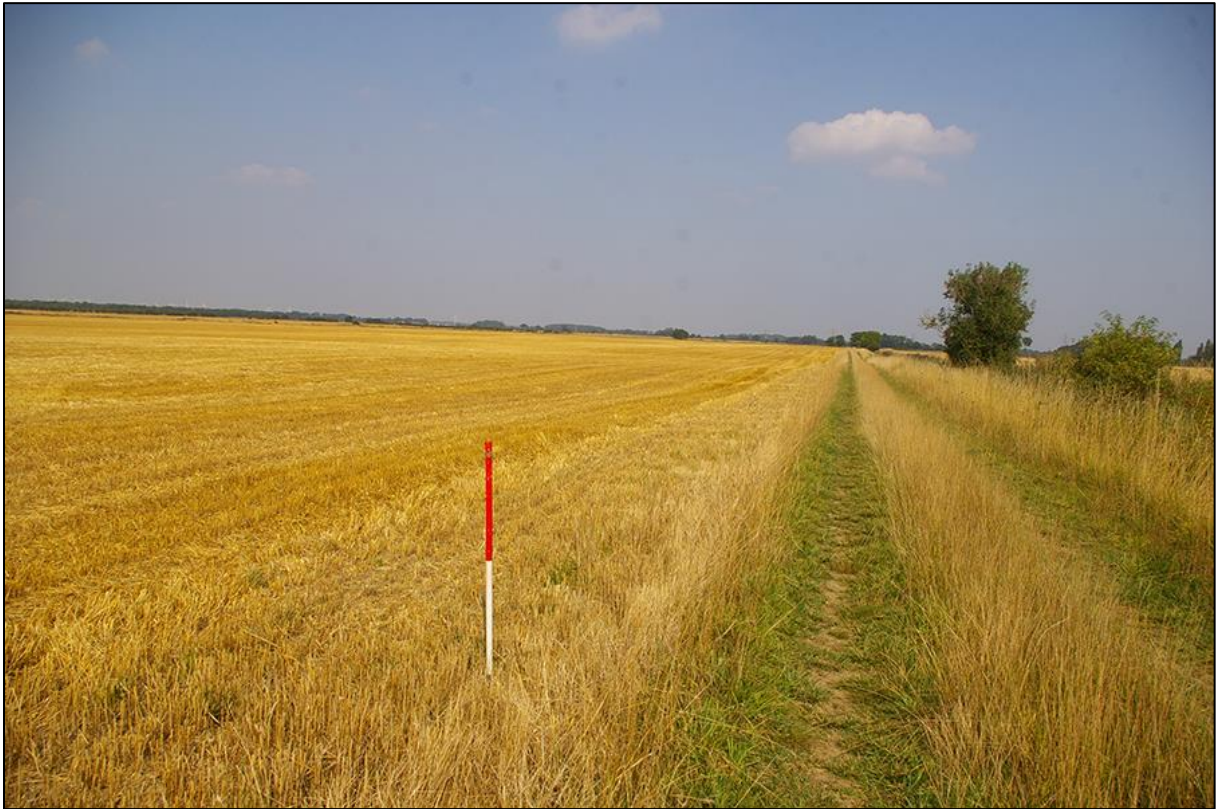
31. VIEW ACROSS FIELD F5 SHOWING DETAIL OF POSSIBLE RIDGE AND FURROW TYPE EARTHWORKS; VIEWED FROM THE SOUTH-SOUTH-WEST (1M SCALE).

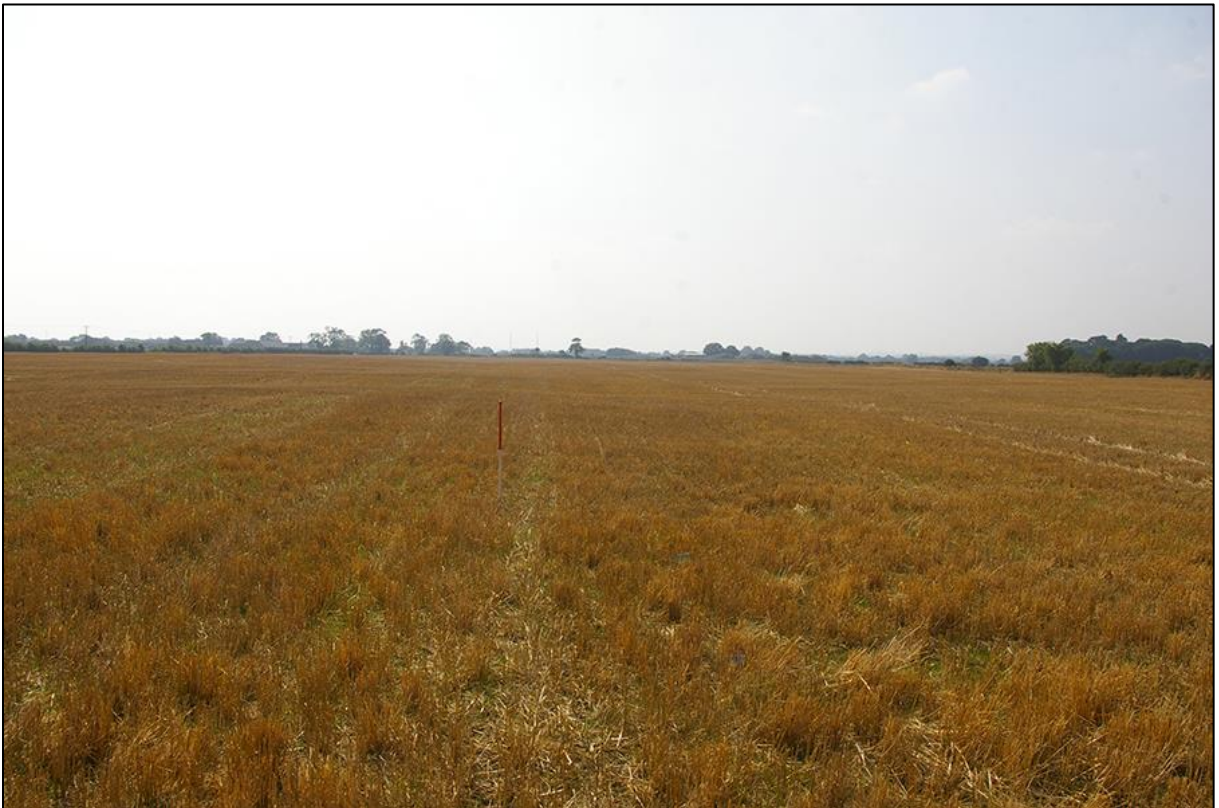
40. VIEW ACROSS FIELD F6, SHOWING RIDGES OF POSSIBLE RIDGE AND FURROW TYPE AGRICULTURE; VIEWED FROM THE NORTH-EAST (1M SCALE).

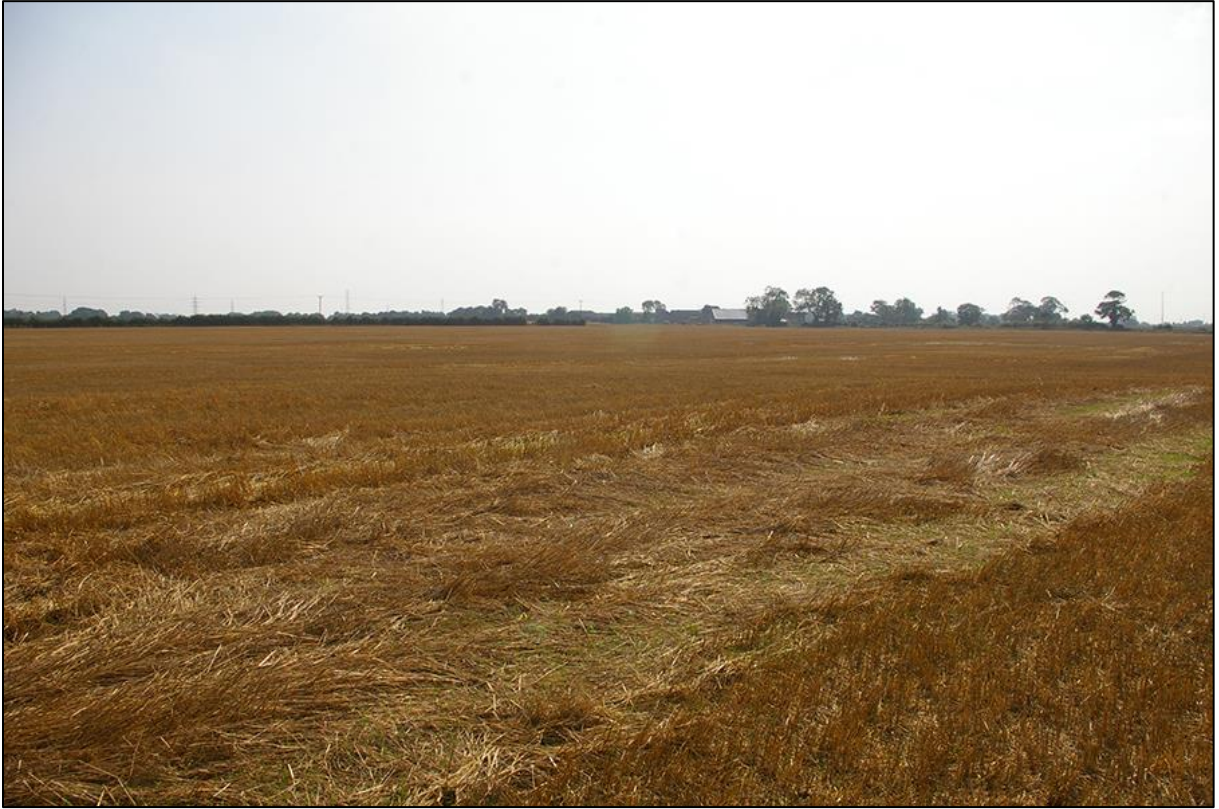
41. VIEW ACROSS FIELD F6 SHOWING POSSIBLE RIDGE AND FURROW TYPE EARTHWORKS; VIEWED FROM THE NORTH (NO SCALE).
