# THE BARNs AT OLD HOUSE YEOLMBRIDGE LAUNCESTON CORNWALL

Heritage Assessment

South West Archaeology Ltd. report no. 020322

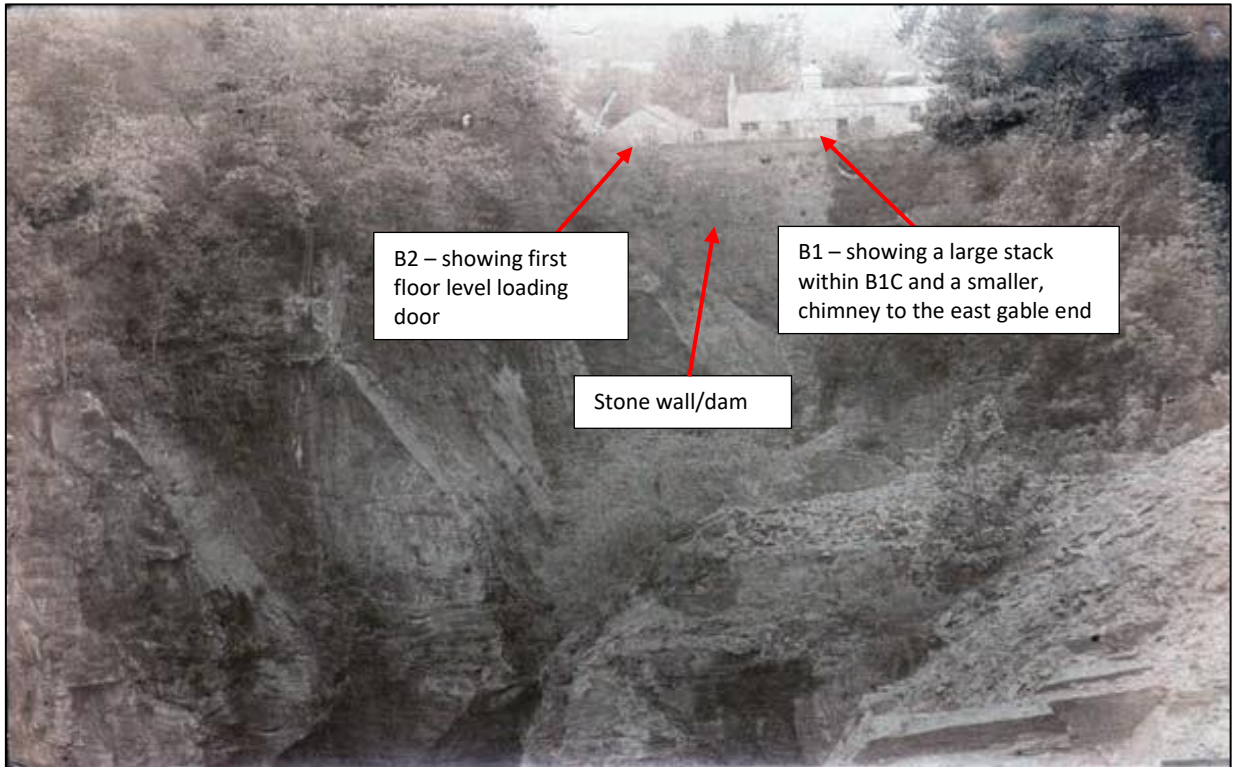
FIGURE 5: PHOTOGRAPH OF YEOLMBRIDGE QUARRY c.1910, SHOWING B1 & B2 IN THE BACKGROUND. SOURCE: LAUNCESTON, THEN & NOW, ACCESSED 2022.

The picture found above c.1910 shows the barns within the background of Yeolmbridge Quarry, providing a snippet of the northern elevations of both barns. Interestingly, B1 is seen with two stacks, one to the east gable end of B1D, which fits the evidence of a remaining chimney to the first-floor level, and a much larger stack to B1C. There was little evidence from the site visit to suggest a former stack in this location, but a stack this large could be associated with industrial processing, and the need for more through-draft, or is evidence of an earlier medieval building.

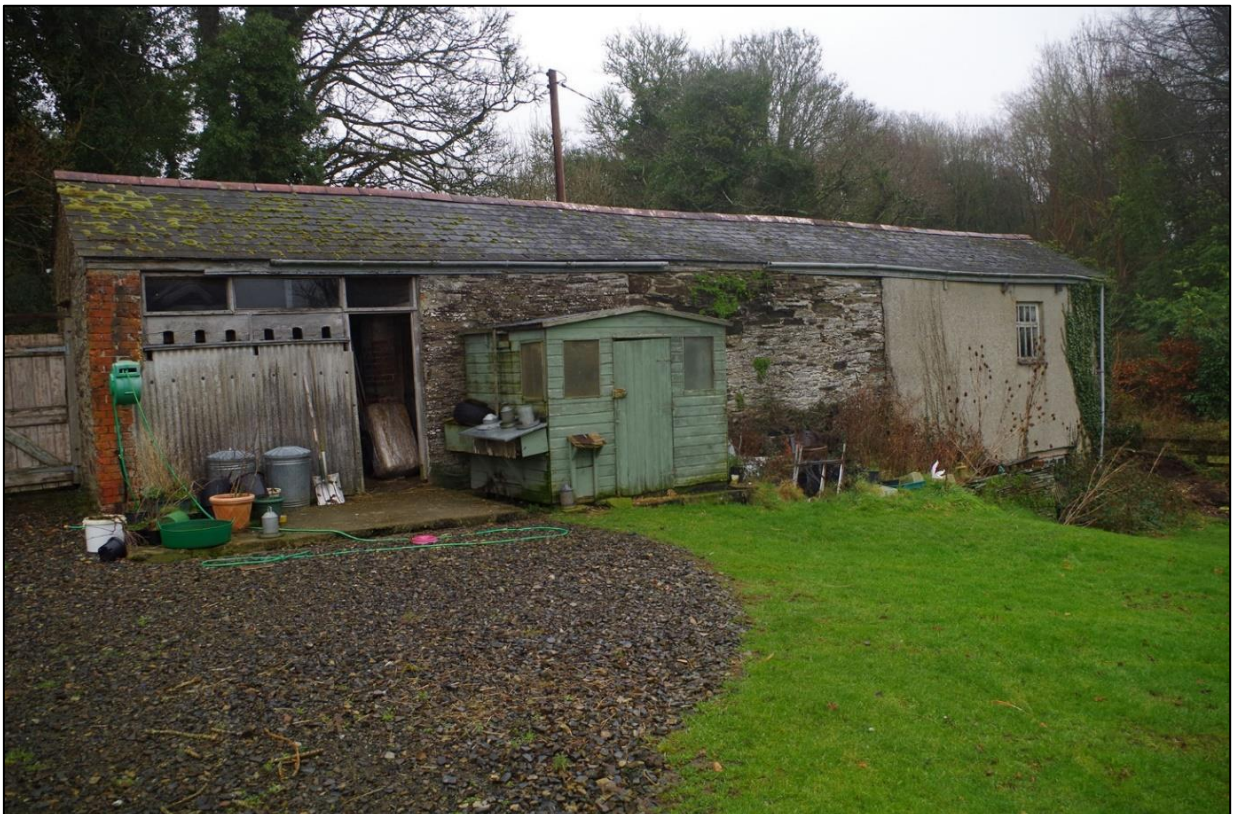
There are several blocked openings throughout the building; there are blocked or forced openings in the walls between B1A and B1B and blocked doors and windows, some re-cutting each other in the south wall in B1B and B1C. On the north side, three good windows survive to B1B and B1C, each with eight, single-glazed lights, splayed sides, and detailed timber framing - suggestive of domestic or quarry office use. Room B1D is a large room that has been heavily altered to the south, rebuilt in concrete block, where another range once adjoined. Within the eastern gable wall, a chimney/ flue is present at first floor height, although it has been capped, likely when the roof was replaced, for evidence of a stack does not exist to the exterior. This looked to sit above another larger, blocked fireplace or oven/dryer to the ground floor and a blocked opening to the north end, which could possibly be another flue. Whilst the mezzanine is a later 20<sup>th</sup> century addition, socket holes for floor joists survive within the north internal elevation, these sit along a projecting wall sill that would have accommodated a large, former upper floor. It is not clear if the flues are for semi-domestic heating of offices or localized processing, they are of fairly basic form but not enough survives to clarify function.

FIGURE 11: THE SOUTHERN ELEVATION OF B1. TAKEN FROM THE SOUTH-WEST.

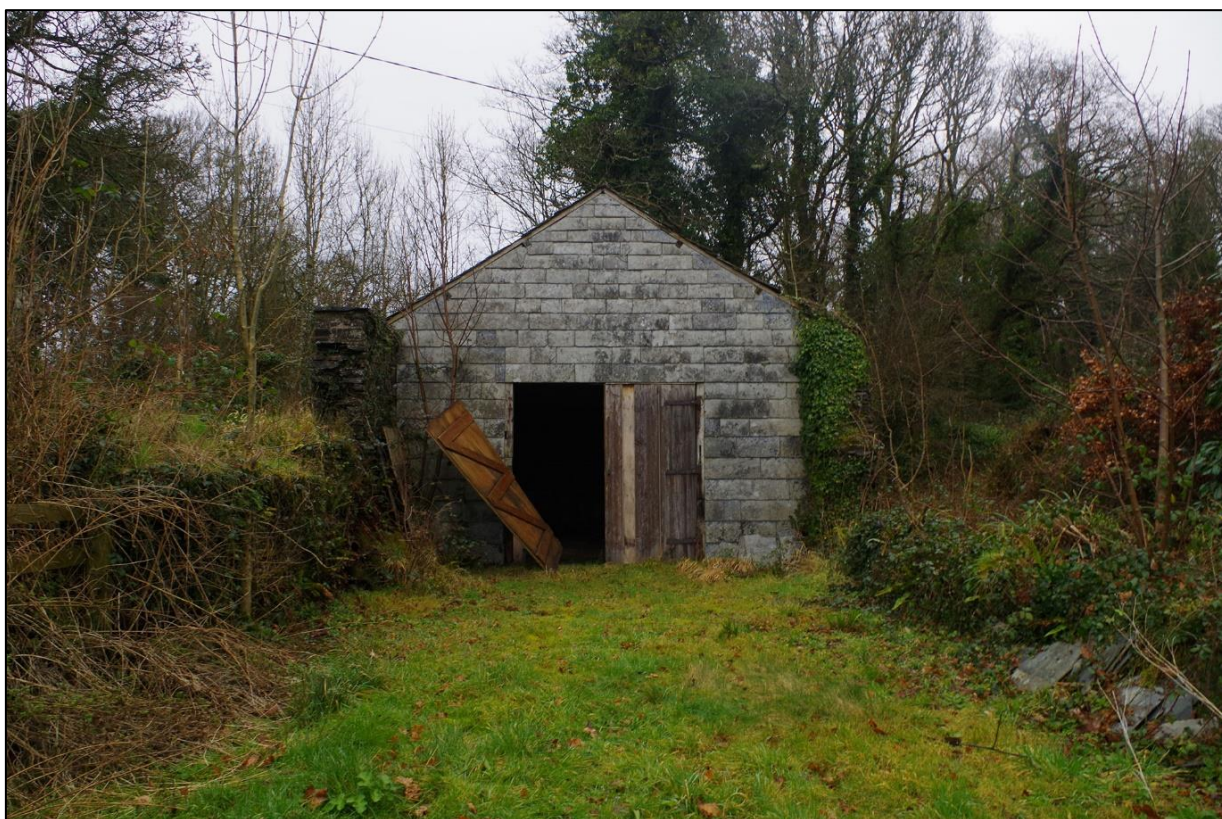
FIGURE 12: THE SOUTH ELEVATION OF B2, WITH SLATE CLADDING, OVERGROWN AND RUINOUS SURVIVING SECTIONS OF B2A RUNNING FURTHER SOUTH. TAKEN FROM THE SOUTH-WEST.

B2 is a surviving, upstanding section of a longer building; the southern half is ruinous, with only overgrown lower sections of wall on all elevations remaining. B2 & B2A sit close to B1, although at a lower level, on a north-east – south-west alignment. Internally it is clear it existed as a part of a larger building – a roof truss and timber posts are evidence of this and makes the lightweight south gable end, with slate-hung exterior finish.

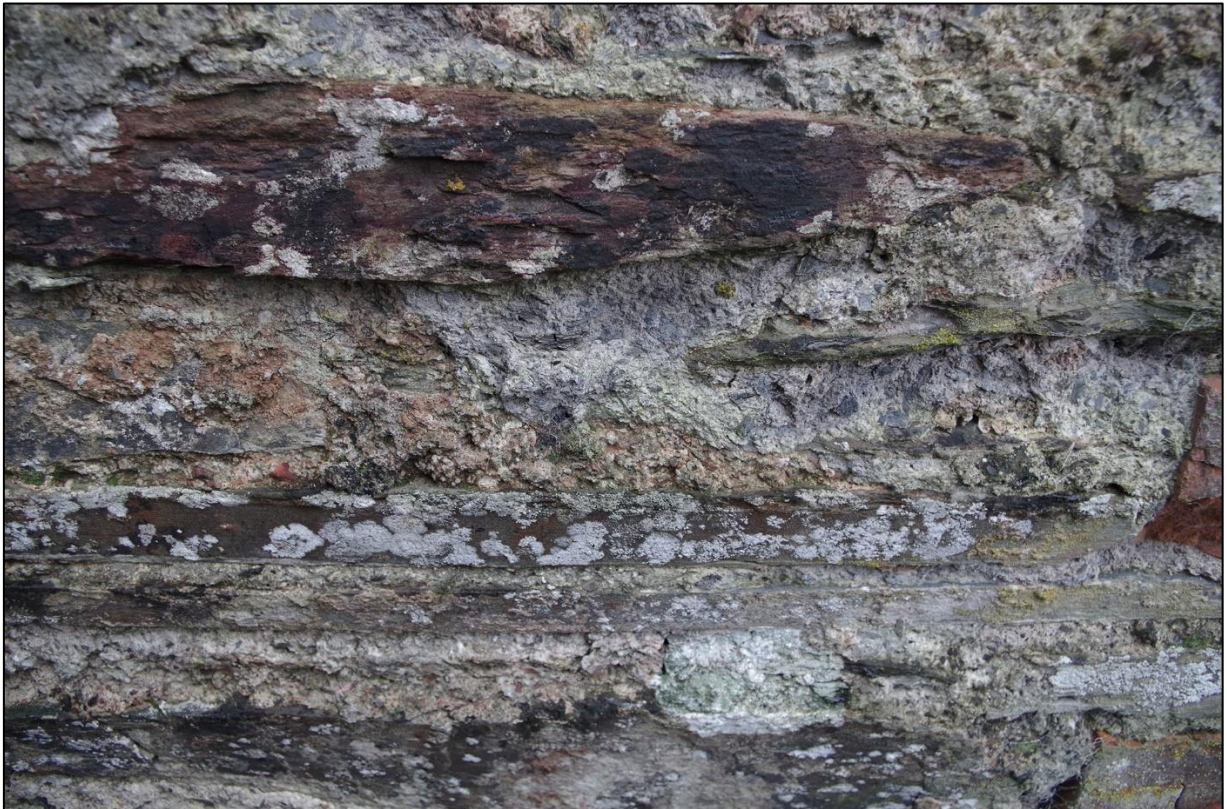
The stonework of both buildings was noted as being in very good condition to the exteriors, although B1 has been heavily re-pointed at a later date. Barn 1 was of semi-coursed, slate rubble build to all elevations, with the exception of a rebuild phase to B1D's southern elevation, where it had been rebuilt in concrete block and rendered with cement, to the exterior. Furthermore, the south-west corner of B1 had been rebuilt using bricks, with brick quoin details to the sides, although corners had been chipped off simulating bull-nose bricks and left rough. This end façade to B1A had been rebuilt with timber framing and showed signs of a possible lost wing to this area of the barn, although a thin slate threshold survived to the entrance. Barn 1 also has cement render patching to the eaves, where the roof had been replaced in recent years.

The re-pointing of Barn 1 has been done using a light grey lime mortar, mixed with crushed slate. This mortar sits above an earlier, refined, pink-grey clay/ lime mix, due to the local red-grey, brown soils of the area; it is likely both of these earlier mortars were mixed on-site. The roof has been recently replaced, so did not retain any original slate. Internally, the walls again, had been re-pointed heavily in parts, particularly to B1A, B1B & B1C but not so much within B1D. Lime plaster survived to the walls in B1B and B1C, although was noted to not be great condition, as particularly to the south internal elevation of B1C it was beginning to fall away from the wall. Concrete render had been used to fix a failing slate window lintel in B1B, and partition walls to B1B were noted as a larger slate build, with fresh-looking pointing work. B1D had not been as heavily pointed internally, but did have an earlier phase of lime plaster, particularly to the north internal elevation, that was in good condition. This plaster was light pink-yellow grey, and a much thinner mix than that of B1B and B1C.

FIGURE 15: PICTURE OF THE STONEMWORK AND LIME AND SLATE REPOINTING TO THE WEST ELEVATION OF B1.

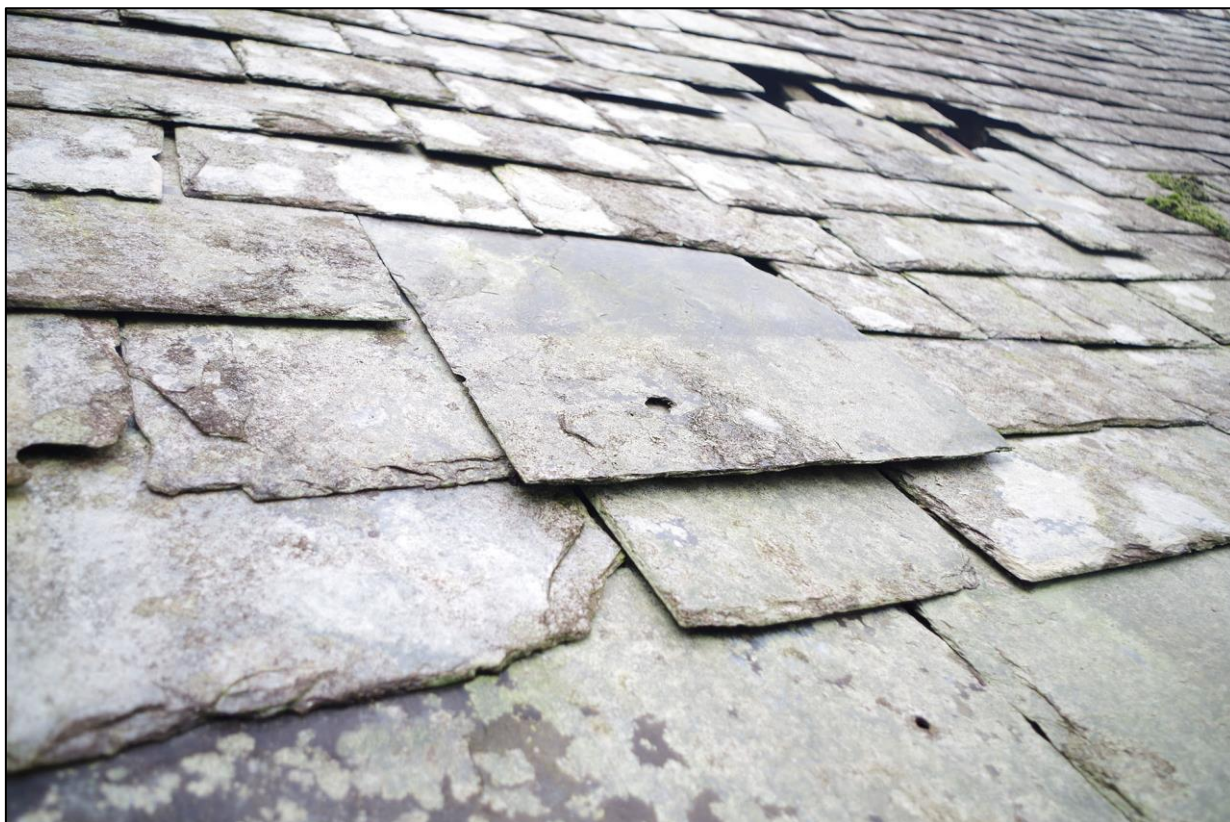
Barn 2 is very similar, although it had not been re-pointed to the same detail as B1. The west external elevation was largely overgrown with ivy, and the northern elevation very muddy from passing vehicles. The east elevation had a double height blocked opening to the north side, that had been concrete rendered over and painted. The stonework is rough, semi-coursed, mixed state rubble, with an earlier

refined, pink-grey clay/ lime mix surviving in places, although it had been heavily weathered. Some areas were lightly re-pointed with a light grey lime mortar mixed with crushed slate, same as Barn 1. As the barn had not been reroofed like Barn 1, it retains its original slate roof. The tiles were large, thick and square, with neatly punched holes for tacks and in notably good condition all over.

FIGURE 16: BARN 2 RETAINED AN ORIGINAL SLATE ROOF, COMPLETE WITH VERY LARGE, SQUARE SLATE TILES WITH NEATLY PUNCHED HOLES FOR TACKS. TAKEN FROM THE NORTH-WEST LOOKING AT THE WESTERN RIDGE.

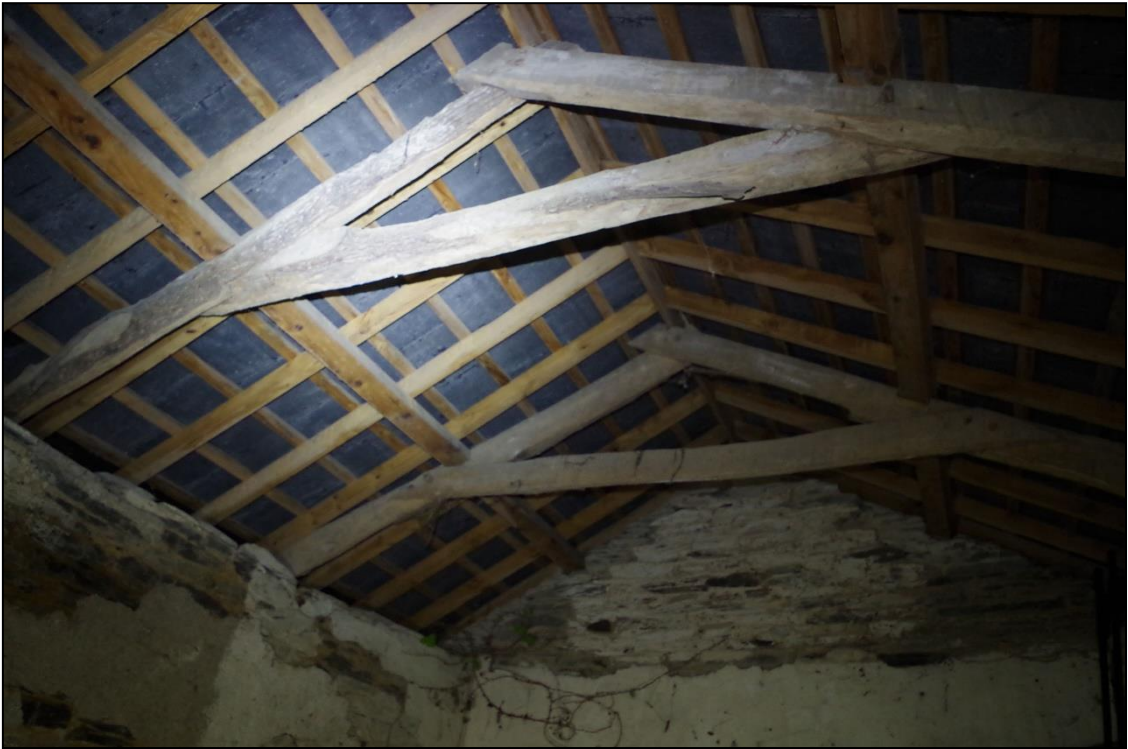
3. THE GOOD, ORIGINAL A FRAME TRUSSES TO B1C. VIEWED FROM THE WEST.

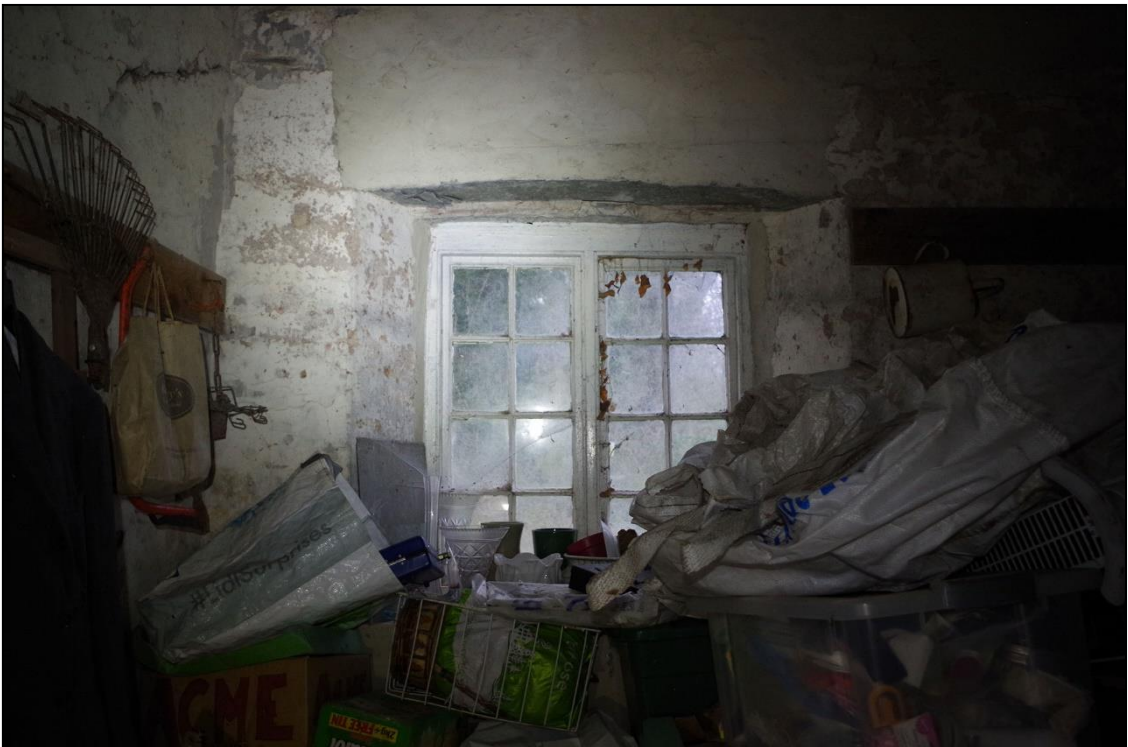
4. 19<sup>TH</sup> CENTURY WINDOWS SURVIVE TO THE NORTHERN ELEVATION OF B1B AND B1C, VIEWED FROM THE SOUTH.

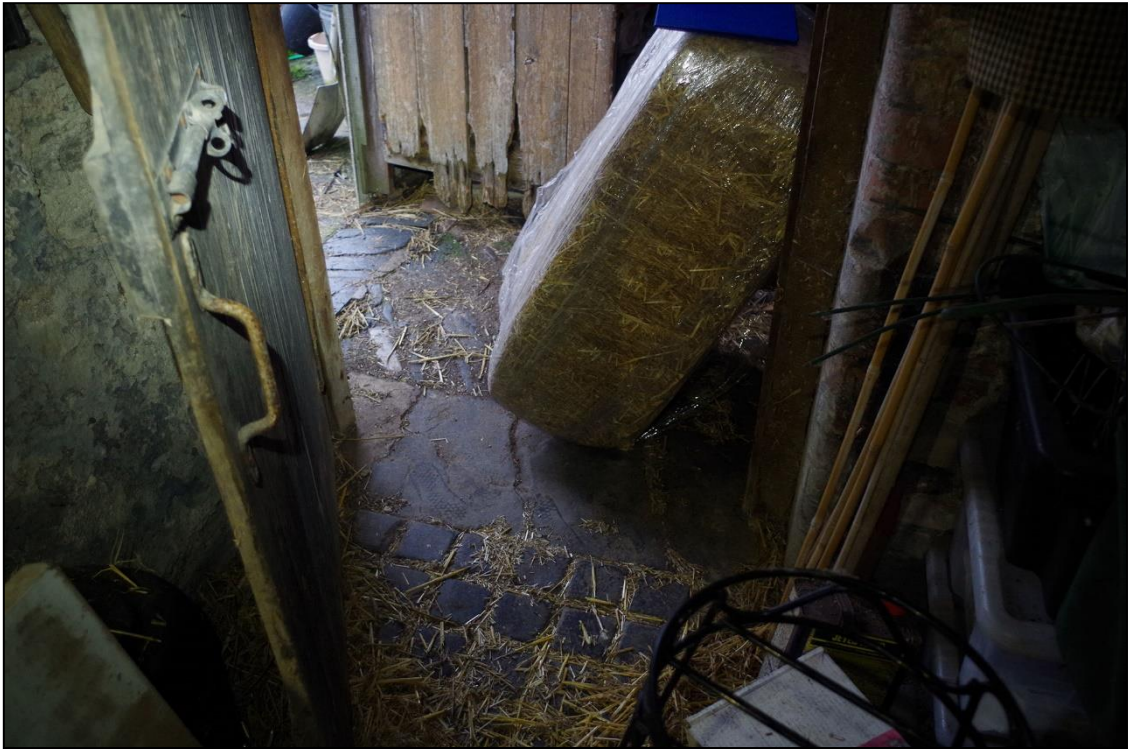
5. THE SLATE HERRINGBONE-PATTERNED FLOOR OF B1A MEETS THE QUARRY TILED FLOORING OF B1B.

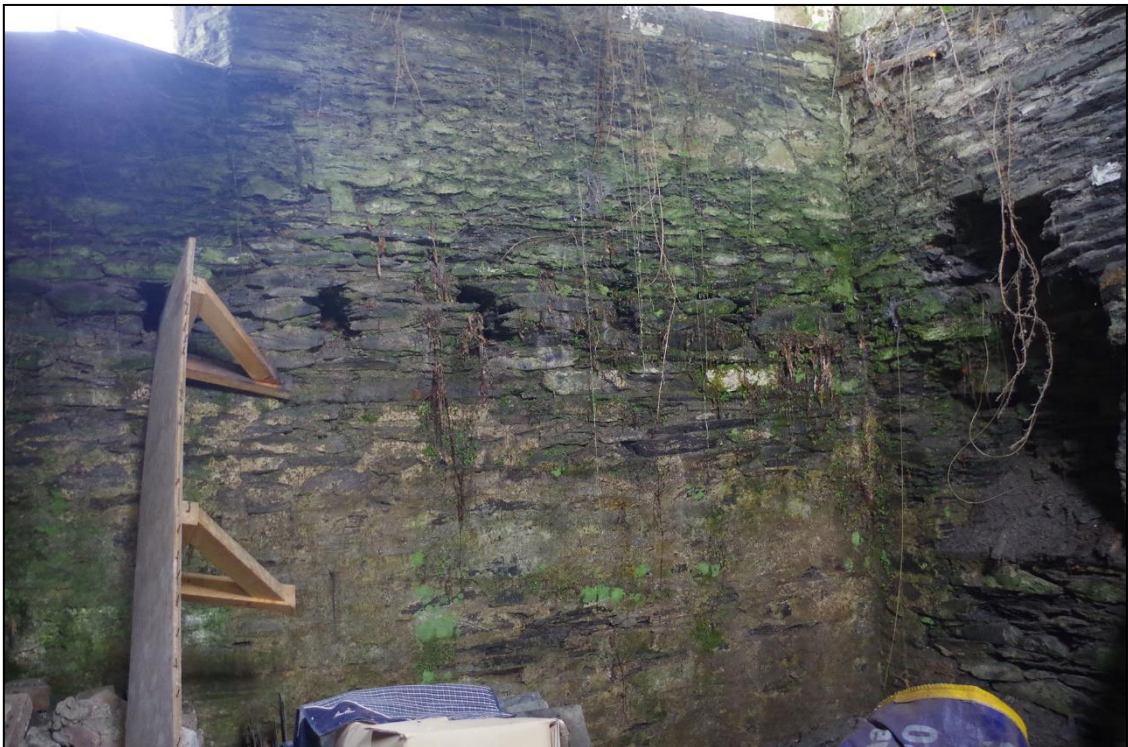
6. SURVIVING SOCKET HOLES TO B1D FOR A SECOND FLOOR, RIPPED OUT AND REPLACED WITH A MEZZANINE FLOOR IN 20<sup>TH</sup> CENTURY.

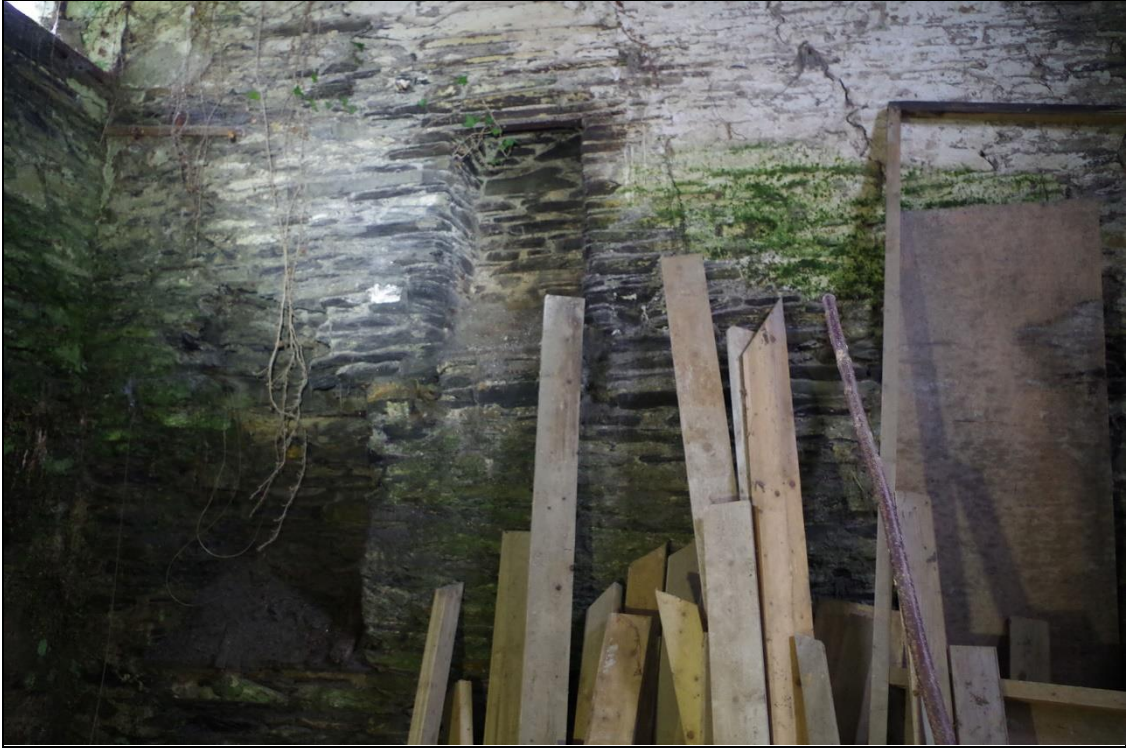
7. THE SURVIVING FLUE HOLES TO FIRST FLOOR AND GROUND FLOOR IN B1D, VIEWED FROM THE WEST.

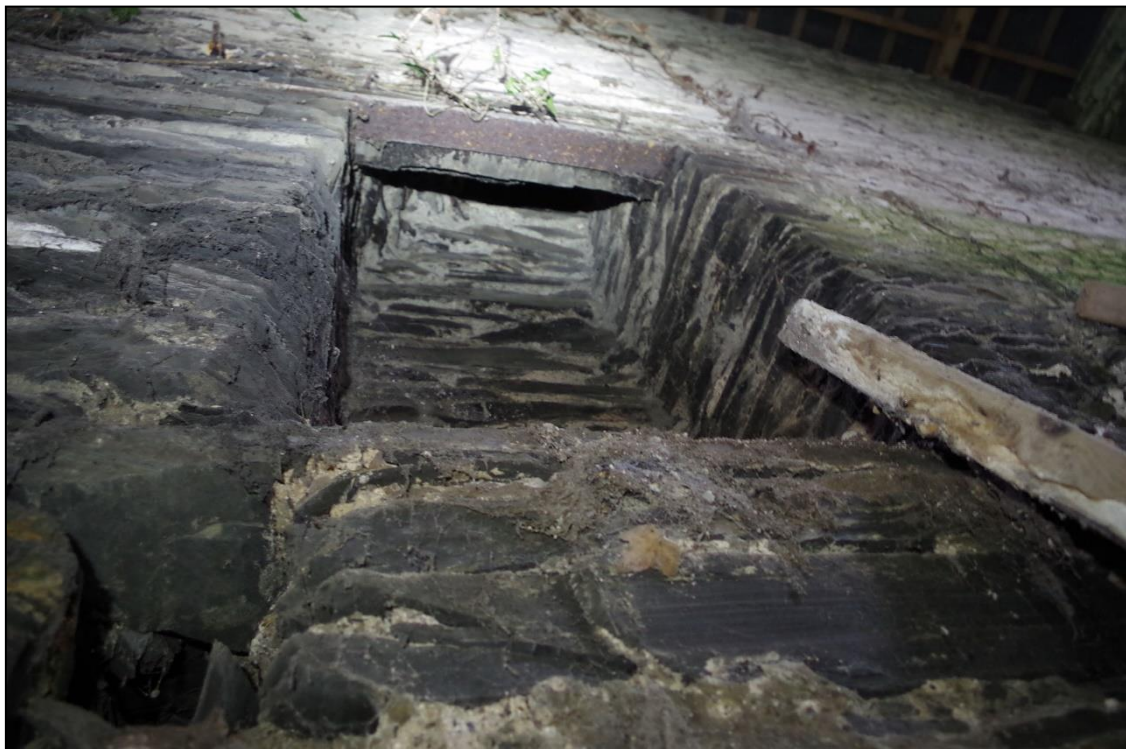
8. FIRST FLOOR CHIMNEY FLUE TO B1D, STACK WAS REMOVED WHEN ROOF WAS REPLACED.

Whilst the barn has been remodelled, a few significant individual features of historic value survive internally, including the chimney/ flues within the internal eastern elevation of B1D. The proposed breaching of B1D to the southern end has been well located to avoid these, however, the current placement of the staircase has the potential to damage or require the removal of the surviving projecting flues and is therefore suggested the stairs are moved to the north elevation within the partition hallway, whilst building works are careful to block the flues in situ and retain behind modern wall coverings, if these cannot be incorporated within the designs. Retention of these features in the final design, even if not visible will result in an acceptable **negligible** impact from conversion. Removal of the flues couldn't be supported from a heritage perspective. Neither the flues are noted on the measured survey of the building but have been added on the SWARCH annotated phased plans to reflect narrative. It would enhance the record of the buildings if these could be included.

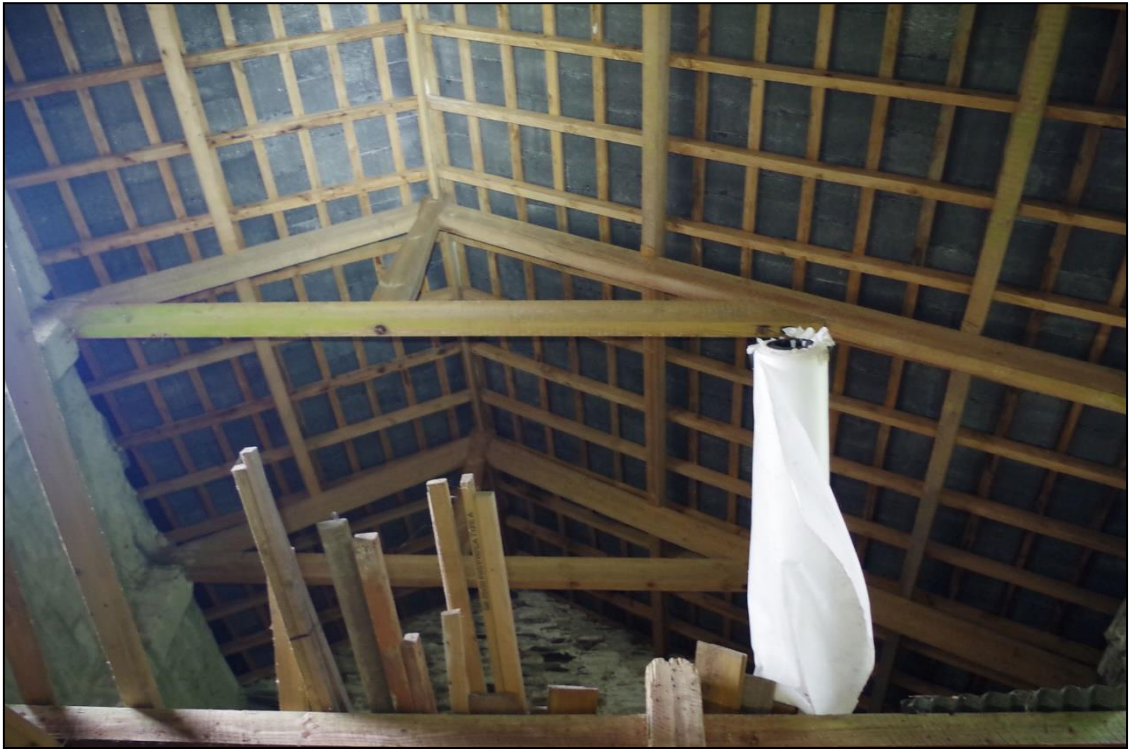
9. 20<sup>TH</sup> CENTURY ROOF STRUCTURE IN B1D.

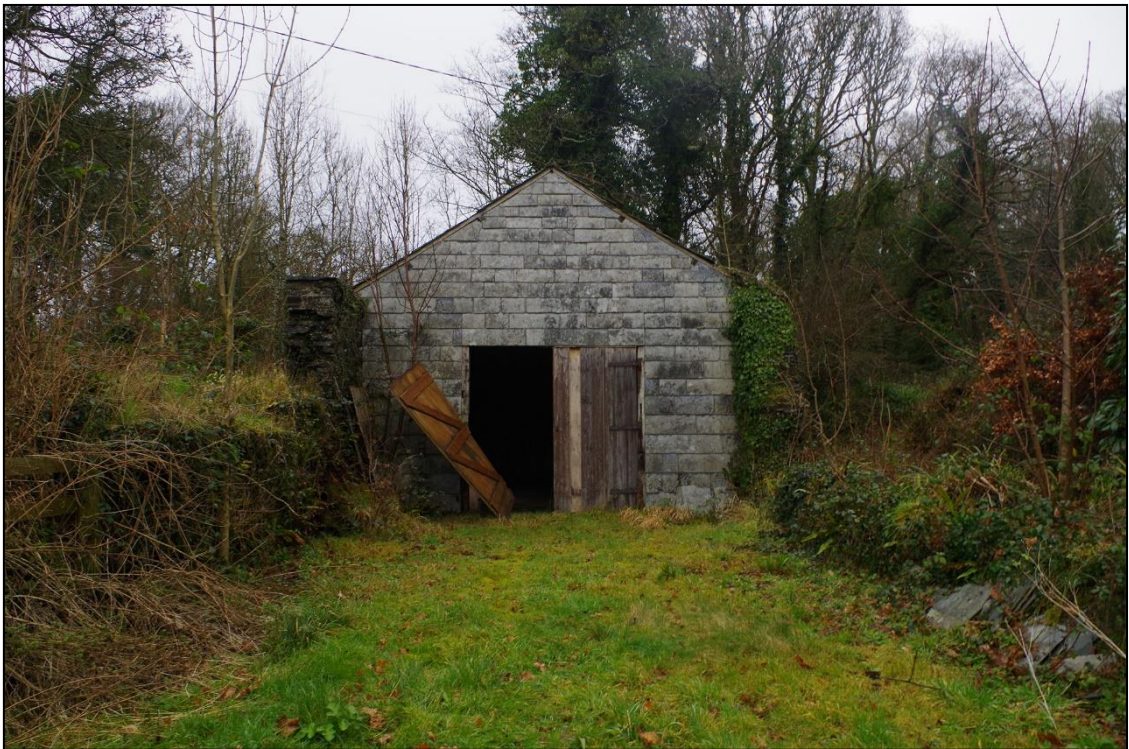
10. SOUTH ELEVATION OF B2, AMONGST RUINOUS B2A. VIEWED FROM THE SOUTH.

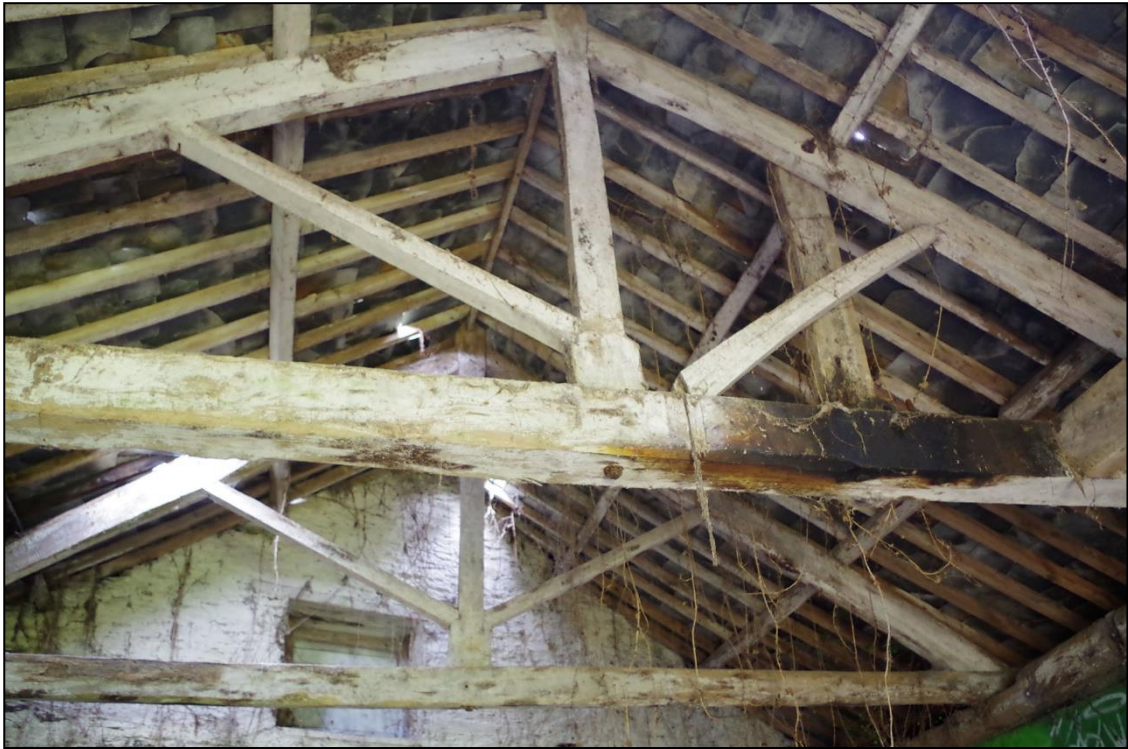
11. BOLTED KING POST TRUSSES WITH QUEEN STRUTS IN B2, MID-LATE 19<sup>TH</sup> CENTURY.

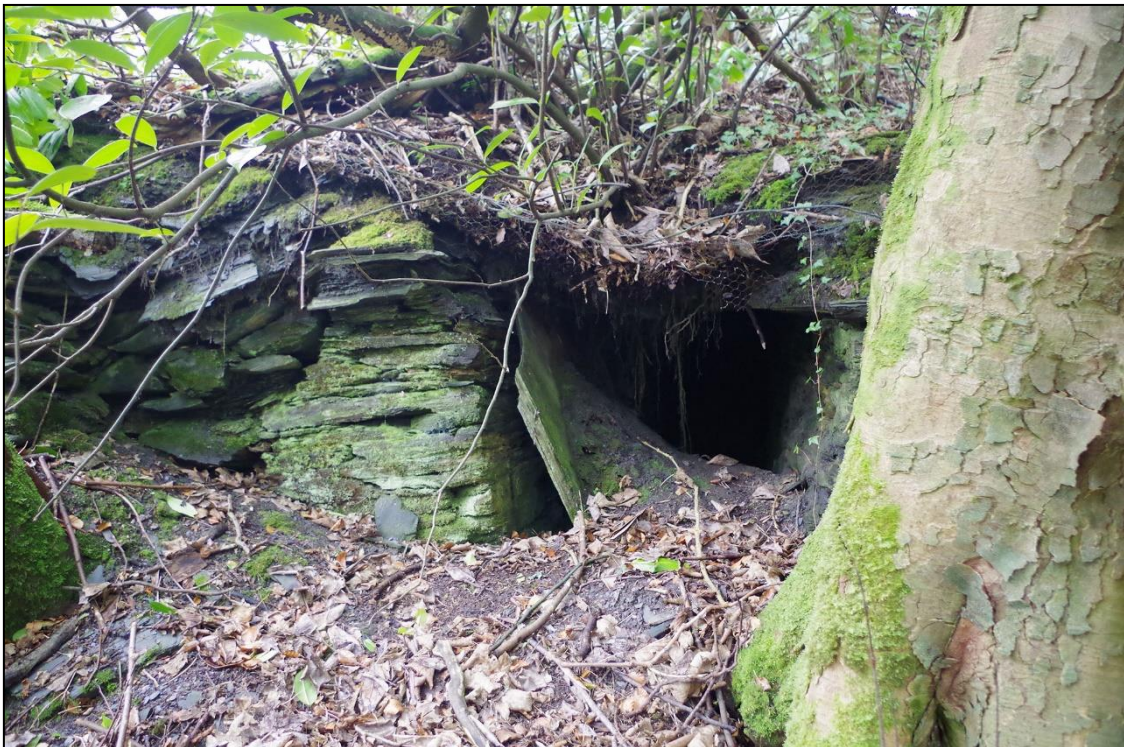
14. FORMER STRUCTURES ASSOCIATED WITH WATERWORKS SITTING BELOW POND TO THE EAST, THIS STRUCTURE APPEARS ON EARLIER MAPPING. VIEWED FROM THE SOUTH.
