**PINE TREES
TRESCOWE ROAD
GOLDSITHNEY
CORNWALL**

Results of a Heritage Assessment

South West Archaeology Ltd. report no. 220525

By E. Wapshott, MCIfA and A. Allen, ACIfA

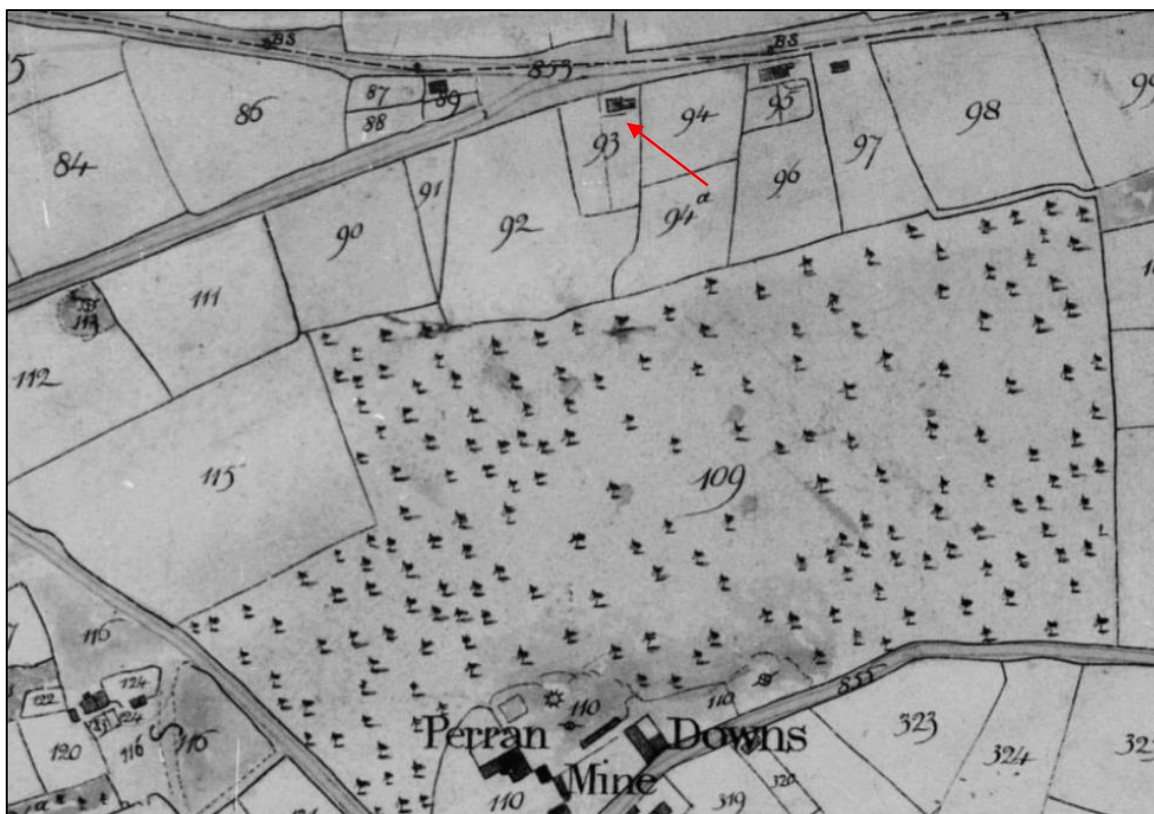
FIGURE 2: EXTRACT FROM THE 1841 TITHE MAP OF PERRAN-UTHOU, PINE TREES IS INDICATED IN RED. SOURCE: THE GENEALOGIST.

The 1841 Tithe map for Perran-Uthoue (Figure 4) illustrates a building within the location of the modern Pine Trees property, within plot number 93, where it is listed as *houses, homestead and gardens*. This plot is known to be owned by the Lady Carrington and occupied by Humphry King (as discussed above). The property boundary extends from the roadside to the south, amongst smaller divided fields to the east and west. Plot 93 seems to be slightly divided into three smaller plots using faint lines, suggesting small fences may have divided the plot. The house sits as a small, square block on an east-west alignment, with a projection to the west end. According to the Tithe Apportionment (see Table 1 below) Humphrey occupies four smaller fields to the east and west of the property plot, which looks to have been sub-divided from earlier common grounds. Plots 95 and 97 to the east appear to be similar small holdings, and contain buildings, and given the layout of the field pattern appear to be part of the same common land intake as Pine Trees. To the south of the Site, is a larger plot (109) illustrated as a plantation, which includes a faint division and plot 110 – occupied by Perran Downs Mine Adventurers and listed as *mine, buildings and ground destroyed by mining*.

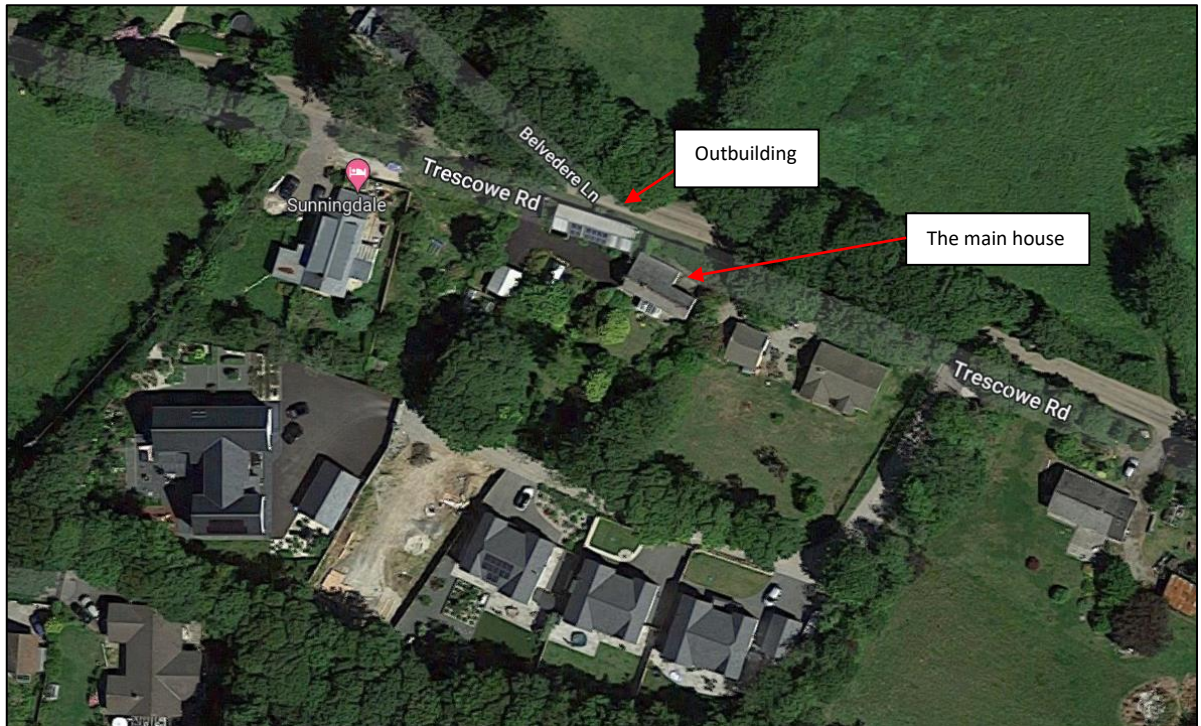
FIGURE 5: 2021 AERIAL PHOTOGRAPH SHOWING THE PROPERTY IN ITS MODERN CONTEXT (GOOGLE, 2022)

A 2021 aerial photograph (Figure 7) shows the property in its modern context, surrounded by several new building developments, particularly to the south and west within the former Trevelyan Plantation. Earlier field boundaries can be seen to still exist, although much of the former mining network to the south, across Perran Downs, has been lost to modern development.

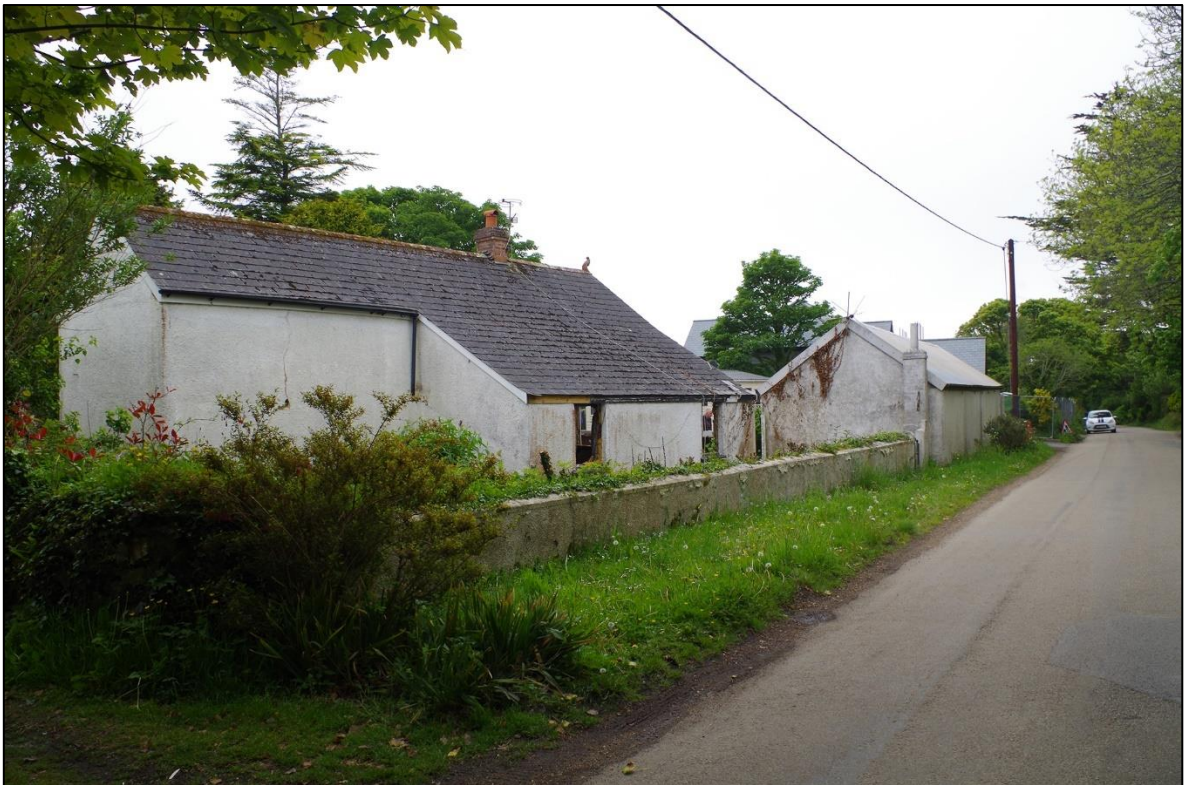
FIGURE 7: THE ROADSIDE SETTING OF PINE TREES TO THE NORTH, INCLUDING THE HOUSE AND OUTBUILDING. TAKEN FROM THE NORTH-EAST.

Pine Trees is located on the south side of Trescowe Road, approximately 1km east of Goldsithney and 8km north-east of Penzance. It is surrounded to the south and west by a series of new developments accessed from Trevelyan Grove to the east. To the north, across the road, the plot is framed by large pockets of later enclosed, post-medieval fields, and a small cart track Bevedere Lane, cuts the landscape to the north-west. It has a small grass verge along the property boundary on the north side, with a low boundary wall and small iron gate connected to the outbuilding. A small, raised bed frames the north elevation with a large water tank situated on the north east corner of the house. A section of small, low stone wall lines the east boundary, with a later central blocked gate/ door opening. To the south is a recently cleared garden space that includes larger conifer trees amongst smaller shrubs. The property is currently accessed to the west via a small drive and yard, with an associated, long outbuilding divided into three compartments along the north boundary and a modern static caravan sits opposite.

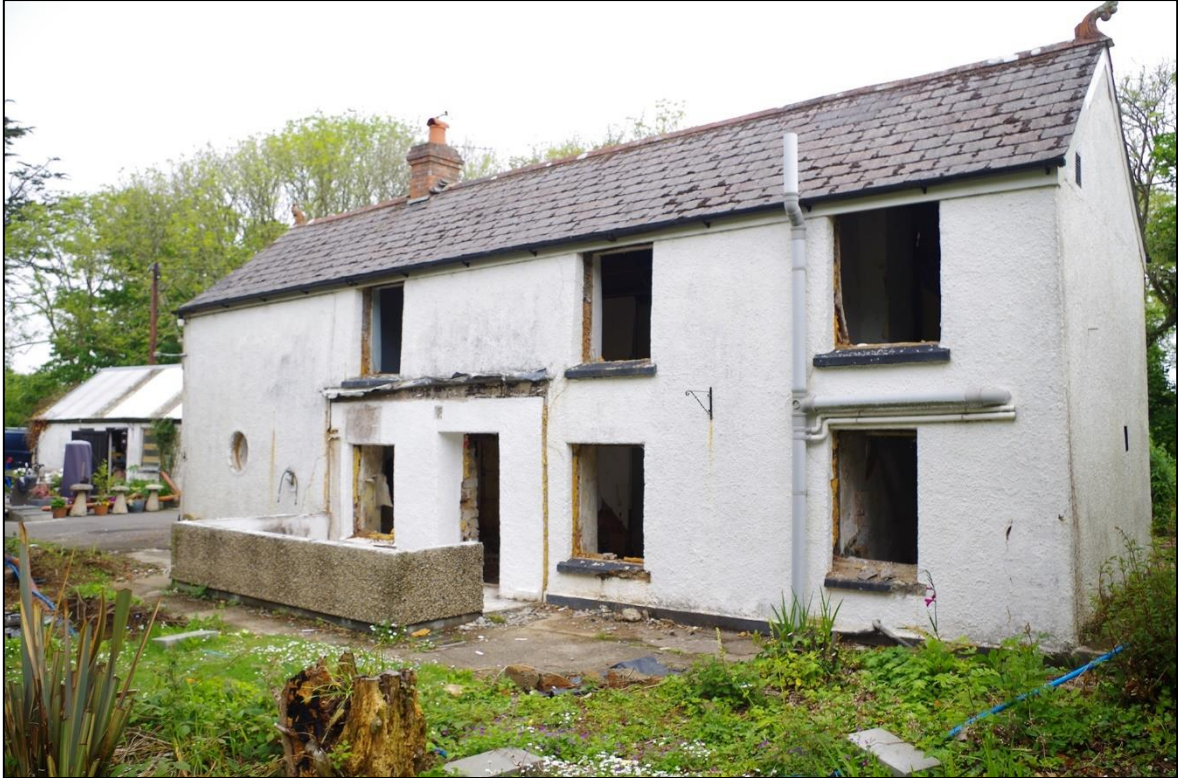
FIGURE 8: THE SOUTH ELEVATION, SHOWING MODERN EXTENSIONS, AMONGST AN EARLIER COB BUILD, THE EAST END IS BATTERED. TAKEN FROM THE SOUTH-EAST.

The current main house (B1) sits on an east-west alignment along the south side of Trescowe Road, within a small yard that includes an associated outbuilding (B2). The house has been heavily altered; no windows or doors survive within the building and the walls, and first floor ceilings have largely been stripped out; almost no original fixtures/ fittings or features survive. The external faces have been rendered in heavy 20th century pebbledash and thickly painted in an external white paint making some phasing/ features hard to identify, although some evidence of disturbance can still be found in places across the external elevations. The roof is a modern replacement using imitation slate tiles with terracotta to the ridge and decorative terracotta finials to each gable end. There is a slight raise within the roofline to the east end suggesting a removal of an original stack, and a

modern 20th century, brick stack has been inserted towards the west end, within the line of the former west gable end. Thick, battered walls exist on the east external elevation suggesting an earlier cob build towards this end of the building. Evidence from the window reveals indicate the house has been raised by approximately 1m to support a full two-storey build and a new, modern roof.

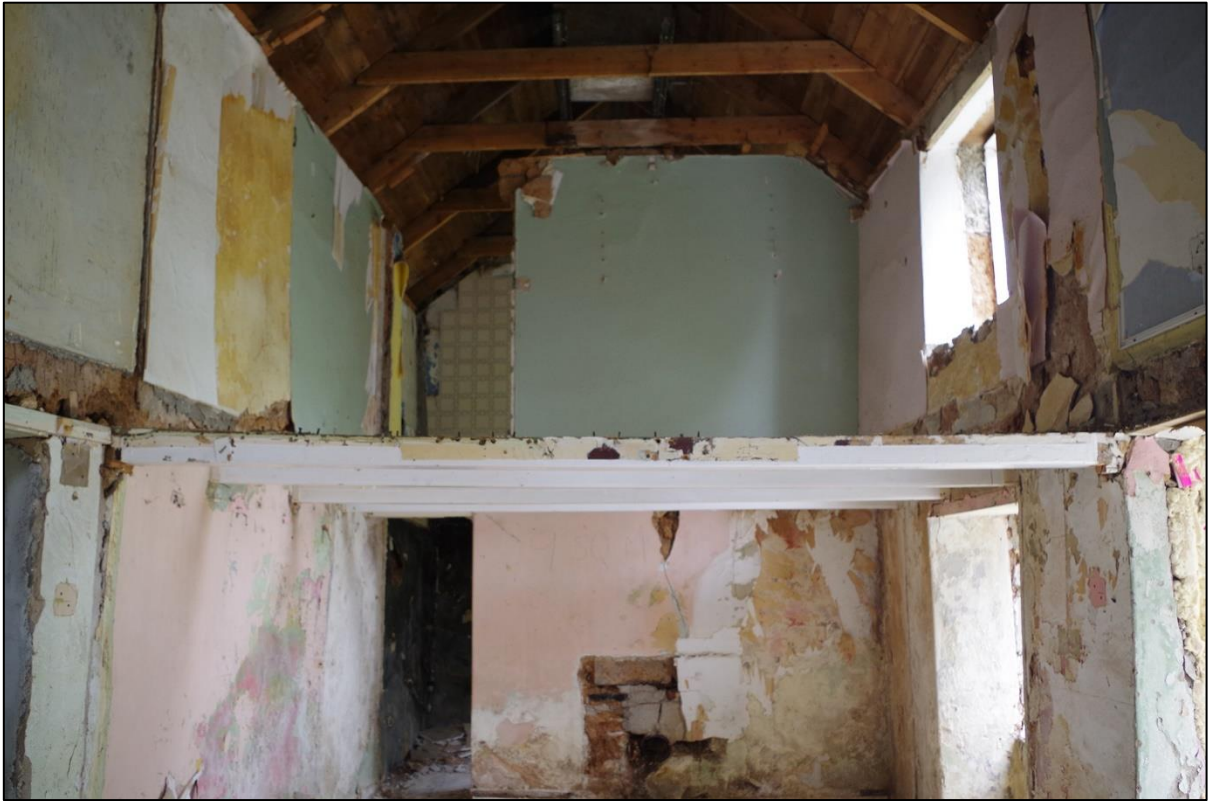
FIGURE 9: R3 INCLUDES THE MAJORITY OF COB WALLS WITHIN THE BUILD AND CUT HISTORIC STACK, AND BLOCKED FIREPLACE BELOW. TAKEN FROM THE WEST.

R3, within the historic range, is currently a large, open space that would have been divided into two rooms, from a central corridor, although all partitions have been removed. Scarring for the staircase exists within the north-west corner, along with two blocked openings, suggesting a later layout alteration, and a possible change in stair position. There are two window openings in the south wall to the ground floor, and a large, forced doorway that would have led on to a modern conservatory. The openings have deep splayed sides, with shallow timber lintels. The opening to the west end has reused, deep, ogee moulded skirting acting as a timber plate to the lintel – providing evidence of late 18th-19th century details. Modern pine joists run north-south across the room, and the shell of the first-floor level can be seen from below. To the reveals of the upstairs windows, a clear concrete raise, potentially a ring beam or similar, can be identified. The roof is a modern a-frame with half-lapped timber blades to the ridge. A large, riveted, galvanised water tank has been inserted between two a-frames on cut steel beams above the former stack at the east end of the roof space, and was likely introduced when the roof was redone. A blocked fireplace sits centrally within the east wall of this room within a chunky stack, blocked with a mixture of concrete

block and rubble around a later inserted iron flue pipe, that has been blocked with newspaper dated to c.1972. Large, modern, square red quarry tiles survive to the floor to the east end. The space formerly occupied by the first-floor, patches of cement render could indicate a former layout, all other possible features, fixtures, fittings, and partitions have been removed. It likely had two bedrooms to this level with a thin bathroom to the east end and a small square landing from the stairs to the west, with a forced doorway into an extended western bedroom indicated by scarring and partition lines.

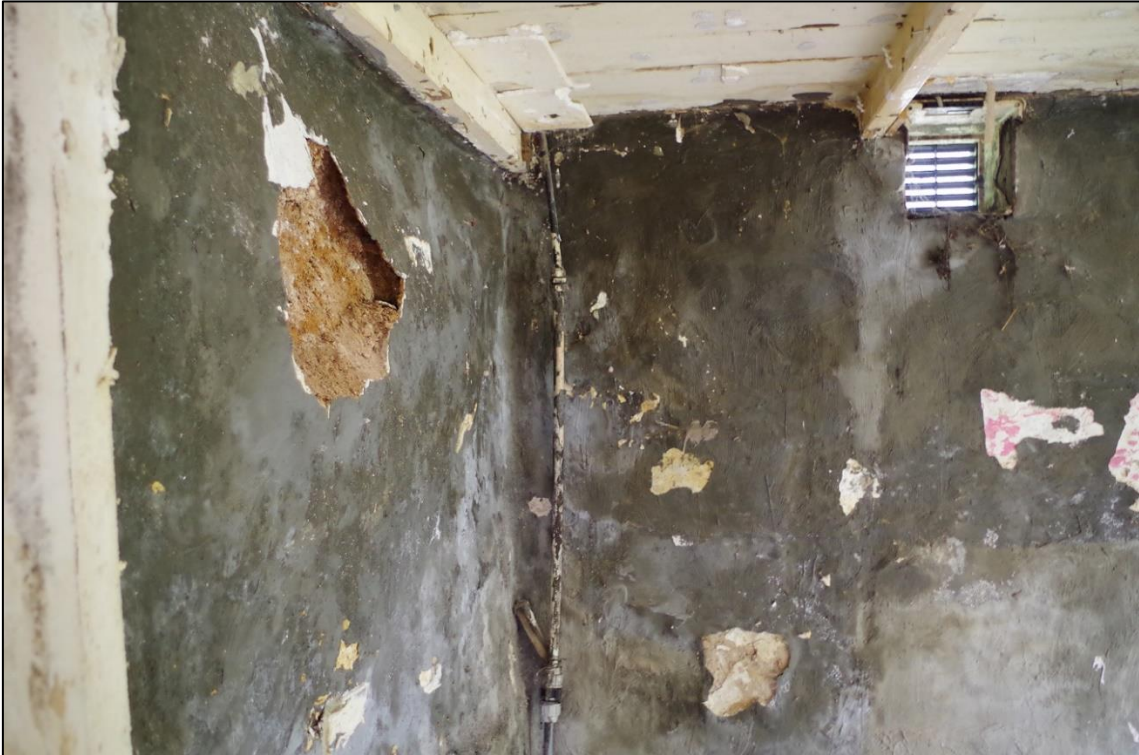
FIGURE 10: BATTERED COB WALLS WITHIN THE EAST EXTENSION, AND EVEN-WIDTH PLANKED FLOOR TO FIRST FLOOR, WITH CHAMFERED JOISTS -KEY 19TH CENTURY DETAILS. TAKEN FROM THE WEST.

R4 is a thin extension on the east end of the historic block, accessed through a forced doorway in the north-east corner of R3. The ceiling is low and boasts even-width planked floorboards, and some chamfered joists amongst later forced steel joists running east-west. The north, east and west walls are particularly battered within this room and a blocked doorway, now a thin window opening sits in the south-west corner. A stack has been removed and heavily altered within the west wall, with boxing evidence surviving at first floor level. It has been cut at the loft level, and likely altered when the roof was raised and replaced suggesting this end of the house is likely a small service extension. The south-west corner of the first floor exhibits a potential blocked corner fireplace for a first-floor bedroom, which may use the flue of the adjacent stack.

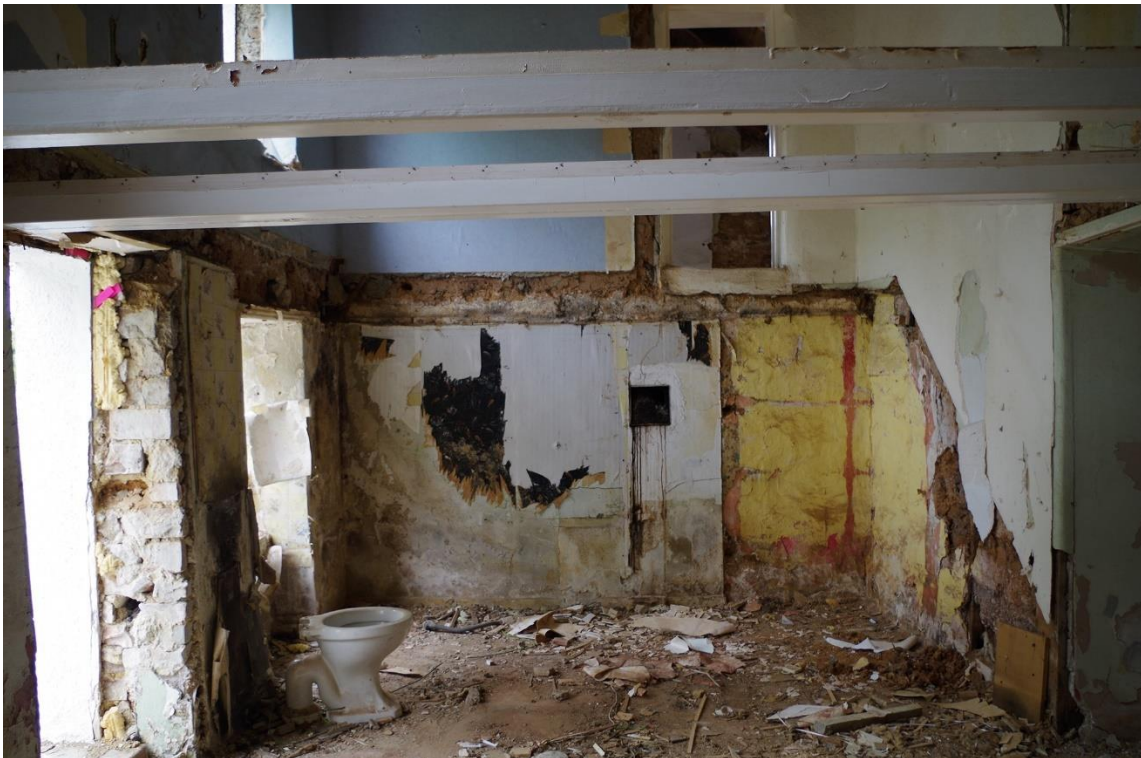
FIGURE 11: THE WEST END OF R3 SHOWING BLOCKED OPENINGS TO THE NORTH THAT SUGGEST A CHANGE IN STAIR PROJECTION. TAKEN FROM THE EAST.

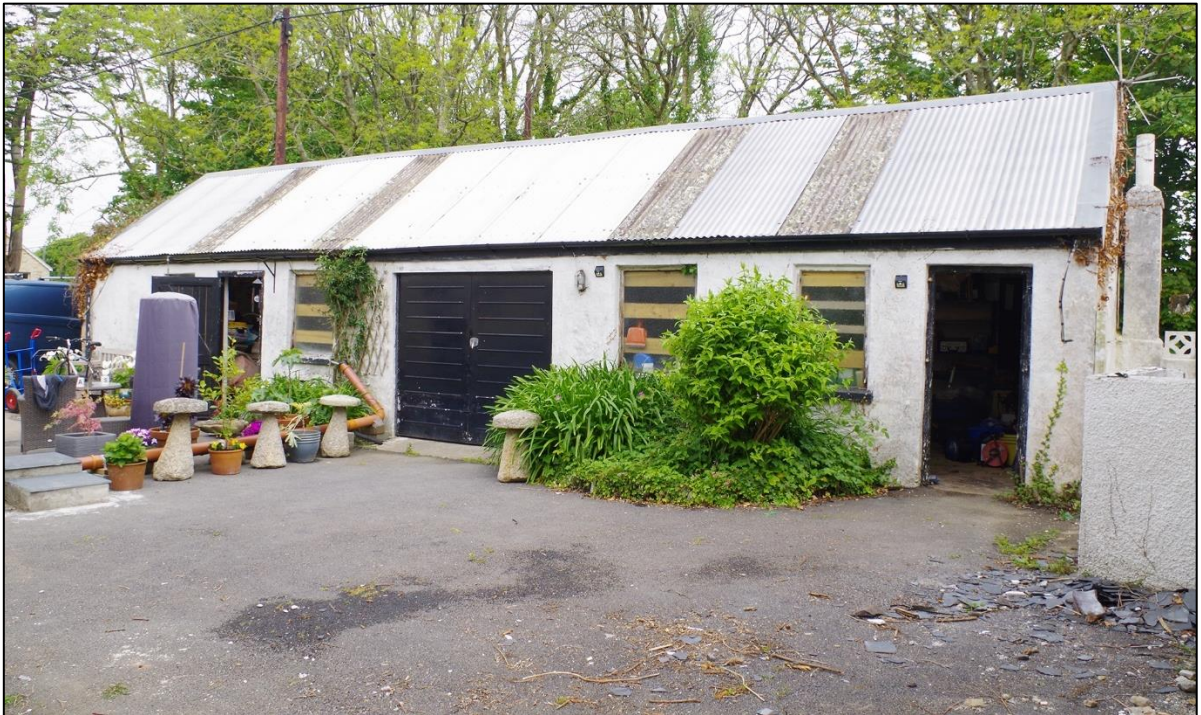
FIGURE 12: THE OUTBUILDING ON THE NORTH BOUNDARY; TAKEN FROM THE SOUTH-EAST.

A long outbuilding sits along the north boundary of the Pine Trees plot. It is a single storey, poor quality, much altered stone, and cob build, currently divided into three compartments. The partitions between the rooms appear to be stone, but are very thin, so could be later sub-divisions. There was a small, square brick stack on the north-east corner (since demolished) serving a plastered brick boiler or copper. A large granite post sits to the north-west corner likely a reused gate post. R1 in the west end, has an uneven packed earth floor possibly with some limecrete and some attempt at cobbling visible. This building was likely once a small, low linhay, and has been raised to fit a modern plastic corrugated roof, heavily changing the pitch, two sockets were seen on the north wall to R1. R2 can be entered from R1 in a forced doorway to the south of the partition of wall, which enters a large room with a concrete floor. Later 19th or early 20th century A-frames survive within this room, but have been re-set and the roof raised (at least once). The gable ends of the building appear to have been raised in mix of stone and cement.

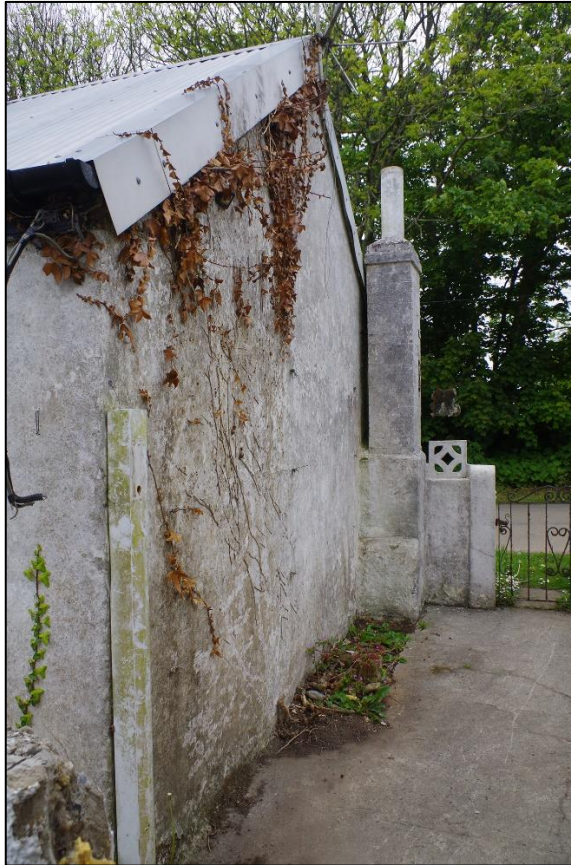
FIGURE 13: BRICK STACK (NOW REMOVED) ON OUTBUILDING TO THE NORTH-EAST CORNER.

- Detached small, square external brick stack (now removed) to the north-east corner of the build, serving a plastered boiler/ copper.
- Possible limecrete and/or early concrete floors, with some crude cobbling visible, poorly surviving.
- Changes in wall thicknesses and forms of walls – some stone, some cob. Subdivisions very narrow (stone walls) and may be replacements.
- Timber ties at eaves in party walls suggest raise of roof, likely twice given the empty sockets in north wall. Gables raised
- Reused granite post in the external face of the west end. The post has no evidence of pinties, so may not have been used as a gate previously.
- Good, plank door with heavy ledging bars and braces cut to form stable style, two-leaf door, iron lock with good brass handle. Fudged Bakelite handle.

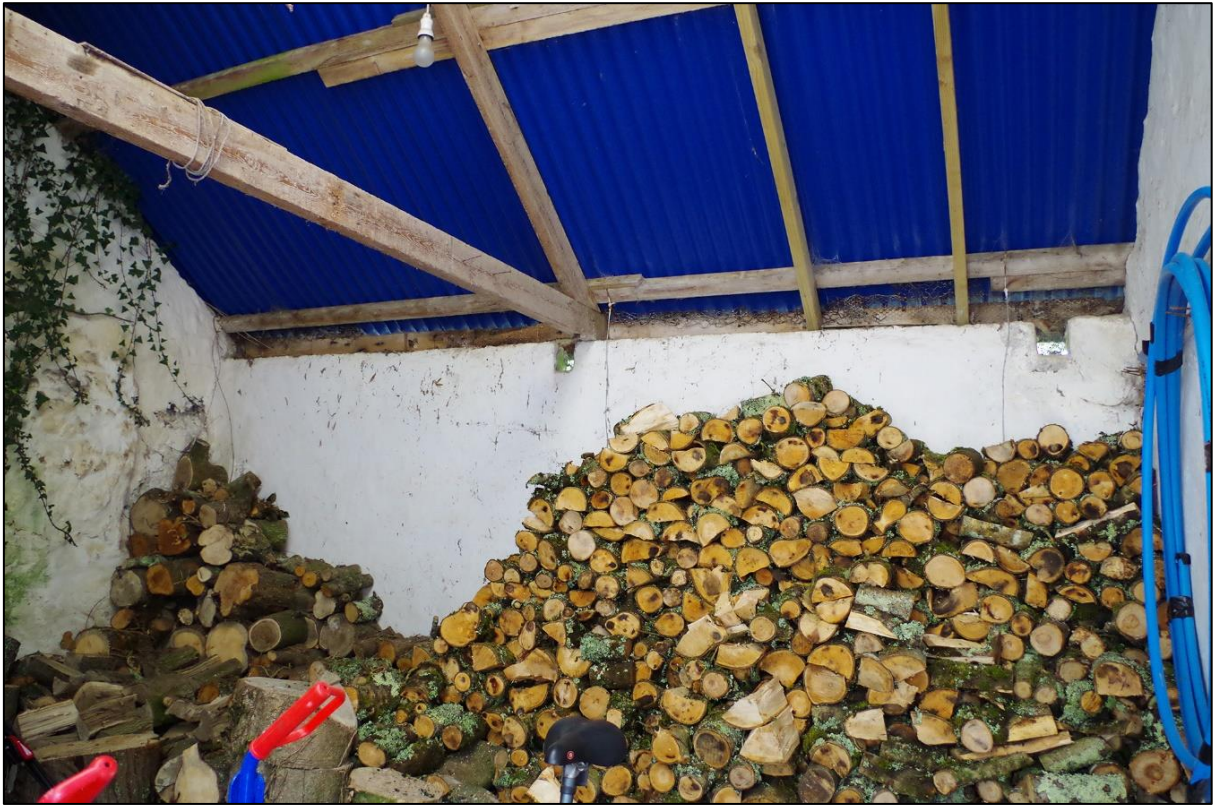
FIGURE 14: SOCKET HOLES SHOW THE OUTBUILDING HAS CHANGED USE AND DEVELOPED OVER ITS PERIOD, AND SUGGEST A CHANGE OF PITCH FOR THE BUILDING. IT IS CLEAR THE ROOF HAS BEEN REPLACED, LIKELY TWICE, EARLY-MID 20TH HALF-LAPPED TRUSSES AND LATER EARLY 21ST PLASTIC CORRUGATED ROOF, WITH SIMPLE PINE A-FRAMES AND RAFTERS.

- Four early 20th century surviving (but re-set) trusses with half-lap at ridge, rest of roof otherwise replaced and raised.
