# ALTERATIONS TO ACCESS ROAD ROSEWASTIS HOUSE ST COLUMB MAJOR CORNWALL

Heritage Impact Assessment

South West Archaeology Ltd. report no. 210209

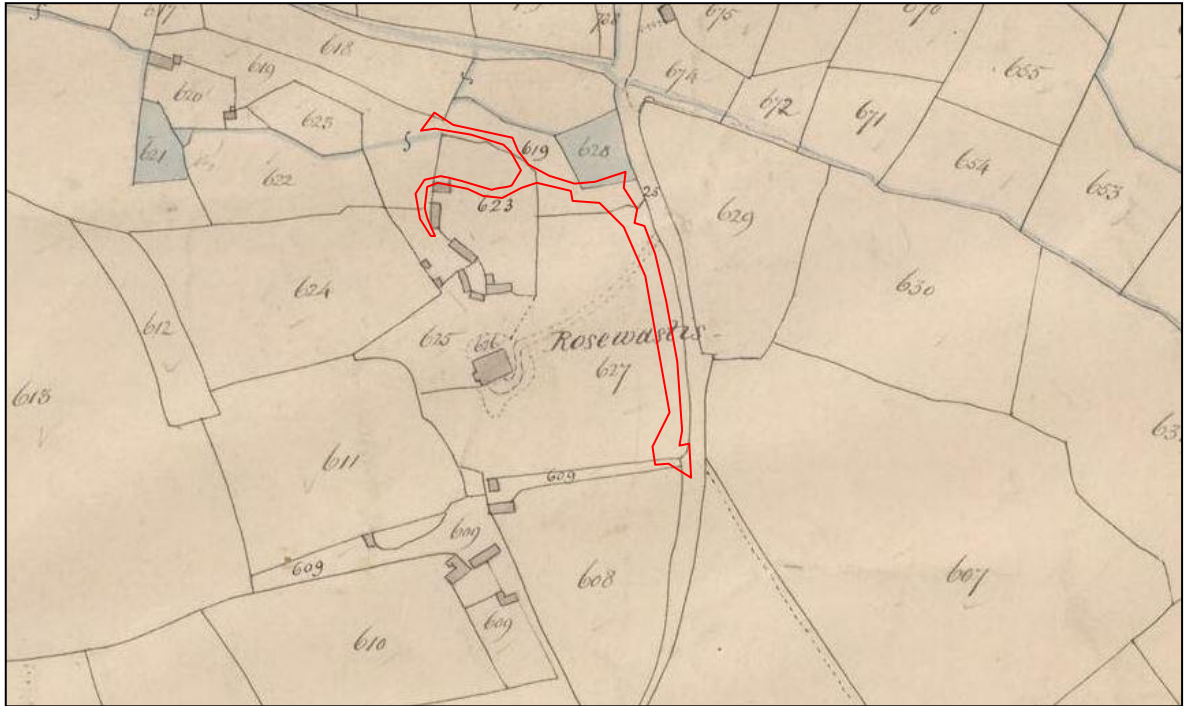
FIGURE 3: EXTRACT FROM THE ST. COLUMB TITHE MAP (PART 2) OF 1840. THE APPROXIMATE ROUTE OF THE PROPOSED NEW ACCESS IS INDICATED.

The 1840 Tithe map for St Columb Major (Figure 3) appears to show relatively substantial changes to the landscape around Rosewastis, which seems to have been consolidated into one holding by this date in the ownership of William Veale. The mill buildings, leat and ponds are shown to the north of Rosewastis and a number of buildings form a rough linear to the north of Rosewastis Farm House. The tithe apportionment describes the farmstead and buildings to its north as 'homestead and cottages', presumably accommodation for the mill and agricultural workers on the estate. Only one driveway is shown on this map, to the south of Rosewastis Farm House, presumably the route shown on the surveyors draft map accessing Higher Rosewastis. A trackway is shown leading from Rosewastis Farm House to the north east, joining the St Columb Major road.

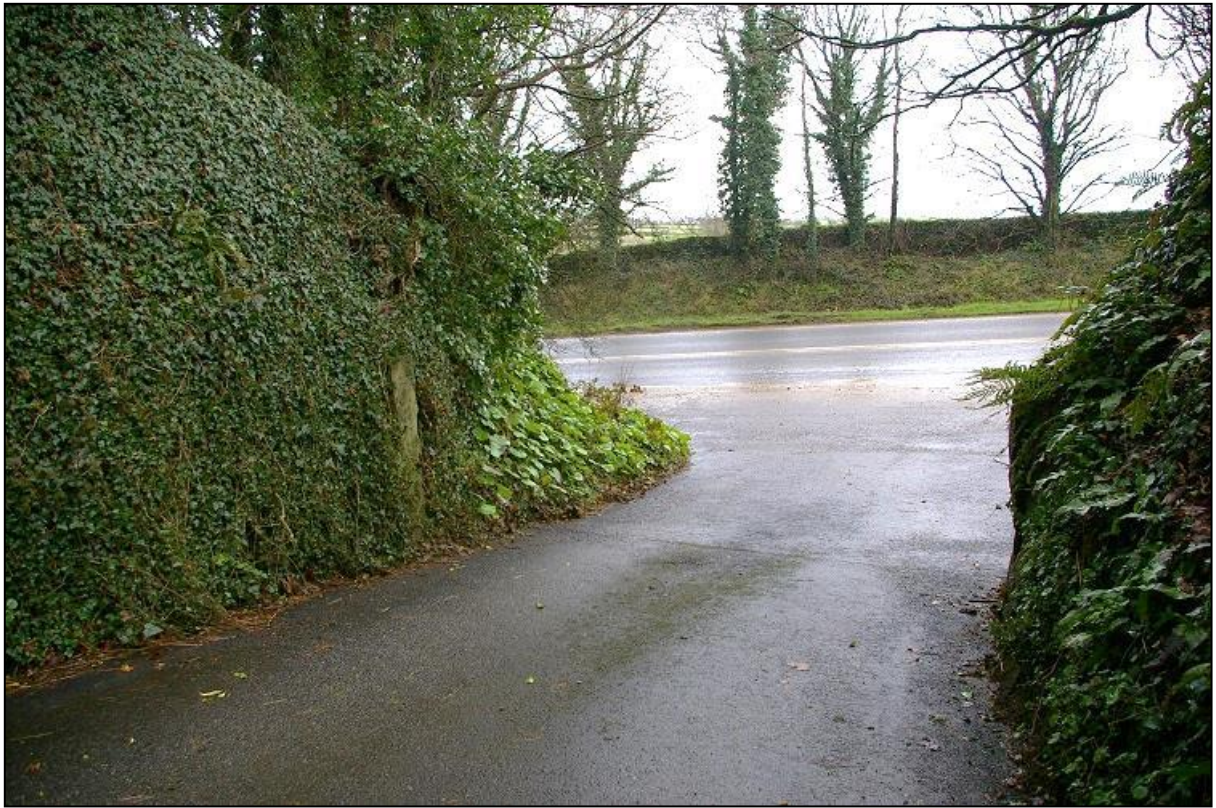
1. VIEW THROUGH THE NARROW HISTORIC GATEWAY BETWEEN DRIVE AND A39; FROM THE WEST.

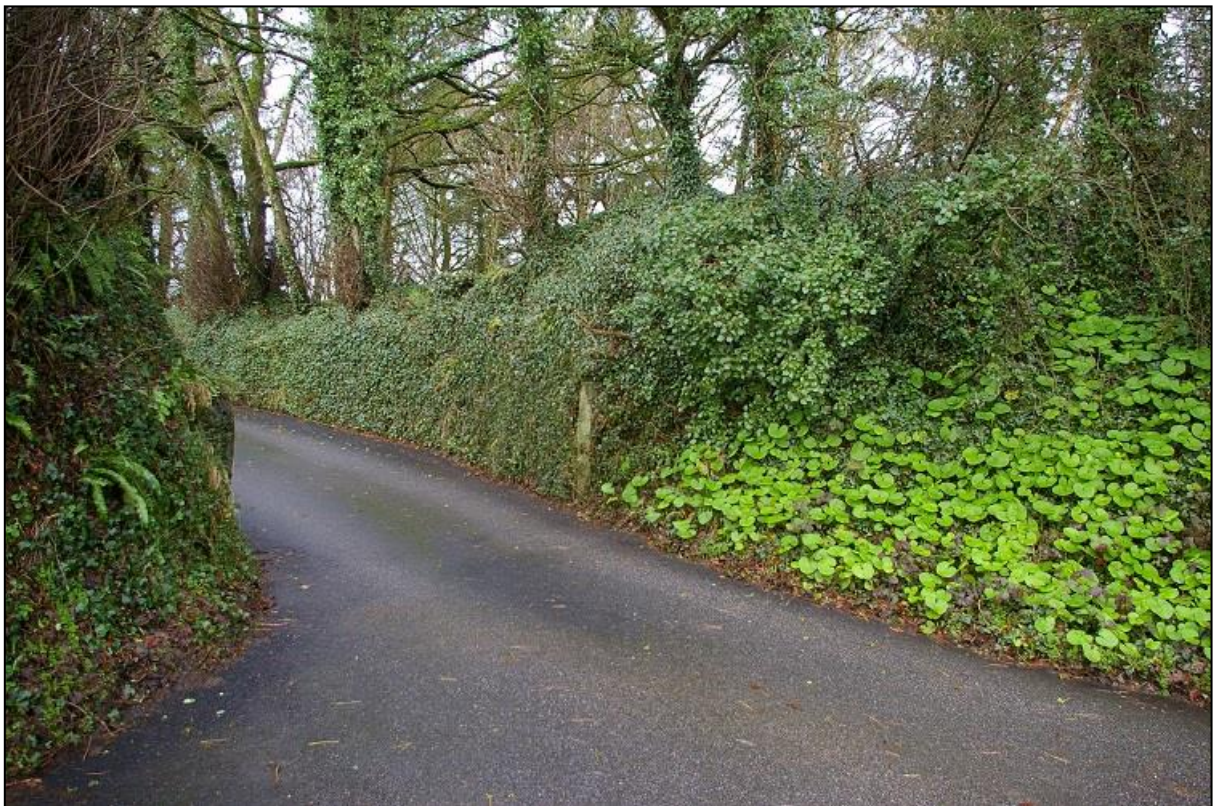
There is an obvious visual and physical impact in breaching the hedge bank/retaining bank and this would be negative to the heritage value of the bank and have indirect impacts on the gateway. The historic gateway itself and granite posts will not be altered, retaining the physical understanding of the original boundary. The bank would be breached where there is already slumping from a fallen tree or soil slippage at some stage. Mitigations can be applied if the breaching of the historic structure was to be monitored, allowing for a record of the construction and dateable finds to be recovered. Visually, there will obviously be a change but mitigations could be applied here too as the stone from the bank can be used to make good the new sides of the entrance. Design at the opening will be key to limiting the visual impact, allowing the retention of some of the older trees on the bank and the narrowness of the outer historic entrance is such that views when moving along the road would be fleeting at best. The small cottages on the south side of the drive which belong to the holding block wider views.

2. INWARD VIEW THROUGH THE GATE FROM THE BUSY A39 ROADWAY, LOOKING AT THE SECTION OF BANK TO BE REMOVED; FROM THE EAST-SOUTH-EAST.

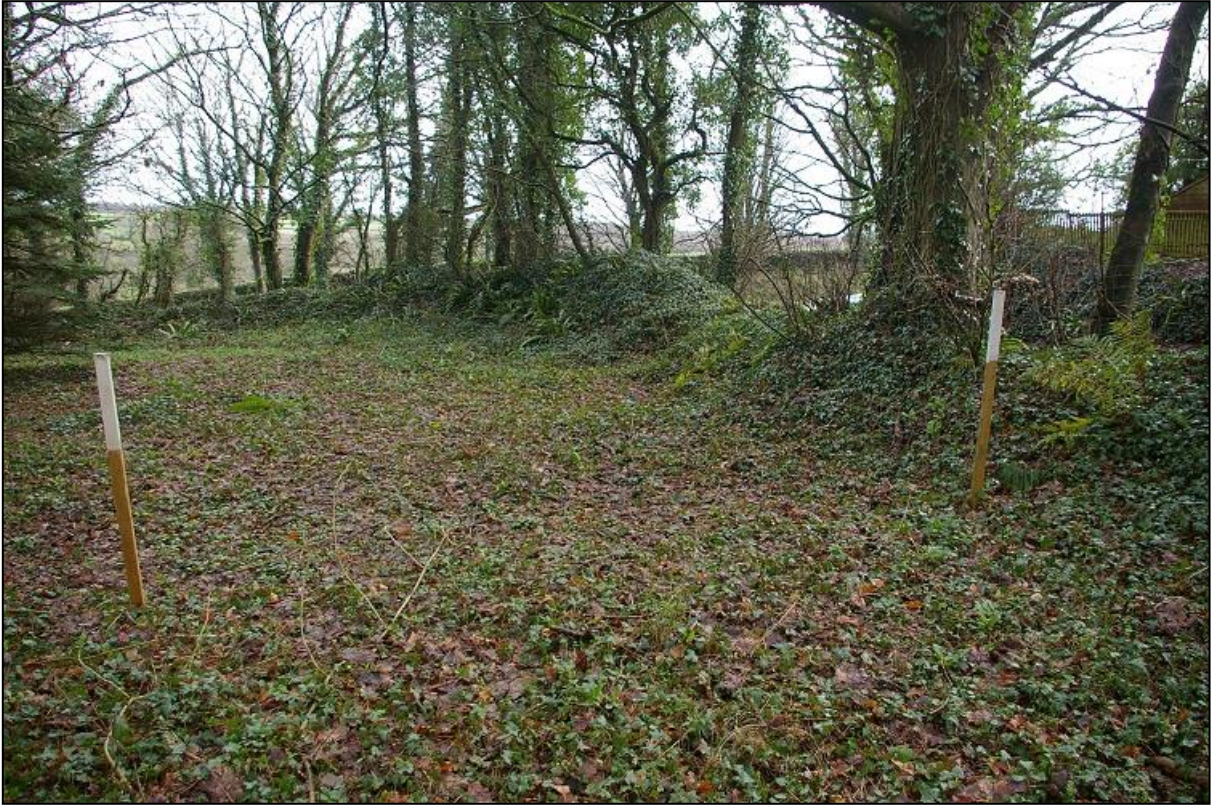
3. THE RAISED BANK BEHIND THE HEDGE BANK TO BE BREACHED, SHOWING THE SLUMPED SECTION TO THE RIGHT; FROM THE WEST.

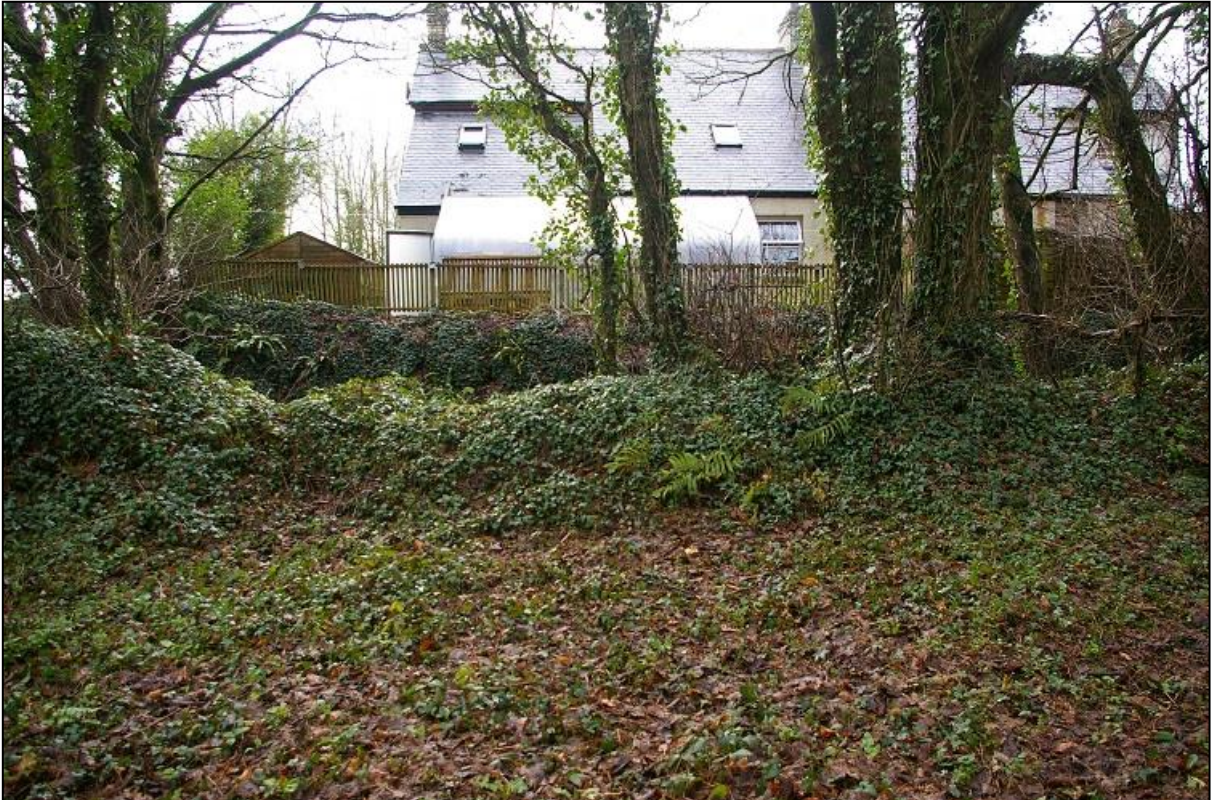
4. VIEW TO THE SLUMPED HEDGE BANK WHICH WILL BE BREACHED TO PROVIDE A NEW ENTRANCE TO THE NEW DRIVEWAY; FROM THE NORTH.

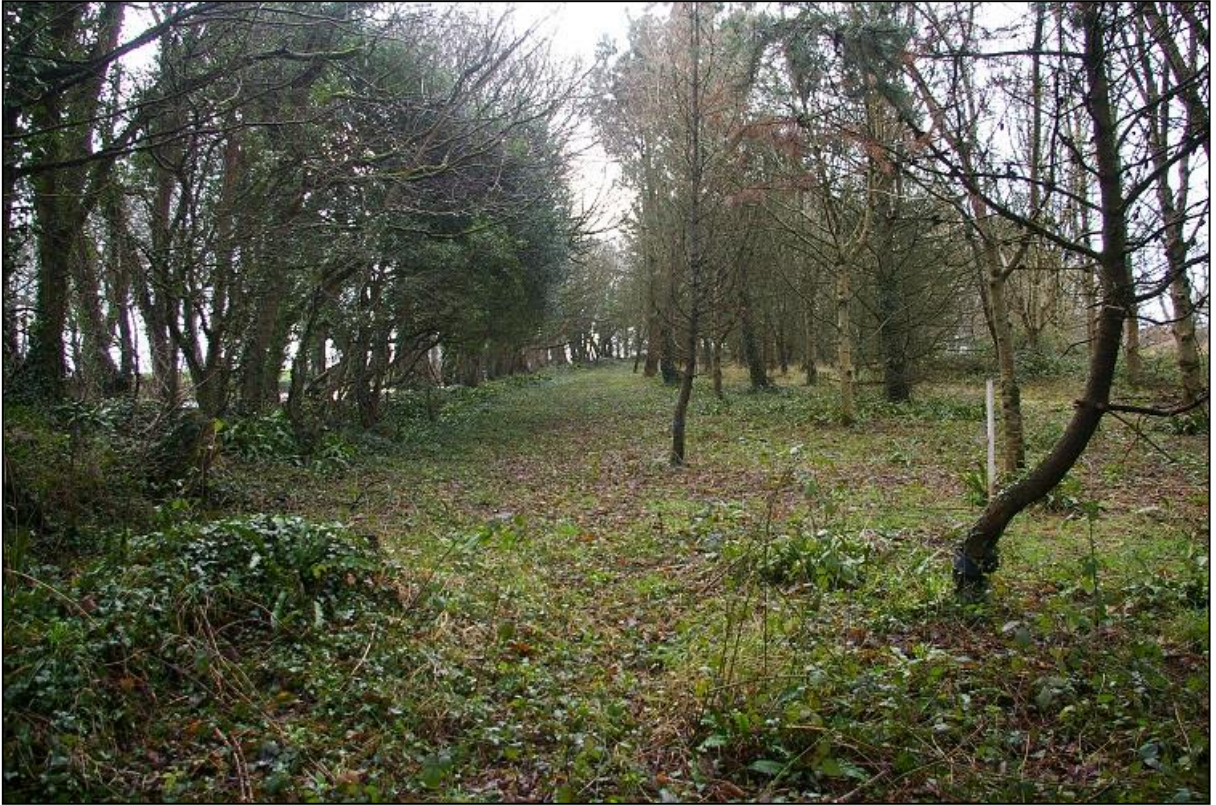
5. VIEW BACK UP THE ROUTE OF THE DRIVEWAY, SHOWING THE ESTABLISHED PLANTING IN THE FIELD, SCREENING THE HOUSE FROM VIEWS TO THE DEVELOPMENT; FROM THE NORTH.

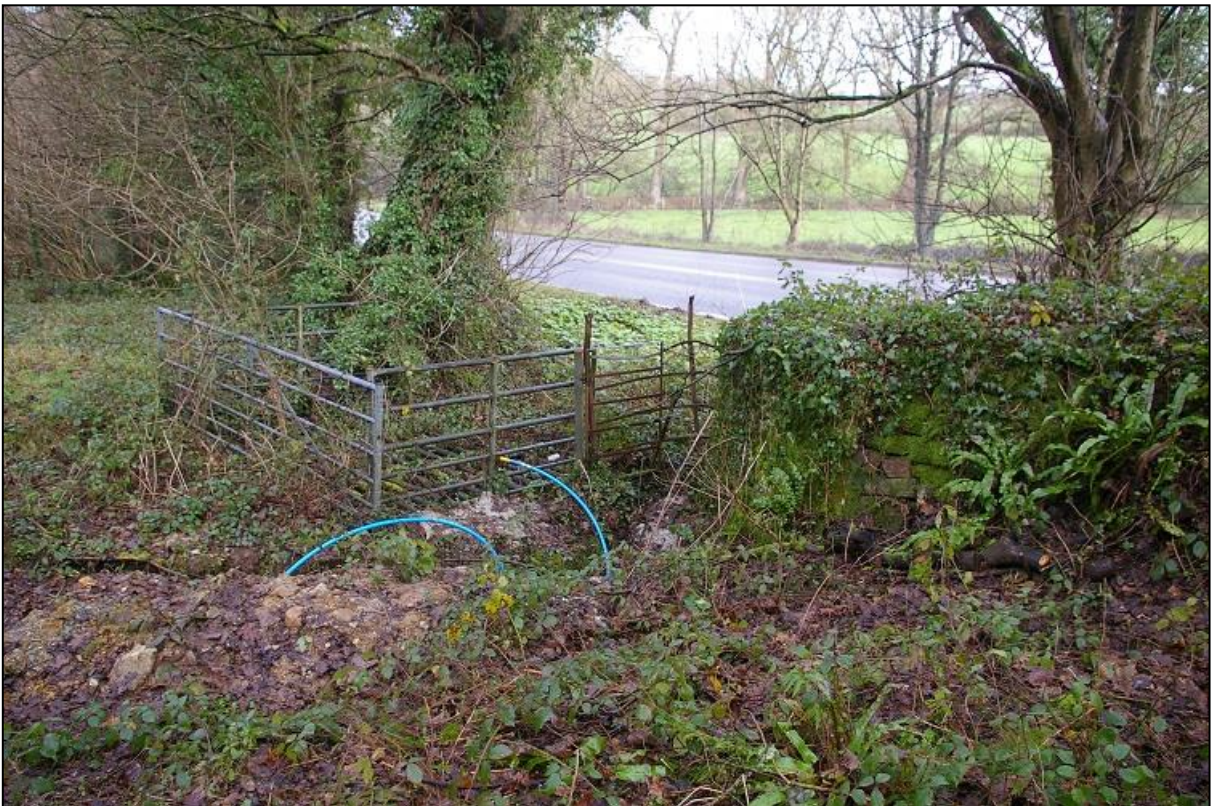
The blocked original carriage entrance to Rosewastis lies further down the eastern boundary on the long valley bend in the A39 road. This entrance can never go back to being fully functional as the traffic flow and speeds are now too dangerous. The current visual of this entrance are obscured and it is overgrown with brambles and galvanised abandoned farm gates and hurdles tied up over a sunken failed-rusted cattle grid. This is negative to the setting and narrative of the house and its pocket landscape. A positive impact of the driveway works, which will pass right by this gate is that some of the stripped soil could be used to infill and bury the cattle grid and the granite gateposts and the estate style pedestrian kissing gate could be restored. Rather than closing the gateway with a full-height bank within the opening, a lower bank could be created just outside, allowing the reading of this former historic primary entrance to be retained. This would have an indirect but positive effect on the wider site and it is believed could be used to outweigh some of the harms of the driveway project; **positive/slight** impact.

6. THE FORMER MAIN CARRIAGE DRIVE ENTRANCE INTO THE SITE, BLOCKED WITH A RANGE OF LOOSELY TIED GALVANISED GATES; FROM THE SOUTH-WEST.

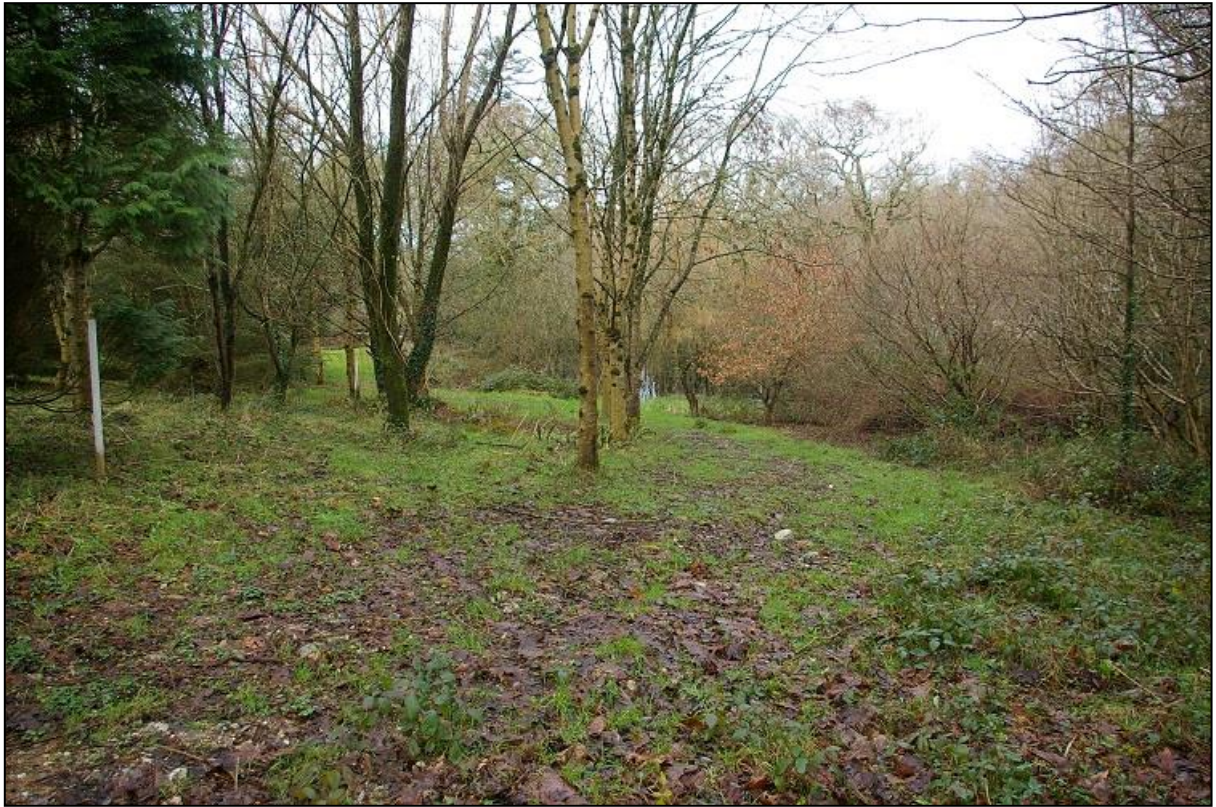
7. VIEW OF WHERE THE DRIVEWAY CURVES TO THE NORTH-WEST AND RUNS PAST THE LAKE; FROM THE SOUTH-SOUTH-EAST.

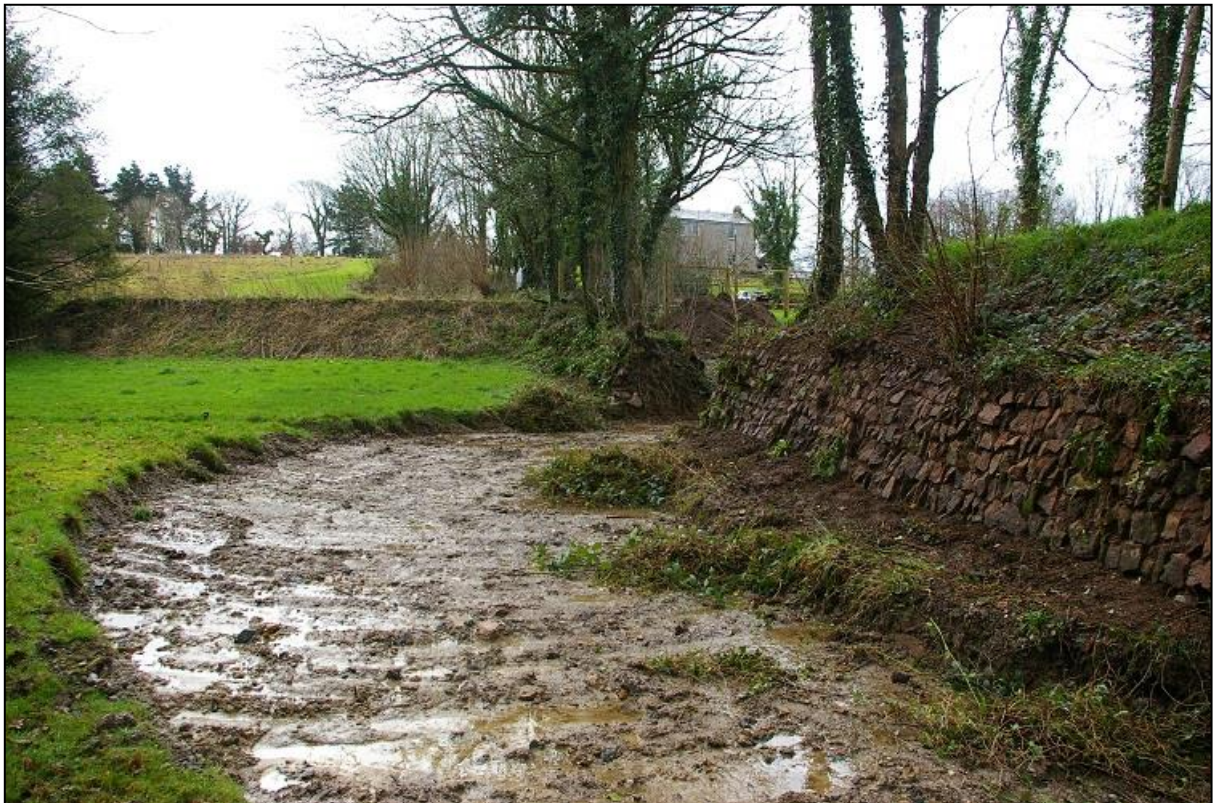
As the drive runs west and north-west, down and into the valley, a hedge bank has already been breached between the garden area and the field and between two historic fields adapted into garden areas. The drive would run through this and along the field side of the hedge bank and then re-enter the grounds higher up the slope. The breaching of both hedge banks without recording and stripping of ground across and in front of a historic carriage entrance to the site (granite gateposts, metal estate-style fence remains and pedestrian gate) and through the site of the former scattered farmstead, noted on the Tithe map, is inherently negative. A small fragment of walling of one of the historic buildings survived next to the hedge bank, to the west of this area this has been partially breached but a small amount still remains. It is of rubble build, with a clay and lime bond, where visible. The monitoring and recording of the hedge banks and site strip would have been appropriate mitigations which could have offset for the impacts of this work. The blending of farmland and gardens by breaching the boundaries is also inherently negative. A fence has also been partially built here; modern semi-suburban fencing in visual character is inappropriate and set in straight lines with no reference to historic boundaries is also damaging visually and spatially to our understanding of this landscape. All of this work is negative visually and on the narrative of the farmstead as a whole.

8. VIEW OF THE LOWER DRIVE, WHERE A TARMAC SPUR HAS ALREADY BEEN REMOVED AND THE HEDGE BANK BREACHED; FROM THE NORTH-EAST.

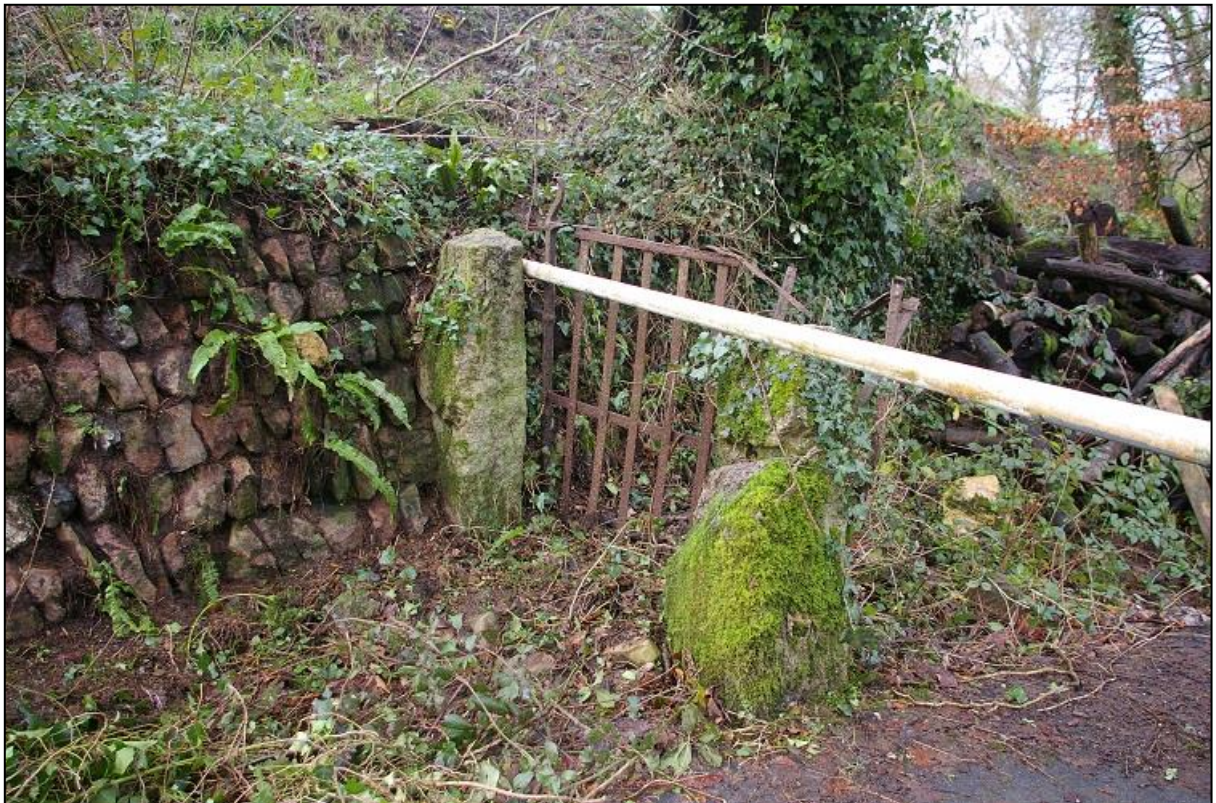
To the south, just below the house is a low hedge bank with a further gateway flanked by granite posts, which likely divided the gardens from the outer grounds and farmyard. The current tarmac drive here will be raised, grass sown and the opening blocked with a grass bank. Appropriate mitigation here would be to leave the gate posts *in situ* and install a lower bank within the blocked gate so that the reading of this rear (blocked) entrance between gardens and wider grounds will still be retained. Balancing the closing of this gate and changes in flow around the site, while retaining a visual 'ghost' of the opening is considered to reduce this impact to **negligible** on this part of the work.

10. DETAIL OF THE GRANITE GATE POSTS AND DAMAGED PEDESTRIAN GATE TO A FORMER CART ENTRANCE BETWEEN THE HOUSE AND ITS GROUNDS AND THE TRACK TO THE MILL BUILDING; FROM THE SOUTH-EAST.

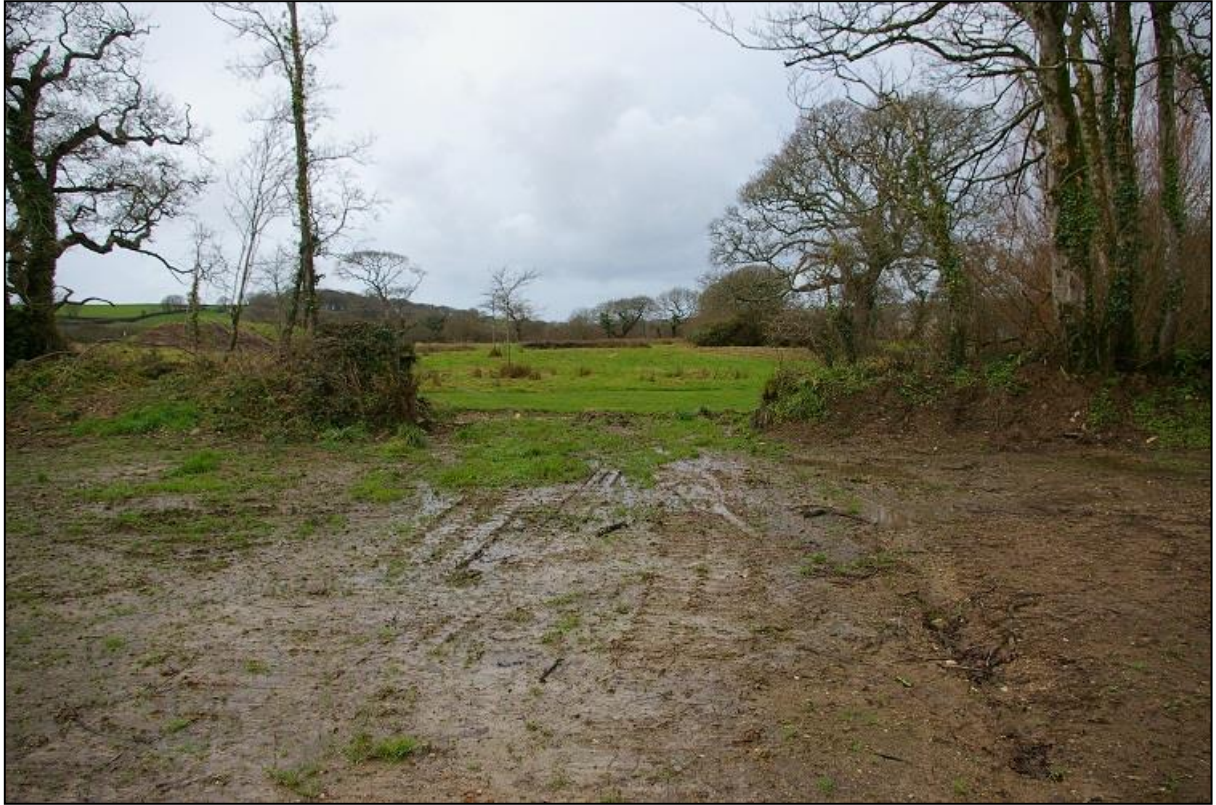
11. VIEW OF THE OVERGROWN AREA WHICH HAS BEEN CLEARED AND BREACHED HEDGE BANKS, IN THE LOCATION OF THE EARLIER SCATTERED FARMYARD NOTED ON THE TITHE MAP; FROM THE EAST.

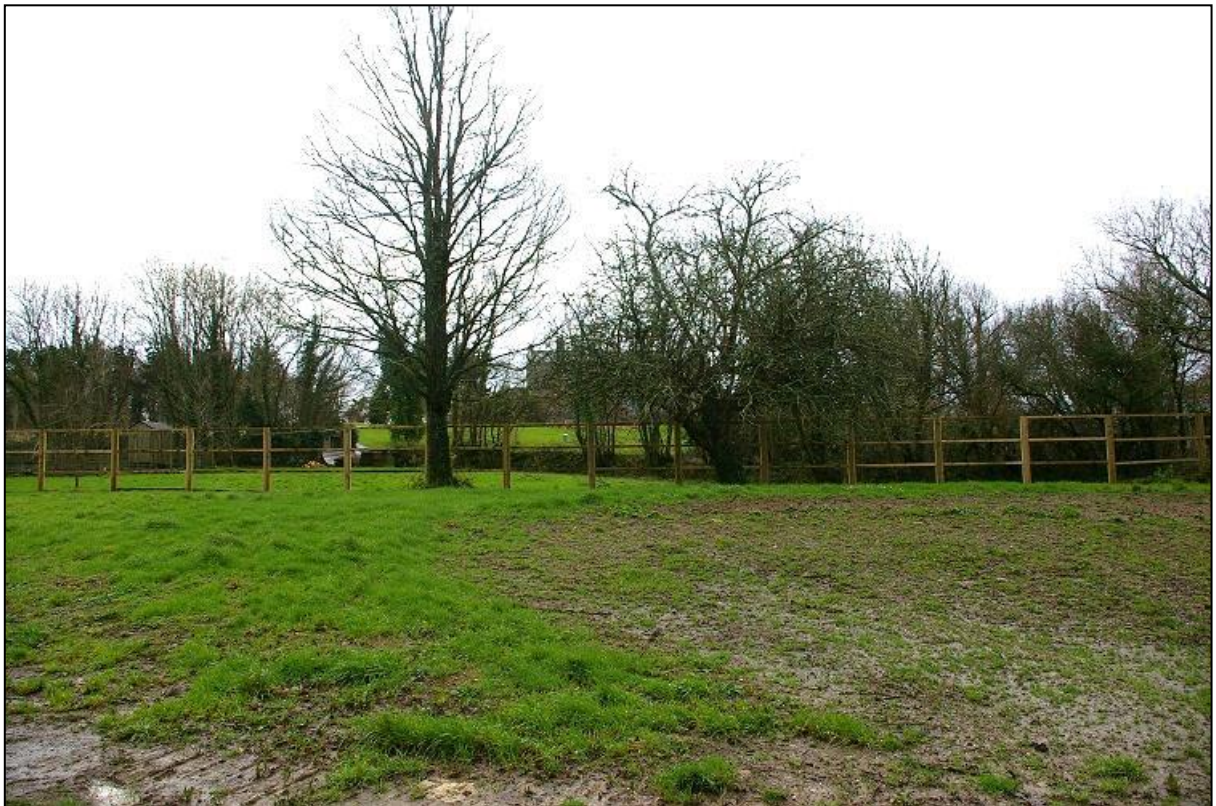
12. PART OF THE FENCING ALREADY IN PLACE, WHICH WILL BLOCK VIEWS AND PROVIDES ARTIFICIAL STRAIGHT BOUNDARIES IN THE LANDSCAPE, WITH THE HOUSE BEYOND; FROM THE NORTH.

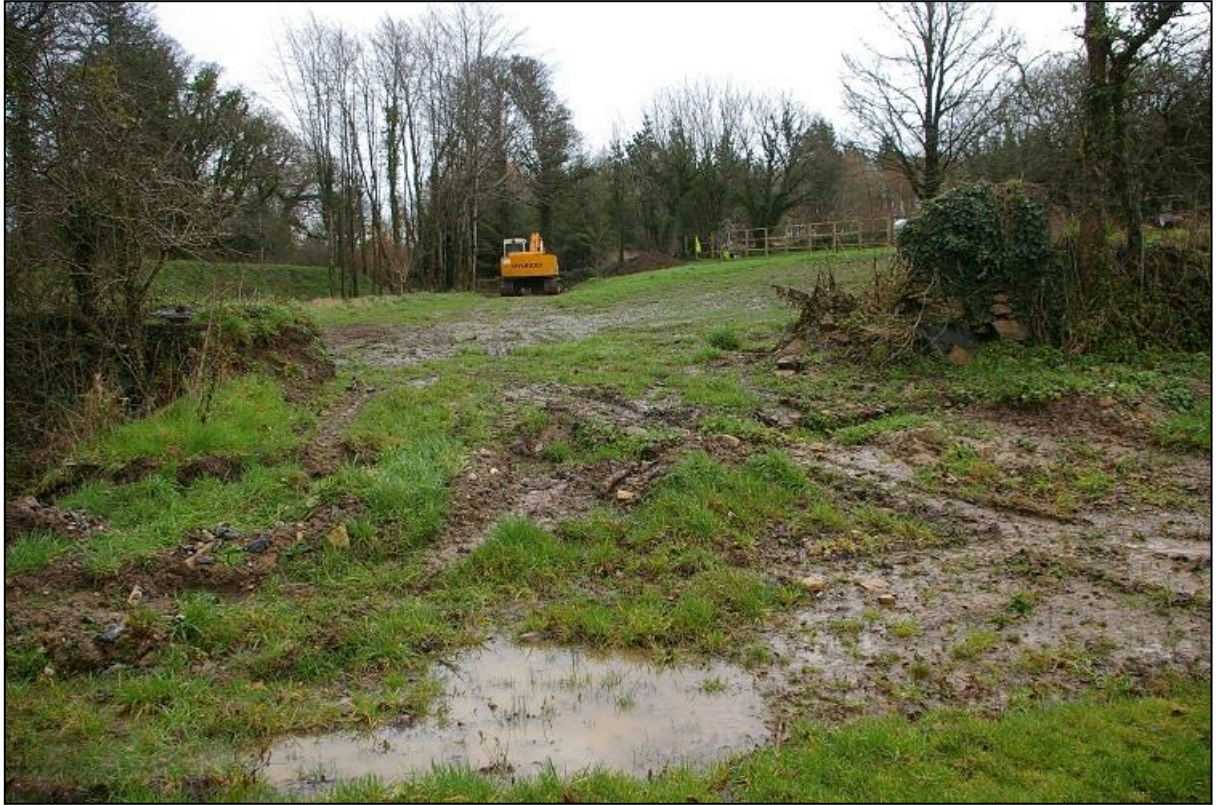
13. VIEW FROM THE FIELD THROUGH THE LARGE BREACH IN THE HEDGE BANK, WITH THE FRAGMENTARY RUINED BUILDING TO THE RIGHT AND CLEARANCE OF THE AREA WITHIN THE BOTTOM OF THE GARDENS; FROM THE WEST.

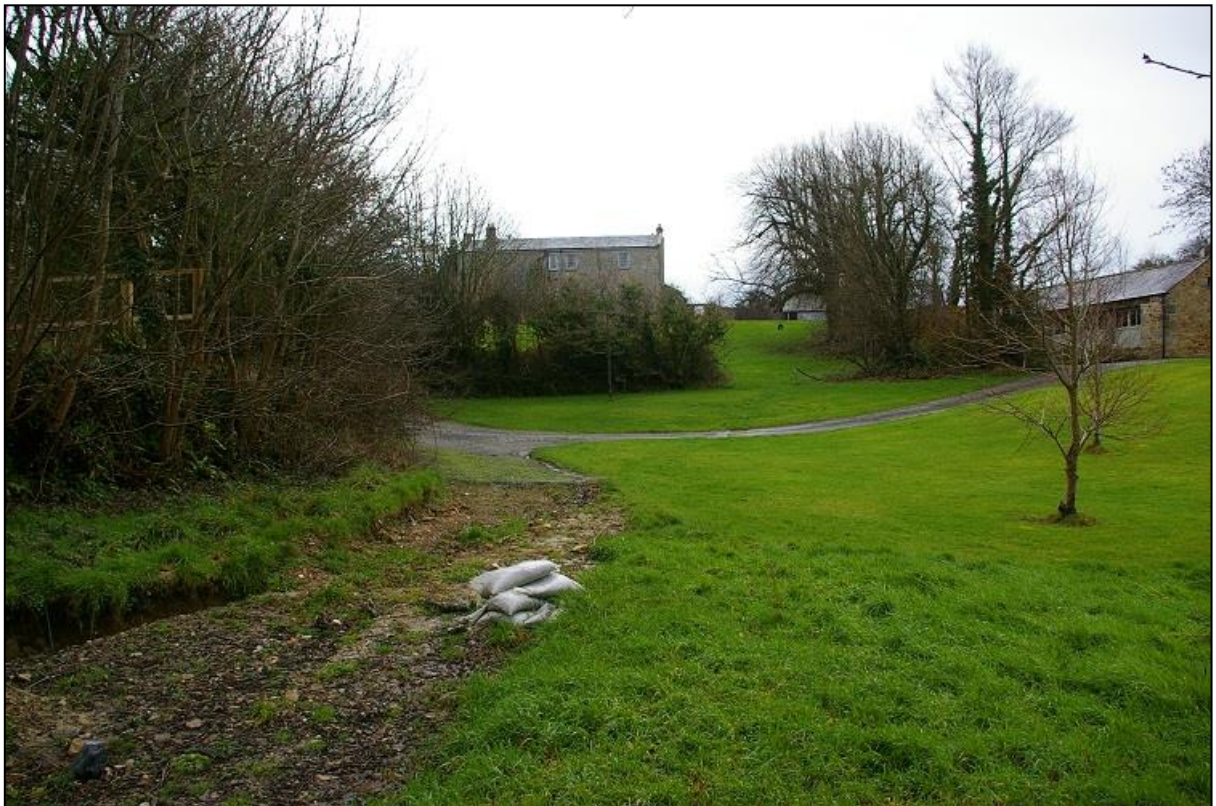
14. VIEW OF THE EXTANT TARMAC DRIVEWAY ON A DIFFERENT LINE, BEING REMOVED, WITH A VIEW TO THE SMALL CURVING HEDGE BANK WHICH ENCLOSES THE IMMEDIATE GARDENS AROUND THE HOUSE, WITH THE HOUSE ABOVE ON THE SLOPE, ALSO SHOWING THE RELATIONSHIP WITH THE HOLIDAY LET; FROM THE NORTH.

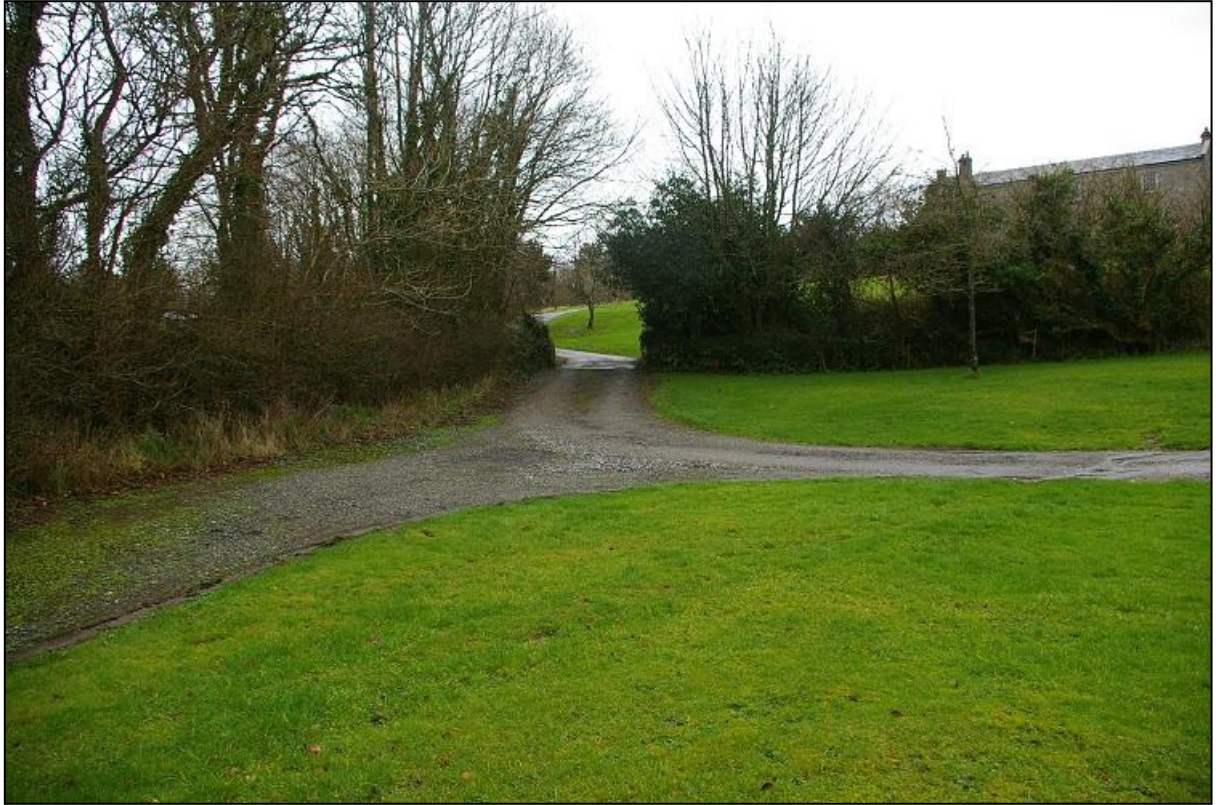
The movement of traffic through the site will change, possibly dramatically. If elements of the wider farmstead such as the mill and lower barns/holiday let are sold off into separate ownership there is an over-arching negative impact of the division of the holding on the important asset at its centre; Rosewastis Farmhouse will lose its ring-fenced context, and the landscape will lose its direct connection as part of a mixed character farm. This is slight but cumulative; **negligible** impact.

15. VIEW OF THE CURRENT SWEEPING DRIVEWAYS WHICH LINK THE HOUSE WITH ALL PARTS OF ITS HOLDING, WHICH WILL BE TRUNCATED AND CUT OFF, SEPARATING THE DIFFERENT AREAS OF THE HOLDING; FROM THE NORTH-NORTH-WEST.

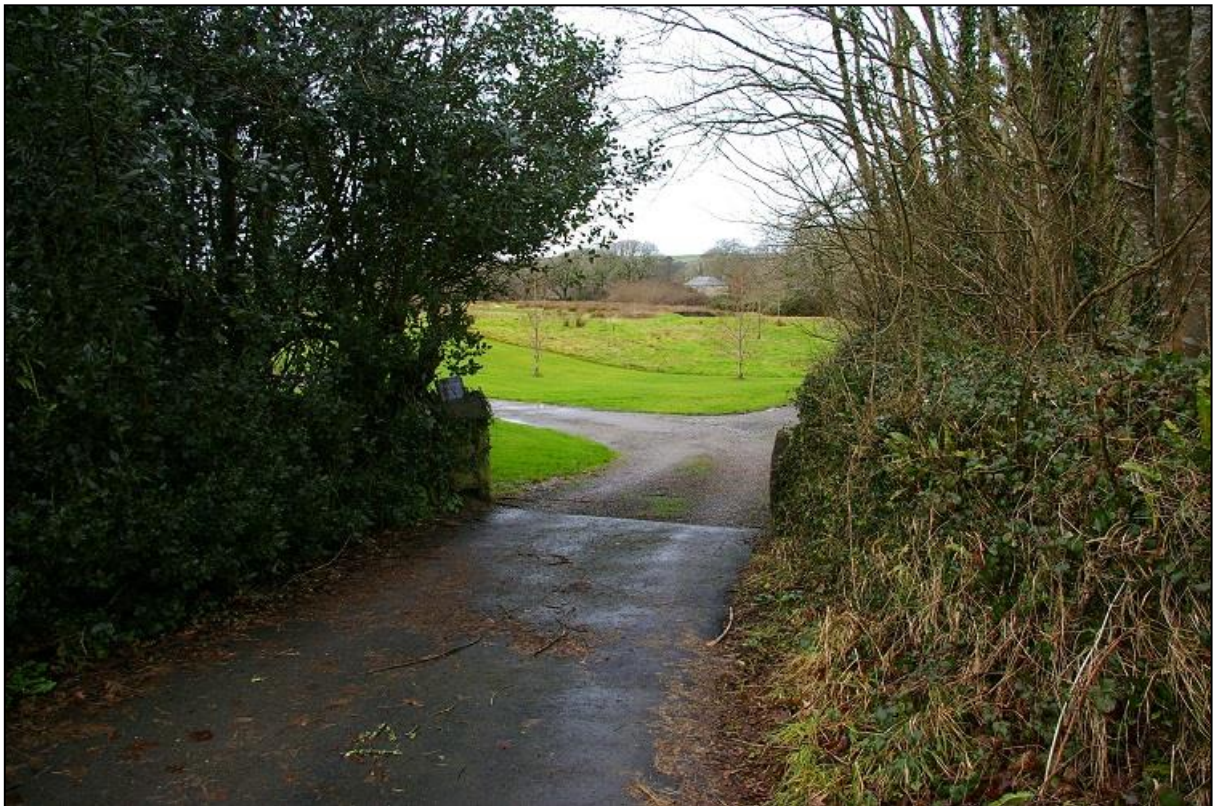
16. VIEW THROUGH THE GATEWAY WHICH IS ALSO TO BE CLOSED, SEPARATING THE HOUSE AND ITS LOWER ENCLOSURES WHICH USED TO CONTAIN A SCATTERED FARMYARD; FROM THE SOUTH-EAST.

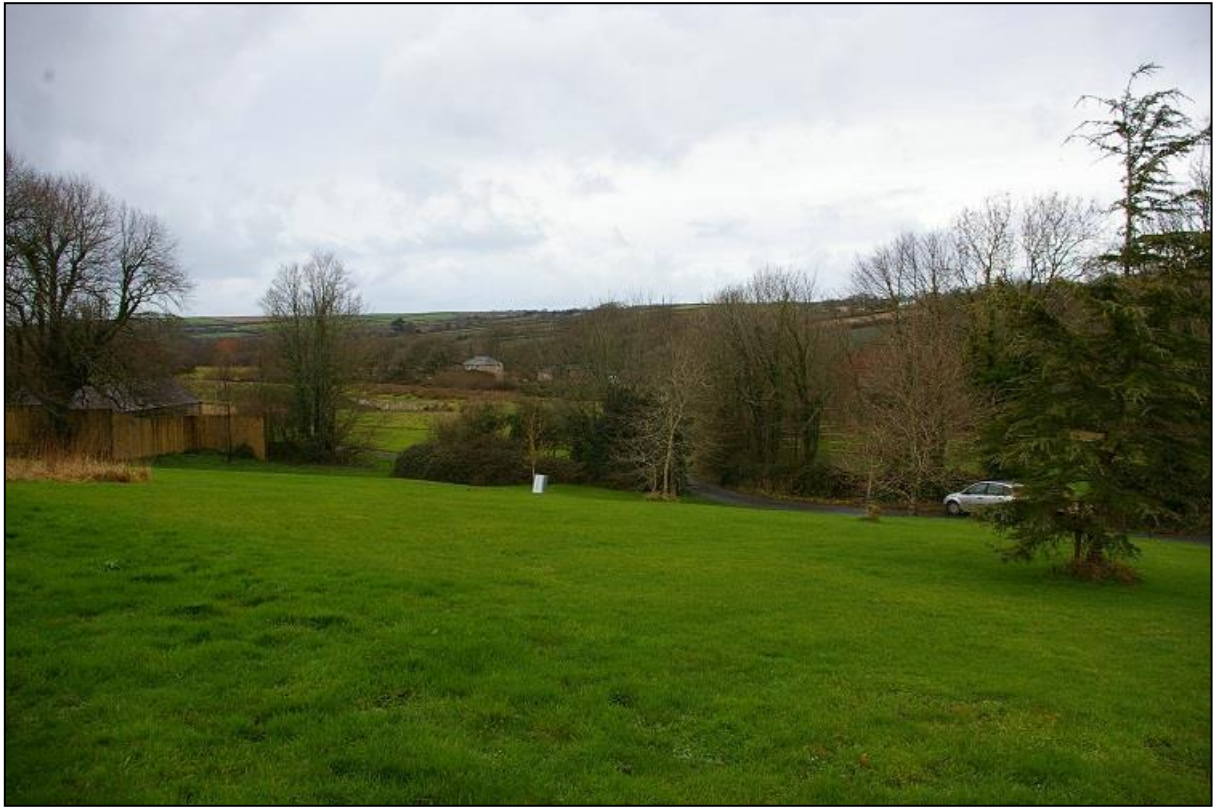
17. VIEW ACROSS TO THE MILL BUILDING FROM THE LAWN IN FRONT OF THE FARMHOUSE AND SHOWING SCREENING FROM HEDGE BANKS AND TREES WITHIN THE GARDENS; FROM THE SOUTH.
