# Judleys Thatch, Ingleigh Green, Winkleigh, Devon

## Brief Heritage Assessment

By E. Wapshott, MCifA  
Approved by Dr. S. Walls, MCifA  
Report Version: FINAL  
Draft Issued: 08<sup>th</sup> April 2022  
Report Finalised: 12<sup>th</sup> April 2022

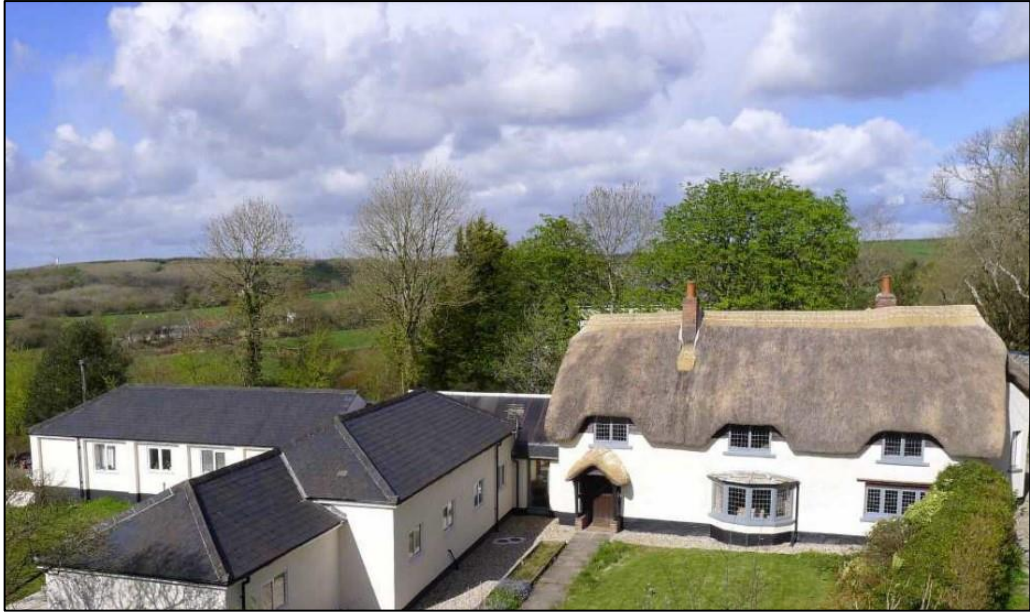
FIGURE 2: DRONE PHOTOGRAPH OF HOUSE AND EXTENSIONS (FROM STAGS SALES BROCHURE).
