# THE OLD CHARCOAL MILL PONSANOOTH ST GLUVIAS CORNWALL

The Results of a Building Appraisal and heritage impact assessment

South West Archaeology Ltd. report no. 221023

Draft01 issued: 6<sup>th</sup> November 2022  
Revised with impact assessment: 5<sup>th</sup> May 2023  
Finalised: 11<sup>th</sup> May 2023

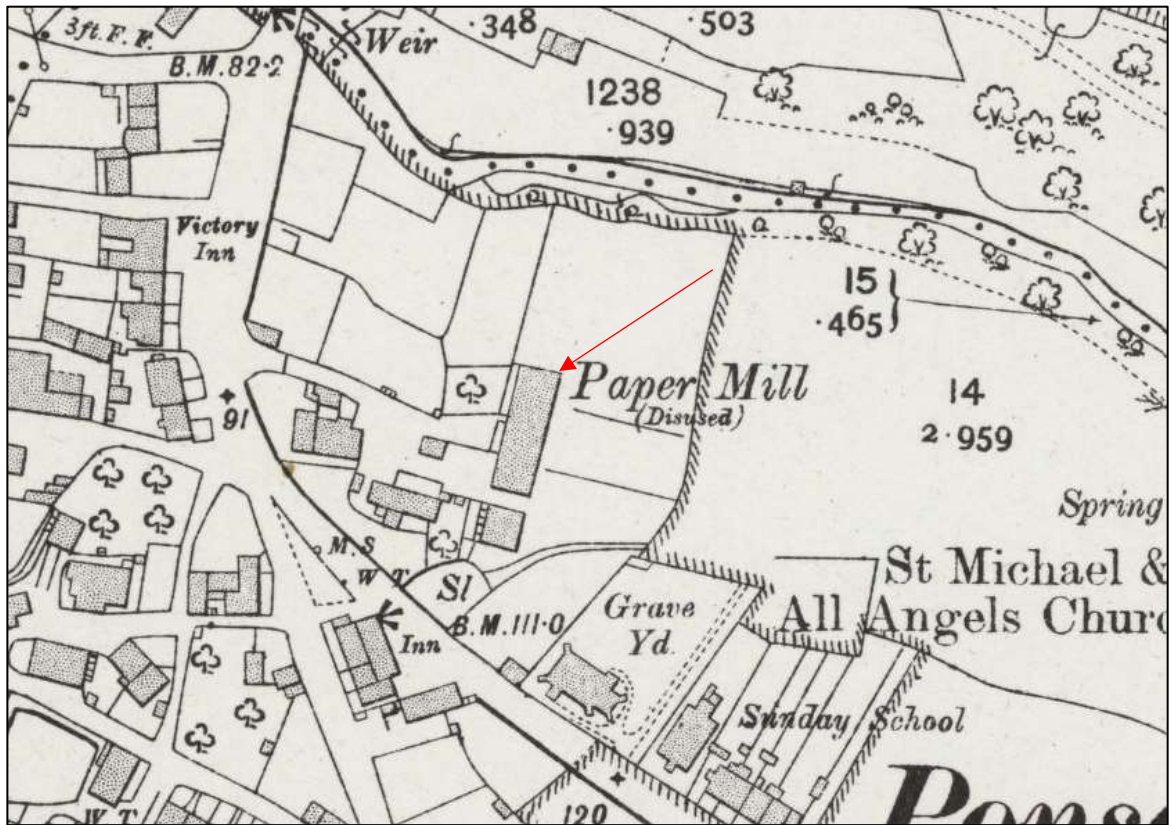
FIGURE 4: EXTRACT FROM THE 25-INCH OS SECOND EDITION MAP REVISED 1906, THE SITE IS INDICATED (NLS).

The revised Second Edition OS mapping of 1906 illustrates little change to the mill building, aside from site boundary changes. The property now sits within a large, field wrapping its north, east and southern elevations, and two separate wheel pits are illustrated to the west elevation. The culvert/lead illustrated to the south of the mill feeding the pond still is recorded here with a sluice gate (SI). The mill building is stippled on this Map suggesting it is occupied/in use, or at least not ruinous or derelict, although interestingly it is still labelled as disused. The smaller mill building to the south appears to now include a set of steps to its west elevation, implying a change in function to this building; this building appears to now sit separately, within new boundaries associated with the neighbouring plot to the west.

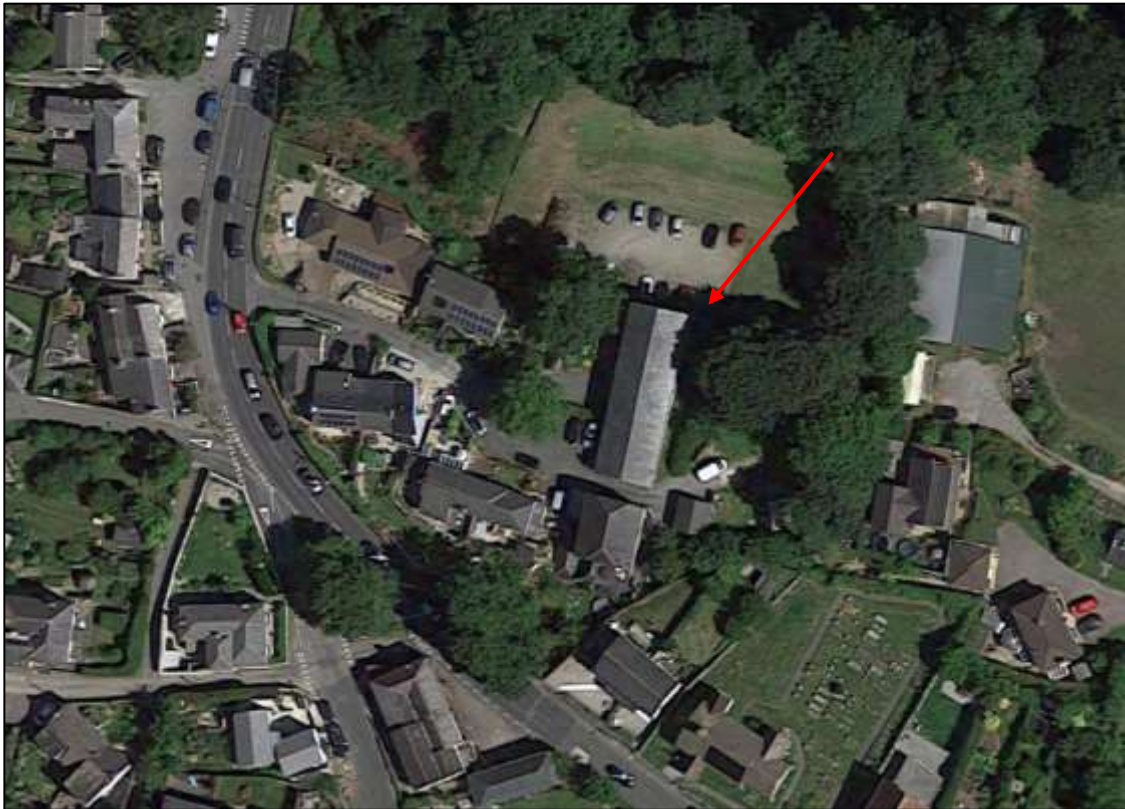
An aerial photograph (Figure 5) shows the property within its modern context, surrounded by several converted building developments. The mill building was renovated within the mid-late 20<sup>th</sup> century, changing its function to an electrical business with associated car parking to the north and south-west corner.

FIGURE 5: 2021 AERIAL PHOTOGRAPH SHOWING THE PROPERTY IN ITS MODERN CONTEXT (GOOGLE, 2022)

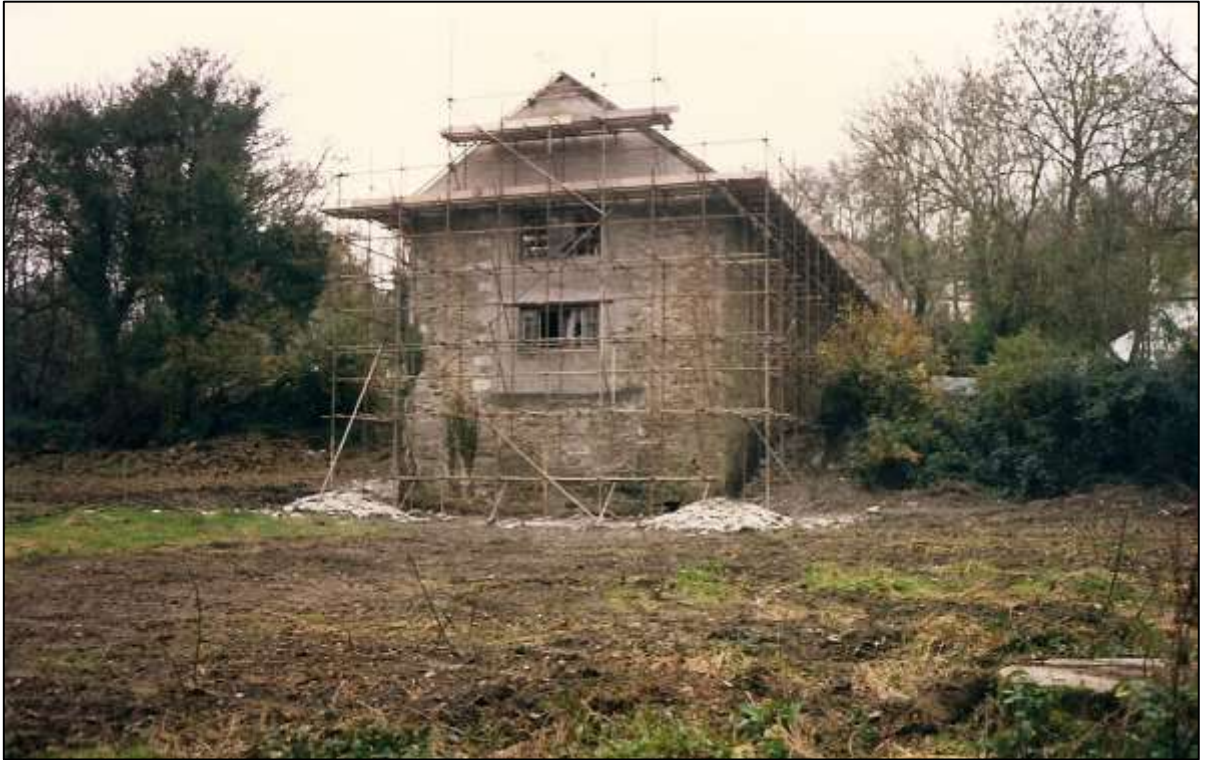
FIGURE 6: THE REBUILDING OF THE NORTH ELEVATION, NOW NEATLY COVERED WITH SLATE-HANGING; FROM THE NORTH-WEST. PHOTOGRAPH COURTESY OF THE CLIENT.

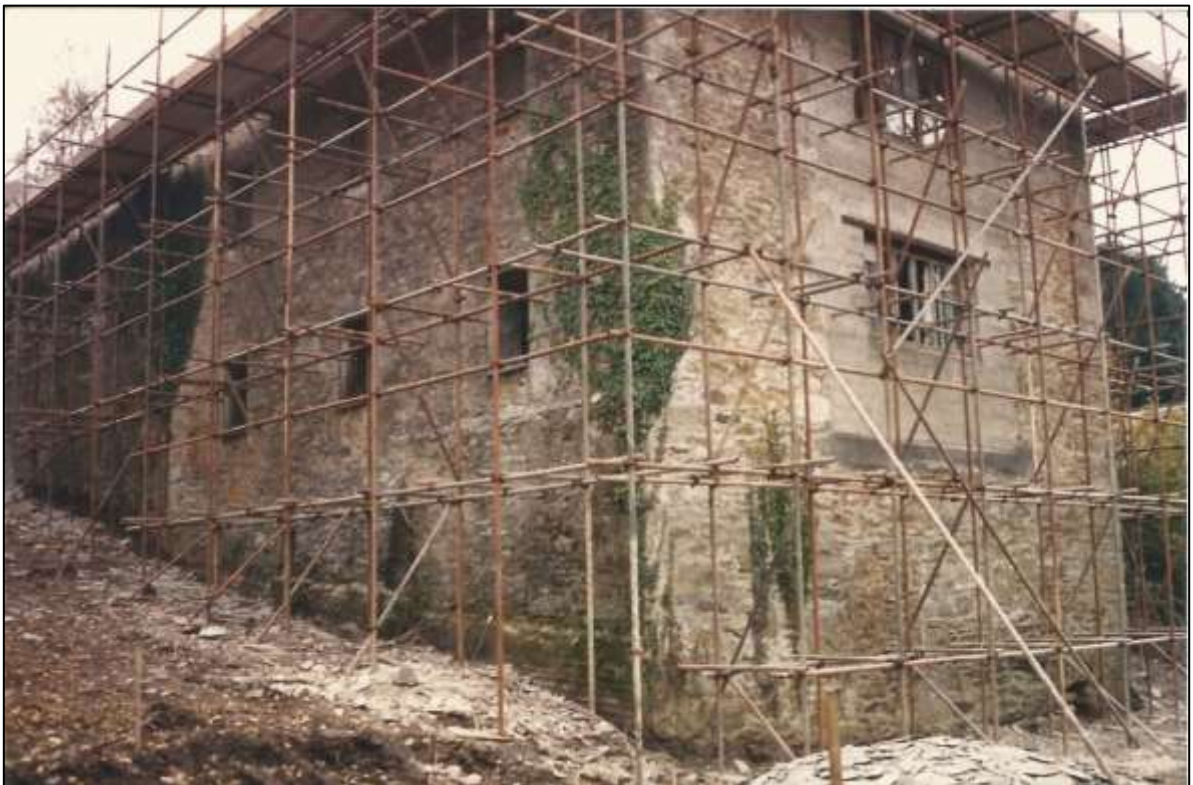
FIGURE 7: THE EAST ELEVATION SHOWING THE OPENINGS HAD BEEN REDUCED BEFORE THIS DATE. NORTH ELEVATION SHOWING POSSIBLY TWO FORMER BLOCKED WINDOW OPENINGS, ONE OF WHICH NOW EXISTS AS A FIRE DOOR AND SLATE RUBBLE FROM FORMER ROOF; FROM THE NORTH-EAST. PHOTOGRAPH COURTESY OF THE CLIENT.

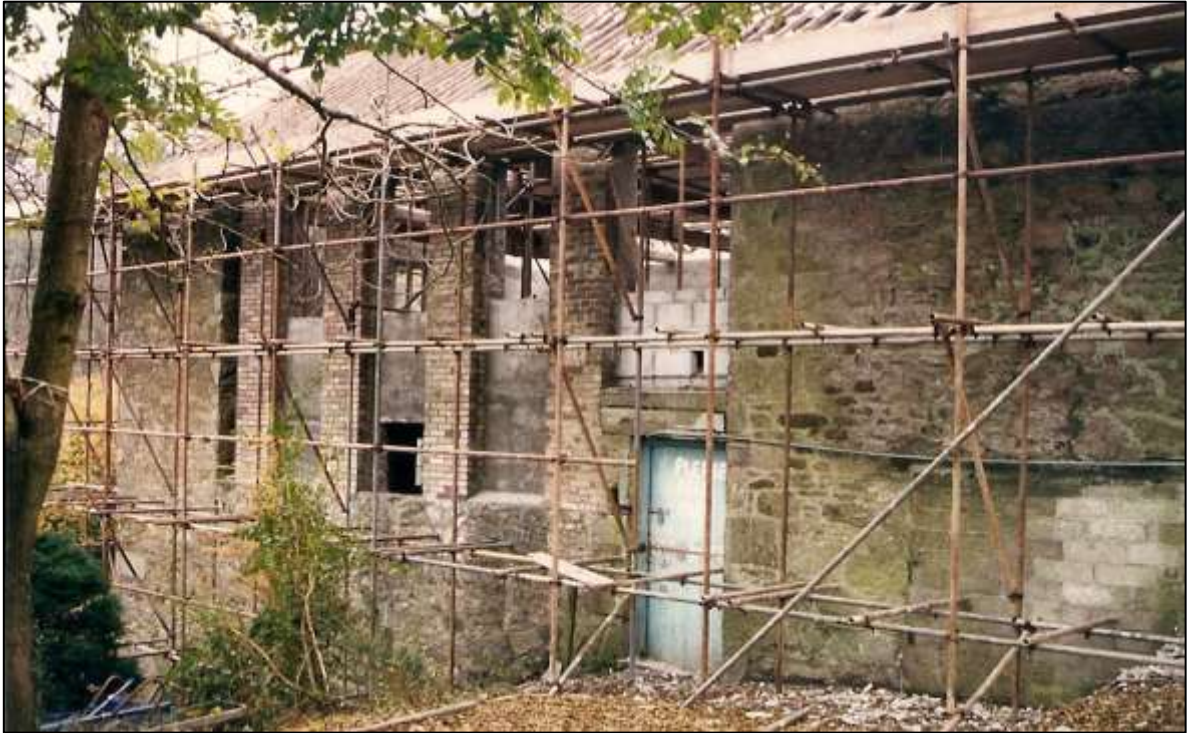
FIGURE 8: THE WEST ELEVATION, THE WALL ABOVE THE FORMER WHEEL PIT HAD BEEN REBUILT DURING THE EARLY-MID 20<sup>TH</sup> CENTURY; FROM THE SOUTH-WEST. PHOTOGRAPH COURTESY OF THE CLIENT.

- The west elevation has been heavily altered, although the wheel pit and scarring remain to the north end. The stonework centrally to this elevation presents with very good, semi-coursed granite suggesting this has always been a presentational front. Elements of the former culvert feeding the wheel pits survive to the stone terrace – a small section of segmental stone arching survives amongst later blocking and infill.

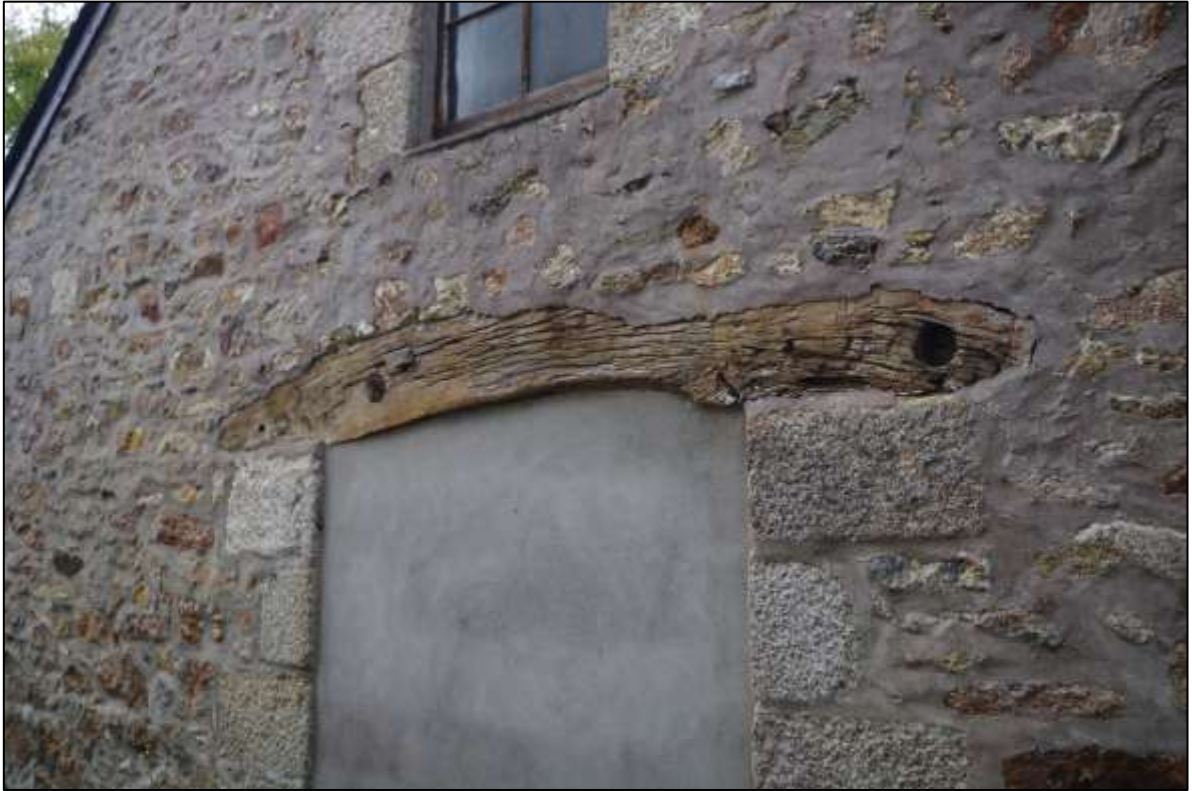
- The south elevation includes a very interesting length of timber (Figure 11), used in this location for a lintel above a door, although is unlikely to be original to this space. It likely resembles an element of earlier wooden mill framework. Its rustic curving form suggestive of a pre-19<sup>th</sup> century date.

FIGURE 11: TIMBER LINTEL SURVIVING TO BLOCKED DOOR IN SOUTH ELEVATION. INCLUDES PEGS HOLES, BLOCKED SOCKET HOLES AND MAY HAVE FORMED PART OF AN EARLIER ROOF STRUCTURE OR WAS AN ELEMENT OF OLDER MACHINERY.

The proposed design of the south elevation also focusses on the retention of fabric, although there are some alterations, i.e. re-opening part of the blocked central historic doorway to create a window. The quoins and large timber lintel are to be retained, maintaining the stronger vernacular character of this elevation, and therefore representing the more complex narrative of earlier phases on the site. It also appears like the sections of damaged stonework patched with concrete, and those areas above the window/loading door at first floor are to be repaired to restore this façade and this is a distinct benefit to the asset.

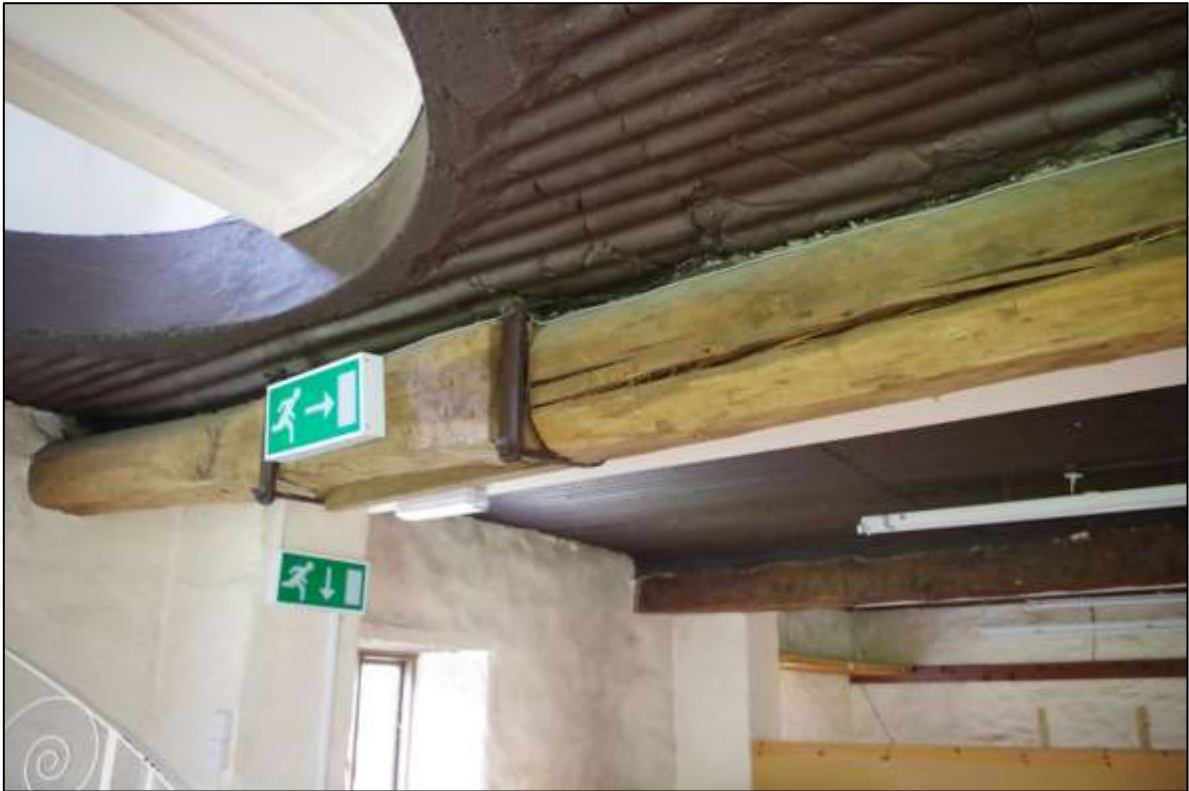
FIGURE 12: BEAM TO NORTH END OF R1, WITH DEEPLY CHAMFERED EDGES AND BRACED WITH HEAVY IRON STRAPS.

- Two large, heavy rustic beams to R1, with thick iron straps to the west ends – integral features that could be associated with earlier milling equipment & the need for strong flooring.

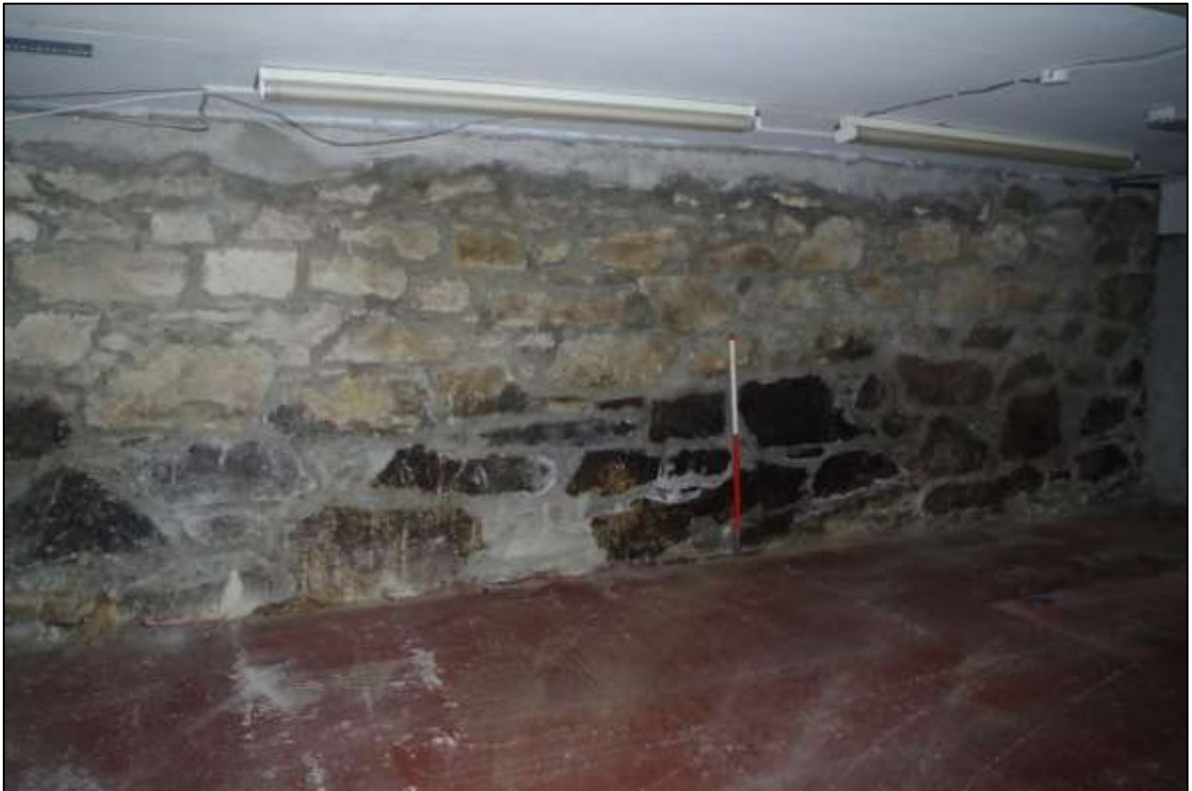
- Very thick, blocked, faced granite stonework to the south elevation of R2b – suggestive of an earlier build, or a build needed for heavy industrialised activity of which the walls needed incredible strength to withstand vibrations from macerators or earlier milling machinery.

FIGURE 13: THIS IS THE HEAVIEST SECTION OF STONEWORK SEEN THROUGHOUT THE BUILD (ALONG GF SOUTH END), AND INCLUDES LARGE BLOCKS OF GRANITE INDICATIVE OF AN EARLIER BUILD FORM. TAKEN IN R2B FROM NORTH-NORTH-EAST, WITH 1M SCALES.

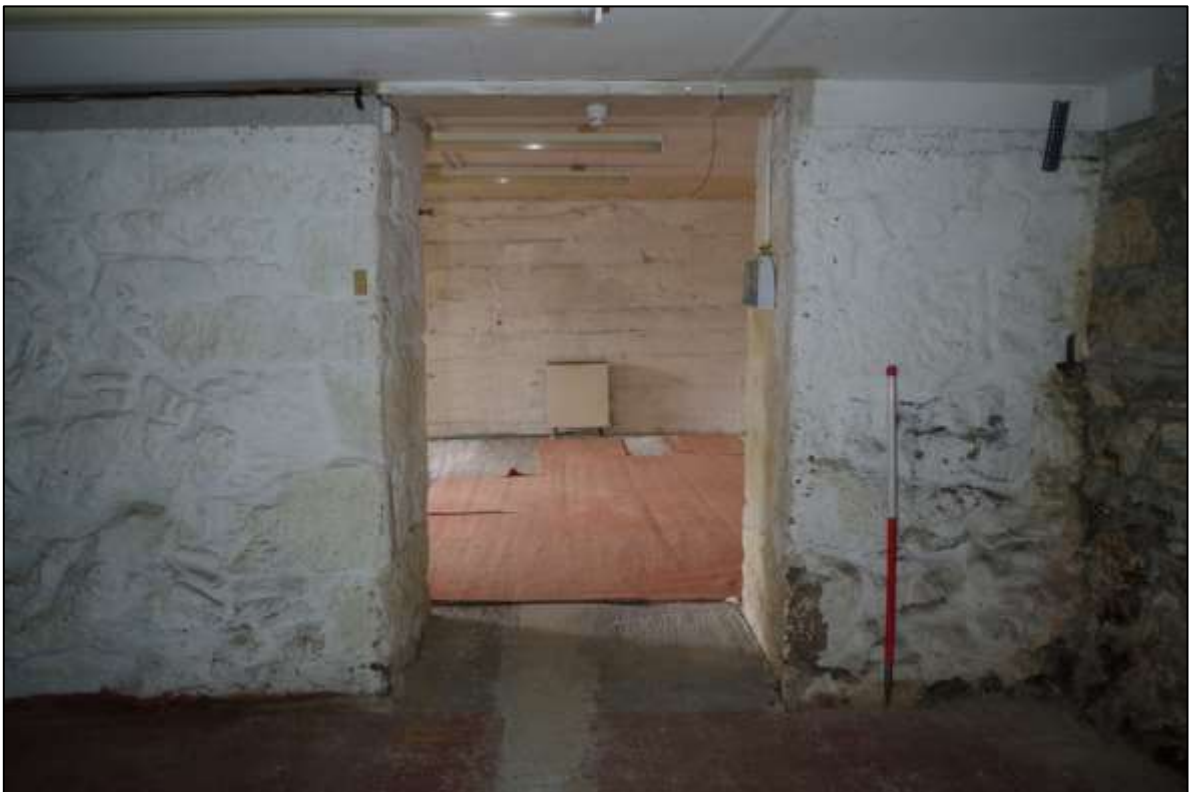
FIGURE 14: THICK STONE WALLS LINING SOUTH ELEVATION OF R2A, LEADING INTO R2B. WALLS HERE ARE PARTICULARLY DEEP, APPROX. 1M, WITH BATTERED WALLS AND VERY GOOD, LARGE QUOIN DETAILING TO THE OPENING (FORMER EXTERIOR WALL SOUTH ELEVATION OF R2A?), ALTHOUGH HAS BEEN REBUILT IN CONCRETE TO TOP. TAKEN FROM THE SOUTH FROM R2B WITH 1M SCALE.

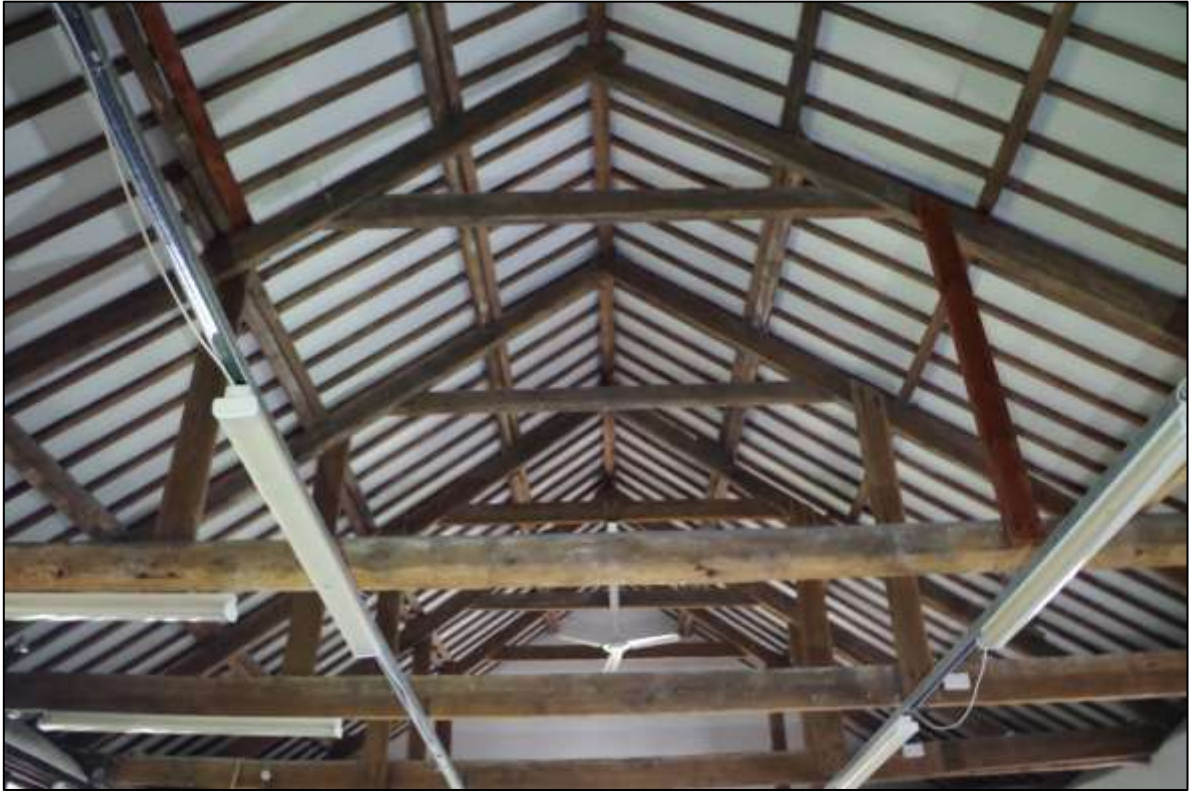
FIGURE 15: THE A-FRAMES TO THE NORTH OF R3 WERE DIFFERENT IN STYLE, PEGGED AT THE RIDGE WITH HALF-LAPPED COLLARS AND RUSTIC TIE-BEAM. TAKEN IN FROM BELOW IN NORTH END OF R3.

retained within the new roof design. If all the historic trusses are to be replaced this represents significant historic fabric loss, which has a quantifiable effect on the wider asset and will need to be considered an inherently negative effect; likely to be assessed as moderate/adverse impact, as it represents the partial loss of the resource and changes to key characteristics. This could be reduced through mitigation by the retention wherever possible, and/or, raising of the trusses, minimising the amount of fabric lost here. If the roof trusses aren't structurally sound could some be retained within the scheme, at least decoratively, if they are sound, they should be retained.

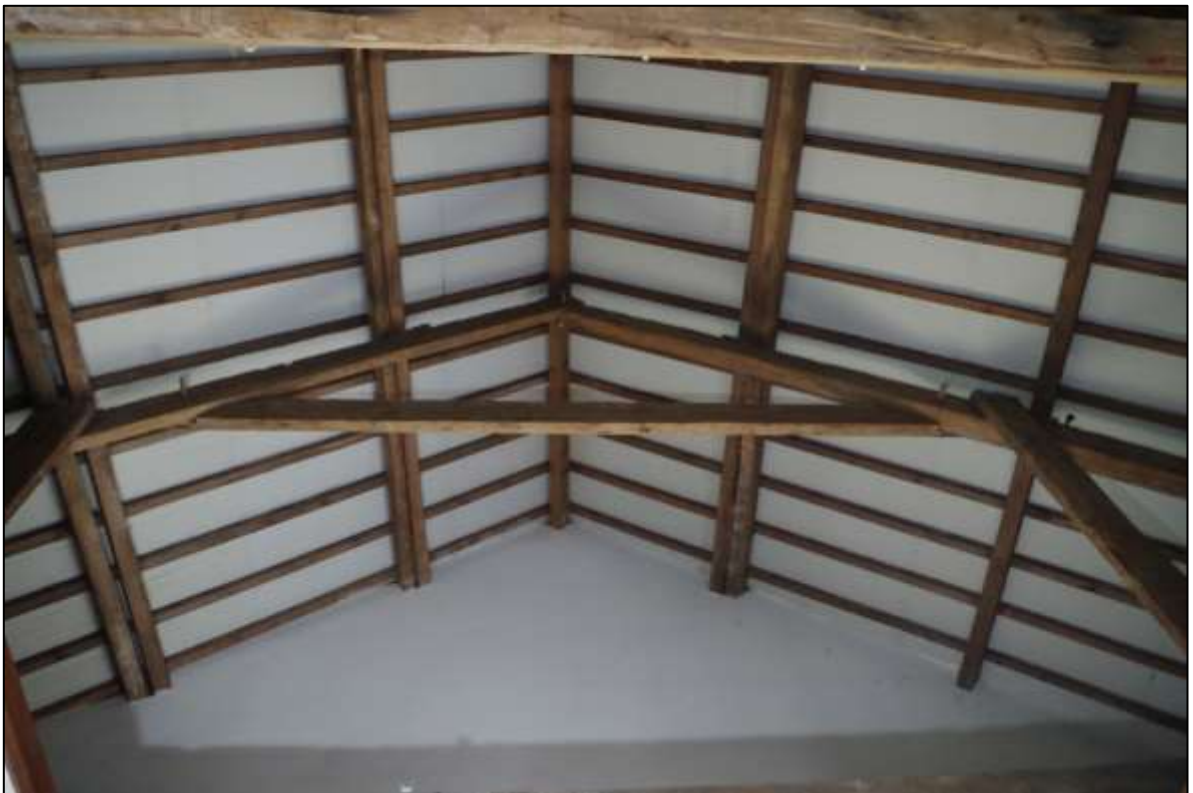
FIGURE 16: RUSTIC A-FRAMES PEGGED AND SPIKED REPRESENT GOOD INDUSTRIAL FORM AND CHARACTER. TAKEN FROM BELOW IN TO NORTH END OF R3.

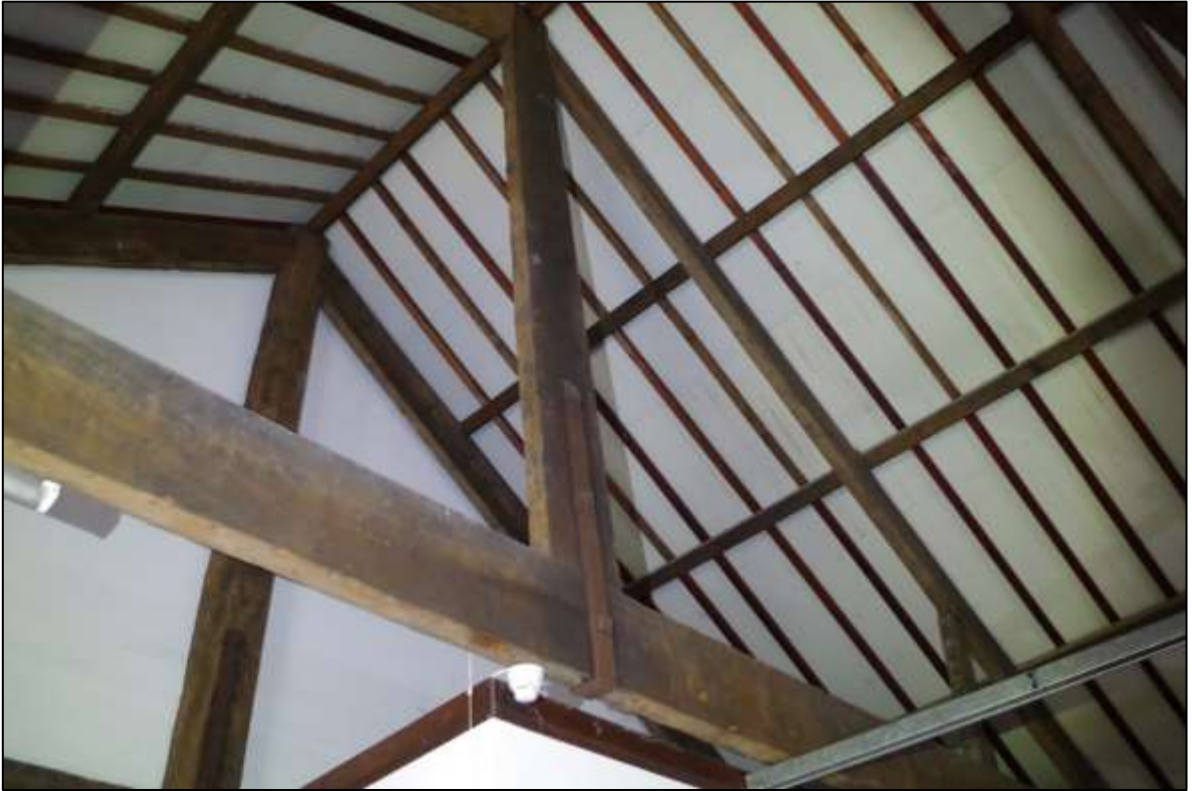
FIGURE 17: A-FRAMES TO THE SOUTH SIDE OF THE BUILDING EXUDE POST-MEDIEVAL, INDUSTRIAL FORM – WITH CENTRAL KING POST STRAPPED WITH HEAVY IRON BRACES TO THE TIE BEAM. TAKEN FROM BELOW TO THE SOUTH END OF R3.

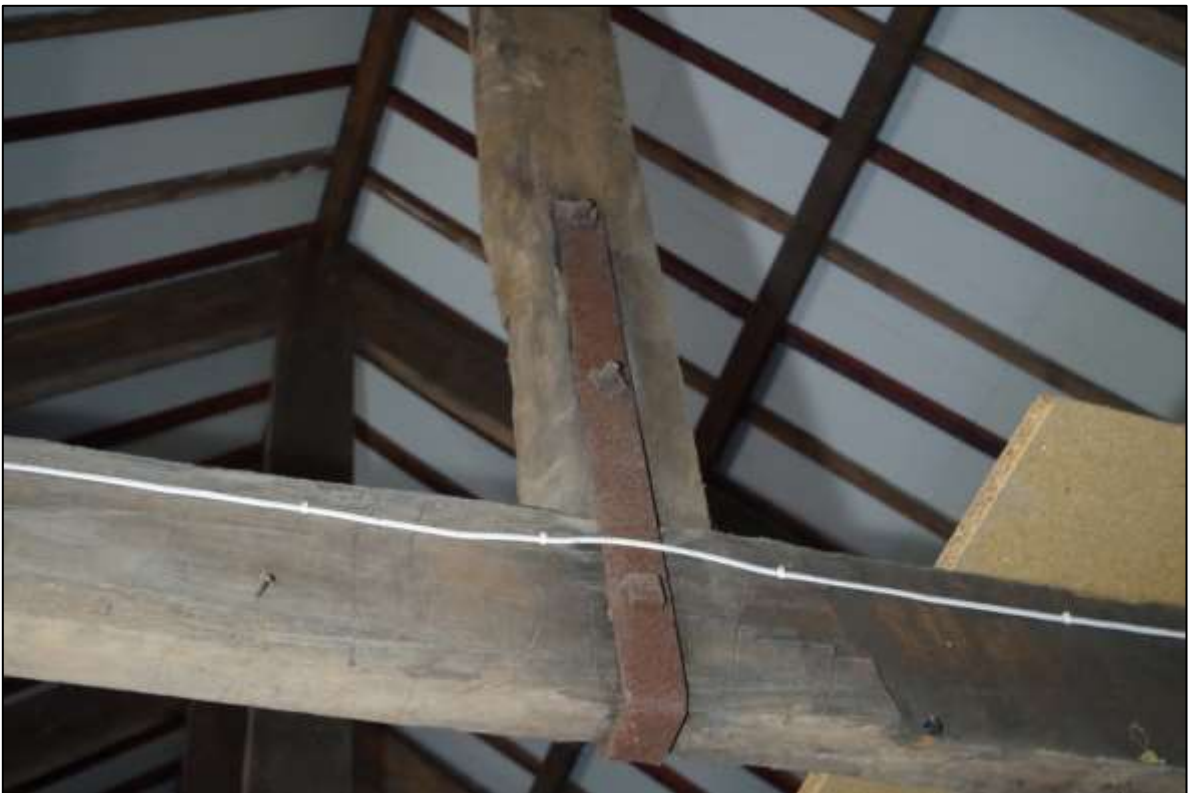
FIGURE 18: THE LARGE, HEAVY IRON STRAPS BRACING KING POST AND TIE BEAM REPRESENTING GOOD INDUSTRIAL FORM, WITH JOINERS MARKS. TAKEN IN BELOW TO THE SOUTH END OF R3.

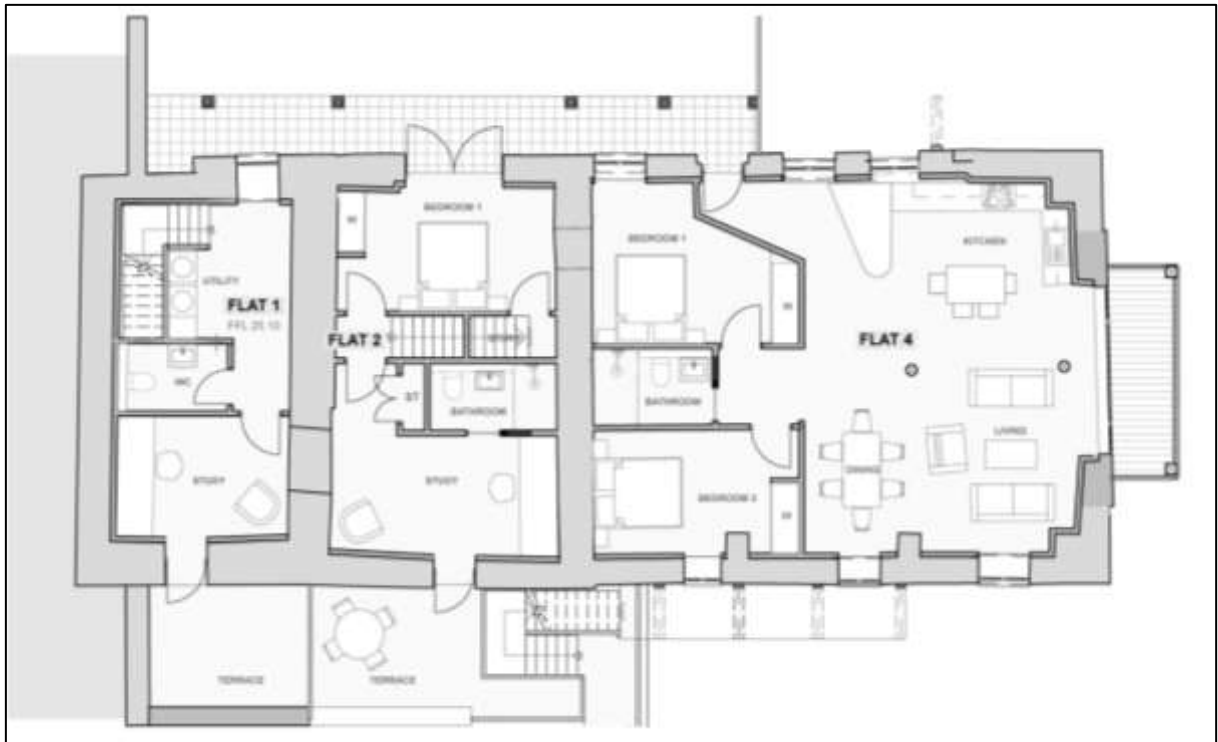
FIGURE 21: FIGURE SHOWING PROPOSALS FOR FLATS 1, 2 AND 4 AT THE FIRST-FLOOR LEVEL (PLANS AS SUPPLIED BY CLIENT APRIL 2023).

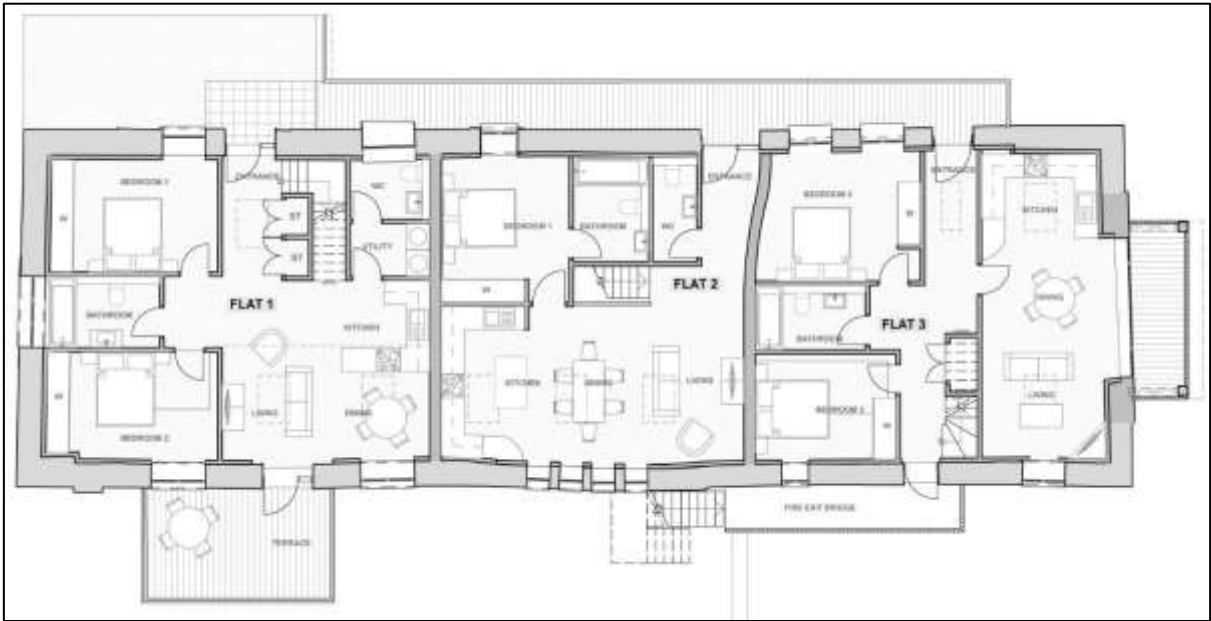
FIGURE 22: FIGURE SHOWING PROPOSALS FOR CONTINUATION OF FLAT 1, 2 & 3 TO THE SECOND-FLOOR LEVEL (PLANS AS SUPPLIED BY CLIENT APRIL 2023).

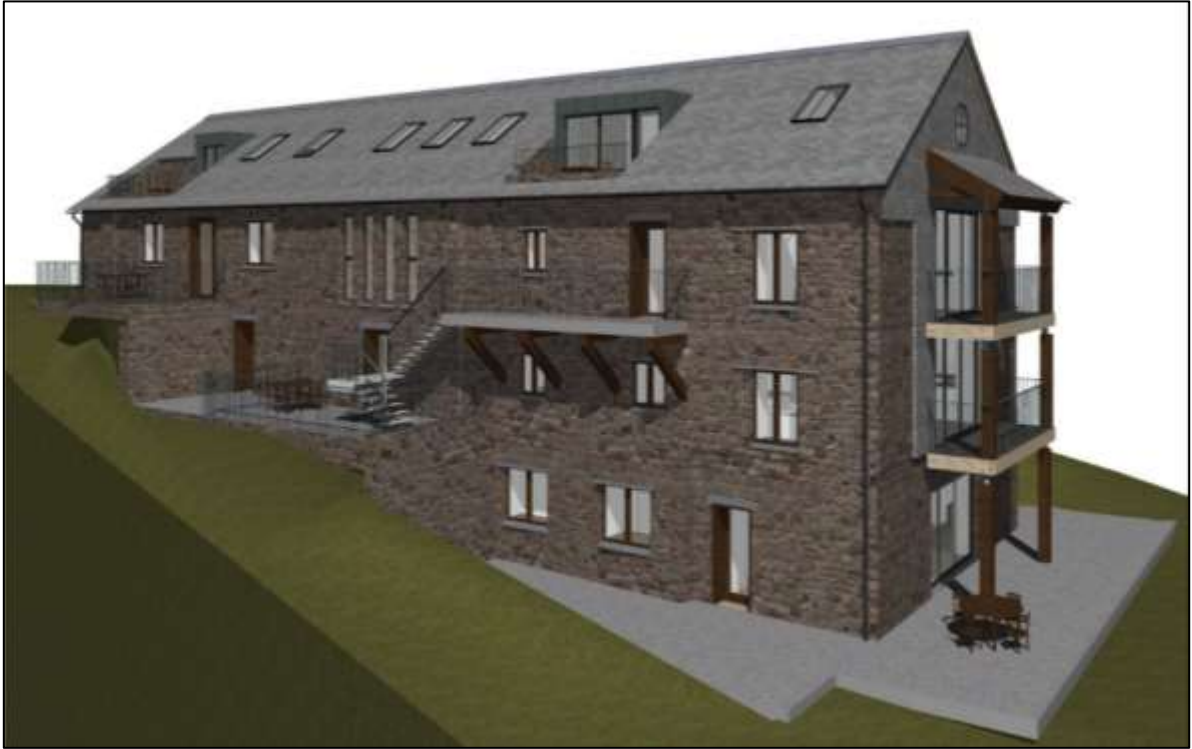
FIGURE 24: COMPUTER-GENERATED VISUALS OF EXTERIOR ELEVATIONS (AS SUPPLIED BY CLIENT APRIL 2023).

The restoration of the stone facades is a positive aspect of this scheme, and the use of slim, dark-wood effect, or wood glazing and large panes will mimic mill openings, without having an obviously domestic character and will ensure the continuation of this building’s industrial aesthetic. The use of slate roofing and slate details to the roof terraces allows these to blend into the roofscape colours and forms, but also contribute architectural-design quality elements to the scheme. The simple, visually-porous metal balustrades to the balconies and walkways are of good modern industrial style

and appropriate and the timber cladding to support posts helps these blend into the overall colourscape of the site and introduces traditional materials to honour the site's heritage. The use of modern render and timber boarding is minimal and well applied to areas of stonework and façade too damaged or altered to reasonably repair. Overall, this feels like a design-led scheme, which has engaged successfully with the character and feel of the setting and the buildings narrative.

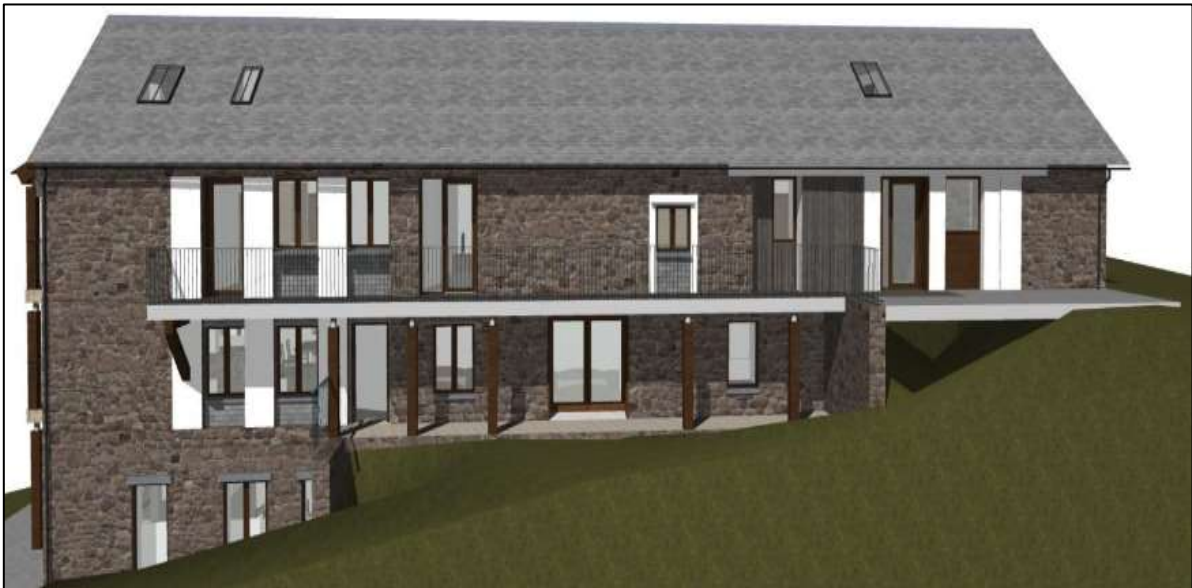
FIGURE 25: COMPUTER-GENERATED VISUALS OF EXTERIOR ELEVATIONS (AS SUPPLIED BY CLIENT APRIL 2023).

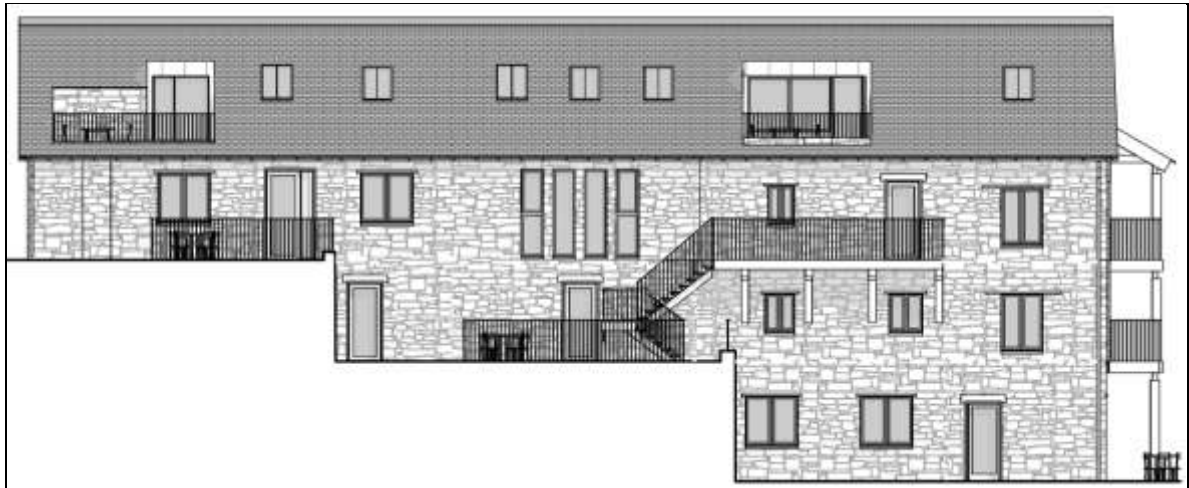
There has been clear and careful consideration of the openings here, to minimise historic fabric loss and retain the complex industrial visuals of the façade and the build lines between phases of build and infill have been respected. Where new openings are to be formed, they have been focussed on sections of walling already damaged or altered, and have been reduced in number from previous

iterations, through consultancy, to balance the need for light and access with the importance of the exterior appearance of this building. The railings and walkways are of plain, workaday, modern design appropriate for the working character of the building and minimally applied. The use of inset terraces within the roofline will reduce their visibility and places the burden of change on the new roof structure rather than the historic walls. It also raises the terraces, an obviously modern element of the design far above natural eye level, reducing their visibility. The location of rooflights (presumed of conservation form) on this façade, turned away from the majority of the village and road is also a good use of this, less sensitive elevation.

FIGURE 26: EAST PROPOSED ELEVATION (PLANS AS SUPPLIED BY CLIENT APRIL 2023).

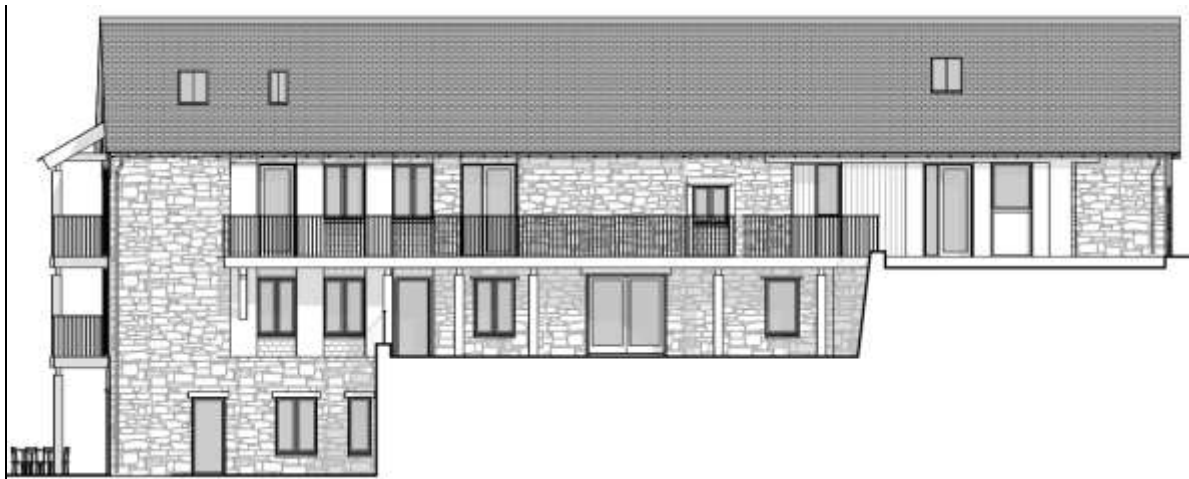
As to the east, this proposed elevation design respects the fabric and irregular form of the façade, with some small rendered or boarded elements bringing in some other details to break up the stone and address where modern elements currently detract from the historic-industrial character of the building. Since this is the side which faces the majority of the village and road – the most visible, it is good that the roof here is retained, with only a few rooflights, which it is assumed would be conditioned as requiring to be conservation grade. There is more obviously linear alignment on this façade and the continuous, plainly-designed access terrace respects those aspects of this façade well. It is felt that the scheme is successful in respecting the industrial historic character of the façade here and respects the clear build lines in the design, wherever possible.

FIGURE 27: WEST PROPOSED ELEVATION (PLANS AS SUPPLIED BY CLIENT APRIL 2023).

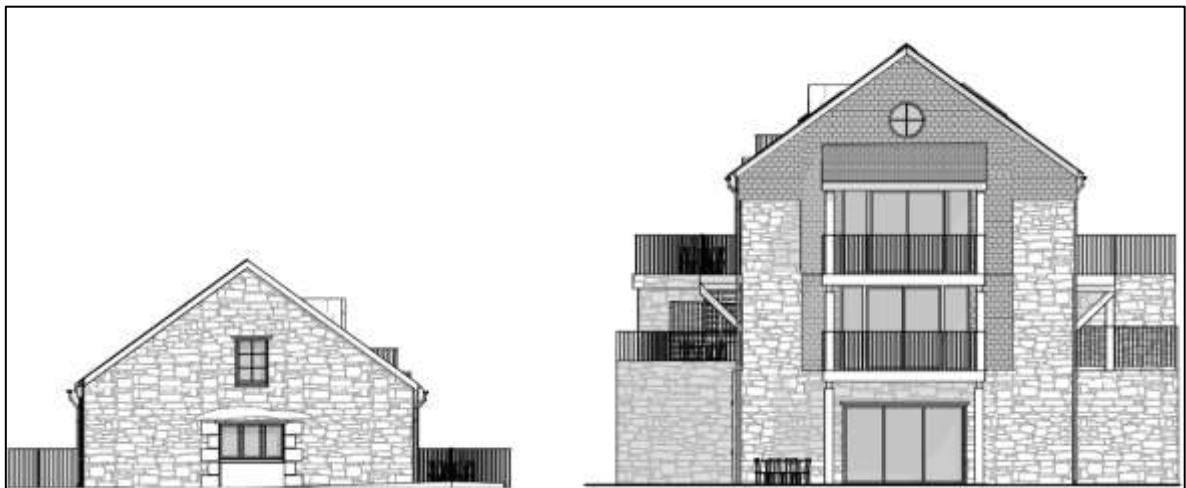
To the north by utilising the slate-hung altered, more modern material to bear the burden of change and installing balconies on this side which mimic the timber winch housing that would have occupied the apex of this gable and served the various floors in the building, when it was a mill. The placement of the central aligned openings emphasises the symmetry and minimises fabric loss, allowing the retention of blocked and altered openings and integral quoins to the side.

Both elevations are considered very successful adaptations. The only issue of slight concern is the whimsical round window in the apex of the north elevation, which throws off the proportions and aesthetics of this elevation. This type of window is a feature historically associated with high-status houses, as an oculus, a feature of neo-classical design.

FIGURE 28: LEFT – SOUTH PROPOSED ELEVATION. RIGHT – NORTH PROPOSED ELEVATION. (FROM THE ARCHITECT).
