NORTH-EAST GRAVEYARD EXTENSION

ST LADOCA'S CHURCH

LADOCK

Results of a Geophysical Survey

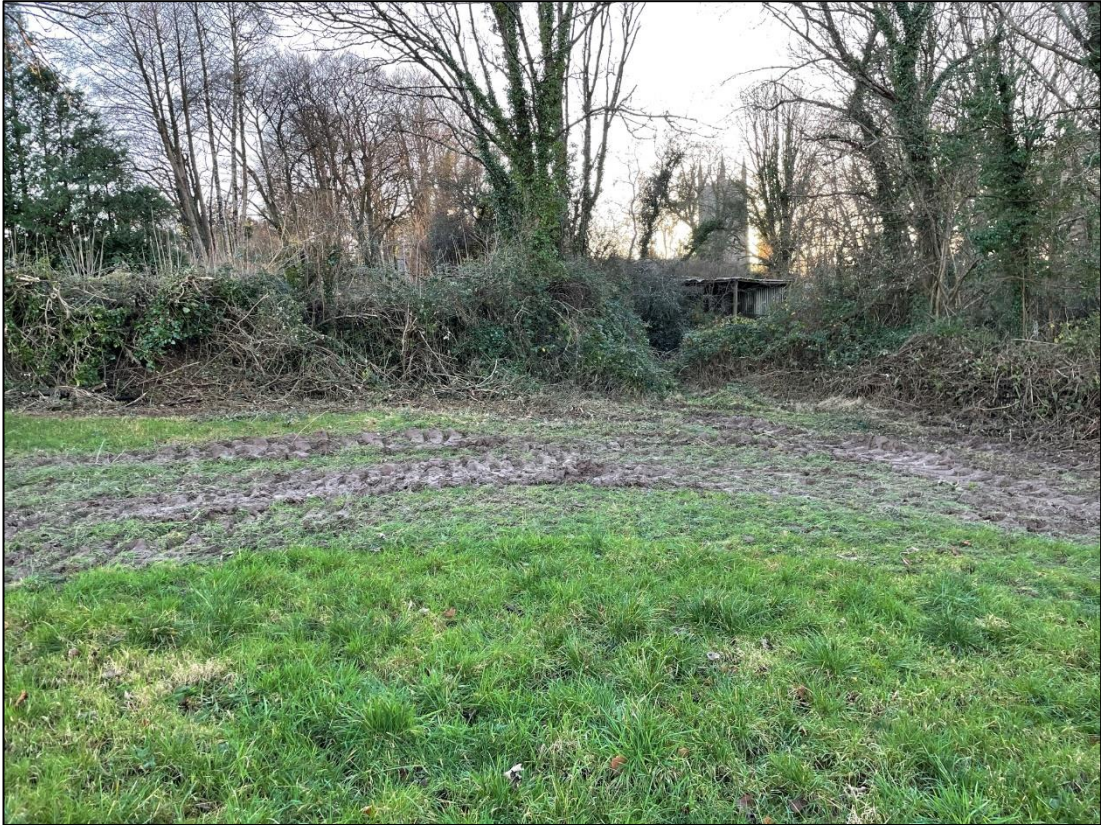
5. F1, VIEW OF THE SOUTH-WESTERN CORNER OF THE SITE, SHOWING THE CORRUGATED METAL STRUCTURE; VIEWED FROM THE NORTH-WEST (NO SCALE).

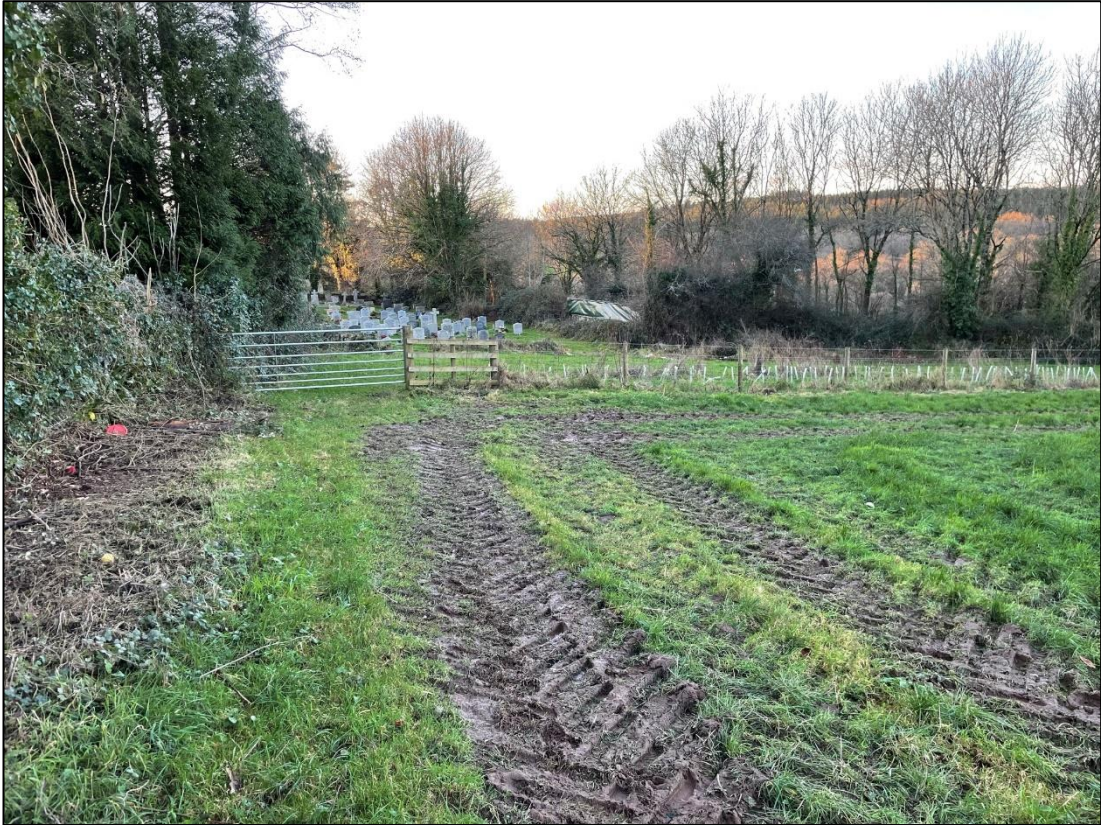
7. DETAIL OF THE EXISTING GRAVEYARD BOUNDARY TO THE SOUTH-WEST OF THE PROPOSAL SITE; VIEWED FROM THE EAST (NO SCALE).
