SANDBAY SOLAR KEWSTOKE NORTH SOMERSET

Results of a Heritage Assessment

South West Archaeology Ltd. report no. 220921

By B. Morris and P. Bonvoisin
Report Version: FINAL01
29th November 2022

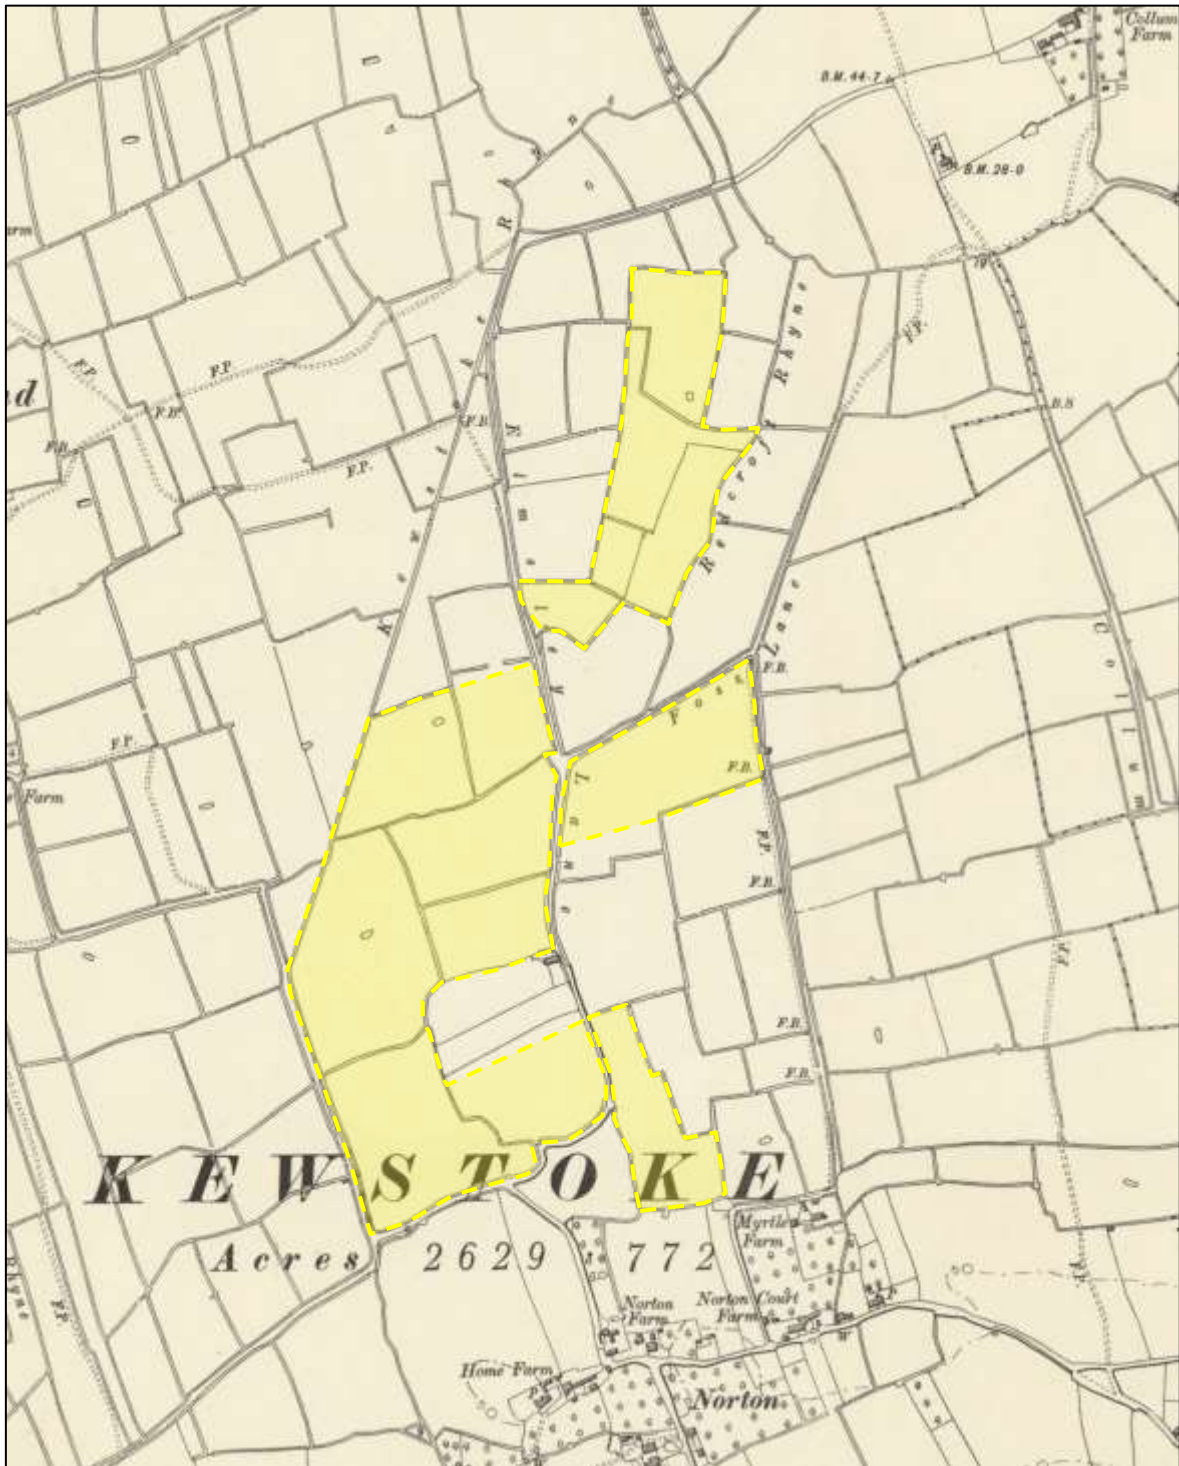
FIGURE 7: EXTRACT FROM THE 1903 25" OS MAPS OF THE AREA, REVISED 1902 (PARTS OF SOMERSET SHEETS IX.8, IX.12, X.5, X.9) (KYP). THE SITE IS INDICATED.

There are no apparent changes shown between 1885 and 1958x63. During the second half of the 20th century the remaining field boundaries between tithe field nos. 160, 163-169 and 172 were removed to create Field F7. The boundary between field nos. 150 and 151 was removed to form Field F6. A fence was inserted to remove a dogleg in the southern boundary of field no. 229 to form Field F5. A nursery was established at Elmsley, and this expanded slightly to the south of the original field boundary to redefine Field F8. In general and more widely, the dispersed character of

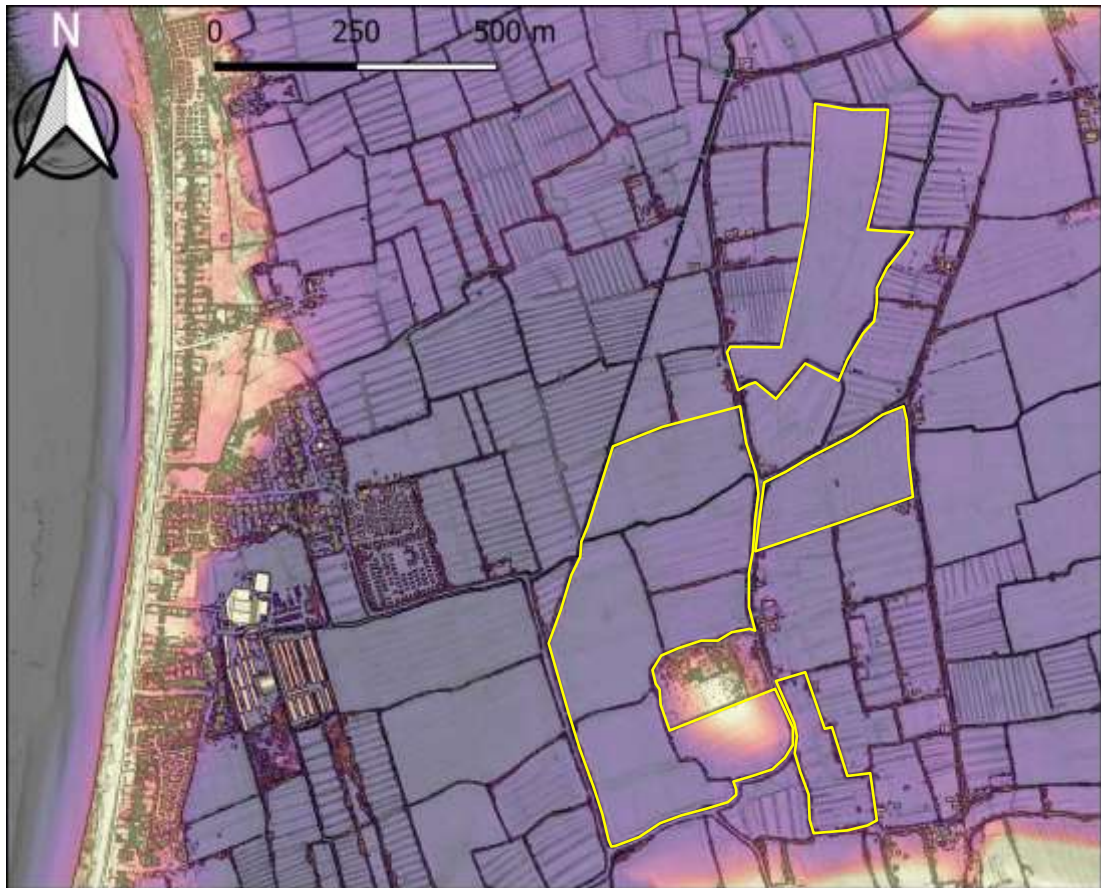
FIGURE 8: IMAGE DERIVED FROM 1M DSM LIDAR DATA. USED UNDER THE OPEN GOVERNMENT LICENCE 3.0. SITE INDICATED.

Images based on 1m DSM LiDAR data obtained from the Environment Agency can be found in Figures 8-11. Figure 8 shows the general area. The landscape is very flat but is slightly lower-lying to the west and south-west (darker colours), with higher areas along the coastal fringe, at Collum Farm, Elmsley, and to the south (lighter colours).

The LiDAR imagery is very useful for identifying earthworks even, as in this case, when the fields have been subject to ploughing. Many of the surrounding fields are shown marked by narrow, closely-spaced parallel gripes, or spade-cut surface drainage gullies. These survive in Field F9, and traces are visible in Fields F1, F4, F5, F6, and F7. In Field F6 these gripes are cut by Kewstoke Rhyme and thus predate that watercourse (built pre-1809×22?). Field boundaries lost before 1840 are indistinctly visible in Fields F1, F2, F5, F6, and F7 (see Figures 12-14); these lost field boundaries are congruent with the existing fieldsystem and do not appear to predate it. One element that might be expected but which is not readily apparent is palaeochannels. Only two small channels are visible to the north of the site, following the edge of Collum Farm 'island', with a second indistinct one just to the west. Most of the palaeochannels identified by the geophysical survey do not express themselves as earthworks, only perhaps a very subtle one in Field F2.

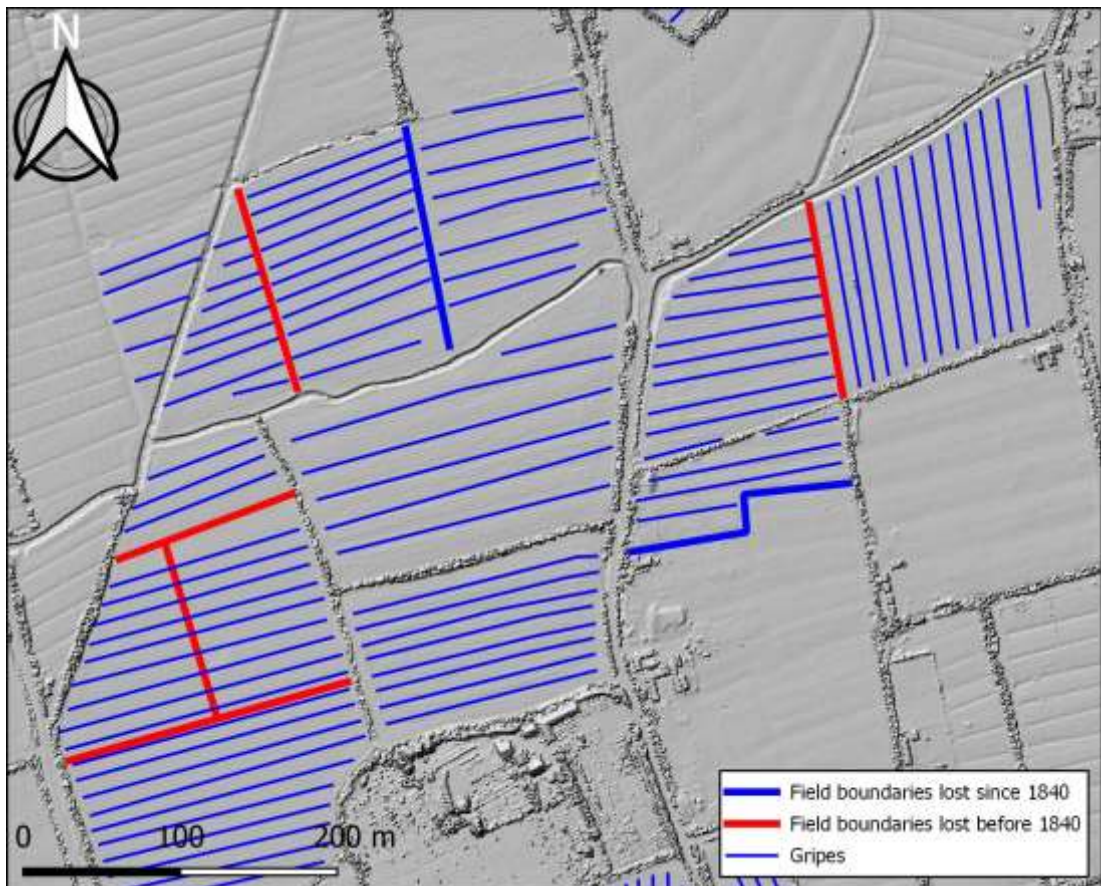
FIGURE 14: IMAGE DERIVED FROM 1M DSM LIDAR DATA SHOWING RELICT FEATURES. DATA USED UNDER THE OGL 3.0.

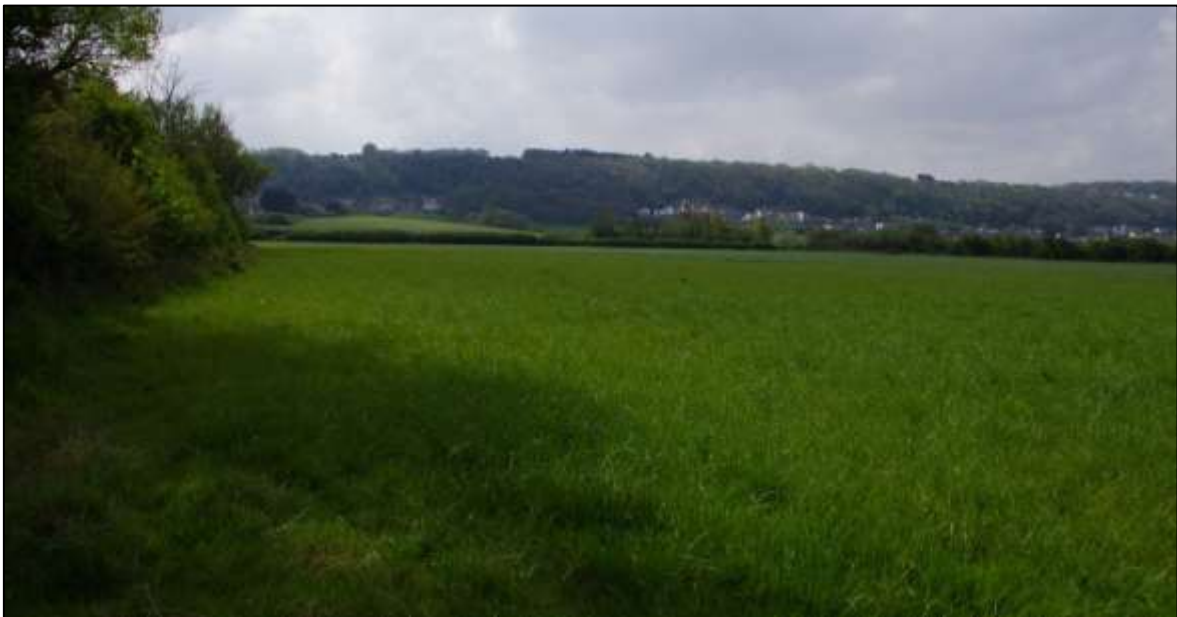
4.03ha. Field F1 is located to the south-west corner of the site, with fairly regular boundaries to the north, west and south, but a highly irregular boundary to the Field F8 to the east, arising from the amalgamation of several smaller fields here. Several piles of debris were observed along the south and west boundaries, with overhead cables also running along the western boundary

FIGURE 23: FIELD F1. VIEWED FROM THE NNW, LOOKING SSE.

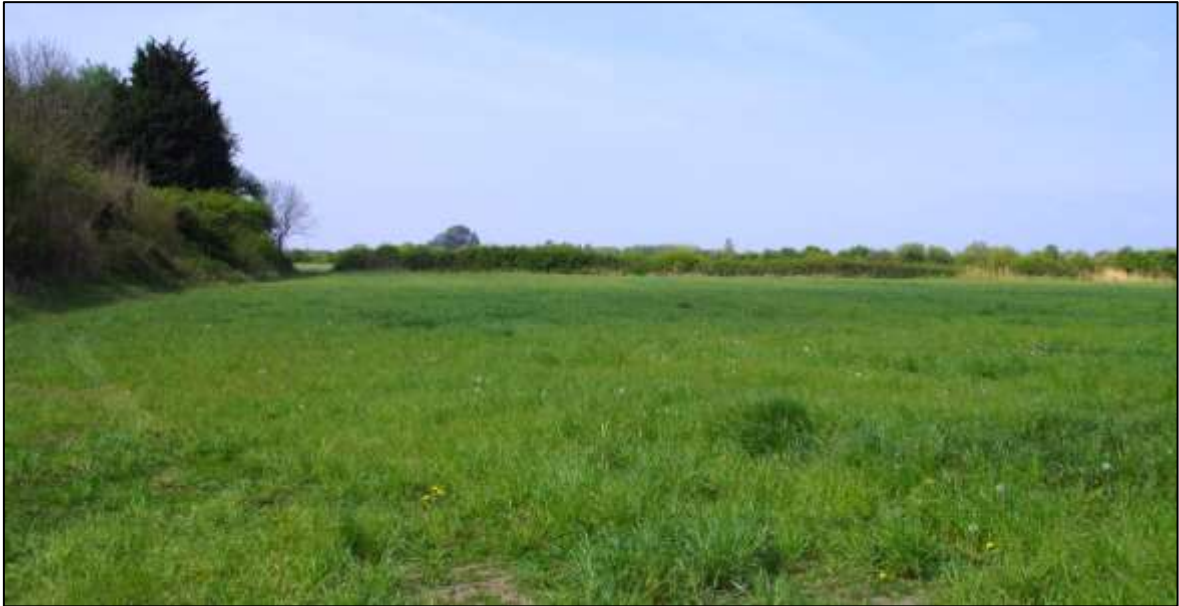
1.66ha. Field F3 is located to the north of Elmsley Nursery and is rectangular in shape. Hedges border this field to the north, east and west, with the nursery and a partly wooded boundary to the south.

FIGURE 25: FIELD F3. VIEWED FROM THE ENE, LOOKING WSW.

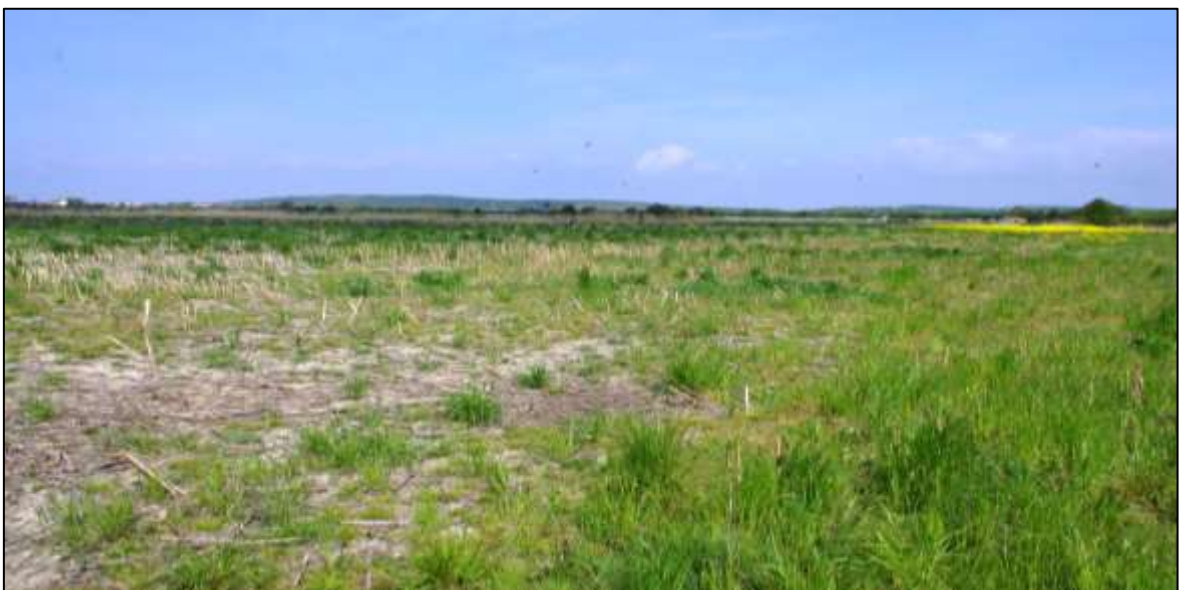
2.76ha. Field F4 lies to the centre of the site, between Fields F2, F3 and F6; it is basically rectangular in shape. Collum New Rhyne runs along its northern side. The remnants of an oilseed rape crop to the corners of the field may have contributed to the stagger visible in the survey data.

FIGURE 26: FIELD F4. VIEWED FROM THE SOUTH-EAST, LOOKING NORTH-WEST.

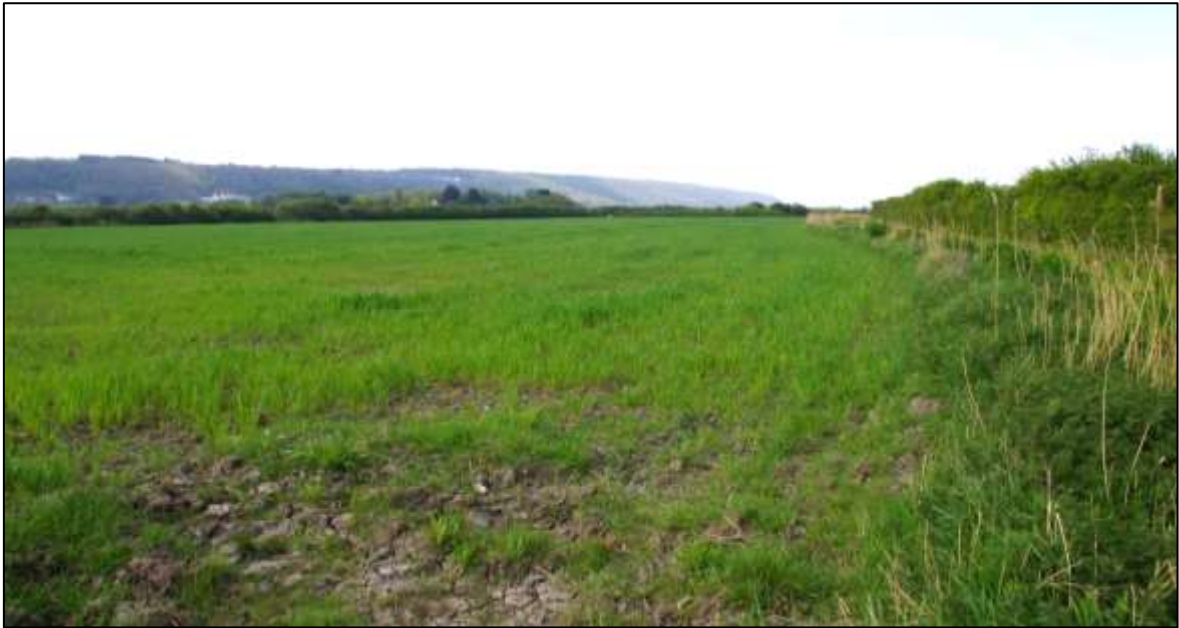
3.65ha. Field F5 is located to the west of Elmsley Lane; it is roughly rectangular in shape. Collum New Rhyne runs along its northern side. Field F5 was under a crop of winter wheat at time of survey; the northern corner of the field was wet even during the hot weather.

FIGURE 27: FIELD F5. VIEWED FROM THE ENE, LOOKING WSW.

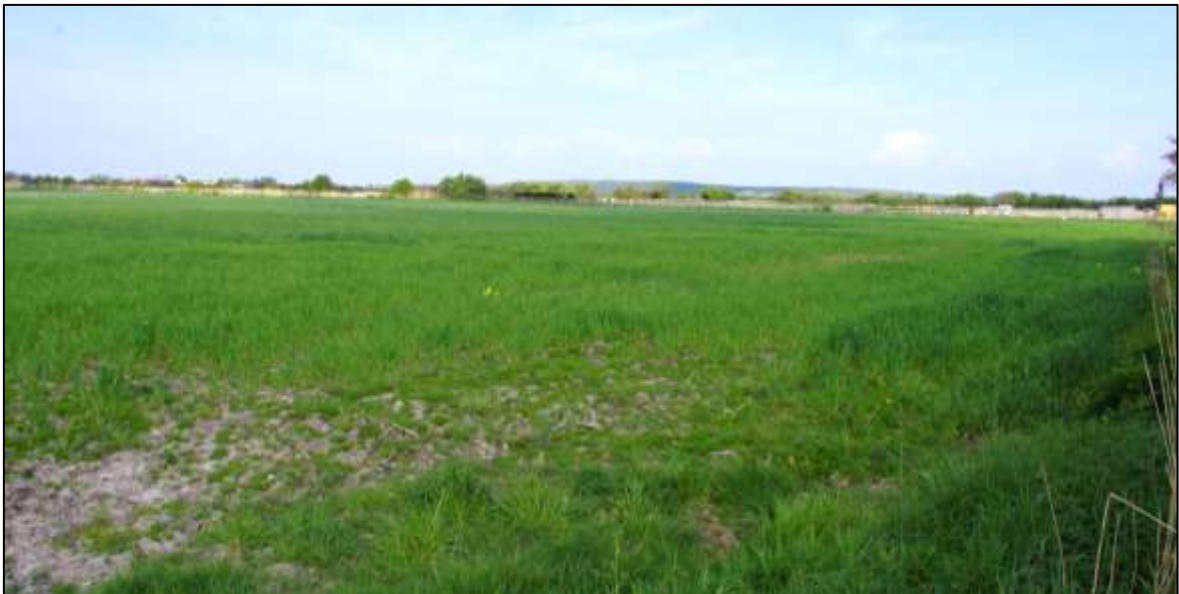
4.0ha. Field F6 is location to the northern side of the main block of fields. It is basically rectangular except for its western side, where the Kewstoke Rhyne cuts across. Collum New Rhyne runs along its southern side. Field F6 was under winter wheat at the time of survey.

FIGURE 28: FIELD F6. VIEWED FROM THE SSE, LOOKING NNW.

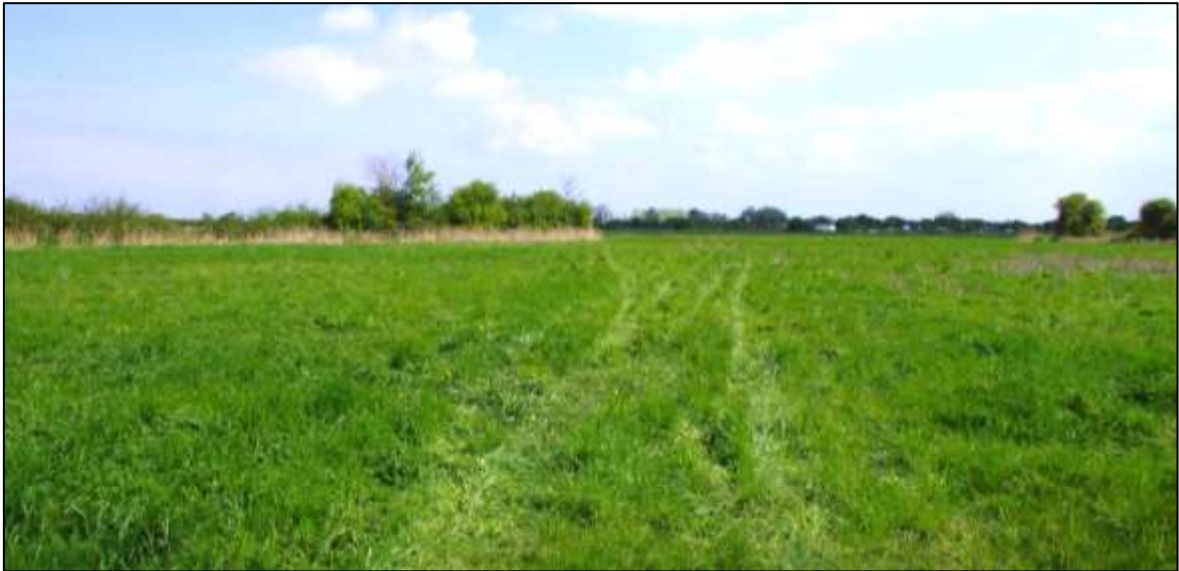
6.88ha. Field F7 lies to the north-eastern side of the site and is highly irregular in shape, arising from the amalgamation of at least six earlier fields. The Redcroft Rhyne runs along part of its south-eastern boundary. Shallow earthworks relating to the removed field boundaries were observed during the survey.

FIGURE 29: FIELD F7. THE SOUTHERN END, VIEWED FROM THE SOUTH-WEST, LOOKING NORTH-EAST.

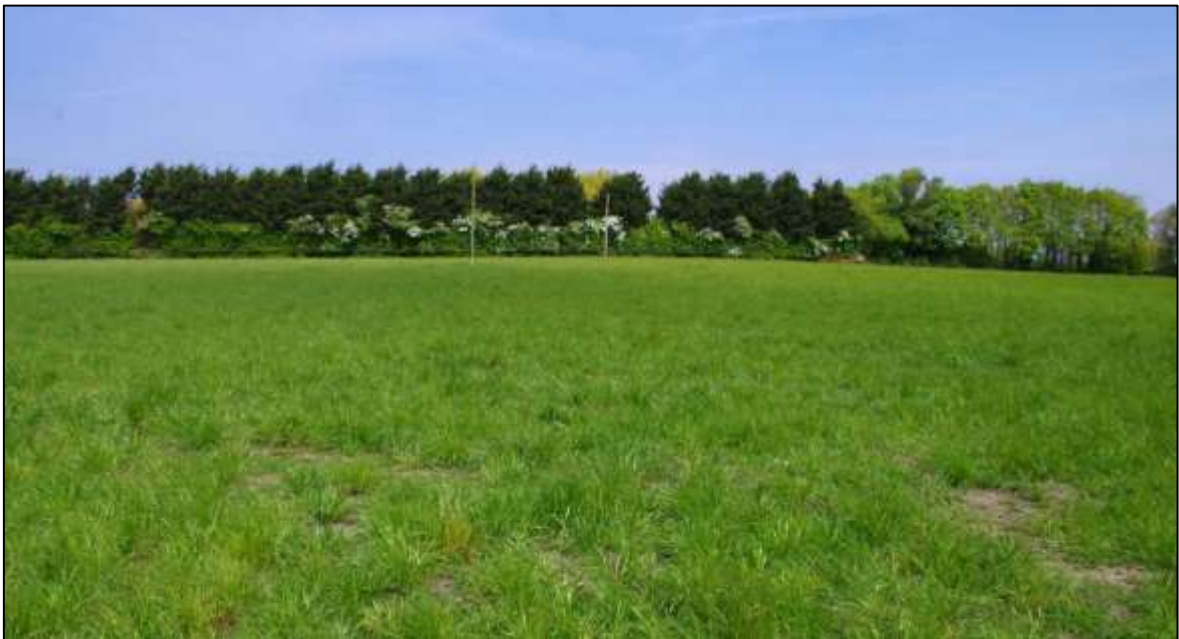
2.18ha. Field F8 is located on the southern edge of the site and comprises most of the ‘dryland’ area (i.e. slightly elevated relative to the former wetland). This is one of the *Elmshay* fields and it has a long curving boundary to the east and south, making it look like a summerdike. The boundary to the north, which separates it from the nursery, is lined by tall quick-grown conifers.

FIGURE 30: FIELD F8. VIEWED FROM THE SOUTH, LOOKING NORTH.

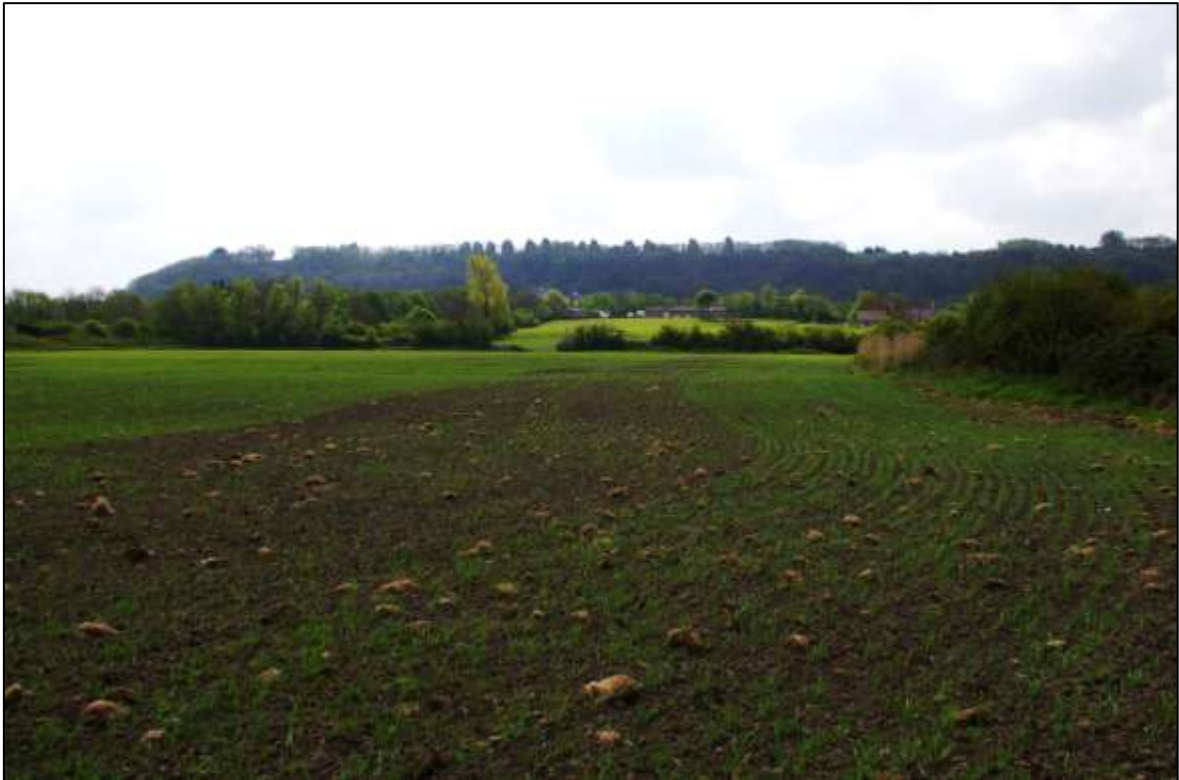
2.28ha. Field F9 lies to the south-east and beyond Elmsley Lane. This field is highly irregular, having been created out of three smaller enclosures. This was the only field that was ploughed and reseeded this spring, and while the spring barley was 60-80mm high, enough bare soil was visible for a certain level of fieldwalking to be attempted. Towards the middle of the field, to its western side, one 30m grid produced a small assemblage of Romano-British pottery (×11 sherds 95g greyware; ×2 sherds 25g LIA-ER jar; ×1 sherd 1g abraded Samian). This indicates, as might be anticipated, the present of a Romano-British settlement close to the interface between the dryland and the former wetland.

FIGURE 31: FIELD F9. VIEWED FROM THE NORTH, LOOKING SOUTH.

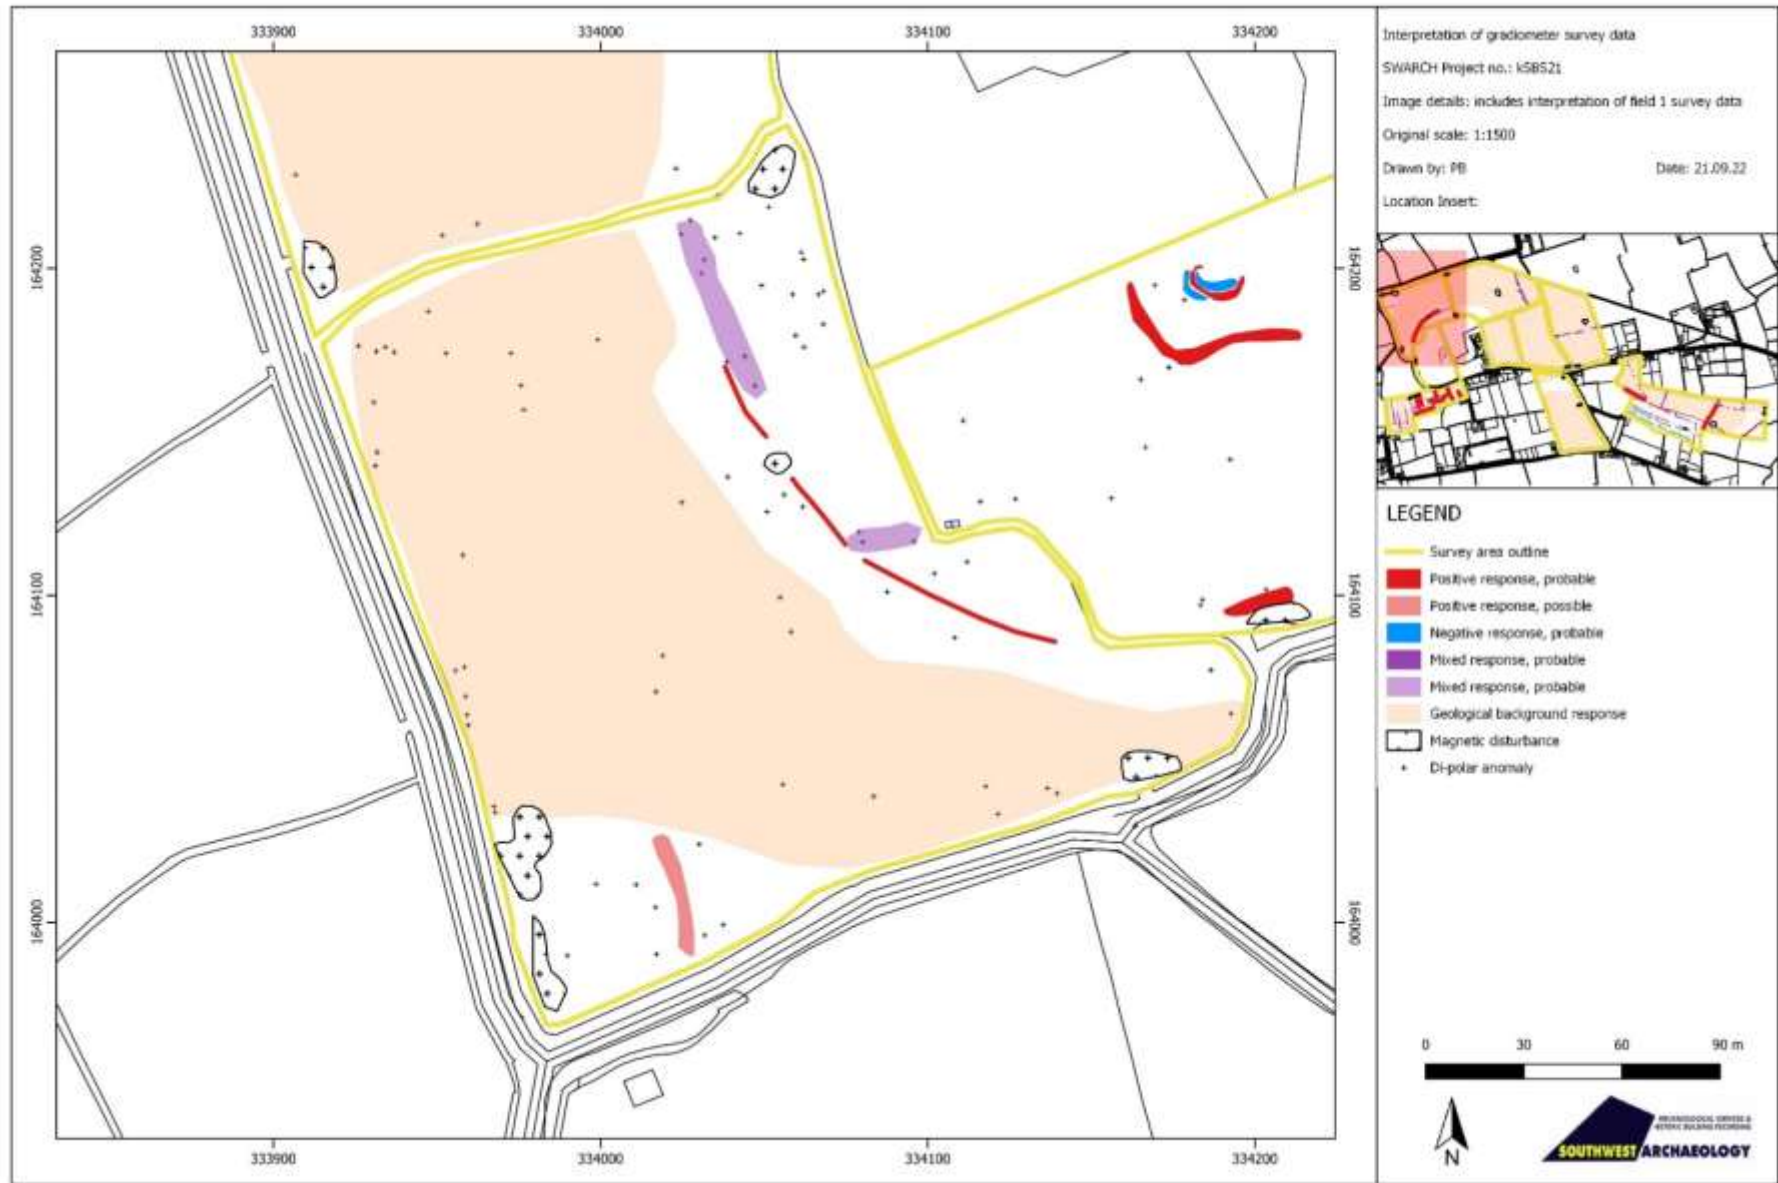
FIGURE 32: FIELD F1. INTERPRETATION OF GRADIOMETER SURVEY DATA.

Table 8, with the accompanying Figures 32 to 41, show the analyses and interpretation of the geophysical survey data. Additional graphic images of the survey data and numbered grid locations can be found in Appendix 1.

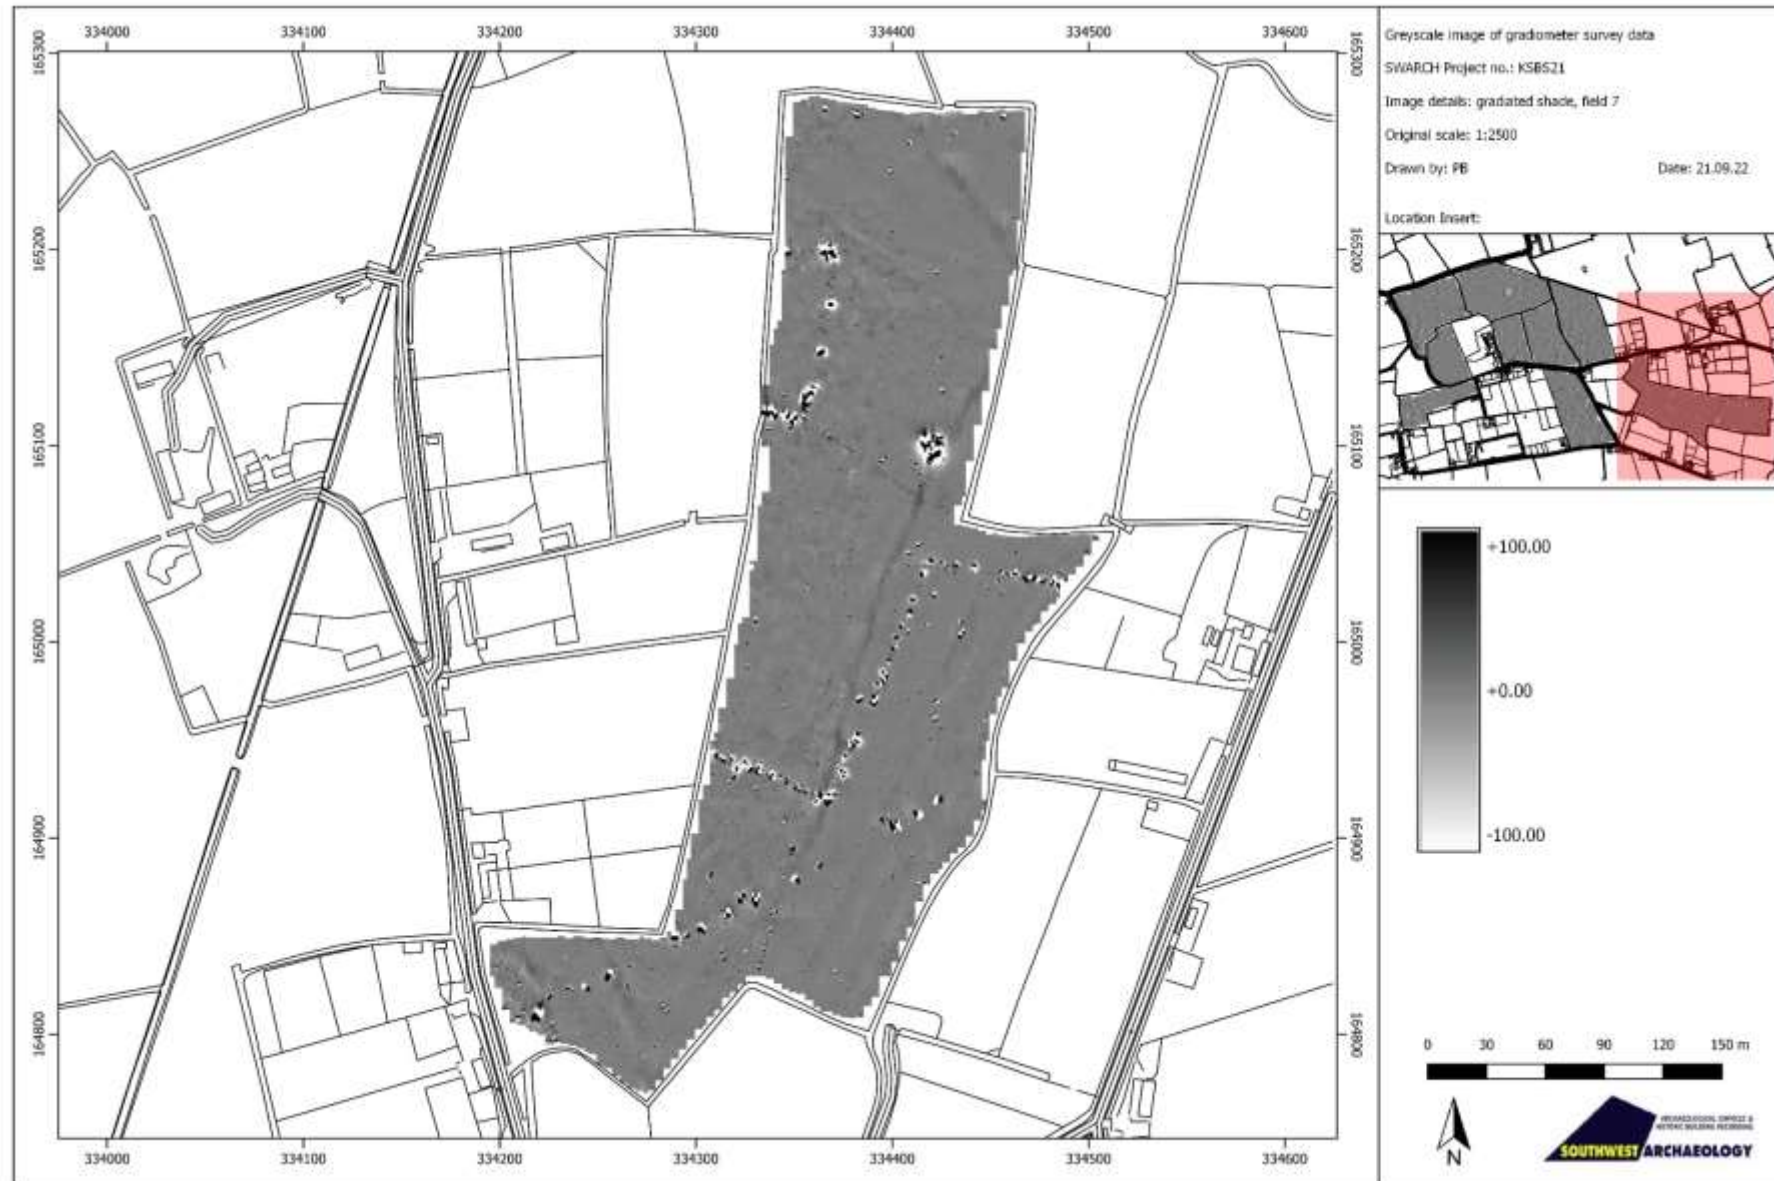
FIGURE 41: FIELD F7. GRADIOMETER SURVEY DATA, GRADIATED SHADING.

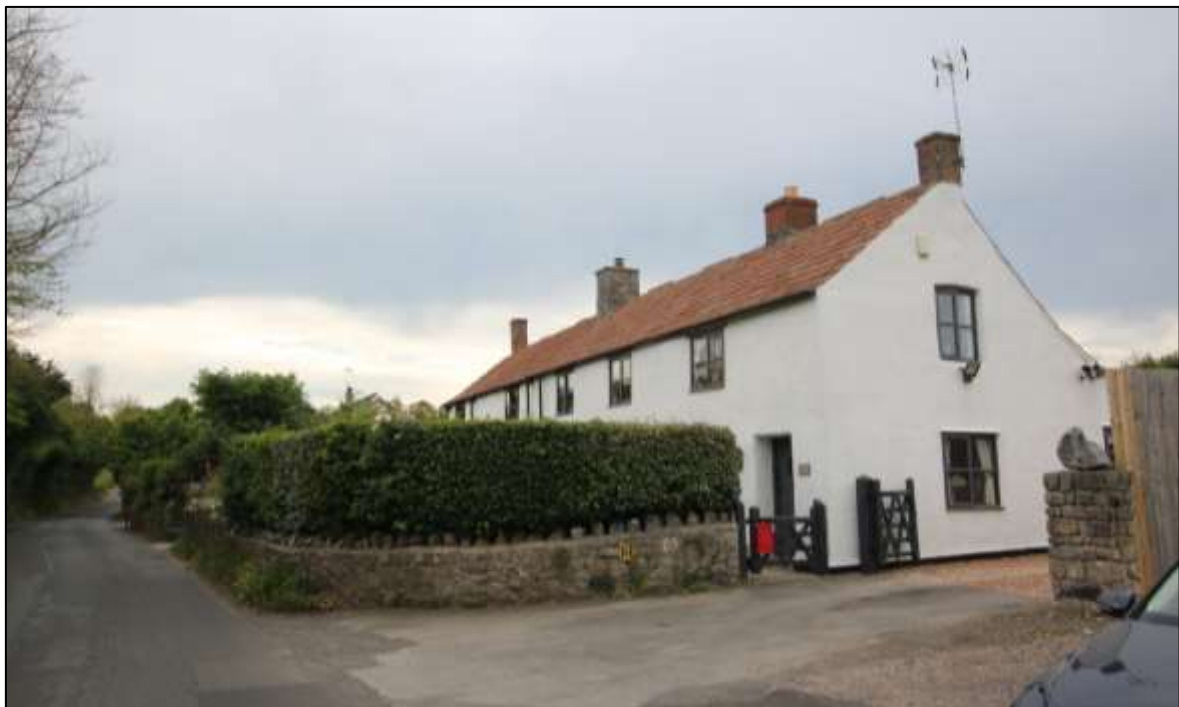
this could be a medieval building with inserted floors and stack. It has historic/illustrative value as an example of a vernacular building and now subdivided farmhouse. No communal value.
<i>Authenticity and Integrity:</i> The building is in good repair. Its authenticity as a <i>farmhouse</i> is not impaired by conversion to cottages, as this is a common event in the use-life of the larger rural houses.
<i>Topographical Location & Landscape Context:</i> The building is located on level ground at the base of a slope that rises gently to the east, south and west. It is open to the level to the north.
<i>Setting:</i> The former farmhouse stands next to the parish lane, with small walled and hedged gardens to the front, and slightly larger walled or fenced gardens to the rear. The field to the east and north of the house has recently been converted to a holiday park for upmarket cabins. To the west are a pair of later 20 th century homes and their plain walled and hedged gardens. Beyond the lane to the south is an open grass field. The garden of the adjacent property runs back to the north and both hedgerows feature mature deciduous trees.

<i>Principal Views:</i> Views to and from the building are limited by the screening provided by adjacent buildings and trees. There is nothing that could be described as a principal value – the structure is only visible from the roadside and its garden.
<i>Landscape Presence:</i> It is not visible on a landscape scale.
<i>Sensitivity of Asset:</i> The value of this building is largely evidential and historical/illustrative, neither of which would be affected by the proposed development.
<i>Contribution of Setting to Significance of Asset:</i> Incidental. While the current setting does not actively detract from the appearance of the building, it hardly sets it off to best advantage. The house is hemmed in by the redevelopment of the adjacent holiday part and its pronounced new entrance.
<i>Magnitude of Effect:</i> The proposed development would be located some distance from the property, and at least partly screened by intervening structures and trees. The building is a recessive visual feature and is largely screened from view save for the roadside. The development would not affect the ability to appreciate the significance of the building. The development would introduce a significant non-agricultural visual element to the area.

<i>Magnitude of Impact:</i> Negligible change + Medium value asset = Neutral/Slight effect
<i>Overall Impact Assessment:</i> Negligible Adverse

FIGURE 42: ROSE TREE FARMHOUSE; VIEWED FROM THE ESE, LOOKING WNW.

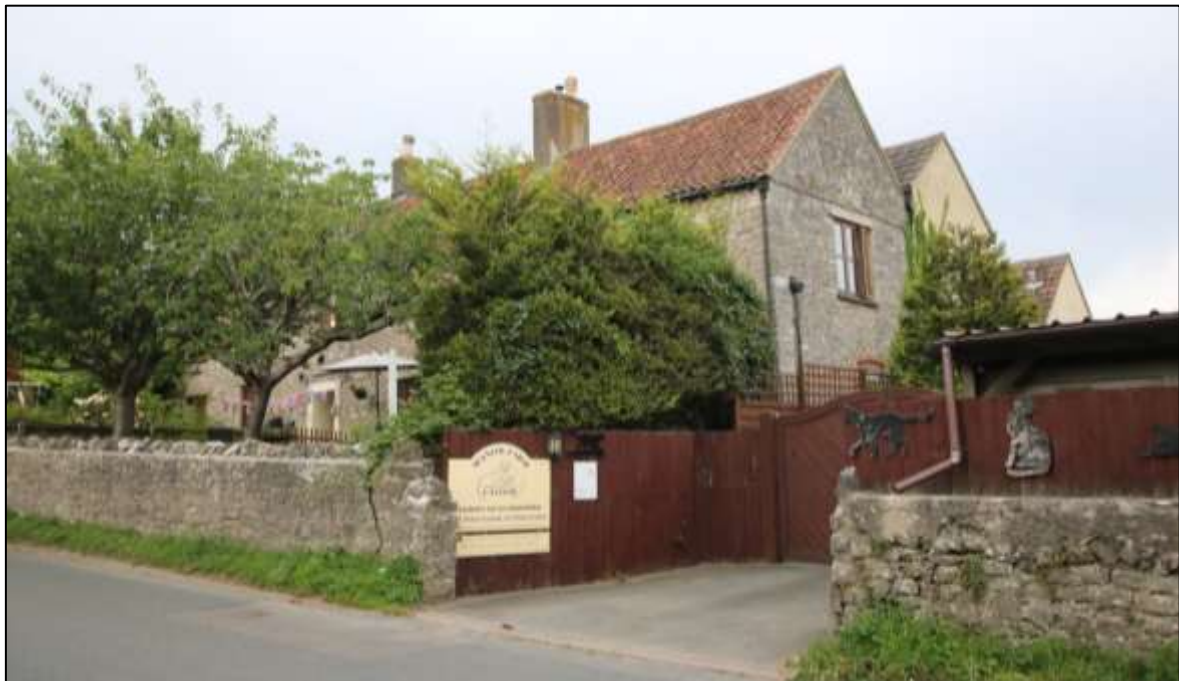
<i>Authenticity and Integrity:</i> The building is in good repair. Its authenticity has a <i>farmhouse</i> is not particularly impaired by conversion to wholly residential use.
<i>Topographical Location & Landscape Context:</i> The building is located on sloping ground towards the base of a slope that rises gently to the south and west. It is open to the Level to the north.
<i>Setting:</i> The former farmhouse stands next to the parish lane, with small walled and hedged gardens to the front, with a large but plain garden/lawn with car parking to the rear. This is open to a small field that runs back to the north and which is bounded by tall hedges. Immediately to the east is a Manor Farm Cattery, a low later 20 th century bungalow with a modern mono-pitch shed to the roadside, partly concealed behind a tall wooden fence. To the west is a track and thin strip of grass field, beyond which is the garden of another bungalow. Beyond the lane to the south is an open grass field.

<i>Principal Views:</i> Views to and from the building are limited by the screening provided by adjacent buildings and trees. There is nothing that could be described as a principal value – the structure is only visible from the roadside and its garden.
<i>Landscape Presence:</i> It is not visible on a landscape scale.
<i>Sensitivity of Asset:</i> The value of this building is largely evidential and historical/illustrative, neither of which would be affected by the proposed development. It has some aesthetic value, but this is only really to be appreciated within its immediate setting.
<i>Contribution of Setting to Significance of Asset:</i> Incidental. While the current setting does not actively detract from the appearance of the building, it could be more sympathetic. The proximity of the Cattery, its fencing and signage, is a negative visual feature.
<i>Magnitude of Effect:</i> The proposed development would be located some distance from the property, and at least partly screened by intervening structures and trees. The building is a fairly recessive visual feature and is largely screened from most views save that of the roadside. The development would not affect the ability to appreciate the significance of the building. The development would introduce a significant non-agricultural visual element to the area.

<i>Magnitude of Impact:</i> Negligible change + Medium value asset = Neutral/Slight effect
<i>Overall Impact Assessment:</i> Negligible Adverse

FIGURE 43: NORTON COURT FARMHOUSE; VIEWED FROM THE SSE, LOOKING NNW.

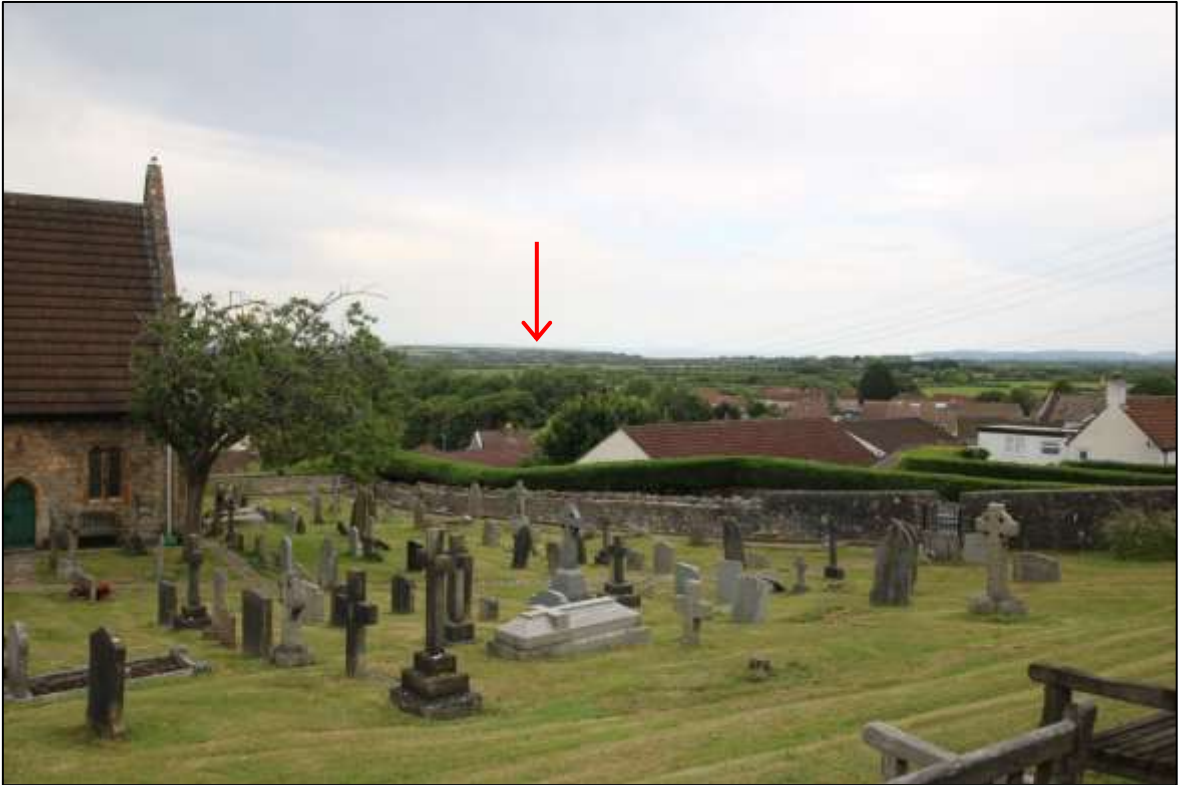
<p><i>Authenticity and Integrity:</i> The church appears to be in good condition. It remains an authentic place of communal worship.</p>
<p><i>Topographical Location & Landscape Context:</i> The church is located towards the base of the steep NNW-facing lower slopes of Worlebury Hill, on a slight projection from that slope.</p>
<p><i>Setting:</i> The church stands in a small sub-rectangular churchyard bounded by stone walls. Kewstoke Road runs along the contour to the south of the church, above which the wooded slopes of Worlebury Hill rise steeply. There are houses and other structures to east and west, and below to the north. Immediately to the west is the community hall, converted from the parish poorhouse, with the tall double-depth vicarage beyond. To the east is a linear car park, with further historic residential homes beyond. The housing to the north is slotted into the narrow former strip fields here, with two-storey buildings along Crookes Lane, and a long narrow estate of single-storey holiday homes.</p>

<p><i>Magnitude of Effect:</i> The proposed development would be located some distance from the church, and there would be some partial screening from hedgerows. In most views to the church the development would not appear, and the development would not affect the ability to appreciate the significance of the building itself. However, it would appear in the background in that principal view down to the church from its entrance, and it would interpose itself in views across the Level to and from Woodspring Priory. The development would introduce a significant non-agricultural visual element to the area.</p>
<p><i>Magnitude of Impact:</i> Minor change + High value asset = Moderate/Slight impact</p>

Overall Impact Assessment: **Minor Adverse**

FIGURE 44: THE VIEW FROM THE CHURCHYARD OF ST PAUL'S IN KEWSTOKE TOWARDS WOODSPRING PRIORY AND ACROSS THE PROPOSED PV SITE. WOODSPRING PRIORY IS INDICATED. VIEWED FROM THE SSW, LOOKING NNE.

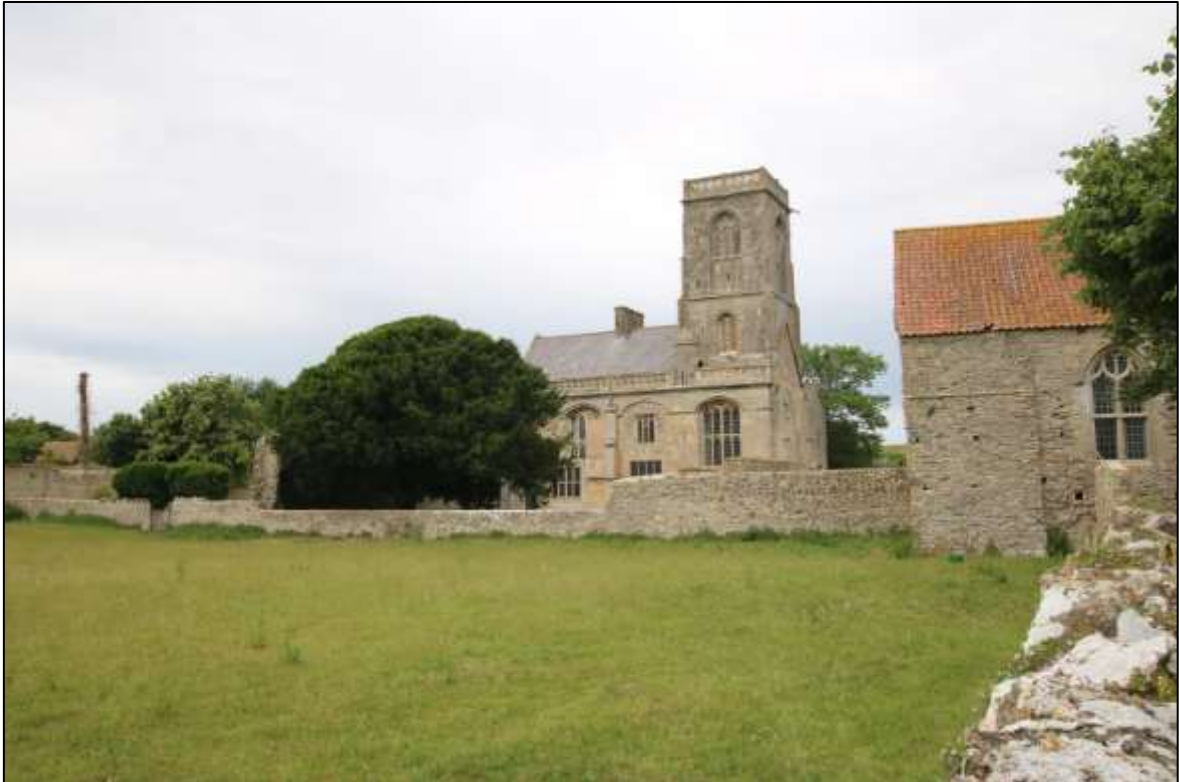
FIGURE 45: THE TOWER OF THE PRIORY, WITH LISTED INFIRMARY TO THE RIGHT; VIEWED FROM THE SSE, LOOKING NNW.

Infirmary. C15. Rubble, pantile roof. North elevation has two 2-light transomed perpendicular windows and a later segmental archway. East gable is blank. South elevation has one window as north and recess for stair turret. West end has a smaller 2-light window above a pointed moulded doorway under a hoodmould. Roof is of arch brace collar beam construction with 3 rows of windbraces. C19 restoration removed archway to south chapel. C20 repairs include a concrete brace at wall plate; steel brackets to roof and the rebuilding of the east gable.

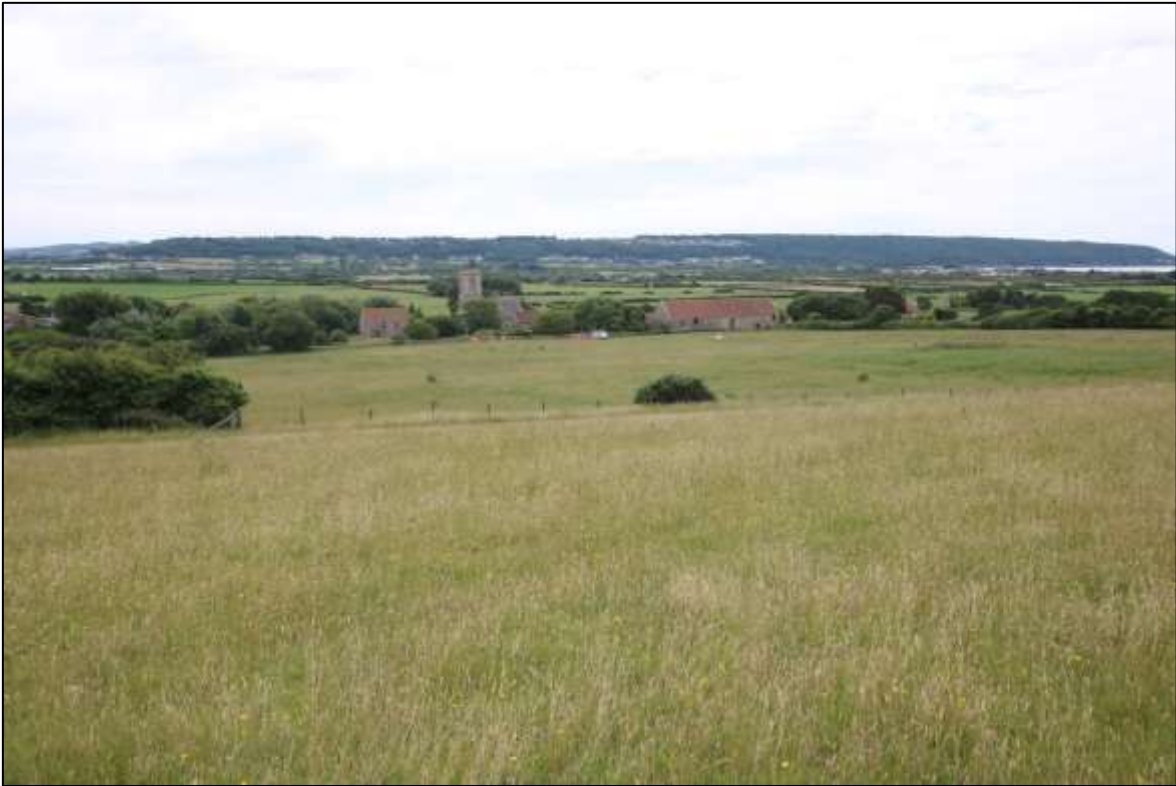
Authenticity and Integrity: The complex is in good repair (and repairs were taking place during the site visit). Since the Landmark Trust took control of the complex it has been adapted to serve a number of functions, including holiday let, which undermines its authenticity but ensure integrity (e.g. features of its use as a farmstead, such as the large tractor door in the east wall of the Infirmary, have been tidily 'corrected').

Contribution of Setting to Significance of Asset: Important. Although settlements in these fen-edge environments (e.g. Weston, Milton, Kewstoke) are typically located towards the lower slopes of the hillsides, and the tower of the priory is somewhat later than the foundation. Its size and prominence was clearly intentional when it was built, and the Levels provide an expansive and largely rural backdrop to the church.

Overall Impact Assessment: **Minor Adverse** [principally affects Priory tower]

FIGURE 46: VIEW ACROSS THE CLUSTER OF HIGH VALUE ASSETS AT WOODSPRING FROM THE MIDDLE HOPE RIDGE. IN THE BACKGROUND IS WORLEBURY HILL WITH KEWSTOKE AT ITS BASE. THE PROPOSED PV SITE WOULD BE LOCATED IN THE FIELDS BEHIND THE PRIORY. VIEWED FROM THE NNE, LOOKING SSW.
