SANDBAY SOLAR KEWSTOKE NORTH SOMERSET

Results of a Heritage Assessment

South West Archaeology Ltd. report no. 220921

By B. Morris and P. Bonvoisin
Report Version: FINAL01
29th November 2022

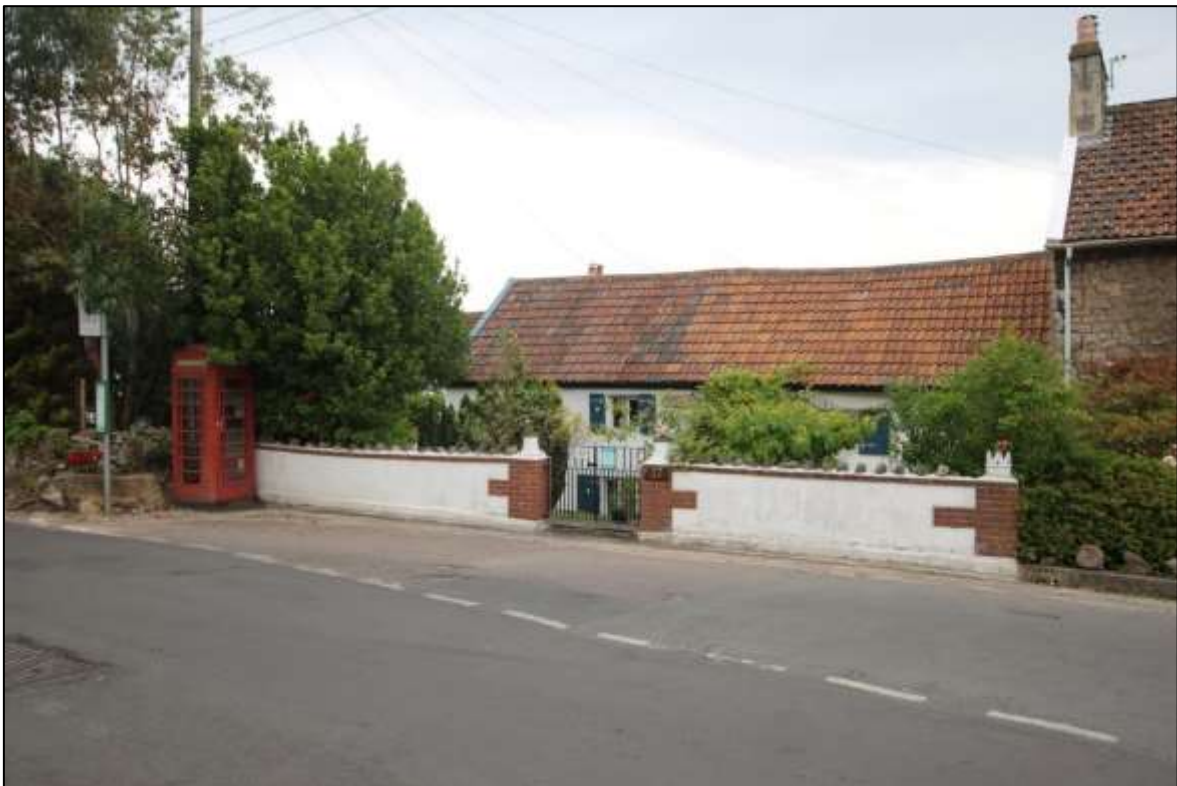
<i>Conservation Value: The building is not unattractive, and uses vernacular materials, but it is set down into the slope in such a way as to make it very difficult to appreciate that vernacular aesthetic. It will have evidential value as the Listing is not very detailed – this could easily be medieval in origin with inserted floors and stack. It has historic/ illustrative value as an example of a vernacular building. No true communal value.</i>	
<i>Authenticity and Integrity: The building is in good repair. Its authenticity as a farmhouse is likely to have been compromised by conversion to service wing, dwelling, then café.</i>	
<i>Topographical Location & Landscape Context: The church is located towards the base of the steep NNW-facing lower slopes of Worlebury Hill.</i>	
<i>Setting: The café is located towards the centre of the historic village. Kewstoke Road runs immediately to the south, with Crookes Lane branching off to the north just to the east. Accordingly, the road widens here in front of the café. The front garden of the café is bounded by a modern rendered wall with brick details; the K6 telephone box stands</i>

Overall Impact Assessment: **Neutral**

FIGURE 47: THE OWL'S COTTAGE CAFÉ; VIEWED FROM THE SOUTH-EAST, LOOKING NORTH-WEST. LISTED K6 TELEPHONE BOX TO THE LEFT.

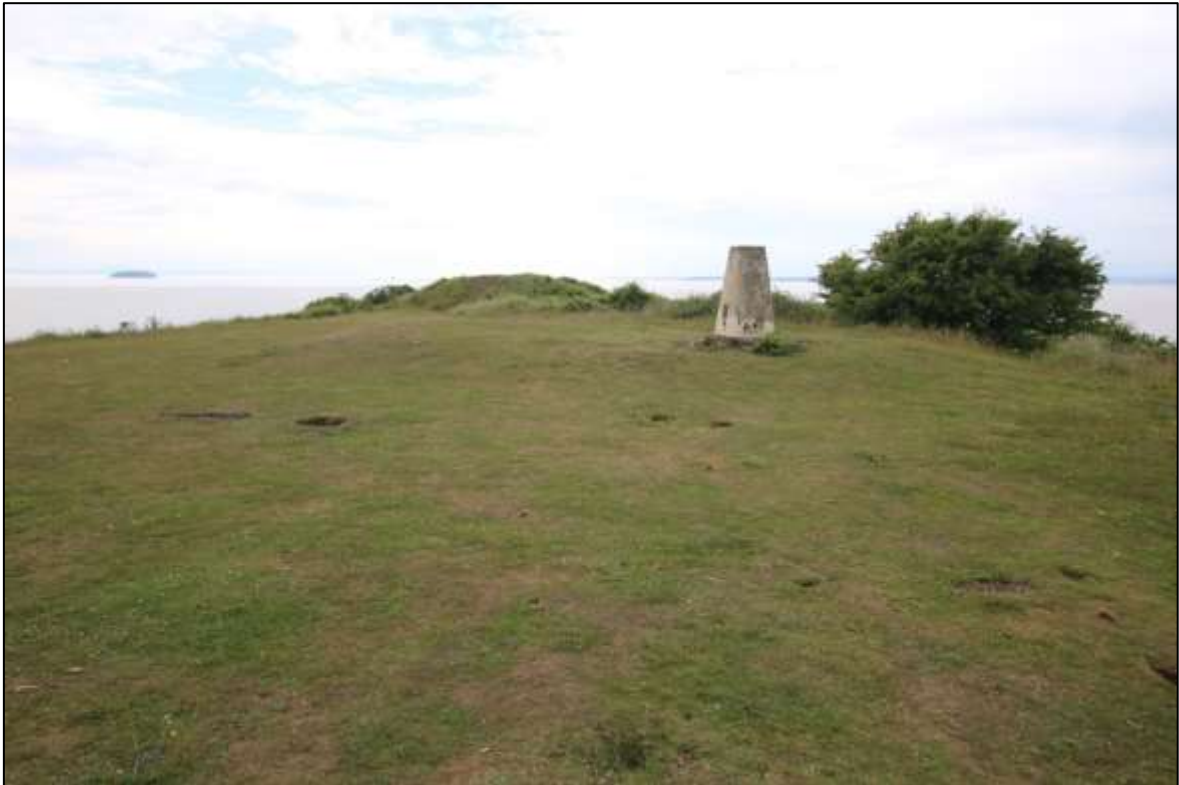
<i>Contribution of Setting to Significance of Asset: Paramount. This location was deliberately selected for its physical (and spiritual) qualities. While the monuments have historical and evidential value, that value is likely to be limited. This is an extremely liminal location, even allowing for landscape change following the Bronze Age, and is likely to be more about the seascape than the landscape.</i>	
<i>Magnitude of Effect: The proposed development would be located some distance from the monuments, with some (albeit limited) screening from hedgerows/trees. The monuments are very slight. The development would not affect the ability to appreciate the significance of the monuments, which look seaward. The development would introduce a significant non-agricultural visual element to the area when looking back to the south-east.</i>	
<i>Magnitude of Impact: Minor change + High value asset = Moderate/Slight effect</i>

Overall Impact Assessment: Minor Adverse

FIGURE 48: THE BOWL BARROW (BENEATH AND TO THE LEFT OF THE TRIG POINT); VIEWED FROM THE EAST, LOOKING WEST.

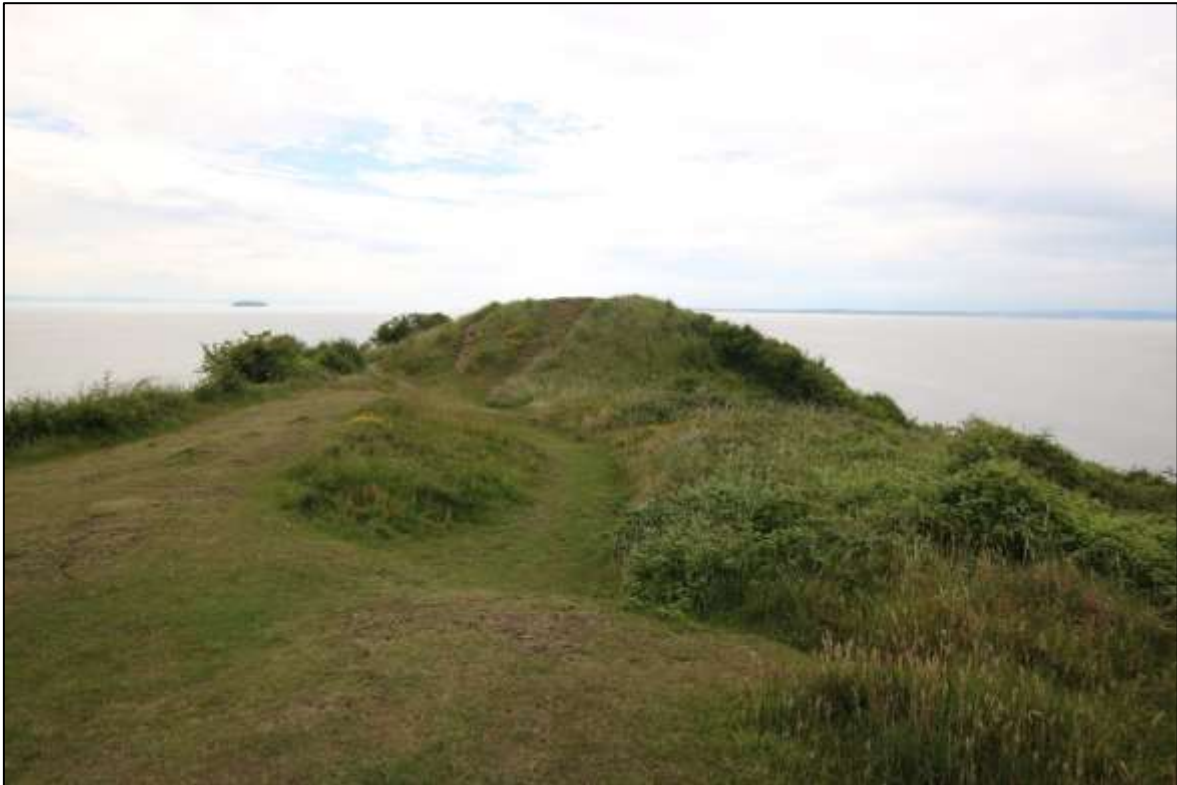
FIGURE 49: THE 'MOTTE AND BAILEY' AT THE WESTERN TIP OF THE MIDDLE HOPE RIDGE; VIEWED FROM THE EAST, LOOKING WEST.

Asset Name: Motte & Bailey Castle at Sandpoint	
<i>Parish:</i> Kewstoke	<i>Views to/from site verified:</i> YES
<i>Designation:</i> SAM	<i>Value:</i> High
<i>Distance to the site:</i> 1.85km	<i>Condition:</i> Fair
<p><i>Description: Scheduling:</i> The monument includes a motte and bailey castle situated on the crest of a coastal promontory overlooking Sand Bay 650m NNW of Sandpoint Farm. The motte, known variously as Castle Mound and Castle Batch, is an artificial mound c.30m in diameter and c.2m high. It is situated within the south-west area of the monument and is surrounded by a rock-cut ditch c.8m wide from which material was quarried during its construction. The ditch is visible on the eastern side of the motte as an earthwork c.1.5m deep; elsewhere it survives as a buried feature. Adjacent to the motte is the bailey. This feature is defined by the ditch surrounding the motte in the west and the steep natural slopes of the hill to the south and north. To the east it is defined by the extent of visible earthworks. Numerous building platforms, some surviving to a height of c.0.5m, are visible in this area of the monument. The eastern area of the bailey has been partly disturbed by military activity, possibly dating from the Second World War.</p>

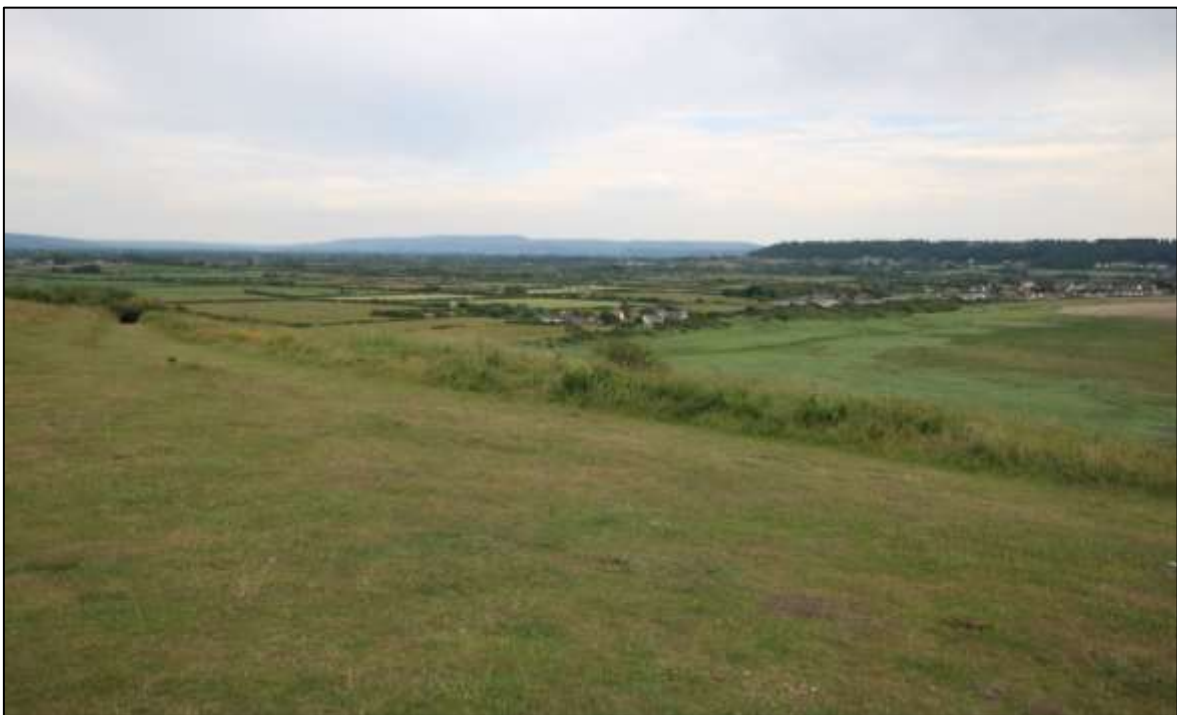
The proposed development would be located towards the centre of that area of reclaimed marsh book-ended by Worlebury Hill to the south, Sand Bay to the west, the Middle Hope ridge to the north and the Banwell River to the east. Most of the general observations made of this character area are borne out here. The ridge to the south screens the area from the urban sprawl of West Wick, Worle, and Weston-super-Mare, the sound of the M5 is muted or imperceptible, and the holiday facilities along Sandbay are not particularly visible or intrusive. One noticeable development here is the proliferation of small sheds and paddocks, facilitated by the disparate pattern of landownership. Out on the Level, hedge shrubs and trees along the ditches provide a good, but not comprehensive, level of screening. The key issue for this site is the existence of elevated viewpoints to the north (the Middle Hope ridge) and south (Worlebury Hill), and less dramatic viewpoints from raised ground along Sand Bay and at Collum Farm. These viewpoints provide clear and uninterrupted views across the landscape, within which the proposed PV development would be highly visible. Mitigation in the form of additional screening is unlikely to be able to offset that visual impact. The overall effect on the historic landscape here of a large modern PV installation is likely to be **minor to moderate adverse**.

FIGURE 50: THE VIEW BACK ACROSS THE LEVEL FROM THE WESTERN TIP OF MIDDLE HOPE RIDGE; VIEWED FROM THE NORTH-WEST, LOOKING SOUTH-EAST.
