BATSON HALL FARM

Updated - Heritage Impact Assessment – House and Cottage 2022

South West Archaeology Ltd. report no. 220614

Batson Hall Farm, Batson, Salcombe, Devon

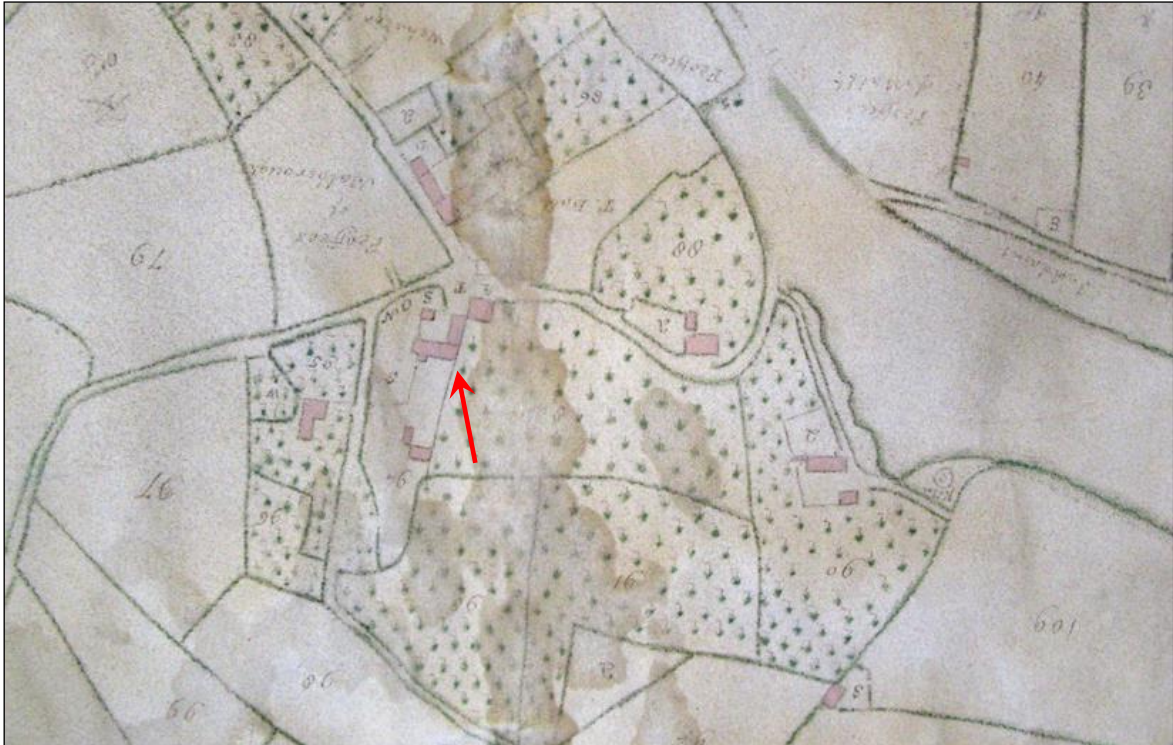
FIGURE 2: EXTRACT FROM THE 1821 ESTATE MAP COMPILED ON BEHALF OF THE POLLEXFEN-BASTARD FAMILY. NOTE THE EXTENSIVE SURROUNDING ORCHARDS. THE FARMHOUSE IS INDICATED (DHC).

The earliest accessible map for this study is the 1821 Pollexfen-Bastard estate map. This documents Batson Hall Farm as having a main L-shaped range, with both the cyder pound-house and bakehouse also being roofed and in use, marked 'pink'. This indicates that the north-east range, containing a stack and blocked openings which now survives as the L-shaped walls enclosing the courtyard garden to the front of Batson Hall farmhouse was fully occupied and roofed in the early 19th century. The presence of the stack has led previous interpretations of this range as the former hall of the manorial complex; a hypothesis which is supported by the proximity of the detached bakehouse/kitchen.

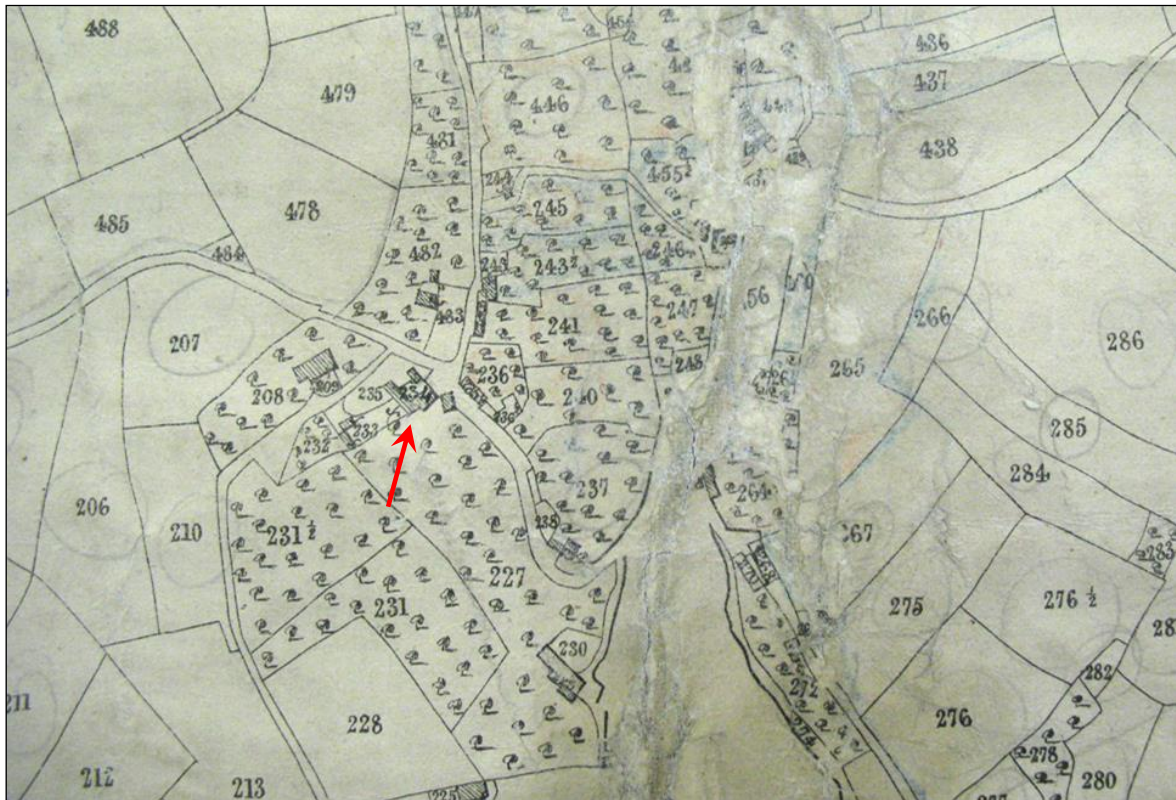
FIGURE 3: EXTRACT FROM THE 1841 TITHE MAP FOR MALBOROUGH. THE FARMHOUSE IS INDICATED (DHC).

By the tithe map of the mid-19th century the east end of the main range appears to have been truncated, as it now steps back from the wall line of the north-east range, which is still shown as stippled and therefore occupied and roofed. The walled yard running out to the south away from the main range and linking to the barns is retained, but a section of the open yard area beyond the barns is now also converted to orchards. The cyder pound-house is shown at a marked oblique angle on this map which is a mistake by the cartographer.

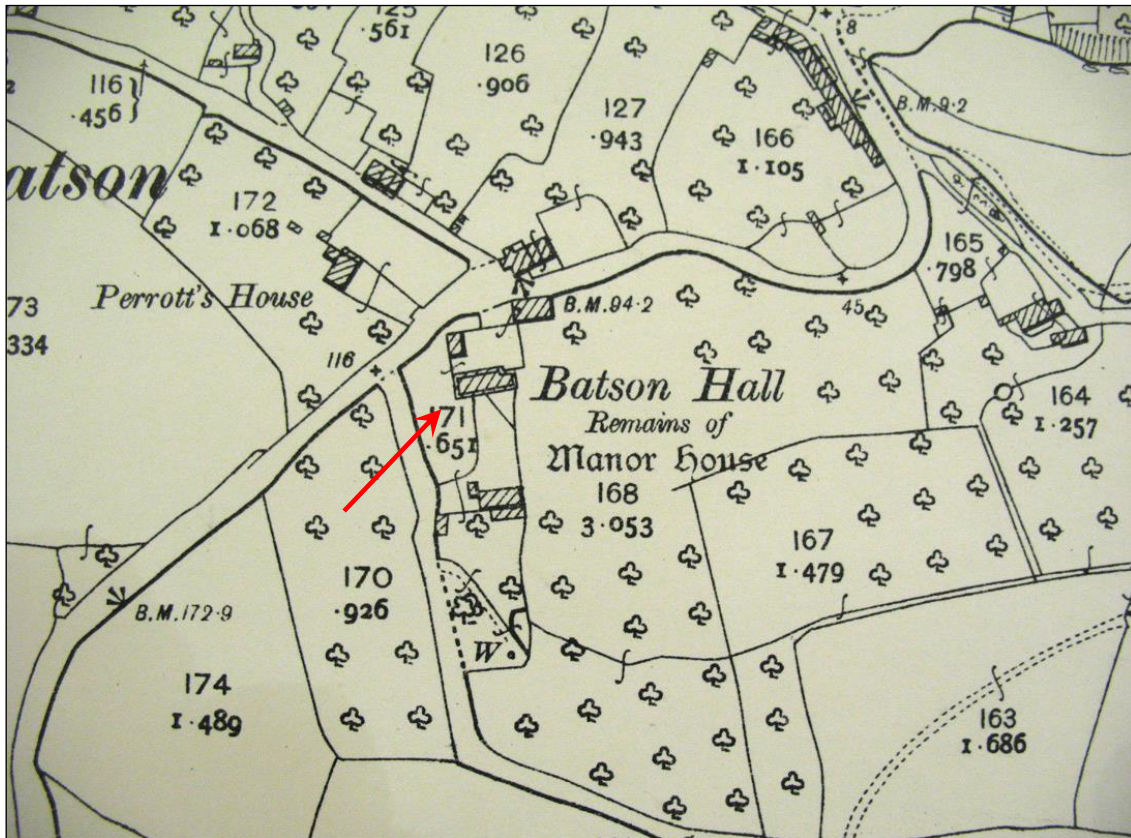
The next map, the 2nd Edition OS Map of 1906 records the loss of the west wall of the north-east range, with the front yard assuming the appearance it has today. The outline of the walls here is however more detailed and it can be seen that the front, east wall of this building returns and adjoins the main range, on its north-east corner.

FIGURE 5: THE ORDNANCE SURVEY 2ND EDITION 1:2500 SCALE MAP OF BATSON, PUBLISHED 1906. SHEET 136.11 (DHC).

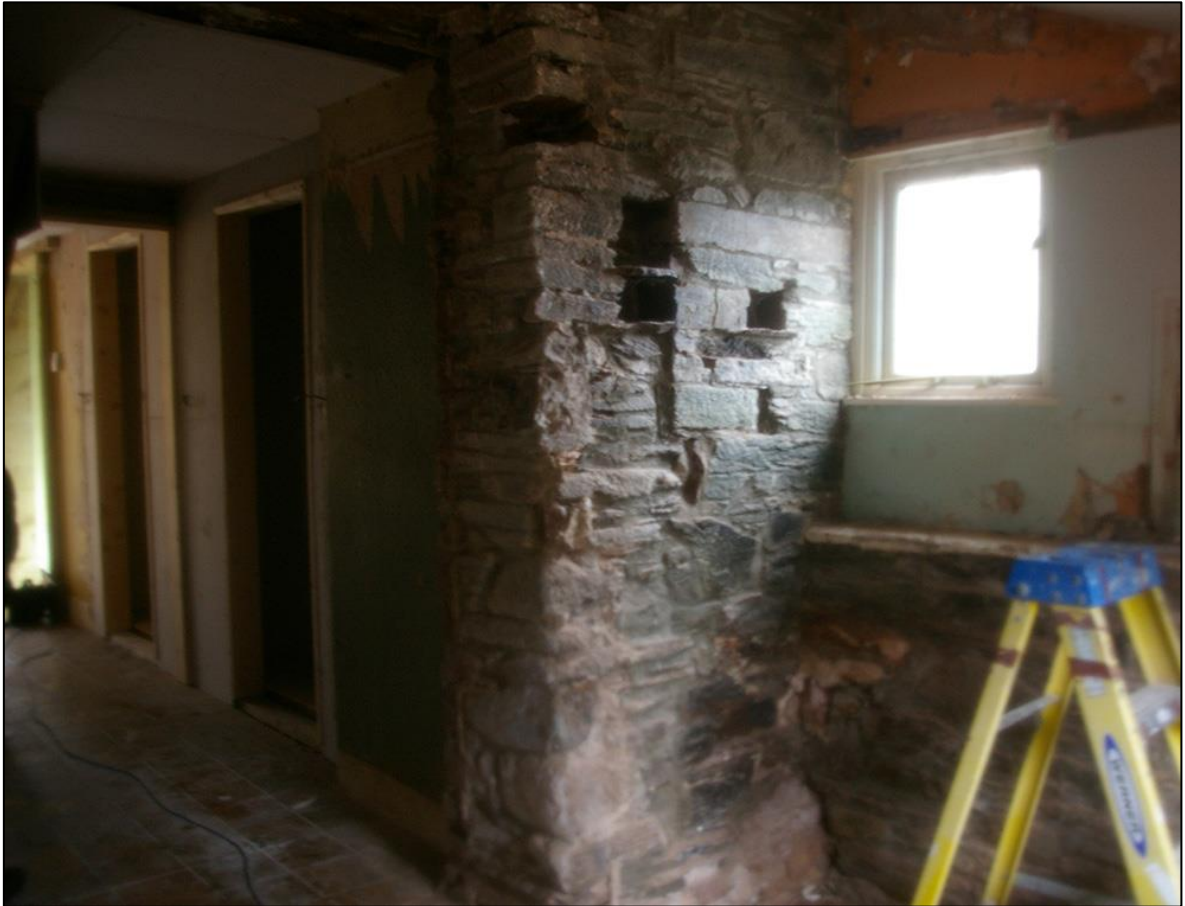
FIGURE 6: THE SHORT LENGTH OF GOOD DRESSED AND FACED MEDIEVAL STONEMWORK, WITH ABUTTING HEAVY SLATESTONE RUBBLE AROUND OPENING AND PUTLOG HOLES, REWORKED AS DOVE HOLES, WITHIN THE PROJECTION ON THE SOUTH ELEVATION OF THE FARMHOUSE, NOW ENCLOSED WITHIN THE OUTSHUT; FROM THE SOUTH-WEST.

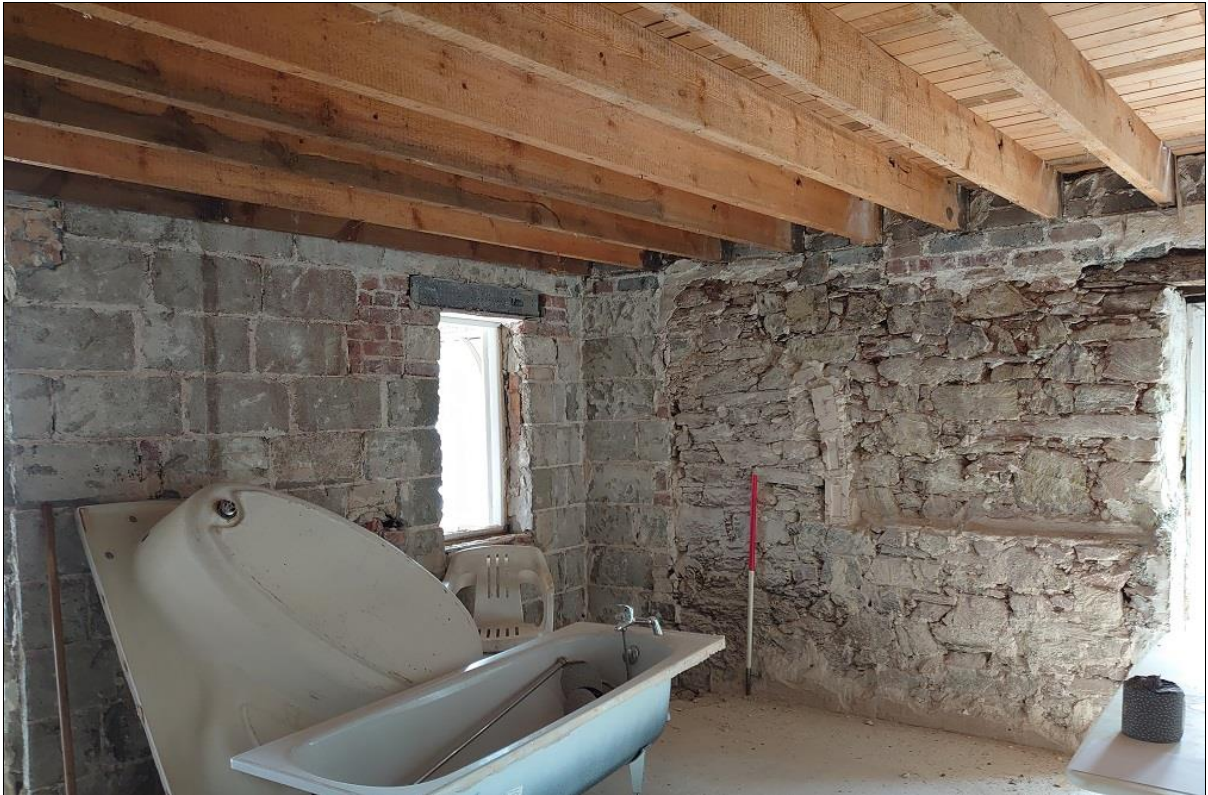
FIGURE 10: THE GROUND FLOOR, BATSON FARMHOUSE, SOUTH WALL, WITH MEDIEVAL AND POST -MEDIEVAL STONE WALLING AND THE CONCRETE BLOCK AND BRICK EAST GABLE, INNER FACE (1M SCALE); FROM THE NORTH-WEST.

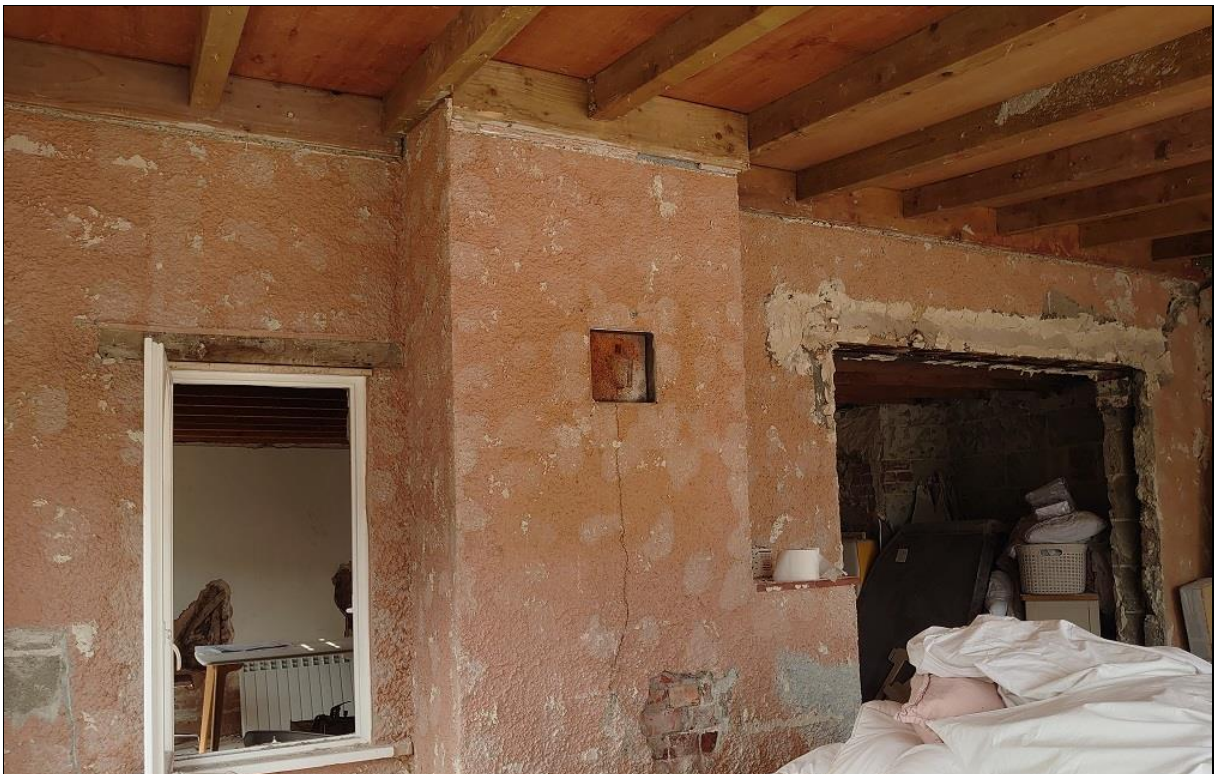
FIGURE 11: THE OUTER FACE OF THE EAST GABLE WITH EARLIER BRICK STACK; FROM THE EAST-SOUTH-EAST.

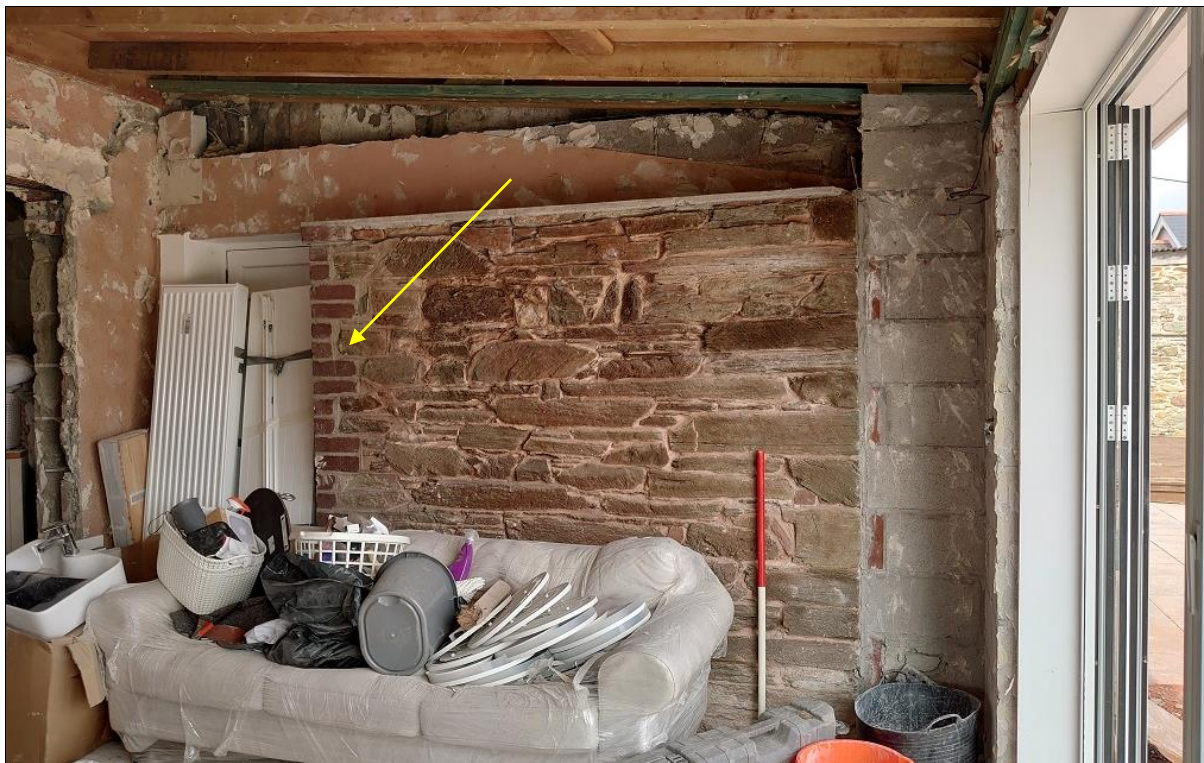
FIGURE 12: THE FRAGMENT OF MEDIEVAL WALLING WITHIN THE CONSERVATORY; 20TH CENTURY BRICK REBUILT REVEALS TO FORCED DOORWAY ARE INDICATED (1M SCALE); FROM THE SOUTH-SOUTH-EAST.

cannot rule out an opening here being contemporary to either the medieval or post medieval phase in this position, even if the reveals have been rebuilt. The blocking of this doorway will therefore pose a theoretical risk to the narrative and evidential value of this element of both the standing house and the ruins and historic relationship between these two ranges. It is an inherent minor change to the historic fabric of the heritage asset (group), which would cause less than substantial harm. This effect will, however, only occur if the visible sign of the doorway is lost; therefore, the loss of the doorway could be mitigated by clearly evidencing the blocking and leaving the reveals or build lines, allowing in some regard a visual continuance of the former relationships between the former ranges. This is somewhat achieved by the recessed nature of the proposed stonework which will create a clear visual of a 'blocked doorway'. This will echo the many other blocked openings within the current house – the main significance of which is derived from its evidential value. This could result in a minor/adverse impact, being reduced to negligible/adverse. Archaeological evidential value loss could be mitigated with a programme of archaeological monitoring during the works, considering a section of medieval wall is to be affected, although the fabric around the opening is modern. It is important to note that the north elevation is the primary façade which now conveys this building narrative value and at present it has two main doors, which lead into the two separate elements of the range, plus this visually recessive secondary door to the east end, which presents as a modern alteration despite its possible historic nature. The primacy of the relationships between the two elements, the yard and each other is communicated via the 'two front doors'; there would therefore be minor element of cumulative impact from multiple additions or moving of doors creating changes in this key aspect of this façade.

Slight/adverse effect on narrative and evidential value (archaeological interest) of the assets (inherent change to historic fabric) and the total loss of a doorway, but retention of medieval walling. This would have a limited but real effect on the narrative that the standing house and ruin were once formerly attached. Mitigations could be considered which would reduce this impact to negligible.

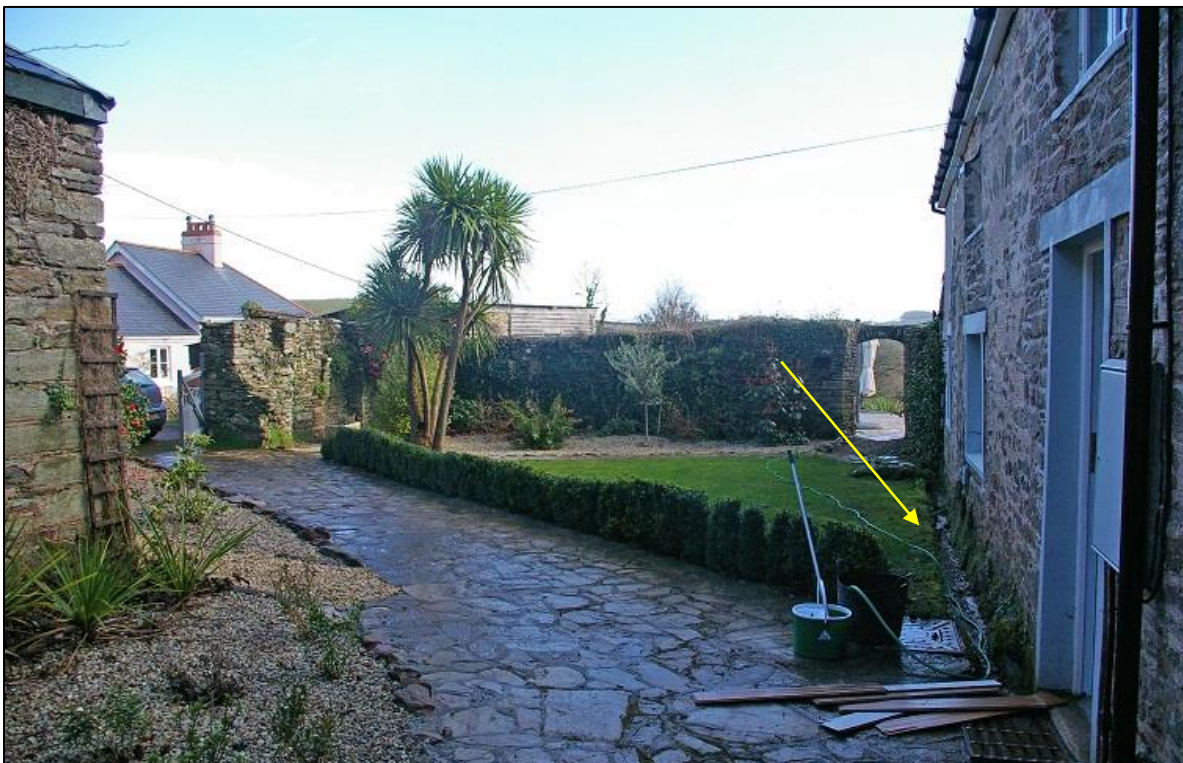
FIGURE 13: THE COURTYARD TO THE NORTH OF THE HOUSE FORMED BY THE VARIOUS MEDIEVAL RUINED WALLS, SHOWING 20TH CENTURY CONCRETE-LINED GULLY, EXCAVATED AGAINST THE WALL OF THE HOUSE DUE TO GROUND LEVEL INCREASES, WITHIN THIS SPACE; PHOTO APRIL 2022.

A new drainage gully will replace the original 20th century concrete and brick structures which attempted to carry water away from the building; the nature of the site being an adapted ruin many areas of external ground are now higher than the interior floor levels. Repairs and remodelling are considered necessary change, as the damp ingress is one of the many issues which would over time threaten the structure of the Listed *standing building* part of the overall asset; addressing this is therefore beneficial to the condition of the overall heritage asset. A test area of excavation, examining the make-up of the ground in the yard, for drainage information gathering purposes, found a well-preserved 17th century cobbled yard surface approximately 0.35m below the modern grass lawn and flower beds. The overburden of soil and most of the landscaping in this area, is therefore of low archaeological interest but the cobbled yard surface and any deposits below will be of high (untested) archaeological interest, presumably undisturbed since the 1600s; the yard defined as an area of *high archaeological potential*. The depth of build-up in this area, also highlighted the need for better drainage. It also clarifies where the archaeological sensitive layers are, within this yard and how the gully may interact with them; any works associated with altering the gully could be practically mitigated through a programme of archaeological monitoring and recording during works and conditioned through the planning system.

Slight/adverse effect on evidential/archaeological value (archaeological interest) of the assets when the gully is remodelled and represents the potential total loss of already damaged areas of the cobbles, of likely low value, as a collateral effect of the excavation and replacement of 20th century fabric but associated with a finer widespread floor of archaeological interest. This would have a limited but real effect on conservation values but would also ensure the condition of the building over time (inherently beneficial to the heritage asset) and mitigations could be considered which would reduce this impact to negligible and may even provide public value/interest through information gathering on the important early phases of this site, with a possible outcome of slight/beneficial, after reporting.

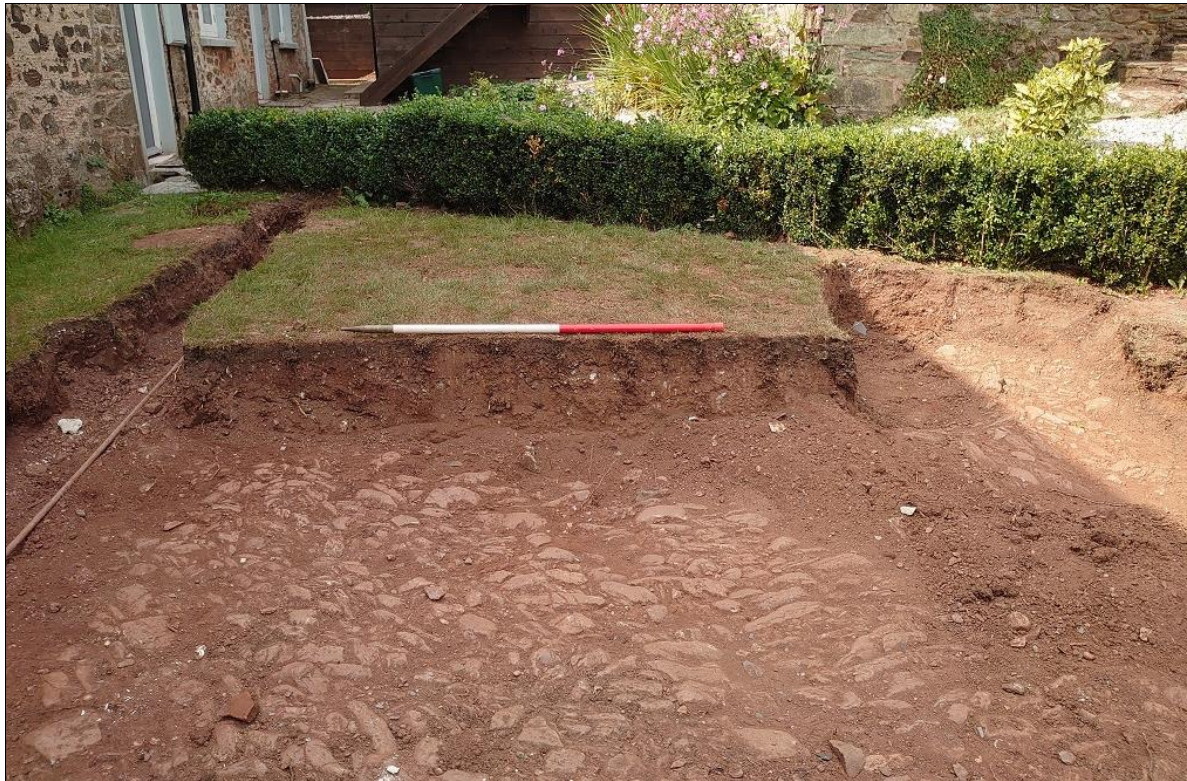
FIGURE 14: HISTORIC GROUND SURFACE IN NORTH YARD OF BATSON FARMHOUSE AND COTTAGE, EXPOSED BY TEST EXCAVATION AND EXPOSURE OF SERVICE LINE, HIGHLIGHTING THE POST MEDIEVAL BUILD UP WITHIN THE COURTYARD, OVER 17TH CENTURY COBBLES (1M SCALE); FROM THE EAST.

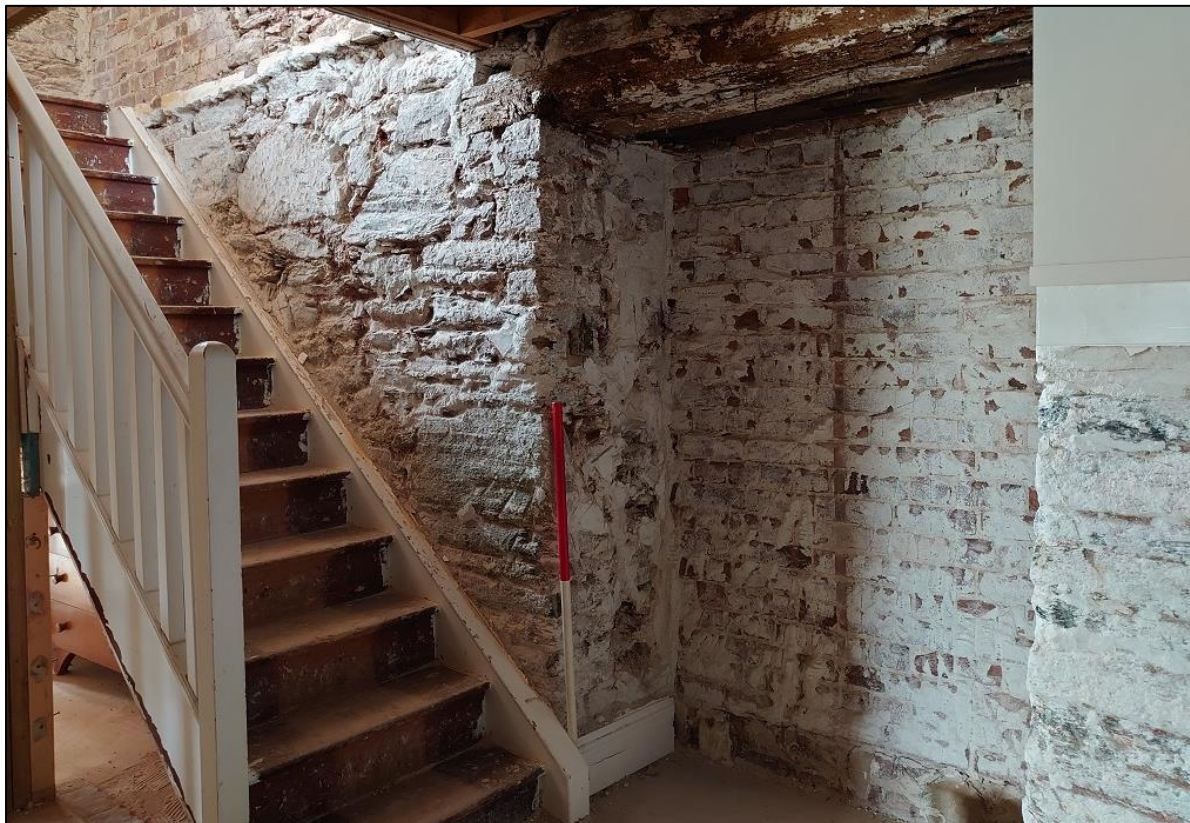
FIGURE 15: THE BLOCKED DOORWAY BETWEEN THE COTTAGE AND MAIN FARMHOUSE, BLOCKED WITH 19TH CENTURY BRICKWORK (1M SCALE); FROM THE NORTH-EAST.

There is a large, low blocked doorway opening between the main house and cottage, within the cross-passage space. This informs the narrative of the Cottage being a 19th century extension, possibly remodelling or incorporating earlier remains, having replaced a service end or barn. This blocked doorway is proposed for reopening, removing the brick infill, which is of 19th century or even early 1900s date. The infill is of limited, low heritage value; its value is derived from its minor contribution to the narrative of the whole range, suggesting connection between the farmhouse and cottage, which was then stopped when the cottage presumably became a separate dwelling. Loss of this division will inherently adversely affect the narrative (loss of phasing and historic fabric), which is a minor/negligible change to the heritage asset as a whole. This is considered less than substantial harm. There is also an opportunity to monitor the removal which may bring dating evidence to light.

There isn't expected to be a quantifiable heritage impact here as the nature of the thick medieval fragment of wall between the farmhouse and cottage and the awkwardness of the two spaces within the range will remain, protecting the overall narrative of the asset to some extent: **Slight/adverse** impact.

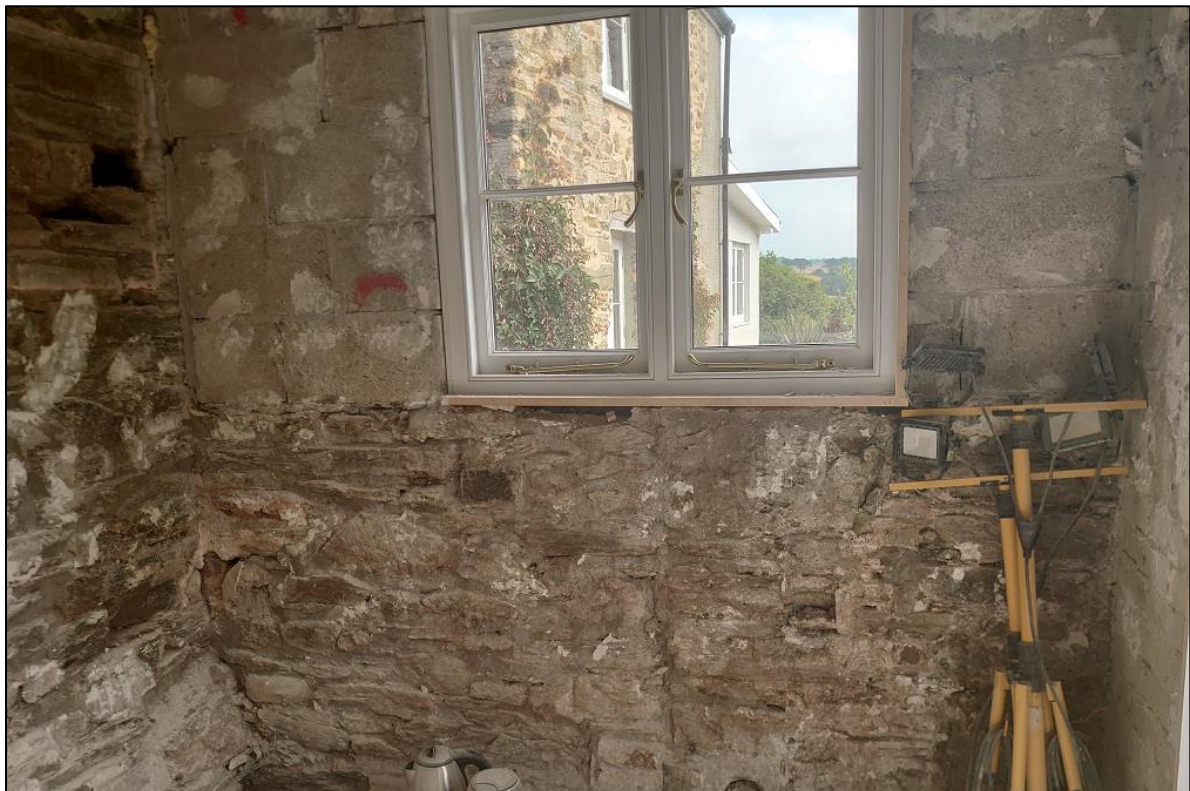
FIGURE 16: THE EAST WALL OF THE PORCH, SHOWING POST MEDIEVAL STONEMASONRY AND CONCRETE BLOCK MODERN RAISE TO THE WALL, WHICH IS PROPOSED FOR REMOVAL; FROM THE WEST.

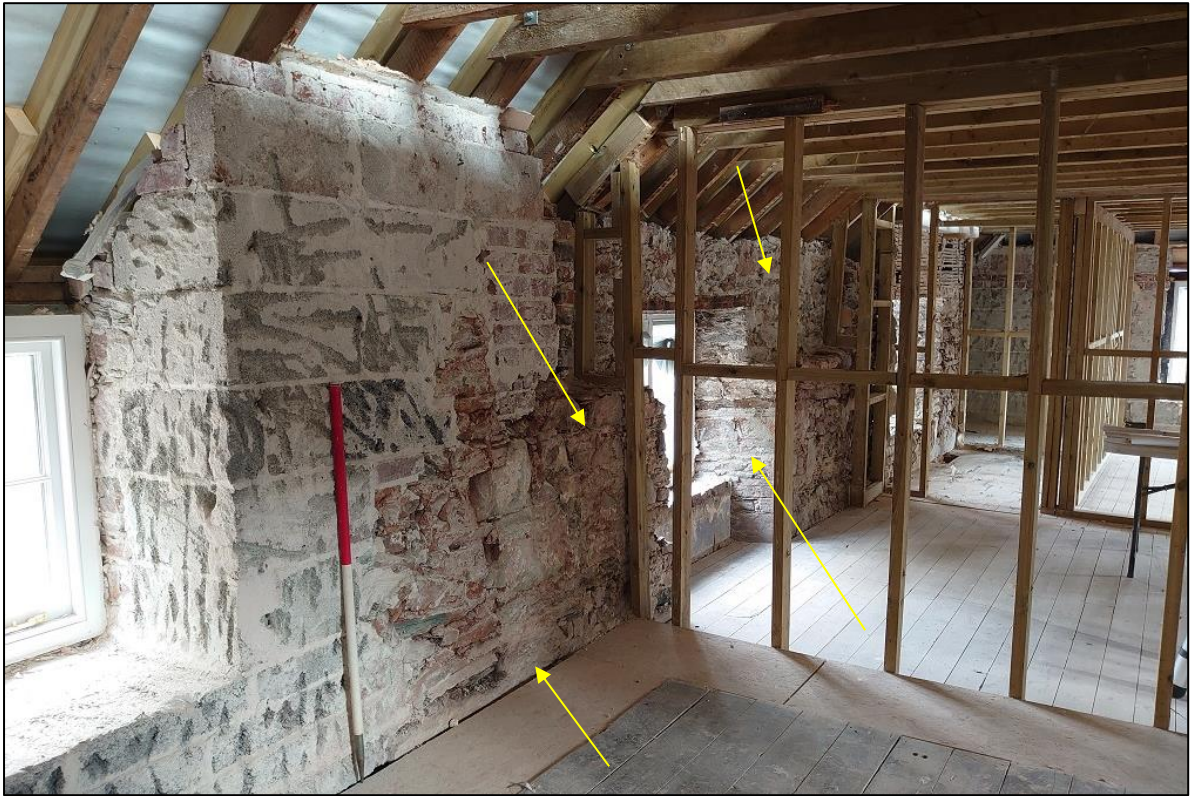
FIGURE 17: THE NORTH WALL OF THE FARMHOUSE, SHOWING 20TH CENTURY CONCRETE BLOCK, POST MEDIEVAL RUBBLE AND GOOD MEDIEVAL WALLING, IN THE COMPLEX PHASED REMAINS OF THE BUILDING (1M SCALE); FROM THE WEST-SOUTH-WEST.

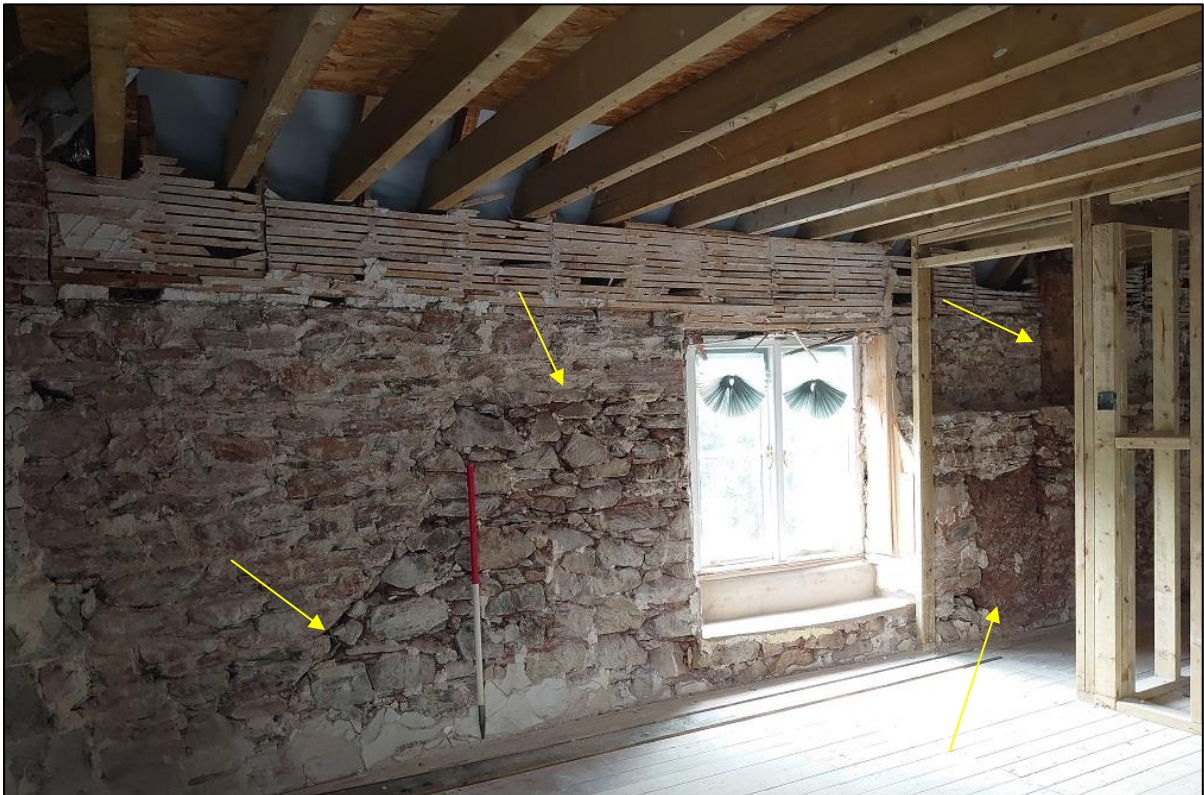
FIGURE 18: THE SOUTH WALL OF THE FARMHOUSE, AGAIN ILLUSTRATING THE COMPLEX PHASING OF THE WALLS (1M SCALE); FROM THE NORTH-EAST.

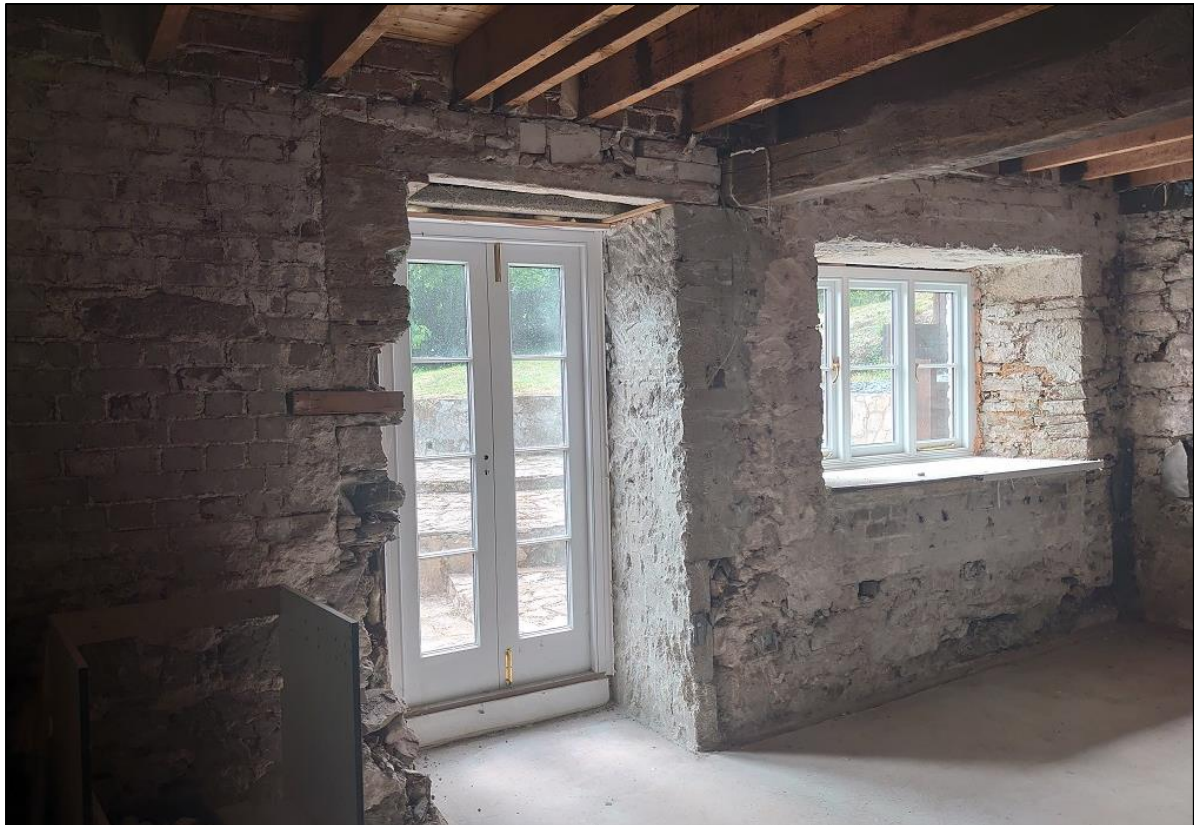
FIGURE 19: THE SOUTH WALL OF THE COTTAGE, WITH MEDIEVAL STONEMWORK, POST MEDIEVAL RUBBLE AND 19TH CENTURY BRICKWORK, INFILLING THE EARLIER WINDOW; FROM THE NORTH-EAST.

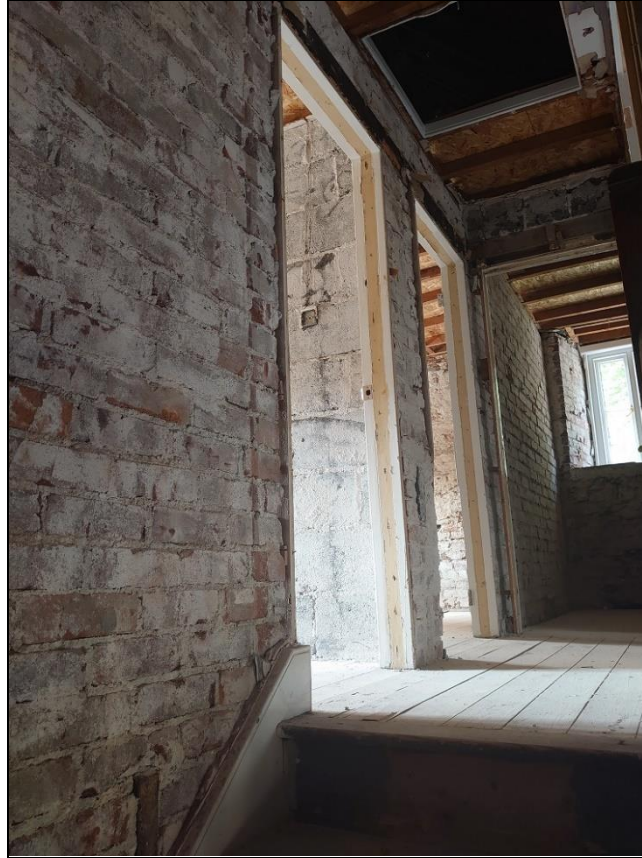
FIGURE 20: THE FIRST FLOOR, MUCH ALTERED BRICK PARTITIONS ON THE FIRST FLOOR OF THE COTTAGE; FROM THE EAST-NORTH-EAST.

There is a cumulative consideration here, in light of the layout changes to the ground floor, changes to a door on the south wall and the removal of the dormers on the first floor and access being opened up to the main range. This has the potential to wipe away the ‘story’ of the cottage as a separate dwelling. **Moderate Adverse** impact on the cottage from these proposals.

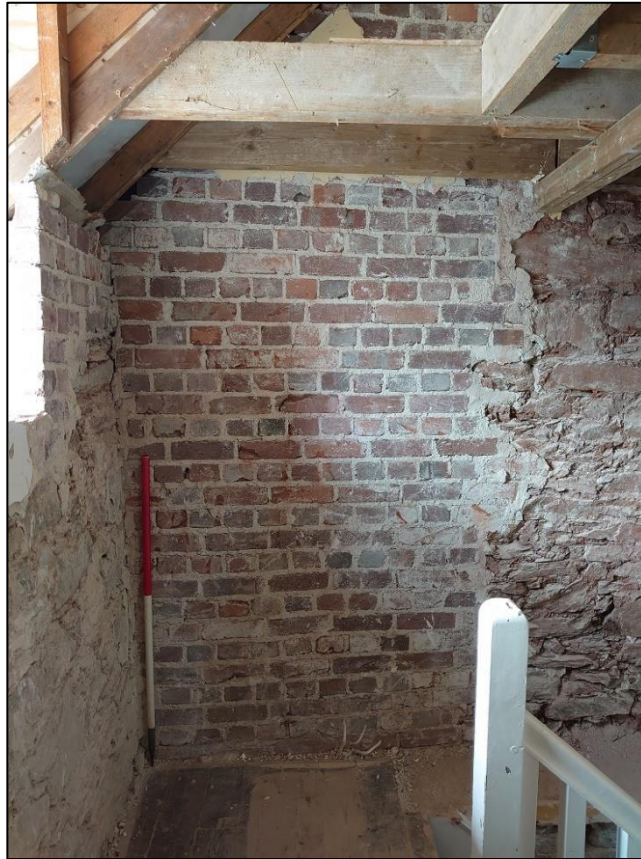
FIGURE 21: THE REBUILT BRICKWORK TO THE SOUTH OF THE CENTRAL PARTITION WALL BETWEEN THE FARMHOUSE AND COTTAGE , OF 19TH CENTURY DATE, (1M SCALE), FROM THE EAST.

The wall to the south of the stack is built in brick, repairing earlier failed/ruined stonework, or reflective of the 19th century changes, possibly the loss of a stair turret here. Removing this brick will not have a significant effect on the wider asset, being a minor change, but will again reflect the inherent loss of some low value historic fabric. This opening up of the cottage to the main farmhouse will again affect the narrative of the two being separate dwellings, weakening the evidential value the wider asset contains to be able to convey this narrative and once again

This is a minor change, with **Slight/adverse** impact in its own right but cumulatively it adds to the heritage fabric losses sustained in the cottage-element of the linear range.

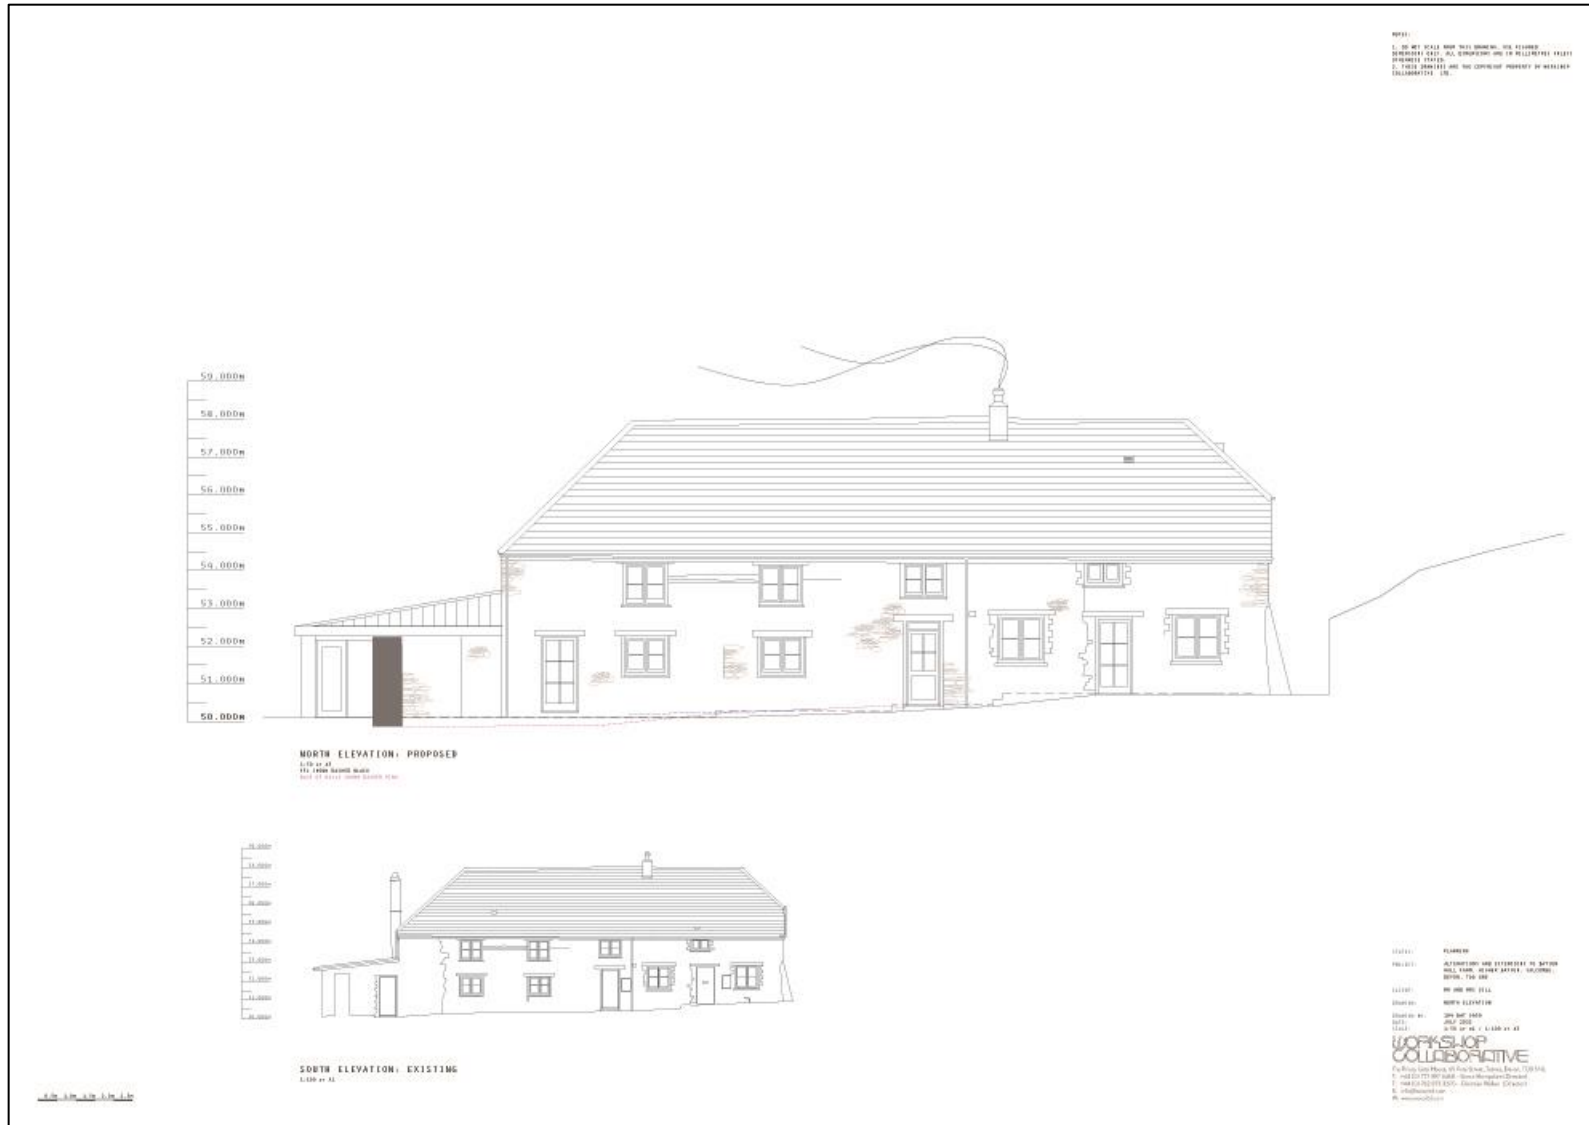
FIGURE 22: THE NEWLY PROPOSED NORTH ELEVATION (AS SUPPLIED BY AGENT AUGUST 2022).

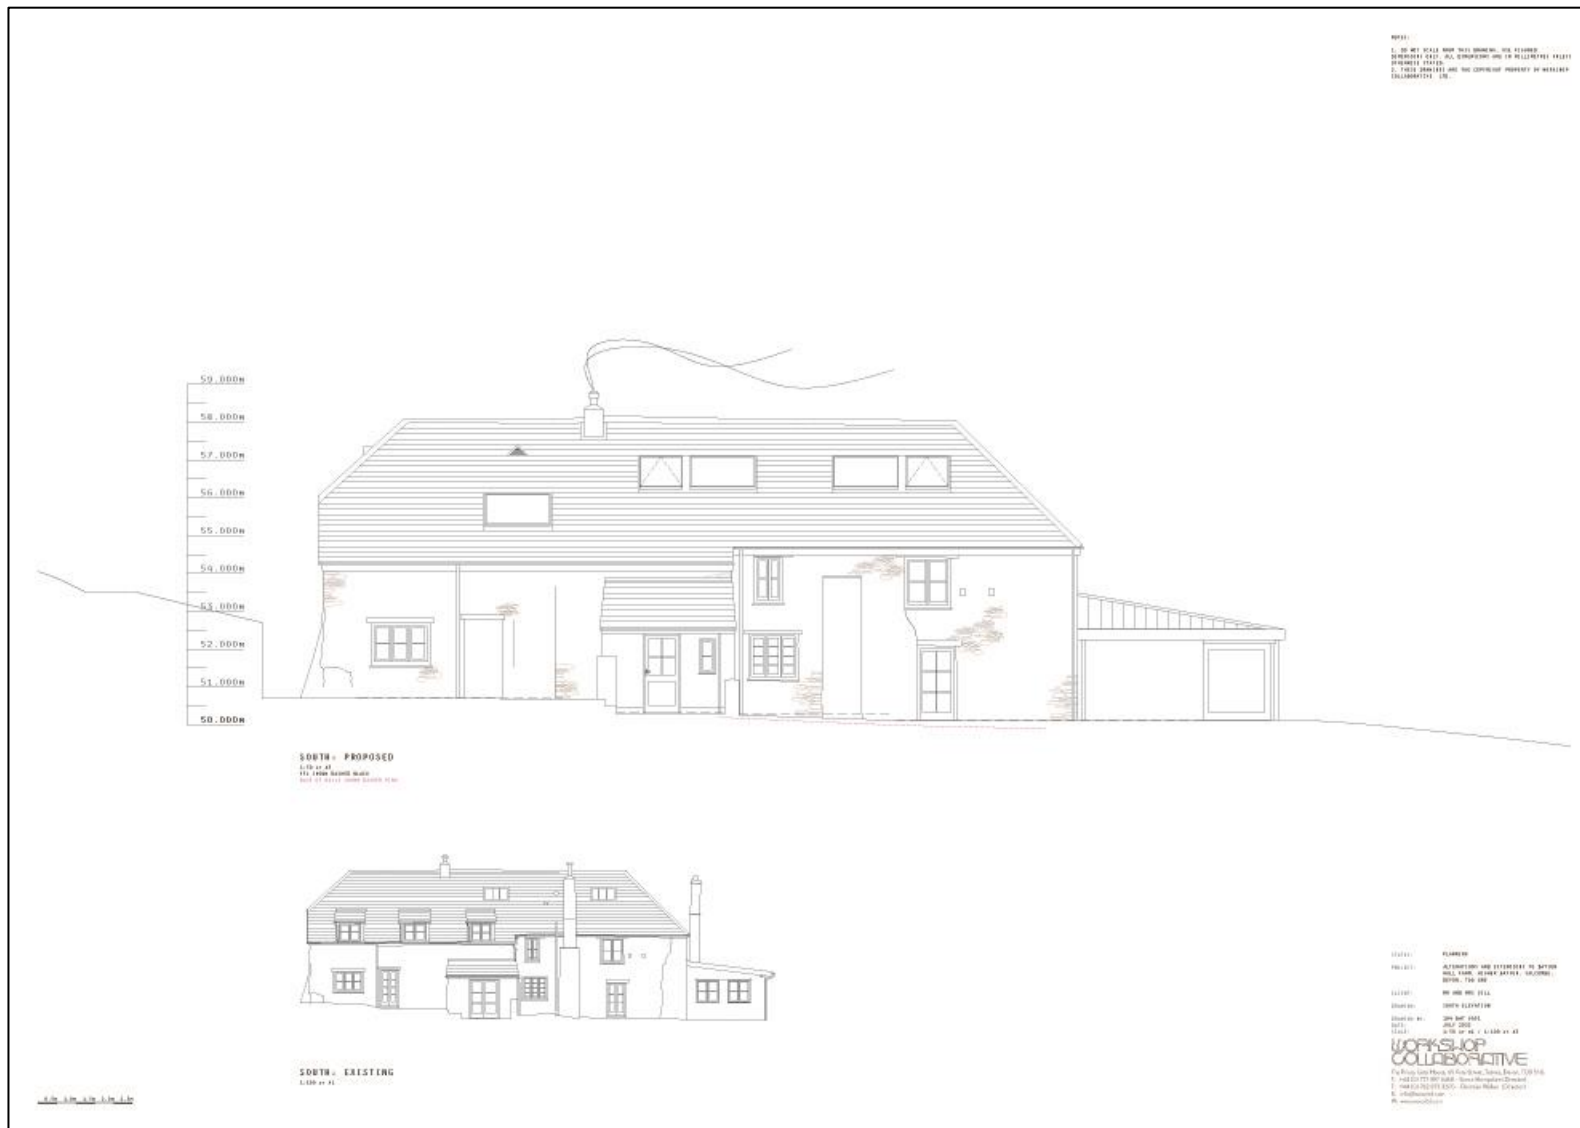
FIGURE 23: THE SOUTH ELEVATION OF BATSON HALL, AS PROPOSED (SUPPLIED BY AGENT AUGUST 2022).
