BATSON HALL FARM

Updated - Heritage Impact Assessment – House and Cottage 2022

South West Archaeology Ltd. report no. 220614

Batson Hall Farm, Batson, Salcombe, Devon

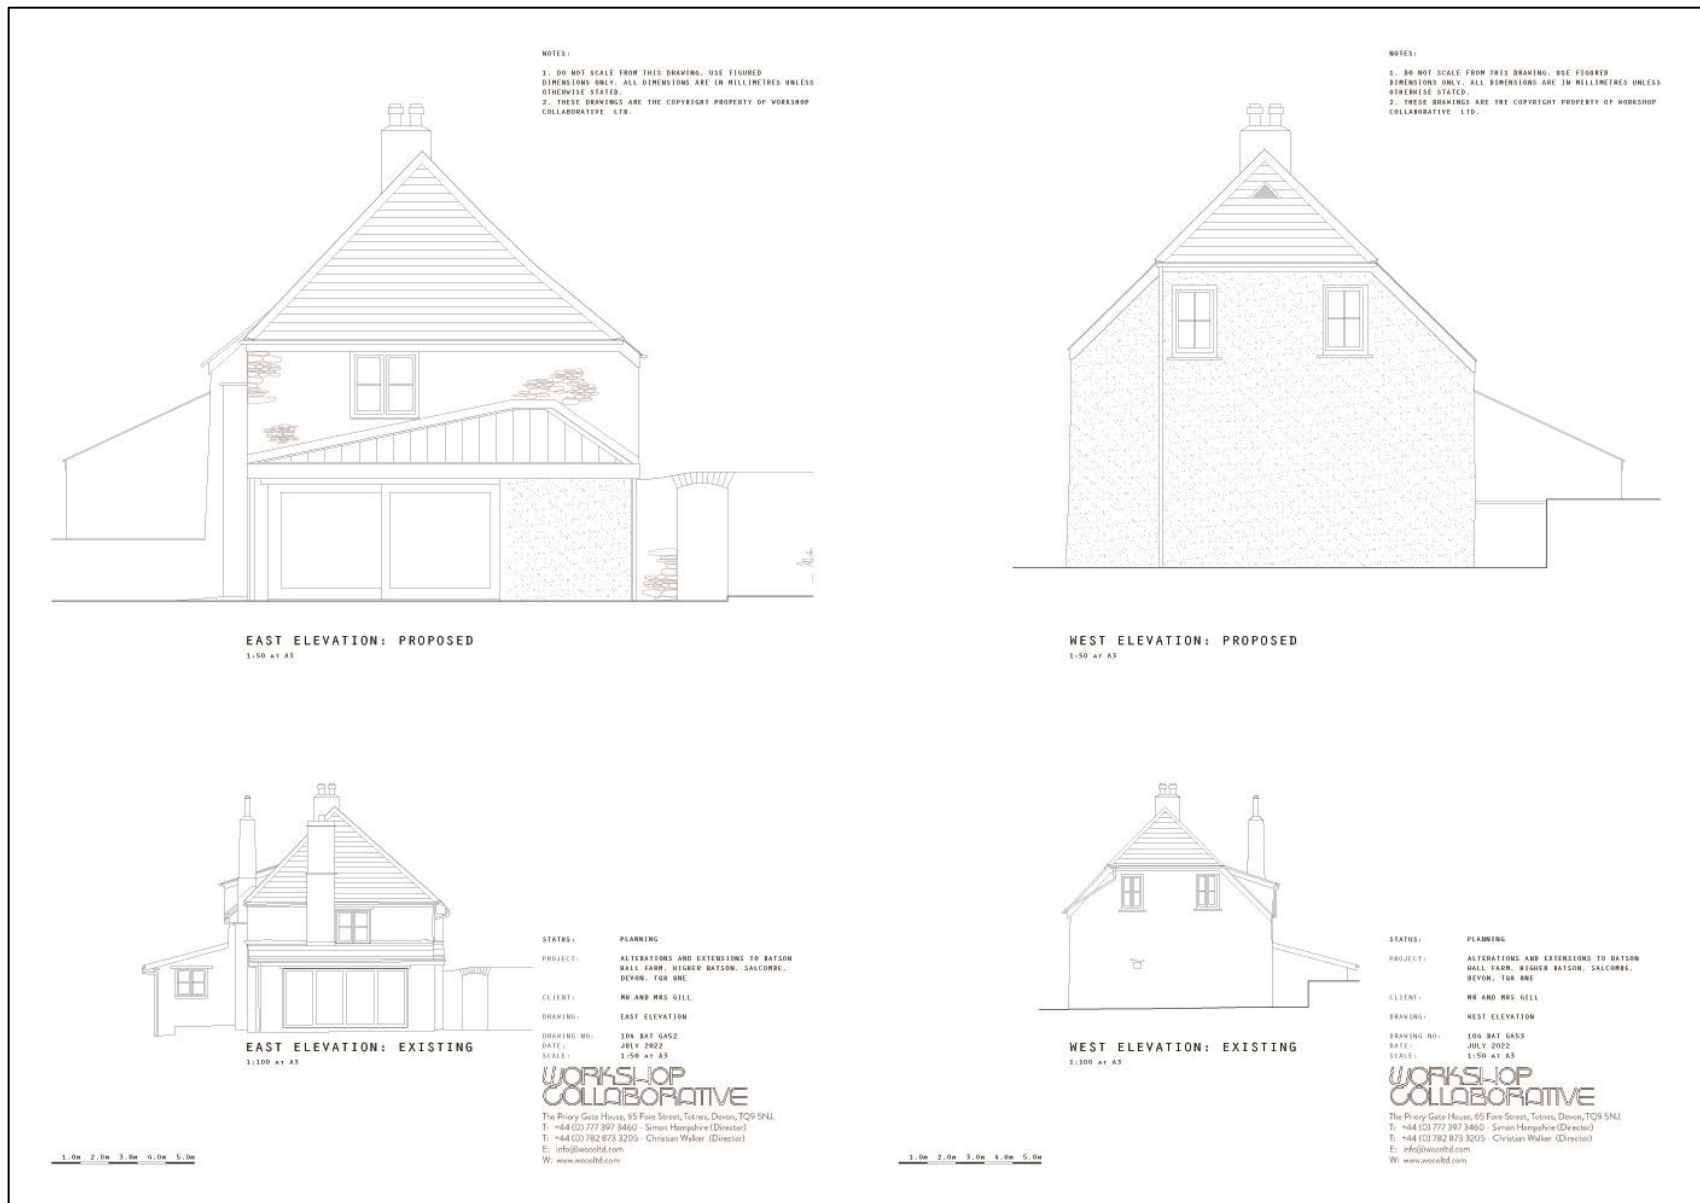
FIGURE 24: NEWLY PROPOSED GABLE ENDS OF THE BUILDING (AS SUPPLIED AUGUST 2022 BY THE AGENT).

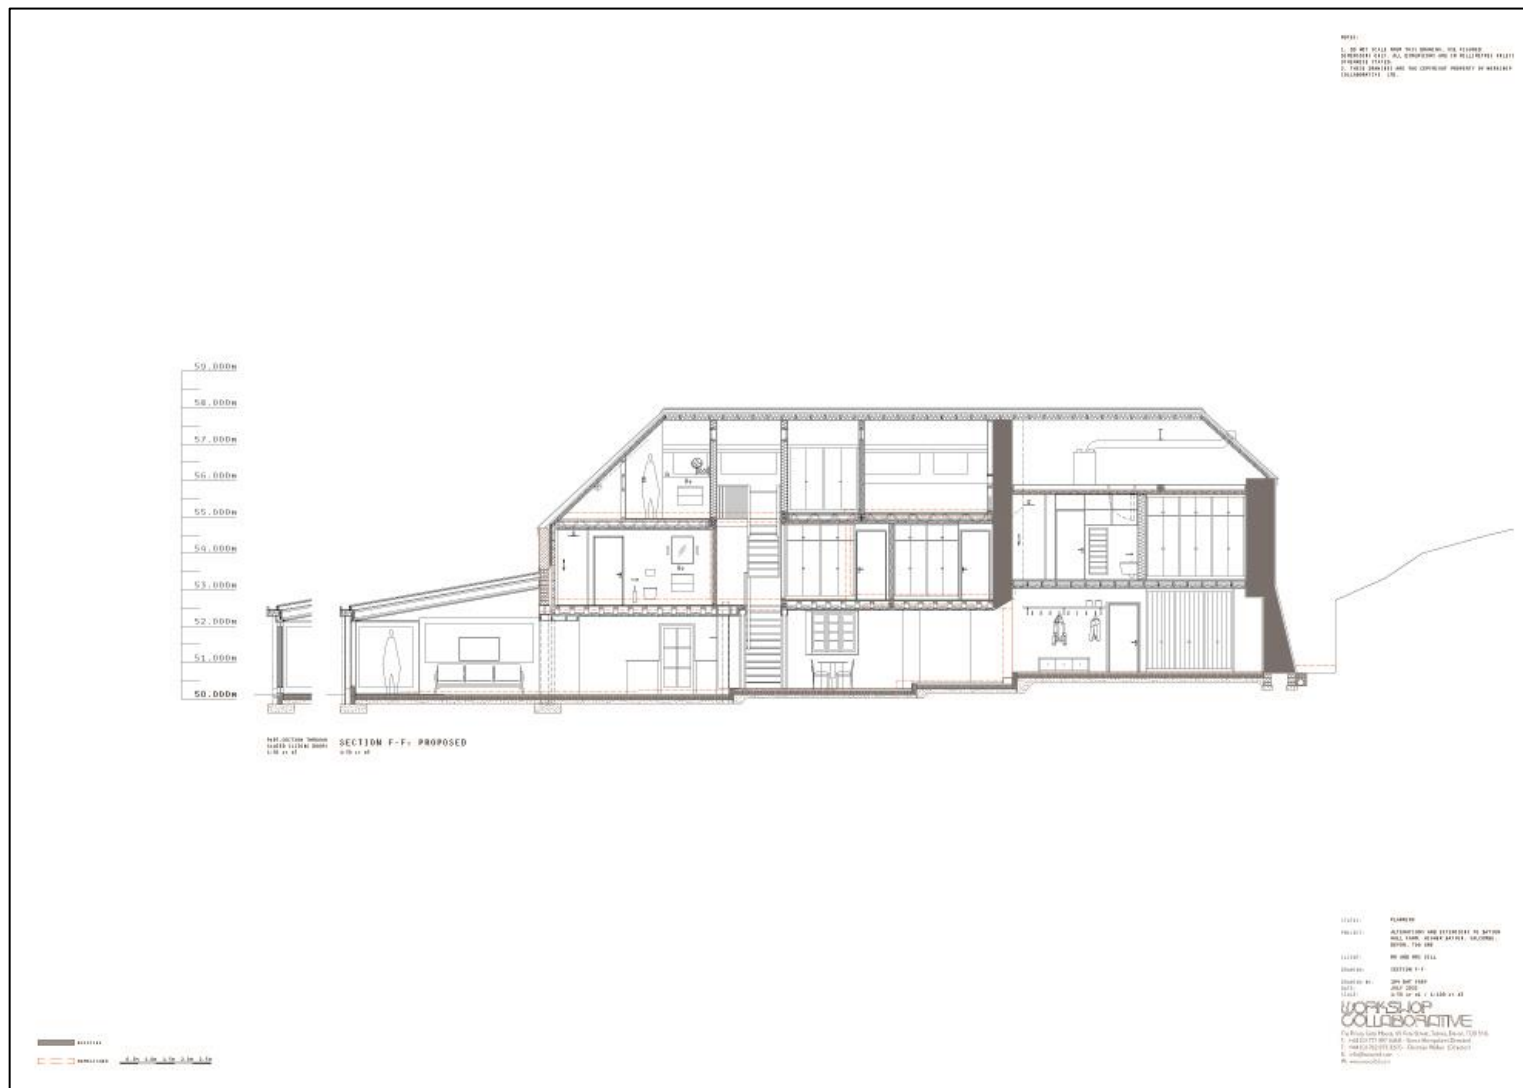
LONG SECTION THROUGH THE BUILDING ON AN EAST-WEST AXIS.

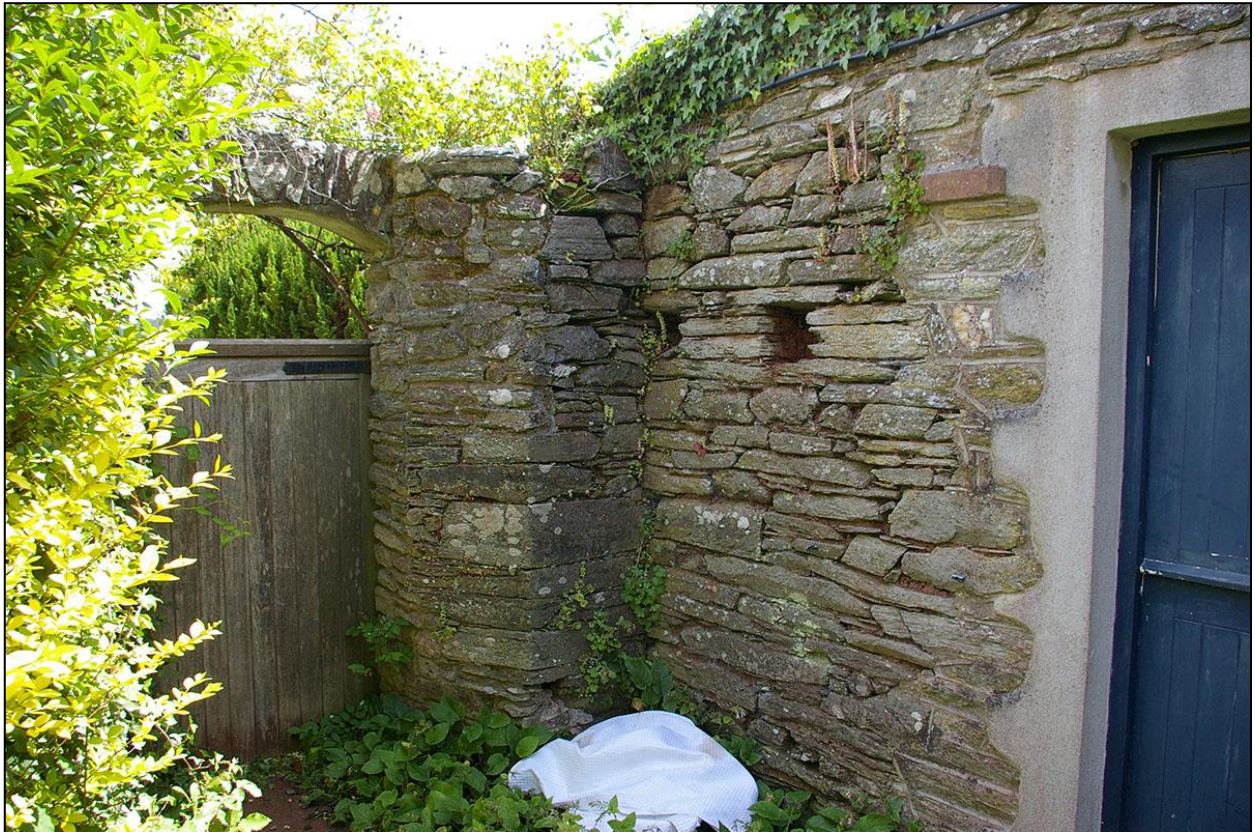
3. ONE OF THE OLDER SECTIONS OF WALLING INCORPORATED INTO THE FARMHOUSE AT THE EAST END, ATTACHED TO THE GARDEN WALL; FROM THE NORTH-WEST.

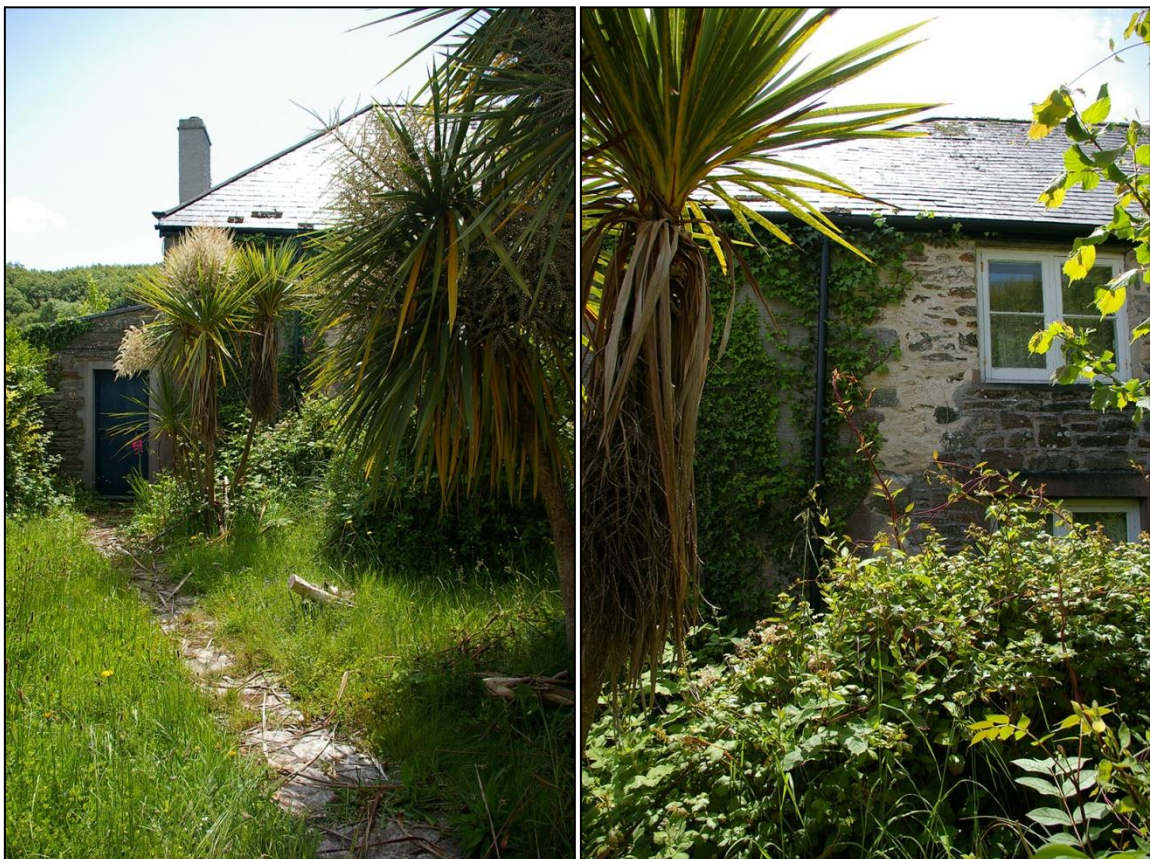
4. LEFT: THE LEAN-TO WITH AN OLD SECTION OF WALLING WHICH THE CONSERVATORY ABUTS FROM THE SOUTH SIDE; FROM THE NORTH, NORTH-WEST. RIGHT: THE RENDERED NORTH-EAST CORNER OF BATSON HALL FARM AND THE BADLY REPOINTED STONERWORK WHICH PARTLY OBSCURES A SET OF QUOINS, AT LEAST 1M INTO THE NORTH ELEVATION; FROM THE NORTH.

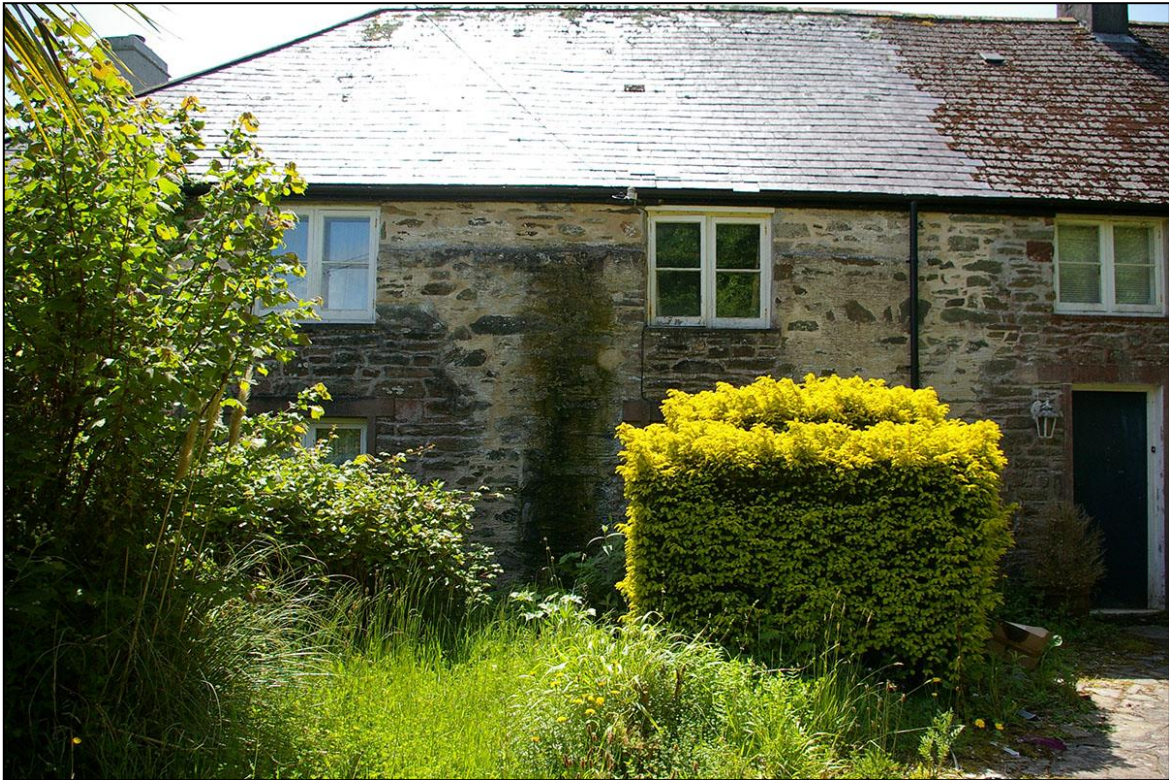
5. DETAILED VIEW OF THE THICKER LOWER SECTION OF WALLING WHICH DOMINATES THE NORTH FRONT OF THE FARMHOUSE, AT THE EAST END, THE REMAINS OF A RUINED EARLIER BUILDING; FROM THE NORTH.

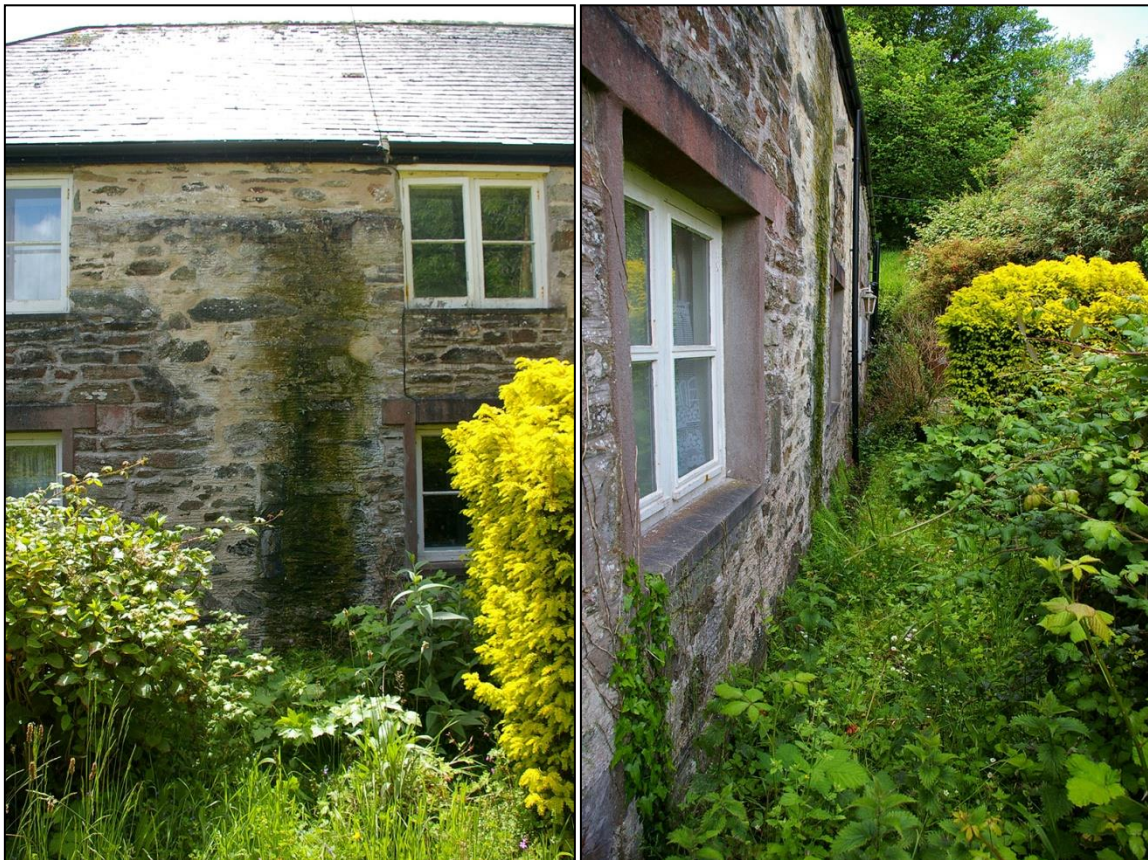
6. LEFT: DETAIL WITHIN THE RUINED WALL INCORPORATED INTO THE BUILDING SHOWING A POTENTIAL SET OF RAGGED LARGE SLAB QUOINS AND ALSO A POTENTIAL BLOCKED OPENING AT GROUND FLOOR; FROM THE NORTH. RIGHT: VIEW ALONG THE FRONT OF THE BUILDING, SHOWING HOW THE RUINED SECTION OF WALL IS ANGLING OUTWARDS QUITE CONSIDERABLY AND HOW THE ALIGNMENT OF THE RANGE CHANGES; FROM THE EAST.

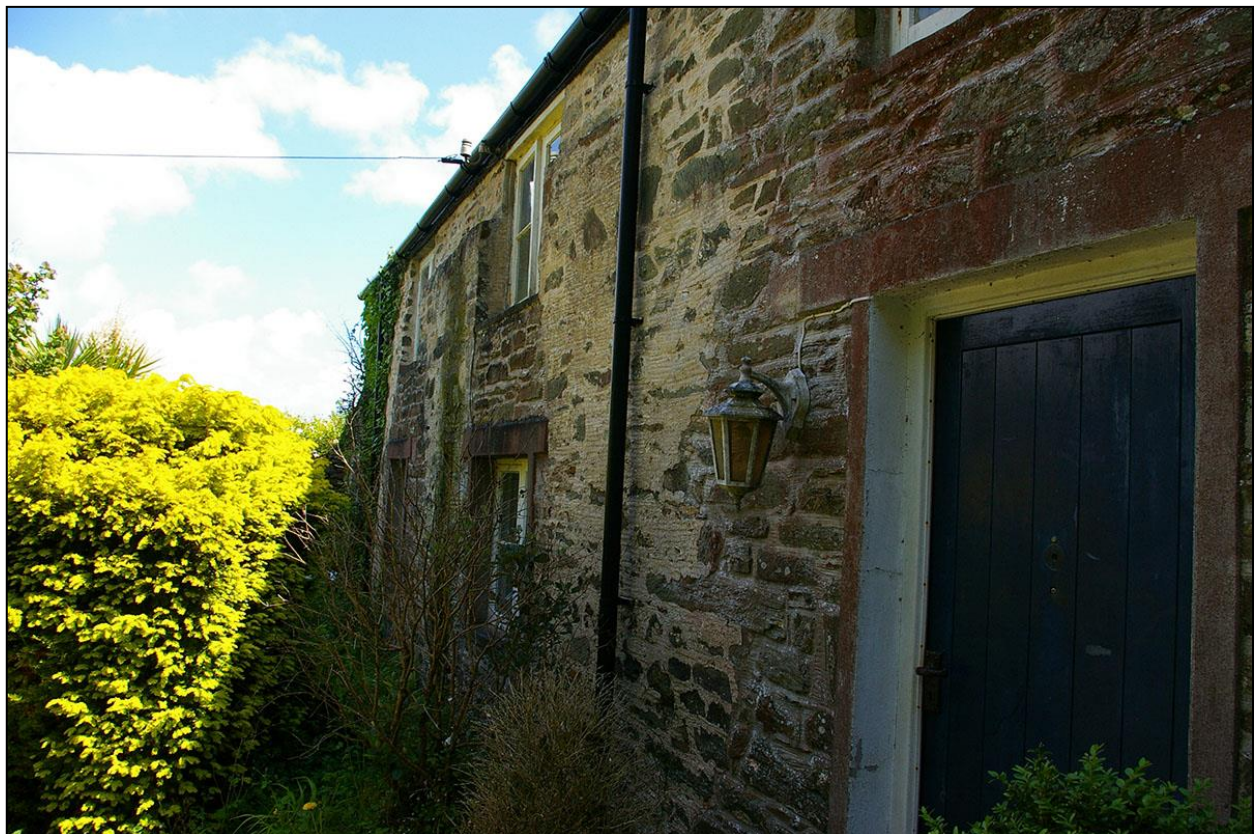
8. WIDER ANGLED VIEW SHOWING THE INCORPORATED RUINS AND FORCED FRONT DOOR, LEADING INTO THE INTERIOR; FROM THE WEST, NORTH-WEST.

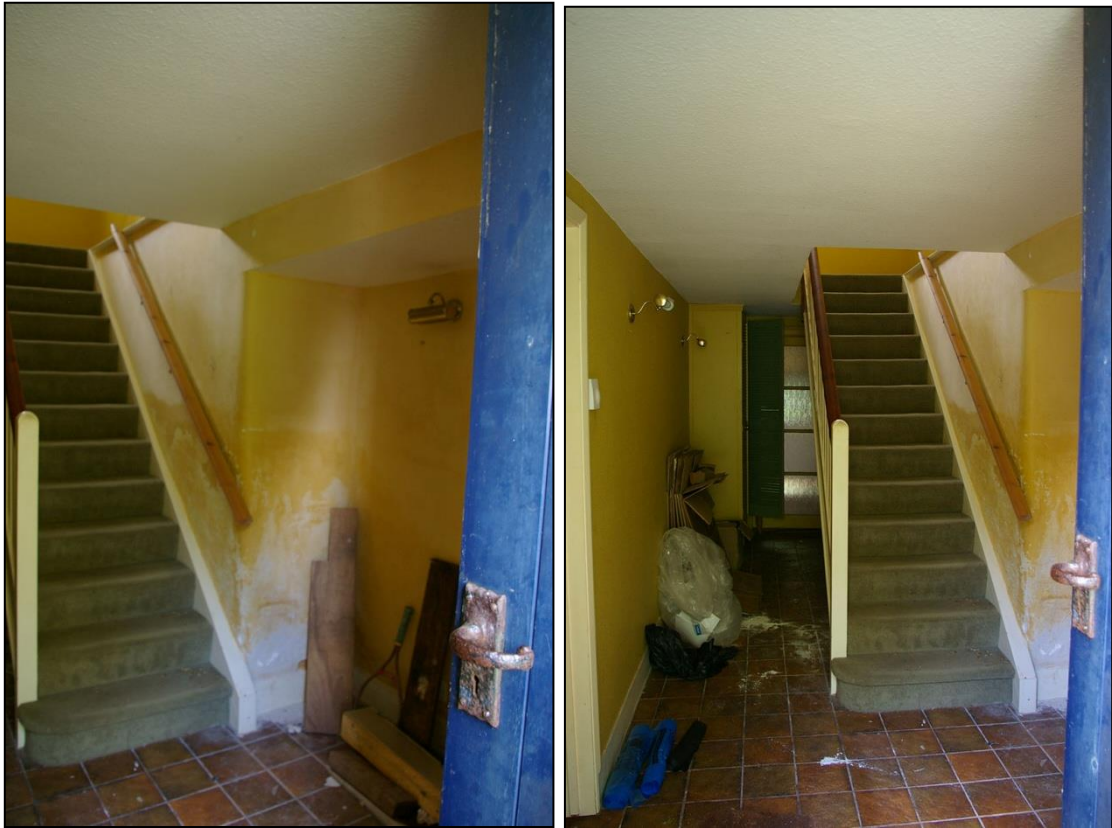
9. LEFT: INTO THE ENTRANCE HALLWAY AND STAIRS, ROOM 1, SHOWING HOW THIS DOOR HAS BEEN FORCED UP AGAINST THE PARTY WALL TO THE COTTAGE, WHICH HAS A LARGE BLOCKED DOORWAY WITHIN IT; FROM THE NORTH-EAST. RIGHT: THE HALLWAY, ROOM 1, ENTRANCE AND STAIRS, QUARRY TILED FLOOR, MODERN PARTITIONS DIVIDING THE SPACE AND PLASTER BOARDED CEILING AND MODERN GLAZED DOORS; FROM THE NORTH.

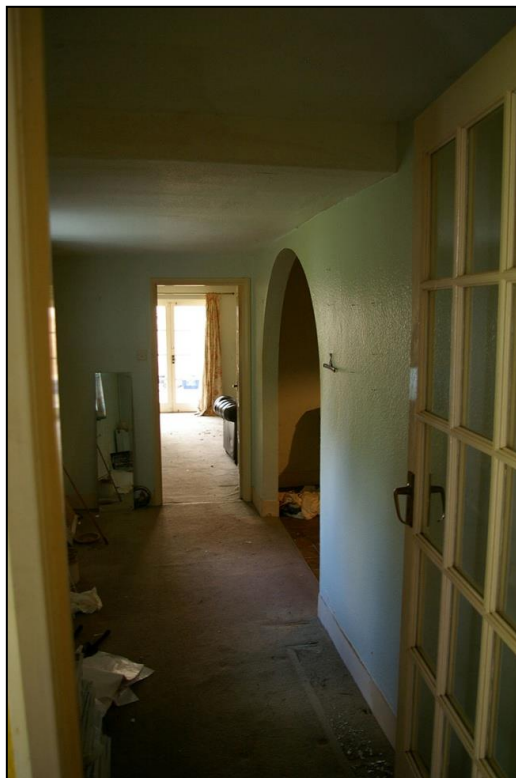
10. VIEW FROM THE HALLWAY INTO THE LOBBY/CORRIDOR CREATED BY ANOTHER MODERN PARTITION AND ARCHWAY, FORMING A FITTED KITCHEN, ALSO SHOWING FURTHER MODERN GLAZED DOORS AND MODERN FITTINGS; FROM THE WEST.

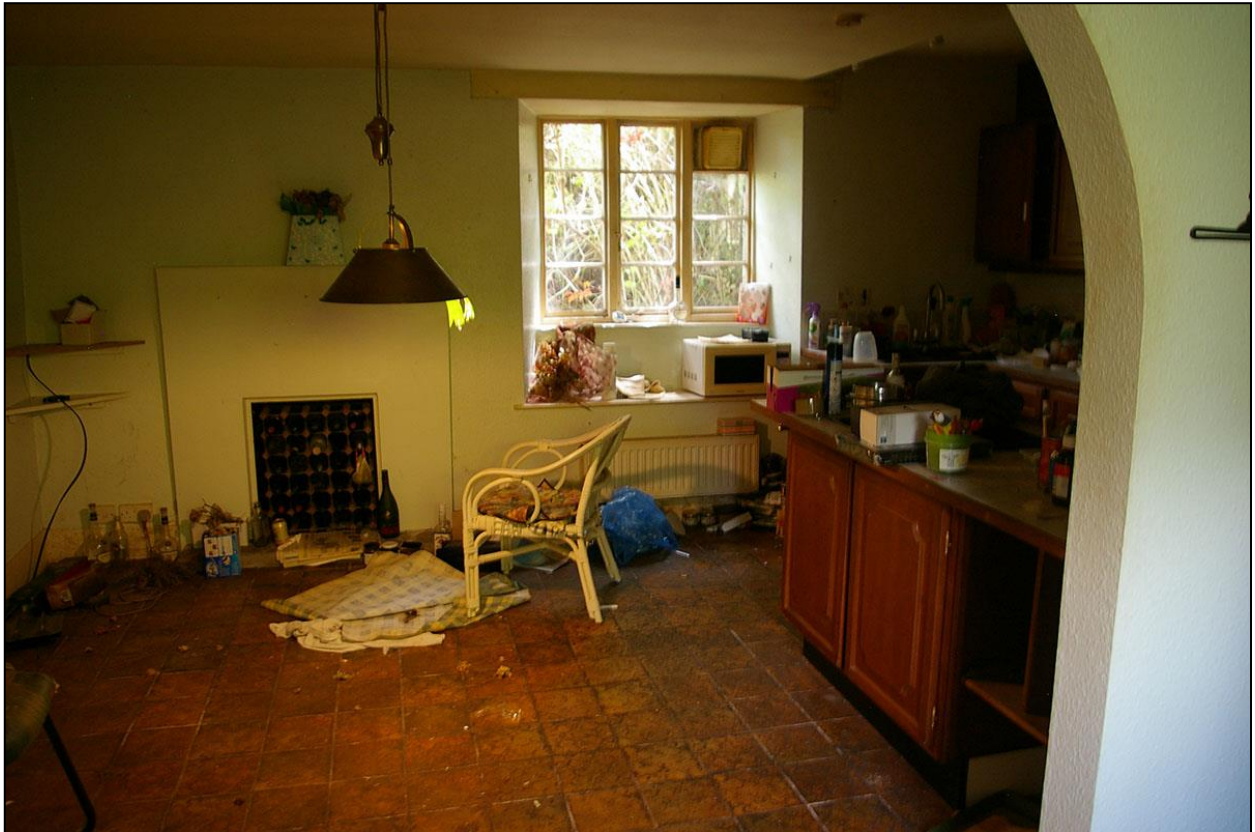
11. THE FITTED KITCHEN, WITH THE THREE LIGHT 19TH CENTURY CASEMENT AND WINDOW SEAT, BLOCKED FIREPLACE ON THE REAR WALL, MODERN QUARRY TILED FLOOR, BOARDED OUT CEILING WHICH OBSCURES A CHANGE IN CEILING HEIGHT; FROM THE NORTH, NORTH-EAST.

The only historic feature viewed in the building was the rear window which lit the former kitchen, a three light 19th century casement with a plank boarded window seat beneath. The north and south walls to the centre, where they contain the medieval fragmentary remains of an earlier range, are significant. There was a much-altered fire grate to the east of the window, with a post medieval stack. In the 2022 works the wall between former kitchen and sitting room was highlighted as a brick/stone rubble partition with timber framing – typical of post medieval alterations, suggestive of changes to layout in this period.

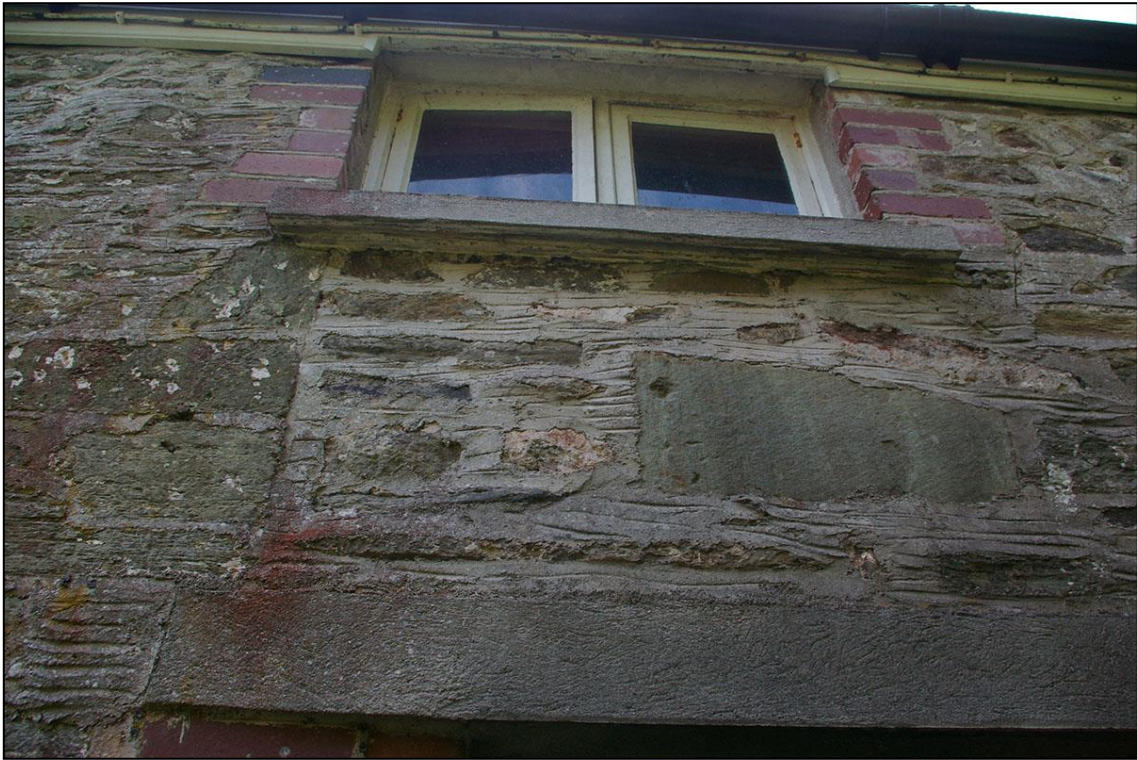
13. THE SMALL BLOCKED WINDOW WITH BRICK REVEALS SET INTO A LARGER OPENING, A LOADING DOOR ABOVE THE FORCED DOORWAY TO THE FRONT OF THE ATTACHED COTTAGE; FROM BELOW (NORTH-EAST).

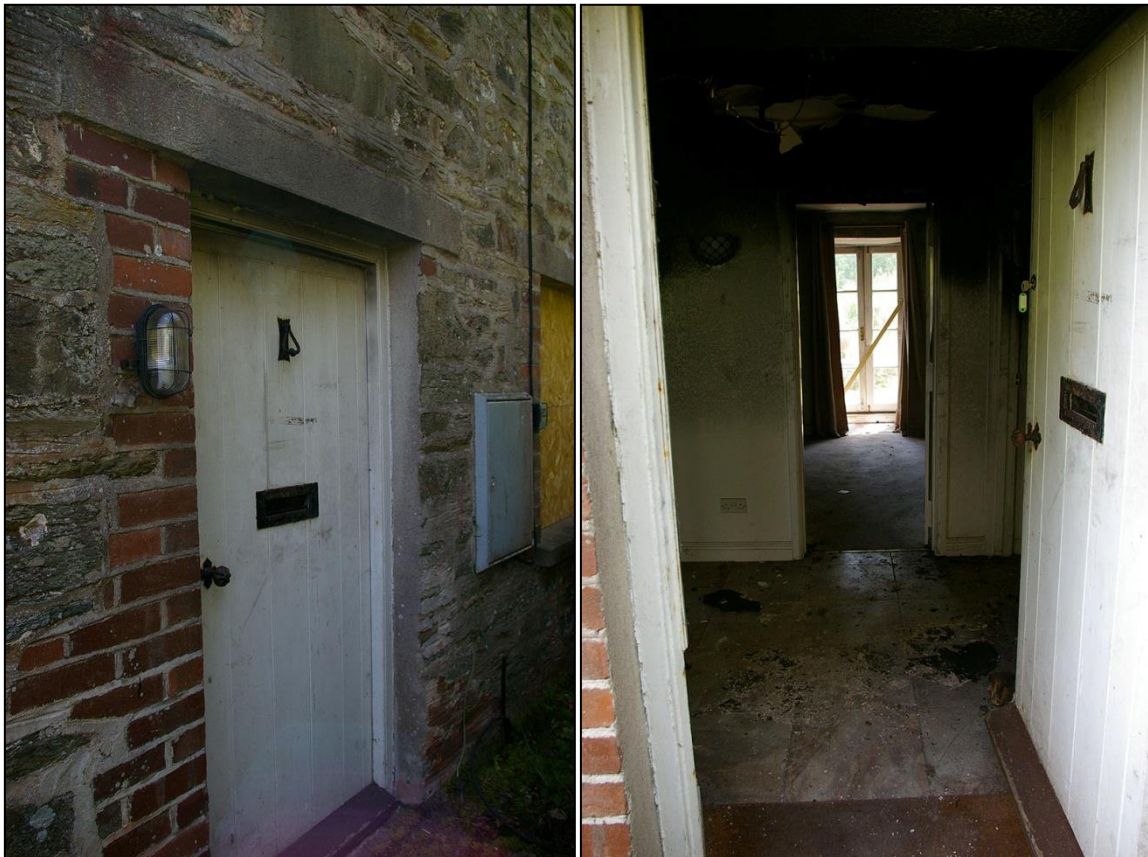
14. LEFT: THE FRONT DOOR TO THE COTTAGE, BRICK PATCHED REVEALS TO THE EAST, CONCRETE RENDER PATCHING TO THE WEST AND RENDERED LINTEL; FROM THE NORTH-EAST.

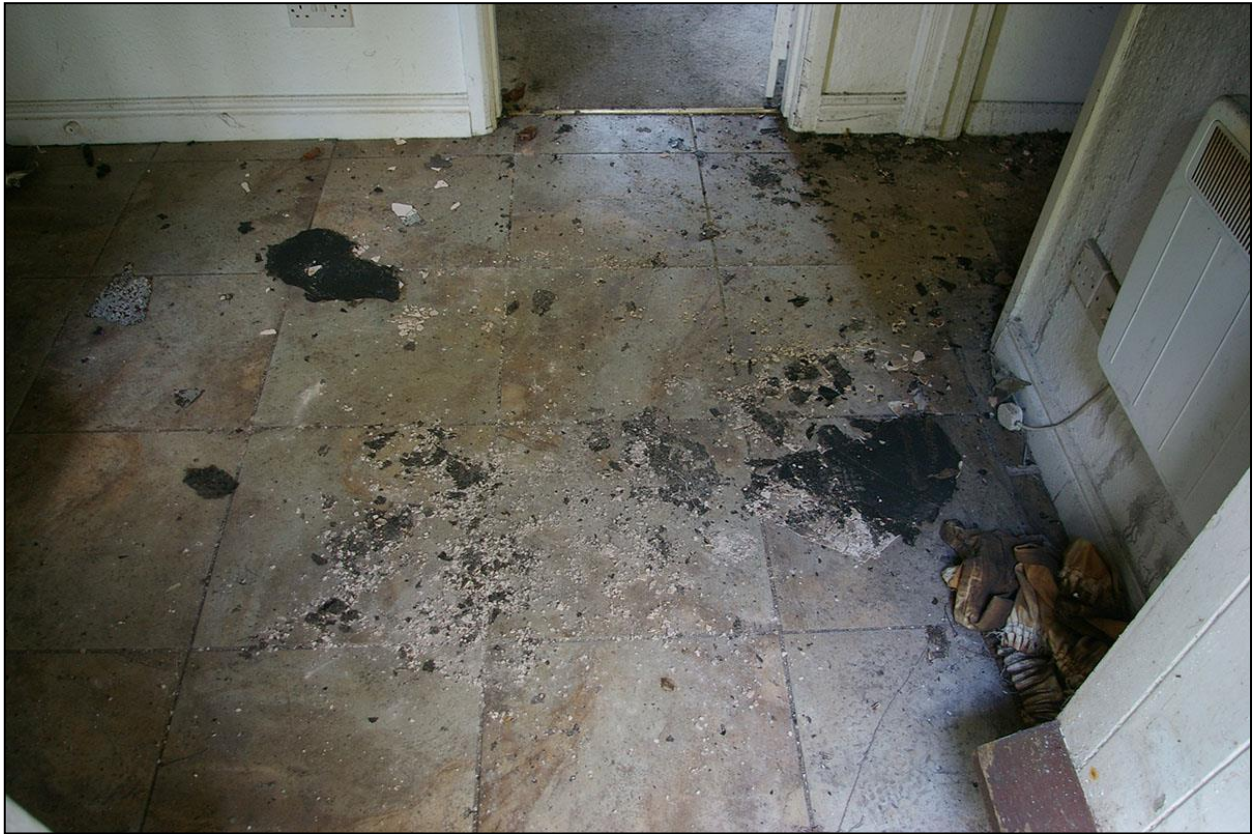
16. VIEW OF THE MODERN STONE TILED FLOOR IN CR1, THE HALLWAY; FROM THE NORTH.

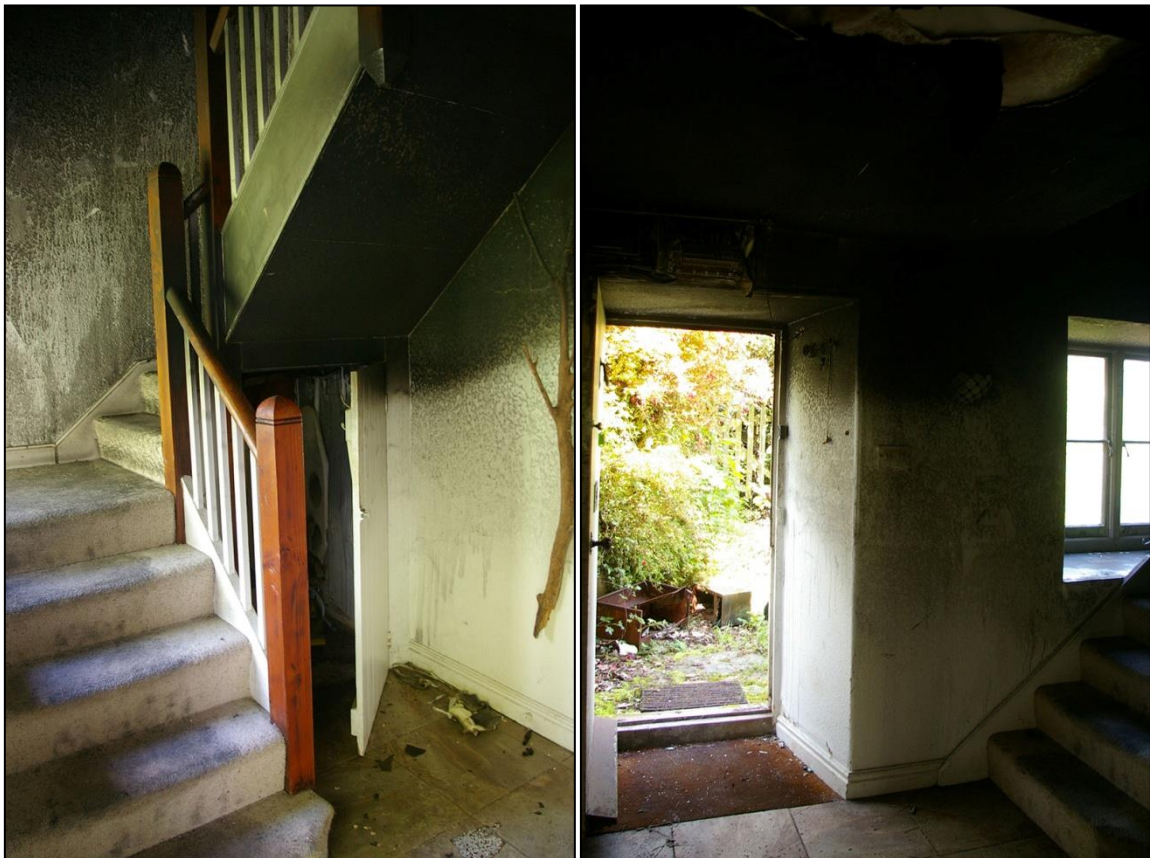
17. LEFT: VIEW OF THE LATE 20TH CENTURY TIMBER STAIRCASE, HEAVILY SMOKE BLACKENED; FROM THE NORTH-WEST.

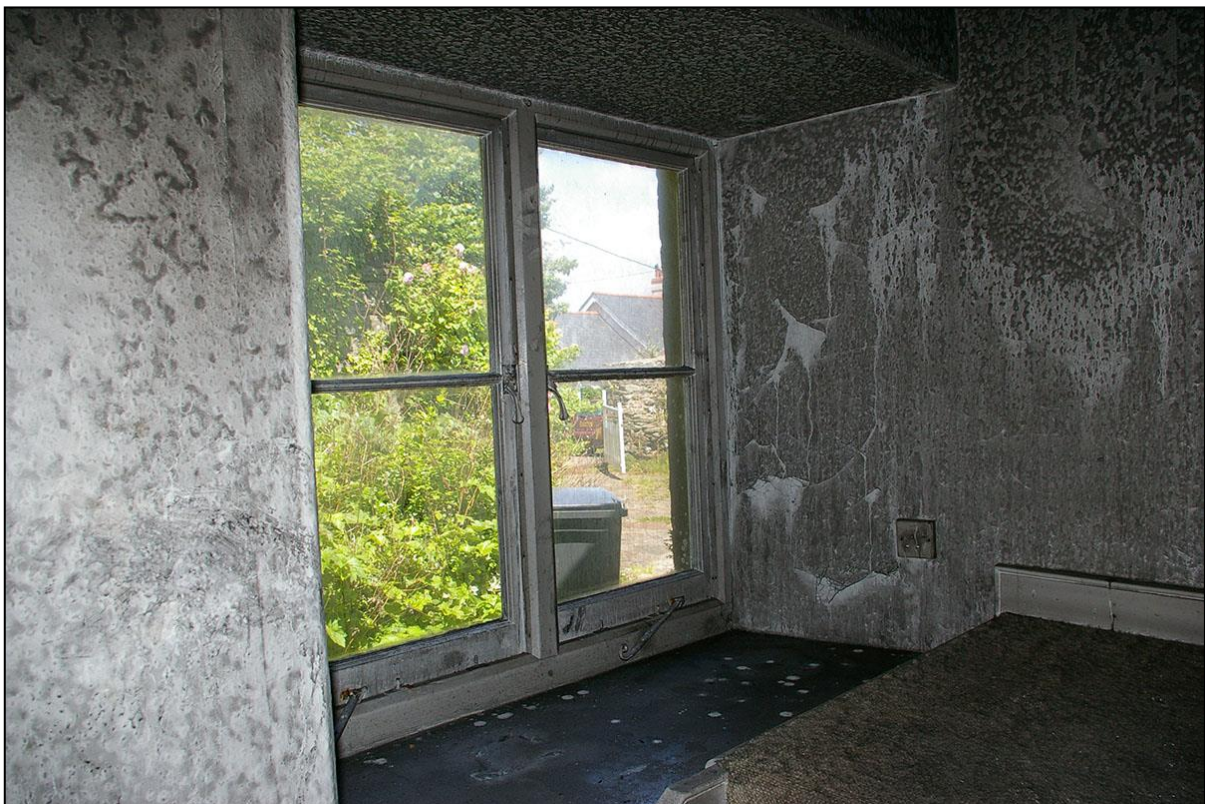
20. DEEP BEADED OPENING, PLANK SILL AND TWO LIGHT BEADED CASEMENT IN CHAMFERED PEGGED FRAME, A 19TH CENTURY FEATURE CW1; FROM THE SOUTH-WEST.

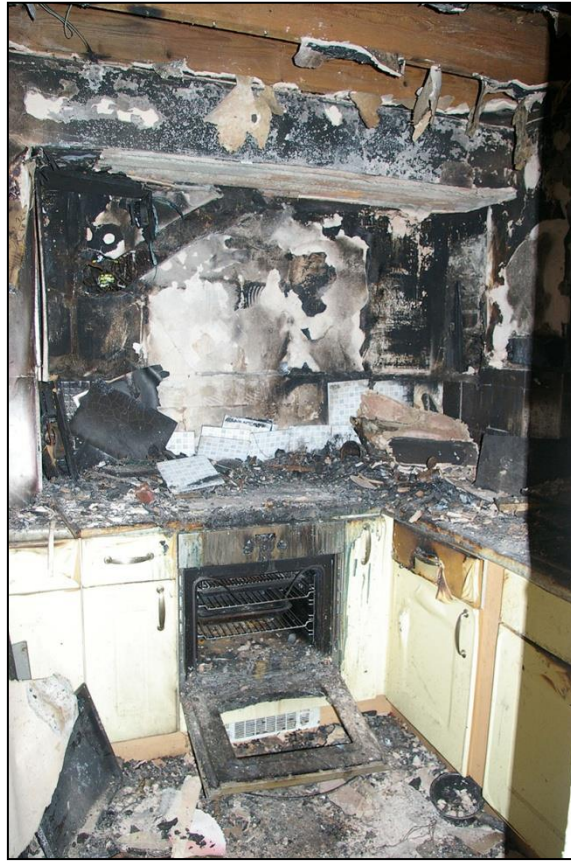
21. THE RUINED KITCHEN, CR2; FROM THE EAST.

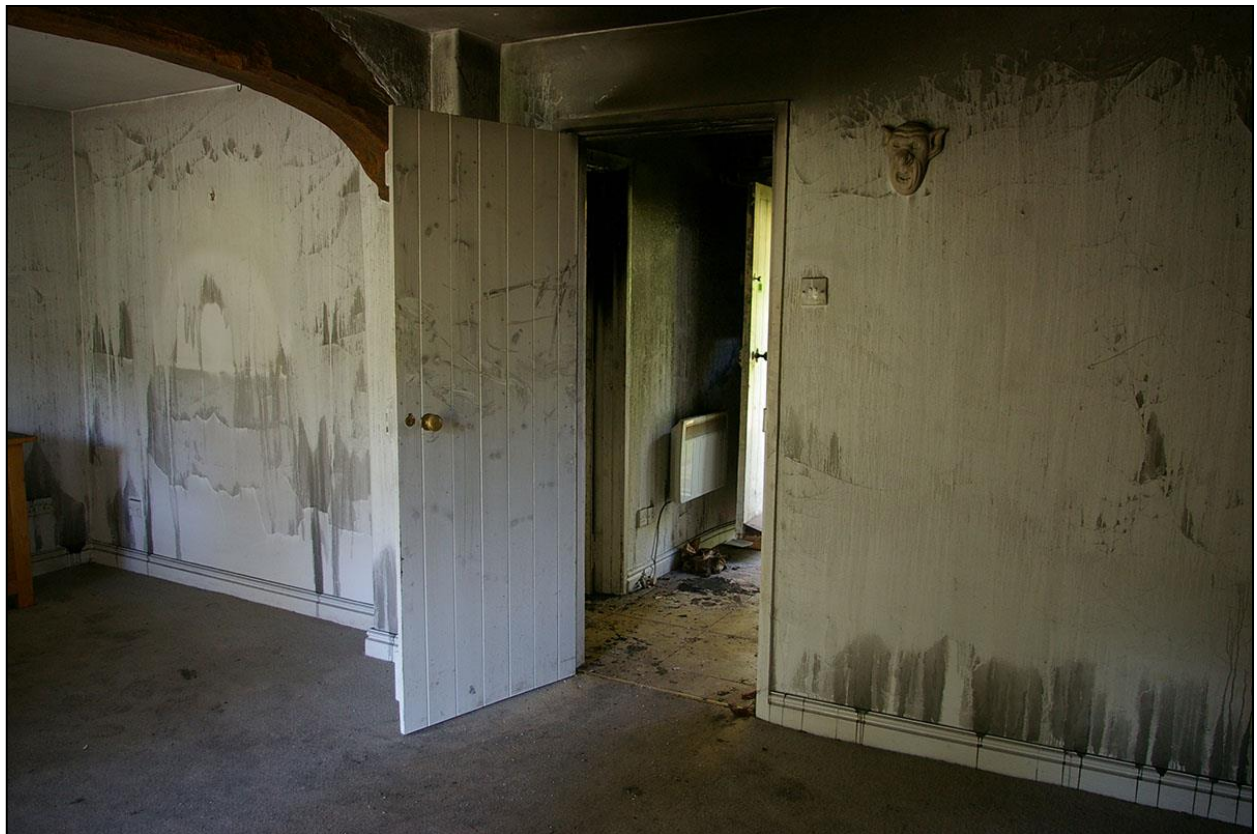
22. THE MODERN PARTITIONS, WITH A STUD OF EARLIER WALL BRACED BY A HACKED BACK BEAM IN CR3, THE SITTING ROOM, ALSO WITH DOOR BACK TO THE HALLWAY; FROM THE SOUTH-EAST.

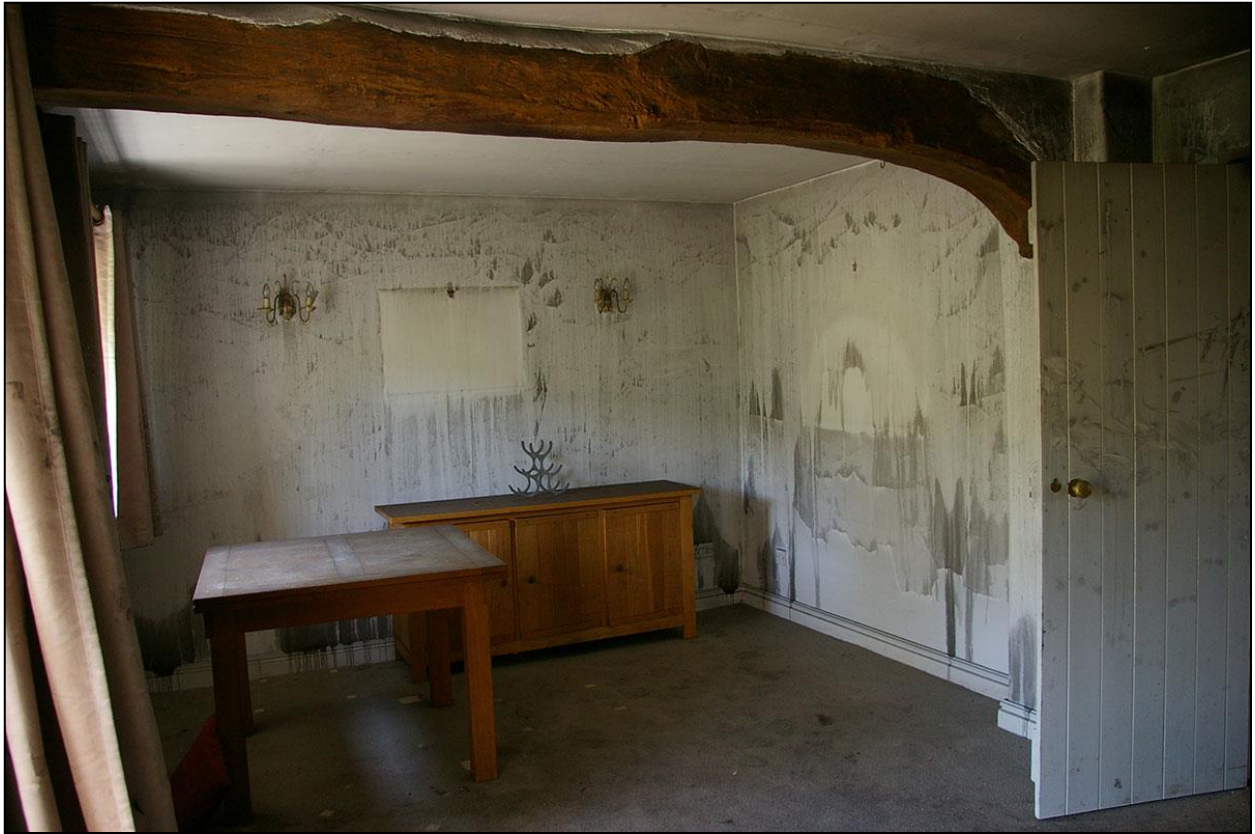
23. THE BEAM IN MORE DETAIL, BRACING A FORMER PARTITION LINE/WALL LINE; FROM THE SOUTH-EAST.

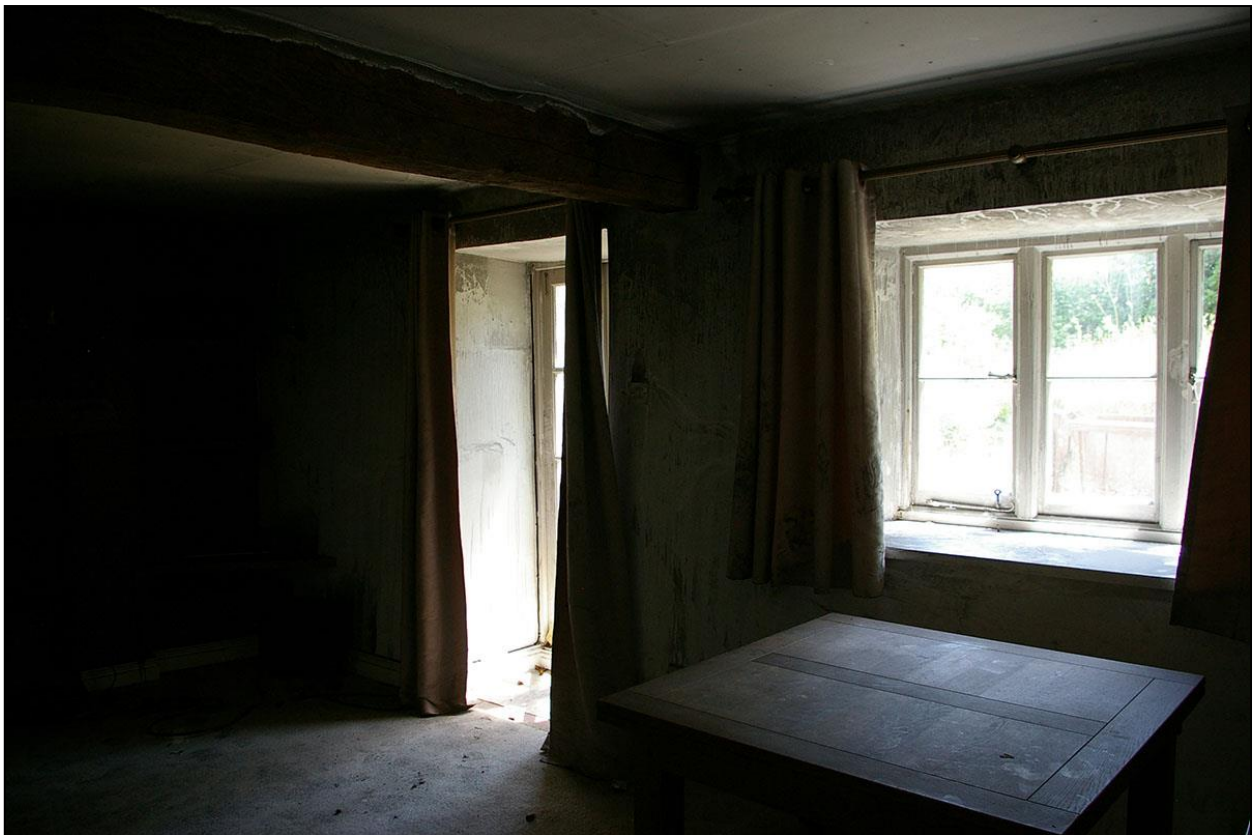
24. THE SOUTH WALL OF CR3, WITH FORCED PATIO DOORS AND 19TH CENTURY WINDOW; FROM THE NORTH-EAST.

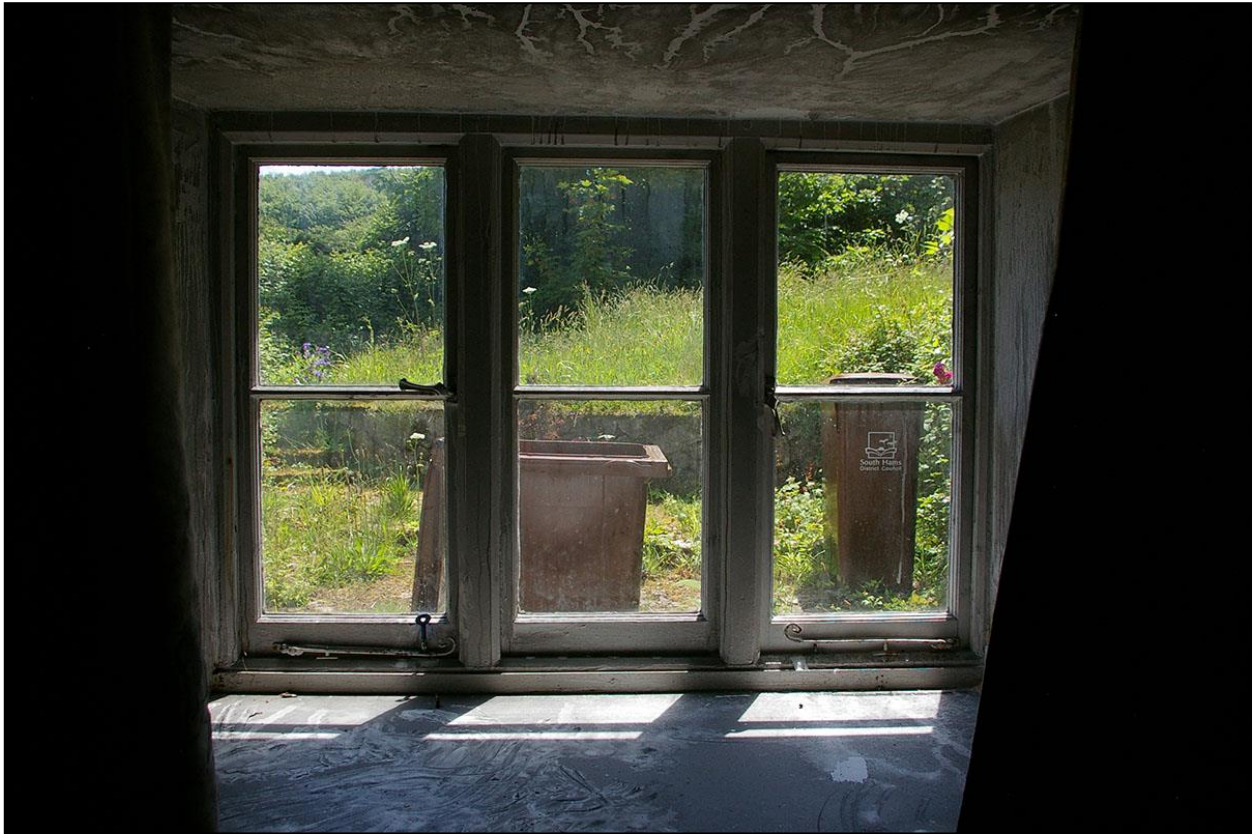
25. DETAIL OF THE GOOD 19TH CENTURY THREE LIGHT CASEMENT WINDOW CW3; FROM THE NORTH.

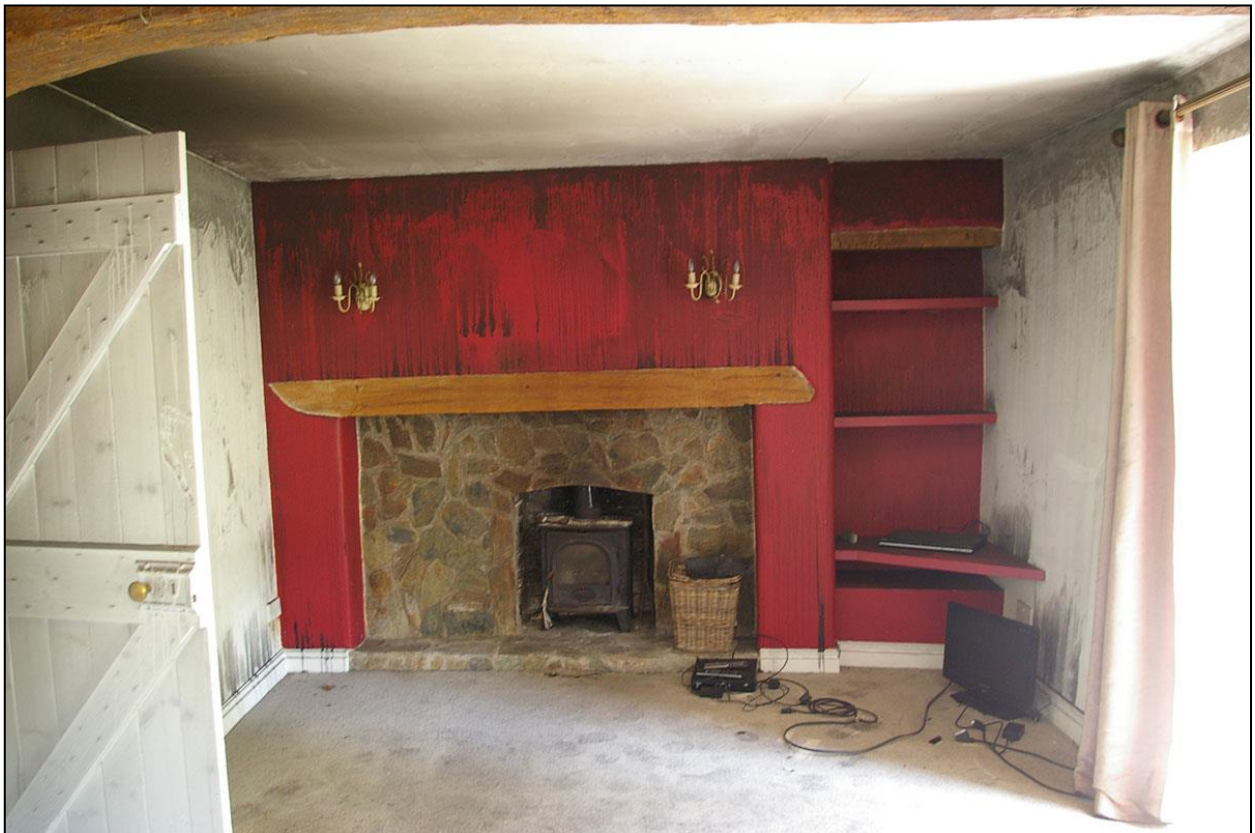
26. THE SHALLOW STACK AND BLOCKED FIREPLACE, WITH ALCOVE TO THE SOUTH, WITH TIMBER LINTEL; FROM THE WEST.
