BATSON HALL FARM

Updated - Heritage Impact Assessment – House and Cottage 2022

South West Archaeology Ltd. report no. 220614

Batson Hall Farm, Batson, Salcombe, Devon

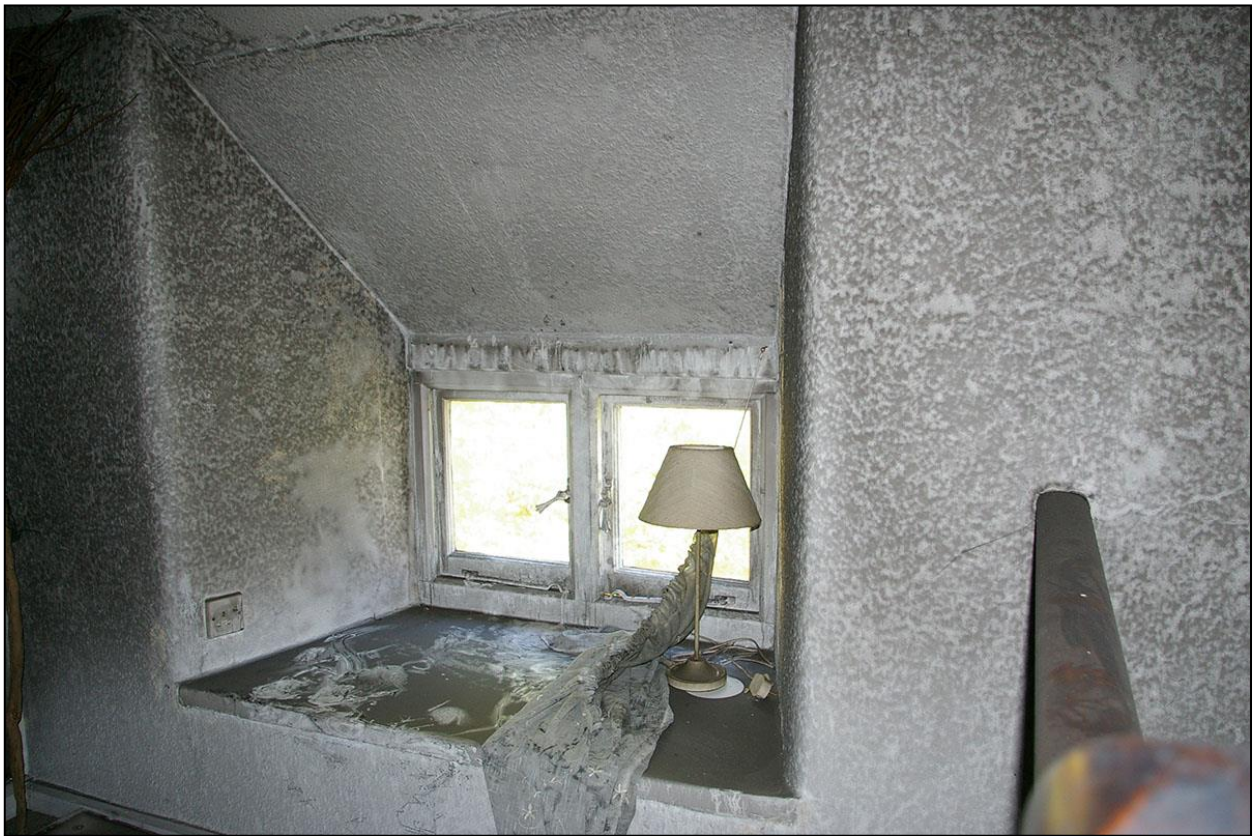
28. THE TWO LIGHT WINDOW SET INTO A BLOCKED LOADING DOOR IN THE FRONT WALL, CW4; FROM THE SOUTH-EAST.

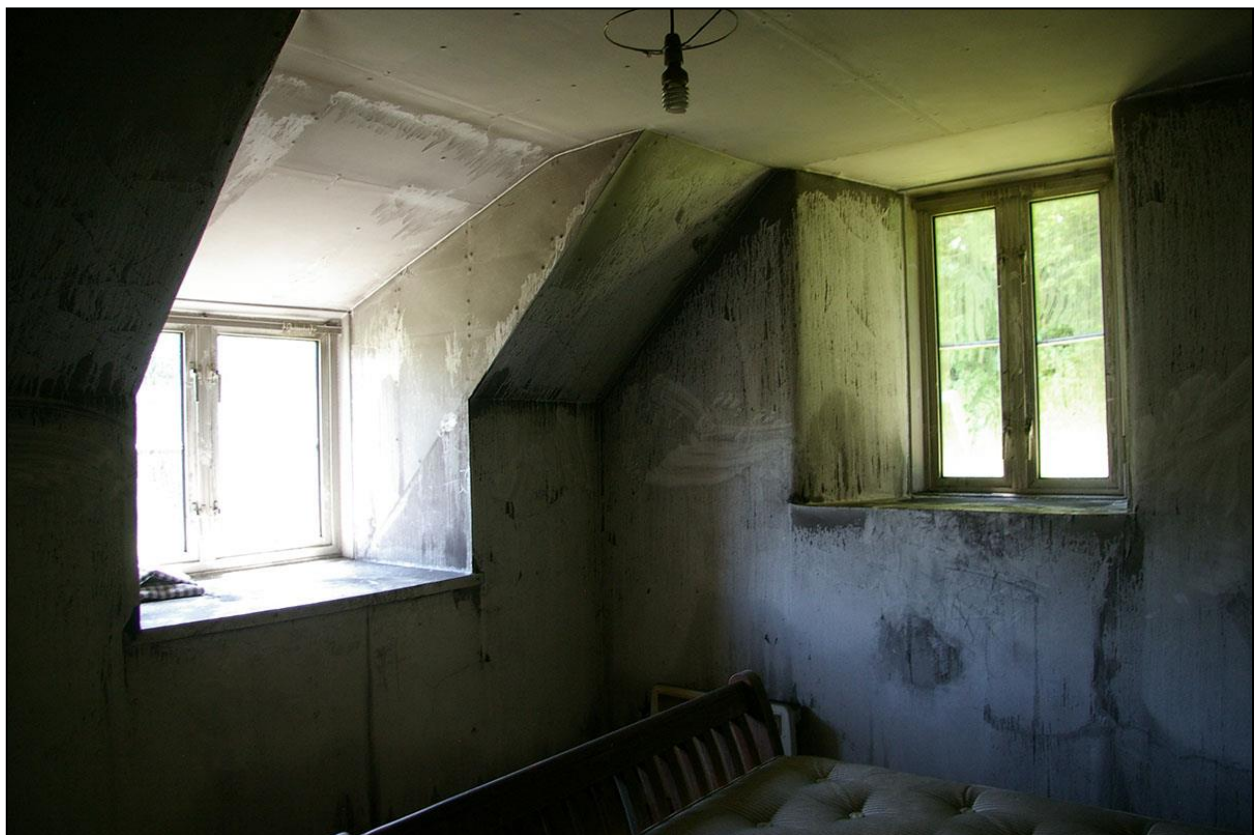
30. BEDROOM 1 WITH FORCED WINDOW OPENINGS AND PVC UNITS; FROM THE NORTH-EAST.

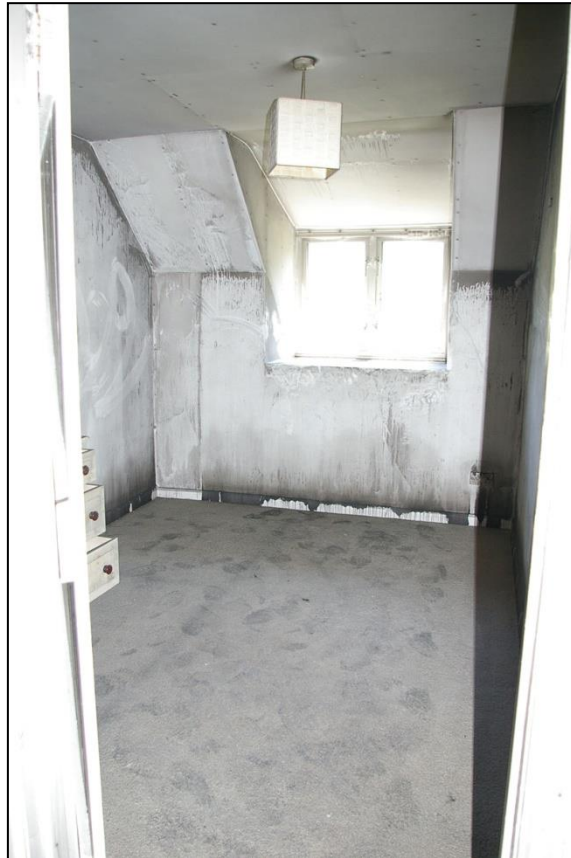
31. BEDROOM 2 WITH FORCED DORMER WINDOW TO THE REAR; FROM THE NORTH-WEST.

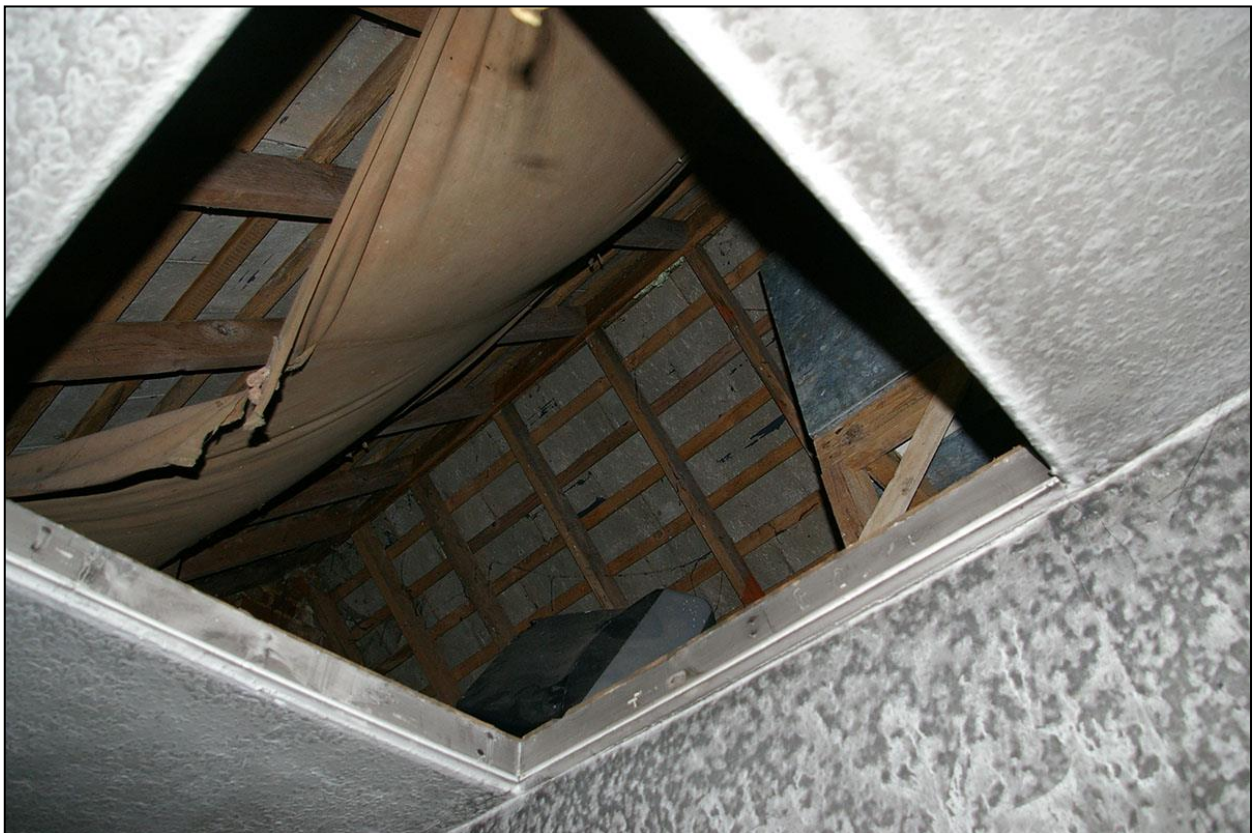
32. VIEW UP INTO THE LOFT, SHOWING THE MODERN COMMON RAFTER REPLACEMENT ROOF; FROM BELOW (NORTH-WEST).

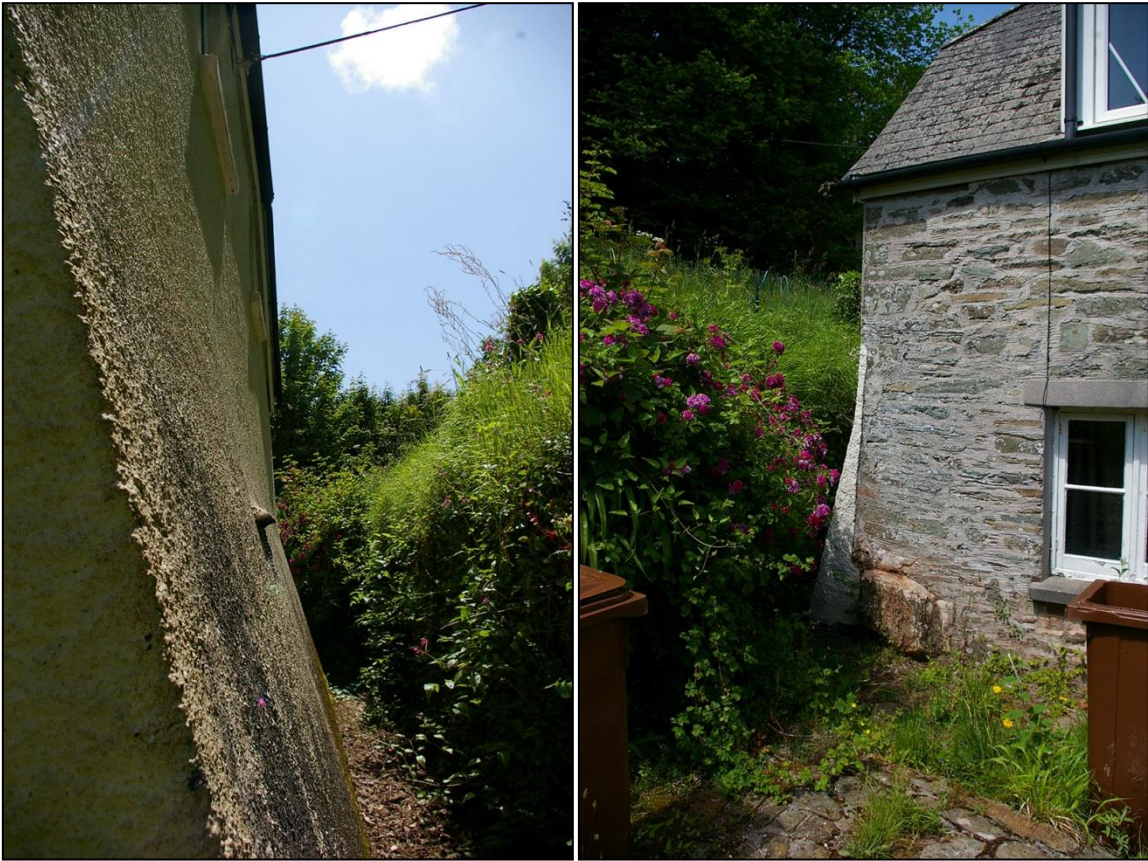
33. LEFT: THE WEST GABLE END OF THE COTTAGE, SHOWING HEAVY BUTTRESS AND FORCED WINDOWS SET HIGH IN APEX; FROM THE NORTH.

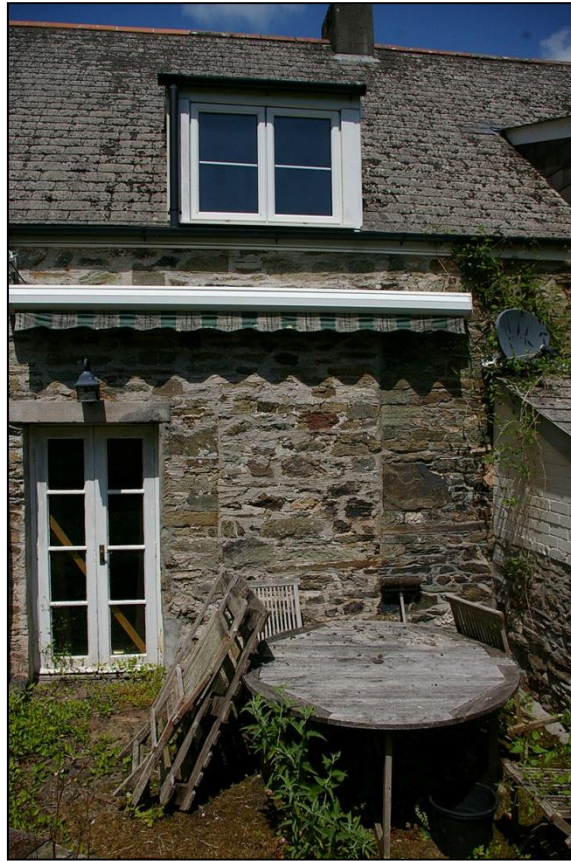
36. THE BLOCKED DOORWAY IN THE SOUTH ELEVATION OF THE COTTAGE IN THE SOUTH-EAST CORNER, SHOWING GOOD DRESSED REVEALS; FROM THE SOUTH.

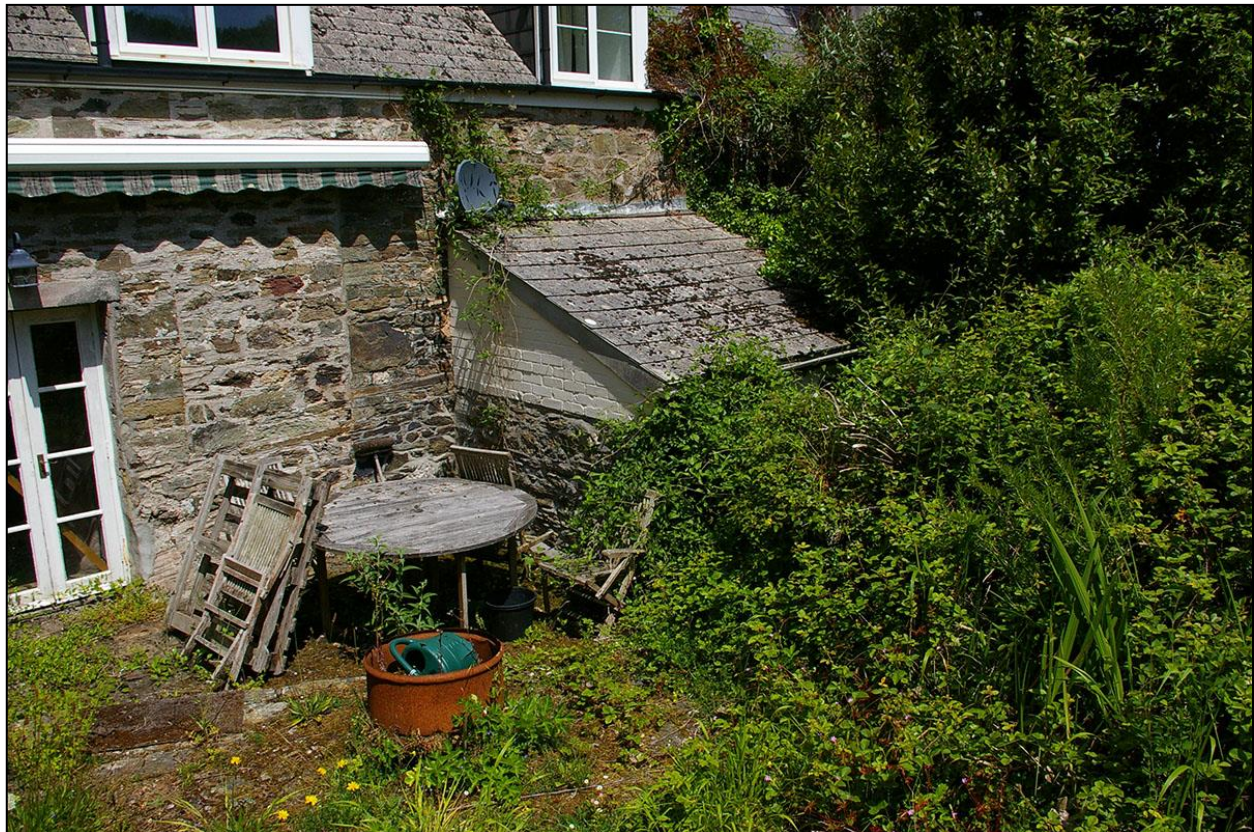
37. THE PROJECTING BLOCK, OF AN OLDER FORM OF PLATEY STONWORK, OFF THE BACK OF THE SOUTH ELEVATION ACROSS THE JOIN BETWEEN COTTAGE AND FARMHOUSE; FROM THE SOUTH-WEST.

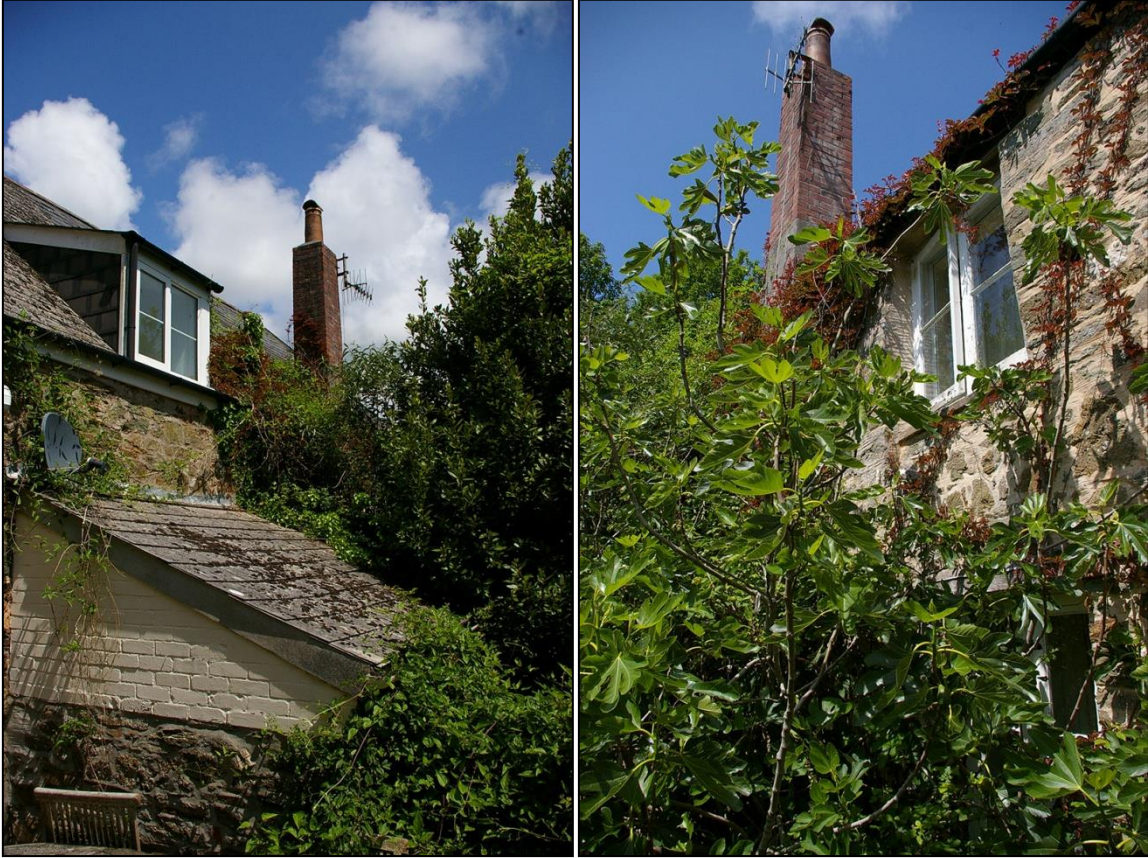
38. LEFT: VIEW BACK ALONG THE REAR OF THE FARMHOUSE, SHOWING LOOSE POST MEDIEVAL RUBBLE AT THE EAVES AND A REBUILT BRICK CHIMNEY SHAFT, AS WELL AS A DISTINCT CHANGE IN ALIGNMENT ON THE ROOF; FROM THE WEST, SOUTH-WEST.

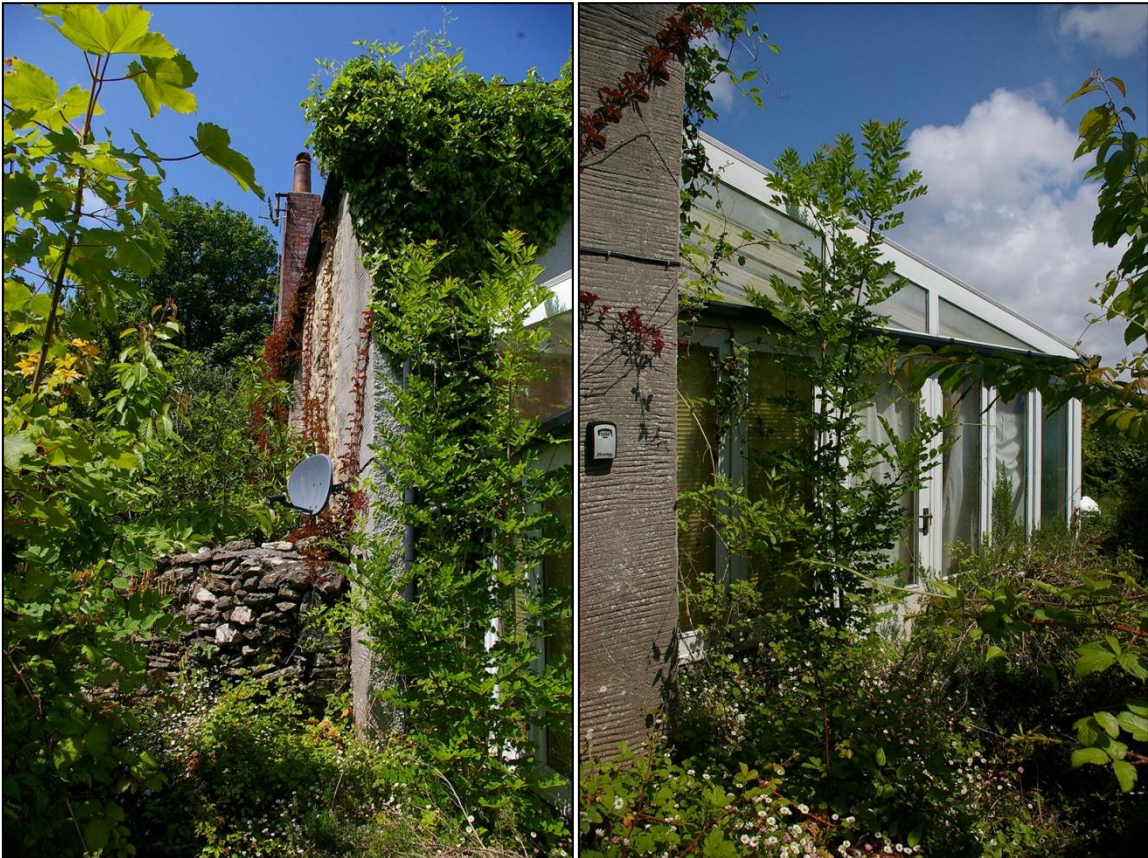
40. LEFT: VIEW ALONG THE BACK OF THE FARMHOUSE, SHOWING HOW IT IS ALMOST TOTALLY OBSCURED BY OVERGROWTH; FROM THE EAST.

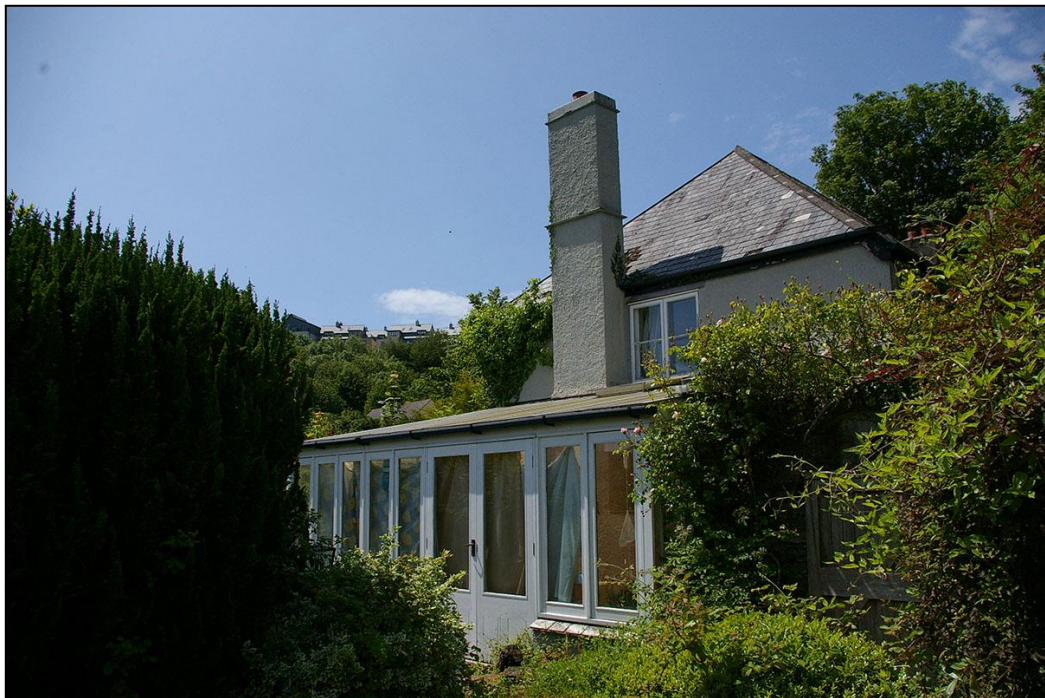
42. THE EAST GABLE END OF THE FARMHOUSE, WITH HIPPED ROOF, BOX STACK AND SHAFT AND LARGE MODERN CONSERVATORY; FROM THE NORTH-EAST.

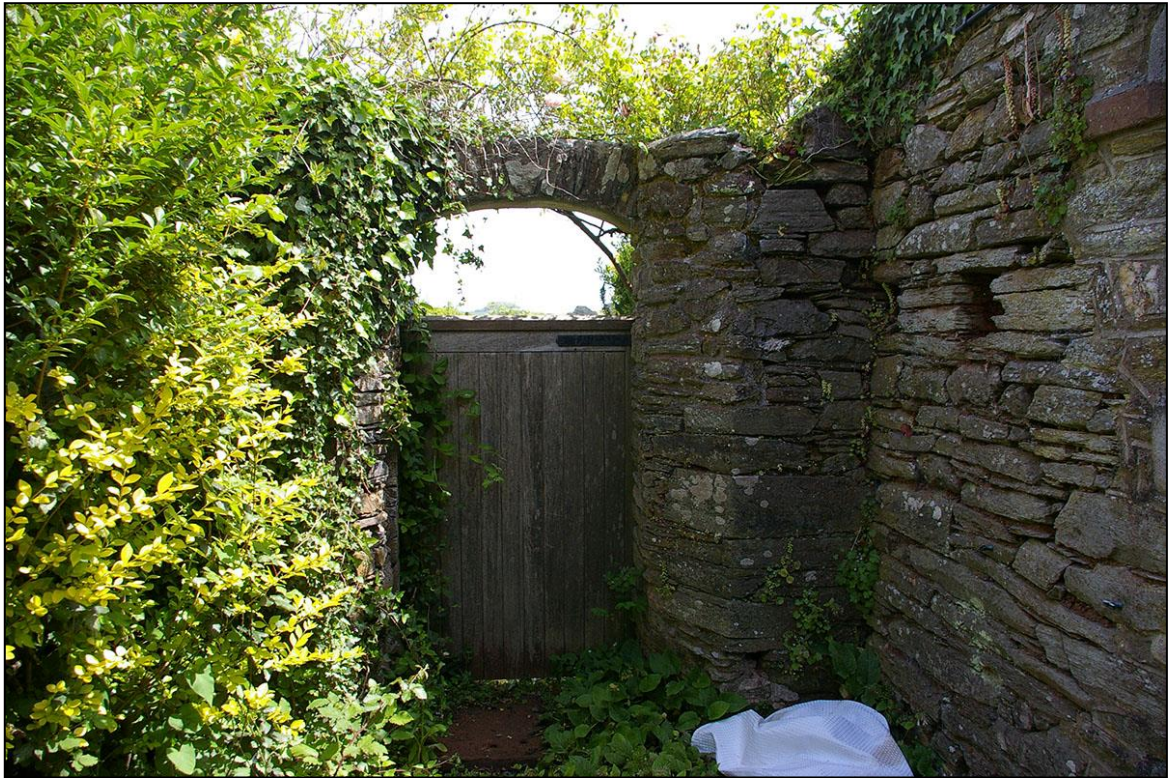
43. DETAILED VIEW OF THE FINE HEAVY SLATESTONE AND SOME DRESSED BLOCKS AND PUTLOGS, ALL OF WHICH IDENTIFY THESE GARDEN WALLS, AS IN FACT RUINS OF AN EARLIER QUITE FINE BUILDING, LIKELY PART OF THE COMPLEX WHICH SUPPORTED THE MANOR HOUSE WHICH STOOD ON THE SITE; FROM THE WEST.

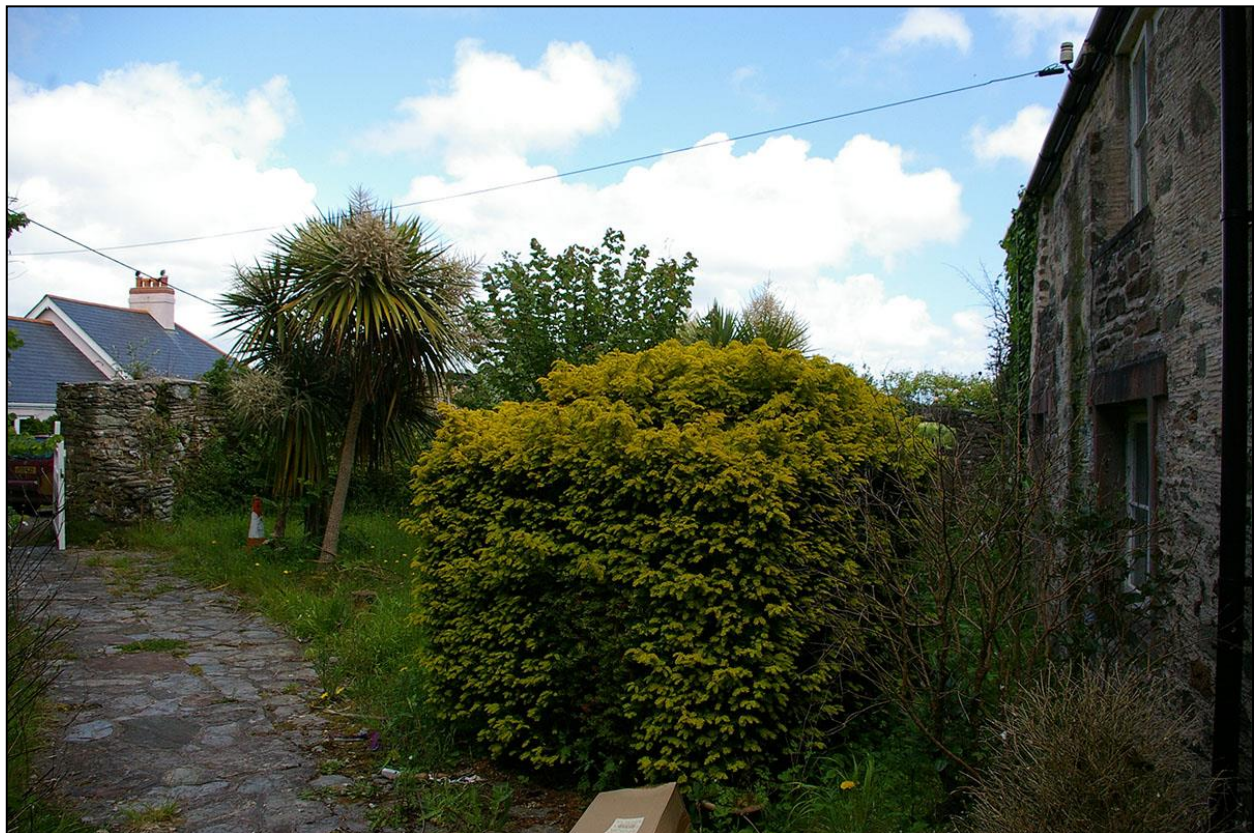
44. VIEW OF THE RECTANGULAR PLAN WALLS, OF SINGLE STOREY HEIGHT, WHICH ENCLOSE AND FRAME THE NORTH FRONT GARDEN, ACTUALLY MARKING OUT THE FOOTPRINT OF A RUINED MEDIEVAL BUILDING; FROM THE WEST.

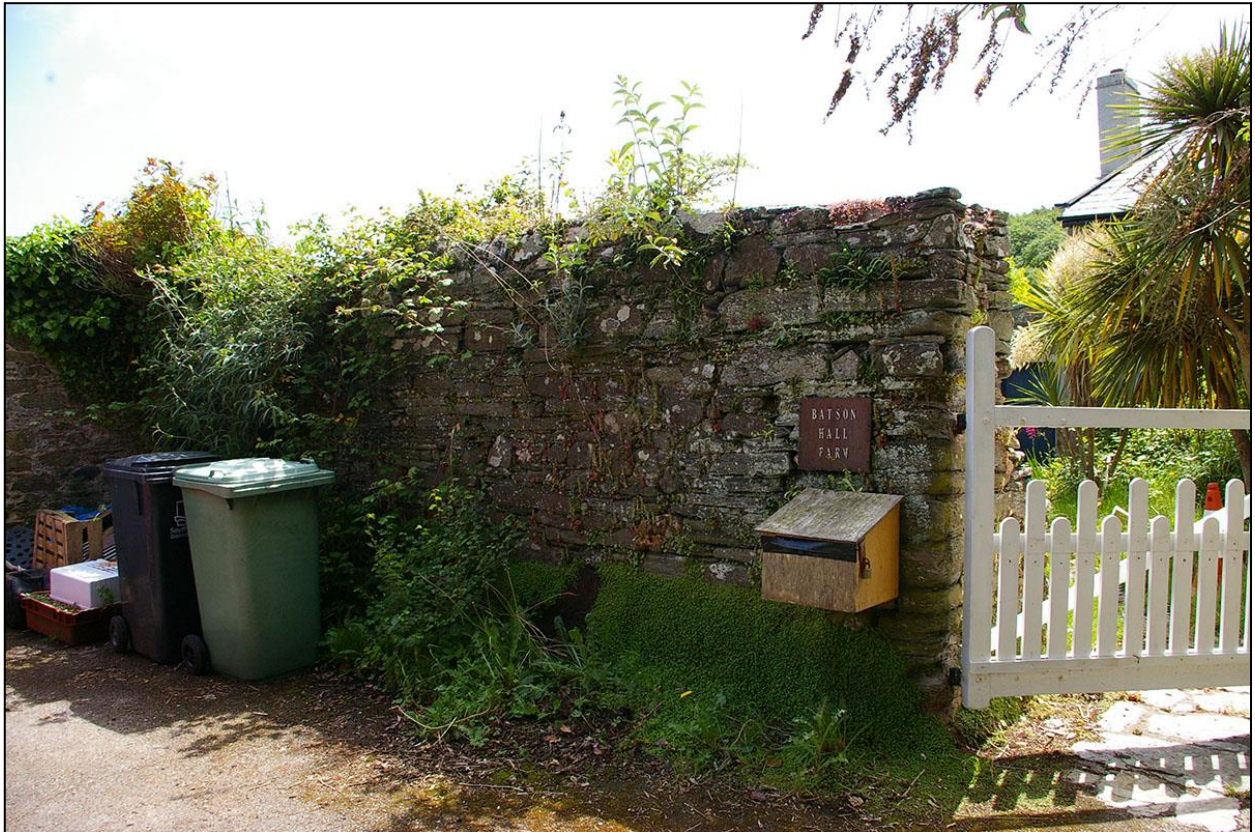
45. THE NORTH OUTER FACE OF THE HEAVY SLATESTONE WALL, WHICH IS THE FORMER GABLE END OF AN EARLY BUILDING; FROM THE NORTH-WEST.

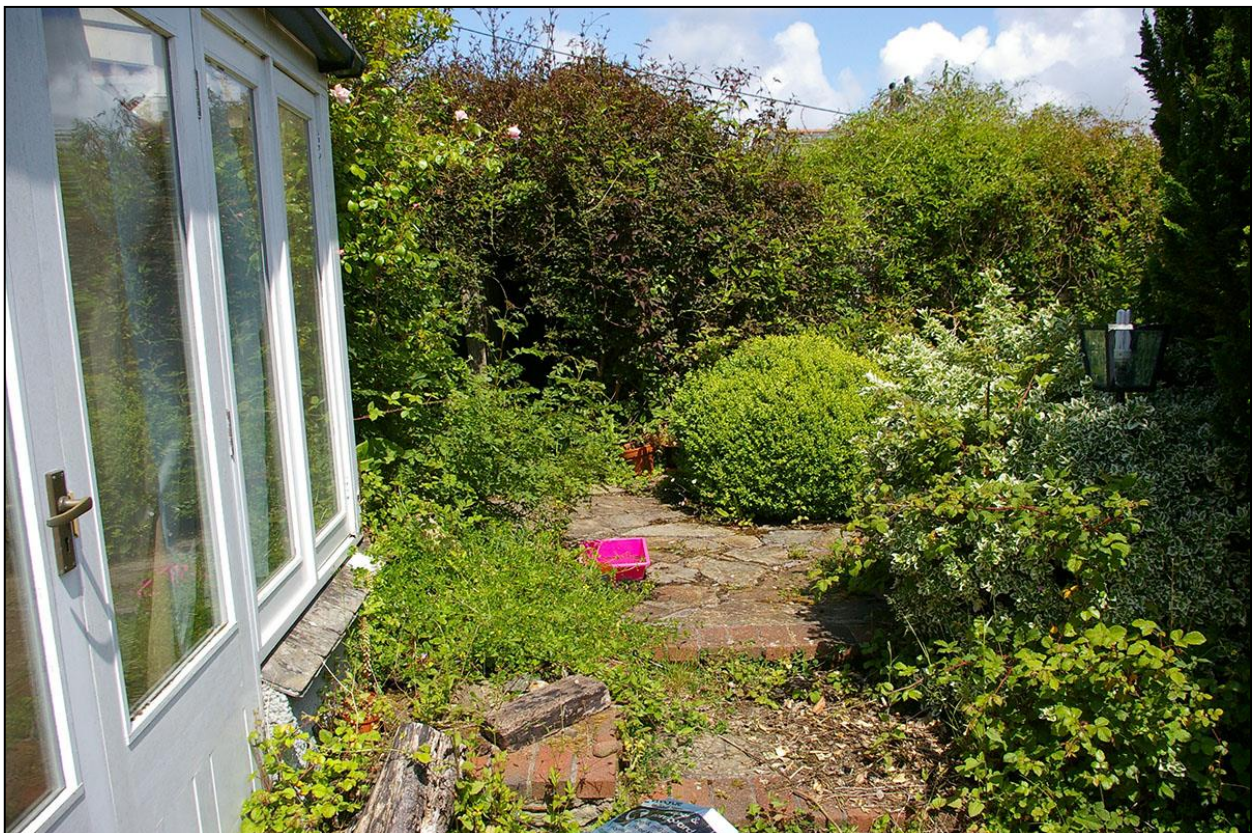
46. THE TERRACED AREA, PAVED STONE AND BRICK EDGING, OF MID TO LATE 20TH CENTURY DATE, TO THE NORTH-EAST OF THE MAIN HOUSE, ACCESSED BY THE CONSERVATORY; FROM THE SOUTH.

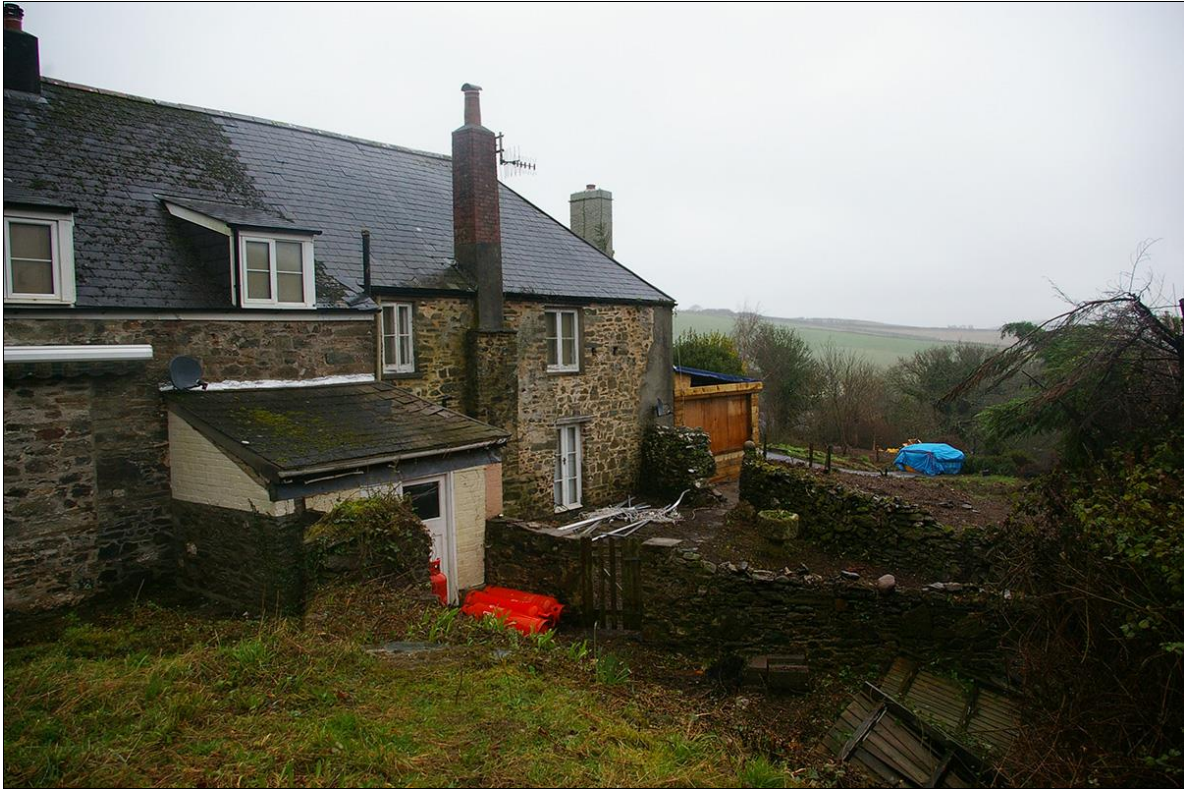
48. THE SOUTH ELEVATION OF THE FARMHOUSE, SHOWING THE PROJECTION TO THE WEST AND SMALL LATERAL STACK BUILT AGAINST THE EARLIER STONework OF THE MEDIEVAL RUIN, WHICH OCCUPIES A SECTION TO THE CENTRE OF THE WALL, FROM THE SOUTH-WEST.

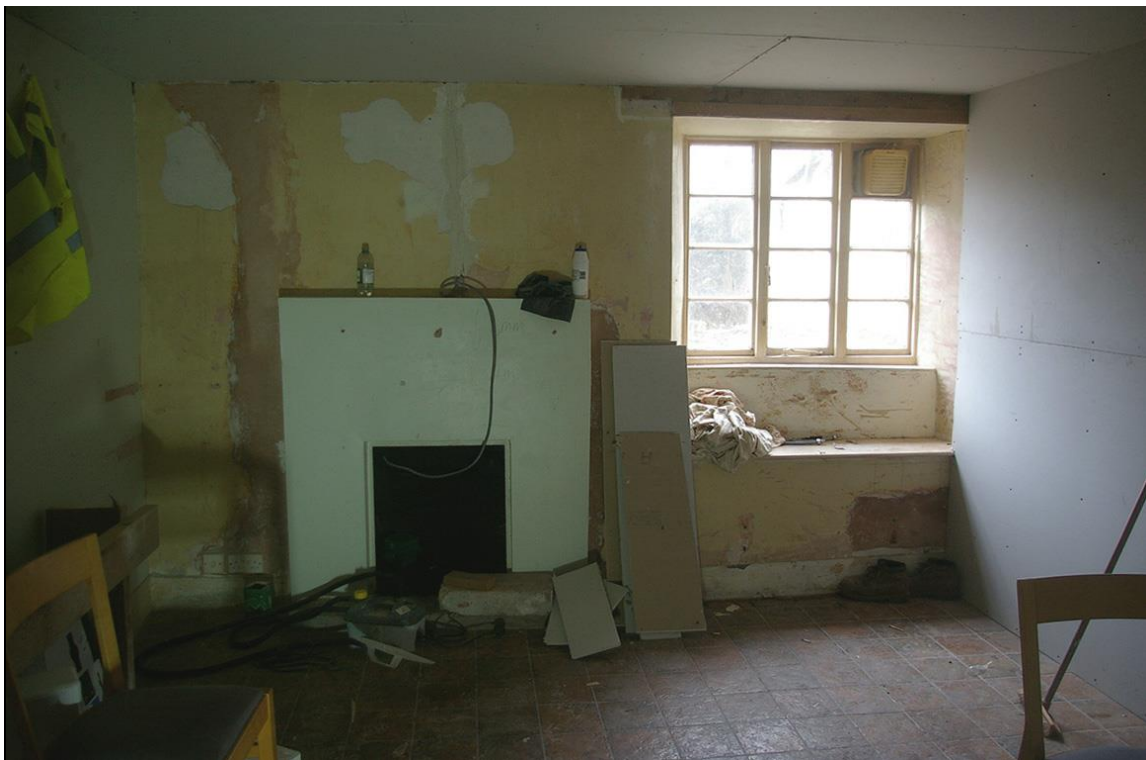
49. THE MODERNISED KITCHEN FIREPLACE AND GOOD 19TH CENTURY WINDOW, ROOM 2B; FROM THE NORTH.

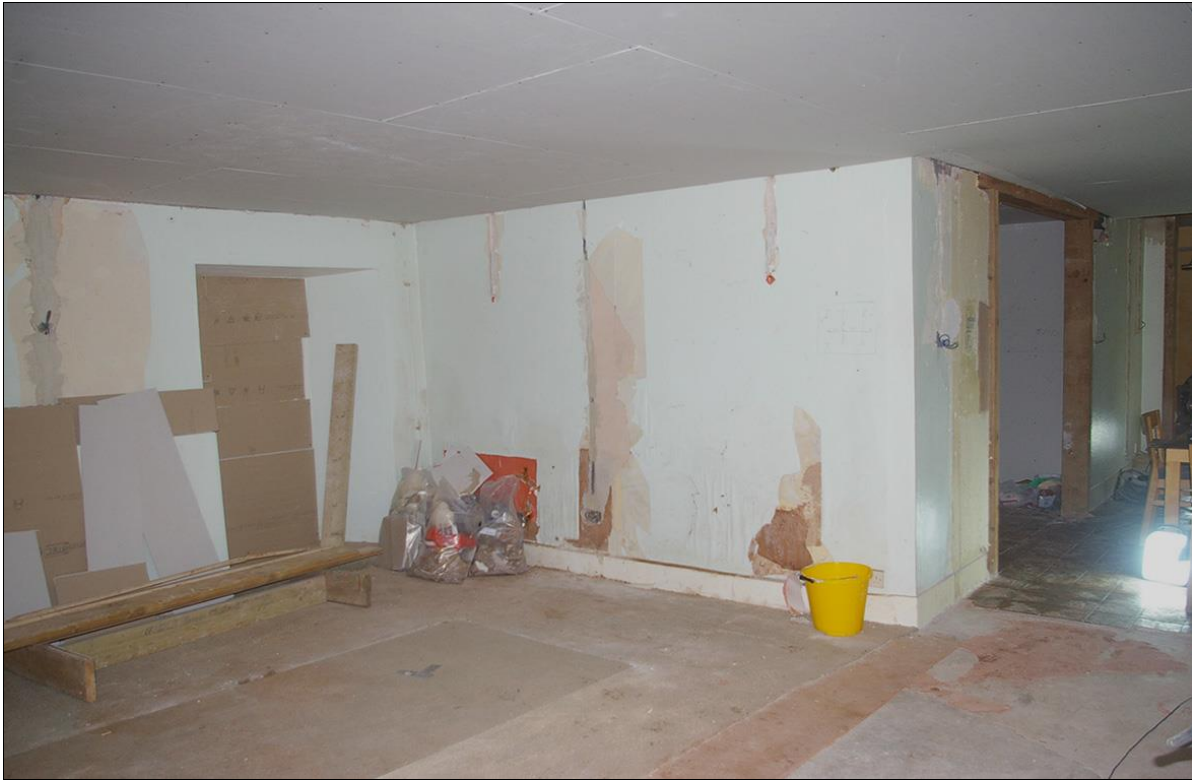
50. ROOM 3, IN THE FARMHOUSE, THE MAIN SITTING ROOM, WITH BOARDED OVER FRENCH-STYLE PATIO DOORS TO THE GARDEN; FROM THE NORTH-EAST.

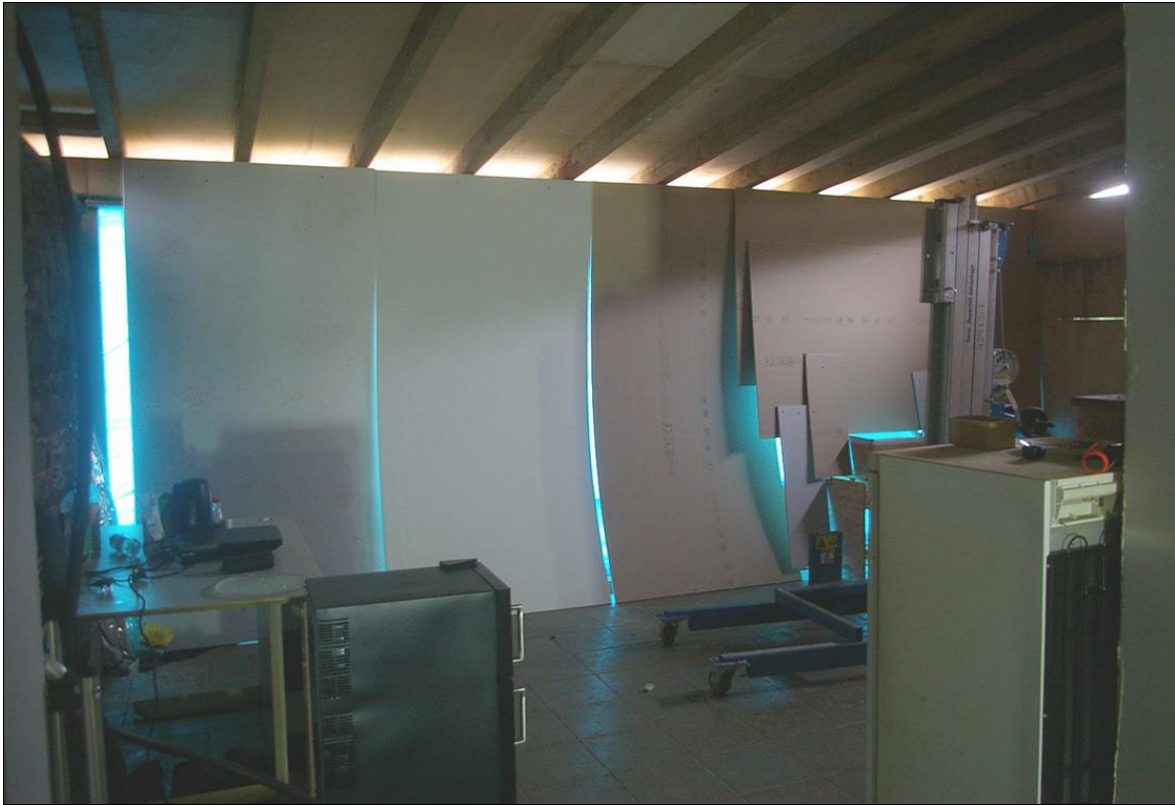
52. THE CONSERVATORY, WHICH HAS BEEN BOARDED OUT FOR SECURITY AND DUE TO PARTIAL COLLAPSE; FROM THE WEST-NORTH-WEST.

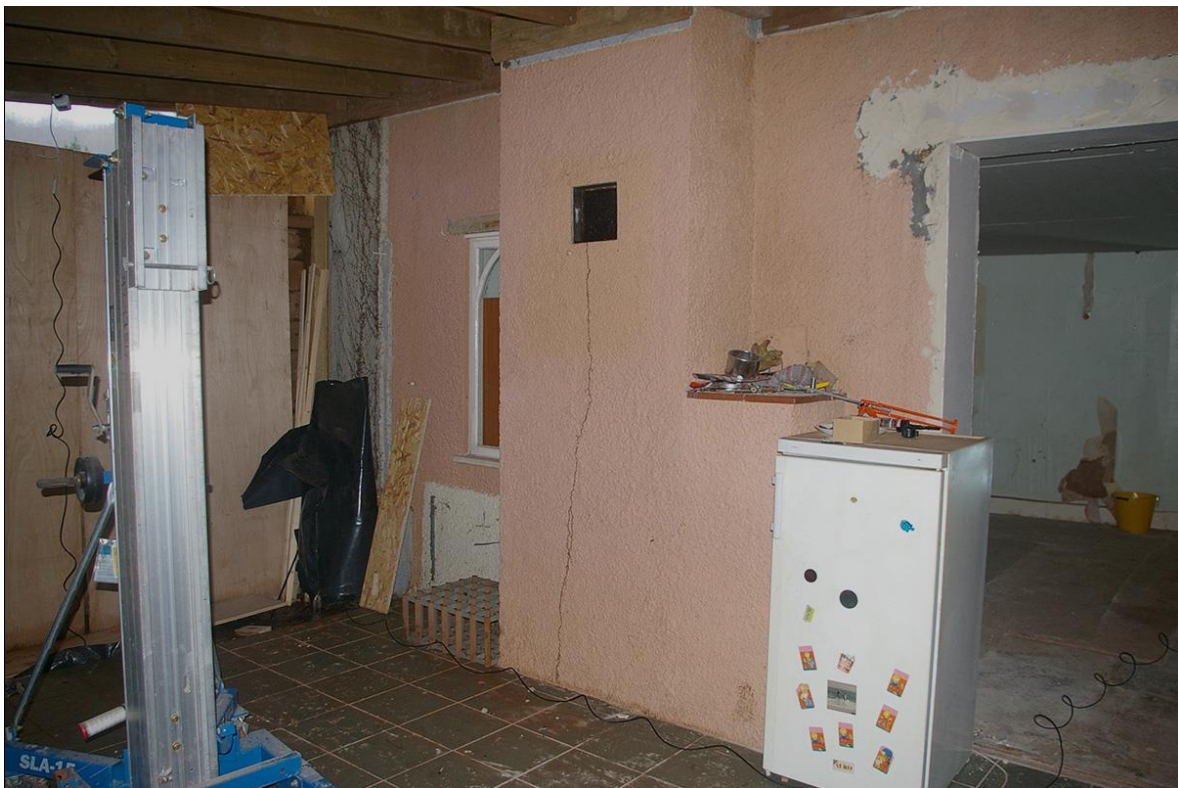
53. THE MODERN BOXY STACK SERVING THE SITTING ROOM FIREPLACE, ENCLOSED WITHIN THE CONSERVATORY; FROM THE NORTH-EAST.

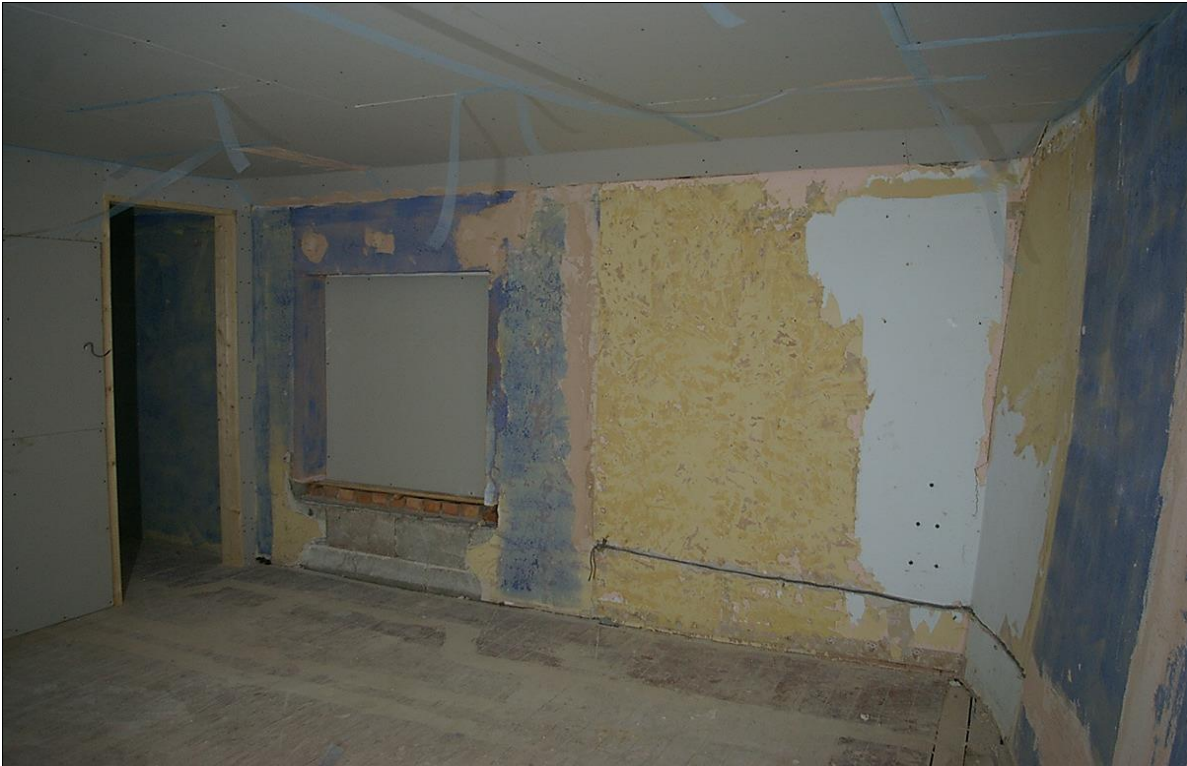
54. ROOM 9, BEDROOM 1, TO THE SOUTH OF THE BUILDING, SHOWING THE BATTERED AND ANGLED FRAGMENT OF EARLIER WALL TO THE SOUTH-EAST CORNER; FROM THE SOUTH-WEST.

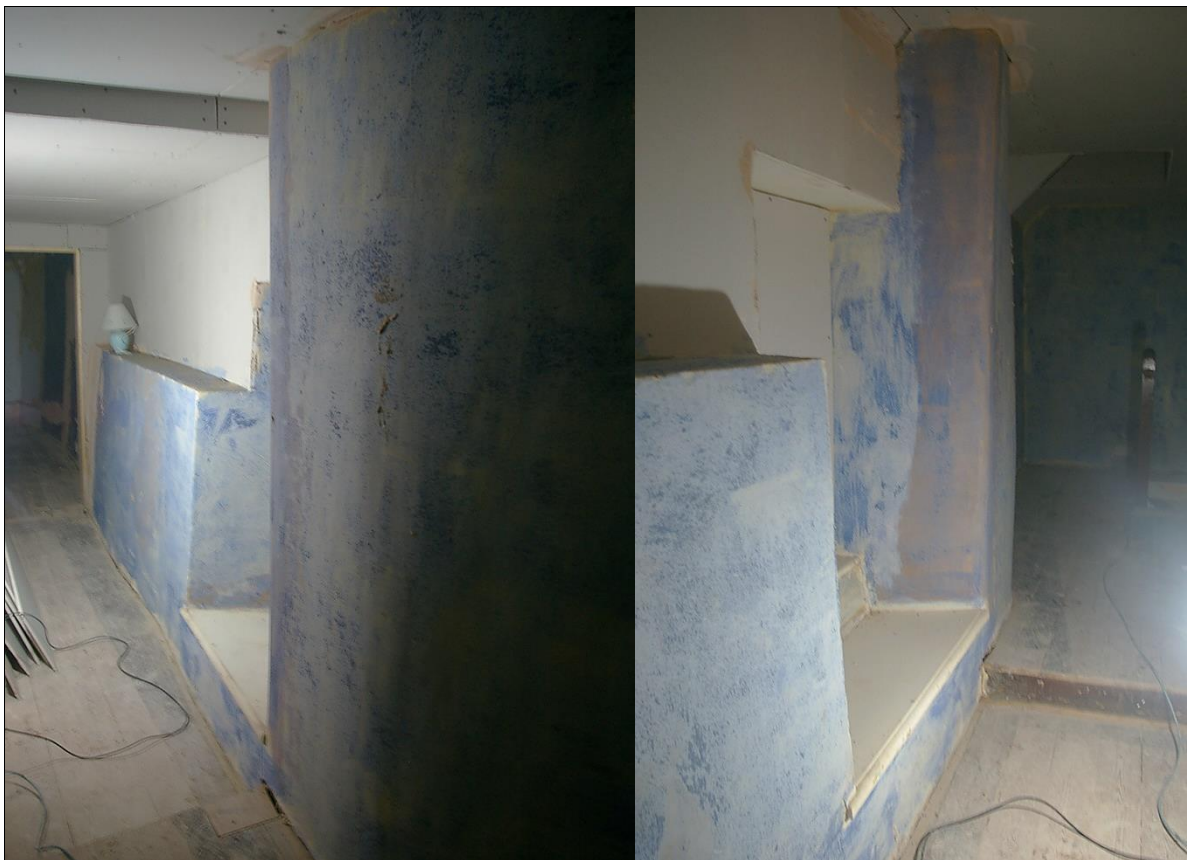
55. LEFT: THE SOUTH WALL OF THE FARMHOUSE, SHOWING THE BATTERED LOWER EARLIER SECTION OF WALL AND THE TALL ANGLED WEST PROJECTION, WITH DISTINCTIVE CURVE; FROM THE WEST-NORTH-WEST.

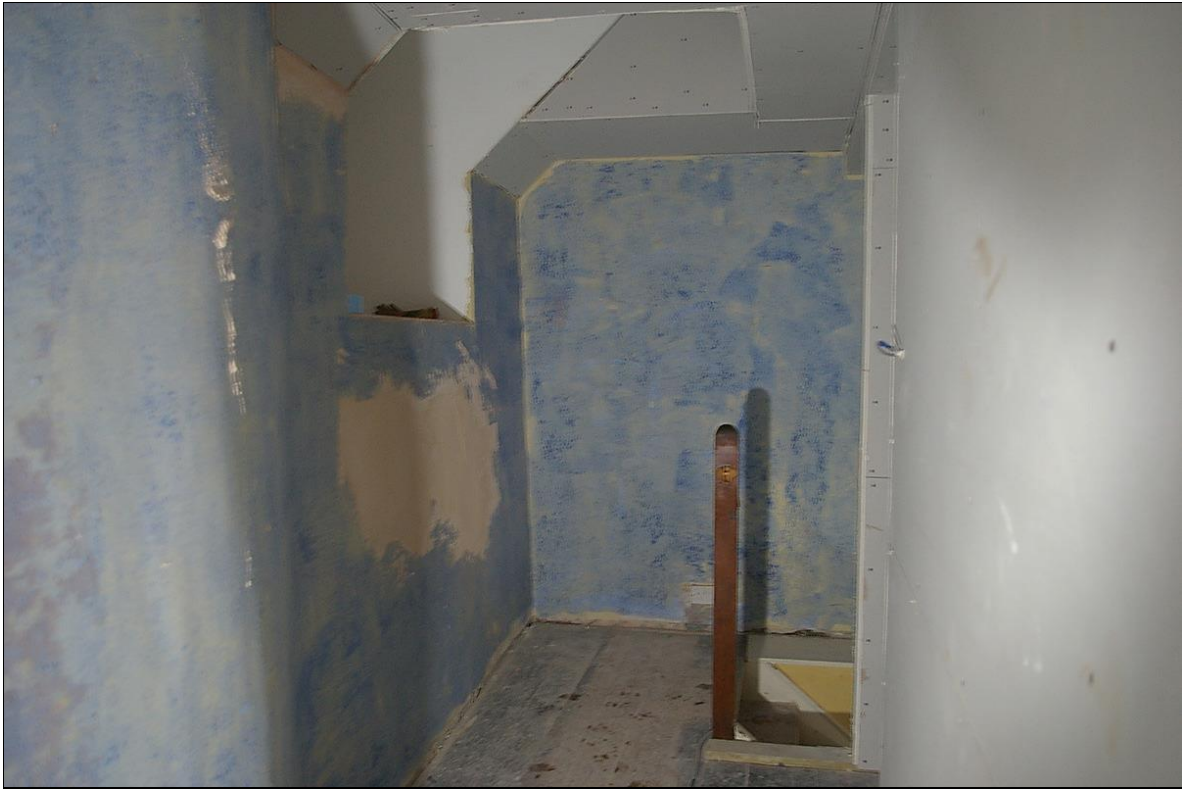
57. THE WESTERN PROJECTING END OF THE FARMHOUSE, WITH DISTINCTIVE CURVE TO THE WALL, WHERE A TALL BLOCK OF GOOD DRESSED AND FACED MEDIEVAL STONEMASONRY SURVIVES, FROM THE EAST.

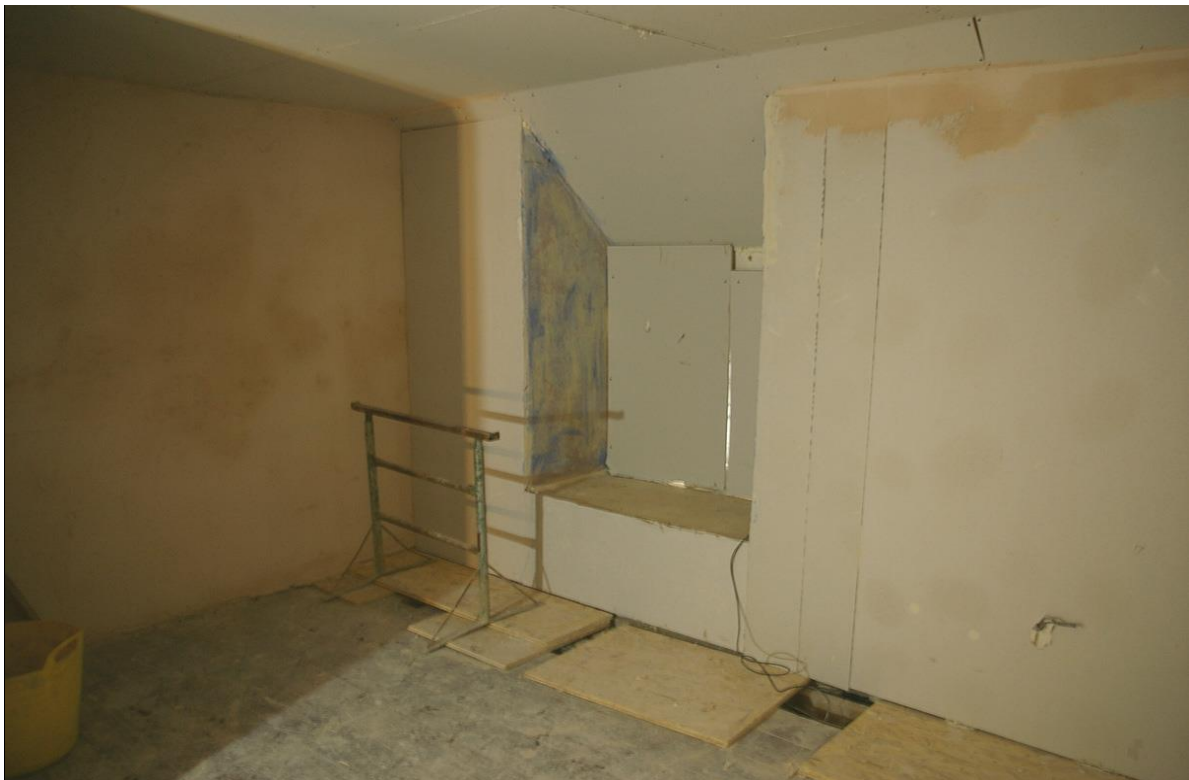
58. THE WINDOW WITHIN THE EXTENDED SECTION OF FRONT NORTH WALL, LEADING TO THE GABLE, OF THICK FULL TWO STOREY HEIGHT.

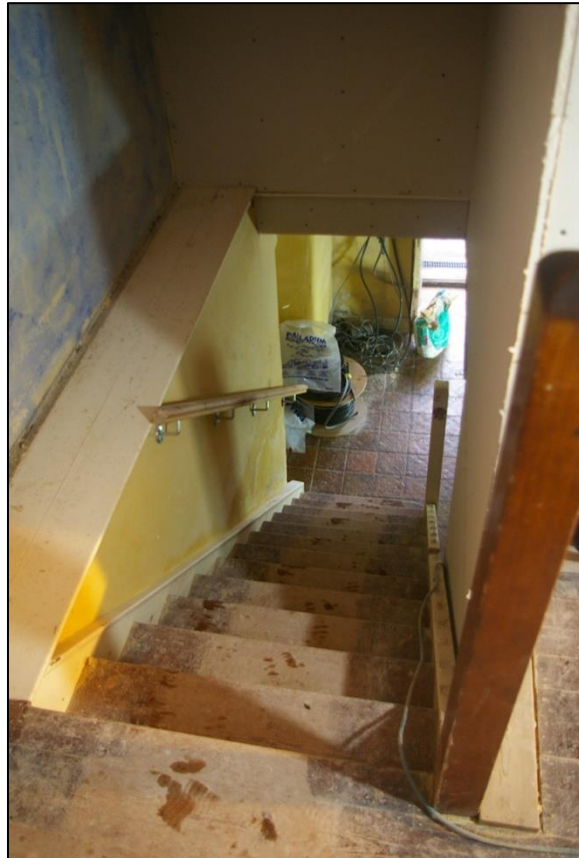
59. VIEW DOWN THE STAIRS IN THE FARMHOUSE, BUILT AGAINST THE THICK SLIGHTLY BATTERED FORMER GABLE WALL, SHOWING IT IS FAR THICKER TO THE GROUND FLOOR, WITH A MARKED LEDGE, WHERE THE MEDIEVAL WALL STOPS, HAVING BEEN RUINED AT SOME STAGE, FROM THE SOUTH.
