BATSON HALL FARM

Updated - Heritage Impact Assessment – House and Cottage 2022

South West Archaeology Ltd. report no. 220614

Batson Hall Farm, Batson, Salcombe, Devon

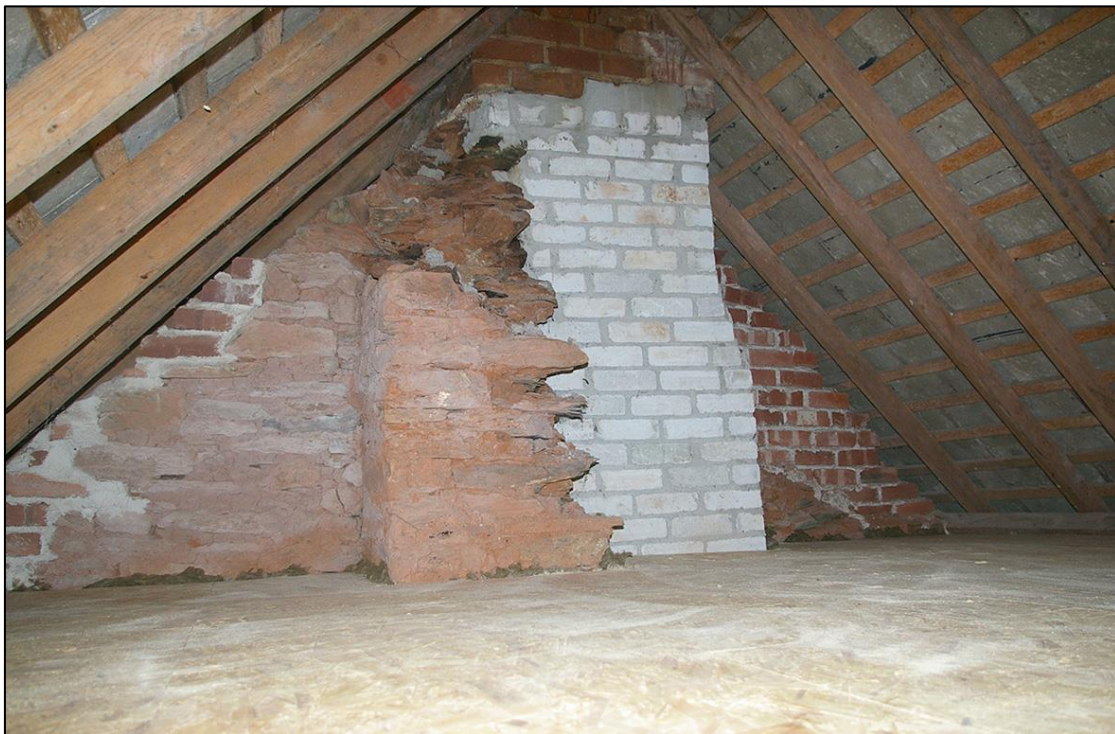
60. THE STACK TO THE WEST END OF BATSON HALL FARM; WITH FRAGMENTARY REMAINS RISING TO ONE AND A HALF STOREYS, THE STONWORK PATCHED IN BRICKWORK IN LIME MORTAR, THEN IN LATER BRICKWORK IN CEMENT AND IN CONCRETE BLOCK, INDICATING 19TH AND SEVERAL PHASES OF 20TH CENTURY REMODELLING.

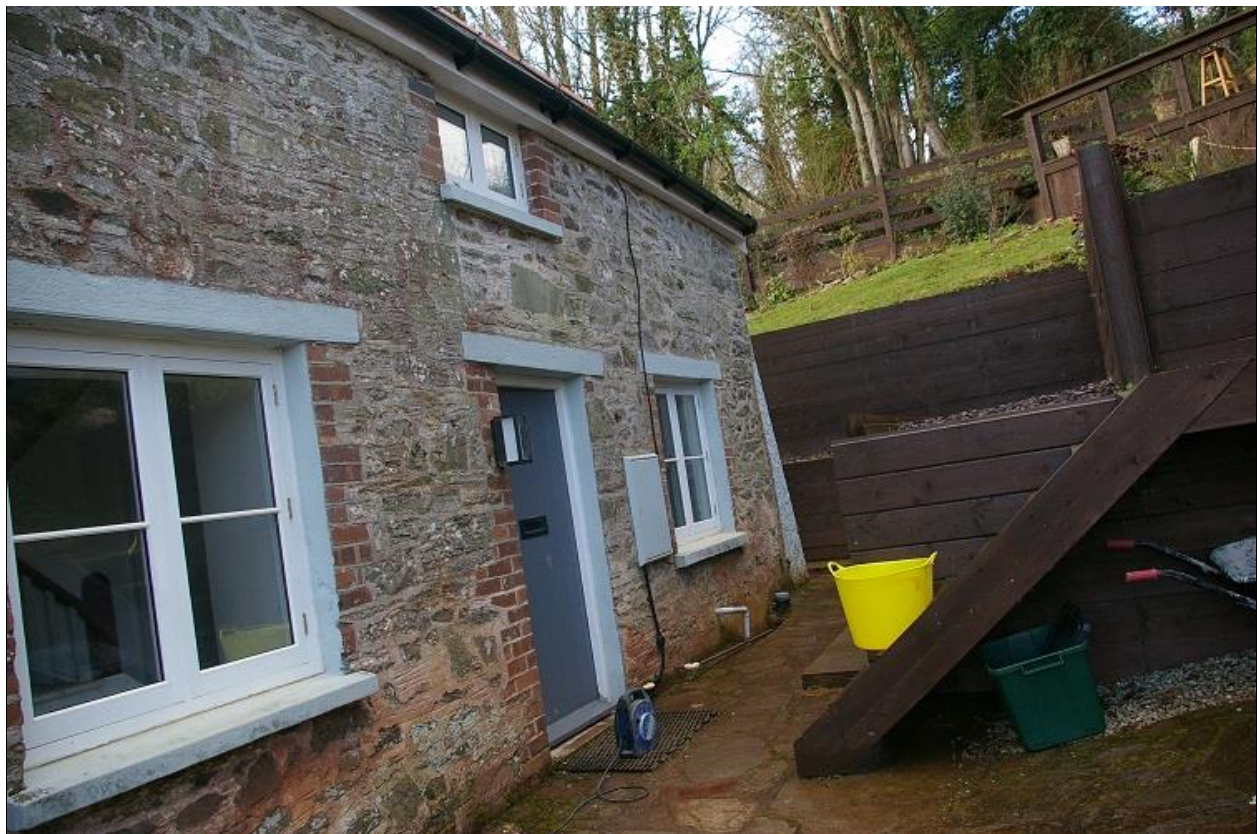
62. THE NORTH ELEVATION OF THE COTTAGE AND RETAINED WALLS OF PLANKS AND STEEL GIRDERS.

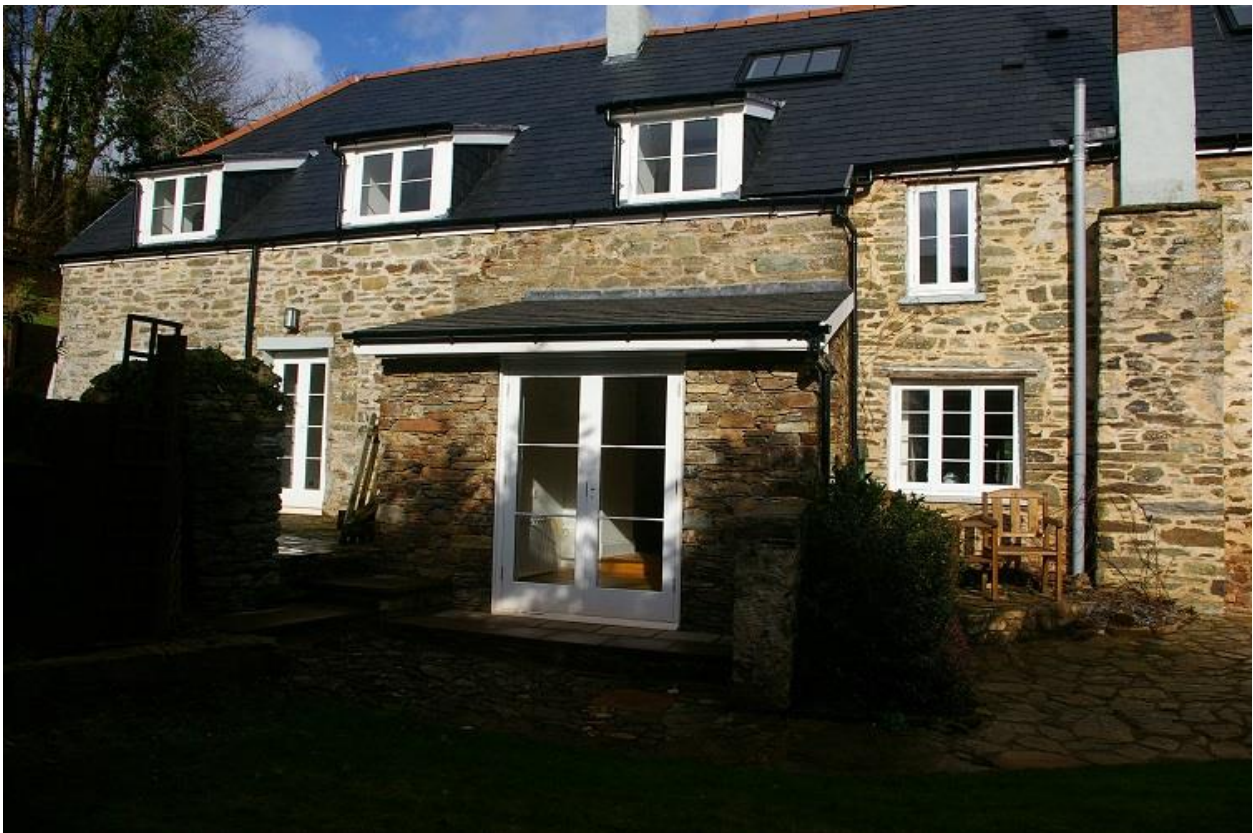
64. THE POSSIBLE STAIR TURRET, PORCH AND CENTRAL PART OF THE SOUTH ELEVATION.

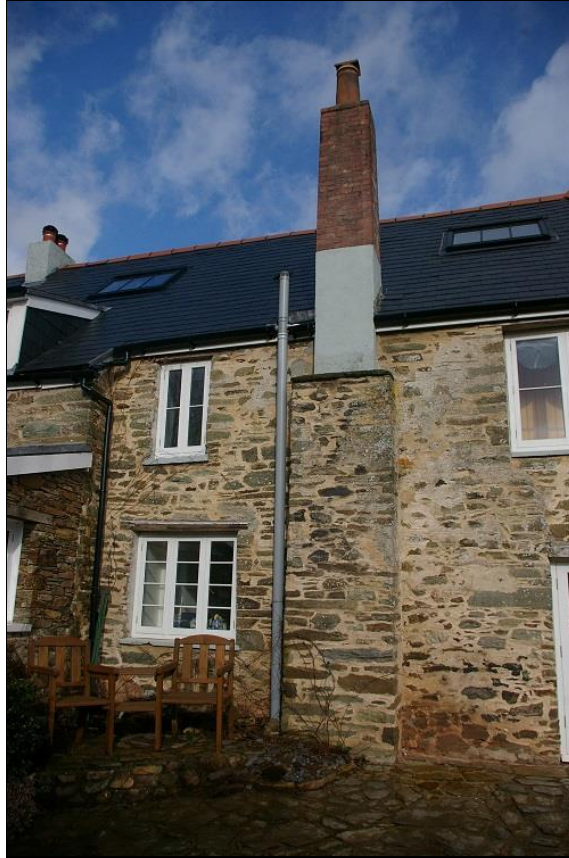
65. THE POST-MEDIEVAL STACK ON THE SOUTH ELEVATION OF THE FARMHOUSE.

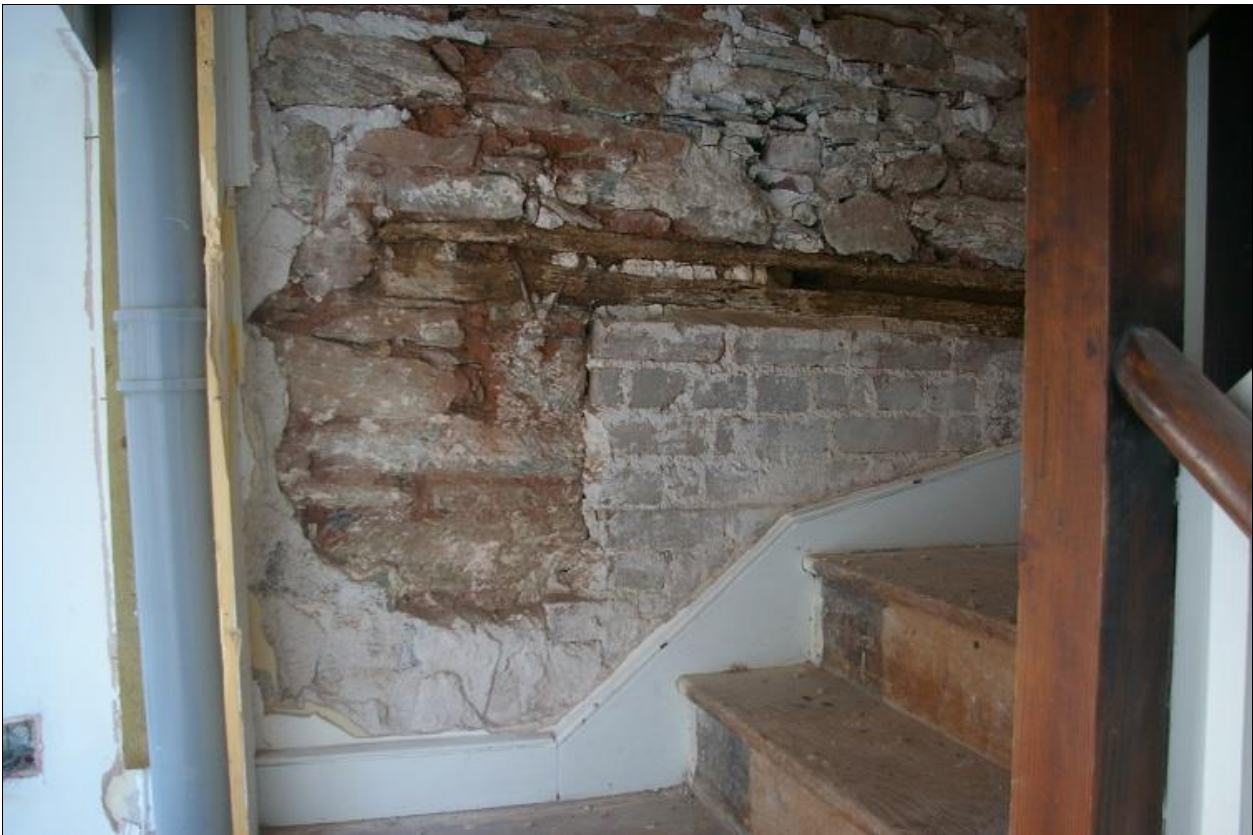
68. BLOCKED DOOR WITHIN FARMHOUSE AND COTTAGE, BLOCKED BY BRICKWORK.

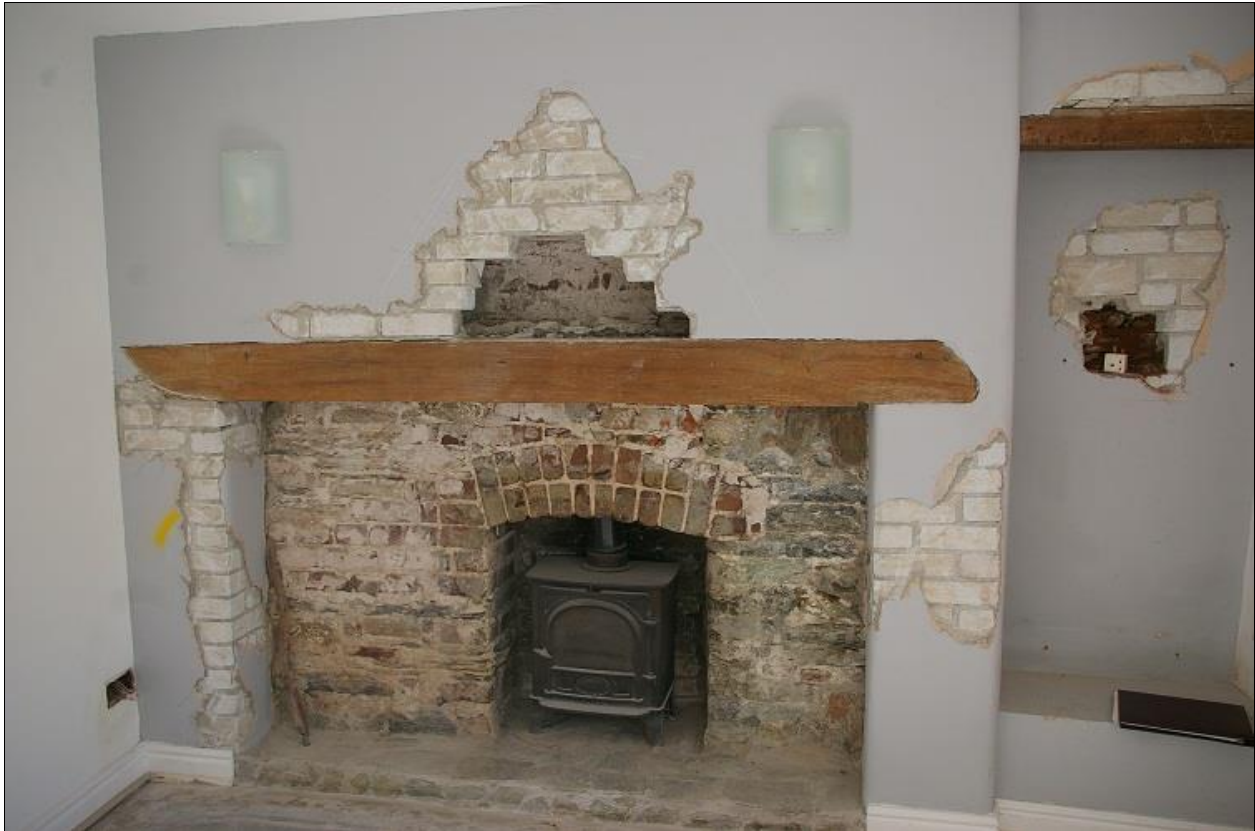
69. POST MEDIEVAL SMALL BOX HEARTH SET INTO THICK MEDIEVAL WALLING, FORMING A SMALL FIREPLACE, COVERED OVER BY MODERN BRICK.

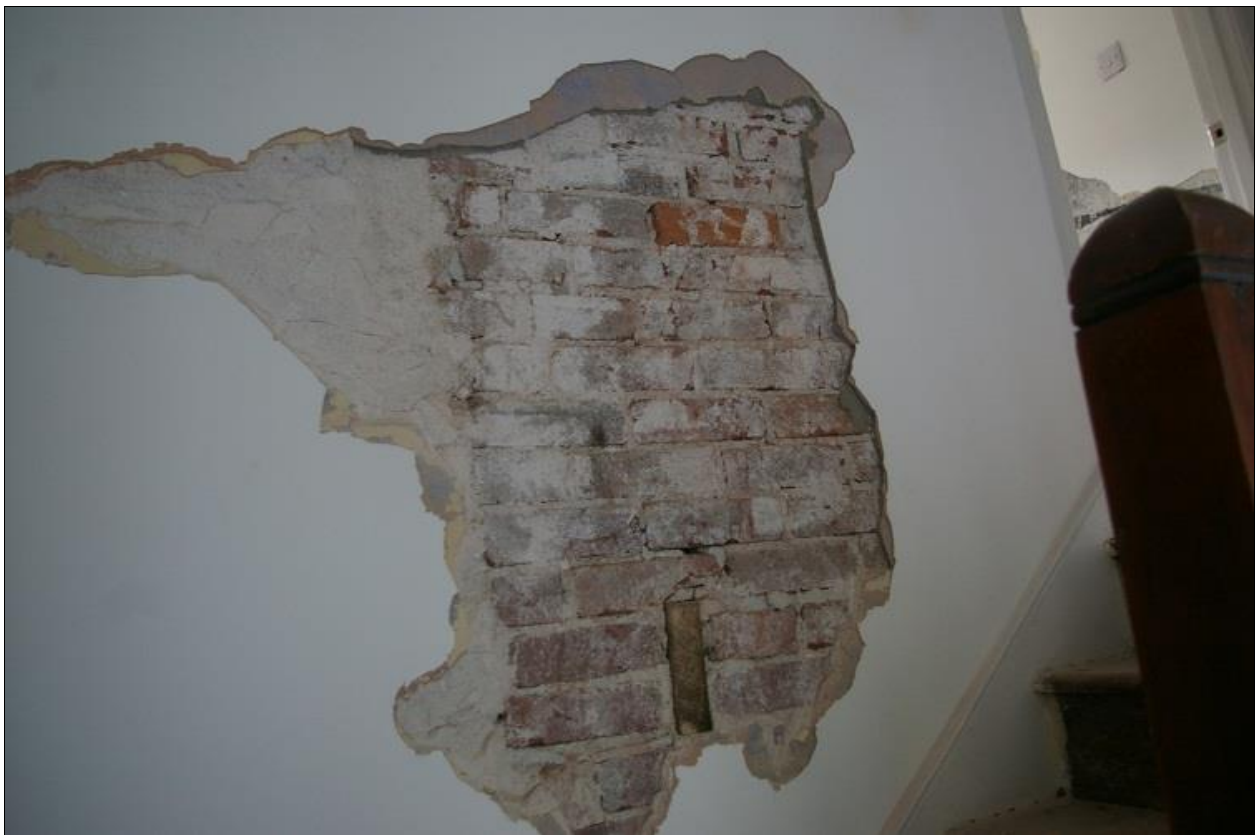
70. BRICK NOGGIN WALL FORMING PARLOUR AND BEDROOM IN THE COTTAGE.

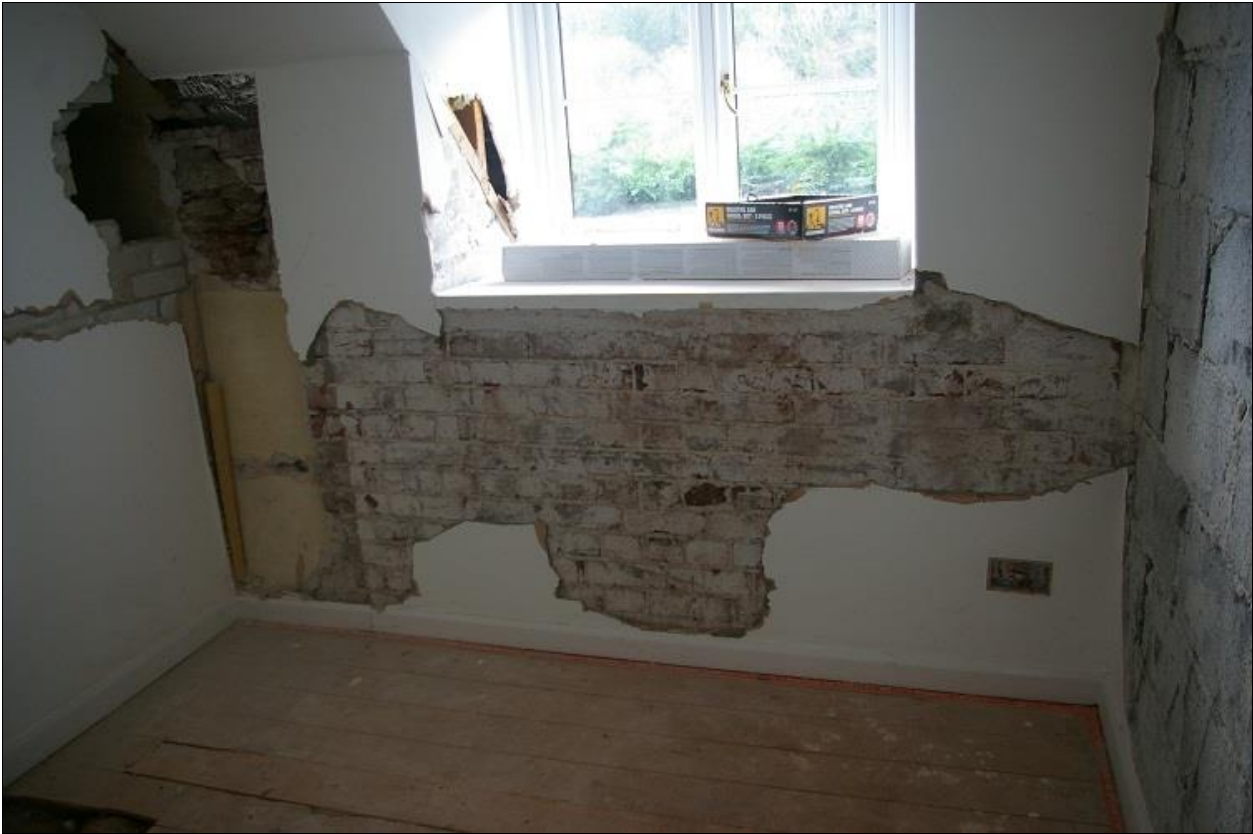
71. BRICK WALLING RAISING THE OLDER RUINED MEDIEVAL WALLS FORMING THE COTTAGE.

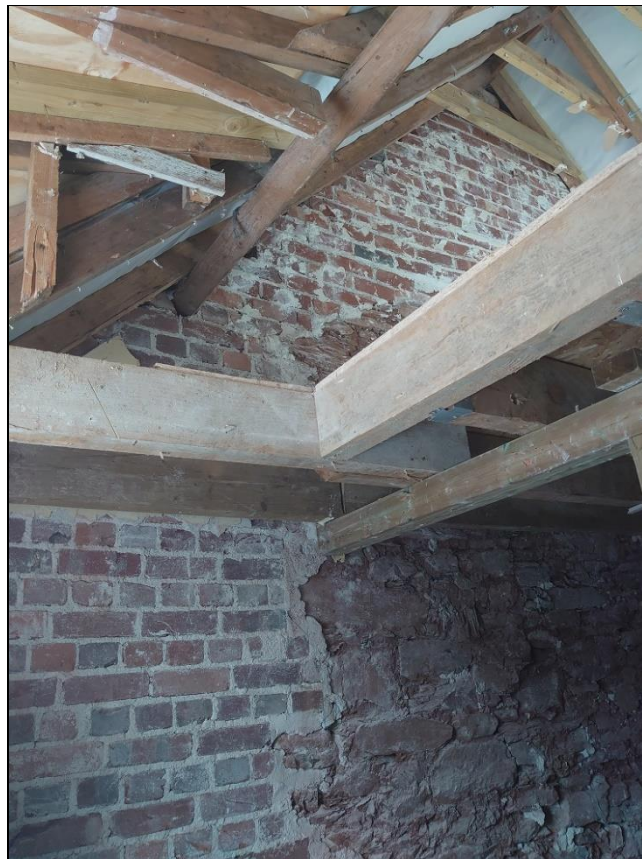
72. 19TH CENTURY BRICKWORK RAISING 17TH CENTURY RUBBLE STONEMWORK, WITHIN THE PARTITION THAT SEPARATES THE COTTAGE AND FARMHOUSE; FROM THE SOUTH-EAST.

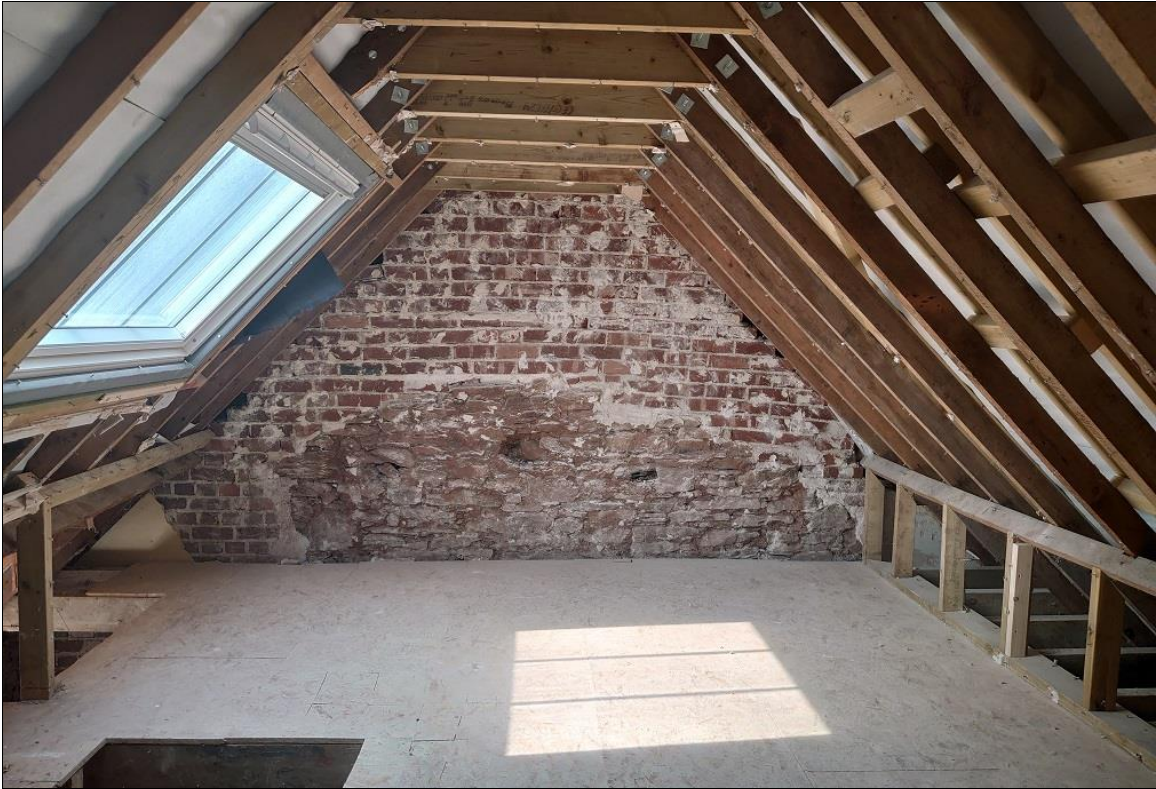
73. THE APEX OF THE PARTITION BETWEEN THE COTTAGE AND FARMHOUSE, SHOWING 19TH CENTURY BRICK RAISE TO 17TH CENTURY FABRIC; FROM THE EAST.

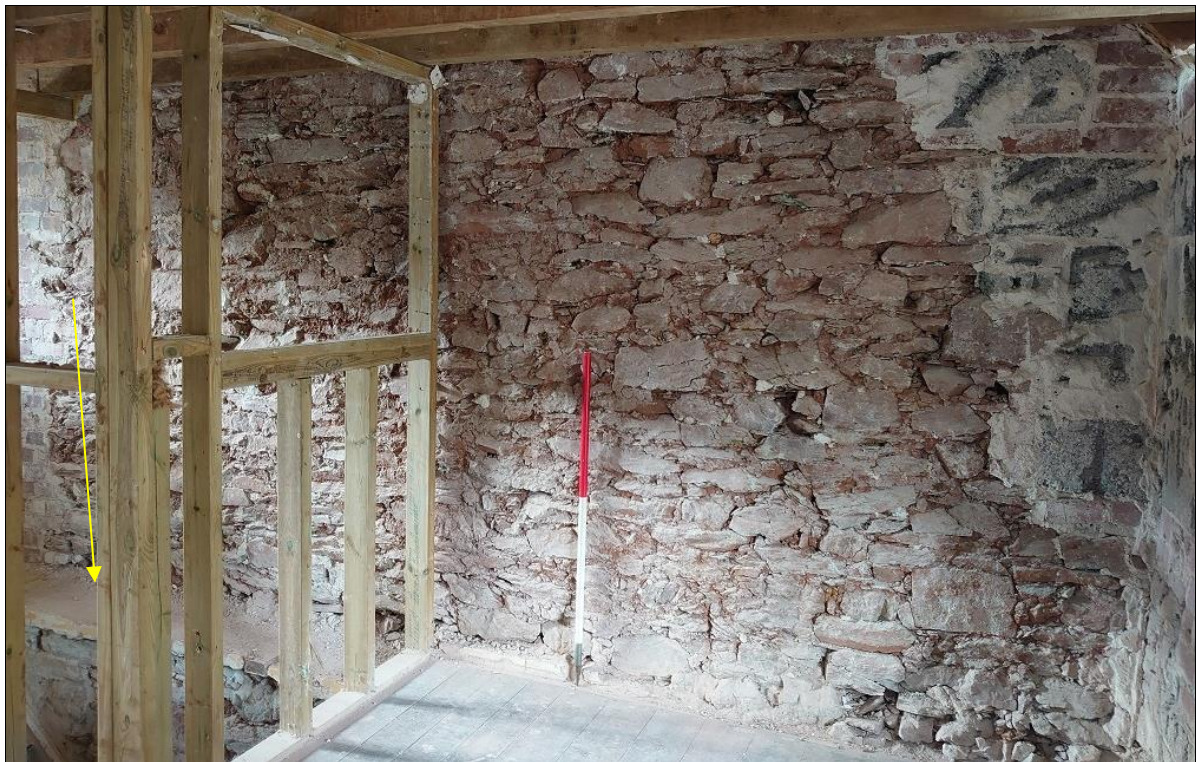
74. THE 17TH CENTURY PARTITION WHICH IN TURN RAISED A RUINED MEDIEVAL WALL (1M SCALE), THICKER MEDIEVAL WALL ARROWED; FROM THE EAST-NORTH-EAST.

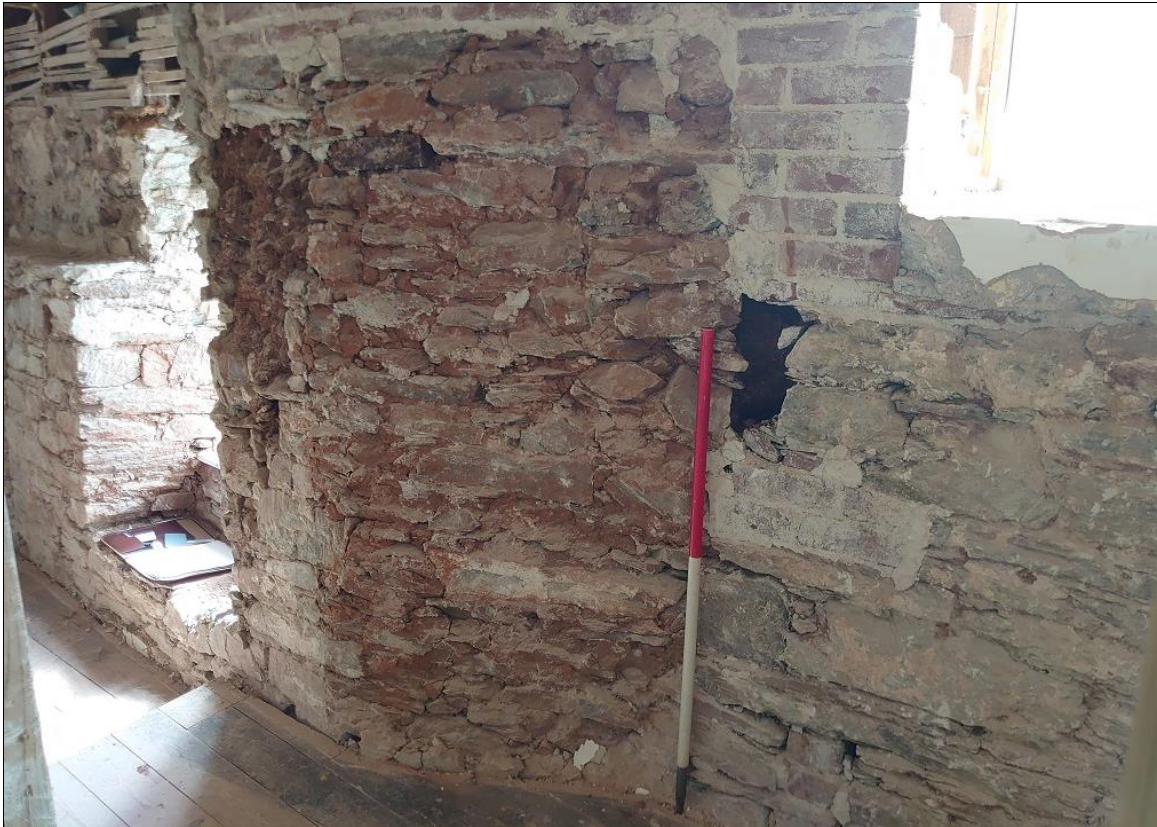
75. THE 17TH CENTURY FABRIC OF A RUBBLE-BUILT STAIR TURRET, INFILLING BETWEEN TWO FRAGMENTS OF EARLIER MEDIEVAL STONework, REMAINS OF DETACHED BLOCKS, PART OF A COMPLEX EARLIER SITE, ALL CONTAINED WITHIN THE SOUTH FIRST FLOOR WALL OF THE FARMHOUSE (1M SCALE); FROM THE NORTH-WEST.

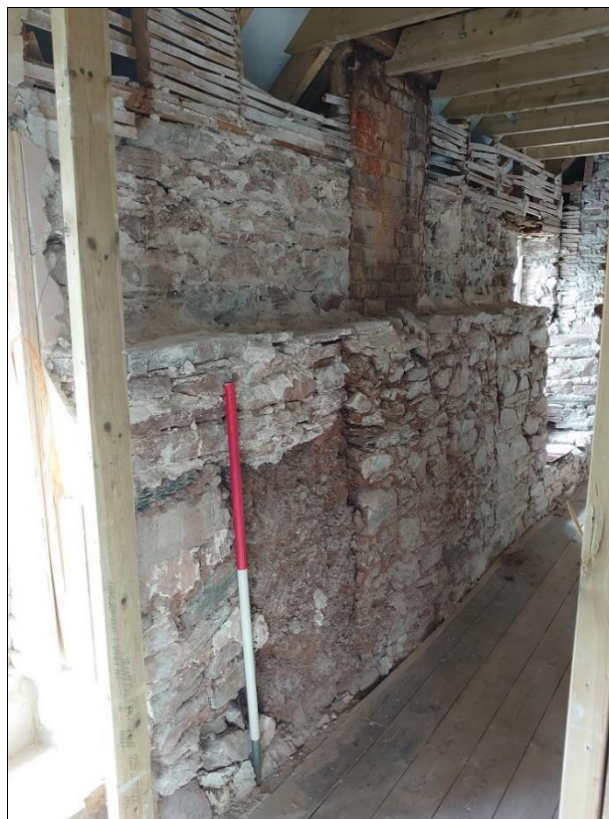
76. THE SOUTH WALL OF THE FARMHOUSE, AT FIRST FLOOR, WITH AT LEAST TWO PHASES OF POST MEDIEVAL FLUE CUT INTO BELOW MEDIEVAL STONework AND ABOVE AN EARLIER, LIKELY 17TH OR 18TH CENTURY RAISE AT THE EAVES (1M SCALE); FROM THE NORTH-EAST.

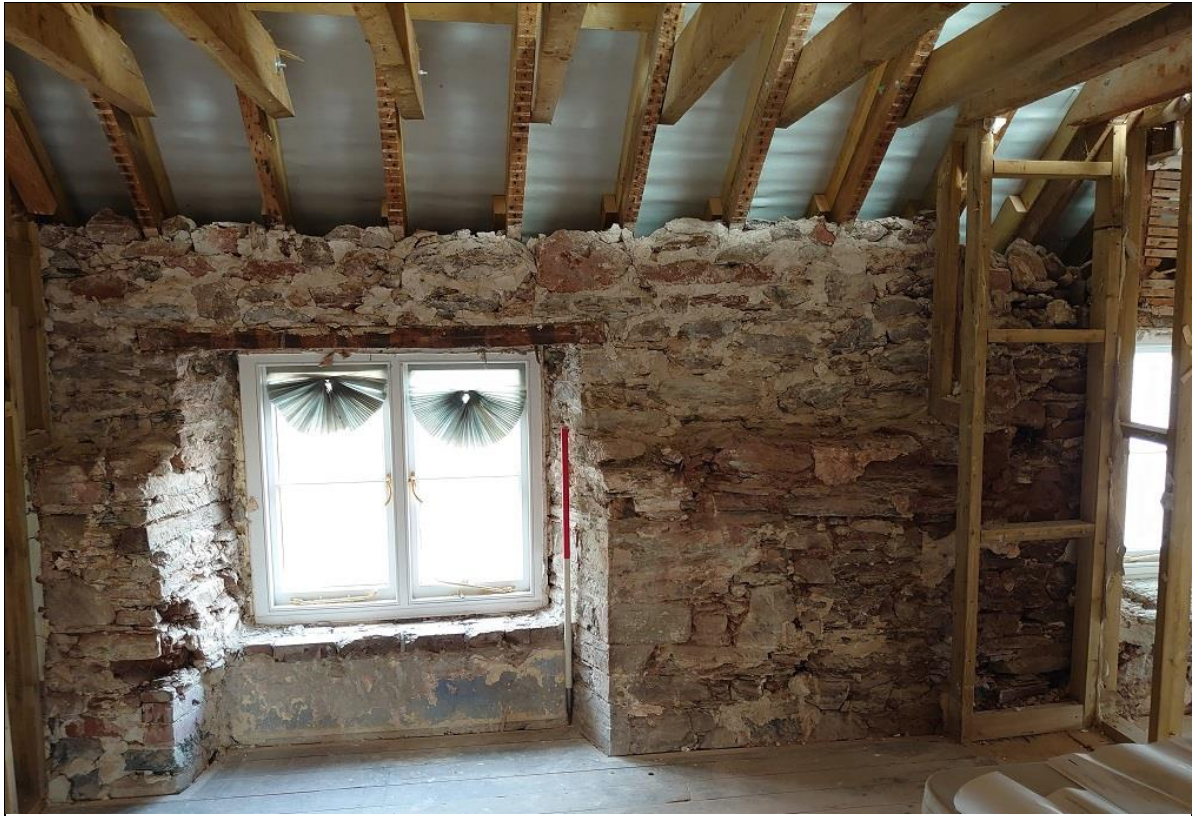
77. THE SOUTH WALL OF THE FARMHOUSE, WHERE MEDIEVAL WALLING, WITH FINE DRESSED DETAILS CAN BE SEEN TO BE RAISED BY POST MEDIEVAL RUBBLE (1M SCALE); FROM THE SOUTH.

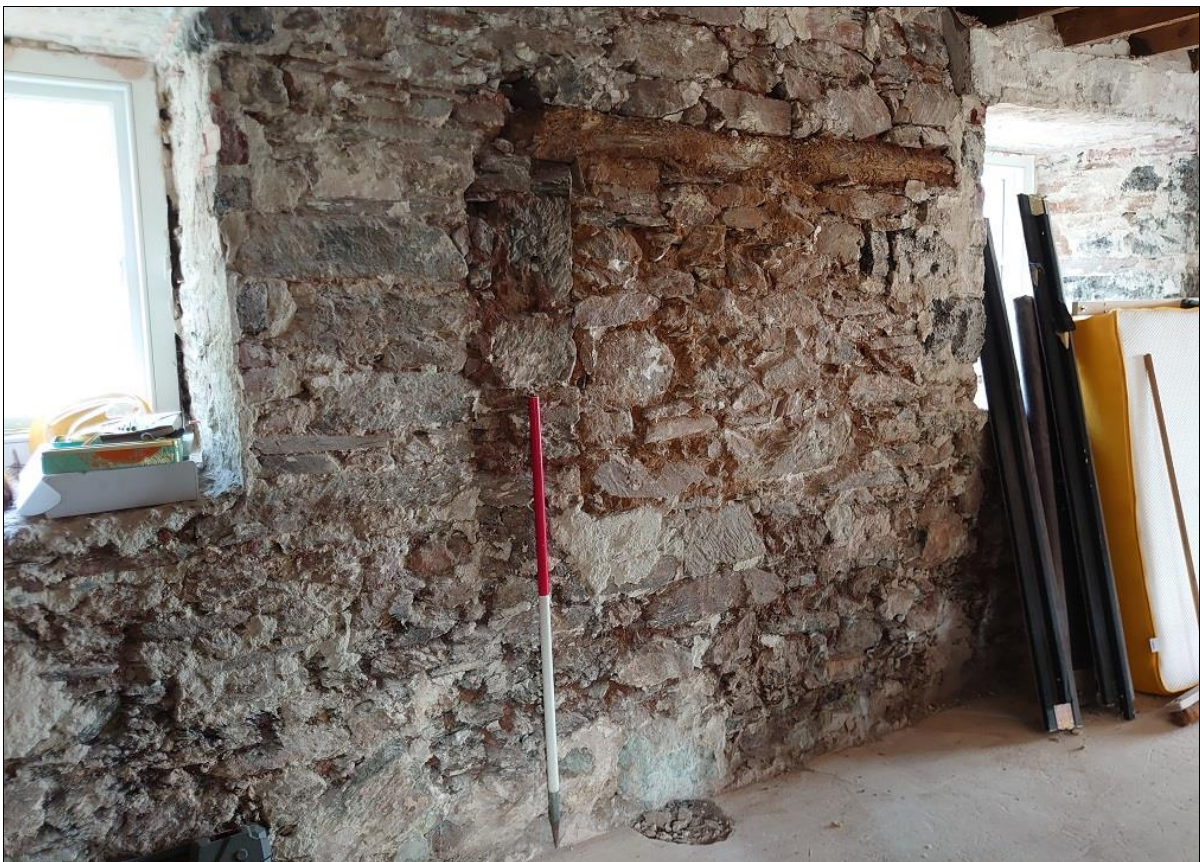
78. THE BLOCKED WINDOW IN THE NORTH WALL OF THE FARMHOUSE, WITHIN THE MEDIEVAL STONEMWORK, BLOCKED BY POST MEDIEVAL RUBBLE (1M SCALE); FROM THE SOUTH-WEST.

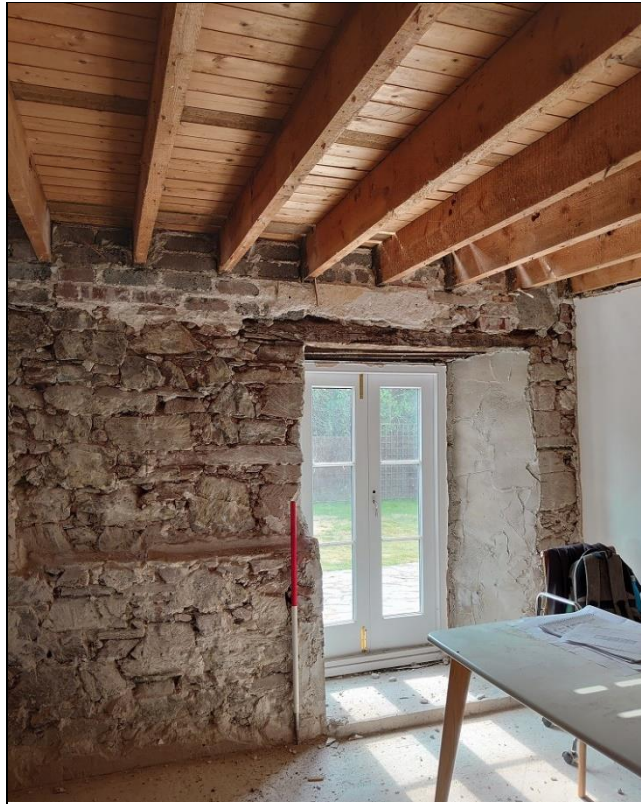
79. STEPPED MEDIEVAL FABRIC IN THE SOUTH WALL OF THE FARMHOUSE AT GROUND FLOOR LEVEL (1M SCALE); FROM THE NORTH-EAST.

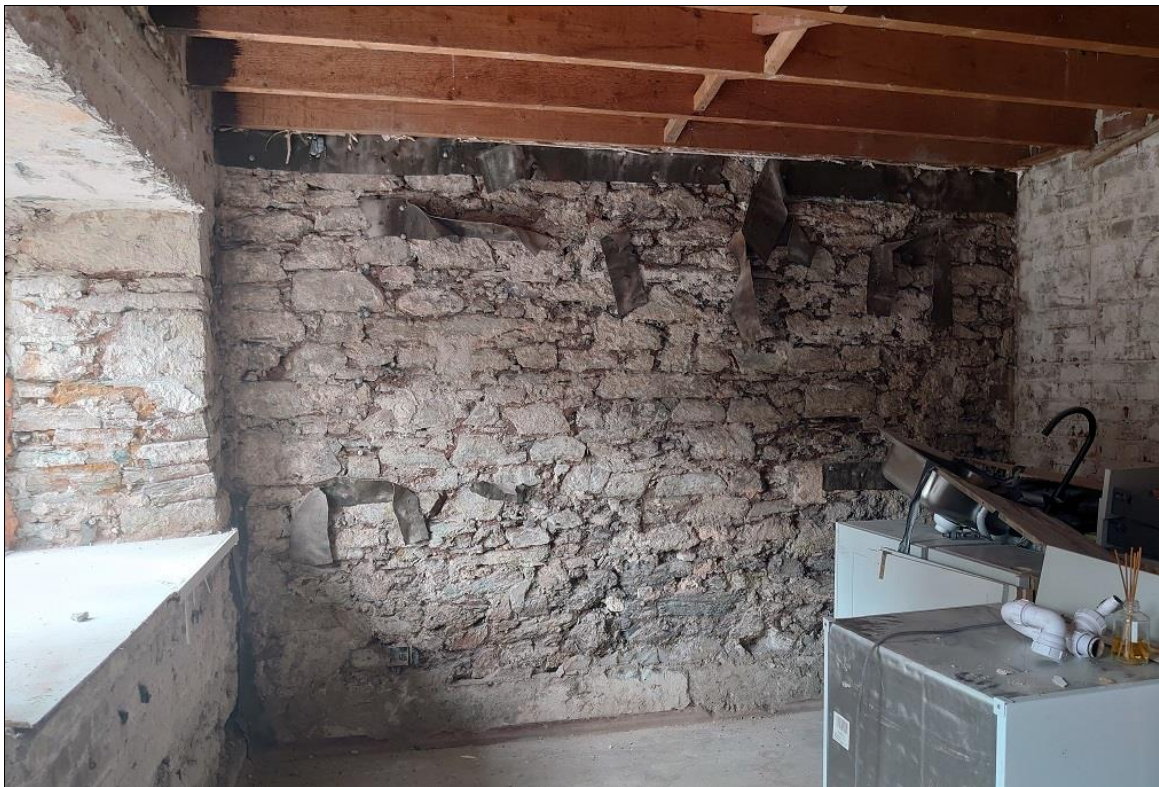
80. HEAVY MEDIEVAL WALLING TO THE WEST END GABLE OF THE COTTAGE, WITH FINE DRESSED DETAILS, ANOTHER FRAGMENT OF THE EARLIER COMPLEX; FROM THE EAST.

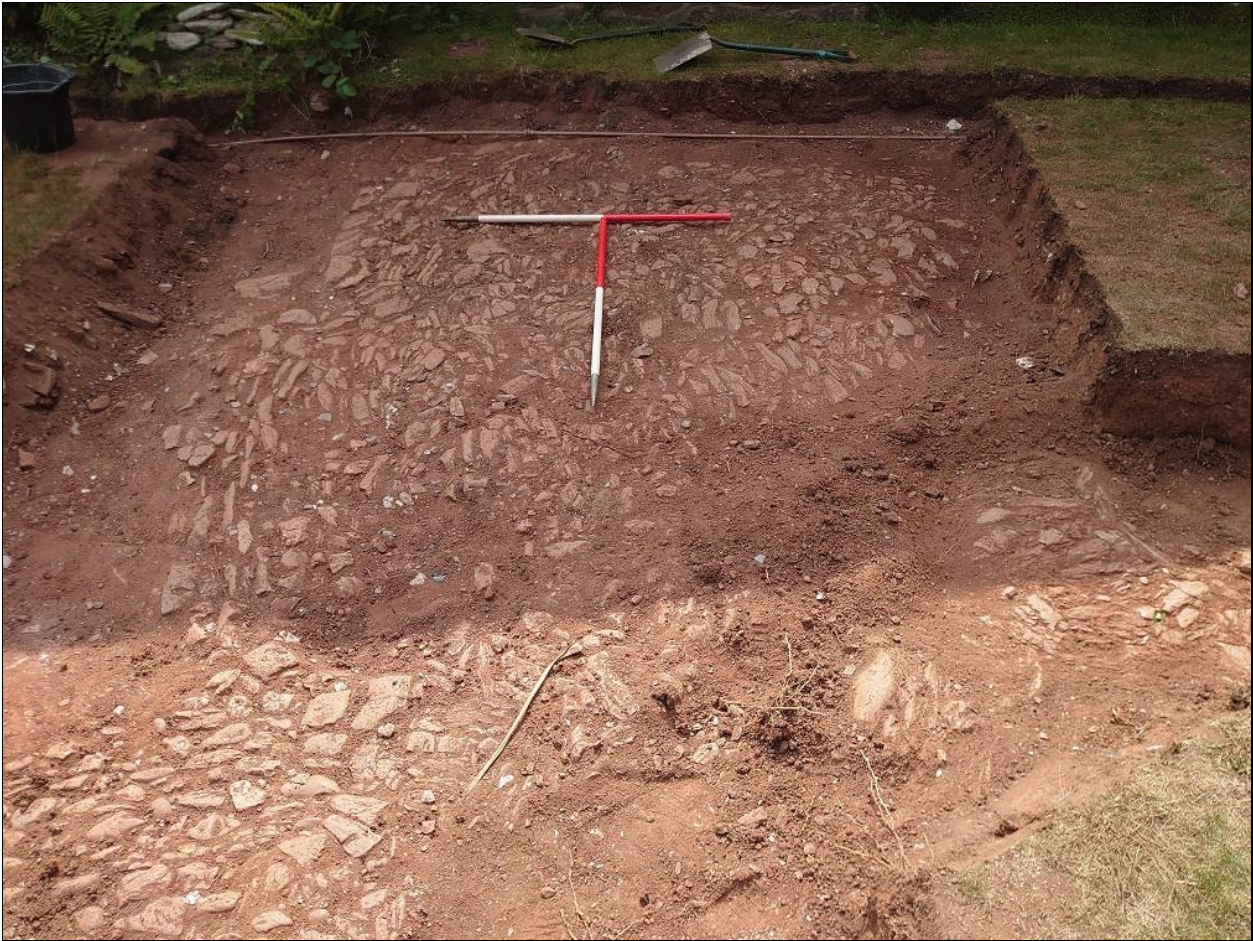
81. DETAILED VIEW OF THE COBBLED YARD TO THE NORTH OF THE FARMHOUSE, UNDER THE RELATIVELY MODERN GRASS LAWN (1M SCALES); FROM THE NORTH.
