BARNS AT HIGH MEADOWS GOOSEHAM BUDE CORNWALL

Results of a Desk-Based Assessment
&
Historic Building Recording

Report No.: 110715
Date: 15.07.11
Author: E. Wapshott

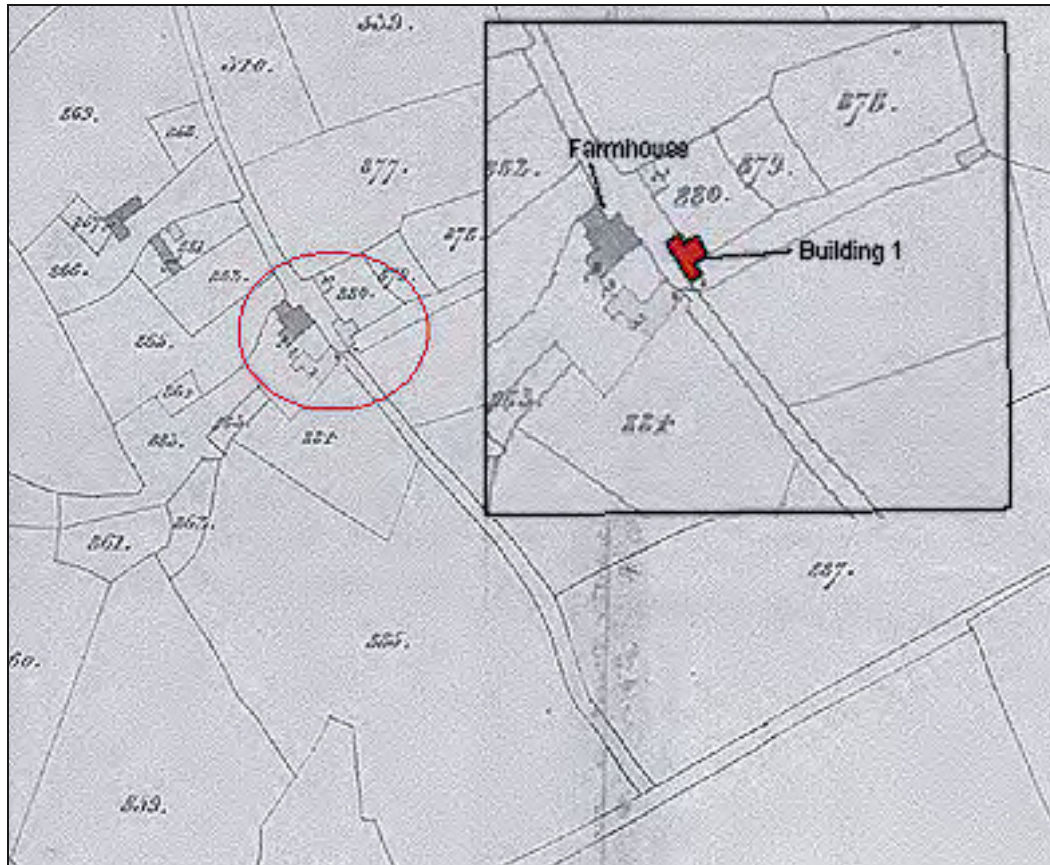
Figure 3: Extract from the 1842 tithe map of Morwenstow Parish, showing the threshing barn (B1) and engine house (B1b).

Both the Threshing barn and Engine house can be seen on the 1842 tithe map, across the road from the large farmhouse. The threshing barn and engine house (Building 1 and Building 1b) are highlighted in red on the inset showing how the shape of the buildings has barely changed between the 1840s and the 1880s. In 1842 the engine house would have been a horse engine house, and appears larger than the extant building on the site. It is noticeable that on the 1880s map the engine house appears to have a polygonal wall to the east and on this early tithe map it appears to be squarer; this could simply reflect the vagaries of early mapping, but equally it may actually indicate a change in shape in the building. The fact the engine house is present in the 1840s suggests the main threshing barn (Building 1) is even earlier in date since the engine house merely abuts the eastern wall of that structure and is not tied-in to that wall. Building 1

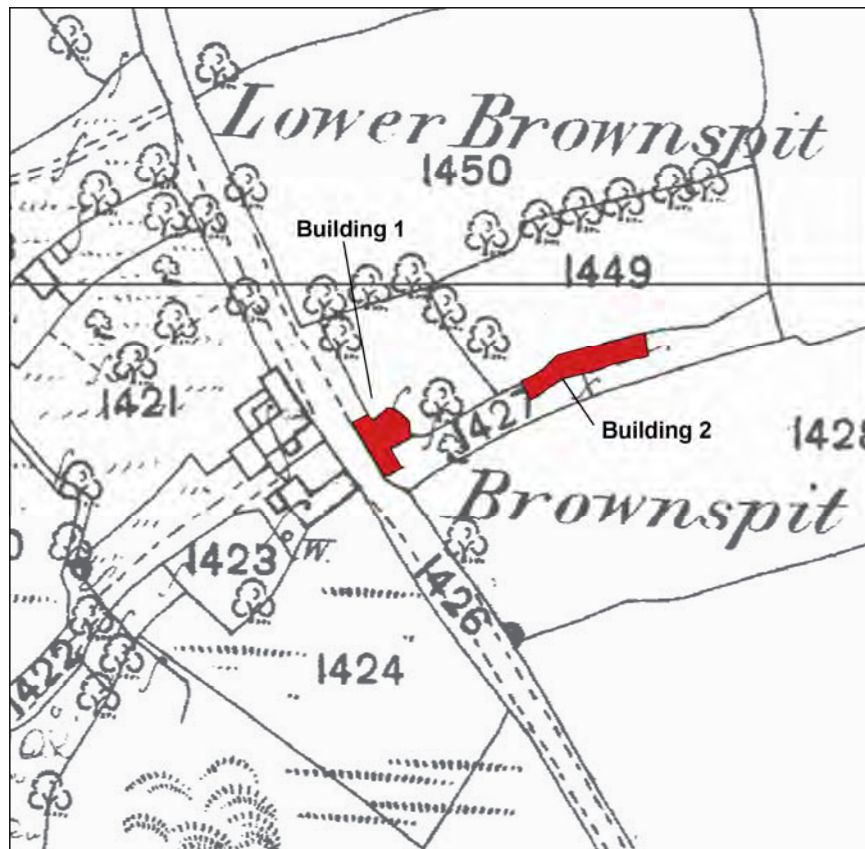
Figure 4: Extract from the 1885 First Edition Ordnance Survey map, showing the threshing barn (B1) and engine house (B1b), with the cart-shed/linhay (B2) at Brownsplit Farm.

The larger building, now a threshing barn (B1), can be seen on the 1885 map (Figure 4) adjacent to the road, across from the farmhouse and the other substantial ranges of agricultural buildings of various uses. To the east of the threshing barn is a small paddock which is shown as having walls (or traditional Cornish banks), with trees. This bank or wall projects from the north end of the threshing barn and to the south adjoins the southern elevation of the engine house.

The threshing barn appears to be of the same shape and size as we see today, except for the addition of the lean-to to the south, now evidenced only by the sockets in the wall of the south elevation and the blocked opening. The horse engine is shown to the east of the threshing barn with an opening or access shown in the north. This engine house would probably have had

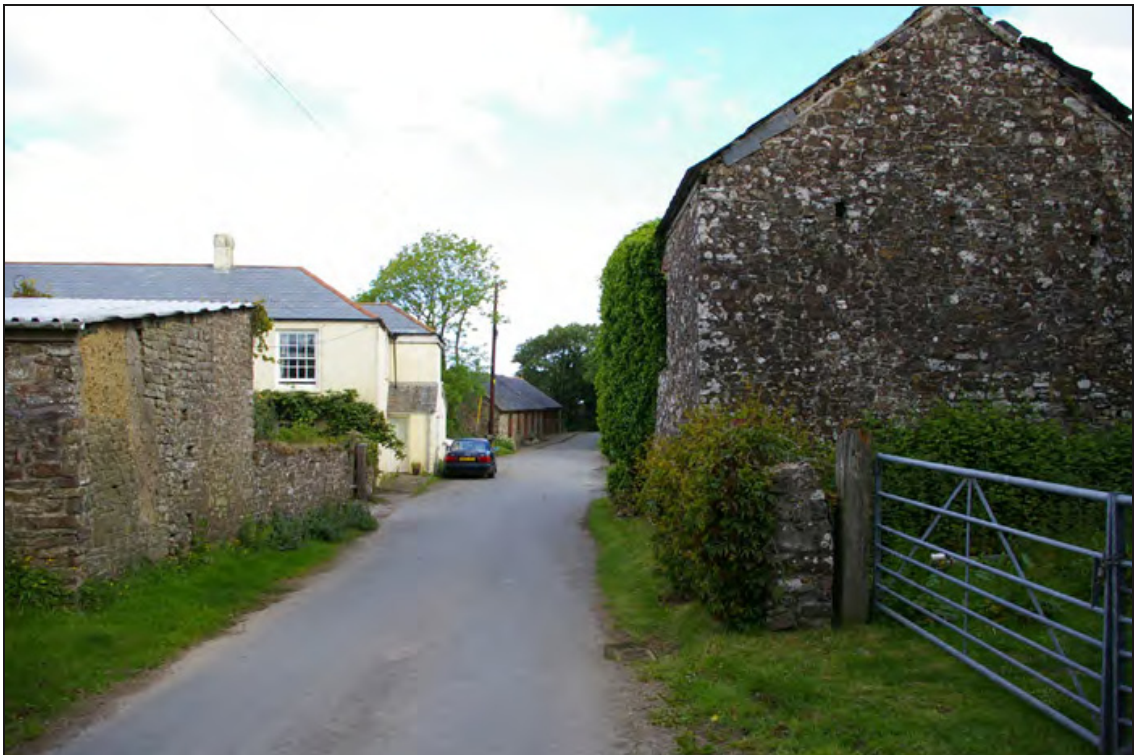
Both buildings are currently redundant and the threshing barn has fallen into disrepair with slipped slates and water-damaged roof trusses and rotten, failing floor timbers within the granary extension.

Figure 6: The threshing barn (B1) (on the right) and the farmhouse at Browns Pitt Farm, viewed from the south.

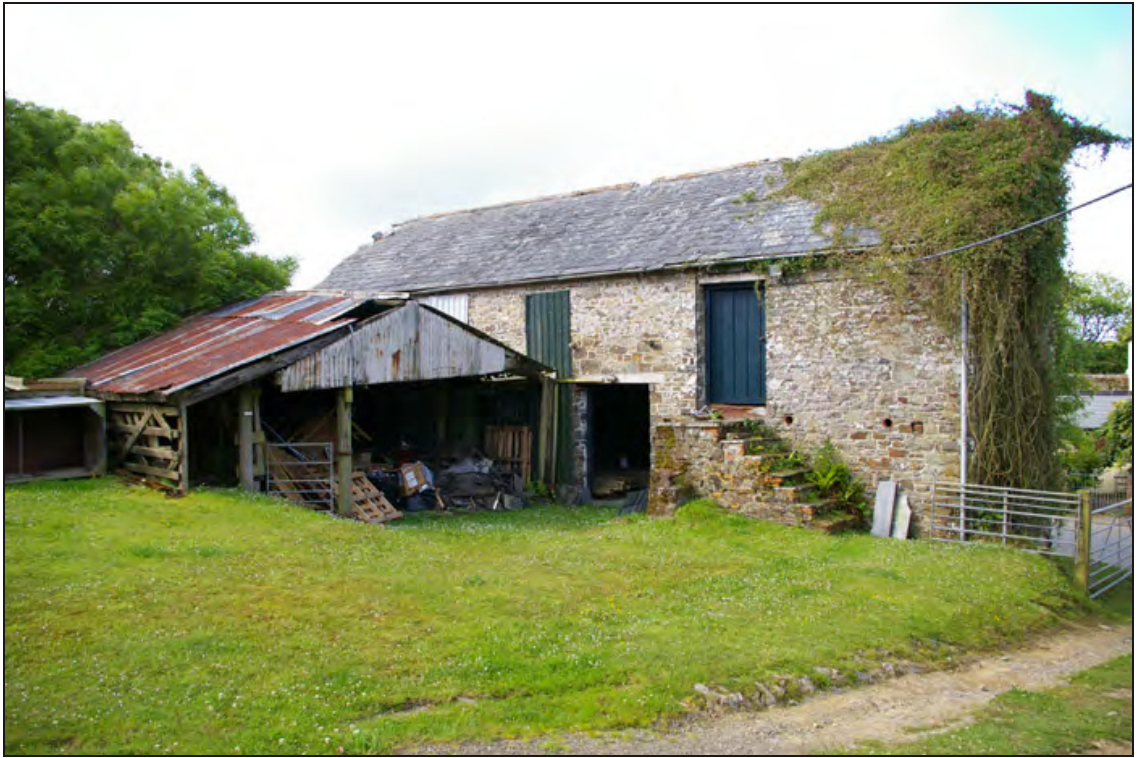
The east elevation is largely obscured by the engine house at the south end and there is a large timber wall plate at the eaves. The large blocky rubble stonework is set in yellowish-white lime mortar which shows many variations of colour suggesting re-pointing and possibly some rebuilding on the addition of the granary. Much of the stonework to the south is covered by corrugated iron sheeting, preventing analysis. There is one wide ground-floor doorway at the north end, with a boarded 19th century timber stable door, ledged and braced to the interior, with a substantial slate slab threshold and narrow timber lintel. The stonework above and around this opening appears to have been re-pointed and the reveals to the opening do not appear to be as formally arranged as that in the blocked doorway in the south wall. To the centre of the elevation there is an opening, with a narrow timber lintel and now covered by corrugated sheeting, formerly for the drive shafts for the threshing engine which was once housed in the adjacent timber structure. There are stone quoins to the south end, adjacent to the abutting stone wall of the engine house and to the north end adjoining the granary there appear

to be areas of quoins remaining although sections have been rebuilt to tie in the structures (see Figure 7).

Figure 7: The east elevation of the threshing barn (B1) and granary (B1a), viewed from the north-east.

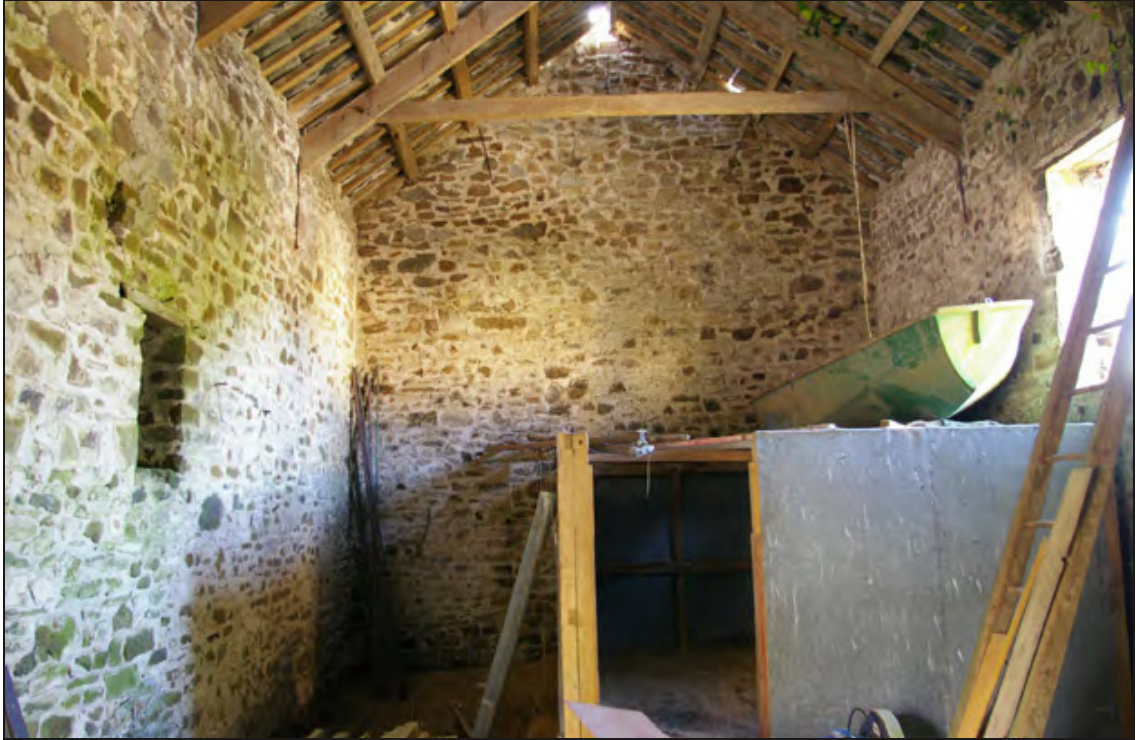
The interior walls of the threshing barn are of exposed stone that shows evidence of re-pointing in many areas. In the east wall there is a small opening with timber lintel for the drive shafts to enter and run the threshing equipment. In the south wall the blocked opening has quoined reveals, as to the exterior, with an internal timber lintel surviving, which is now partially covered by a modern grain box. There is a surviving raised plank threshing floor at the northern end which is approximately 0.5m above the internal ground level and which appears to terminate in line with the first floor loading door in the west elevation. This floor is supported on large timber joists, set into the walls of the building, running east-west, with the planks running north-south. The floor seems to have been cut or has rotted away to the south at the eastern side and has a modern timber and galvanised sheet built-in grain box to the south end (see Figure 8). To the west there is the possibility that the change in the floor height at this point was due to the area being used for straw storage, forming a lowered straw bay as seen in other historic threshing barns.

Figure 8: Interior view of the north wall of the threshing barn (B1), viewed from the south.

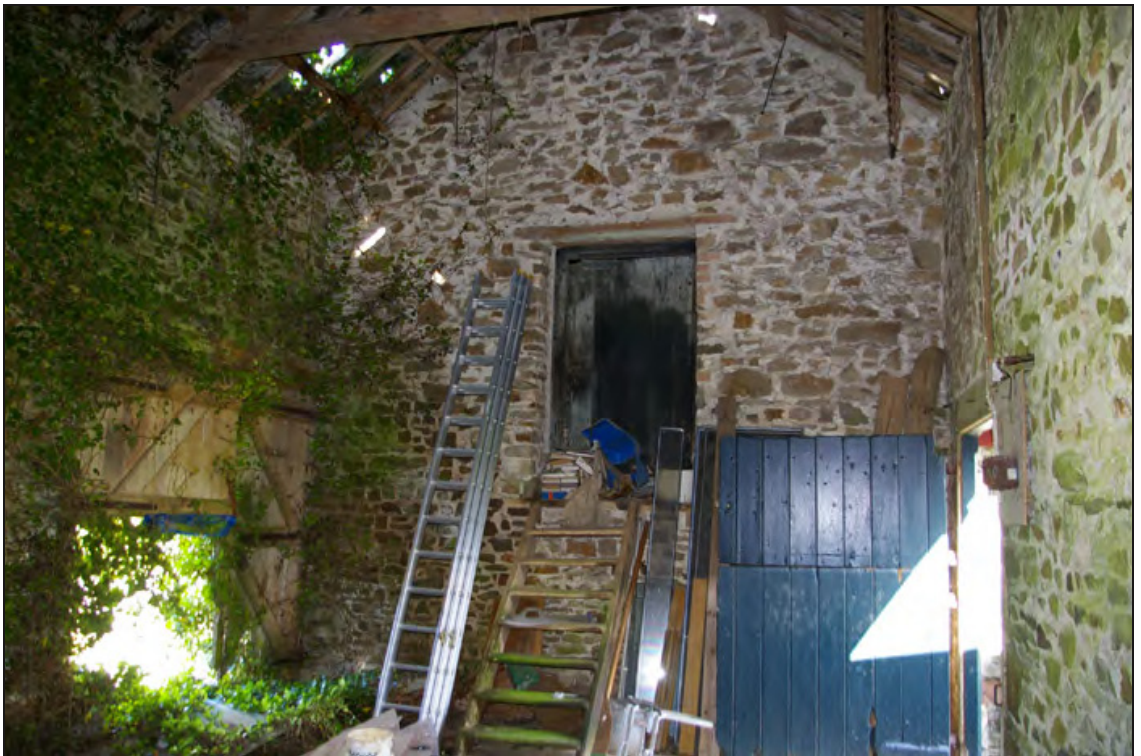
Figure 9: Interior view of the south wall of the threshing barn (B1), viewed from the north.

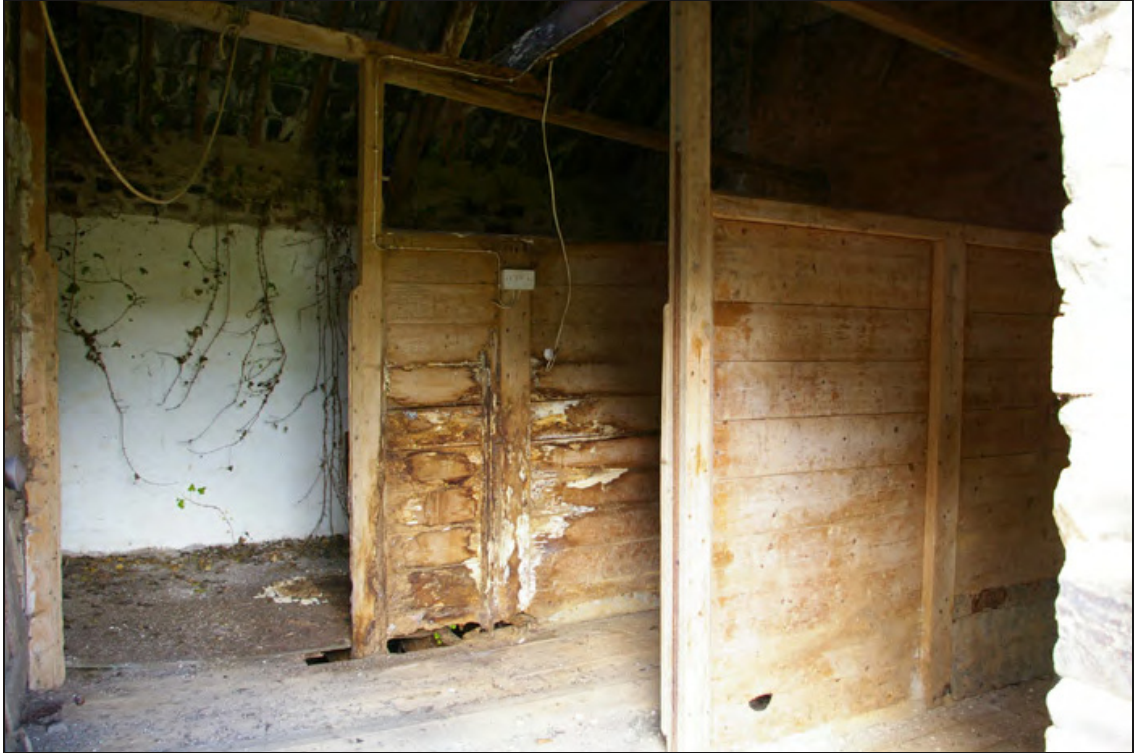
The interior walls are of exposed stone, which have been re-pointed in some areas. The west wall at the southern corner appears on its internal face to abut the threshing barn wall, with a

large crack running down the join where little effort appears to have been made to 'tie-in' the structures. The floor is of wide timber planks, which have suffered from considerable water damage, due to the leaking roof and are now rotten, making access unsafe. There is a large *in situ* timber internal frame supporting three grain boxes of various sizes, formed of pine planks (see Figure 10). Within each grain box the stonework is plastered and whitewashed. The floor to wall joint has been rendered around the boxes, again providing a vermin-proof seal for grain storage. The sliders to seal the grain boxes were not observed, but the room could not be fully accessed due to the dangerous floor structure. The internal door has clearly been forced into the north elevation of the threshing barn; the section of wall to the east and above the doorway has been rebuilt showing a heavy use of mortar and some bricks used in repairs. The lintel for the door is very narrow in nature and the door is of timber planks, ledged and braced, with strap hinges and a timber latch, it has a timber frame and a timber sill and a raised stone threshold, to prevent vermin entering the grain store.

Figure 10: Interior view of the first floor of the granary (B1a), viewed from the south-east.

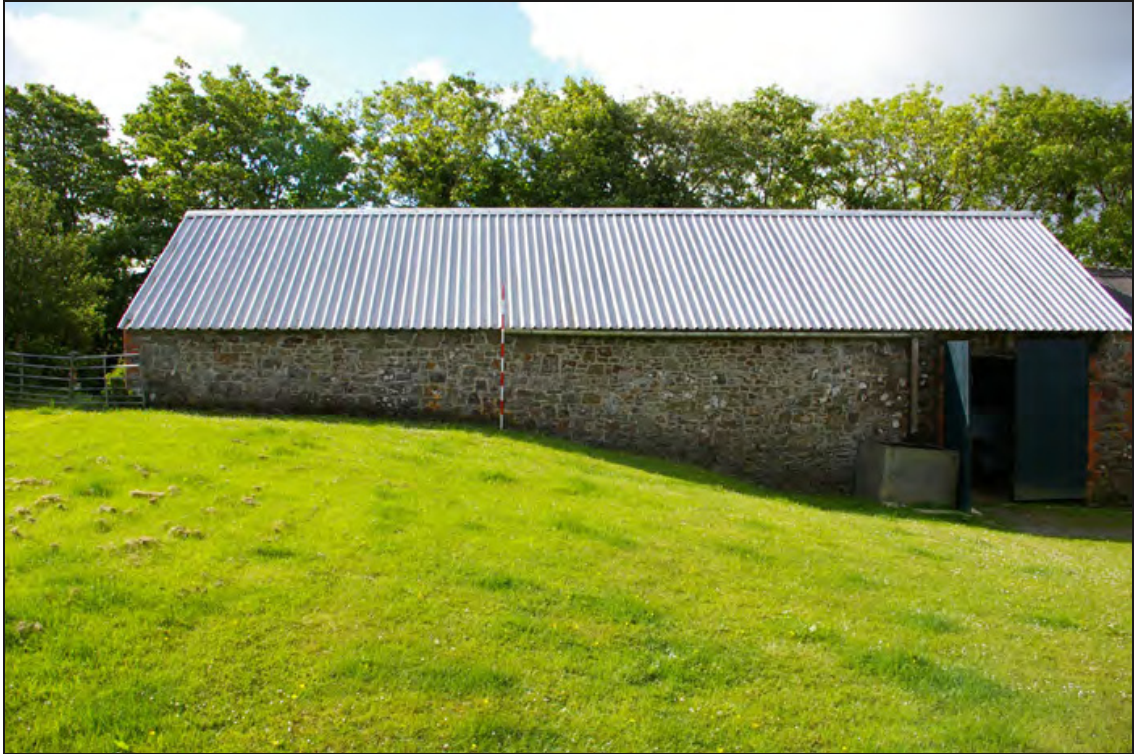
The north elevation is dug into the bank to the east end and constructed of rubble stonework with bull-nose brick quoins and a large double doorway to the west end, with plain brick reveals and a timber lintel, set back into an alcove, possibly a larger lintel has been removed from here, replacement plank timber doors, this lintel appears set back from the elevation. This elevation is abutted to the west by the concrete block cattle byre. The roof is of modern replacement corrugated iron (see Figure 11).

Figure 11: The north elevation of the cart-shed/linhay (B2), viewed from the north.

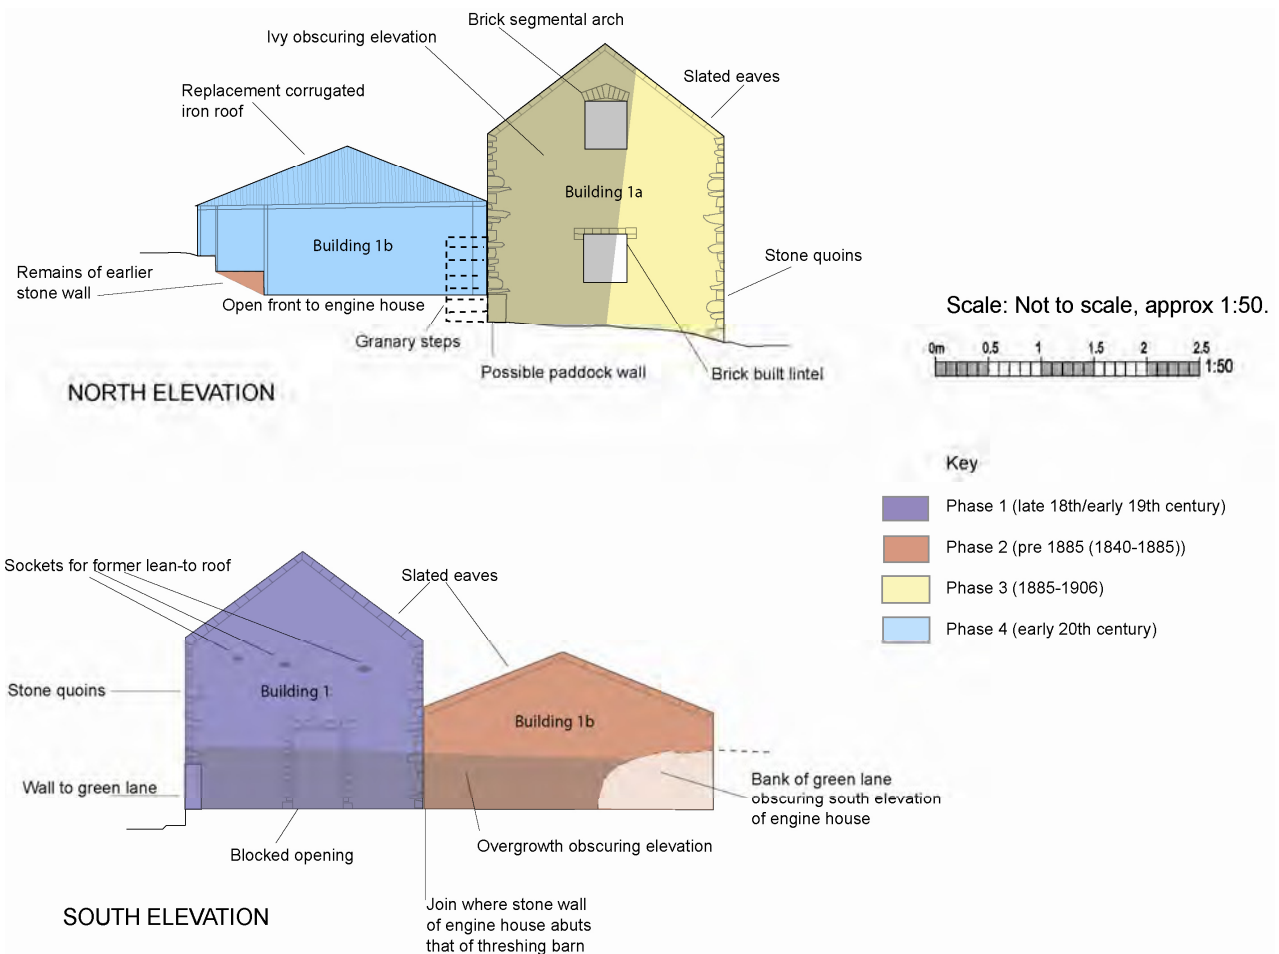
Figure 14: Phased drawing of the east and west elevations of the threshing barn (B1) and additions (B1a & B1b).
