THE FORMER GLOVE FACTORY PILTON BARNSTAPLE DEVON

Results of a Desk-Based Assessment
&
Historic Building Recording

Report No.: 120105
Date: 05.01.2012
Authors: T. Green
E. Wapshott

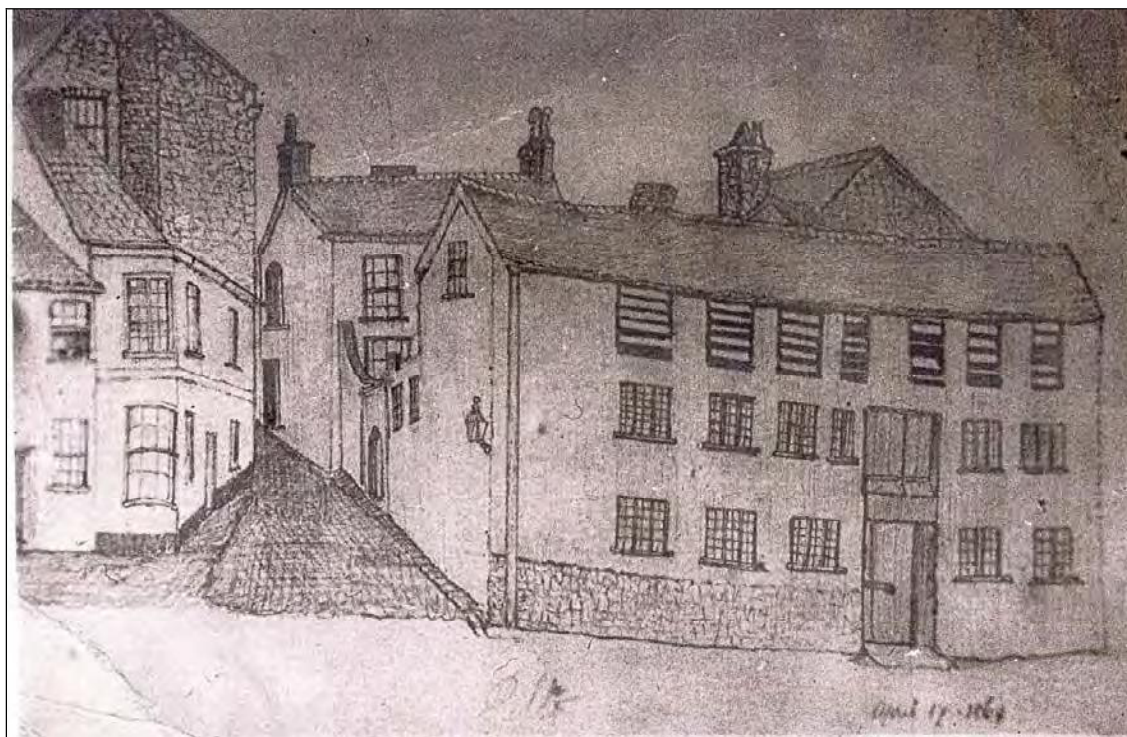
Figure 2: Drawing dated 1864 and entitled 'Fellmongers yard top of Pilton'. The glove factory is the tall rubble stone building on the left. The prominent building in the foreground was removed between 1864 and 1886. (Drawing supplied by Mr Lakeman)

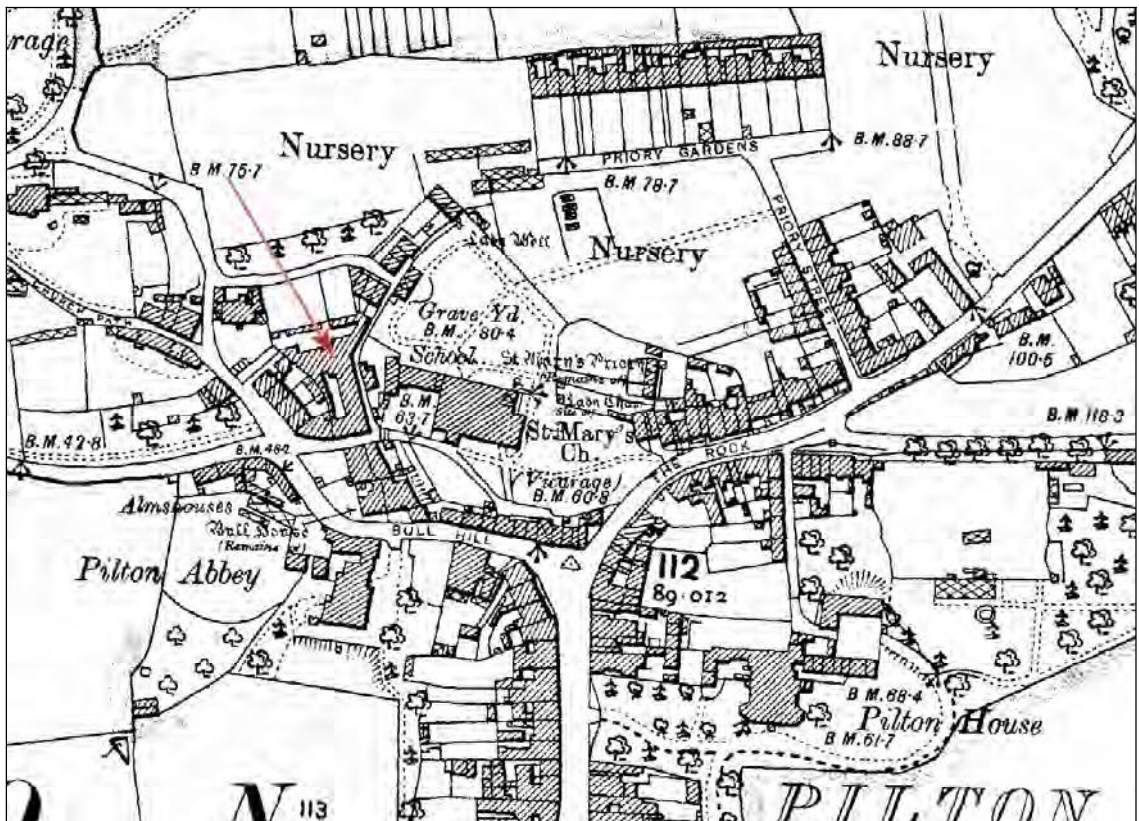
Figure 5: Extract from the Ordnance Survey Second Edition map at a scale of 1:2500 published 1905. The Glove Factory is indicated.

The Ordnance Survey Second Edition 1:2500 map of 1905 (Figure 5) indicates no change apart from the addition of outbuildings along the northern boundary of the site. Likewise the Ordnance Survey revised map of 1932 (Figure 6) suggests no further change of layout during the first half of the 20th century. Later 20th century mapping indicates the removal of what were possibly lean-to structures on the west side of the yard. From comparison of the drawing of 1864 (Figure 2) and the set up at the present day, it is evident that an originally domestic building on the corner to the south-west of the glove factory has been added to the factory and adapted. Its ground floor has been largely removed to make an arched vehicle entrance to the yard behind. By the time the 1971 Ordnance Survey map was produced the factory had radically changed shape with the outbuildings to the north and north-east being demolished and a new large rectangular wing constructed running almost up to the northern boundary of the site (Figure 7). The buildings to the north-west appear to remain the same although all of the buildings in the west yard have now been demolished along the western boundary. The site has continued with this layout to the present day.

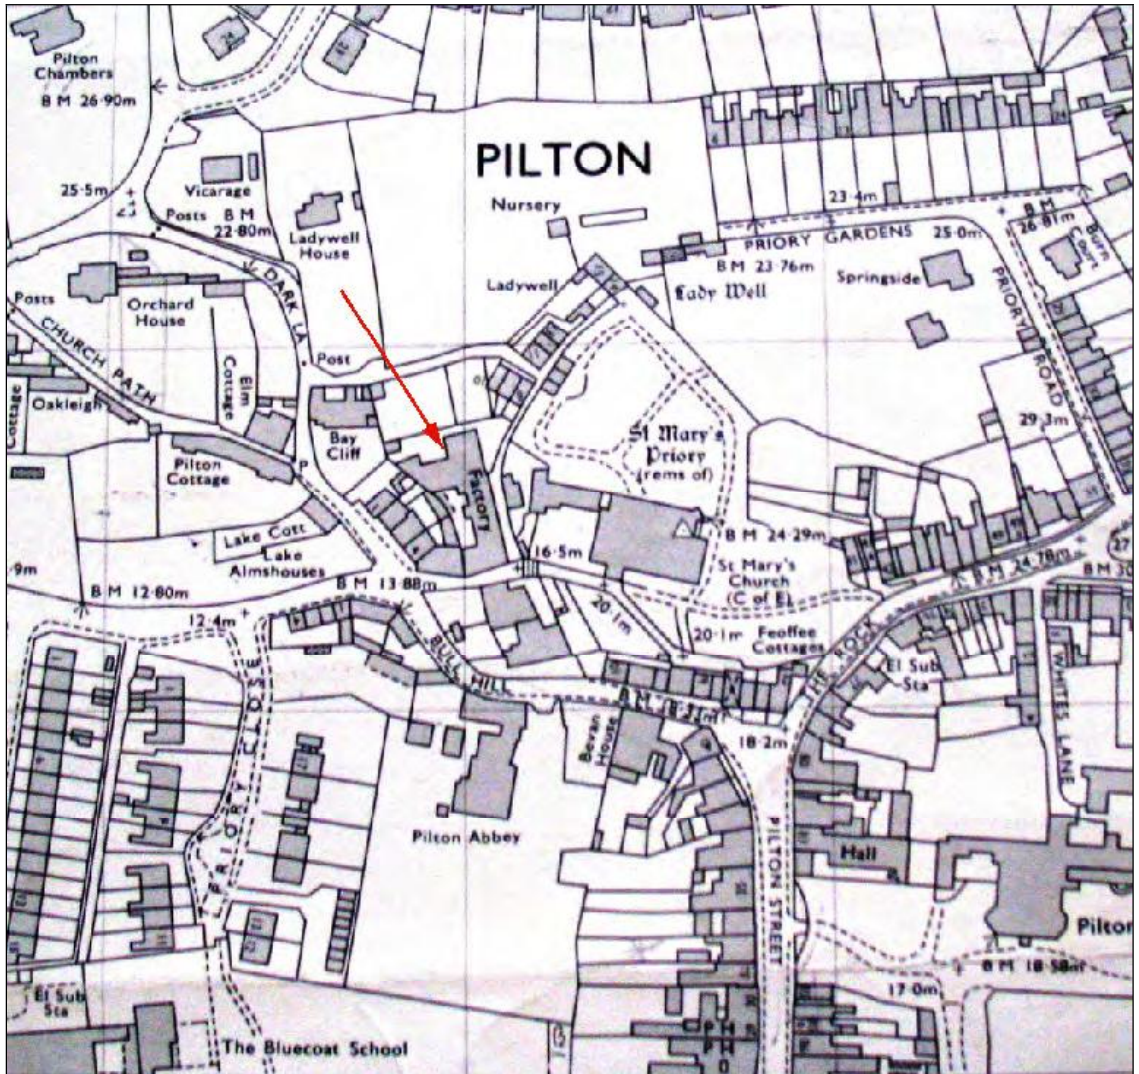
Figure 7: Extract from the 1971 Ordnance Survey map at a scale of 1:2500. The Glove Factory is indicated. Notice the marked change in shape of the main north-west wing, which no longer runs along Ladywell Lane but is squared off with a new extension.

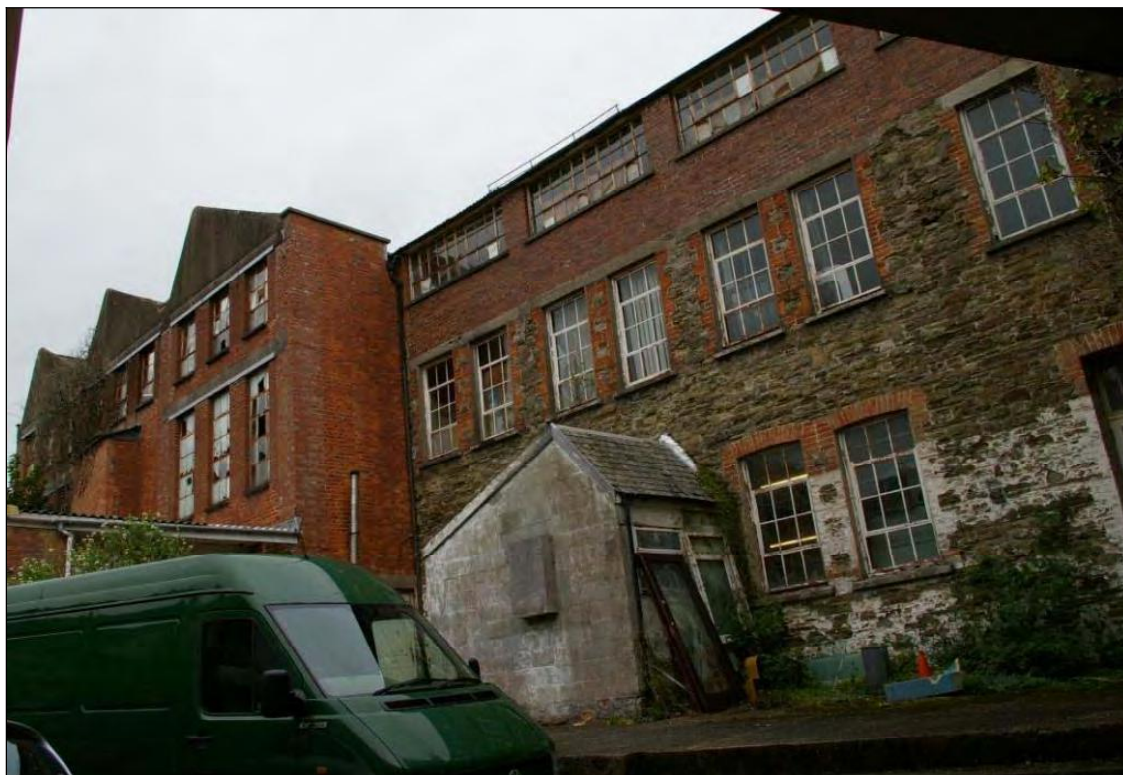
The former Glove Factory is a large stone building with brick extensions and brick architectural details (Figure 8). It stands at the Bull Hill entrance to Ladywell Lane, which leads up to the church steps and then turns north, into the heart of the former precincts of the medieval Priory. The main three storey buildings form a reversed L-shape which bounds this lane to the west. The buildings continue around to the north, but are only of one storey; forming a yard between the factory and the row of residential cottages to the west which face onto Lake. The yard is now accessed through a large open archway, forced through an adjoining former residential cottage that has been incorporated into the factory site as first floor offices (Figure 9). The south wing lies directly opposite the historic Bull House, presumed to have once been the Prior's house. This building is of three storeys, all of stone, with the various openings all with creamish-yellow Barnstaple brick reveals and with a brick-built sign forced into the elevation between the second and third storeys possibly spelling *SANDERS*, the name of the early 19th century owners of the building. The long east wing which runs north along the length of Ladywell Lane is also of three storeys; the ground and first floor are of stone, with red brick reveals to the regular sash window openings. The top floor of this wing has been extended in modern brick and there is a large three storey modern brick and concrete extension to the north, which has large skylights and large glazed openings to the north and east, with long windows to the west to give the appearance of sash windows.

Figure 8: The west elevations of the east and north wings of the factory from under the entrance archway, viewed from the south-west.

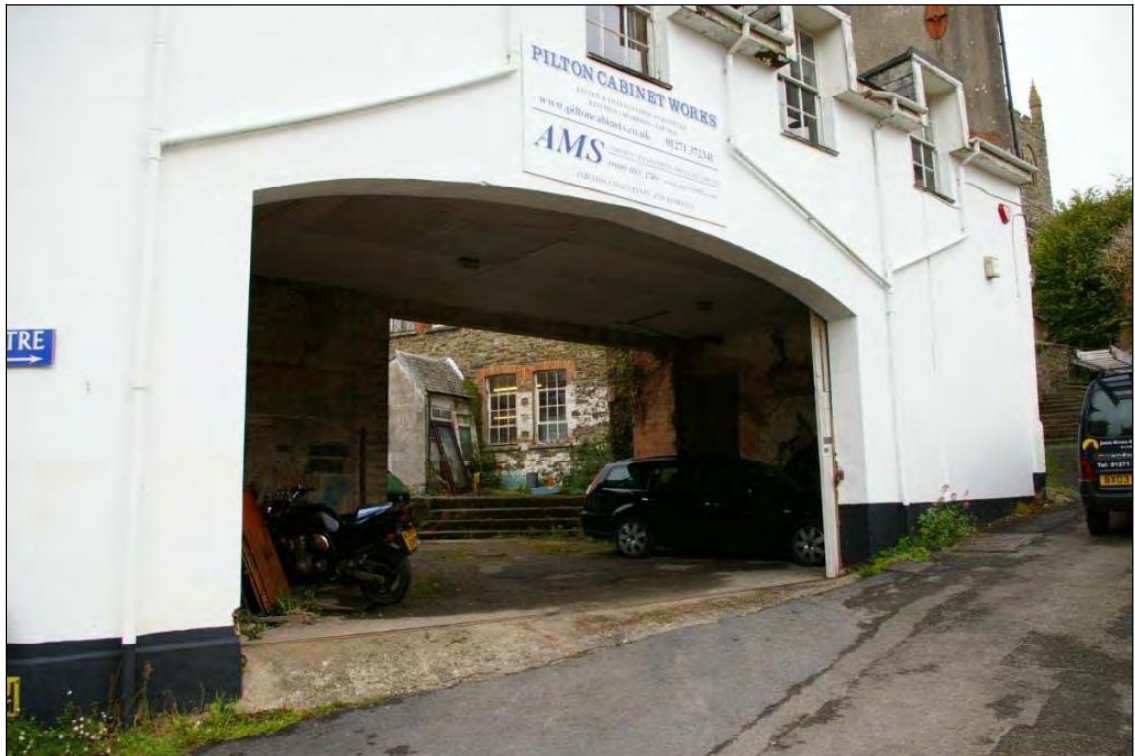
The complex of buildings at the former Glove Factory is entered through a large archway from Ladywell Lane and Bull Hill; this has been formed by removing the ground floor of a cottage which abutted the south wing (Figure 9). From the exterior the appearance of a domestic dwelling has been somewhat maintained with white render to the walls and a slate roof, with four dormer windows with sashes. The walls of the former cottage abut those of the surviving row of cottages which face onto Lake; in the north-west corner are the remains of the ground and first floor fireplaces which once heated the demolished rooms (Figure 10). These fireplaces display several phases of construction, the earliest built using greyish-yellow bricks.

Figure 9: The entrance archway from Ladywell Lane to the factory complex with view into the enclosed yard, viewed from the south-west.

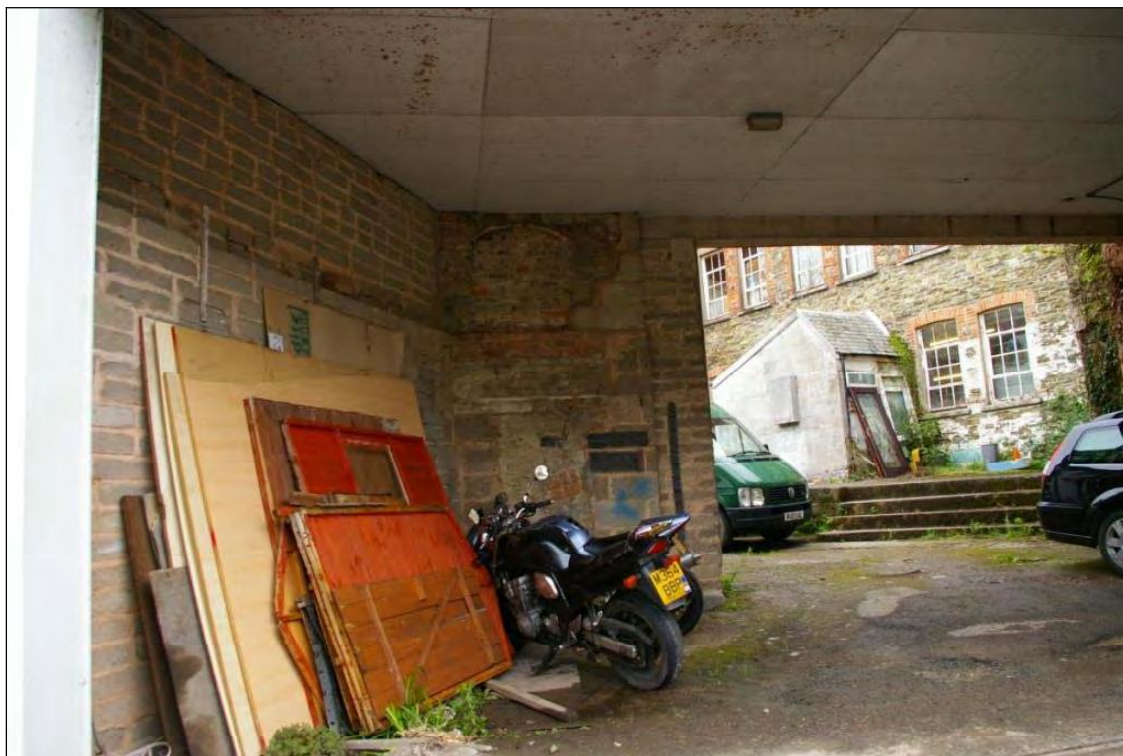
The west wall of the archway has been rebuilt and lined in concrete blocks with a concrete block plinth supporting the first floor at the inner opening, leading to the yard in front of the main buildings. The east wall, the party wall with the south wing of the factory, is largely of stone patched and supported by concrete block work. There are also two fireplaces in this elevation on first and ground floor, the chimney stack to these has been capped but projects from the exterior of the west elevation of the factory wing, above the roofline of the former cottage. A forced opening, now blocked, leads through to the covered former entranceway on the ground floor of the south factory wing. The north elevation facing onto the enclosed factory yard is rendered with small modern windows.

Figure 10: The west wall of the building containing the entrance archway, showing various phases of fireplace and the enclosed yard beyond, viewed from the south-west.

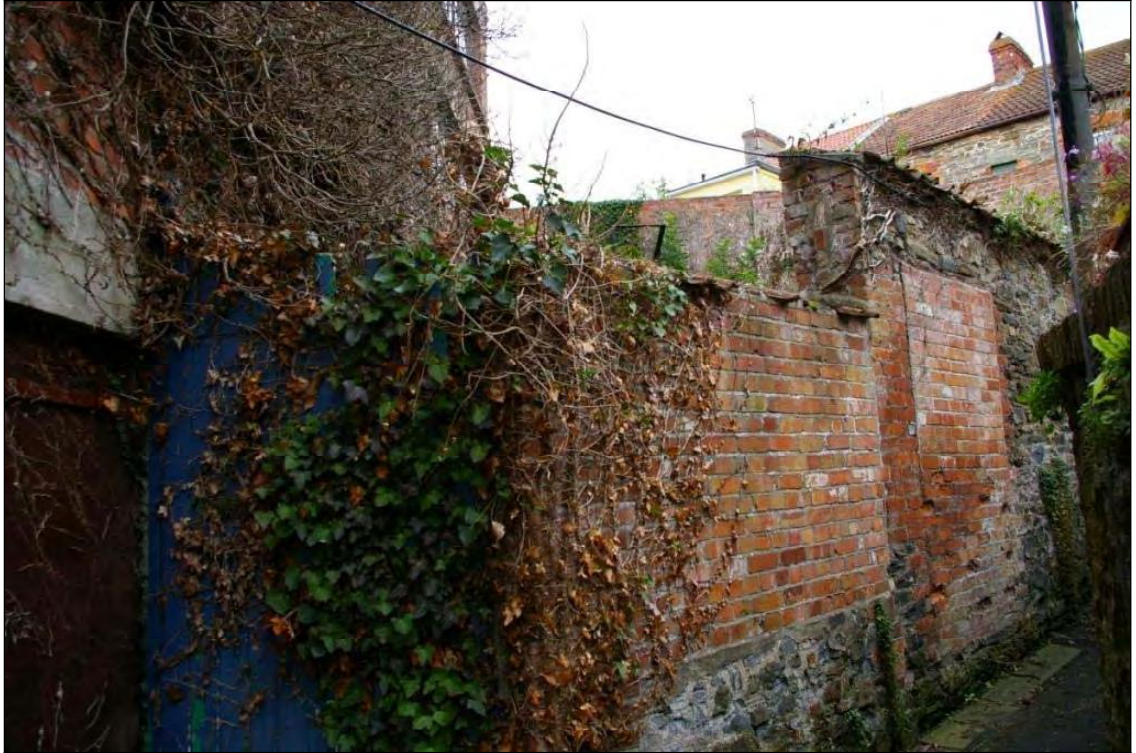
running along Ladywell Lane to the north-east (Figure 11) is of stone rubble construction similar to that of the long east wing, it has a number of blocked openings into the overgrown yard to the north, with brick reveals in orange-coloured brickwork, as seen on the long east wing of the factory, and narrow timber lintels, typical of the 19th century. There appears to be corrugated iron roofing running along the top of the wall here which may remain from the service buildings formerly occupying the yard.

Figure 11: The stone wall of Ladywell Lane running along the length of the former north-east yards, showing the brick arches and blocked doorways into the former yards, viewed from the south-west.

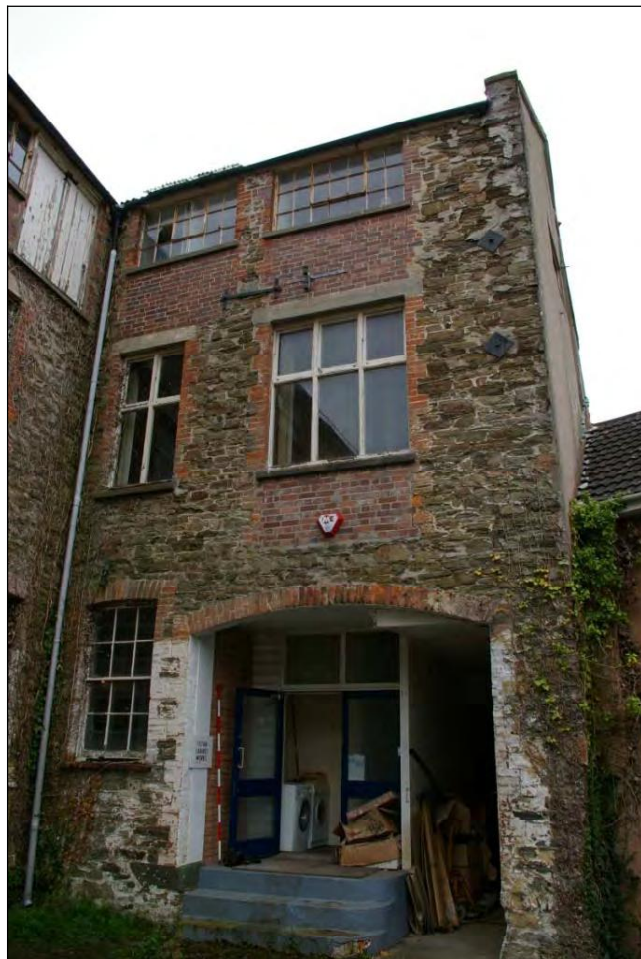
The north elevation of this wing overlooks the enclosed yard; the elevation is three storeys high, of rubble stone construction in a creamy lime mortar with five window openings and a large access archway to the west on the ground floor (Figure 12). The roof is pitched and of red clay pantiles. The top, second floor storey has two large modern metal framed windows with cement sills inserted into large earlier openings which have orange brick reveals. These former openings have been partly blocked and infilled with modern red brick below the windows. The windows are similar to those found on the north wing of the main factory building; formed of small glass panes in metal frames, there are small central sections of casement which open to allow air flow. There are two windows at first floor level; a narrow four light modern timber window to the east, adjacent to the east wing, with orange brick reveals and slate sill and inserted concrete lintel. To the west is a matching six light timber window also with orange brick reveals, slate sill and cement lintel which has been inserted into a larger earlier opening. This opening, positioned centrally above the archway below, may have been a large loading door, as the orange brick reveals run down past the inserted concrete sill and modern brick infill below. At ground floor level is a window opening to the east and a large archway, with symmetrically positioned orange brick reveals to both openings. To the east is a narrow

Figure 12: The north elevation of the south wing, with phases of blocked openings and the former entrance archway.

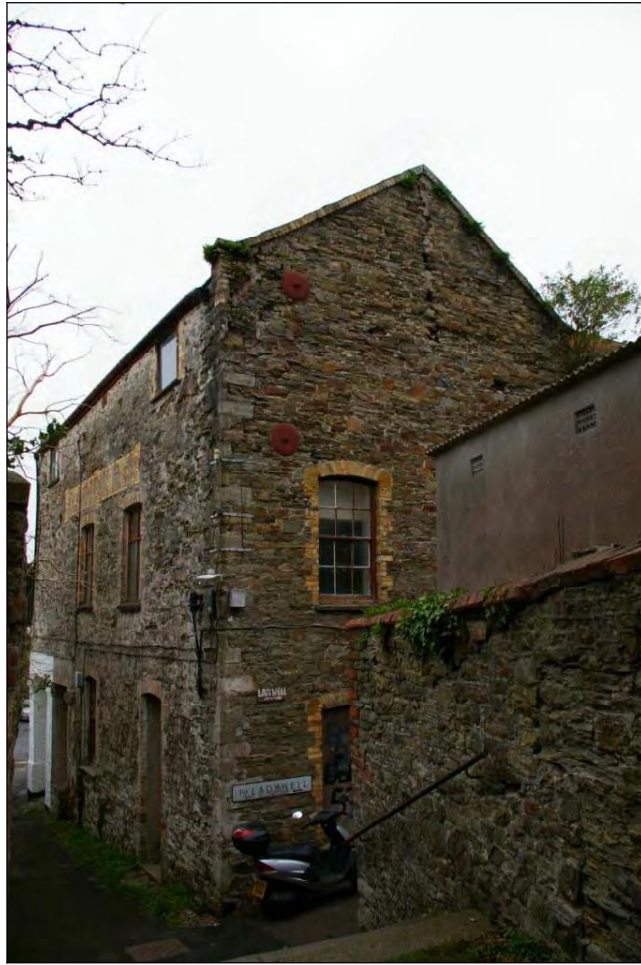
Figure 13: The south wing showing the yellow brick detailing and the raised gable, with the matching first floor hornless sash windows, viewed from the south-east.

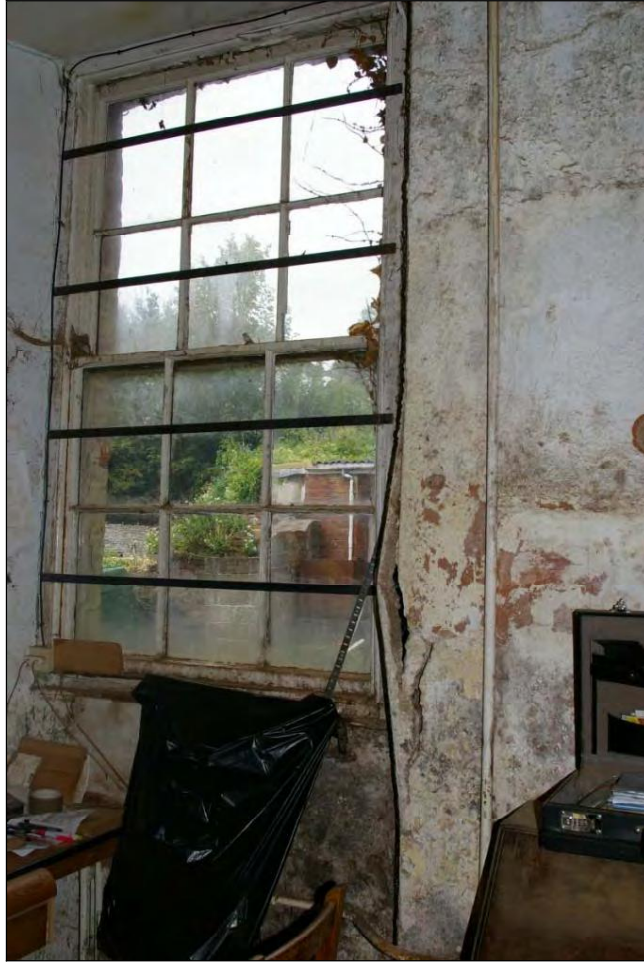
The window is in a timber frame with a single bead to the opening, the glazing bars are quite thick and are moulded in a loose form of ogee.

Figure 14: The hornless sash window in the north wall of the south wing, note the square top to this window, different from the others in this wing, viewed from the south-east.

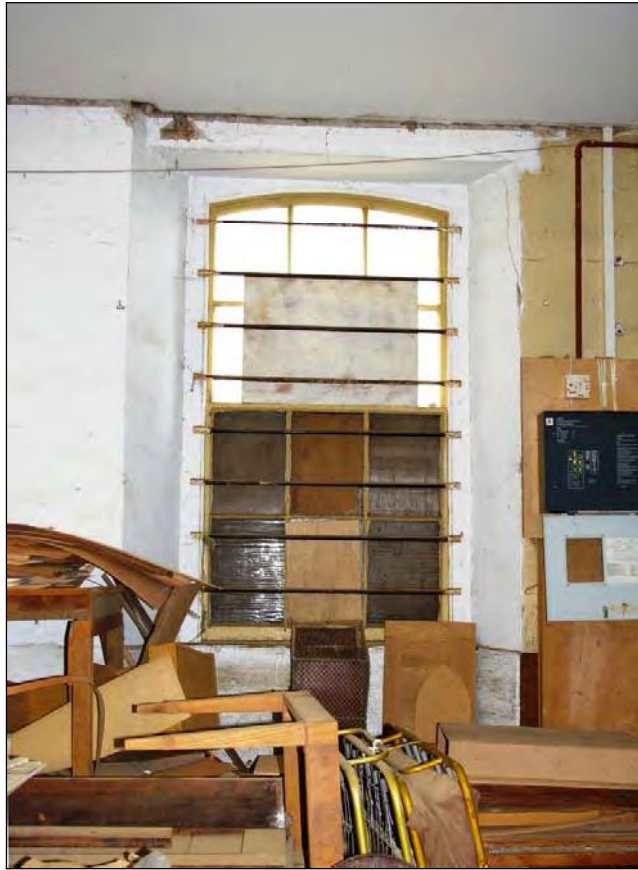
Figure 15: The sash window in the south wall of the south wing, showing the shallow arch to the top sash, viewed from the north.

steps. The sash is hornless, with the shallow arch to the top sash as found on the ground floor windows; the sash is boxed in and cut by the inserted false ceiling, a number of the glass panes have been replaced. A door in another partition wall to the north leads through to a third small office/store which also has a window in its east wall which overlooks the church and school. This sash window is the same as the others found in the south wing, with the shallow arch to the top.

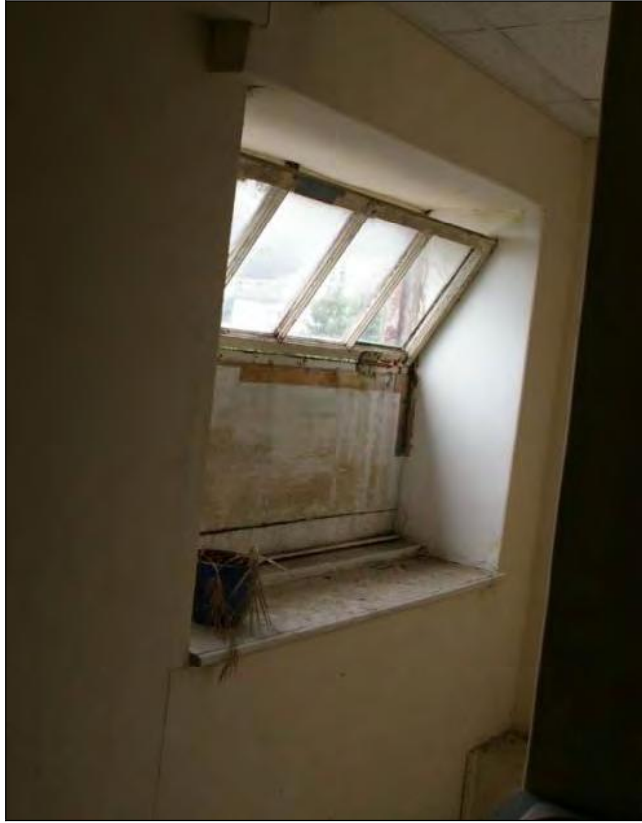
Figure 16: The narrow window in the kitchenette area, viewed from the south-east.

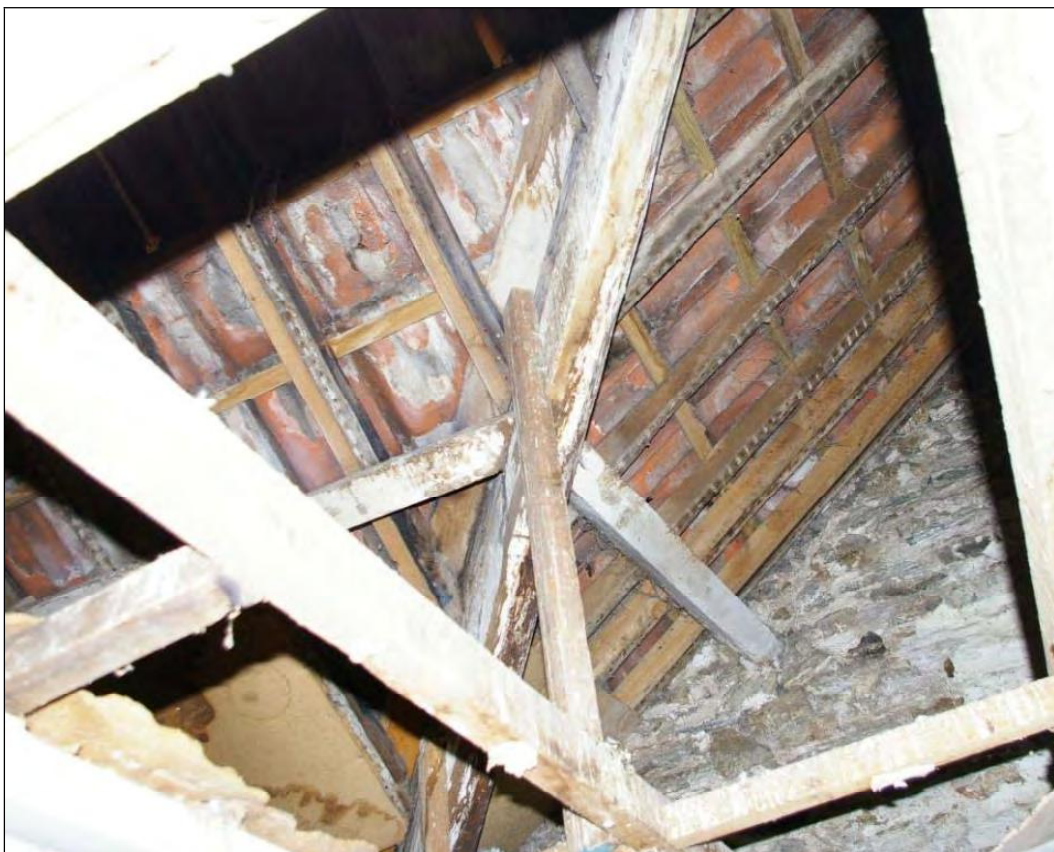
pan tiles are attached directly to the rafters, there is some intermediary felt between rafters and tiles on the south side. The eastern elevation is visible to the gable apex and the stone wall has the remains of plaster and whitewash in places, the rafters also have nail staining and the marks of former lath and plaster suggesting that the building was once open to the apex with a lathe and plaster ceiling attached directly to the rafters (Figure 17).

Figure 17: The roof structure over the south wing, showing the integration with the east wing roof and the marks of a former lathe and plaster ceiling to the rafters, viewed from below.

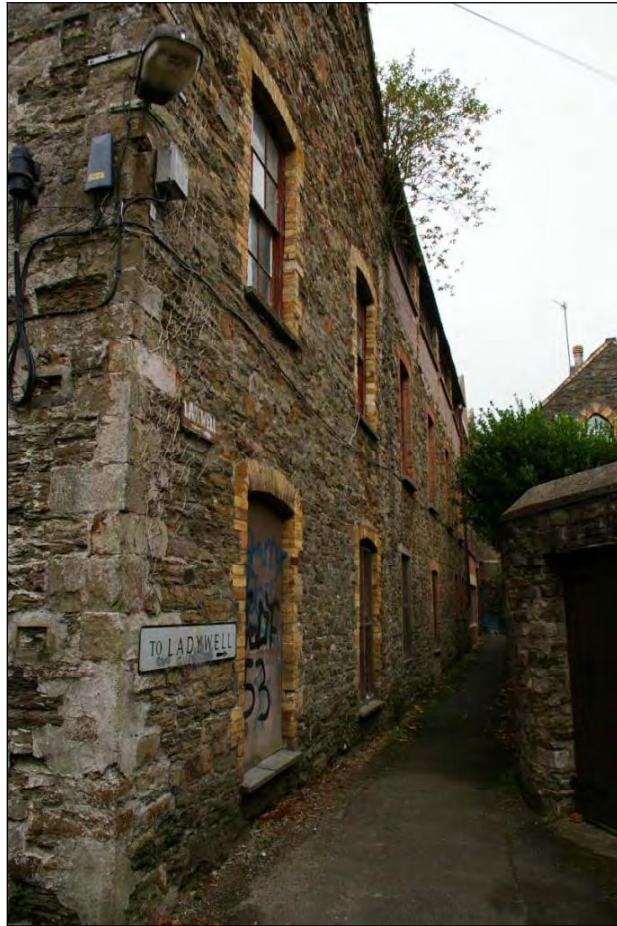
Figure 18: The east side of the factory complex, along Ladywell Lane with a view to the east elevation of the east wing, with red brick detailing in the distance, viewed from the south.

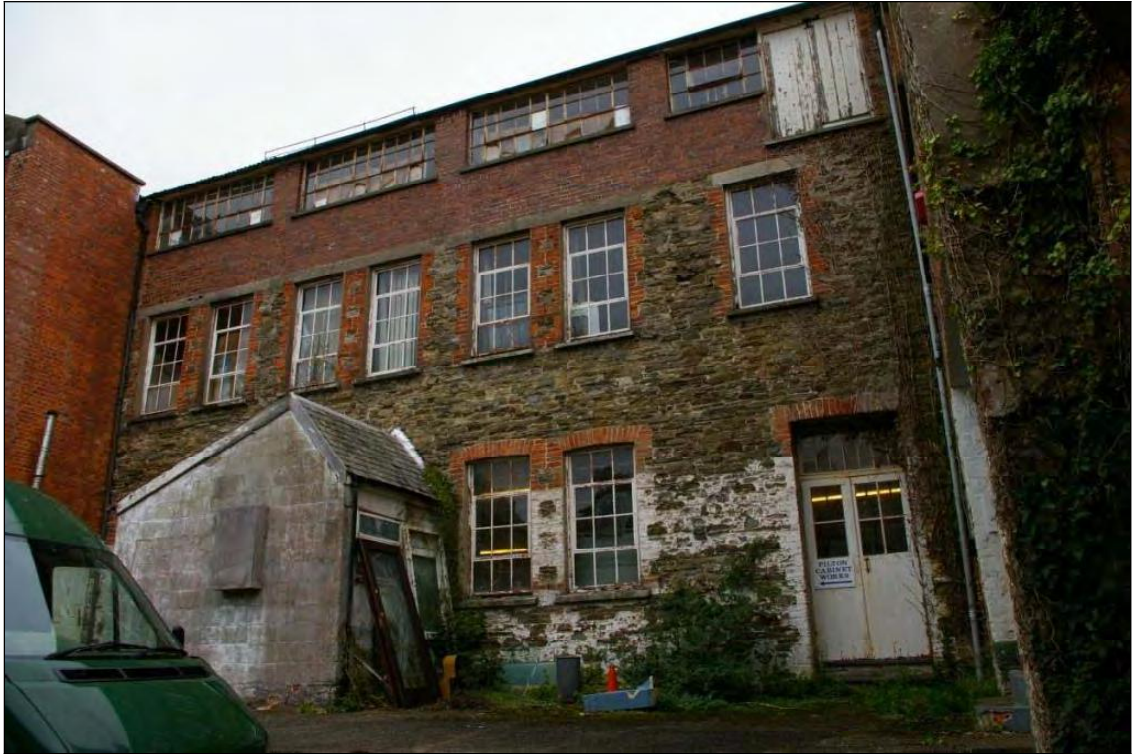
Figure 19: The west elevation of the east wing of the factory, viewed from the south-west.

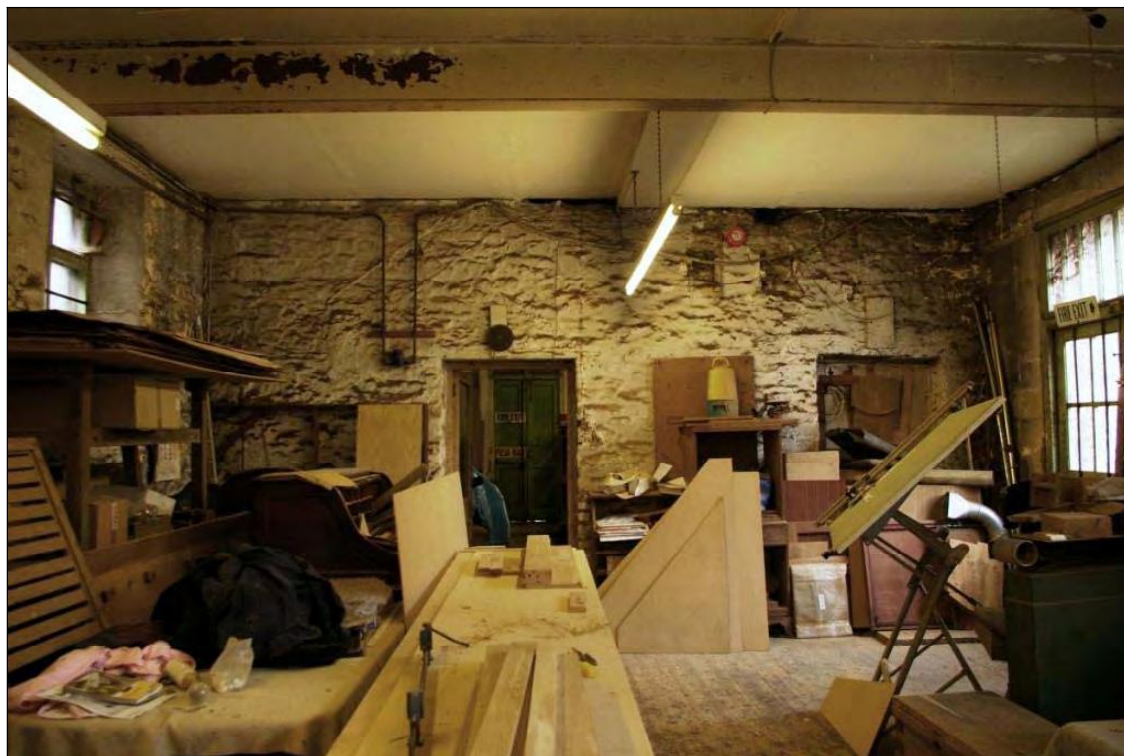
Figure 20: The south wall of the ground floor of the east wing, the former exterior north wall of the south wing. With the small square blocked window to the west and the angled scar of the roofline of a former building to the east at first floor height, viewed from the north.

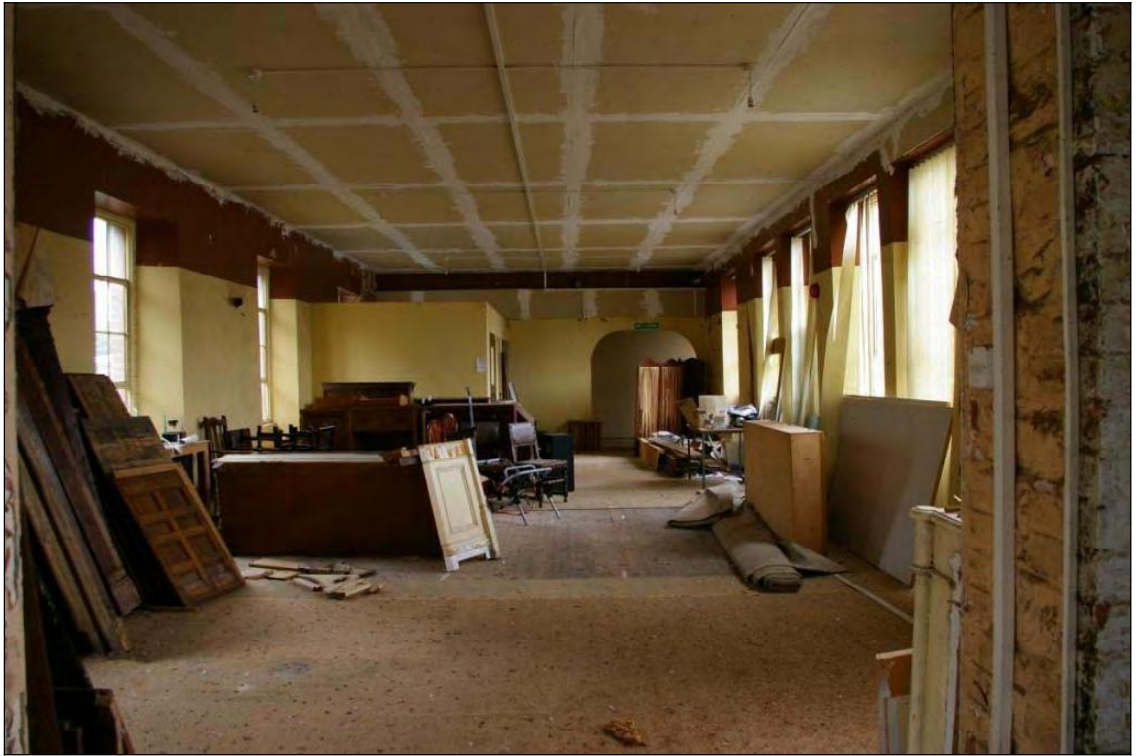
The first floor of the east wing (Figure 21) is accessed from the stairs in the south wing where a large archway has been forced into the north wall leading into the large open space, lit by numerous windows to the west and east. These tall windows are described with the exterior elevations (see 3.6.3 above). The floor is of slim timber planks, possibly 19th century in date. The ceiling is plastered and the walls are plastered and painted. There is a small modern partition office in the south-east corner. There is a large opening in the north wall where access has been created to the north wing. This opening is partially supported by metal girders.

Figure 21: The large open first floor space of the east wing, viewed from the south.

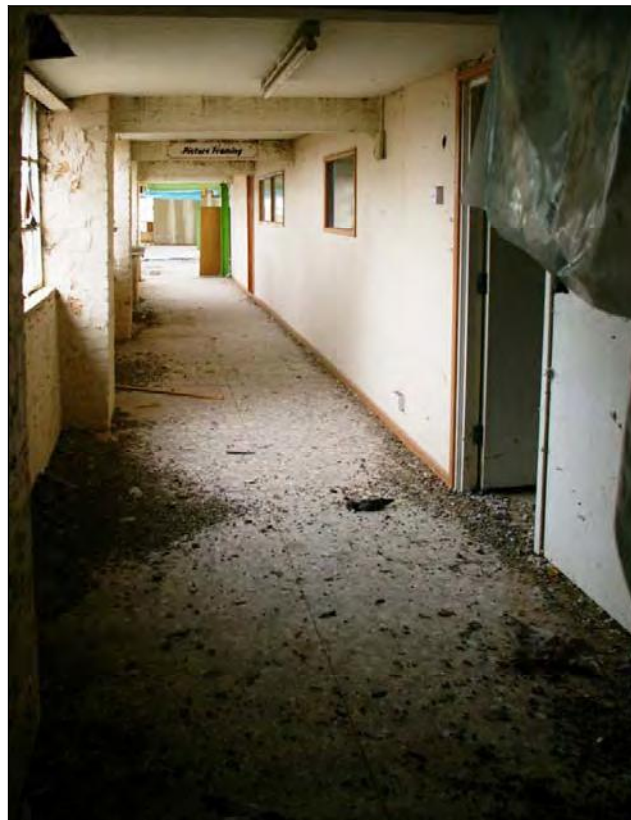
The second floor of the east wing is also accessed from the south, via a long corridor which runs down the west side of the building (Figure 22), leading to the open space of the north wing. The long glass panel windows between large brick built pillars in the west elevation light this corridor. To the east are small offices and work rooms, with large glass panels which face onto the corridor allowing for visibility and light. In one of these work rooms the false ceiling has collapsed and the roof structure is visible. The roof, timbers and boarding are all whitewashed. The roof structure is again of king and queen posts without bracing or struts.

Figure 22: The second floor corridor to the west side of the east wing, viewed from the south.

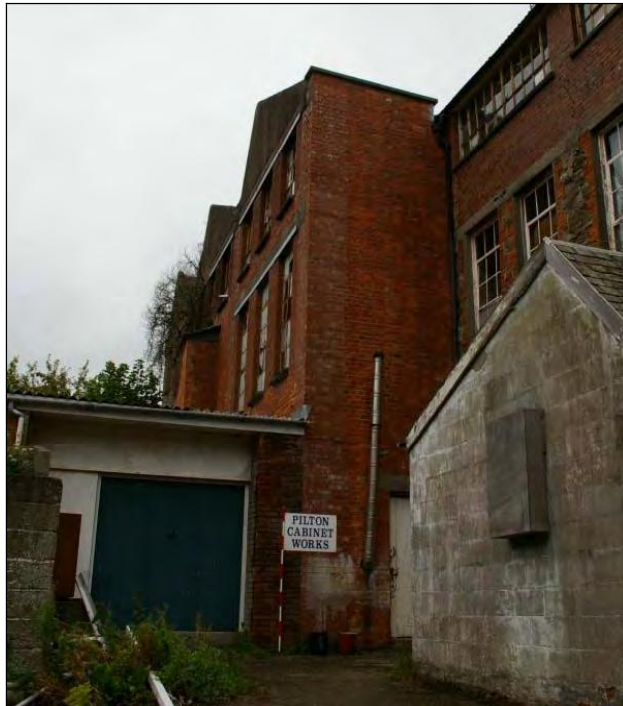
The west wall of the modern north wing is of three storeys constructed in red brick with a corrugated iron or fibre sheeting roof (see Figure 23). The elevation is divided into three sections with a large projecting chute or stack in the centre on the first floor, running down to the ground floor. The roof is set in three peaks with two long valley gutters running across the building, creating three off-centre pitches, which have rendered gables to the west elevation. The top storey has three windows symmetrically positioned within each of the three sections, nine in all. The windows are all the same, metal framed, with a row of three fixed panes to the bottom, with a hopper casement, of 2x3 panes, above. Some of these windows are boarded, many broken. Metal RSJs appear to run under the large concrete lintels directly above the windows in each set and sections of brickwork giving the appearance of brick pillars run between the long window openings. On the first floor there are three symmetrical windows to the south section and three to the north, the central section has the large projecting chute or stack. These windows are as before but are much longer than those above on the second floor. On the ground floor the elevation is abutted by a single storey buildings to the south and to the north there are three long windows which as those on the first floor, with metal frames, these are boarded.

Figure 23: The north wing and single storey northern buildings, viewed from the south-west.

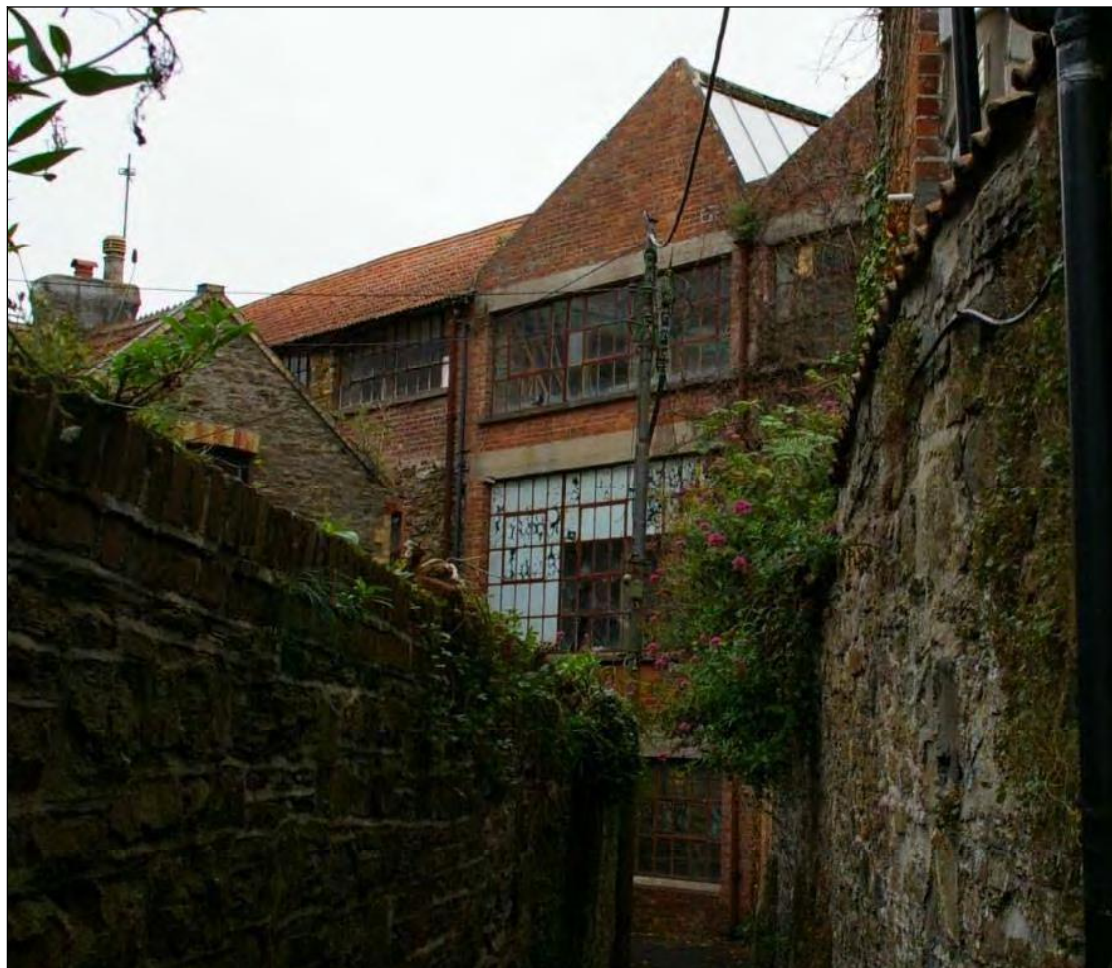
The east elevation faces onto Ladywell Lane and onto the overgrown yards and ruined service buildings to the north-east (Figure 24). The roof is of corrugated iron or fibre sheeting. The elevation is of modern brick, divided into three sections as on the west elevation, of three storeys, with large concrete lintels running between brick pillars on each floor. The elevation is dominated by the eight large glass panels which run between the brick pillars, comprised of small panes in metal framing with some opening sections, they have concrete sills and there is one panel on each floor of each section, three on the second floor, three on the first floor and two to the north and south on the ground floor. At the centre of the ground floor elevation the wall is abutted by the stone wall of Ladywell Lane, once the perimeter wall of the site, there is a modern doorway with concrete lintel, which opens onto Ladywell Lane. There are three

Figure 24: View down Ladywell Lane to the modern brick east elevation of the north wing of the factory, with large glass panels and triple pitched roof with skylights, viewed from the north-east.

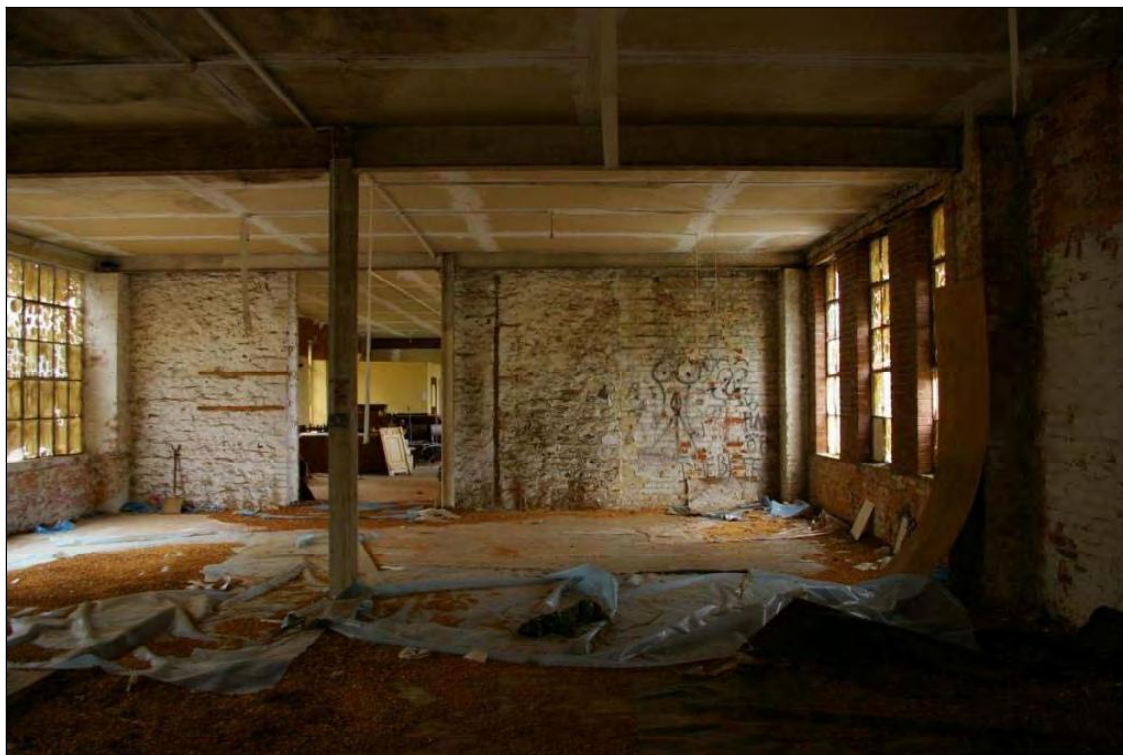
length of the south wall (Figure 25). The brick of the modern wing is not tied into the earlier wall but abuts the stonework here, extending the length of the wall further to the west.

Figure 25: The former exterior north wall of the east wing, abutted to the west by the brickwork of the modern north wing, viewed from the north.

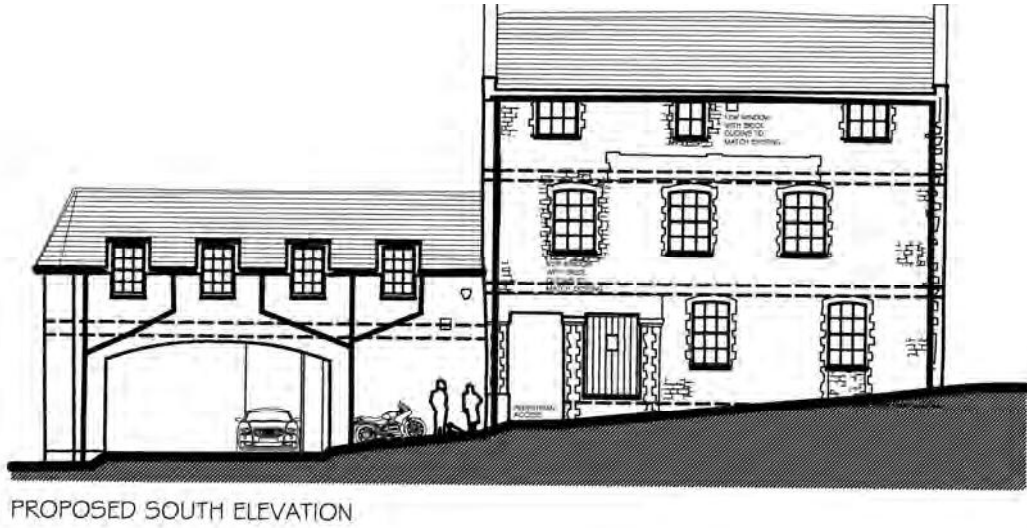
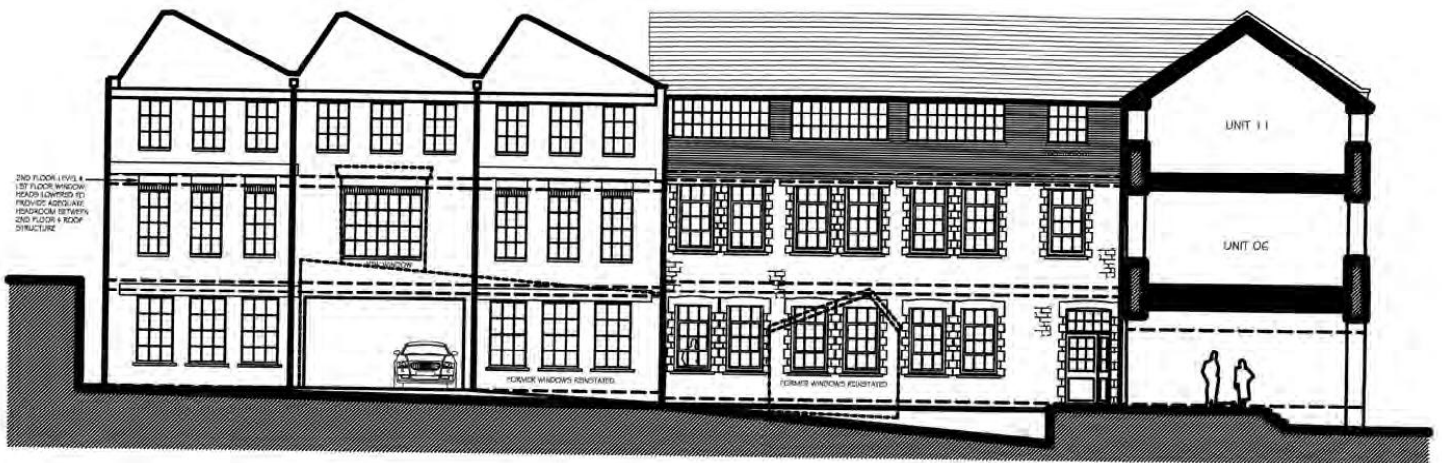
Examples of the proposed plans for the development of the building (not to scale)

----- Walls to be demolished
