THE COMMUNITY CENTRE
ST DAVID'S
EXETER
DEVON

Results of an Archaeological Building Survey

REPORT No. 050220

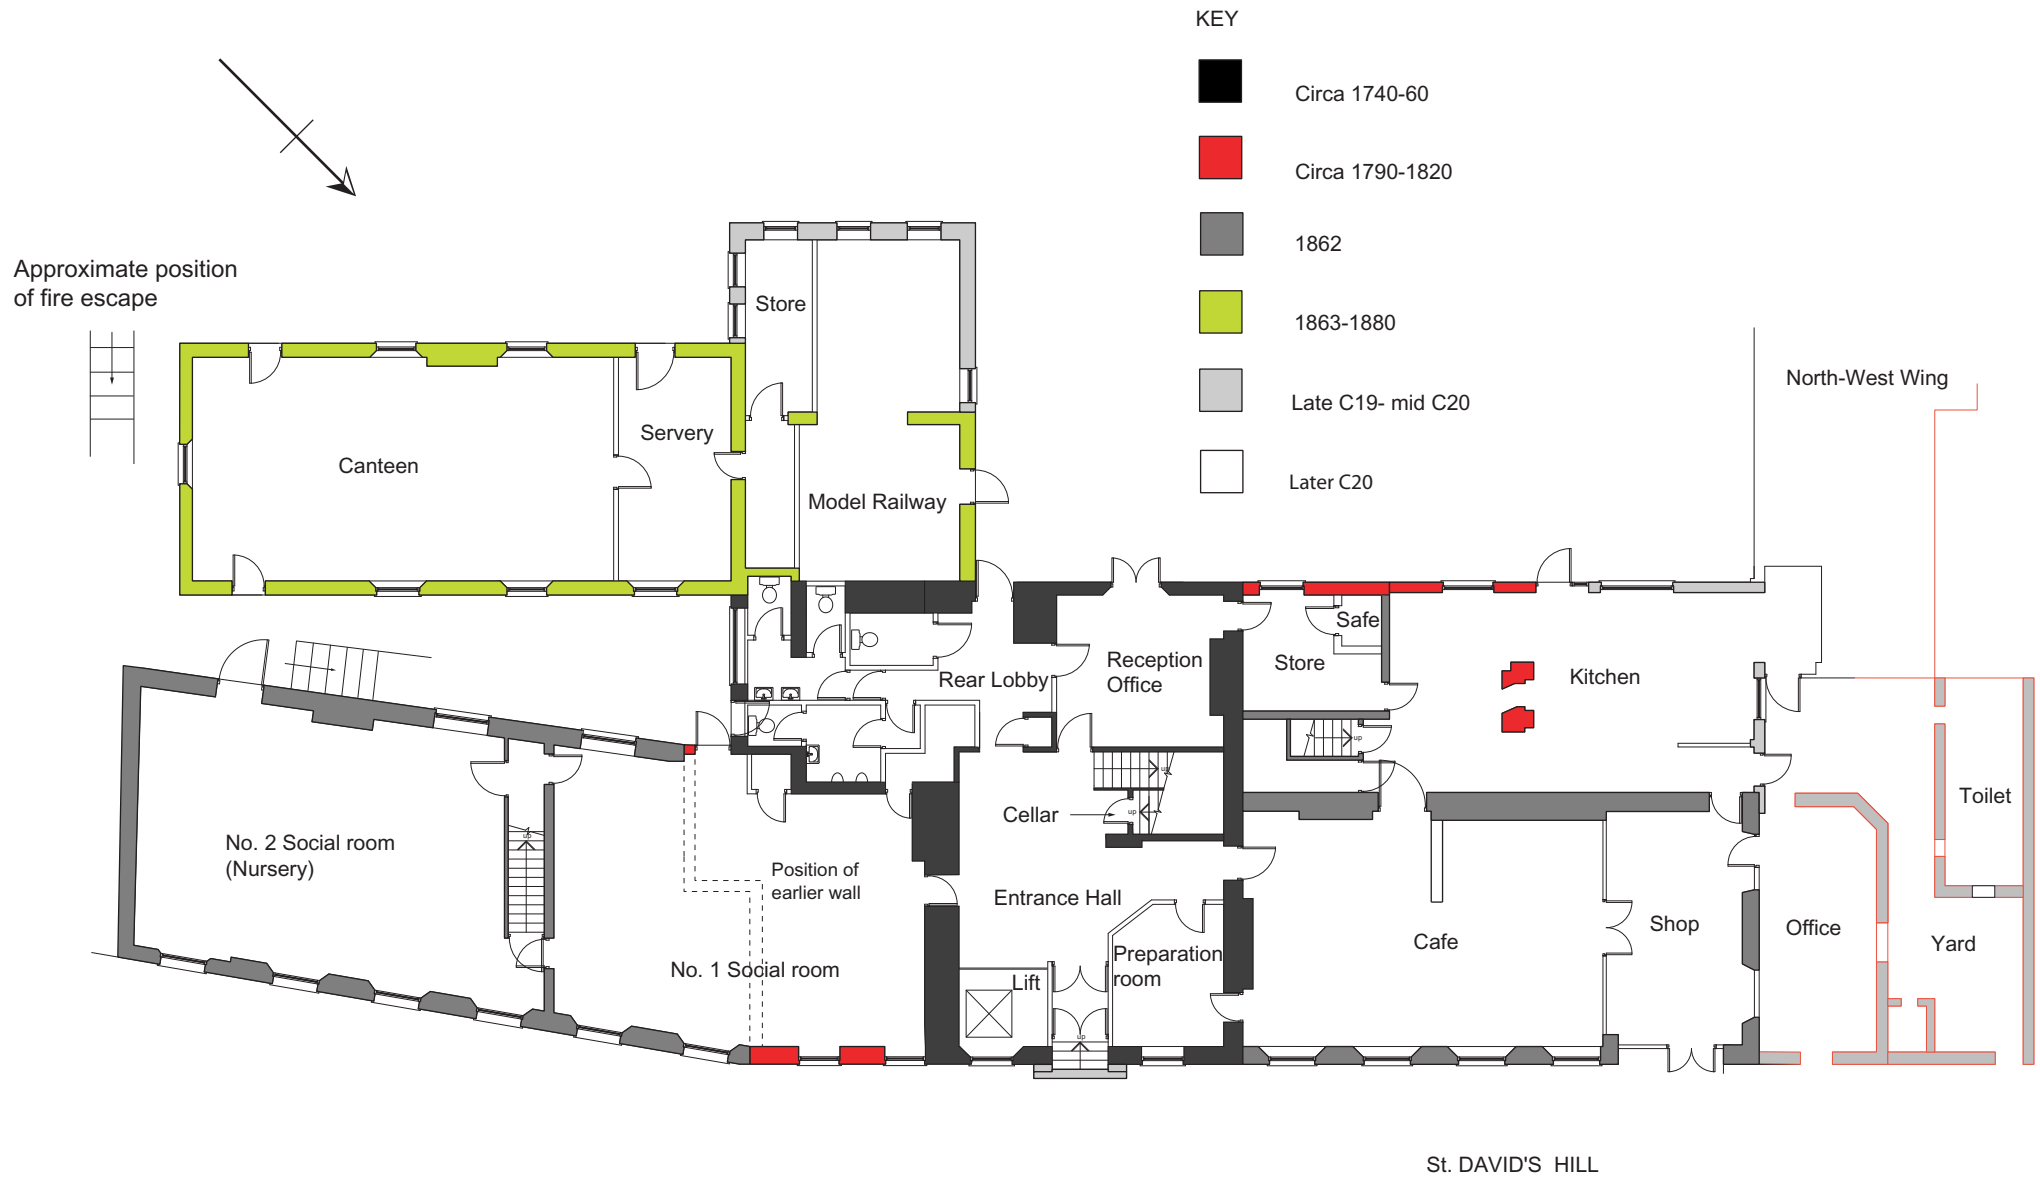
Fig 3: Community Centre, ground floor plan showing historic phasing, based on drawing supplied by King Sturge (Bristol), areas outlined in red, Not to scale.

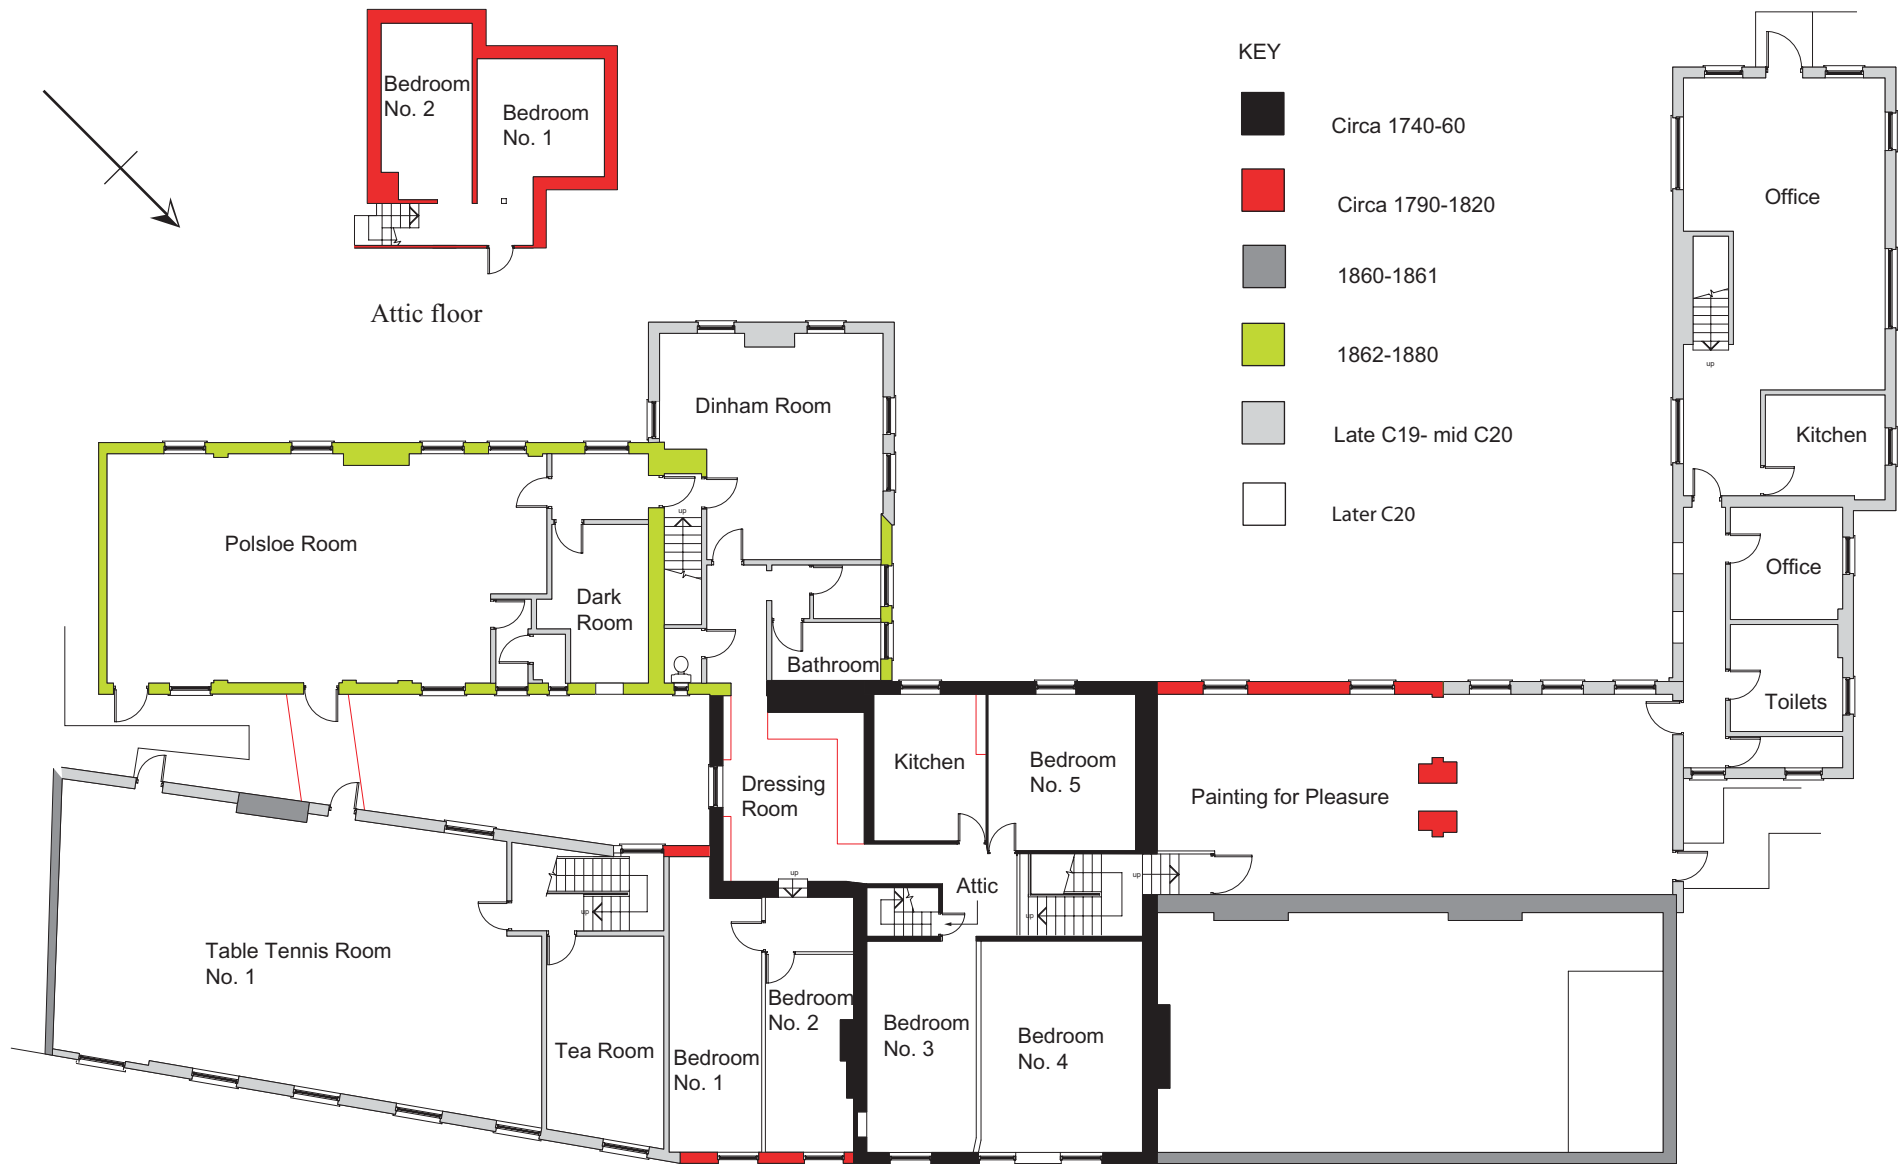
Fig 5: Community Centre, Second floor plan showing historic phasing, based on drawing supplied by King Sturge (Bristol), areas outlined in red, Not to scale.
