THE COMMUNITY CENTRE ST. DAVID'S HILL, EXETER DEVON

Results of a Desk-Based Assessment

Report No.: 100816
Date: 16.08.2010
Authors: T. Green
B. Morris
E. Wapshott

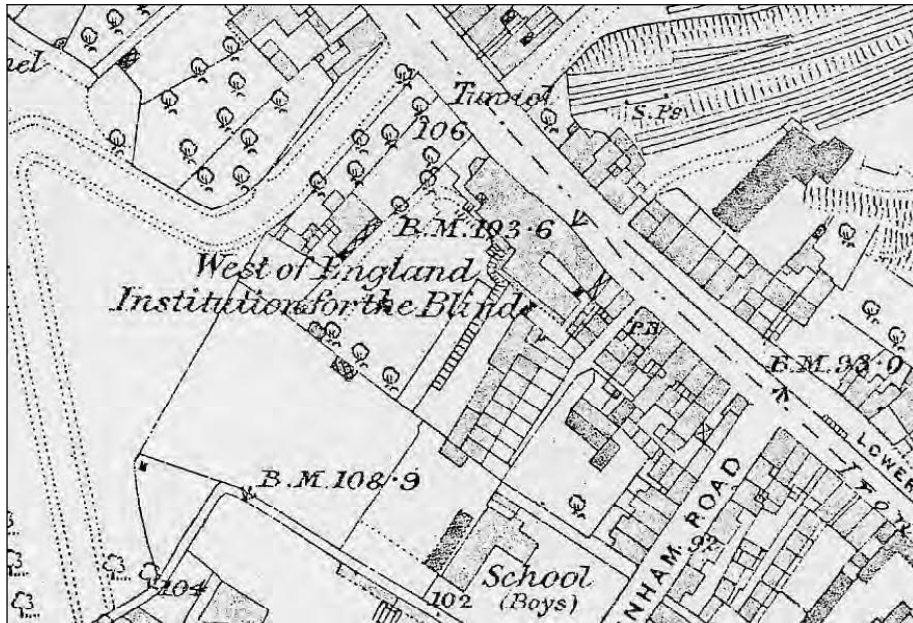
A further extension at the north end and standing at right angles to the earlier structure does not appear on the plans until after 1904. We are told in the School History that further workshops were built in 1907 and this may account for this wing as well as that beside the gymnasium (see Figures 14-16).

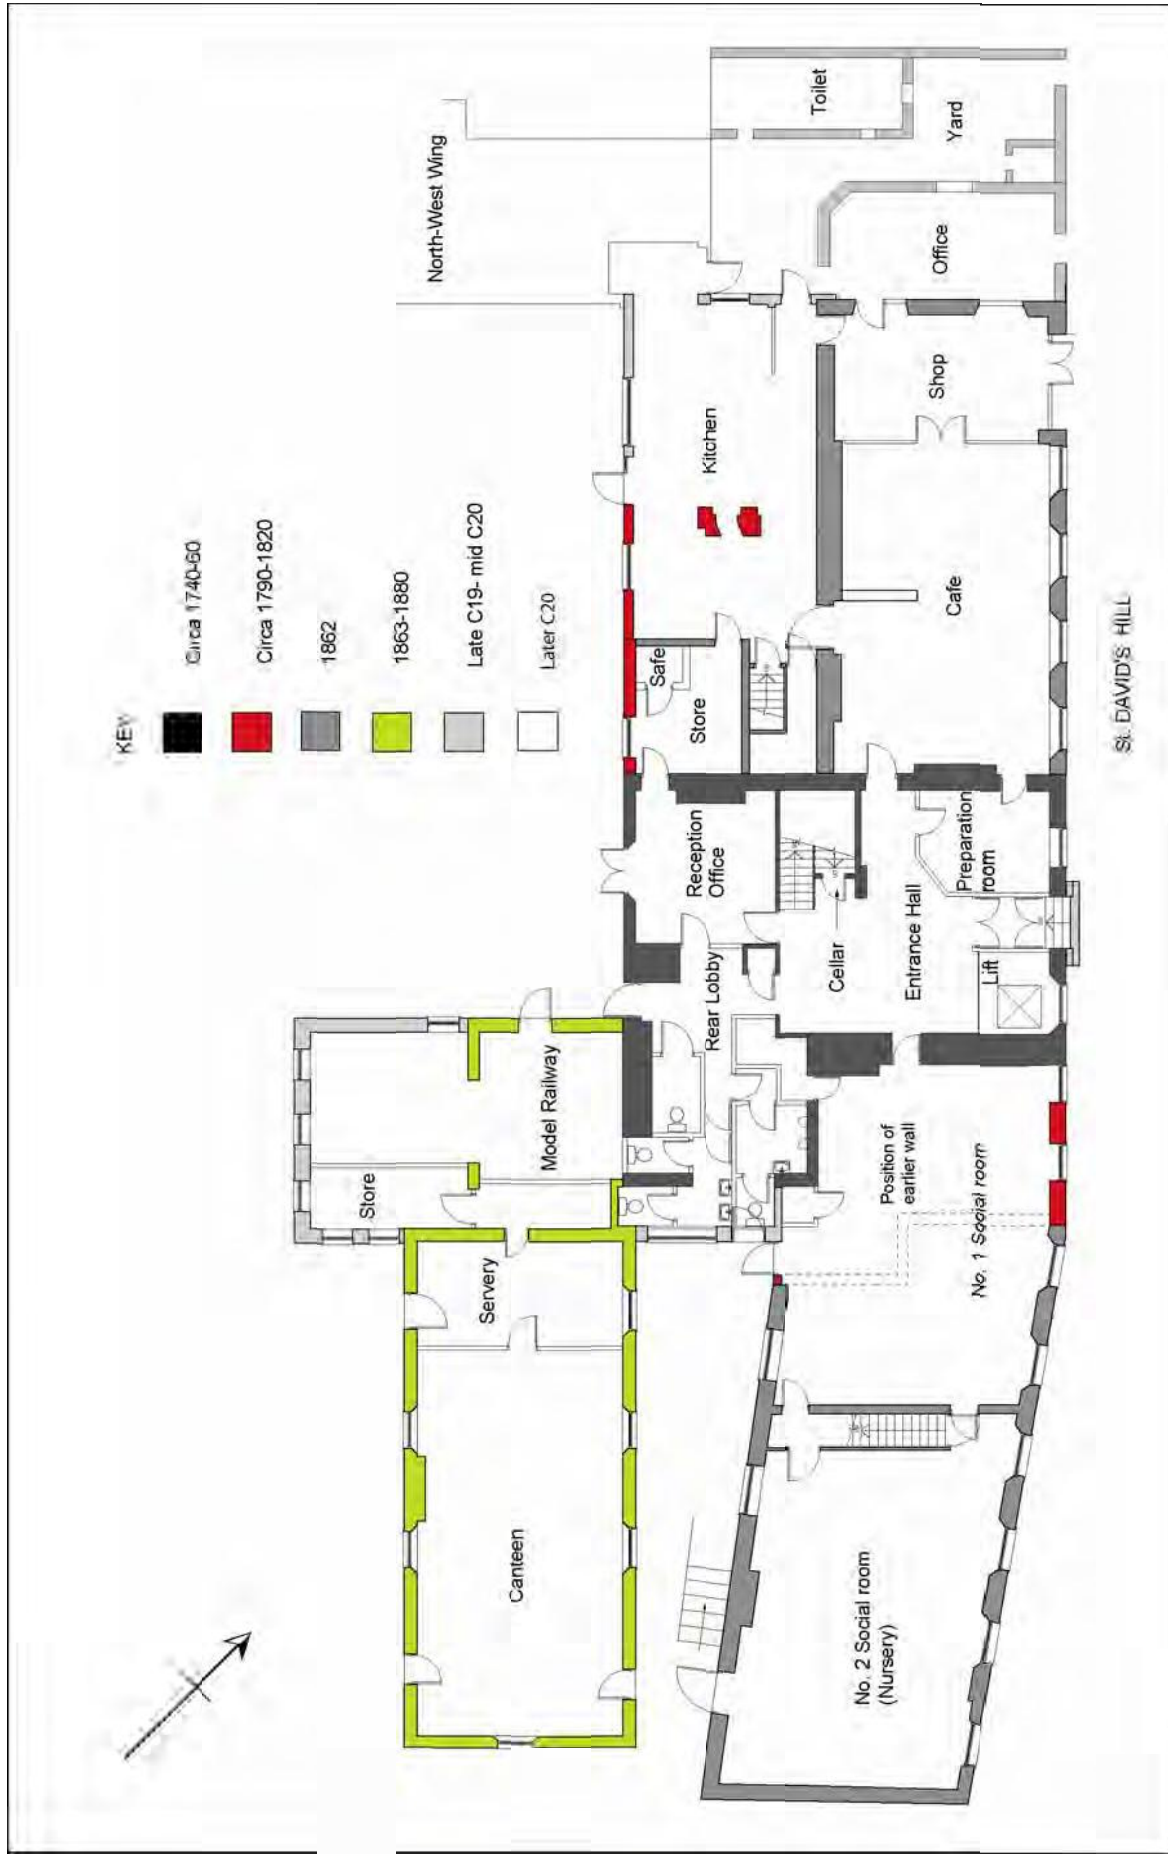
Figure 18: Community Centre, ground floor plan showing historic phasing, based on drawings supplied by King Sturge (Bristol) (not to scale).
