Devon County Council Historic Environment Record

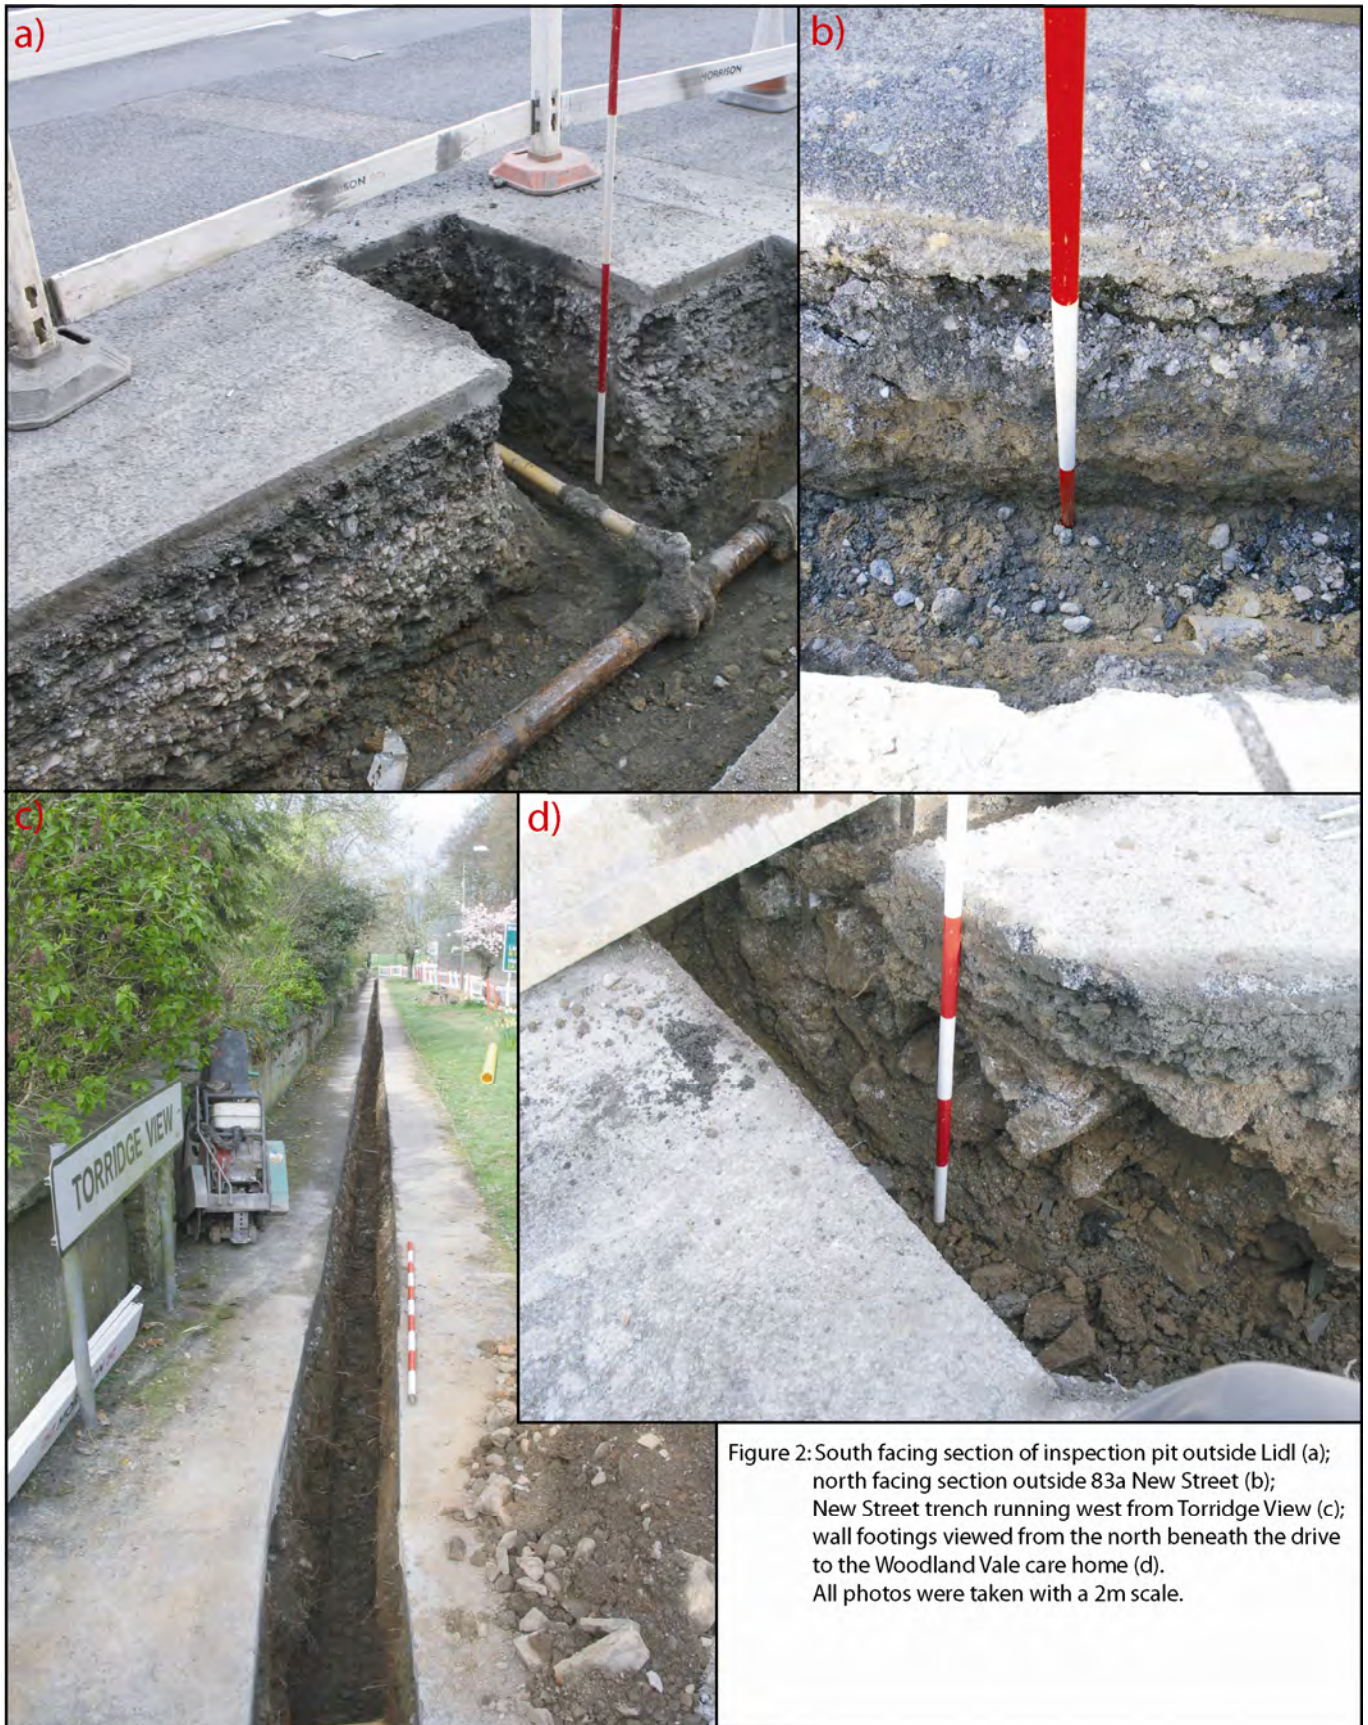
Figure 2: South facing section of inspection pit outside Lidl (a); north facing section outside 83a New Street (b); New Street trench running west from Torridge View (c); wall footings viewed from the north beneath the drive to the Woodland Vale care home (d). All photos were taken with a 2m scale.
