STRAND MEWS THE STRAND BARNSTAPLE

Results of a Desk-Based Assessment
Archaeological Monitoring
&
Historic Building Recording

Report No.: 111114
Date: 14.11.11
Author: S. Walls
E. Wapshott

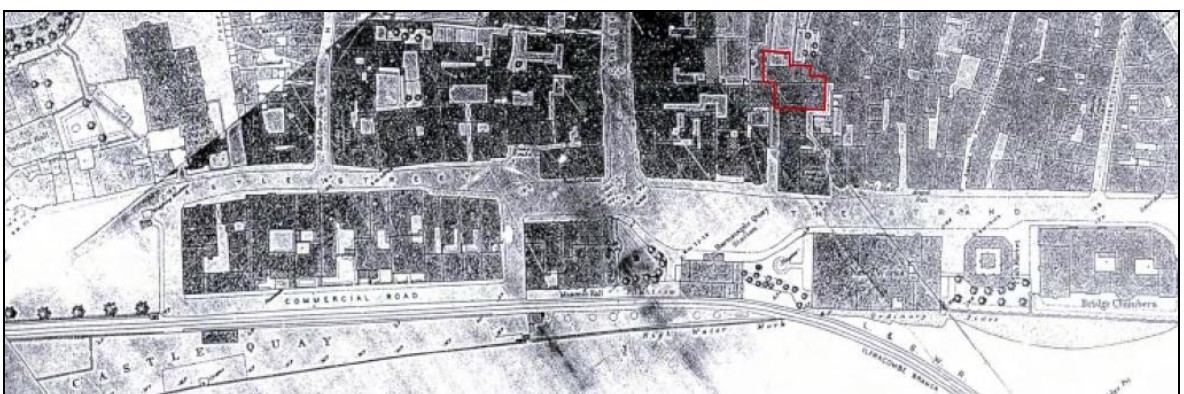
Figure 6: Extract from the Ordnance Survey 1st Edition Map of 1888. The current building is outlined in red.

The Ordnance Survey First Edition map of 1888 (Figure 6) provides the first reliable plan of buildings contained within the proposed development site (the finer detail is not apparent on the copy at the scale reproduced here). The map indicates the presence of several different buildings within the floorplan of the current site which may reflect several different ownerships or uses. At the core of the plot is part of the existing building, probably a former warehouse, and this is adjoined to the south by a very narrow building to the east (the current lean-to office) which widens to the west and extends beyond the present development area, suggesting later probable 20th century division or demolition of this element. To the west of the warehouse a building accessed via the alley adjacent to the Old Customs House is located, this has since been demolished. To the north the situation is less clear, with five separate buildings shown abutting the north wall. The most eastern of these is part of the rear of 97 High Street, to the west of this is a rectangular building with a small garden (trees shown in the yard), followed by a very narrow building, which adjoins the centre of the probable warehouse building and may suggest the former presence of a passage and opening here, which was subsequently enclosed. A small rectangular building is located to the west

of this (corresponding with the Small Office), and finally a further building, orientated east-west (contrary to the others) is located at the western end of the warehouse.

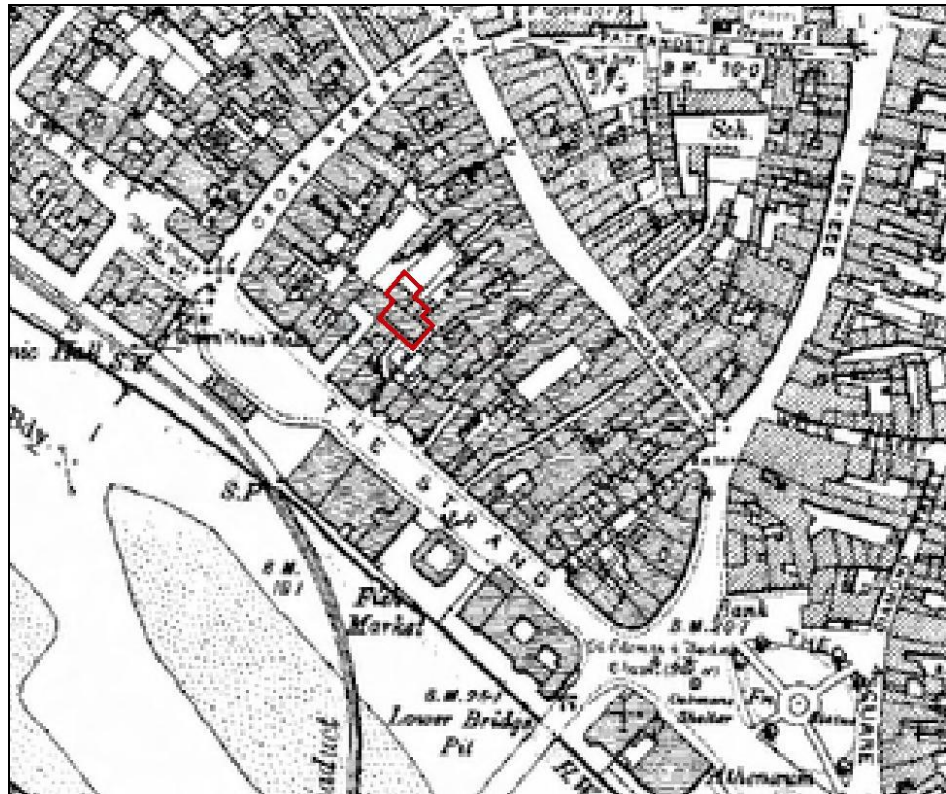
Figure 7: Extract from the Ordnance Survey Second Edition Map of 1912. The current building is outlined in red.

The Ordnance Survey 2nd Edition Map (Figure 7) suggests that this arrangement of buildings remained largely unchanged. The sole exception is that only four buildings are indicated to the north of the warehouse, and it appears that by 1912 the central narrow building (passage?) had been joined with the building to its east.

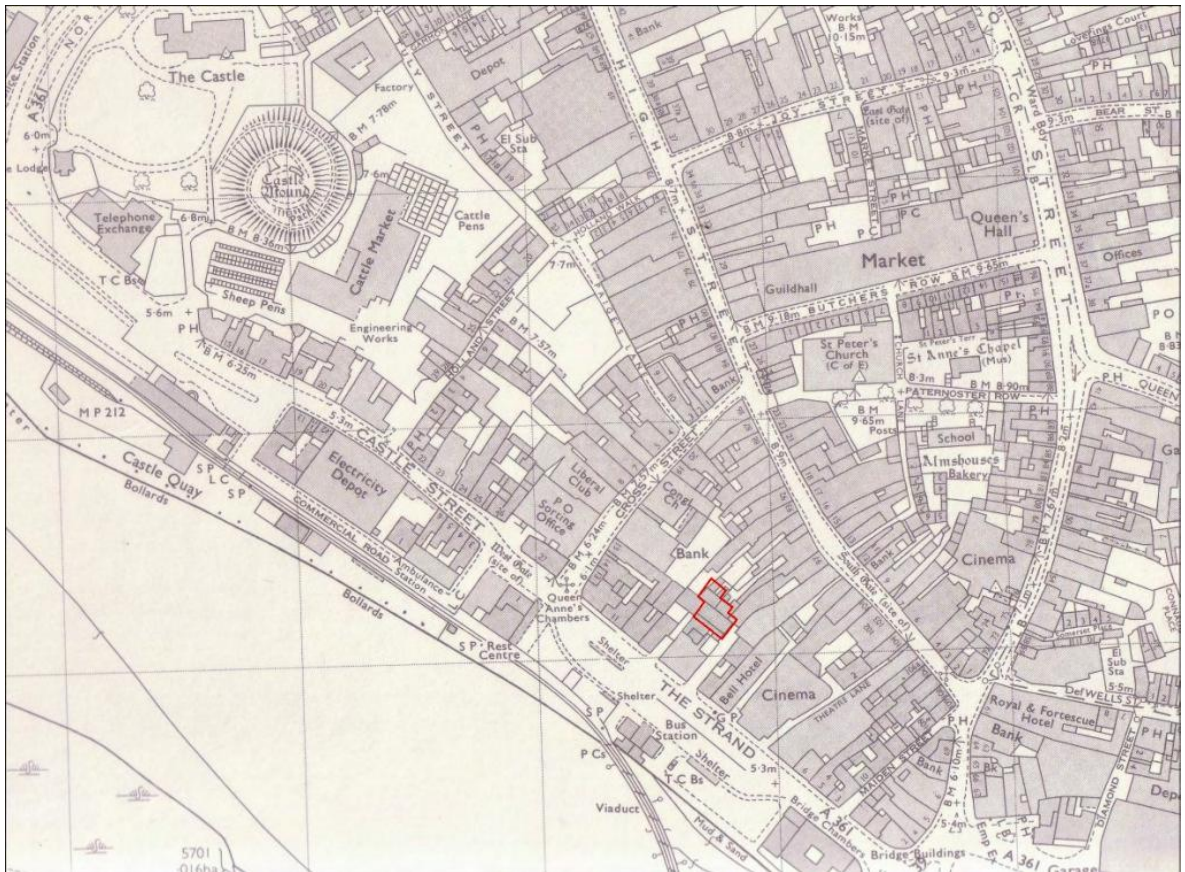
Figure 8: Extract from the Ordnance Survey County Series Revision Map of 1972. The current building is outlined in red.

The Ordnance Survey County Revision Map of 1972 (Figure 8) suggests that the arrangement of buildings had seemingly altered little by this date with the main warehouse adjoined by separate buildings to the south and west but with just three buildings shown as adjoining to the north, the central, formerly three, buildings having been merged or re-built.

However, the buildings have significantly changed since the 1972 mapping, with the building to the west demolished and that to the south divided. The most drastic changes appear to have occurred to the north of the warehouse, with the rear part of 97 High Street being demolished and the buildings radically altered or demolished to form the single Strand Mews complex.

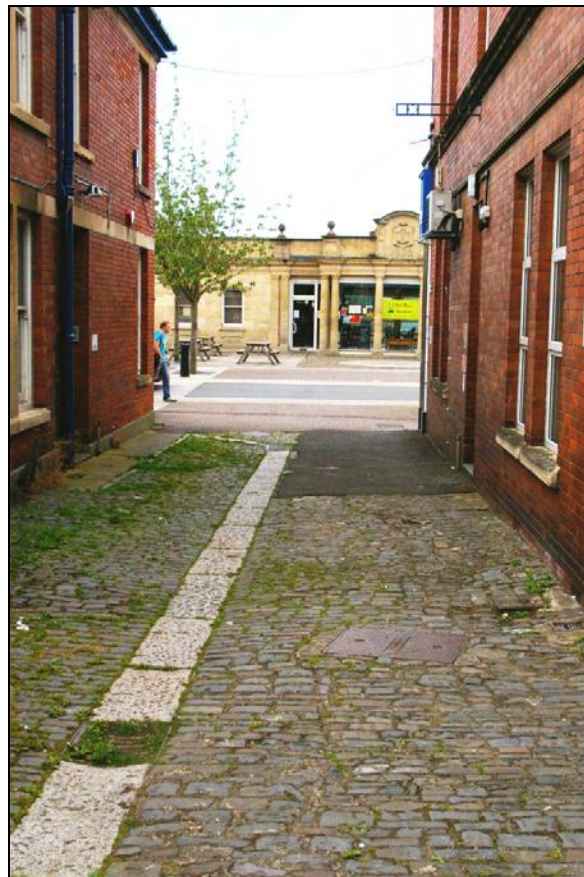
The site is set back from the modern frontage of the Strand, which was laid out largely in the 19th century as the land was reclaimed. The building immediately to the front of the Strand Mews building is of typical late 19th or early 20th century appearance; a large three storey building constructed in red brick, with stone architectural elements to steep dormers and projecting central bay window. Strand Mews itself is accessed from the main thoroughfare up a wide alleyway between this red brick building, now Perrins Solicitors, and another smaller two storey red brick building to the east. The alleyway is noticeably sloped, of fine stone cobbles with a central granite slab drain, running under the road to the south, suggesting this may be a surviving slipway to the former Quays or an early passageway down to the former waterfront (Figure 9).

Figure 9: The wide cobbled alley onto the Strand, facing the Bus Station (built 1922), viewed from the north-east.

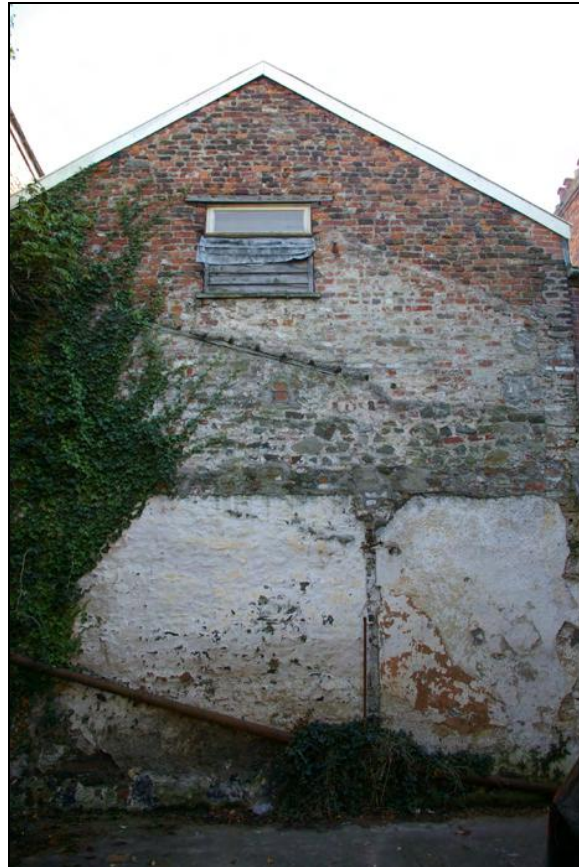
The building is of white painted rendered elevations under a slate roof with black glazed terracotta ridge tiles, apart from the north elevation which is rubble stone to first floor height with brick above (Figure 10). There are numerous single storey extensions leading from the main two storey

building, to the front and rear with flat roofs, or to the rear, a 'cat-slide' sloping roof adjoining the main structure. The building has undergone significant works during the 20th century to convert it into office space; some interior walls are of painted exposed stone, others are plastered or boarded to create square rooms. To the south and west the building fronts onto a wide cobbled alleyway leading down to the main Strand thoroughfare, to the north the building faces onto an open yard behind the adjacent Customs House building (see Humphreys and Green 2001; Milton and Reed 2004). To the east the building abuts a covered yard and further buildings behind No. 94 High Street and a small open yard behind No.96 High Street, which is formed from former Burgage plot walls.

Figure 10: The exterior north elevation.

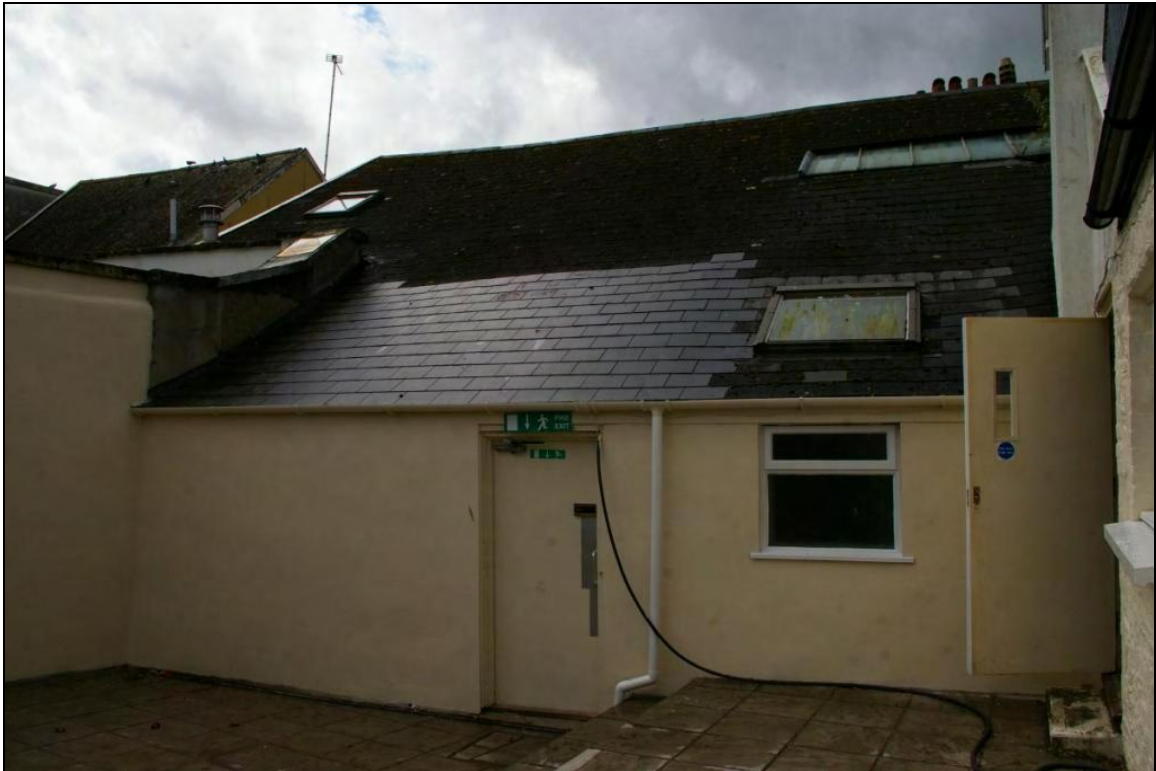
The courtyard is framed to the north and south by large stone walls, which project back from the buildings lining the High Street. The walls are of stone, and are constructed of small blocks closely

packed in rough courses with lime mortar which have been extensively re-pointed in cement. Where the wall to the north has been forced to provide openings for access into the building it has been repaired/rebuilt in brick, some of the openings have brick quoins and cement or timber lintels. A modern partially glazed lockable door leads to a further corridor and small store rooms and a window and door lead into the entrance hall, stairs and toilets of the next section of the Strand Mews building.

To the south the large stone wall is heavily plastered and with a section of increased width to the west which is visible as a bulge in the elevation below the coping stones, the wall returns to its normal width further to the east. This wall continues down to the west, and almost seems to transect the Strand Mews building, which is built in a dog-leg around the wall which is clearly of earlier date. To the east (Figure 11) is the modern single storey extension to the rear of No. 96 High Street, which is now an Italian restaurant; this is separated from the courtyard by a modern timber fence. To the west is a single storey lean-to extension to the Strand Mews building, with a sloping roof which extends down from the main building, of composite slate or slate effect fibre roofing. This extension has a central door to the entrance corridor and a room inaccessible at the time of the survey. It also contains a small office with a window onto the courtyard to the north of the elevation, which abuts the possible Burgage plot wall at its north end.

Figure 11: View of the courtyard and rear (east) elevation of the property, viewed from the north-east.

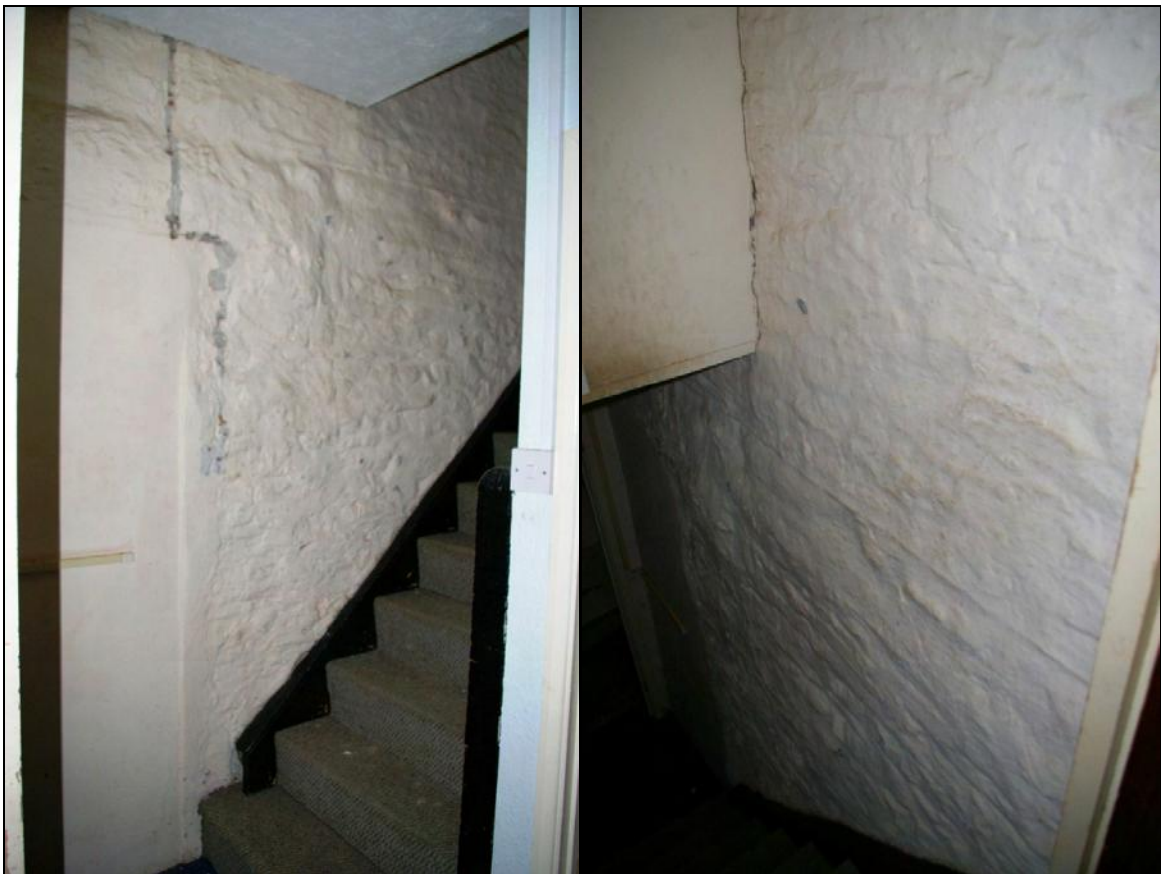
The north wall of the stairhall is of exposed painted brickwork which could be historic as the wall is substantial and the brickwork appears to be a form of English bond. The south wall, against which the stairs are built, is of stone, constructed in large blocks, with smaller stones nearer the top; the wall rises to two storeys, rebuilt or repaired in brick in places from first floor height up to the roof, with an inserted brick chimney stack. The wall reduces in width at first floor height, creating a shallow inward slope to the wall face. This slope becomes more pronounced at the east end, at the bottom of the stairs, becoming a narrow sloping ledge. There appears to be a blocked square opening roughly at first floor height which may have a lintel, this could be a further fireplace, forced into the elevation or perhaps a window or former loading door. There is a forced doorway in the wall at the bottom of the stairs (Figure 12) which appears to have been repaired in cement, probably a 20th century opening that was subsequently re-blocked.

Figure 12: Left: The south wall of the stair, running east-west through the building on the line of the former burgage plot wall from the High Street, viewed from the bottom of the stair. Right: The same wall viewed from the top of the stair.

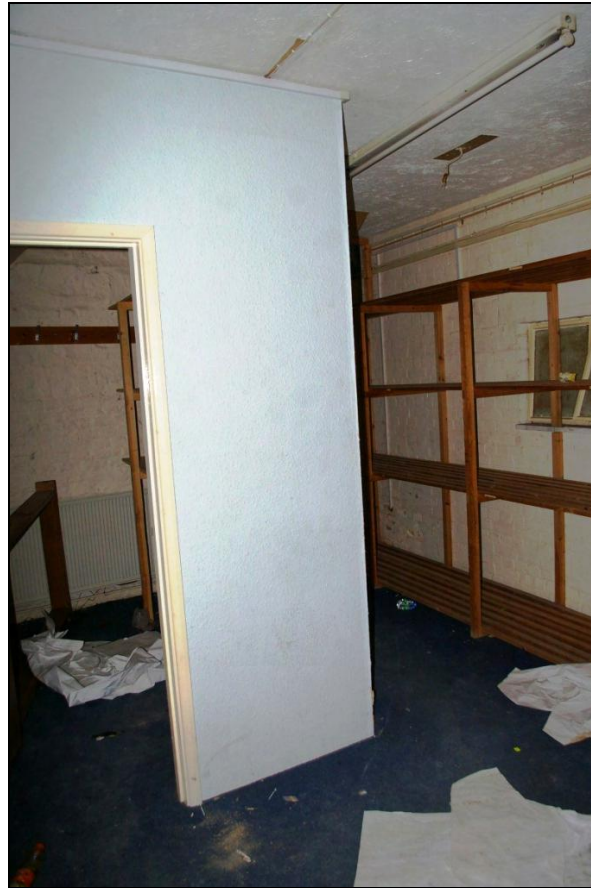
corridor and entrance hall is probably of single-skin brickwork associated with the 19th century brick walls to the north and west of the stair hall (see Figure 13) and to the east of the toilets; the wall appears to contain several blocked openings formerly into the entrance hall. This may have been a small outhouse associated with 19th century occupation of the site or could have been built up against the walls of the yard behind No.94 High Street, then incorporated into the building in modern times by the breaching of the former burgage plot wall line between No.94 and No.96. The door to the toilets to the north of the lobby has been forced through the thick brick north wall. The toilet area is modern. The west (exterior) wall, through which a window has been forced, is constructed of probable 19th century brick as is the south wall and window has been forced through into the stair hall. The east wall of this room is also of brickwork, of slightly thicker width.

Figure 13: The stairhall west and north brick walls, probably of 19th century date, viewed from the south-east.

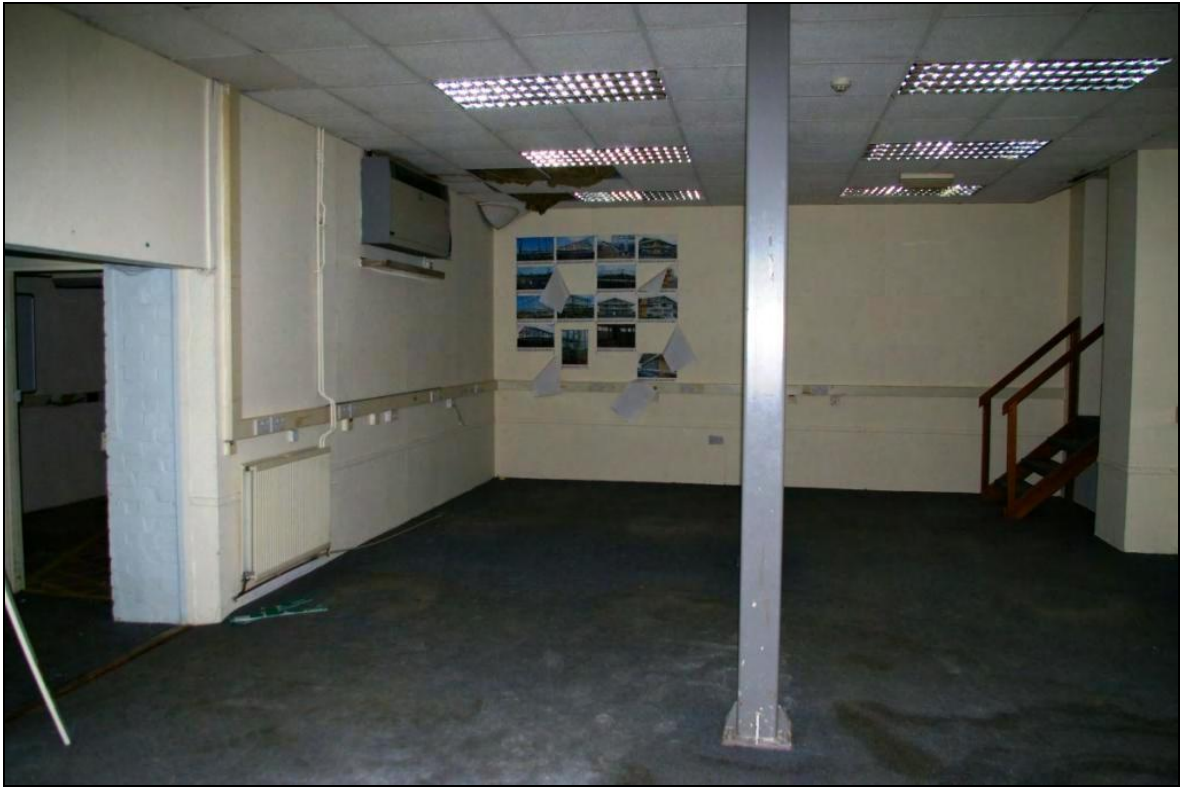
From the stair hall a forced doorway in the large stone and brick patched west wall leads down modern timber steps into the main ground floor office. The floor level here is 85-90cm lower than elsewhere. The room is large and unlit, with a false ceiling with polystyrene tiles and grated lights (Figure 14). The ceiling appears to be supported on large metal columns, possibly with RSJs above. The walls are plastered and boarded/lined, making analysis of their construction difficult. The wall to the west is of considerable thickness and is possibly of stone construction. The wall to the north; the exterior of which faces onto the rear courtyard behind the adjacent Customs House, is of stone below and brick above (when viewed from the exterior). There is a substantial opening south of centre in the west wall which may be a modern enlargement of an earlier opening or a forced new opening; the quoins are brick with a concrete lintel. The floor surface level drops again here sloping downwards to the west to the small lobby and two further offices (described at 2.3.5 below). There

is a short projecting section of brick wall to the south end of the opening, a former wall has been truncated which may have once divided this large space. The floor is concrete with modern carpeting. A door in the modern partition wall to the south leads to an inner office and there are steps up to an opening in the east wall into a small office that overlooks the courtyard to the east. The apparently modern south-east corner walls project into the room and are newly plastered. The short southern section of this wall may be the truncated remains formerly associated with the wall remnant projecting from the west wall.

Figure 14: The main ground floor office, with the large forced opening in the west wall, viewed from the south-east.

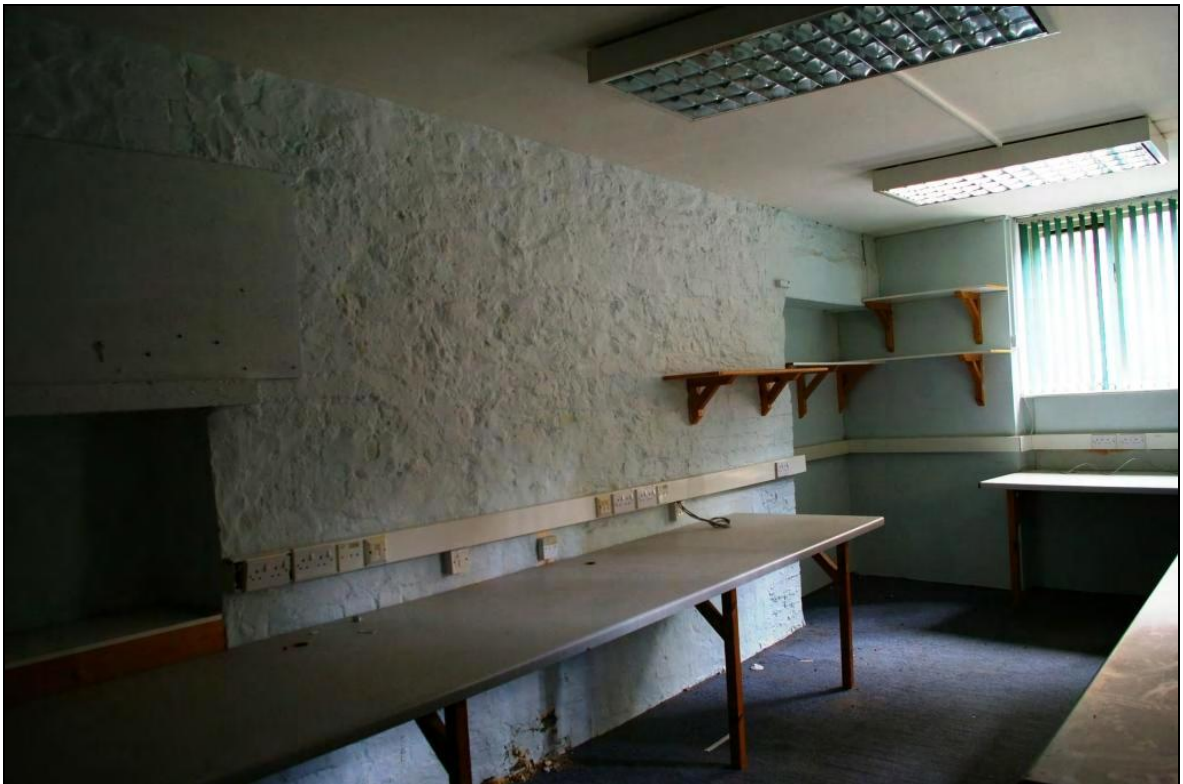
Figure 15: The larger front ground floor office with the stone east wall with blocked openings, viewed from the north-west.

The larger office (Figure 15) is long and narrow, with windows to the south and west. The ceiling is modern, boarded and with modern lighting fitments. The east wall is painted exposed stone with brick repairs and patching. To the north-east there is a large low opening with a narrow lintel, possibly formerly a door opening or perhaps a cupboard forced in the wall utilising the lintel above. The reveals to the opening below the lintel are roughly plastered but above and to the left of the lintel another straight, brick quoined edge, on a different alignment to the wall edge below the

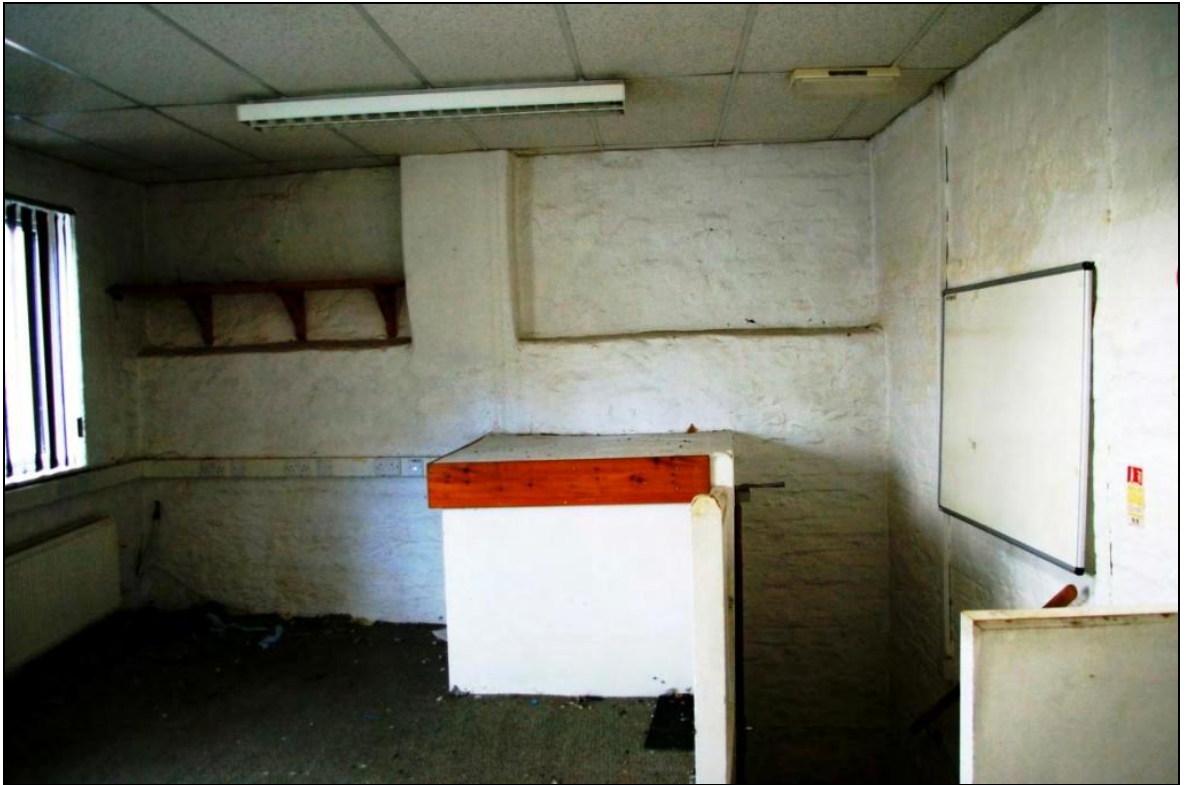
The stone wall to the south of the stairs at first floor height shows some patching with brick and the stones are of a smaller size to those at ground floor level. The wall steps back and reduces in width halfway up its length but the slim brick central chimney stack continues to extend upwards at the lower wall width, creating the impression of alcoves to either side (Figure 16). The chimney stack is heavily plastered and has been forced into the stonework of the earlier wall. To the ends of this wall where it is abutted by the east and west walls it appears to have brick repairs. There is a possible blocked opening, probably a window, to the east side where a long narrow lintel appears to be visible beneath the plaster. The inserted stair has been brought up against this wall, with the modern boxing enclosing the lower run and projecting upward to half the wall height in this room. The stair turns to the north after a quarter landing and rises against the west wall.

The north wall is a modern partition separating the lobby from the modern kitchenette area. The east wall is of brick, possibly historic, with two modern windows at this lobby end. The west wall is of brick, possibly of 19th century date, with a central doorway leading down steps into the attic office to the west (Figure 17). The door is framed with modern boarding with the upper part of the wall above the opening reduced for ease of access. The height of the opening suggests it is earlier than the raising of the floor levels both below and at this level. It is possible that the opening was formerly a loading door, or an enlargement of a window opening. To the north of this is a further former opening at the same level as the door, with a narrow timber lintel, typical of the 19th century, which may also have been a window or former loading door, now blocked and truncated by the modern partition north wall.

Figure 16: The first floor lobby, with stone south wall with the brick chimney stack and brick walls to east and west, viewed from the north.

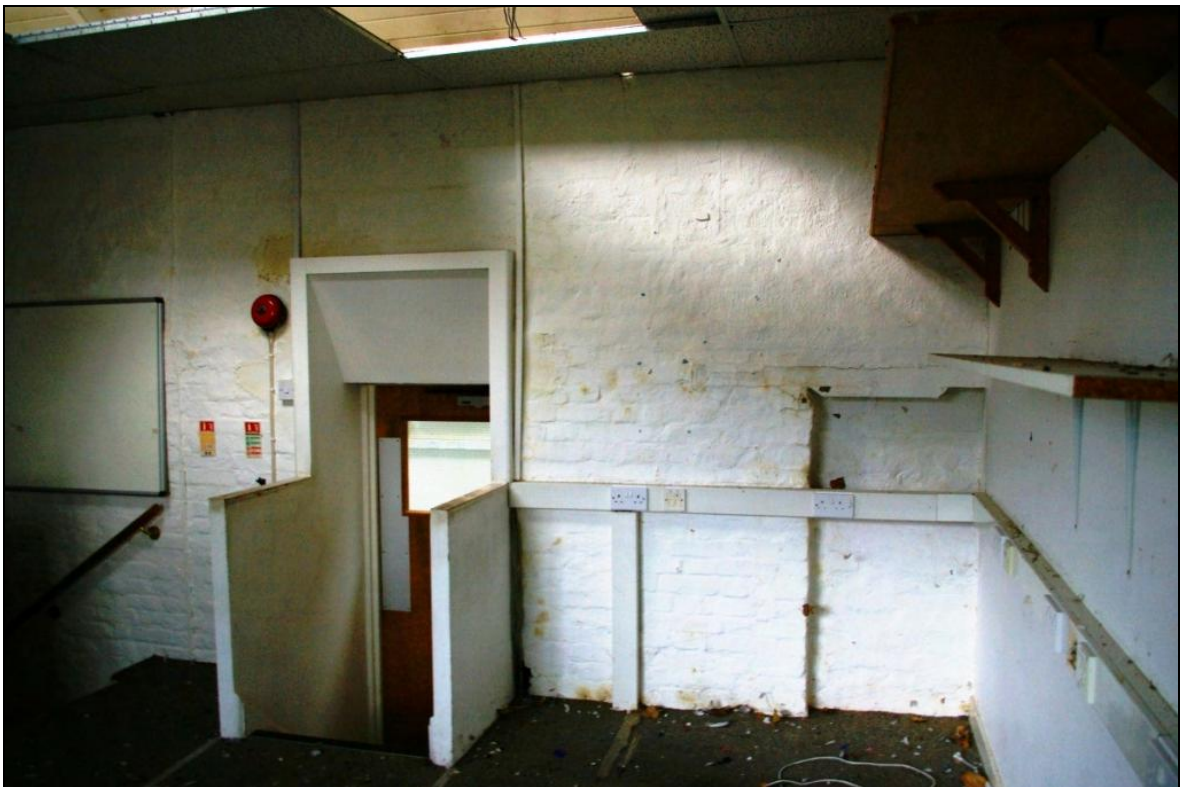
Figure 17: First floor lobby, the brick west wall with existing doorway and blocked opening, viewed from the north-east.

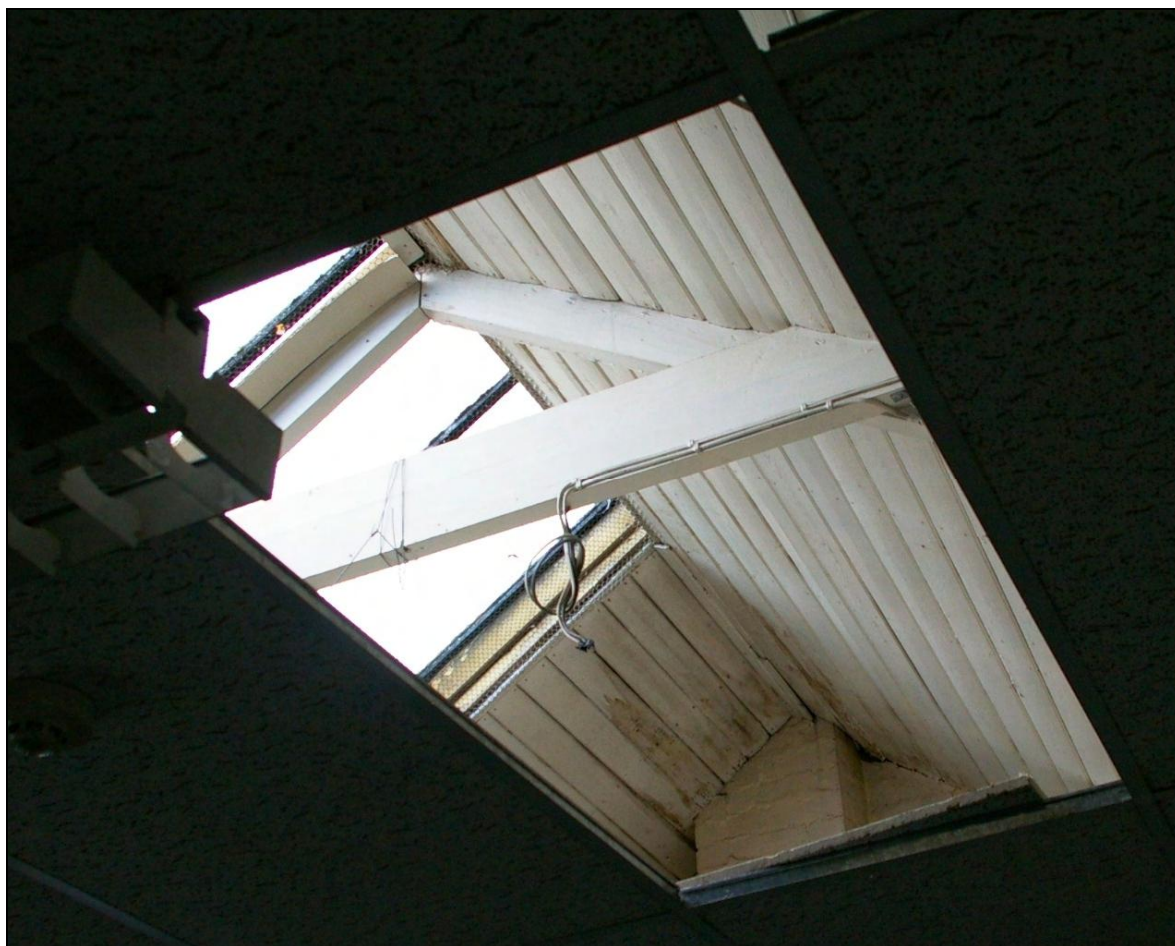
The roof structure is composed of timber A-frames which are nailed and bolted (Figure 18). The roof is planked and later skylights have been inserted into the roof above the modern ceiling height, and cut into the planking to provide extra light. The roof is of late 19th/early 20th century style.

Figure 18: Showing roof structure above the first floor lobby, viewed from the north-west.

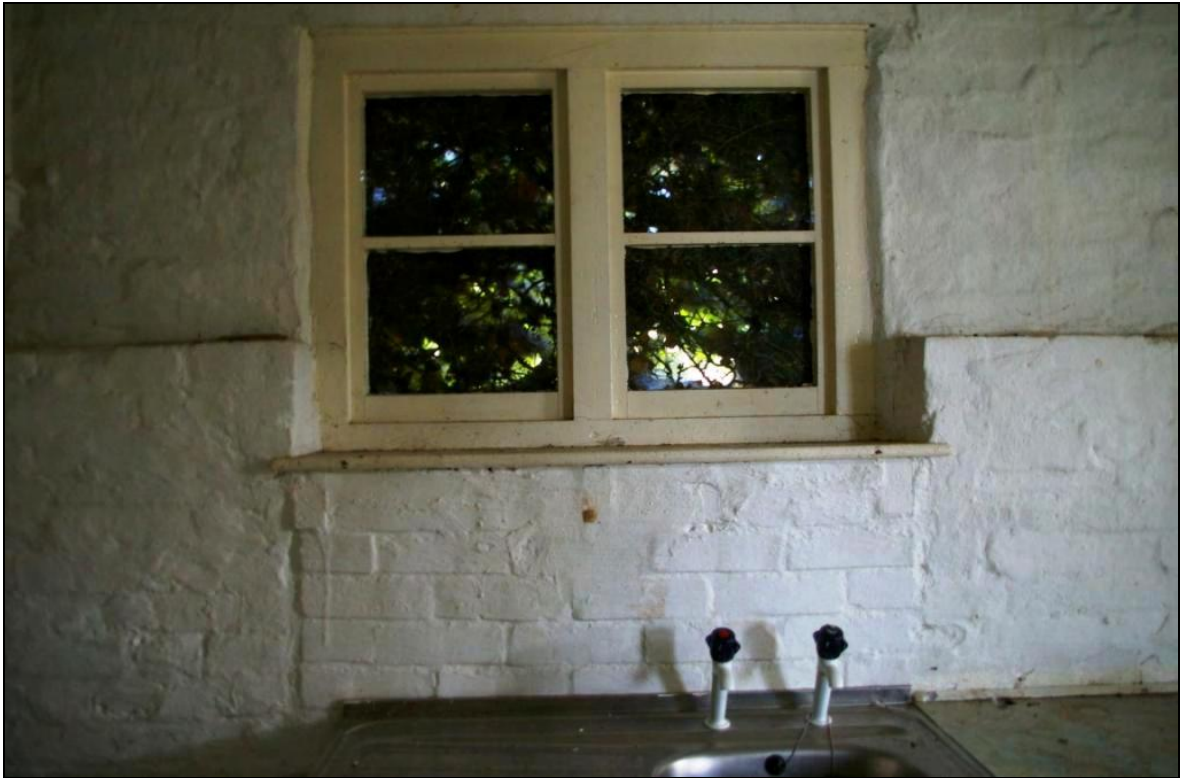
The small kitchen area is accessed from the first floor lobby through the door in the modern north partition. The brick east wall is a continuation of the east wall of the first floor lobby, which here has a door onto the flat roof to the rear of the building. The north wall is also of brick, it reduces in width half way up the wall, as the south wall of the lobby, and in the centre there is a small timber casement window probably of early to mid 20th century date with wooden sill just below the change in wall width. This window blocks the upper part of an earlier opening which is infilled below with brick. This opening is deeper possibly to incorporate a sash window, a typical 19th century window type or to incorporate a loading door (see Figure 19). The brick north wall is built up against the western brick wall, which also incorporates some possible stonework. The west wall is again a continuation from within the lobby area and it has the corresponding side of the blocked opening, cut by the modern partition wall. The current first floor level of the lobby and kitchenette truncate this opening horizontally, suggesting that the floor is a later development. The opening is blocked with bricks. The floor of the kitchenette is carpeted, with a section removed, beneath are regular timber boards, wider than modern floor boards and possibly of late 19th century or possibly early 20th century date. There is a small length of modern fitted units against the north wall.

Figure 19: The north wall of the kitchenette, with the early to mid 20th century timber window and modern brickwork blocking former the former window opening or loading door, viewed from the south.

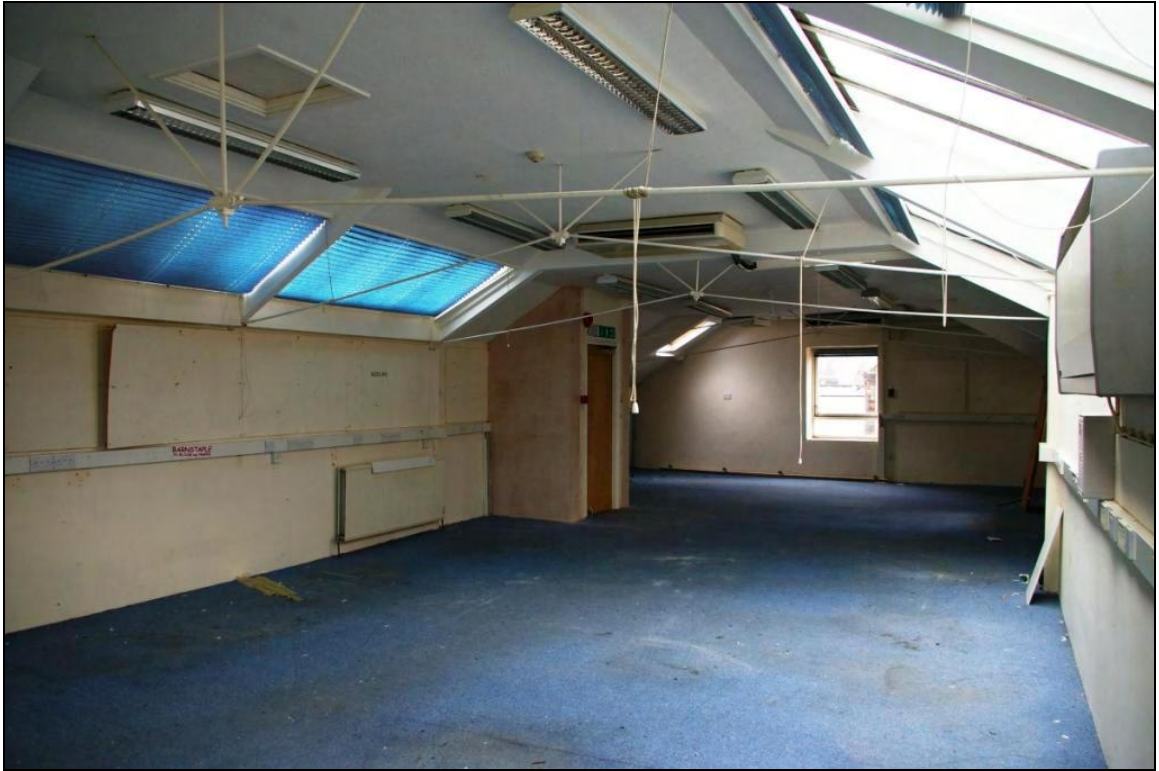
The main office (Figure 20) is accessed down some steps and through the doorway discussed above within the first floor lobby. The main 'attic' office is one large open space within the roof space, with a modern roof with skylights at the north end, and boarded to the south. The structure is of A-frames but the collars have been replaced with a scissor-arrangement of metal rods, bracing the timber truss blades. The roof is of very late 19th century/early 20th century date and the modern roof coverings are of mid to late 20th century.

Figure 20: The large main attic office with long skylights cut into the roof, viewed from the north-west.

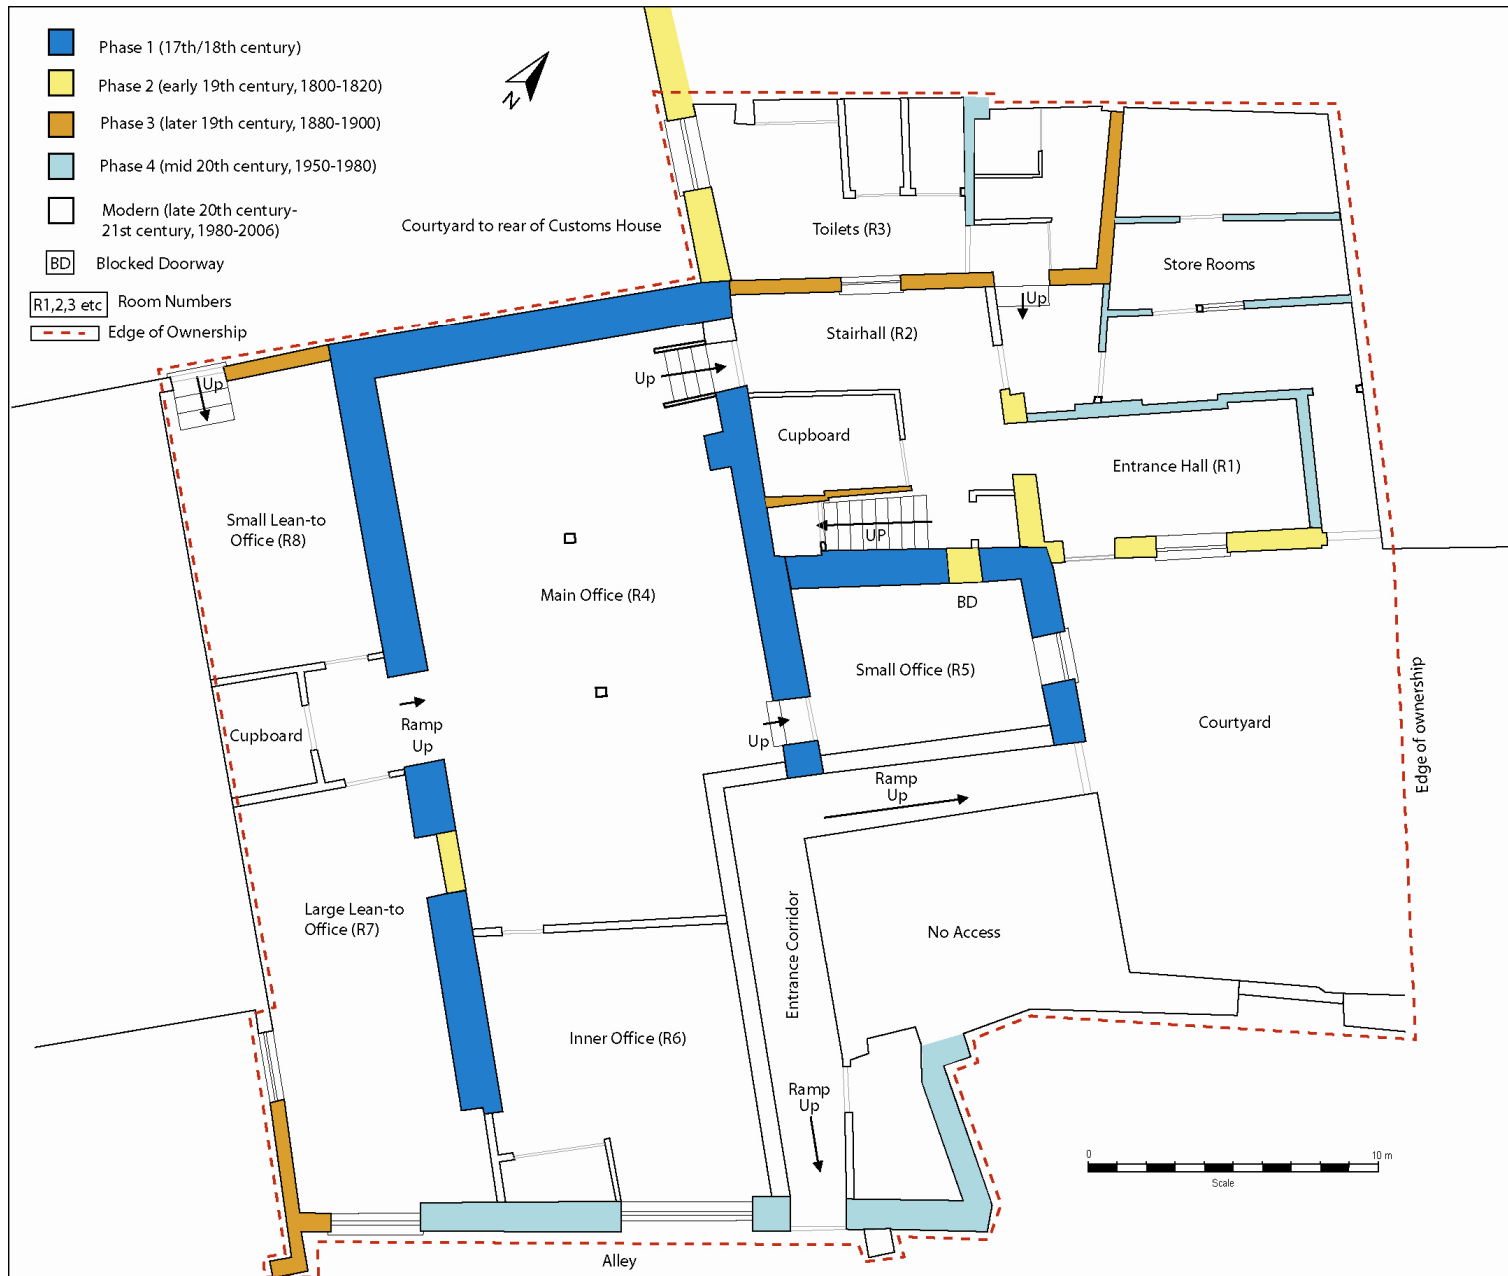
Figure 23: Phased ground floor plan of Strand Mews.

The earliest structures within the current building are the stone walls found to the west, north and east of the main ground floor office (Room 4). The thickness and quality of the construction of these elevations is of note, as is the marked narrowing of the walls as they reach first floor height. This building possibly dates from the 18th or even late 17th century and was probably built as a warehouse. However it is built across the ends of the earlier burgage plots which run back from the high street and the building sits on a slanting axis respecting the ends of these plots to which it lies at right angles. This may suggest the building could be earlier than the 18th century as there seems to be some relationship between the stone building and stone burgage plot walls, possibly dating to the remodelling of the quay areas which occurred in the 16th century. If the building is 18th century however it may have just been built over and around the earlier medieval walls. The wall to the north of the small office (Room 5), which contains the forced brick chimney stack, and the base of the north wall of the main ground floor office (Room 4) may both be evidence of burgage plot wall being reused, as they seem to be on an alignment with the walls which form the courtyards to the east. There is no definitive evidence and no specific datable finds were recovered to identify if the stone walls within the Strand Mews building are older than the 18th century or even medieval, but the possibility does remain.

warehouse were blocked and the brick buildings were extended to first floor height up against the earlier stone structure (Rooms 9 & 10). Further doorways were built or forced into the elevations to provide access. The Strand Mews building has been truncated to the south-east and has lost the first floor level, it is not possible therefore to say that the accommodation or offices stretched further along the length of the stone warehouse. As mentioned above the nature of this new build does suggest accommodation due to the fireplace; however it is possible that this building merely contained a heated office or counting house, for the warehouse manager or other service building, the status of which required a heat source (Room 5). The painted plaster of the walls and deep moulded skirting in the small office certainly suggests a late Victorian room, including possibly some wooden fitted shelving or possible desk and office fittings, the remains of which can be seen in the north-east corner. This building and part conversion work dates from the later 19th century, with some possible early 20th century sub-phases of work, such as the boarding to the roof above the first floor lobby.

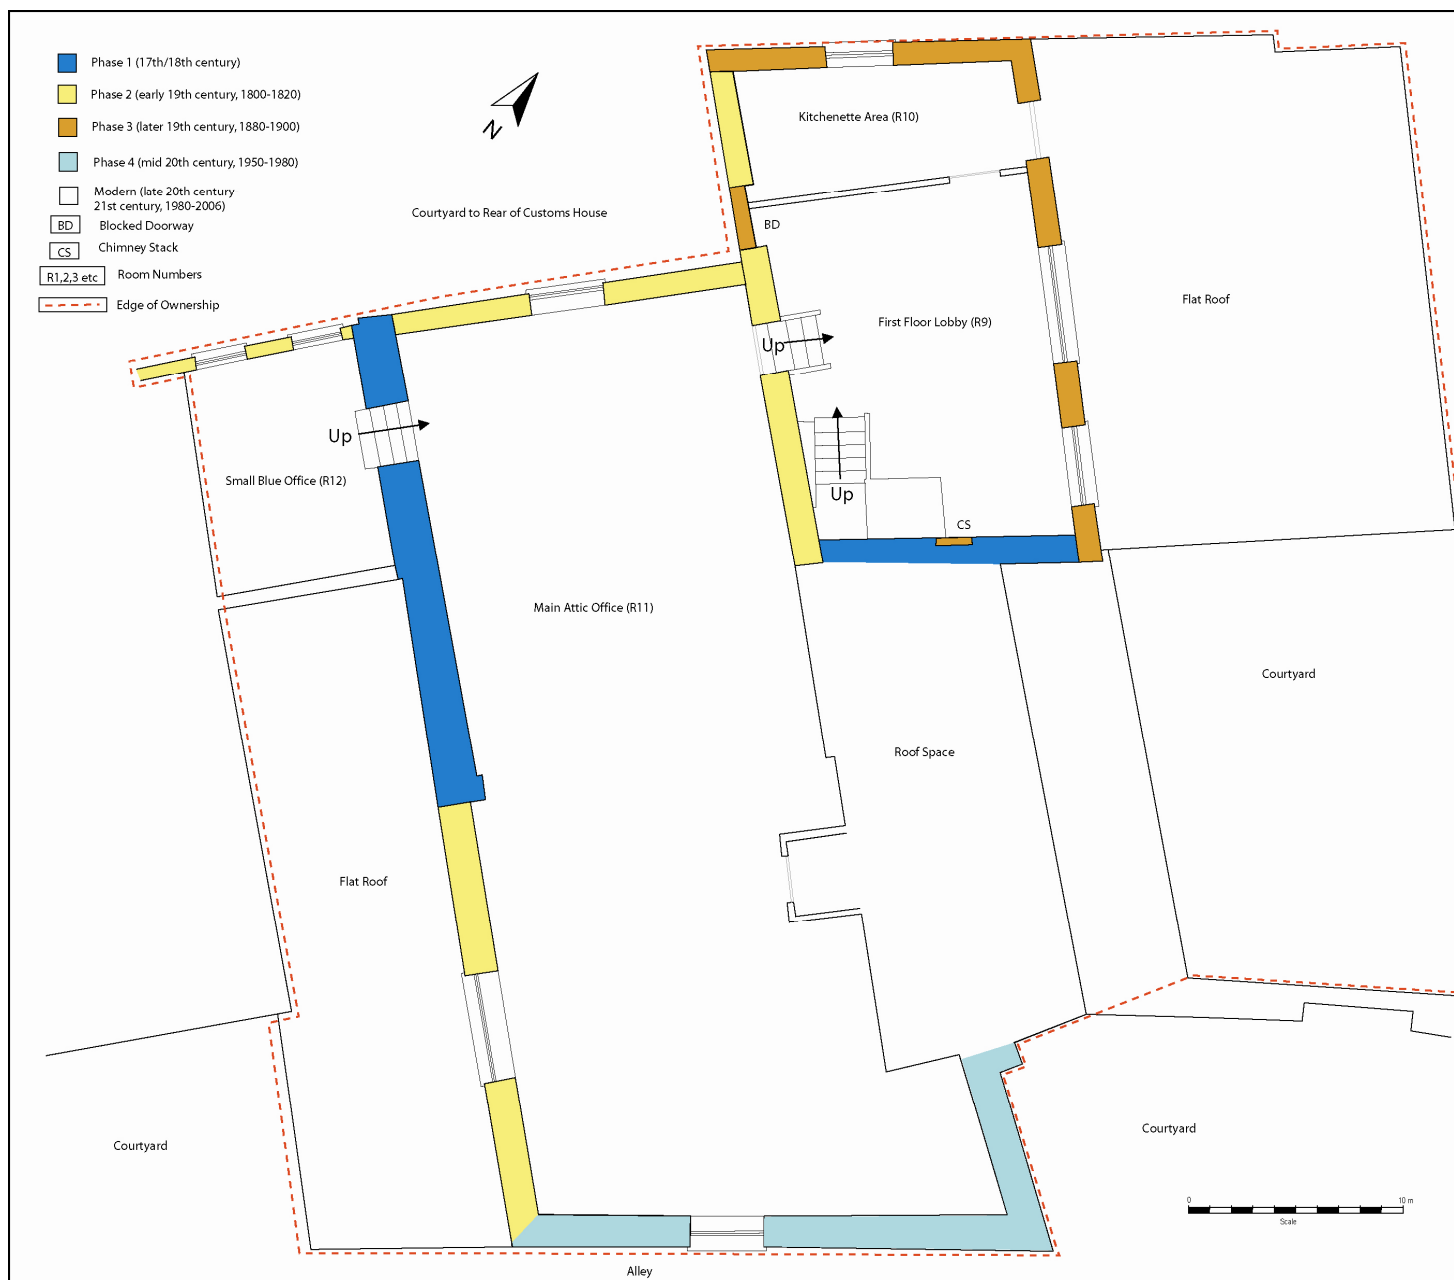
Figure 24: Phased first floor plan of Strand Mews.

The later 20th century saw the buildings opened up, walls removed, openings forced and areas converted to office space for a local newspaper. Historic features were removed and walls were boarded to provide tidy office work areas obscuring the details until the recent works.

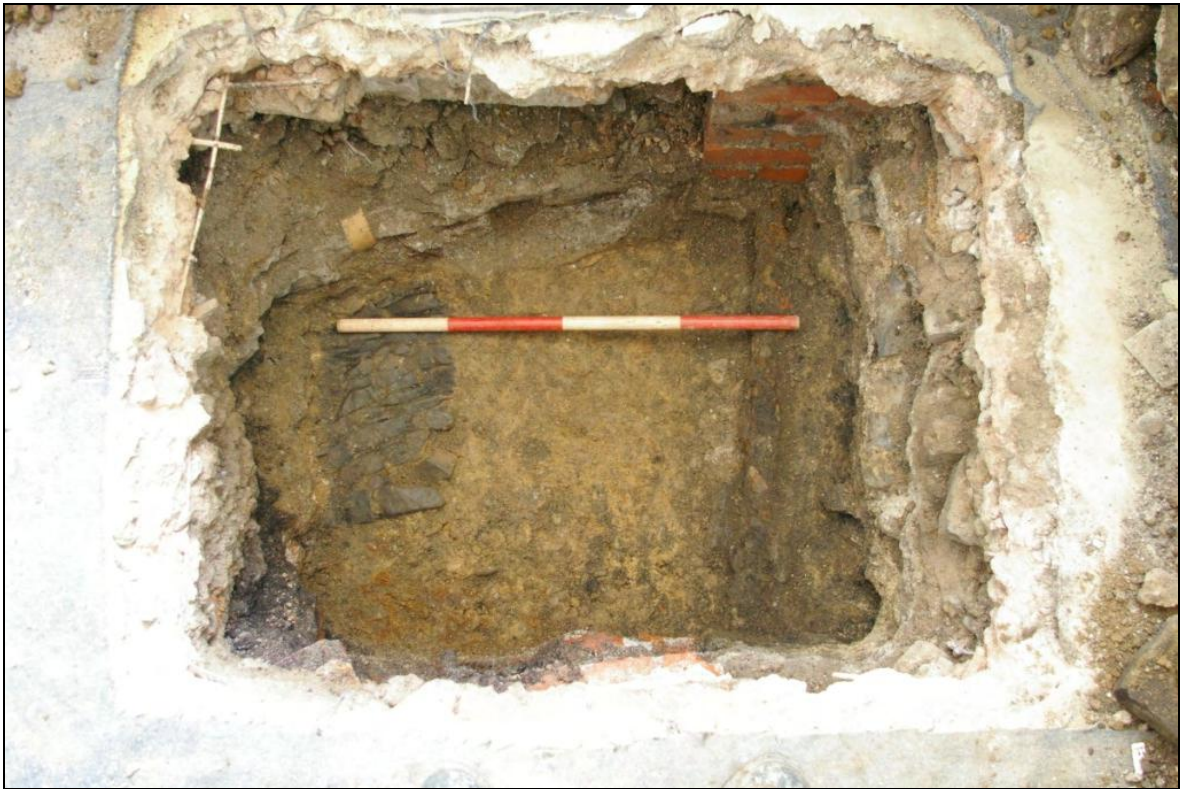
Figure 27: Post-excavation shot of Trench 1 with the cobbled surface (114) set in (115), viewed from the north-west (1m scale).
