## Devon County Council Historic Environment Record

<b>Civil Parish &amp; District:</b> Chulmleigh, North Devon	National Grid Reference SS68621446		Number:	
Subject: Erection of a bungalow with garage, and access				Photo attached? YES
Planning Application no: 51294, 44967	Recipient museum: Museum of Barnstaple & North Devon			
OASIS ID: southwes1-111228		Museum Accession no: NDMS2007.62		
Contractor's reference number/code: COS11		Dates fieldwork undertaken: 11 <sup>th</sup> -13 <sup>th</sup> October 2011

## Description of works.

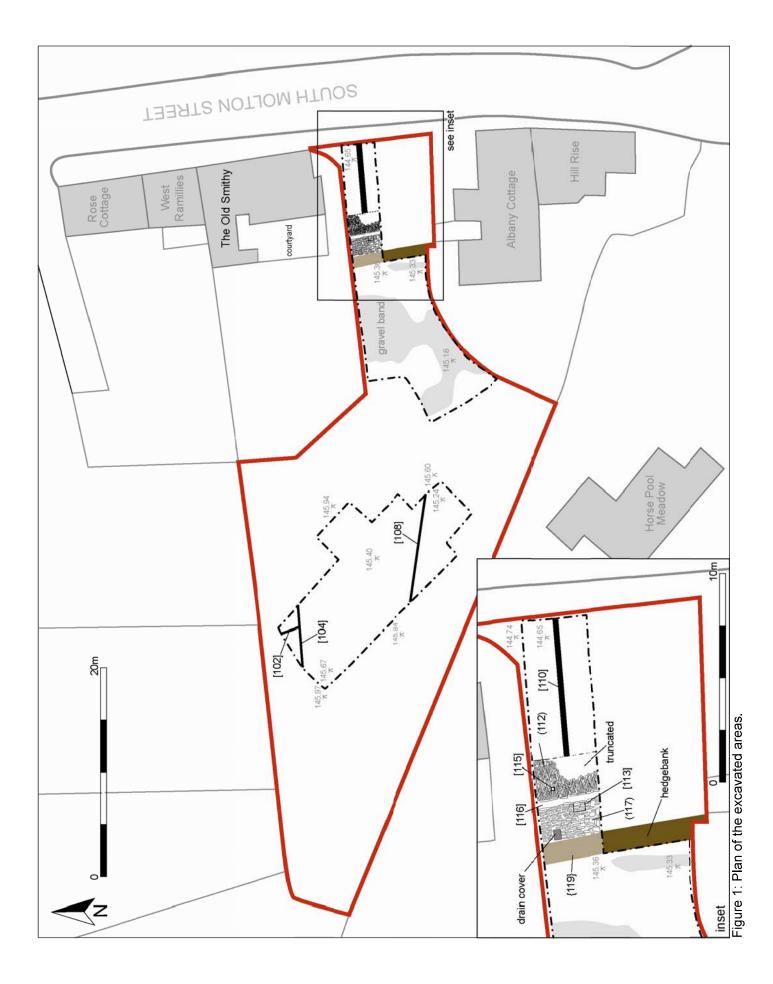
In the area stripped for the bungalow three linear features were exposed (see Figure 1): Linear [104] was 0.4m wide and extended southwest for c.6m from the eastern limits of excavation before disappearing beneath the northern limit of excavation. It contained a single fill (105), a mid-to-dark mottled grey clay-silt with common sub-rounded to sub-angular stones (60-120mm). Linear [102] ran north-west by south-east for 2.6m from the northern limit of excavation to join linear [104]. This linear was 0.3m wide and filled by (103), a grey clay-silt with common sub-rounded to sub-angular stones (60-120mm). The third linear [108] was 10m long and 0.3m wide and was orientated north-east by south-west c.10m south of [104]. Linear [108] was filled by (109), a buff grey-brown clay-silt with common charcoal flecks and frequent sub-angular stones (50-100mm). Linears [102] and [104] joined at the southern end of [102], while linear [108] and [104] were on a very similar alignment, suggesting that they all represent elements within a system of post-medieval field drains. This is supported by the single sherd of post-medieval North Devon ware recovered from (107). The topsoil was notably shallower across this part of the site, and it seems likely some topsoil had been removed prior to the current development.

In the area stripped for the site access and garage, c.12m of a 0.8m wide linear [110] was exposed running eastwest from the eastern limit of excavation. This linear was filled with a mixed and mottled grey-buff gritty clay-silt (111) containing common sub-angular stones (50-100mm), occasional charcoal flecks, and rare brick fragments and sherds of flowerpot. This cut may have been a wall foundation trench, as its western limit was defined by a cobbled surface (112/117), but its fill was certainly of 19<sup>th</sup>-20<sup>th</sup> century date. The cobbled surfaces (112) and (117) extended west from the end of [110] to hedgebank remnant {119}, which suggests that this boundary, together with the cobbles, probably relates to the garden/yard of the (17<sup>th</sup> century?) cottage demolished after 1908 (SWARCH 2007). This is supported by the close alignment of the hedgebank and end of the cobbles with the area of the walled courtyard to the north (see Figure 1). The cobbles were overlain by a layer of loose and mixed buff-yellow clay-silt (121) containing sub-angular stone rubble (200×100mm), perhaps cob derived from the demolition of a structure.

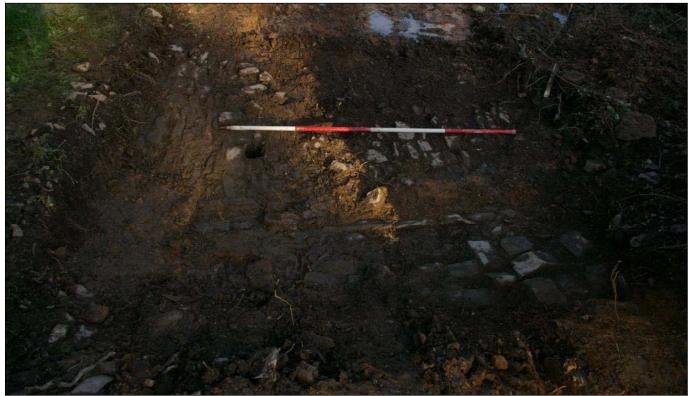
The cobbled surface (112) was made up of blocky sub-angular to sub-rounded stones (typically 200×50mm) orientated east-west and set in gritty greyish-yellow clay-silt earth packing (see Figure 2). These east-west orientated cobbles are very similar to the cobbles fronting the surviving cottages to the north. The western 1.5m of

Figure 2: Cobbles exposed in area of access drive, viewed from the west (2m scale).

(112), although similar, were orientated north-south and generally (particularly to the south) comprised of slightly larger, squarer stones (220×100mm). The different orientations may suggest two phases of cobbling. A post-hole [115] of 0.25m across cut through the cobbles (112) but as this survived as a void it was probably cut from higher up in the stratigraphic sequence. Two rotten timber posts were removed from this area during the topsoil strip.

The cobbled area (112/117) was bisected by what appears to have been a cobbled drain 0.4m wide, orientated north-south [116]. The cobbles, typically 200×100mm in size, were also orientated north-south. This feature [116], which was very probably a drain, nonetheless contained a very compact yellow-buff slightly gritty clay-silt fill (118) containing common sub-rounded stones (up to 70mm), somewhat similar to (121). This might reflect a secondary reuse of the drain as a wall foundation trench.
