THE PAVILIONS ADMIRALTY HOUSE MOUNT WISE PLYMOUTH

Results of a Desk-Based Assessment
&
Historic Building Recording

Report No.: 111122
Date: 22.11.2011
Authors: E. Wapshott

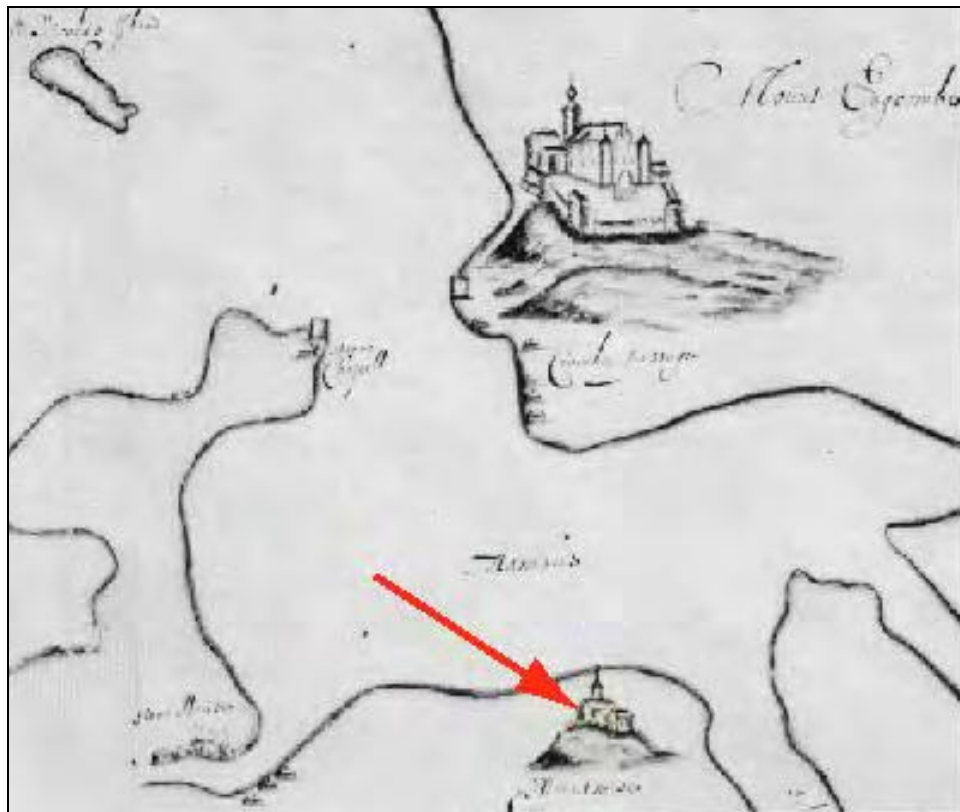
Figure 2: The 1665 map of Plymouth, Mount Wise is arrowed.

The early maps of Plymouth and its surrounding areas document the settlements which give the areas of modern Devonport their names today. Mount Wise, the site of Admiralty House and the Pavilion buildings is documented on the 1665 map by *Bernard de Gomme* (Figure 2), showing what appear to be fortified buildings and possibly a church and other buildings in a small pictogram. Churches and religious buildings near maritime settlements were often built in prominent positions overlooking the sea, the importance of the spiritual protection of sailors and fishermen being of vital consideration for the families and communities left on land.

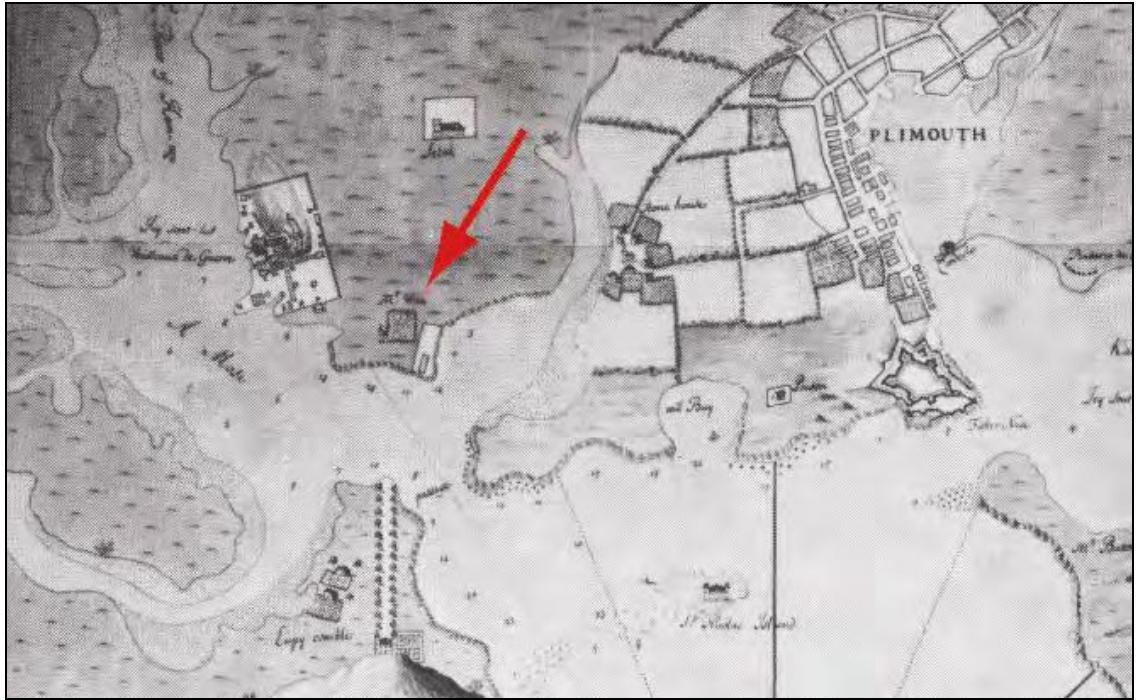
Figure 3: 1698-1712 plan of Plymouth, drawn by G. Delehave. Mount Wise is arrowed.

Moving into the early years of the 18th century, in which the majority of development in the area was undertaken, we have the map of *G. Delehave*, dated between 1698 and 1712 (Figure 3). This map shows us Plymouth (*Plimouth*) to the east and the Devonport settlement with the docks to the west. Between these is the promontory of Mount Wise, shown as a square walled complex with a projecting building in its south-west corner, possibly the church indicated on the earlier map (Figure 2 above). Adjacent to this complex is a further rectangular walled area lying parallel to the creek leading along the coast to Stonehouse and containing a long rectangular building that also sits parallel to the coastline.

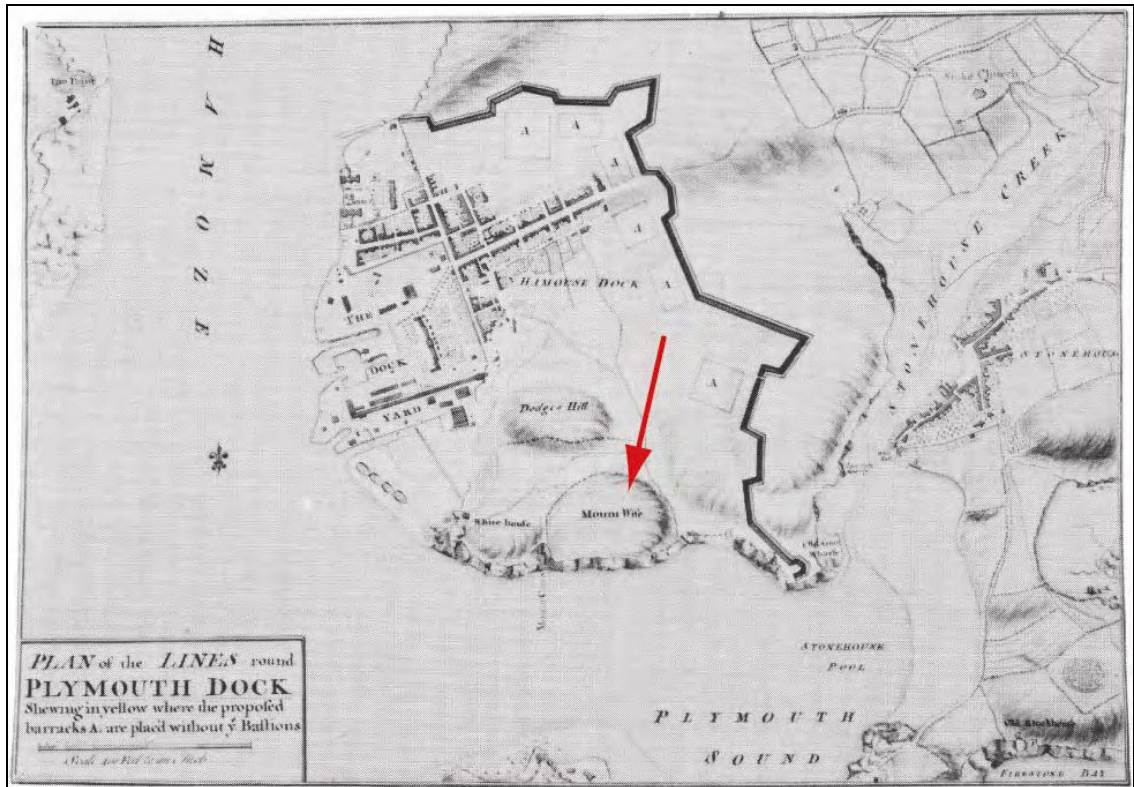
Figure 4: The pre 1756 plan of the defensive lines around Plymouth dock, by D. Slack. Mount Wise is arrowed.

By the middle of the 18th century we have a plan of the defensive lines now enclosing the dockyards at Devonport (Figure 4). Drawn by *D. Slack* and dating to before 1756, this map provides a more detailed picture of the expanding dockyard areas and the increased militarisation of the site with the creation of the barracks to the north and east of the docks.

The raised promontory at Mount Wise map is clearly shown and the neighbouring Dodges Hill, both of which appear devoid of development or buildings at this time, although the 'old wharves' to the immediate south-east of Mount Wise, along the creek to Stonehouse, are marked.

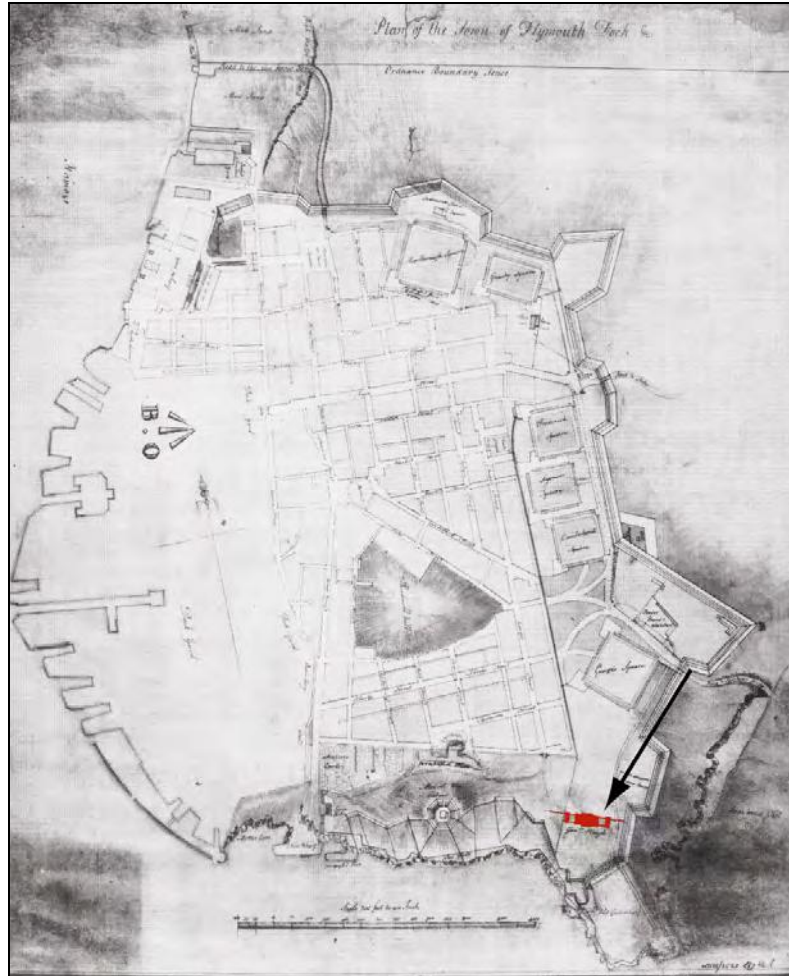
Figure 7: Map of Plymouth Dock dating from *circa*.1789, showing the first evidence of Government House, indicted in red.

A more detailed plan was re-drawn by Lt COL *Durnford* himself the following year clearly showing the lighthouse on the mound (Figure 7). To the east of the mound and adjacent to the defensive lines, a long building or complex of buildings, that appear to be marked as Gov. T. House, are now apparent. There appears to be a main building with projecting wings to the east and west and that this building is Admiralty House there can be no doubt. The date of this plan is given as *circa*.1789 but this seems unlikely as it clearly documents Admiralty House when the architectural plans by the architect James Wyatt suggest it was built during the 1790s.

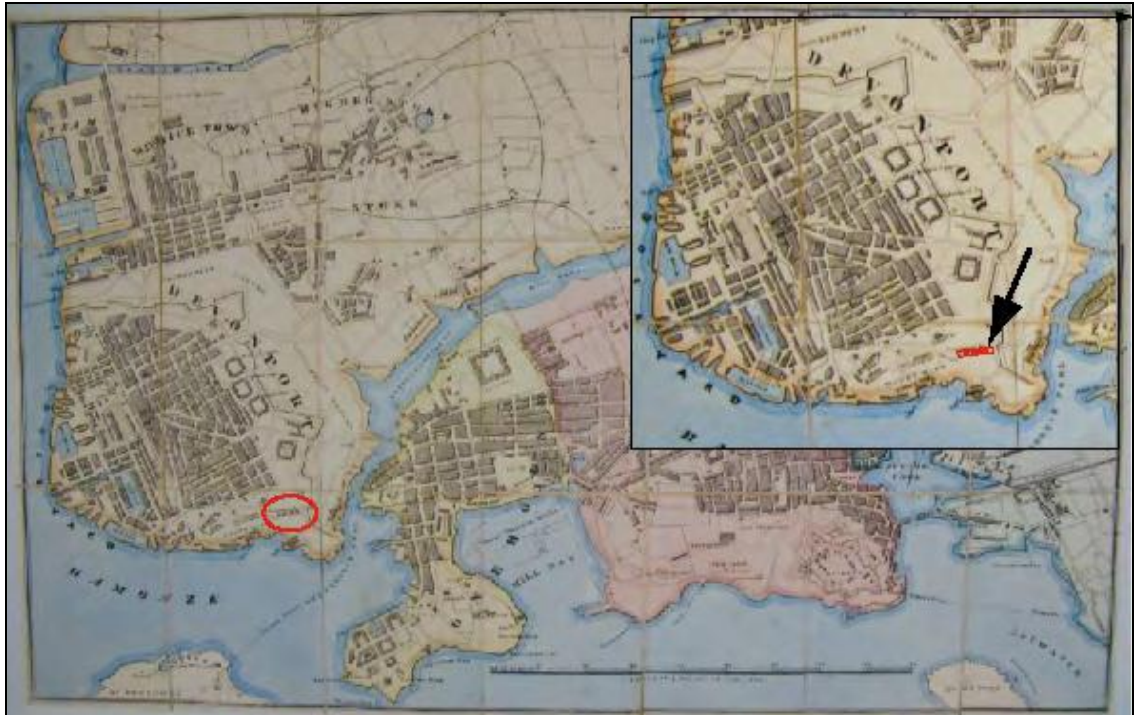
Figure 8: The 1848 Map of Plymouth, showing the addition of the railway network, drawn and published by W. H. Maddock, Plymouth. The position of Government House is marked with a ring on the large map and the building itself is highlighted in red with an additional arrow on the inset.

The 1848 plans of Plymouth, Devonport, Stonehouse and other surrounding communities, drawn up by W. H. Maddock for the recording of the addition of the railways and other improvements, show Mount Wise, the parade grounds and various important buildings, the largest of which is Government House (Figure 8). The layout of the complex is clear, with the central building flanked by the pavilions to east and west which are separated from the main building by small courtyards, with the whole enclosed within the large elongated curtain wall, creating further courtyards to the east and west of the pavilions.

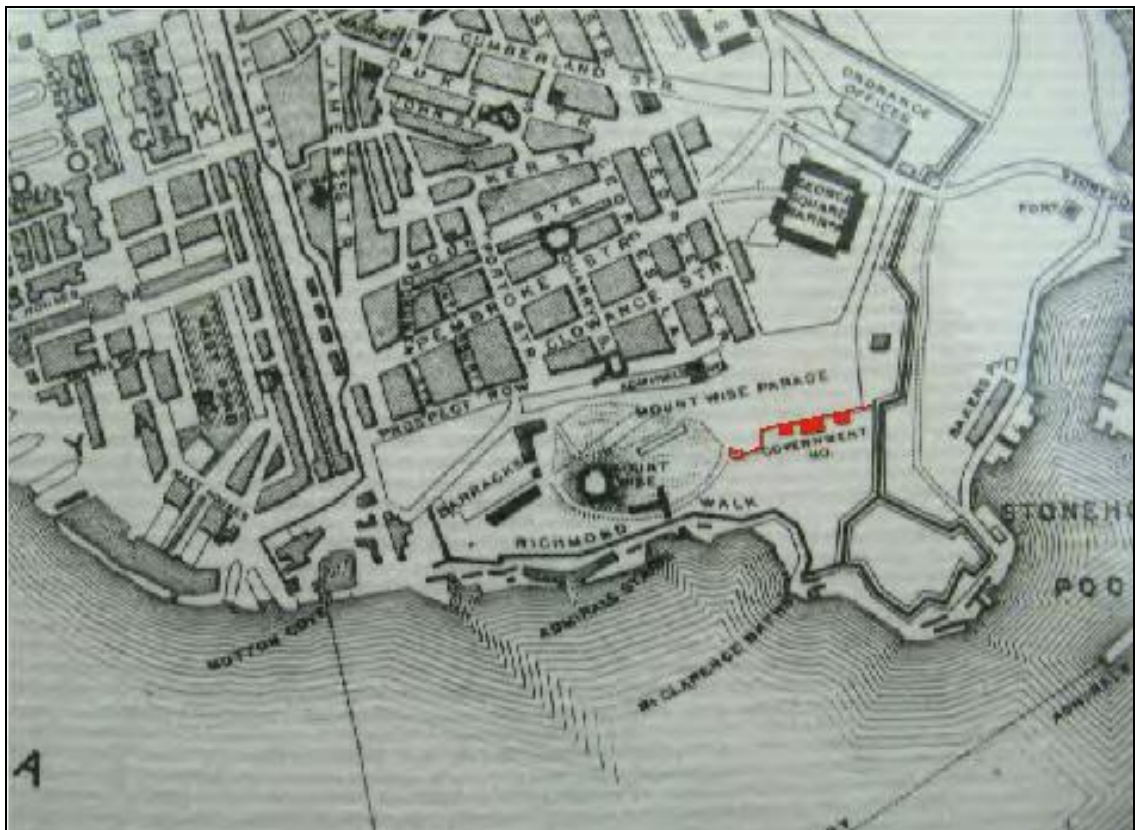
Figure 9: Detail of the Mount Wise area from the 1860 Map of Plymouth, Devonport and Stonehouse, by J. Rapkin, published by Whitehall Press, London. Government House is indicated in red.

On the 1860s map of Plymouth, drawn up by J. Rapkin, Government House is shown to the south of the Parade ground with the main building and pavilions to east and west clearly detailed (Figure 9). Interestingly it appears to show the curtain wall running only around to the north of the buildings which does not fit with the initial plans drawn up by James Wyatt or with

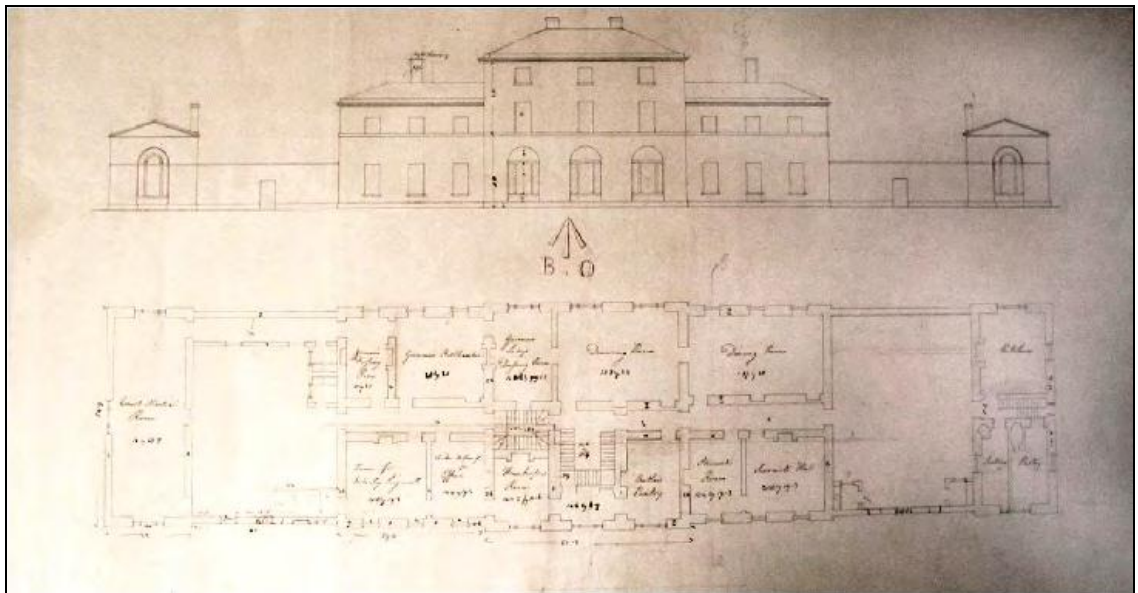
Figure 10: The 1790 plan by James Wyatt, showing the original design for the exterior north elevation and the interior layout and function of the rooms; it is especially noticeable how the two pavilions have widely varied uses. (PRO:MPHH 1/538)

For the buildings themselves the plans drawn up by James Wyatt in 1790 are our best source for the original layout and function of the Pavilions within the complex (Figure 10). We can see that the two pavilions are separated from the main house by the open courtyards, with curtain wall to north and south. The West Pavilion is designated as a kitchen block, with a large main kitchen to the south and two small service rooms to the north and with two small rooms, possibly dairies or stores, built within the western courtyard against the north curtain wall. The inclusion of a central stair hall between the kitchen and the service rooms suggests a first floor in this building. The East Pavilion, is set up as a Court Martial room, designed as a single open space, accessed from the main building via a stone passageway along the south curtain wall, with two small cells for holding the defendants built within the eastern courtyard against the east wall of the main house. The functions of the pavilions are led by the divisions within the main house, to the west there is a largely domesticated focus with a dining room, servants hall, butler's pantry and drawing room, with to the east offices serving the various aspects of management of the naval base.

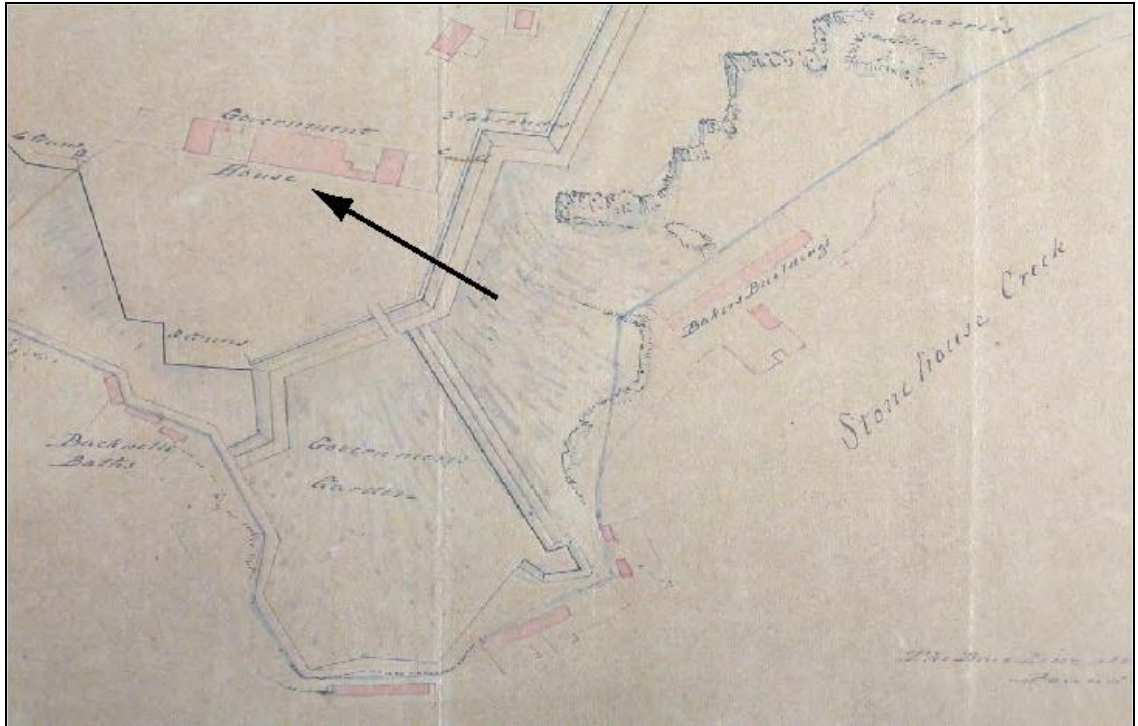
Figure 11: Detail of Government House from an 1815 plan of Devonport. The building is arrowed. (PRO: WO 55/797).

A map dated 1815 shows the addition to the main building of the semi-circular porch on the north side, with the pavilions remaining the same (Figure 11). Drawn as a plan, this clearly shows the wide corridor leading to the court martial room to the east and the small square buildings within the western courtyard, serving the kitchen to the west.

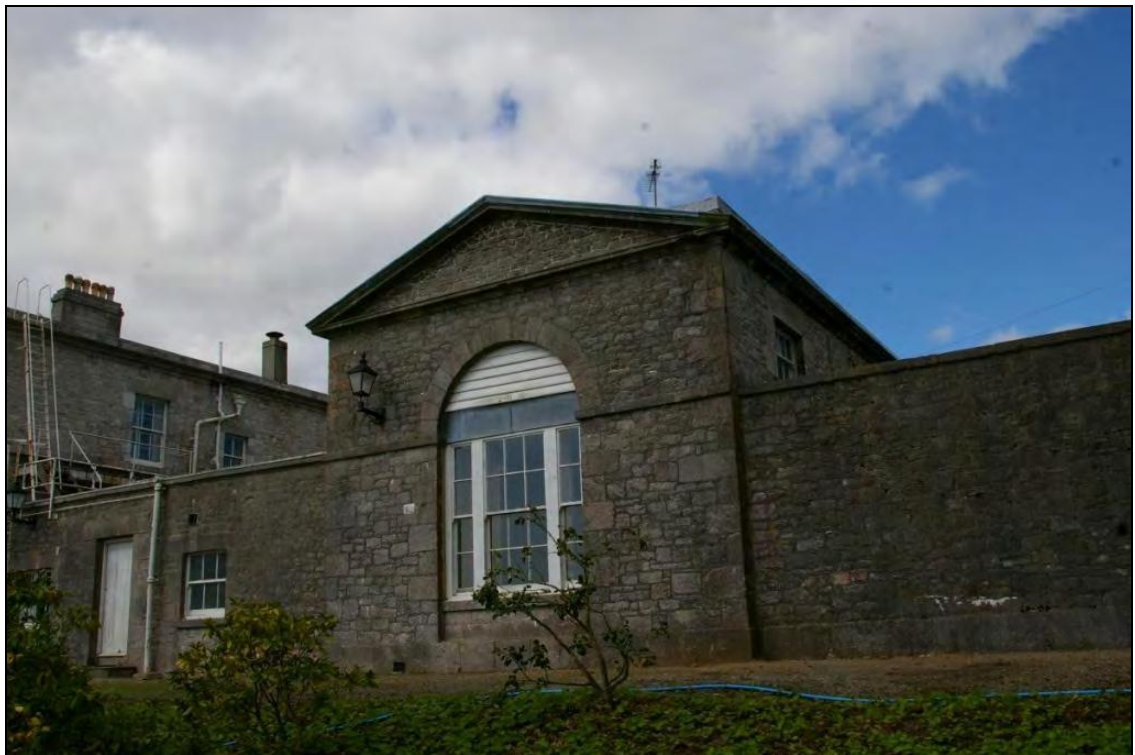
Figure 12: The south elevation of the East Pavilion, viewed from the south-east.

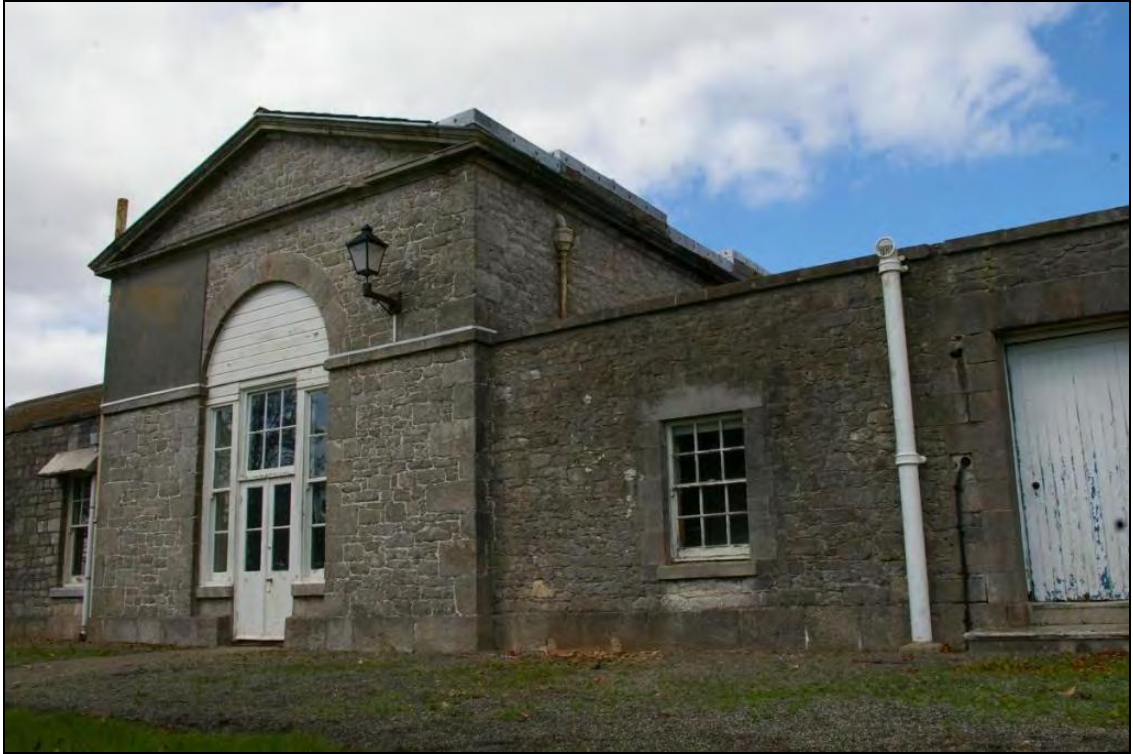
Figure 13: The south elevation of the West Pavilion, viewed from the south-east.

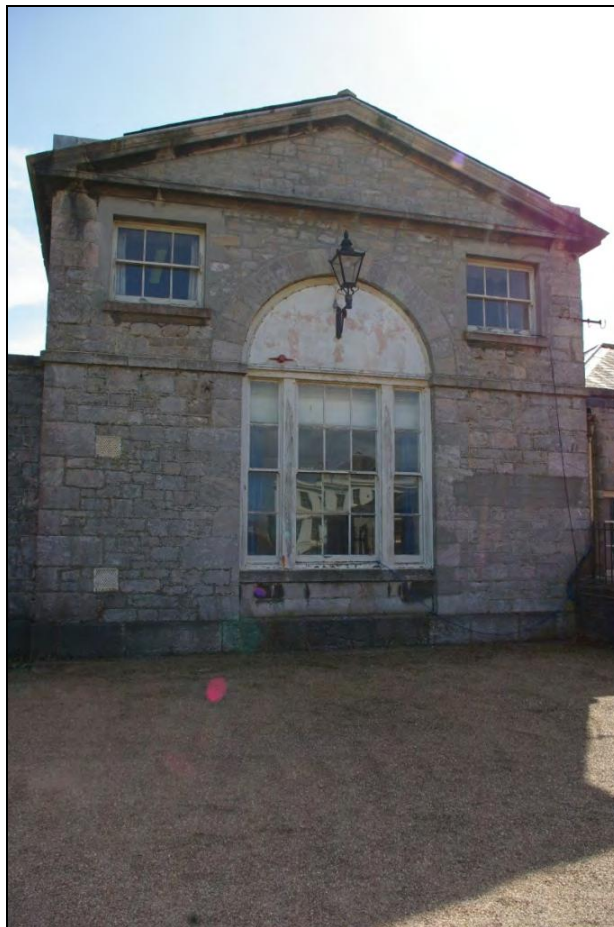
Figure 14: The north elevation of the West Pavilion, viewed from the north-east.

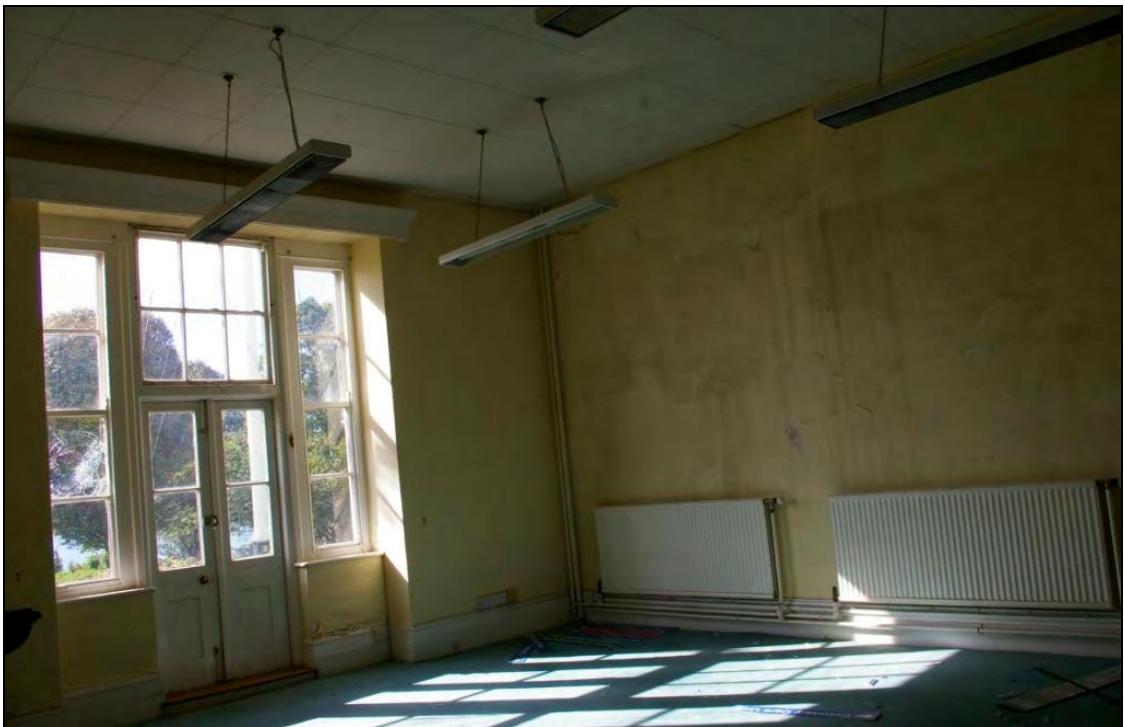
Figure 15: The south wall of the former kitchen, viewed from the north-east.

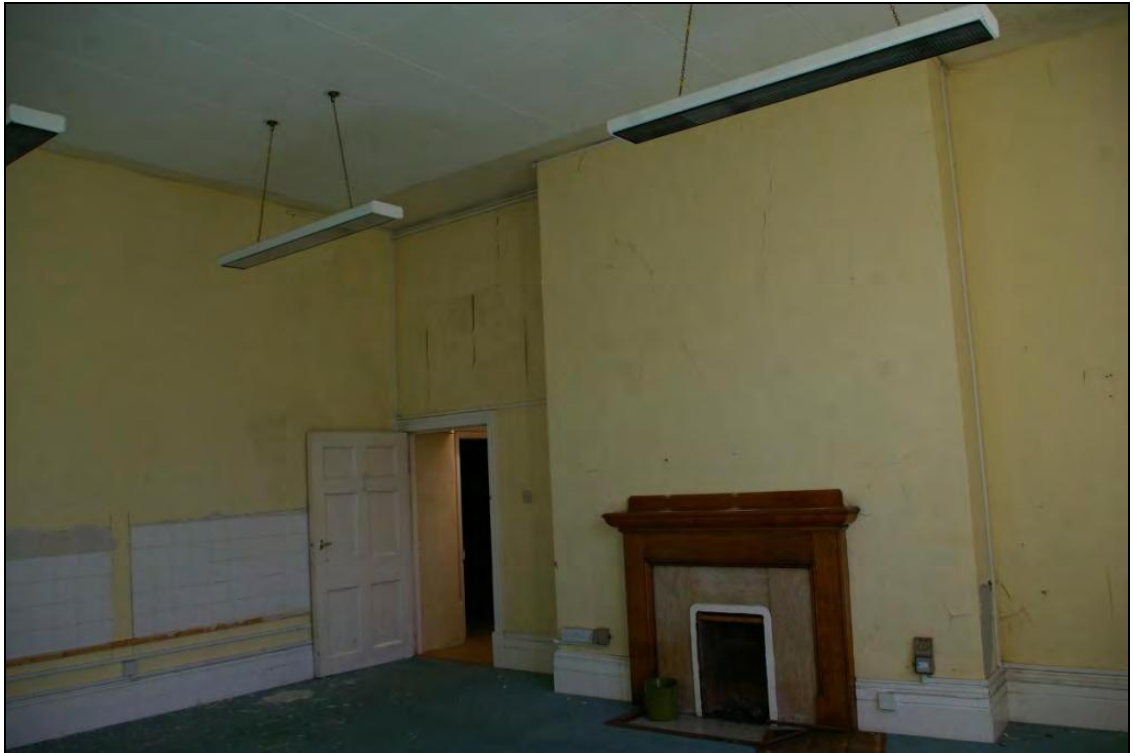
Figure 16: The east side of the southern former kitchen in the West Pavilion, viewed from the south-west.

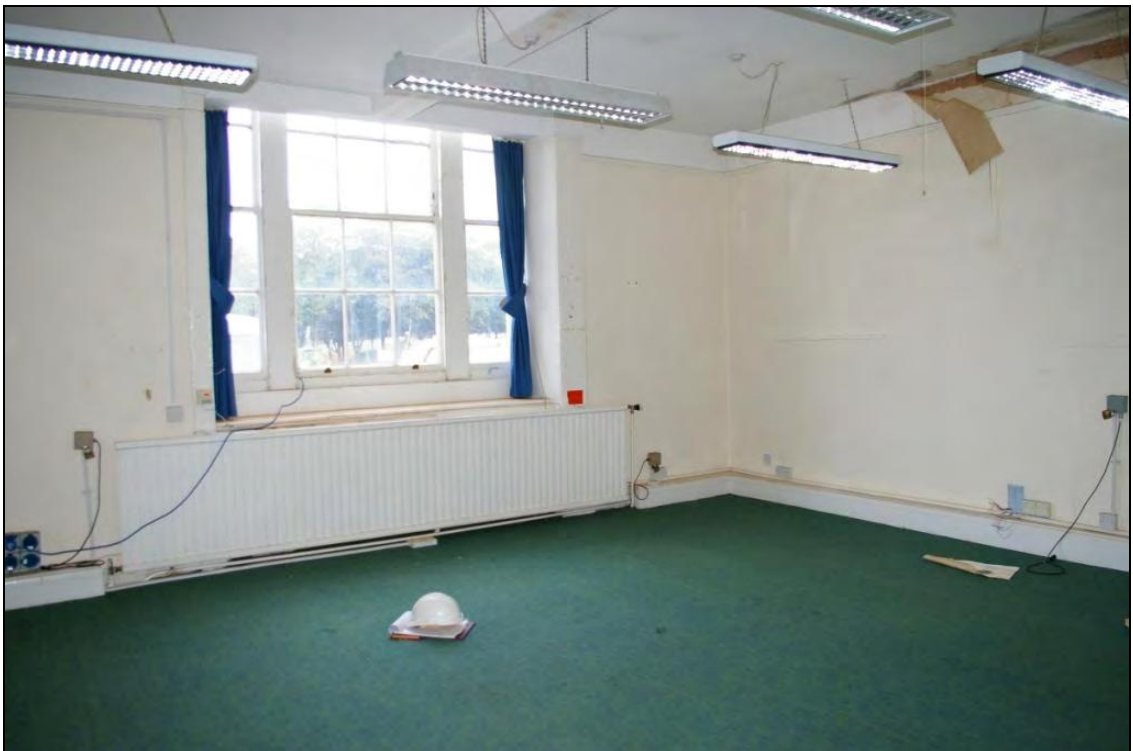
Figure 17: The north wall of the northern office, with the large central window, viewed from the south-west.

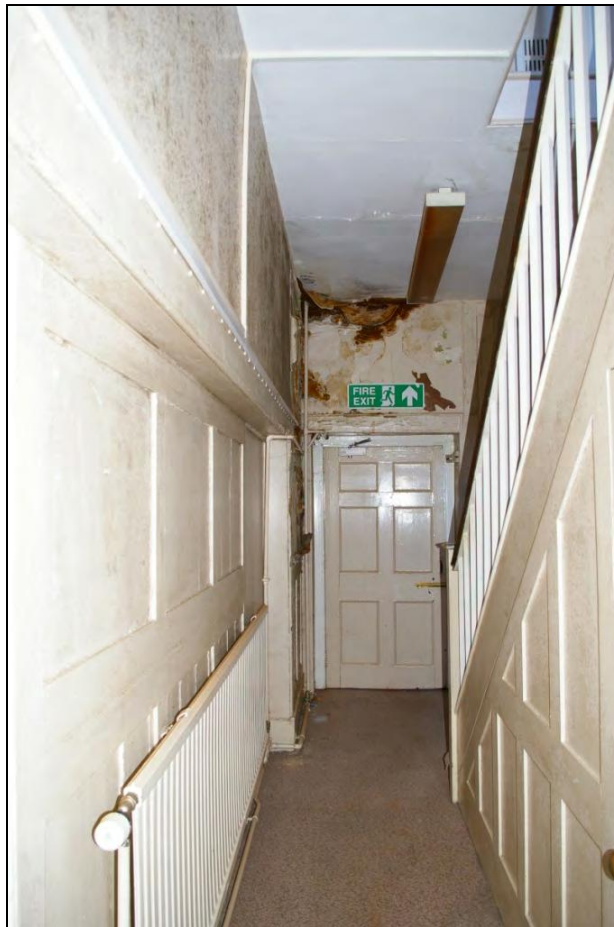
Figure 18: The stair hall in the centre of the West Pavilion, viewed from the west.

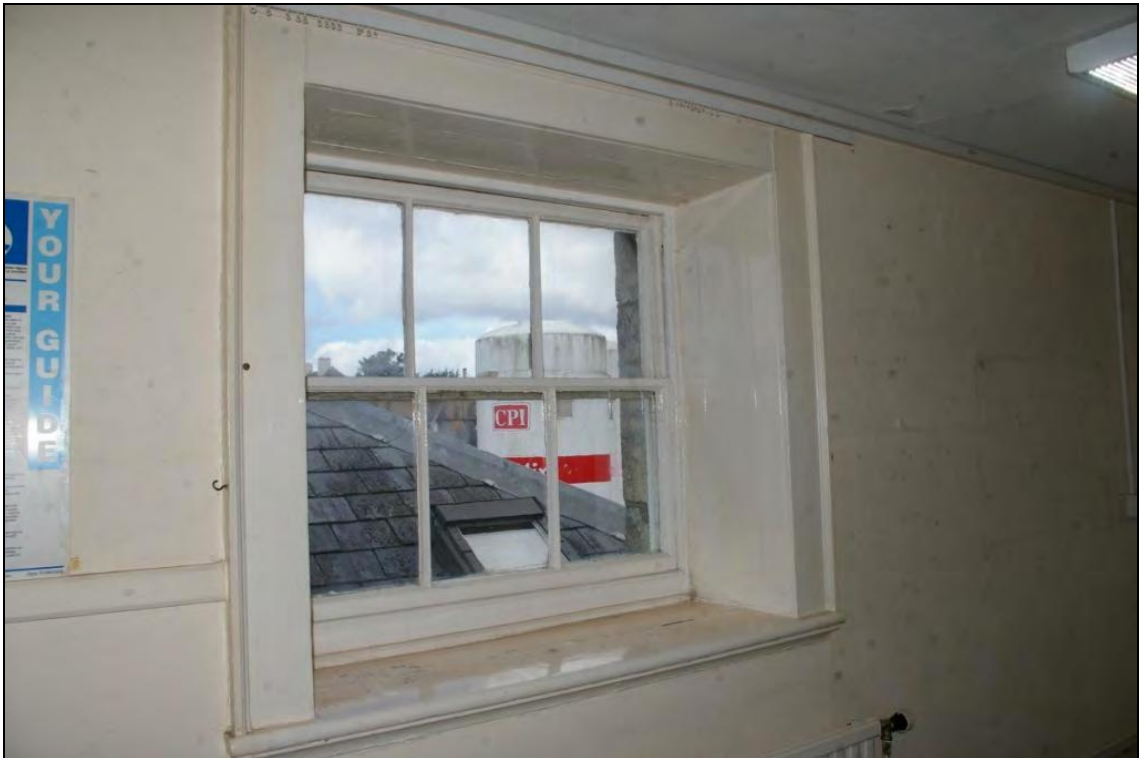
Figure 19: The large hornless sash window in the west wall of the West Pavilion, at first floor height, in a deep moulded architrave with painted shutters to either side, viewed from the south-east.

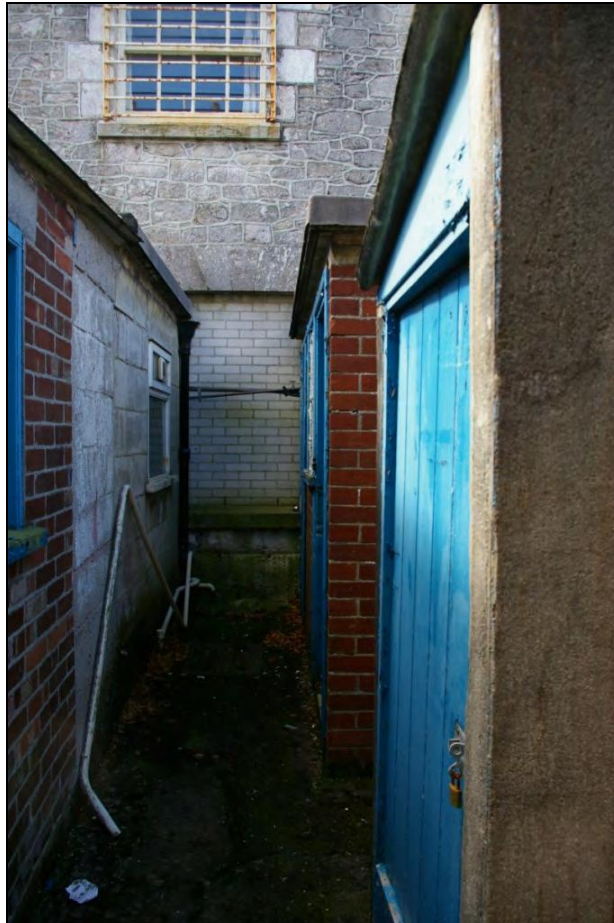
Figure 20: The east elevation of the West Pavilion, showing the blocked window opening overlooking the courtyard, viewed from the east.

This courtyard (Figure 20) is bounded to the north and south by the curtain wall. This north section of the wall has a central doorway with formal ashlar quoin reveals and ashlar segmental lintel, this doorway is integral to the build of the structure and would have provided service access direct to the courtyard; to the west end of the wall is a small forced opening with a timber boarded hatch. The curtain wall has the large stone block plinth to its base, which respects the doorway opening. On the south section of wall there is also one central doorway identical to that on the north section and a small horned sash window which has been forced into the wall to the west end. This courtyard would formerly have been open, providing storage space and work areas and has been filled during the 20th century by modern brick buildings, with a covered walkway from the pavilion to the main house running across the centre from east to west, with storage rooms to north and south as well as toilets and additional service

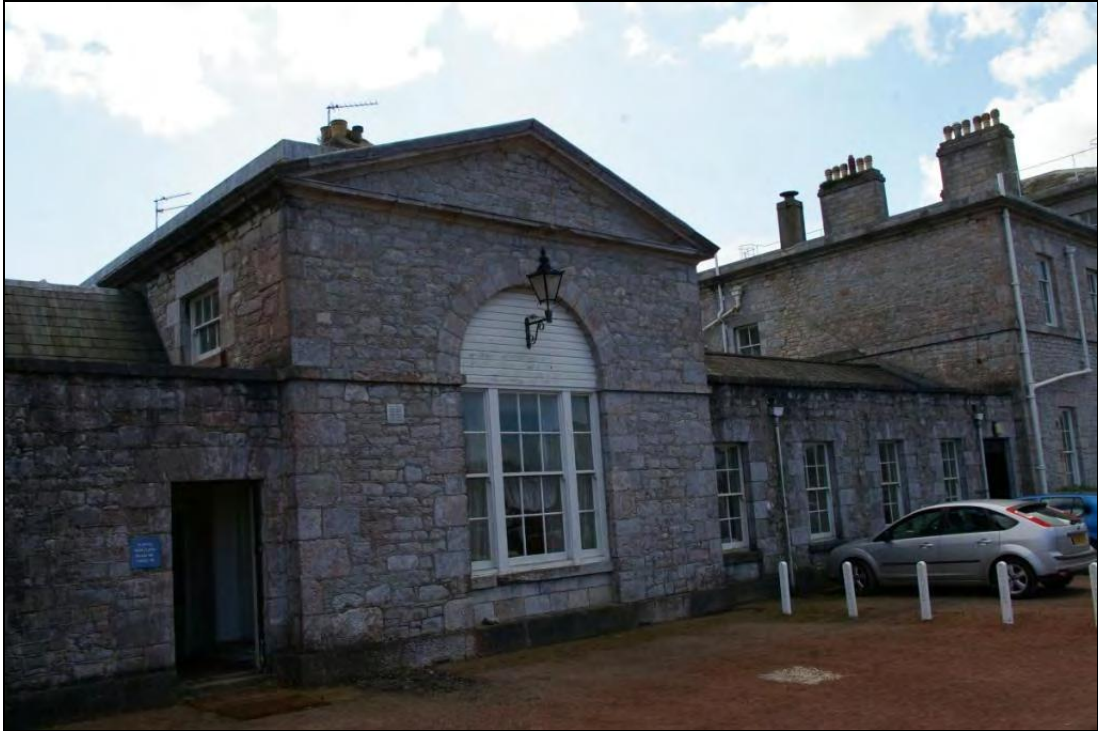
Figure 21: The north elevation of the East Pavilion, viewed from the north-east.

As with the west pavilion and Admiralty House, the east pavilion is built in large dark grey blocky stonework, closely set, in formal courses providing a very plain, classical appearance, with ashlar architectural details. The north and south elevations are as on the West Pavilion, designed to be identical, with a pedimented gable-end to each slate pitched roof. The gable-end pediment has cavetto moulding to the interior with an outer stepped ogee moulding to the upper outer edge; this moulding continues around the building at eaves height as a form of stylised drip course. The pediments are identical to north and south elevation. Both north and south elevations have substantial formal ashlar quoins to east and west corners and a large deep row of rustically faced blocks form a plinth to the base. Both elevations share a large central opening, a window, with arched top, a three light sash, with narrow fixed lights to either side and wide central light, both of which now are now fitted with horned sashes which are replacements. The arched top to the windows, on both north and south elevations are boarded in; this on the East Pavilion is because of the insertion of the first floor. Below the main arched window on the north elevation there appears to be infill of large paler stone blocks (Figure 21).

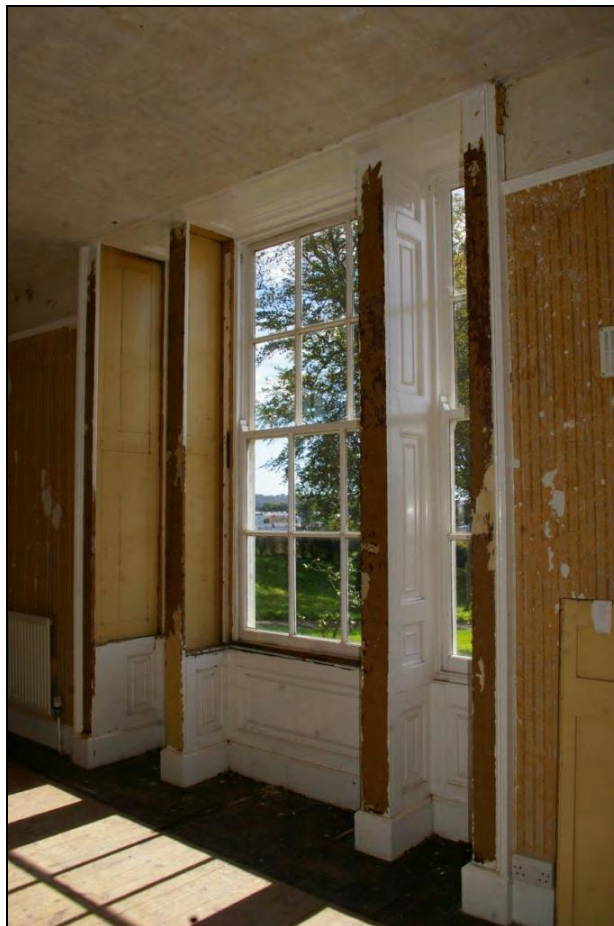
Figure 22: The south wall of the south cottage in the East Pavilion, viewed from the north-west.

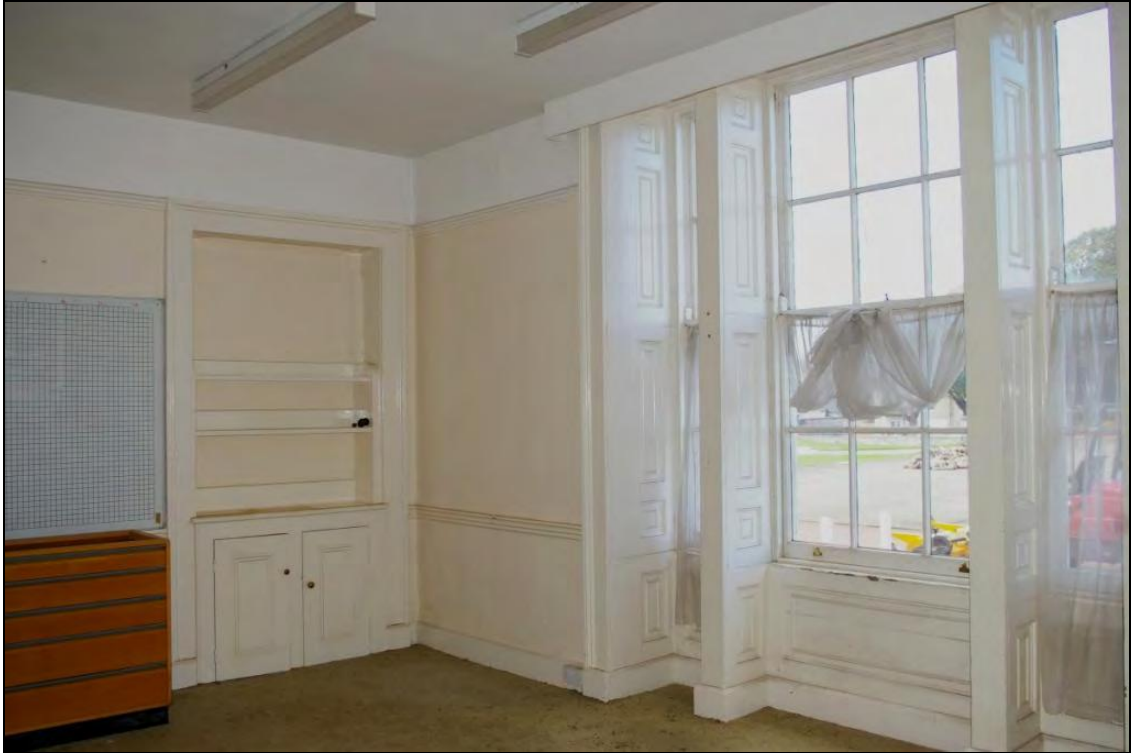
Figure 23: The north and west walls of the north cottage, showing three light central window in the north wall and the possible blocked door or window in the west wall, from the south-east.

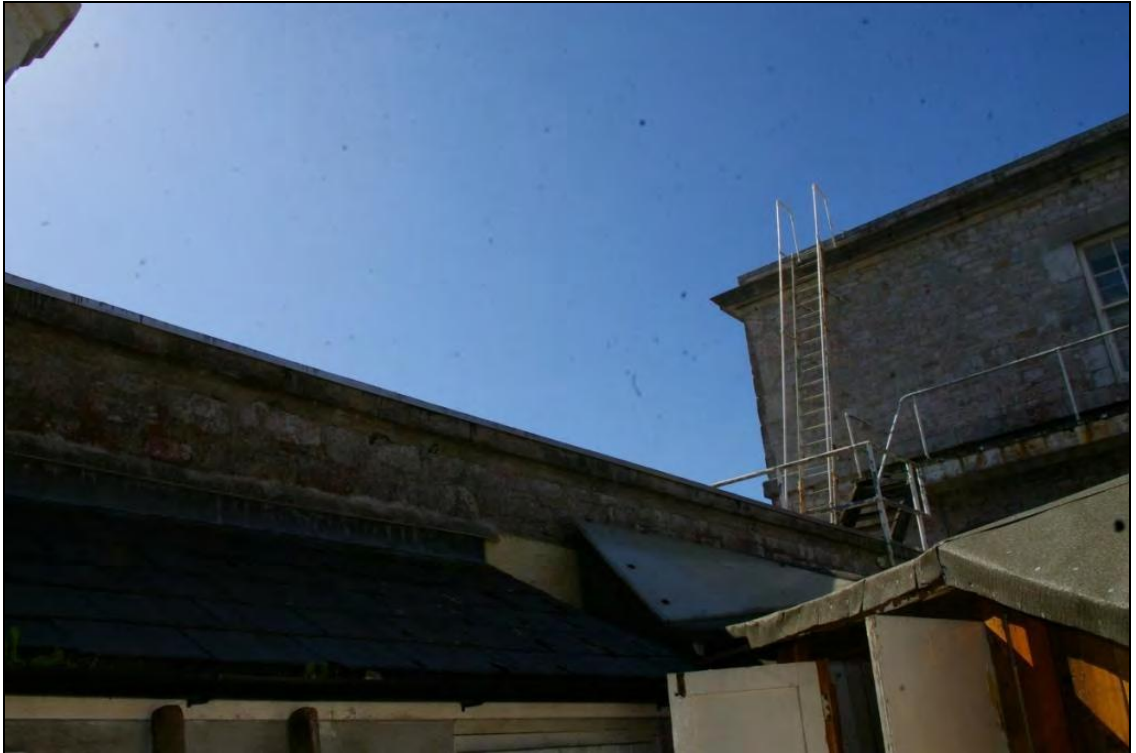
Figure 24: The Courtyard between the East Pavilion and Admiralty House, showing the south curtain wall and the passageway built up against it, viewed from the north-east.

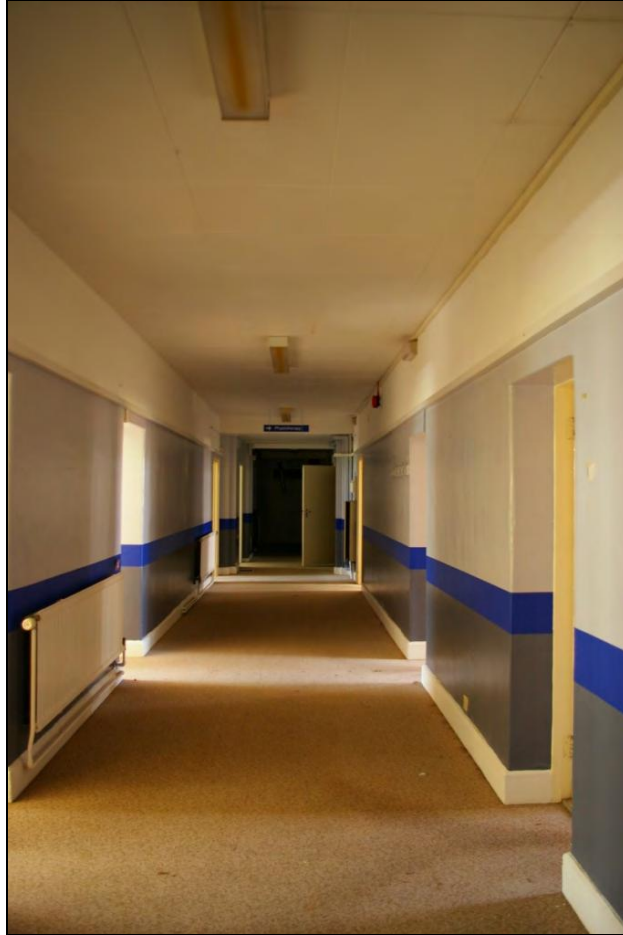
Figure 25: Corridor of the infirmary built to the west of the West Pavilion, viewed from the east.

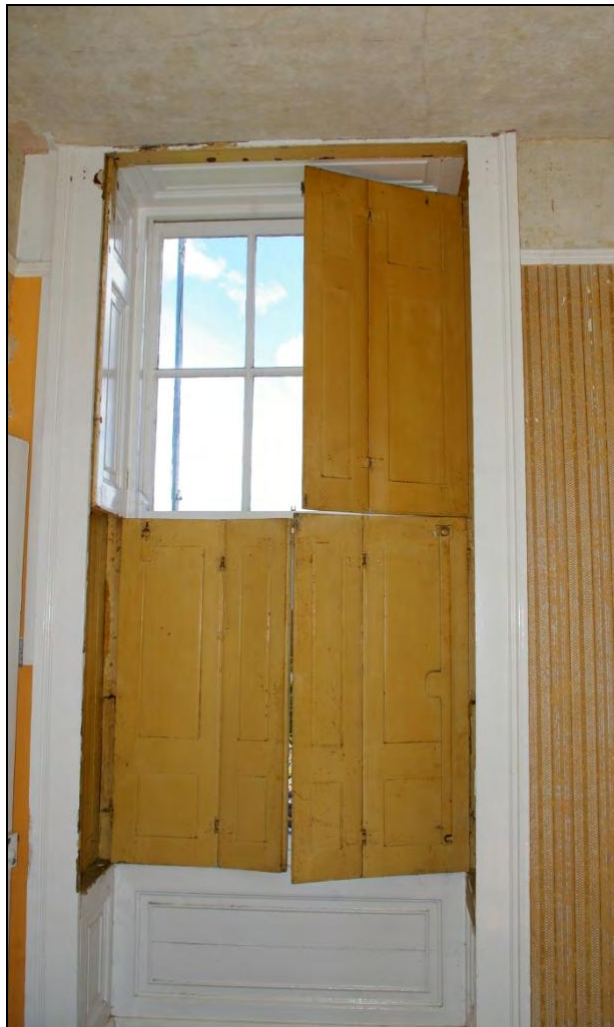
Figure 26: The south window in the east elevation of the East Pavilion, viewed from the west.

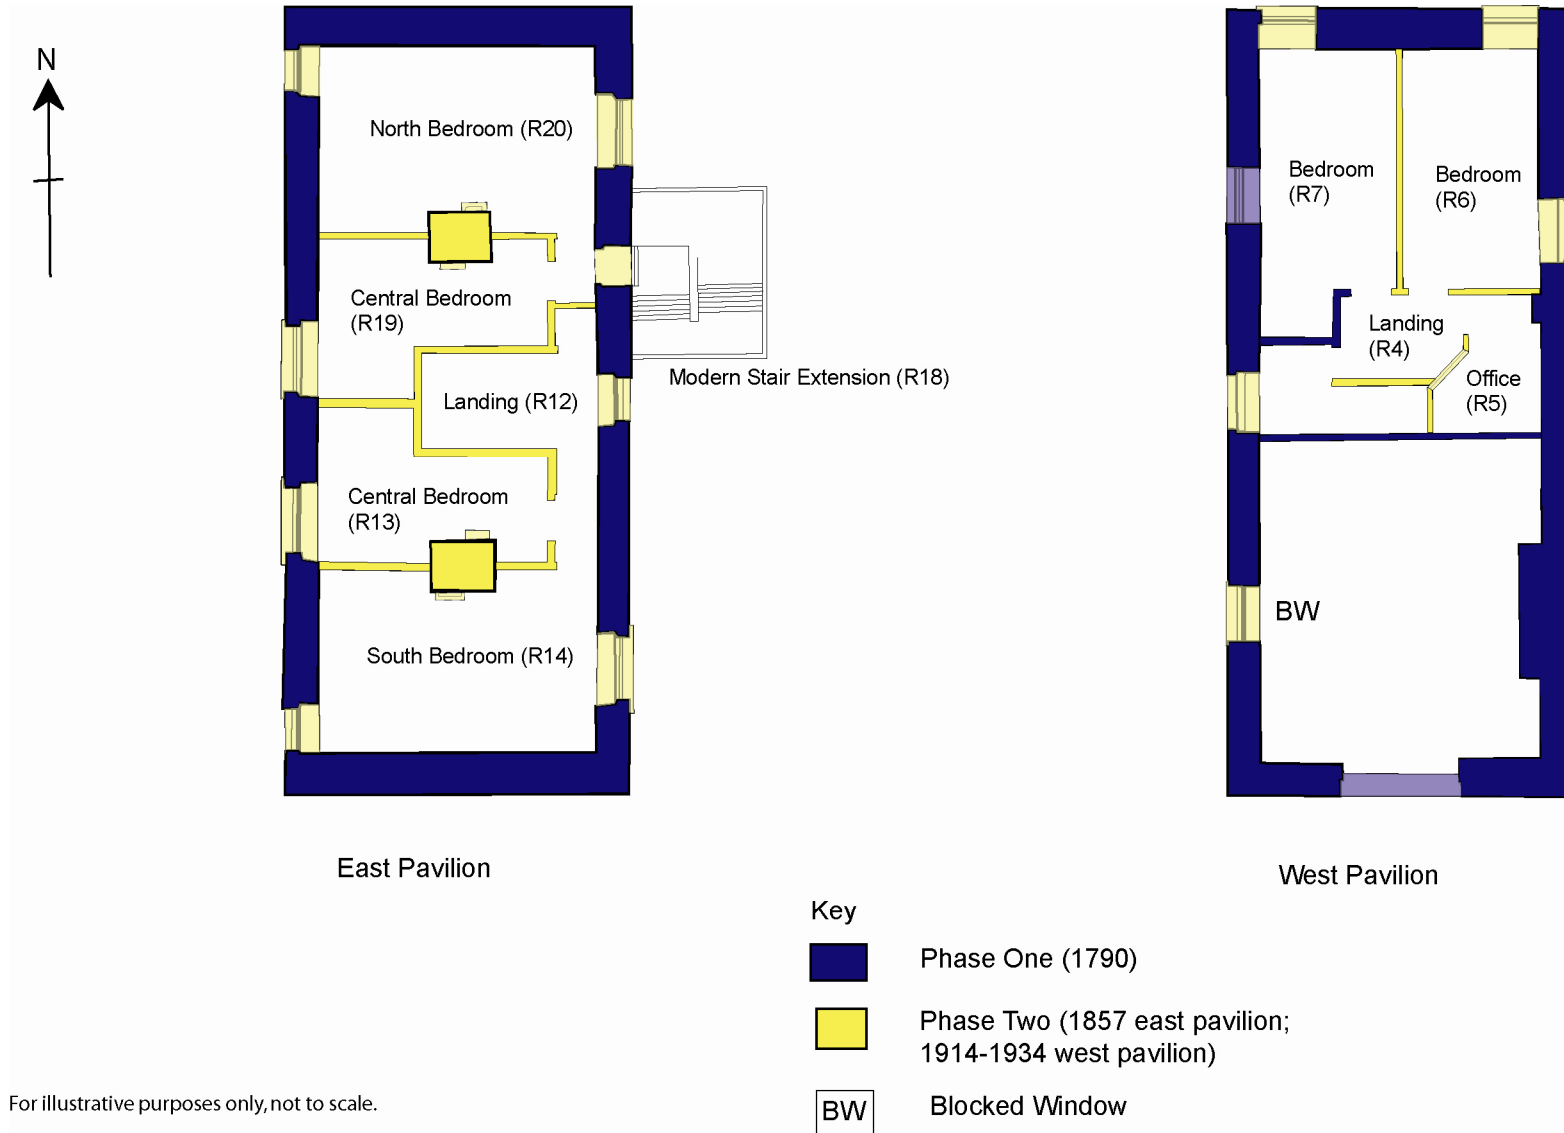
Figure 28: First floor phased plans of the East and West Pavilions (not to scale)

3.4 Phasing and Development of the Buildings (See Figures 27 & 28)
