Devon County Council Historic Environment Record

Civil Parish & District: Clawton, Torridge	National Grid Reference SX34949929	Number:
Subject: The Barn at Old Churchtown, Clawton: Conversion of a barn to form a dwelling, with extension		Photo attached? YES
Planning Application no: 1/0121/2011/FUL	Recipient museum: Museum of Barnstaple & North Devon	
OASIS ID: southwes1-104650	Museum Accession no: NDMS2011.29	
Contractor's reference number/code: COC11	Dates fieldwork undertaken: 11 th and 19 th October 2011

Description of works

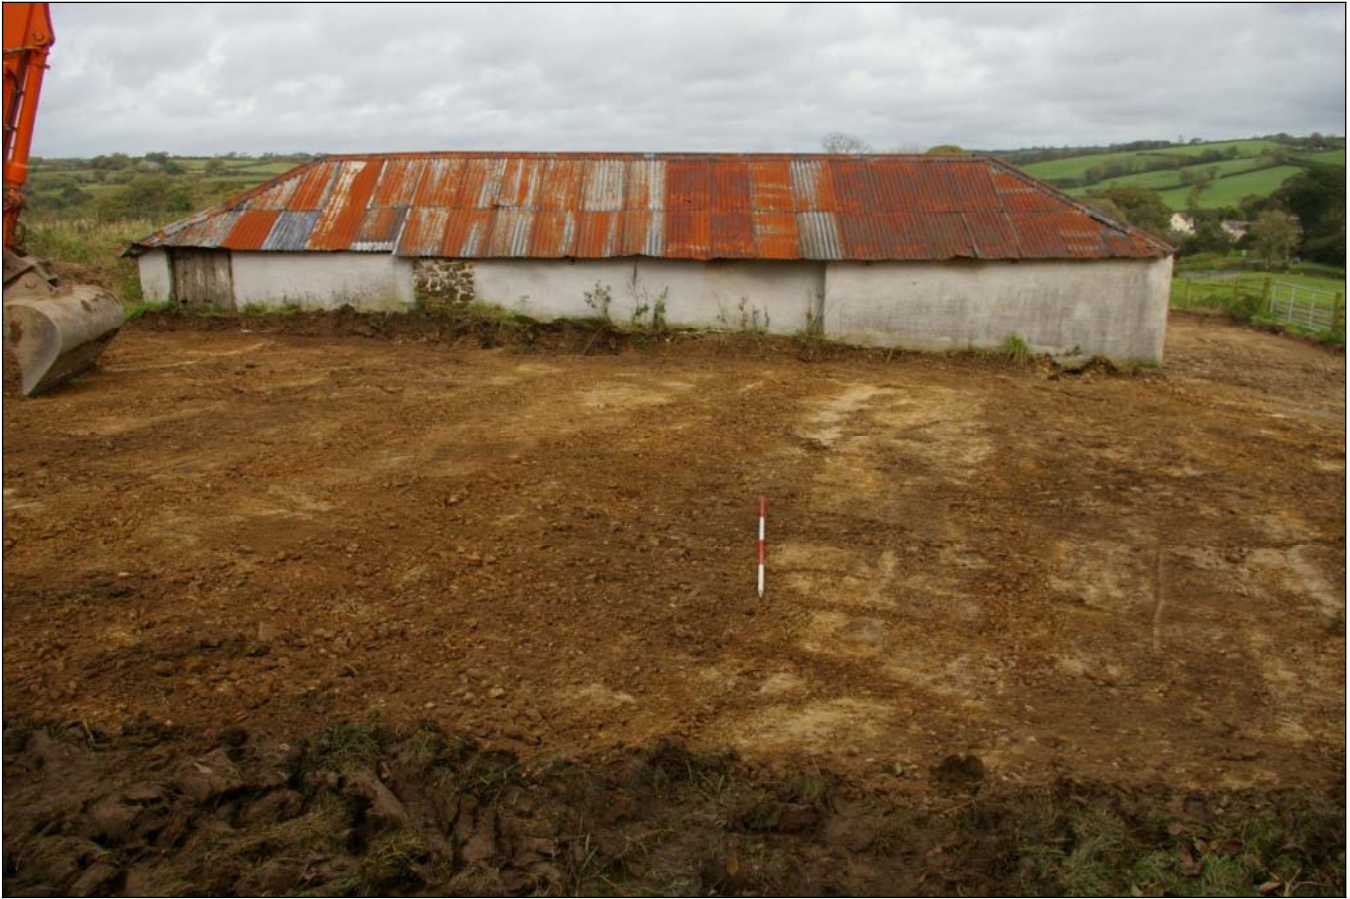
Figure 2: Area of excavation with the barns in the background, viewed from the west (scale 2m).

The area to the west of the barn had a greater number of archaeological features, although most of these were again of a relatively recent date and related to the use of the barn (see Figure 2). The most southerly feature was a linear spread of gritty greyish-brown silt-clay (105) containing common sub-angular stones (up to 120mm) and roots. This material (105) survived to a depth of 0.03m and related to the remnant hedgebank (constructed between 1844 and 1889) which had formerly abutted the south-west corner of the barn. The fact that there was no evidence of any flanking ditches suggests that the material used in the construction of the hedgebank was probably derived from the demolition of several other boundaries (and buildings) at this time (see SWARCH 2008). This is perhaps supported by the single find recovered from deposit (105), a small (3g) residual sherd of badly abraded 12-13th century North Devon gravel-tempered pottery. Otherwise, the bank material may have come from a possible quarry pit lying between the church and the development area.
