LAND TO THE REAR OF 28 BRIDGELAND STREET & 5 QUEEN STREET BIDEFORD

Results of a Desk-Based Study
&
Historic Building Recording

Report No.: 120211
Date: 11.02.2012
Authors: T. Green
S. Walls
E. Wapshott

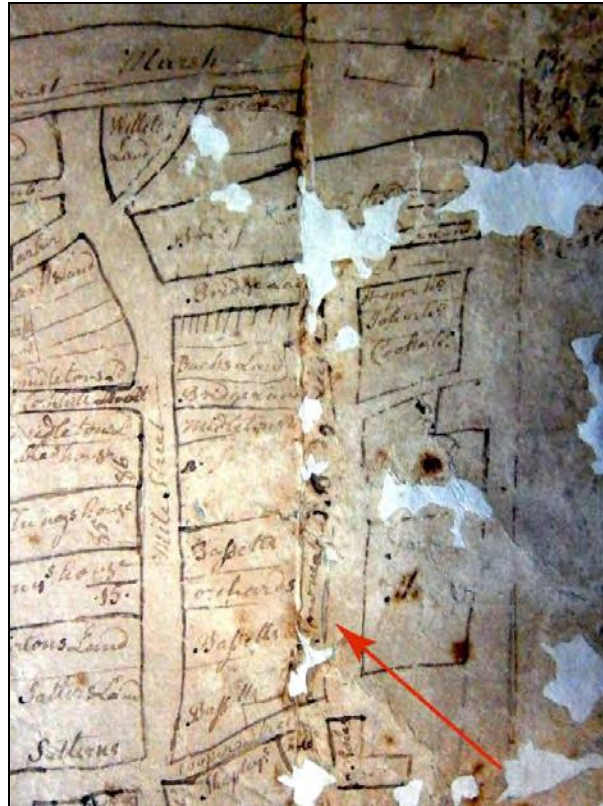
Figure 6: Extract from a plan of 1720 showing properties between Bridgeland Street, Mill Street and *Little Lane*. The approximate location of Number 5 Queen Street is arrowed (NDRO B69 add4/1).

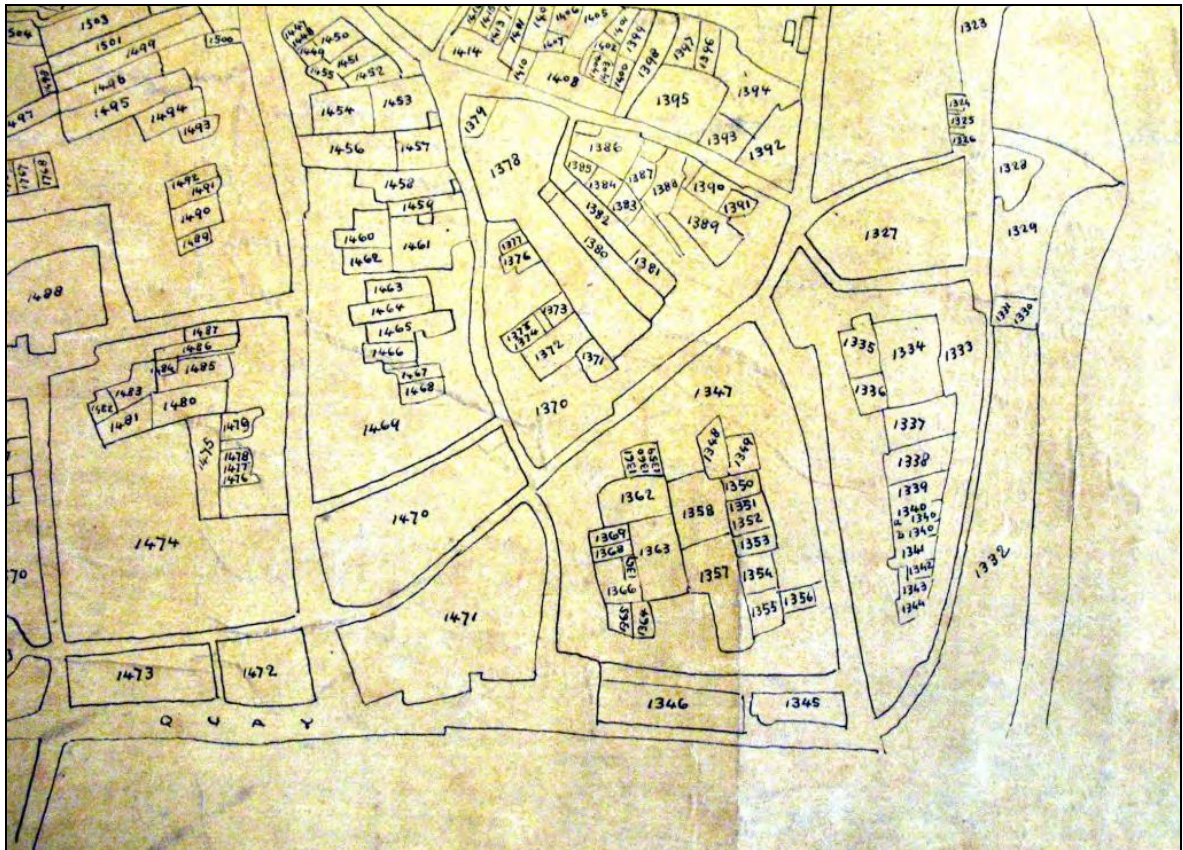
Figure 9: A wider view of the inset map attached to the Bideford tithe map of 1839 showing other 'exempt' gardens in this part of Bideford (DRO).

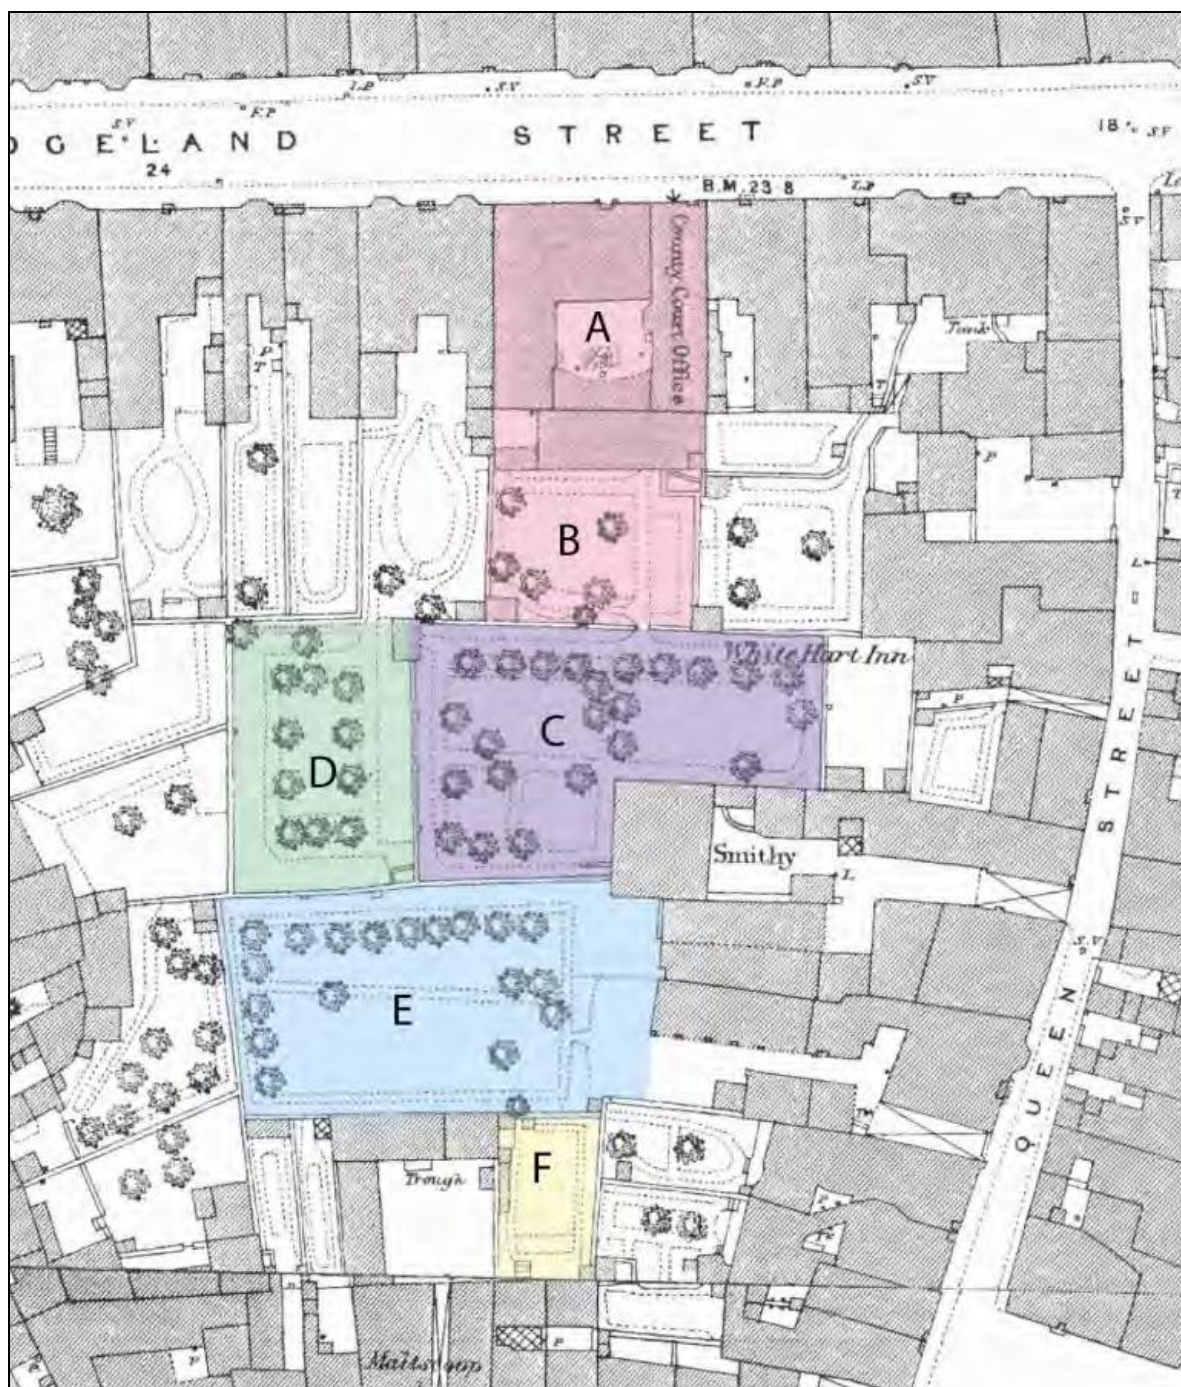
Figure 12: As Figure 11 with garden areas for individual attention lettered A-F (See text).

Features of the internal courtyard (Area A in Figure 12) include a 19th century pump which stands over an original well, pebble cobbling with the date 1693 set in and a milestone apparently carried

In the late 19th century the property was internally divided. The east part, which was already in use as the County Court Office in the 1880's (see Figure 11), became number 28A when the post-office re-numbered the street. The gardens of areas A, B and C (see Figure 12) were all associated with number 28 in 1886.

The map of 1886 shows outbuildings to the rear of the Number 5 Queen Street on either side of a long yard, the larger one to the north appears to be open-sided at this time (Figure 11). Garden area E (Figure 12) appears to be part of this property by this date.

The town plan of 1842, while useful in that it shows the footprints of buildings and the names of the occupants, seems not to represent accurately the lay-out of the gardens (Figure 10). Corresponding more closely to the tithe map and to the limited but precise detail provided by the 1745 plan, the Ordnance Survey First Edition map at a scale of 1:500 (Figure 11), surveyed in 1886, makes the most useful contribution to the understanding of this area. The OS map shows, within the area of present interest, five gardens. In Figure 12 these gardens are marked B-F, each of which are discussed below (see also Appendix 8).

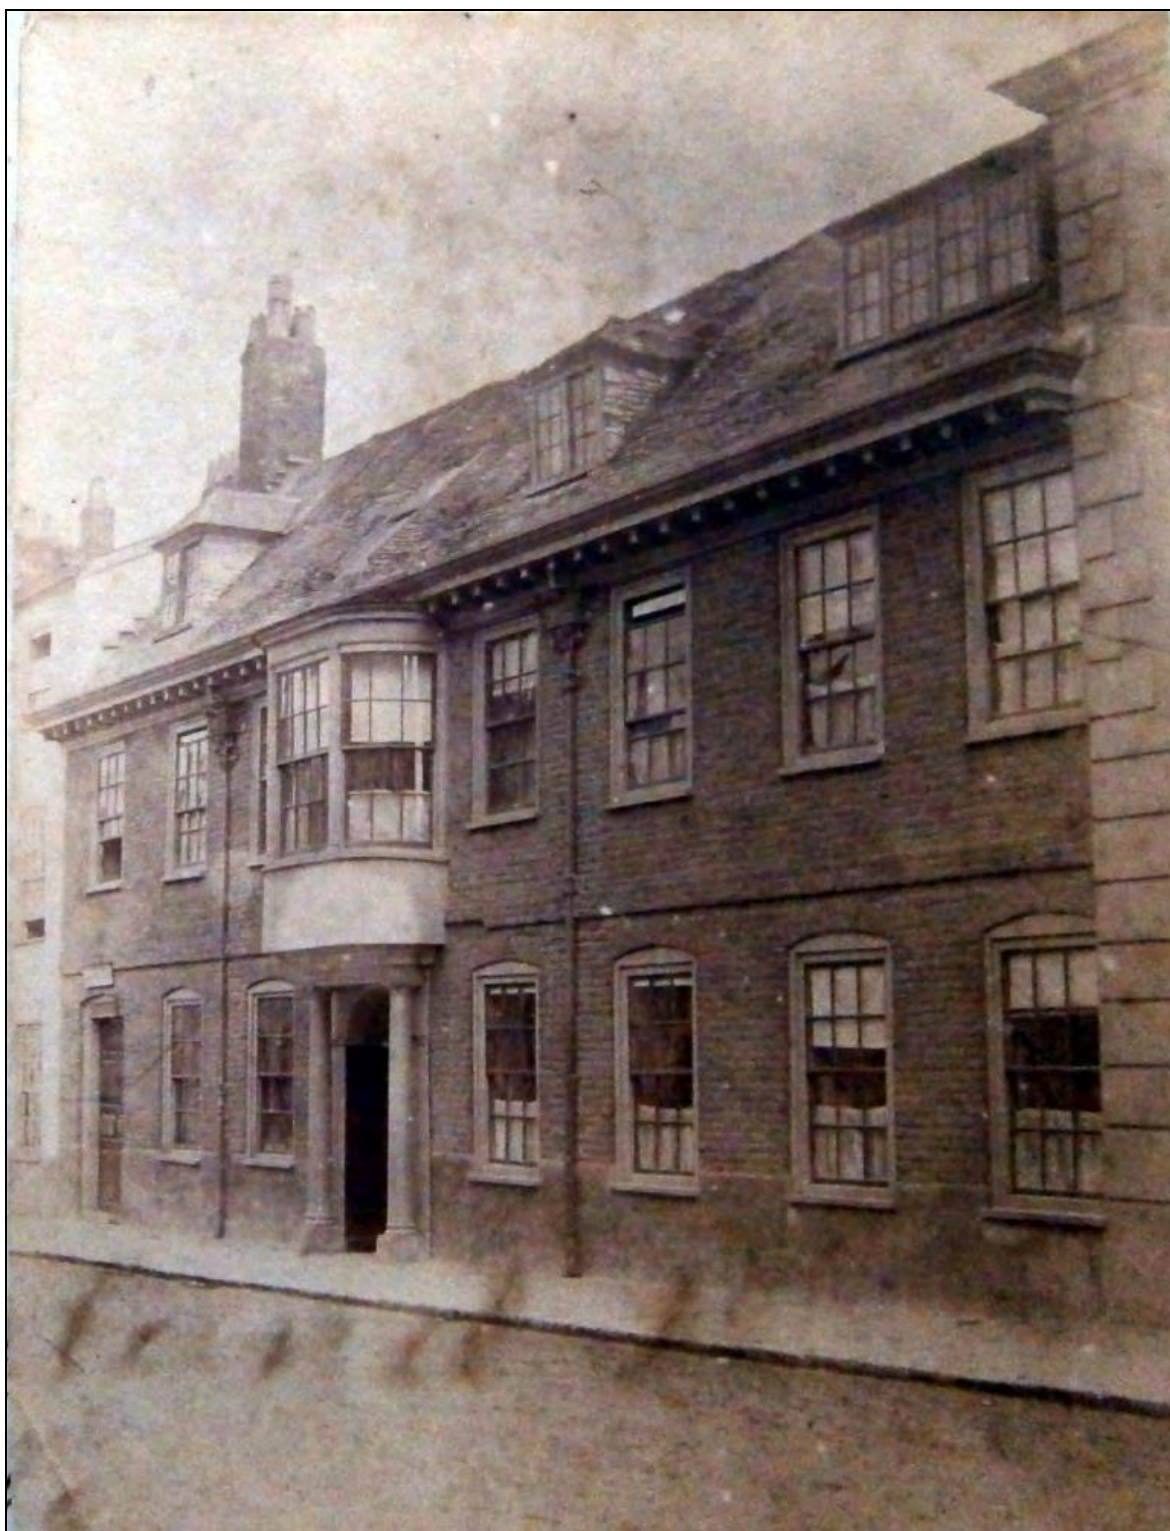
Figure 13: Photograph of Number 28 Bridgeland Street in 1890 from a photographic survey undertaken for the Bridge Trust (NDRO).

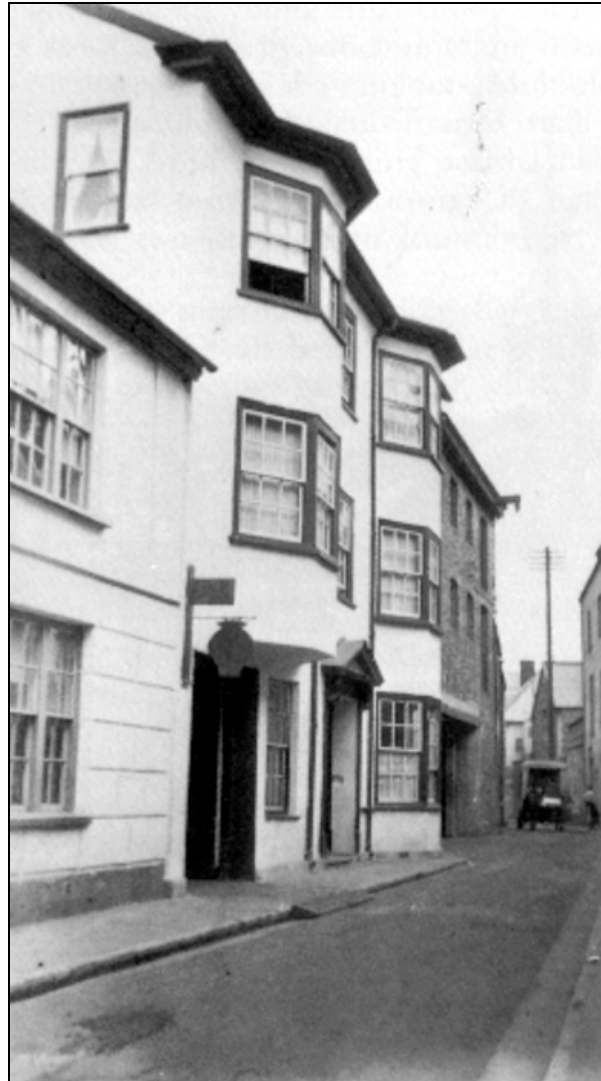
Figure 16: Early 20th century photograph of Number 5 Queen Street with Number 6 (now Heard's) beyond (Courtesy William Isaac).

The accuracy of the 1842 town map (Figure 10) is questionable in respect of the gardens, but is probably relatively reliable when it comes to the relationship of properties along Queen Street. It is almost certainly guaranteed however, that the First Edition OS map of 1886 is accurate (Figure 11). From the 1886 1st Edition it appears that the house at the western end of plot 38 in 1745 (see Figure 5) had become or had been replaced by a smithy and that the north side of the garden of this plot had been filled in with outbuildings. At least the north side of the eastern house remained, but to the south of the through passage was now a quite large square building with outbuildings joined to the rear (west). The footprint of this building appears to correspond to a building visible on the aerial photograph of the 1920s (Figure 17) and included in a photograph of this part of Queen Street dating from the early 20th century (Figure 16).

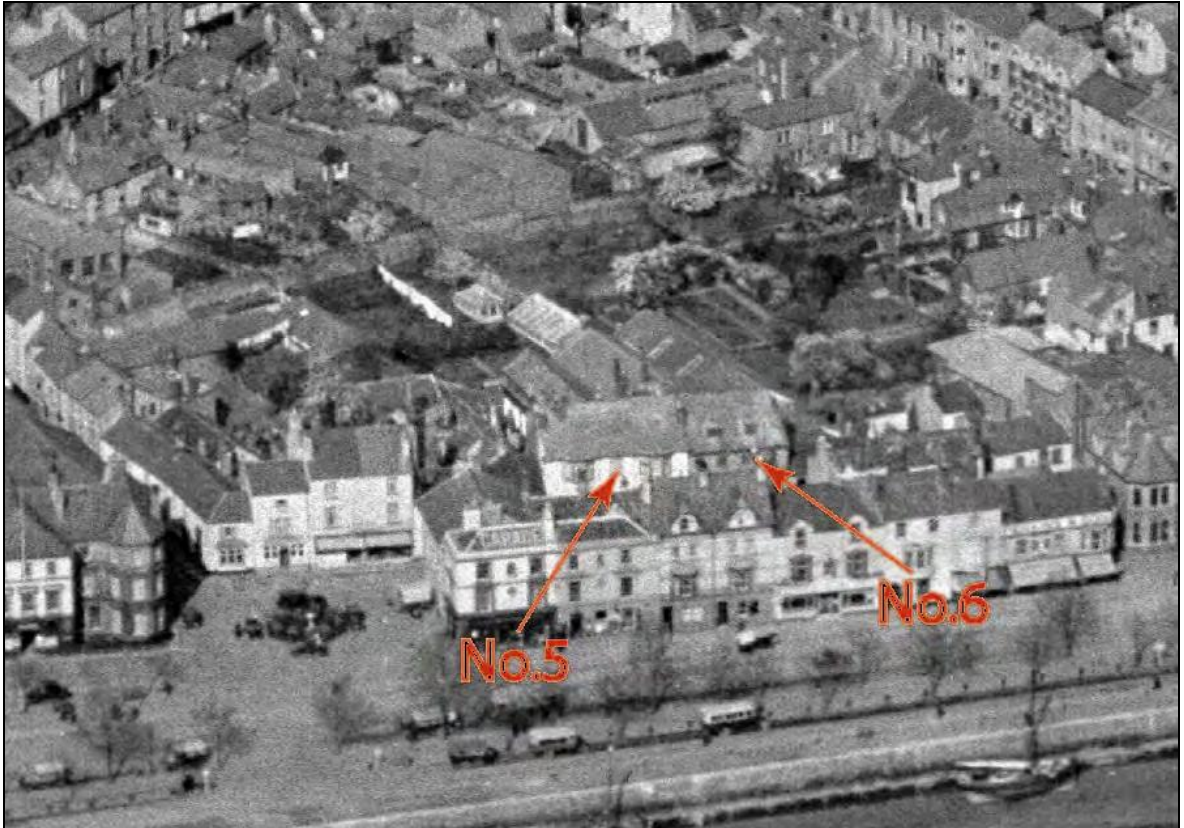
Figure 17: Aerial photograph apparently from the 1920s showing Numbers 5 and 6 Queen Street and the backland behind (Courtesy William Isaac).

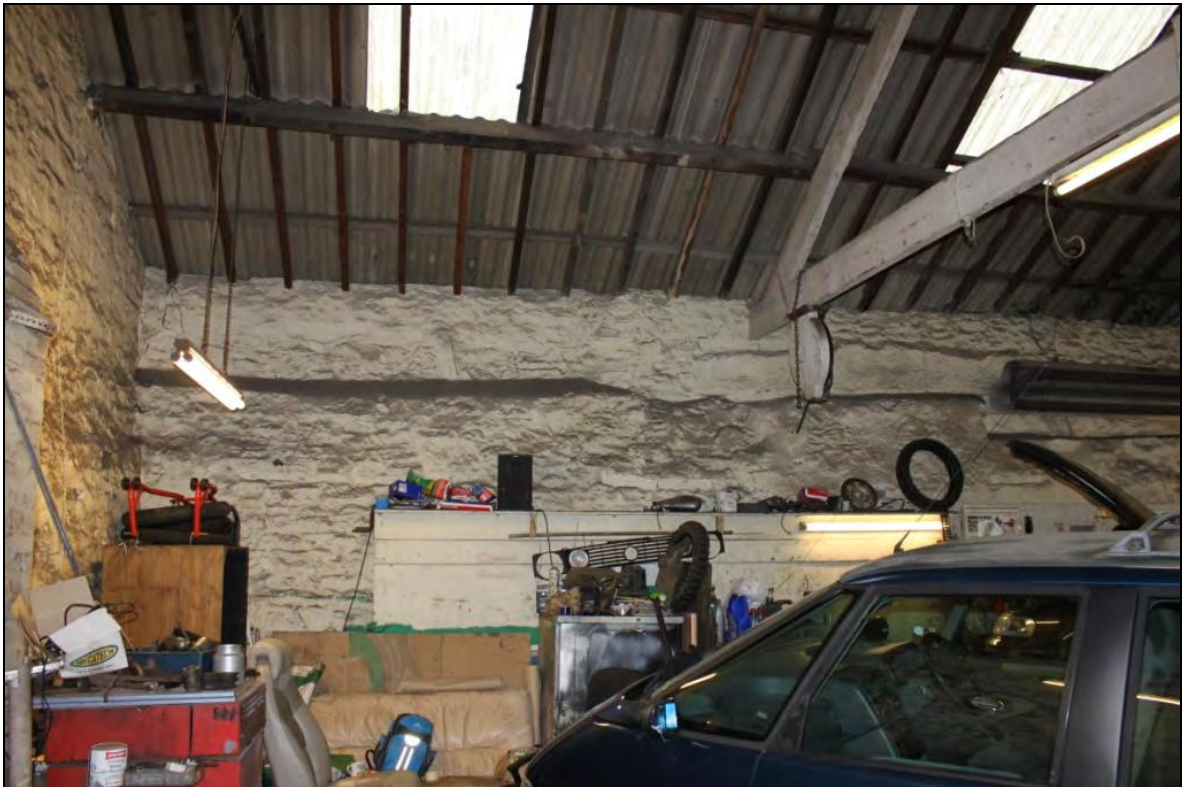
Figure 19: Scar of building visible on the north elevation of Heards Garage probably relating to the House shown on plot 38 of 1745 (Figure 5), viewed from the south.

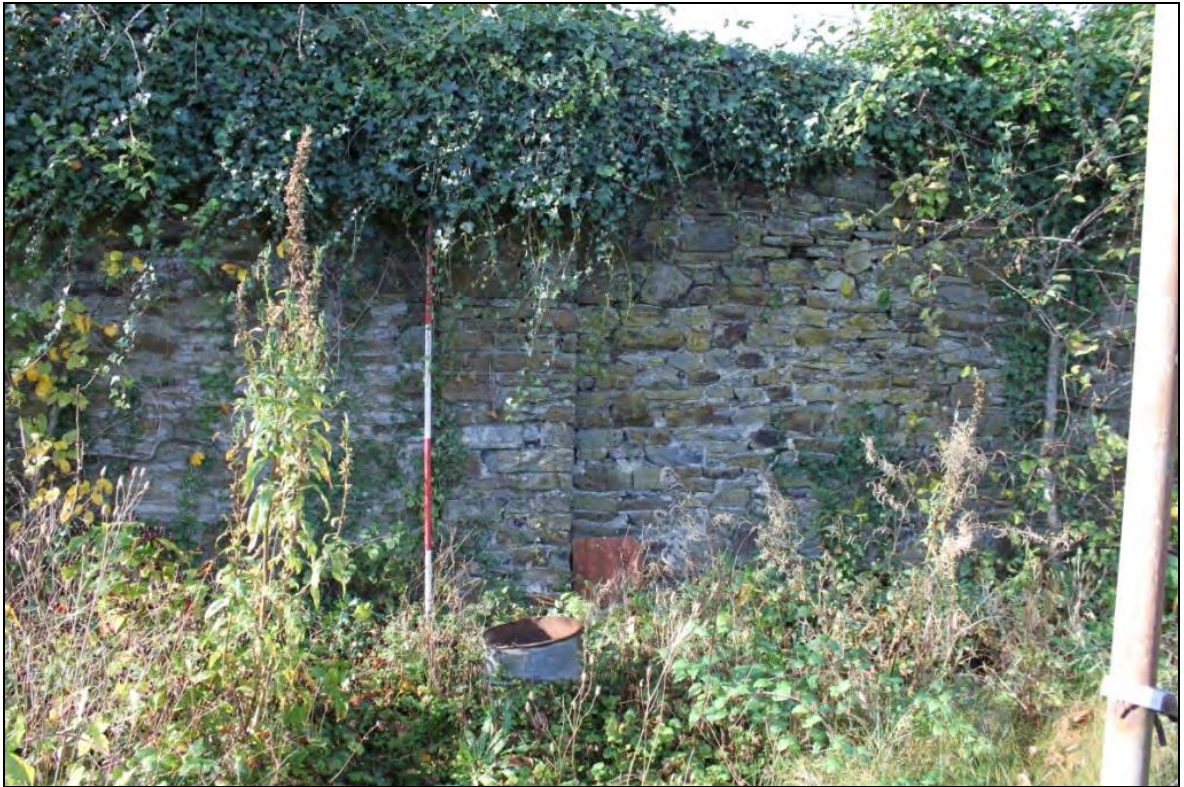
In the 1880s all the five main garden areas appear to have been separated from each other by walls, many of which survive today, although a number of wide openings have been forced since 1973. The walls are mostly of similar construction, with slight variations in height and build techniques. They are typically of approximately 1.5-2m height, 0.3-0.6m width and constructed of blocky sub-angular stone with a hard lime mortar bonding (Figure 20).

Figure 20: Western elevation of the buttressed boundary wall of Garden C, viewed from the east (2m scale).

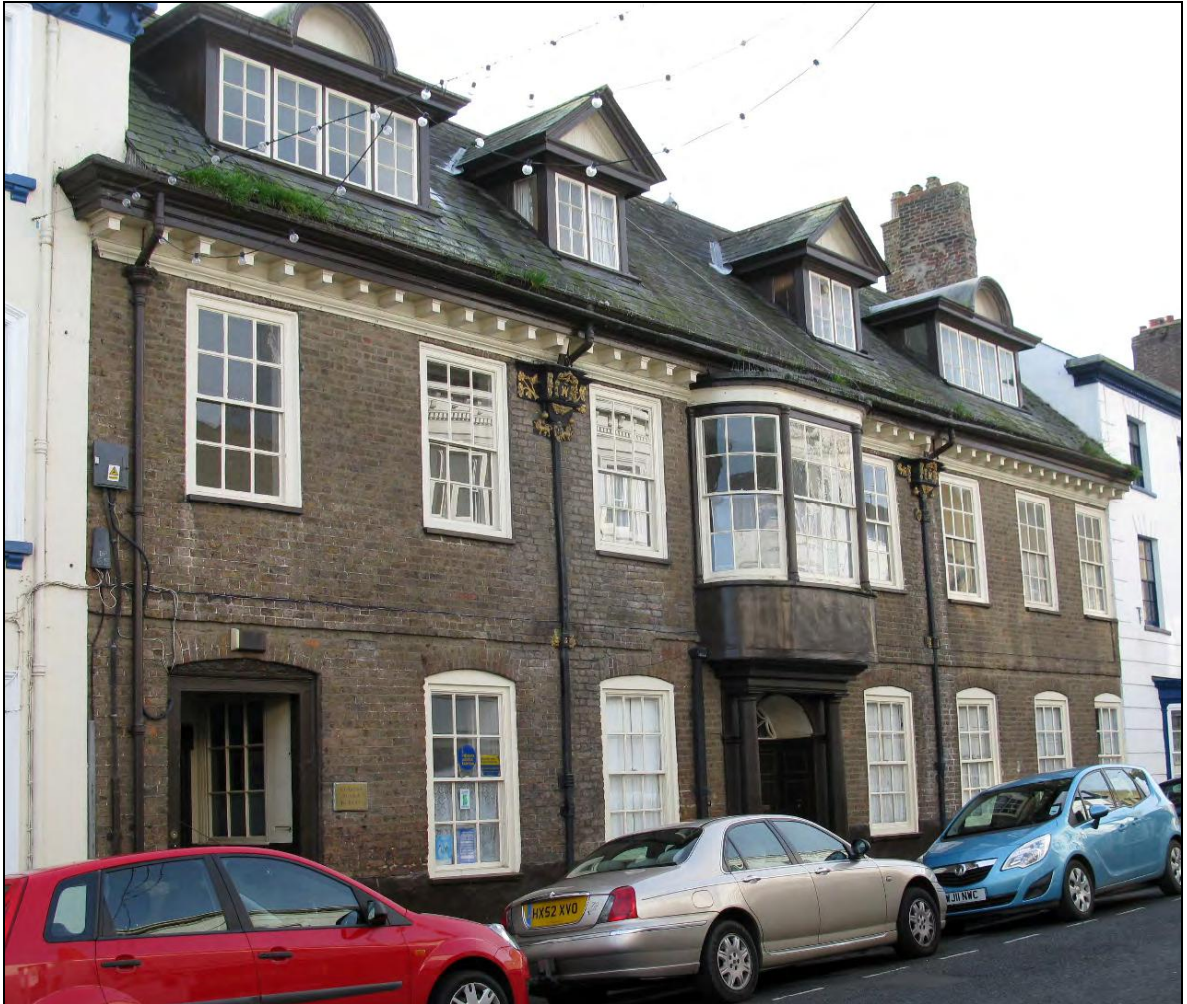
No.28 Bridgeland Street is a large, grand brick built late 17th century merchant's house (Figure 21) built around a square courtyard, with a through passage, to left (west) of centre, and a further entrance giving access to the eastern end of the building and the rear east wing. Later additions to the building include a late 18th century extension to the rear (south) of the main front range, with a more formal rear hallway and linking to a secondary stair to the east and original late 17th century stair to the west. The eastern (former stable/store) wing of the property which was originally a single storey structure was raised during the later 19th century and a first floor added and the wing converted to offices. The 18th century rear extension to the main domestic range was also raised and the first and second floors of the late 17th century front range and east wing were altered. This later work was completed in newer red brick with the roofs raised and remodelled and dormer windows added.

Figure 21: The north front elevation of 28 Bridgeland Street, viewed from the north-east.

The north front elevation is of late 17th century brick, Flemish bond, with a projecting string course of three courses of bricks between the ground and first floor and flanking the windows above. To either side of the main entrance is a pair of original ornate lead downpipes dated 1692 and 1693 (Figures 21-22). With a deep moulded boxed-eaves cornice with block modillions and bands of ogee and cavetto moulding below a steeply pitched slate roof with four 19th century dormer windows, two light to the centre, with four light to east and west. There are two rows of sash windows in the north elevation, these appear correct (see interior description and Appendix 6) although further research may enable more precise dating. To the ground floor there are four windows to the west and two to the east of the main entrance, with the easternmost opening containing a second door opening, all openings have segmental brick arches. To the first floor are square headed sash boxes that sit flush to the wall and a late 18th century oriel window above the pillared architrave surround to the main entrance. The main doorway, to east of centre, is arched with the door set back from the street and opening onto the main through passage. A second door at the east end of the building opens into an eastern access passage which runs to the full depth of the building into the rear eastern wing, this is possibly also original and giving access to possible stores or stables to the rear. The four dormer windows have deep pediments to their apex, with triangular pediments to the centre and half circular pediments to east and west. There are 19th century axial chimney stacks to east and west.

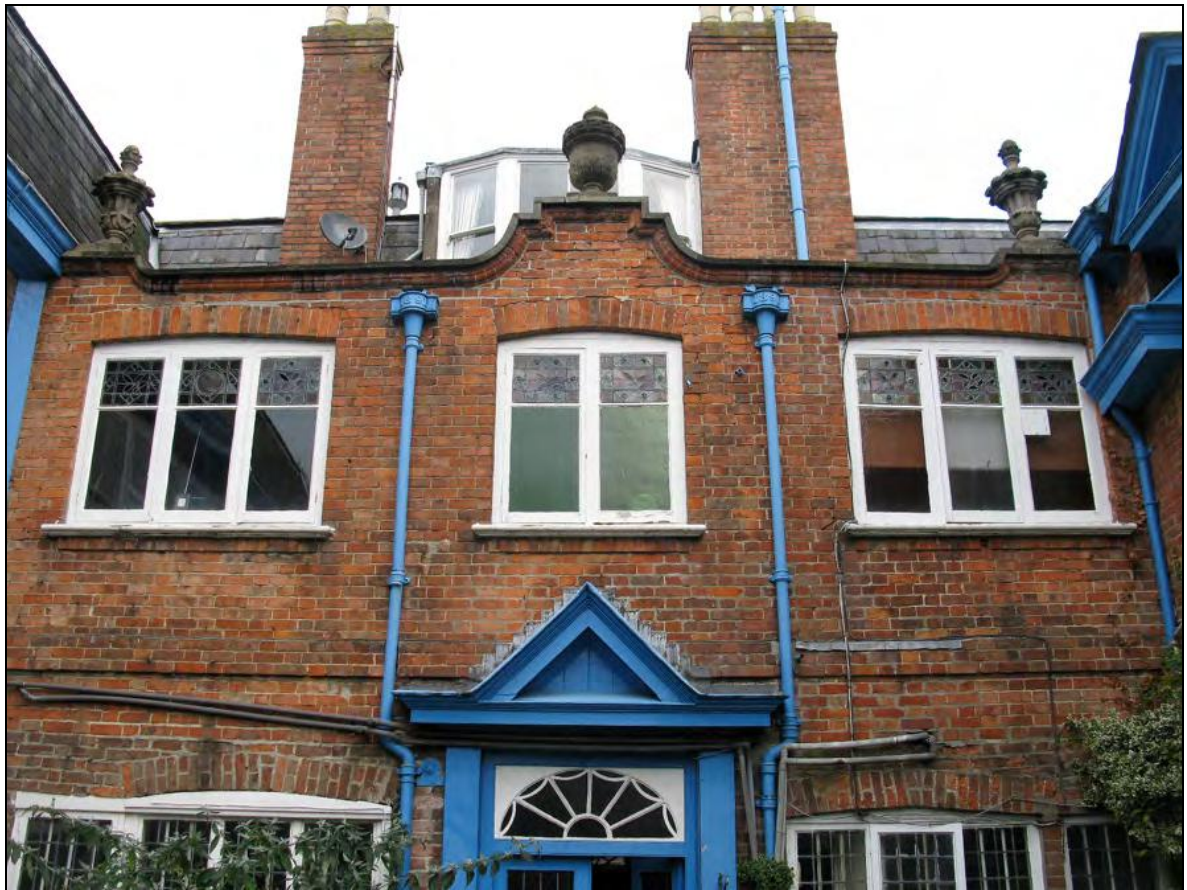
The rear elevations of the building are also of brick of various phases and grouped around a cobbled courtyard. The rear (south) wall of the main range has had a later 18th century single storey brick extension added to enlarge the formal entrance hall, infilling between the original east and west ranges and possibly giving access to the original stair to the west and a new additional stair to the east, probably also added at this time. As noted above (see 2.3) the Sun Insurance plaque fixed to

the exterior wall just to the left (west) of the door into the courtyard is suggestive of a date for this work (see Figure 23). This extension was further altered, the windows changed and the elevation raised in the 19th century with the addition of a red brick first floor topped by a decorative ovolo moulded parapet with three cement urns. This is mirrored to the south where the single storey late 17th century rear south range (possibly originally a dairy) has been aggrandised by the addition of a similar parapet to its north wall facing onto the courtyard. This work can also possibly be dated to 1891 as marked on the downpipes flanking the central door to the rear extension to the main front range (Figure 23). The east wing was also raised and converted at this stage with the early brick on a stone plinth wall topped by red brick and the addition of three large six light first floor windows with deep triangular pediments. The original two storey west wing is constructed of the same brick on a stone plinth as the front (north) elevation and the ground floor south and west elevations and is of 17th century date, built as the kitchen with possible pantry behind to the south. It is topped by a mansard roof, probably raised in the 19th century when this wing of the building also underwent further alteration. All elevations overlooking the courtyard have had the original door and/or window openings altered from the original arrangement, with those added to the rear of the main (north) range in the late 19th century including decorative coloured glass.

Figure 23: The rear south elevation of the main range, viewed from the south. Note the dated downpipes and the firesign just to the top left of the fanlight.

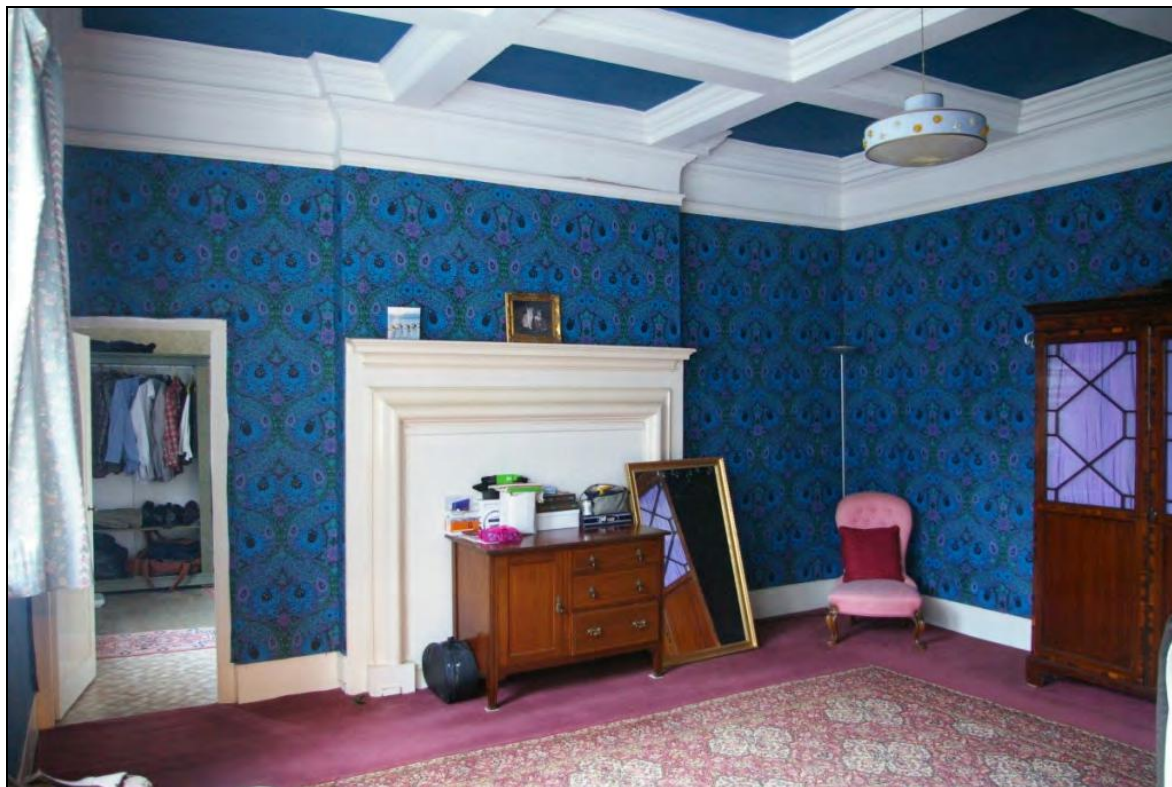
Figure 24: The south-west corner of R28 showing the moulded box frame ceiling and late 17th century fireplace, viewed from the north-east.

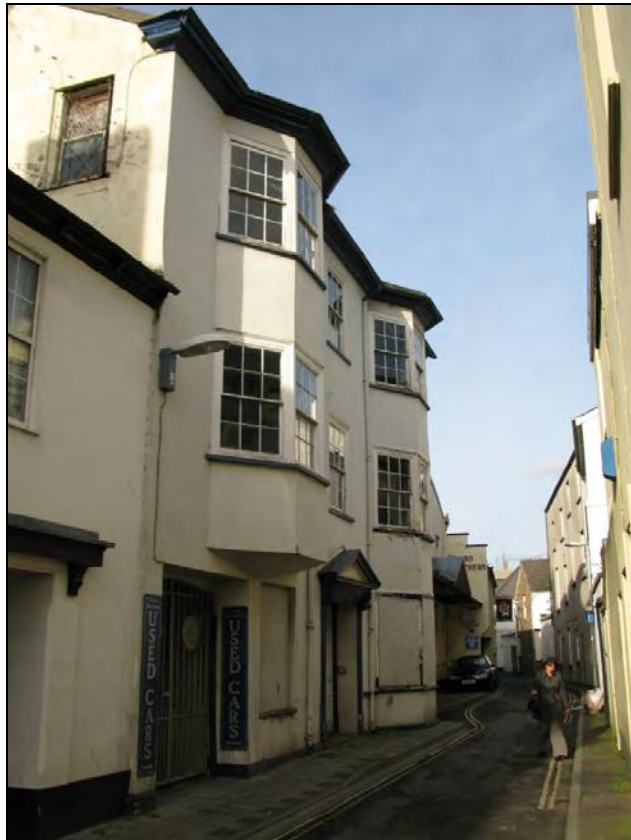
The bays have a set of sash windows to each floor, apart from the south ground floor which is replaced with a later 8x8 pane horned sash. The sash windows are in sets of three lights, in moulded frames with a stepped ogee outer band and a stepped plane and bead to each opening. The sashes are double hung and sit flush with the exterior, with simple metal catches and are hornless, with moulded glazing bars, which although not thick are quite deep and do project quite far from the glass. The ground floor northern sash windows are boarded up and the first floor southern set were replaced after a lorry hit the building; the owners installed exact copies. The northern bay window on the ground floor has a stepped ovolo moulded sill which runs under the windows and continues towards the centre of the elevation almost to the panelled pediment central door. The bays are rendered as the main building however where this has come away the small reddish-orange brick construction is visible, in contrast to the main structure which is rubble stone in a clay and lime bonding. Between the bay windows are two sash windows to the first and second floors; the second floor window is a hornless sash in a beaded stepped frame, similar but narrower than those to the sashes of the bay windows. The window is also of 6x6 panes, with moulded glazing bars. The

window below is also set in a moulded frame with ogee band and stepped plane with bead to opening but the frame is much thicker than that to the window above and the render around the window appears disturbed.

Figure 25: The east (street) elevation of 5 Queen Street, viewed from the south-east.

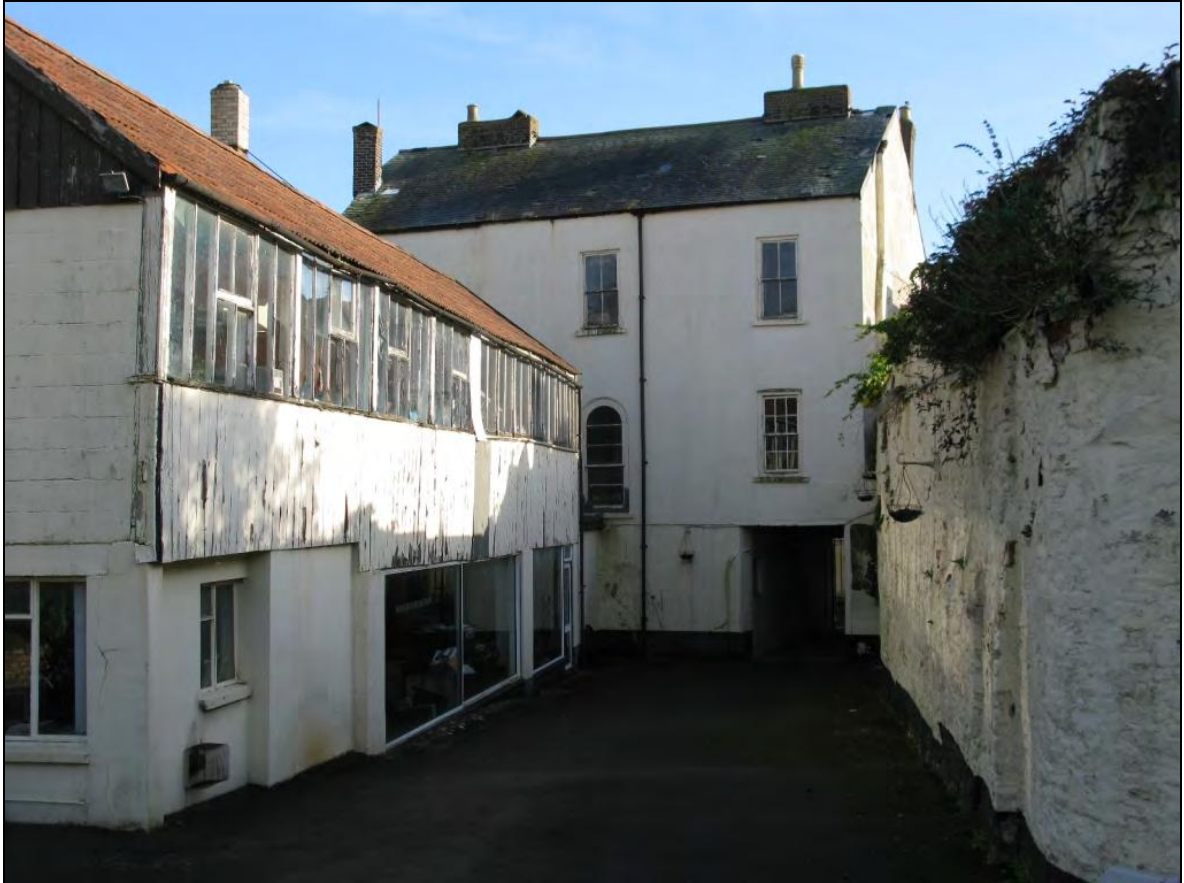
more recent adjoining warehouse to the west. To the south side an alleyway has been forced through the building creating access to the back-plots, from the street; a blocked doorway filled by a small single pane window and a further doorway to the east enter this alleyway from the building. The first floor has three sash windows of varying dates, one to the south and two positioned close together to the north side; to the north a horned modern sash and a hornless sash, with 6x6 panes and another hornless sash with 6x6 panes to the south side. The first floor also has a large central arched double-height opening, which lights the main stair. This appears to be a single hung sash with a fixed upper section of two rectangular long horizontal panes and curved upper pane and a sash to the lower section of two horizontal panes. This window sits in a moulded stepped window frame. The second floor has three sash windows all horned sashes of 2x2 panes.

Figure 26: The west elevation of 5 Queen Street and the rear warehouses, viewed from the west.

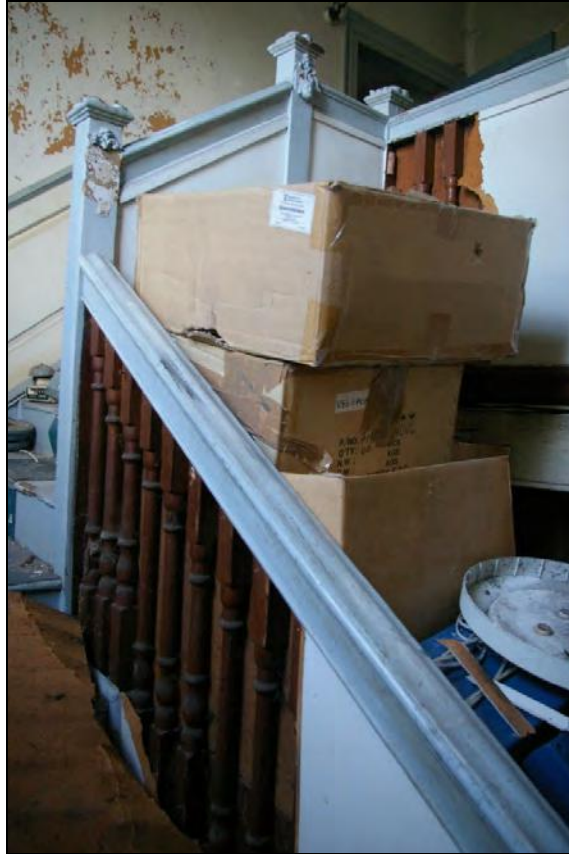
Figure 27: The deep moulded 'toads-back' handrail and square newel posts of the stairs, viewed from the south-west.

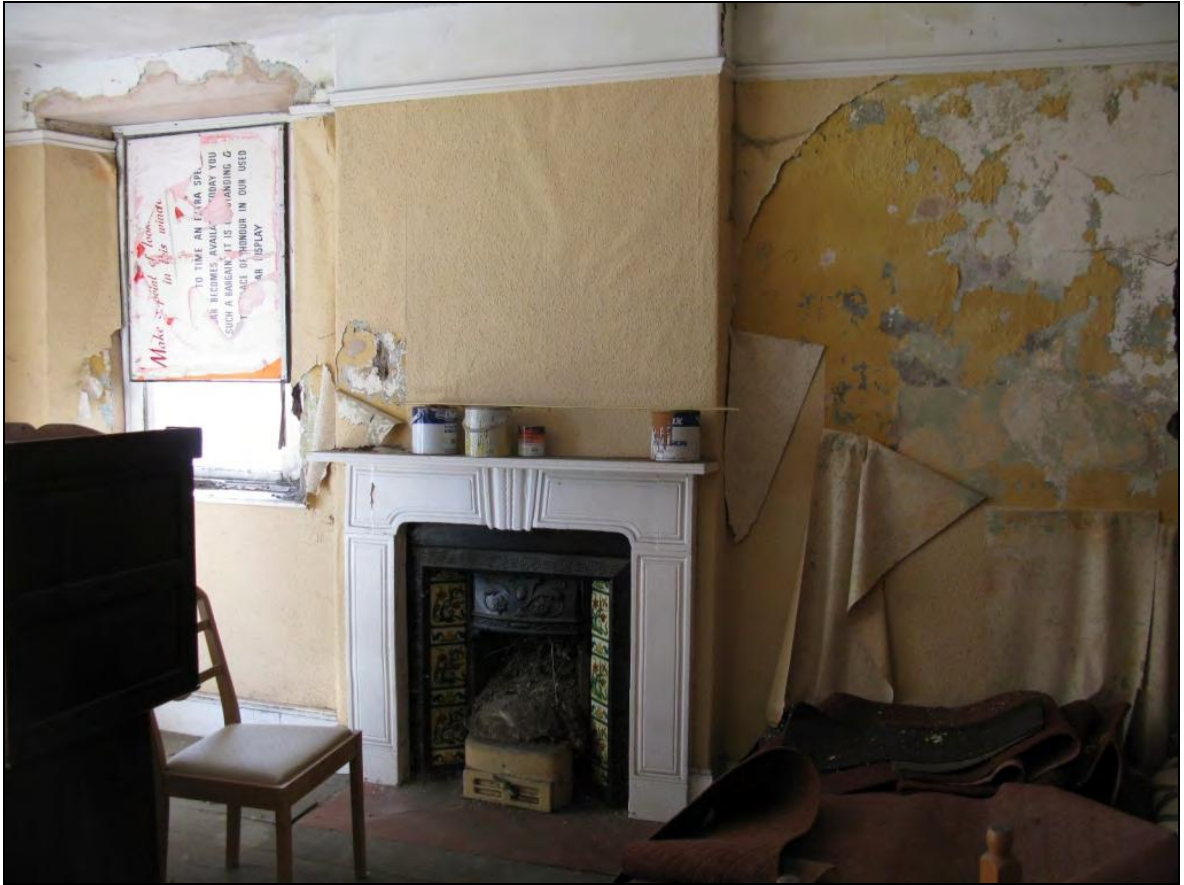
Figure 28: Shot of the fireplace in R15, this is an earlier form of surround dating to the 18th century which may have been reset on the second floor, viewed from the north.

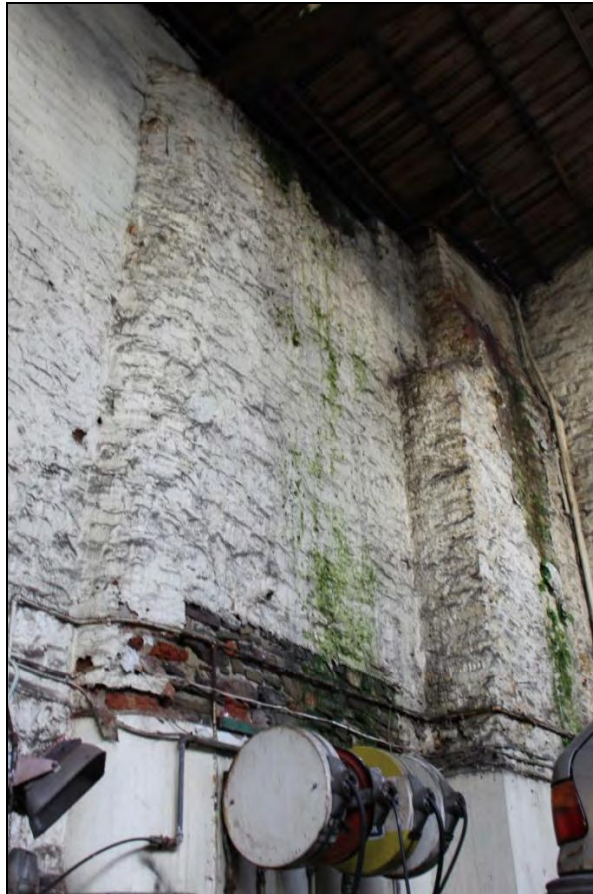
and the brickwork appears to be built between them. The stonework to the lower two storeys of wall is of rubble construction with some attempt at coursing visible in areas; the stone blocks used to the base of the wall are significantly larger than those used higher up and the wall appears to taper inwards as it rises. At roughly first floor level the wall appears to drop back, creating a ridge or step, upon which joists may have been braced or carried. The lower sections of wall are often rendered or lined in brick in places, associated with the use of the space as a garage. To the east end there is a large chimney stack which projects from the wall; this stack is of stone rubble, it reduces in width considerably at second floor level rising to the east side again with a narrow brick upper stack (Figure 29).

Figure 29: Chimney stack in the north-east corner of the garage, viewed from the south.

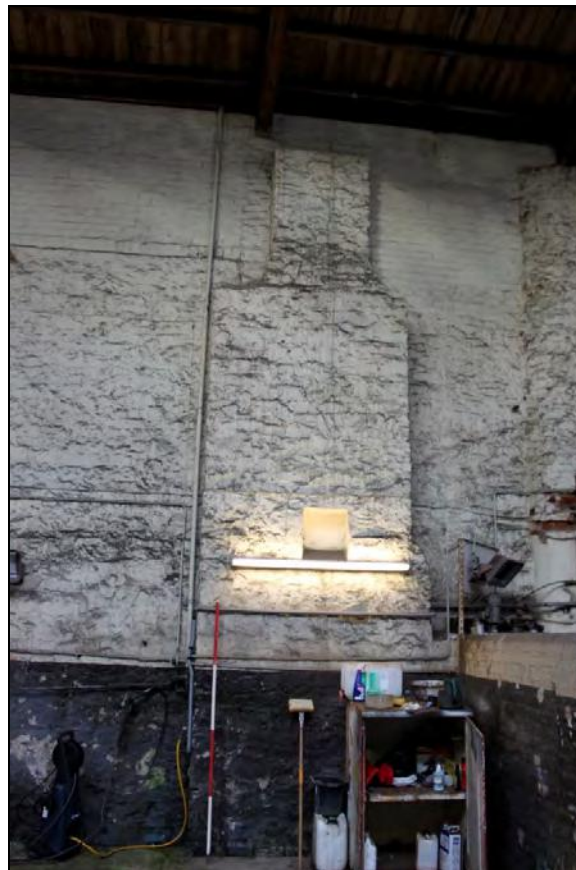
There is a further chimney stack to the west of the first, this is capped to the top but appears to be stone all the way up, although it is stepped and reduces in width as it rises to each floor. This stack has a small square opening at roughly first floor level which appears to be partially rebuilt to the sides with brick (Figure 30). The brickwork above and around this stack at second storey level appears to have several phases, either of repair or rebuild. There is a further stack to the west at the end of the stone section of wall. Between these two stacks the stonework of the lower sections of wall appears to have been repaired in brick in places. There is a large ground floor opening between these two stacks, this appears to be built into the stonework, it is rendered to the interior sides and is used as shelving. At first floor level there is a window, with deep straight reveals which appear to be built in brick, with an outer timber bead. There is a timber two light window, with an opening casement to the east side. There is some timber lacing to the opening, which would appear to date this to the 19th century, as this is a typical form of construction during that period. The stack to the west is wider than the rest, of stone rubble, with stone quoins, this rises to two storeys, to the east side the stack appears to continue to the third storey where it is capped; the stack to the west here is

capped at the second storey level. A brick pillar is built up and around the stack at third storey level to support the roof timbers and the stack is abutted to the east and west by brick wall at its upper level. The wall here drops back considerably but continues in stone up to the top of the second storey where again it has been raised in brick. As before the stonework is of random rubble, dropping back in width as it rises, with a sloping top. There is a projecting brick pillar which rises to the full height of the wall to support the roof timbers. Beyond this pillar the wall seems much disturbed with a ragged possible projecting chimney stack which is part rendered at first floor level with neat chamfered sides but appears possibly hacked away to the base. The wall drops back twice beyond this and the stonework is far rougher and of a poorer quality construction. The wall is then abutted by a brick partition, creating a separate work space to the west end of the garage. There is a patch of heavy render at this point in a rough square shape which appears to be recessed from the rest of the wall and may be a further blocked opening.

Figure 30: Further stack in the north elevation of the garage, viewed from the south (2m scale).
