THE WALRONDS CULLOMPTON DEVON

Report No.: 020114
Date: 02.01.2014
Authors: S. Walls
J. Bampton

**The Walronds,
Cullompton,
Devon**

**Results of Archaeological Monitoring
& Recording**

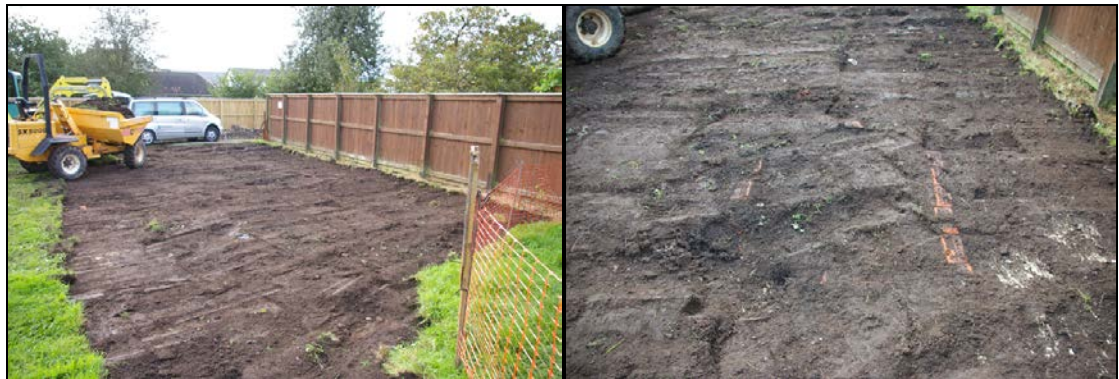
The machine excavated to a depth of c.0.20-0.24m, solely within the topsoil, which comprised of a soft dark greyish-buff-brown slightly clayey silt loam with occasional chert nodules (up to 80mm dia.) and coal fragments. There were several features exposed within the topsoil relating to 20th century garden features, most notably 7 iron stakes running east-west, which presumably relate to a former fenced division. To the south of this boundary and seemingly built to respect it were the footings of two small red brick structures (Figure 4). These structures were comprised of a single course of un-bonded 20th century machine bricks sunk into the topsoil, the western example measured 1.80m by 1.40m and the eastern example 1m by 1.60m. There was nothing else of note within the topsoil, although a small assemblage of post-medieval finds was recovered; including 17th Century stonewares and a 19th century gun mechanism (see Appendix 3).

Figure 3: Left – Car park area post-excitation, viewed from north-east (no scale).

Figure 4: Right – Modern brick structure in car park area, viewed from north (no scale).

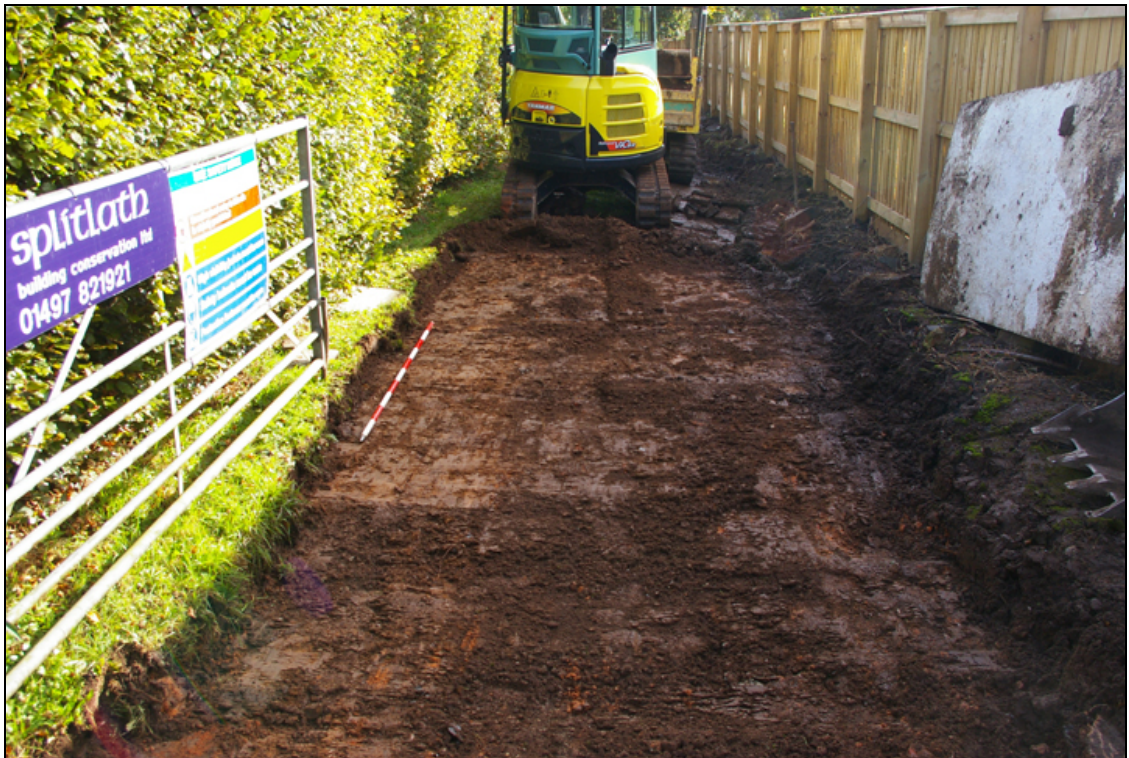
car park (Figures 5-6). It was excavated to a depth of between 0.18m and 0.20m by a machine fitted with a 1.60m wide toothless grading bucket. It never penetrated beneath the existing disturbed topsoil and hardcore/sand levelling layer of the previous driveway. Occasional modern and post-medieval finds and CBM were encountered, including White Refined Earthen Wares, South Somerset Wares and North Devon Wares (see Appendix 3 for details).

Figure 5: Driveway, post-excavation, viewed from west (2m scale).

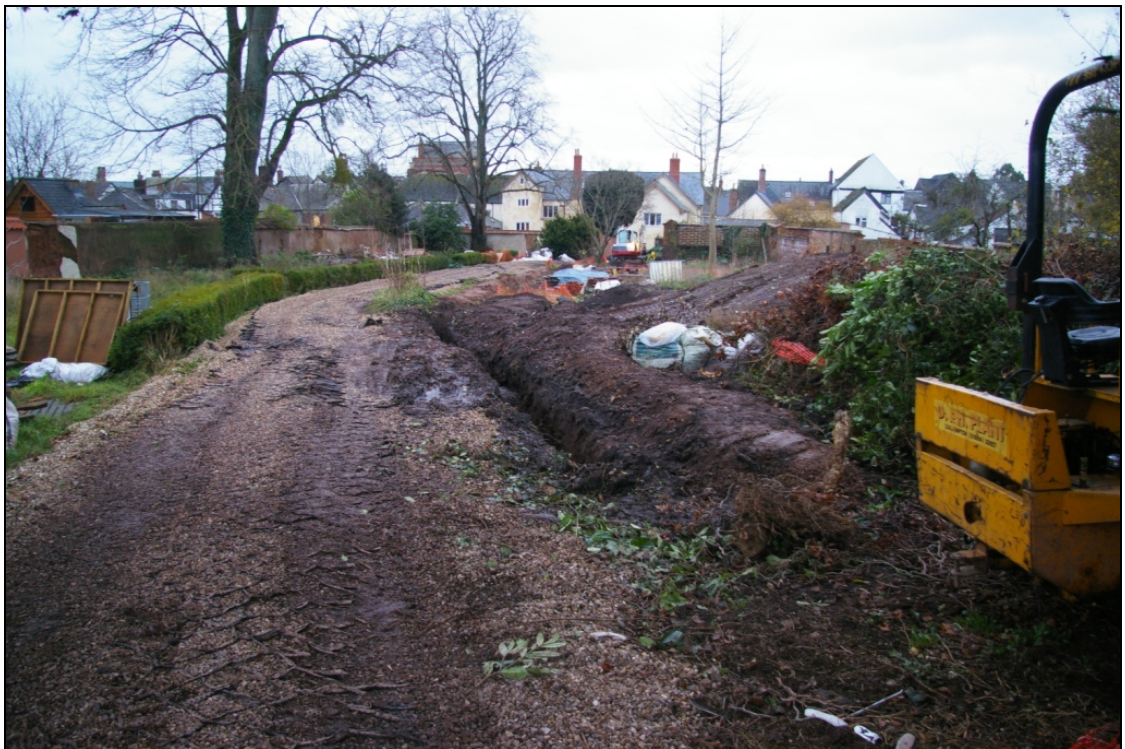
Although the service trench was excavated to an average depth of 0.75-0.8m this was primarily within topsoil deposits. The natural was however exposed from the edge of the yew tree’s TPO to the eastern limits of the service trench. The only features which were noted in the western end of the service trench were a series of service pipes and their associated trenches (see Figure 6). A small assemblage of largely modern finds was recovered from the topsoil in this area including White Refined Earthwares and a small quantity of post-medieval material including 17th Century Delft Wares (see Appendix 3 for full details).

Figure 7: Service trench during excavation within the ‘Big Garden’, viewed from west (no scale).

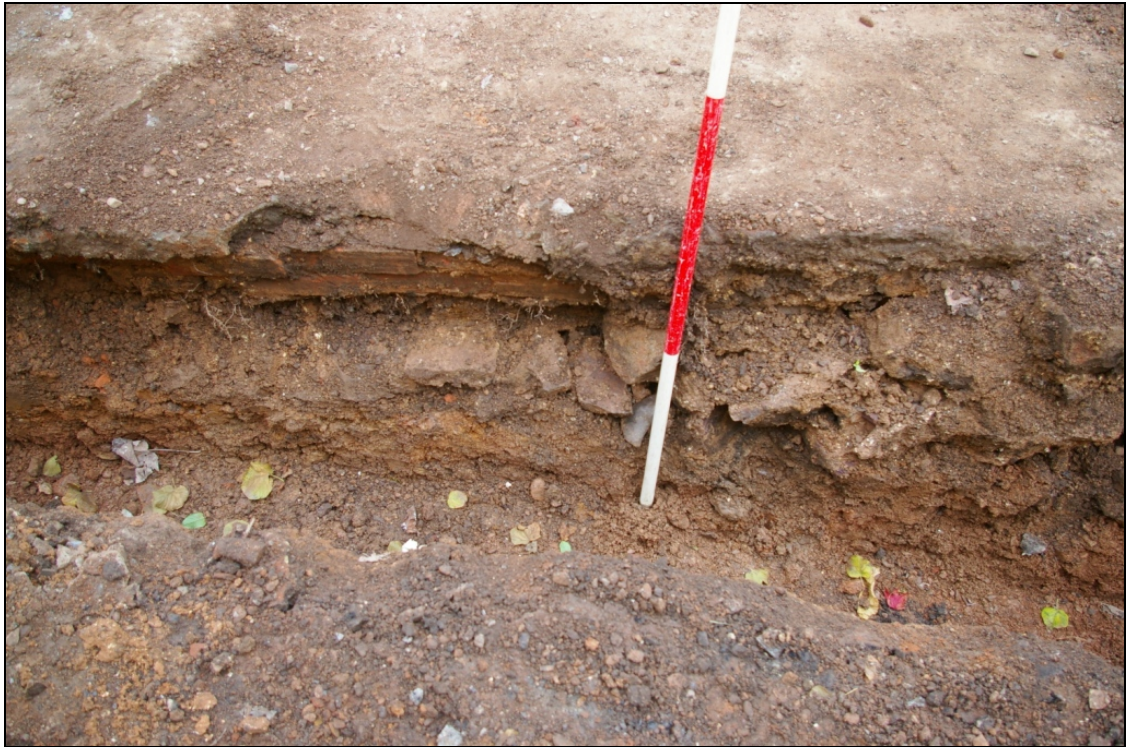
Within the courtyard to the southwest of the house the service trench extended from an existing manhole cover located just outside of the former service block (see Room 4 below) and extended west and almost immediately bisected the footings of a building (see Figures 8-9). This footing was 0.52m wide and extended for 14.2m, the upper surviving portion (1-2 courses) was constructed from 19th century orange-red bricks, below which was a footing of large blocky sub-angular stones (up to 0.4mx0.52mx0.15m) and a mixture of sub-angular stone rubble, 18th century hand-made bricks (as seen in nearby garden walls) and rare 19th century brick fragments. The wall was bonded with a soft and crumbly creamy white mortar, although there was also some red clay-silt bond within the core of the stone footing.

Figure 9: South facing section of the service trench, at the eastern end of the exposed wall footing (visible in section), viewed from south (2m scale).

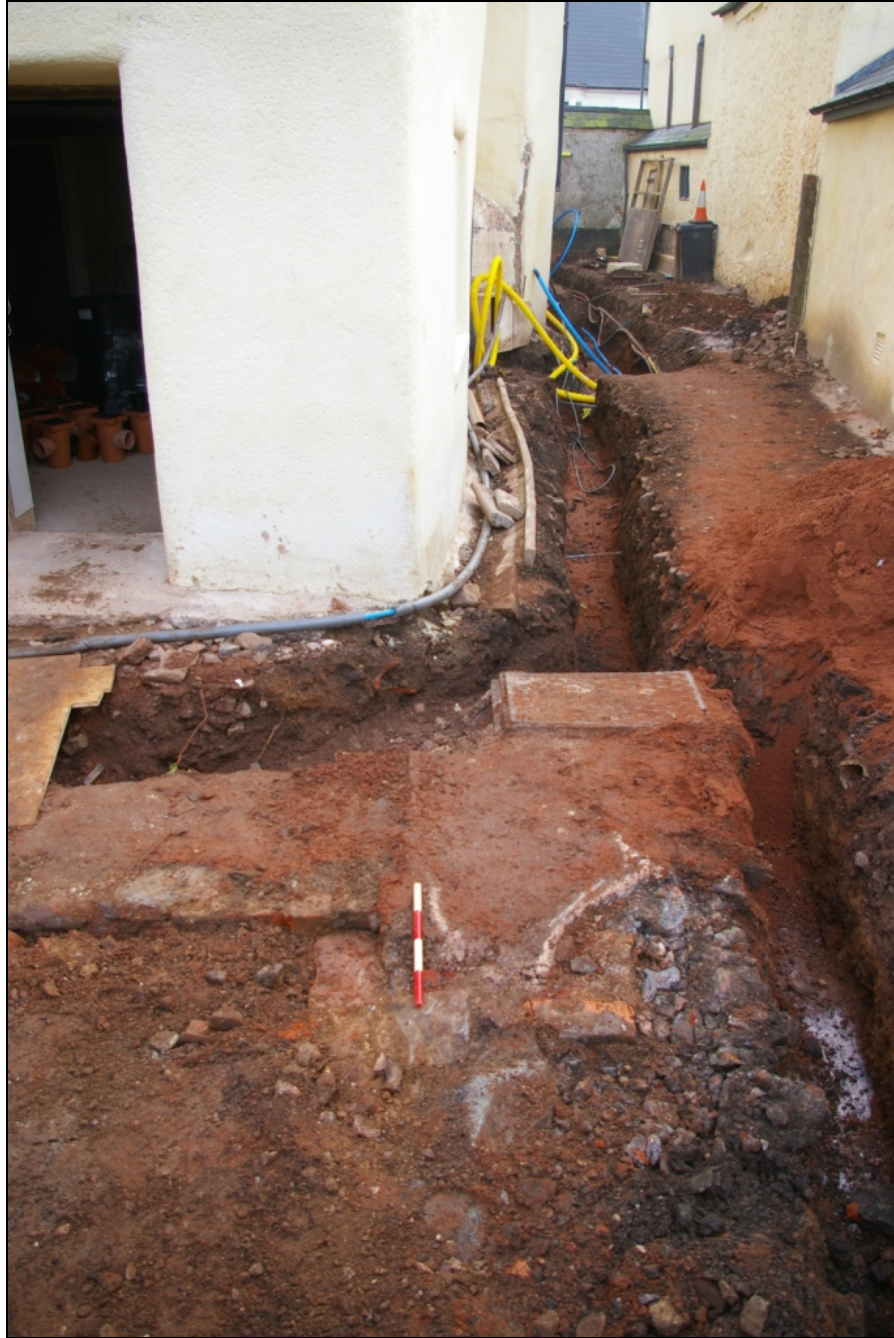
There were extant concrete floors in this area which appear to have roughly corresponded with these footings, although the slightly lower floor to west (nearest the house) overlay the surviving footings (see Figure 9). There was a higher floor (formerly of 19th century quarry tiles) set to the east of the identified footings, suggesting a possible lean-to or yard against the western end of this building. Following the identification of the footing, part of the concrete floor to the east was removed, revealing a return to the footing, suggesting that there was a passageway between this building and Room 4 (see Figures 8 & 10).

Figure 10: Southeast corner of the wall footing, following the partial removal of the concrete floor, viewed from west (0.4m scale).

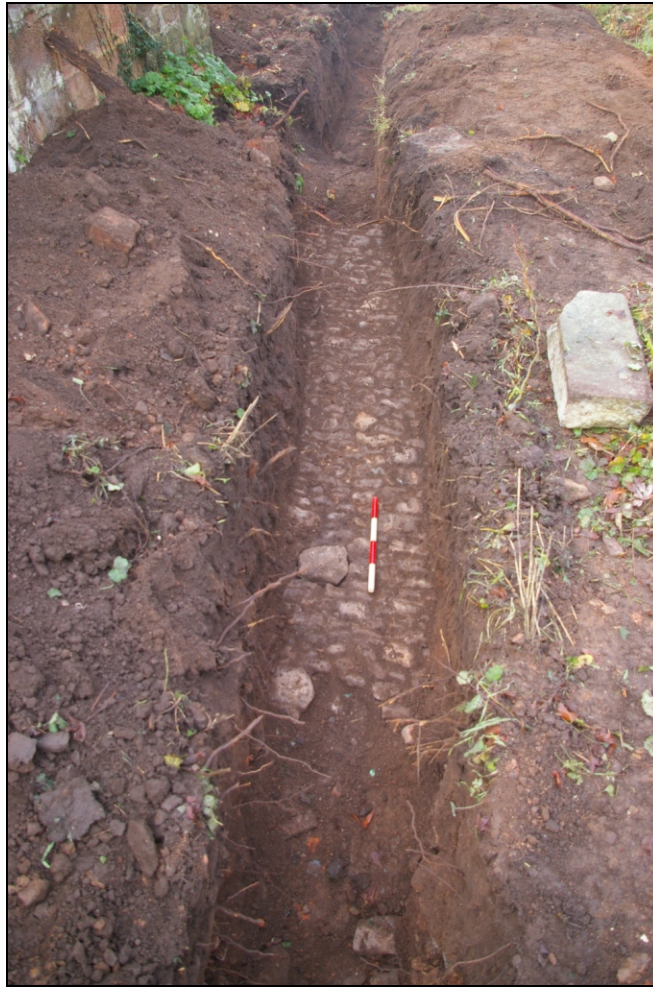
Once the service trench exited the courtyard area there was a noticeable change in the depth of topsoil, rising from c.0.1m to 0.5m quite quickly. The ground level also rises to the east at this point, which emphasises that a degree of landscaping has probably occurred in the area of the courtyards and house. There was only one feature of note within this portion of the service trench, and this occurred within the various layers of topsoil. There was an area of buried cobbling which extended for 3.9m from the break in slope (at its eastern end) to the point at which the garden widens (to the west). The cobbling was comprised of sub-rounded to sub-angular ovoid stone of relatively consistent dimensions (c.0.08-0.12m diameter) set in a gritty grey-brown sandy-silt. It was overlain with topsoil deposits, and itself overlay a further 0.08-0.1m thick deposit of buried topsoil.

Figure 11: Buried cobbled surface seen in service trench, viewed from east (0.4m scale).

The buried cobbling noted in the garden ended just short of the point at which the garden widens, suggesting that the surviving stone and brick pillar located to the south of the service trench was formerly part of a boundary which extended north (across the service trench), and most likely across the entire garden plot. This would also correspond with a change of build visible in the northern boundary wall. No surviving footing of a wall cut was noted within the service trench, although the western edge of the cobbled surface was seemingly disturbed, presumably during robbing out of the wall. Any footing for a garden wall subdividing the 'Big Garden' would have most likely been solely within the (*c.*0.65m deep) topsoil deposit. There were several large blocky stones recovered from the topsoil in this area (see on edge of trench in Figure 11) which may have been derived from a demolished wall or structure. The 1841 tithe map shows this pillar seemingly forming the northeast corner of a building, at this date,

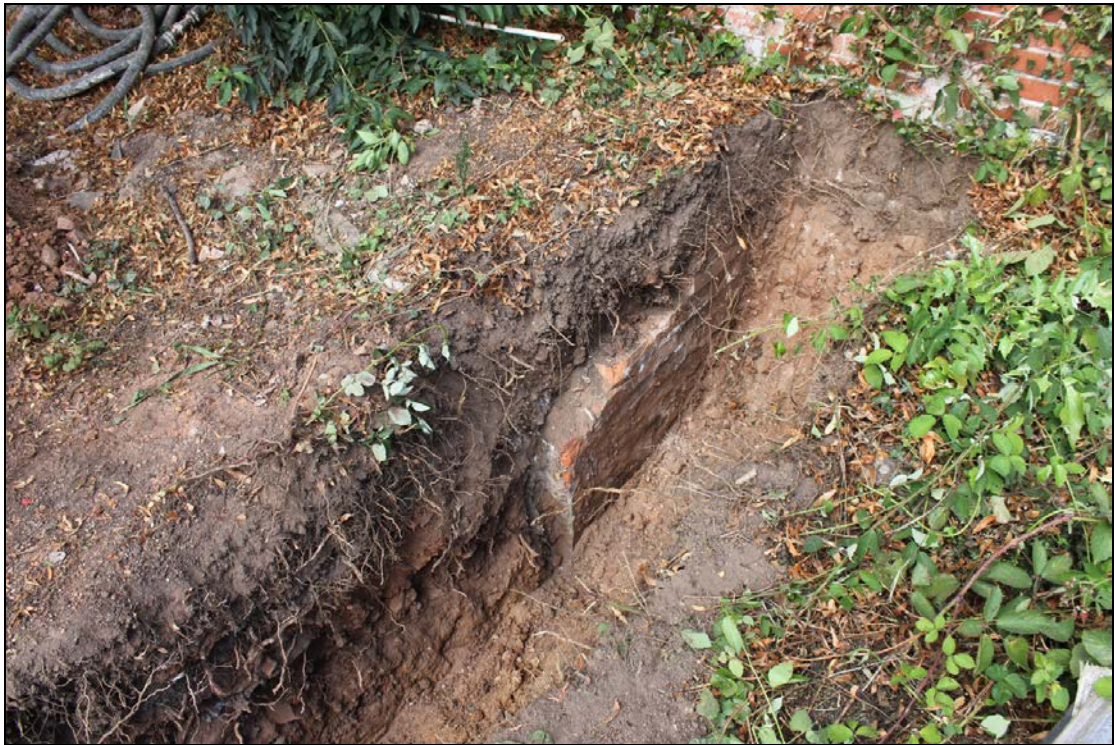
At the northern end of the trench (and abutting the garden wall) were the remains of a brick-built structure, which projected 1.45m out from the extant boundary wall and survived to a maximum height of eight courses of bricks. The bricks were a mixture of un-frogged 18th century and hand-made bricks and were bonded with a soft moist grey-white lime mortar with almost no inclusions. The structure appears to have had a brick flagged floor also, and there were noted traces of coal and coal dust adhering to the former floor surface, perhaps suggesting a coal-shed. The structure had been in-filled with a loose mixture of topsoil and natural sands and was abutted by a thin lens of loose rounded pebbles and slate fragments, which can perhaps be tentatively interpreted as suggesting the presence of a former cobbled

path leading to the structure (presumably from the east) and that it had a slate roof at some point in its life.

Figure 12: Brick structure at north end of footing trench, viewed from south-east (no scale).

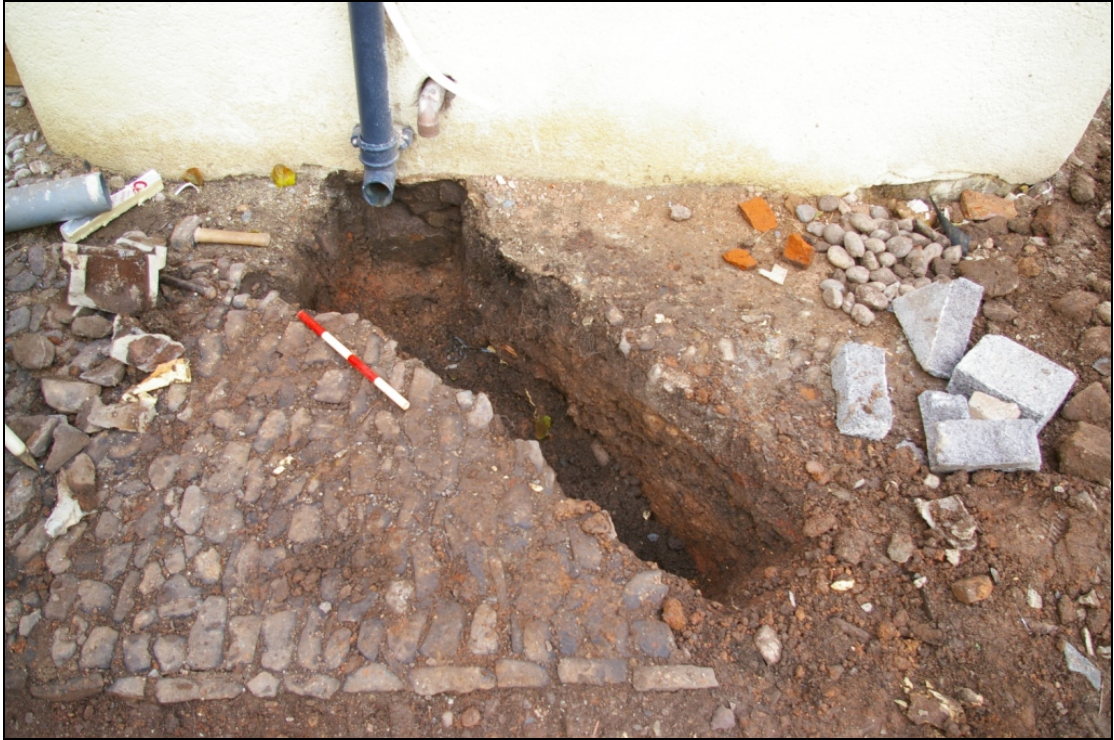
The western most of these service trenches was located adjoining ‘Craft Cottage’ (see Room 4 below) and was excavated to a depth of 0.32m revealing a simple stratigraphic sequence. The sequence comprised of a cobbled surface set in a gritty grey-yellow sandy-silt (c.0.09m thick) overlying a deposit of yellow-buff sandy-silt (c.0.22m thick) and containing occasional sub-angular to sub-rounded small stones (up to 0.08m dia.). This overlaid the natural, which comprised a buff-yellow gravelly slightly silty-sand. This small service trench also exposed a small part of the footings of ‘Craft Cottage’ which was constructed from mixed-sized stone rubble (0.25-0.08m dia.), seemingly with an earthen bond (see Figure 13).

Figure 13: Western-most service in walled garden, viewed from north (0.4m scale).

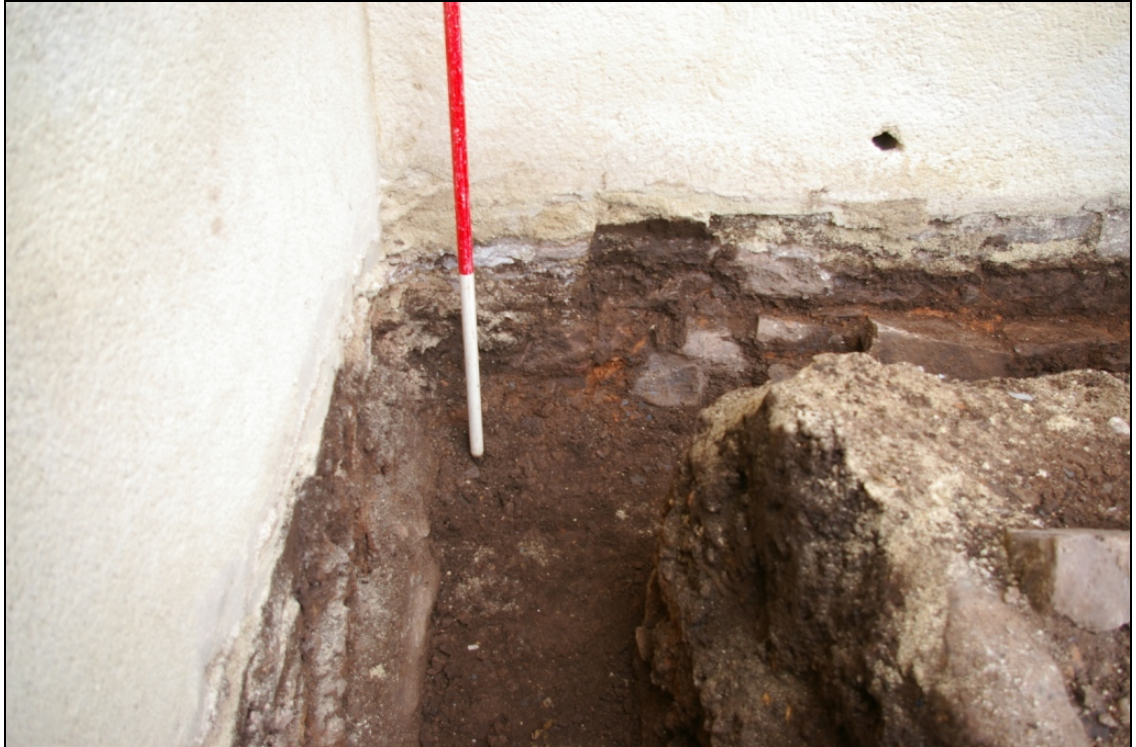
A much more substantial service trench was excavated along a large portion of the western face of the Main Hall (Room 3) and the Main Stair. The stratigraphic sequence revealed was solely of topsoil directly overlying the natural, suggesting that the excavated areas were contained within the former construction cuts for the building. It was noted that the topsoil in this trench contained a much larger amount of slate fragments than has been seen elsewhere on the site. The trenches did however reveal several details in the buildings footings which correlate with details noted in the building survey carried out by Keystone (2010 and forthcoming). For example, the Main Stair has been added on at a later (although seemingly almost contemporary) date to the main range, as there is a straight join visible in the build of the Main Hall (Room 3), although this join is slightly ragged in the footings (see Figure 14). The footing to the stair is flush with the build above, and the stone is not as tightly packed as for the build of the main hall, which also has a projecting basal course of regularly sized sub-angular blocky stones. Little of the bond was evident but for the stair it appears to have been a largely soft grey-yellow silt-sand possibly with some lime mortar. The bond for the main hall is also largely unclear, but appears to have been earthen, although there is a very compact yellow-red clay bond to the lowest course of stones, which may indicate that this belongs to an earlier phase (pre-1605) of structure.

Figure 14: The footings of the Main Hall (to the right) and projecting Main Stair (to the left), viewed from west (2m scale).

Finally the external groundworks also helped to confirm that the Main Stair is of a separate, if similarly dated, build to the Majority of the house (i.e. 1605), as the foundation is markedly different.

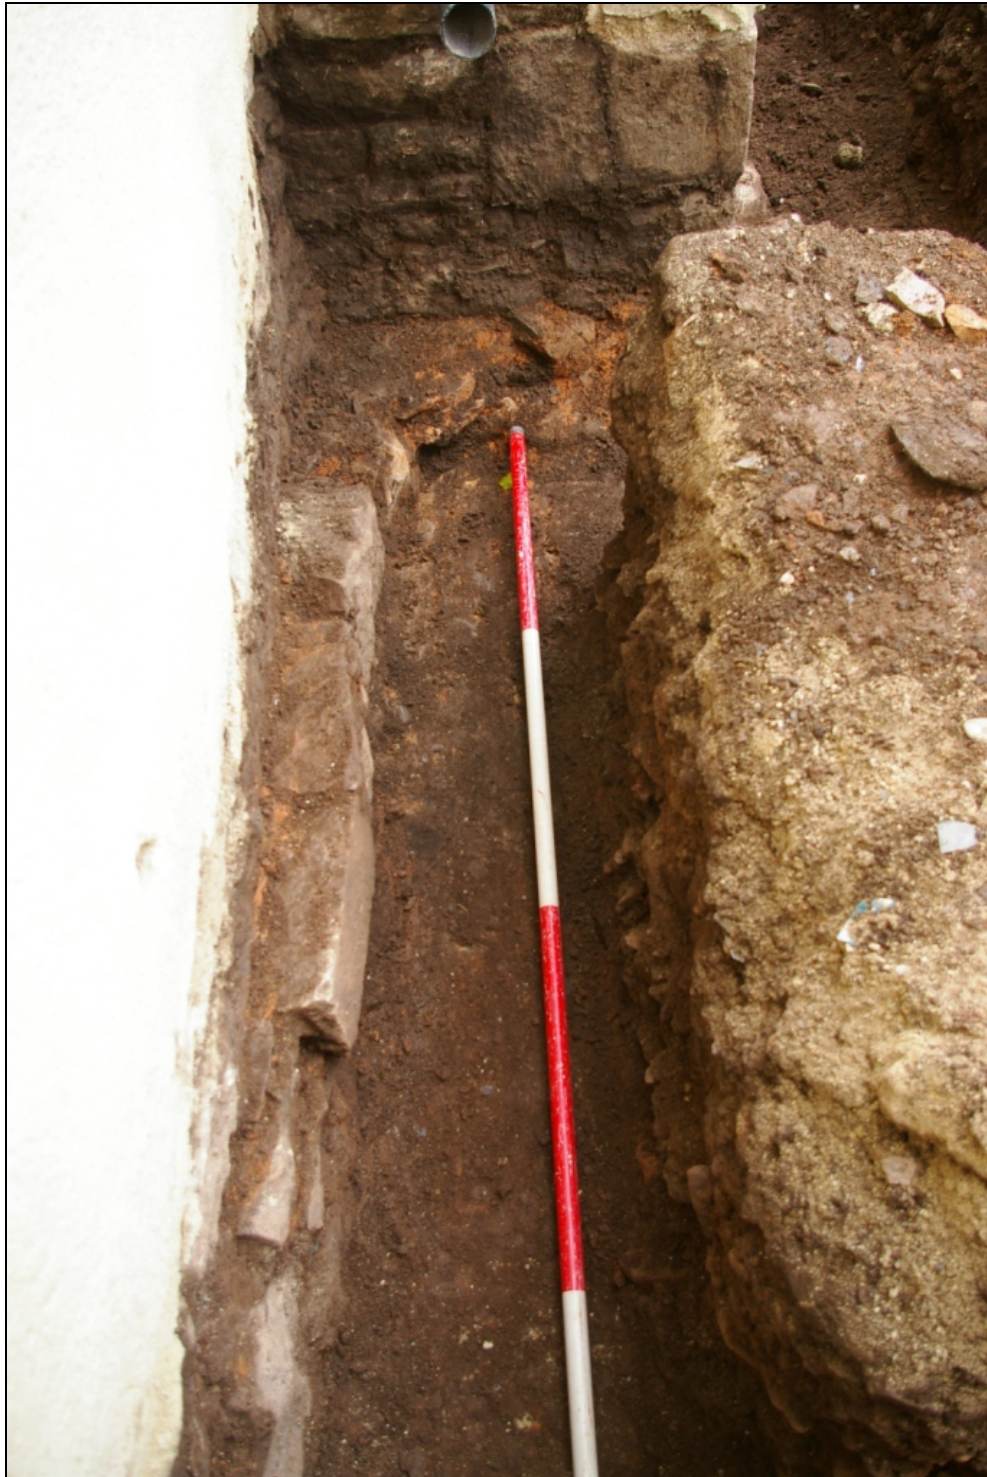
There also appears to be a change in the build of the footings for the stack to the Main Hall when compared with the adjoining build of the hall, in that those for the stack are set slightly deeper, and there is a much thicker layer of compact orange clay used to level the lowest projecting course (see Figure 15). The build of the stack also includes very nicely faced blocky quoins but with a much more mixed tightly packed coursed rubble infill between. The stack and the hall are of a much better quality build than the later stair.

Figure 15: Shot of the footings the main hall (Room 3) and projecting stack, viewed from north (2m scale).

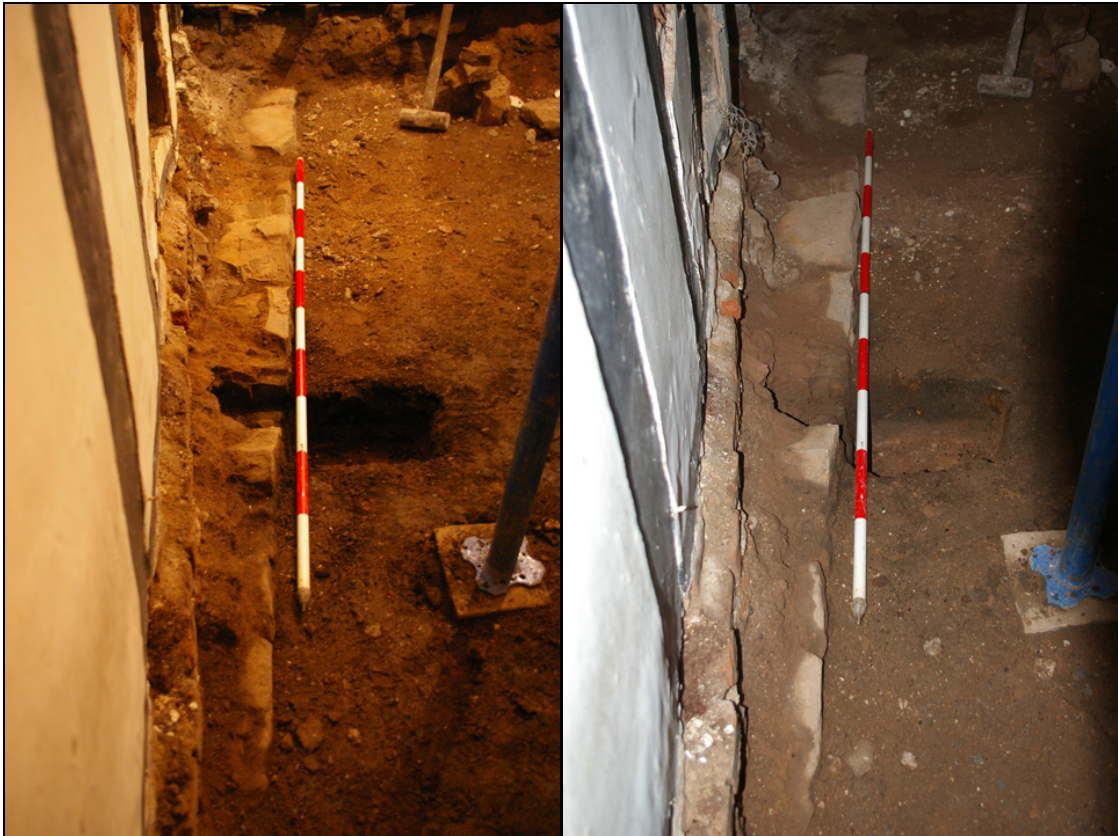
Wall {109}, 3.20m+×0.40m+×0.34m, was a stone wall aligned WNW-ESE with a red-clay bonding which had evidence of burning/firing in places. It was seemingly slightly re-aligned to form the threshold of the north-west entrance into Room 1, which was constructed of the same sized and type of stones and with a clay bond. Wall {109} overlaid a thin (0.04m) layer (101) of yellow-grey sandy-silt a possible remnant of the construction cut backfill, although no construction cut was visible. Wall {109} was abutted by a 0.19m thick demolition/destruction layer (102) of dark grey-black, friable sand-silt with charcoal that covered the entire floor to Room 1. Destruction Layer (102) was overlaid by Demolition Layer (103), 0.07m thick a mid yellow-red, compact sand-silt with moderate charcoal flecks and stones. Demolition Layer (103) was probably largely comprised of re-deposited natural. It was cut by Robber Trench [107], 1.80+×0.65×0.24m, a linear aligned north-west by south-east with a moderate curved north-eastern slope, near vertical south-western slope and a flat base. It ran from the south-east corner of the room and terminated c.2m into the room and contained a single fill (108). This was in turn overlaid by further Demolition/Cleaning Layers (104), similar to Destruction Layer (102); and (105), similar to Demolition Layer (103), respectively and each was 0.06m thick. Layer (106), 0.23+m thick, was a mid brown loose-friable sand-silt with frequent debris inclusions that formed the made-ground for the buried cobbled surface which only survived in the southeast corner of the room.

Figure 18: Left – Wall {109}, with flash; Right – without flash; both viewed from west (2m scale).

Wall {109} and potentially a now missing structure from within cut [107] were abutted by Destruction Layer (102) and an initial demolition layer, (103), after a destructive event seemingly involving a fire judging by the amount of charcoal and burnt/heated earth and stone. This destruction occurred prior to the rebuilding and realignment of the house in 1605, when the previous building on the site was removed e.g. robber trench [107] and backfilling and the spread of further demolition layers took place, thereby burying the destructive event layers (in Room 1 at least). The new (c.1605) building used Wall {109} in part as a foundation and was realigned for a threshold to Room 1 and potentially the re-building/re-use of Room 4 to the west. Once constructed a cobbled floor overlying a deposit of Made-ground (106) beneath it (which may have been in place as a working occupation level during construction) were instated. This floor was then overlain in the 20th century with a concrete floor. The cobbled floor was largely disturbed and destroyed by the instatement of this concrete floor, and this may have removed all traces of drains and other features, which could be anticipated in a Kitchen floor. It should be noted that if Room 1 was indeed the historic

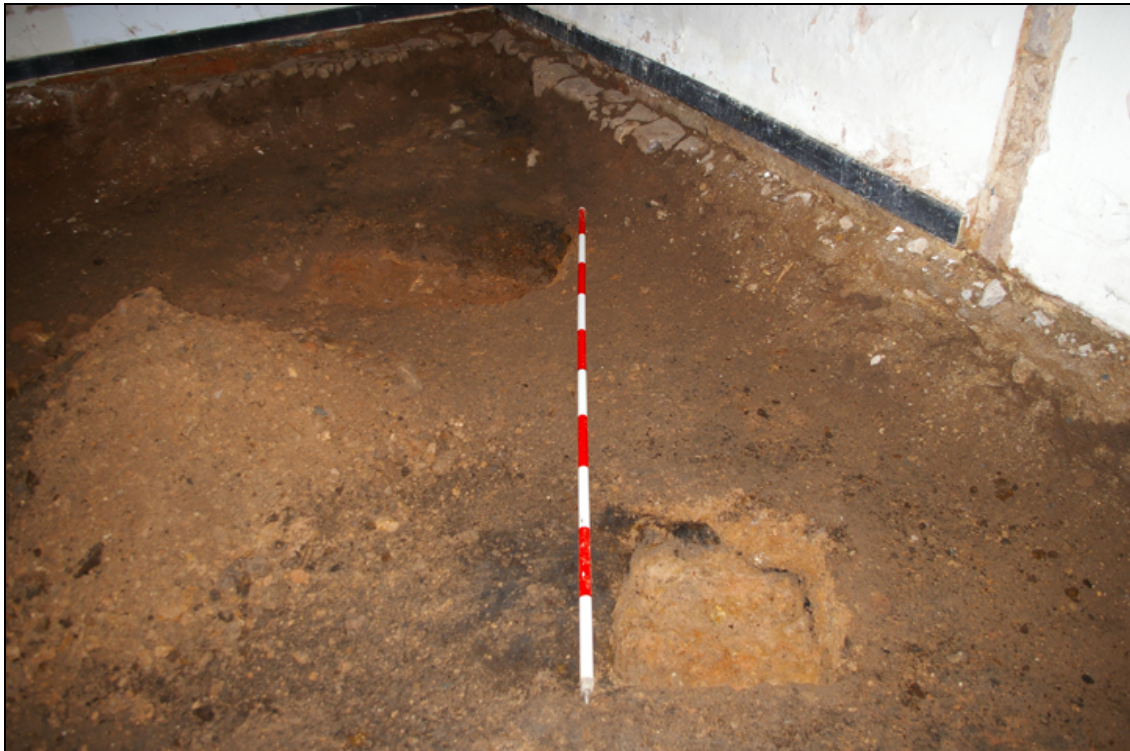
Finds from Room 1 came from layers (102), (105), (106) and (108). Destruction layer (102) produced 36 sherds of South Somerset wares; twelve (530g) of which equated to two vessels of 16th century South Somerset ware taken from slot C, abutting Wall {109}. Demolition layer (105) produced a single sherd (5g) of a glass vessel. Made-ground (106) produced a variety of debris, but notably an ivory brush and eight sherds (285g) of South Somerset ware. Fill (108) produced rubble including slate; large stones including a worn piece possibly from a floor; and mortar, which arguably constitute the remnants of a robbed out wall.

Figure 19: South-east corner of Room 1 showing [107]; slots A & B; & the cobbled surface, viewed from northwest (2m scale).

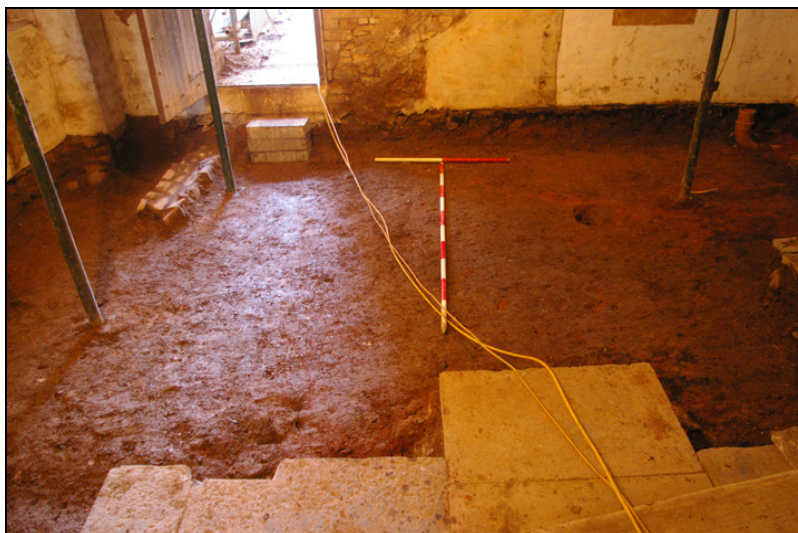
On the 13th and 18th of February 2013 J. Bampton observed the reduced floor levels in Room 4. The west half of the floor in Room 4 was reduced by between 0.26 and 0.35m, while the flagstone floor on the east half of the room was left in place. Two modern drains, a buried in-floor cobble drain, two postholes and a pit were revealed (Figures 16 & 20-23).

The majority of the area reduced was made up of six layers. Floor Surface (200), a 0.05m thick light blue-grey flagstone floor, overlaid Bedding Layer (201), 0.02m thick red-yellow, loose sand. This overlaid a 0.04m thick layer of blackish friable silt (202) with frequent charcoal, fine mortar and CBM rubble, which overlaid a 0.04m thick layer of friable clay-silt (203) containing common charcoal. Layer (203) was overlying a Buried Floor (204), a 0.05m thick compact mid-light yellow-red brown, mortar floor, which in turn overlaid a layer of made-ground (205), a 0.15m thick yellow-red brown, friable clay-silt with charcoal flecks and occasional stones that produced a single sherd of 18th century brown salt-glaze stoneware. Made-ground (205) overlaid the Natural (207), a mid yellow-red, compact sand and gravel conglomerate.

Figure 20: Room 4, post-reduction, viewed from east (1 & 2m scale).

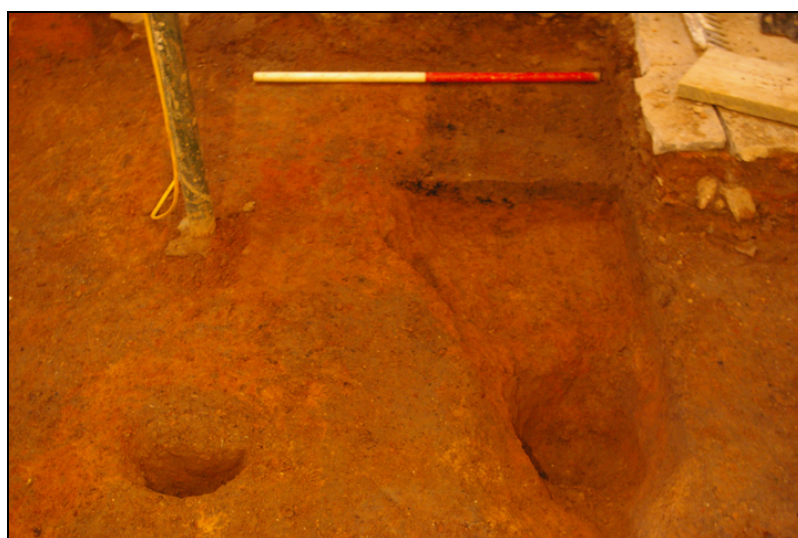
Four features were identified at the required formation level; a drain, a pit and two postholes. Drain {215}, 1.50×0.30m, was a built-in cobble floor drain aligned east-west that ran under the southern edge of the door in at the west elevation of the room (an exterior door inserted in the 19th or 20th century). It was set into made ground layer (205). At the north end of the reduced area was Pit [212], 1.75×1.50+×0.22m, this was rectangular in plan with near vertical curved sides and a flat base, although slightly irregular at its southern end where it cut Posthole [210]. The majority of the feature ran under the retained flagstone floor. Pit [212] contained two fills; a 0.19m thick upper fill of mid-brown-grey friable clay silt (214) with moderate charcoal inclusions; and a 0.07m thick basal fill of mid-red friable sandy-clay (213) with occasional charcoal flecks. Neither fill produced any finds. Pit [212] cut the light red-grey friable clay-silt fill (211) of Posthole [210]. Posthole [210] measured 0.35×0.30×0.26m, and was oval in plan with near vertical sides, a curved break of slope and a flat base that cut into the Natural (207). West of Posthole [210] was Posthole [208], 0.24×0.25×0.18m, which was similar in form to [210] and contained a single fill (209), which was identical in composition to (211).

Figure 21: Room 4, features; [208], [210] & [212], viewed from south (1m scale).

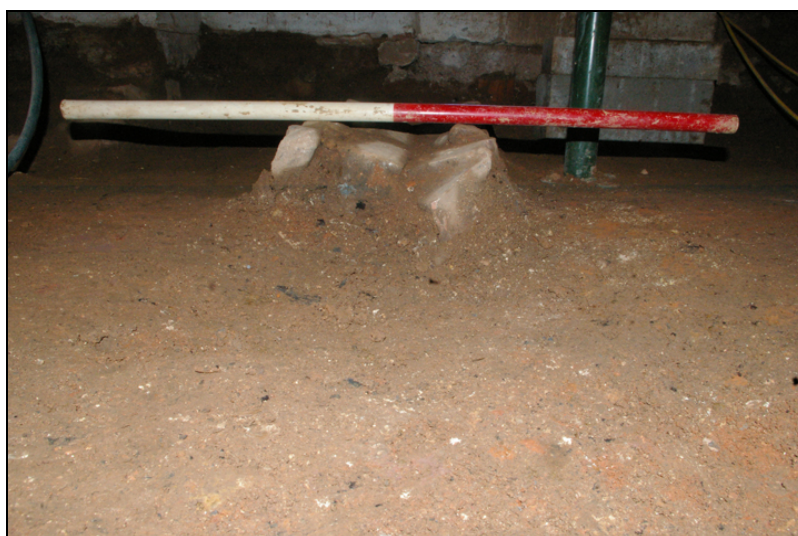
Figure 22: Room 4, Drain {215}, viewed from east (1m scale).

That is not to say that the unexposed part of the floor does not show signs of the fire or that the destruction layers have been terraced or swept away prior to the instatement of the buried (18th century) floor. It is more than likely that Pit [212] was associated with the c.1605 demolition and rebuild, in that it contains charcoal rich fills and a distinct lens of burnt material. Although Pit [212] seems to be part of the post-destruction demolition and rebuild, why it was so localised is unclear, it can only be assumed that the area may have needed substantial renovation or backfilling after the fire of 1602. That it cuts and seals posthole [210] and that both postholes ([208] and [210]) have distinctive fills from the layers above, i.e. not mixed destruction/demolition deposits, suggests that the postholes had probably gone out of use prior to the destruction event evident within Pit [212]. Therefore, the postholes represent an earlier phase of construction than the buried 18th century floor and cobble drain in Room 4, and probably an earlier phase than that destroyed in 1602.

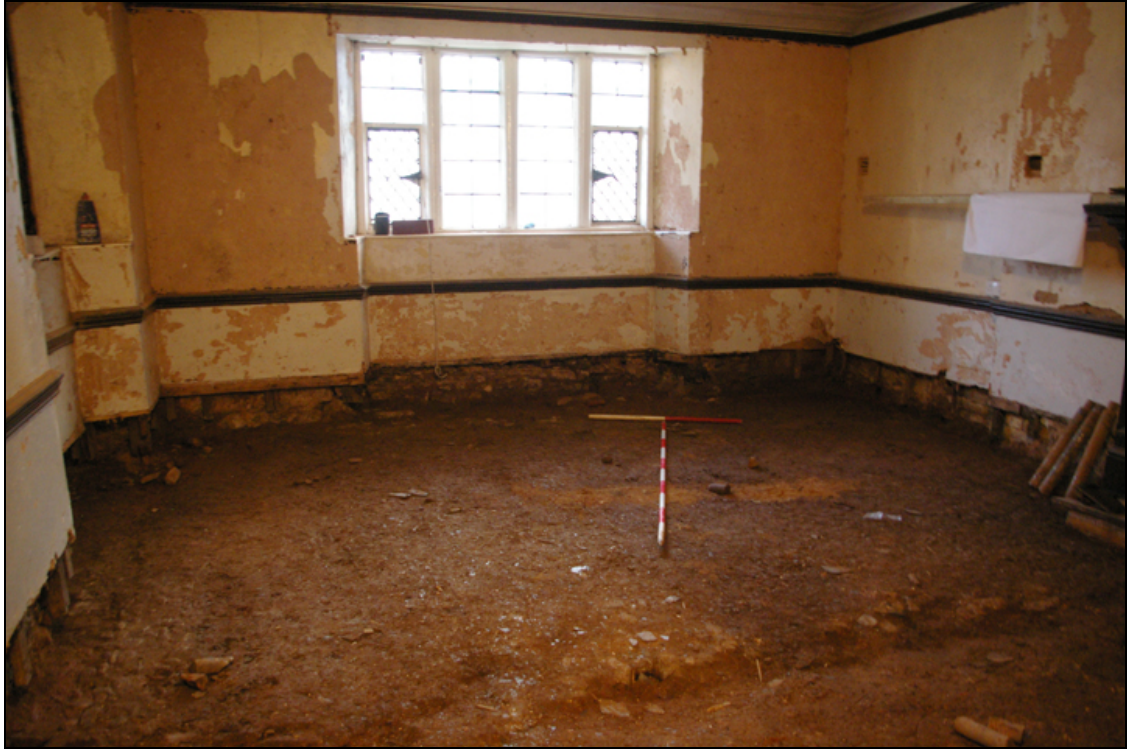
In February 2013 the wooden floor in Room 5 had been lowered to the base of the existing floor joists, which were replaced. A layer of largely in-situ cobbles were overlaid by the joists (Figure 24). These were to be left in place and built over in much the same way as to before the ground reduction; joists overlaid with floor boards. This cobbled floor surface was preserved and no other significant archaeological deposits were encountered.

Figure 24: Room 5 post floor reduction, showing cobbled surface, viewed from north-west (1 & 2m scale).
