# LAND TO THE WEST of DUNSCOMBE FARM, CREDITON DEVON

Results of a Desktop Appraisal  
&  
Archaeological Evaluation

Report No.: 120516  
Date: 16.05.12  
Authors: S. Walls  
B. Morris

*South West Archaeology Ltd. carried out a desk-based appraisal and archaeological evaluation at Higher Dunscombe Farm, Crediton, Devon, in advance of the construction of a dam and agricultural reservoir. The site lies within the eponymous Dynni's Cumb and a landscape of high archaeological potential – the cropmarks of four probable Iron Age or Romano-British enclosures lie within 500m of the site. The desk-based appraisal established that the late 18<sup>th</sup> century historic fieldscape survived largely intact into the second half of the 20<sup>th</sup> century, but a number of field boundaries and many of the buildings belonging to Lower Dunscombe Farm have been lost since the 1960s. Dunscombe is first recorded in 1242, and belonged to the notable Bodley and Buller families.*

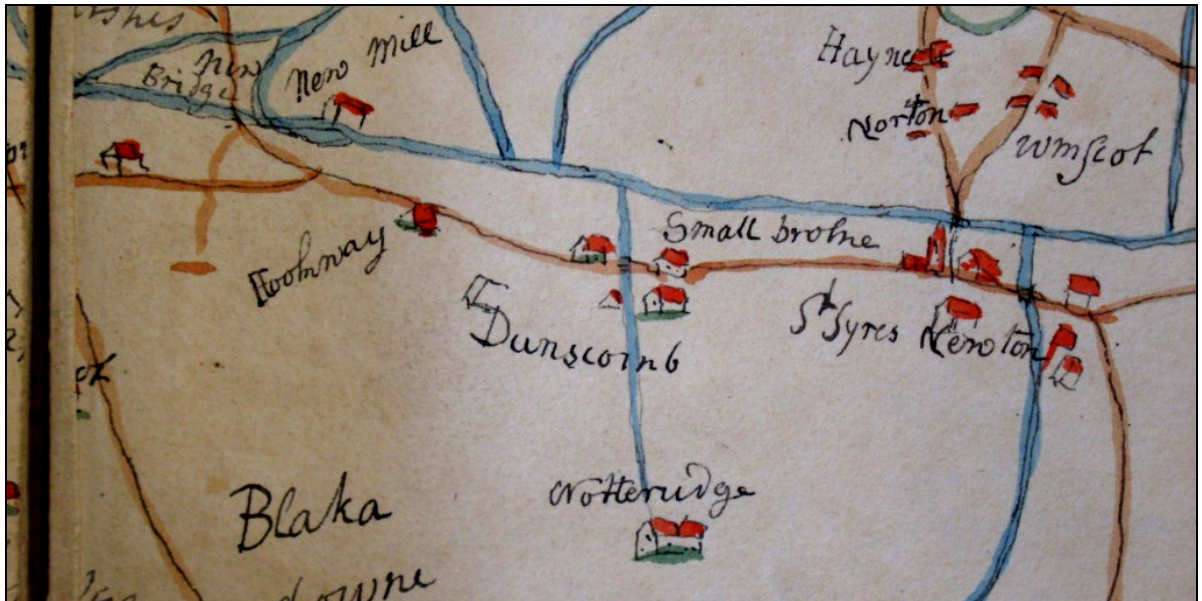
Figure 2: Extract from the 19<sup>th</sup> century copy of Norden's Map of 1598.

The earliest available cartographic source is a 19<sup>th</sup> century copy of Norden's 1598 map of Crediton Manor (DRO 1660/A add4/E1), which shows a collection of buildings to the south of the River Creedy marked as *Dunscomb* and *Small brook*. The stream shown dissecting these four buildings presumably represents the Small Brook, shown on later sources running to the east of these estates. It is of note that at this date the road continued west from Dunscombe to Hookway before heading into Crediton as the turnpike had yet to be constructed.

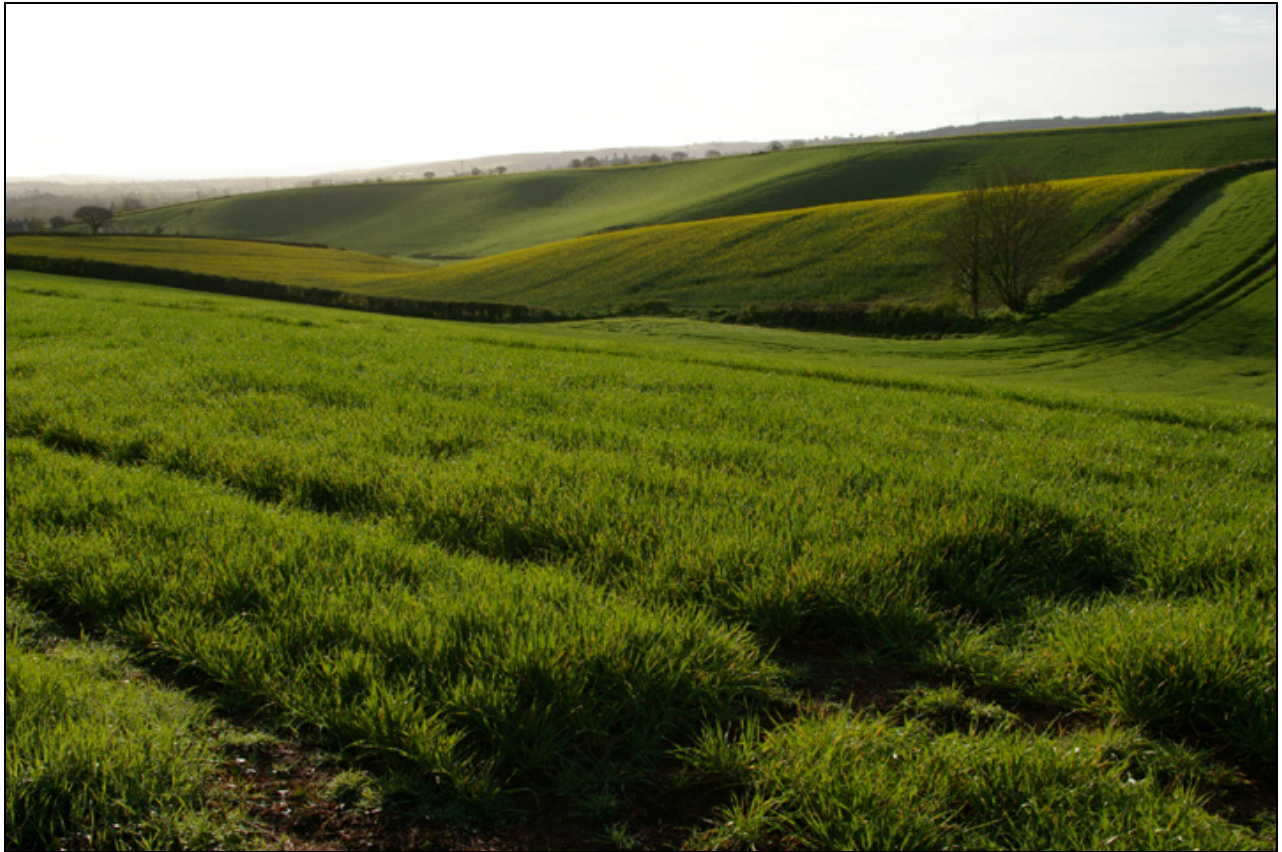
Figure 10: *Dynni's Cumb*, viewed from the north-west, looking south-east.

Dunscombe lies within a distinct but shallow combe formed between gently sloping land to the north and south (see Figure 10 and Figure 11). The underlying geology is of the Newton St Cyres Breccia Formation (BGS 2012). The local soils are the well-drained gritty reddish loamy soils of the Crediton Formation (SSEW 1983).

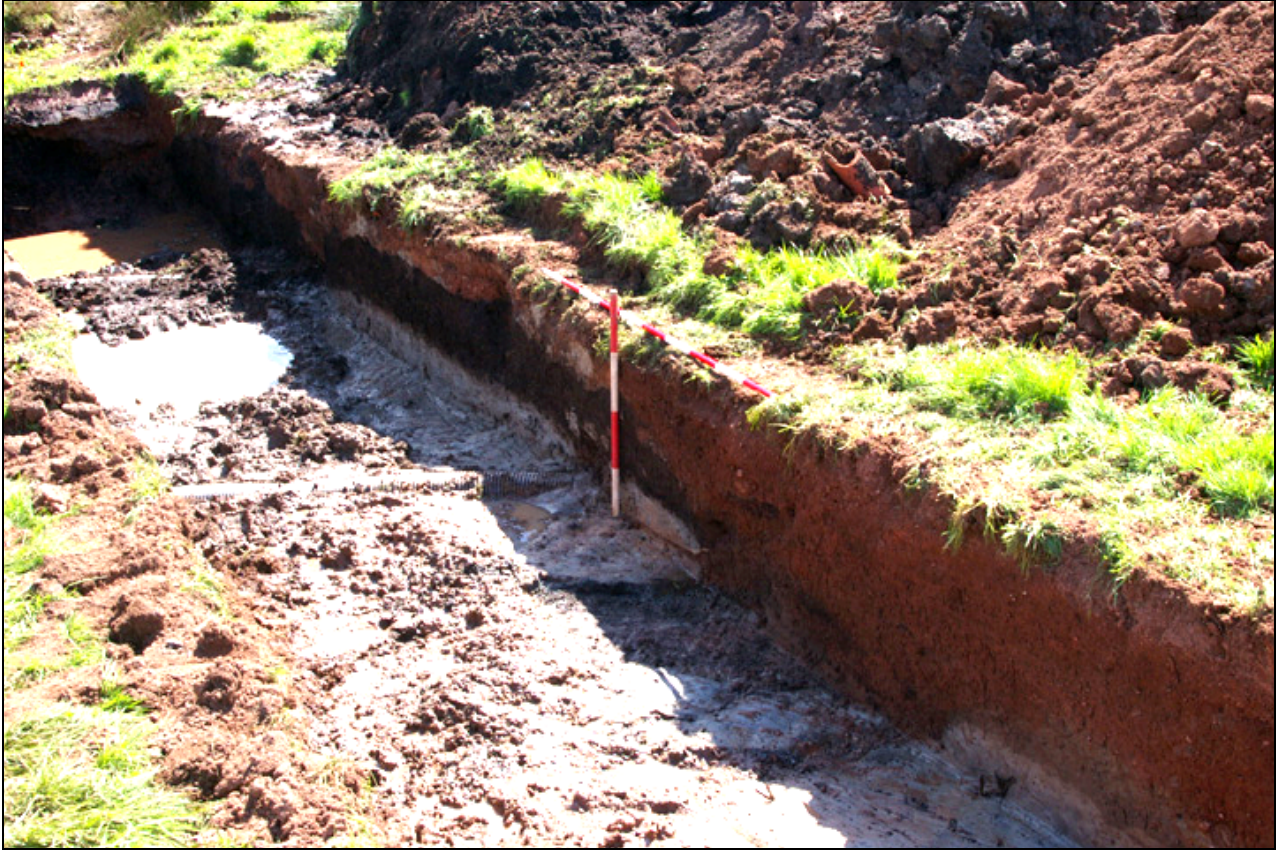
Figure 12: The southern end of the north-east facing section of Trench #2 (scales 1m & 2m).

Trench #2 was excavated towards the base of the combe on a north-west to south-east orientation. It revealed a number of archaeological features, mostly associated with the post-medieval drainage of a wet hollow (see Figure 9). The natural subsoil appeared to be a clean sticky grey clay (217), trending to gritty and reddish-brown in colour (216) at the north-west end of the trench. At the south-eastern end of the trench, a deposit of compact gravel (205) was encountered overlying (217). These deposits were sealed by a thick deposit (0.44-0.62m) of dark-brown humic peat (202). These peaty deposits may contain potentially important palaeo-environmental information, depending on the date they started to form. However, given the extensive network of land drains revealed in Trench #2 (see below) it may prove difficult to locate an undisturbed profile for sampling.

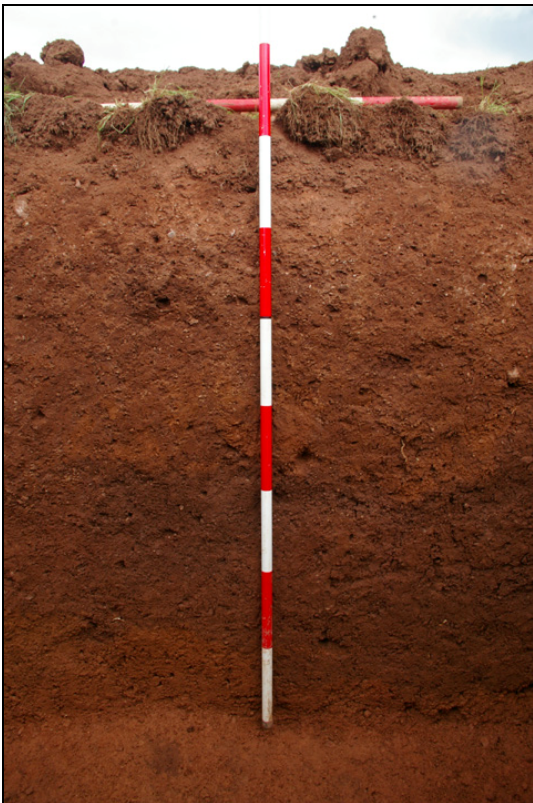
Figure 13 (left): South-facing section of Trench #1, showing the depth of colluvial deposits (scale 1&2m).

This trench was located on the northern slope of the proposed development area and was orientated east-west. It revealed a significant depth of colluvial deposits, increasing from 0.8m to 1.4m west-to-east. It is surprising that even at this relatively elevated position (at least in terms of the development area) that there was such a good depth of topsoil (100) and colluvium (contexts (101)-(104)). No features were identified and no finds were recovered. The natural undisturbed subsoil (106) appeared to be comprised of compact pinkish-brown gravels.

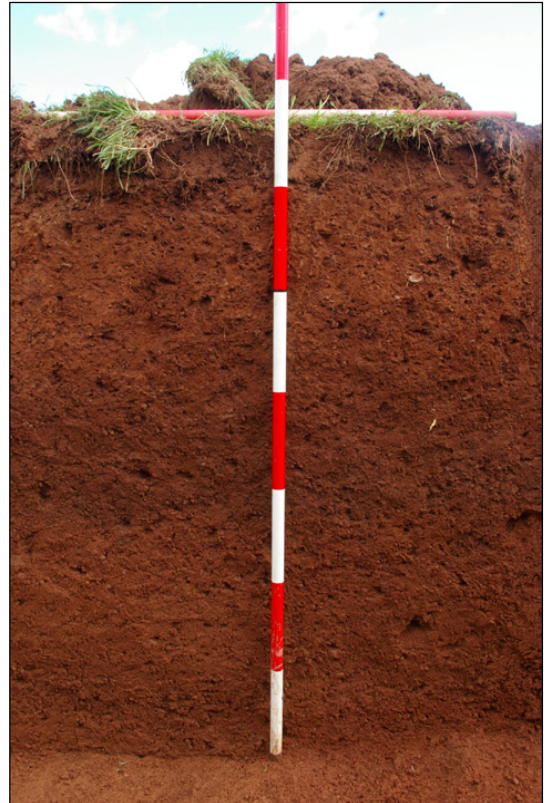
Figure 14 (right): South-west-facing section of Trench #3 (scale 1&2m).

Trench #3 was positioned towards the south-west of the site, and lay on a north-west to south-east alignment. This revealed that below the 0.11m thick topsoil (300) there were a series of five colluvial deposits, excavated to a total depth of 1.35m. The basal deposit (305), while very clean, did contain occasional charcoal fragments. A single feature was noted in this trench: a 0.35m wide linear stone drain [306] orientated north-northeast to south-southwest. This drain [306] was filled by (307) a mix of large sub-angular stones (250mm). The natural subsoil was not reached in this trench. Only a single find was recovered: two co-joining sherds from a small fragment of probable Iron Age pottery found on the spoil heap (see Appendix 5).
