# Devon County Council Historic Environment Record

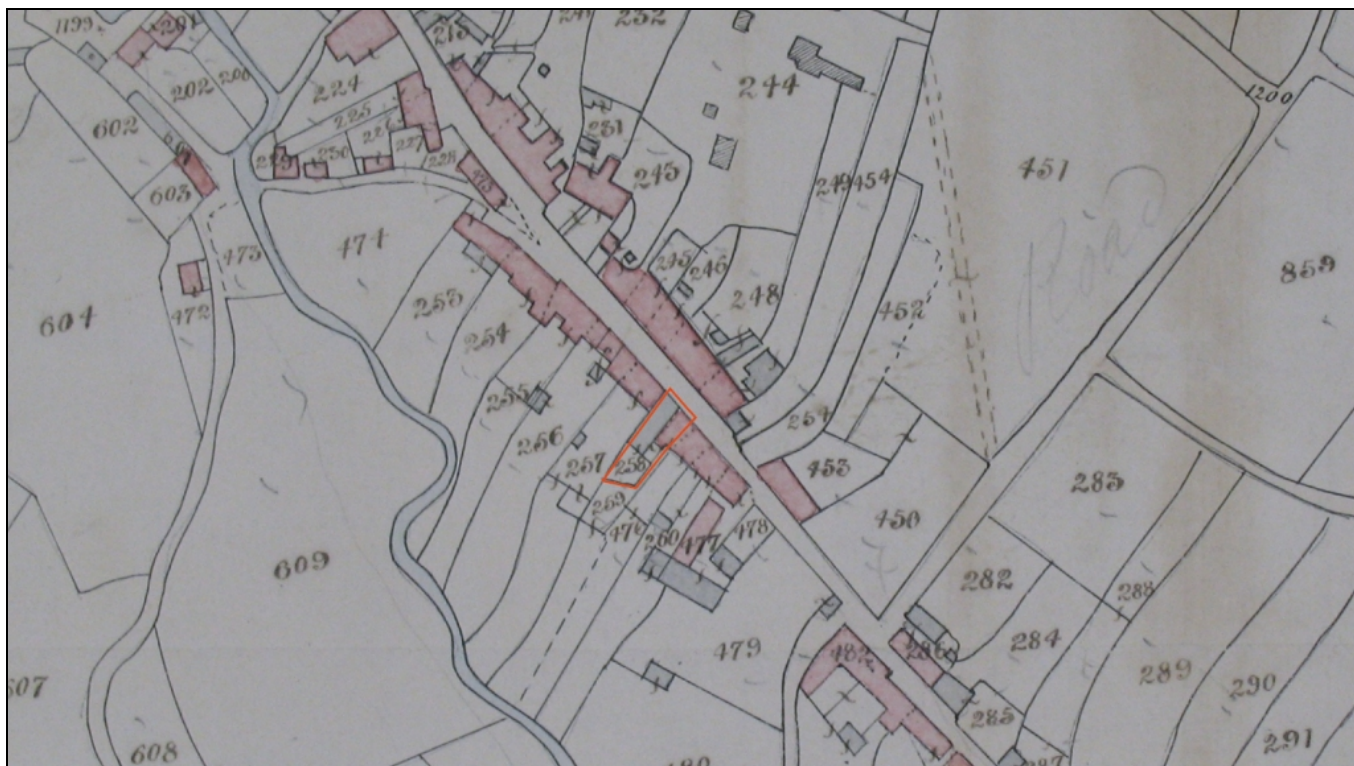
Figure 2: Extract from the 1842 Combe Martin Tithe Map. The development site is bounded in orange.

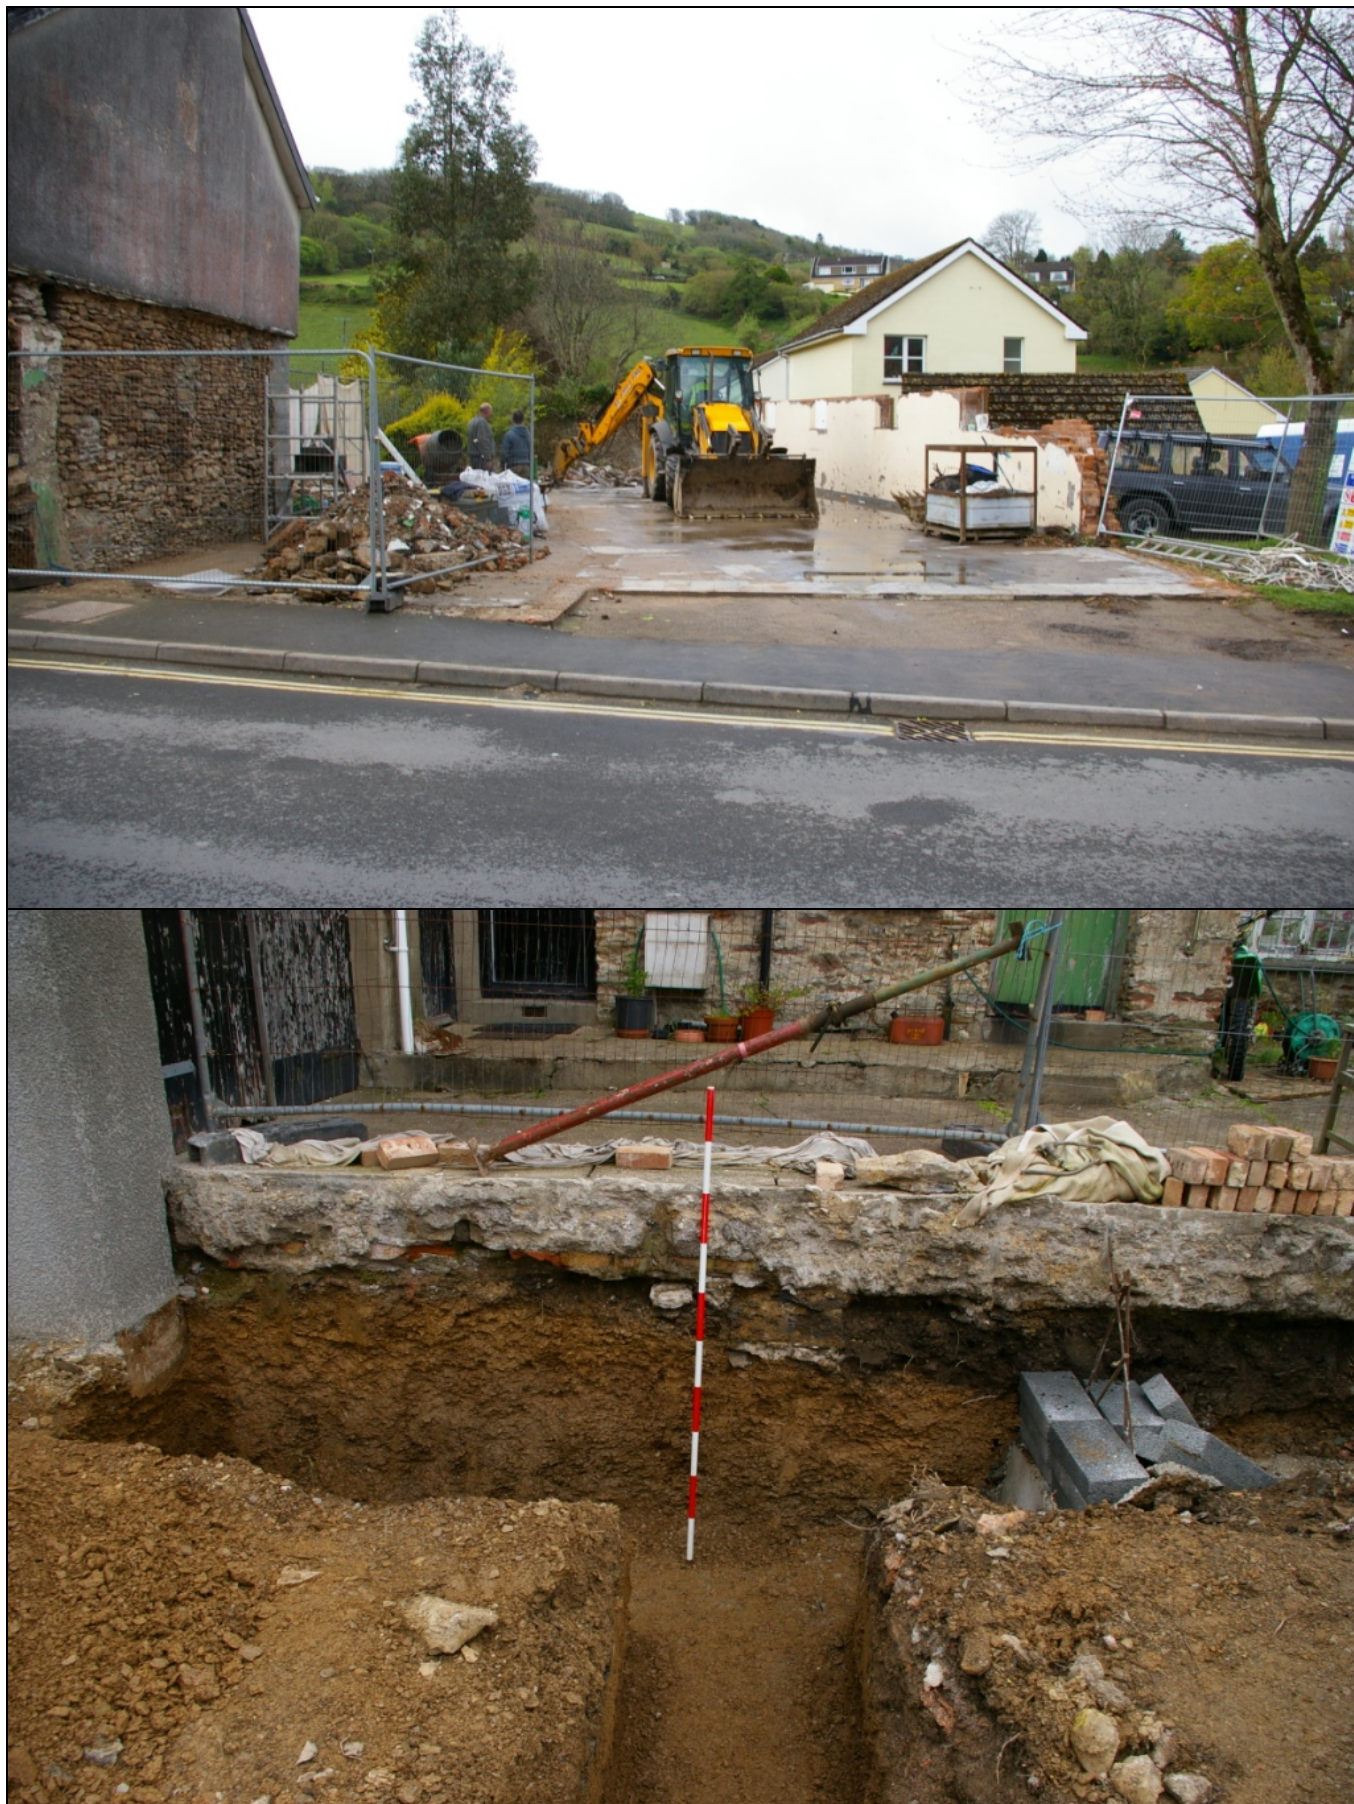
Figure 4: Above: The site during the removal of the concrete floors and foundations, viewed from the north-east. Below: Photograph showing wall {108} in Section C, viewed from the north-west (scale 2m).

The rest of the site had been covered by buildings, and was sealed by a layer of concrete 0.22m thick overlying a deposit of rubble 0.15m thick containing common slate fragments and salt-glazed sewer pipe fragments (109). These modern deposits again overlay the re-deposited natural (110).

The footings against the eastern boundary of the site (adjoining the 17<sup>th</sup>-18<sup>th</sup> century house next door) were excavated to reveal details relating primarily to the stratigraphy of the adjoining plot (see section 3 of Figure 3). The truncated remains of a wall was revealed; this was 0.45m wide and 0.3m high {108} and built of slate and stone with a hard white lime mortar containing small occasional fragments of slate and stone (>40mm). Wall {108} had cut into topsoil deposit (101) (see Figure 4). It appears the re-deposited shillet (110) had been terraced, presumably at the time the house was built, and a garden created on top of this mining waste.
