THE BELVEDERE BICTON PARK ESTATE EAST BUDLEIGH DEVON

Results of an Archaeological Desk-Based Assessment
&
Historic Building Recording

Report No.: 121025
Date: 25.10.12
Author: E. Wapshott

Proposal: conversion of the existing structure to holiday accommodation including internal alterations, reopening blocked windows replacement lead roof and new hand rails, formation of log store and repair of historic fabric
Historic Environment Service ref: ARCH/DM/ED/18373

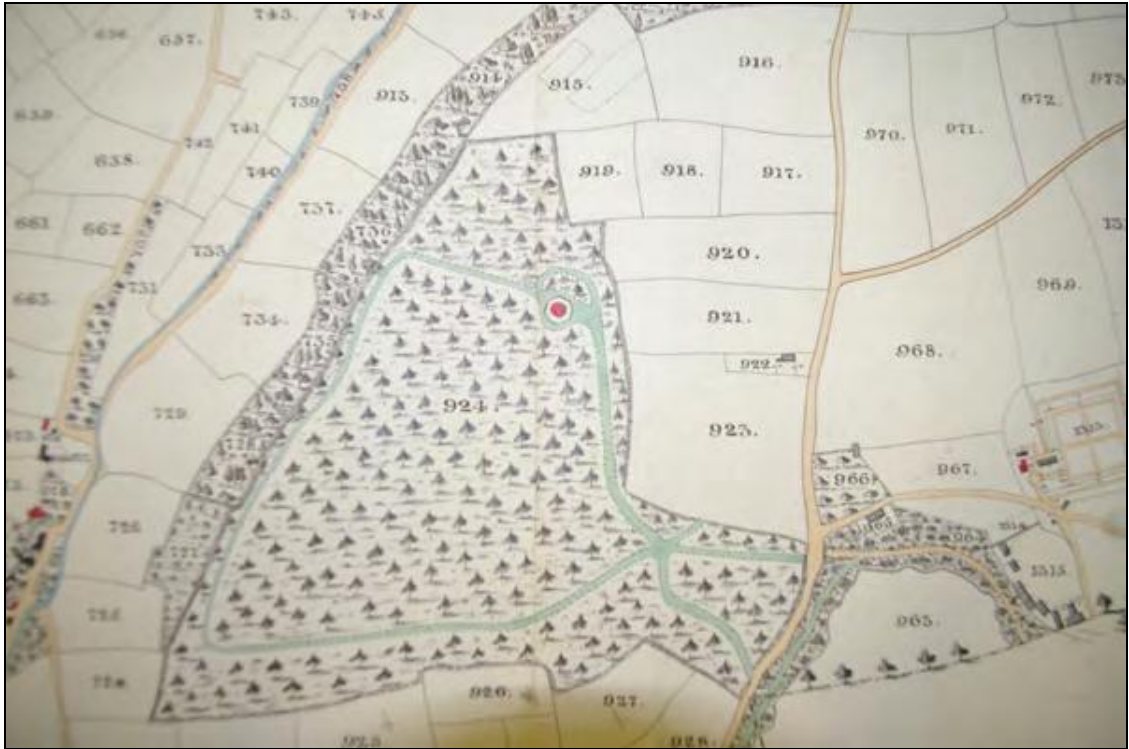
Figure 2: Extract from the Colaton Raleigh tithe map of 1842. The belvedere is picked out in red. (Bicton Park Estate)

The boundary between the parishes of Bicton and Colaton Raleigh runs through Bicton Park, placing the tower within the parish of Colaton Raleigh and therefore it appears on the Colaton Raleigh tithe map of 1842 (Figure 2). From this it is evident that the tower was completed between 1838 and 1842. On the map the tower is situated within an area numbered 924 which the tithe apportionment (1845) identifies as 'Tower, Plantation etc.'. Lady Rolle names the area Bakers Brake, a name which persists today. The detailed and coloured copy of the tithe map, presumably commissioned by the estate, shows that the area numbered 924 was plantation woodland in 1842.

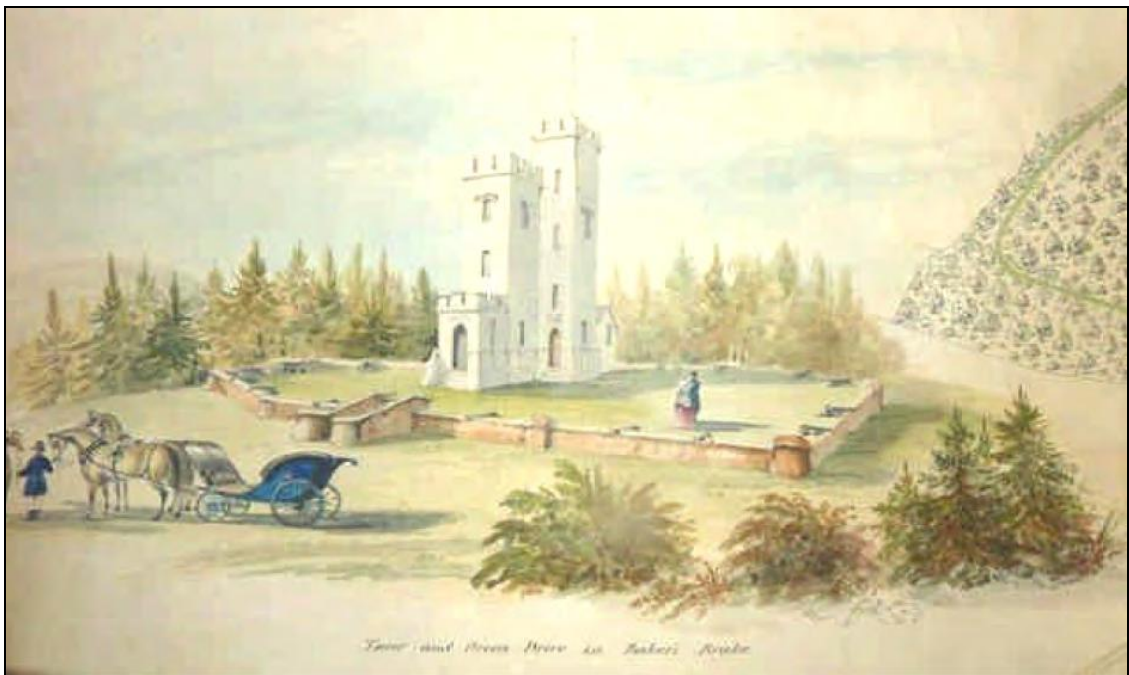
Figure 3: Painting taken from the margin of the 1845 estate map depicting the belvedere and surroundings. (Bicton Park Estate)

The painting of the tower (Figure 3) appears to show a square tower, with a square turret, suggesting that this was possibly the initial or intended design. The painting also shows the tower as only of three storeys with a fenestrated first and second floor. In addition, it appears to show a small ground floor extension to the rear with a pitched roof, possibly further kitchens or a wash house, which would have been in the position of the current concrete block structure. The painting is clearly only a representation (using artistic licence and possibly only drawn from a distant view), with the finished product potentially constructed differently. There is no evidence currently to suggest the tower has been altered that dramatically, from square to octagonal and with a storey added. And as noted above, the concrete block extension and internal alterations could not really be considered as an independent phase in themselves, at present. If a building was demolished here on the south-west side, an entrance from the tower blocked, and the concrete block building erected in its place then that would be more significant.

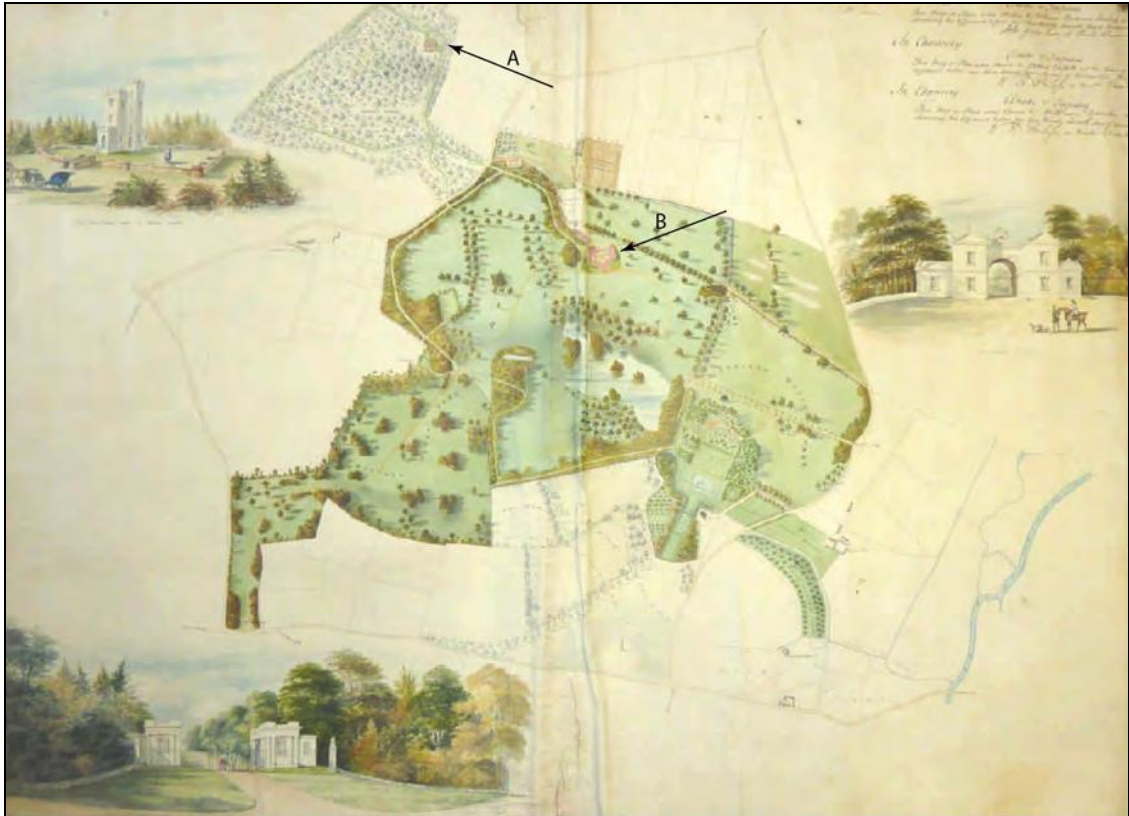
Figure 4: The estate map of 1845: Arrow A - the tower, arrow B - Bicton House. (Bicton Park Estate)

A painting of 1845 (Figure 3) depicts the tower surrounded by a low wall and set in a clearing with coniferous plantation in the background. From the map it is evident that paths laid out through the plantation were intended to incorporate the tower in a circular walk, where it would have provided a point of interest. The walk would be accessed from the north side of the main house, as shown on an estate map held by the Bicton Park Estate (Figure 4).

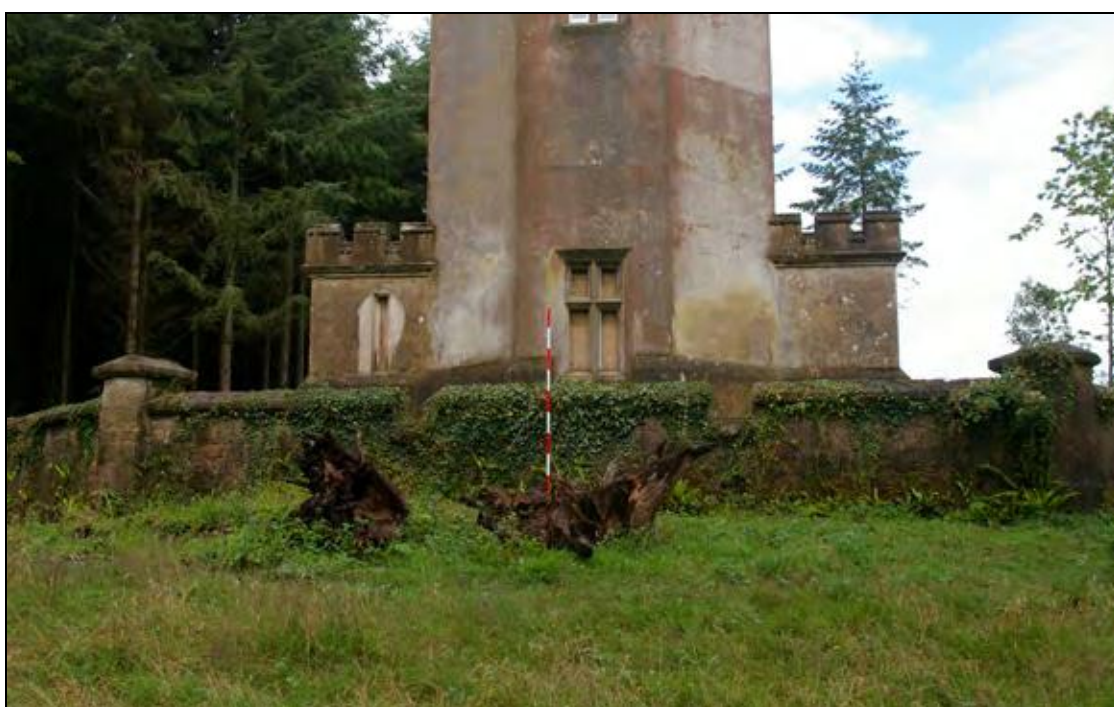
Figure 7: The terrace and tower, showing the blocked ground floor mullion-and-transom window; from the south.

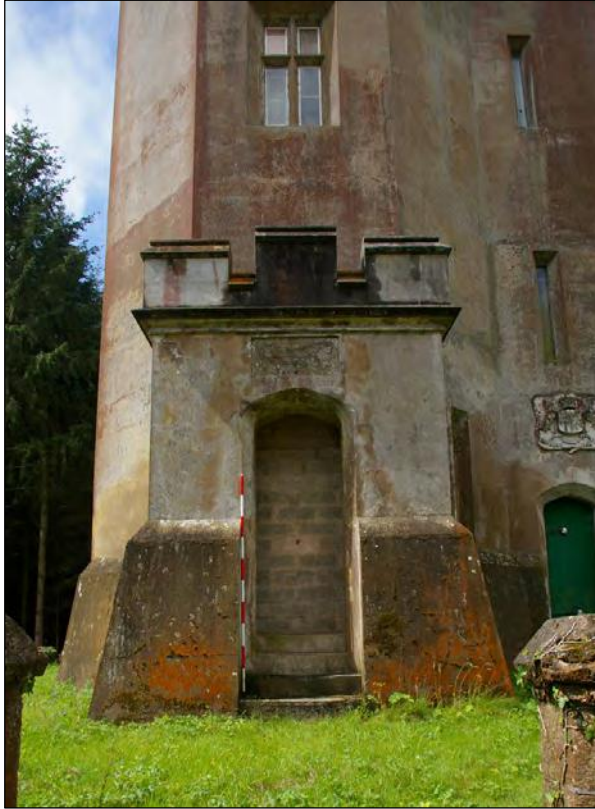
Figure 9: The main entrance porch, viewed from the east

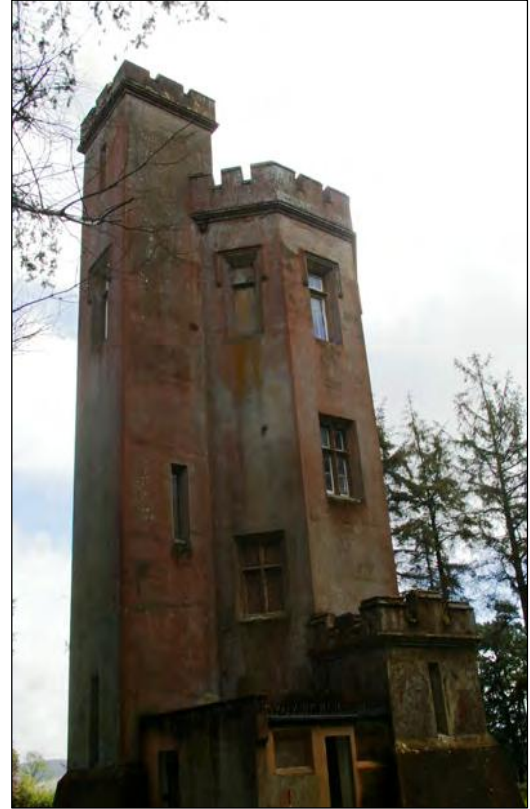
Figure 10: The tower and stair turret, viewed from the north-west

The square stair turret poses the only significant question; its shape seeming to contradict both the octagonal tower and its interior spiral stair (Figure 10). Why have a round spiral stair in a square turret and then have the stairs cut across the long windows designed to light them

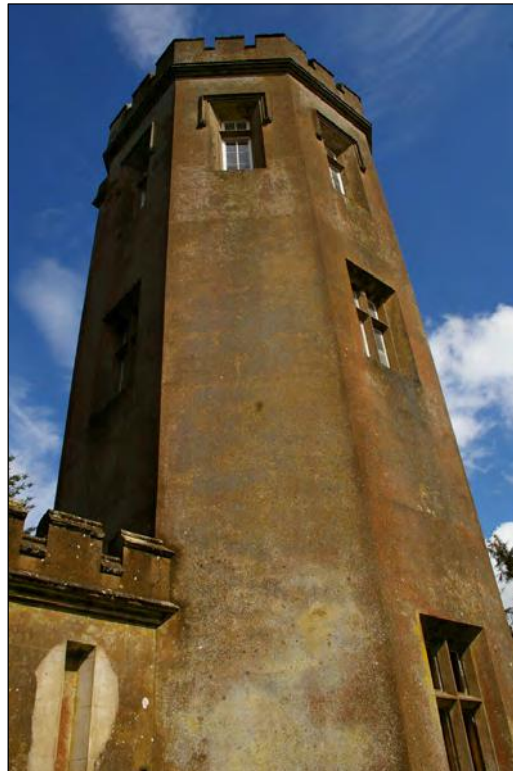
Figure 11: View up the south-west side of the tower.

The tower sits on a raised octagonal grassed terrace, with stone retaining walls, with moulded coping and embattled parapet, similar to that on the tower (Figure 11). The terrace is accessed via a set of wide stone steps with moulded balustrades which rise on the north-eastern side opposite the main entrance porch.

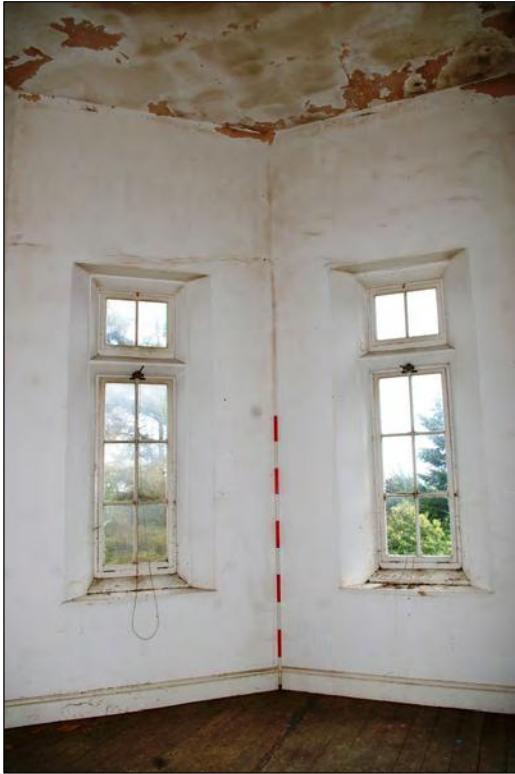
Figure 12: The north and east sides of the third floor, showing the transom windows; from the south-west.

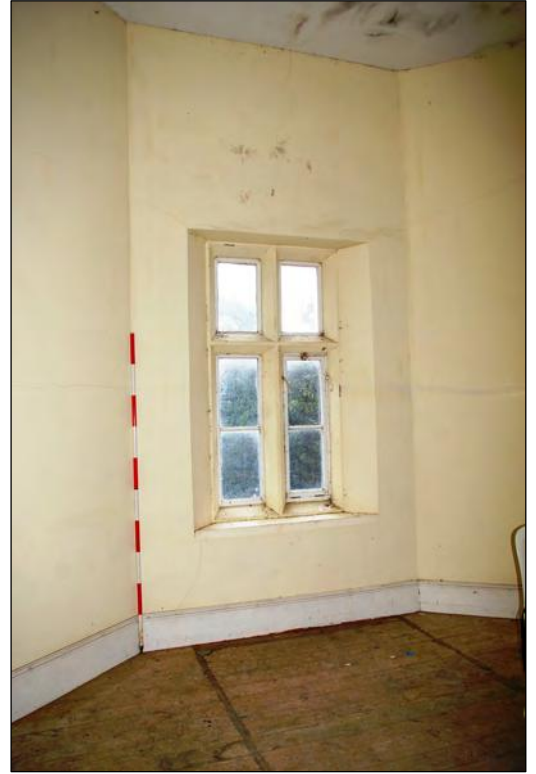
Figure 13: The east side of the second floor room, showing the mullion-and-transom windows; from the north-west.

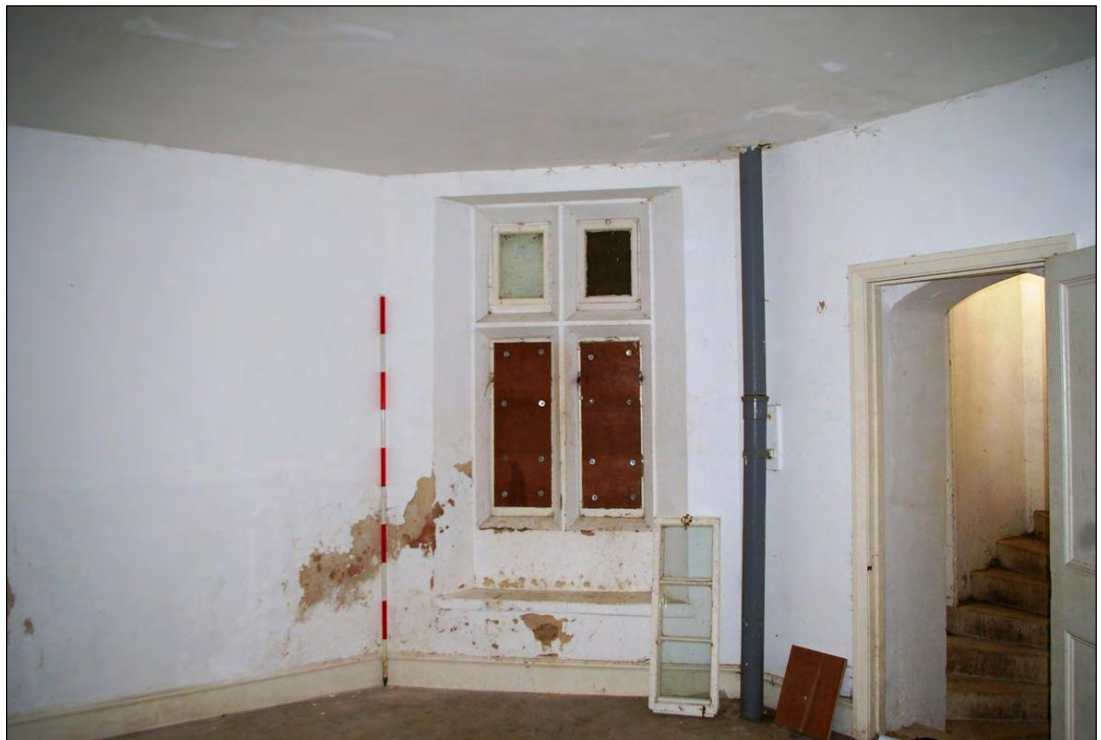
Figure 14: The south-west side of the first floor room showing the blocked mullion-and-transom window, from the north-east.

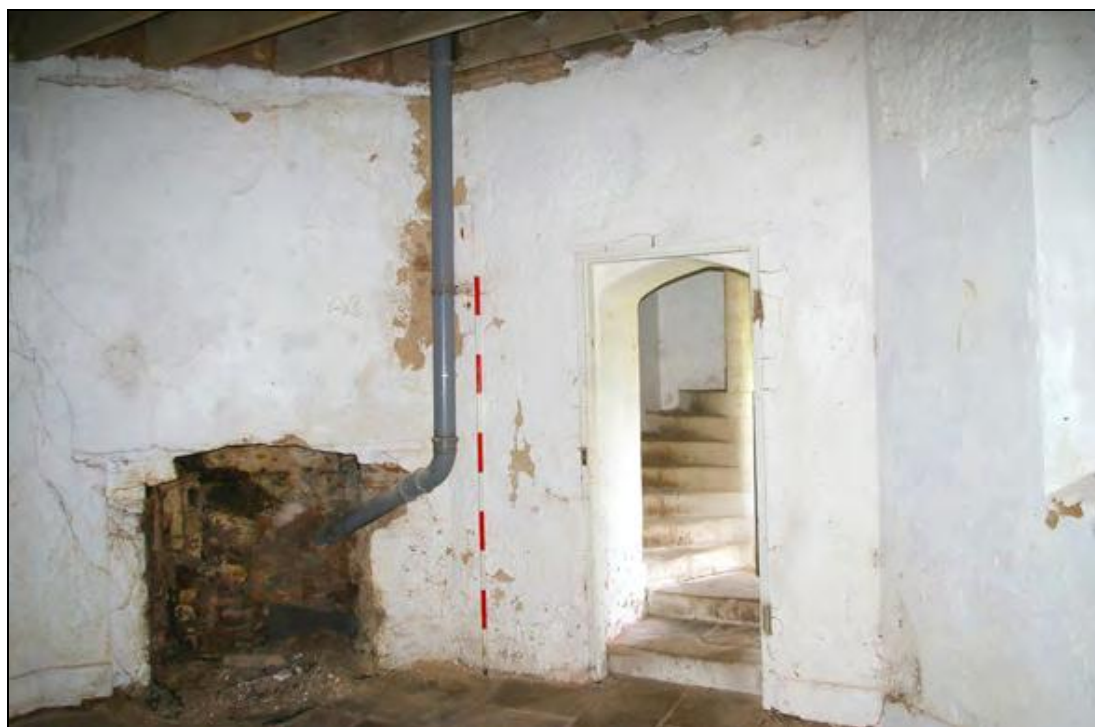
Figure 12 The south-west corner of the ground floor room, showing the fireplace and door to the stair; from the north-east.

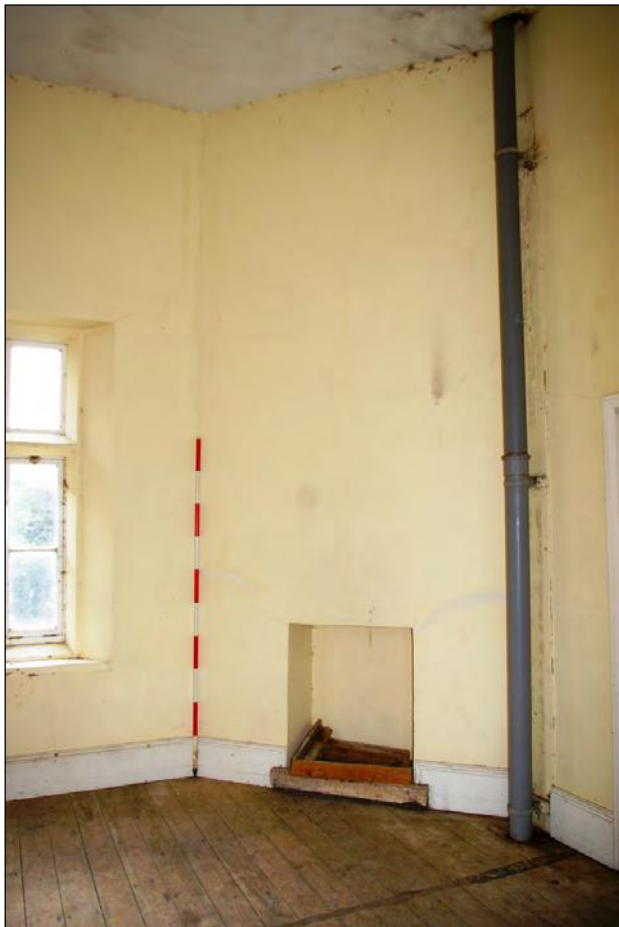
Figure 14: The south-west side of the tower, showing the fireplace.

There are only two significant structural changes proposed; the first is the forcing of a small fireplace into the south-west wall of the third floor, which has a blocked window, linking in to the existing flue from the ground and second floors. This fireplace will be shallow, leaving the semblance of a blocked mullion-and-transom window on the exterior and will therefore not outwardly change the appearance of the tower. The second, on the first floor, which will become a bedroom, is the addition of a window on the east side overlooking the park. The window will be designed to exactly copy the other window on the south-west wall of the first floor, keeping to the style and size. This will change the outward appearance of the tower however the relationship between the decreasing size and styles of the windows will be

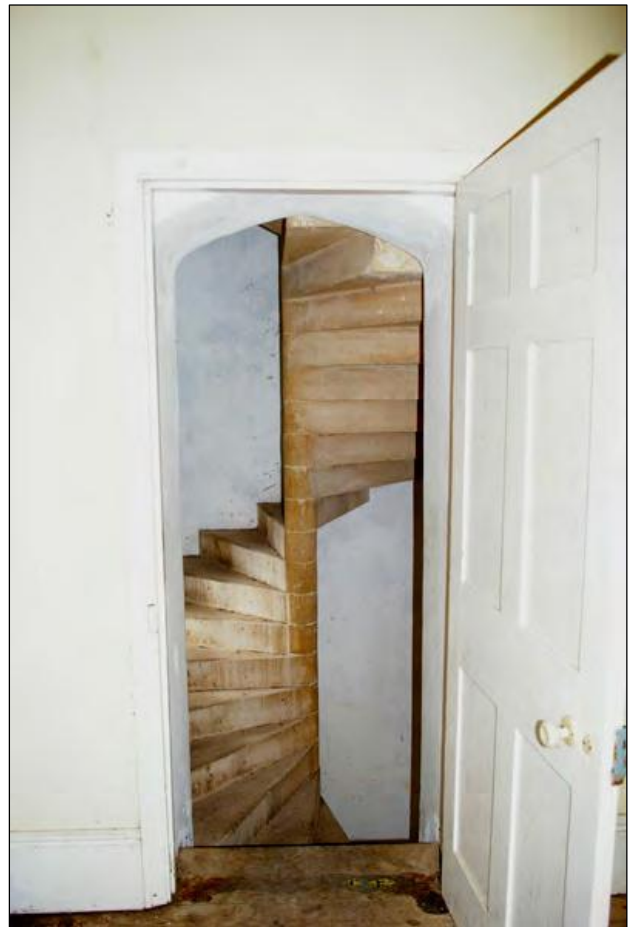
Figure 13: The first floor doorway to the stair, viewed from the east.

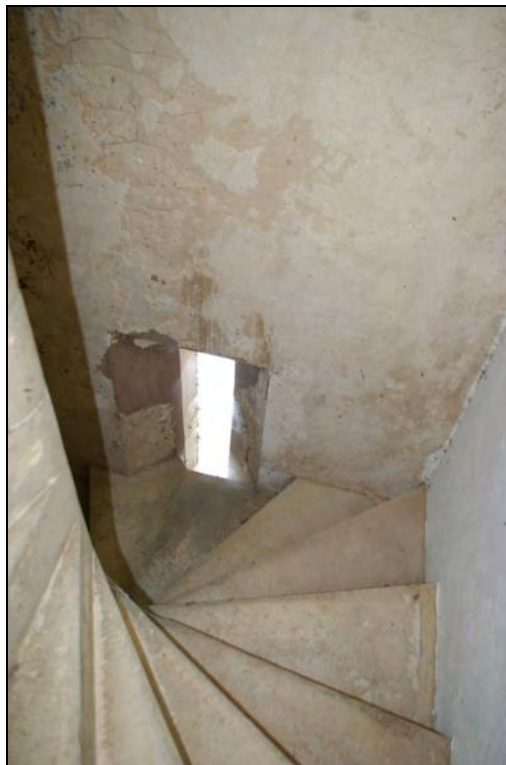
Figure 15 View down the spiral stair, showing the square corners and the stairs cutting across a window; from the south.

(Figure 18). This seems like an awkward design, at odds with the care and attention that has gone into creating the appearance of the tower, such as the moulded cornices, hoodmolds and mullion-and-transom windows (Figure 10). Could there initially have meant to have been a series of short straight flights of stairs, later changed to a spiral stair once the exterior was constructed; hence the off-set windows? Could there have been a change in construction teams, a problem with funding or a design change part-way through construction which affected the build, or a restricted timescale which forced an alteration? The stair turret also appears dominant in the exterior views of the tower, seeming large and ungainly in comparison to the main octagonal structure. Since the simple interior design would suggest the main focus of the building was its exterior this juxtaposition between tower and stair turret seems questionable. There does not appear however to be any present direct evidence to suggest the stair turret construction itself is later or not of the first phase. Therefore we can only hypothesise as to the odd nature of the stair and the possible causes of this.

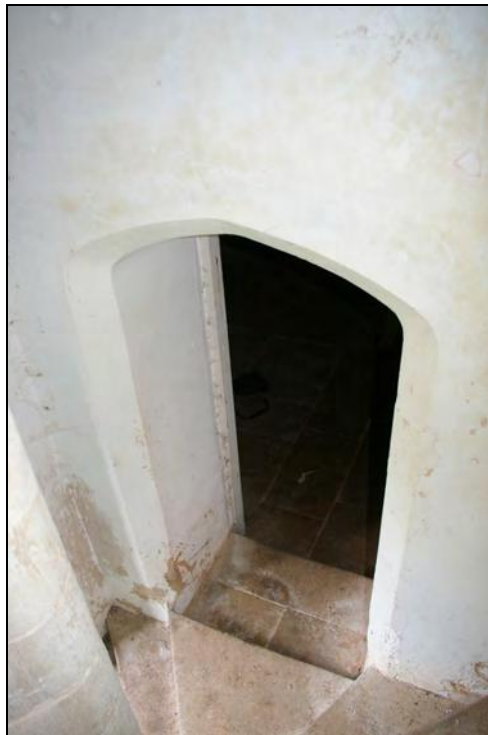
Figure 16 The door to the kitchen, from the north.

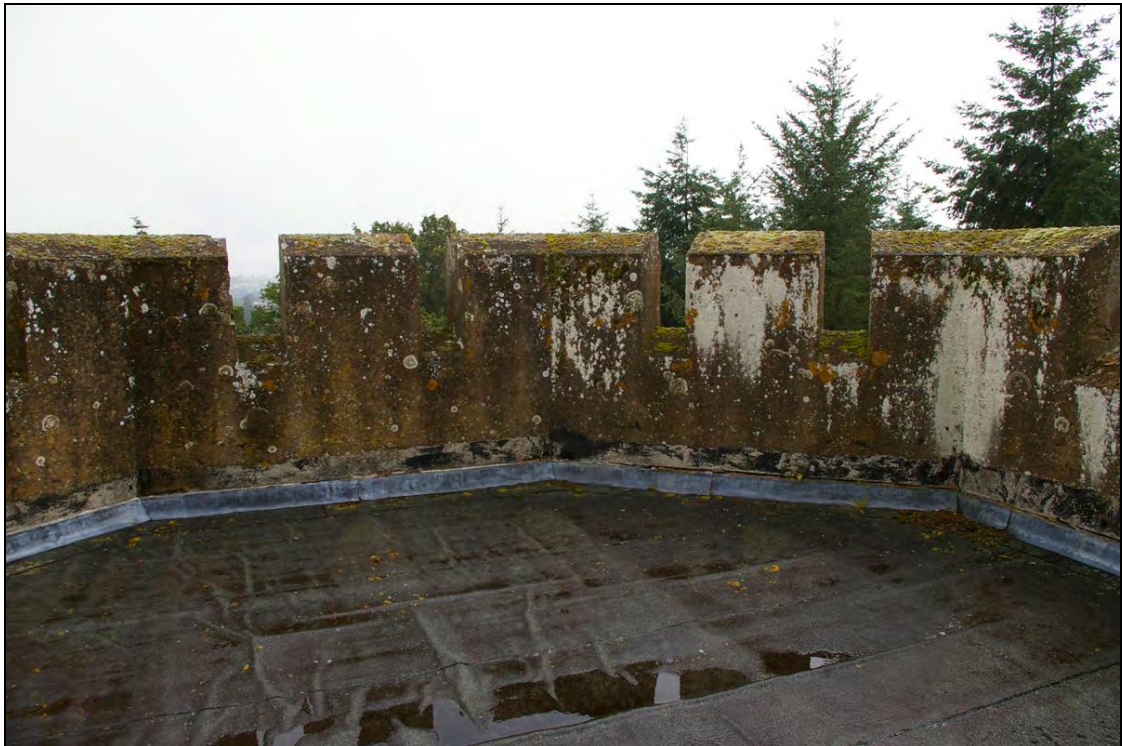
Figure 20: The flat roof and parapet of the tower, from the north-east.

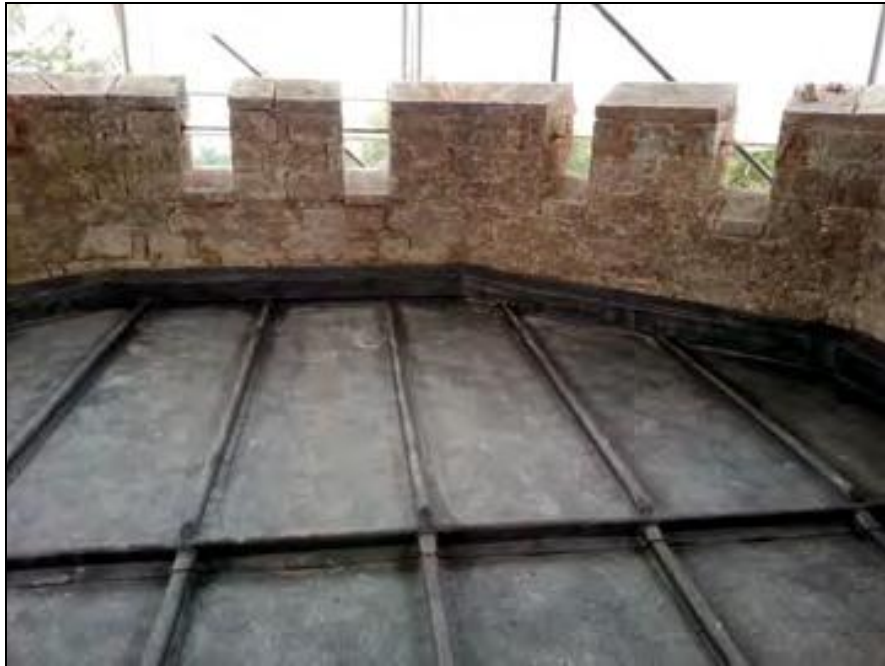
View of roof terrace with embattled parapet which has been stripped of render, exposing dressed stone to the crenellations; this may originally have been pointed, contrasting with the original white render of the building when new, adding to its Gothic-style. The new leaded roof can be seen to have been fitted.

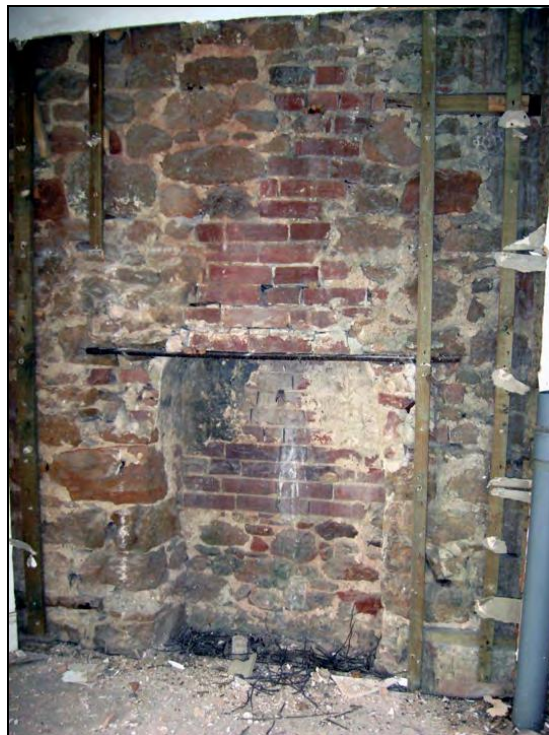
Photograph of the fireplace which serves the third floor room; showing it stripped of plaster. The stone stack and former open stone-built hearth can be seen to be patched with brick, possibly from late 19th century or a 20th century grate or stove.

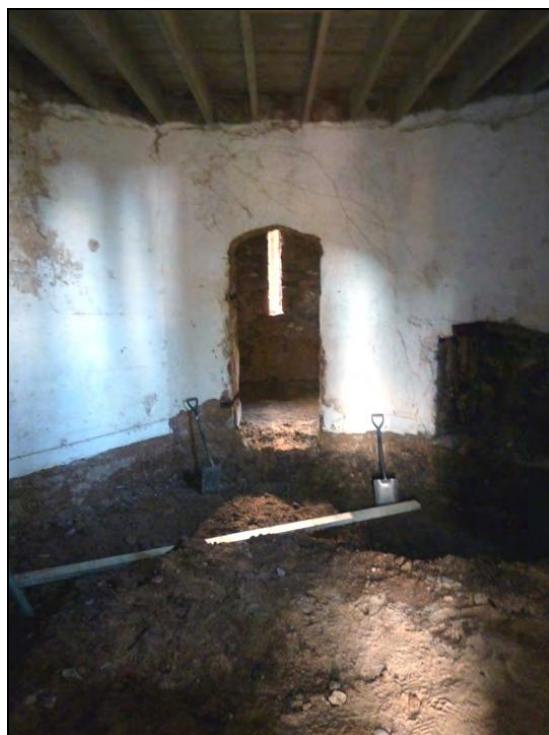
View from the entrance porch across the kitchen to the service room; showing the earth floor which has been removed by hand. The blocked arrow slit window in the service room can be seen to have been opened.

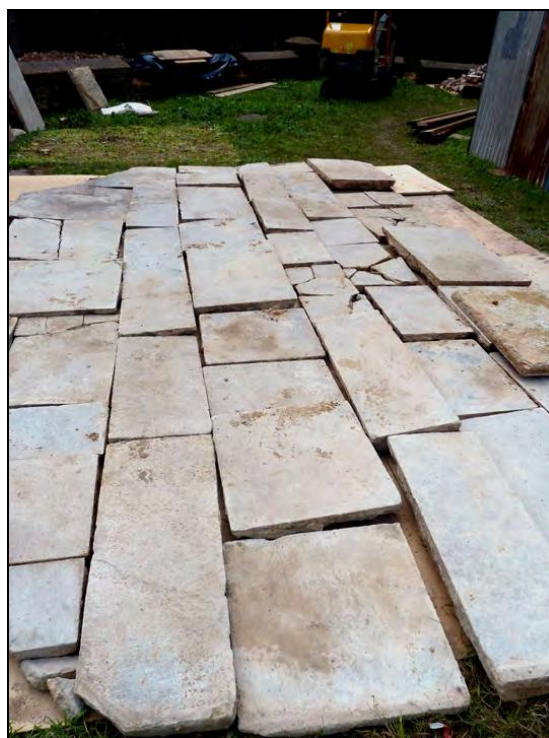
Photograph of the stone flagged floor from the kitchen, removed by hand, showing the cleaned and recorded stones.
