POOLE FARM THORVERTON DEVON

Results of a Desk-Based Study, Geophysical Survey,
Visual Impact Assessment & Evaluation Trenching

Report No.: 120918
Date: 18.09.12
Author: B. Morris
J. Bampton

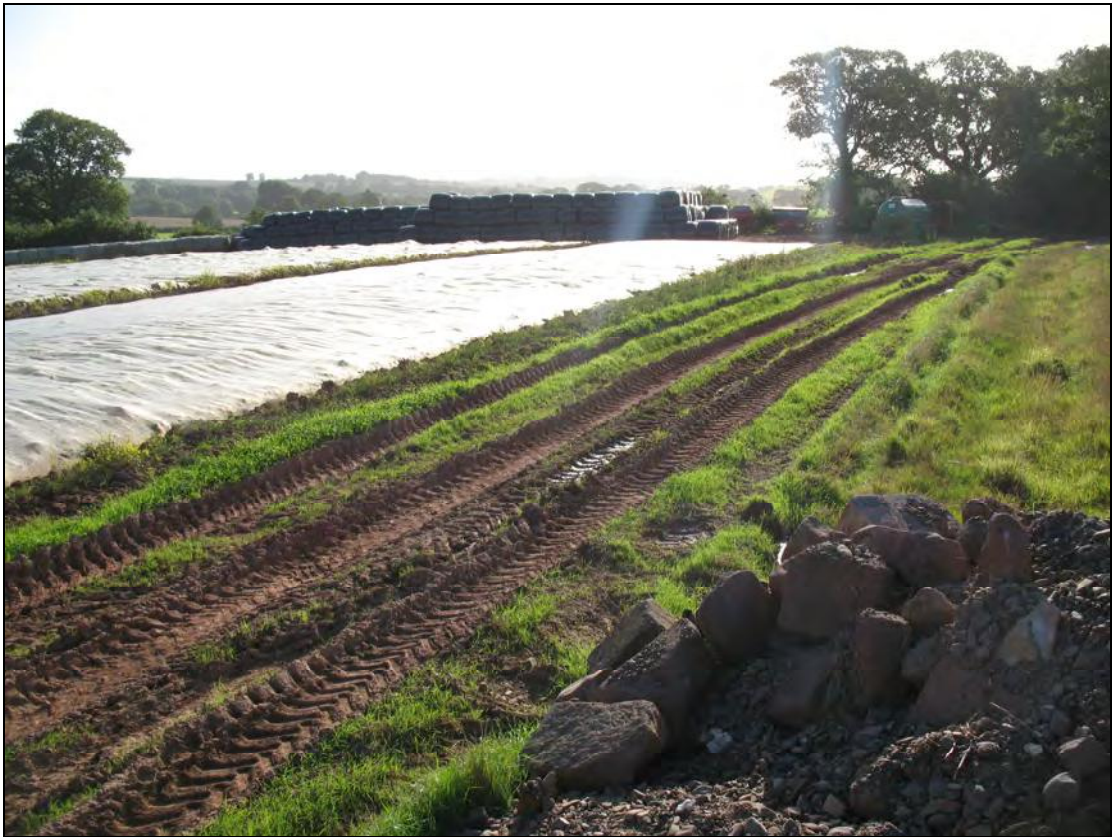
Figure 6: The site, panoramic, from the western edge of the site, looking east.

The site is bisected by a narrow track (Figure 6) made up of rounded pebbles/cobbles, implying it is not recent in date. At the time of the survey, wrapped and unwrapped round bales, farm machinery and hardcore were stored around the edges of the development area. A rapid survey of the limited amount of exposed soil did not identify any artefacts.

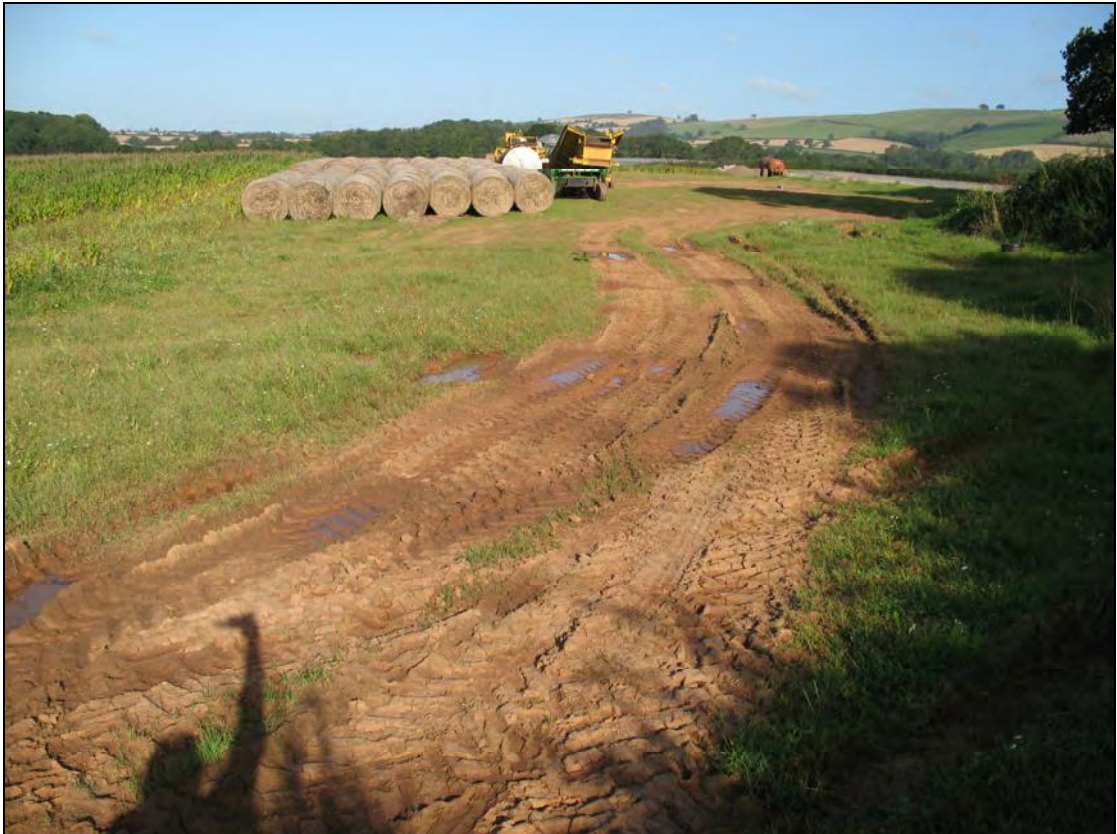
Figure 7: The site, from the south-east corner of the development (proposed mobile home site, looking north-west).

The walkover inspection was conducted on 5th September 2012 by Dr. Bryn Morris. The weather was fine, dry and sunny; visibility was good, but slightly hazy. The field to the south of the development contained a half-grown maize crop (Figure 7) and the field to the north was covered with plastic sheeting protecting a young brassica crop (Figure 6). No earthworks were visible, although the maize crop would have concealed all but the most obvious of features. The area of the development was almost flat with no visible earthworks, and low, dense weed coverage concealed the soil (Figure 7). The ground falls away to the north, west and south, leaving the site atop a low prominence.

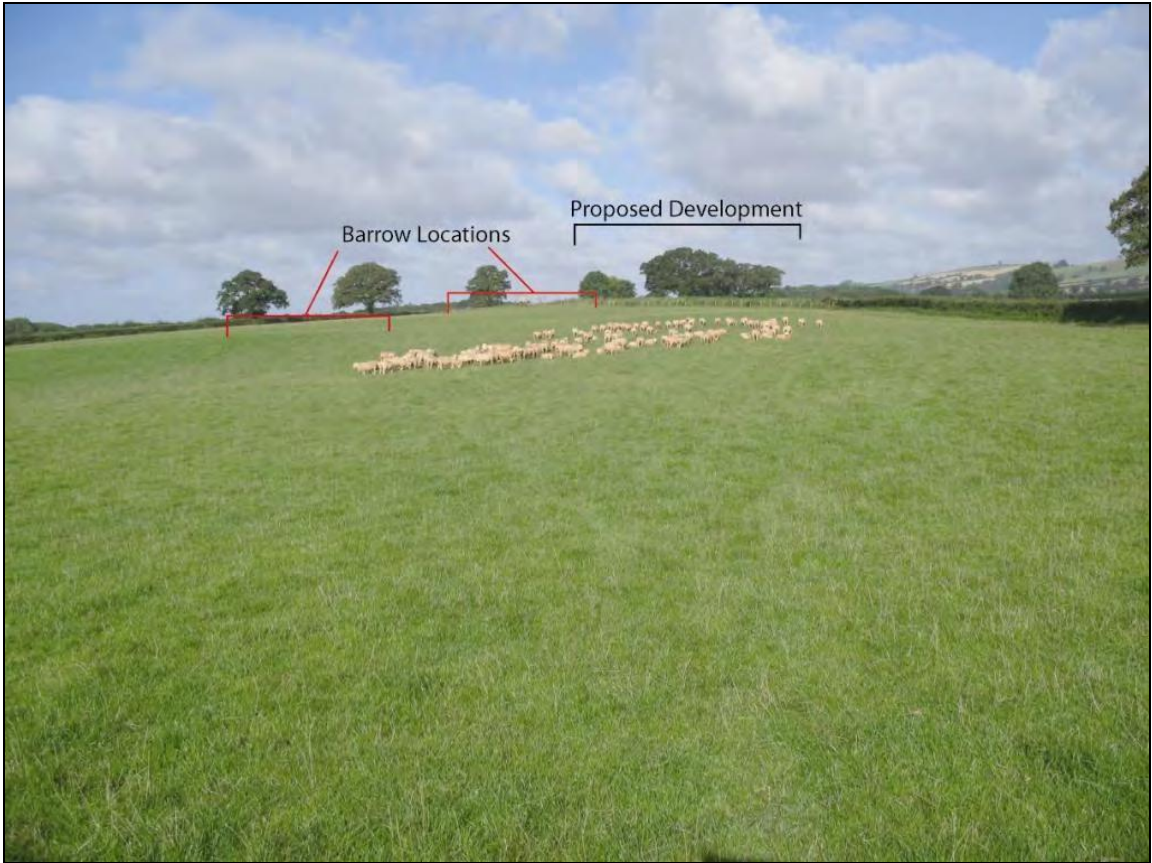
Figure 8: The view from the eastern barrow, looking WNW, towards the proposed development.

The three barrows lie on a south-east facing slope, and address a south-eastern aspect. The area of the proposed development lies just beyond the crest of the ridge, and is almost completely screened by the present field boundaries and the oak trees growing there. In terms of the setting of these monuments (Figures 8, 9 & 10), the construction of the proposed farmstead would not have a particularly significant visual impact. If the trees were maintained, augmented or replaced when felled/died, they would effectively screen the site from the monuments. This is especially the case from the two eastern most of the three barrows, as the topography (and the western barrow) acts to obscure the proposed development entirely.

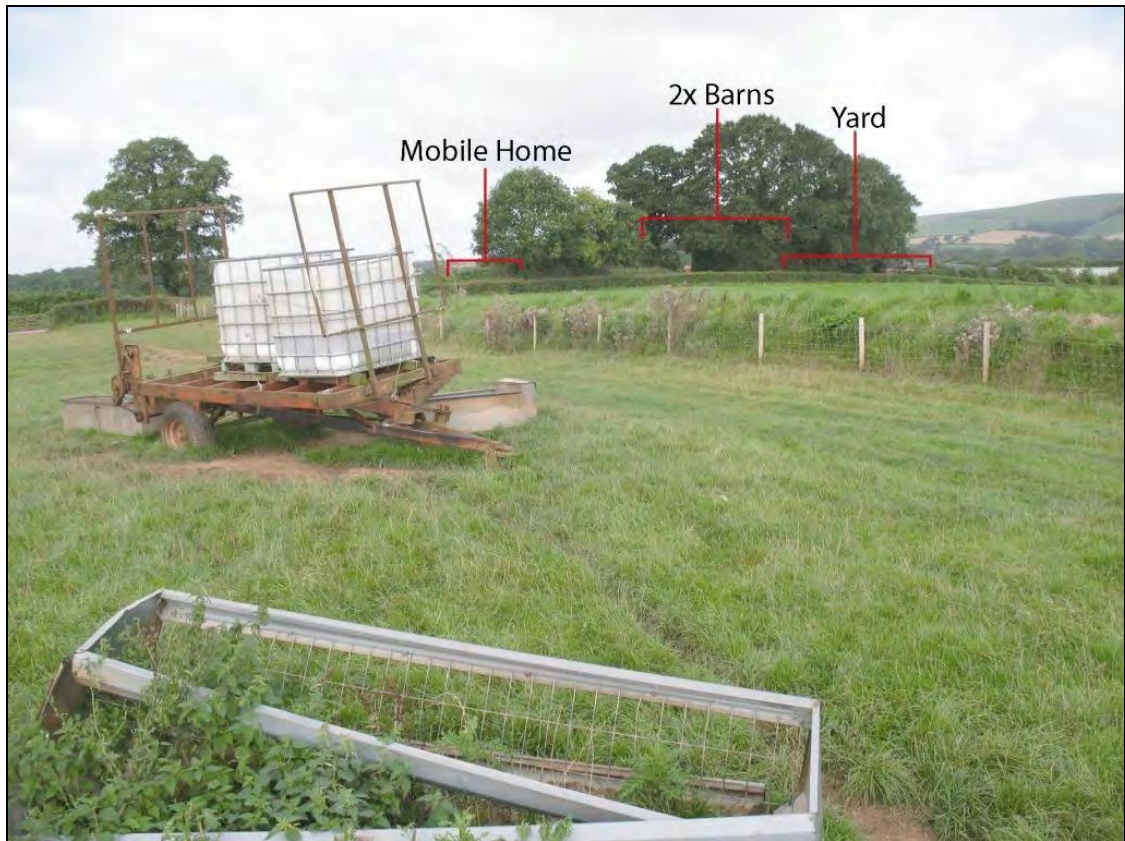
Figure 10: The view from the western barrow, looking NW, towards the proposed development site. The height of the barns and mobile home is indicated.

The western of the barrows would in contrast have its setting slightly impacted visually by the proposed development, although the proposed planting schemes negate most of the visual impact. The exception being the slight gap created by the entrance to the development site (see Figure 10), which will mean that one of the two proposed agricultural buildings will be partially visible from the barrow. However the setting of this particular monument is already compromised by the mid-20th century well which has had a **negative major, permanent irreversible** impact on the barrow having cut through part of the extant mound, and resulting in the ongoing erosion of the monument (see Figure 11).

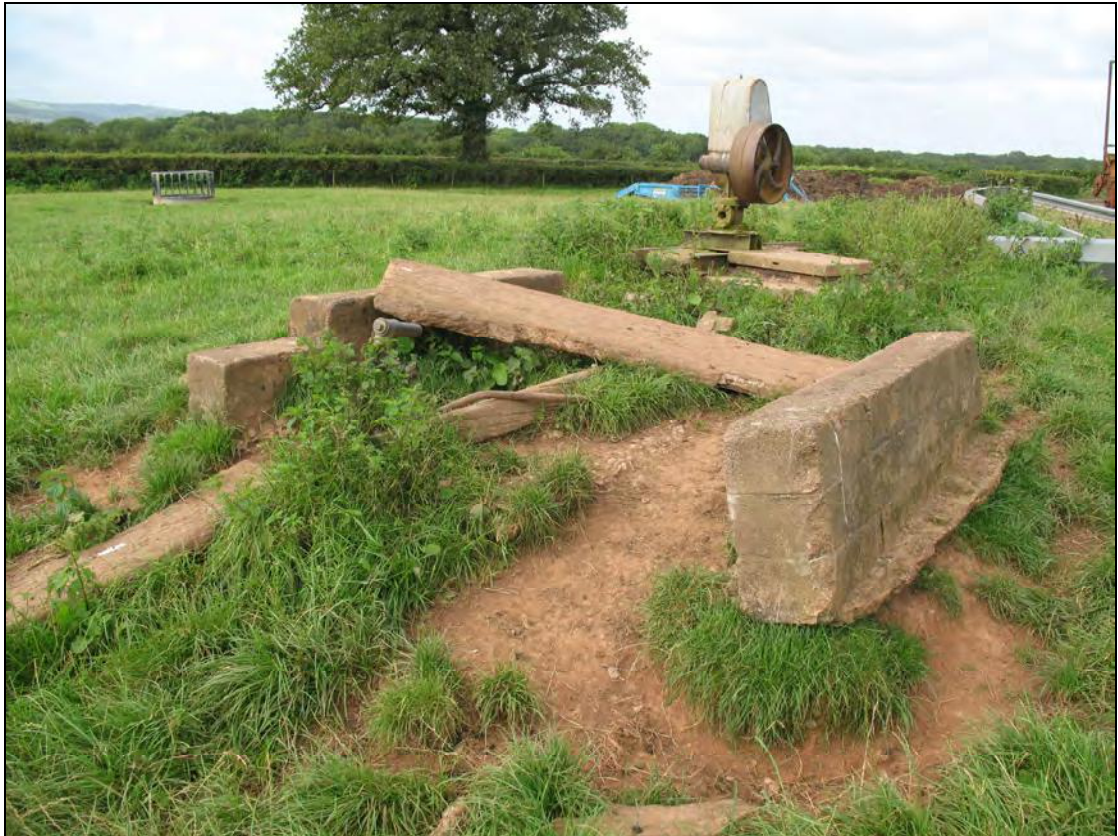
Figure 11: Well and water tank foundation inserted into the western barrow, viewed from the east.

The three Scheduled Monuments [Scheduled Monument No. 1017133] – all round barrows (Tumuli on Figure 1) – lie in a field to the east of the road. At the time of the survey, the field was closely grazed and relatively subtle features would have been apparent. Even so, the three barrows have been lowered and spread through ploughing and are not at all obvious features (e.g. Figure 8). They all appear to be *c.*30-40m in diameter, and *c.*0.5m high. The two eastern mounds are low, ploughed-down mounds within the open field. The western mound is slightly better preserved, but a 20th century well, with concrete capping, pump and water tank foundations, has been sunk through the eastern part of the mound (Figure 11). The well is *c.*5m deep to the water level.

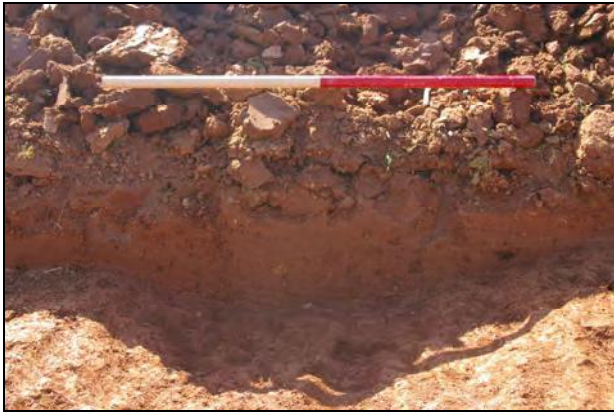
Figure 13: Ditch [101]. NE facing section, viewed from the SW (scale 1m).

Trench 6 was 14.40m in length. It contained Ditch [101] (Figures 13-15, 21.1, 21.2, 21.3). A single shallow concave linear, between 1 and 1.30m wide, aligned roughly east-west with a very gentle northern slope and gentle-moderately steep southern slope. It contained Fill (102), which contained fragments of hand-made brick, and most likely dated to the 18th century. The exposed length of this feature was 100% excavated.

The linear present in Trench 6 (Ditch [101]) produced hand-made brick fragments from the post-medieval period; most likely the 18th century. It possibly equates to a weak positive anomaly from the geophysics survey conducted by *Stratscan* (anomaly 1e, see Figure 12). This type of anomaly is generally non-conclusive and may be geological or modern features particularly close to the surface. Two similar such anomalies that would have run through Trench 1 were proved not to be archaeological and given the alignment of the anomaly and the feature it is possible that this anomaly too is not the result of the archaeological feature that conveniently occupies a similar location. Ditch [101] seems to line up closely with- and equate to an earlier field boundary running south-west from the three-way entrance to the site that would have divided the field south of the sites trackway in two (Figure 22). This boundary can be seen on the 1808 Raddon Estate map (Figure 3) dividing the fields numbered 129 and 131. This boundary is still present on the 1889 title map (Figure 5) as dividing the fields numbered 945 and 947 and on later OS maps (Figure 23). Due to extensive ploughing and agricultural activity post the removal of this boundary no evidence was present of it as an earthwork during the earlier conducted walk-over survey and what survives of the boundary was immediately sealed by topsoil.

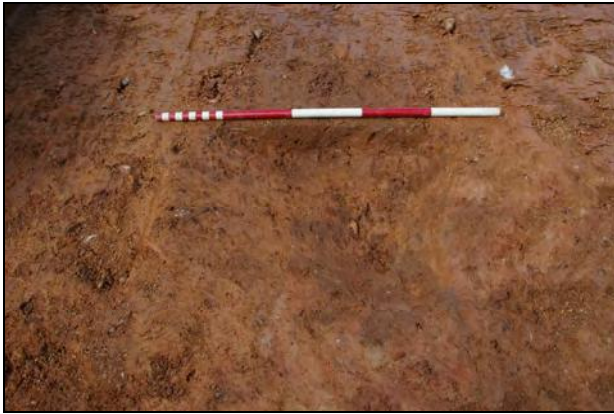
Figure 16: Posthole [103]. SE facing section, viewed from the SE (scale 0.5m).

Trench 7 was 12.10m in length. It contained three postholes (Figures 15-19 and 21.7). From the south-east running north-west these were [103] (Figures 15, 21.4), [105] (Figures 16, 21.5), [107] (Figures 17, 21.6). Each contained one fill and had been disturbed by ploughing. Posthole [107] contained a single fragment of slag. None of these features produced dateable finds. These features were 100% excavated.
