CROSSWAYS ATHERINGTON UMBERLEIGH DEVON

Results of a Desk-Based Appraisal &
Archaeological Monitoring & Recording

> Report No.: 121129 Date: 29.11.2012 Authors: J. Bampton

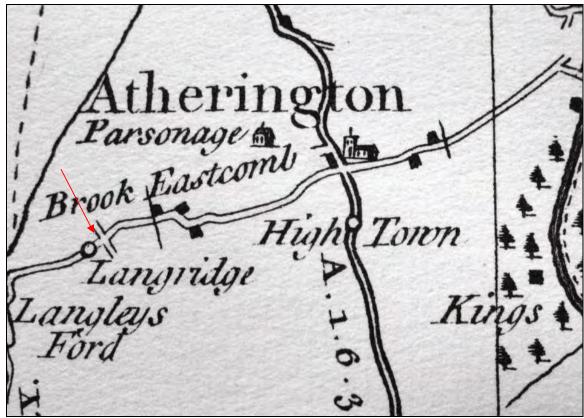
Figure 2:Extract from Benjamin Donn's map of the County of Devon, 1765 (the site is arrowed).

The earliest available cartographic source for Atherington is Donn's map of Devon published in 1765 (Figure 2), which shows the crossroads at Langridge (this is on the opposite side of the B3227 to the Crossways site) as having no buildings around it. Although this early map may contain errors or omit some contemporary buildings it does appear to suggest that there may have been no significant settlement or holding on this site at the time.

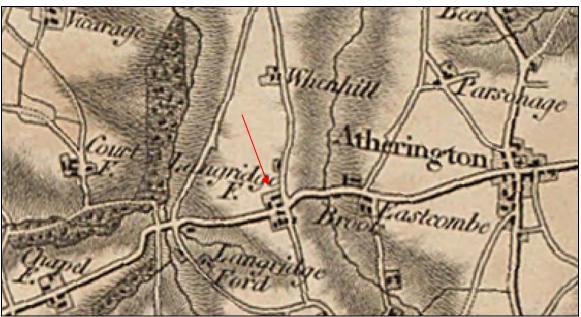
Figure 3: The Ordnance Survey "Old Series" 1 inch to the mile, 1809, sheet 26 (the site is arrowed).

This is the published version of the first Ordnance Survey draft map (Figure 3) and clearly shows a number, perhaps three buildings at the location corresponding to the farmstead at Crossways. The exact layout and number of buildings cannot be accurately or positively stated due to the possible conglomeration of structures for their simplified depiction.

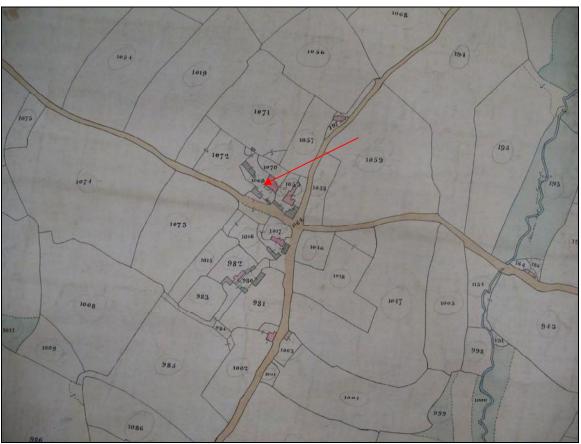
Figure 4:The 1840's tithe map for the parish of Atherington detailing Crossways. The site is arrowed.

The 1840 tithe map (Figure 4) is the first clear depiction of the structures on the site, although this is not to say that there may not be dimensional or interpretive errors. The domestic buildings at

Crossways are coloured pink, whilst the agricultural or non-domestic buildings are coloured grey. The map shows some adaptation of medieval field boundaries, which follow the aspect of medieval furlongs. This with the scattered pattern of land holdings suggests a piece meal conglomeration of plots based on the late medieval field systems.

The site in question occupies the plots numbered 1069 and 1070 'Hardings', and comprises a house, yard and garden with four outlying barns occupied by a John Harris (see section 2.4 below). The adjacent property with two outlying barns, numbered 1053 'Snows', was occupied by a Thomas Hunt. The domestic building or farmhouse within plot 1053 now constitutes the only existing farmhouse at Crossways. The former property, 'Hardings', now the development site, has only a single extant building the rest having been removed. The fields abutting the proposed development area are two orchards flanking a meadow.

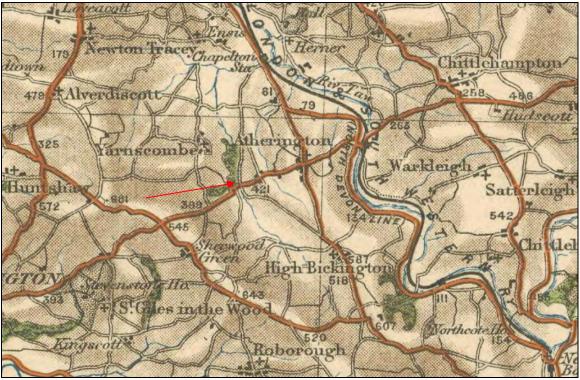
Figure 5: The Ordnance Survey Coloured Edition, 1903 (@1:253440).

As with the 1888 1st Edition Ordnance Survey map above, the 1904 2nd Edition can be observed at old-maps.co.uk and at the Devon Record Office. It shows continuity of detail with the 1888 map apart from the loss of the small plot that occupied part of the former farmhouse site. Also, a possible lean-to structure, visible on the tithe map and the 1888 Ordnance Survey map, on the west end of the north elevation of the only remaining building on the former site of 'Hardings' is absent (Figure 20). This map therefore corresponds to the current layout of the site. The 1903 Ordnance Survey Coloured Edition (Figure 5) below, for which the 2nd Edition 1904 map mentioned above provides more detail, simply highlights the continuity in the presence of a settlement at the site.

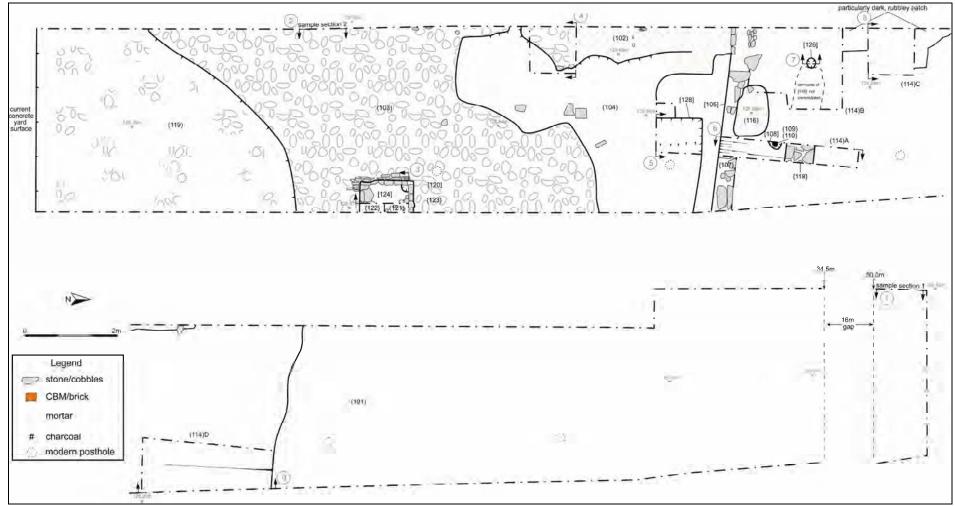
Figure 8: Plan of the excavated trackway, including figure numbers and locations for sections.

No archaeological features were encountered in the northern half of the excavated trackway (see Figures 8 & 13). All archaeological layers occurred within 23m of the southern limit of excavation (Figure 7). All contexts were dated to the 18th or 19th century although residual post-Medieval wares and a single sherd of 16th century pottery were recovered. The following description addresses the site running from the south to the north. Further details of any contexts can be seen in Appendix 4 and details of the finds in Appendix 5.

The monitoring and recording of the trackway revealed a number of 19th century deposits with three walls and three cobbled surfaces (Figures 8 & 23). The earliest features were two postholes associated with the construction of wall {118} and sealed by its construction. A third posthole beneath the wall {122} to the south of the site supports the interpretation that these features were an early part of the construction phase for the building. The post nearest to the *in situ* element of wall {118} was burnt and the wall abutted on its north side by a charcoal spread which occurred across the width of the excavation. This signified a destruction event over which a series of demolition layers, including re-deposited natural layer, was spread. One of these layers ((113)) was then cut by the cut for wall {107}, which, aligned east-west, bisects the site. The north side of this wall was abutted by a mortar floor and to the south were three cobbled surfaces tiered to the south and overlaid with mortar and demolition rubble close to the wall. The cobbles respected wall {122}, which terminated within them.

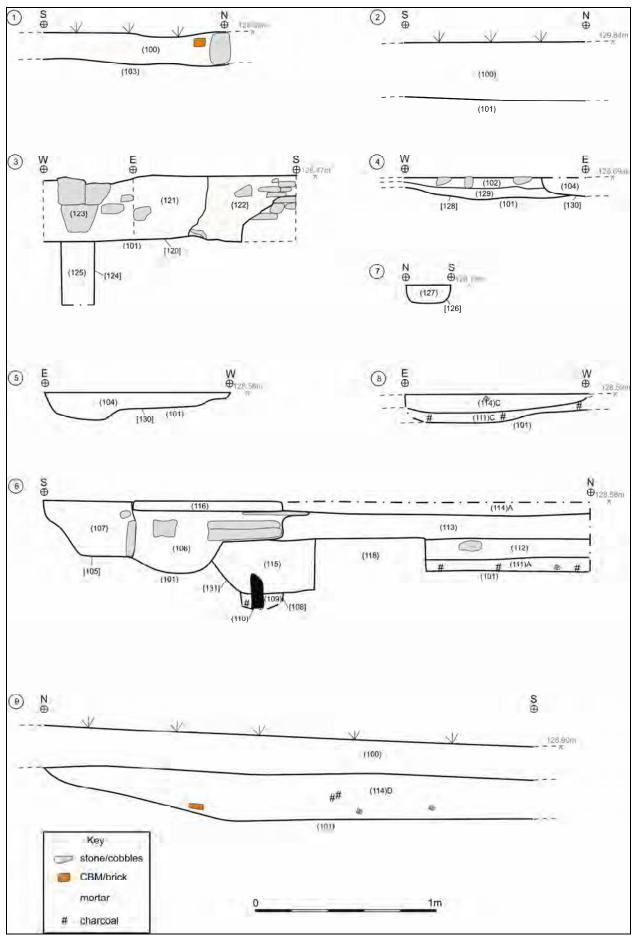
Figure 9: Section drawings, numbered 1-9 on Figure 8.

Within layer (103) the west end of wall $\{122\}$ was set (Figures 9.3, 10), which terminated 0.75m from the eastern limit of excavation. The cobbles (103) respected/abutted the lining of the wall suggesting they were instated contemporarily with the wall, although it is not impossible that the wall was inserted later and the cobbles neatly rearranged to respect it. The construction cut [120] for the wall was 1.15m wide and cut c. 0.35m into the natural and was lined by substantial squared stones up to 15 x 10 x 15cm $\{123\}$, with the remnants of mortar bonding. The southern half of the cut was filled with the wall proper $\{122\}$, of various sized flat stone slabs c. 0.05m thick and heavily lime mortared in places. The gap between $\{122\}$ and the north lining $\{123\}$ of the cut was 0.40m wide and filled with construction fill (121); earth and cobble like rubble set in a mid orange brown, soft clay-silt matrix with moderate flecks of mortar.

A stone slab within (121) was sealing post pipe void (125), which must have been cut by construction cut [120]. Posthole [124] (see Figure 9.3), 0.20m across x 0.35+m deep, was so neatly related to the end of wall {122} that it probably marked the layout for the construction. (125) was primarily a void with some shillet and silty-clay within it suggesting that its' post was most likely to have been removed immediately prior to the completion of the wall.

Cutting cobble layer (103) to the north was disturbance [130] that contained layer (104) (Figures 9.5, 23) which, at a similar level to that of (103), was probably a continuation of the cobbled surface. (104) was a dark grey-brown, firm silt-clay, much like the earthy bonding of the extant cobble surfaces, with frequent cobble and CBM rubble and occasional charcoal flecks. This layer of disturbance ceased approximately 0.30m south of wall {107} but cut the upper tier of the cobbled surfaces, layer (102).

Cobbled surface (102) (Figures 9.4 & 15) was mainly comprised of finer, sub-round cobbles on average 2.5 x 8 x 5cm, set in a regular course into a silty clay matrix and re-deposited natural. It included frequent flecks of mortar near to wall {107}, which it abuts. (102) was set into the ground surface raised with re-deposited natural (129), which filled the terracing cut [128]. This terracing of the land appears to have stripped the topsoil and softer clayeyer natural from the cobbled areas to a suitably compact natural and then been used to make-up the cobbled surfaces into three distinct tiers.

North of the cobbled and disturbed surfaces the natural was cut by linear construction cut [105] for wall {107} (Figures 9.6, 11 & 16). [105] was a steep sided cut aligned east-west with a flat base slightly sloped down to the north. The north side of construction cut [105] cut demolition layer (113). Cut [105] contained wall {107} in its southern half: this was abutted by construction fill (106), which filled the northern half of the cut. Fill (106) was a dark browngrey, friable-soft silt-clay with squared stone block rubble and provided the make-up layers for the lime mortar floor surface (116), which also abutted wall {107}. Wall {107} was comprised of flat, squared, semi-coursed stone with occasional lime mortar bonding. Floor surface (116) had a single broken piece of flat stone with mortar bonded to its base that may suggest a stone floor was formerly in place but now removed.

Approximately 0.6m north of wall {107} was posthole [108] (Figures 9.6 & 18), 0.25m across, an ovoid, vertical sided cut. It contained fill (109), a dark grey soft silt-clay with occasional charcoal flecks; and an *in situ* broken and burnt post {110}, 0.13m across and protruding c.0.22m from the cut and section. This was sealed within demolition rubble (115), a dark grey friable clay-silt with frequent rubble and mortar flecks. This may constitute the fill for construction cut [131], which cut or engulfed posthole [108]. It contained wall {118}.

Wall {118} (Figures 9.6, 22), was comprised of large square blocks of semi-coursed stone with earth bonding within it, as well as occasional mortar bonding, particularly evident on its south face and top. It appears to be the lowest of wall courses, set directly onto the hard shillet stone natural. It was abutted by demolition/destruction layers (115) on its south and (111)A and (112) on its north, and overlaid by demolition layer (113). It runs parallel to wall {107} and only survives as a rubble patch to the west that ends at posthole [126]. Posthole [126] (Figures 9.7, 19), 0.25m across and 0.10m deep, had vertical sides and a flat base and contained fill (127), a dark grey-brown, soft clay-silt with no finds or inclusions. It was sealed by the mixed demolished remnants of wall {118} and destruction layer (111)B.

Destruction layer (111) (Figures 9.6, 9.8 & 22), a dark black-grey, soft clay-silt with frequent charcoal flecks and occasional stone debris abutted wall {118} and was suggestive of a burning

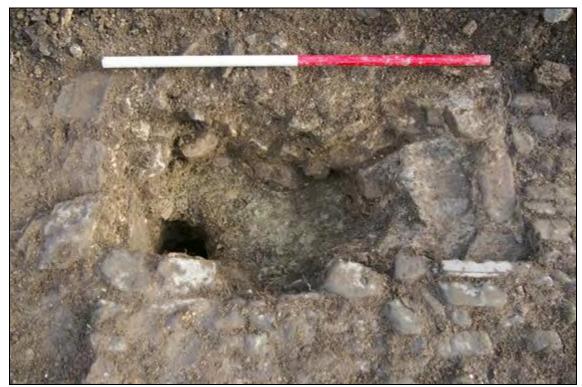
Figure 10: Wall {122}, Posthole [124], looking east (1m scale).

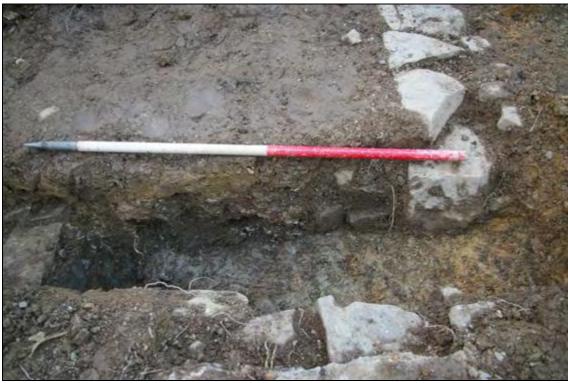
Figure 11: Walls {107}, {118} and associated contexts between, looking east (1m scale).

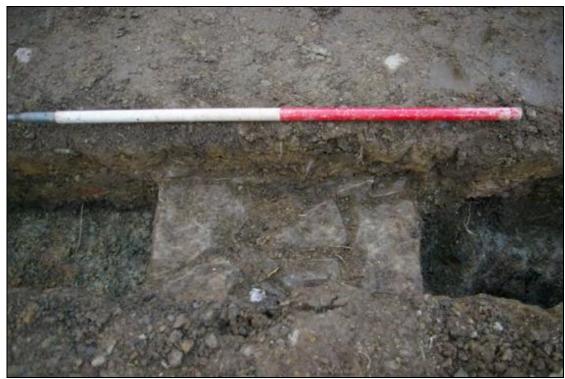
Figure 22: Wall {118}. Layers (111) and (112) visible on left with (113) sealing the wall and beneath (114), looking east (1m scale).

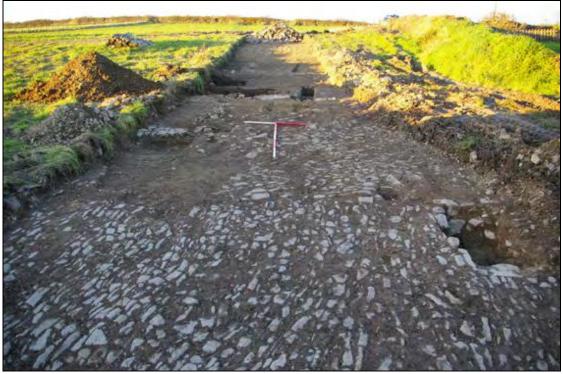
Figure 23: Site shot post-excavation, looking north (2m & 1m scale).
