# 8-11 MARKET PLACE BIDEFORD DEVON

Results of an Archaeological Evaluation

Report No.: 120903  
Date: 03.09.12  
Authors: J. Bampton  
B. Morris

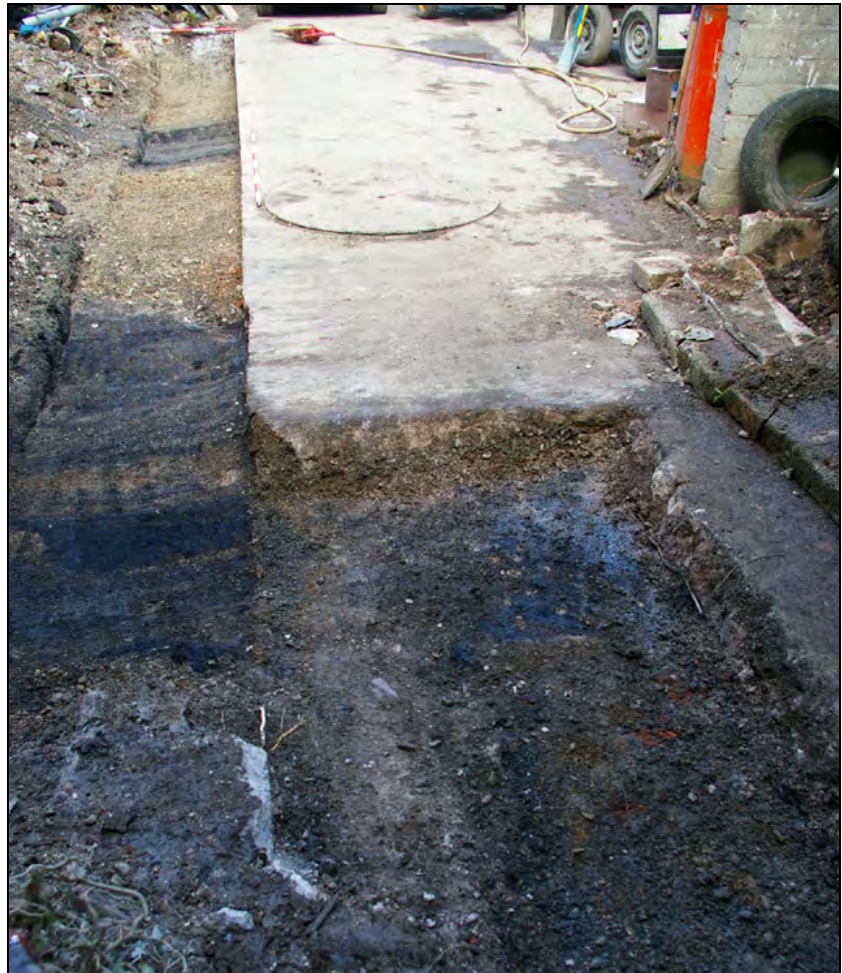
Figure 3: Trench #1, viewed from the south, looking north (scale 1&2m). Note the dark bands in the natural shillet bedrock.

Trench #1 (see Figures 3 and 11) was 12m long and orientated north-south, on the western side of the central burgage plot. It was sealed by modern floor surfaces and a concrete yard surface. Very little stratigraphy survived beneath these floor surfaces, and it is clear this part of the site has been heavily truncated. The natural bedrock is comprised of bands of rocky shillet and fine soft shales, some with black staining that probably relates to the famous Bideford paint mines.

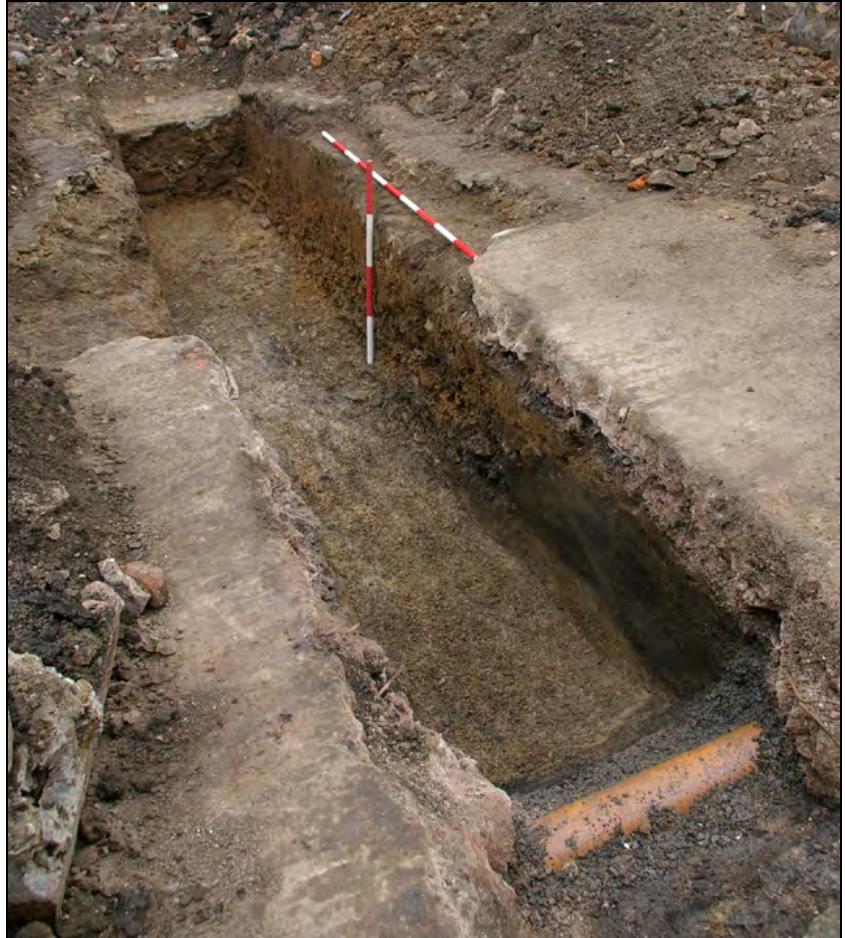
Figure 4: Trench #2, viewed from the west, looking ESE (scales 1&2m).

Trench #2 (see Figures 4-5 and 12) was located just to the south of the modern concrete and steel portal framed building in the central burgage plot. It was 7m long and orientated east-west. It was sealed by a cobbled floor (200) and the concrete yard surface. Any archaeological deposits at the upper, western end of the trench had been lost when the burgage plot was terraced, and the base of the extant floor surfaces lay just above the natural bedrock. At the lower, eastern end of the trench, archaeological deposits did survive. The modern sewer pipe observed in Trench #1 crossed the western end Trench #2.

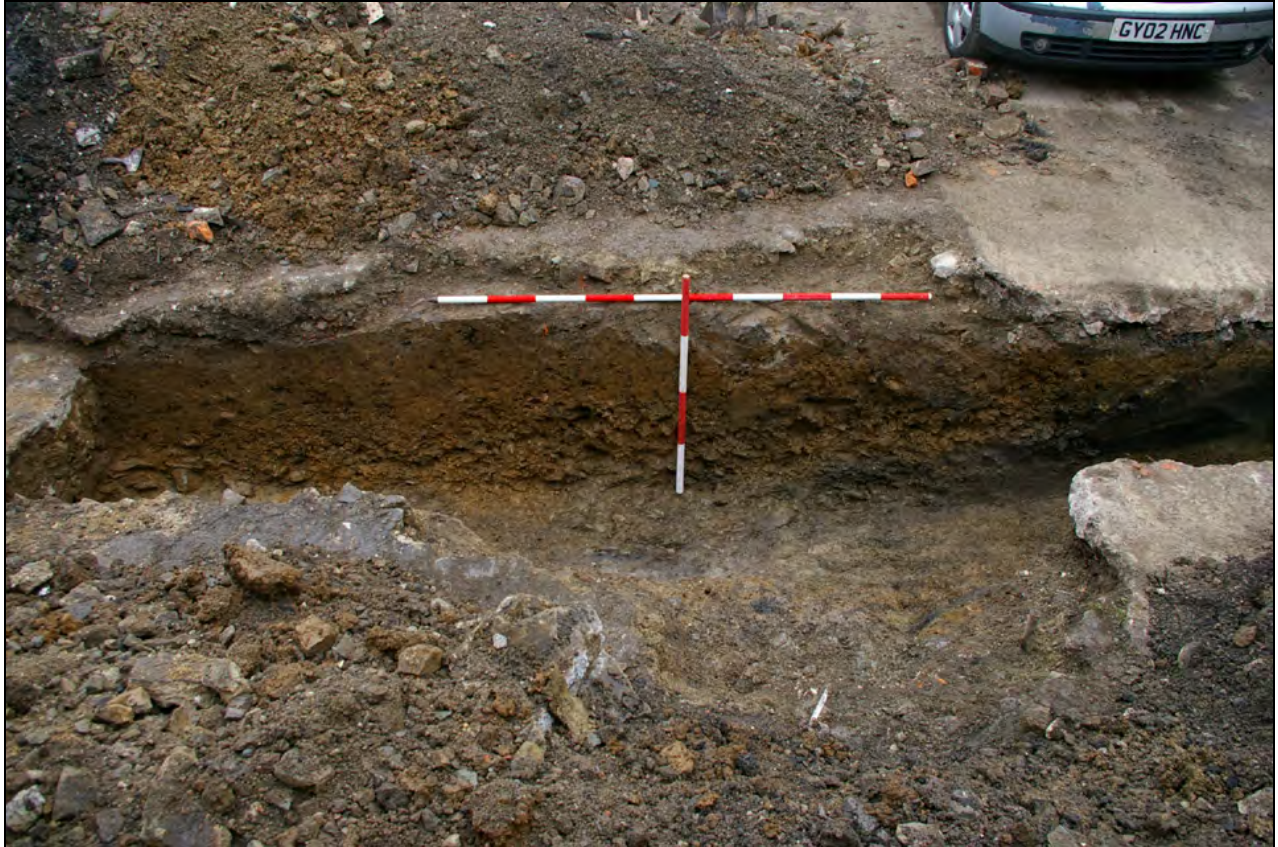
Figure 5: The north-facing section of Trench #2 (scales 1&2m).

The trench just clipped the northern edge of a large steep-sided ovoid pit [209]. It contained several fills (205-8), all of which were very clean, and contained frequent to abundant amounts of sub-angular stony rubble, with the suggestion of waterlogging. This pit was not fully excavated and produced no dating evidence. It was cut by a second pit or linear feature [213] adjacent to the eastern burgage wall {212}. Pit [213] was steep-sided with a sloping base and contained a single fill (214), a greyish-buff brown stiff clay silt. A small number of sherds of medieval North Devon pottery were recovered from this feature during the machining.

These features were sealed by layer (203), a cobbled floor surface, and this was overlain by a thin levelling deposit (202) almost entirely composed of late 17<sup>th</sup> century pottery waste. This was dominated by North Devon gravel-tempered coarsewares, but also contained sagger and burnt slate fragments and burnt sgraffito fragments. The discovery of pottery waste would normally indicate the presence of a kiln nearby, but the volume and nature of the deposit

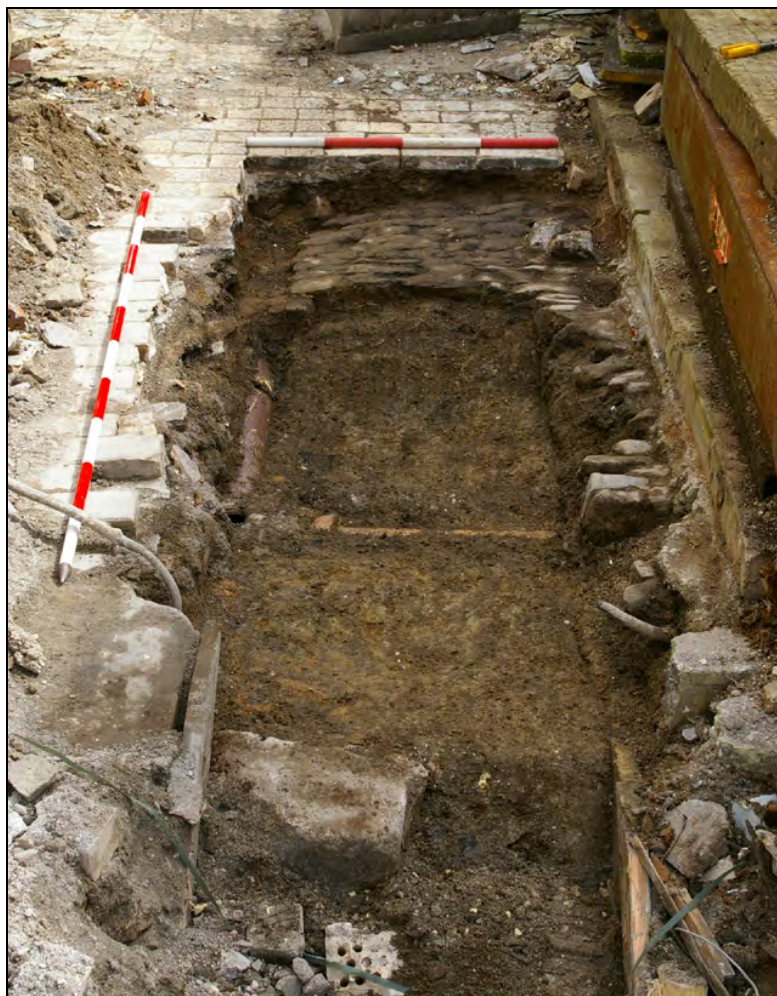
Figure 6: Trench #3, viewed from the north, looking south (scales 1&2m).

Trench #3 (see Figures 6-7 and 11) was located within the eastern burgage plot; it was 3.5m long and orientated north-south. The extant Peters Marland stable-brick floor (300) overlay an earlier cobbled surface (302) that sloped down to the east. This floor was set onto a make-up layer (303) that directly overlay the natural subsoil. Two salt-glazed sewer pipes were observed to cut through cobbles (302). At the northern end of the trench, the floors had already been dug out to below the level of the natural.

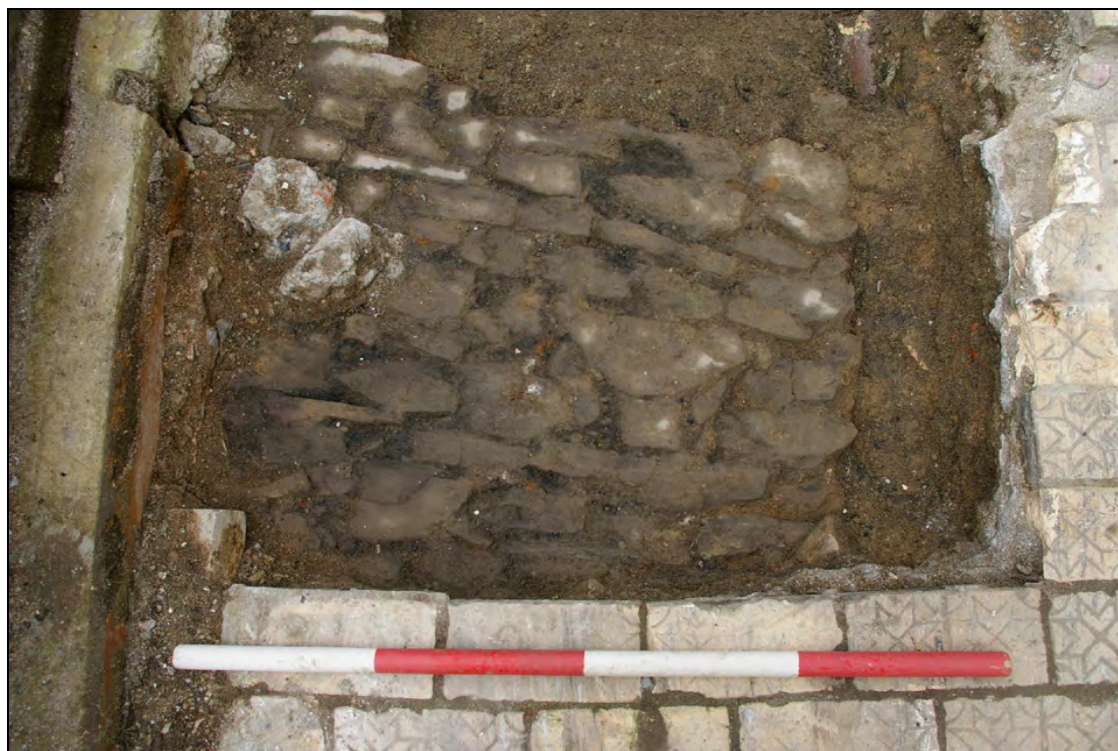
Figure 7: Detail of the cobbling (302) in Trench #3; viewed from the south (scale 1m).

(302)	Cobbled floor surface; cobbles c.60-80mm thick, blocky and irregular varying in size c.120×250mm to 20×60mm; cobbles orientated east-west and sloping to east; a working floor surface but not particularly worn; coal pressed into surface; possible drain where sewer pipe now runs.	Overlain by (301); overlies (303); cut by [304]	0.06-0.08m

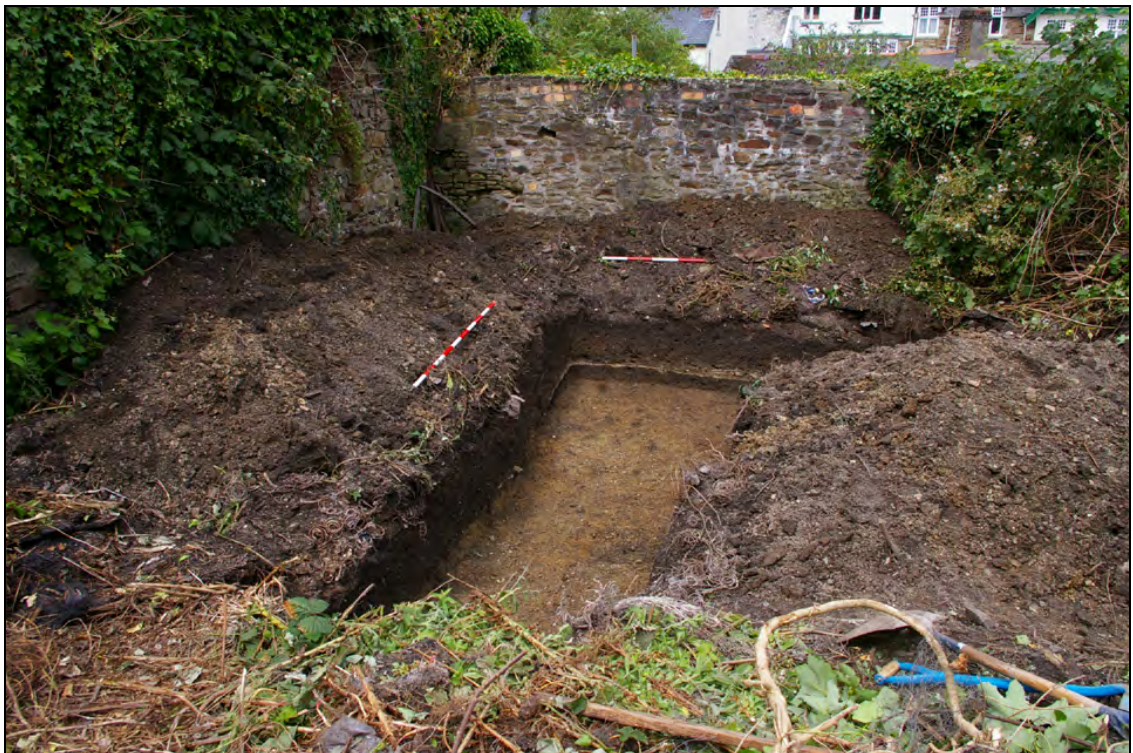
Figure 8: Trench #4, viewed from the south, looking north (scales 1&2m).

Trench #4 (see Figures 8-10 and 13) was located in the northern corner of the upper, western burgrave plot. It was 8m long and orientated north-south and east-west. The ground was observed to slope to the north-east, and in that part of the trench a soil layer (410) was preserved. This produced 60 sherds medieval North Devon pottery. It appeared to seal a small posthole [413], which contained (perhaps as post-packing) a smithing-hearth bottom.

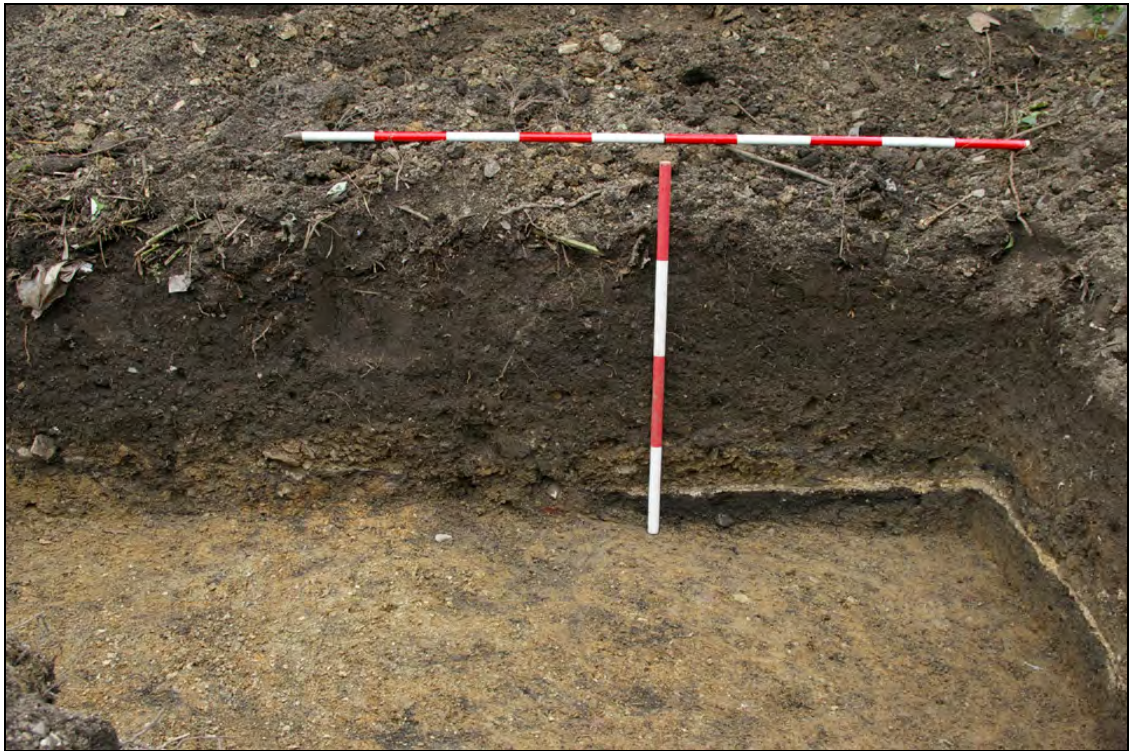
Figure 9: East-facing section of Trench #4 (scales 1&2m).

This buried soil had been truncated, and was cut by a shallow concave pit [421] containing a dark humic deposit (408). This was then sealed by a thin (20-40mm) deposit of white lime mortar (407), probably the floor of a post-medieval structure. This floor was overlain by a number of successive layers of waste: a dump of ashes and burnt material (406), and dumps of redeposited stony natural subsoil (405) (416). These deposits were sealed by a layer of dark brown friable garden loam 0.5-0.7m thick.

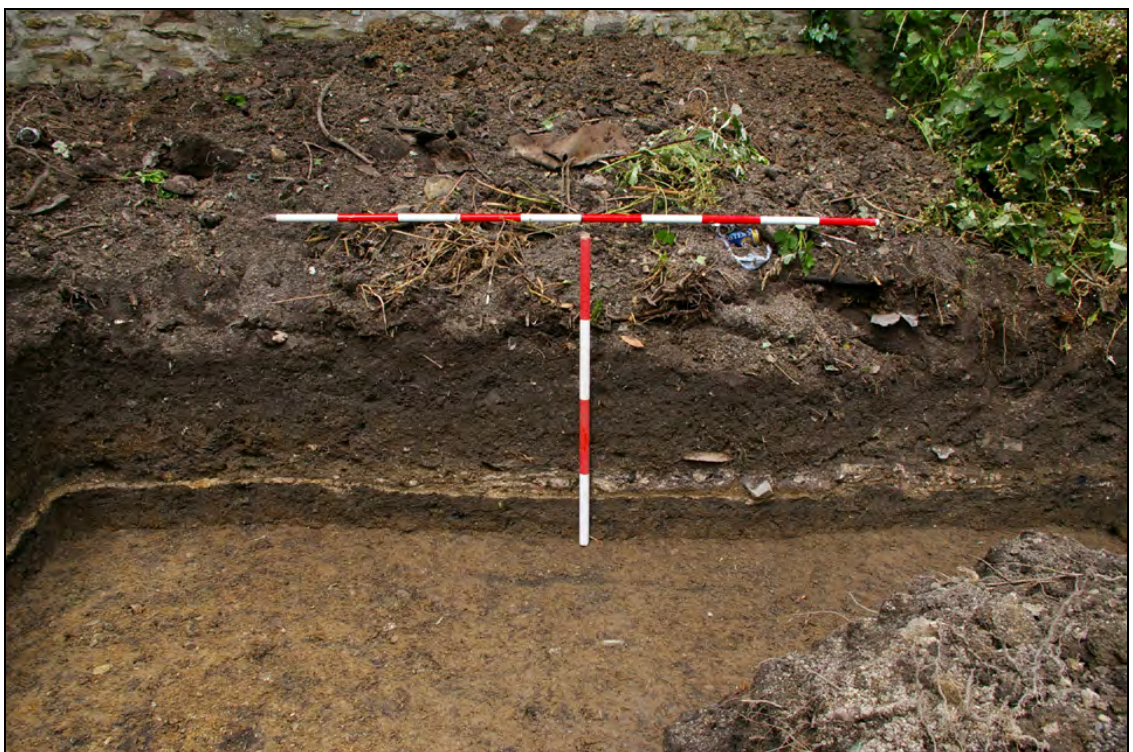
Figure 10: South-facing section of Trench #4 (scales 1&2m).

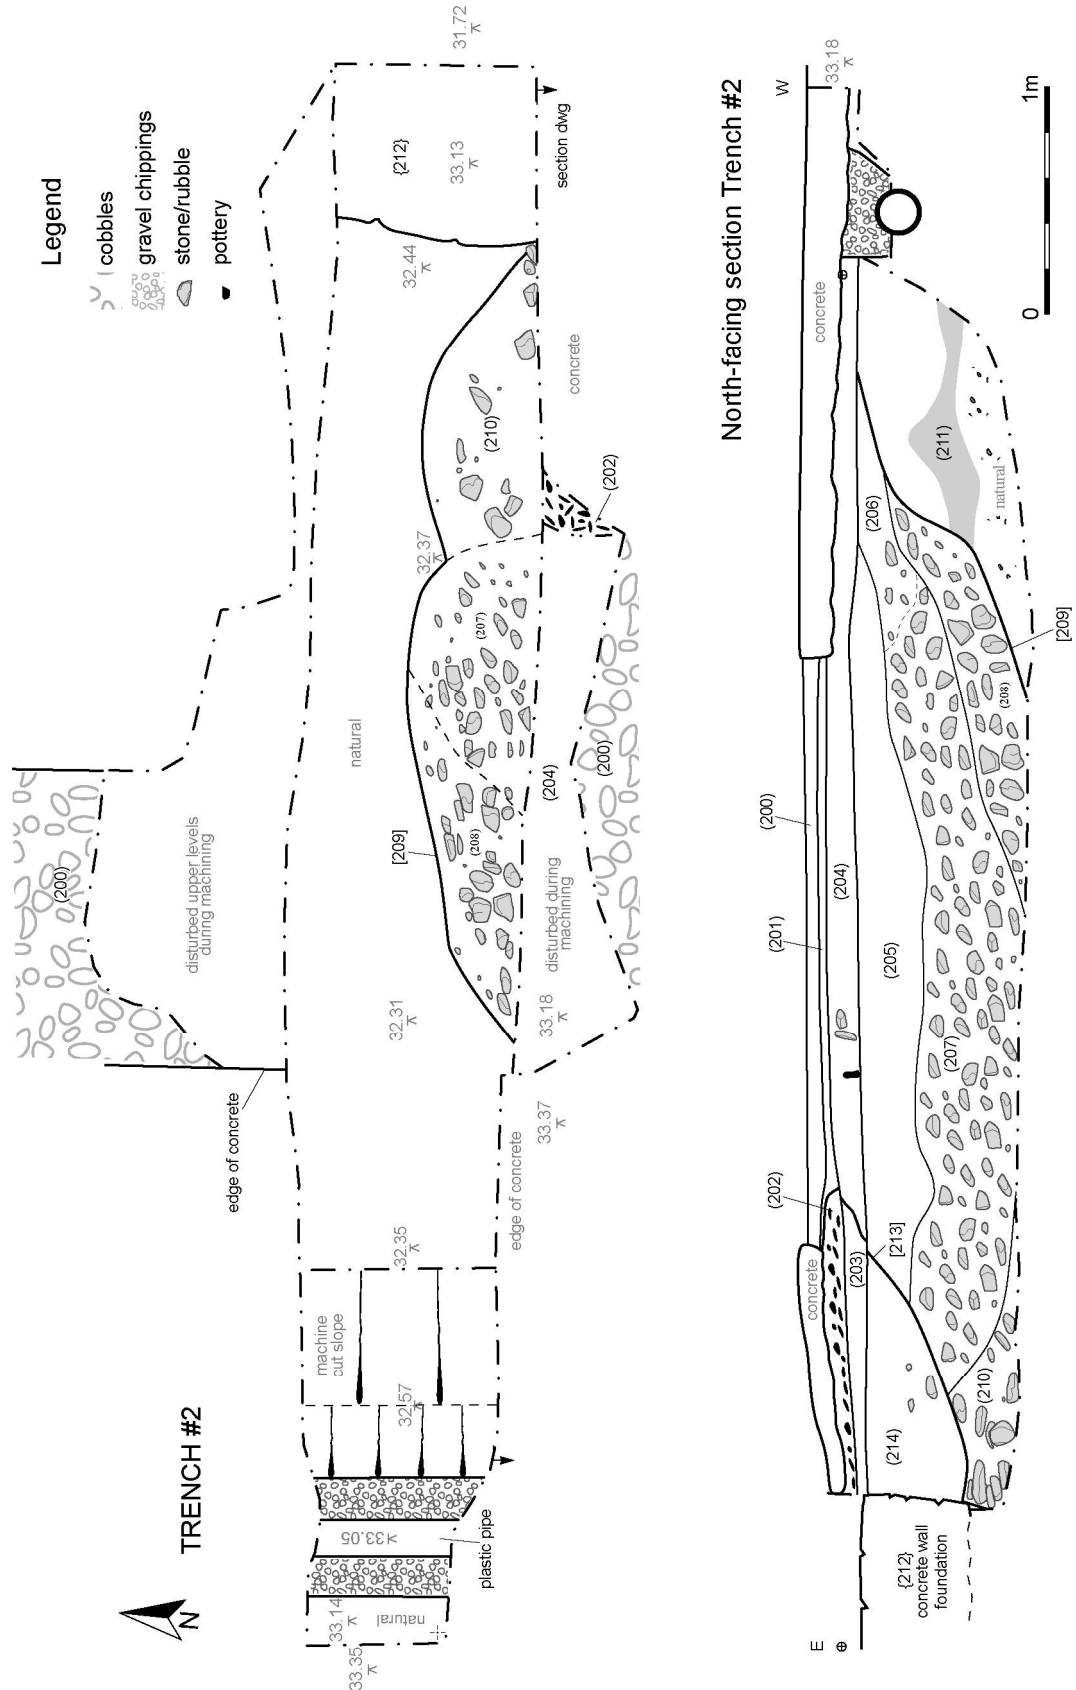
Figure 12: Plan and section of Trench #2.

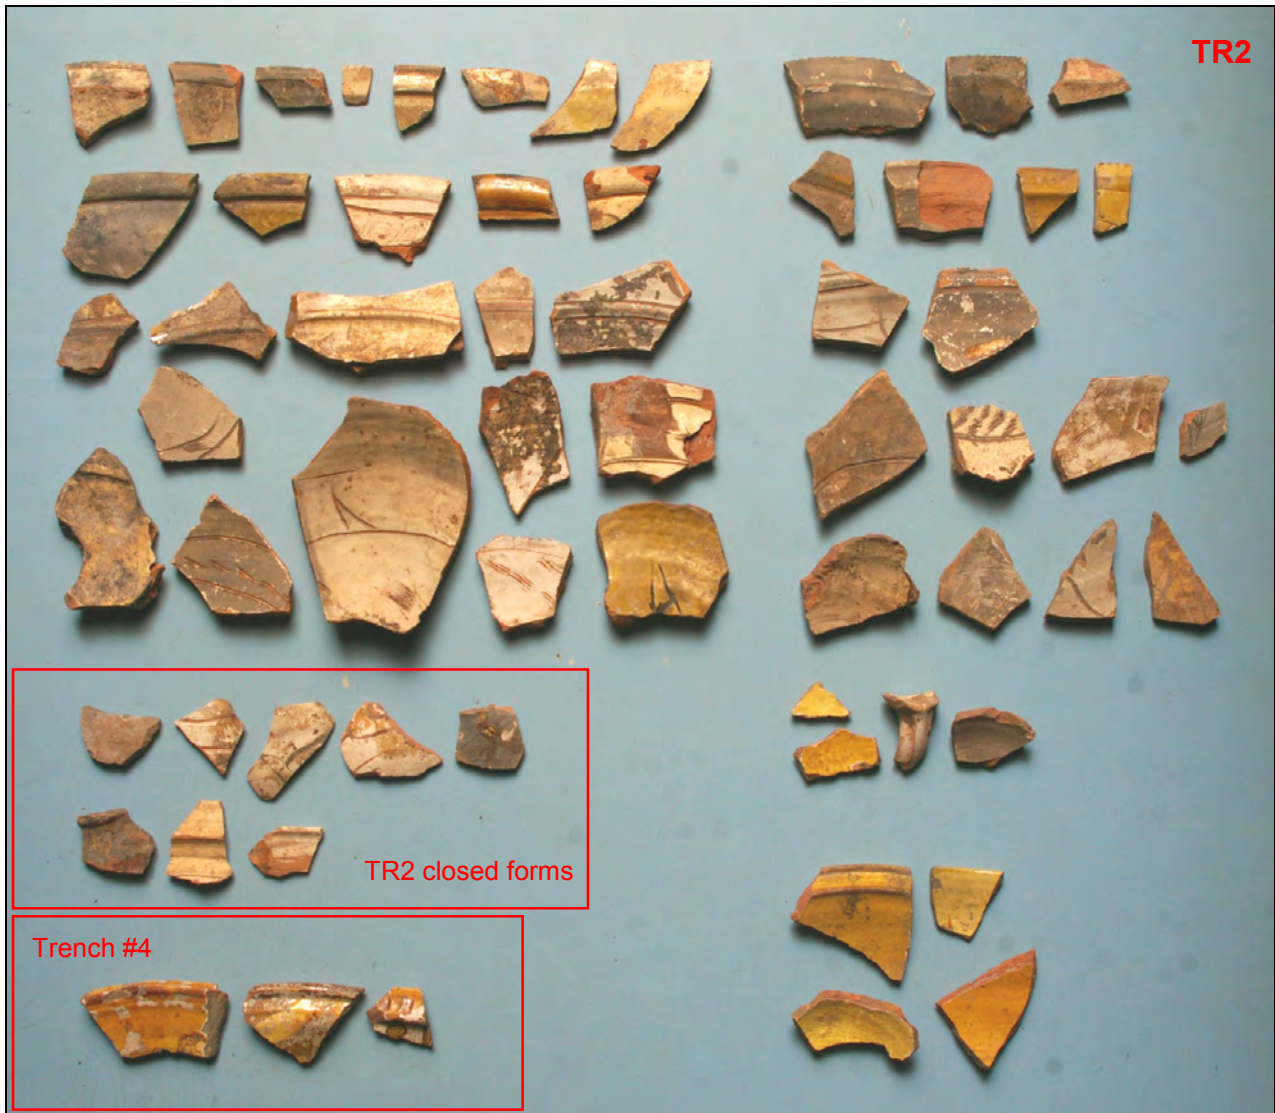
Figure 14: Photograph of the Sgraffito pottery from the site (all from Trench #2, and probably all from (202)), save the three rims in the bottom left-hand corner, which were unstratified sherds in Trench #4).

The large pit [209] encountered in Trench #2 appeared entirely sterile, but it again demonstrates archaeological features survive beneath the eastern half of this burgage plot. The nature and date of this feature could not be determined, but the fills suggest it was rapidly backfilled and that might imply it was extractive in nature (the Bideford paint mines perhaps?). It was cut by a pit or linear feature [213], and this could easily represent an earlier burgage boundary. The layers found subsiding into [213] – cobbled surface (203) and levelling layer (202) – could be 17<sup>th</sup> century in date, if the pottery was deposited at or close to the date of manufacture. The pottery itself is clearly derived from kiln waste – containing wasters, saggars and burnt slate – but was probably brought to the site from elsewhere in the town. It is not impossible that there was an operating kiln in the immediate area, but one would expect a far greater volume of waste material to be present. The pottery recovered is comprised of heavy North Devon gravel-tempered vessels (generally Type 3 bowls) and finer sgraffito-decorated dishes and jugs. This material is very similar to that excavated at the Stella Maris site in the town (see Allan *et al.* 2005), and dates to the period *c.*1660-1700 (John Allan *pers. comm.*; see Figure 14).

In terms of the assemblage, it contains the usual mix of coarse gravel-tempered wares – mainly Type 3 heavy bowls – and a rather smaller amount of plain yellow-slipped gravel-free dishes and jugs, some with sgraffito decoration (see Figure 14). As a group, and in terms of the sgraffito decoration, it is very similar to that recovered from the Stella Maris site on Northam Road (see Allan *et al.* 2005). However, there is less variety of form, and very little in terms of geometric decoration, but this may reflect the size of the assemblage rather than being a true reflection of the products of that kiln. In general terms, the decoration is minimal and fairly simplistic, with few decorated rims. Dish decoration falls into a fairly limited repertoire of

the 'Stella Maris Tulip' and possibly the 'Swansea Bird' types (see Allan *et. al* 2005, 190). As with the Stella Maris site, most of the sgraffito sherds were unglazed, and thus failed before the second firing.
