Report No.: 120427
Date: 27/04/2012
Authors: S. Walls
B. Morris

Lundy View Farm, Davidstow, Cornwall

Results of a Desk-Based Assessment, Geophysical Survey & Visual Impact Assessment

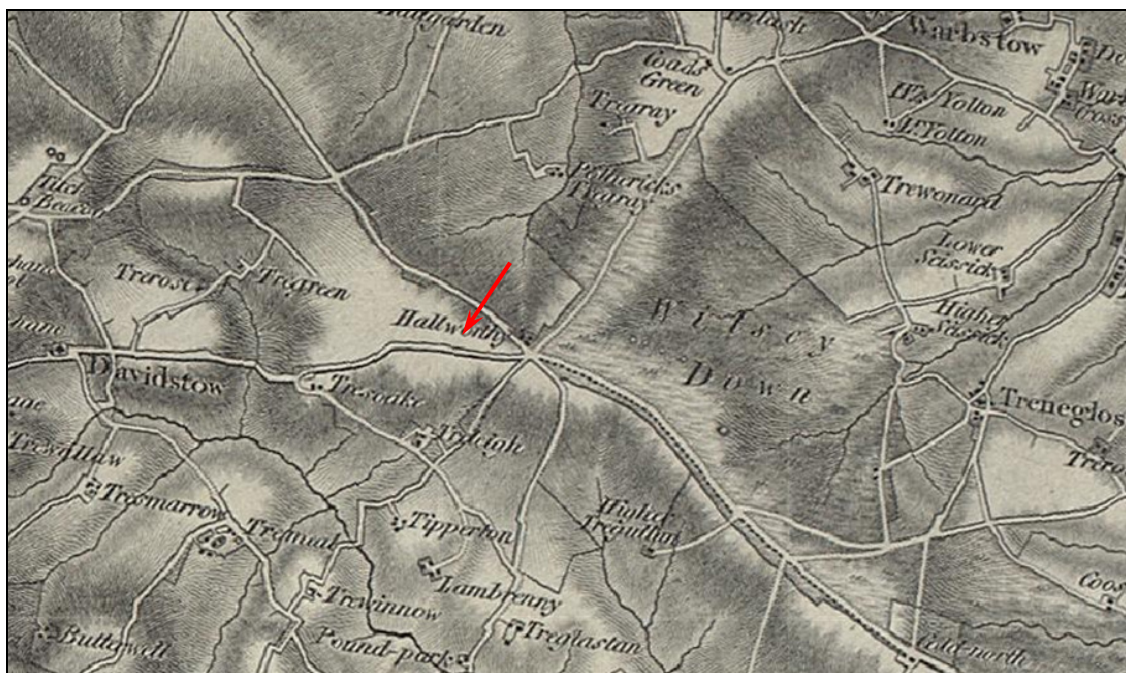
Figure 4: Ordnance Survey ‘Old Series’ map, *c.*1808 (the site is indicated).

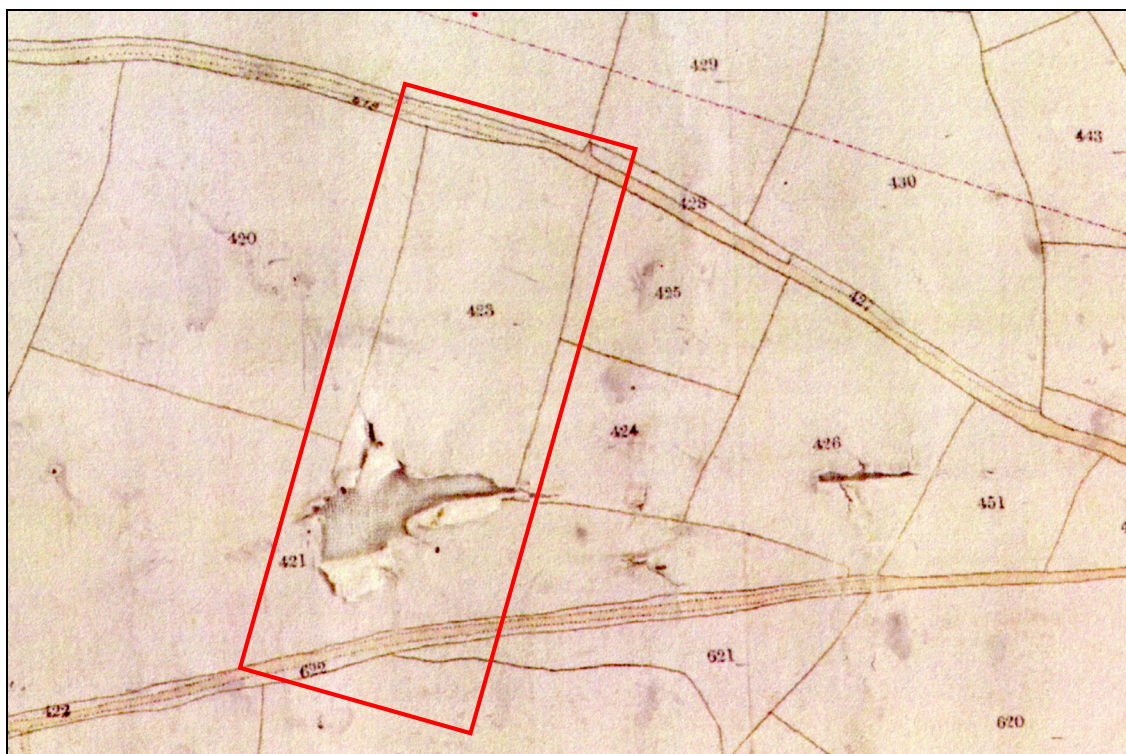
Figure 5: The 1839 Davidstow tithe map (the site is indicated).

The first detailed map of the area in question is the Davidstow tithe map of 1839. All of the fields in the immediate vicinity of the proposed turbine site are owned and apparently cultivated by one Richard Dodge Esq., and belonged to Trelay Farm in the valley to the south. In 1841 the Census lists William Saunders, an agricultural labourer, and his family as being resident at Trelay, which implies Richard Dodge lived elsewhere. By 1851, Philip Ham and his family were living at Trelay and farmed *c.*220 acres.

Several points can usefully be derived from the tithe apportionment data. Firstly, the field names are, for the most part, prosaic and largely uninteresting. The use of the term ‘down’, taken together with the shape and form of these fields, strongly suggests that this area was enclosed from the open moor (as noted in 2.1) in the post-medieval period but before the 19th century. Secondly, all of these fields are listed as being under arable cultivation in 1838, indicating that if archaeological deposits or features are present, they will have been plough-damaged. Lastly, the fields immediately to the east of the one in question are listed as *Burrow Down* and *Lower Burrow Down*, and this would usually indicate the (former) presence of one or more burial mounds.

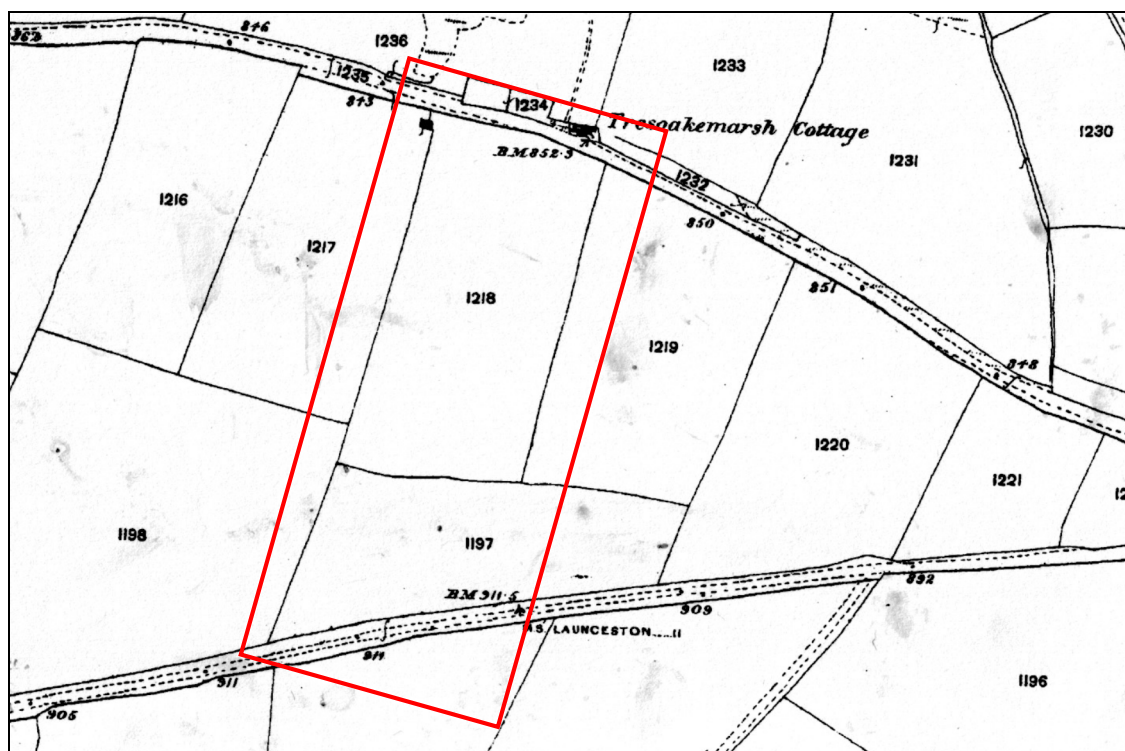
Figure 6: The c.1880s First Edition Ordnance Survey map (original scale 1:2,500) (the site is indicated).

By the 1880s some change is evident. Fields 420 and 421 have been subdivided, and Burrow Down and Lower Burrow Down have been amalgamated. Most significantly, Treslake Marsh Cottage has appeared in a scrap of roadside waste. This pair of cottages was built after 1851, and in 1861 was inhabited by Thomas Tucker, an agricultural labourer, and William Bone, a shoemaker, and their families.

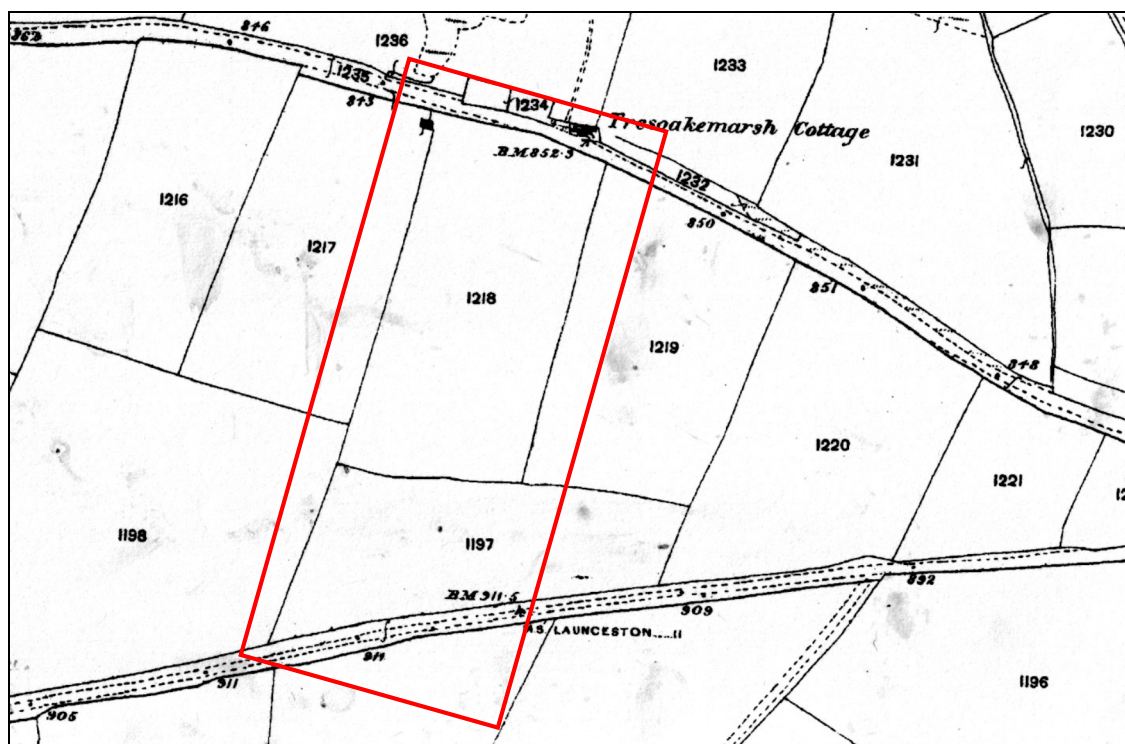
Figure 7: The c.1908 Second Edition Ordnance Survey map (original scale 1:2,500) (the site is indicated).

No change is apparent between 1880 and 1908. Lundy View Farm was established by the middle of the 20th century, probably originally as field barns remote from the original farmstead. Some boundary loss occurs in the later part of the 20th century.

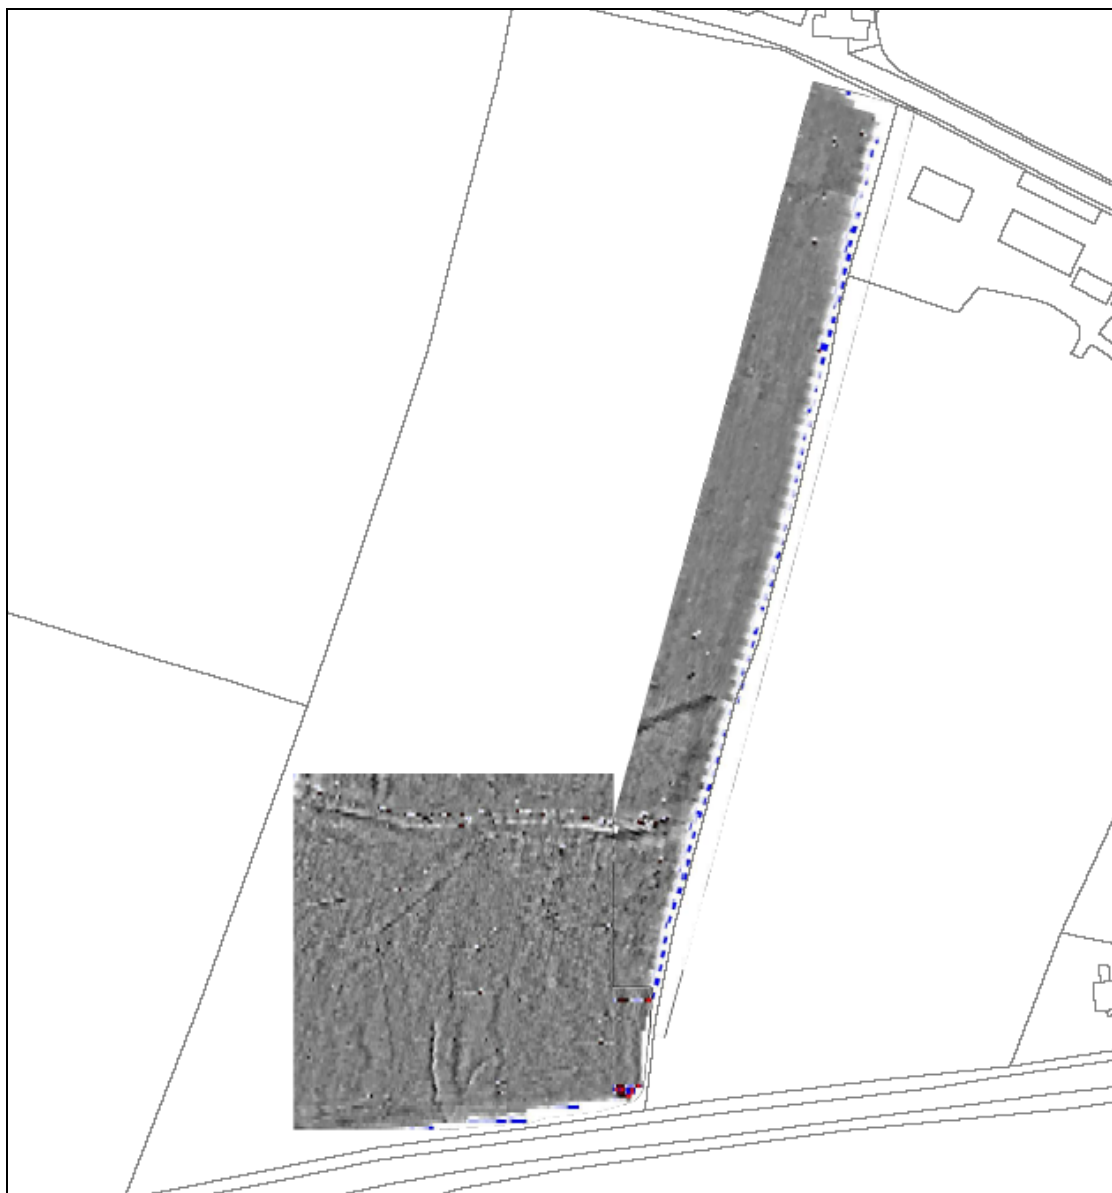
Figure 8: The results of the magnetometry (gradiometer) survey (source: Stratascan).

A magnetometry (gradiometer) survey was carried out at Lundy View Farm on the 20th March 2012 by Stratascan (Stratascan report J3077). An area of approximately 2ha was surveyed, covering the location of the turbine and the route of the cable trench (Figure 8 & Figure 9).

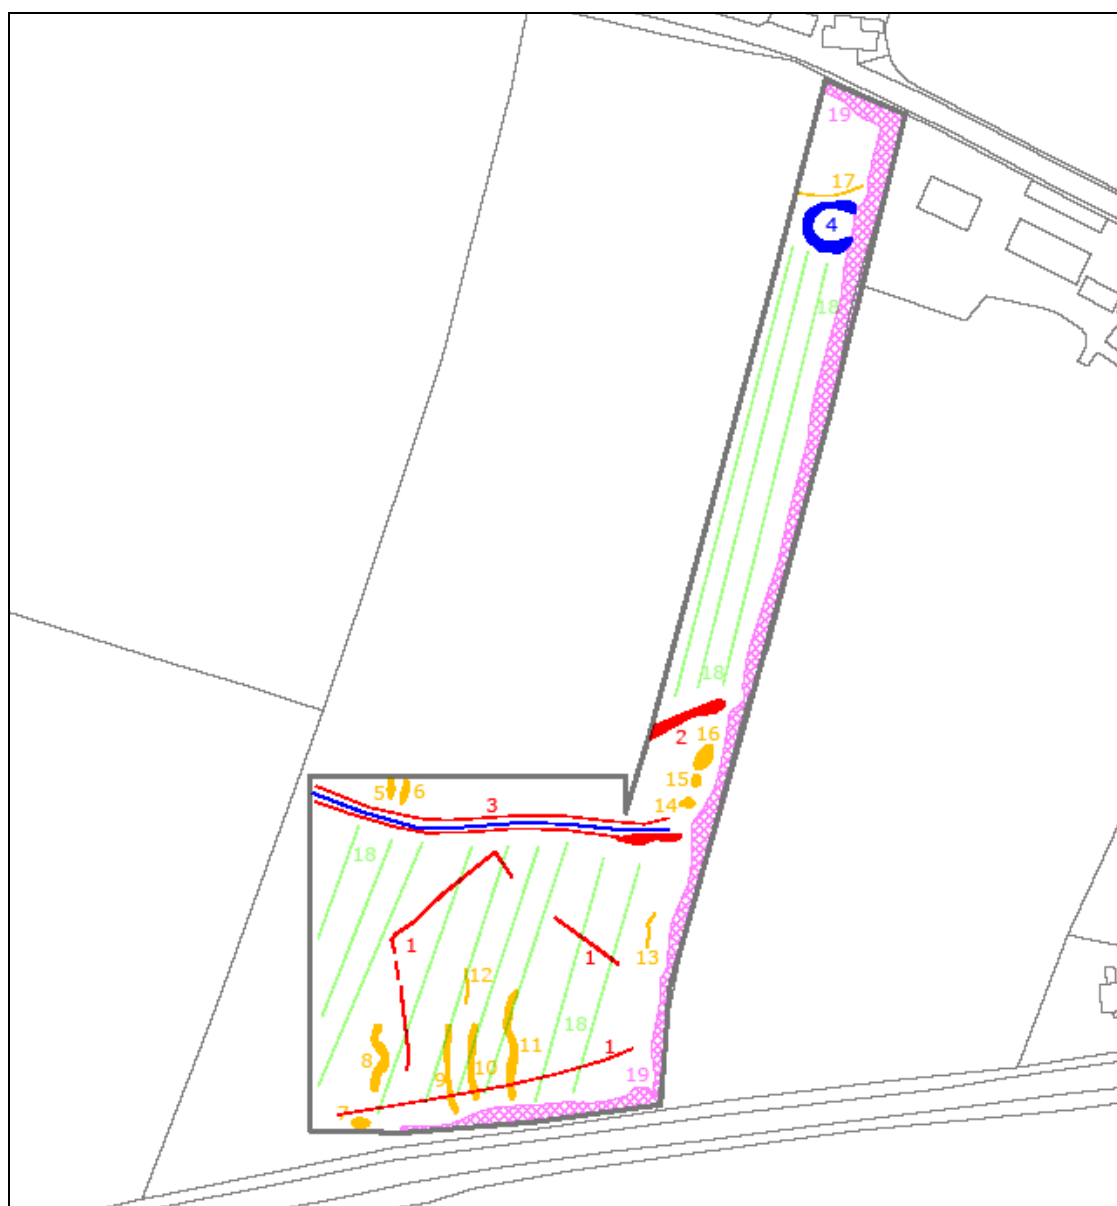
Figure 9: Interpretation of the geophysical survey data (source: Stratascan).

The survey, while limited in scope, identified a number of buried features (see Figure 9):

(1) A sub-rectangular feature on the southern limits of the site may represent an earlier enclosure. The strength of the geophysical anomalies and the morphology of this enclosure would argue against interpreting it as an Iron Age or Romano-British enclosure (or ‘round’), and its location in a relatively recently enclosed upland landscape might imply a function as a stock enclosure of some kind. Given the limited scope of the survey, it is not impossible it forms part of a wider fieldscape of early enclosures.

- (2) A positive linear anomaly, probably representing the line of a former field boundary, but if so, not one shown on the historic mapping evidence.
- (3) A parallel set of positive linear anomalies with an associated negative linear anomaly can be seen dissecting the southern region of the site in an east-west direction. This relates to a former field boundary removed within living memory.
- (4) A circular negative anomaly was noted at the northern limits of the survey area. Stratascan stated this type of anomaly is characteristic of a ploughed-out circular earthwork. However, this feature forms a clear platform and is located immediately beyond the gate from the farmyard into the field. The Client informs us that this was where the cattle were fed in the winter, and the ground became heavily poached as a result.

(5-17) A number of amorphous, positive linear and area anomalies were evident throughout the data set, particularly to the south. These may represent buried archaeological features, but could equally be natural in origin.

(18) Parallel linear anomalies characteristic of ploughing activity.

(19) Area of magnetic disturbance; in this case the wire fencing around the site.

Despite the remote location of the site, and the relatively small area surveyed, a number of buried archaeological features were identified. Feature (4), while superficially interesting, is likely to be the product of recent agricultural activity. Local knowledge, together with its proximity to the farmyard and the crispness of its earthwork, indicate it developed within living memory.

Feature (3) represents a remnant hedge boundary shown on historic maps, although (2) must relate to some earlier feature. Enclosure (1) remains enigmatic, and given the limited scope of the survey, could form part of a much larger complex of features. The slight nature of its ditches, and the lack of internal features, would support such an interpretation.

A site walkover and inspection was made on 5th April 2012. The weather was generally fine though overcast, but visibility was good. The field in which the windturbine is to be placed was under pasture, cut for silage. Earthworks were noted in the fields surface despite the long grass, these were felt to correspond with the former field boundary (see Figure 7 and Anomaly 3 on Figure 9) and the area of cattle disturbance (Anomaly 4 on Figure 9).

The geophysical survey has identified a number of potential archaeological features within the development area, most of which are likely to be post-medieval in date (see Figure 9). Most notable are Features 1 and 2 which might suggest an earlier possibly medieval or post-medieval phase of enclosures within this formerly upland area. However in the absence of detailed information regarding the survival of sub-surface archaeology within the development area or the depth of the topsoil this impact is considered to be **negative/minor** provided that appropriate mitigating work is carried out. These impacts would be **permanent** and **irreversible**.

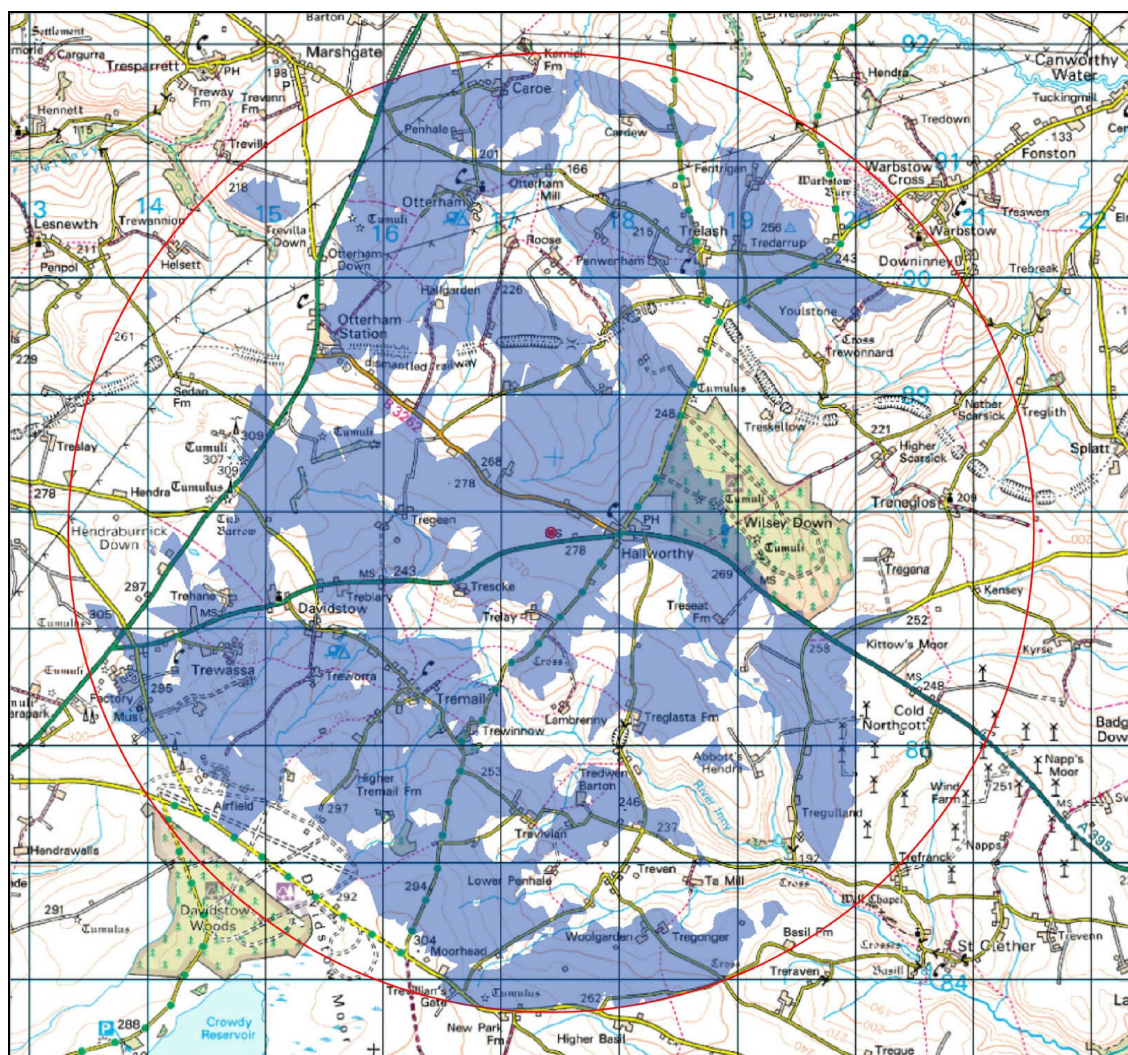
Figure 10: ZTV by Pineapple Rural Consultancy showing the areas with visibility to the turbine in blue.

The ZTV mapping (Figure 10) shows that the wind turbine will be almost ubiquitously visible within a 1km radius of the site. Within the zone from 1km radius to 3Km radius out from the site, the wind turbine will be visible from about 60% of the local landscape due to its topography, except in the valleys of the River Inny to the south and southeast. The viewshed will extend out to the south to just include the Grade II Listed cottage adjacent to Treglasta Farm and the Grade II Methodist Chapel and Manor Farmhouse in Tremail to the southwest. The viewshed mapping suggests that the proposed wind turbine would be on the fringe on intervisibility with further listed buildings at Davidstow and Trelash to the west and northeast respectively. The wind turbine will also be readily visible in whole or in part from all of the scheduled monuments within both the 3km radius ZTV (Figure 11).

Given the elevated location of the site and the height of the turbine mast, the viewshed analysis suggests that the Zone of Theoretical Visibility (ZTV) will be far-reaching. In line with the requirements of the brief, the ZTV was mapped to a distance of 5km from the site by Pineapple Rural Consultancy. However, the visibility of the turbine will diminish with distance, and may be locally blocked by intervening buildings within settlements, by the plantation to the east and natural topography to the north-west and south-east.

On the whole, the ZTV mapping was found to be an accurate representation of the likely intervisibility between the proposed wind turbine and the surrounding landscape out to 3km together with the heritage assets it includes. However some local blocking of intervisibility within the viewshed would be produced by hedges, tree screens and other buildings where they occur within groups and clusters. Intervisibility with the proposed wind turbine was confirmed for the listed buildings at Treglasta Farm and Tremail, and for most of the scheduled monuments within the 3km radius except for the barrows in the Wilsey Down plantation.

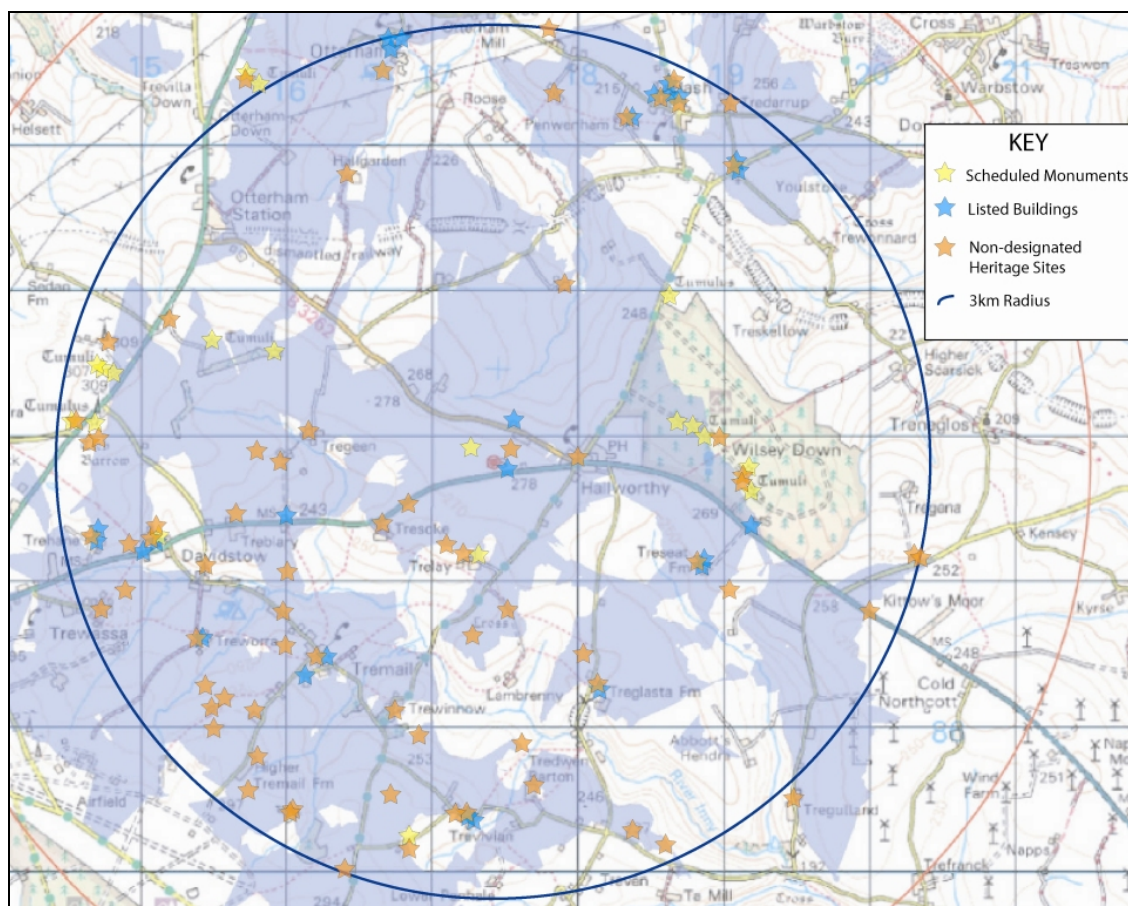
Figure 11: Map of known archaeological and historical sites within 3km of the site.

- During the operational phase of the wind turbine is unlikely to impact to a significant degree on the setting of the 26 listed buildings within its viewshed, given the relatively large distances between the wind turbine and the majority of these designated structures (see Figure 11). Intervisibility between the Lundy View Farm wind turbine and the listed buildings in Davidstow, Otterham or Trelash is unlikely and therefore it will have a **neutral** impact upon these structures. The listed buildings at Tremail and Treglasta Farm will be intervisible with the turbine, though at a distance of 1.8-2km and the impact will therefore be **negative minor**.

4.5.1 Scheduled Monuments (SM) – see Figure 11 and Appendix 4

4.5.2 Listed Buildings (LBs) – see Figure 11 and Appendix 5

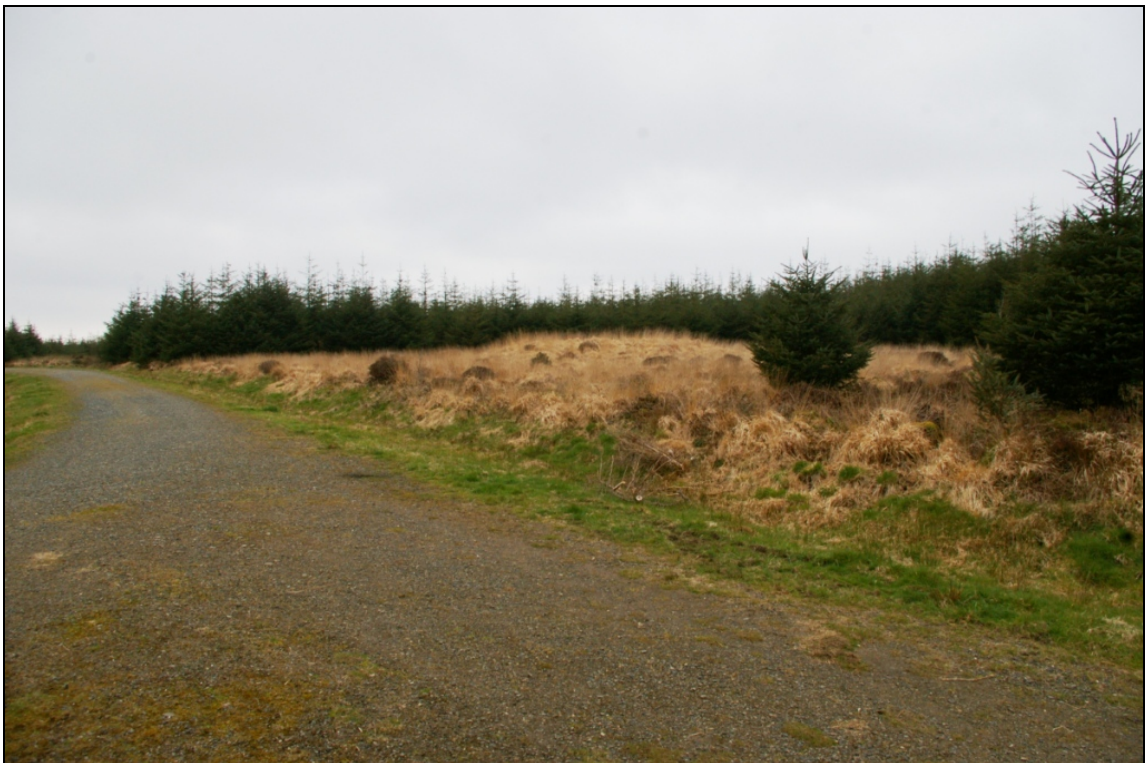
Figure 12: View from Tumuli at SX192 876, looking West to Lundy View.

- A further six of the scheduled barrows (CO927 and CO931) have been effected by 20th century landscape use, with the conifer plantation at Wilsey Down not only prohibiting these monuments from being visually impacted upon by the proposed turbine at Lundy View Farm but also upon their original intended prominence and visibility (Figure 12).

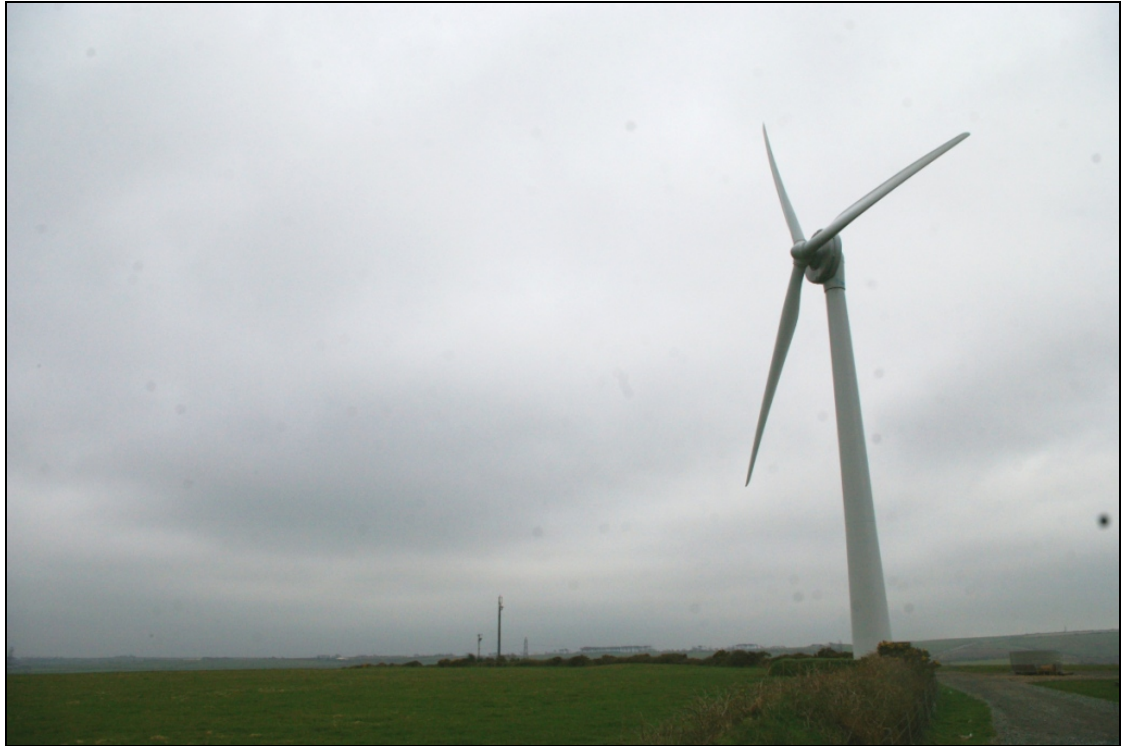
Figure 13: Wind turbine at SX157906, adjacent to Scheduled Barrows (C0924) on Otterham Down.

- In addition, there is already a number of wind turbines located in close proximity to some of these scheduled barrows. Most notably the two scheduled barrows (CO924) at Otterham Down (Figure 13) and the group of six at Hendra (C0323) are located within a couple of

hundred meters of existing turbines or radiomasts. As a result the impact on the broader setting of local scheduled monuments through the construction of the Lundy View Farm wind turbine will be considerably less than were it the first feature of this type to be constructed within the local landscape.

- There are no scheduled sites within the immediate vicinity of the proposed wind turbine, the closest being c.500m away. This monument is a a low, plough spread barrow (CO463), which was not visited as it is located on private land. The proximity means that the potential impacts on this particular site can be assessed as **negative/moderate**, however it is not considered that it would be close enough to the barrow to have a substantial negative impact on its setting, especially given the proximity of other nearby barrows to turbines (e.g. Figure 13).
