Report No.: 120710
Date: 10.07.12
Authors: E. Wapshott

A historic building survey was carried out in June 2012 to record the extant archaeological remains at Little Haven, Newton Moor. The building is subject to a planning application (PA08/00991/F) to convert and restore the structure to a domestic dwelling. The remains comprise the stone walls of a building, the roof structure of which is missing. The building is part of a complex of mine structures with an engine house (with chimney) lying directly to the south-west and a spoil tip to the south-east; further engine houses and evidence of the historic mining industry cover the surrounding landscape.

WRITTEN SCHEME OF INVESTIGATION FOR PHOTOGRAPHIC BUILDING RECORDING OF
A FORMER MINE BUILDING AT LITTLE HAVEN, NEWTON MOOR, TROON, CORNWALL.

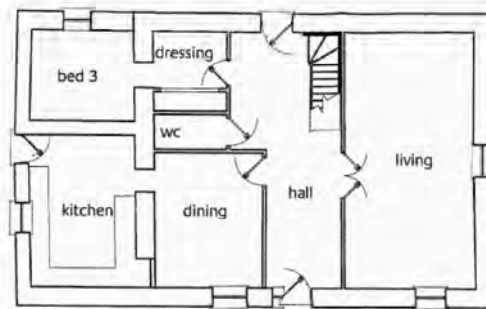
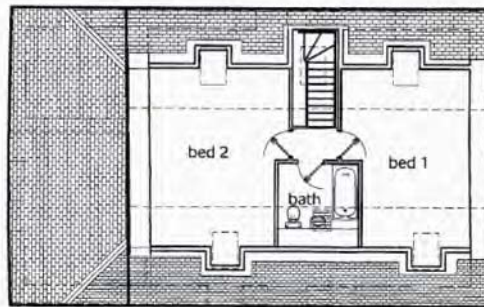
Proposals for the Building at Little Haven, Newton Moor

For illustrative purposes only. Original scale 1:100 at A3.

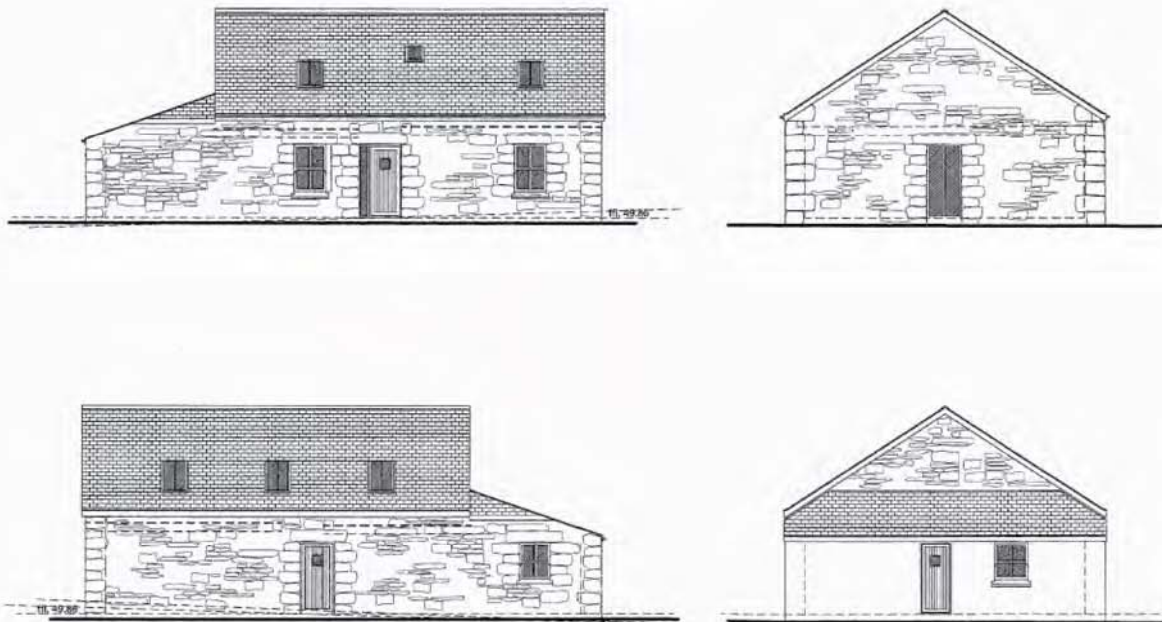
Proposed Elevations of the building at Little Haven, Newton Moor

For illustrative purposes only, not to scale. Original Scale 1:100 at A3.
