# BUILDINGS AT LOWER POOLE FARM NORTH MOLTON DEVON

Results of  
Historic Building Recording

Report No.: 121113  
Date: 13.11. 2012  
Authors: D. Laing-Trengove

*South West Archaeology Ltd. (SWARCH) were commissioned to conduct historic building recording and archaeological monitoring and recording prior to and during demolition of three agricultural buildings at Lower Poole Farm, North Molton, Devon. The work was undertaken to fulfil the criteria of an amended Written Scheme of Investigation previously produced by Wessex Archaeology. The buildings in question form the south and eastern elements of the former farm yard of Lower Poole Farm; most of which were to be demolished prior to the widening of the road to the west of the farm, to allow access to a further proposed development site. The buildings were found to be of no great antiquity and were also of little merit in terms of their construction. Buildings 2 & 3, to the north of the range, may date to the late 17<sup>th</sup> to 18<sup>th</sup> centuries, but contained with no datable elements. The proposed earlier domestic function of Building 2 is unlikely and the rounded north-east corner suggests an agricultural function,

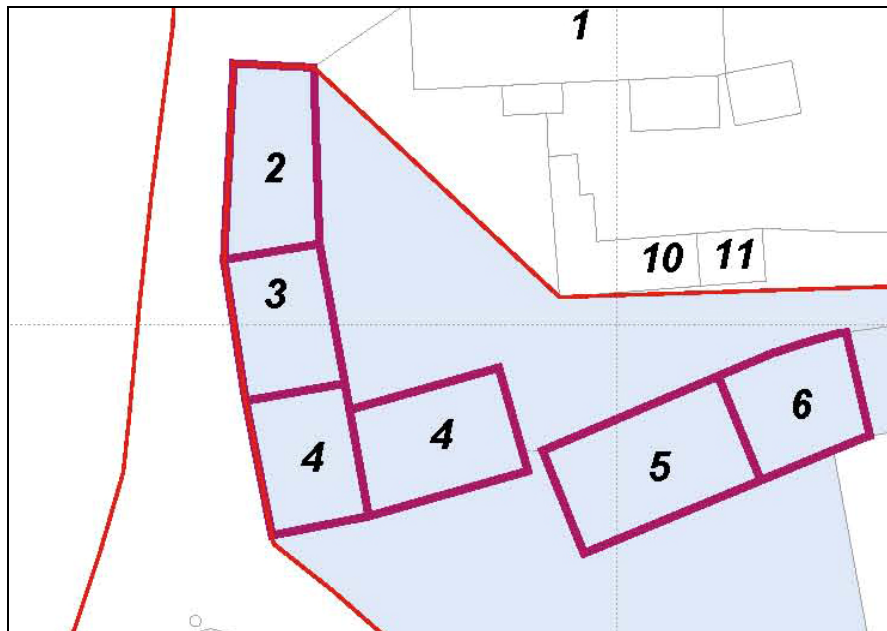
Figure 2: Plan of the buildings at Lower Poole Farm (After WA, Project No. 78080.03)

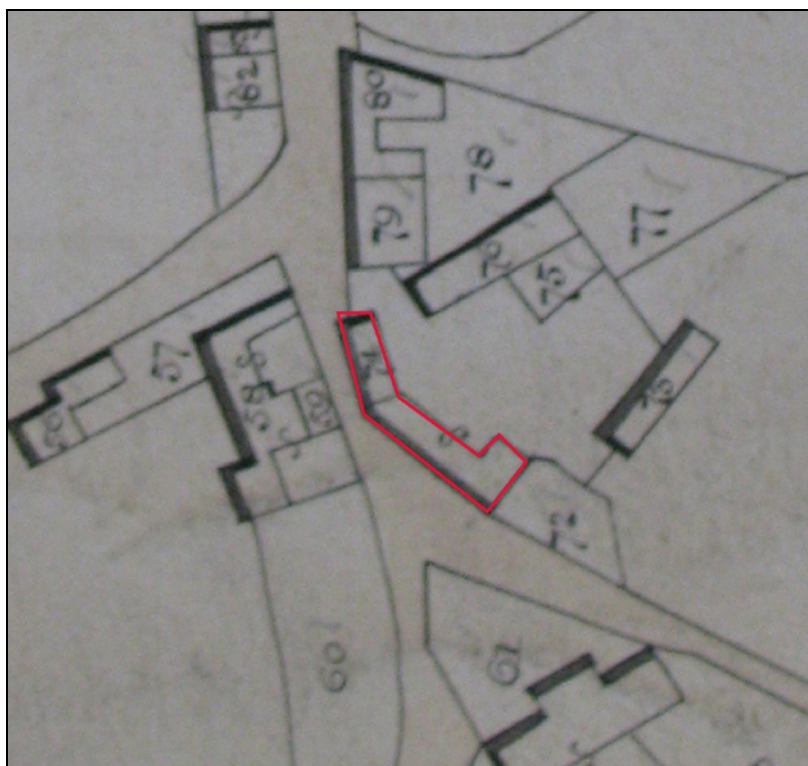
Figure 3: The buildings at Lower Poole Farm (outlined in red).

The buildings illustrated on the tithe map (Figure 3) at Lower Poole Farm (numbered 74) appear to sit on the same footprint as those surveyed. The only visible difference is at the south-east end, where Building 4 appears reduced in size.

None of the buildings on this particular map are coloured, whereas for other parishes domestic buildings are often coloured pink and service or agricultural buildings grey. Therefore there is no clue given here as to their function, and we have no evidence to suggest a former domestic function for Building 2 at the north end of the range.

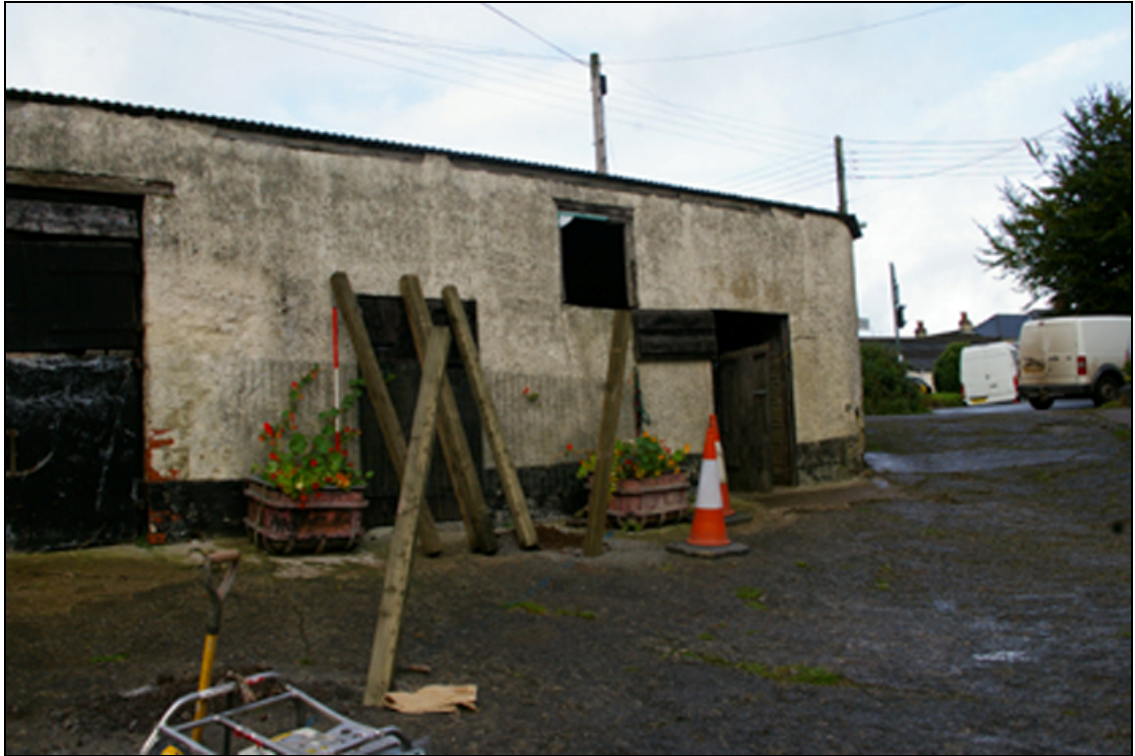
Situated to the south of the former farmyard entrance, this one and a half storey building is cut into the slope to the west, with a lot of modern repair and rebuilding work and little historic fabric remaining. Apparently latterly used for livestock and most recently for storage (Figure 5).

Figure 5: The Exterior east wall of Building 2, viewed from the south-east.

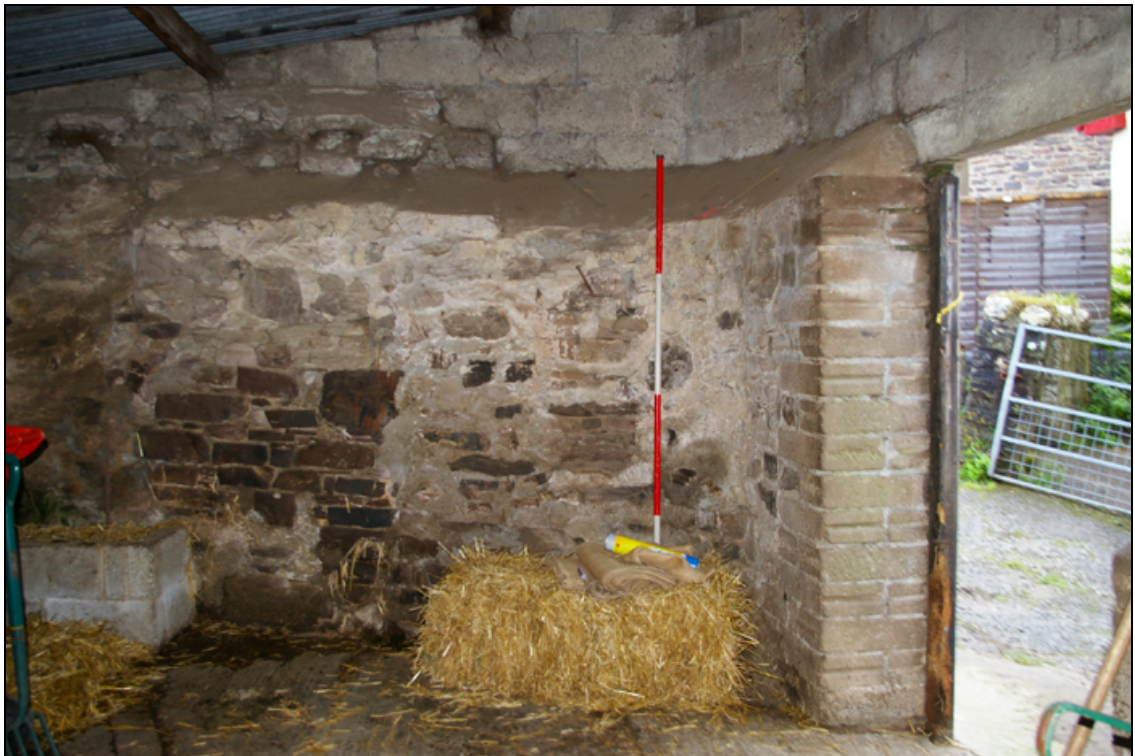
Internally the building is divided into two by a modern concrete half height wall. Within the northern end the semi coursed rubble stone built lower portion of the north wall projects into the building, above this the top of the earlier wall has been capped with cement and the wall rebuilt above in modern concrete block. The stone built, clay bonded portion curves round to the east where it terminates in a repair of modern concrete block, now forming the northern jamb of the north door (see Figure 6). This is the only element of an earlier structure remaining within this end of Building 2.

Figure 6: The interior rounded north-east corner of Building 2, showing the earlier rubble stone construction below, the concrete block upper and door jamb, viewed from the south.

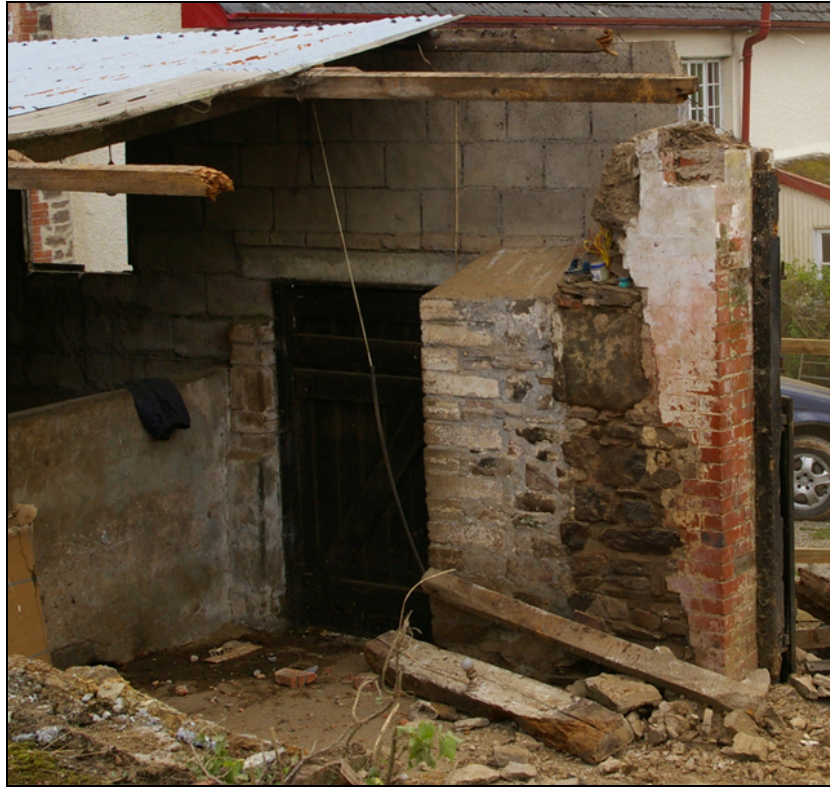
Within the southern portion of the building there is a section of earlier clay bonded rubble stone fabric between the two doors in the east wall (Figure 7), the south-west end of the west

wall is also of stone construction, and the change in materials appears to correspond to the change in the exterior wall line. The south wall is also semi coursed stone rubble but with cob above (although partly obscured at the time of the survey). The thickness of this remaining earlier fabric suggests a post medieval date for any earlier building on the site, but with no features and extensive lime and later cement repairs the fabric is of little merit. The only feature noted at the time of the survey was the remains of a late 19<sup>th</sup> - early 20<sup>th</sup> century drain, in the form of part of a terracotta pipe and brickwork in the south-east corner of the cement floor, adjacent to the southern door opening.

Figure 7: The rubble stone wall between the doors in the east elevation of Building 2 after the demolition of Building 3, viewed from the south-west.

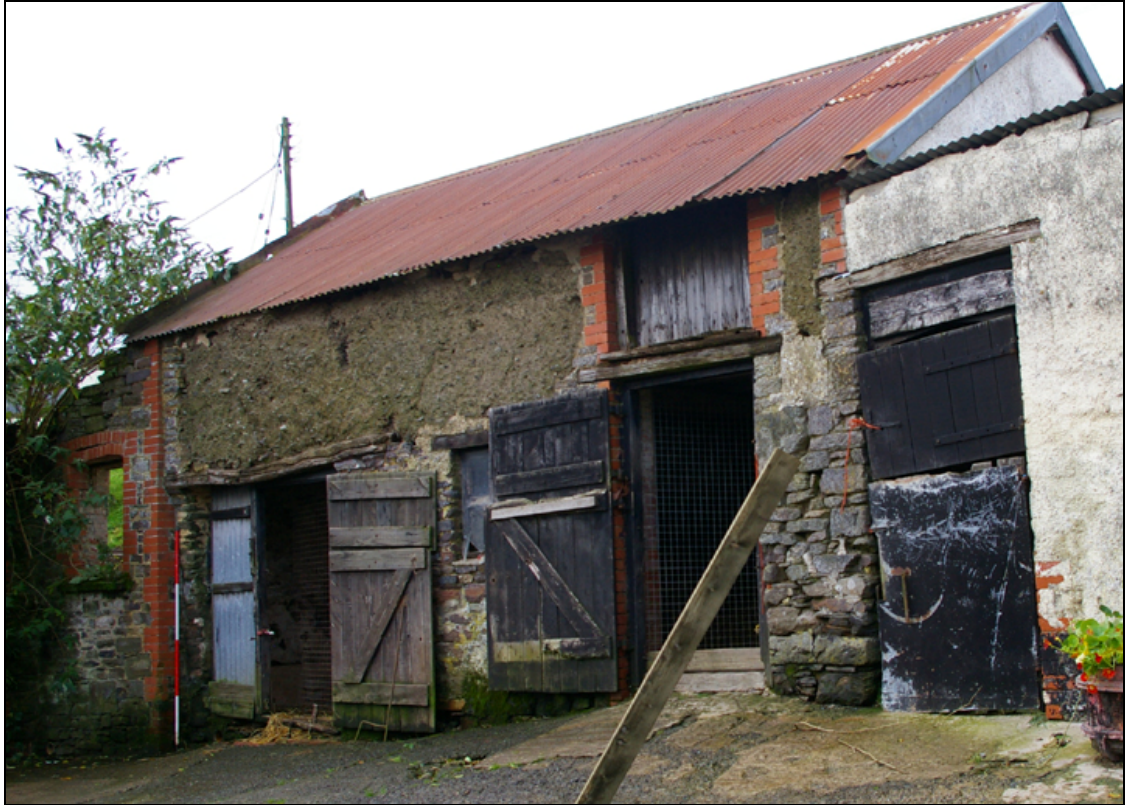
Figure 8: The exterior east wall of Building 3, viewed from the north-east.

*The building is considered to be well preserved as it incorporates some early features and materials. The east facing wall has evidence of infilling and several build styles. The north and south walls are rubble stone on the ground floor with cob walls above first floor level. The central section of walling is built from random coursed rubble on the ground floor with, again, cob on the first floor. The northern most stable door is dressed on its south side with brick, as is the hay loft door above.*

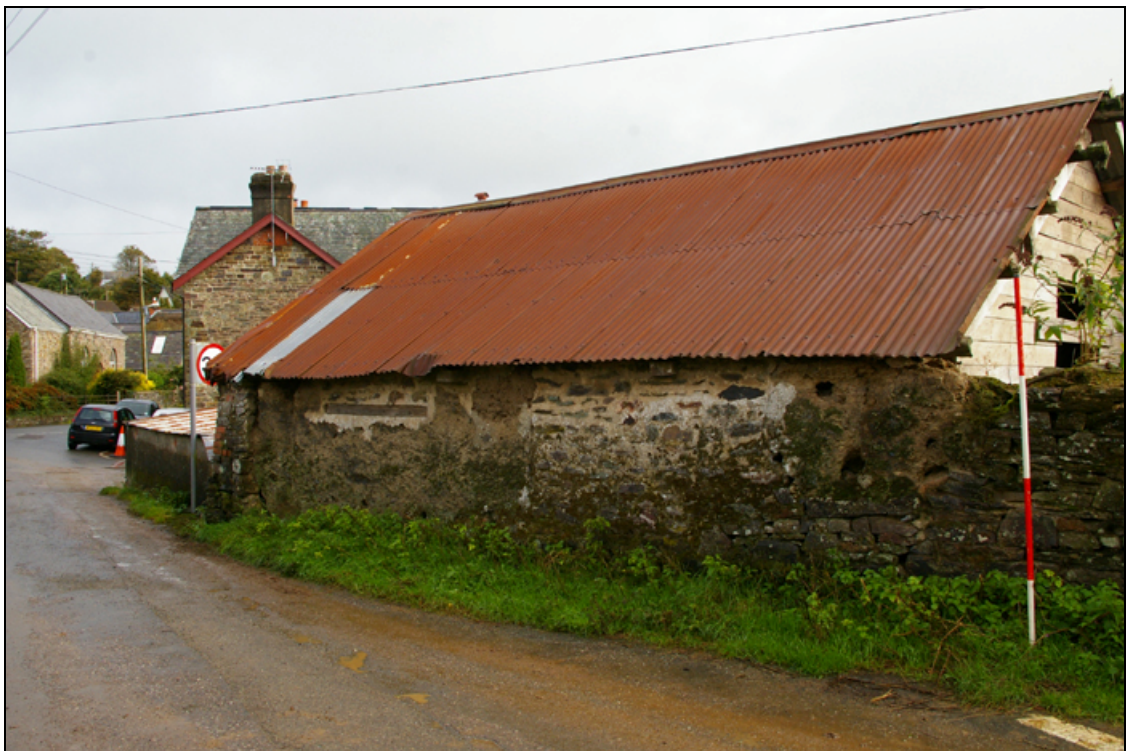
The exterior west wall, adjacent to the lane, is predominantly constructed of cob above a clay bonded, random rubble stone base. Rather than the wall having been infilled with cob, the use of lime mortar bonding within the two rubble stone sections within the upper part of the elevation, and the condition of the remaining cob (heavily weathered) suggests that these stone areas are later repairs rather than parts of the earlier wall subsequently repaired in cob. It also seems unlikely that the two main sections of repair are blocked former openings although this is possible. (Figure 9). The stone built north-west corner has also been subject to repairs, with modern machine made orange brick and lime mortar and cement mortar.

Figure 9: The exterior west wall of Building 3 with the rubble stone and lime mortar repairs, viewed from the south-west.

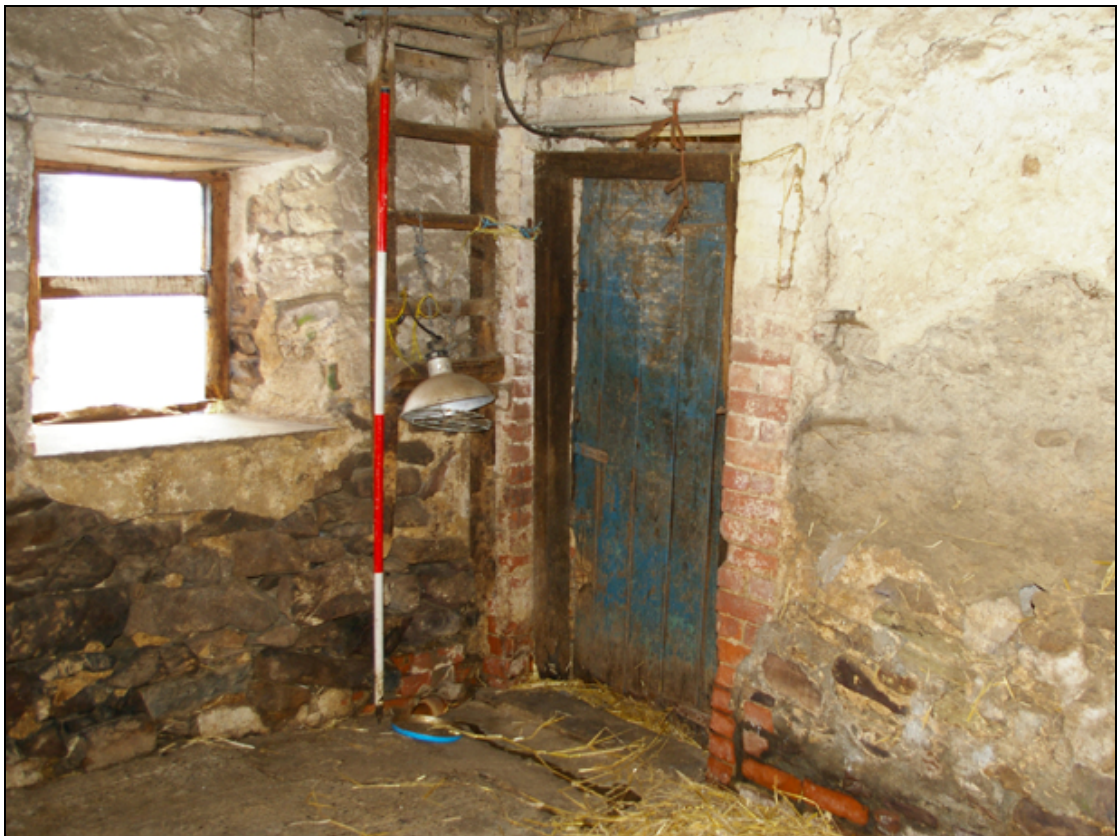
The interior of Building 3 is divided into two by a clay bonded rubble stone and cob built wall that rises only to ceiling height, with the loft above open to both ends as well as the roof of the building. To the north the walls have a lot of repair but were formerly lime rendered and white washed. The cob sections immediately above the rubble stone plinths of the north and south walls have clearly been worn away by the rumps of the animals formerly stabled here. The ceiling of this, the slightly larger of the two former stables, rests on a central joist set into the wall to east and west and there is a gap between the floor planks and the rear west wall for hay to be dropped down to the hay rack formerly positioned below. There is a rough wooden ladder on the east wall in the south-east corner leading to a hatch in the ceiling and a door has been forced through the dividing south wall at the east end with the jambs and wall around the opening rebuilt in orange machine made brick (Figure 10). The window in the east wall is potentially original to the build for it has sloping reveals, although the interior and exterior sills are cement and the interior lintel has been clad in beaded planks and the window is reused. This portion of the building has a cement floor with a cement gully along the base of the south wall with a terracotta pipe leading to the brick gully alongside the exterior of the building. In the centre is the scar within the cement floor of a former partition forming two stalls. The width of the exterior door, the ware on the walls and the size of the stalls suggests that these were for large 'heavy' working horses.

Figure 10: The interior south-east corner of the northern portion of Building 3, showing the forced door opening and the earlier window, viewed from the north-west.

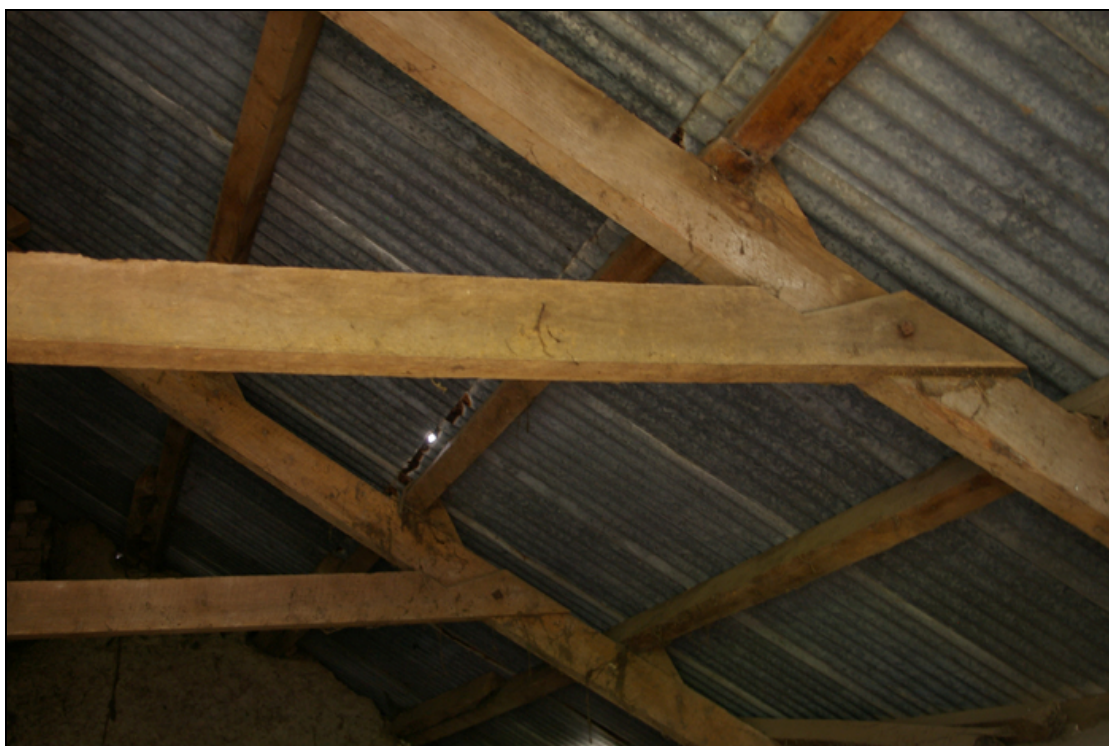
The roof structure of the building, visible in the loft above, comprise of two well made but unremarkable bolted A-frames with nicely jointed collars, three purlins resting on the backs of the principal rafters per side and a double ridge pole (Figure 11). It was noted that at the apex of the gable at the north end there was a roughly rectangular block of brickwork - possibly blocking a former owl hole in the cob or possibly simply a repair.

Figure 11: The roof structure on the eastern pitch of Building 3, viewed from the south-west.

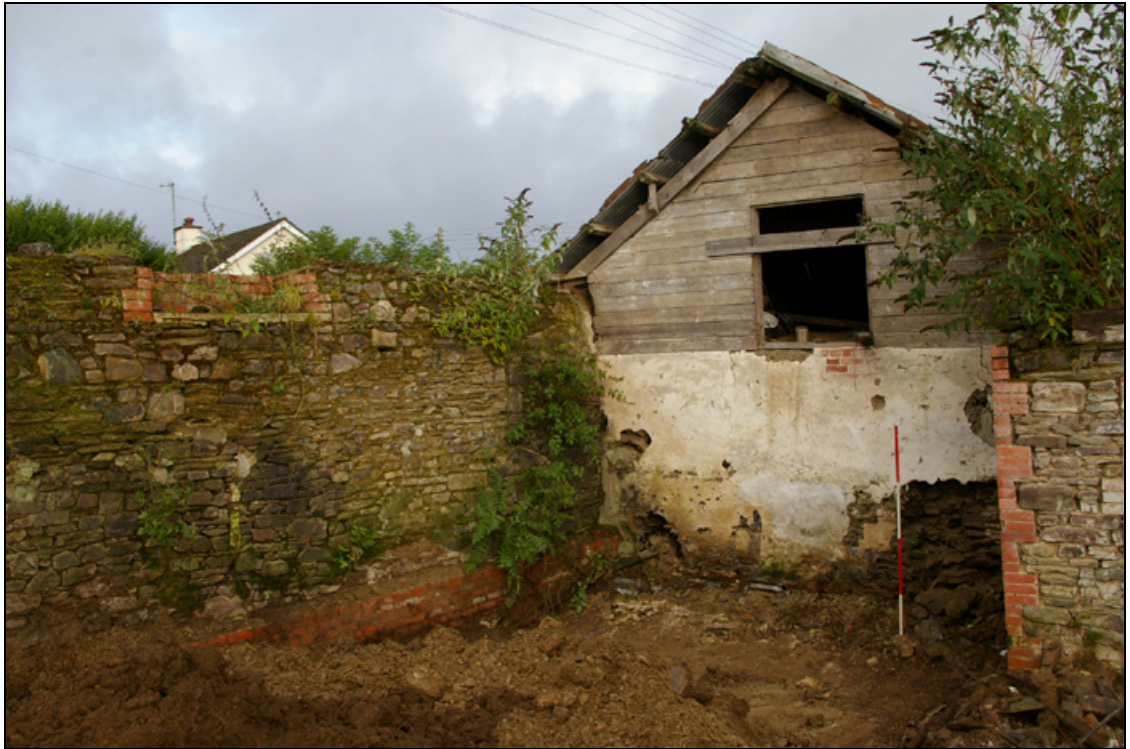
Figure 12: The interior north-west corner of Building 4 and south wall of Building 3, viewed from the south-east.

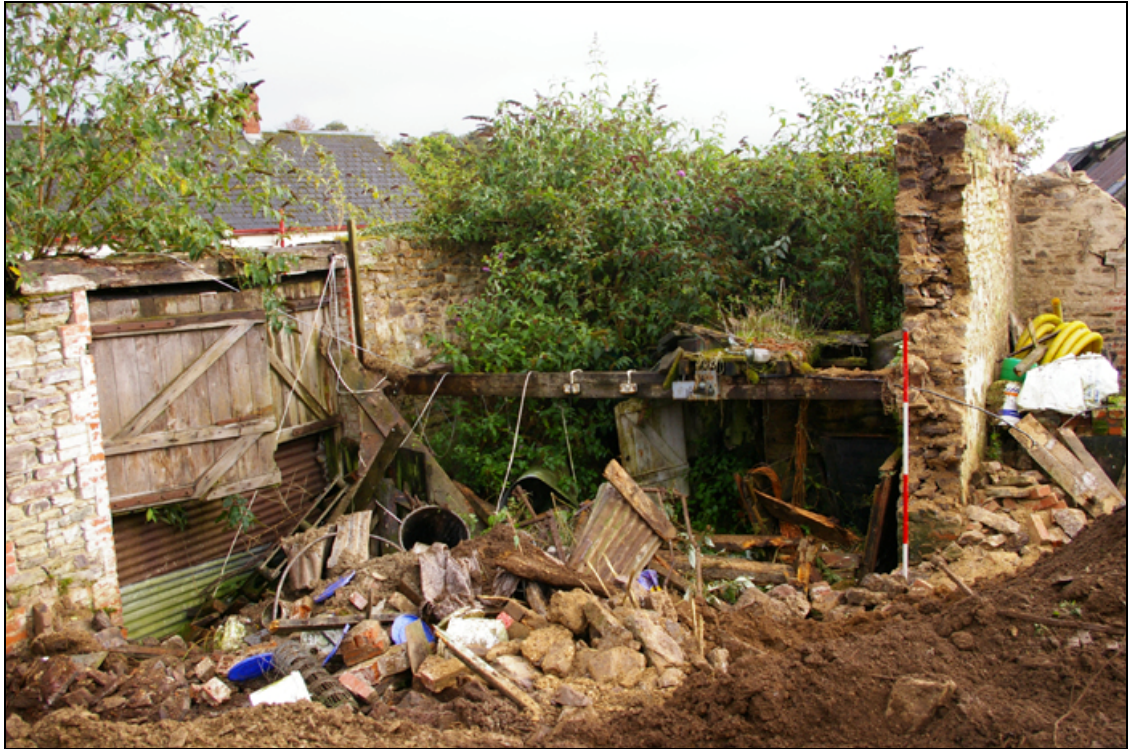
This former two storey reverse L-shaped building, forming the south-east corner of the farmyard, was only partially standing at the time of the survey and there was no clear evidence for the former use of the building excepting the large double doors in the north-east wall which suggested a central former cart shed element or more probably a barn (see Figure 13).

The eastern portion of the building, to the east of the double doorway (Figure 13), was formerly floored and appears to have been divided into compartments/rooms on the ground floor. At the base of the south wall of this element the stonework was intact on the western face, which suggests the jamb of a former door opening, possibly another large opening forming an opposing door to that to the north. This would suggest that this building was perhaps a threshing barn, possibly with storage for grain below and a loft above at the eastern end.

Figure 13: The north -east, east and south walls of building 4, viewed from the south-west.

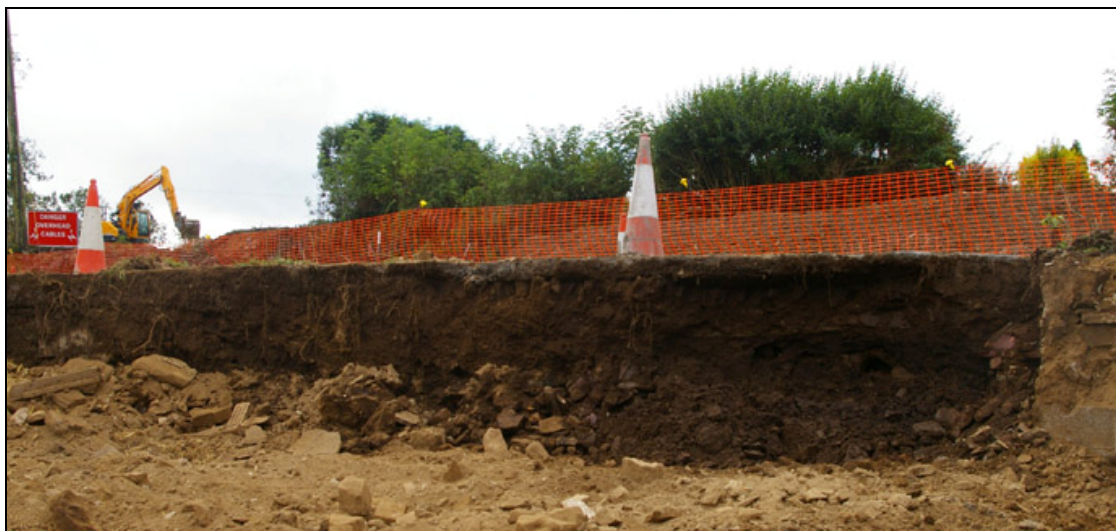
No further evidence for Building 4 was uncovered during the demolition of the remaining structure. However, on removal of the retaining wall to the west, against the road, the stratigraphy of the roadway behind (to the west) was suggestive of a former ditch or gully at the northern end with remnants of possibly two cobbled surfaces, and some large flat stone slabs, laid at an angle at the southern end, possibly representing a more concerted effort to channel the water away from the buildings and yard (Figure 14).

Figure 14: The south-western boundary of the site after removal of the former west wall of Building 4, viewed from the north-east.
