EAST PORTLEMOUTH CHURCH SOUTH HAMS DEVON

Results of Archaeological Monitoring
& Geotechnical Investigation

Report No.: 130503
Date: 03.05.2013
Authors: B Morris

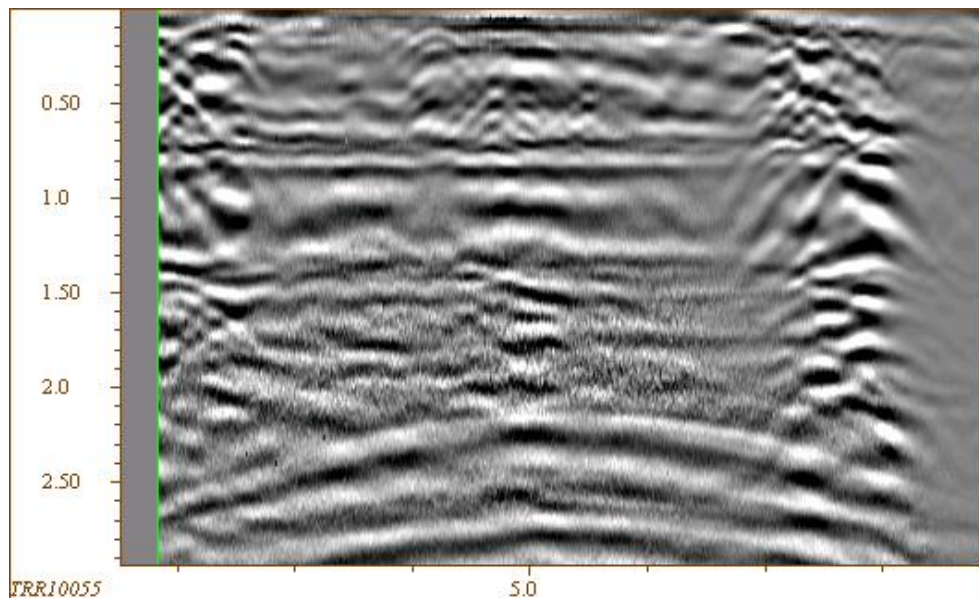
Figure 2: Example radargram, transect 9E (central nave area). Note the strong vertical responses (interpreted as buried walls) and the ‘broad crested anomaly’ at *c.*2.5m below ground level (Stratascan).

The GPR survey identified geophysical anomalies that Stratascan interpreted as buried walls, as well as an enigmatic ‘broad crested anomaly’ *c.*2.5m below current ground levels that might represent a buried vault (see Figures 9-10). Such a structural feature would indeed be exceptional, and the decision was taken to investigate these features further. A subsequent GPR survey carried out in October 2012 failed to identify the anomaly.

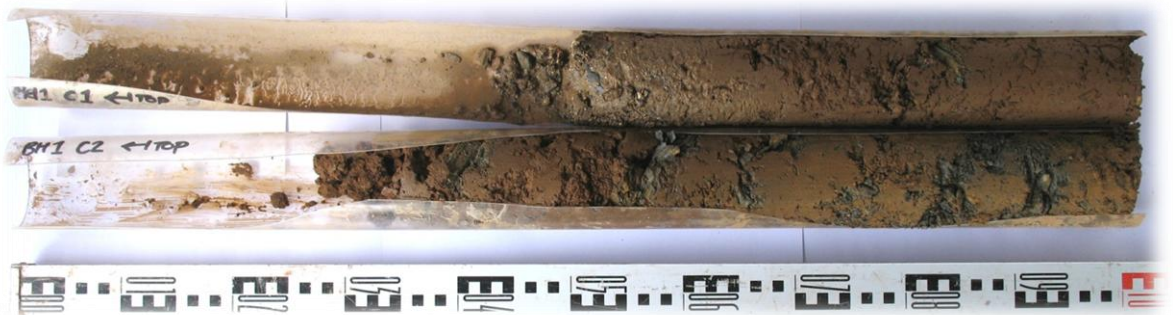
BOREHOLE #1	
CONTEXT	DESCRIPTION
1.1	Rich brown silt clay, contaminated with water from drilling through the floor levels above; common tiny slate fragments, tiny mortar flecks, sub-rounded stones 20-30mm diameter.
1.2	Rich brown moist stiff silt clay; homogenous; common sub-rounded stones 20-30mm diameter, giving the deposit a stony texture; occasional tiny charcoal flecks.
1.3	As 1.2, but slightly lighter brown colour, and slightly higher proportion of sub-rounded stones
1.4	Weathered head deposits; firm to stiff yellowish-brown clayey-silt with frequent stony inclusions

Figure 4: Borehole #1 cores.

Typical grave-earth type deposits.

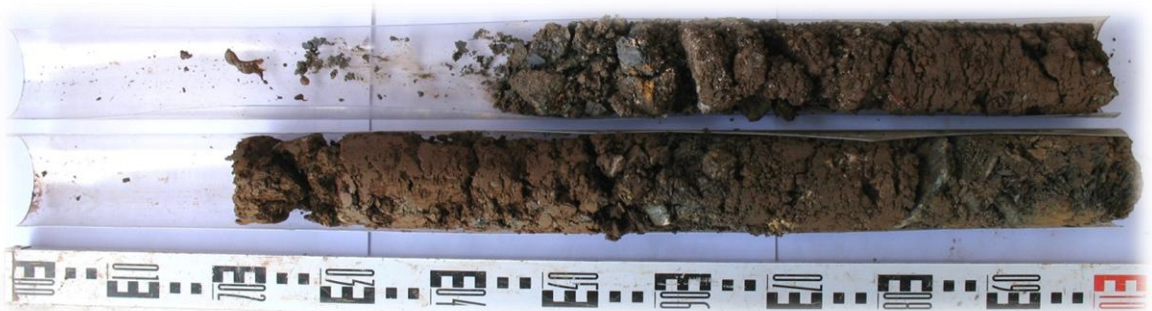
BOREHOLE #2	
CONTEXT	DESCRIPTION
2.1	Loose deposit of material, probably tumble from floor levels above; primarily composed of slate fragments up to 40mm across and sub-angular rock fragments up to 50mm; common mortar fragments sub 10mm, occasionally larger; set in a matrix of loose mixed dirty-looking greyish-brown gritty clayey-silt; junction with 2.2 suggestion

of a trampled surface?
2.2	Slightly friable, soft-to-firm slightly greyish-brown clayey-silt; frequent tiny mortar flecks, occasionally up to 20mm diameter; occasional sub-rounded stones up to 30mm; one tiny fragment of burnt clay noted.
2.3	Rich brown moist stiff silt clay; homogenous; common sub-rounded stones 20-30mm diameter, giving the deposit a stony texture; occasional tiny charcoal flecks.
2.4	Layer of stony material set in fairly loose yellowish-brown clay -silt matrix; high proportion of sub-angular stones 30-40mm across, including some quartz.
2.5	Weathered head deposits; firm to stiff yellowish-brown clayey-silt with frequent stony inclusions

Figure 5: Borehole #2 cores.

Typical grave-earth type deposits; suggestion of a trampled floor surface at interface of 2.1 and 2.2.

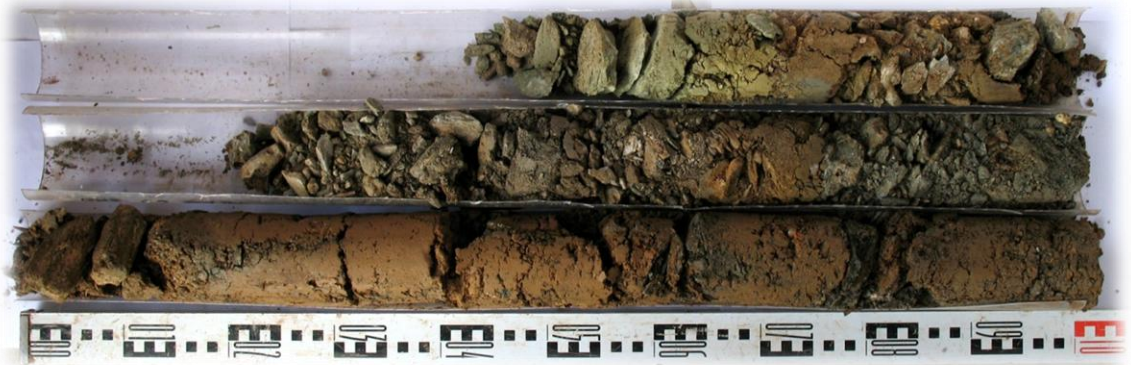
BOREHOLE #3	
CONTEXT	DESCRIPTION
3.1	Loose stones with stone dust, derived from a single fragmented stone slab, probable flooring material. This is likely to be a hornblende schist, and thus would have to have been brought to the site from the south-west corner of the parish.
3.2	Loose light greenish-yellow sandy-silt, probably derived from the decay of stone similar to 3.1.
3.3	As 3.2, but pale gingery-brown colour.
3.4	Loose and unconsolidated stony rubble; high proportion of angular and sub-angular stones 40-60mm across, including some quartz; set in a matrix of soft light-grey stone 'meal' derived from the stony material; occasional lumps of stiff brown clayey-silt with occasional charcoal flecks (i.e. backfill material, similar to 1.2 etc.); a single tiny

fragment of lime mortar noted.
3.5	Band of decayed stone, as per 3.3.
3.6	Same as 3.4.
3.7	Weathered head deposits; firm to stiff yellowish-brown clayey-silt with frequent stony inclusions

Figure 6: Borehole #3 cores.

Angular stony deposits, together with redeposited brown soil with mortar flecks, is suggestive of unconsolidated backfill within a robber trench. Note that while these deposits go *c.*0.6m deeper than in the other 3 boreholes, the floor levels near the north door of the church appear to have been built up by *c.*0.4m.

The coring that took place at East Portlemouth Church failed to produce conclusive evidence for buried walls or the ‘broad crested anomaly’. The closest thing to walling was located in Borehole #3, where *c.*0.85m of loose stony rubble was encountered. This probably represents backfill within a robber trench, as no trace of mortared masonry was encountered. The other three cores all contained fairly nondescript mid-brown grave earths, although the contents of Borehole #4 were so compressed that these deposits must also have been very loosely consolidated.

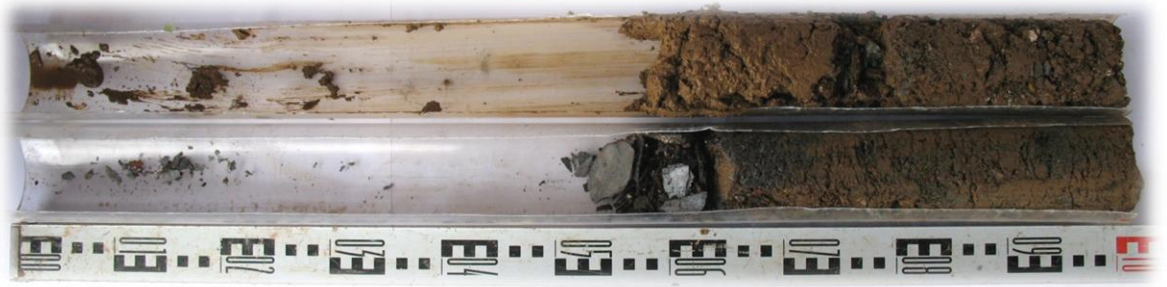
BOREHOLE #4	
CONTEXT	DESCRIPTION
4.1	Wet mid brown clay silt, contaminated with water from drilling through the floor levels above; common tiny mortar flecks and fragments sub 10mm, occasionally up to 40mm; common sub-angular stones 20-40mm diameter, up to 80mm.
4.2	As 4.1, but slightly lighter yellowish-brown colour.
4.3	Thin band of slate waste, perhaps roofing slate; white lime mortar adheres to two slate fragments; minimal matrix, of dark brown ?humic silt with fragments of reddish-brown stone sub 20mm (burnt?); common tiny mortar fragments sub 10mm.
4.4	Weathered head deposits; firm to stiff yellowish-brown clayey-silt with frequent stony inclusions; less stony that noted elsewhere.

Figure 7: Borehole #4 cores.

Presence of mortar flecks and fragments suggestive of waste from building work; the slate meal is intriguing and may be derived from roof slates or perhaps grave lining. Extreme compression in this core implies very loosely consolidated material, which is at odds with the differential GPR readings. Perhaps a loose material within a robber trench, but if so lacking the expected stony elements (as per 3.4).

It is of interest the revised GPR survey confirmed the presence of a large area of disturbance in front of and beneath the rood screen. The material in the core taken from this area (number #4) suggests it is filled with very loosely consolidated material, and it is possible there was some form of monument or perhaps a collapsed/backfilled/destroyed burial vault at this location. This is a highly prominent location for burial within any church, so we may conclude the individual(s) involved were of some importance. The area of disturbance extends beneath the rood screen, and this would imply it predated the screen or the screen itself has been moved and re-erected.

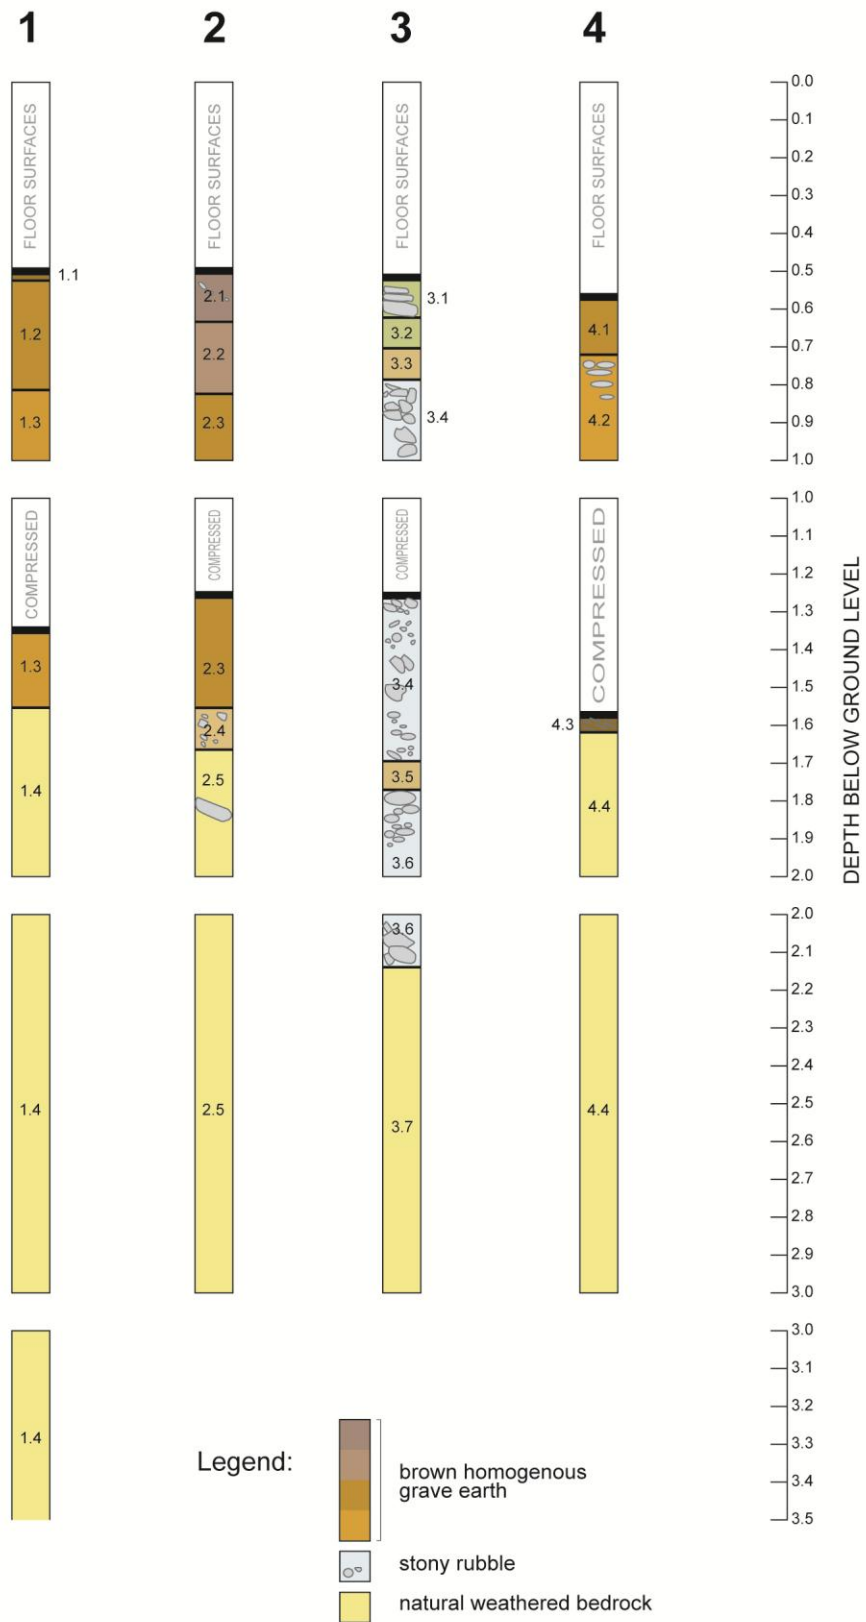
Figure 8: Summary of the core data.
