Devon County Council Historic Environment Record

Civil Parish & District: Lympstone, East Devon	National Grid Reference SS 9922 8425		Number:		
Subject: Lympstone Primary School, School Hill – Provision of new single- storey building to provide additional classroom space, demolition of Church Hall and renewal of two temporary classrooms Photo attached? YES					
Planning Application no: DCC/3478/2013		Recipient museum: RAMM			
OASIS ID: southwes1-148872		Museum Accession no: N/A – finds discarded			
Contractor's reference number/code: LPS13		Dates fieldwork undertaken: 19 th and 26 th August 2013

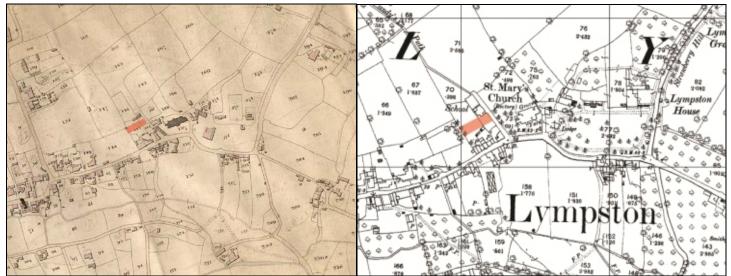
On the 1840 tithe map a school is shown to have existed in the present location, and at this date, it is surrounded by (Glebe?) lands owned by the vicar (Reverend John Bartholomew). By the time of the First Edition OS map of 1889 the school building had been extended and a long narrow enclosure to the south, stretching along School Hill lane had seemingly become incorporated as school grounds (Figure 2). In the 20th century the Church Hall and a temporary classroom had been constructed on the development area, both of which were demolished prior to monitoring taking place.

Figure 2: The Lympston Tithe Map of 1840 and 1st Edition OS Map of 1889, showing the school building with an open area to the south, now the development site.

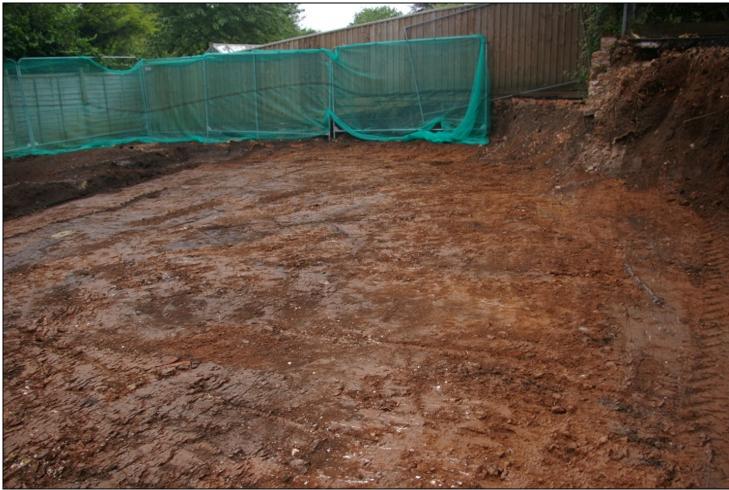
The initial topsoil strip was undertaken by a 5 tonne tracked swing shovel fitted with a toothless grading bucket under the direction of the supervising archaeologist, the tarmac and rubble having previously been removed by toothed bucket. The site was stripped from the west corner to the eastern access, to minimise tracking over the active area. The majority of the eastern part of the site had been heavily disturbed previously and in part during the recent demolition work. The topsoil consisted of an upper (c.0.25m thick) layer of dark reddish-brown silt-clay with occasional sub-angular to sub-rounded stones (>80mm dia.) and a lower (c.0.25m thick) deposit of grey-brown silt-clay with rare sub-angular to sub-rounded stones (>80mm dia.). The topsoil directly overlay the natural subsoil, which was comprised of a clean dense reddish-brown clay (Figure 3).

Figure 3: The stripped development area, viewed from the northeast.

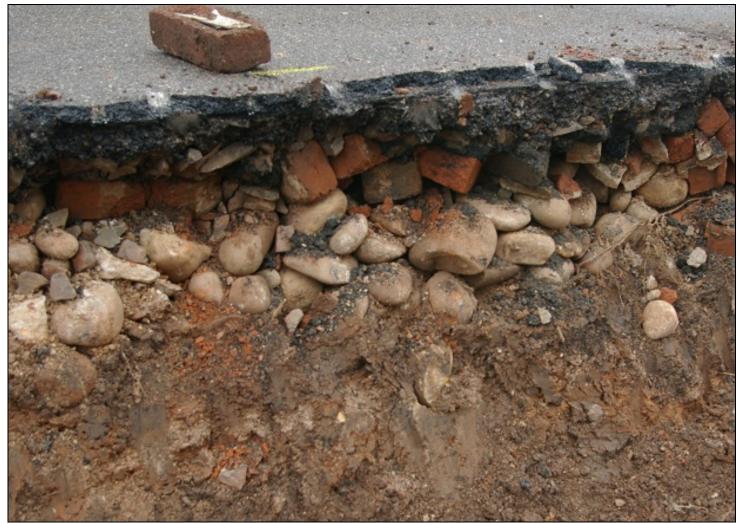
The site was re-visited a week later, when a deep trench was dug along the north side of the site, for a retaining wall to be constructed, this was supervised and photographs were taken, nothing was observed of any archaeological interest, the natural clay continuing undisturbed. The site had been terraced in by almost 2m and to the eastern end, just under the tarmac which initially covered the area was a layer of pebbles, laid over sand and some herringbone brick, which represented the remains of former paths and possibly a school yard, associated with the 19th century buildings to the north. This had been damaged during previous construction work, possibly in the mid to late 20th century, it was too fragmented, to be fully recorded and only survived in part (see Figure 4).

Figure 4: The area of pebbles with possible herringbone brickwork above in the northern retaining wall trench, viewed from the southwest.
