# MEADOW PARK LODGE CASTLE HILL FILLEIGH DEVON

Results of a  
Historic Building Assessment

Report No.: 130628  
Date: 28.06.2013  
Authors: D.Laing-  
Tregrove

*South West Archaeology Ltd. was instructed by Martin Sturley of Jonathan Rhind Architects to undertake an historic building survey of Meadow Park Lodge, Filleigh, Devon, prior to demolition works.*

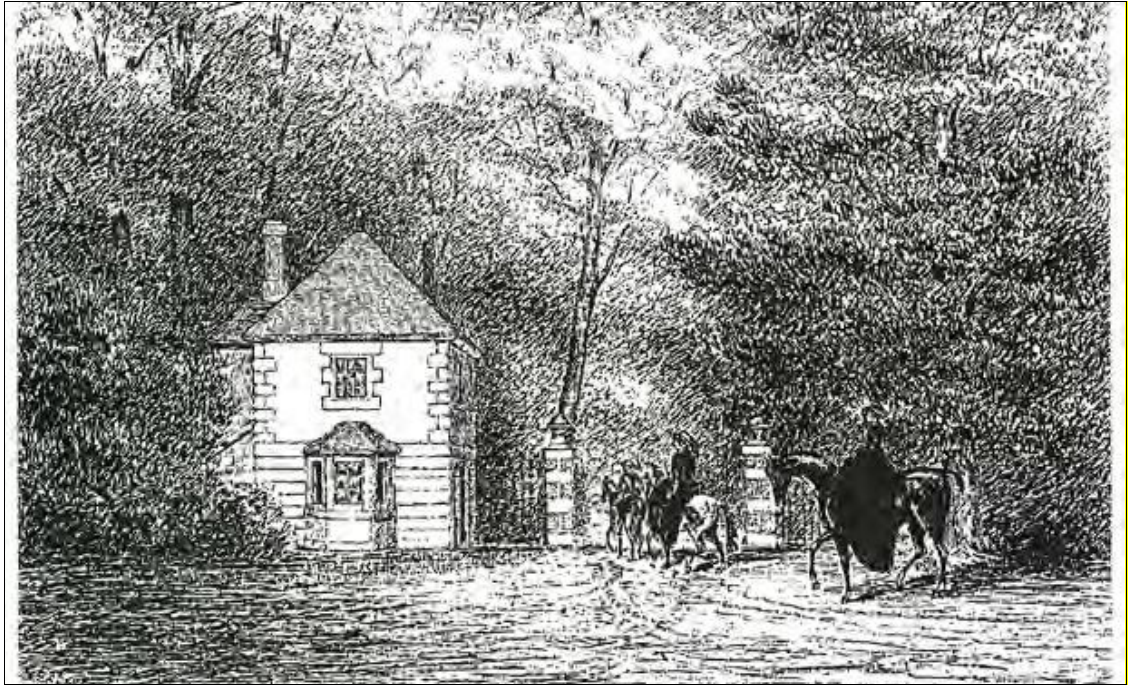
Figure 2: Meadow park Lodge circa 1850 (After Colvin & Moggridge 2000).

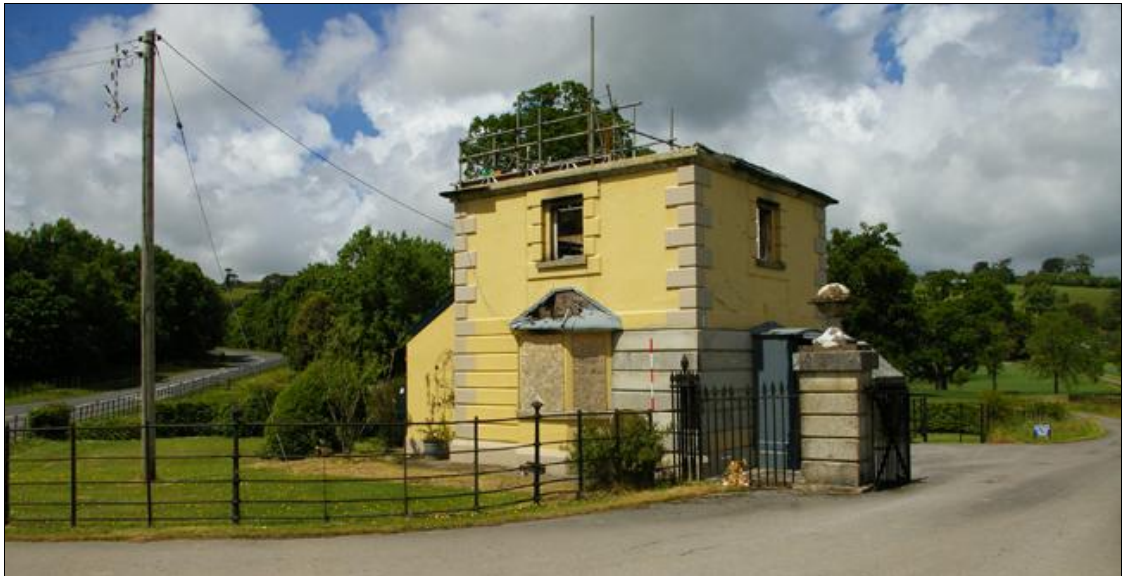
Figure 3: The exterior south and east elevations of the Lodge, viewed from the south-east (2m scale).

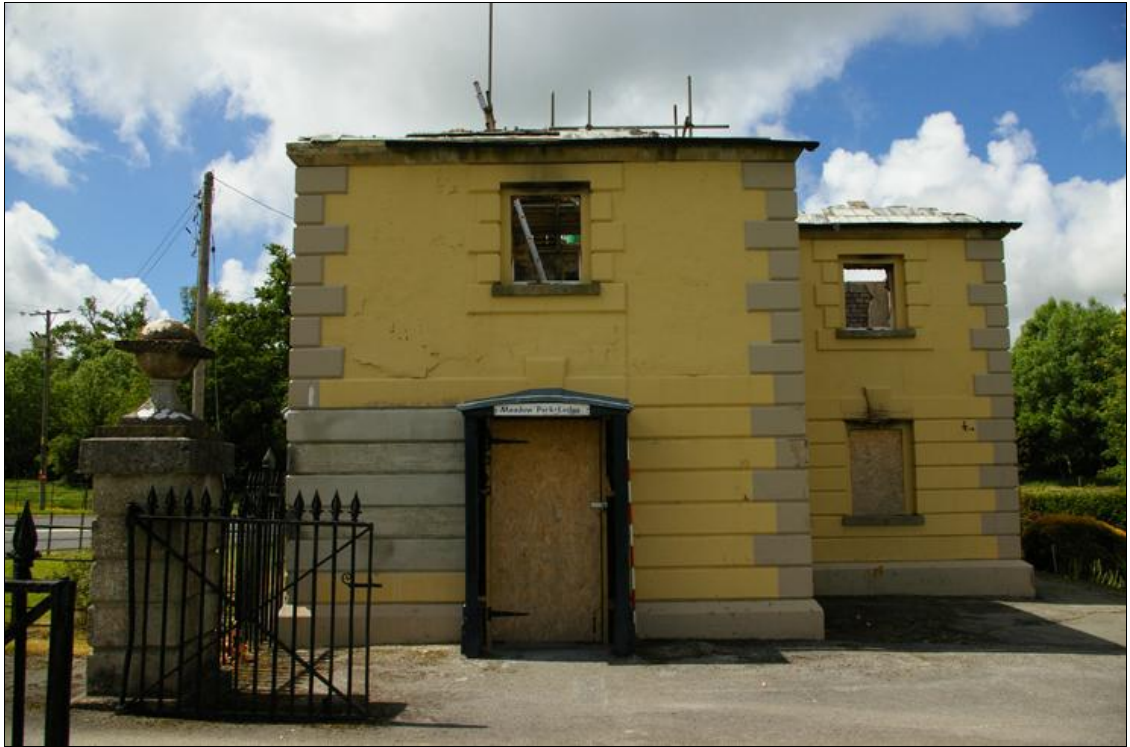
The east elevation (exterior Room 1) has a central door opening with a stucco keystone above, a later projecting timber plank porch at ground floor level, with a central window opening above (Figure 5). To the north, the north elevation of Room 1 (R1) has a slim ground floor window opening just to east of centre, with plain metal vent set within the plinth below, and stucco horizontal banding to the ground floor; stucco quoins to the north-east corner, but no keystone above the single light window opening. The exterior east elevation of R2 is as before with a central window to the ground floor, with a stucco keystone above, and to first floor with stucco quoins, both with cement sills. The north elevation of R2 is as the east wall.

Figure 5: The exterior east elevations of the Lodge, viewed from the east (2m scale).

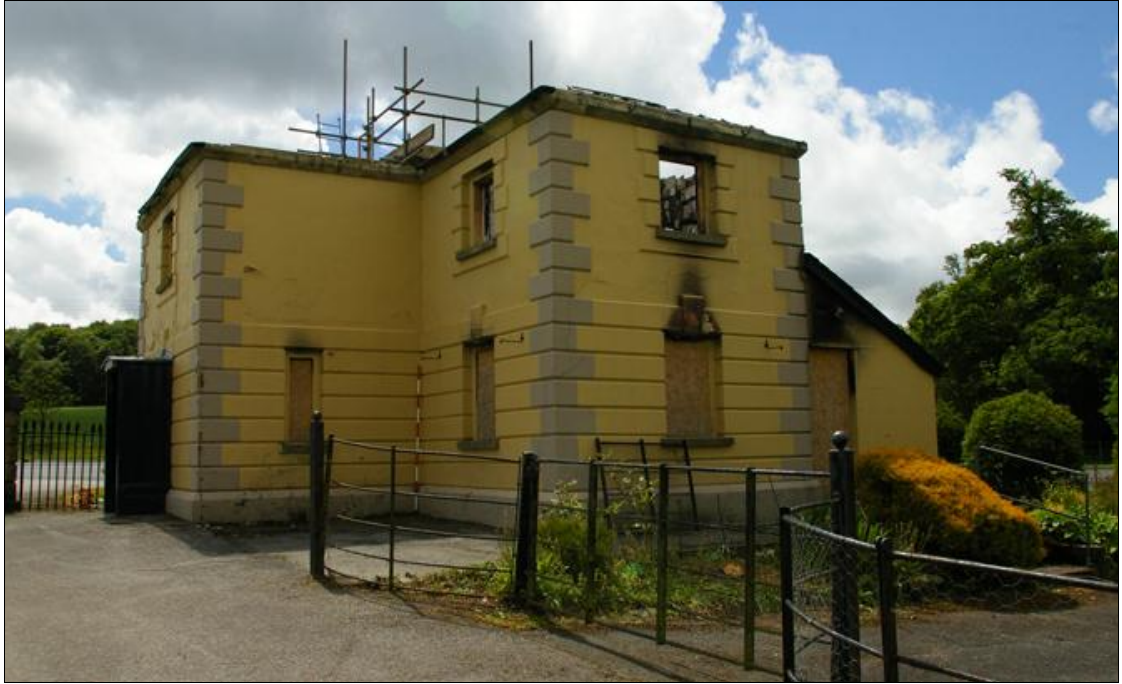
Figure 6: The exterior north and east elevations of the Lodge, viewed from the north (2m scale).

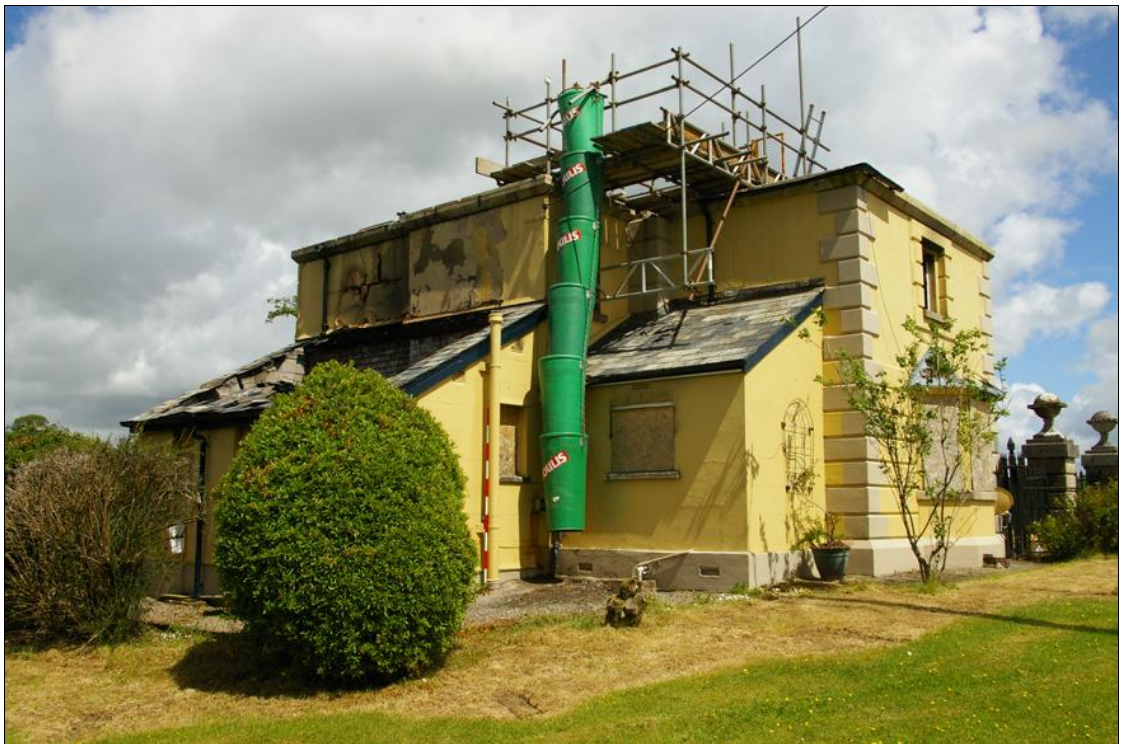
Figure 7: The south and west exterior elevations of the Lodge, viewed from the south-west (2m scale).

The west wall of R1 is as to the east and west, with stucco banding and stucco quoins to corners and to the chimney stack to the north. The stucco banding continues round behind the single storey bathroom lean-to suggesting that this element is a later extension. The walls of the bathroom have no banding and a slimmer, plain plinth to the base, set lower than to the south, with a projecting central brick drain surround and two decorated vents to either side on the west wall. There is a central window opening in the west elevation with a cement sill, and

some scarring to the lower levels of the wall, possibly repair work. The single pitch roof slopes down to the west and is slated as the kitchen extension.

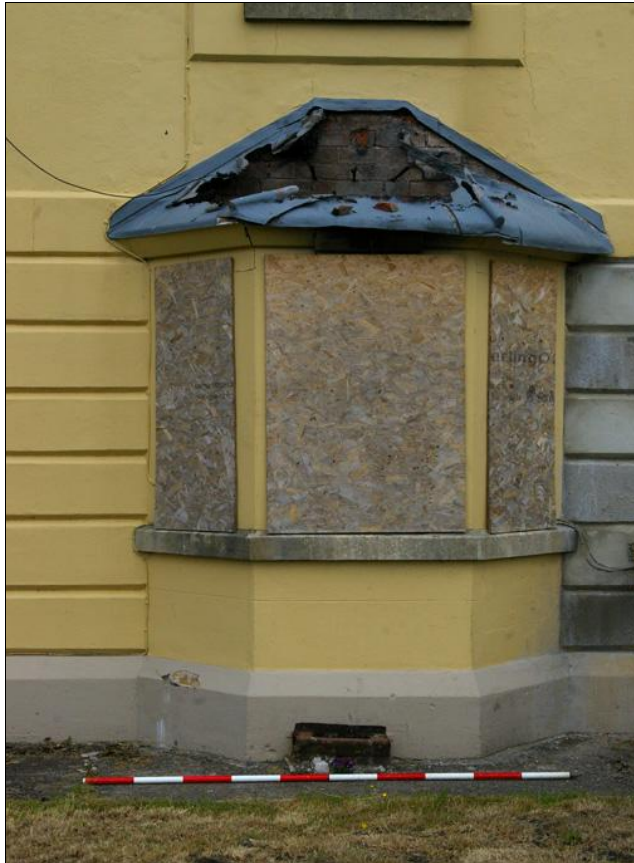
To the south, the elevation of R1 has the same stucco render detailing as before and a central bay window at ground floor level and first floor window as to the north and east elevations. The bay window has sandstone frames and sills to the three lights, with a lead canopy above and central brick drain surround below projecting from the plinth (Figure 8). The first floor window above has a sandstone frame and sill.

Figure 8: The bay window on the exterior south elevation of the Lodge, viewed from the south (2m scale).

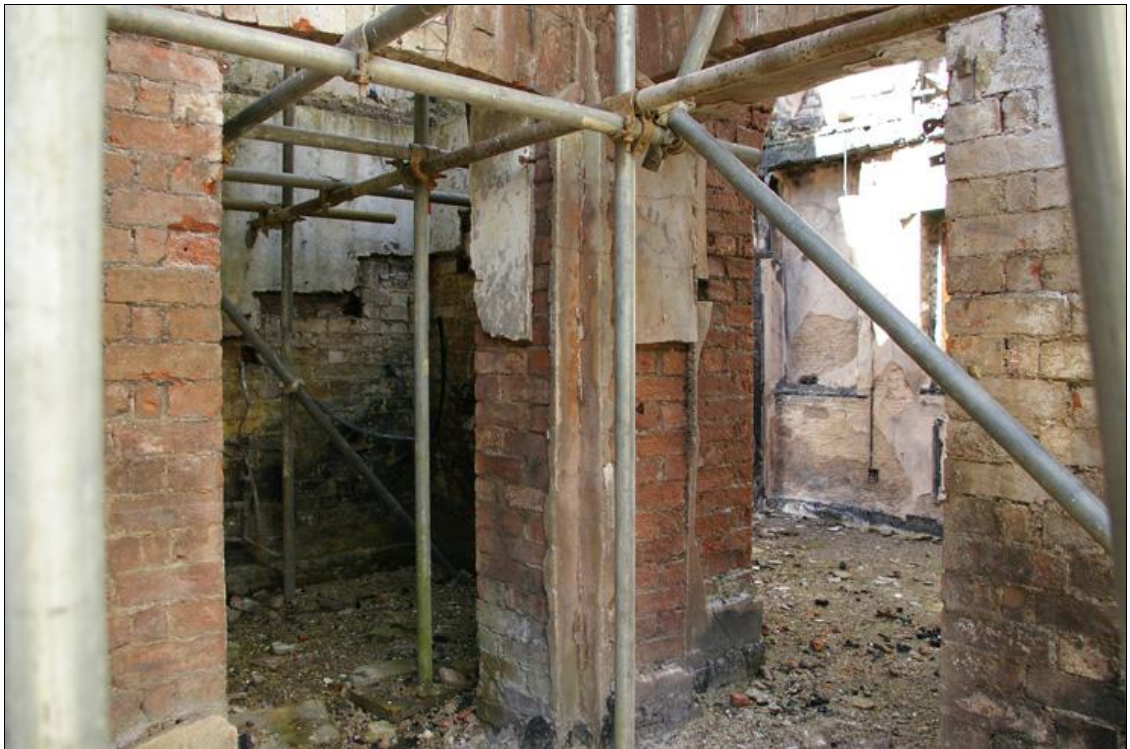
There are ground floor door openings to east, south-west and north-west, with the main front door (D1) to the east, with a straight brick arch lintel and with a central window opening above. D2, into Room 2 (former Kitchen), is located at the western end of the north wall, D3 and D4 are within the west wall and access the stair well to the north-west and the bathroom to the south-west (see Figure 9).

Figure 9: The door opening (D4) into the stair lobby (R4) and the opening (D2) into kitchen (R4) in the north-east.

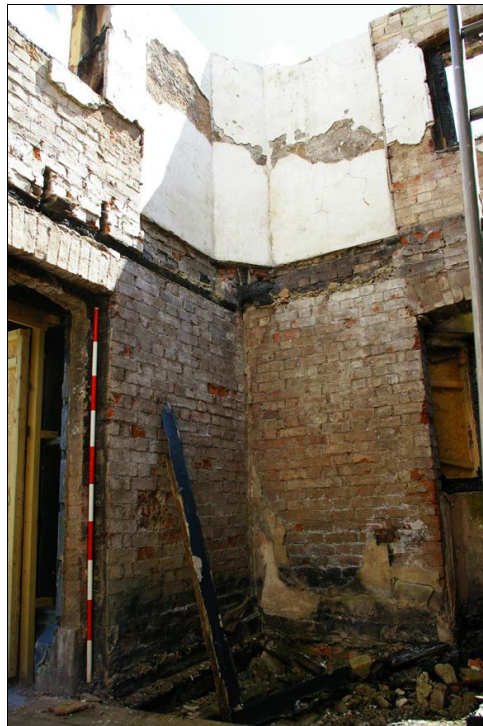
those below but the slimmer sections of wall are set back to either side of the openings at first floor level (as to R2, see below). The corners of the first floor bedroom are in-filled and plastered (Figure 10), possibly adding strength to the structure.

Figure 10: The north-east corner of R1, with the projecting wall sections and in-filled corners at first floor level, viewed from the south-west (2m scale).

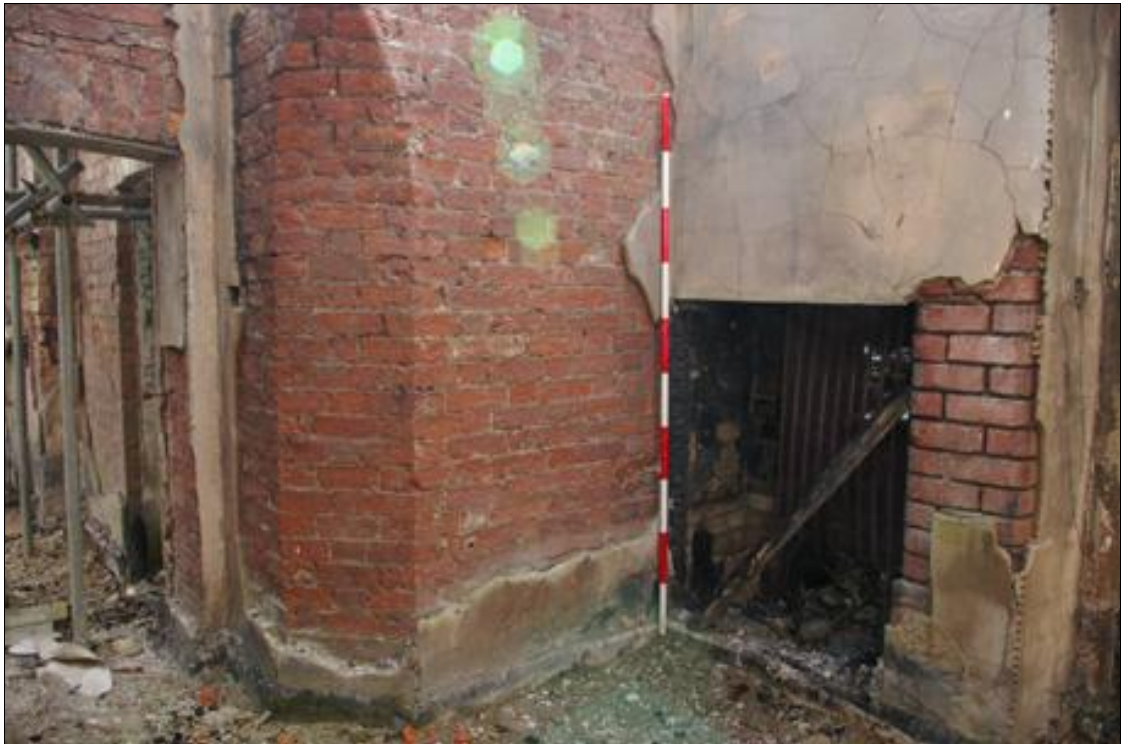
The floor is solid with modern tiles over cement and with modern skirtings that are chamfered to the top as R1. There is a fireplace in the south-west corner built against the south wall, of red, machine-made bricks, bull nosed to the upper section of the cheek to the north plastered and with metal strap lintels to the arch of the opening (Figure 11). The opening appears to go through to the modern extension to the west and may latterly have contained a modern boiler. Above the opening the projecting wall face is plastered and at first floor level to the west there is disturbance in the wall, suggesting either the removal or insertion of a chimney stack or modern flue liner inserted into the wall above. Although this probable fireplace appears to be later than the building, R1 does not appear to have a fireplace that could be adapted for a cooking range and it must therefore be surmised that this room acted as the kitchen prior to the addition of R5 to the west.

Figure 11: The south-west corner of the kitchen (R2), with brick built fireplace (for a range), viewed from the north-east (2m scale).

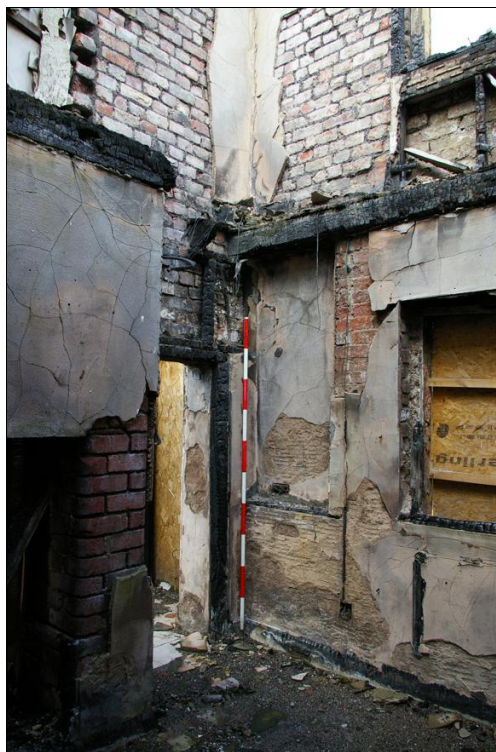
Figure 12: The north-west corner of the kitchen (R2), with door opening into the modern kitchen extension, viewed from the south-east.

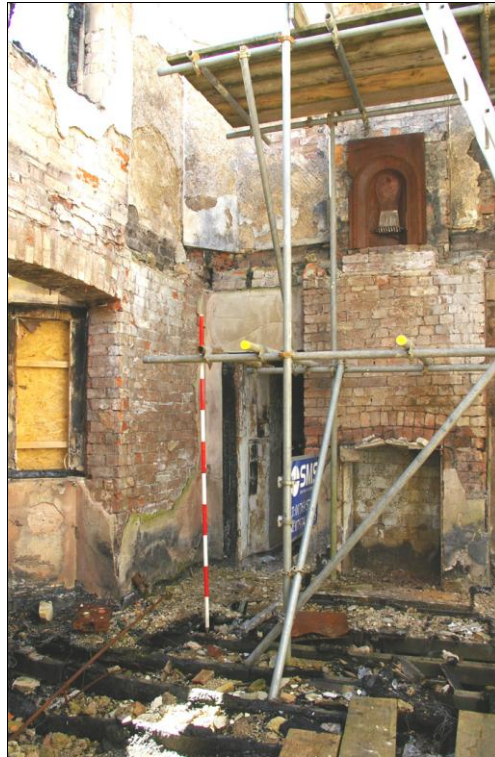
There is a chimney stack roughly central in the west wall with fireplaces at ground and first floor levels. The ground floor has a brick opening with some modern plaster within and around the opening and with modern tiles to the hearth, the first floor fireplace contains a small 19<sup>th</sup> century bedroom grate, probably original to the build.

Figure 13: The interior south-west corner of R1, with door (D3) into the bathroom (R3) and the fireplaces in the west wall at ground and first floor levels, viewed from the north-east.

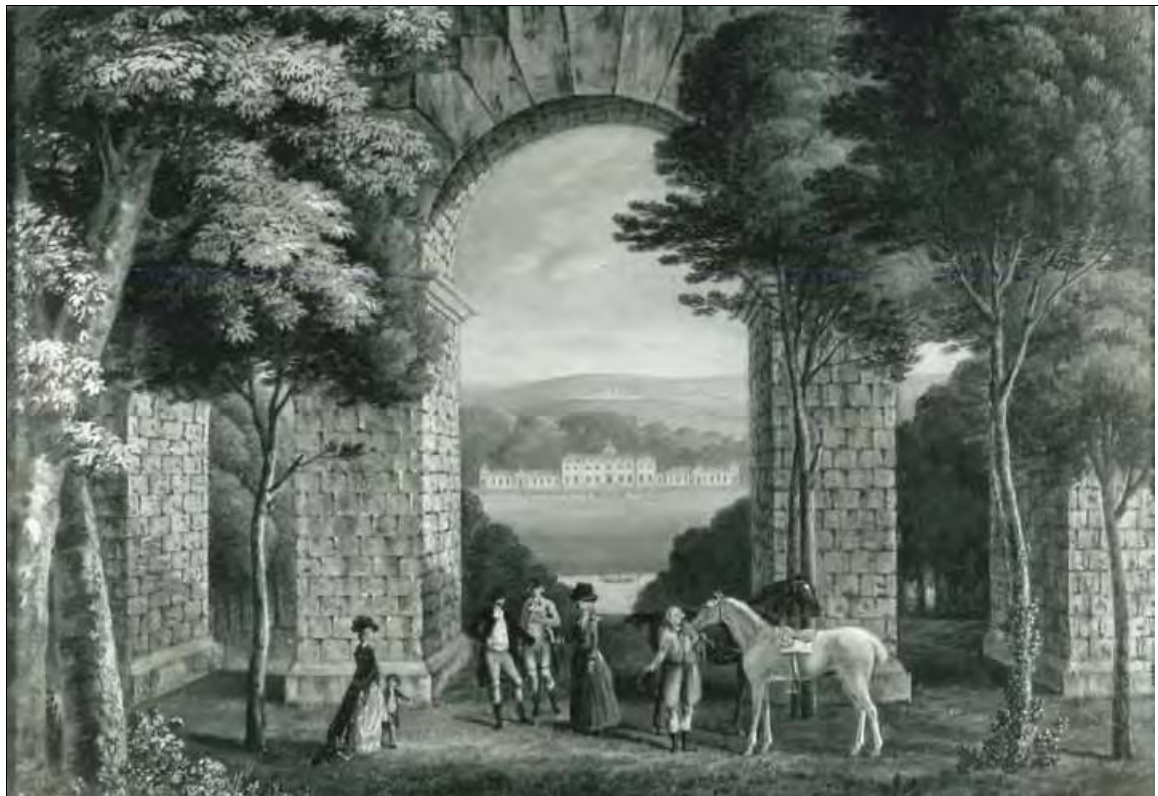
Fig. 1B

The park design occurred during the transitional years between the English formal garden of the late 17th century and Lancelot Brown's naturalistic landscapes of the later 18th century. Following the works of Charles Bridgeman at Stowe, Lord Clinton aligned a 1.4km axis through the centre line of the new mansion, which he closed with a sham Gothic castle on the hill above, and a triumphal arch on the hill opposite (Figure 1A). The vale between was ornamented with a symmetrical paddock enclosed by embanked formal avenues, with a cruciform pool at its centre, aligned on the mansion axis (Figure 1B).

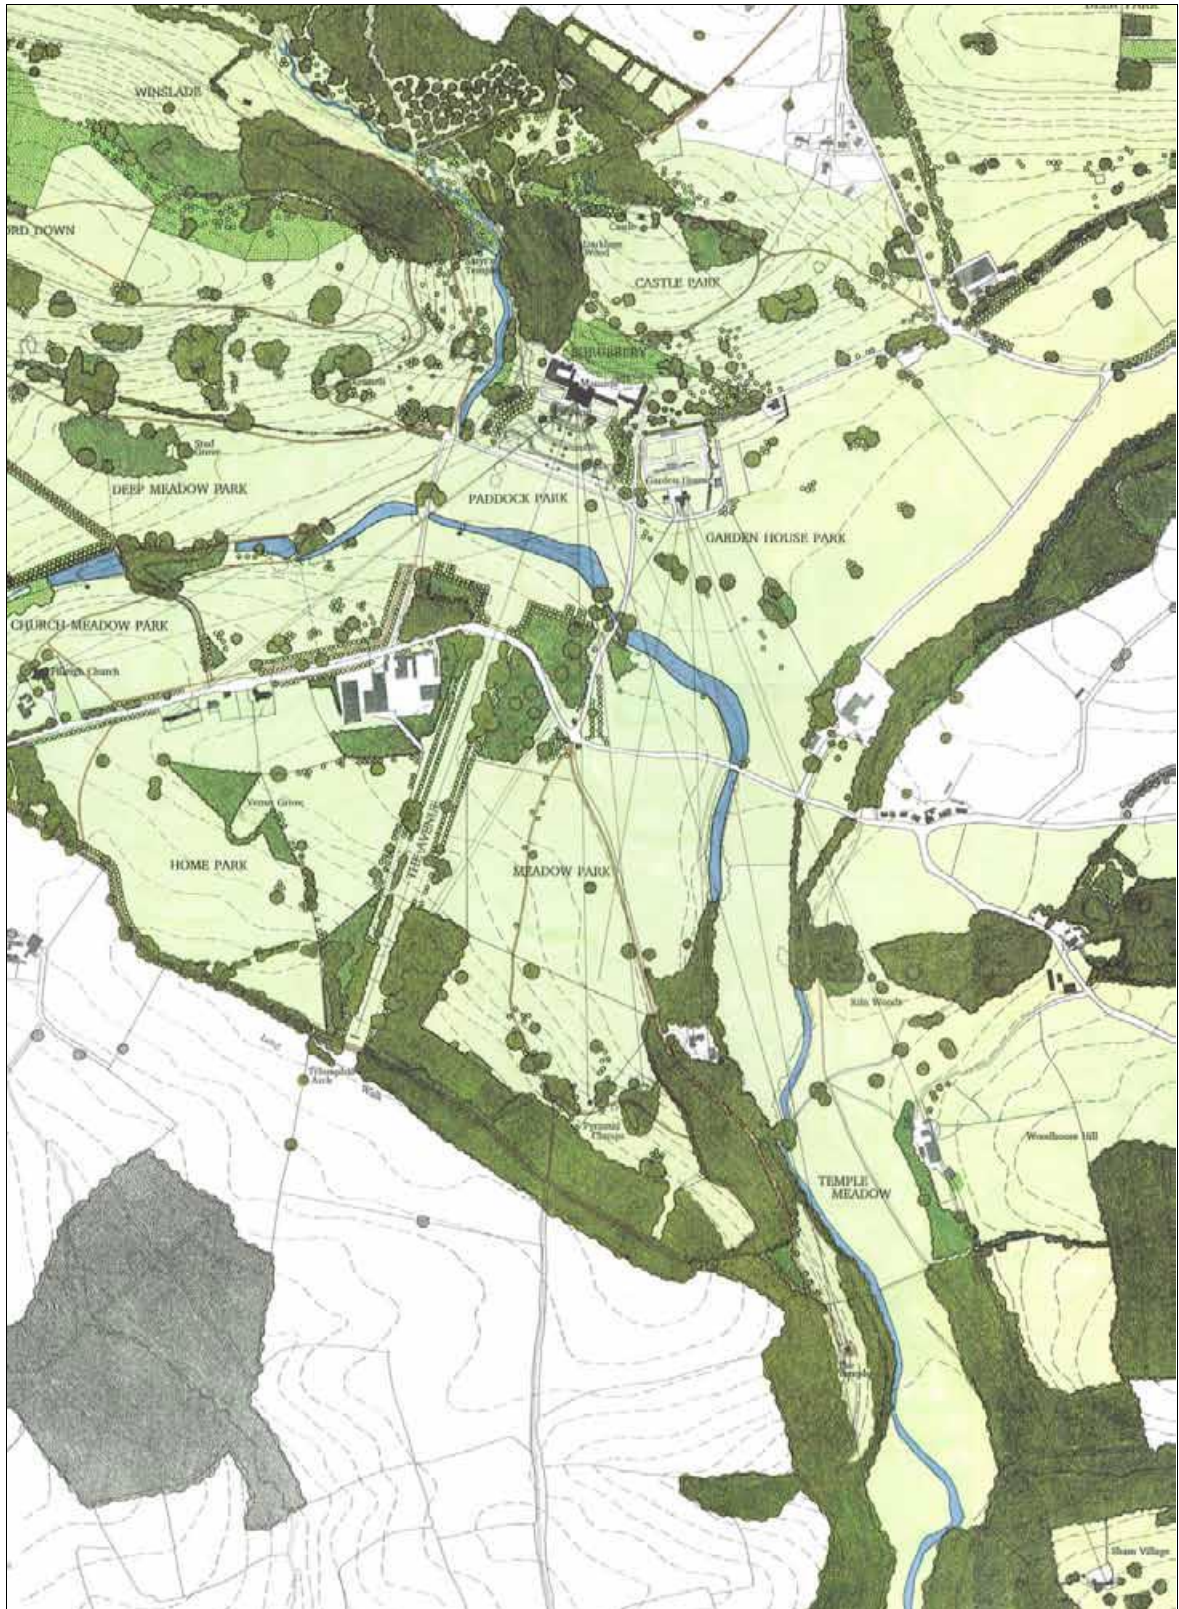
Fig. 10

The 1991 Restoration Management Plan for Castle Hill Park sought to redress this structural loss by reinstating East Paddock Wood and elements of planting east of the lodge entrance (Figure 10). Plantings established during the 1990s are starting to restore the historic landscape setting of the building.
