# LAND at NEWHALL MANOR FARM ST TEATH CORNWALL

Results of a Desk-Based Assessment,  
Geophysical Survey,  
Walkover Survey & Visual Impact Assessment

Report No.: 130714  
Date: 14.07.13  
Authors: B Morris  
E Wapshott

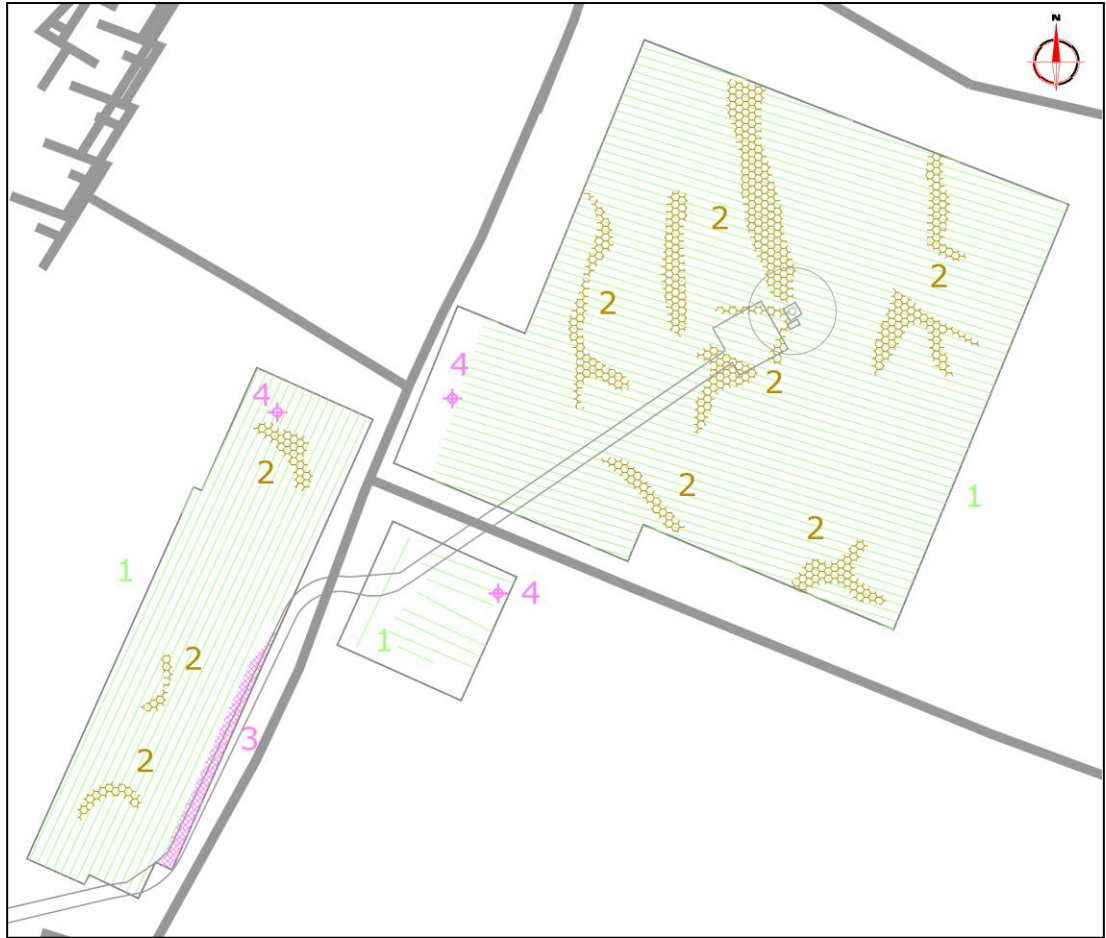
The data retrieved during the survey is very noisy, particularly along the line of the access corridor. This probably represents close-centred agriculture (i.e. potato ridging, deep-ploughing), and makes interpretation of the underlying data difficult. On the basis that the other anomalies present are amorphous and poorly-defined, these have been interpreted as being probably geological in origin. The walkover survey (see below) noted pronounced undulations in the surface of the field, particularly to the south. However, given the cellular character of these anomalies, and the proximity of a long curving cropmark in the adjacent field (MCO38343), it is equally possible they represent archaeological features. A worst-case interpretation of these results would indicate that there is a round (i.e. a Prehistoric or Romano-British enclosure), but the evidence is suggestive rather than conclusive. It should be noted that this field contained a silage clamp for a number of years (Allingham *pers. comm.*), and thus some of the apparent anomalies may relate to relatively recent agricultural use.

Figure 6: Interpretation of the geophysical data (Stratascan 2013, Figure 5).

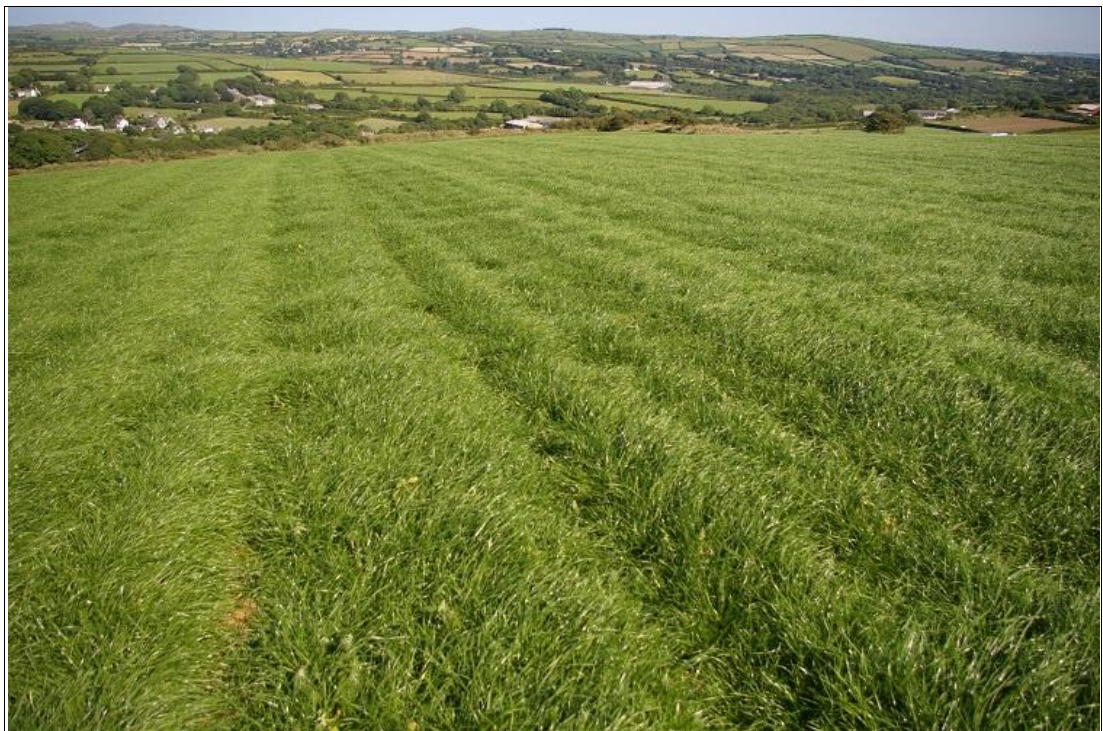
Figure 7: View across the field in which the turbine is to be situated; viewed from the north-west, looking south-east.

The field in which the proposed turbine is to be located is of regular sub-rectangular shape, laid to pasture, with tall established hedgebanks to the north and west. The hedgebanks to the south and east are in poor condition, with a few scattered mature wind-blown trees along their length. Some significant undulations were noted within the field, possibly natural as they appeared to follow the contours of the slope, and these were more marked at the southern end of the field. There appeared to be some ground disturbance and possibly earthworks in the northern-eastern corner of the field, which may extend into the adjacent field.

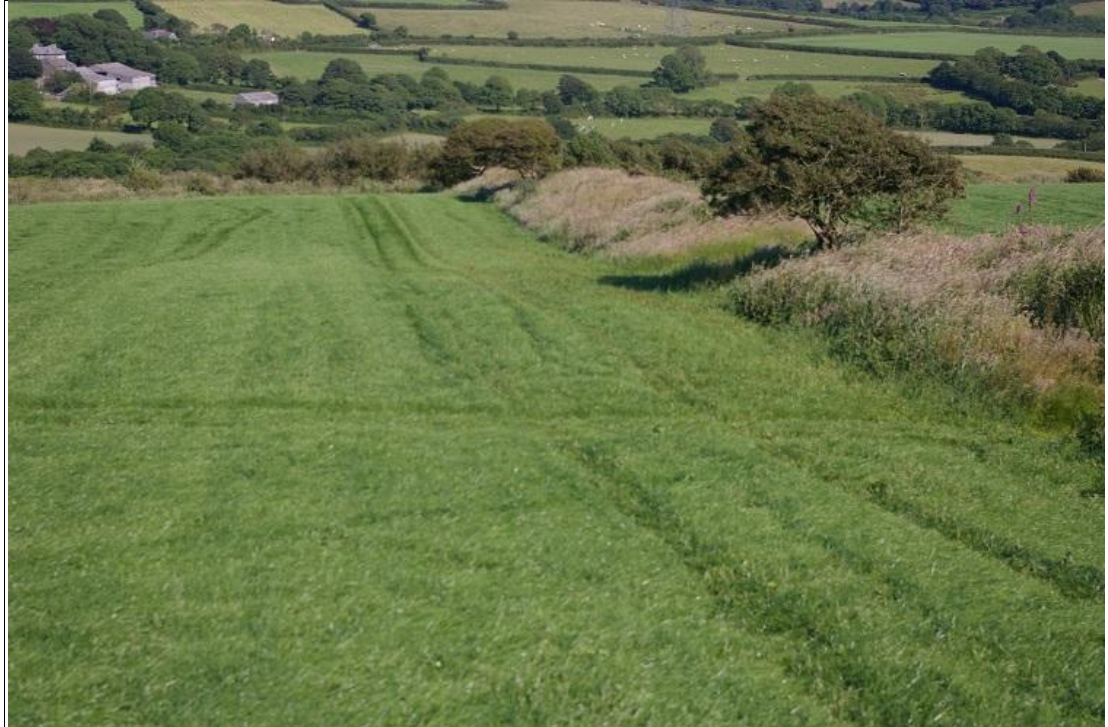
Figure 8: View from the south-western corner of the field, along the southern boundary, showing the pronounced undulations noted during the walkover survey; viewed from the west, looking east.

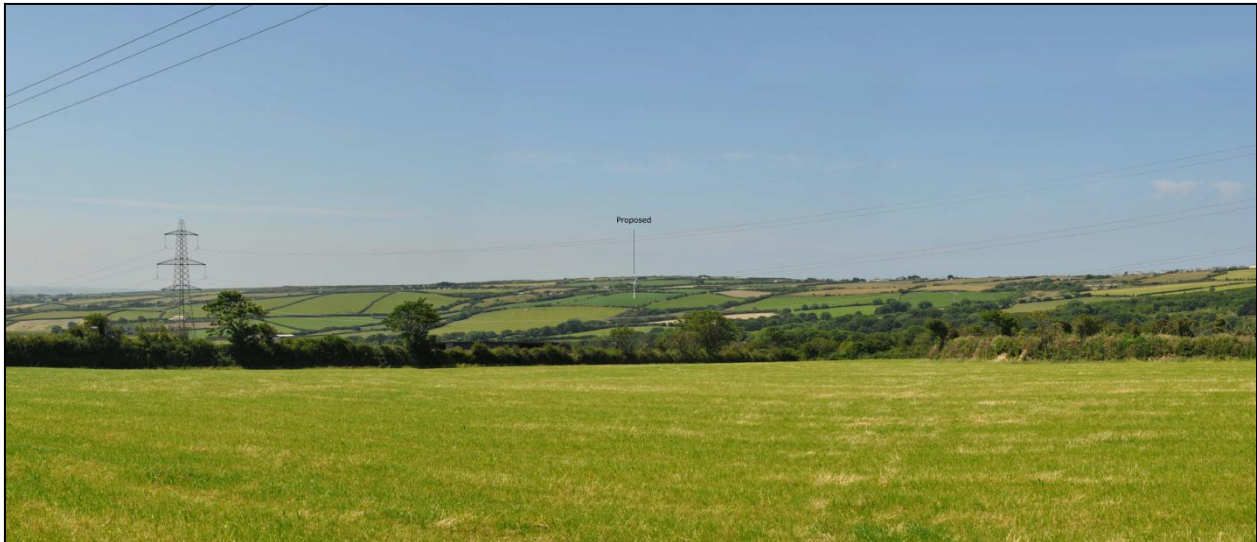
Figure 11: View from adjacent to the ‘round at Delinuth’ and Castle Goff; viewed from the east-north-east. Note this is a *verified photomontage*; supplied courtesy of Mi-Grid and produced by Amalgam Landscape and Plumedia (Figure 13c-Photomontage-Viewpoint 6).

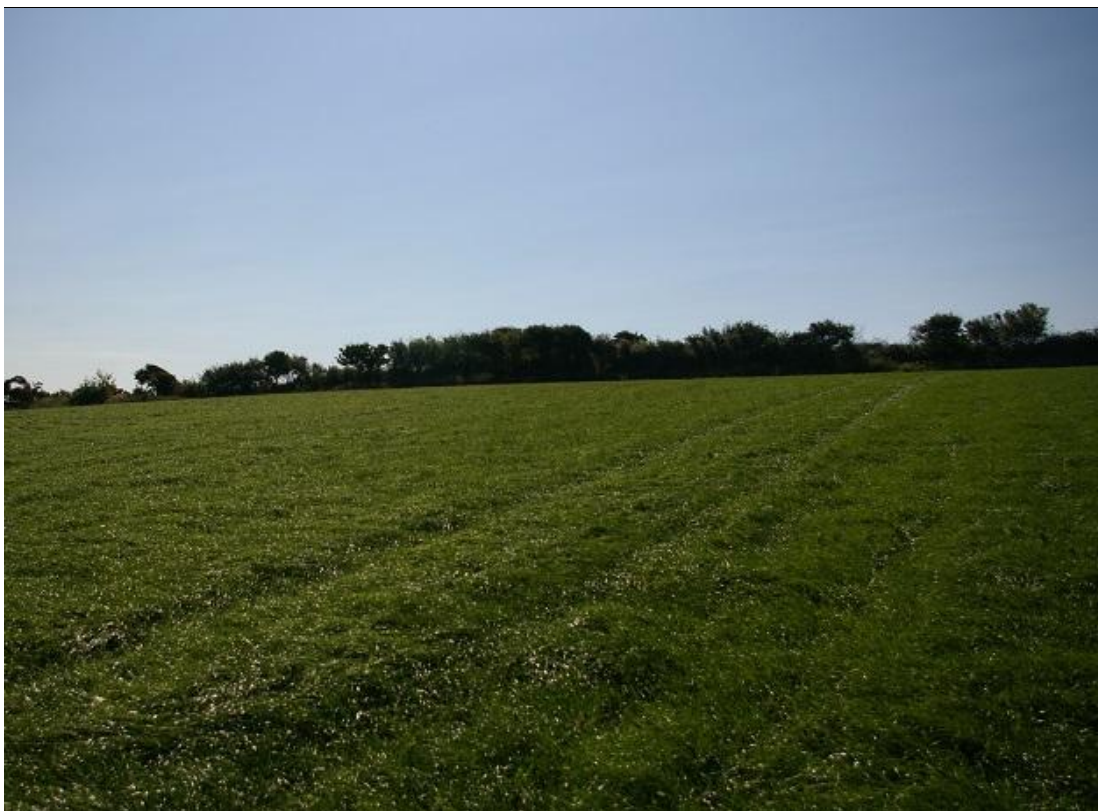
The field in which the turbine is to be situated has a marked eastern slope, the hill peaking just beyond the western hedge-bank field boundary; from the east.

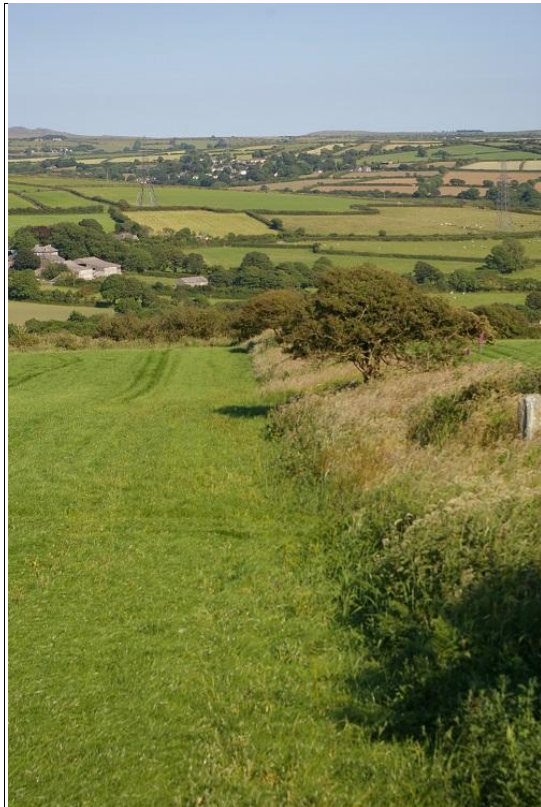
View of the decayed and overgrown southern hedgebank; from the west.

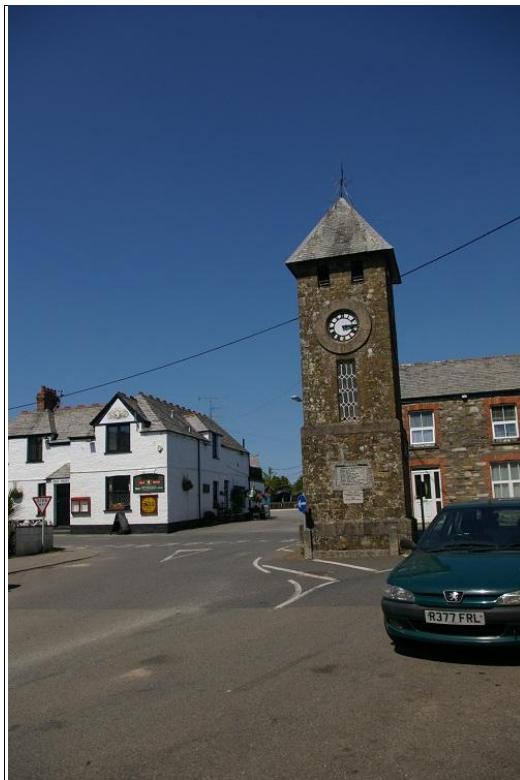
- Clocktower at St Teath; medium significance; Grade II; condition: excellent. This structure is surrounded by buildings in the village square, and this setting would not be affected by the proposed turbine; impact **neutral**.

View of clock-tower in St Teath village square; from the south.

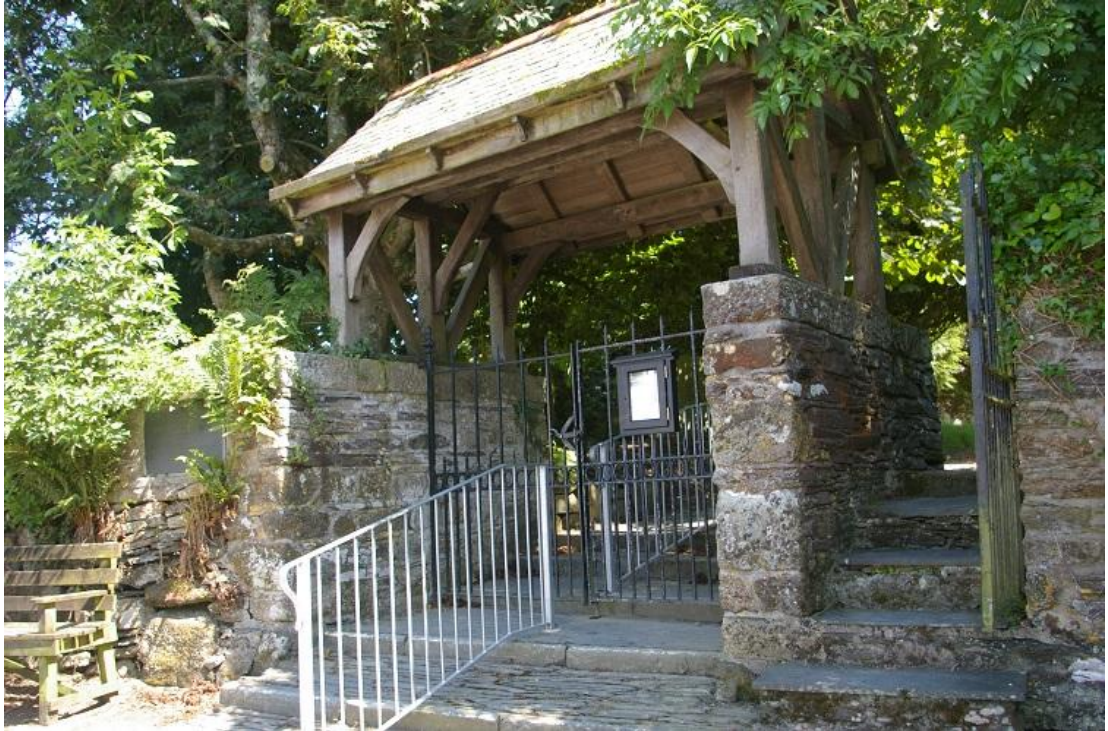
- Churchyard walls, St Teath; medium significance; Grade II; condition: fair. This structure is defined by its relationship with the churchyard and is experienced within the heart of the historic part of the settlement; there would be no views to the proposed turbine; impact **neutral**.

View of lych gate and Listed churchyard walls in St Teath, facing onto the village square, framed by trees; from the south-west.

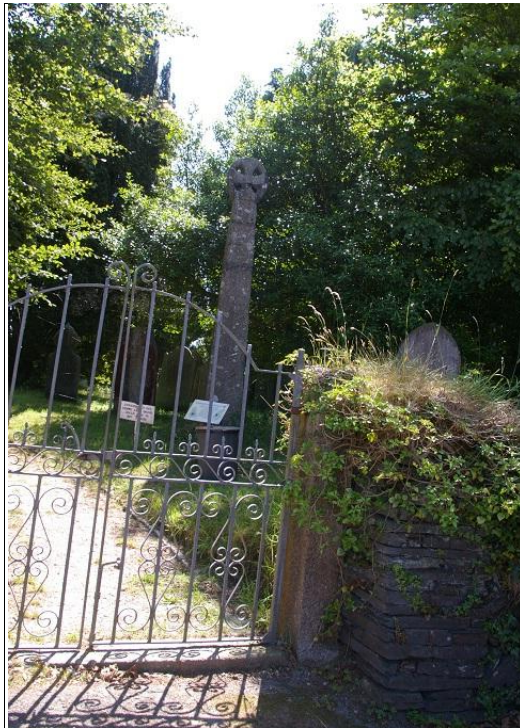
- Churchyard cross in St Teatha cemetery; high significance; Scheduled Monument; condition: good. Comprehensive local blocking is provided by the buildings of the village which lies to the north and east; impact **neutral**.

View of Scheduled Monument, churchyard cross in the cemetery at St Teath, showing it bounded by the cemetery walls, enclosed by trees and other monuments; from the north-east.

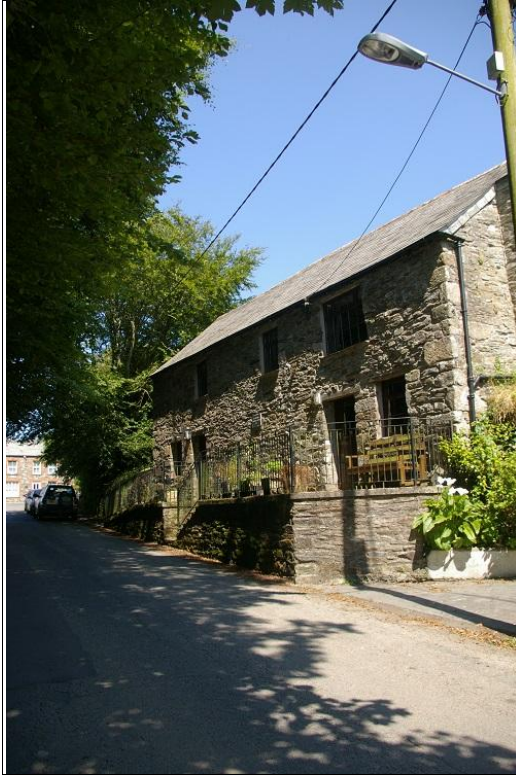
- Community centre, former churchhouse in St Teath; high significance; Grade II\*; condition: excellent. This building is located at the centre of the village, adjacent to the churchyard and built into the churchyard wall, on the edge of the village square and opposite the clocktower. These buildings provide the setting, which is defined by the relationship between the church and its former and current function as a community building. These buildings also provide local blocking; impact **neutral**.

View of the Grade II \* Listed church house in St Teath, now a community centre, showing local blocking from trees and buildings; from the south-west.

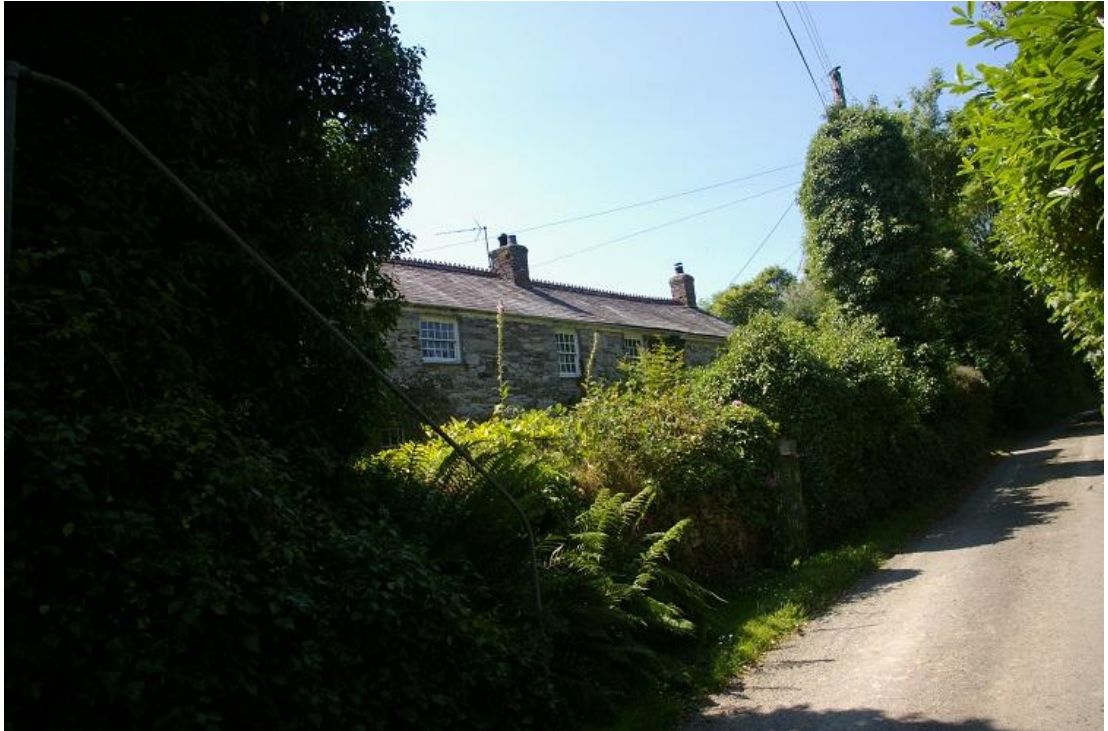
- Tregreenwell Farmhouse, outbuilding, garden walls and barns; medium significance; Grade II; condition: excellent. Located in a shallow valley alongside a road, with some limited views up the hill towards the A39 and beyond to the proposed turbine site. Mature trees and tall hedgebanks reduce these views, and there are significant wooded areas around Knightmill. The house and its buildings provide their own setting and are defined and experienced together through their historic function and relationships; despite their increased group value they would have little to no intervisibility with the turbine; impact **negative/minor**.

Tregreenwell Farm, showing how the farm is framed by trees and its outbuildings and set in a shallow hollow, the area has views to the proposed turbine, but those from the farm are limited; from the south-east.

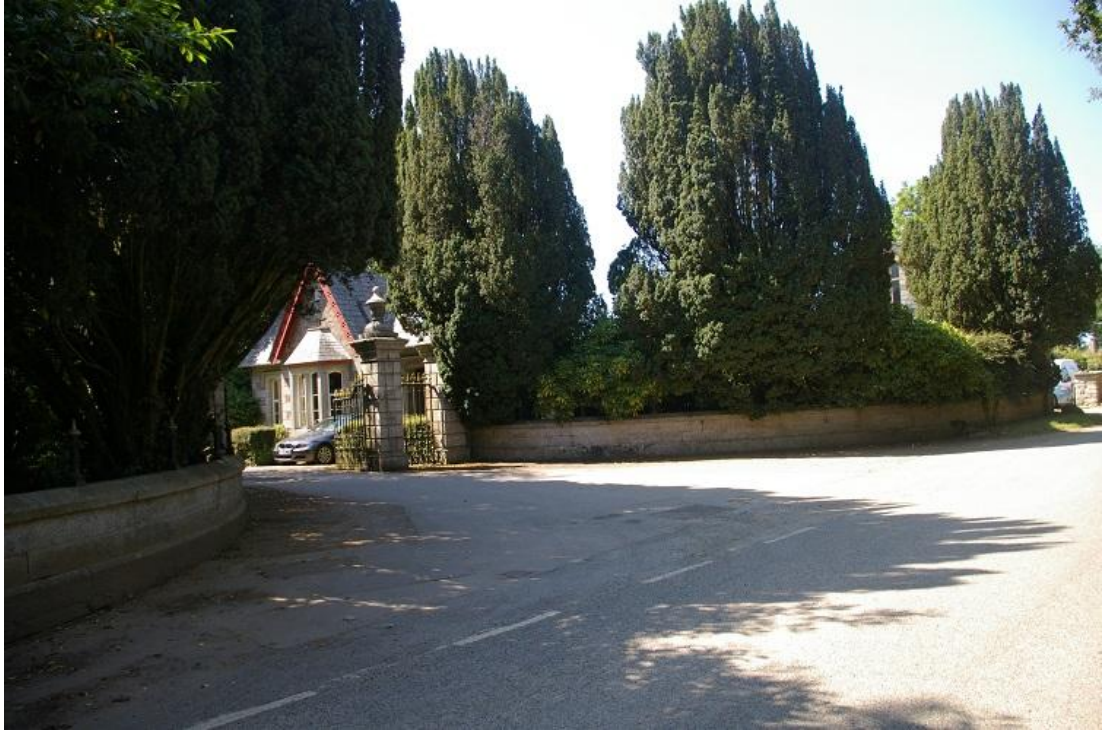
- Lodge to Michaelstow House, gatepiers and walls; medium significance; Grade II; condition: good. Located south-west of Michaelstow village, with rising land to the north. The structures are roadside features with a specific function at the entrance to the grounds of the house; they are wholly shielded by tall roadside hedgebanks. The turbine would not have an impact on these monuments, nor change their setting or function; impact **neutral**.

View of gatepiers, walls and lodge to Michaelstow Manor, showing blocking from specimen trees, planted in the grounds; from the east.

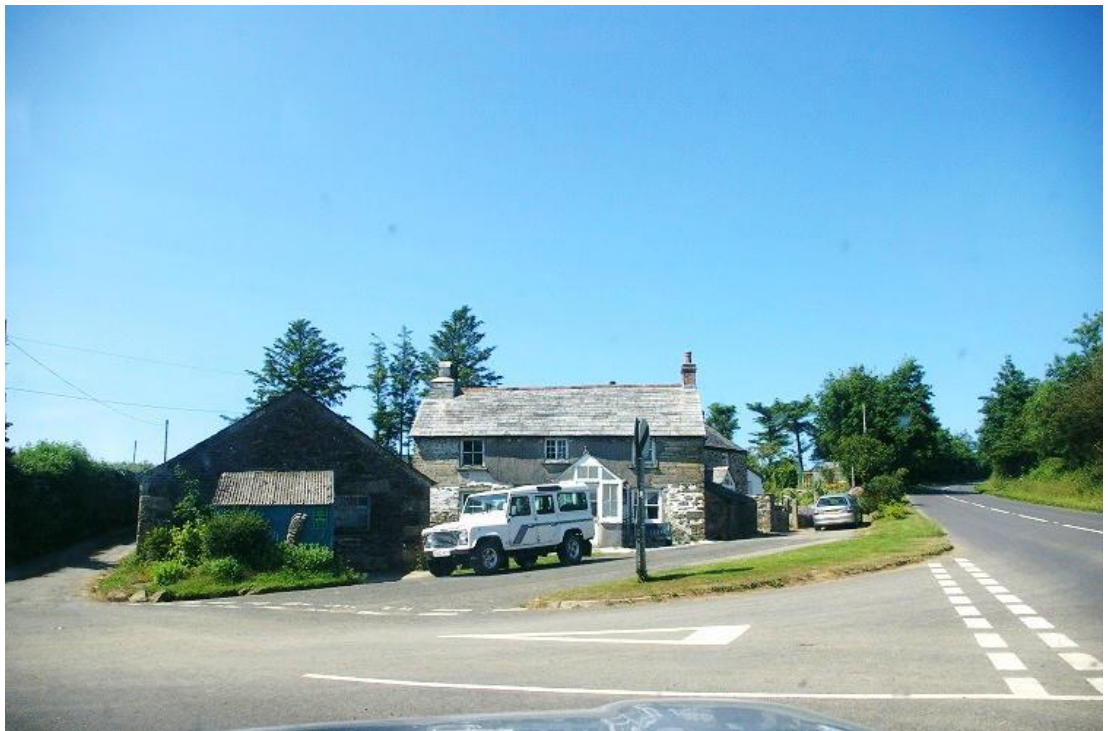
- Cottage and outbuilding north and south-west of Lethern Bottle; medium significance; Grade II; condition: fair. Located at the side of the B3266, there would be views across the fields to the north-west, but the two buildings provide their own setting and the experience of the buildings will not be changed by a turbine at a distance of 4km; impact **negative/minor**.

View over the cottage and outbuilding at Lethern Bottle, adjacent to the B3266; from the south-east.

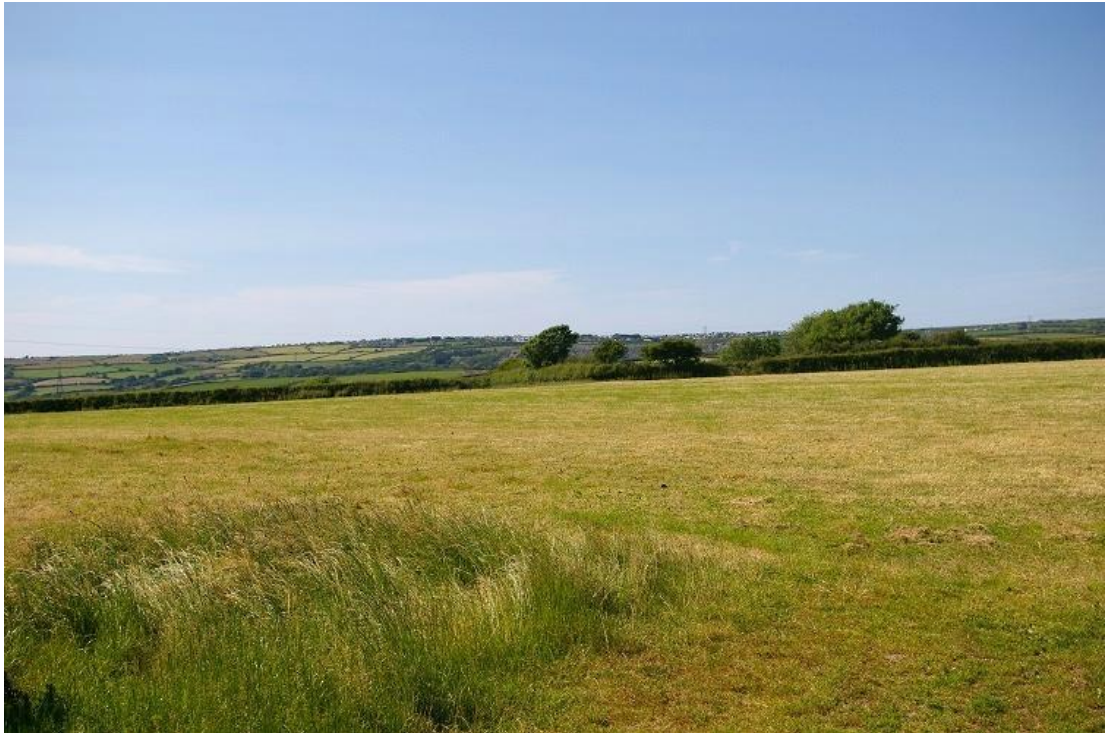
View across the round adjacent to the B3266, visible as the curving hedgebank in the foreground, looking over towards the proposed turbine; from the south-east.
